# Recent excavations at St. John's Priory, in Cowcross Street, EC1

Mark Atkinson  
Gordon Malcolm

## Introduction

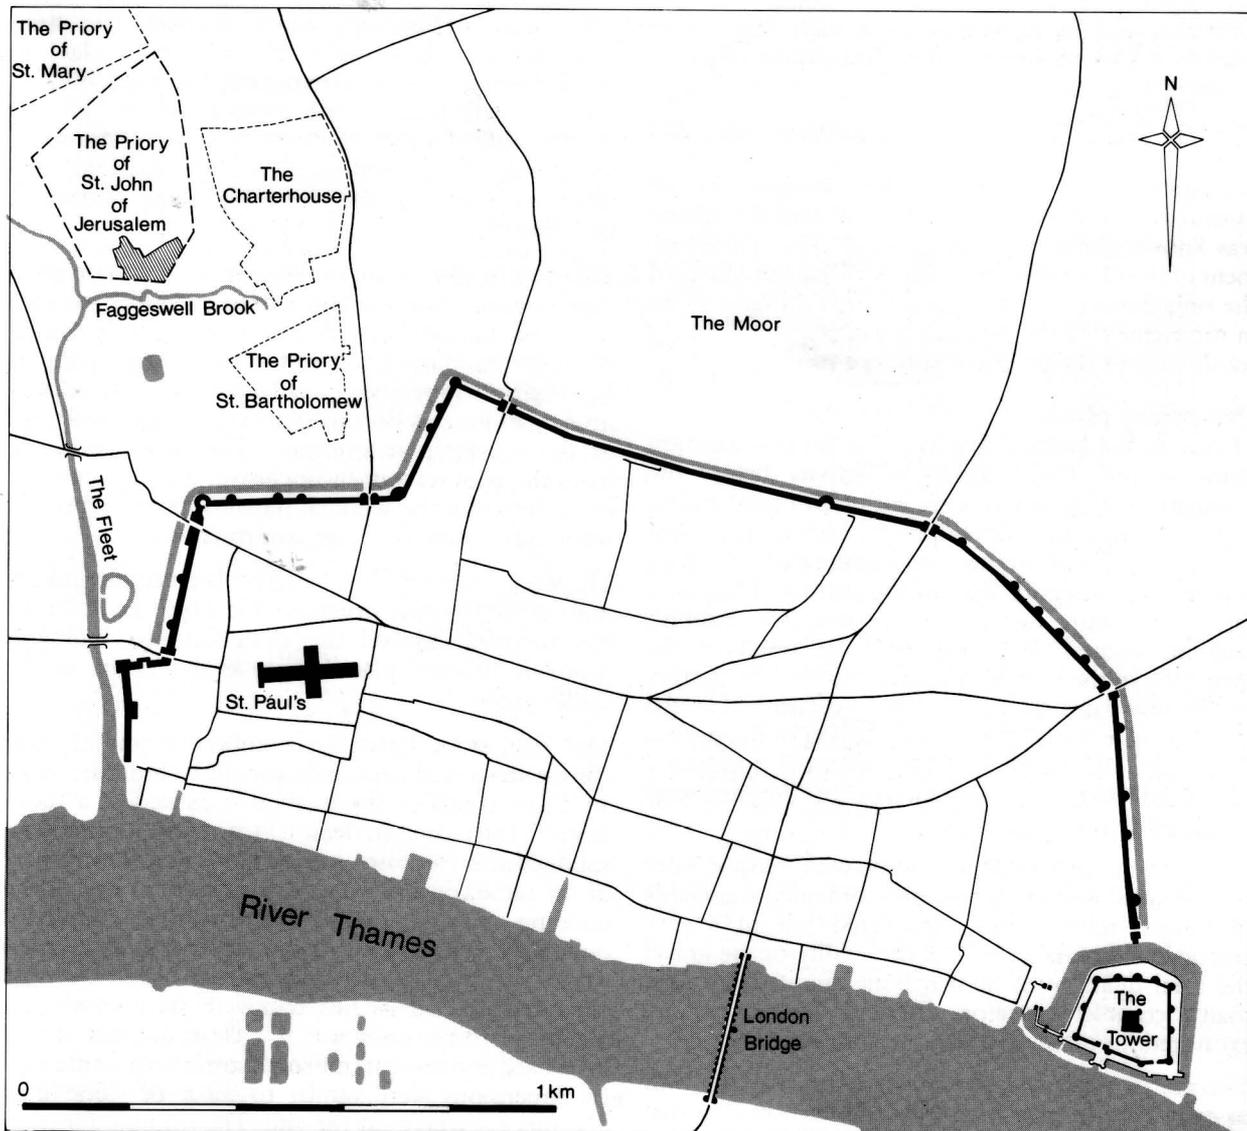
Fig. 1: map showing the position of the Priory in relation to the walled City of medieval London.

The Cowcross Street excavation by the Museum of London's Department of Greater London Archaeology, conducted between June and September 1989, was located within a development about 100m (330ft) north of Smithfield market, in the parish of St Sepulchre-without-Newgate (Figs. 1 and 2). It was

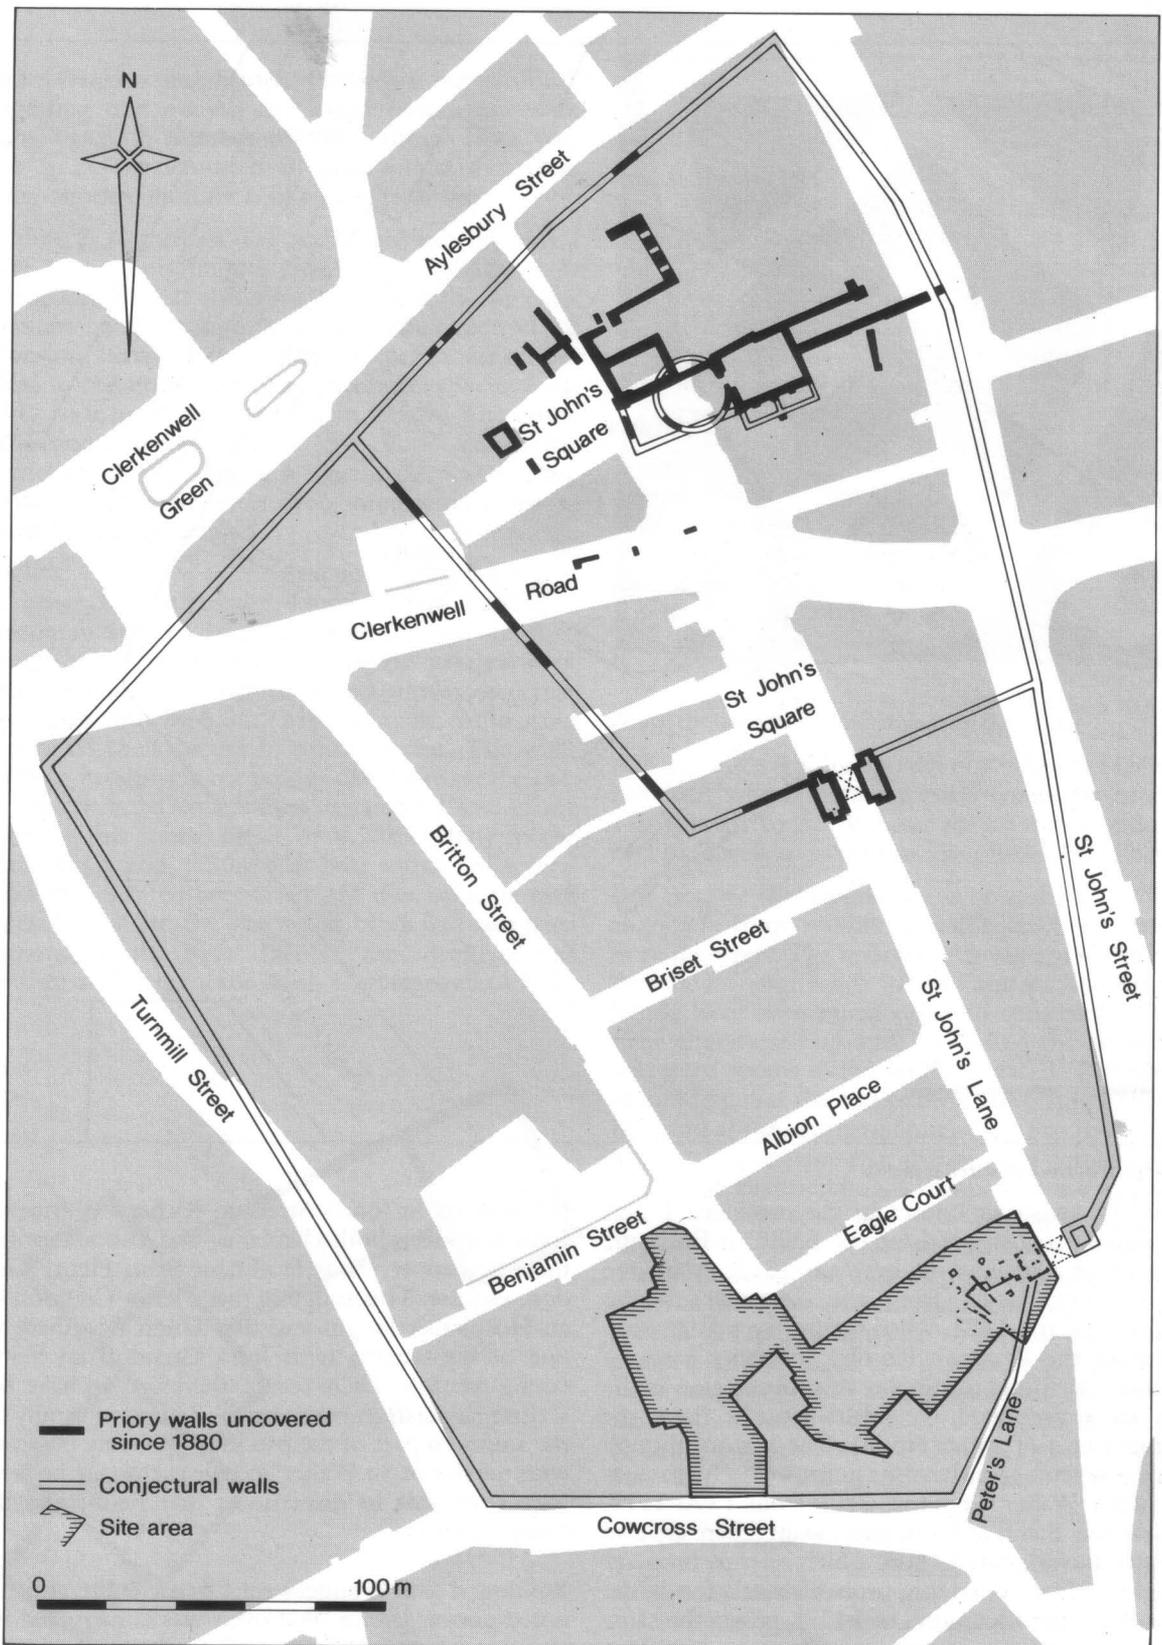
Fig. 2: site location map, showing outline of Priory precinct remains uncovered since 1880.

Previous observations and investigations, since the 1880s, had revealed the remains of structures belonging to the priory's monastic complex in the north-east corner of the precinct, but almost nothing was known about the southern end. The redevelopment of the Cowcross Street site afforded the Museum the opportunity to investigate an area thought to be in the vicinity of the precinct boundary, immediately south-west of the probable entrance to the priory.

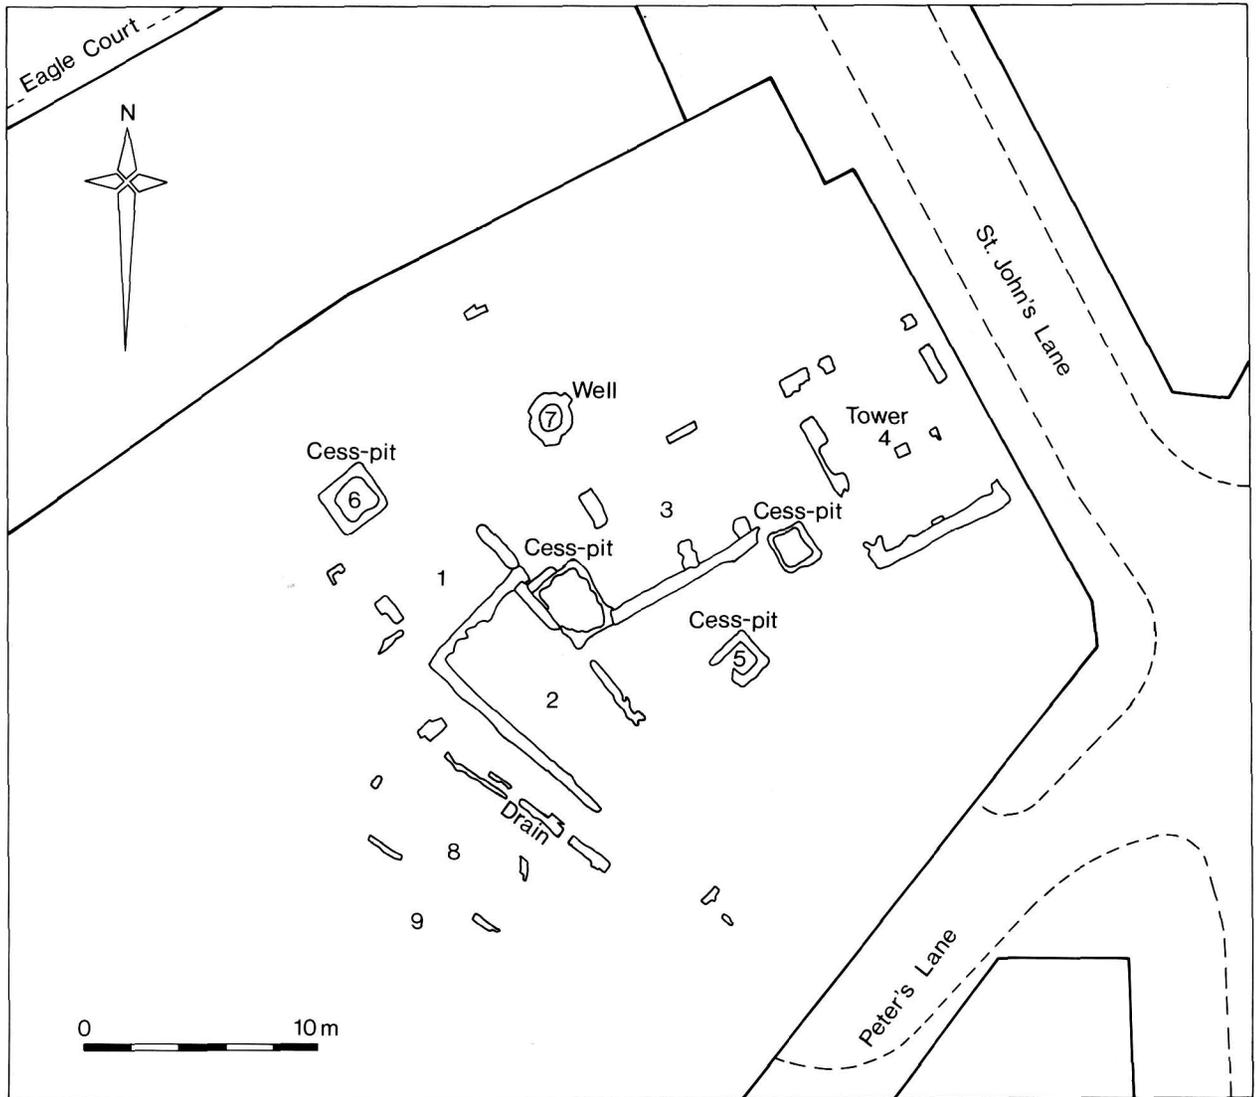
Fig. 3: plan of the excavated remains.

The excavation produced much evidence for medieval occupation to the south of the main priory buildings. From the structural evidence collected it has been possible to distinguish at least three construction phases which illustrate the development of the buildings on the site until their eventual decline in the late 14th or early 15th century. The buildings within these phases have been numbered for reference and are shown on Fig. 3.

The first stone building, numbers 1 and 2, was constructed on an alignment parallel to St John's Lane and 20m (66ft) to the west. It consisted of a room 5.5m (18ft) by at least 14m (46ft), internally subdivided by an east-west partition that formed part of the same construction. At the northern end of the building a small square structure was excavated, building 6, which at one time may have been attached to building 1. This structure had been severely truncated and all its fills removed: its lowest chalk course survived, so it was not clear whether it had been used as a cess-pit or a small storeroom – although its dimensions were similar to those of stone-lined cess-pits elsewhere on the site. The original function of buildings 1 and 2 must also remain speculative since in a later phase the eastern wall had been demolished and rebuilt on a slightly different alignment – converging with the western wall to the south. The western wall had been partly repaired and an extension added at the southern end, only 2.0m (6½ft) of which had survived. This would seem to indicate that the original building was 14.0m (46ft) long though the east-west return had not survived. As the only substantial stone building present at this date, it must have been built for a particular purpose: documentary sources indicate that the Bailiff of Eagle, one of the four Grand Crosses of England, had a house on St John's Lane<sup>1</sup>. No other Knights are specifically referred to as having had houses in the area but there was provision made in the rules of the Order for land and timber to be made available for Knights who

Building 3, to the east of 1 and 2, was initially only a single wall connecting building 2 with building 4. It is probable that at this time it formed the precinct boundary wall though after a further period of expansion between two and four penthouses were added to the north side. The penthouses were 4.0m (13ft) wide and c 6.5m (21ft) in length. The crude occupation surfaces and a clay floor inside the penthouses do not suggest a specific purpose but the buildings have tentatively been interpreted as store-rooms serving building 2.

Building 4 survived in the ground better than any of the other structures: the southern wall had been incorporated into a later basement and still stood to a height of 1.7m (5ft 7in), albeit below ground level. Together the walls formed a rectangular structure 9.0m (29ft 6in) by 6.5m (21ft) robustly constructed from faced chalk blocks in a fine mortar. The walls had been extensively robbed, as elsewhere on the site, but the construction trenches remained. Close to the centre of this room, offset by 0.25m (10in) to the south, was a pad, 0.50m (1ft 8in) square, of several pieces of mortared greensand and tiles on a tile and mortar bed. A smaller greensand block had also been mortared to the inner face of the southern wall opposite and at the same level. Unfortunately a brick

Structure 5 was a cess-pit to the south of the main range of buildings, constructed of faced chalk blocks and on the same alignment as building 2. The pit had been back-filled with animal bone at a later date but the alignment seems to indicate that it was contemporary with the earliest stone construction phase.

Number 7 was a circular chalk well that seems to have been built in an ascending spiral. It too probably relates to an early stone phase because of the similarity of construction. A large house would need a water supply possibly obtained from this well.

Building 8 was added to the west side of building 2 after the partial reconstruction and extension to the south of building 2. The interior of building 8 had been severely truncated by basements with only a later drain and several gravelled paths alongside building 2, which pre-date building 8, surviving. The most unusual feature of this building was an apsidal bulge in the western wall; whether this was some sort of buttressing or a architectural feature was not clear.

Building 9 had been completely robbed out after demolition so very little can be said with certainty about it. One notable feature was its relative level in the ground: although there was a slope across the site from east to west building 9 seemed to be at least

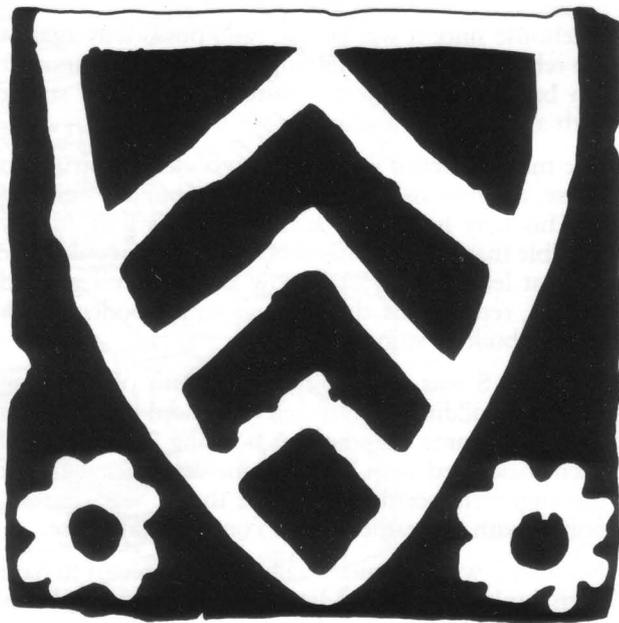
Fig. 5: the late 14th-century decorated floor tile.

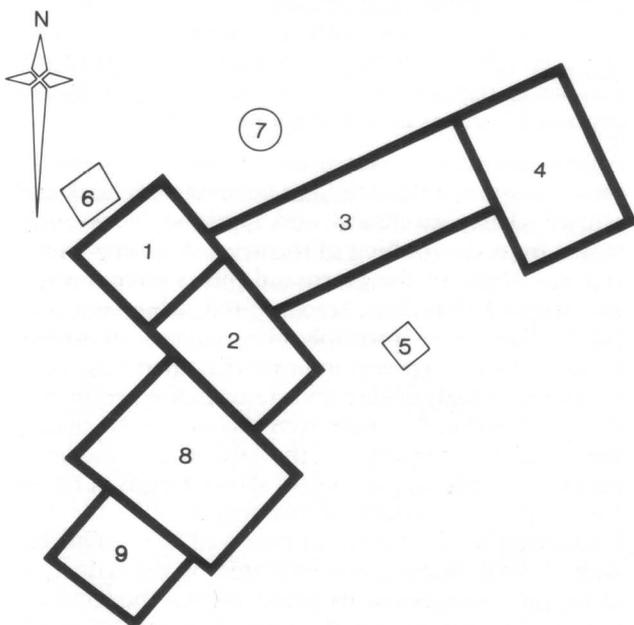
Fig. 4: diagrammatic plan of the main construction phase.

### The medieval buildings (Figs. 3, 4)

It is notable that building 4 is on a slightly different alignment from building 1 and 2 which was set back from the street. The reason for this seems to have been that the frontage on St John's Lane was important: it would have been much easier to construct it on the same alignment as 1 and 2 avoiding the necessity of odd-sized rooms to the north of wall 3. The position of building 4 at the end of the Lane facing Smithfield Bars and at the southern limit of the precinct all point to the interpretation that this was the entrance to the priory and that building 4 was part of the gatehouse. The substantial walls and solid construction seem out of place for a single-storey structure at the entrance to one of the wealthiest monastic houses in the country<sup>6</sup>. None of the above-ground features survived but it was probably of two storeys with a roof-top walk-way and parapet. The presence of a gatehouse is supported by documentary evidence which places the gate 96 ells to the north of Smithfield Bars, a position that matches building 4 remarkably well<sup>7</sup>. Further sources<sup>8</sup> suggest that the gate was similar to the 1504 Docwra

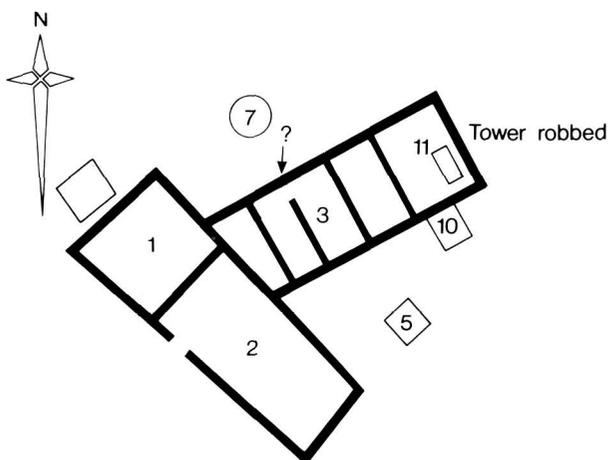
Fig. 6: diagrammatic plan of the pre-Dissolution phase.

### Pre-Dissolution phase (Fig. 6)

It appears that many of the medieval buildings had been allowed to fall into disrepair before the Dissolution. Though a few may have been maintained it is difficult to determine whether they were occupied or merely used for storage. A drain servicing the medieval building 8 was removed and replaced with one constructed of re-used masonry lined with roof tiles. This improvement appears to have occurred around 1500 though an associated rough rubble surface and the ruinous condition of the building's walls suggest that structure 8 had ceased to exist by this date and that this area became some kind of a courtyard.

Elsewhere, particularly in building 3, evidence of repair in red Tudor brick to partition walls, and the insertion of a small brick-lined feature, 11, filled with charcoal and ash, presumably an ash-pit associated with a hearth further to the east which did not survive, suggest some use in this period. The partition walls were accompanied by deposits of occupation debris which date to c 1450-1500. The continued use of the chalk-lined pit 5 and well (7), established in the medieval period, also indicates that at least some of the buildings were still occupied. Although not completely excavated, the well was found to contain 17th-century infill, and it seems likely that it was in use in the 16th century. The square chalk-lined pit contained a substantial amount of animal bone in a slightly humic matrix. Although these contents have not been fully examined as yet they appear to be the butchered remains of approximately 10-15 horses deposited perhaps as a final fill in a cess-pit.

A new cess-pit was created to the east of structure 3. On excavation, it was found to be lined with brick and re-used chalk, greensand and ragstone blocks, obtained from the robbing of medieval structures in the vicinity. Many of the greensand pieces were worked and some of these bore traces of red, white and blue paint. They were probably the remains of ornate window mouldings and indicate that there had been buildings of high quality and status in the precinct; it is even possible that they were derived from one of the structures present on the site in the medieval period. The pit's upper courses showed signs of repair with a greater amount of masonry rubble, tile and brick being used. This repair may well have coincided with its final cleaning out indicated by the reduction of the pit's base, below its lining, during the scouring process. The pit contained a total of ten fills of which the lower were rich in human waste. Above, the fills

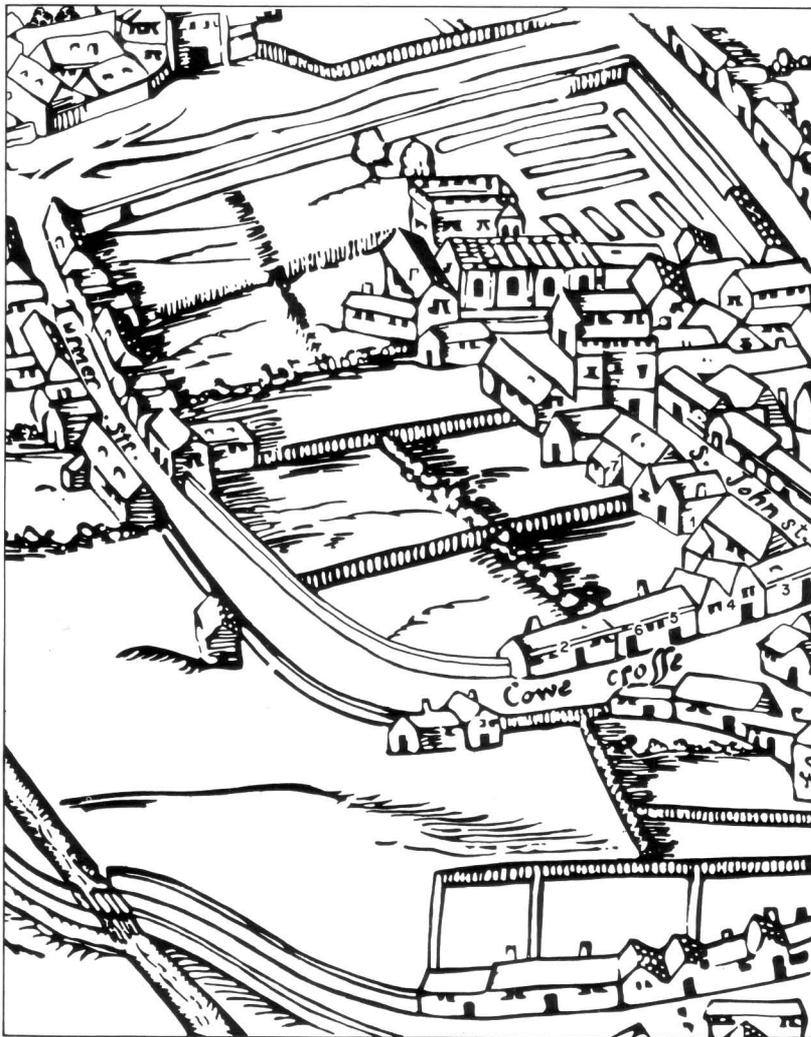
Fig. 7: Agas' map of the area with householders' names.  
 1. Rob Tirwitt, 2. Will Aprice, 3. Will Arrowsmythe, 4. George Benson,  
 5. Nick Ryshetton, 6. John Fox, 7. Olive Overton, later Will Rygge.

tenement plots, and it is possible to reconstruct them on the 1550 Agas map of London (Fig. 7).

Indeed, the Agas map gives a good indication of the site with new brick constructions lining the St John's Lane and Cowcross Street frontages and the division of the gardens behind into square plots. This may explain the fragmentary lines of brick and masonry rubble as the last traces of garden plot boundaries.
