Urban development in Londinium, AD 50 to 120: Leadenhall Court excavations 1984-86

Gustav Milne
Paul Wootton

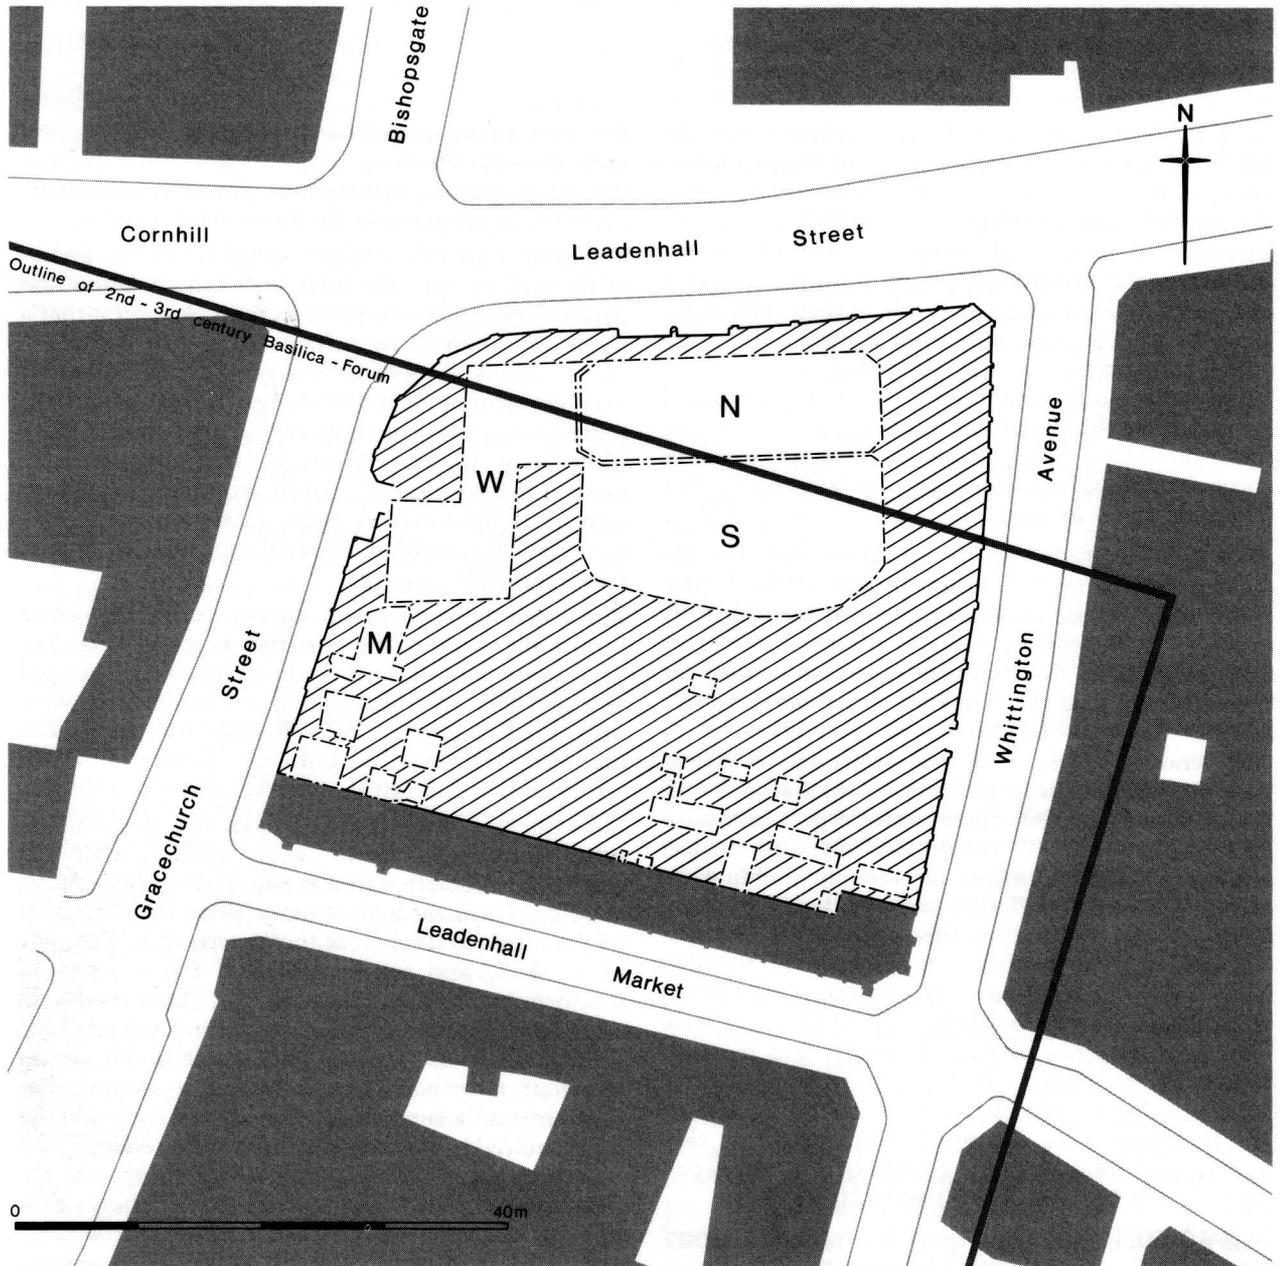
Fig. 1: plan to show the Leadenhall Court project in relation to modern streets and to outline of the north-east corner of the late 2nd-century basilica.

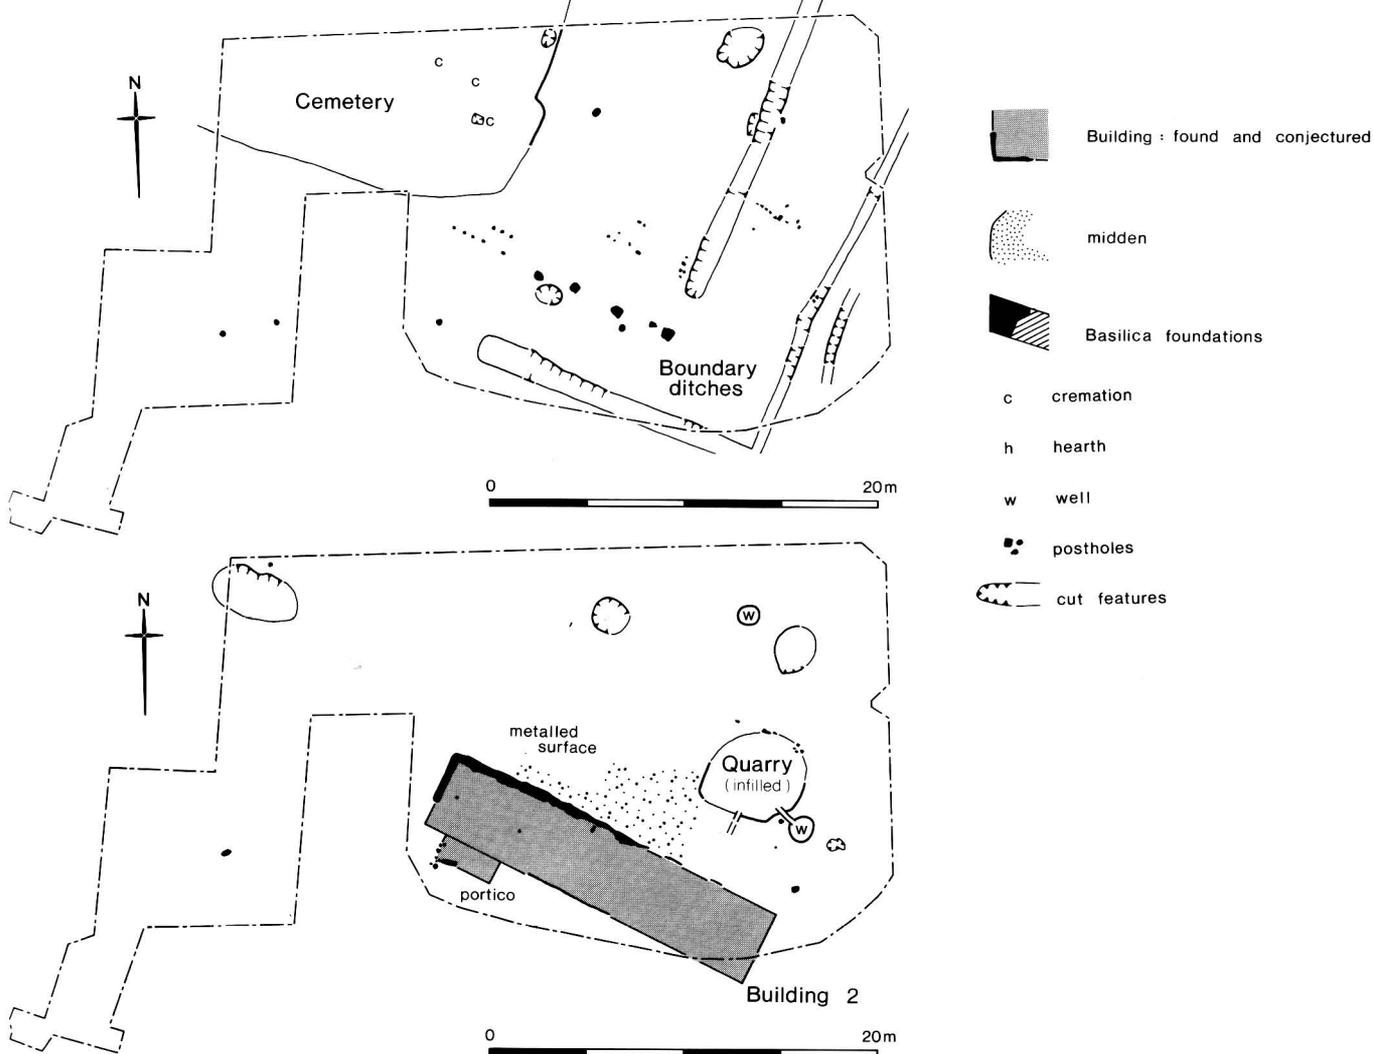
Fig. 2a: beyond the town boundary: plan of northern half of the site in the mid 1st century, with a small cremation cemetery and ditched enclosures.

Fig. 2b: ribbon development: the settlement encroaches over the former extra-mural area, with introduction of buildings fronting street to the east, beyond the limit of excavation.

Further boundary/marker ditches were dug on a similar alignment to the ones they replaced (Fig. 2a). The quarry floor of the preceding phase was now used as a cemetery, in which several cremations urns were discovered (Fig. 3). Under Roman law, cemeteries occupied positions outside the limits of urban settlement, in contrast to medieval parish graveyards.

Building 2 was then constructed (Fig. 2b). It was aligned E-W and was at least 18m long by 2.5m wide (60ft × 8ft). A series of post-holes on the south side of the building's west end suggests the presence of a verandah or portico marking an entrance. Two wells were dug and a metalled surface was laid to the north of the building, partially sealing the infilled quarry. The latter had been surrounded by a fence, the line of which had been defined by post-holes.

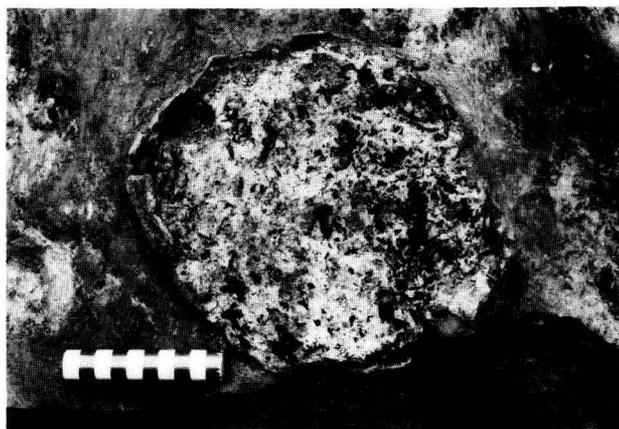
Fig. 3: mid-1st-century cremation: detailed vertical view showing material dumped in backfilled quarry (on which 10 × 10mm scale rests) into which the urn was set. Neck of pot truncated when building activity encroached on the cemetery.

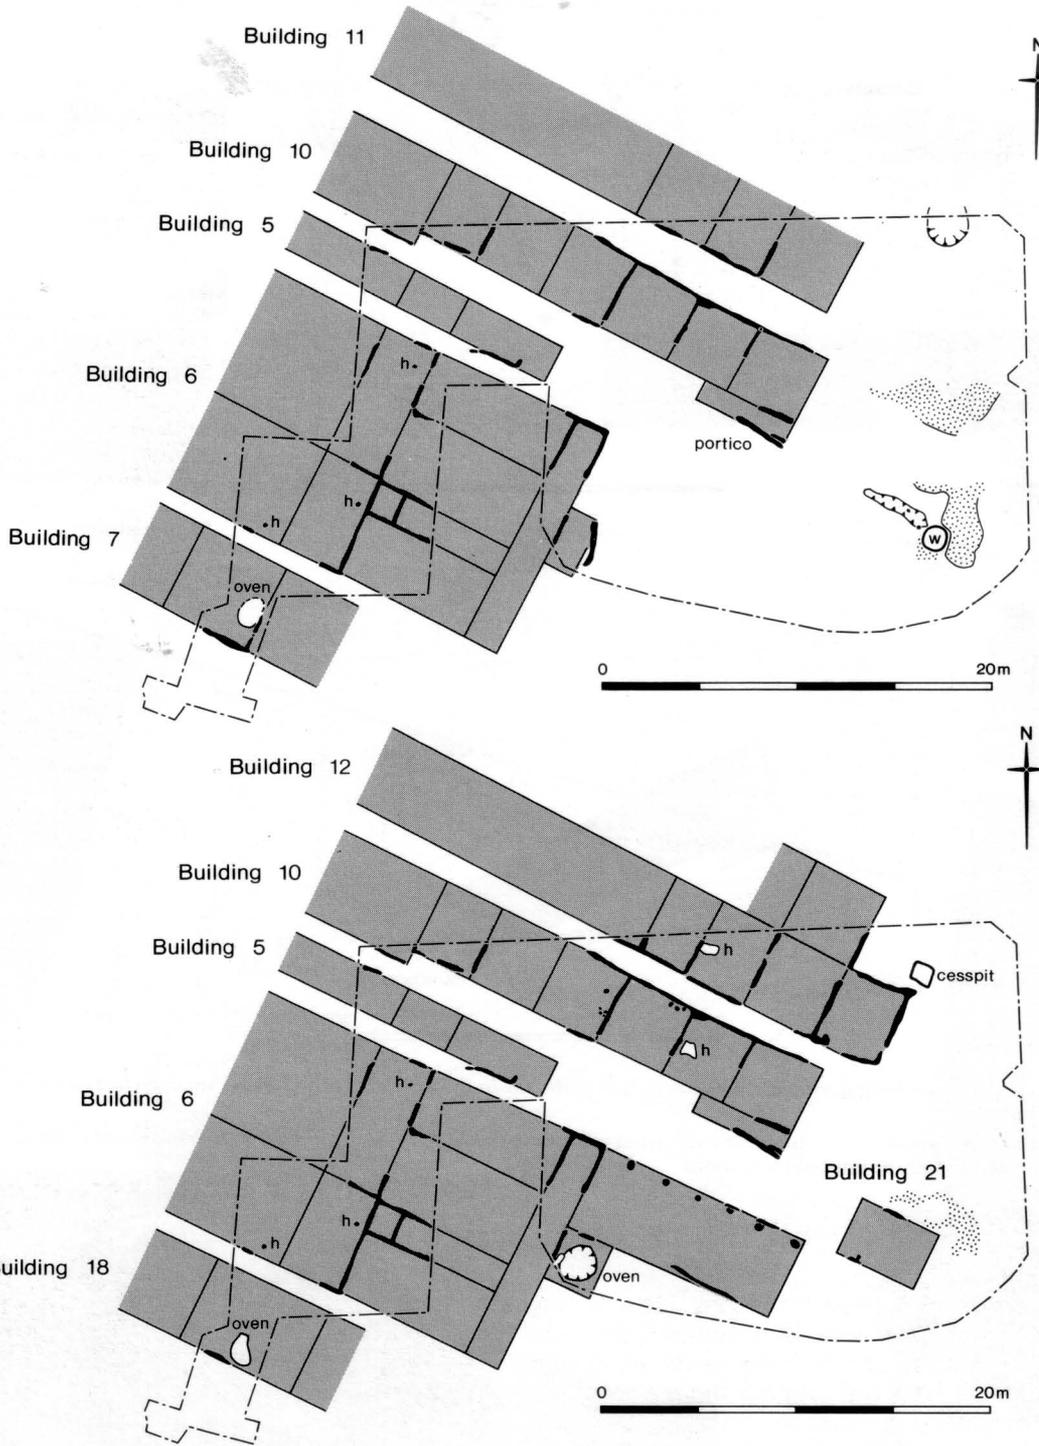
Fig. 4a: AD 80: urban expansion. A new insula is laid out with buildings fronting a street just beyond the western limit of excavation. More middens and wells in backyards.

Fig. 4b: AD 90: urban occupation. Several brickearth and timber buildings shown on Fig. 4a have been repaired or replaced by the buildings shown here.

Building 2 was demolished, to be replaced by a formally laid-out series of buildings constructed with an extensive open area to the east, used for the dumping of waste material (Fig. 4a). This major

The second phase of development (Fig. 4b) saw the buildings of this new formalised layout repaired and in some cases rebuilt. In the north, Building 12 (Fig. 6) replaced Building 11, while in the south Building 18 replaced Building 7. The area to the east of the site remained a dumping ground to which all alleyways from the main street led. To the east of the site in Area S the small Building 21 was constructed. Since the midden-like material found inside it appeared to have accumulated shortly after its construction, this outbuilding may have functioned as an animal enclosure.

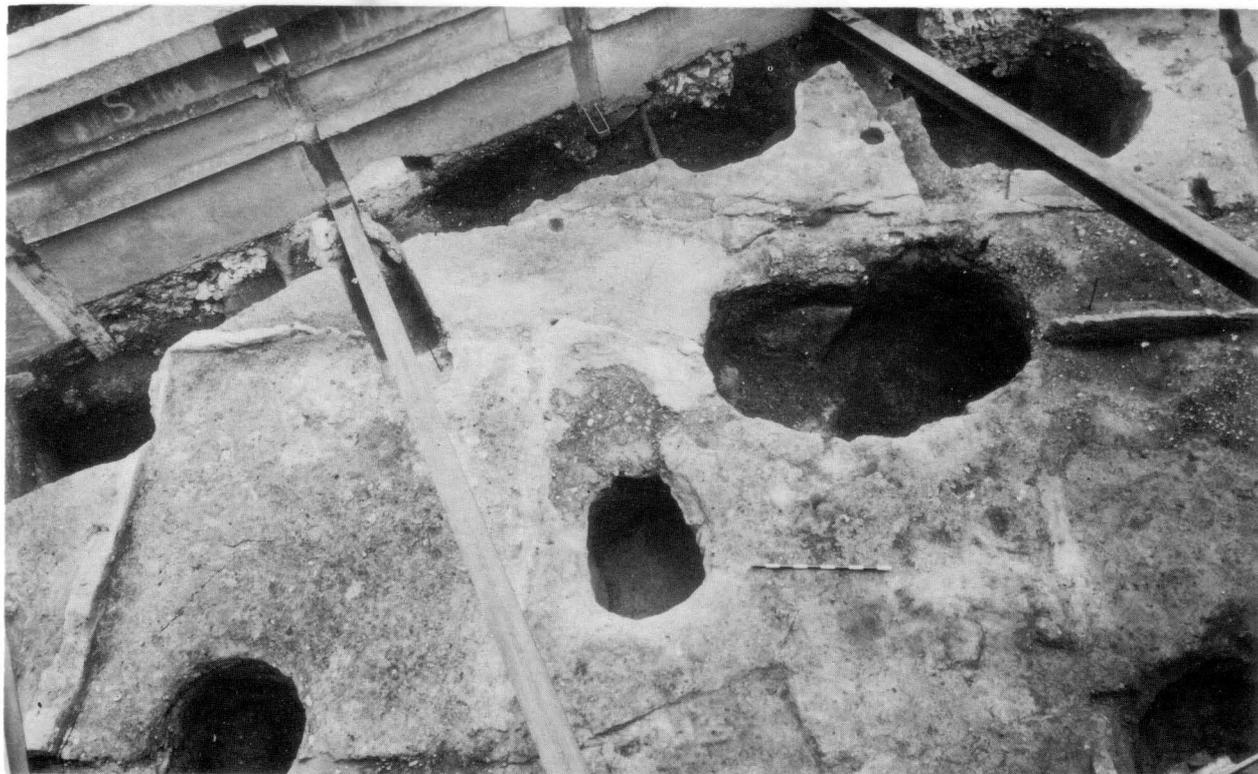
Fig. 6: part of Building 10 to south (top) and Building 12, in which $5 \times 100\text{mm}$ scale rests. They are separated by a narrow gravel alley, and are cut by later pits. Outline of thin brickearth and timber walls defined rooms no more than 4m (13ft) wide. Easternmost room in Building 12 (to left of scale) later demolished and sealed beneath midden deposits (*cf* Fig. 10).

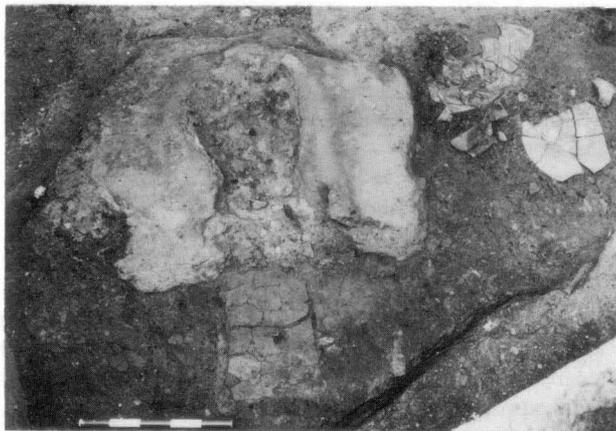
Fig. 5: Building 7: hearth with tile apron (next to $5 \times 100\text{mm}$ scale) and brickearth superstructure built directly against brickearth wall footing, visible at top of photograph.

An alleyway 1m (3ft) wide separated Building 6 from a structure to the south, Building 7, which extended both east and west beyond the limits of Area M. A 'bee-hive' oven occupied most of the only room excavated. It was larger than many of the other hearths or ovens discovered at Leadenhall Court, which were usually of the 'key-hole' type (Fig. 5). Evidence for

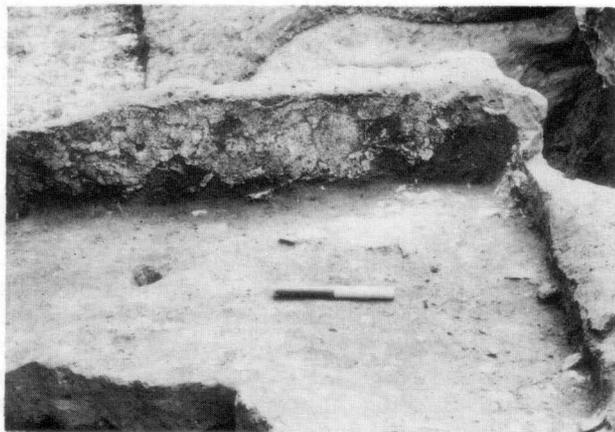
Fig. 7: Building 6: $2 \times 10\text{mm}$ scale rests in north-east corner of room. Note plaster rendering on internal face of wall footing.

Building 6 was also substantially repaired, with an extension built onto the east end of the property. The N-S aligned corridor at the back of the property was repaired and decorated with painted wall plaster (Fig. 7). Such quality of internal decoration contrasts significantly with that recorded in all the other buildings on the site, as does that building's large and complex plan. These facts suggest that, unlike its immediate neighbours, Building 6 should not be seen as an artisan dwelling. Subsequently more repairs were undertaken when a fire in the newly-decorated north-east corner of the building damaged much of the eastern end.

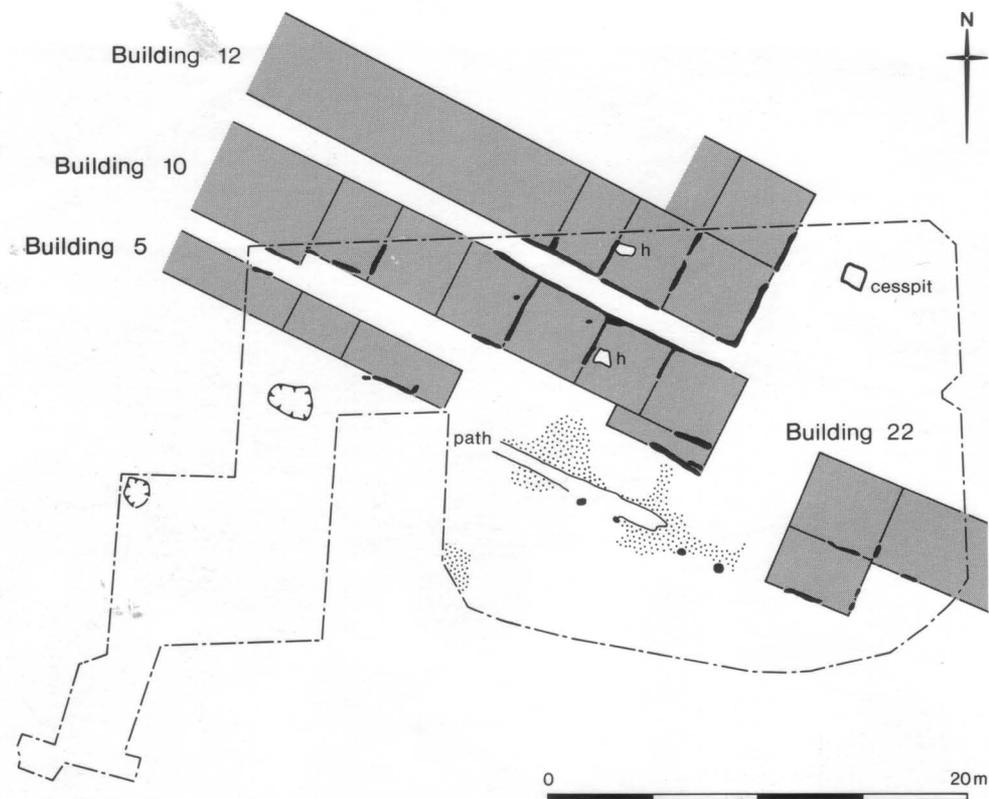
Fig. 8: AD 110-120: inner-city redevelopment (cf Fig. 4b).

a) Buildings 6, 18 and 21 demolished in advance of construction work for the enlarged basilica.

b) Buildings 5, 10, 12, 15, 20 and 23 may be temporary site huts, stores and canteens on the building site. Note mortar-mixing pit and spread of ragstone chippings associated with laying of foundations of basilica.

The next major change in the development of the site saw a contraction in the area of occupation. This was marked by the demolition of Buildings 6 and 18, and Buildings 17 and 19, which lay south of the area illustrated in Fig. 8a. A large area had therefore been cleared in the south of the site, but occupation of the properties in the north continued until these structures were demolished some time after *c* AD 100. At least two interpretations may be put forward to explain the protracted contraction of the settlement. One is that the area, having become run-down, may

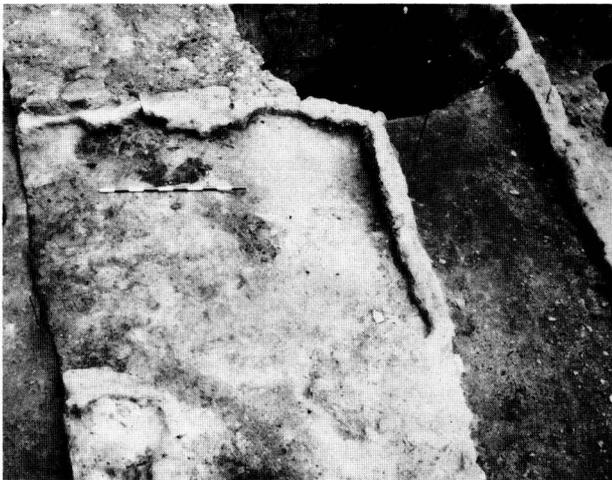
Fig. 9: Building 12 contracts. 5 × 100mm scale lies within easternmost room, with footings of brickearth walls to east (top) and south (right). Note hearth, and tiles marking position of cupboard to west, next to threshold opening onto narrow alley cut by later pits. North wall of Building 10 visible to south. Midden deposits dumped against east wall of Building 12 seal remains of the east room shown on Fig. 9.

However, occupation and activity in the north of the site did not cease immediately after the phase of contraction just described. Although Building 22 was demolished, three new structures were erected (Buildings 15, 20, 23) and Buildings 5, 10 and 12 (Fig. 9) were modified. This new layout is quite distinct from the previous development, and the occupation seems to be not only contemporary with, but also directly related to, the construction of the enlarged basilica. Since the new structures shown on Fig. 8b seem to function with the mortar-mixing pit and the area where ragstone for the basilica was prepared, they are interpreted as representing site huts, canteens and store-rooms associated with a

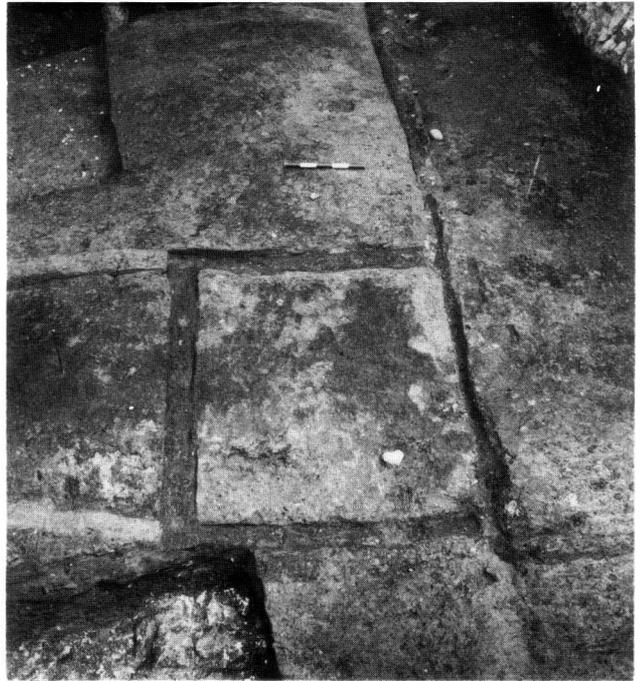
Fig. 10: Building 6: 2 × 10mm scale rests in one of the rooms defined by slots in which decayed traces of squared timber base-plates were recorded.

Buildings with a timber framework were also common in early Roman London (Fig. 10). A shallow construction trench was dug, into which was laid a timber base-plate with mortices cut into its upper face to support vertical timber posts, known as studs. On the Leadenhall Court site, fragments of decayed wood were all that survived of the base-plates, and few traces of upright studs were recorded. (Much clearer
