Archaeology and the Fulham Palace Refurbishment Project: managing expectations

Phil Emery and Chris Mayo

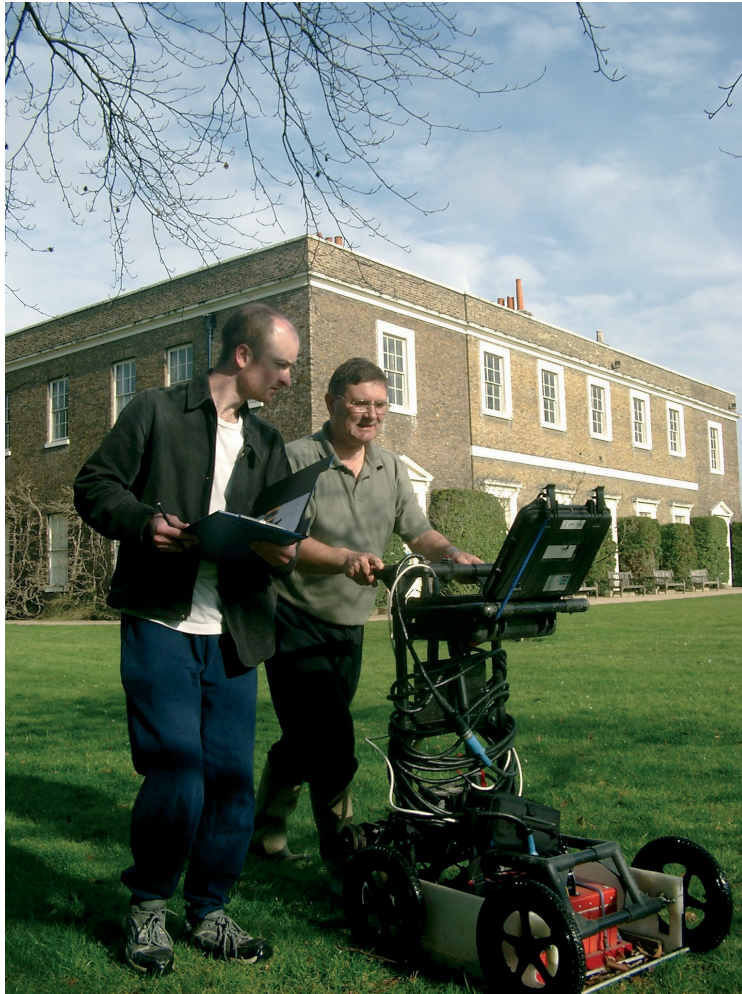
Fig. 4: Ground Penetrating Radar Survey in East Lawn by Stratascan Ltd in 2005 (© Gifford)

Routing of new and replacement services within the western part of the palace grounds was guided by the mapping of buried anomalies of potential archaeological significance by three geophysical techniques: resistivity, magnetometry and ground penetrating radar²² (Fig. 4). This augmented resistivity surveys undertaken by North East London Polytechnic in 1976 and the Ancient Monuments Laboratory in 1989.

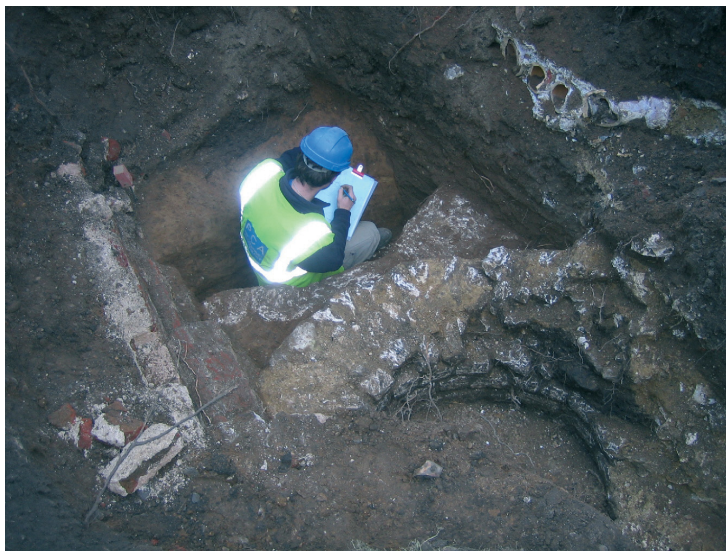
Fig. 5: remains of a medieval well found beneath the North Lawn (© Pre-Construct Archaeology Ltd)

In the area of the North Lawn, to allow the installation of new service runs, archaeological excavation exposed a pitched-tile hearth and a chalk well. Fills from within the well

were dated to the late 12th or early 13th centuries, but also contained a well-preserved coin of Crispus (AD 323–324). The hearth was associated with an outbuilding, and showed evidence of at least one repair; it was sealed by a soil horizon dating from the 13th century. The proximity and date ranges for the well and hearth imply that both constructions were associated with the reorganised medieval ground-plan of the palace following its rebuilding in its current position (Fig. 5).

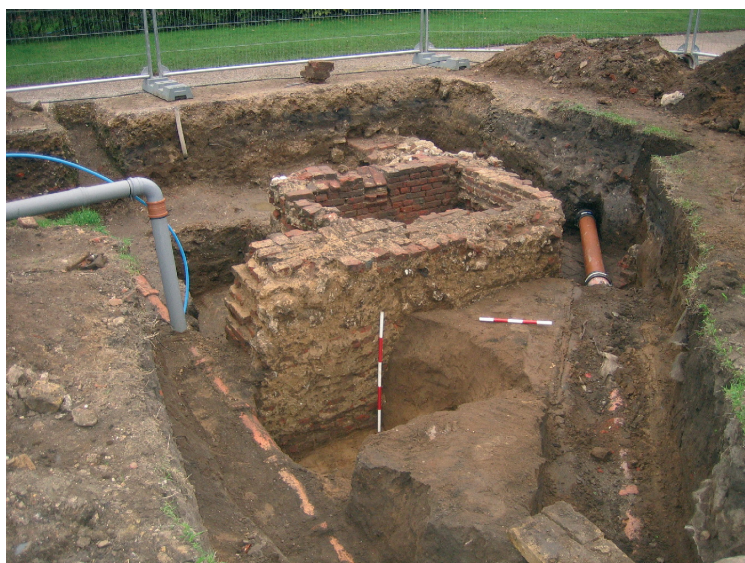
Fig. 6: remains of the 16th-century State Wing found beneath the North Lawn (© Pre-Construct Archaeology Ltd)

In the area of the North Lawn, detailed archaeological investigation was conducted to allow the installation of new service runs. Excavation revealed the north-west corner and easterly extent of the 16th-century State Wing of the palace, with a cellar that had altered in use (to include a privy or cesspit) before the block's demolition in 1715. Judicious use of previous truncations through the walls enabled all new services to be installed with no additional impact upon the archaeological remains, which were protected and left *in situ* (Fig. 6).

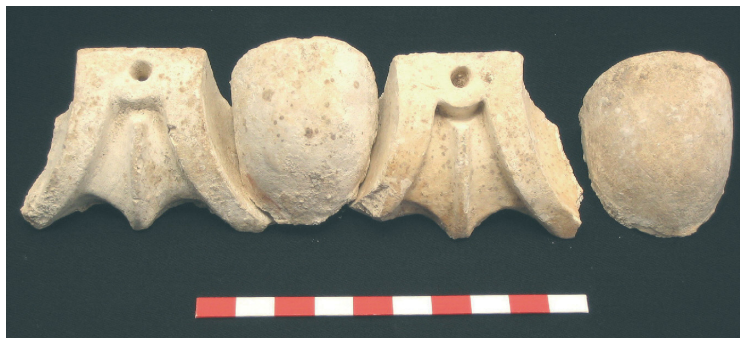
Fig. 8: Egg-and-dart plaster mouldings found beneath the floor in Bishop Sherlock's Room
(© Pre-Construct Archaeology Ltd)

They included the foundations of both the 19th-century kitchen range and a later gas range, complete with pipe-work intact (Fig. 7). A highlight of this excavation was the recovery of large quantities of plaster mouldings – both finished and unfinished – that can be recognised in the current Rococo ceiling and cornice (Fig. 8).
