# The Thames at War: foreshore archaeology and the Blitz

*Gus Milne and the Thames Discovery Programme team contribute to the expanding field of 'Conflict Archaeology' from a proactive non-combatant perspective, with this study of how Londoners responded to the Blitz.*

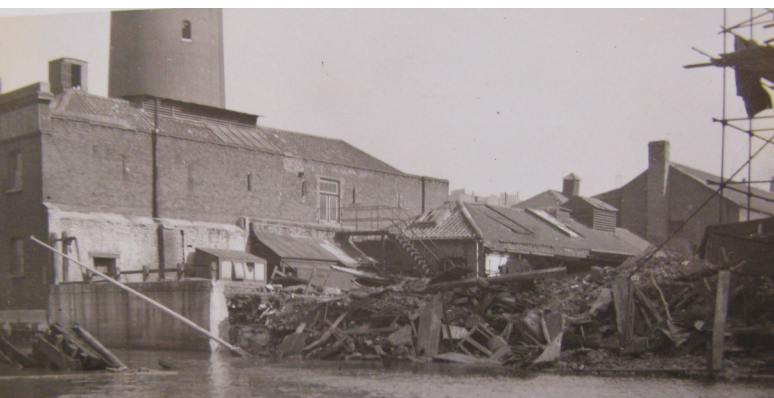
**ABOVE RIGHT:** An example of temporary repairs of a breach here at Bullivants Wharf, Millwall, secured with 1,000 sandbags until permanent works could begin (Peter Kennedy/LMA)

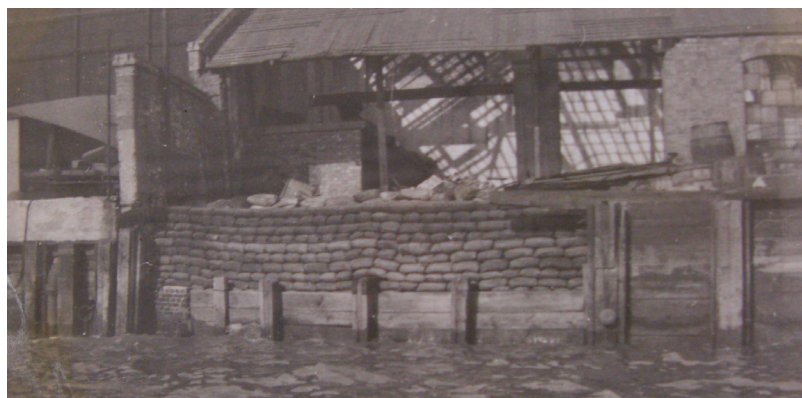
**BELOW:** The TDP team at Westminster, near the Houses of Parliament. The infilled breach can be seen centre-ground (Nathalie Cohen/TDP)

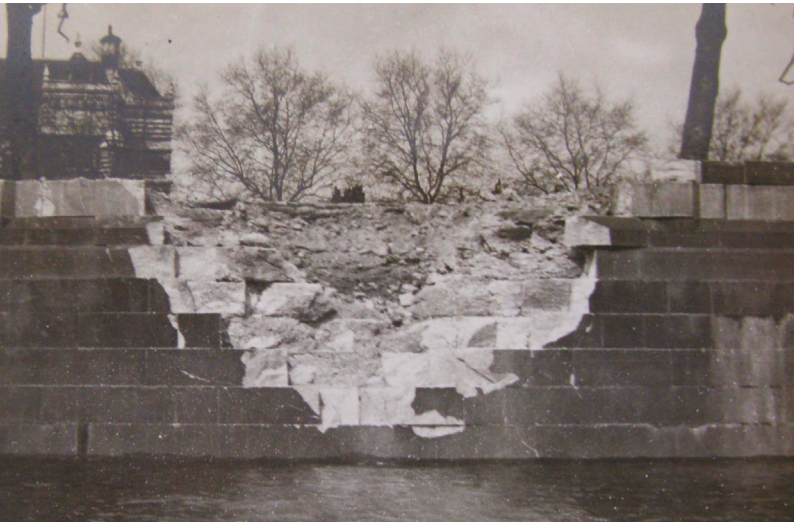
**RIGHT:** The permanent repair shows the breach infilled with concrete, as recorded by TDP in 2015 (Nathalie Cohen/TDP)

The TDP's fieldwork has shown that this phase of the repair involved refacing the Embankment wall with shuttered concrete, adding a reinforced concrete capping to replace its shattered masonry predecessor, and supporting the parapet on the landward side with a coarse mix concrete plinth. All these features still survive today – the plinth repair is visible on the landward side in Victoria Tower Gardens, while the infilled breach itself is clearly visible from the foreshore below. The concrete facade is scored with lines in an attempt to imitate the ashlar blocks of the rest of the Embankment wall. The surprise is surely that these concrete repairs are still here, 80 years on.

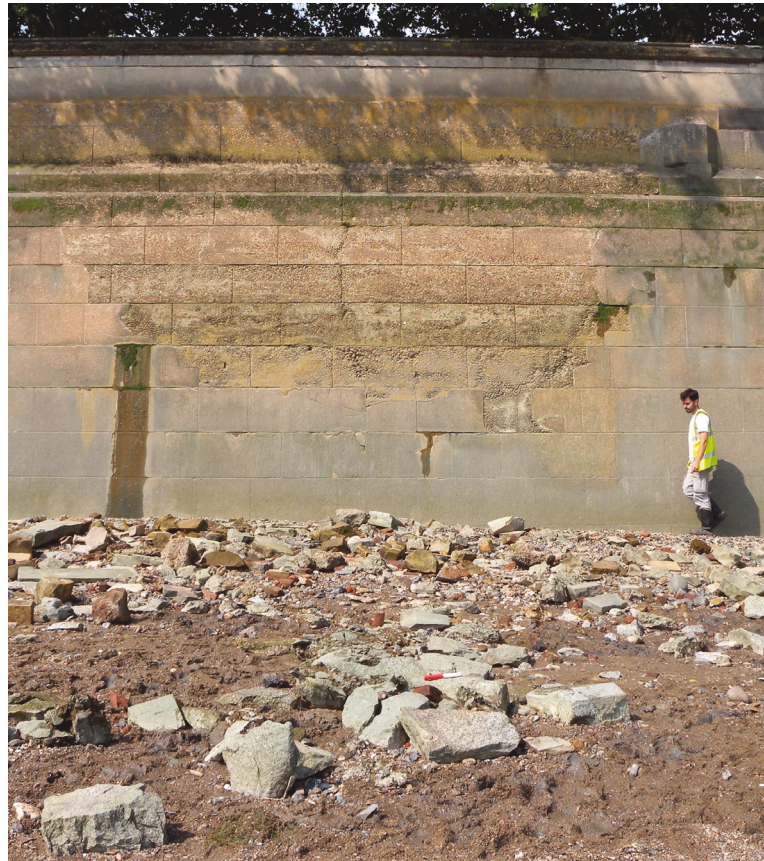
**OPPOSITE TOP:** The TDP team record bomb-blast debris on the Westminster foreshore
