Lift going down: the investigation of Roman buildings at Dyers' Hall, City of London

Joe Abrams

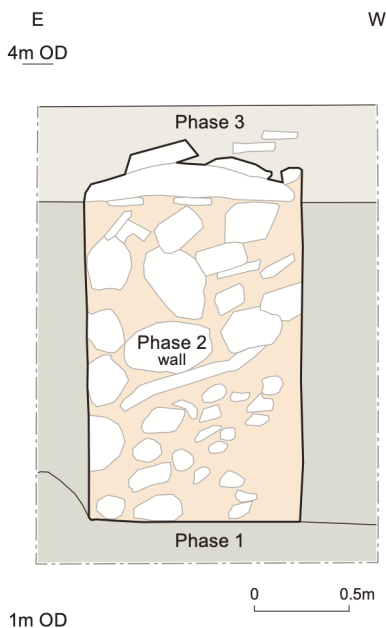
Fig 3: section showing the Phase 2 masonry wall

A masonry wall and associated occupation layers were constructed, and in use during the 1st–2nd century. Cut into the underlying geological deposits, the wall was constructed of ragstone blocks and other material (Figs 3 & 4). It measured a maximum of 1.7m in height and 1.04m wide. The L-shaped corner of a room/building was recorded, the longer section of wall being 2.5m long and the shorter 1.5m long. It is noted that the wall continued west and south beyond the investigation area.

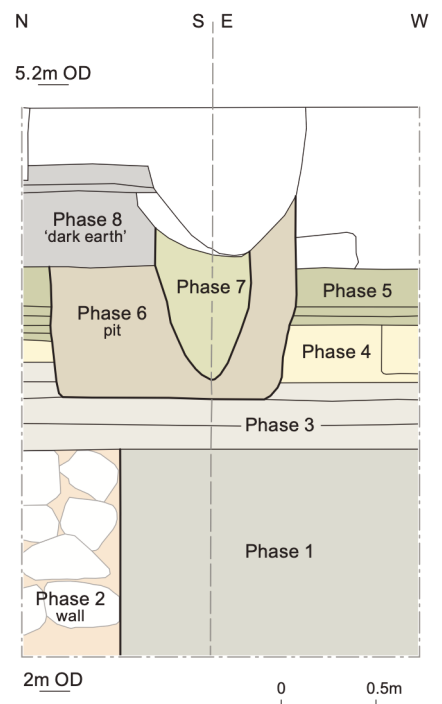
Fig 4: section showing Phases 1–8 with the Phase 2 masonry wall in context

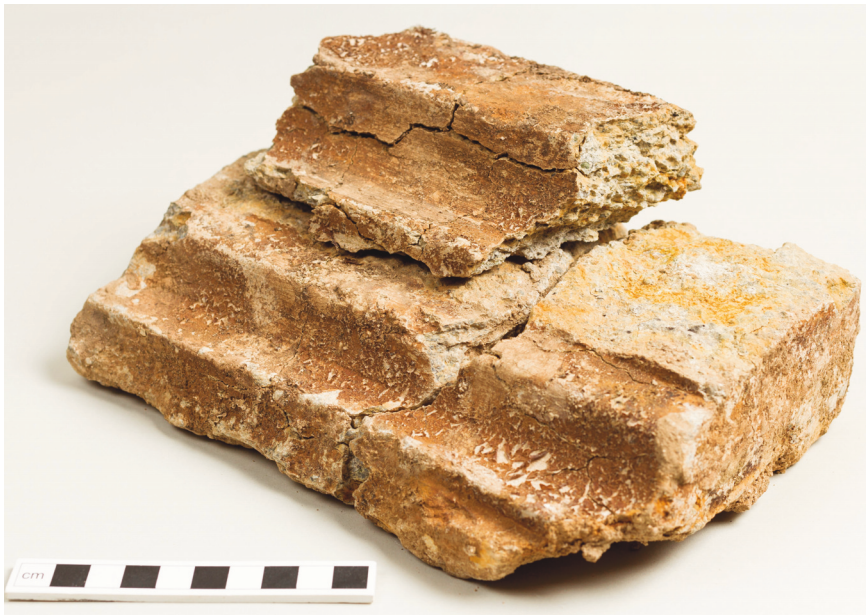
Fig 5: Purbeck marble cornice fragment with traces of red paint surviving

A Purbeck marble cornice was recovered from the earliest 1st-century (Phase 2) levels in the backfill of the construction cut for the masonry wall. It is well preserved (Fig 5) and was clearly derived from an earlier building than that associated with the wall. It is discussed further below. Associated with the Phase 2 wall, and room it defined, were a sequence of layers some of which contained building material including brick.

Of national importance is a finely carved cornice in Purbeck marble, which would have been thickly painted red on three sides with the iron pigment haematite, only traces of which remain (see Fig 5). This is only the second provincial example of this rock to have surviving paint.²⁴ Quarried,

specific cultural context and meaning. Within Dyers' Hall, the 1st-century cornice (Fig 5) is striking because of its red colouring, its curved edges and three deliberately visible sides. The cornice and the dado are devices which conveniently frame spatial areas. Fresco wall paintings are carefully designed to fit certain framed spaces; even simple dividing panels would be of a certain size. The topics which were painted, the use of space and colour within each scene and surrounding it, all had defined rules and customs. There were set approaches to wet rooms and buildings in damp areas which is relevant for any room constructed so close to the Walbrook.

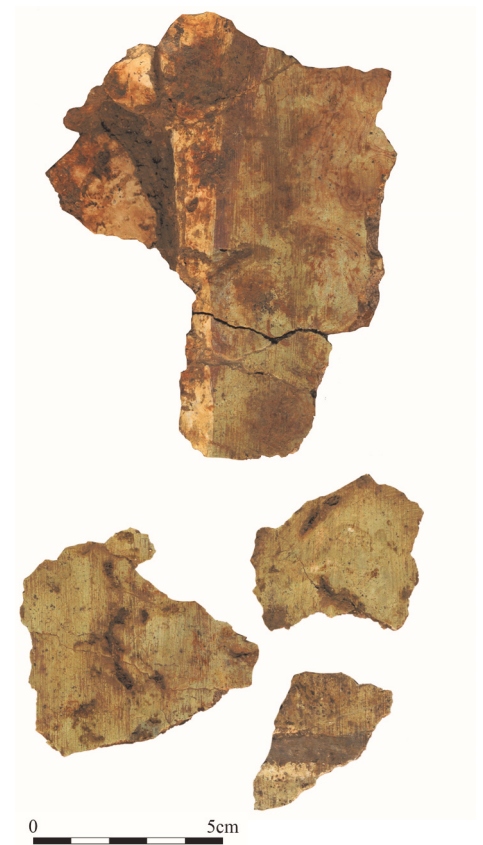
Fig 6: selected pieces of painted wall plaster

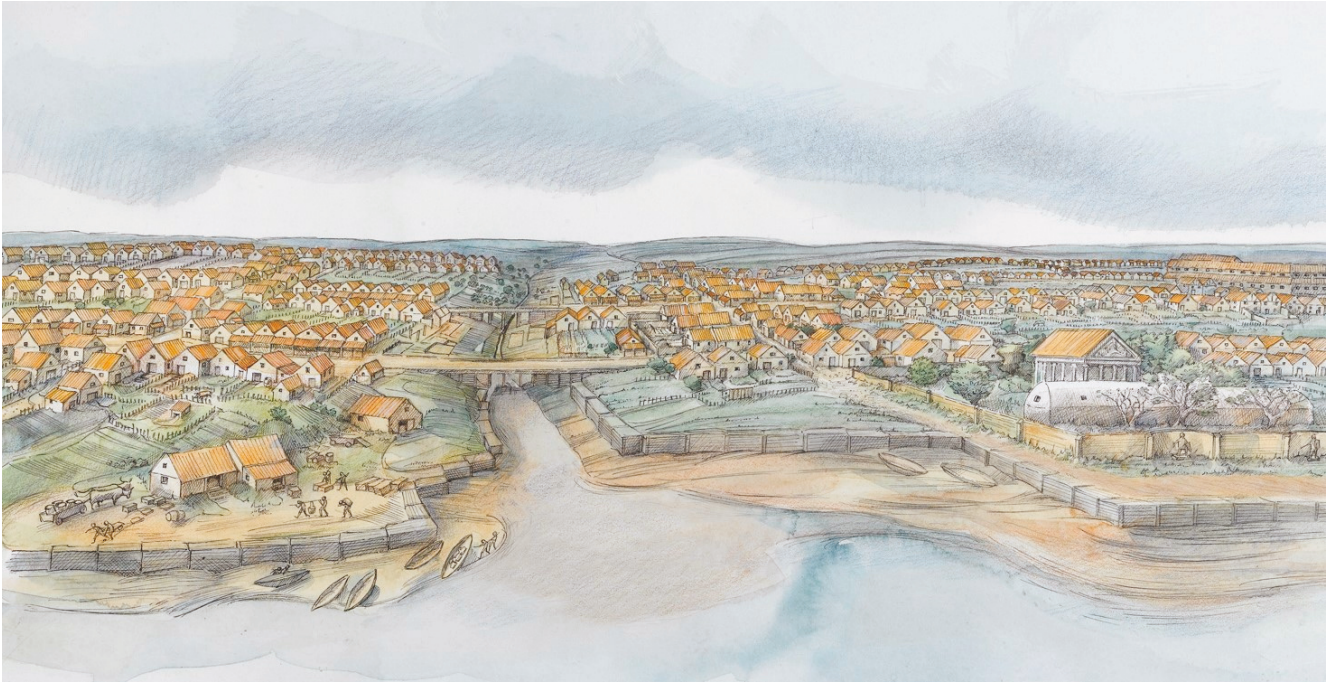
Fig 7: reconstructed view of the mouth of the Walbrook with revetted banks c. AD80. The site of the Dyers' Hall (centre) is as yet undeveloped and the suggested bath-house and temple at Governor's House lies directly east (right) (Judith Dobie/MOLA)

The observations made from this investigation and recent work within the Skinners' Hall¹² support the conjectured, but evidence-based, reconstructed view (Fig 7).¹³ These identify Dyers' Hall as being on dry land immediately east of the Walbrook, slightly higher than the water channel and off the estuary, though in its flood plain.

The similarity of deposit character is amplified when we consider certain artefactual material, specifically the building material and painted wall plaster. This wealth of early well-preserved building material fabrics and finds, in addition to the site's proximity to the footprint of Governor's House shows that, along with the painted wall plaster, these materials once belonged to such a prestigious building complex, now considered to perhaps be a bath-house and temple (see Fig 7).

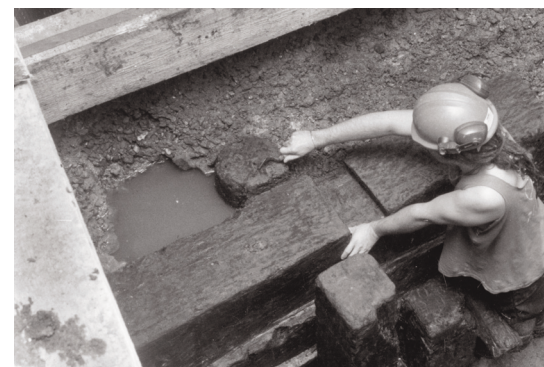
Fig 8: view of part of the Roman revetted timber waterfront under excavation at Suffolk House (MOLA)

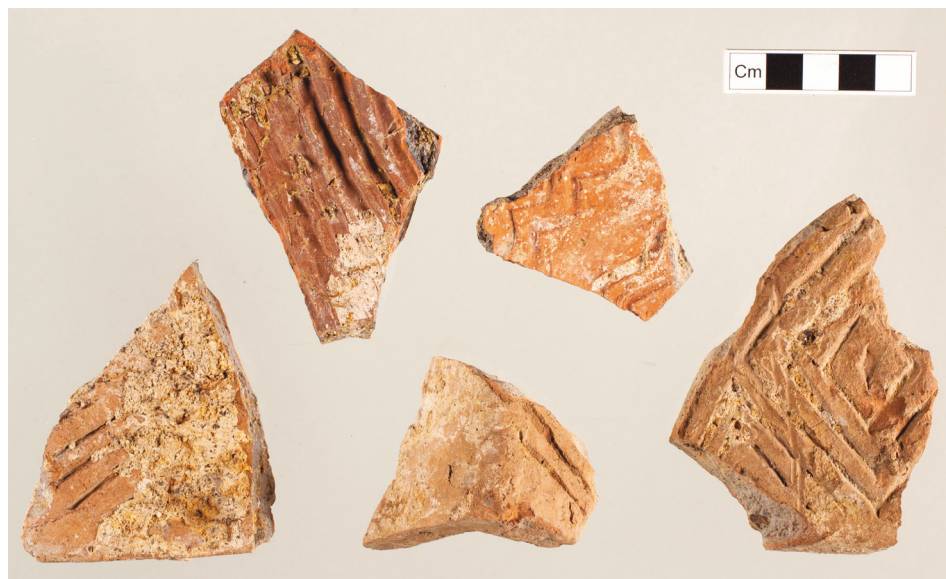
Fig 11: ceramic roller-stamped box-flue tile fragments

building material (below) included 9.2kg of box flue tile, used for moving hot air vertically and laterally. There were also examples of rare ceramic cylindrical *tubuli* for carrying water/air (from Phase 5 deposits) and fragments of *opus spicatum* paving bricks, the latter being commonly used on floors of bath-houses during the 1st century. The small quantity of window fragments found in Phase 3 and 4 (1st-/2nd-century deposits) are of a type associated with high-level, clerestory locations, especially bath-houses.¹⁷

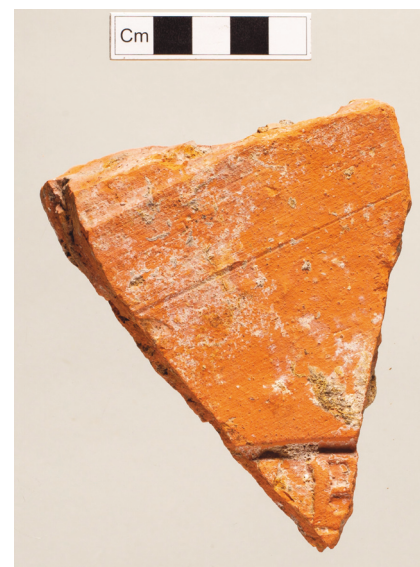
Fig 12: stamped tile fragment showing the 'B' of PPBR

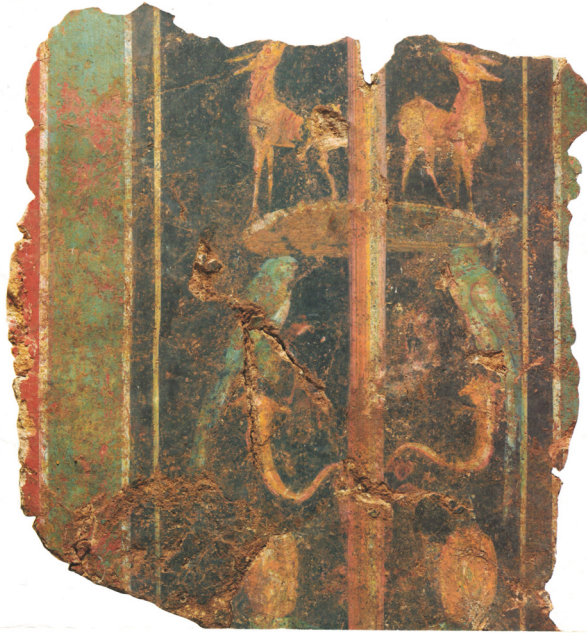
Fig 13: an example of wall plaster from 21 Lime Street showing vertical green bands and red panels, interspersed with a vertical black area depicting a candelabrum with deer and birds (MOLA)

The plaster from Lime Street is more complete and found in higher quantity than at Dyers' Hall. The use of red panels with green decorative (candelabra) borders was noted on a central frieze. The high quality of the painted plasterwork was on a par with similar paintings at *Verulamium* (St Albans) and Leicester – all of 2nd-century date.³⁹ In all these cases, the visitor to these rooms was surrounded with stories and colours which had a

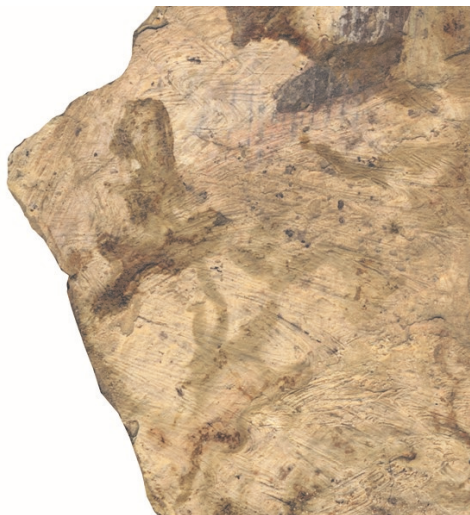
Fig 14: fragment of Dyers' Hall wall plaster showing the brush marks

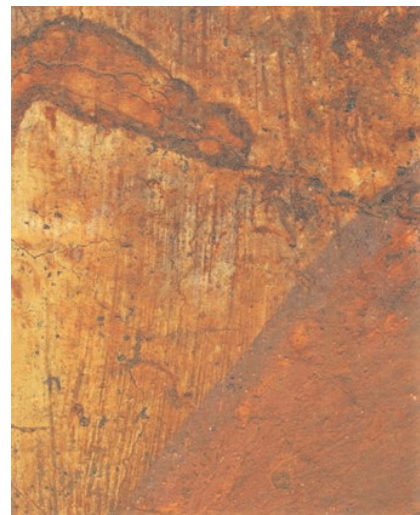
Fig 15: another fragment of wall plaster that clearly shows the vertical brush strokes

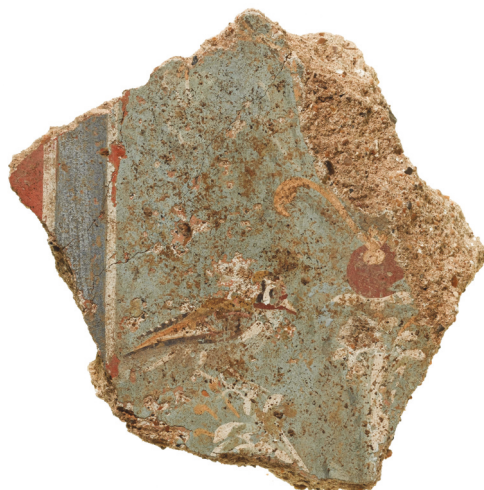
Fig 16: a fine example of wall plaster from 8–13 Lime Street depicting a goldfinch (MOLA)

There are many fine examples of wall paintings across the City of London and Roman Southwark, such as the bath-houses at Billingsgate and Huggin Hill, the special buildings at the nearby Governor's House site and, slightly further afield, the magnificent 2nd-century painted wall plaster schemes revealed at 8–13 Lime Street (Fig 16).³⁸
