The industrial landscape at Tottenham Hale: archaeological investigations at Hale Wharf, Ferry Lane, Tottenham

Ellen Green

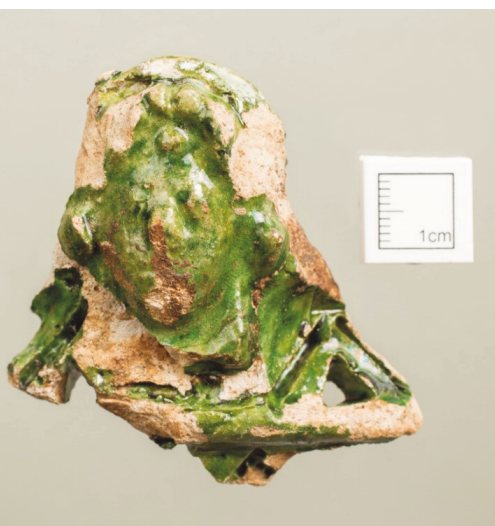
Fig 4: late 16th-century ceramic Saintonge openwork chafing dish from context [385]

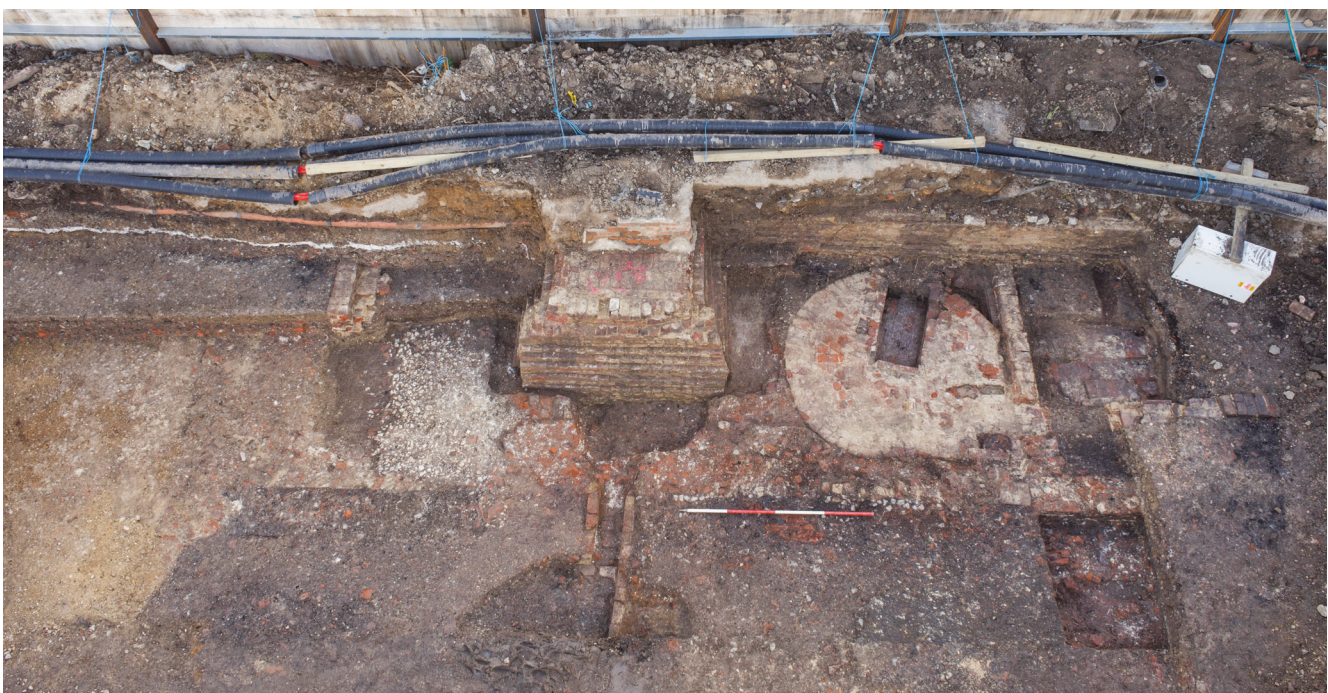
Fig 5: overview of Building 3, Periods 2 and 3, with circular brick structure [287] to the south and chalk internal floor [286] at the northern end of the building, looking east. The robbed-out cobbled yard surface, adjacent to Building 4, lies parallel to the 2m scale.

The most striking feature of Building 3 was the large circular brick-built structure [287] (Fig 5). This structure was circular with a 0.27m deep slot built in the centre, and has been interpreted as a furnace base with a rake-out pit. Similar structures have been observed in excavations of a mill in Colliers Wood in 2003.²⁰ For a paper mill, such a structure would have been used for the process of sizing paper using gelatine. The production of size²¹ required the boiling of a large amount

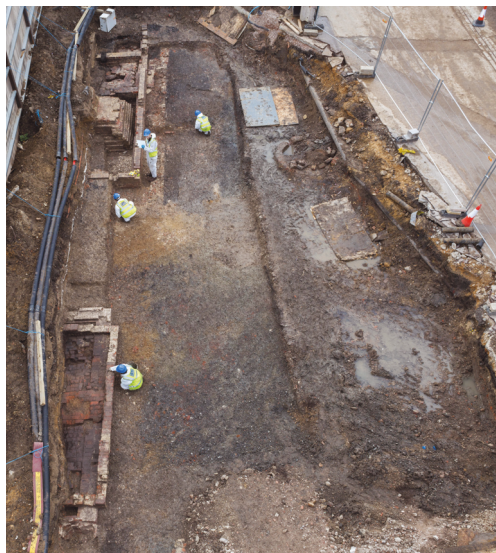
Fig 6: overview of Building 5 (north) and Building 6 (south), Period 4, looking south

room, bounded by a single brick wall was observed within Building 5. Surviving elements of a substantial brick-built foundation/machine base were present under the floor, indicating the presence of heavy machinery for industrial processes.

Building 5 went out of use and Building 7 was built over its remains along with a new building (6) in the southern part of the site (Fig 6). It is impossible from the artefactual assemblage to be certain of the exact date of this. However, historical records indicate that the mill complex was very badly damaged by a flood in 1817, which may explain the relatively short life span of Building 5. A late 18th-/early 19th-century halfpenny recovered from the bedding layer of the external walls of Building 6, supports this theory.

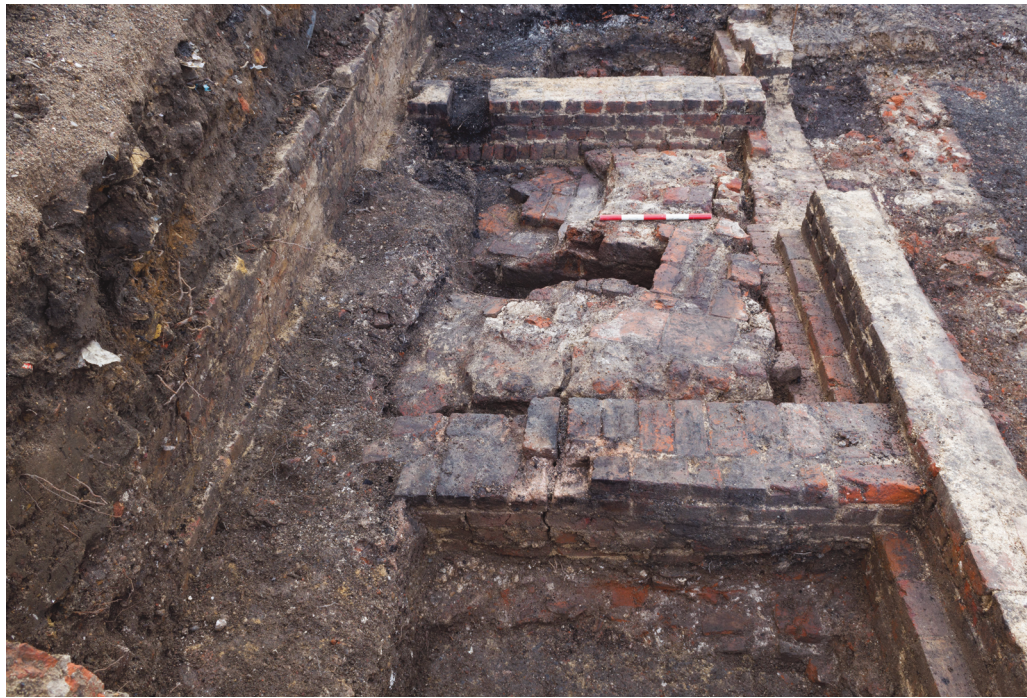
Fig 7: Building 6, Period 4, showing the surviving brick structure/furnace from Building 4 built up with floor tile and brick, retaining a raking out slot, looking south (0.5m scale)

Building 6 was located in the southern-most portion of the excavation, in the same area as previous Buildings 1–4. Three rooms were identified within the excavated portion of Building 6. Two of the rooms contained no evidence of their use, with only a small fragment of brick floor surviving. The central room, however, utilised the furnace base [287] from Building 4, building it up and narrowing the slot. The structure was no longer circular. However, a circular impression was visible on the top (Fig 7). An iron bar was fitted over the western-most portion of the slot, re-inforcing it, and the structure was built up using a mixture of Flemish floor tile and locally-made brick.

The use of the structure in this period is unclear. The brickwork showed no sign of burning or vitrification, and the mill complex was then processing flour which does not require the heating of vats. An inventory from the mill's sale in 1832 lists a drying kiln as part of the complex. However, the structure in Building 6 does not resemble contemporary drying kilns. It is possible that the structure was re-used as a machine base, with the slot acting as a pit for gearing.
