Cambrian Archaeological Monographs No. 4

EXCAVATIONS AT CHEPSTOW 1973-1974

by R. SHOESMITH, F.S.A., M.I.F.A.

The Cambrian Archaeological Association, 1991

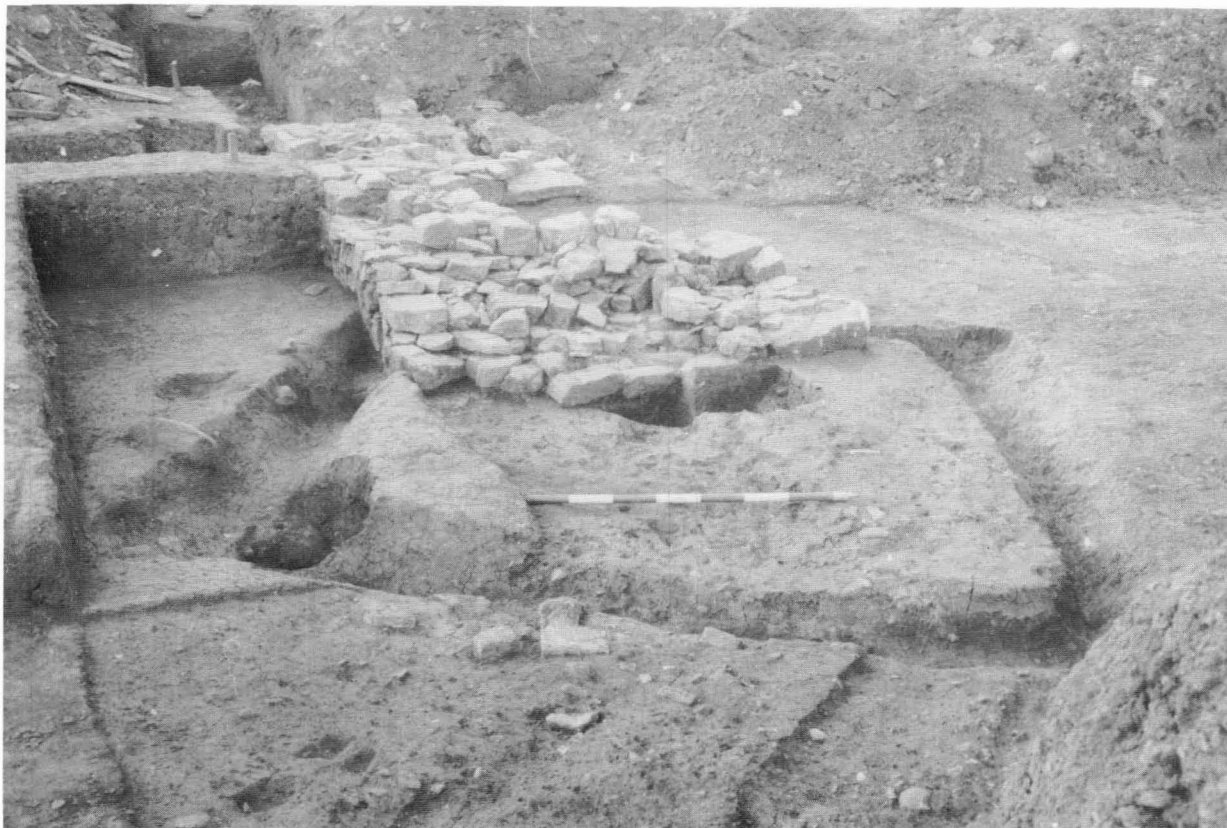
Plate 5 Site 1: Period 1. Foundation trench, F45, for the Roman shrine overlain by the Period 3 wall F28. From the south-east.

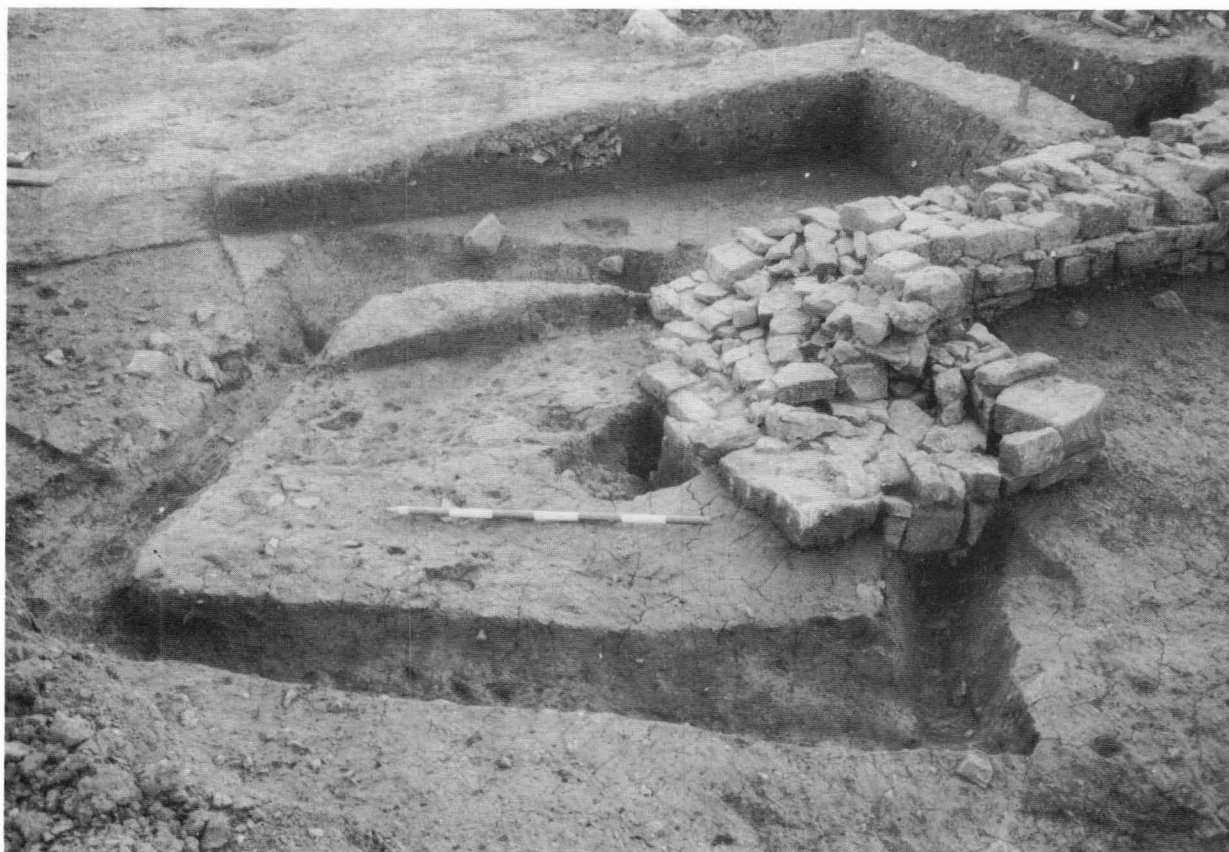
Plate 6 Site 1: Period 1. Foundation trench, F45, for the Roman shrine overlain by the Period 3 wall F28. From the north-east.

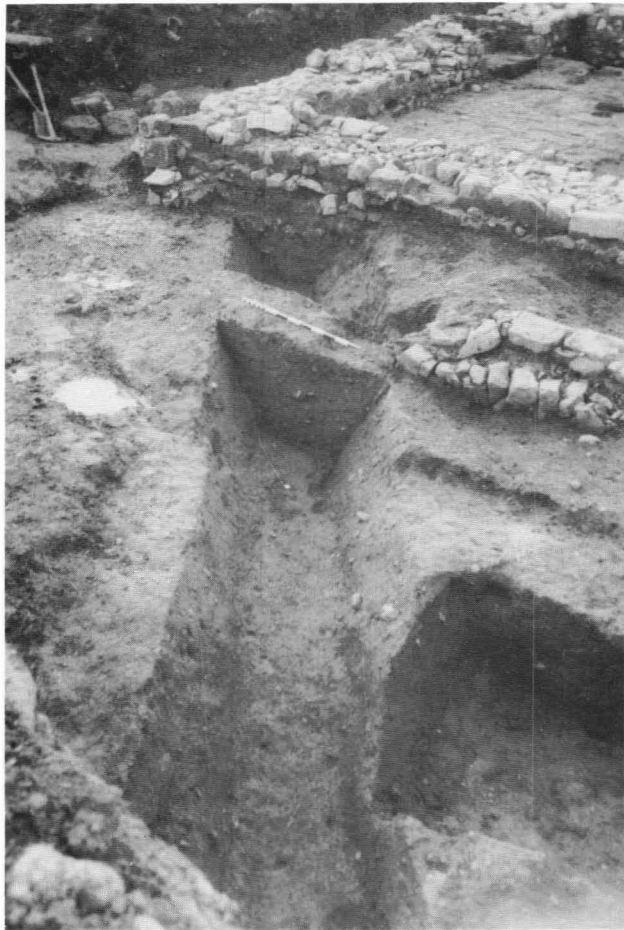
Plate 7 Site 11: Period 1a ditch F56 from the east with wall F4 of Period 3a in the background.
