THE NEW RIVER
THAMES WATER
VICTORIAN MAINS REPLACEMENT WORKS
IN THE VICINITY OF
BLACKSTOCK ROAD, WILBERFORCE ROAD AND RIVERSDALE ROAD
LONDON BOROUGHS OF HACKNEY AND ISLINGTON N4 & N5
DMA MAIDEN LANE 32

AN ARCHAEOLOGICAL WATCHING BRIEF

SITE CODE: TXD11
NGR: TQ 31878 86570

September 2011

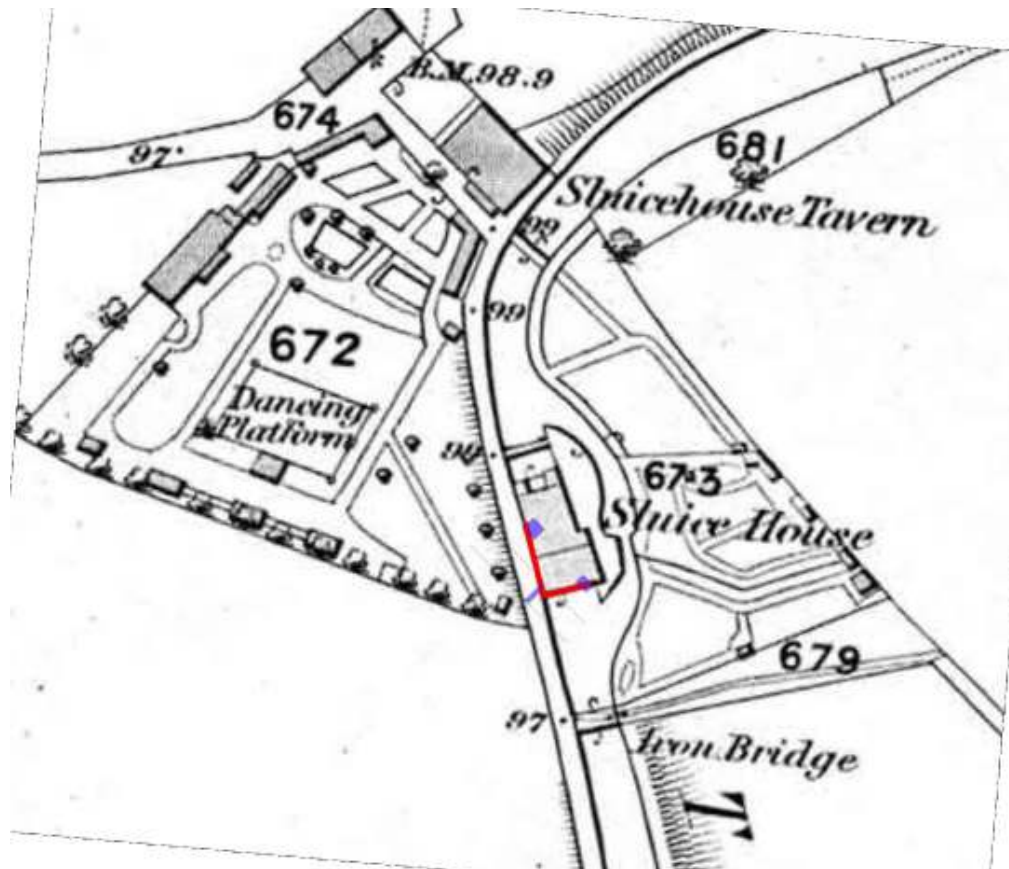
Figure 5: Detail from the Ordnance Survey 1869 map showing the locations of the watching brief Test Pits 1-3 (shown in blue) on Wilberforce Road (*cf.* Section 8.1) and the recorded wall line of the southwest corner of the Sluice House (shown in red).

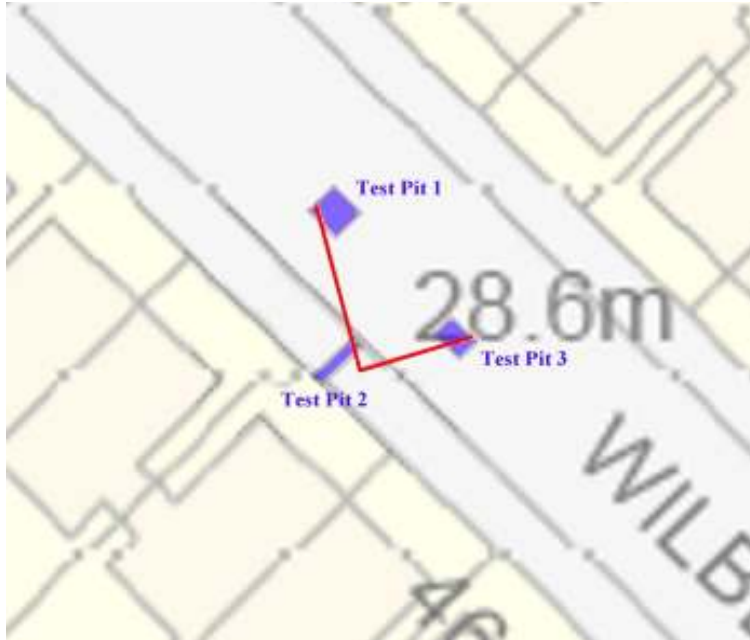
Figure 8: The location of Test Pits 1-3 on Wilberforce Road (shown in blue and discussed in Sections 8.1.1 to 8.1.3 below) and the line of exposed walls (red) in relation to the modern Ordnance Survey map (based on Thames Water Utilities OS Reference Drawing: ZMAIDL32-XX-100-01).

Three pits monitored on 25/11/10 exposed the remains of masonry structures and mortar floors that are thought to be surviving elements of the later 18th century Sluice House that formed part of the New River system. The three pits were recorded as Test-Pits 1 to 3 (Figure 8), pits beyond these contained natural truncated clays (*cf.* Figures 9 to 11).

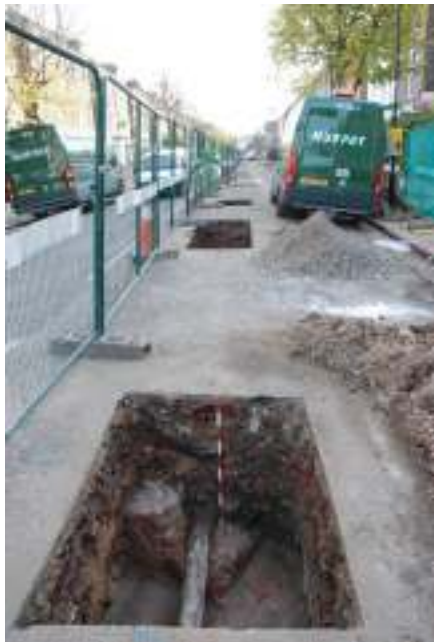
Figure 9: General view looking south down Wilberforce Road from Test Pit 3, showing the nature of water main replacement works on Wilberforce Road. Test Pits 1 and 2 are located to the north of this point. In the next test pits visible, 4 and 5 by the front wheels of the Murphy's van, a stratified sequence of probably natural alluvial clays was recorded (Figures 10 and 11).

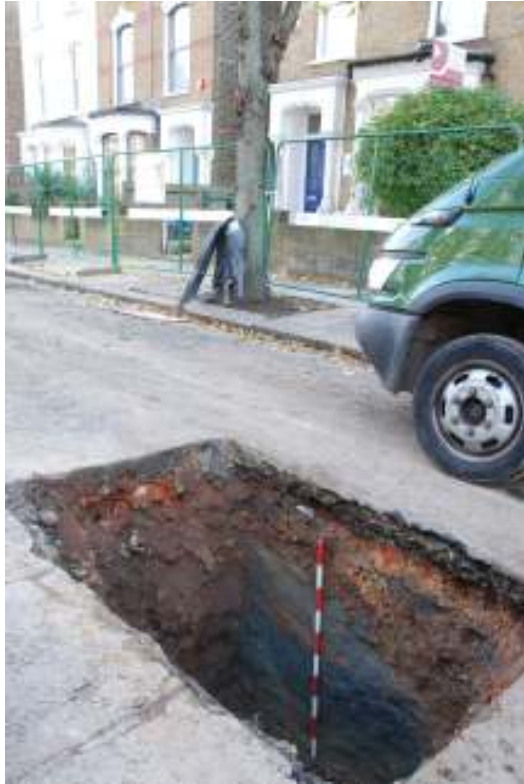
Figure 10: Natural alluvial clays recorded outside no. 46 Wilberforce Road.

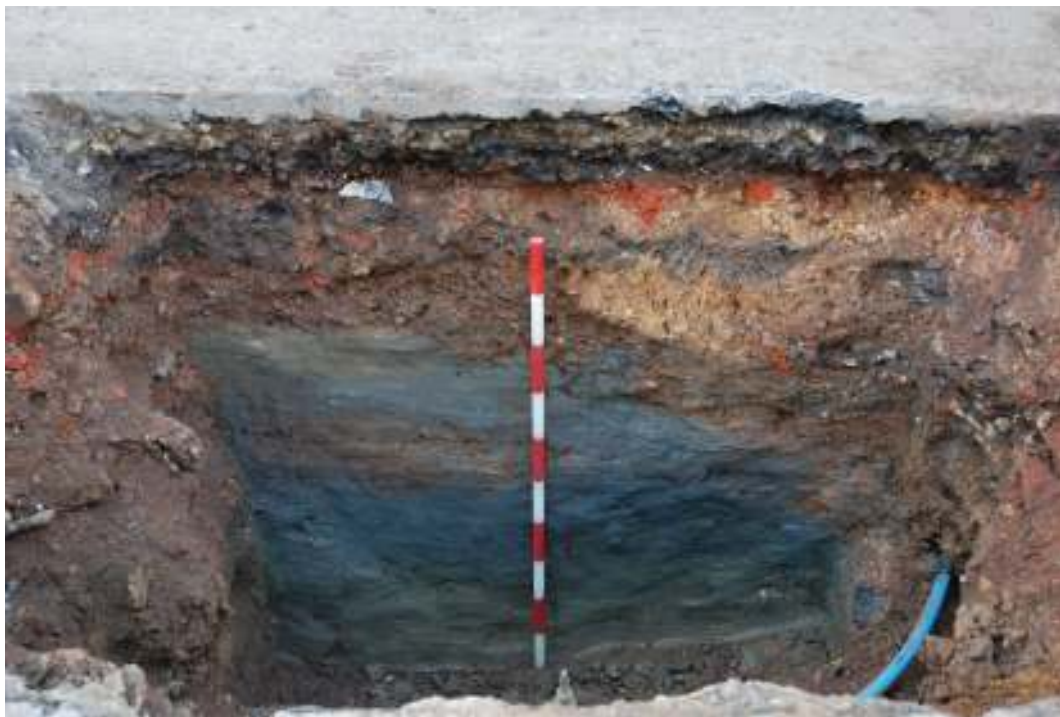
Figure 11: Detail of alluvial clays recorded outside of no. 46 Wilberforce Road and south of the Sluice House recorded in Test Pits 1 to 3.

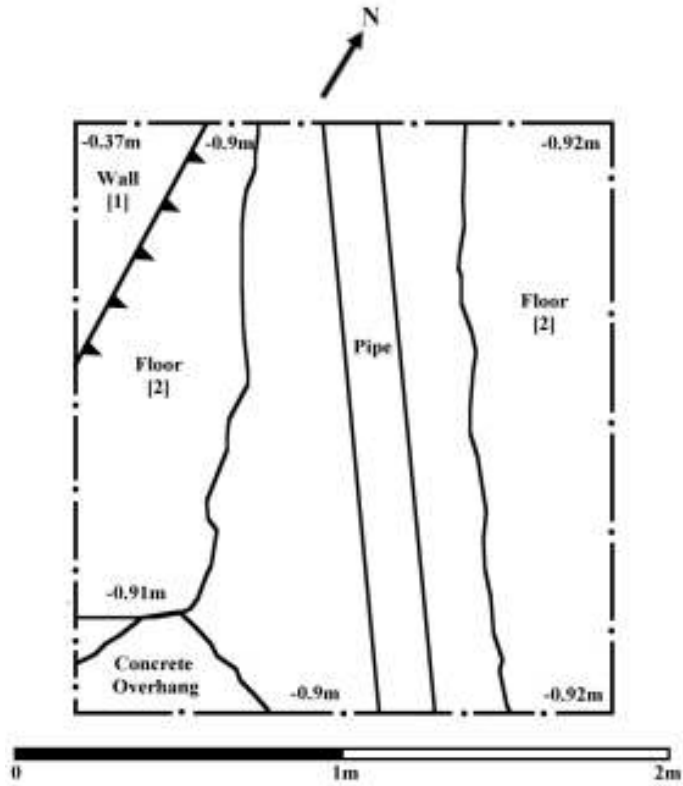
Figure 12: Plan of Test Pit 1 on Wilberforce Road (levels are indicative heights below the current ground surface, which is at approximately +28.80m OD).

Figures 8 (above), and 12 to 14 (below) show a scaled plan and photographs of the structures exposed in Test Pit 1. A detailed discussion of the remains, in relation to those exposed in Test Pits 2 and 3 is presented below (Section 8.1.4).

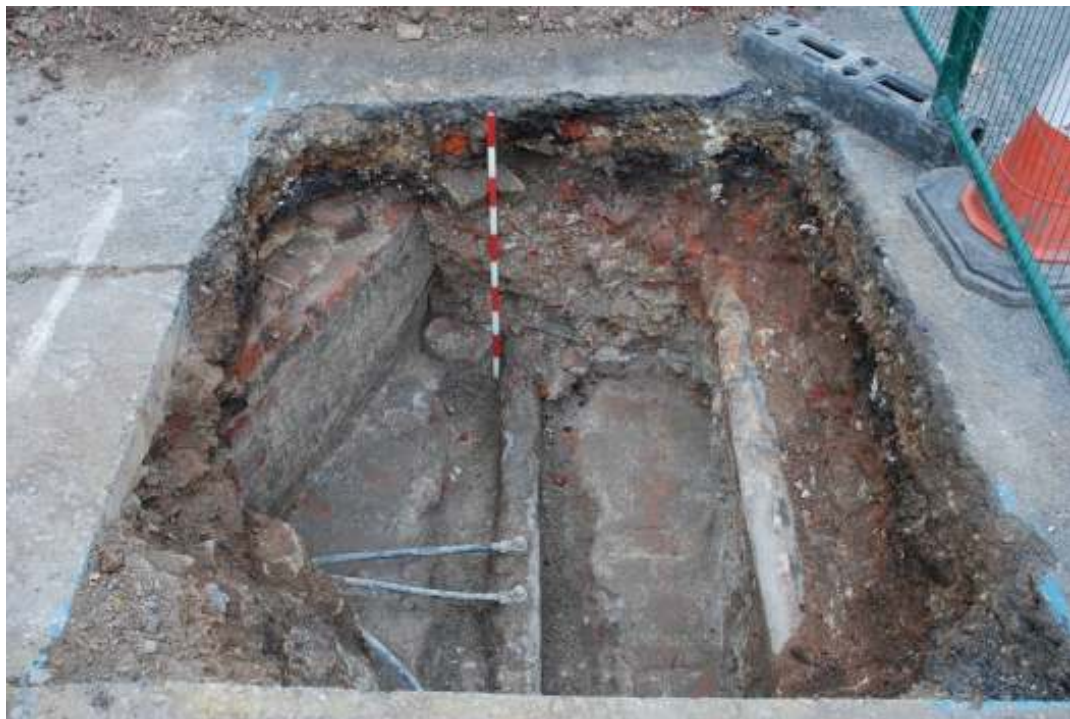
Figure 13: General view of Test Pit 1 showing the brick wall [1] (top left) and mortar floor [2] (cut by centrally placed old service pipe). Looking northwest, 1m scale.

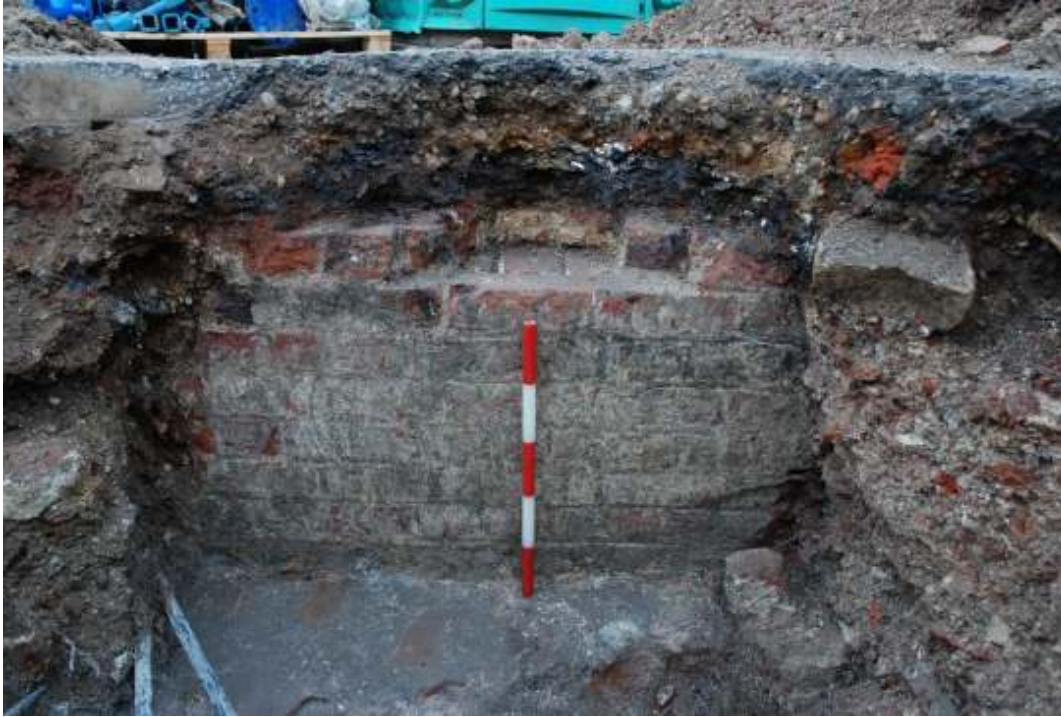
Figure 14: View of brick wall [1] in Test Pit 1 (0.5m scale).

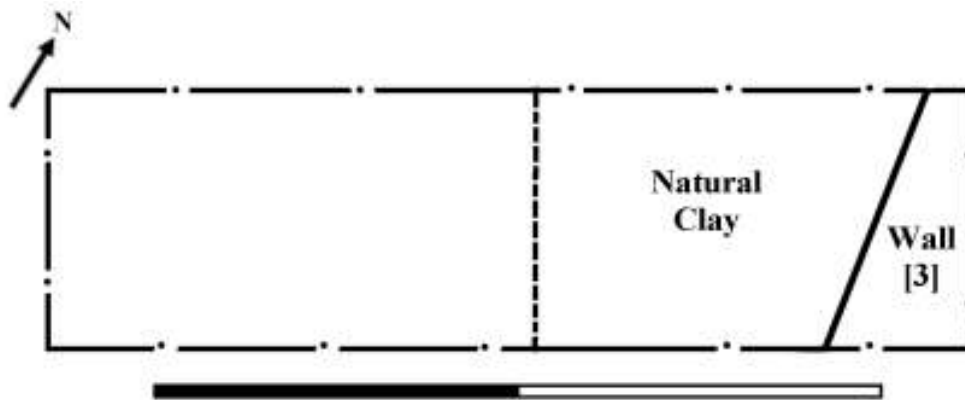
Figure 15: Plan of Test Pit 2 (total scale length 1m).

Figures 15 to 17 (below) show a scaled plan and photographs of the structures exposed in Test Pit 2. A detailed discussion of the remains, in relation to those exposed in Test Pits 1 and 3 is presented below (Section 8.1.4).

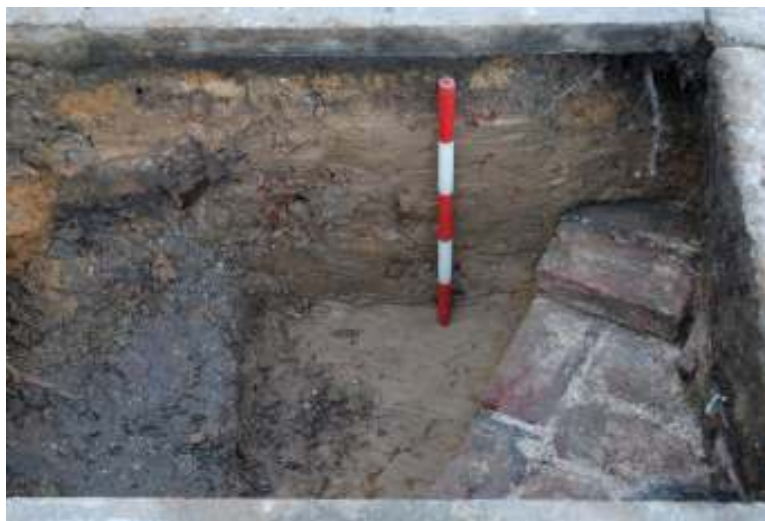
Figure 16: View of brick wall [3] in Test Pit 2 (view northwest, 0.5m scale).

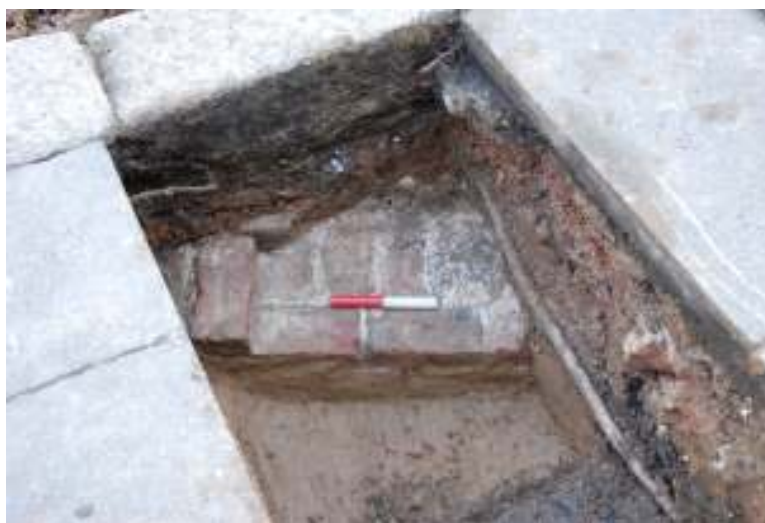
Figure 17: View of brick wall [3] and clay in Test Pit 2 (view east, 0.2m scale).

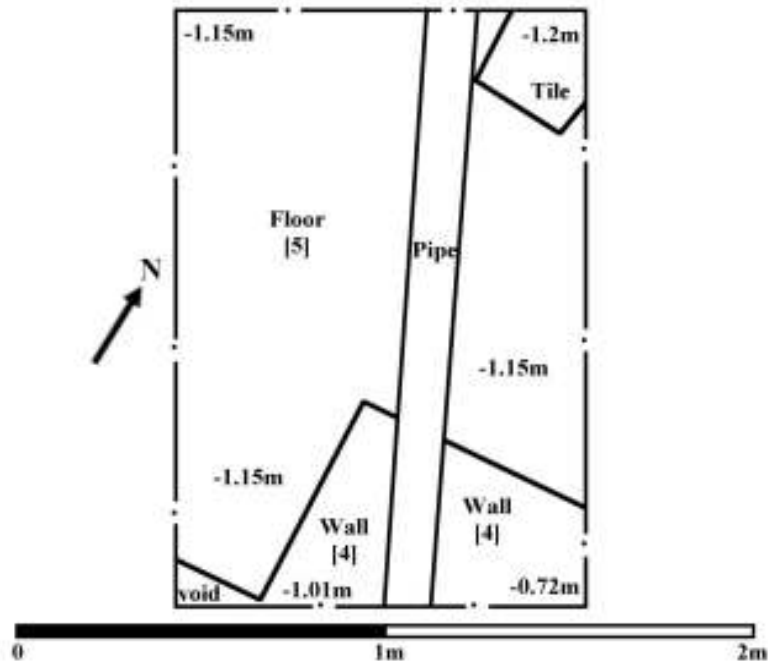
Figure 18: Plan of Test Pit 3. Levels are shown below present road surface, the latter at approximately +28.60mOD.

Figures 18, 19 and 20 below present a scaled plan-drawing and photographs of the remains exposed in Test Pit 3. A more detailed discussion of the remains in relation to those exposed in Test Pits 1 and 2 follows (Section 8.1.4).

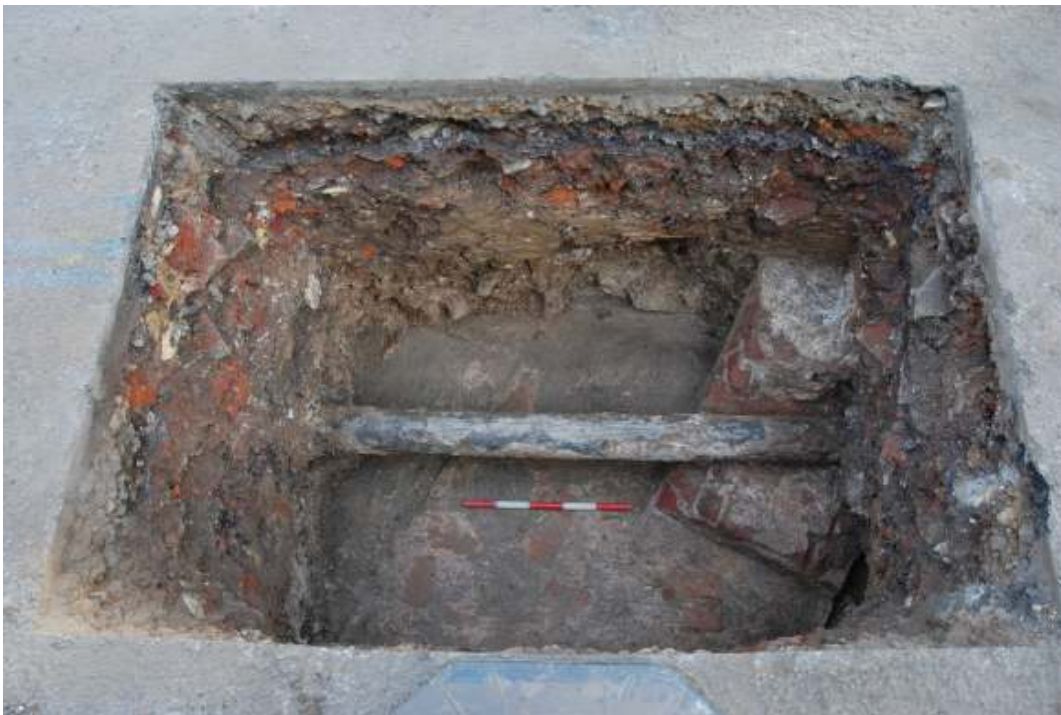
Figure 19: General view of Test Pit 3 (0.5m scale).

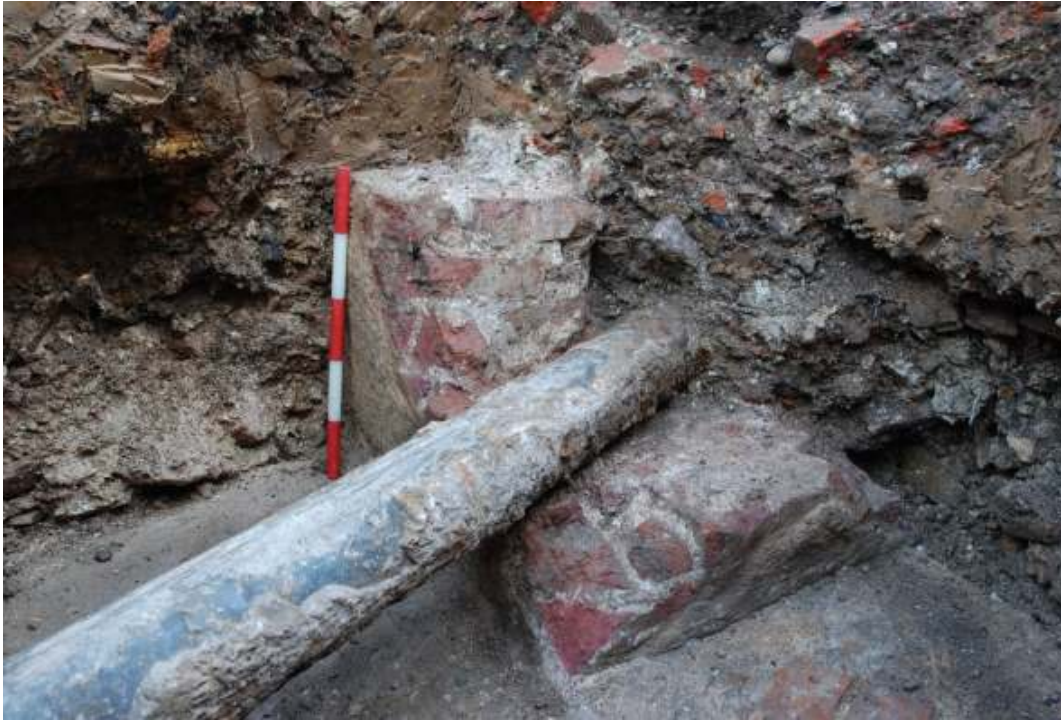
Figure 20: View of wall [4] in Test Pit 3, looking southeast (0.5m scale).

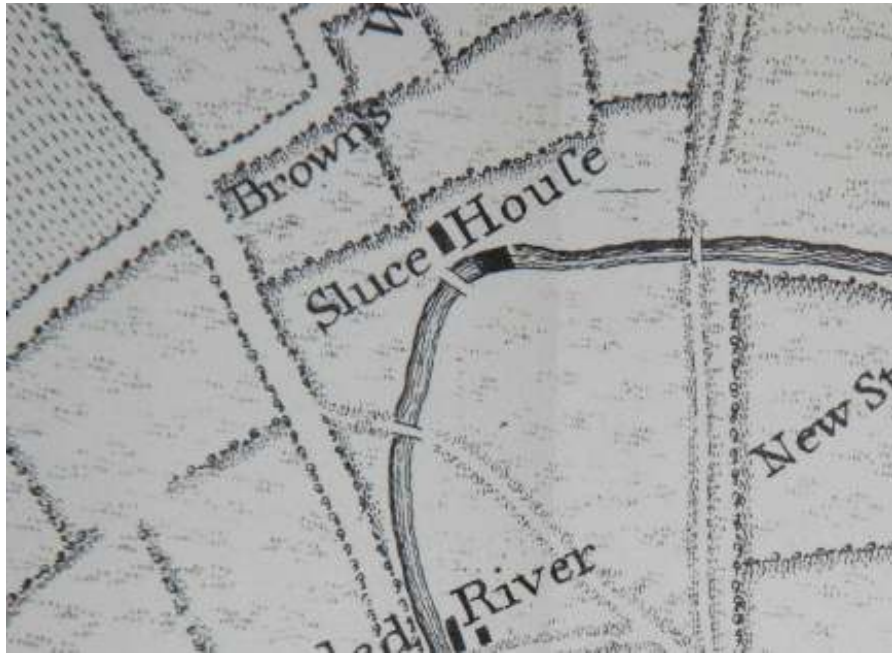
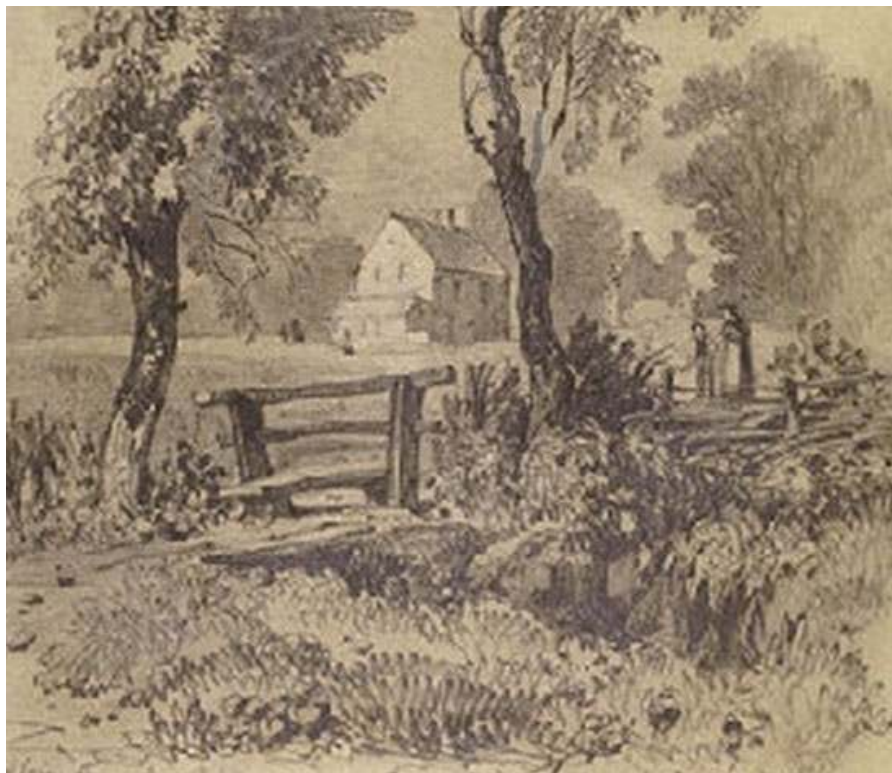
Figure 21: Illustrated Evidence for the Sluce House. Top: detail from John Rocque's map of 1746 showing the '*Sluce [sic] House*' (cf. also Figure 3). Below: '*View of the Sluce House, Finsbury*', by George Hanley, 1823. This illustration appears to be taken from the southeast, the double-pitched roof in the background being the Sluce House Tavern (cf. Cover illustration); London Metropolitan Archive, Wakefield Collection W.F1/NEW.

The New River was constructed between 1604 and 1613 and it is likely that a Sluice House formed part of the construction from its earliest phases, although it may have been constructed in 1619 after the river was rerouted to the south. A Sluice House structure is depicted on Rocque's map of 1746, but analysis of the bricks recovered from the surviving masonry on Wilberforce Road suggests they are part of a later rebuild, *circa* 1780 or later (*cf.* Appendix III Brick Analysis and Figure 21).

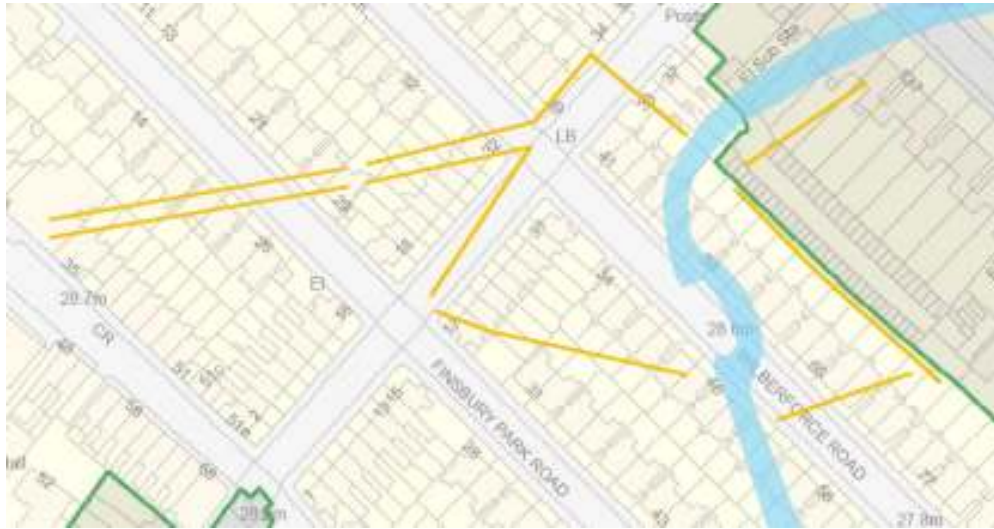
Figure 22: The extent of the Sluice House complex (orange) and New River (blue) in the Wilberforce Rd area in relation to the current Ordnance Survey map (based on Thames Water Utilities OS Reference Drawing: ZMAIDL32-XX-100-01).

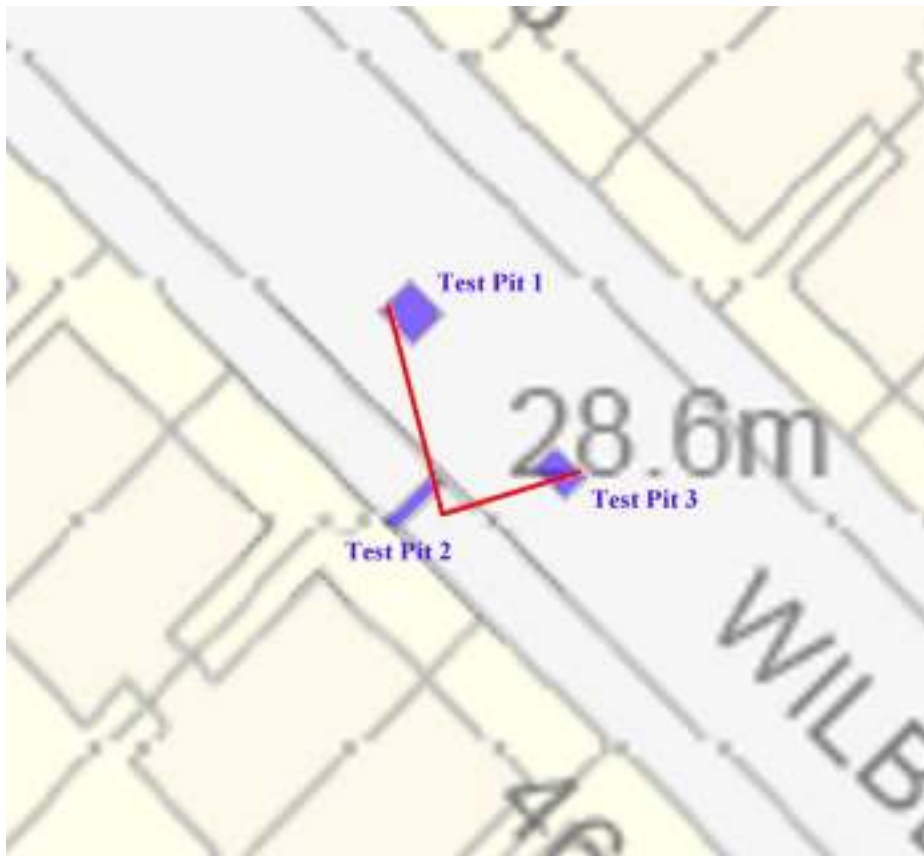
Figure 23: The location of Test Pits 1-3 (blue) and the line of exposed walls (red) in relation to the modern Ordnance Survey map (based on Thames Water Utilities OS Reference Drawing: ZMAIDL32-XX-100-01).

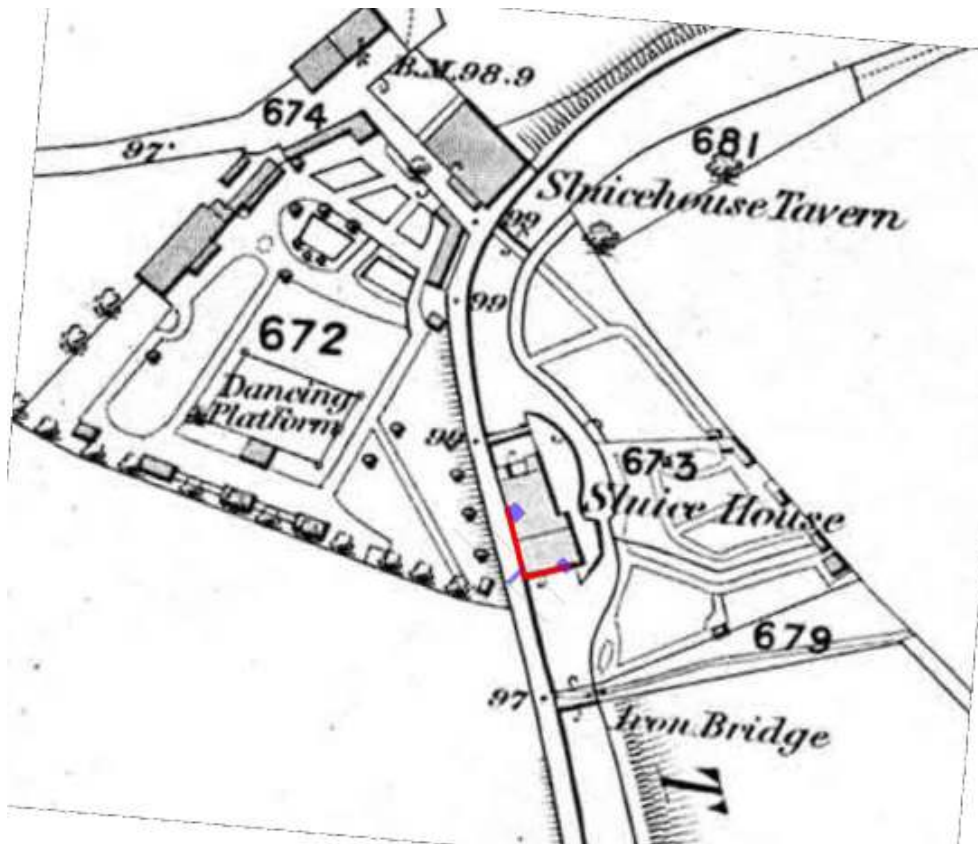
Figure 24: Extract from the Ordnance Survey 1869 map showing the locations of Test Pits 1-3 and the surviving wall line (red).

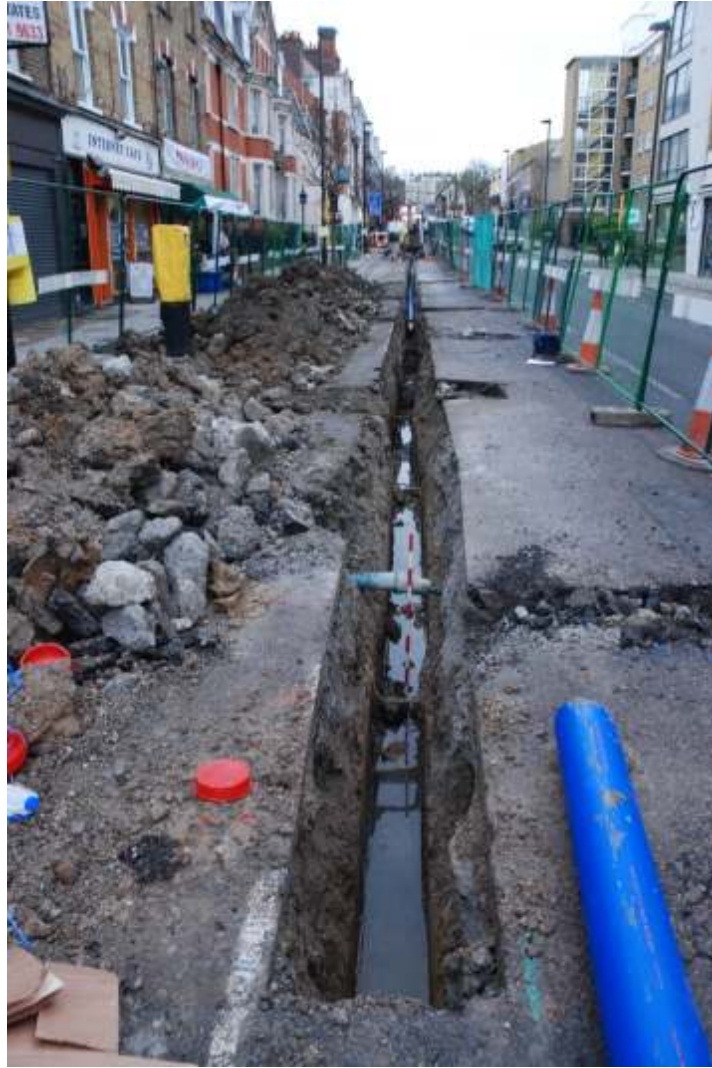
Figure 26 Monitored open-cut trench on Blackstock Road (Trench 1 – 13/01/11) looking south (1m scale).

Approximately 188m of trenching was observed on the east side of Blackstock Road, adjacent to the kerb and running north between the Woodbine Public House (south of Hurlock St) and the south side of the Chatterton Road junction. The trenching was observed in three sections (*cf.* Figure 25 below): Trench 1 (monitored 13/01/11) recorded approximately 90m of open cut trench exposing modern road tarmac overlying concrete hardcore to a depth of 0.8m and truncated natural clay deposits to the remaining depth at 1.1m. Trench 2 (monitored 19/01/11) recorded approximately 32m of open cut trench exposing modern road tarmac and concrete overlying road-makeup rubble to a depth of 0.8m and truncated natural clay deposits to the remaining depth at 1.0m. Trench 3 (monitored 08/02/11) recorded approximately 66m of open cut trench exposing tarmac, concrete and rubble road-makeup to a depth of 0.46m, made-ground consisting of lenses of brick and sand rubble in a silty clay matrix was observed to a depth of 1m, truncated natural clay was exposed at the limit of excavation along the majority of the trench and in section to a depth of 1.4m in deeper areas.

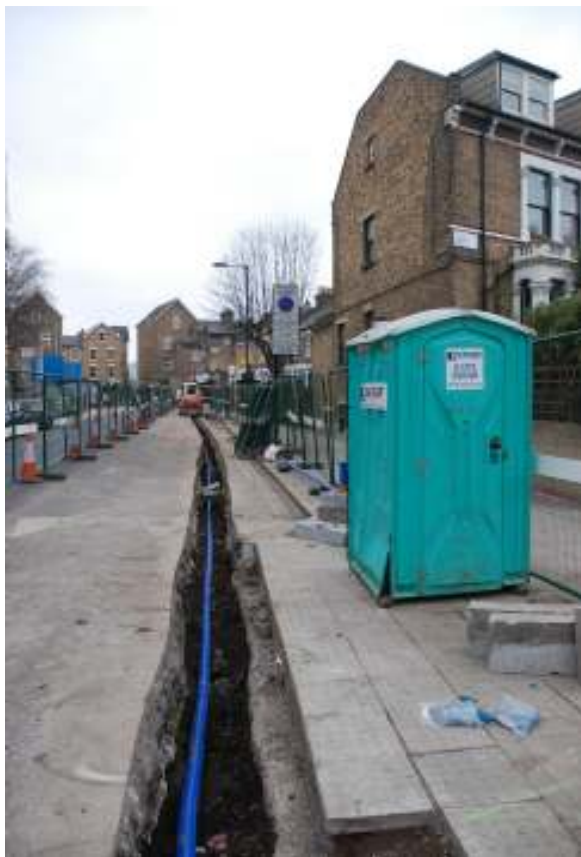
Figure 28: General view of Trench 2 looking approximately west from the junction with Queen's Drive.

Two open-cut trenches measuring 28.8m and 64m respectively were observed in the northern carriageway of Brownswood Road, orientated southwest to northeast and excavated between 1m and 1.3m south of the northern kerb. Trench 1 was excavated between the junction with Wilberforce Road and the access road to Kelvin Motor Wagons and Laura Terrace; the trench measured 0.43m in width and was excavated to a maximum depth of 0.9m below the existing road surface. Trench 2 was excavated between the northeast side of the access road running northeast to the junction with Queen's Drive; the trench measured 0.43m in width and was excavated to a maximum depth of 0.8m below the existing road surface. Both trenches recorded the existing tarmac road surface overlying rubble road make-up to a depth of 0.6m, natural mid-grey/brown clay was observed for the remaining depth. The clay deposits are likely to have been truncated during road construction.

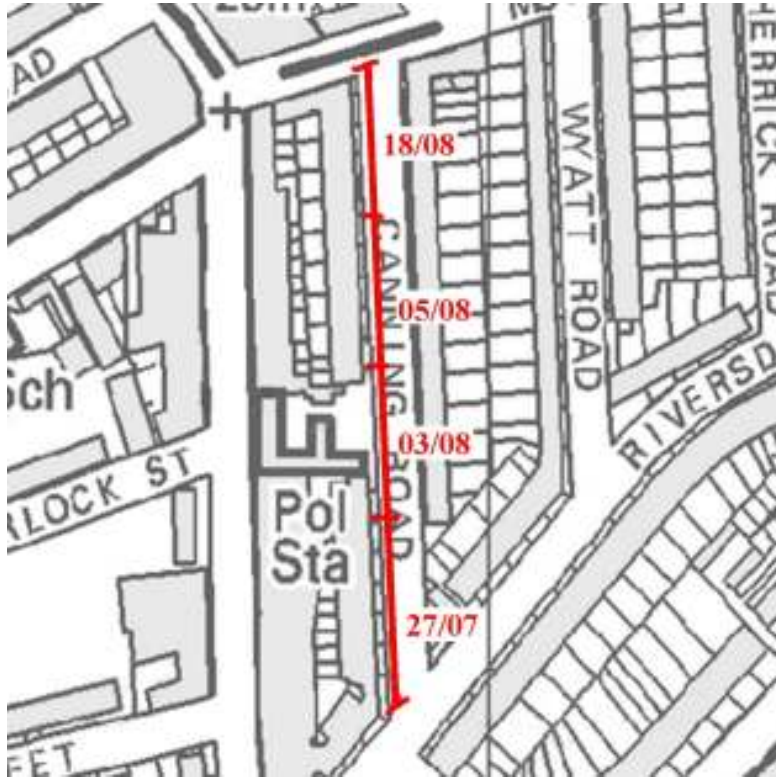
Figure 29: Location of trenching on Canning Road in relation to the current Ordnance Survey 1:2500 map.

All monitored excavations on Canning Road exposed modern road layers and ground make-up deposits (presumably later 19th century), overlying truncated natural clay deposits. No archaeological finds or features were observed, and no evidence for structures or excavations associated with the New River survived. The River is clearly recorded as crossing Canning Road, but it was within an embanked section high above the contemporary land surface. The land surface was generally truncated during the later 19th century redevelopment work to the level of the natural clay (*cf.* Figure 30).

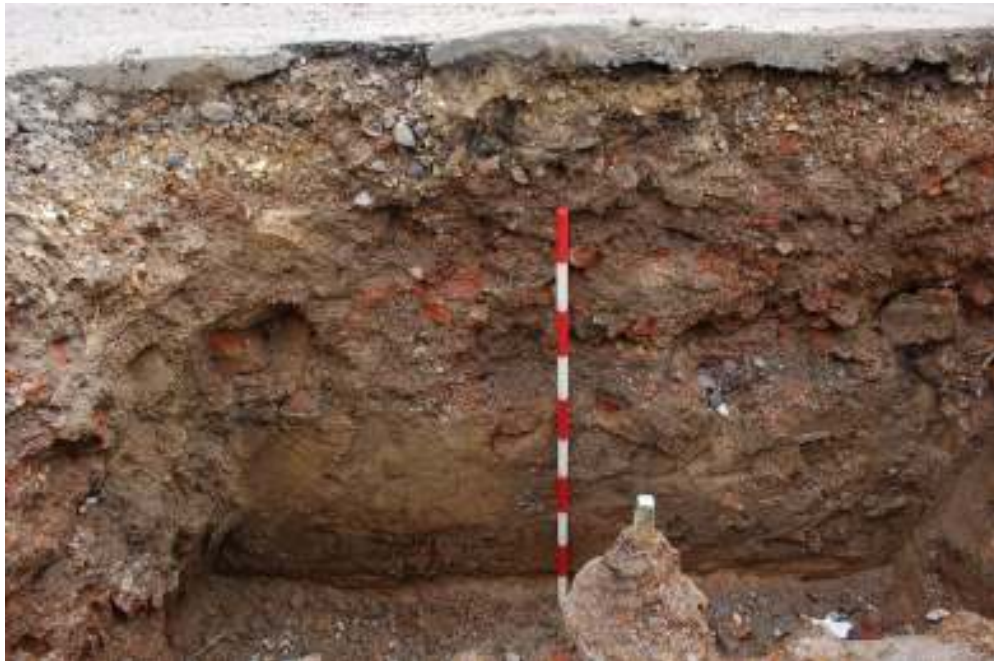
Figure 30: East facing section of a pit on Canning Road (05/08/10) showing made-ground deposits over truncated natural clay (1m scale).

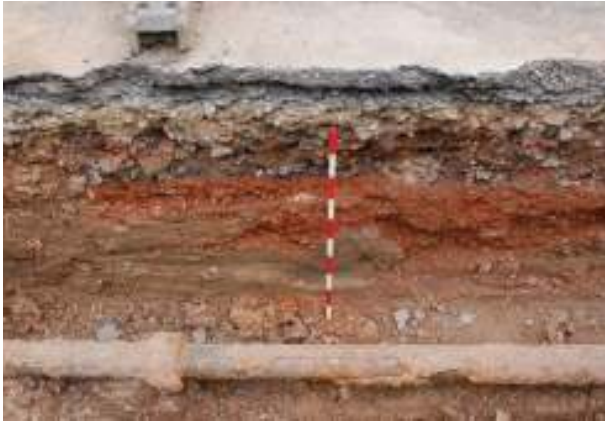
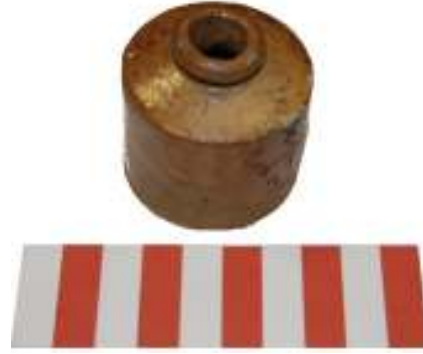
Figure 32: Section of trenching on Finsbury Park Road (12/08/10) and a 19th century stoneware ink bottle from later made ground deposits (10cm scale).

The finds recorded (but not retained) during trenching on Finsbury Park Road are all typical 19th century domestic wares and were recovered from deposits with high quantities of crushed 19th century red and yellow brick. The deposits are likely to represent ground levelling and make-up contemporary with the construction of Finsbury Park Road in the late 19th century. The exposed sequence suggests the ground was levelled to the natural clay horizon resulting in the truncated deposits recorded in section, and subsequently built-up using building rubble and domestic rubbish to create a hard-core base for the road surface.

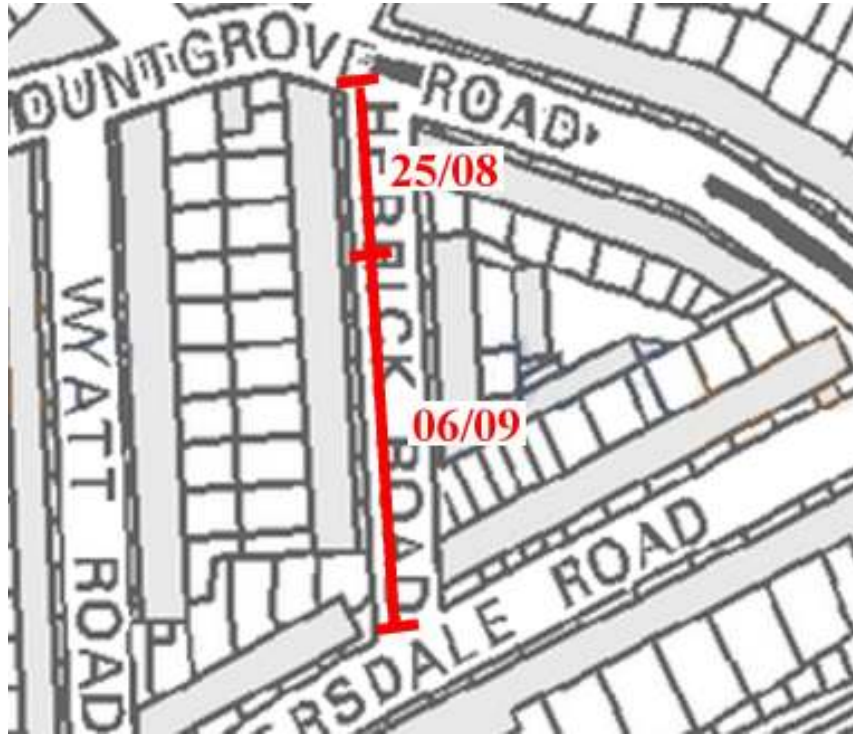
Figure 33: Trenching on Herrick Road in relation to the current Ordnance Survey 1:2500 map.

Trenching on Herrick Road exposed a simple sequence of modern road layers overlying a series of 19th century dump layers, which in turn overlay truncated natural clay deposits. The dump layers contained a large assemblage of 19th Century brick, pottery, glass, clay pipe and other domestic waste, of which a small sample was recorded but mainly not retained (see summary table below). The exposed sequence suggests the ground was reduced and levelled to the natural clay horizons resulting in the truncated deposits recorded in section, and subsequently built up with a mix of building and domestic rubble to provide a hard base for the overlying road surface. The original Victorian main was exposed in the northern end of Herrick Road with associated 19th Century backfill deposits.

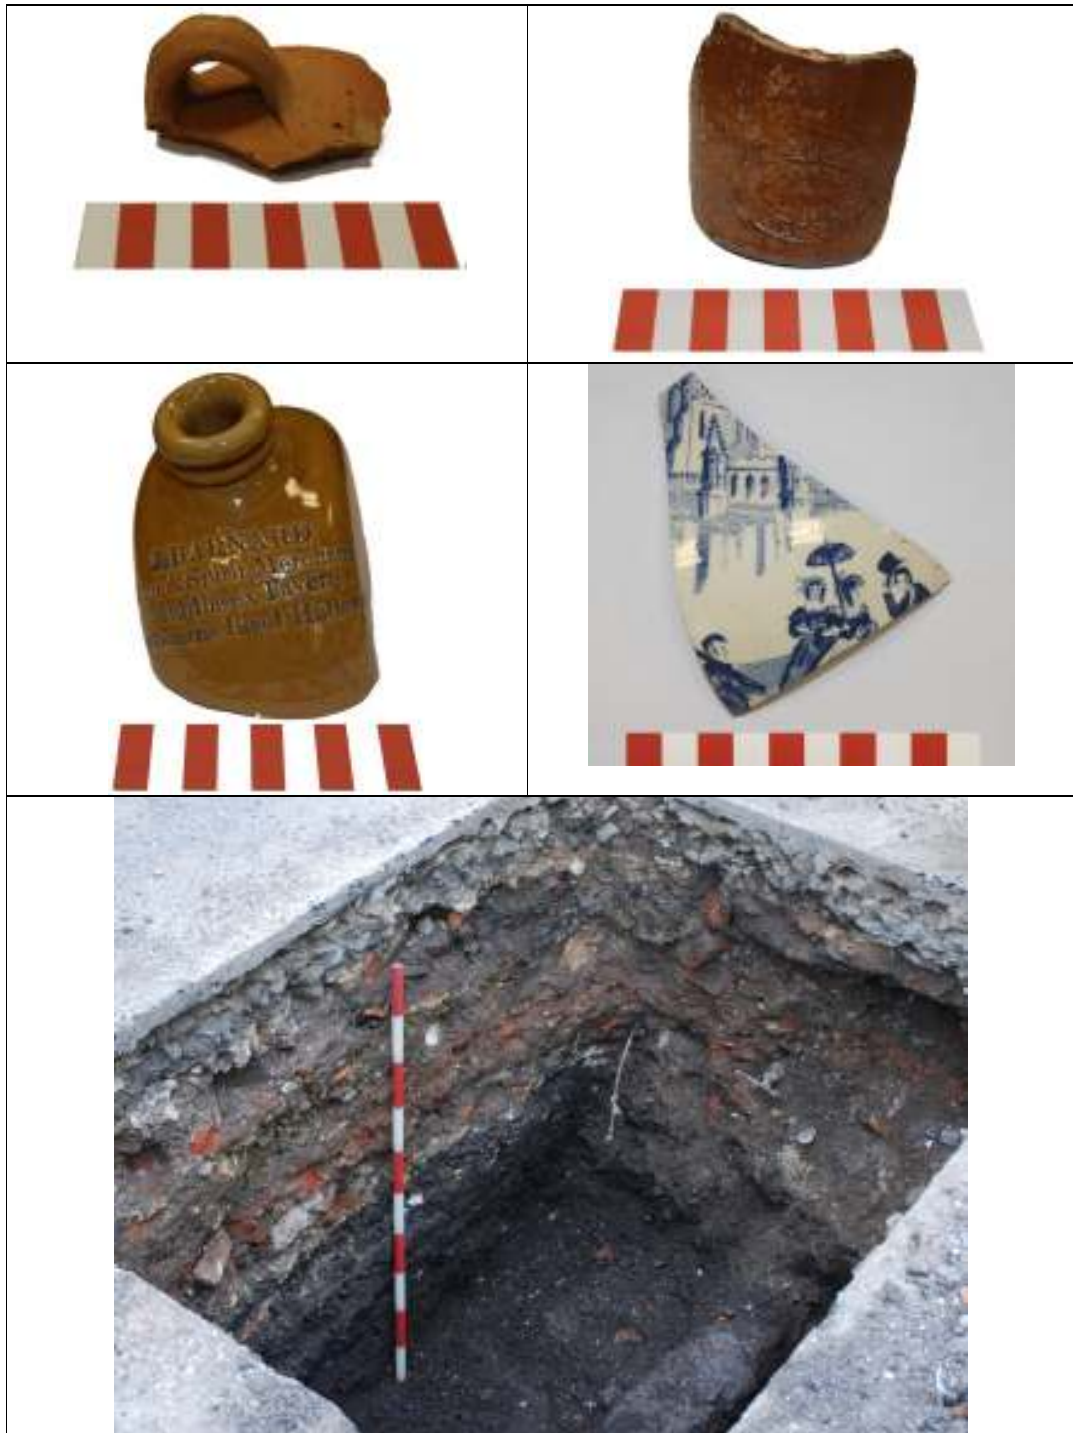
Figure 34: Retained finds from trenching on Herrick Road (top left: Post-medieval redware jug or cauldron handle [Context 3], top right: Denby bottle base [Context 2], middle left: Middlesex Tavern bottle top [Context 2]), middle right transfer printed ware and below west facing section of trial pit (25/08/10 – 1m scale).

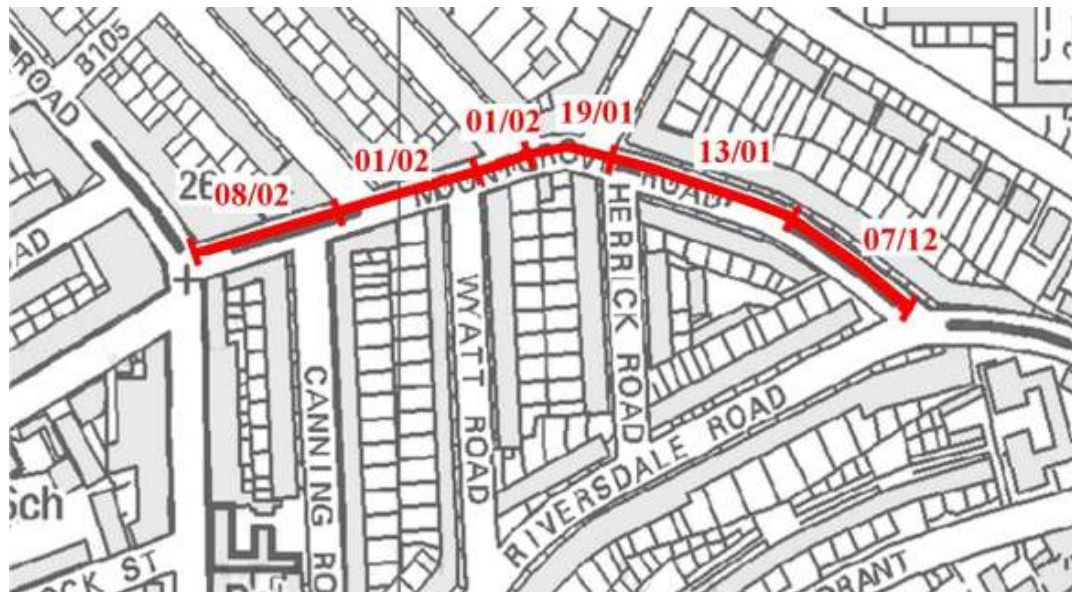
Figure 35: Location of trenching on Mountgrove Road in relation to the current Ordnance Survey 1:2500 map.

The majority of trenching on Mountgrove Road exposed the similar sequence of modern road layers overlying made-ground deposits and truncated natural clay. However, open-cut trenching and trials holes between King's Crescent and Wilberforce Road exposed deep deposits of domestic rubbish overlain by a thin layer of crushed red brick. These deposits may represent ground consolidation in the 19th century, or alternatively they may be part of the wider backfill for the Victorian sewer exposed in the Wilberforce Road junction – unfortunately the extent of the cut for this feature was not exposed. Mountgrove Road follows the historic line of the Hackney Brook, but no evidence for the watercourse was recorded or of the bridge which once stood towards the western end of the road and carried the New River over the Hackney Brook. A summary of the finds recorded from these deposits is presented in the table below; the pottery constitutes typical 19th century domestic wares and the bottle tops and ink bottle are also typical of the period (not retained).

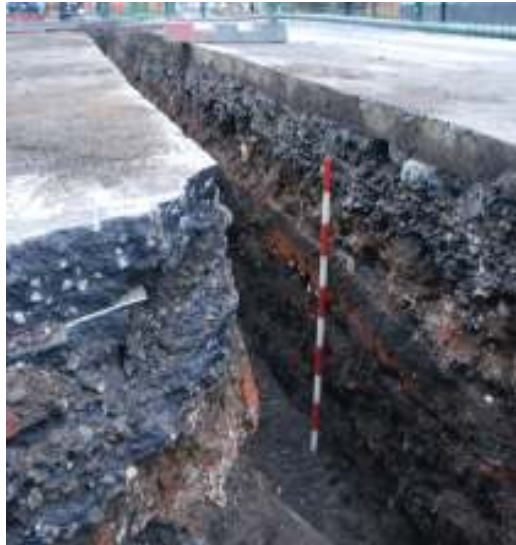
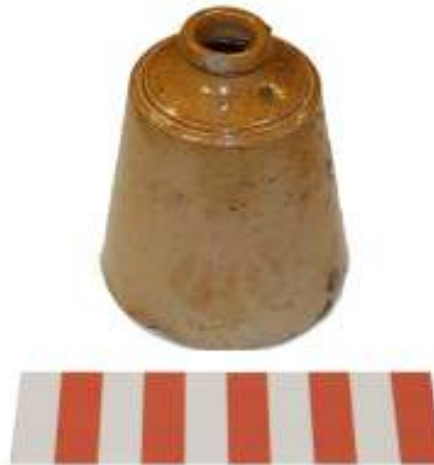
Figure 36: Trenching on Mountgrove Road and a recovered Victorian ink bottle.

Date	Finds	Discussion
19.01.11	Ink bottle 5 pottery sherds	Small stoneware ink bottle (see Figure 36) Typical 19 th century domestic wares.
19.01.11	7 pottery sherds	19 th century, includes 3 bottle/jug rims.

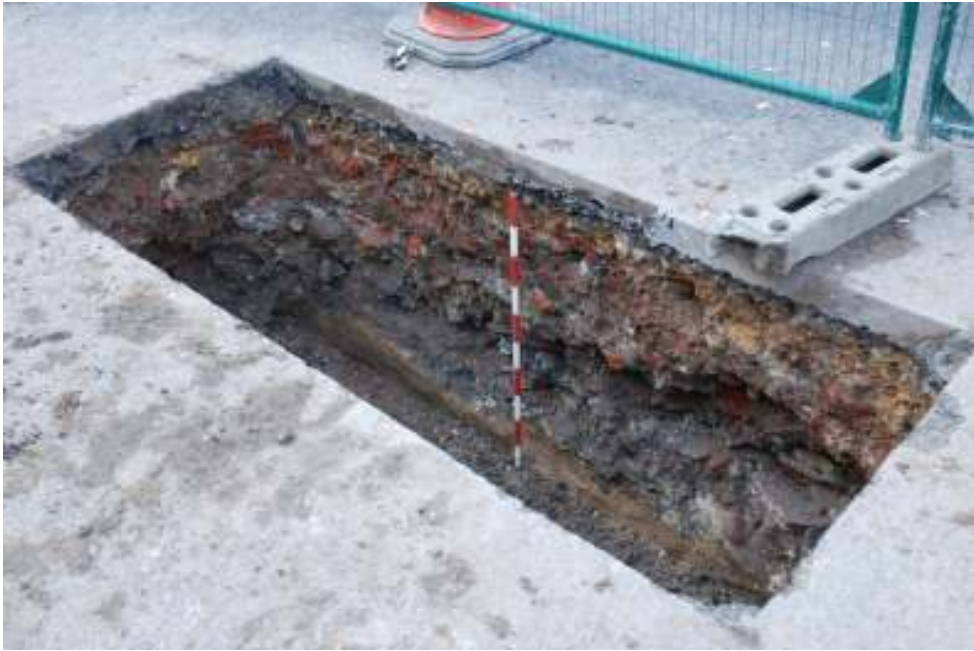
Figure 38: Trenching on Riversdale Road, southeast facing section (1m scale).

Monitoring on Riversdale Road recorded a relatively uniform sequence of modern road layers and made-ground deposits overlying truncated natural, grey clay. The sequence suggests that the area was levelled into the horizon of the clay natural and subsequently built up before the road was laid out. No archaeological finds or features were observed during the course of the archaeological watching brief.

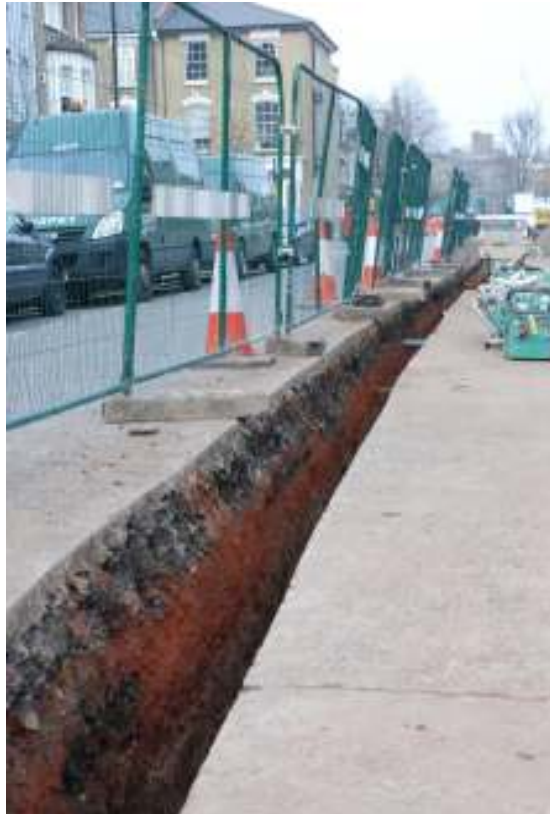
Figure 40: Trenching on Somerfield Road, showing evidence of the red brick made ground layer, which formed a base for the late 19th century road.
