THE NEW RIVER
THAMES WATER
VICTORIAN MAINS REPLACEMENT WORKS
IN THE VICINITY OF
BLACKSTOCK ROAD, WILBERFORCE ROAD AND RIVERSDALE ROAD
LONDON BOROUGHS OF HACKNEY AND ISLINGTON N4 & N5
DMA MAIDEN LANE 32

AN ARCHAEOLOGICAL WATCHING BRIEF

SITE CODE: TXD11
NGR: TQ 31878 86570

September 2011

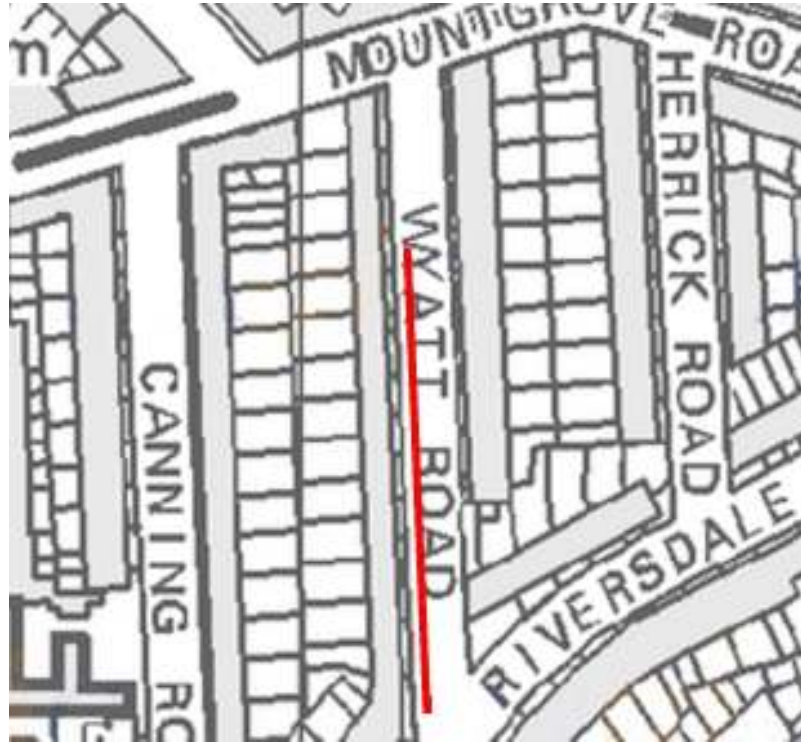
Figure 41: Location of trenching on Wyatt Road in relation to the current Ordnance Survey 1:2500 map.

Trenching on Wyatt Road constituted 17 pits and trial holes, totalling 29.2m of open ground. Figure 41 below shows the extent of Wyatt Road covered by the archaeological watching brief. The majority of trenches exposed tarmac over a gravel base to an average of 0.25m below the existing ground surface. Made-ground deposits or road consolidation layers consisting of rubble and domestic debris in a dark silty matrix were exposed at an average thickness of 0.35m. Dark greenish-grey silty clay, truncated natural was exposed to an average depth of 1.2m in the northern part of Wyatt Road. In the southern part of Wyatt Road, towards the junction with Riversdale Road, one pit exposed compacted clean gravel which is thought to represent part of the New River embankment (*cf.* Figure 42). Further south, two pits exposed alluvial type deposits directly below the present road base; one of these is thought to be part of the surviving river bed, however, the other may be part of a separate small pond-like feature, adjacent to the west bank of the River (*cf.* Figure 4, OS 1869 plan).

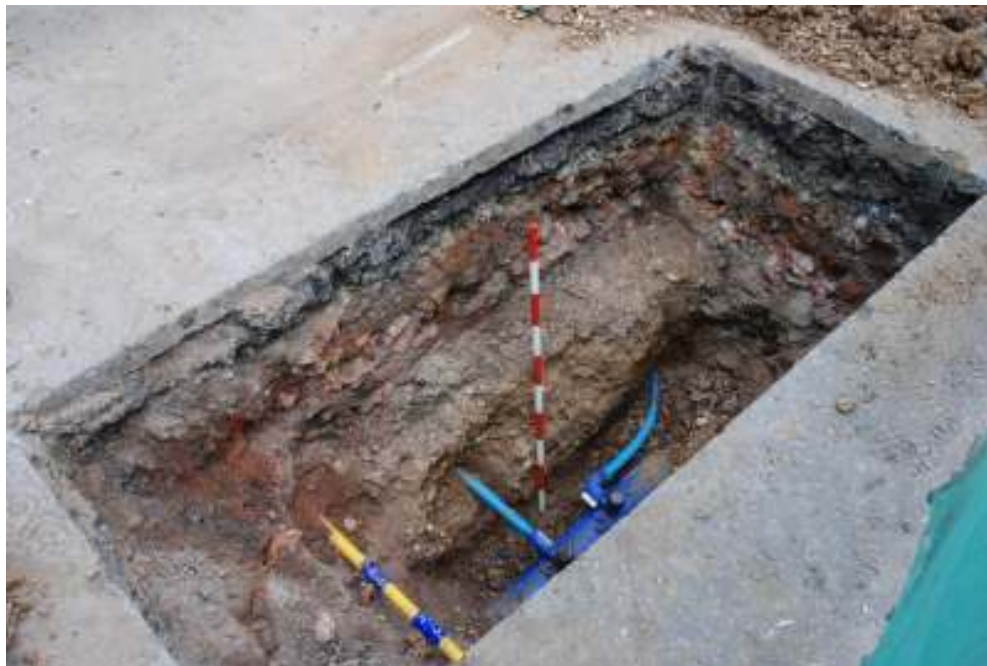
Figure 42: Pit at the south end of Wyatt Road showing clean gravel towards the base of excavations.

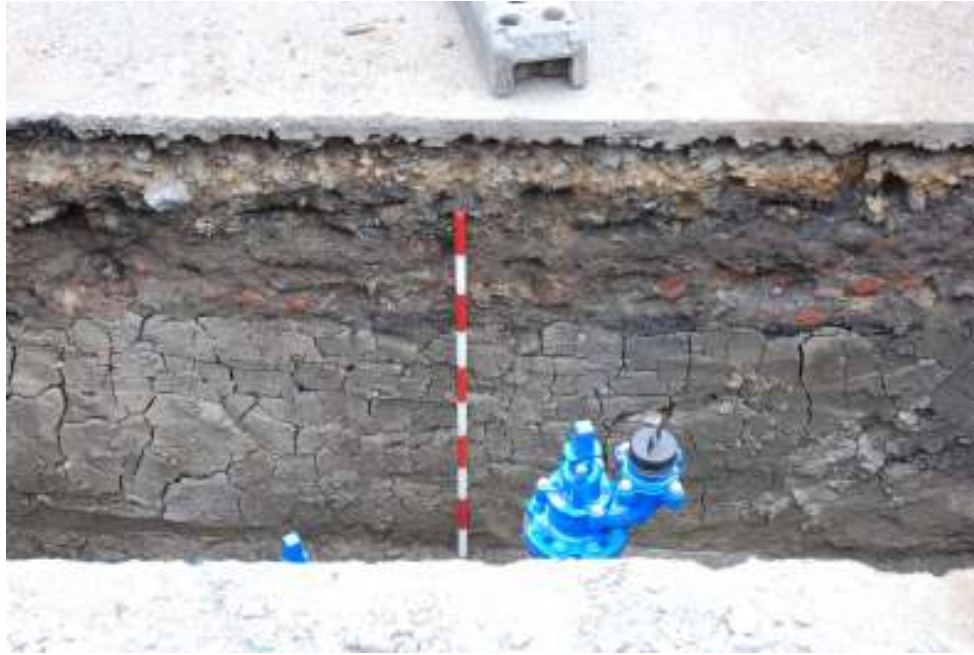
Figure 43: Pit at the Wyatt Road and Riversdale Road junction showing modern road layers overlying alluvial deposits.
