**THAMES WATER VICTORIAN MAINS REPLACEMENT  
WORKS IN THE VICINITY OF CITY ROAD**

**LONDON BOROUGH OF ISLINGTON  
(DMA CROUCH HILL 61)**

**AN ARCHAEOLOGICAL WATCHING BRIEF**

SITE CODE: TZS09

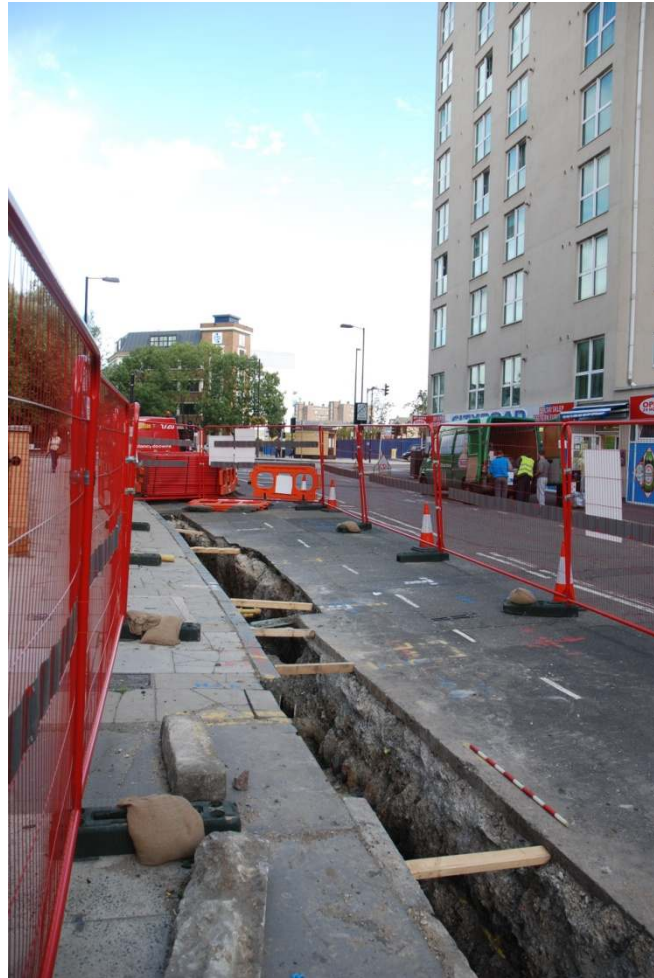
Approximately 107m of open-cut trenching was observed along Central Street, running from the junction with Moreland Street south to the junction with President Street (see Figure 3) and running adjacent to the western kerb. The majority of the trenching exposed the existing tarmac road surface overlying concrete hardcore to an average depth of 0.4m. Modern service cuts and backfills and modern made-ground layers were observed to the remaining depth of excavation in the northern end of the trenching, to *c.* 1.1m below the existing road surface. In the southern end of the trench, approximately outside the Central Street Bar, and opposite the junction with President Street, a small section of brick-wall was exposed in the east side of the trench. The bricks were typical 19<sup>th</sup> century yellow London stock bricks laid in alternating courses of stretchers and headers, and surviving to a maximum height of six courses (0.6m). The exposed wall in the west-facing section appeared to be an internal face (aligned north-south), with an east-west return to the south. The exposed brickwork is likely to be the surviving front wall of a coal-cellar belonging to one of the properties fronting Central Street in the latter half of the 19<sup>th</sup> century, subsequently demolished.

**Figure 4:** General view of trenching on Central Street, looking north to the junction with Moreland Street (1m scale).

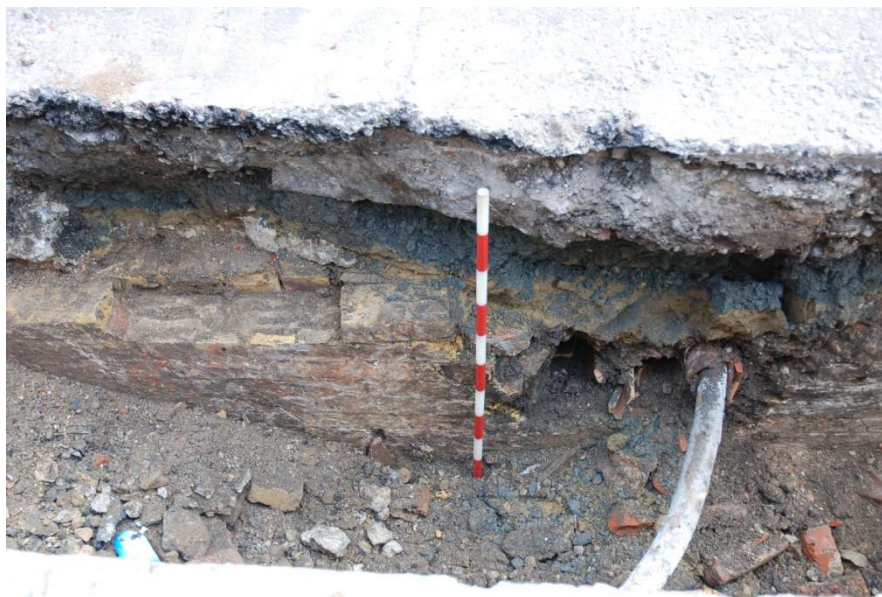
**Figure 5:** Cellar wall in the west facing section of trenching on Central Street , cut by a modern service and backfill (1m scale).

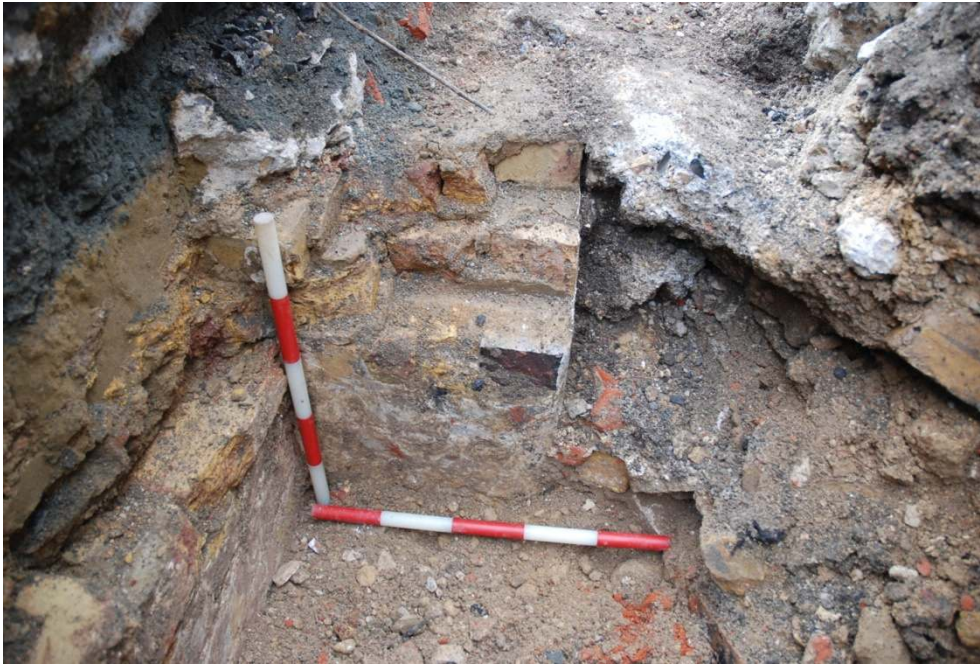
**Figure 6:** Trenching on Central Street showing the east-west return of a brick cellar wall, view south (0.5m scales).

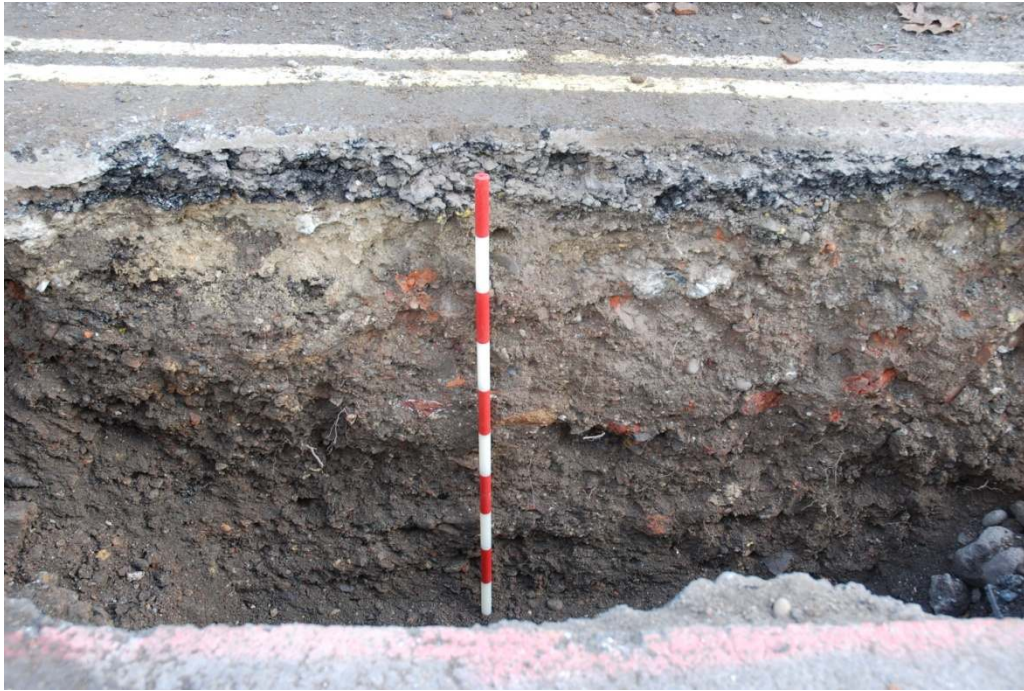
Approximately 261m of City Garden Row was monitored, running south from the junction with Roccliffe Street towards City Road. The existing tarmac road surface was observed overlying varying depths of concrete and crushed stone hard-core. Trenching immediately south of the Coombs Road junction exposed an earlier road surface of concrete cobble directly overlain by the existing tarmac. Various modern services and associated backfills were observed across the trenching and launch pits, to an average depth of 0.9m below the existing road surface. Orange-brown clay was observed near the Coombs Street junction at c.0.9m depth, and at a similar depth immediately north of the City Road junction – the clay is likely to be redeposited natural, possibly dumped as ground-makeup following the early 19<sup>th</sup> excavations of the City Road Basin (c.1820) to the east. Further deposits of made-ground were observed along City Garden Row, consisting of mid-dark brown-grey silty clay with brick, gravel and charcoal inclusions, underlying modern road layers. These deposits are likely to represent ground makeup either as part of the major canal and Basin excavations to the west, or during the residential developments of the later 19<sup>th</sup> century – prior to this wide-scale development, the area was part of the City Gardens (pleasure gardens) for which this street is named. A launch pit immediately north of the Coombs Street junction exposed a small section of brickwork at a depth of 0.85m, surviving as a single course, six bricks wide laid as headers. The bricks had no adhering mortar and no visible frog being flat on all faces. The bricks are likely to be of earlier 19<sup>th</sup> century date, and may represent the surviving section of feature relating to the City Gardens, prior to the residential of the area and subsequent ground makeup.

**Figure 7:** West facing section of trenching on City Garden Row immediately south of the Rocliffe Street junction, showing 19<sup>th</sup> century buried made-ground deposits overlain by modern made-ground and road layers (1m scale).

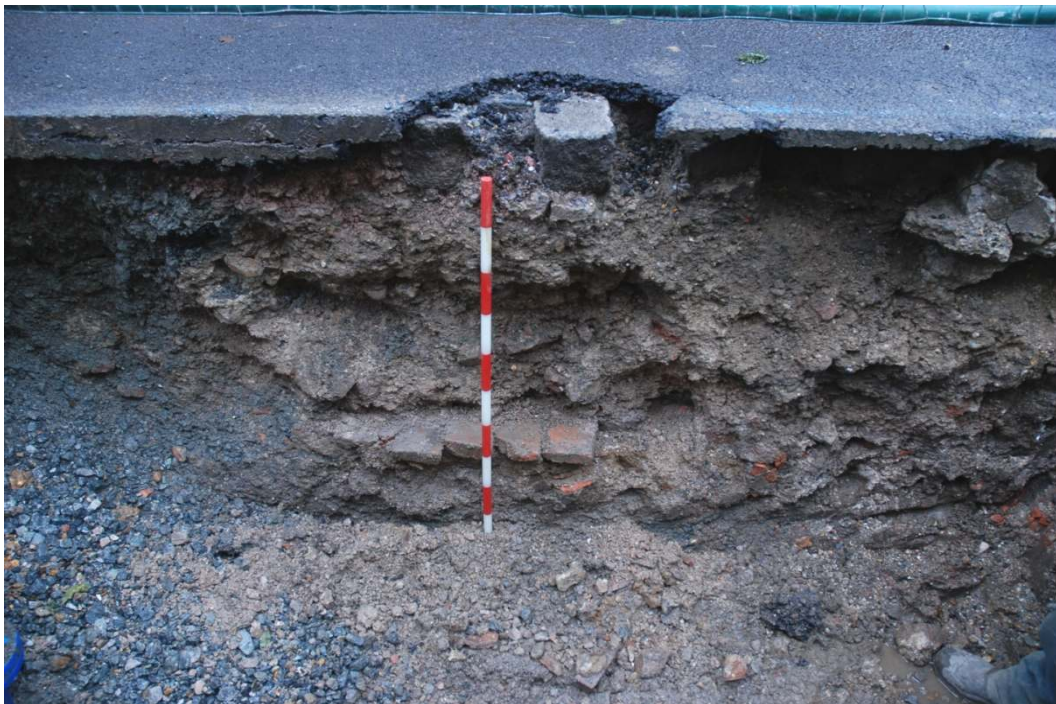
**Figure 8:** Single course of 19<sup>th</sup> century brick-work exposed in trenching immediately north of Coombs Street (1m scale).

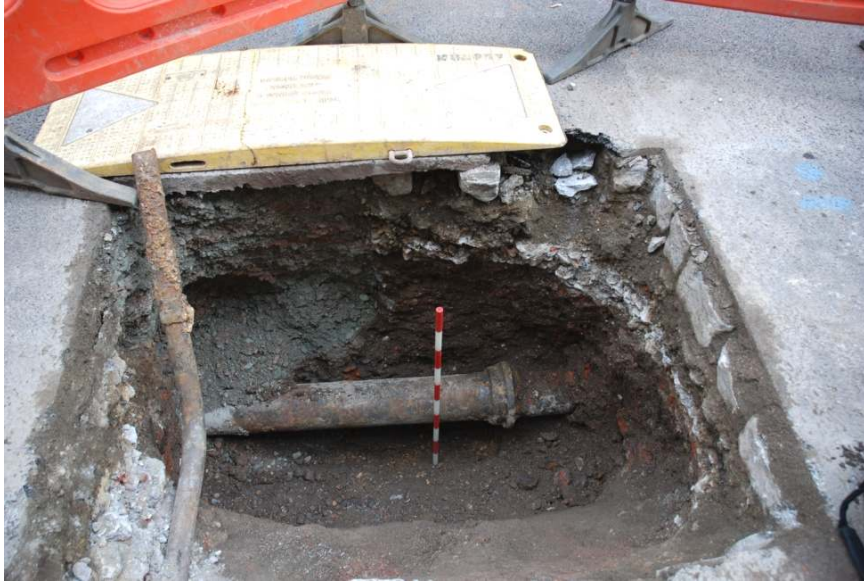
**Figure 9:** Trenching on the east side of City Garden Row c.35m north of the City Road junction, showing cut and backfill of the Victorian water main (1m scale).

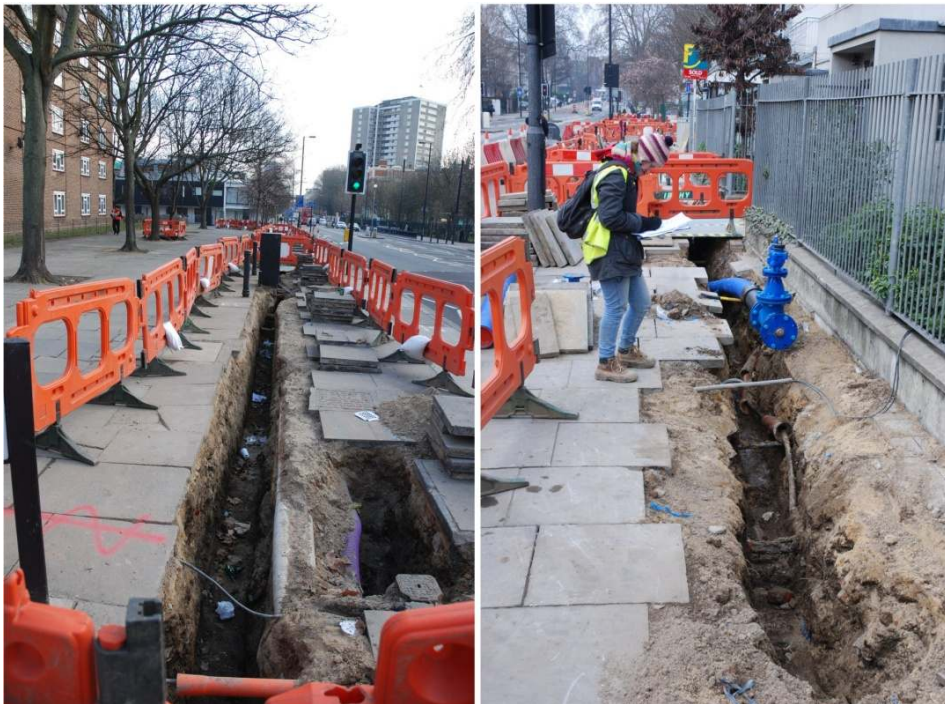
Approximately 238m of City Road were monitored between the junction with Nelson Terrace running east to the junction with City Garden Row. All trenching exposed modern road layers or paving overlying modern service cuts and associated backfills, to an average depth of 1.05m below the existing ground level. No archaeological finds or features were observed during monitoring on City Road.

**Figure 10:** Trenching on City Road, to the east of Nelson Terrace (left) and to the east of Haverstock Street (right), showing modern road and paving over service deposits.

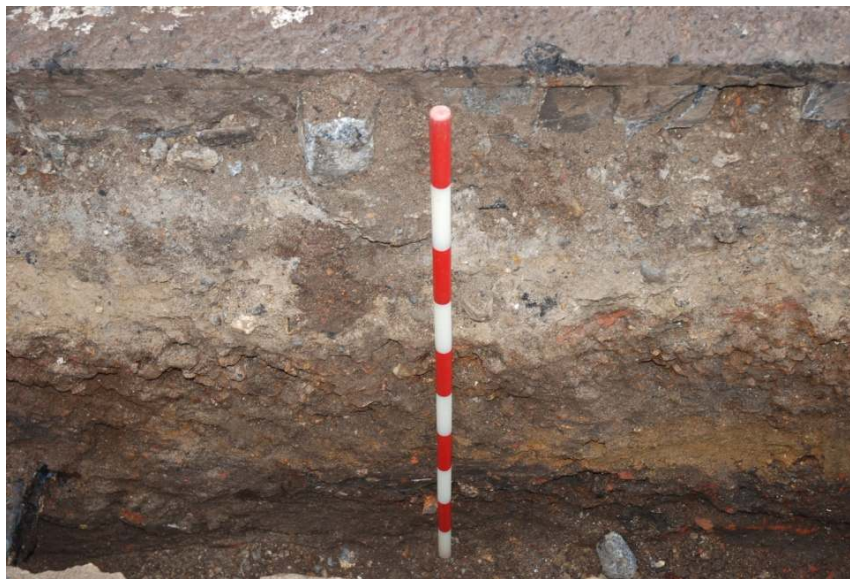
Approximately 100.5m of trenching was observed on Dingley Street between the junctions with Central Street to the west and Hull Street to the east. The existing tarmac road surface was exposed in section, overlying concrete hardcore and crushed stone make-up to between 0.3m and 0.5m depth. Trenching across the Macclesfield Road junction exposed a mid-grey/brown sandy clay with brick inclusions at a thickness of 0.3m, overlying a darker band of the same composition to the remaining depth of excavation at 1.1m. The lower deposit is likely to be a buried soil relating to the 19<sup>th</sup> residential development of the area, this is overlain by material probably reflecting the later demolition of the buildings and subsequent ground makeup. No significant archaeological finds or features were observed on Dingley Street.

**Figure 11:** South facing section of trenching on Dingley Road showing buried soils and ground makeup (1m scale).

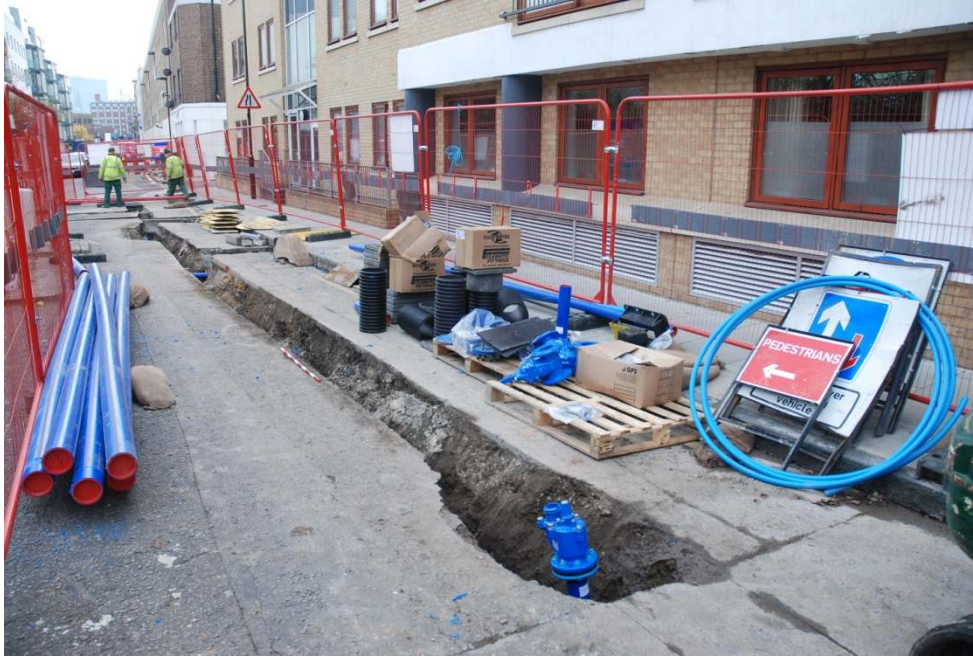
Approximately 258m of Graham Street were monitored from the junction with Vincent Terrace running south. Trenching exposed modern road layers and services to an average depth of 0.6m, overlying further modern made-ground to a maximum depth of 0.9m. No archaeological finds or features were observed within trenching on Graham Street.

**Figure 12:** Trenching on Graham Street, looking north to the junction with Coombs Street (1m scale).

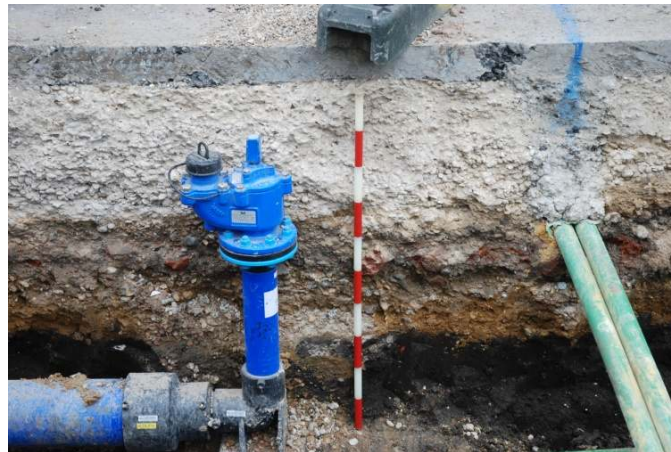
Approximately 134m of trenching was observed on Macclesfield Road running south from the junction with Moreland Street to President Street. Tarmac and concrete hardcore were exposed to 0.5m thickness, overlying service backfills to c.0.7m. A buried soil horizon was exposed at the base of excavations at a thickness of 0.3m. The buried soil consisted of dark-brown silt and clay with occasional brick and mortar flecking and gravel inclusions. The deposit is likely to reflect occupation of the area in the 19<sup>th</sup> century – Macclesfield Road was laid out on its current orientation by 1844 and was lined with contemporary buildings until they were demolished in the 20<sup>th</sup> century.

**Figure 14:** West facing section of trenching on Macclesfield Road showing modern road layers overlying 19<sup>th</sup> century buried soil.

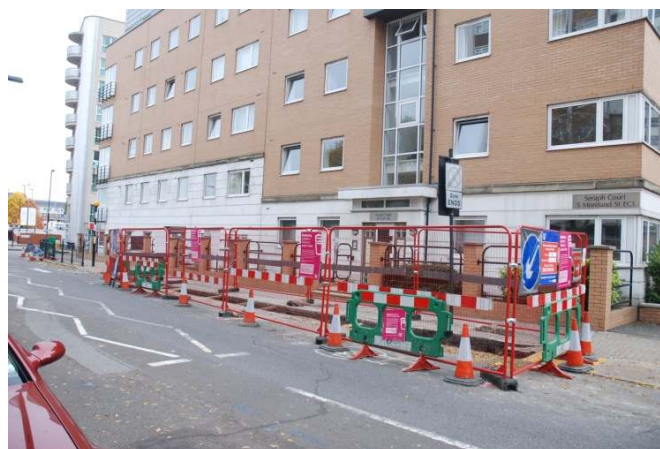
**Figure 15:** General view of trenching on Moreland Street looking northeast towards the junction with Central Street.

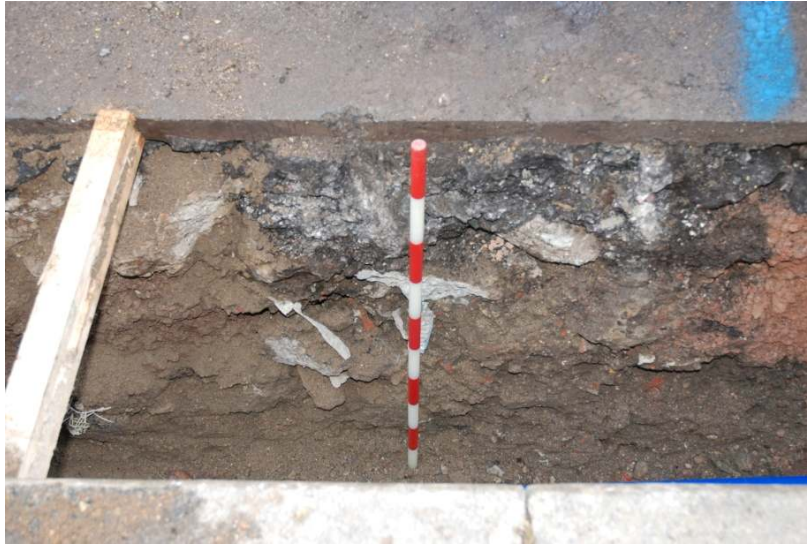
Approximately 53m of trenching was observed on Moreland St, west of the junction with Central Street. The existing modern road layers were exposed overlying concrete hardcore to a depth of 0.3m. Modern service deposits and made-ground were exposed to the remaining depth of excavation at 0.7m below the existing ground level. No archaeological finds or features were observed during trenching on Moreland Street.

**Figure 16:** South facing section of trenching on Moreland Street showing modern road layers over made-ground (1m scale).

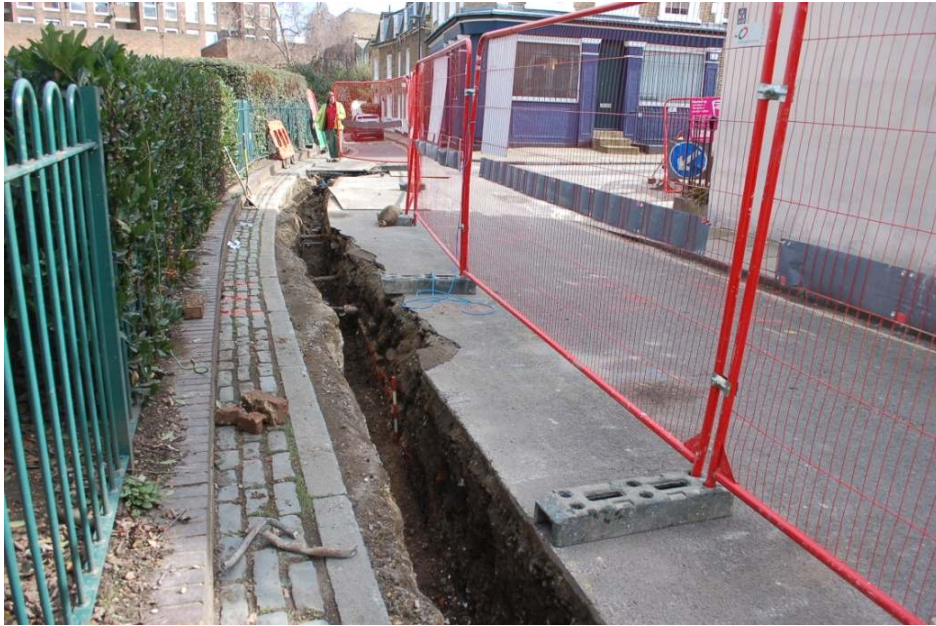
**Figure 18:** Trenching to the west of Remington Street on Nelson Place, showing section of brick wall in the north facing section (0.5m scale).

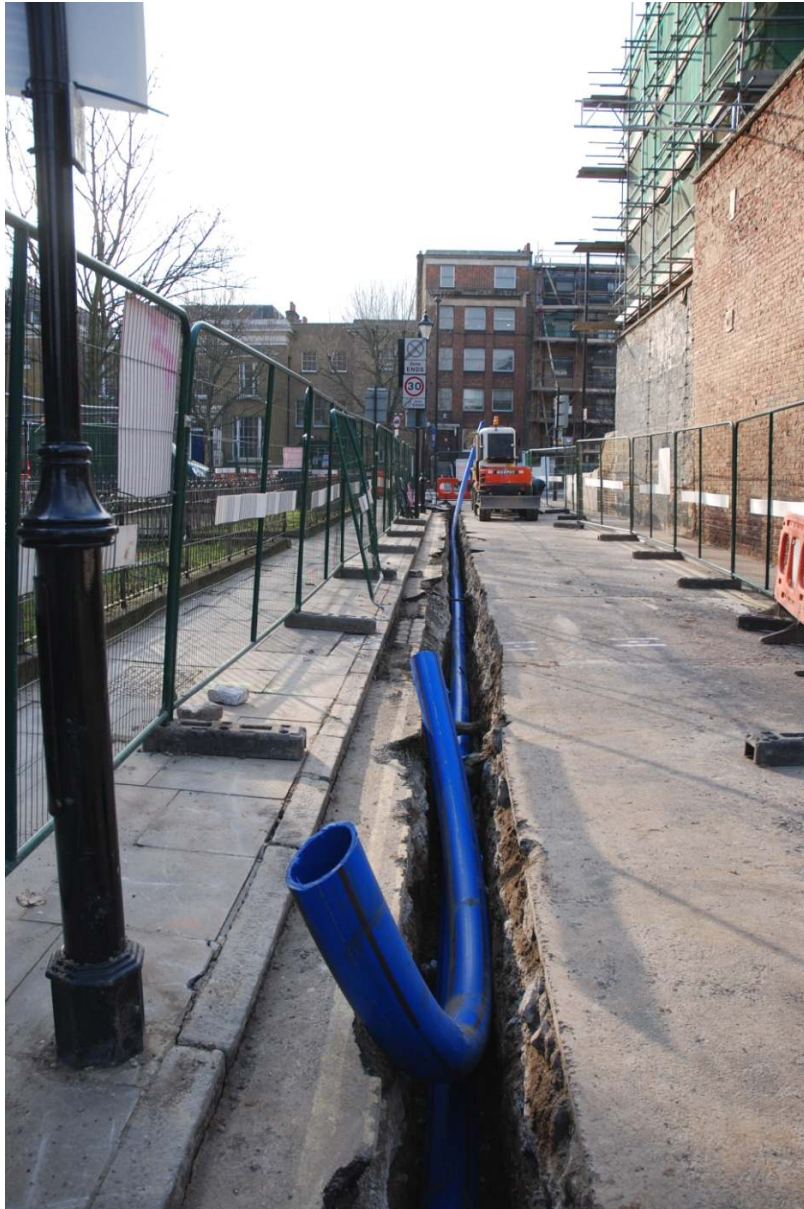
A single 31m trench was monitored on Nelson Terrace running north from the junction with City Road. The trench exposed modern road layers overlying modern made-ground and service backfills to a depth of 0.5m, no archaeological finds or features were observed.

**Figure 20:** Trenching on Nelson Terrace looking south to the junction with City Road.

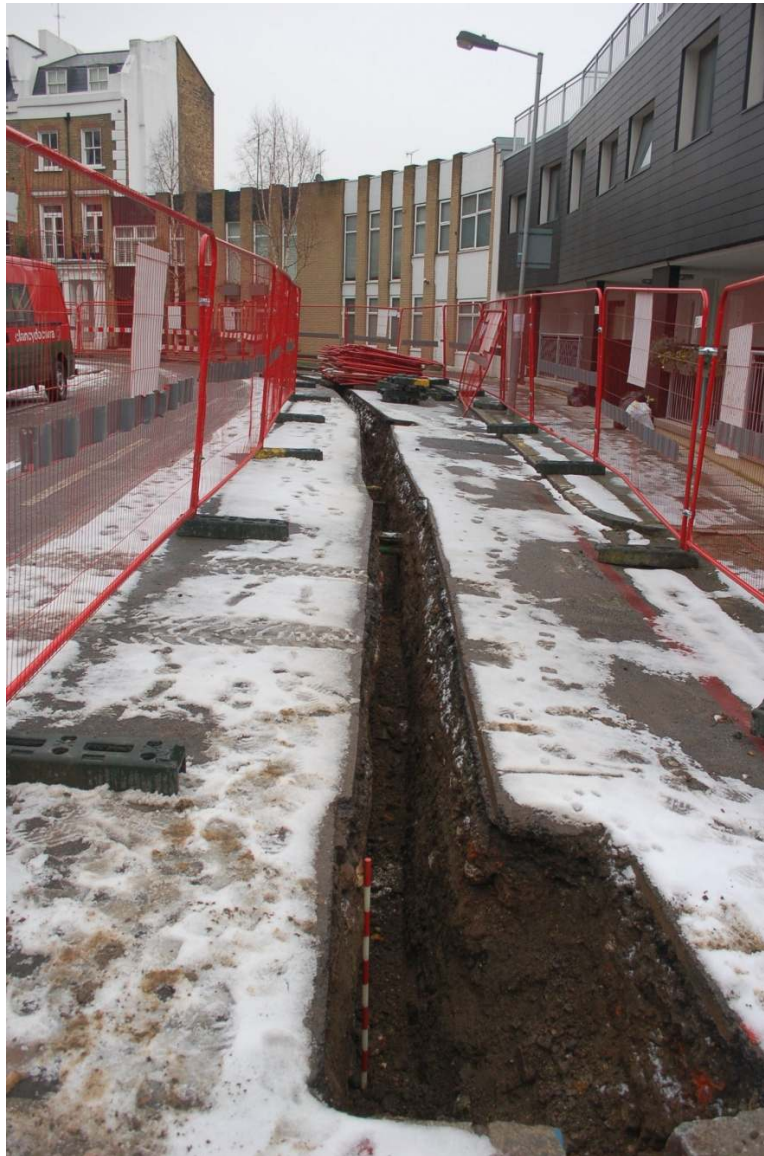
Approximately 52m of trenching were observed on Oakley Crescent from the junction with City Road. Shallow tarmac was exposed overlying a layer of rubble hardcore to a depth of 0.4m. Mixed service deposits and up-cast from cellar excavations was observed to the remaining depth at 1.2m below the existing ground level. No archaeological finds or features were observed.

**Figure 21:** Trenching on Oakley Crescent looking north from the junction with City Road (1m scale).

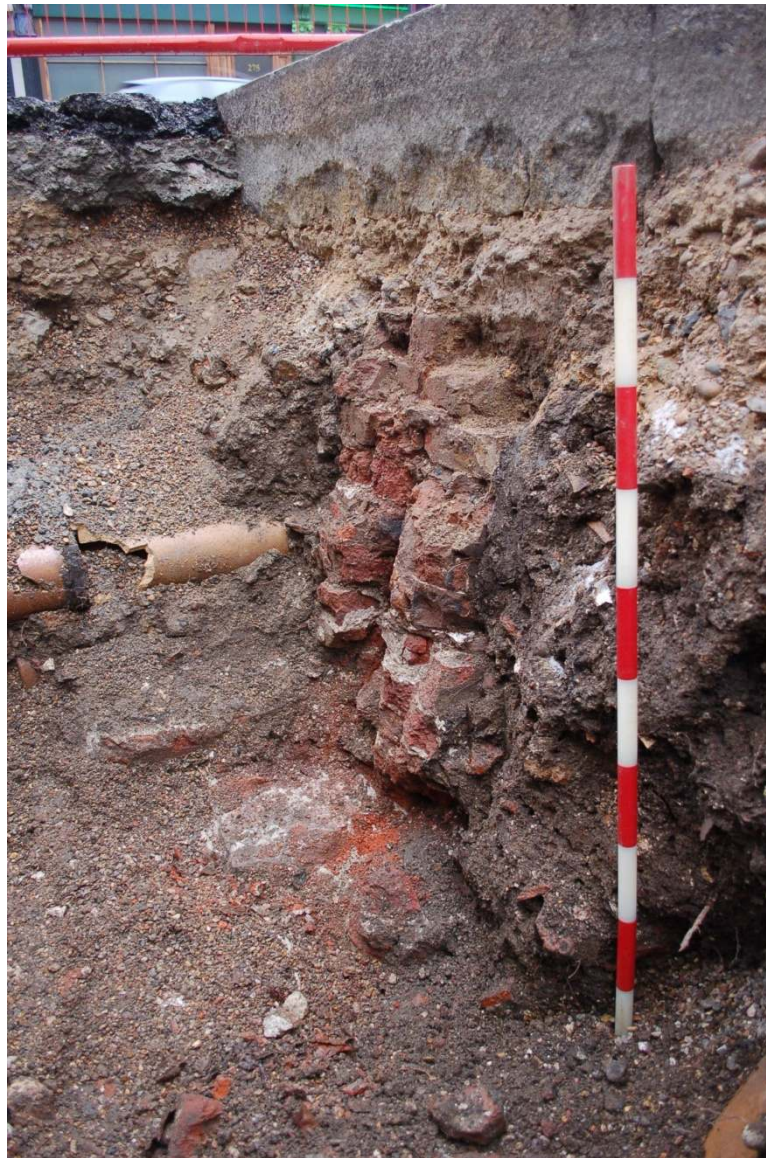
An 8.5m trench was monitored was Pickard Street, running south from the junction with City Road. Paving and concrete hardcore were observed to a depth of 0.44m overlying mixed made-ground layers to a depth of 1.2m below the existing ground surface. A section of purple/red brick wall with lime mortar was exposed in section and orientated east-west, surviving to a height of 0.9m and cut by services and trenching. The wall is likely to be of 19<sup>th</sup> century date, possible part of a coal cellar belonging to a property fronting City Road, and subsequently demolished. Surrounding deposits included brick rubble, likely to represent demolition of the Victorian buildings in the area.

**Figure 22:** West facing section of trenching on Pickard Street, showing a section of 19<sup>th</sup> century brick wall (1m scale).

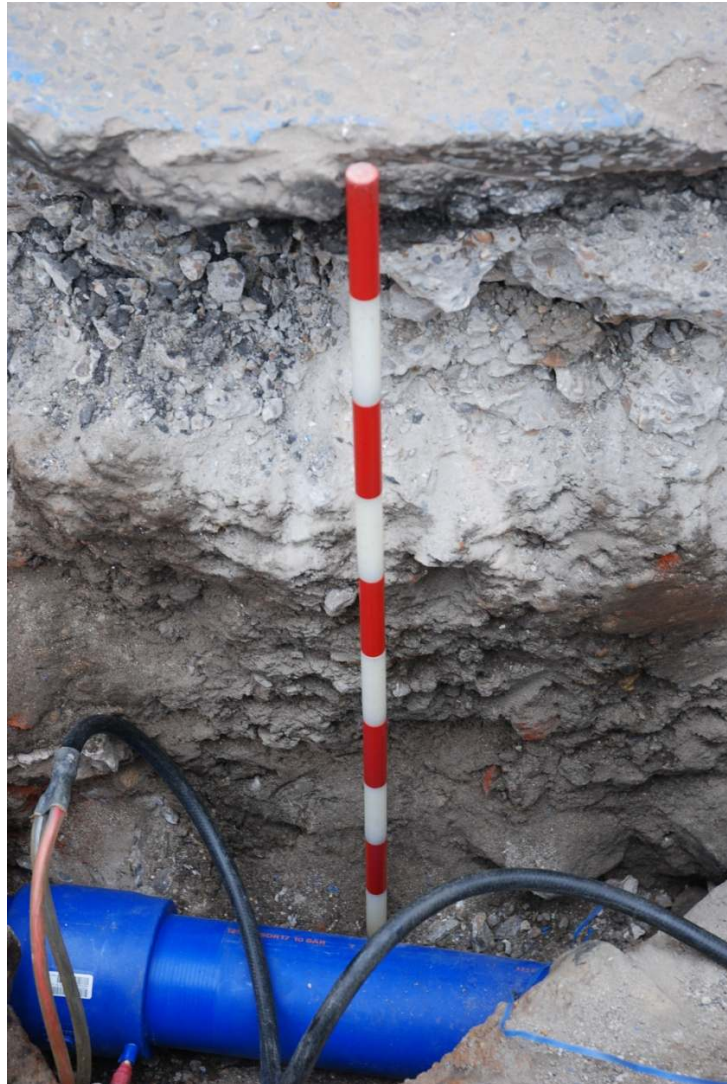
Approximately 50m of trenching was observed on President Street, running the full length of the street between the junctions with Central Street (west) and Macclesfield Road (east). Trenching exposed tarmac and concrete hardcore to a depth of 0.45m, overlying modern road-makeup layers and service deposits to a maximum depth of 1.1m.

**Figure 23:** North facing section of trenching on President Street (1m scale).

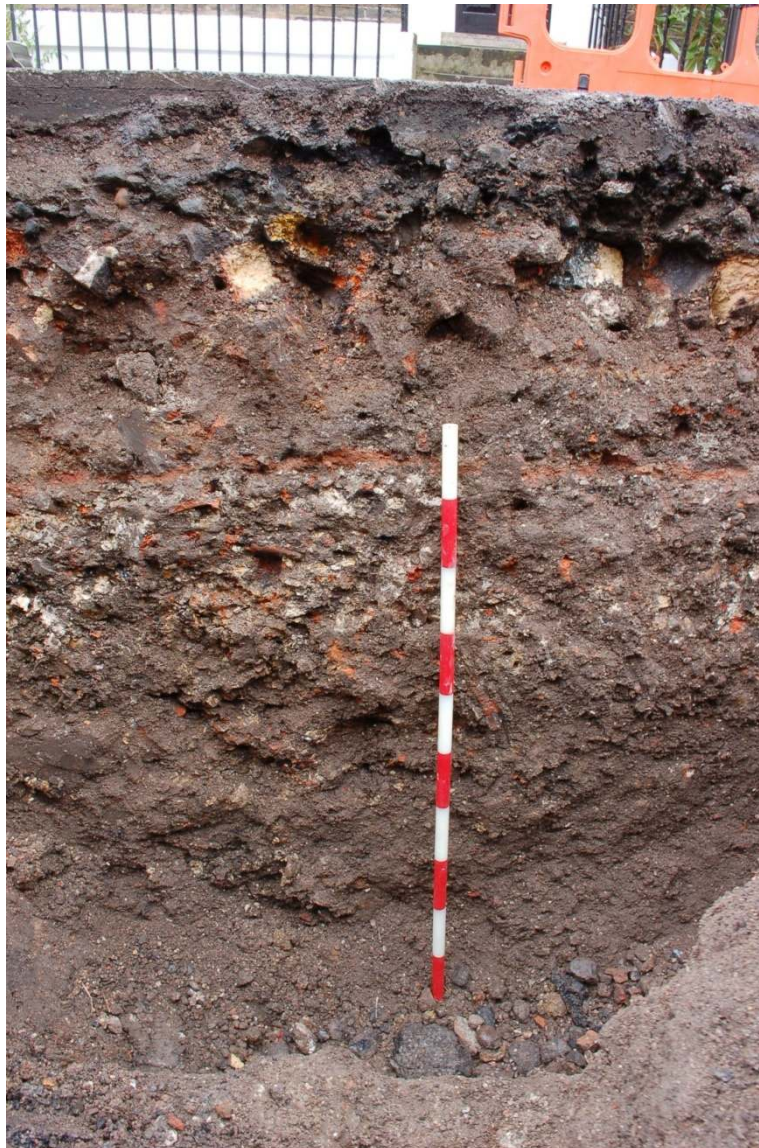
Approximately 102m of Remington Street was monitored, along the full length of the street between the junction with City Road (south) and Nelson Place (north). Tarmac over bitumen rubble was exposed to 0.2m, overlying modern brick rubble hardcore (0.1m) and a mid-brown/grey silty clay soil with frequent brick flecking for a further 0.25m. These modern deposits overlay a thin lense of crushed brick above a layer of heavily flecked brown/grey deposit with frequent brick and concrete at a thickness of 0.35m. The remaining depth of excavation exposed a looser brown/grey deposit with fewer inclusions. The deposits beneath the modern road and hardcore layers are thought to be up-cast dumped following excavation of coal cellars belonging to properties lining Remington St in the 19<sup>th</sup> century.

**Figure 24:** West facing section of trenching on Remington Street (1m scale).
