95-96 CHEYNE WALK, SW10 0DQ

**ROYAL BOROUGH OF KENSINGTON AND
CHELSEA**

AN ARCHAEOLOGICAL WATCHING BRIEF

SITE CODE: CHY11

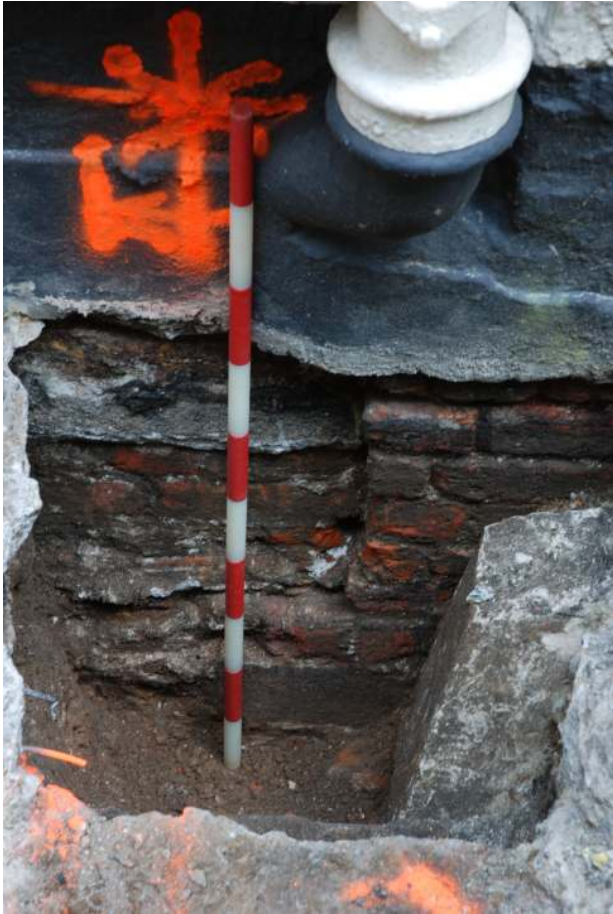
Brick and stone wall foundations to the standing building were revealed in the eastern section of trial pit 1. It is evident that these formed two different phases, as they were constructed of different materials and at slightly different offsets from the standing wall-line. However, the building itself is basemented, so clearly the foundations go down well beyond the present level of investigation – whilst the adjacent material is evidently construction backfill.

The brick foundations in the northern part of the trench stretched down to *c.*0.45m beneath the modern ground-surface, overlying a rubble-brick-mortar-stone base down to a recorded depth of *c.*0.7m. These were flush to the standing wall-line, and were probably just the foundations for this existing wall.

The brick foundations in the southern part of the trench stretched down to *c.*0.6m beneath ground-surface, overlying nicely-faced stone down to 0.8m beneath ground-surface (limit of excavation) and continuing. The southern part of the wall foundations were one course further out (west) from the existing building wall and the northern foundations.

It seems likely that the southern wall foundations are part of an earlier wall, representing the original northern end of the building. Furthermore, the probable end of this earlier building can still be seen in the fabric of the western side of No.95 Cheyne Walk (fig. 4) directly above the wall base observed in trial pit 1, which supports the argument outlined above.

Fig. 3: Photo of the eastern section of trial pit 1, clearly showing the two different wall foundations.

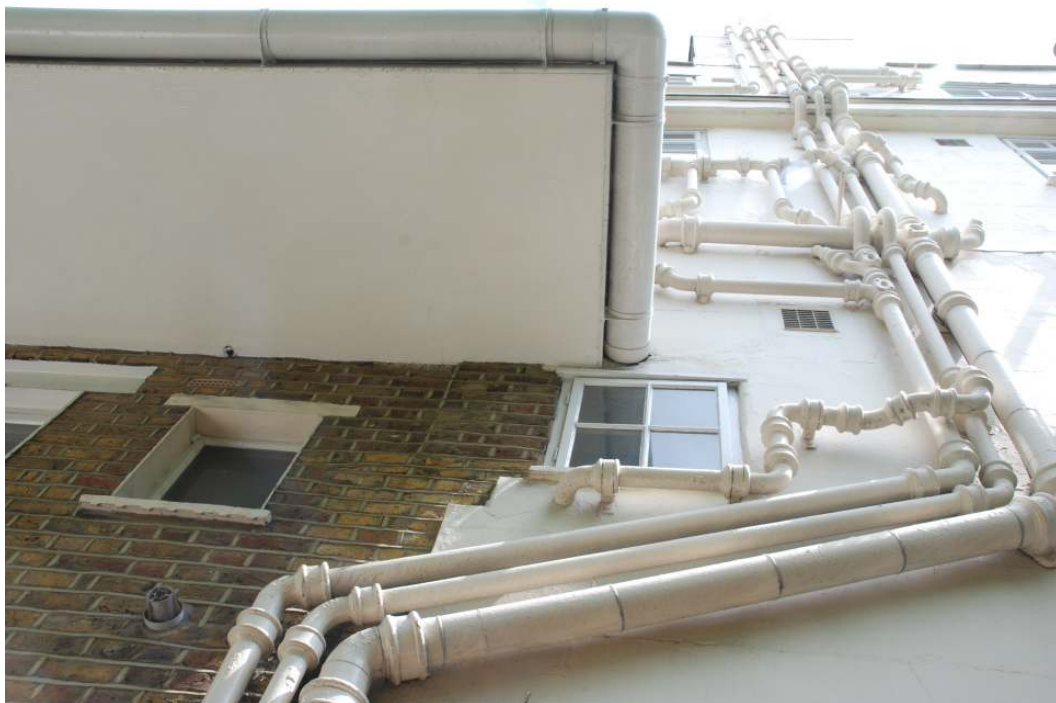
Fig. 4: Photo of the side of No.95 Cheyne Walk, directly above trial pit 1. In the centre of the photo, directly to the left of the window in the white part of the building, is a line in the brickwork which may represent the original back end of No.95 Cheyne Walk, discussed in relation to the wall base in trial pit 1.

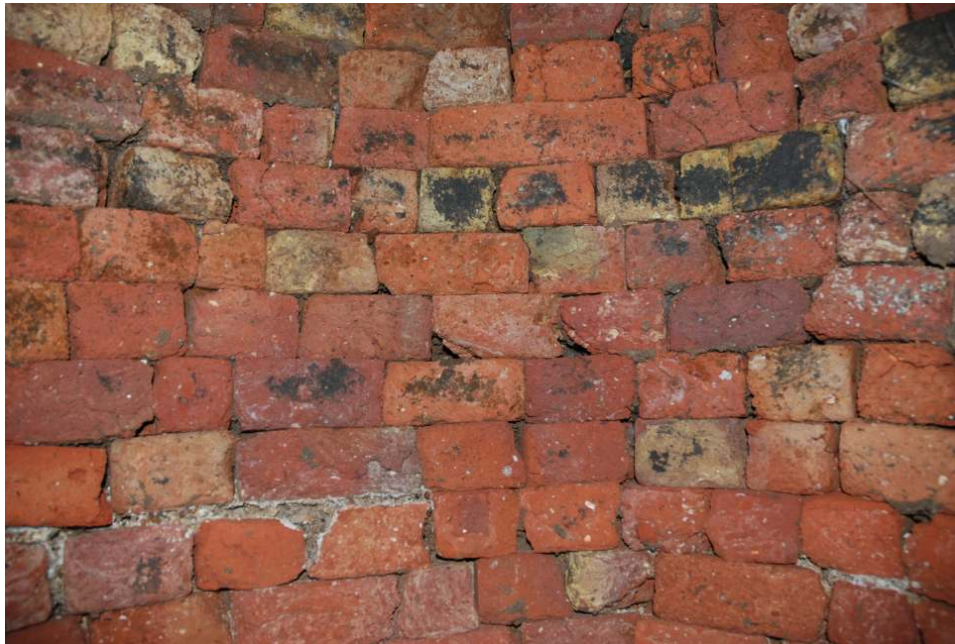
There was a substantial well in the western part of this pit, which appeared as an open void below the present access drive and relatively recent 'made ground' deposits. The eastern end of this well was 1.3m out from the western wall of No.95 Cheyne Walk. The diameter of the well was *c.*1.2m, with the extant top of the brickwork 1.4m beneath the modern ground-surface, and the well being measured at *c.*4m in depth (although possibly originally more and now partly backfilled). It was brick-lined, and appears to have had some form of channel running out of it to the east (i.e. towards the western wall of No.95 Cheyne Walk). Unfortunately, it was not safe to investigate the well any further, to ascertain the date of construction, *etc.* It is likely that the uppermost level (which may well have formed a brick dome) had been removed, and presumably the open shaft had been capped off with timber or similar material which had subsequently rotted away.

Fig. 6: Photo of the interior of the well in trial pit 1, clearly showing its brick-lined structure.

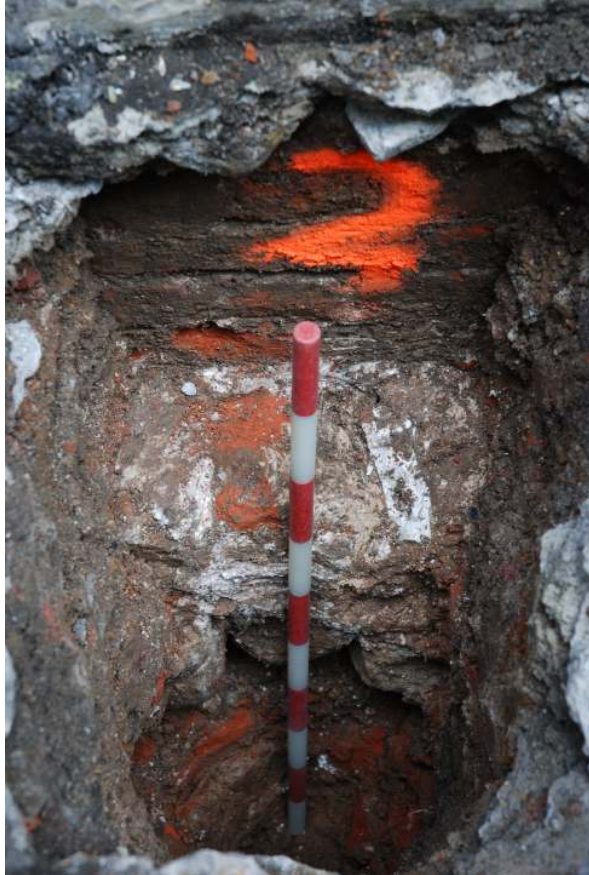
The brick wall-foundations of the western wall of No.95 Cheyne Walk stretched down for 0.5m (beneath the modern ground-surface), followed by a

step out into the trench (west) for *c.*0.17m, over a rubble base for a further *c.*0.35m. This is all part of the fairly modern wall foundations to the rear of No.95, dated to cartographic evidence to between 1836 and 1865 (see above, TP1), and is of no archaeological interest.

Fig. 8: Photo of the eastern section of trial pit 2, clearly showing the mid 19th century wall foundations of No.95 Cheyne Walk

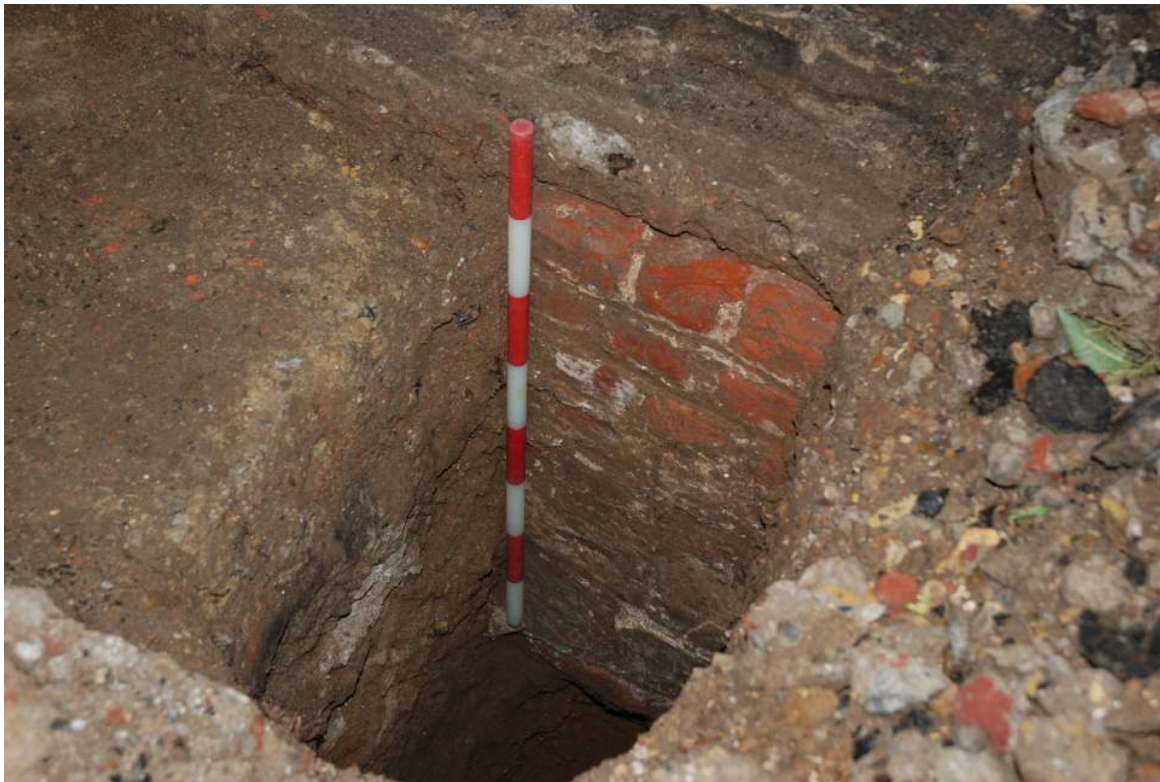
The foundations of the present eastern boundary wall of No.95 Cheyne Walk are concrete, and were observed down to a depth of *c.*0.35m beneath the modern ground surface in the eastern section of trial pit 3. This overlay brick foundations, down to a depth of *c.*0.65m beneath the modern surface: below this were stone foundations, down to *c.*1.2m, with 1 course of brick at the base. This lower section is assumed to have formed the foundation of an earlier wall or building.

The brick samples taken from the lower wall foundations were dated 1450-1700 (fabric-type 3033, see brick report). One sample had an abraded base, suggesting that it was reused, and originally laid with the base upwards as a floor brick. This evidence of reuse suggests that the wall base is later in date than the bricks themselves.

It is difficult to ascertain precisely what earlier wall this foundation might have formed a part of. Certainly, Thompson's 1836 Map depicts a line of buildings along the eastern boundary of the site (and in the eastern section of trial pit 3) which this wall may have been part of. This roughly fits with the brick-dates, as the bricks were dated 1450-1700 but were possibly reused at a later date in this wall. Earlier plans – for example Richardson in 1769 – indicate a freestanding north-south boundary wall in this area (& see also TP8).

Fig. 9: Photo of wall foundations in the eastern section of trial pit 3.

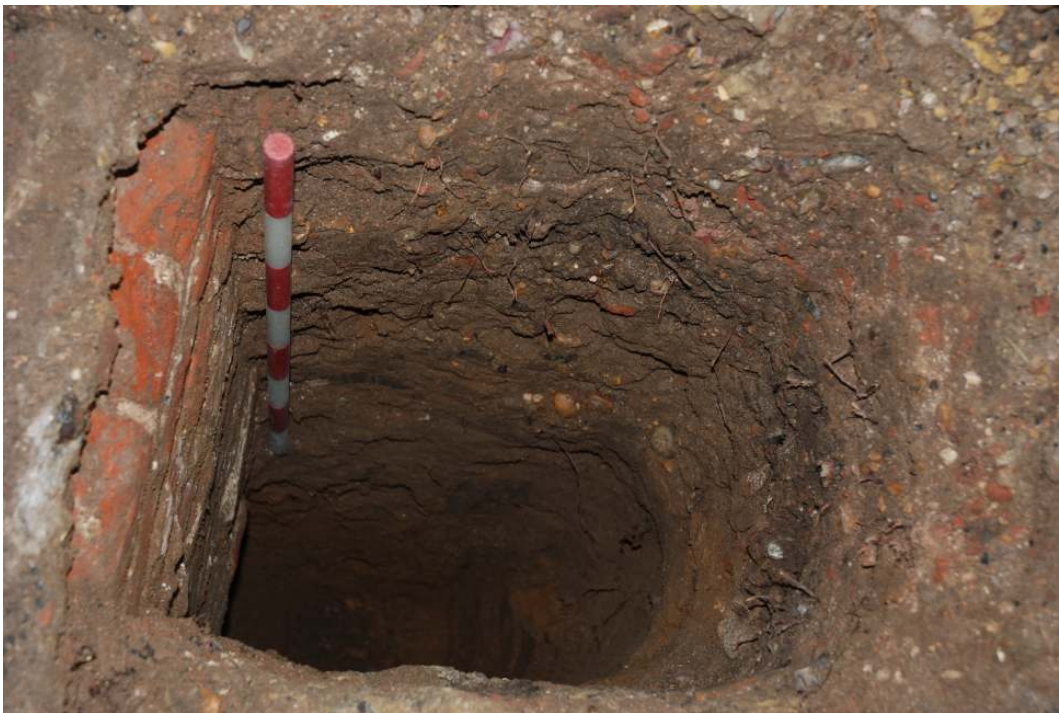
The ‘natural’ soil was observed *c.*1.2m beneath the modern ground-surface, and it was most obviously observed in the western section of the pit. This was a yellow-brown gravelly-sand.

Fig. 12: Photo of southern and western sections of trial pit 3, with the ‘natural’ gravelly-sand visible at the base of the pit.

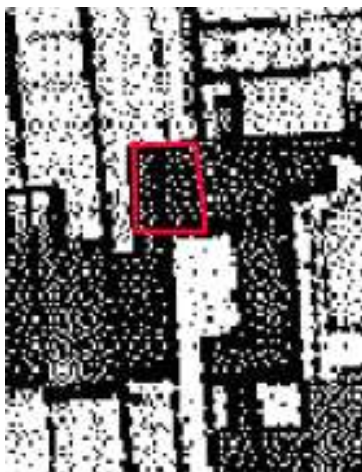
It is tricky to locate these earlier features on the historic maps. Thompson's 1836 Map does depict a building in the approximate location of trial pit 4 (the cross-over between the garage and back garden). It is therefore possible that this plastered wall and floor may have been within these buildings, although the concrete floor base and covering appear to be of slightly later date.

Fig. 13: Extract from Thompson's 1836 Map, with the red-lined area depicting the approximate area of trial pit 4. It is possible that the plastered wall and floor found in trial pit 4 could have been part of these buildings.

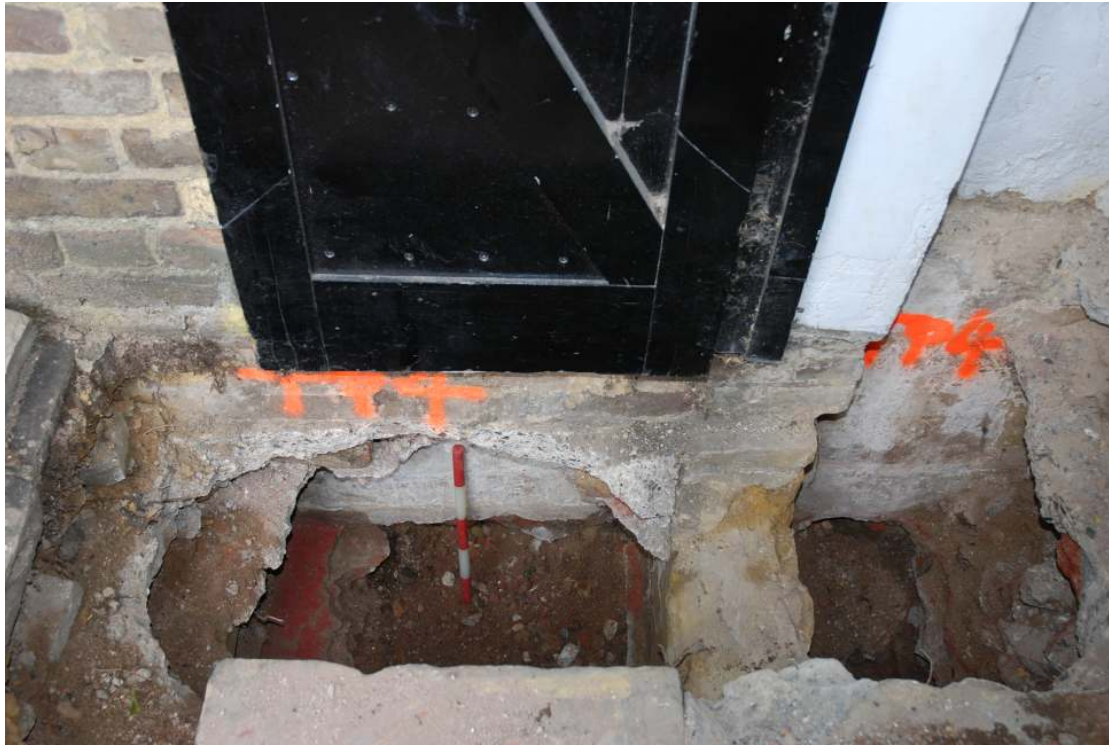
A plastered wall was observed in the eastern section of trial pit 4, set behind the line of the present garage wall by a distance of *c.*0.18m, and probably reflecting the existence of an earlier wall. The top of this was *c.*0.41m beneath the present ground-surface, and the base was *c.*0.77m beneath ground-surface (0.36m in height). A wall-stub was also observed projecting out of this westward into the trench by 40mm, and located *c.*60mm south of the yellow stock-brick wall that crossed the centre of the trench.

Of an even later date than this wall and floor was the yellow stock brick wall observed running east-west across the centre of the trench, 0.42m from the southern end, which clearly forms part of the modern dividing wall between the garage and back garden. It was *c.*0.22m thick, 0.54m in height (& up to *c.*0.2m beneath ground-surface), and was recorded for a length of 1.09m, continuing into the western section.

Beneath these features was a large quantity of 'made ground'. This was a mid-brown silty-sand, with inclusions of pebbles, ceramic building material, brick, concrete, etc, down to a depth of 1.48m (limit of excavation). No 'natural' was observed – which could indicate the presence of an earlier underlying feature (see summary and conclusions for discussion of this).

Fig. 14: Photo of trial pit 4, from above.

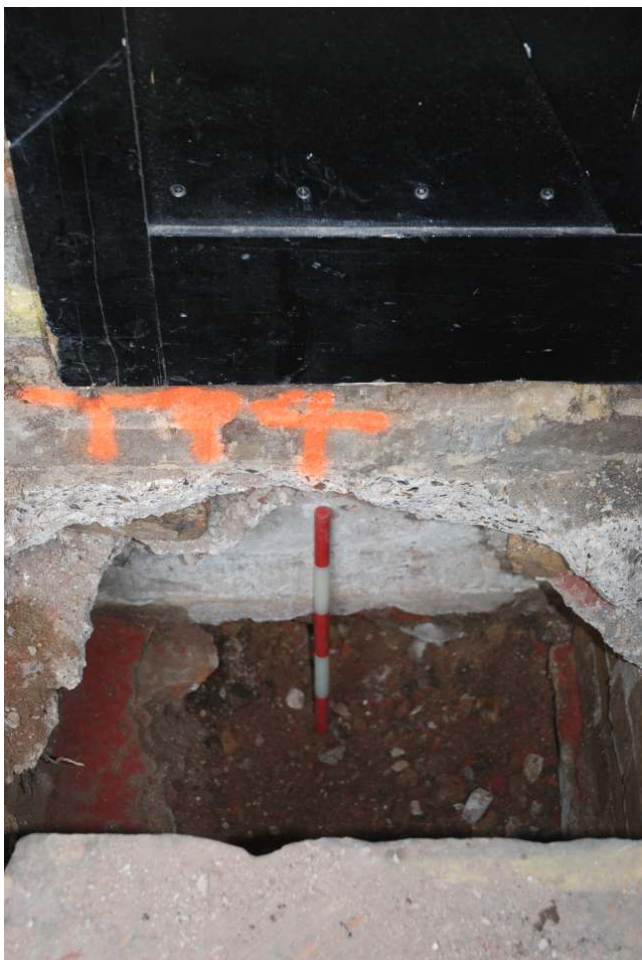
This plastered wall is probably associated with a red floor that was observed *c.*0.77m beneath the modern ground-surface. This was made up of a very red crumbly material (8mm thick), similar to a decayed linoleum surface. It was laid on a concrete base 90-100mm thick.

Fig. 15: Photo of trial pit 4, clearly showing the 'red floor' to the left of the scale

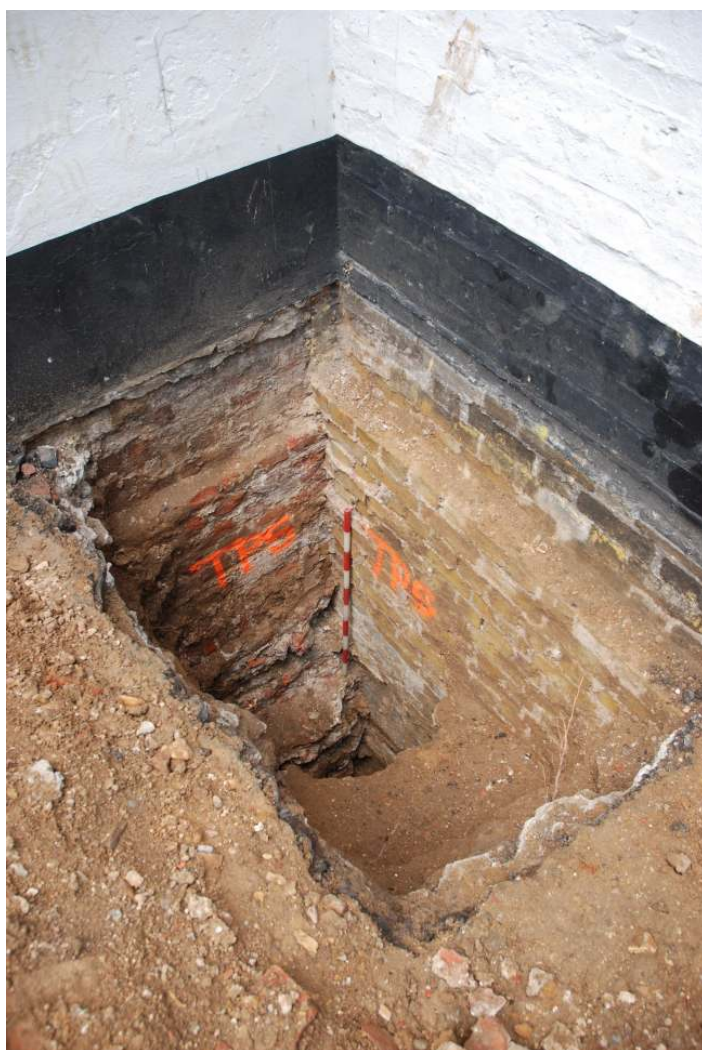
Red brick wall foundations were observed in the western section, for the eastern wall of No.96 Cheyne Walk. The brickwork stretched down to 0.82m beneath the modern ground-surface, overlying a rubble base down to 2.53m beneath the ground-surface. This was clearly earlier than the base to the north, though the date is uncertain. The wall line appears on successive historic plans, although this section is evidently quite late and probably part of a rebuild associated with the basement of the present house (compare lower wall description and depth here with that under TP22, just to the south).

Fig. 16: Photo of trial pit 5, from the south-east, showing the contrasting red brick & rubble and yellow stock wall bases.

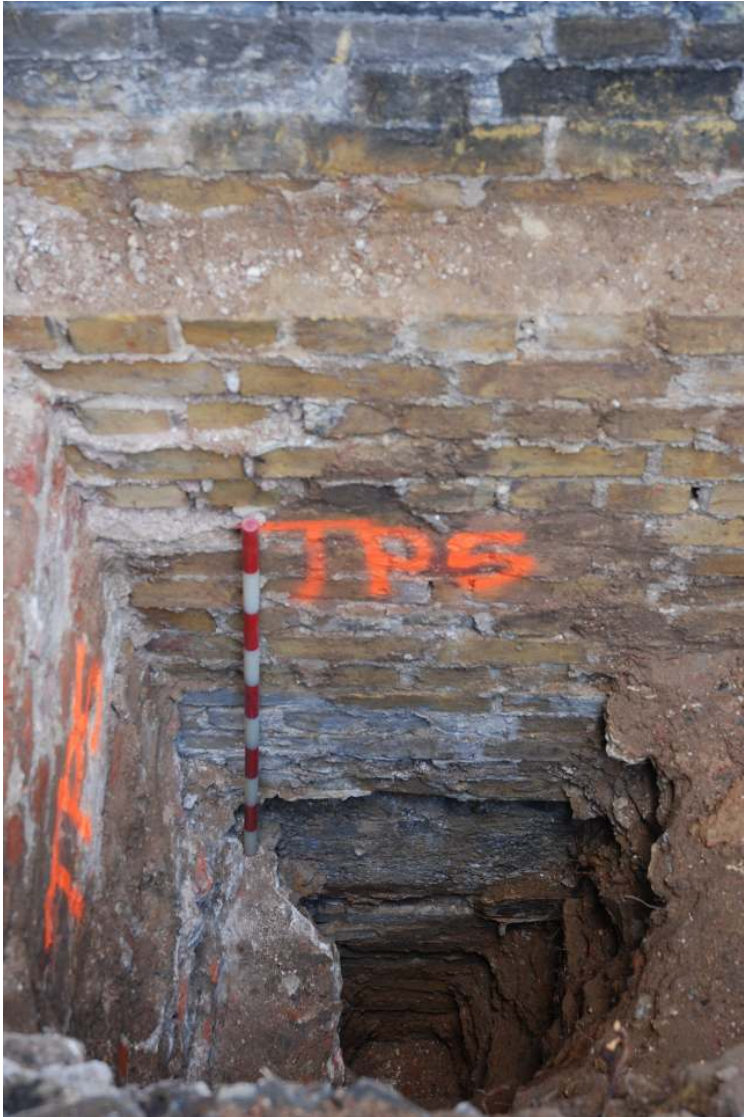
Yellow stock brick wall foundations were observed in the northern section down to a depth of 3.2m beneath the present ground-surface (and continuing down beyond the limit of excavation). These formed the wall foundations of the southern wall of a projecting section of No.96 Cheyne Walk (see plan). The huge depth of these foundations is accounted for by the fact that this area of No.96 Cheyne Walk is basemented. The structure itself appears to be of mid 20th century date, and is only shown on OS plans after 1956.

The 'natural' was not observed in this pit – despite the fact that it was 3.2m in depth. Chunks of brickwork were still being observed at the base of the trench, within a general mid-light brown silty-sand 'made ground'. It is likely that this huge quantity of 'made ground' was related to the existence of the basement, as part of the fill of the construction cut for the adjacent wall, rather than having any archaeological significance as the indication of an earlier feature like an infilled basement (see summary and conclusions for discussion).

Fig. 17: Photo of trial pit 5, clearly showing the yellow stock brick wall foundations in the northern section.

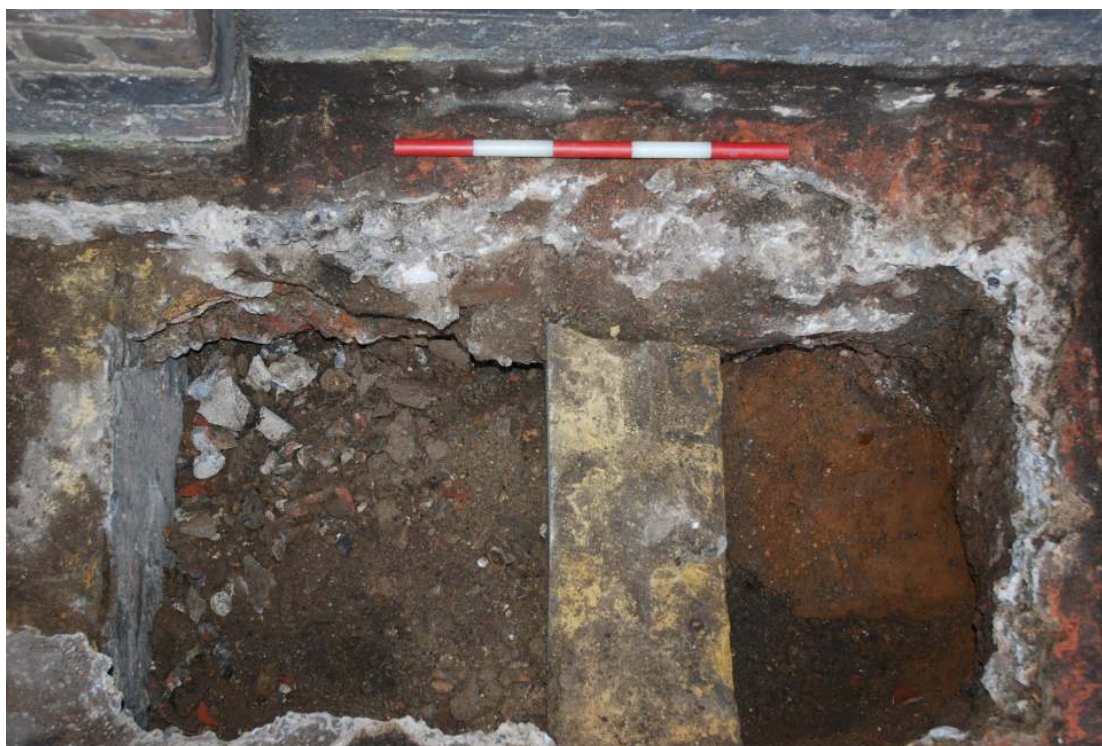
An earlier patio surface was observed over the whole of trial pit 6. This consisted of tiles over a concrete base (c.0.12m beneath the current ground-surface, and for a total depth of c.0.12m).

A drain chamber was observed in the northern part of trial pit 6. Rendered brickwork was observed on both the interior northern and southern sides of the chamber. The whole of the southern wall was observed – it was made of yellow stock brick; was 0.25m thick; c 0.6m in length, and at least 0.5m in height (continuing beneath the limit of excavation). The concrete foundations of the extension to the rear of the house (in the eastern section) cut the yellow stock brickwork of the chamber, therefore establishing that they were later in date. The extension first appears on OS plans in the period 1906-21, whilst the drain chamber – to judge by the character of the brick and render – is probably of later 19th century date.

Fig. 18: Photo of trial pit 6 from above, clearly showing the drain chamber in the northern part of the pit, and the ‘natural’ deposits and cut feature in the southern part

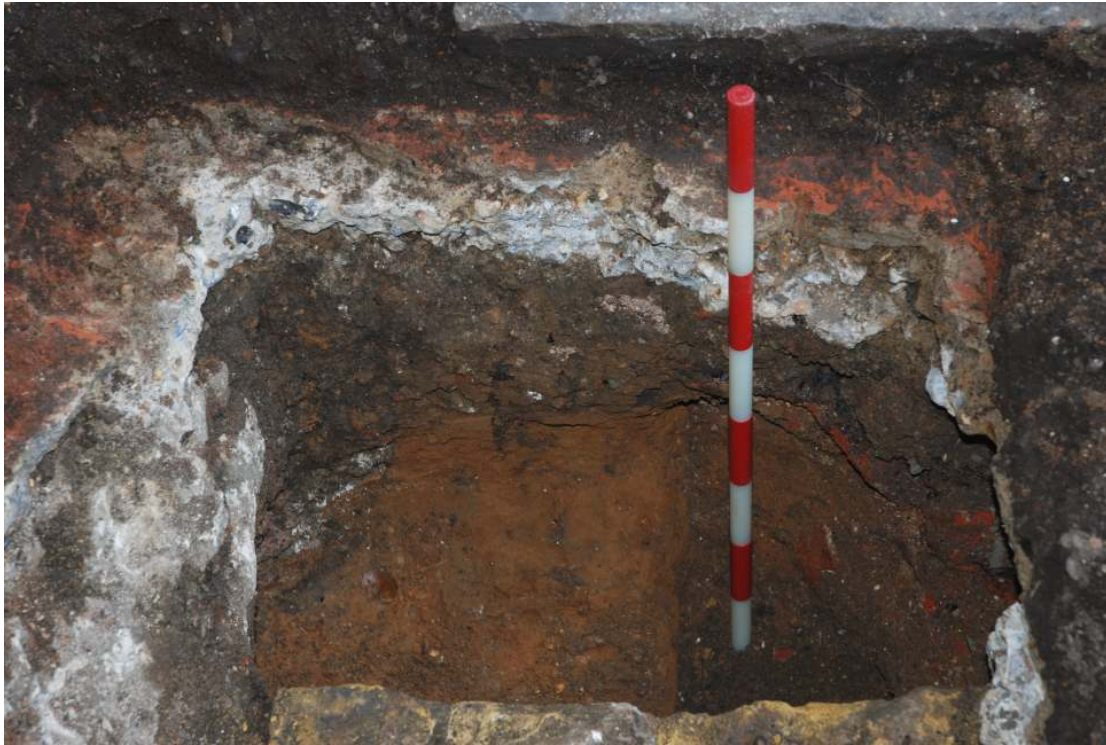
‘Natural’ deposits (an orange sandy-gravel) were observed at a high level in the southern part of the pit, beyond the drain chamber and approximately 0.46m beneath the modern ground-surface. This ‘natural’ had been cut away by the construction of the drain (90mm out from the southern wall line) and infilled by a mid-brown silty-sand. Interestingly, the ‘natural’ had also been cut by another feature in the south-western corner of the pit (approximately 0.55m out from the building-line). This was cut through the natural from a

height of *c.*0.5m beneath the modern ground-surface, and the fill was a mid-brown loose silty-sand, with pebbles. This must represent an earlier feature of some description, though no datable finds were recovered.

Fig. 19: Photo of southern part of trial pit 6, clearly showing the 'natural' deposits and backfilled cut feature directly below the scale

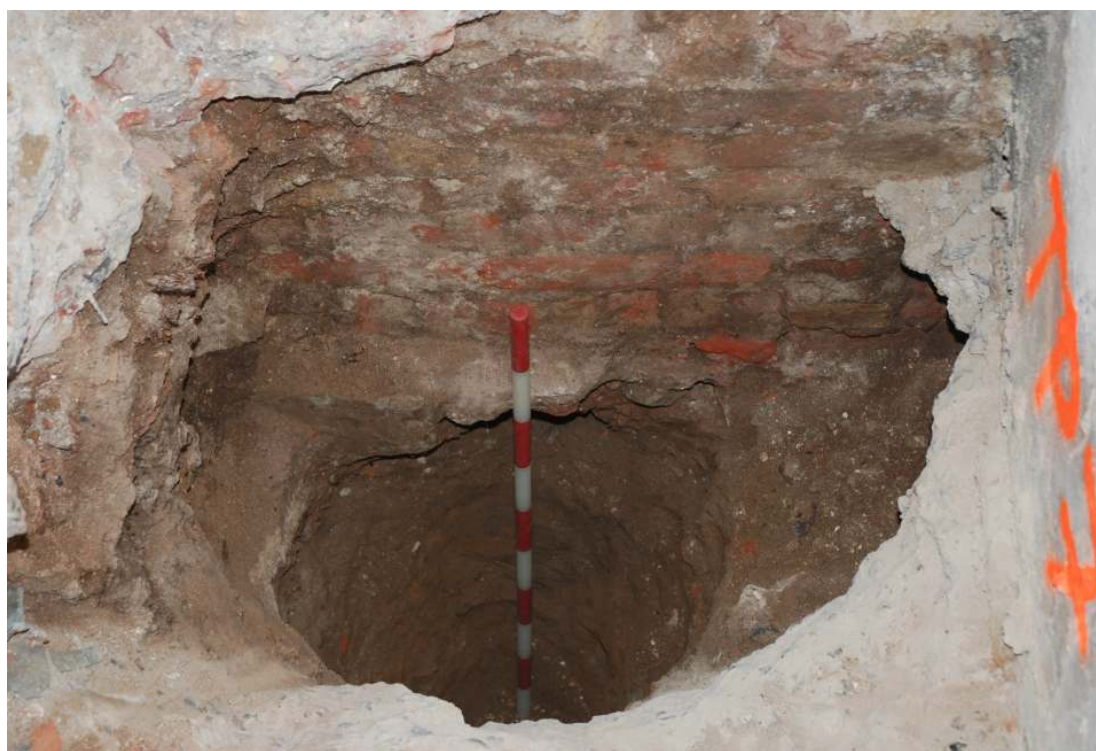
Regular coursed brick wall foundations in the northern section of trial pit 7 stretched down to *c.*0.8m beneath the modern ground-surface, and were positioned approximately 7cm out from the overlying wall-line. Regular coursed brick wall foundations in the eastern section were observed down to 0.4m beneath the ground-surface, and were directly beneath the standing wall-line. Beneath these regular coursed brick wall foundations was a rubble-mortar layer, stretching down to *c.*1.2m beneath the modern ground-surface. This layer consisted of a mix of brick rubble, pebbles, and mortar. These foundations are all related to the existing garage walls, and do not appear to reflect the existence of any earlier walls or to be of any archaeological significance.

The ‘natural’ deposit (a clean compact mid-brown-orange sandy deposit) was observed at 1.2m beneath the modern ground-surface in all sections.

Fig. 20: Photo of trial pit 7, clearly showing the ‘natural’ deposit towards the base of the trench plus the overlying brick wall base in the northern section.

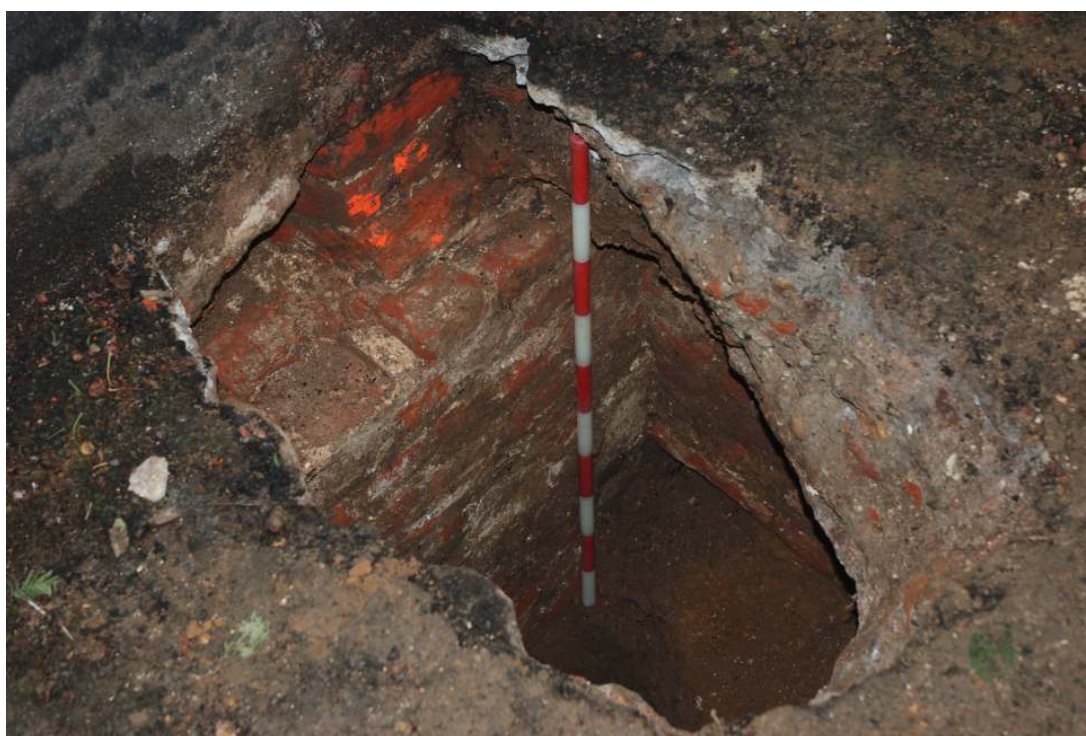
A wall foundation was observed in the eastern section of trial pit 8, below and slightly in front of the present standing wall and clearly part of an earlier construction. This consisted of continuous brick courses *c.*0.4m beneath the modern ground-surface, over a course of tile (at a depth of *c.*0.75m), over stone blocks and further brickwork, from *c.*0.8m to *c.*1.3m beneath the ground-surface. This stood out (west) from the overlying wall-line by about 130mm.

Fig. 21: Photo of wall in eastern section of trial pit 8.

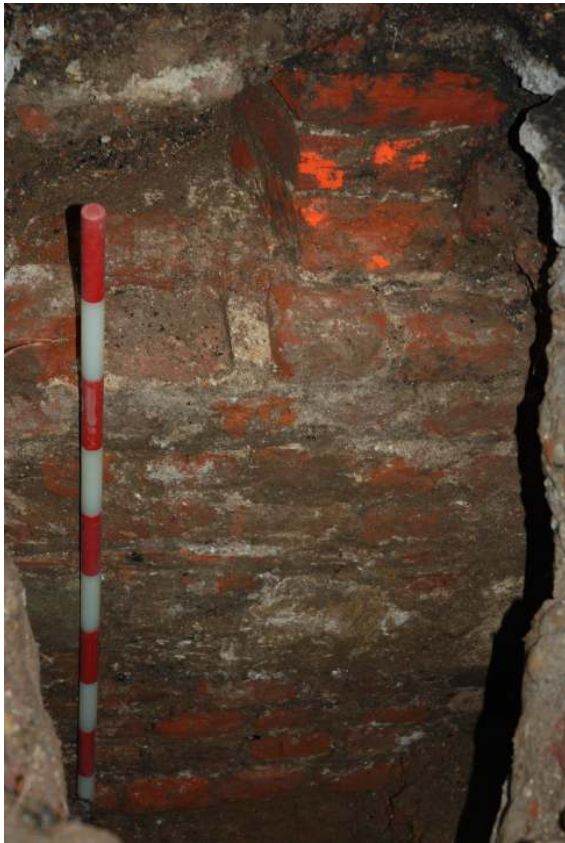
The base/ southern side of a probable doorway was observed directly above the wall foundation, and apparently forming part of the same construction. The top of this was observed *c.*0.12m beneath the modern ground-surface, down to *c.*0.4m beneath ground-surface (the top of the wall foundation described above). This consisted of three courses of red brick, angled in to the north and behind the current wall face at an approximately 60°. There was a definitive cut / edge along this angle. The external face of the doorway rebate was on a line with the present wall-face, and the doorway opening was located approximately 1.2m north of the rear of present building (No. 95).

Fig. 22: Photo of 'doorway', at top centre of the eastern section of trial pit 8.

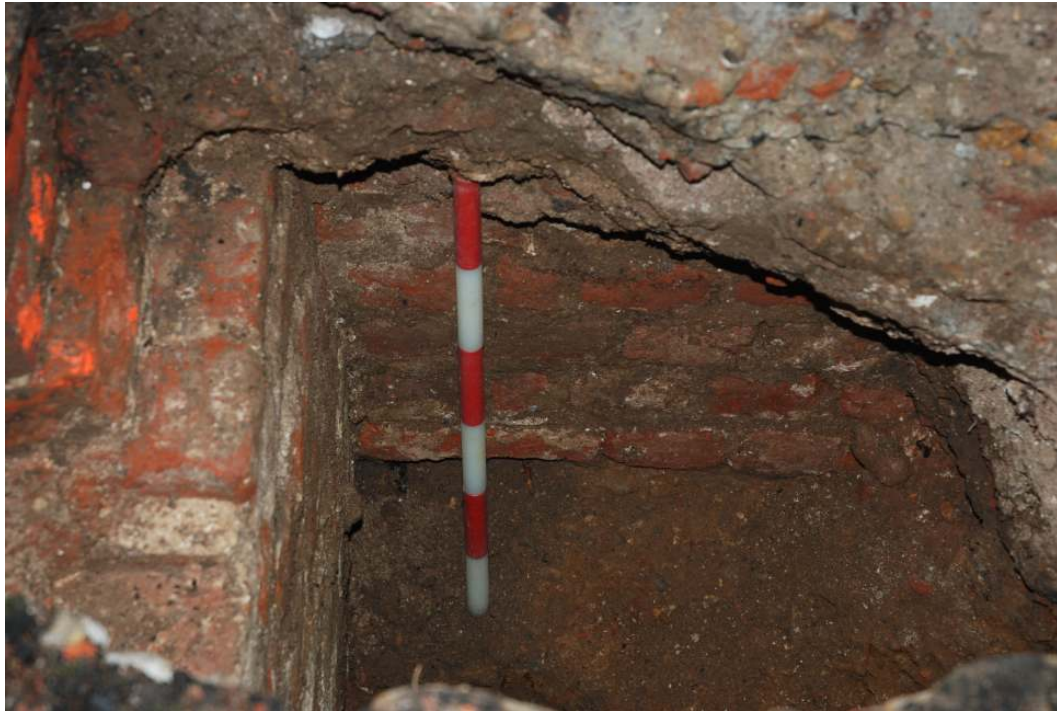
A second brick wall was observed in the southern section, at right angles to the above and *c.*0.7m from the adjacent standing building. This top of this was recorded 0.4m beneath the modern ground-surface, and for a height of 0.4m. It was butted up against the deeper wall in the eastern section, and appeared to be an addition to this.

Fig. 24: Photo of brick wall in the southern section of trial pit 8.

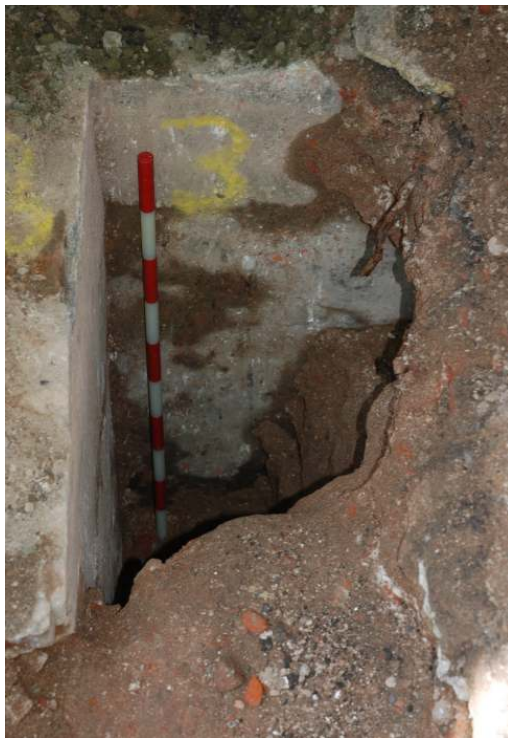
A drain chamber was observed in the northern part of trial pit 9. Rendered brickwork was seen in the northern and western parts of this, lining the internal faces. The rendered brickwork of the chamber goes down to a depth of 1.24m beneath the present ground-surface, over a concrete base which slopes down deeper away from the section (to a depth of at least 1.32m beneath ground-surface). The total east-west width of the hole was observed at its northern end (0.61m); however the total north-south length was not recorded – 0.68m was observed, at which point it appeared to be broken away, although it would probably not have continued much further.

Fig. 25: Photo of the drain chamber in the northern part of trial pit 9.

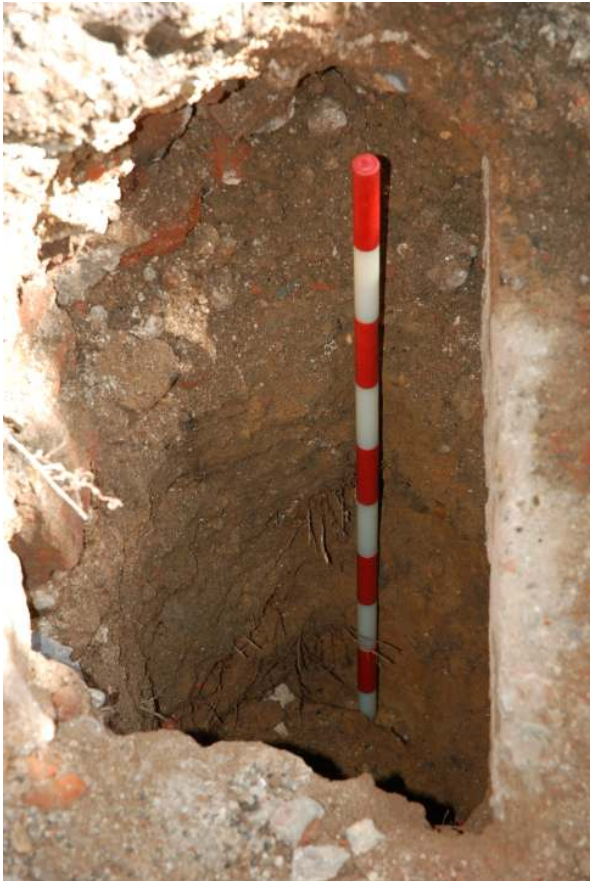
Fig. 27: Photo of the soil profile in the southern part of trial pit 9, clearly showing the 'natural' deposit at the base of the pit.

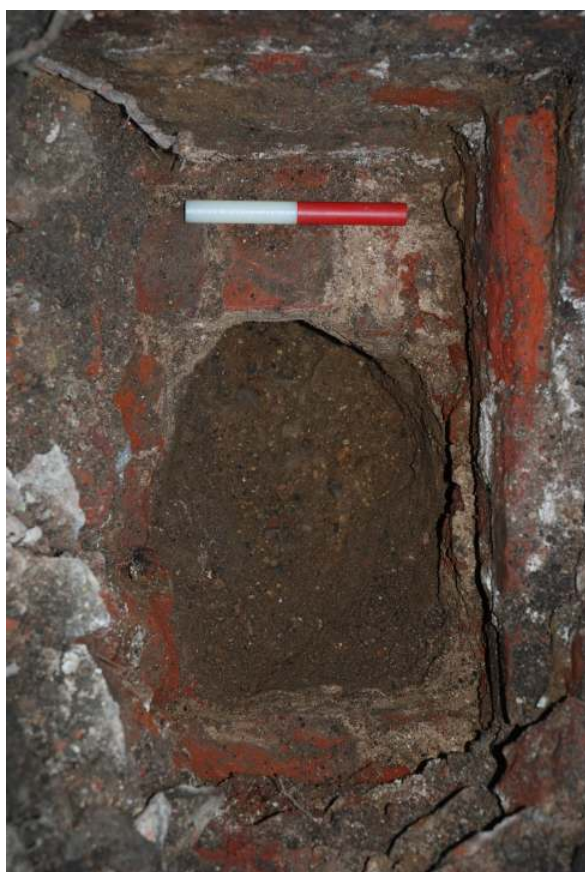
The foundations below the current garden wall were observed for 0.52m beneath the modern ground-surface. Below this level the brickwork continued for a further 0.14m, but also stepping out into the trench to form a continuous floor or plinth.

The bricks from this floor/plinth were dated 1450-1700 (fabric-type 3033, see brick report). Both samples had a worn top or base so may well be reused – particularly in the latter case, where the worn base was presumably once laid uppermost as flooring).

Fig. 28: Photo of brick plinth / floor in trial pit 10A, a deeper hole cut through the centre to expose the underlying natural deposit.

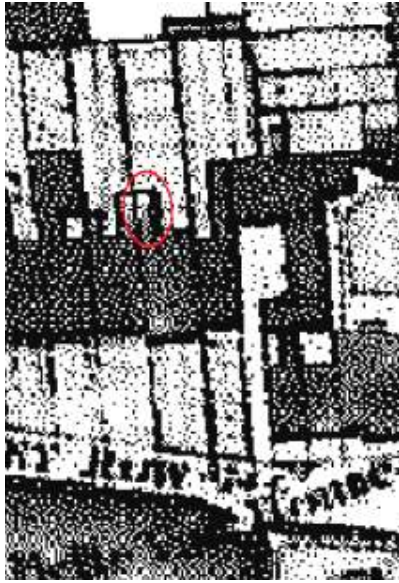
It is possible that this floor can be identified on Thompson's 1836 Map, in the area of the small northern extension on the western side of No.96 Cheyne Walk (fig. 29). This area is still depicted (and appears slightly larger) on the First and Second Edition OS Maps (1865 & 1894-96) but has disappeared by the early 20th century.

Fig. 29: Extract from Thompson's 1836 Map, with the approximate area of the brick floor circled.

The relationship between the drain and wall / floor in trial pits 10A and 10B does however suggest this may predate the small northern extension of No.96 Cheyne Walk seen on Thompson's map of 1836 (figs 29 & 33), and so probably pre-19th Century.

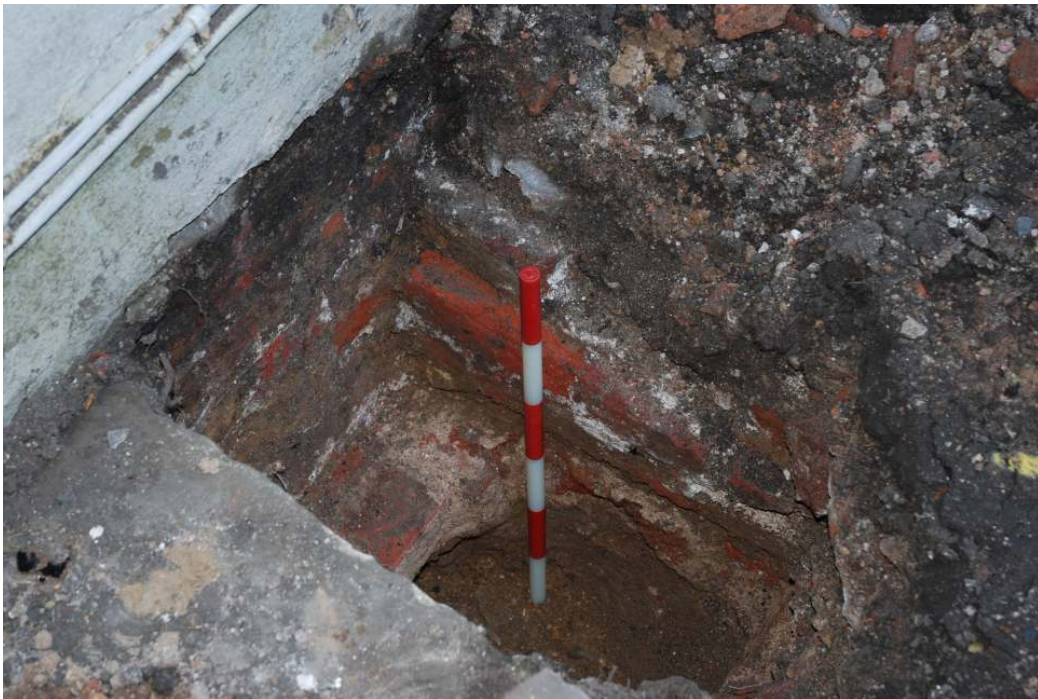
A later brick wall base was observed running east-west along the centre of the pit. This consisted of red-purple bricks within a grey mortar, was *c.*0.35m thick, and ran east-west for at least 0.5m. Three courses were present, standing to a height of *c.*0.24m.

Fig. 30: Photo of east-west running wall in trial pit 10A, taken from the south

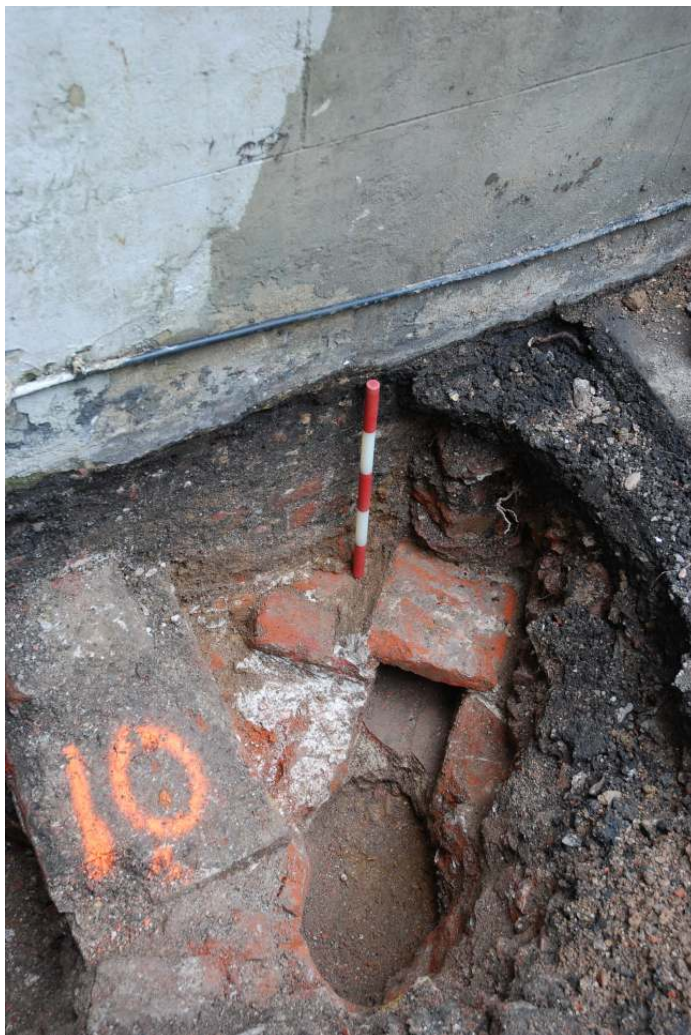
Fig. 31: Photo of brick drain in trial pit 10A.

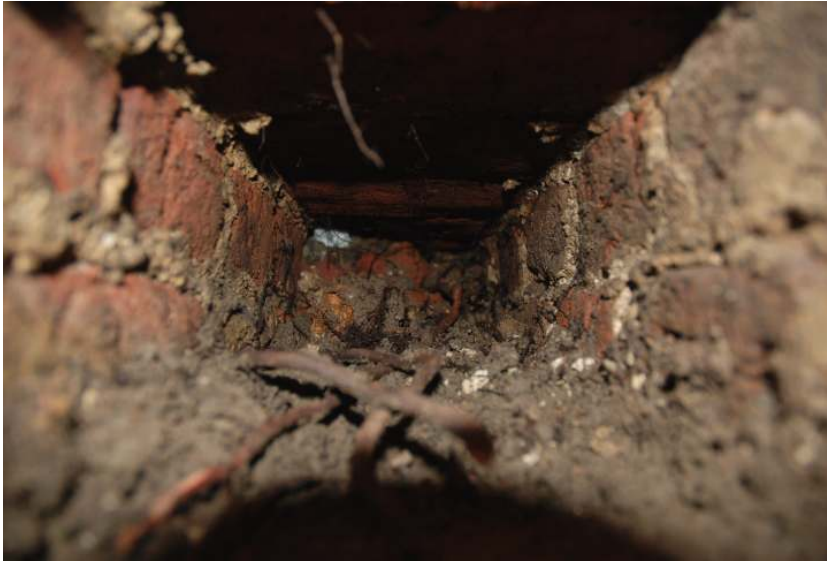
Fig. 32: Photo of interior of the brick drain in trial pit 10A, looking northwest. The drain appears to be blocked approximately 1m along this section.

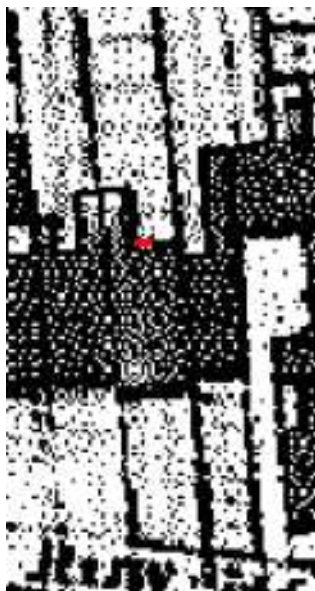
The brick wall foundations of the northern wall of the existing No.96 Cheyne Walk were observed in the southern section of trial pit 10B. These were observed as neatly coursed brickwork down to 0.46m beneath the modern ground-surface, consisting of red-orange bricks within a grey mortar, for 4 courses, and *c.*0.15m in front of the wall-line. This ran across the whole east-west width of the pit, and continued beyond in both directions. Beneath this the coursing was less clear, and the brickwork appears to come out northward into the pit, forming a plinth that joins up with the drain described below. It is possible that this was part of an earlier wall foundation, on the line of the northern wall of No.96 Cheyne Walk as depicted on Thompson's 1836 Map (fig. 33). The appearance and relationship of these features – wall base, plinth and drain – is also very similar to that recorded in TP10A, and it seems likely that they form parts of a single construction, of possible 17th century date.

Fig. 33: Extract from Thompson's 1836 Map, with the approximate line of the earlier wall foundations uncovered in trial pit 10B highlighted in red.

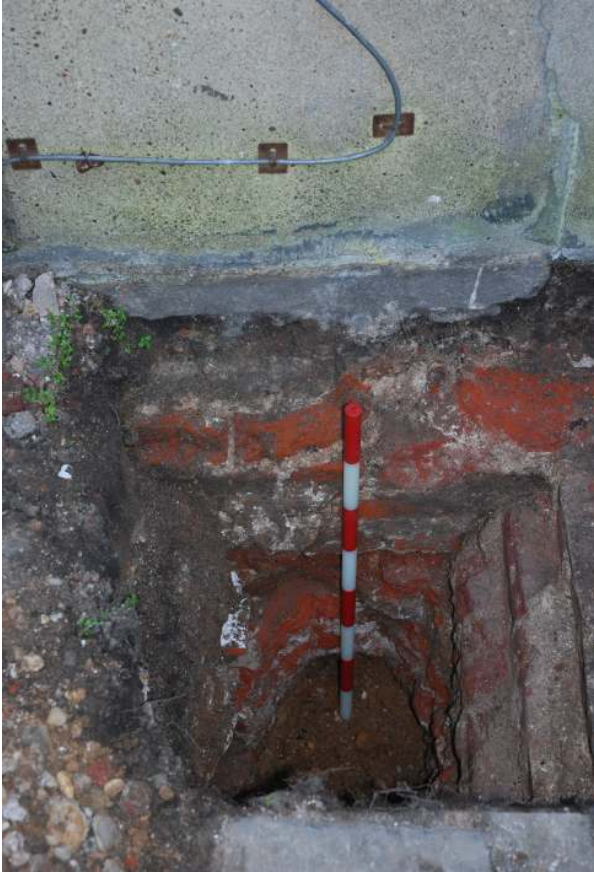
Fig. 34: Photo of brick walls in the southern and western sections of trial pit 10B.

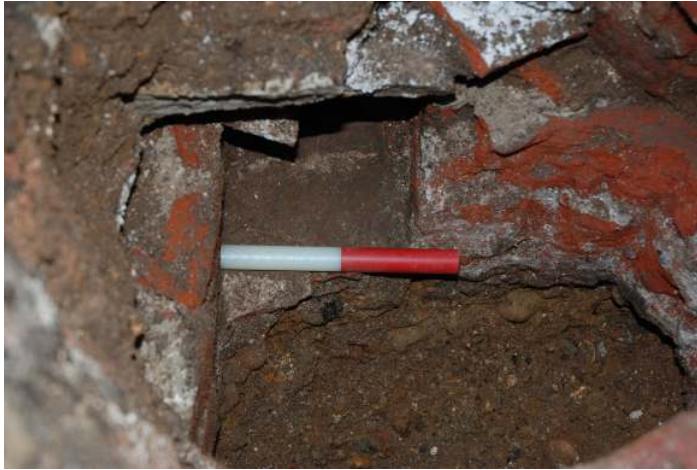
Fig. 35: Photo of drain gully in trial pit 10B.

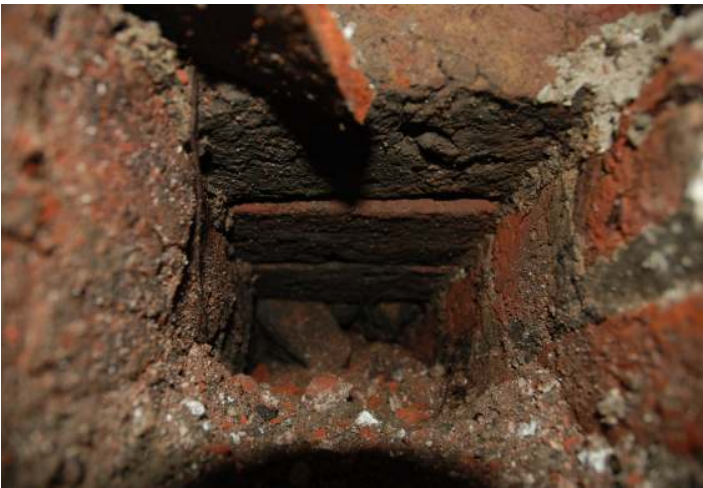
Fig. 36: Photo of interior of drain in trial pit 10B.

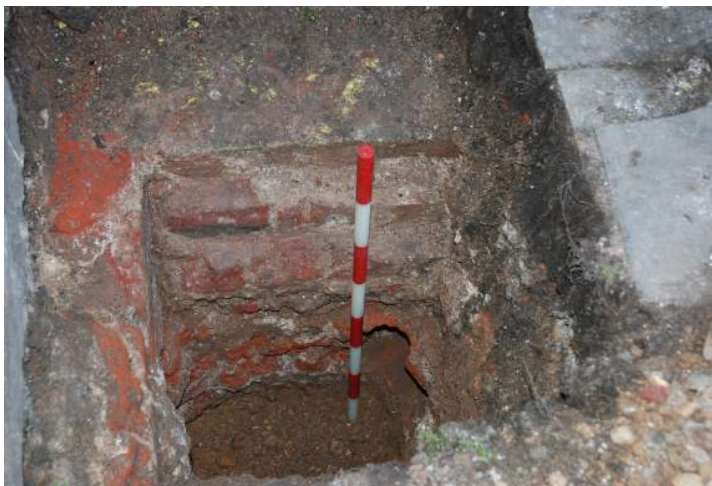
Fig. 37: Photo of trial pit 10B, from the south-east, clearly showing the drain gully in the north-west corner of the pit, and the brick wall in the western section.

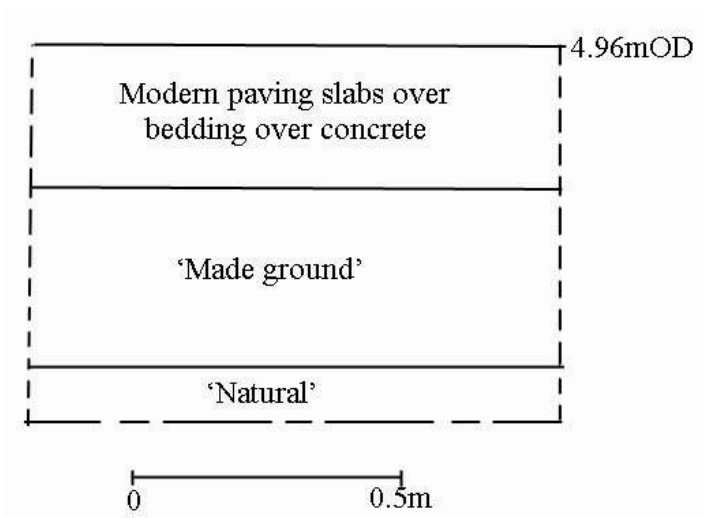
Fig. 38: Sketch section of trial pit 10C. The 'made ground' deposit is a mid-brown silty-sand with CBM and pebbles.
