95-96 CHEYNE WALK, SW10 0DQ

**ROYAL BOROUGH OF KENSINGTON AND
CHELSEA**

AN ARCHAEOLOGICAL WATCHING BRIEF

SITE CODE: CHY11

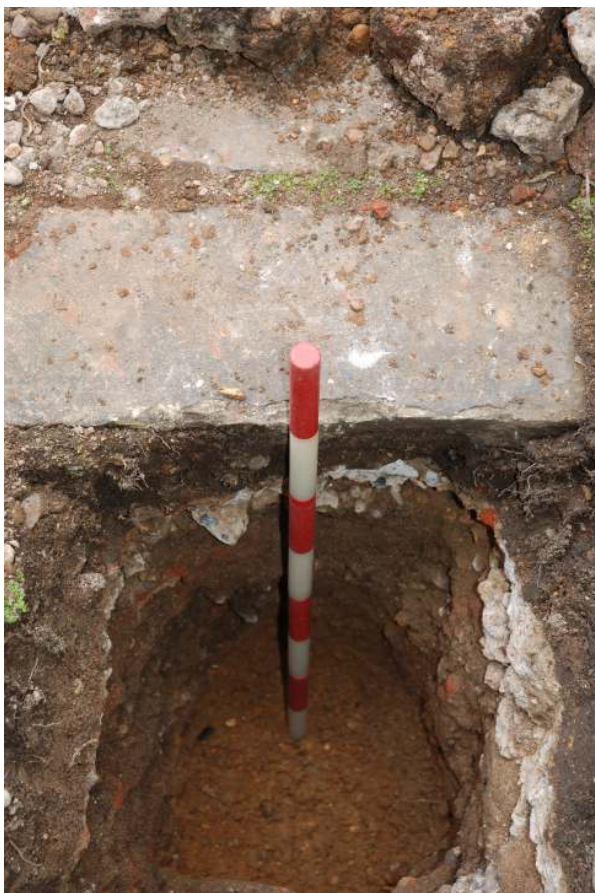
Fig. 39: Photo of trial pit 10C, with the 'natural' deposit clearly visible at the base of the trench.

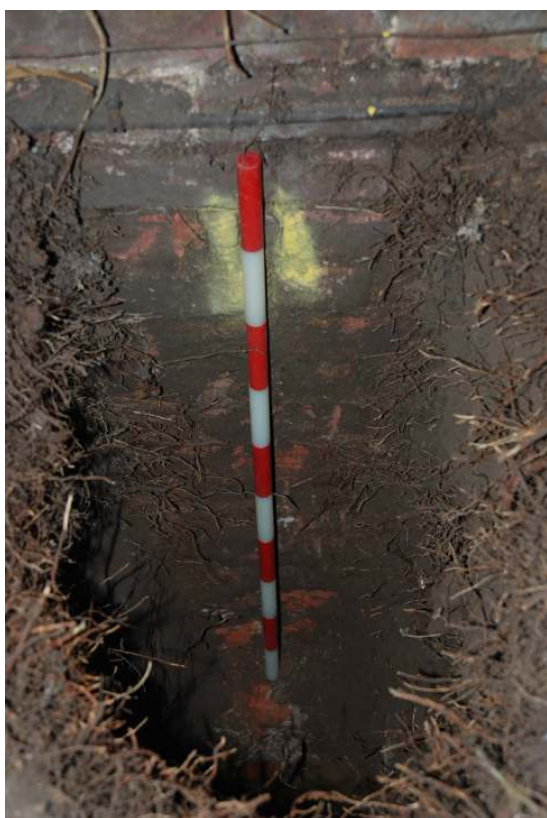
Fig. 40: Photo of garden wall foundations in the western section of trial pit 11.

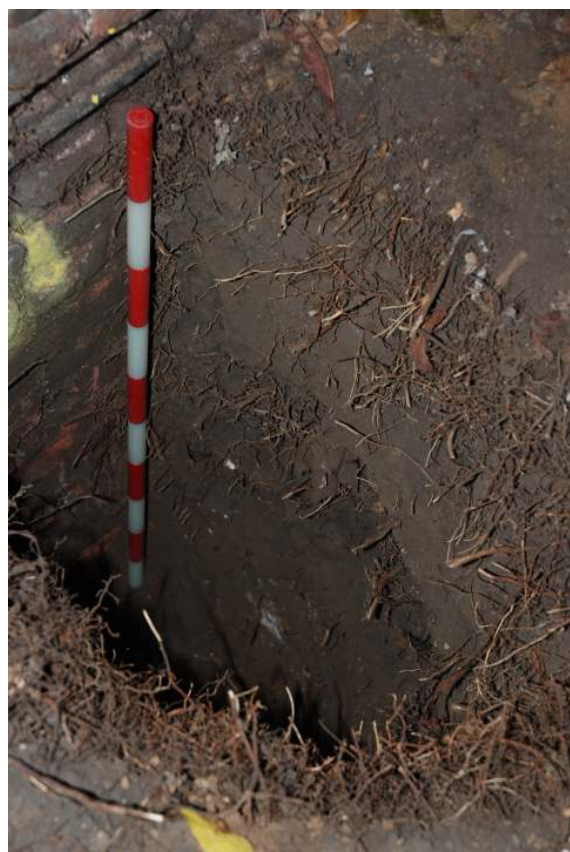
Fig. 41: Photo of trial pit 11, clearly showing the mixed deposit in the northern section.

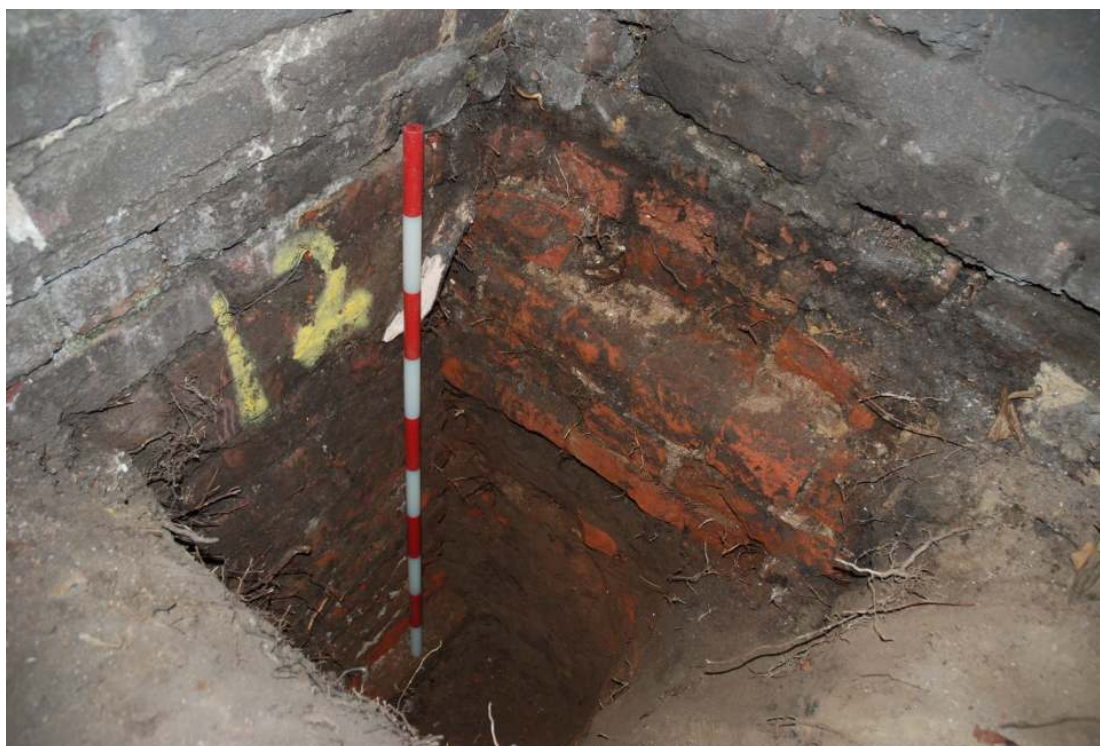
Fig. 42: Photo of trial pit 12, clearly showing the foundations of both the garden wall (left of the scale) and boundary wall (right of the scale)

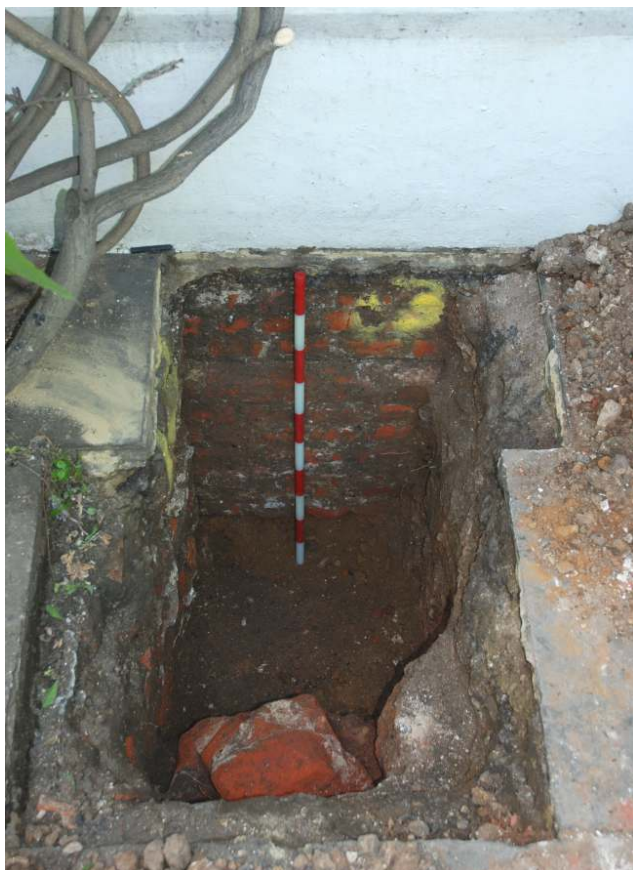
Fig. 44: Photo of brick foundations in trial pit 13 (taken from the south), with the earlier section of brickwork also visible in the foreground.

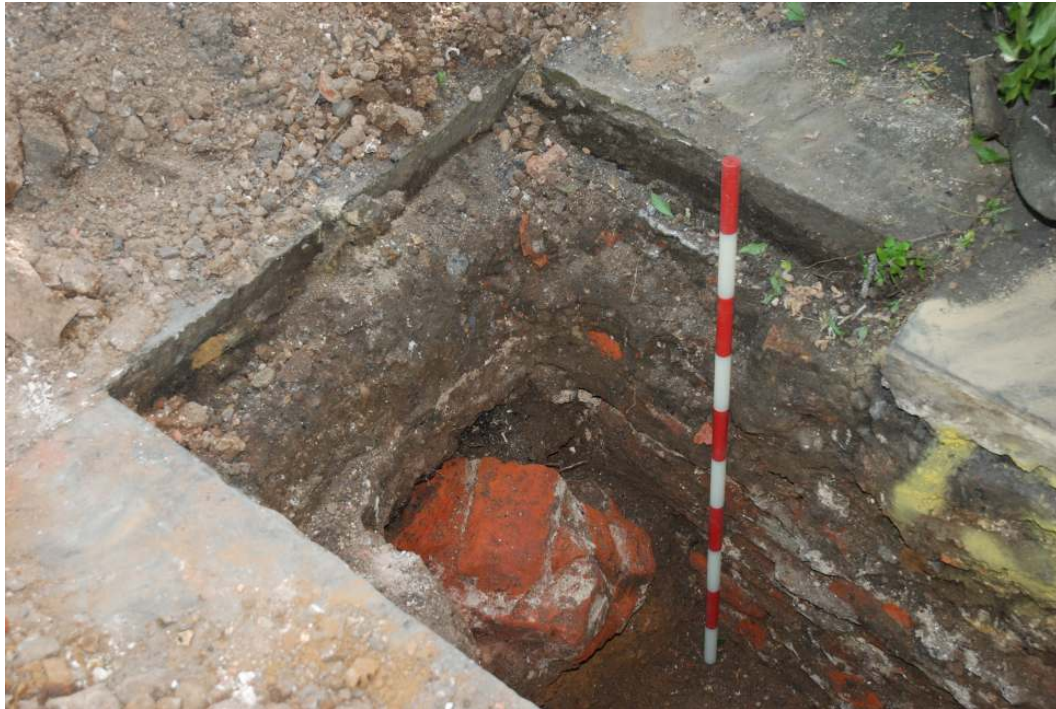
Fig. 45: Photo of earlier brickwork in trial pit 13 (taken from the north-east).

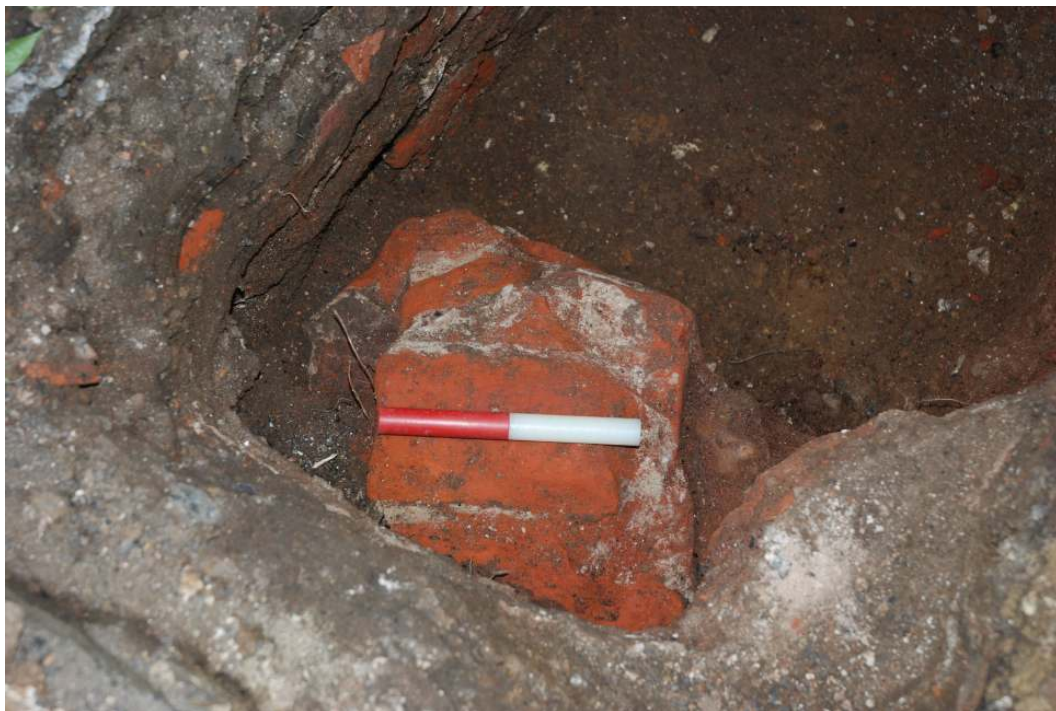
Fig. 46: Photo of earlier brickwork in trial pit 13, taken from above.

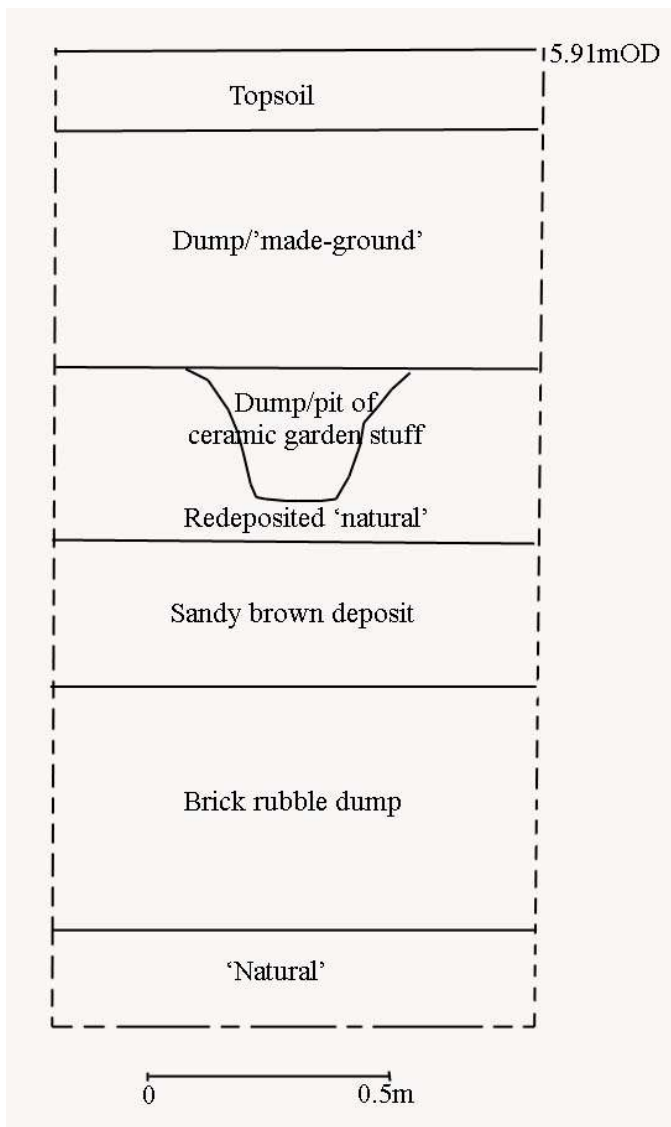
Fig. 48: Sketch section of trial pit 14. The 'topsoil' was a loose grey-brown garden-soil with lots of roots and pebbles. The 'dump / made-ground' was a fairly recent mixed mid-dark brown compact silty-sand with roots, pebbles, and CBM: this also sealed a pit containing fragments of 19th century unglazed ceramic path or border edging. The layer of redeposited 'natural' was a compact yellow-brown gravelly layer. The 'sandy deposit' was a compact brown gravelly sand.

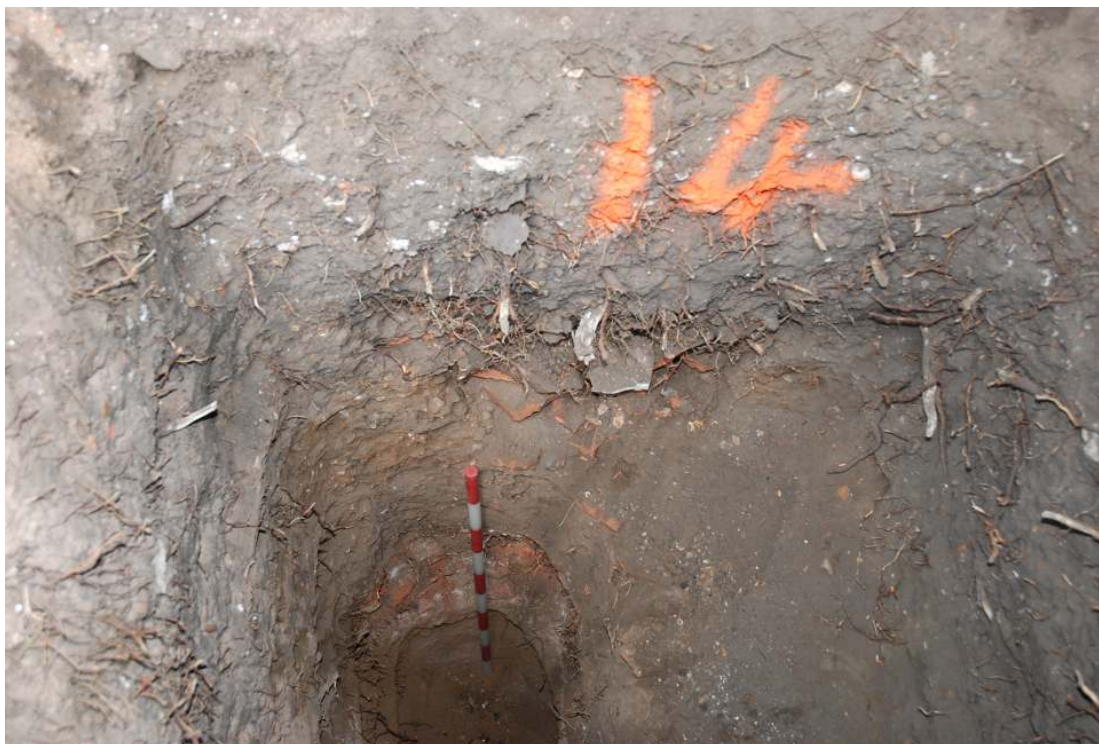
Fig. 49: Photo of trial pit 14.

Various bricks were sampled and identified from this brick rubble dump. This included bricks of the fabric-type 3033 (dated 1450-1700), and one sample of fabric-type 3036 (dated 1600-1800), which was probably a Flemish import. This acts as yet more evidence for early – 17th or more probably 18th Century – activity on the site.

The 'natural' (a yellow-brown sandy deposit) was observed at 1.7-1.8m beneath the modern ground-surface.

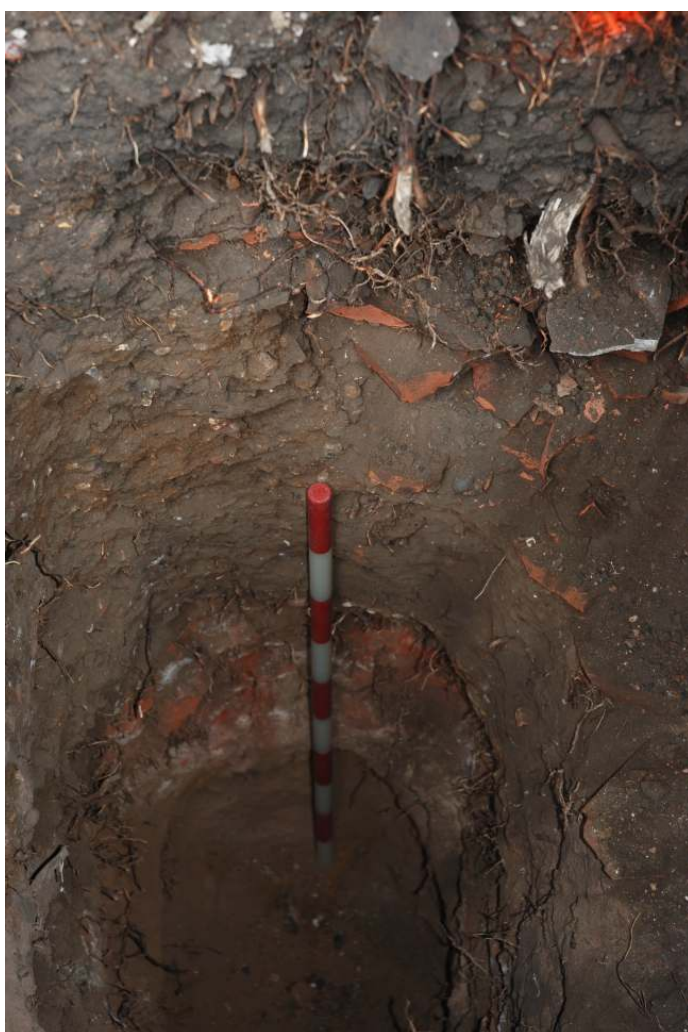
Fig. 50: Photo of trial pit 14, clearly showing the brick rubble / mortar deposit behind the scale.

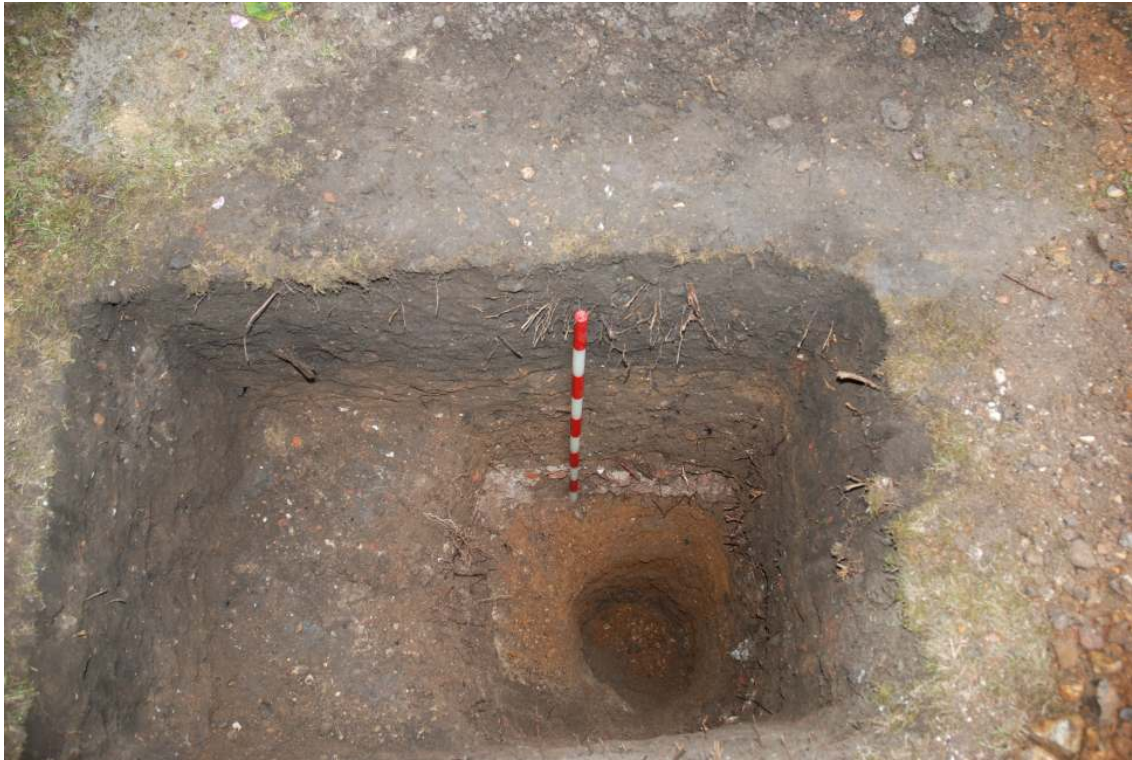
Fig. 52: Photo of trial pit 15, with the 'natural' deposit clearly visible at the base of the pit.

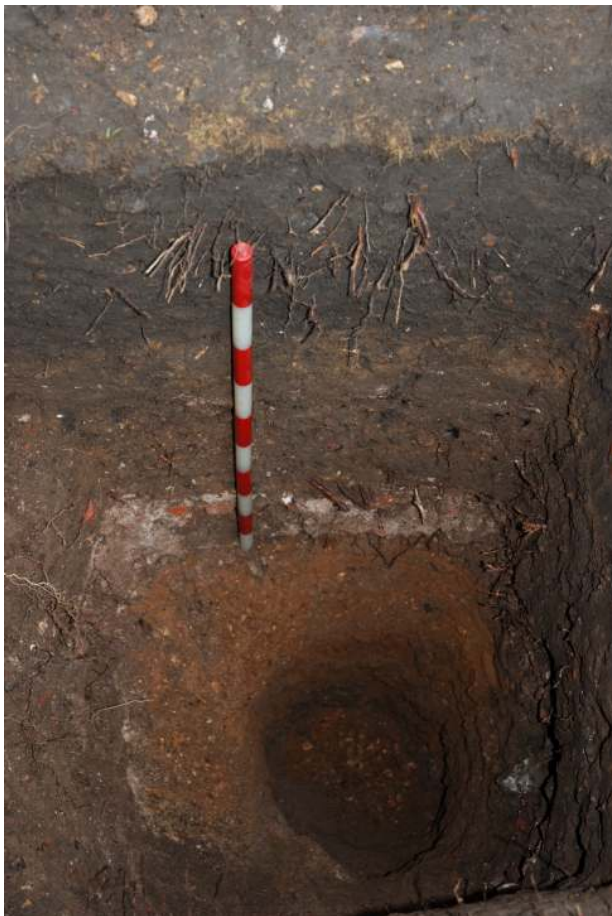
Fig. 53: Photo of trial pit 15, with the brick rubble layer and 'natural' deposit clearly visible towards and at the base of the scale.

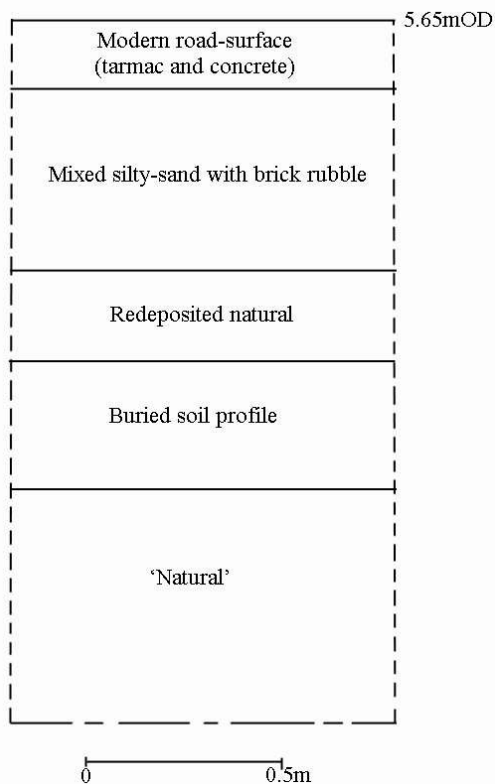
Fig. 54: Sketch section of trial pit 18. The mixed silty-sand deposit was loose with pebbles, roots, and brick rubble. The 'redeposited natural' was a relatively clean and compact orange gravel. The buried soil profile was a darker (grey-brown) clean and loose silty-sand.

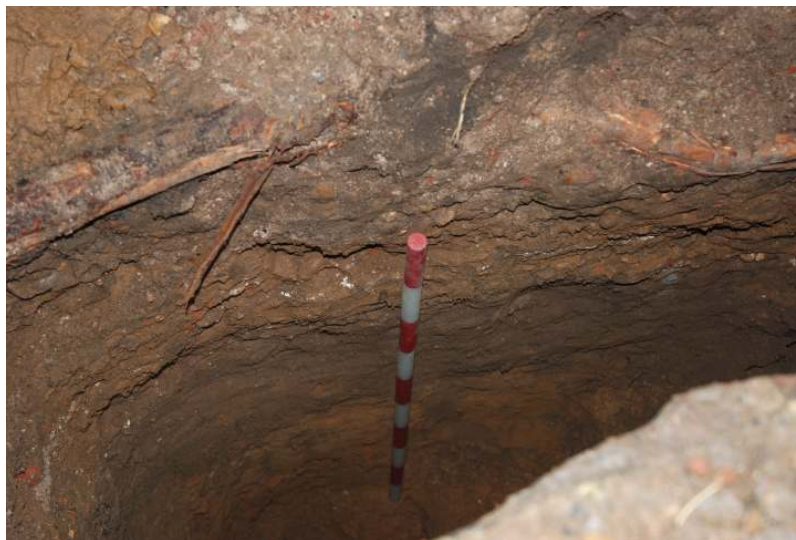
Fig. 55: Photo of trial pit 18, with the 'natural' deposits clearly visible at the base.

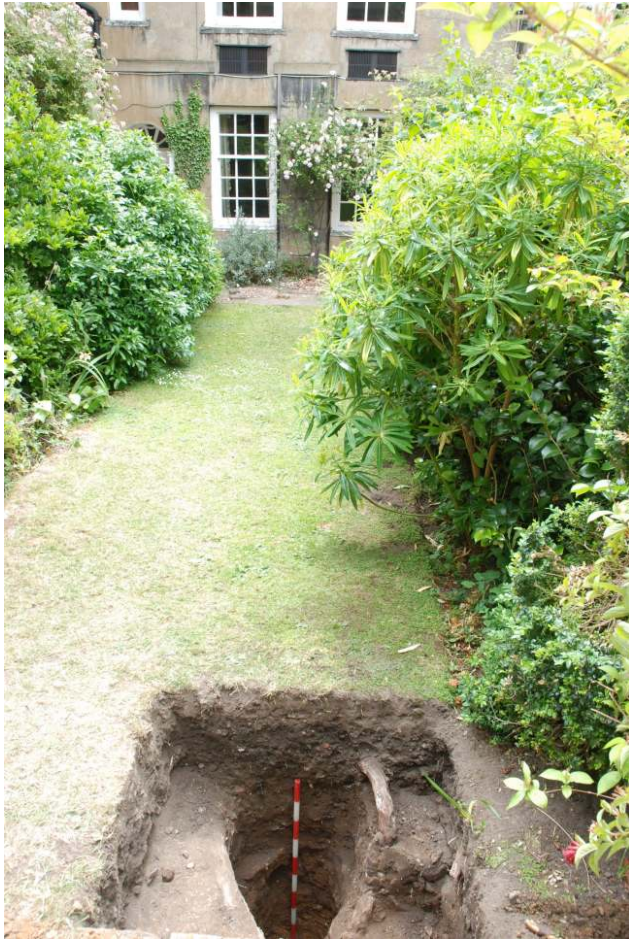
As the section above shows, little of obvious archaeological significance was observed in trial pit 19. Instead, 'made ground' deposits (a mixed mid-brown silty-sand with frequent pebbles and ceramic building material [CBM] fragments), a buried soil horizon (a lighter more compact silty-sand), and reworked natural deposits (a yellow-orange-brown firm sandy-gravel) were observed. The uppermost level of 'natural' (a yellow-orange-brown firm sandy gravel) was observed at *c.*0.85m beneath the modern ground-surface. This then graded down to a clean mid-brown firm silty-sand (*c.*1m beneath the modern ground-surface), and then into the 'clean' 'natural' (a compact yellow-brown gravelly-sand) at *c.*1.1m beneath the modern ground-surface).

Fig. 57: Photo of trial pit 19, with the rear frontage of No.96 Cheyne Walk in the background.

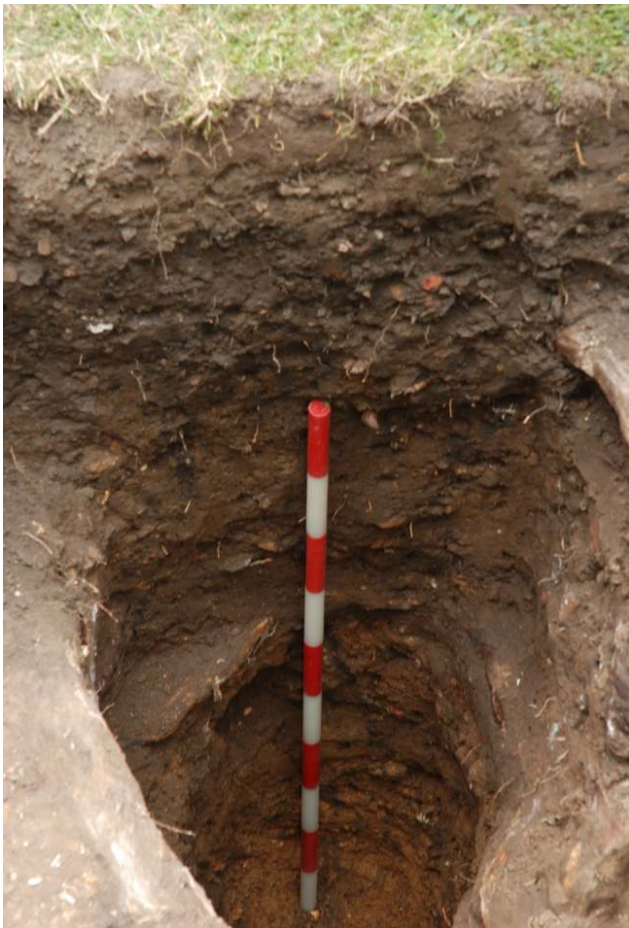
Fig. 58: Photo of trial pit 19, clearly showing the 'natural' at the base of the trench.

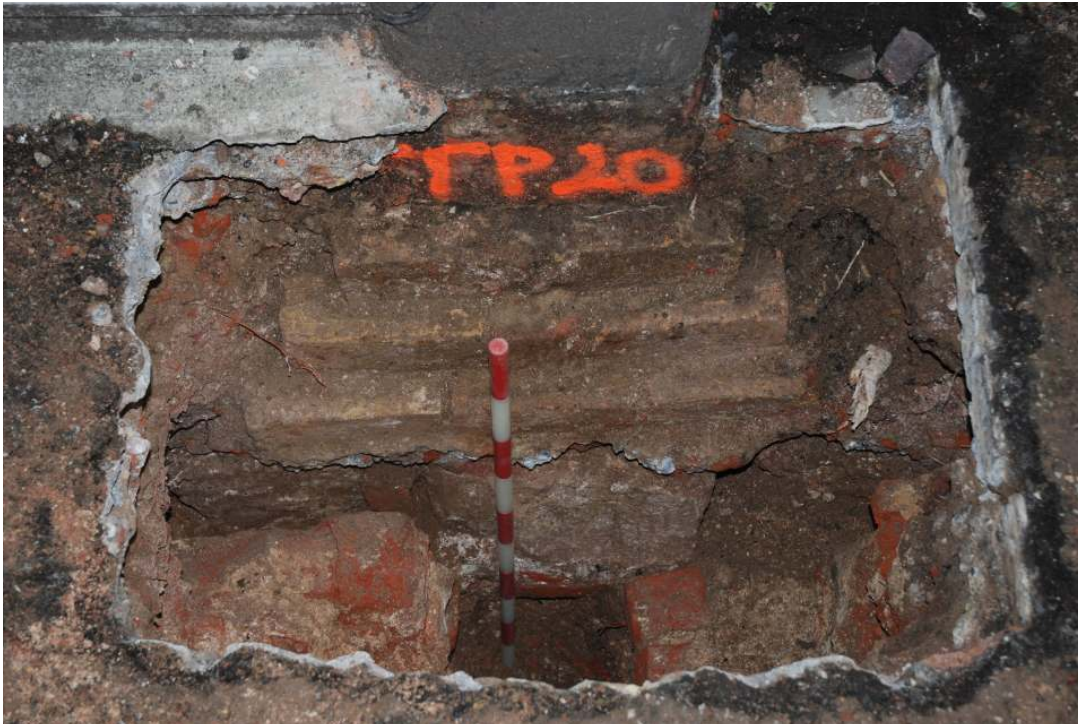
Fig. 59: Photo of trial pit 20, clearly showing the pier base and stone / mortar / brick base beneath this.

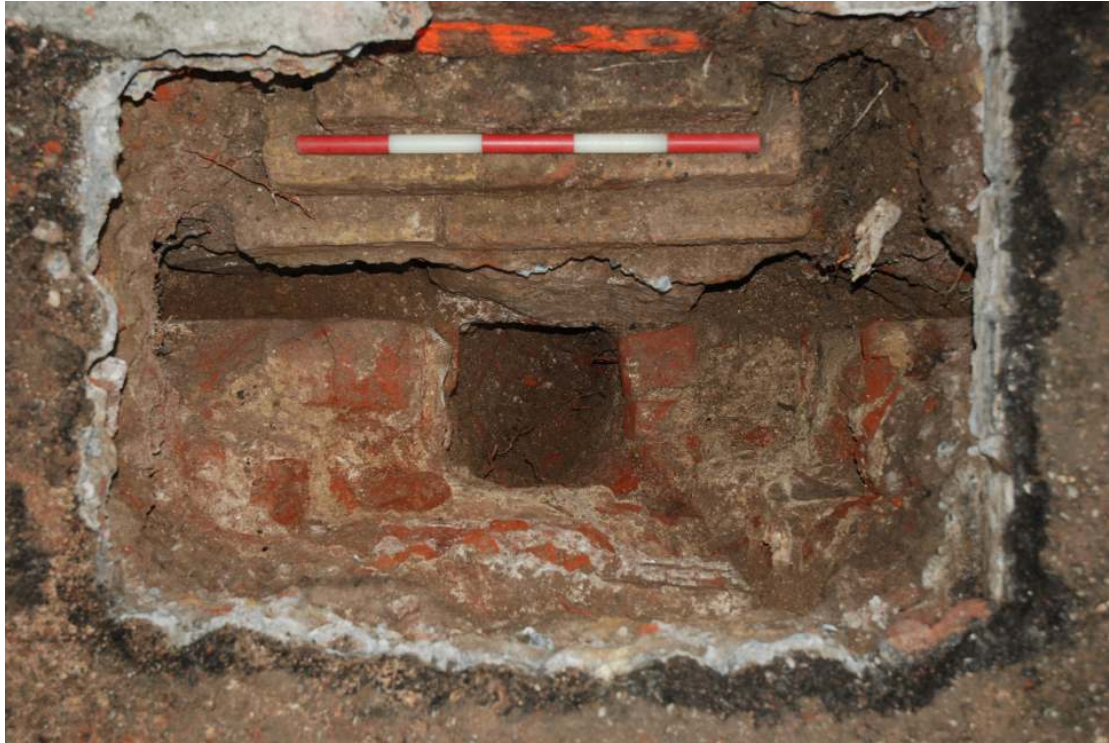
Fig. 61: Photo of trial pit 20, clearly showing the east-west running wall.

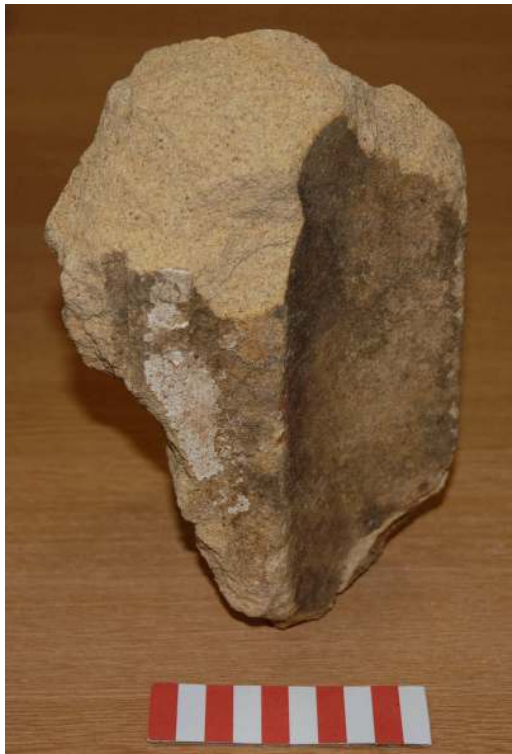
Fig. 62: Photo of the large piece of moulded stone recovered from the interior of the east-west running wall. This was probably part of a window mullion, overall width *c* 127mm. The moulded part of the stone is visible on the right-hand side. Just to the left of the lighter-coloured patch of the mortar or limewash is the vertical groove where the window would presumably have fitted.

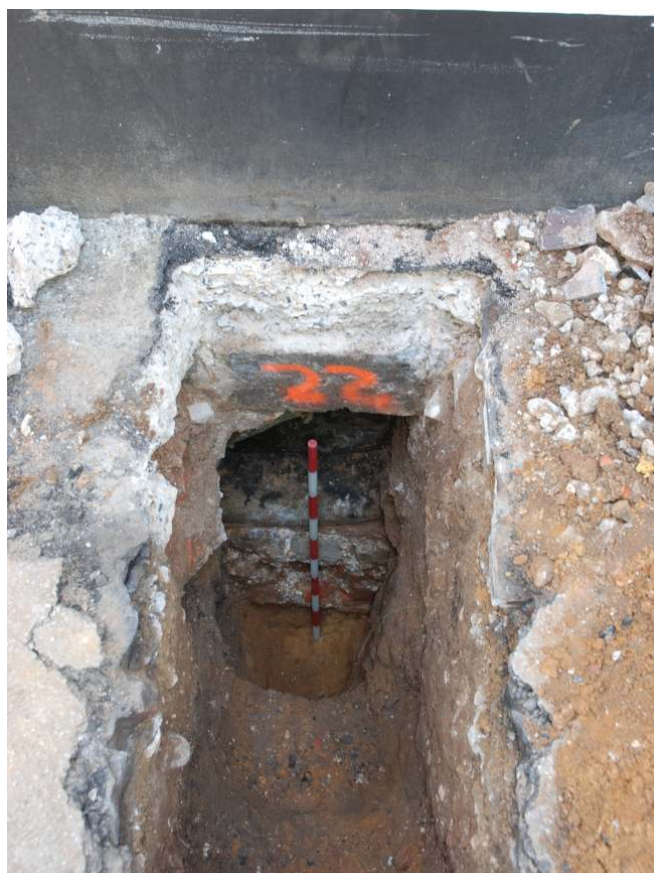
There was clear evidence for an earlier wall footing beneath these relatively modern phases of wall. This consisted of a ragstone and Reigate stone layer, set in lime mortar (for 0.2m), over a rubble base (brick rubble, stone, brickwork etc) for 0.3m. It therefore seems likely that there was a wall running north-south in this location before the current wall, possibly part of the original eastern end of Lindsey House.

The brick samples from the rubble base of the wall were dated 1450-1700 (fabric type 3033, see brick report). One sample may have been a floor brick at one time (due to the distribution of mortar over the brick), and was then reused in this wall. Stone samples from this base were fragments of micaceous greensand.

Fig. 63: Photo of western section in trial pit 22.

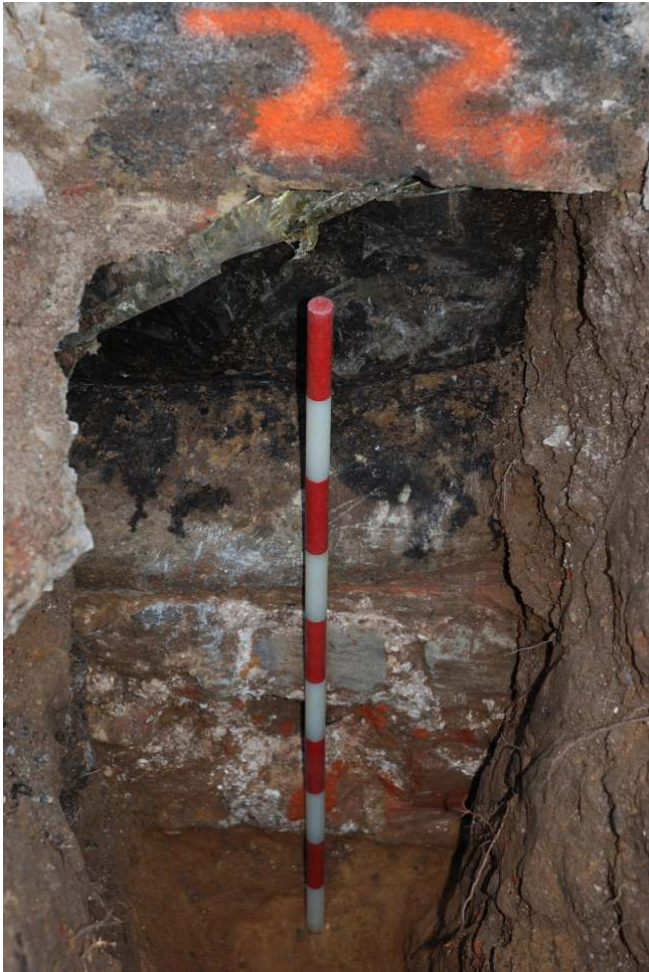
Fig. 64: Photo of the earlier wall base (behind the lower 0.6m of the scale) in the western section in trial pit 22.
