**THAMES WATER**  
**VICTORIAN WATER MAINS REPLACEMENT WORKS**  
**IN THE VICINITY OF ST PAUL'S ROAD, SHELBOURNE**  
**ROAD AND LANSDOWNE ROAD**  
**TOTTENHAM N17**

**LONDON BOROUGH OF HARINGEY**  
**DMA WOODFORD 82**

**AN ARCHAEOLOGICAL WATCHING BRIEF**

SITE CODE: TXL11  
APPROXIMATE SITE CENTRE NGR: TQ 3443 9084

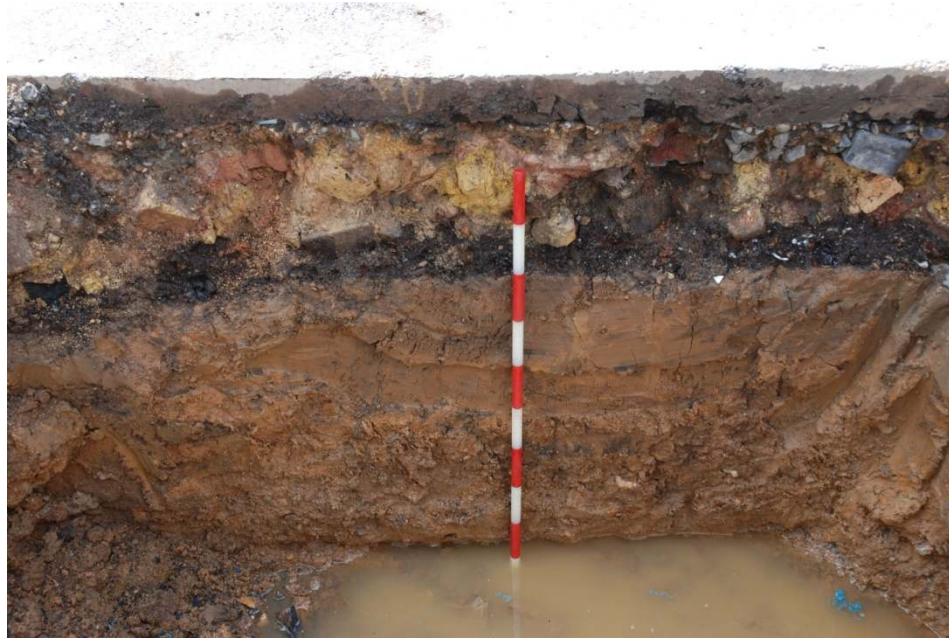
**Figure 8:** Section of trenching on St Paul's Road (1m scale).

Groundworks on St Paul's Road constituted a series of fourteen launch pits and trial holes located in the western carriageway approximately 1m from the kerb line, and covering approximately 130m of the road between Park Lane and Manor Road. The existing tarmac road surface was observed overlying brick rubble and bitumen road makeup to a depth of *c.* 0.35m. Truncated natural silty clay, disturbed at the upper horizon, was observed to 0.75m overlying orange/brown gravels to the remaining depth of excavation at *c.* 1.2m below the existing ground level. No archaeological finds or features were observed during trenching on St Paul's Road.

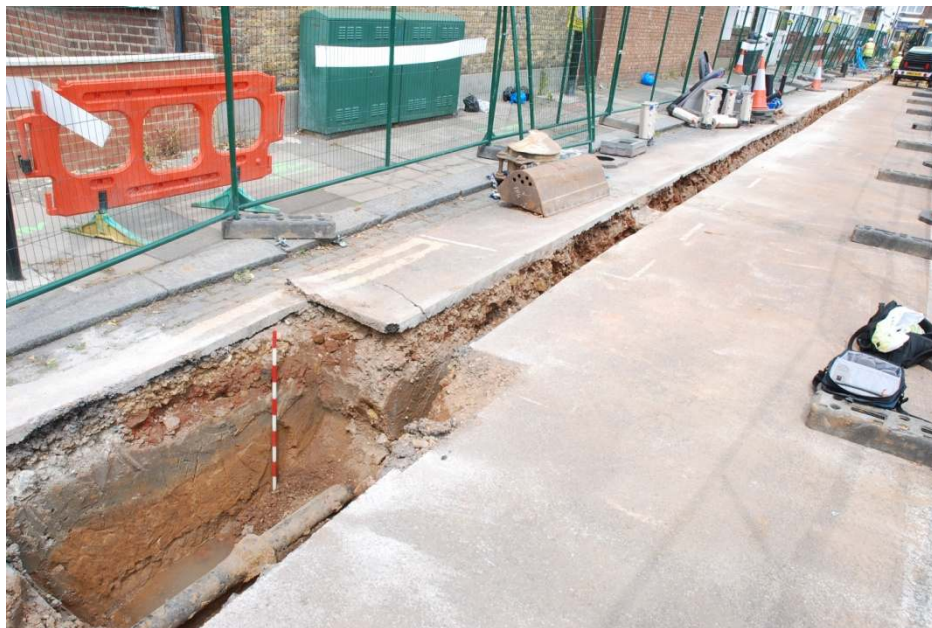
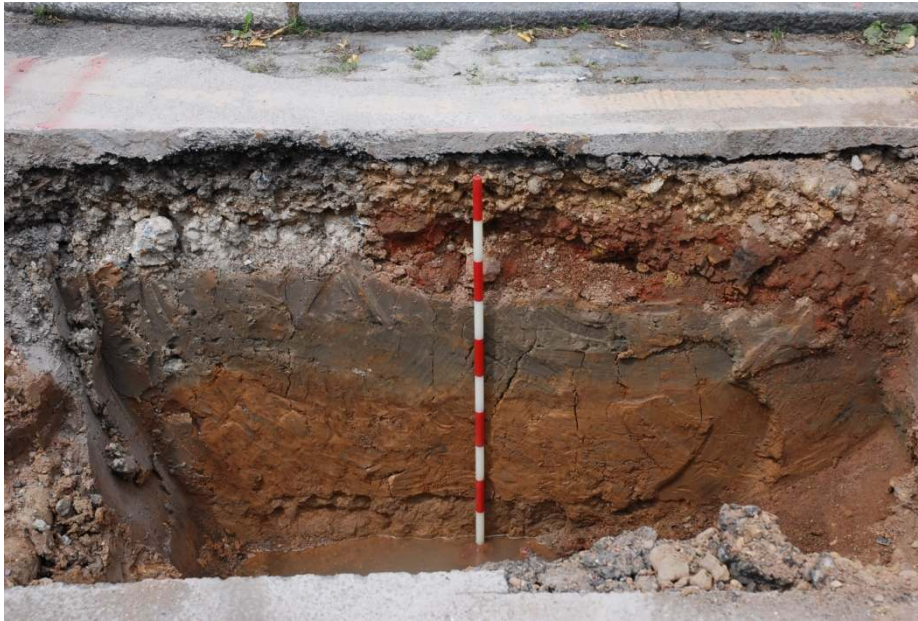
Groundworks on Denmark Street constituted a single open-cut trench running north from the junction with Manor Road for *c.* 98m towards the junction with Park Lane. The existing tarmac road surface was observed overlying road make-up of mixed gravels, stone and crushed red brick to a depth of 0.4m. Discoloured, reworked natural silty clay (light grey and mottled) was observed for a further 0.26m overlying undisturbed natural orange-brown silty clay and gravels to the full depth of excavation at 1.1m. No archaeological finds or features were observed during monitoring on Denmark Street.

**Figure 9:** General view of trenching on Denmark Street (1m scale, looking northwest).

**Figure 10:** Section of trenching on Denmark Street (1m scale).

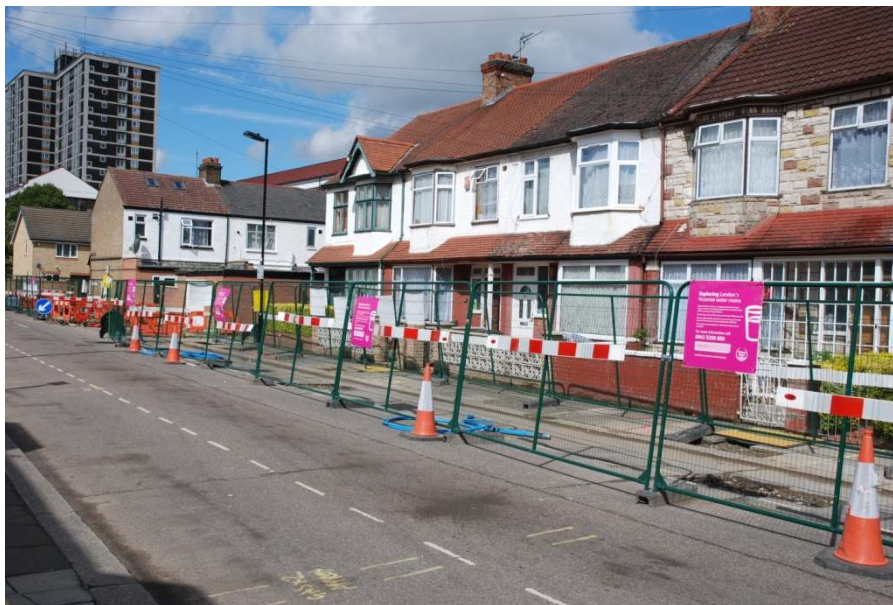
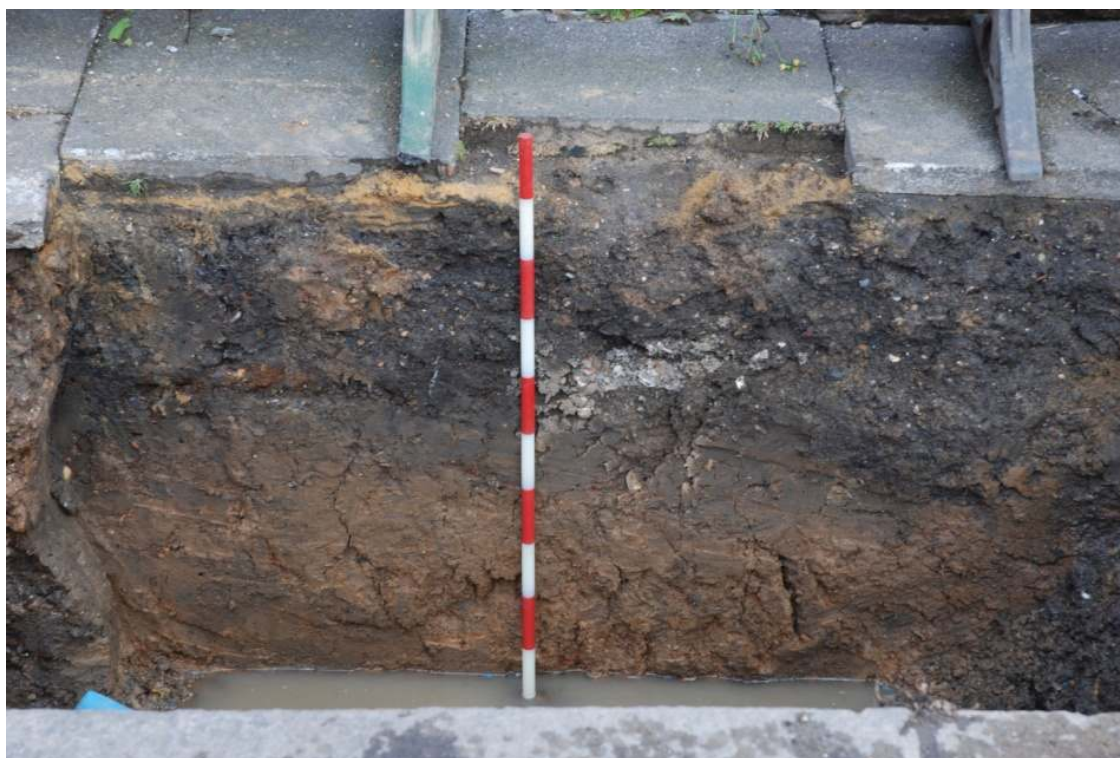
Groundworks on Chalgrove Road constituted seven launch pits and trial holes excavated in the east carriageway adjacent to the kerb line, and within the eastern pavement, covering approximately 100m of the road between Park Lane and Manor Road. Paving slabs in sand bedding were observed to 0.1m, overlying *c.* 0.35m of modern made-ground (dark-brown/grey silty clay with gravel). Natural silty clay was observed to the remaining depth of excavation at 0.95m, the upper horizon (*c.* 0.1m) was disturbed and discoloured, becoming orange/brown and clean with depth. No archaeological finds or features were observed during trenching on Chalgrove Road.

**Figure 11:** General view of trenching on Chalgrove Road, looking northeast.

**Figure 12:** Section of trenching on Chalgrove Road (1m scale).

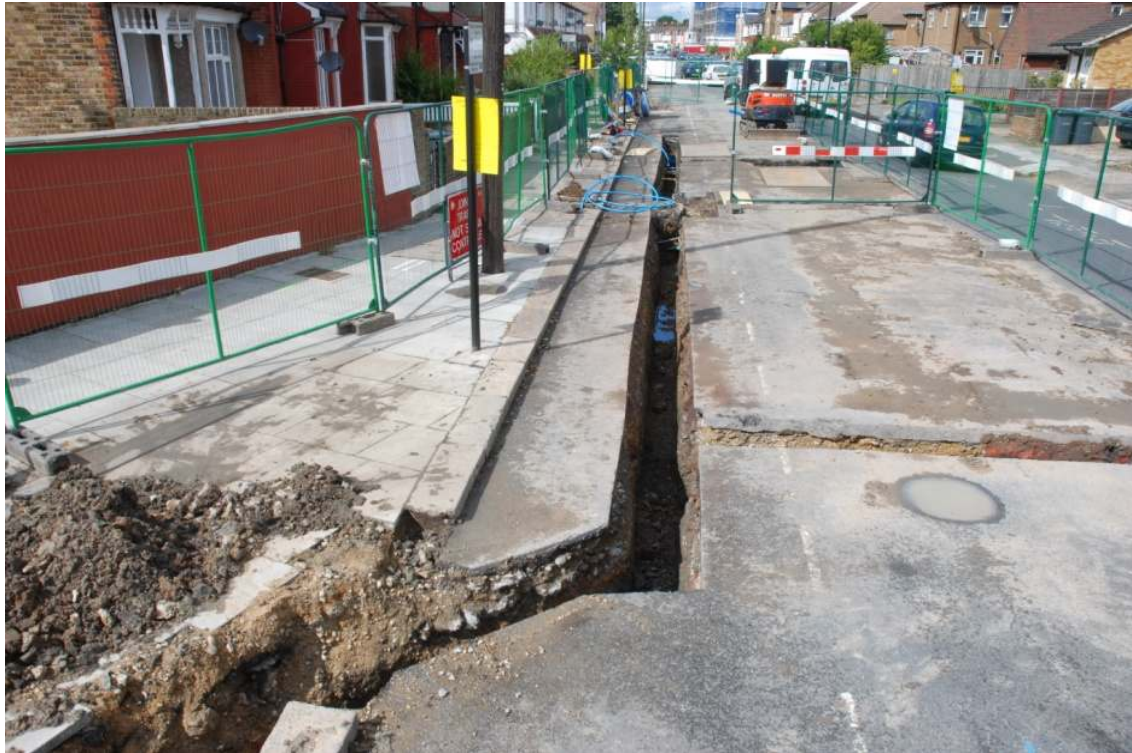
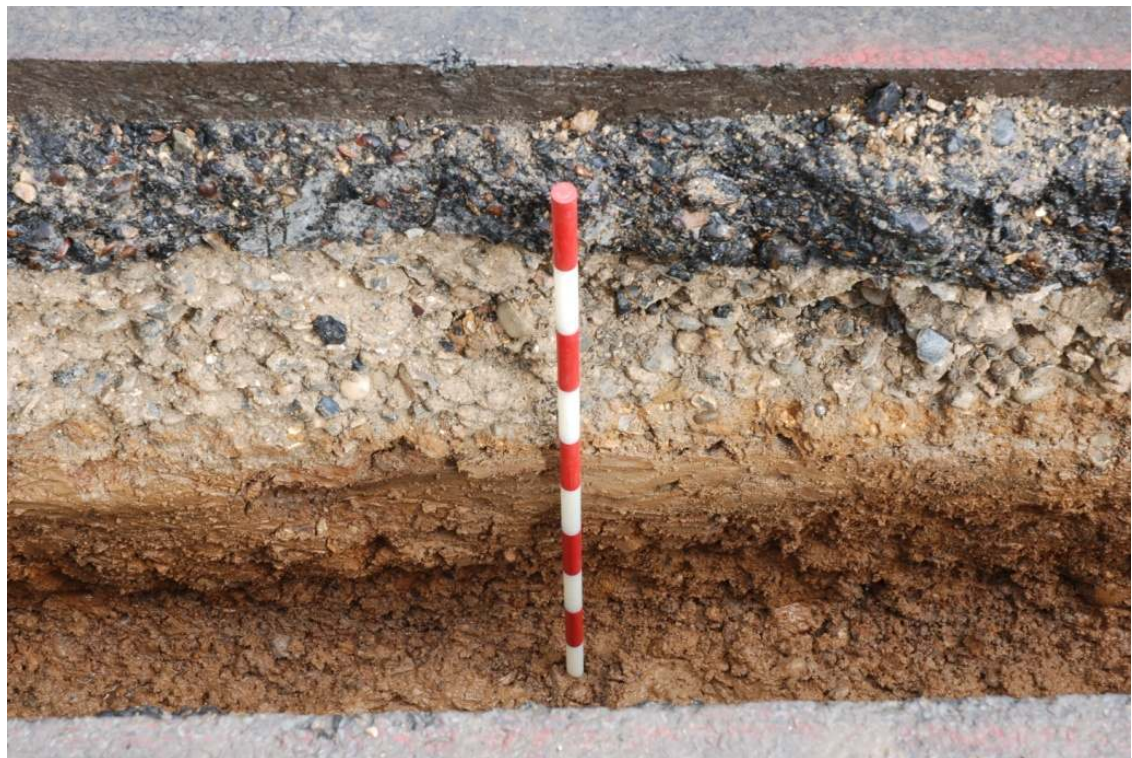
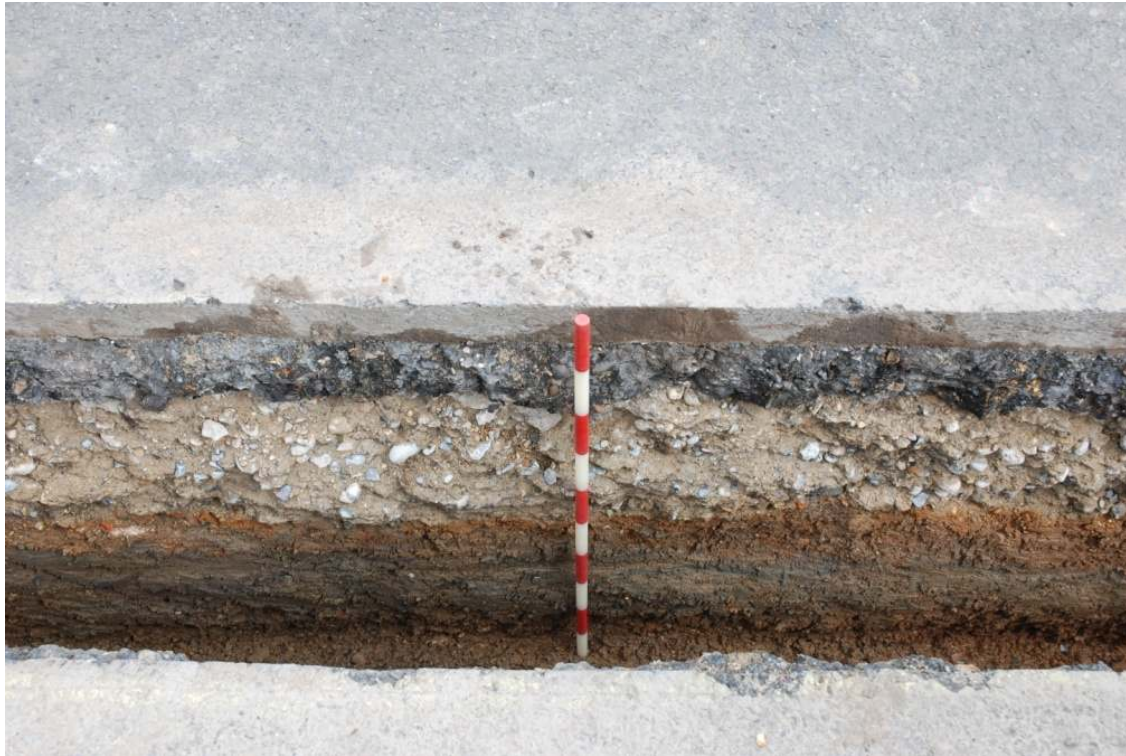
The groundworks in Area 2 constituted of *c.* 270m of open-cut trenching along Shelbourne Road between the junctions with Lansdowne Road (south) and Park Lane (north). The trench was excavated in the western carriageway, *c.* 2.2m from the kerb line. The existing tarmac road surface was observed overlying reinforced stone and concrete mix hardcore to an average depth of 0.4m. The majority of trenching exposed truncated natural orange/brown silty clay and gravels immediately below modern road layers. In two areas thin layers of made-ground or surviving subsoil was observed, in all cases of relatively recent date and consisting of mid-dark silty clay with gravel inclusions and occasional brick fragment. The trench was excavated to a maximum depth of 1.3m below the existing road level. No archaeological finds or features were observed during the course of monitoring on Shelbourne Road.

**Figure 13:** General view of trenching on Shelbourne Road (looking north).

**Figure 14:** Section of trenching on Shelbourne Road (1m scale).

**Figure 15:** Section of trenching on Shelbourne Road (1m scale).

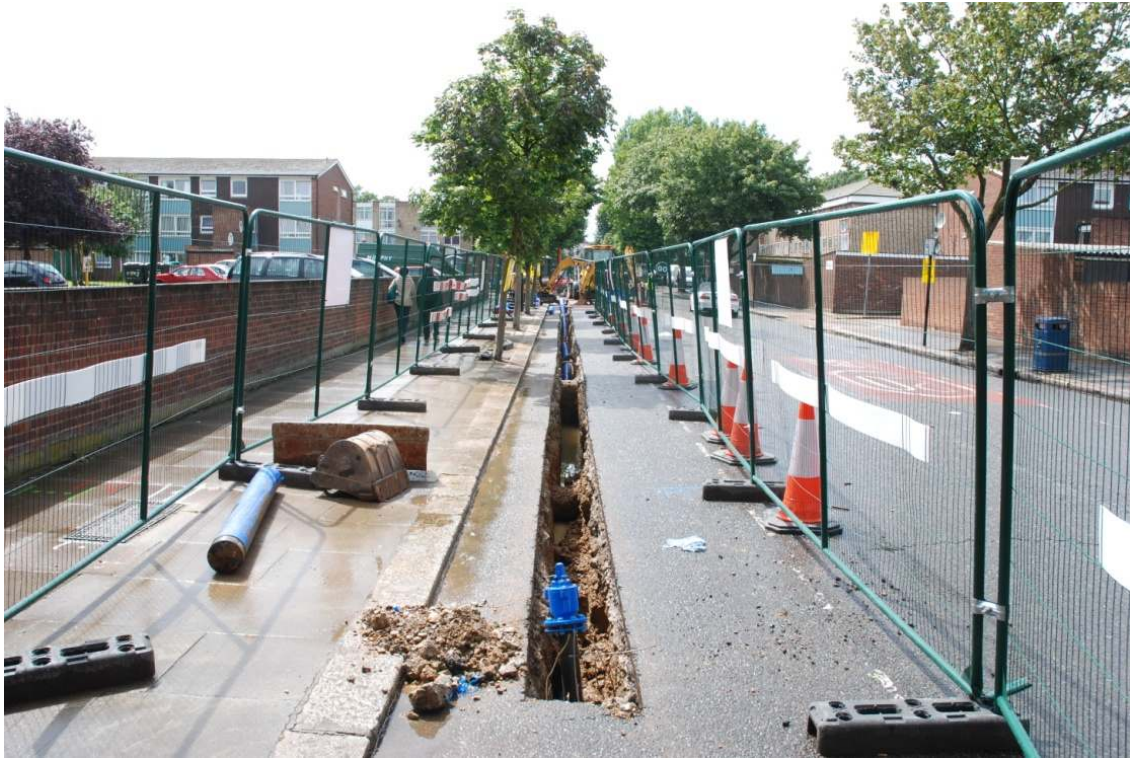
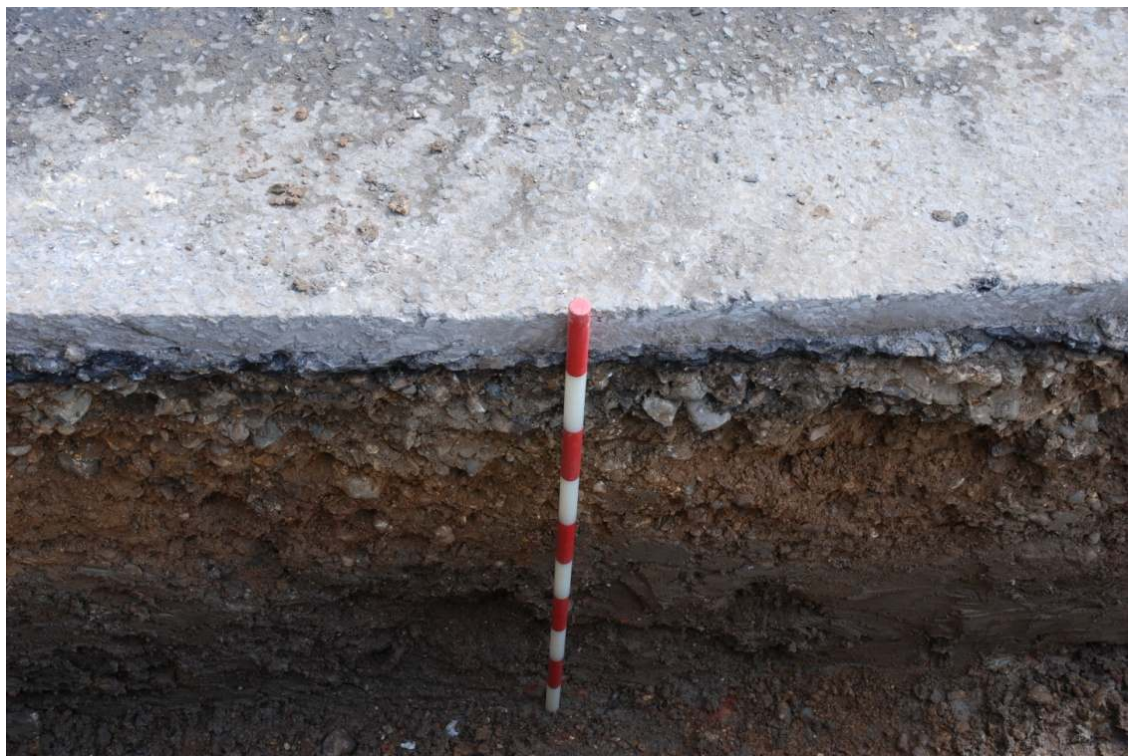
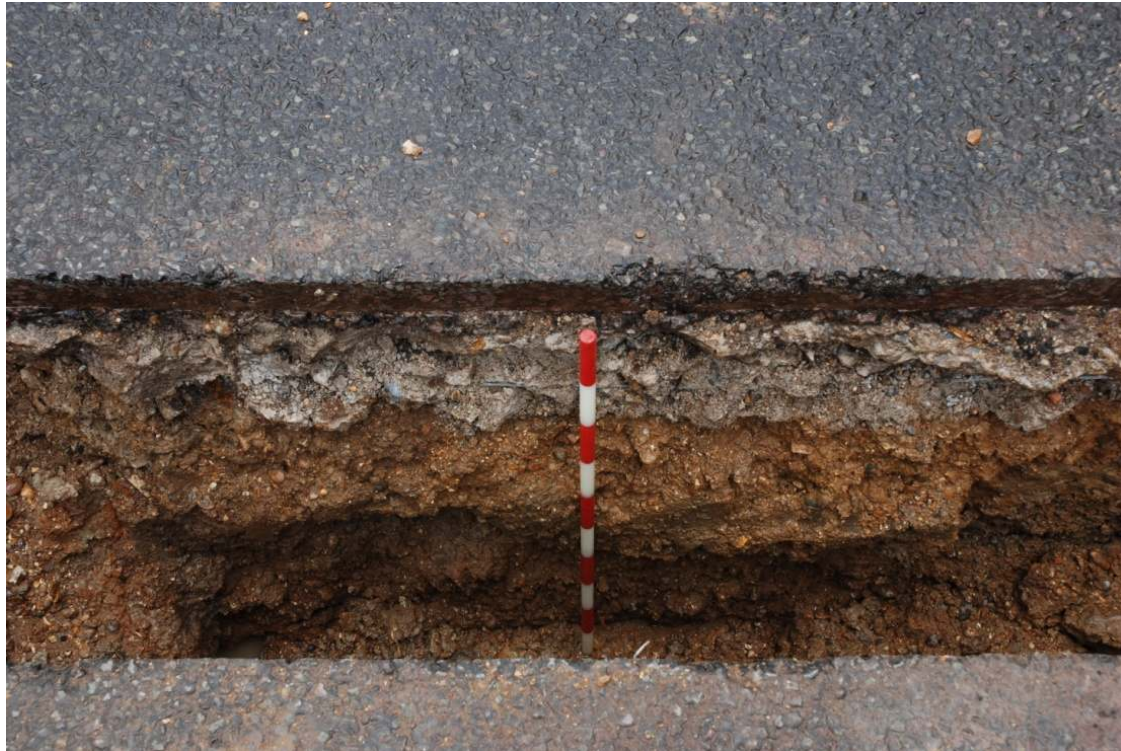
Groundworks on Lansdowne Road constituted a single open-cut trench running east from the junction with High Road for approximately 363m to the line of Stirling Road. The trench was excavated in the southern carriageway, and was located approximately 0.6m north of the kerb line. The existing tarmac road surface was exposed overlying concrete and gravel road makeup to an average depth of 0.4m. At the west end of Lansdowne Road, towards the junction with High Road, modern road levels immediately overlay truncated natural silty sand and gravel. Further east, outside St Mary the Virgin Church, the southern section exposed approximately 0.2m of surviving subsoil, constituting dark brown-grey silty clay with gravel, brick rubble and mortar inclusions. Compact mid-brown/yellow silty clay and gravel was exposed from 0.6m to the remaining depth at 1.1m below the existing road surface. To the west of the Burlington Road junction the trench was excavated within the cut of an existing sewer and consequently exposed only mixed backfill deposits. To the east of the junction with Burlington Road service backfills were observed to the full depth of excavation at c. 1.05m. No archaeological finds or features were observed during trenching on Lansdowne Road.

**Figure 16:** General view of trenching on Lansdowne Road (looking west).

**Figure 17:** Section of trenching on Lansdowne Road (1m scale).

**Figure 18:** Section of trenching on Lansdowne Road (1m scale).
