# **THAMES WATER MAINS REPLACEMENT WORKS**

**City Interim Report 33: CROUCH HILL 59,  
(November 2010-August 2011)  
including  
Remains of Moorgate on the junction of  
London Wall and Moorgate,  
&  
Remains of Aldersgate on the junction of  
Aldersgate Street and St.Martin's-le-Grand**

City Interim Report 33: CROUCH HILL 59,  
(November 2010-August 2011)  
City of London EC2

COMPASS ARCHAEOLOGY LIMITED

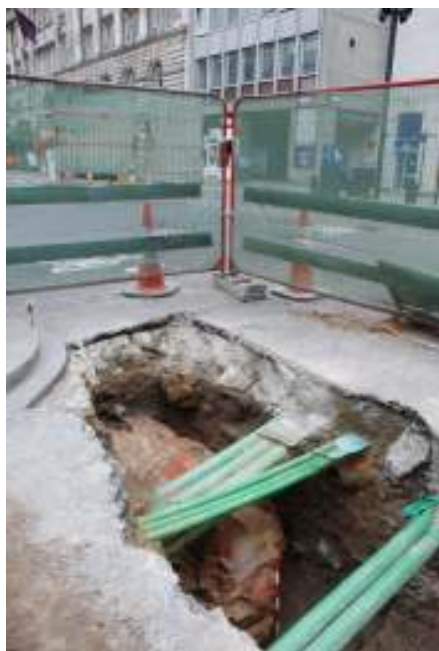
In the northern end of the trench a large block of red-brick masonry was exposed c.0.80m below the modern ground level. The bricks were bonded with a yellow sand-based mortar and measured 23cm in length x 10.5cm wide and up to 6.5cm thick. They formed part of a block measuring at least 2.45m N-S x 1.2m E-W and continuing into the unexcavated section to the north. The brickwork was not bottomed but survived to at least 14 courses, approximately 1.09m in height. Only a partially surviving faced surface was observed on the north-eastern corner of the masonry block for about 0.5m: to the south of this the brickwork appears to turn a corner to the east, although it is then broken away by modern intrusions. A possible further faced surface is represented by a small section of partly detached brickwork at the south end of the structure. Brick samples taken were examined and dated to c.1600-1700AD (fabrics 3039 and 3033)<sup>6</sup>. A clay tobacco pipe bowl was recovered from surrounding overburden material, and, being rouletted around the rim and of a squat bulbous shape with a thick stem attached, interpreted as a Type 17, datable to c.1640-70<sup>7</sup>

Fig.13: *Trench in southern carriageway of junction with London Wall and Moorgate, facing NE*

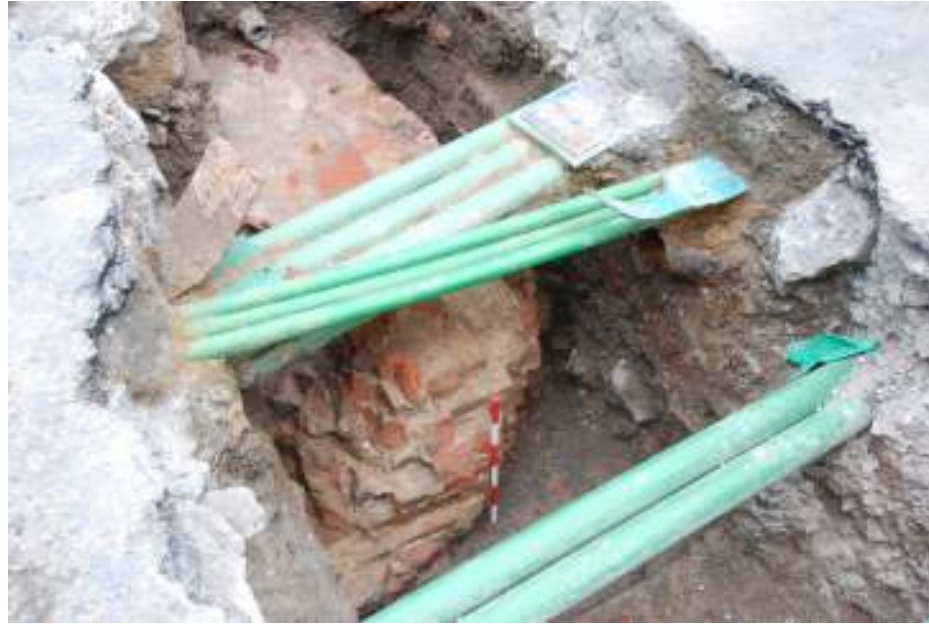
Fig.15: *Brickwork of former Moorgate exposed at northern end of Trench facing NE, (0.6m scale)*

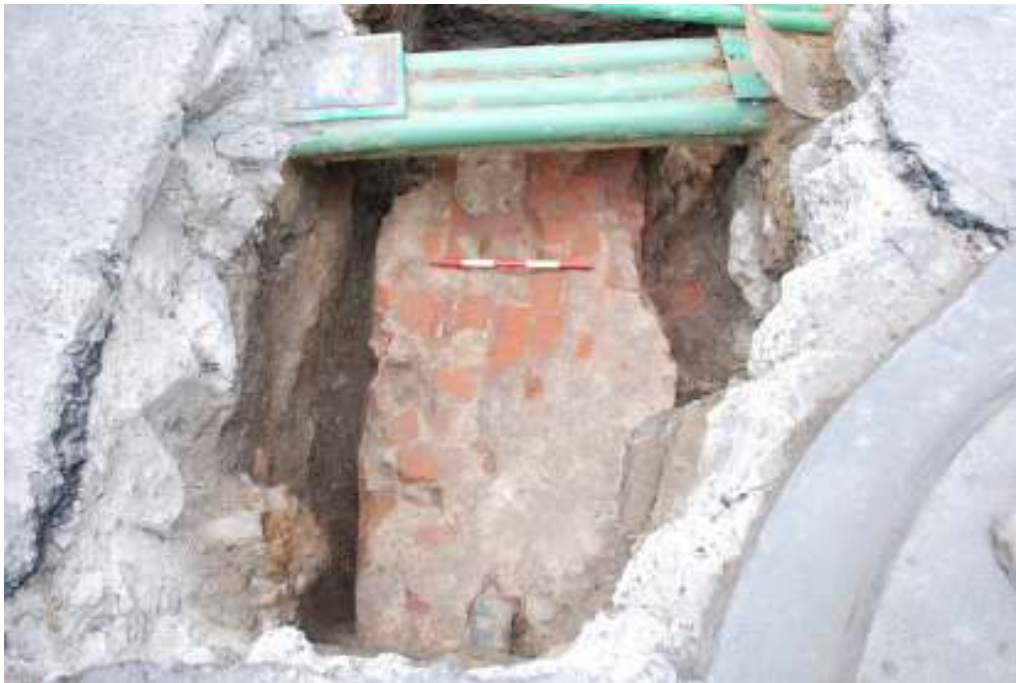
Fig.16: *Brickwork of former Moorgate exposed in Trench, facing S, (0.6m scale)*

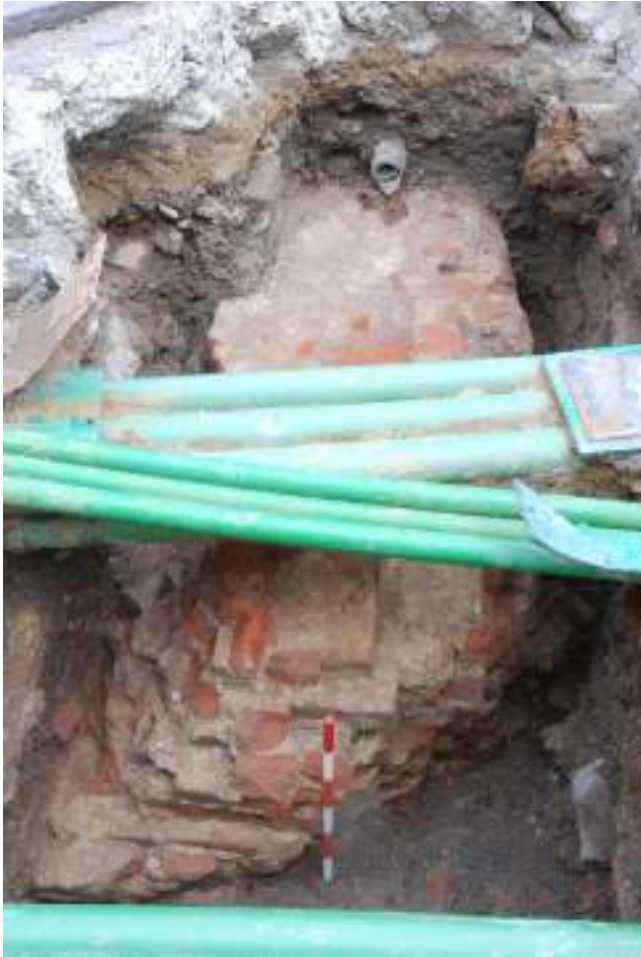
Fig.17: *Brickwork of former Moorgate in Trench facing NNW, (0.6m scale)*

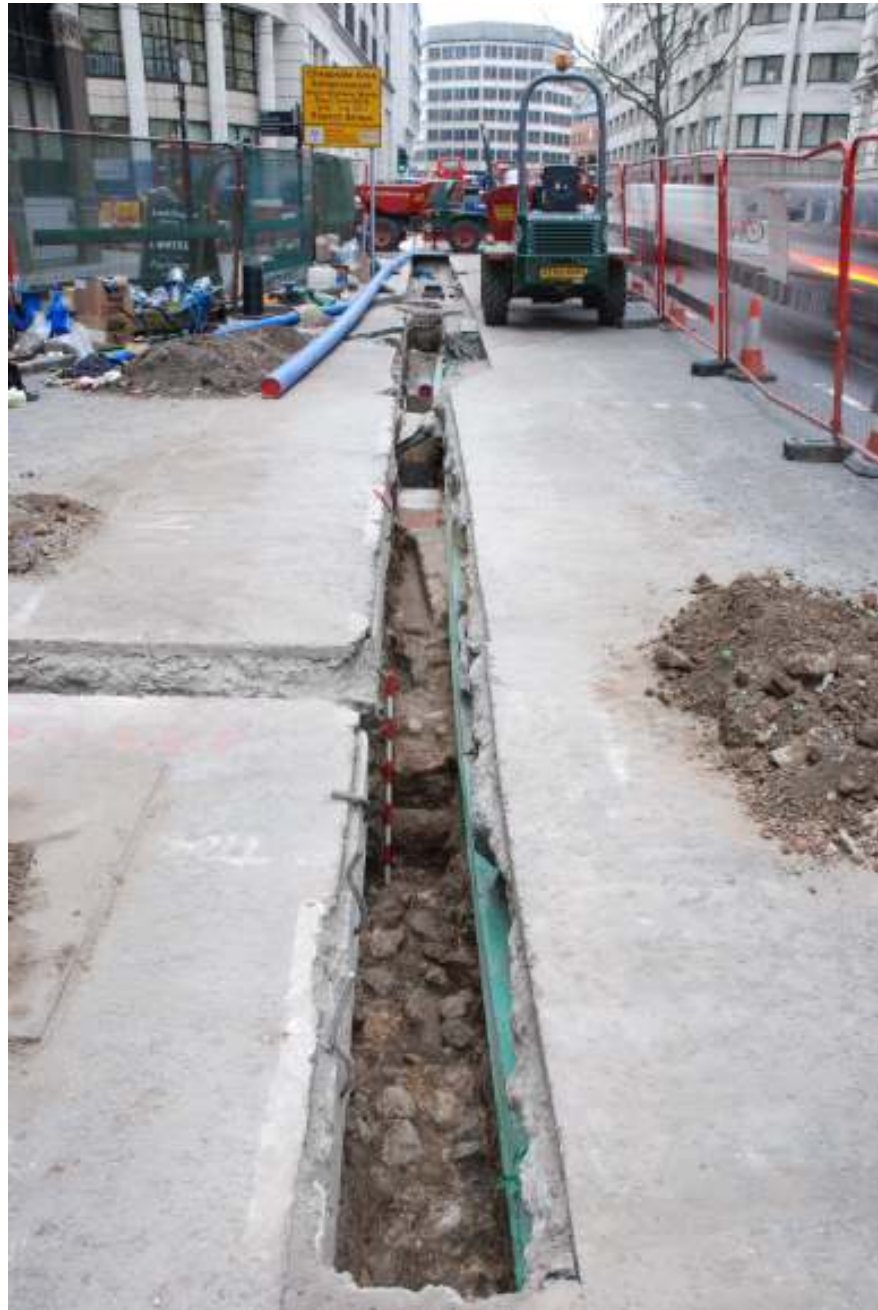
An open-cut trench aligned N-S east of the centre line on Aldersgate Street was observed and recorded between the 5<sup>th</sup> -7<sup>th</sup> of February 2011. It measured approximately 12.78m long x between 0.36-0.66m wide and up to 1.18m deep. Two shorter branches were cut 2.18m from the north end and 1.06m from the southern end, extending eastwards for approximately 1.24m and 1.06m respectively although these did not reveal any significant remains. The following discussion details the archaeological observations made and should be read in conjunction with the trench plan, (fig.36).

Fig.31: *The remains of Aldersgate facing South*

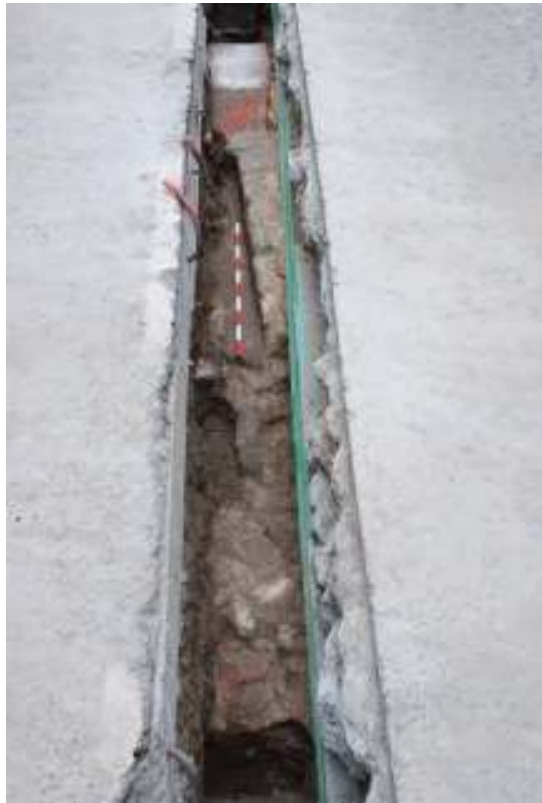
In the far northern end of the trench was a layer of mixed stone and yellow mortar rubble within a silty subsoil deposit, extending for c6.75m southward across the width of the trench and for 0.5m into the northernmost eastern extension. It was interpreted as rubble collapse from a part of Aldersgate. Adjoining this was roughly mortared in situ stonework with standing remnants of the structure thought to be represented by contexts [3] and [4] approximately 2m further to the south. This comprised mixed stone and poured yellow-mortar footings, overlain by a single course of square-cut blocks of mainly Reigate ragstone and one of limestone. To the east of these were several floor tiles, the remains of an interior surface. Due to the confines of the trench it was hard to assess which component of the gate this stonework may have formed.

Fig.32: Contexts [3], [4] & [5] in northern half of trench facing S

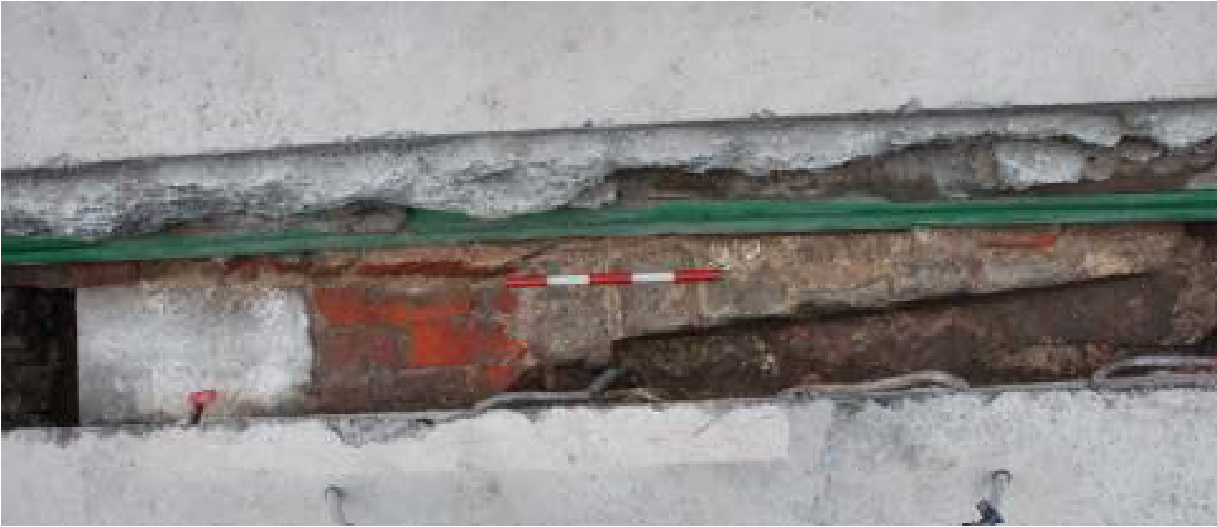
Context [3] was abutted by brickwork [4] immediately to the south and this brickwork also overlay the stone blocks of [3] at the southernmost end. On the southern end of the brickwork was mortared a large square slab of limestone, possibly forming a corner stone. The brickwork may represent the main façade of the gate, whereas [3] may be the foundations, or internal face onto which the brickwork facade is erected. In turn the stone slab at the far southern end may form part of a ‘monumental’ facing onto one of the street frontages. However, due to the spatial confines of the trench it was hard to prove either way.

Fig.33: *Brickwork [4] abutting stonework [3] facing West (0.5m scale)*

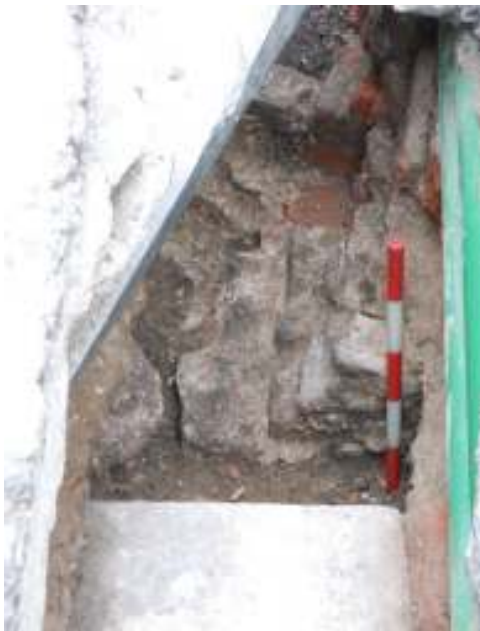
Around 0.4m further south of slab [4] aligned E-W across the trench was a fragmentary section of wall [5]. It was comprised of roughly worked Kentish ragstone rubble bonded with a soft, sandy lime-mortar. It survived to 0.35m in height from the base of the trench, (continuing down for an unconfirmed depth), was 0.45m wide, and appeared to have been robbed out on its eastern side. Its function is unknown, but may have been an element of the earlier medieval gate, destroyed in 1617. It as sealed by the deposit [12], which in turn underlay and abutted the stone slab [4].

Fig.34: *Context [5] in centre of frame and [4] in the foreground, facing S (0.5m scale)*

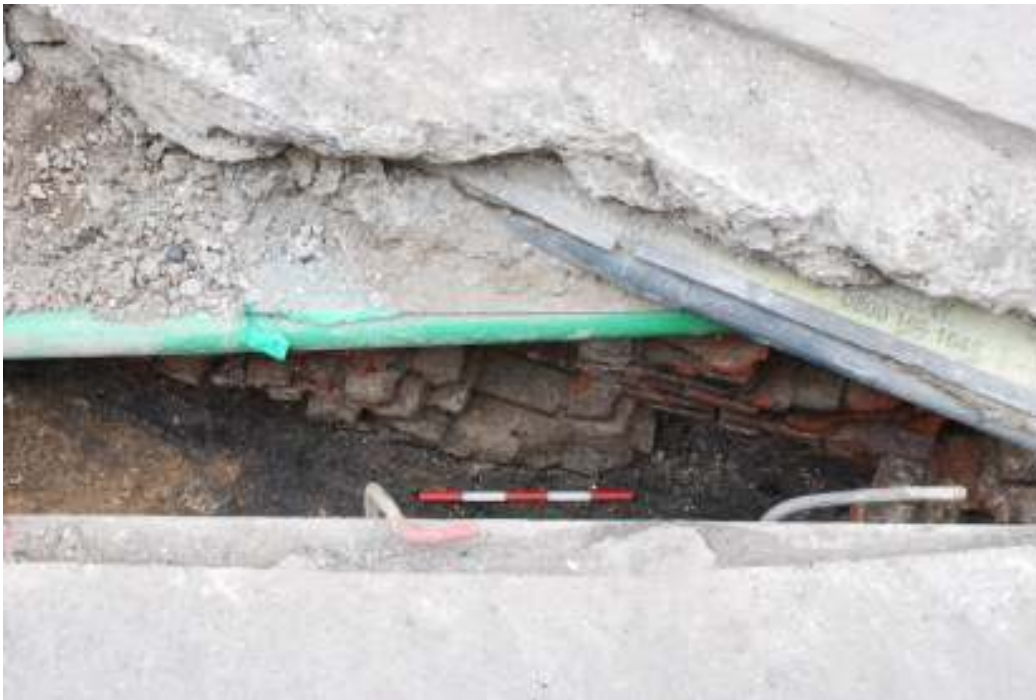
0.18m south of [5], aligned NE-SW in the western edge of the trench a wall of red brick was present [6]. This was abutted by a NW-SE red-brick wall [8] at its northern end joining it at a right-angle. They were both bonded with a greyish lime-mortar, but while [6] was at least several courses thick, [8] was only 2 bricks wide. It is thought that these two walls may have formed the corner of some sort of brick-lined pit, this is further suggested by the dark-grey sandy-silt mix, (10), that was contained within a roughly square area south of wall [8]. It contained a substantial amount of charcoal and occasional CBM and mortar fragments, was excavated to a depth of 0.5m and continued below the limit of excavation. This deposit produced pottery sherds dating from 1550-1700AD, which is contemporary with the later, 17<sup>th</sup> century gate<sup>15</sup>, and a clay tobacco pipe bowl decorated with the British Royal Coat of Arms and conforming to Type 21 (1710-40)<sup>16</sup>. Either side of the spur were the initials P.S.

Fig.35: Walls [6], [7], & [8] in southern half of trench facing W. Deposit (10) in foreground

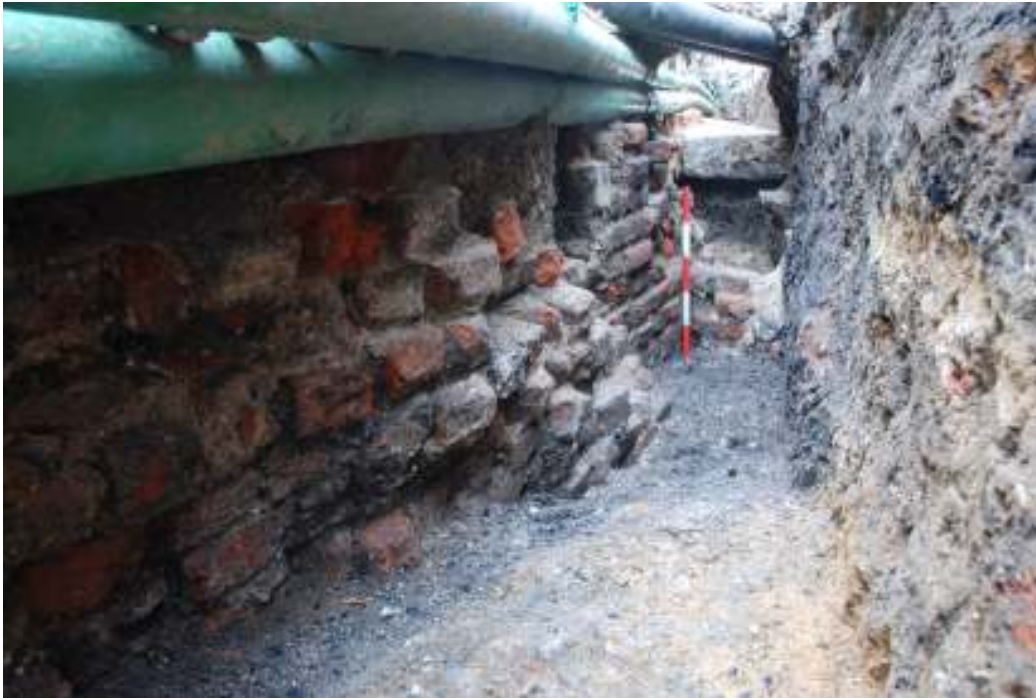
Deposit (10) appears to have been truncated further south and west at a later date and brick wall [7] inserted, abutting next to the south-eastern face of wall [6]. A construction cut, [13], was possibly identified behind the face of the wall, to the west. It may be that deposit (10) was redeposited around the newly constructed wall as the boundary of the fills were very unclear. The purpose of this addition is unknown, but may represent later repair work or an extension to wall [6] and its associated property. The construction cut appeared to truncate deposit (14), an orange-brown compacted sandy gravel 0.16m thick which was only observed south of wall [8] and east of wall [7]. This could imply that (14) represents an exterior surface and (9) an interior dump/surface.

Fig.36: Context [7] with contexts [6] and [8] in the background, facing NNW, (0.5m scale)

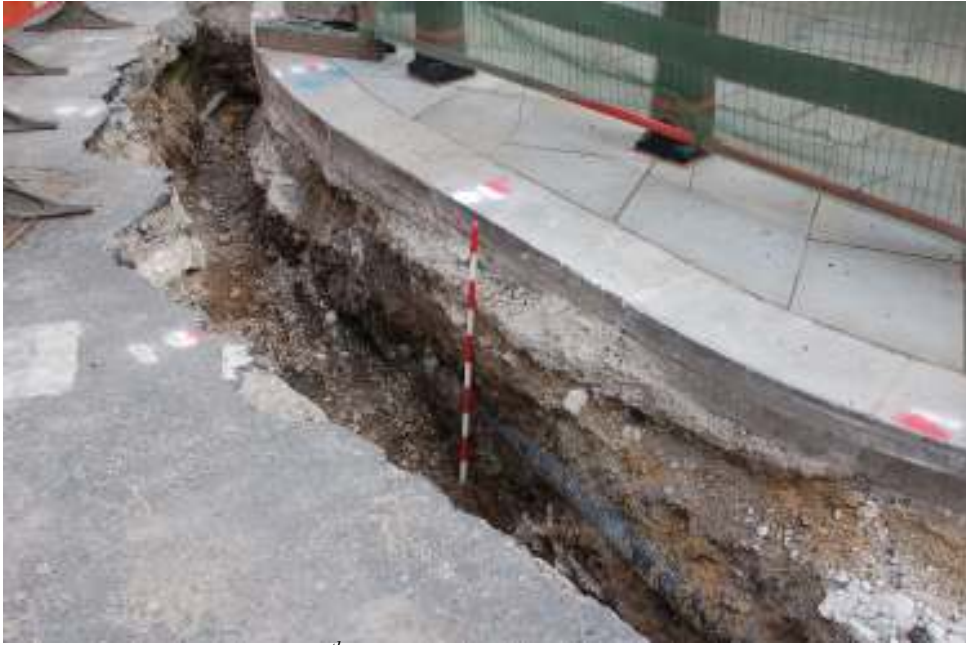
A further 22m of open cut trench were observed on the 7<sup>th</sup> June. The trench extended from the eastern end of Basinghall Street and on to Basinghall Avenue, round the corner onto the south-eastern kerb. A large pit was dug in the SE corner of the turn. Stratigraphy included 0.38m of tarmac and concrete making up the existing road surface over up to 0.9m of made ground and service backfill, ranging from a grey-pink aggregate to a sandy clay, containing frequent CBM and gravels.

Fig.39: *Basinghall Street 7<sup>th</sup> June 2011. Section through trench Facing NE*

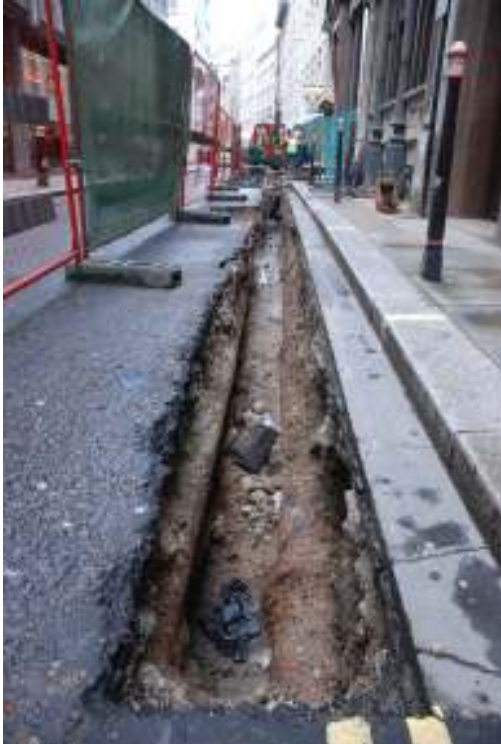
On the 11<sup>th</sup> January 2011 a 25m stretch of open-cut trenching was observed adjacent to the eastern kerb along Coleman Street between Kings Arms Yard and Great Bell Alley. The trench measured 0.5m wide by up to 0.6m deep and contained no archaeologically significant deposits, being purely backfill material around the existing service pipes, below 0.3m of tarmac and reinforced concrete. A similar sequence was observed in a pit dug opposite the Institute of Marine Science and Technology further to the north. This area was revisited on the 20<sup>th</sup> January to observe a further 12m of trench south of the pit. The same sequence of existing road surfaces over service backfill.

Fig.40: Coleman Street, 11<sup>th</sup> January, facing N

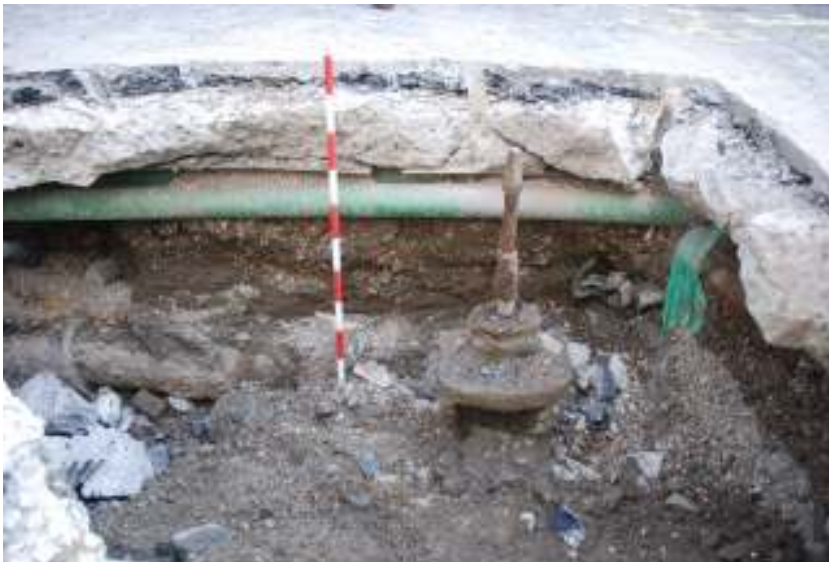
A large L-shaped pit was observed just north of White Horse Yard on the 2<sup>nd</sup> September 2011, measuring 4.3m long x 0.9m wide by 1.2m deep, (N-S arm), and 5.9m long x 1.45m wide x 1.3m deep, (E-W arm). The below ground deposits were heavily disturbed by modern services criss-crossing the trench and their associated backfills. Where earlier deposits were observed, mainly on the eastern side of the N-S arm, they comprised a grey silty-clay containing frequent CBM and gravels up to 3cm big representing post-medieval made-ground.

Fig.41: Coleman Street, 2<sup>nd</sup> September. West facing section in SE corner of L-shaped pit

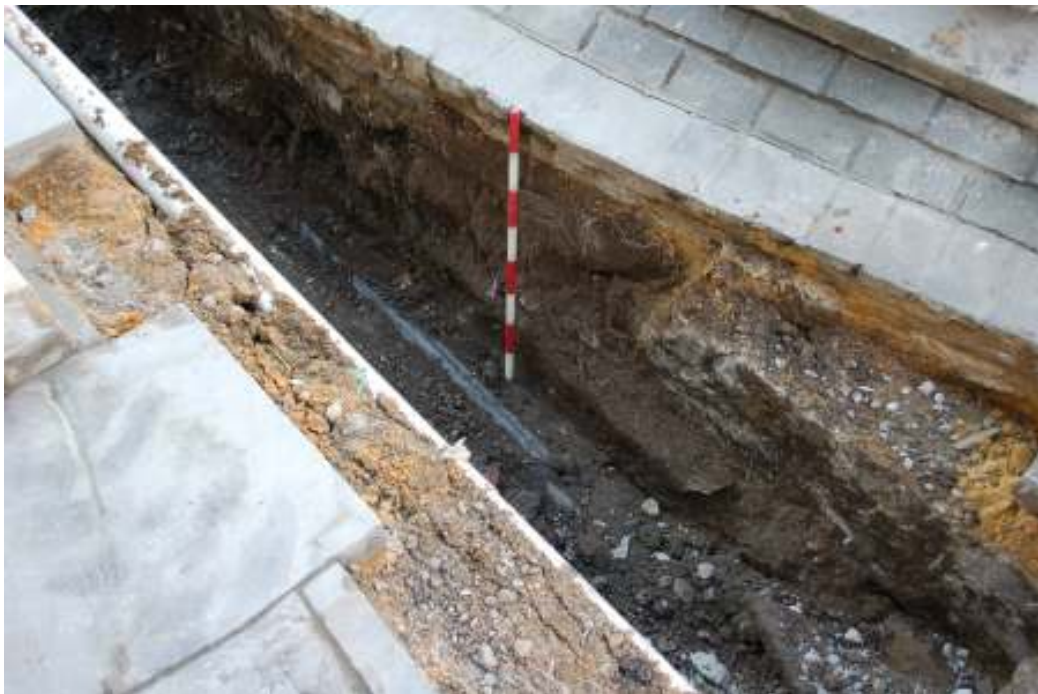
On the 31<sup>st</sup> May a further 7m of trenching measuring 0.6m wide by 0.8m deep was inspected revealing paving slabs over made ground to the south and a concrete slab to the north, which may have been associated with the nearby underground car park. Another visit to the site revealed the same sequence in 10m of trenching further eastwards on the 7<sup>th</sup> June.

Fig.42: *London Wall, 31<sup>st</sup> May 2011. Facing NW*

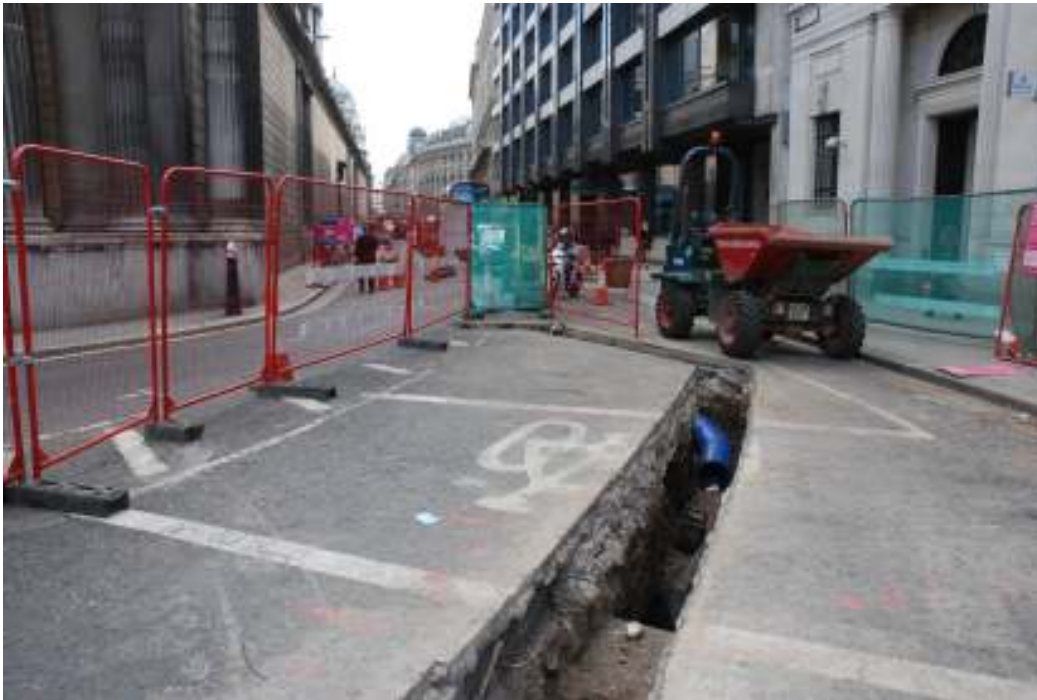
The site was revisited on the 9<sup>th</sup> August to monitor trenching from the centre of Princes Street towards the eastern kerb, 20m north-west up to the centre of Lothbury junction and extending a further 17m south-west down Lothbury street. No further 19<sup>th</sup> century remains were observed. Instead, made ground comprised of a mid-brown silty sand containing small fragments of CBM, pebble and mortar pockets underlay the existing road surface, possibly representing a leveling/demolition spread post widening of Lothbury itself.

Fig.43: *Lothbury 9<sup>th</sup> August 2011, facing SE*

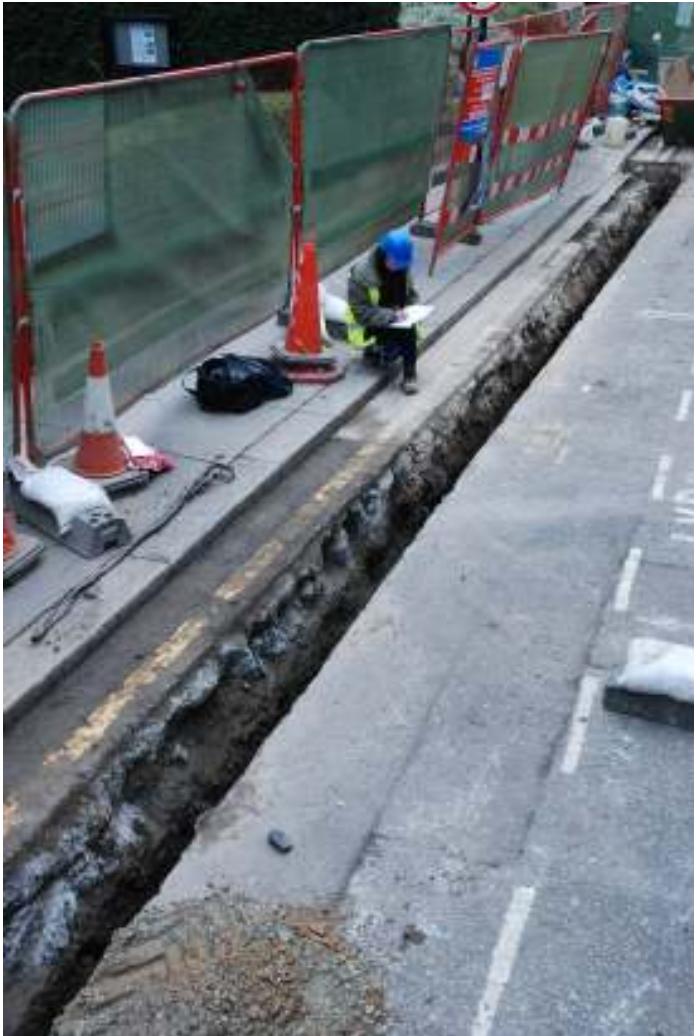
On the 7<sup>th</sup> a 27m length of trenching was observed aligned E-W on the northern side of the carriageway at the junction with Aldemanbury, 0.47m from the kerb. It was 0.49m wide and up to 0.9m deep in places, comprising an existing tarmac road surface 0.25m thick over a previous surface 0.45m thick. Below these recent layers was a contiguous mixed subsoil of silty-loam mixed with mortar and brick fragments, representing re-worked upper service fills as seen over much of the city trenches.

Fig.44: Love Lane 7<sup>th</sup> December 2010, facing NE

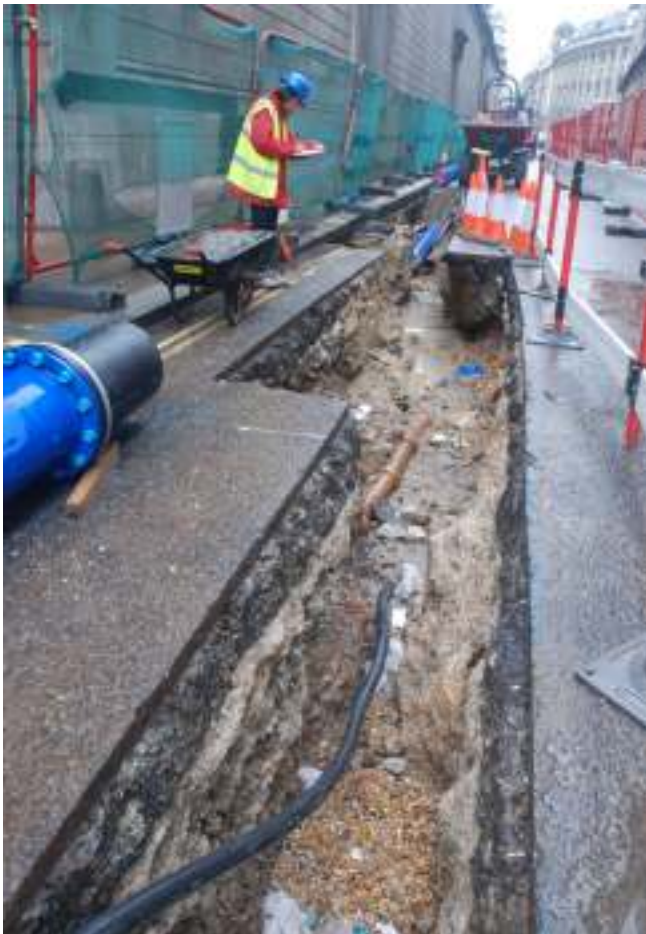
Fig.45: *Princes Street 26<sup>th</sup> August 2011, facing S*

35m of trenching, 0.6m wide and 1.05m deep was monitored along the east side of Princes Street and the Bank of England on the 9<sup>th</sup> August 2011. 0.45m of tarmac and concrete road surface overlay an existing service present along the whole length of the western section, and a loose, mixed brown silty-sand deposit containing CBM and a layer of brick-dust in the eastern section.

A return visit on the 26<sup>th</sup> August revealed a similarly sterile stratigraphy within a stretch of trench 32.8m long. A large water pipe present within the trench had been subject to pipe burst and in consequence the trench could not be accessed to record in full.

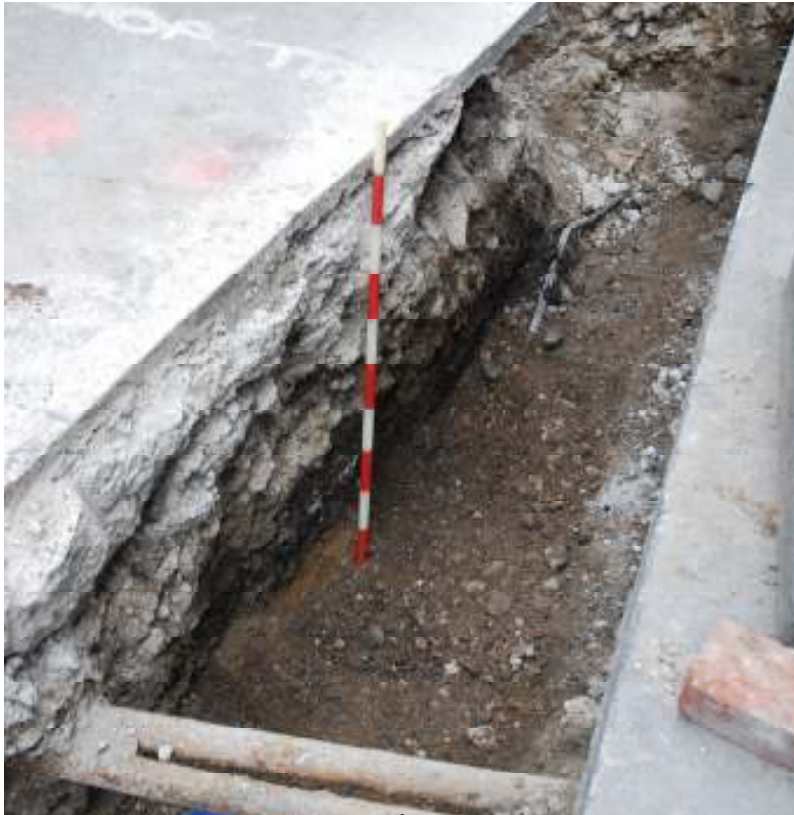
Fig.46: *St.Martin's-le-Grand 30<sup>th</sup> March 2011. Facing NNW*

At the northern end of St.Martin's-le-Grand, near the junction with London Wall, a 10m length of trenching was observed on the 30<sup>th</sup> March 2011. The trench was between 0.6-1.0m wide by up to 1.0m deep, comprising 0.38m of existing tarmac and concrete, overlying up to 0.45m of dark-red/black re-deposited sand and gravel representing made ground.

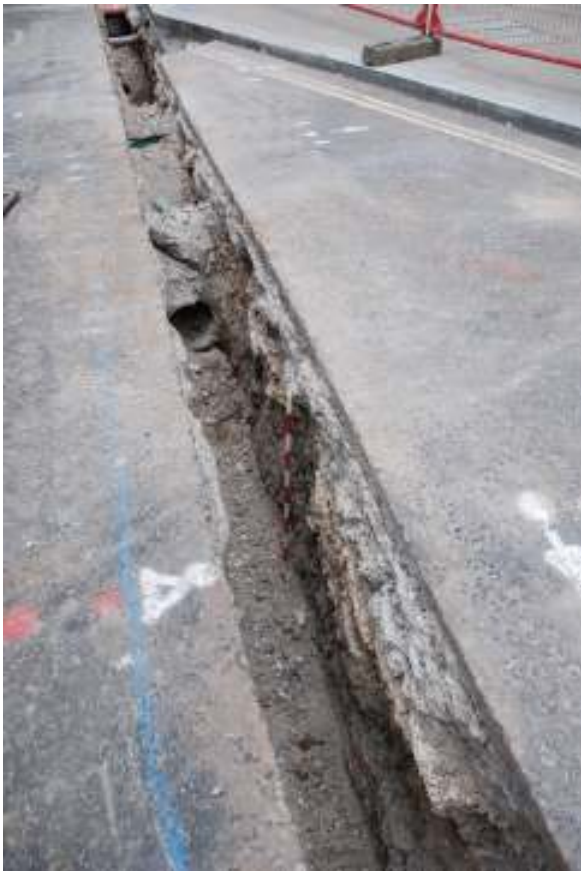
Fig.47: *Wood Street 27<sup>th</sup> July 2011, Facing S*

A stretch of trench was monitored on the 27<sup>th</sup> July running down the centre of the carriageways for c.14m. It was up to 0.46m wide and in places 1.35m deep. However it followed the old path of the existing Victorian water main and so the contents of the trench was purely backfilled yellow-brown silty-sand, and grey-brown gravels.
