# **FRITTENDEN CHURCH OF ENGLAND PRIMARY SCHOOL, THE STREET, FRITTENDEN**

An Archaeological Watching Brief and Historic Building  
Survey

SITE CODE: FPS 11  
NGR: TQ 81382 40965

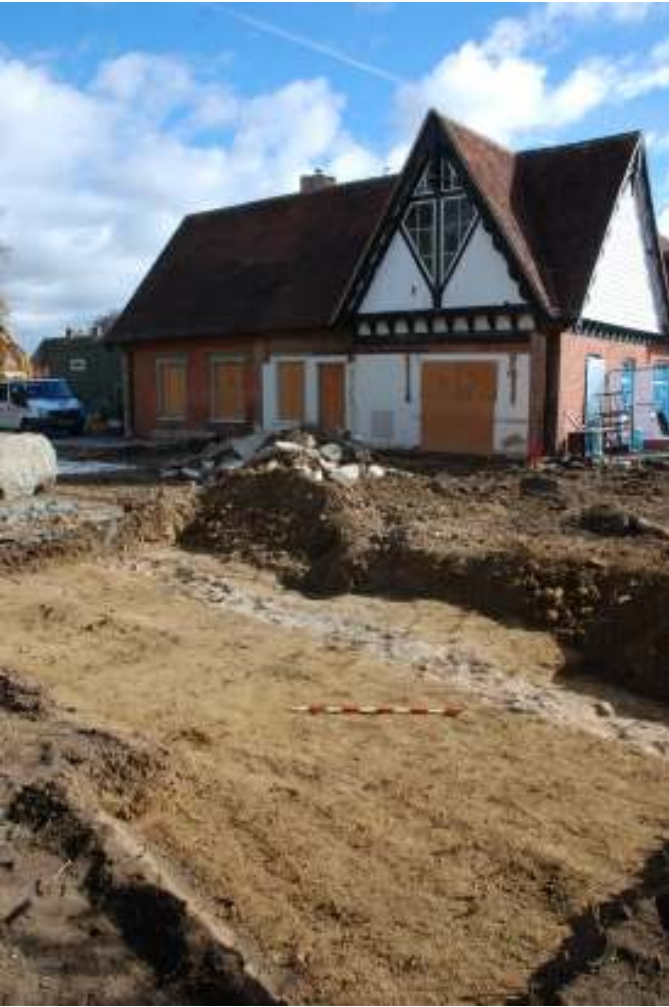
*Fig. 8: Photograph of area 1, looking east, with existing school building in the background. The natural friable clayey-sandy-silt deposits can be seen across the whole trench, with the base of the stone wall running north-east to south-west across the area.*

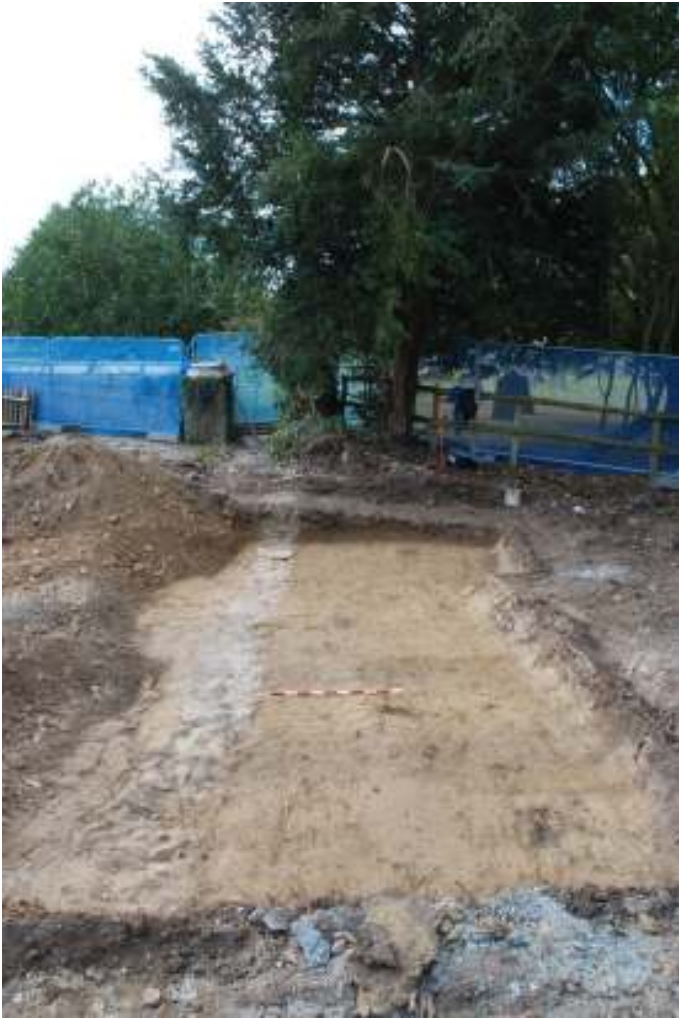
*Fig. 9: Photograph of area 1, looking south (towards the church). The line of the stone wall base can clearly be seen.*

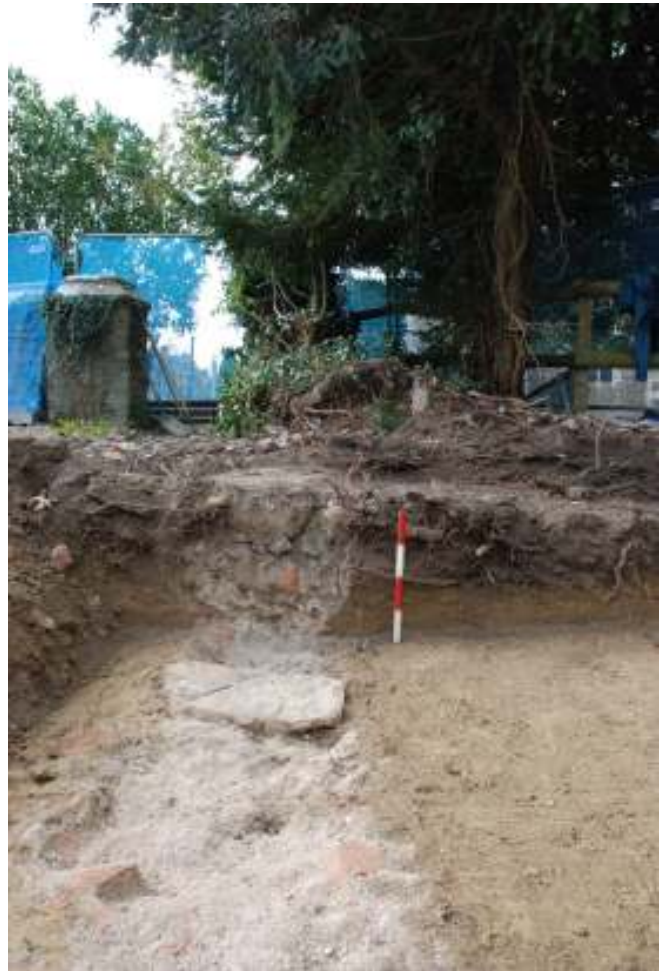
The only structural feature observed in this area was the base of the stone wall which once ran along the northern side of the footpath to the church (it stood before the structures in this area were demolished). The base of this wall was observed at *c.*43.67mOD (*c.*0.6m beneath the present ground-surface), and ran north-east to south-west across the whole of this area. This wall base appears to have been made of stone (and very occasional bricks), with some large stone blocks visible. One piece of moulded stone was taken from this (see figs. 11 and 12) – possibly already reused, and measuring *c.*383mm X 199mm X 91mm. This was oolitic limestone, with a finely worked moulded face at one end and a rough chamfer on the adjacent long side. The stone wall base was built into the natural, and lay directly above the natural clay deposits. One piece of clay pipe stem (see appendix IV) was recovered from the northern side of the wall-base (possibly in association with the wall's construction). It is possible that this wall was contemporary with the construction of the school (1842) and rebuild of the church (1846-48) – particularly because this footpath is depicted on the 1881 OS Map. It may have been part of the general mid-19<sup>th</sup> Century development of this area.

*Fig. 10: Photograph of the stone wall base in section. The gateposts to the church can be seen in the background (which the stone wall once joined up to). The thin (c.0.3m) deposit of topsoil can be seen overlying the natural deposits, in the section either side of the wall base.*

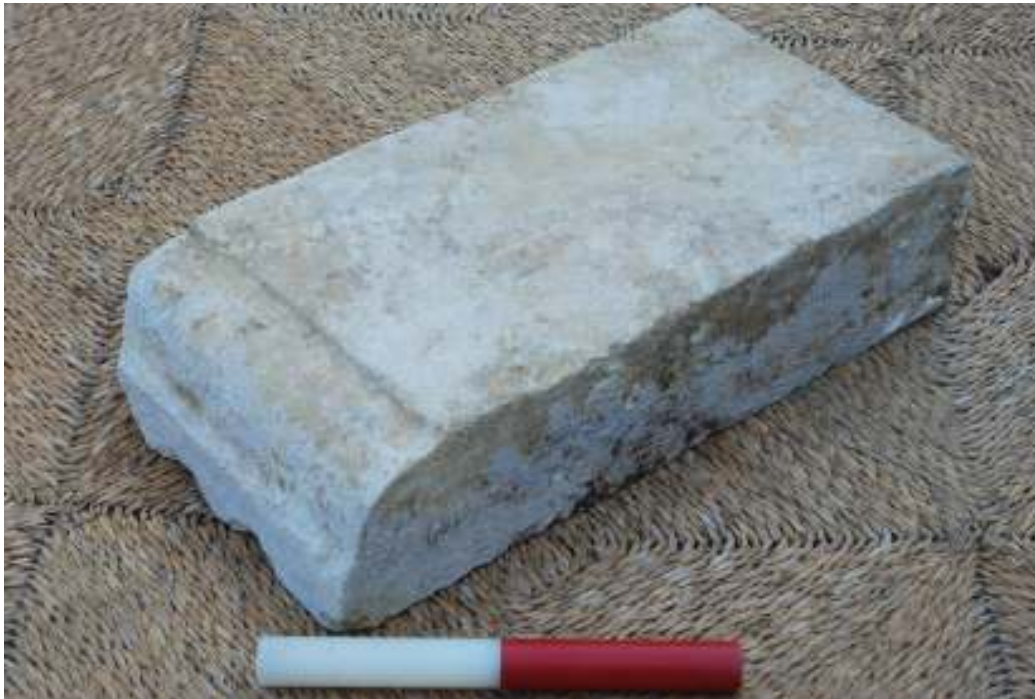
*Fig. 11: Photograph of moulded stone from the stone wall-base, clearly showing the moulded section.*

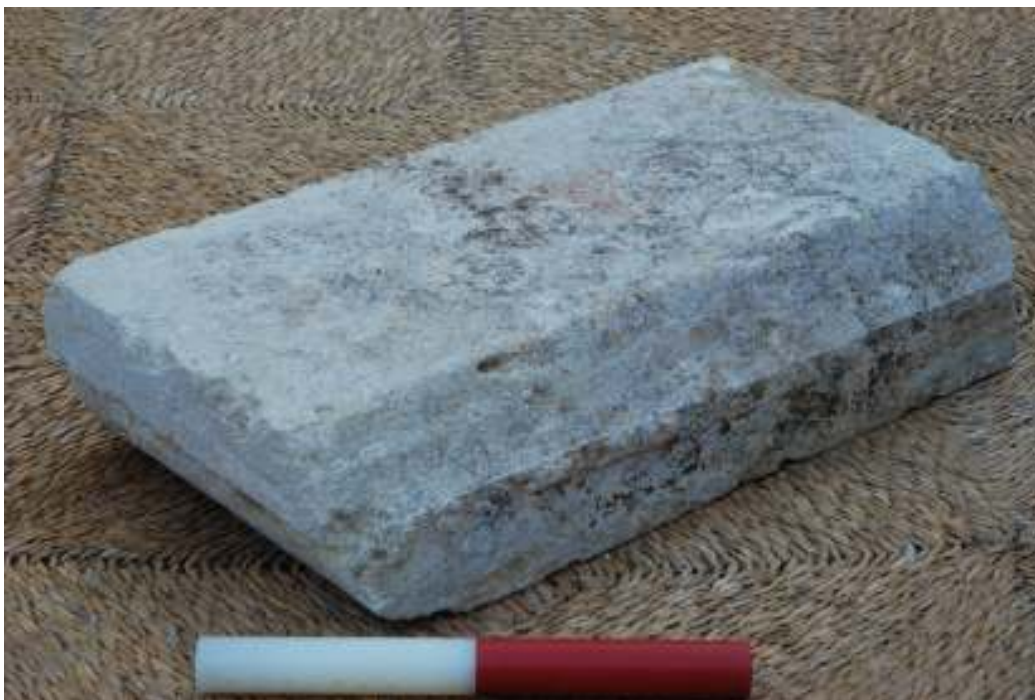
*Fig. 12: Photograph of moulded stone from the stone wall-base, clearly showing the more roughly worked chamfered edge.*

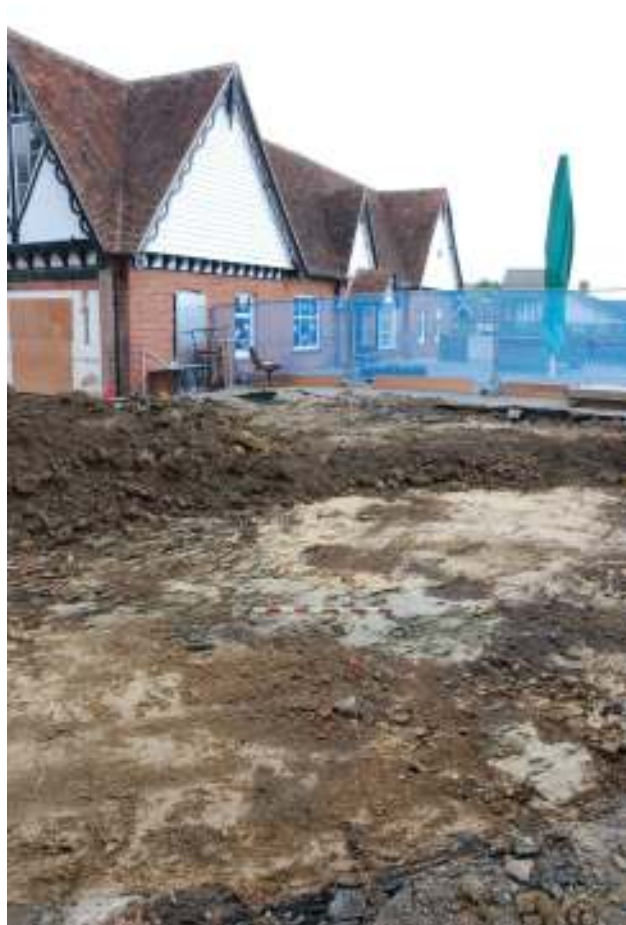
*Fig. 13: Photograph of area 2, looking east (with the school building in the background). The truncated natural clay deposits can be seen in the south-eastern part of this area (truncated by the previous Nursery building), and the friable clayey-sandy-silt natural deposits in the north-western part.*

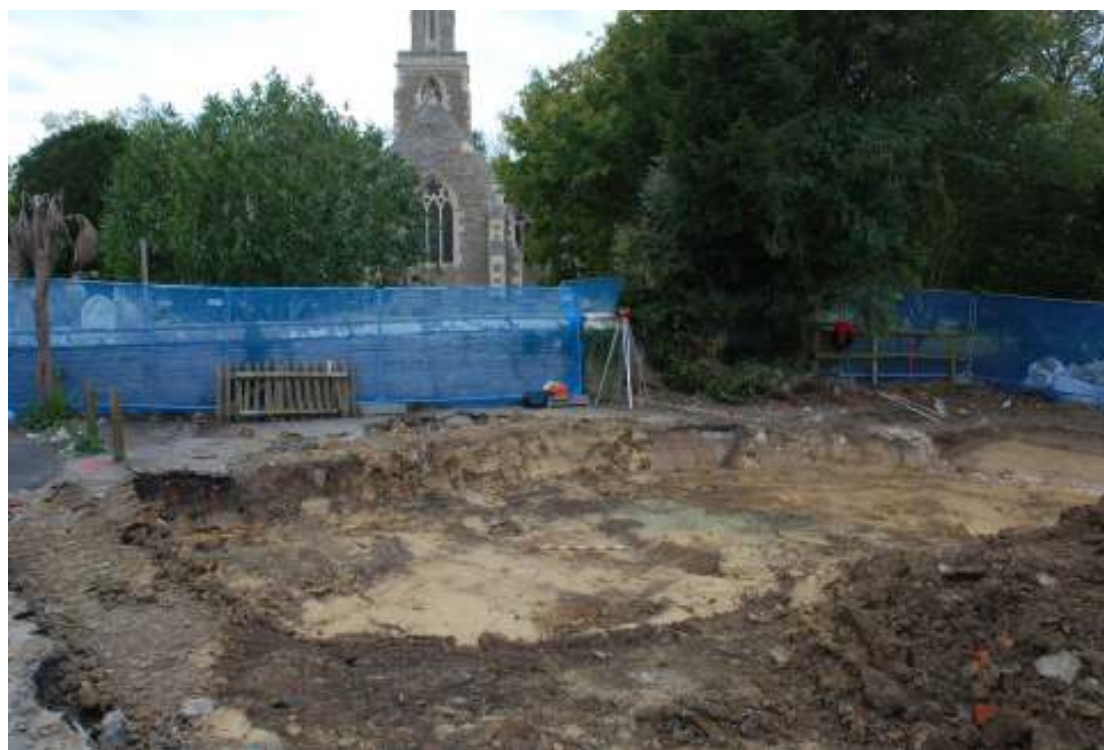
*Fig. 14: Photograph of area 2, looking south-west (towards the church, seen in the background). The truncated natural clay deposits, and friable clayey-sandy-silt deposits, can both be seen.*

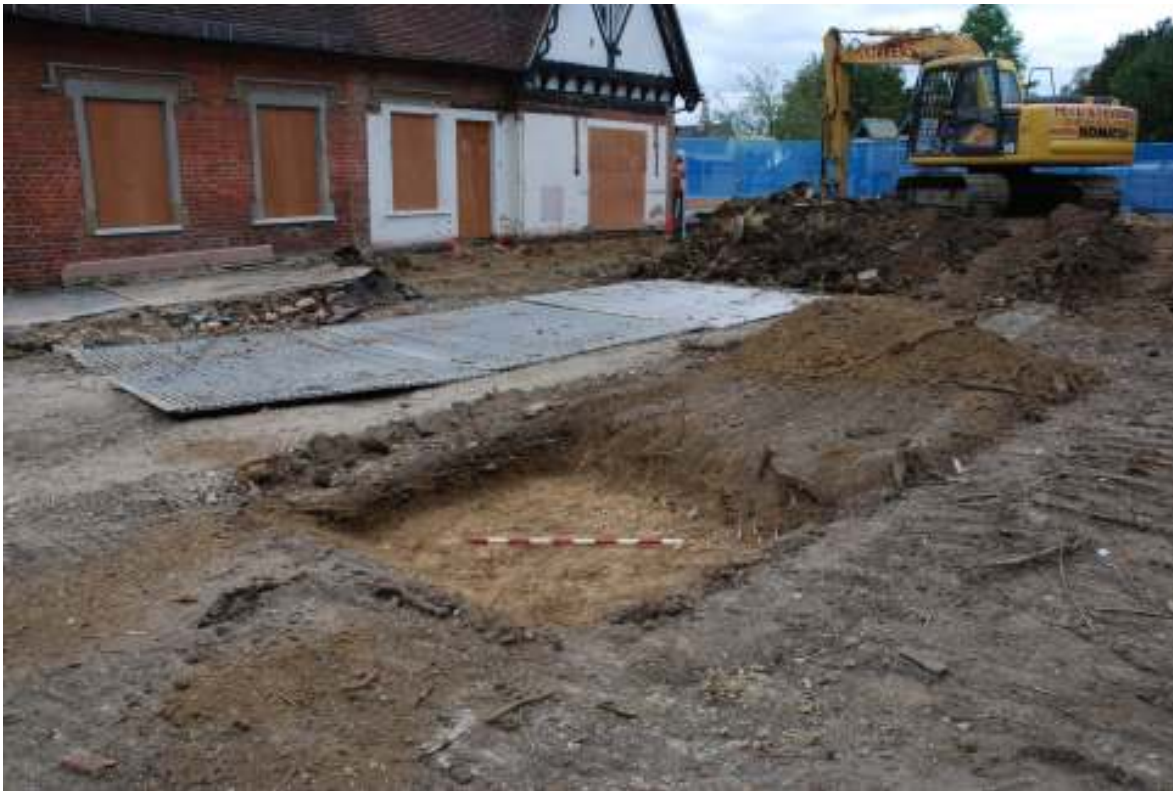
Topsoil (a loose dark-brown garden soil) was observed overlying the natural deposits. This was the yellow-brown friable clean and sterile clayey-sandy-silt, observed elsewhere across the site, and it was observed across the whole of this trial pit, at c.43.7mOD (c.0.27m beneath the present ground-surface). No archaeological finds or features were observed.

*Fig. 17: Photograph of trial pit (area 3), looking south-east (towards the school building). The thin deposit of topsoil overlying the natural friable deposit can clearly be seen.*

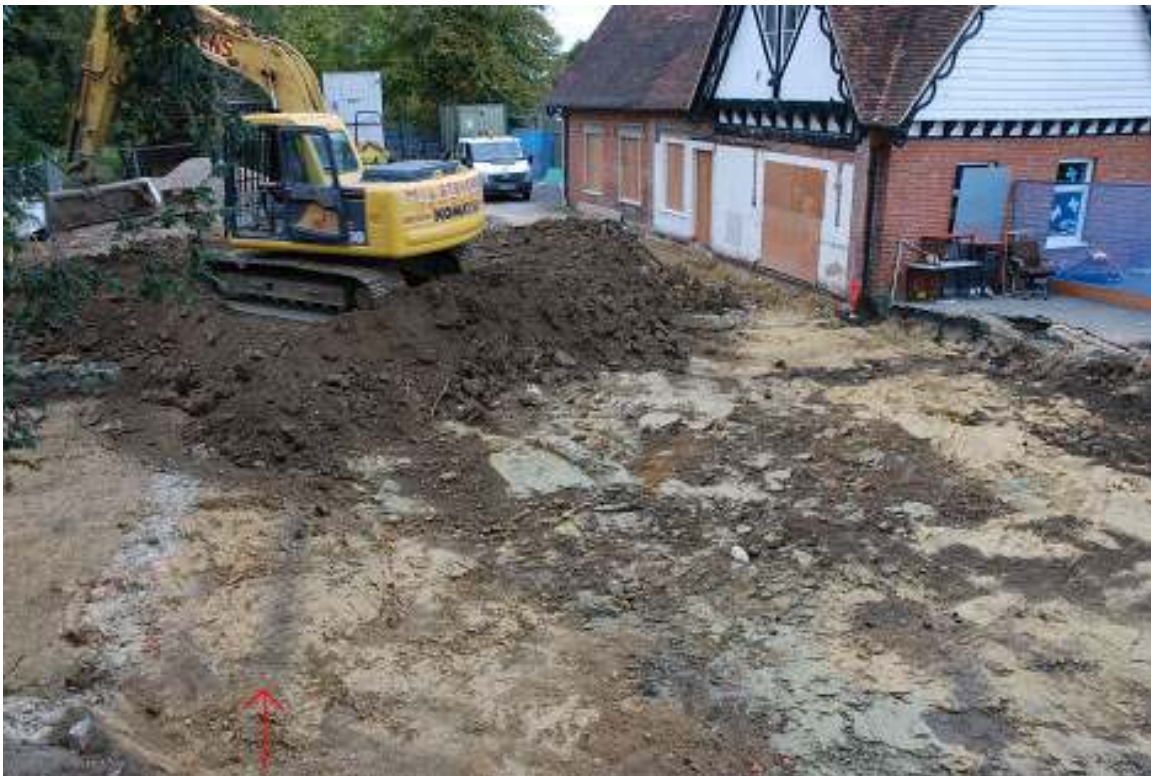
*Fig. 18: Photograph of further stripping being carried out in area 4, looking north-east (towards the school). Further truncated natural clay deposits, and natural friable clayey-sandy-silt deposits, can be seen. The slightly darker line of the land drain (see 8.2) is arrowed.*

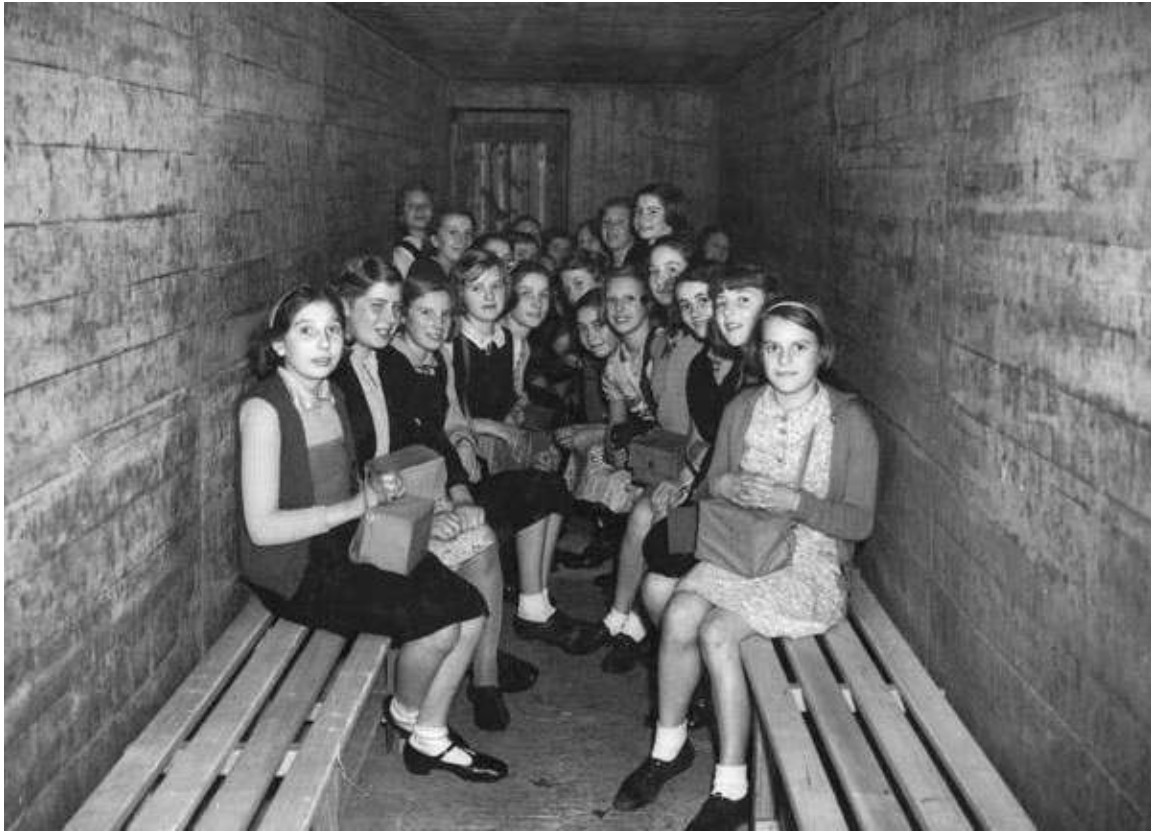
The below photograph (fig. 20), from Manchester Libraries, provides a further indication as to what air raid shelters in schools were like – with the two benches down the side and children arranged along them.

*Fig. 20: Photograph of children in air raid shelter in Manchester.*

Such benches were positioned in all air-raid shelters in schools (see fig. 20 for a pictorial representation of this). Furthermore, the 1939 ‘Air raid precautions in schools’ circular stated that all air raid shelters within schools had to have wooden benches (with each child allowed 28inches of space).

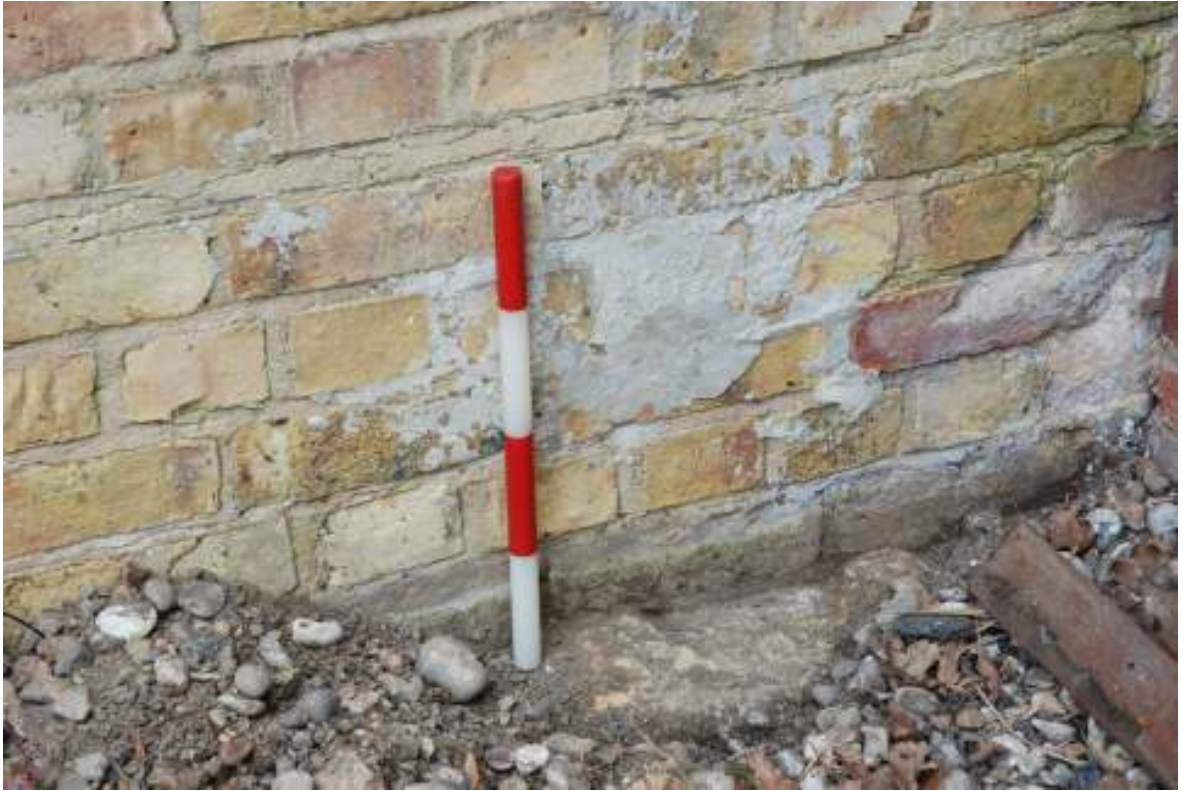
The total height of the original structure was *c.*2.42m (observed along the northern wall, where a sondage was dug down to the foundation slab). This foundation slab was a concrete footing, which projected out for 130mm from the main wall. The wall was brick-built, in an English bond, and *c.*30 courses in height. The differences in height noted around the structure (e.g. 2.02m at the south-western corner of the structure, 1.87m at the south-eastern corner, etc), is because of the different build-up of land, rather than different heights of the actual structure.

*Fig. 22: Photograph of the concrete base of the air raid shelter, northern wall.*

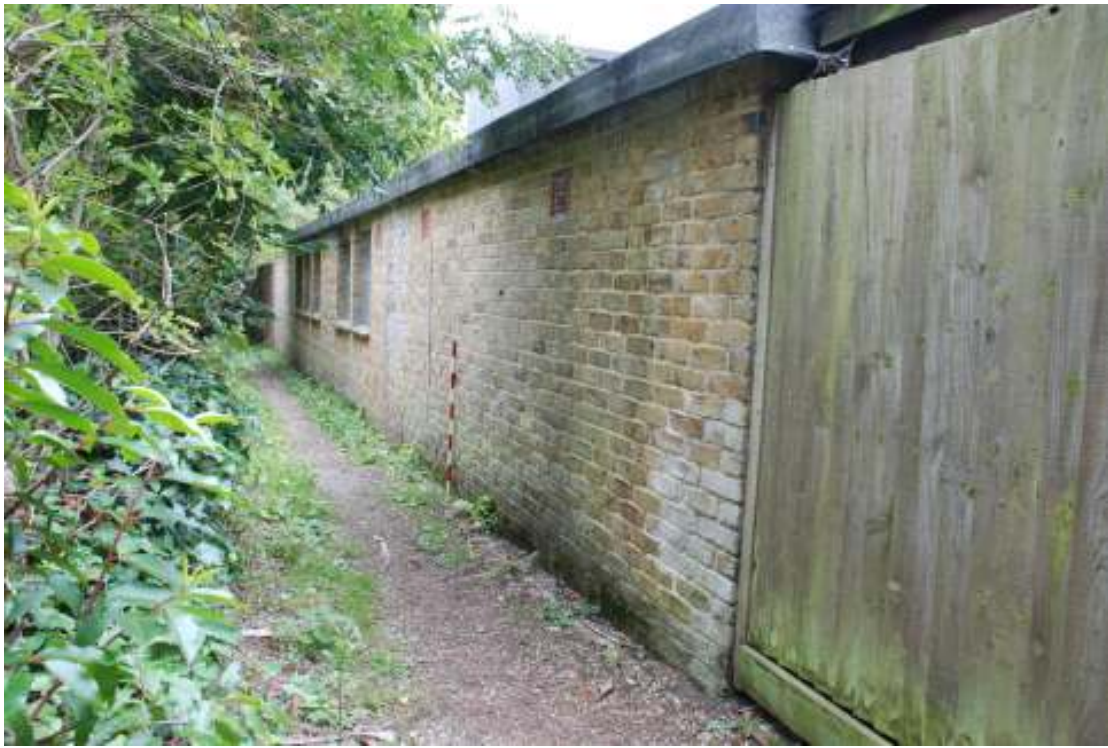
*Fig. 23: Photograph of the western wall, looking north. The more recent southern extension is visible in the foreground, with the original air raid shelter wall in the background.*

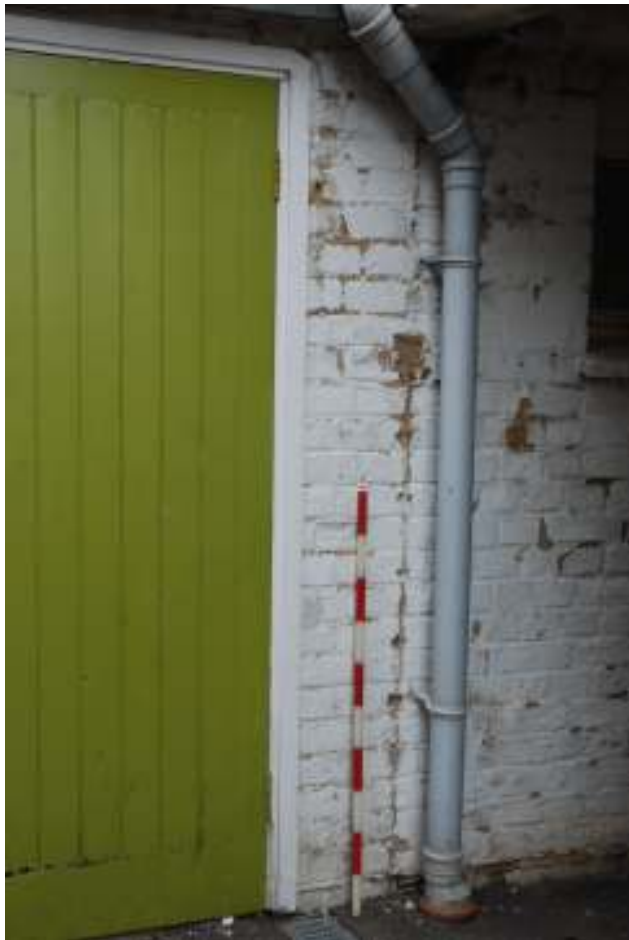
The join between the original and later parts of the structure was not so obvious on the eastern wall. A line in the whitewashing was, however, observed (along with the different types of brickwork, mortar, coursing, etc).

*Fig. 25: Photograph of the line between the original air raid shelter wall (right hand side of image) and the southern extension (left hand side of image) – eastern wall. The line between them is clear.*

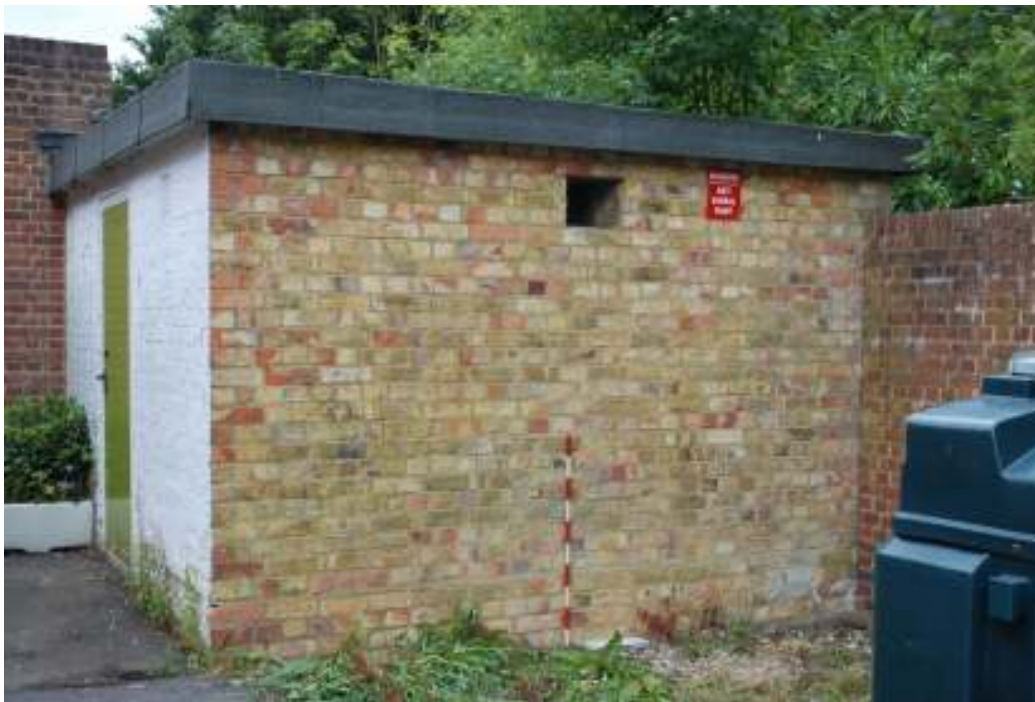
*Fig. 26: Photograph of the northern wall of the air raid shelter. This is an original wall.*

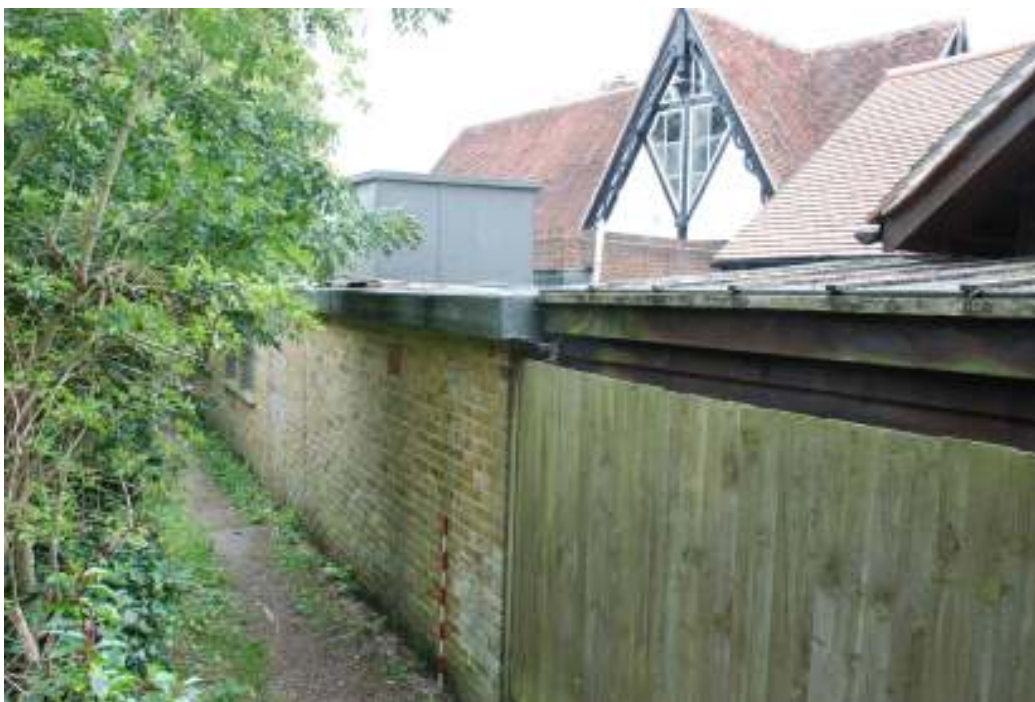
*Fig. 27: Photograph of the western wall of the structure, looking north. The more recent extension can be seen in the foreground.*

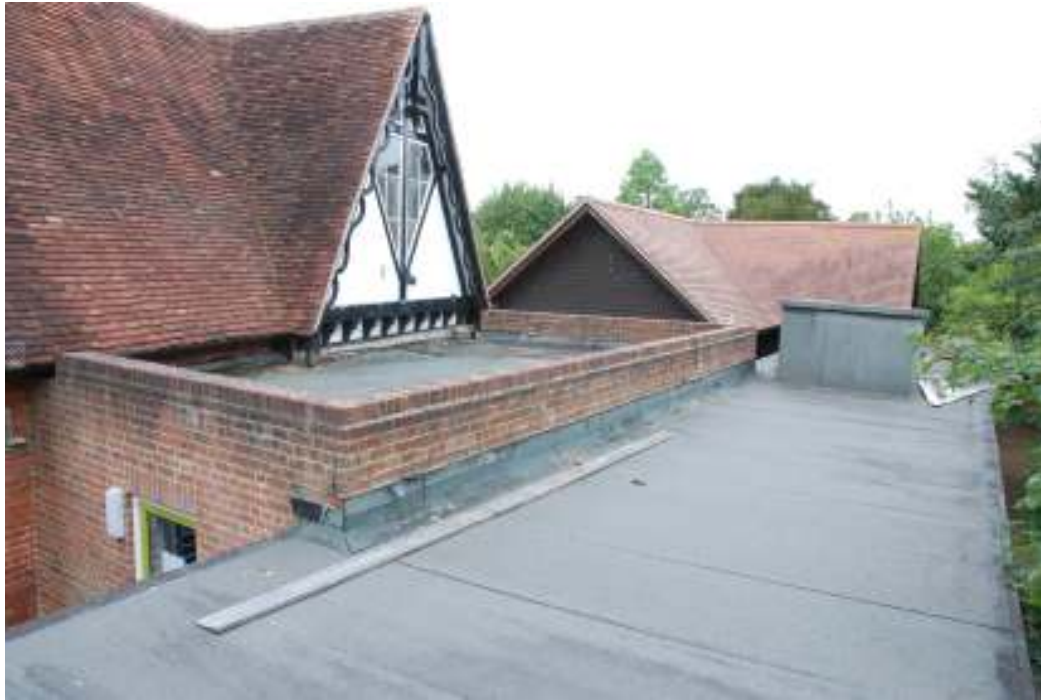
*Fig. 28: Photograph of the roof of the structure, looking south.*

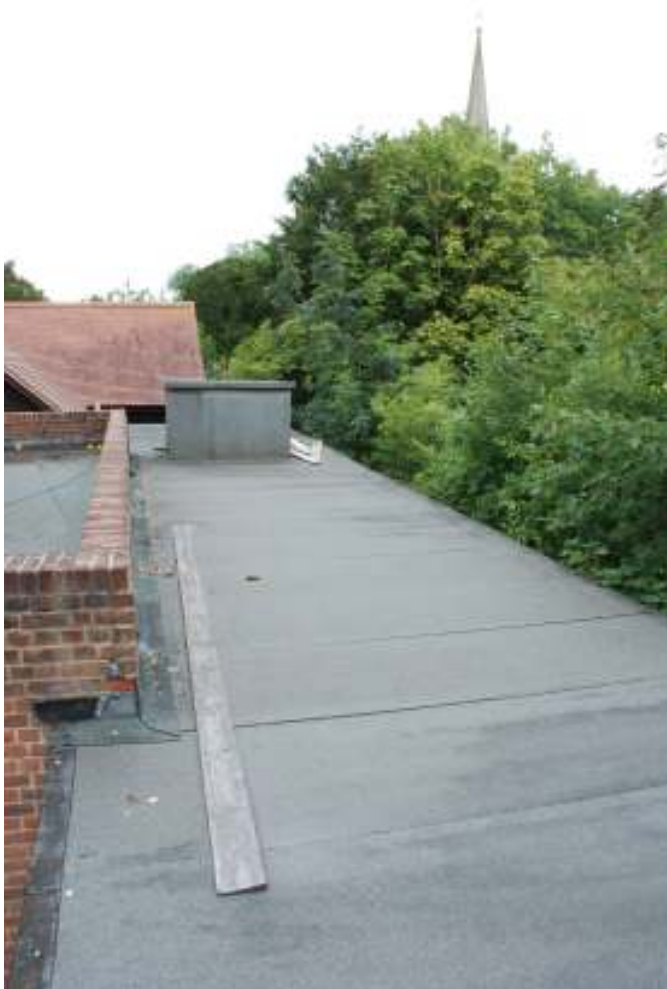
*Fig. 29: Photograph of the roof of the structure, looking south-west, with the church in the background.*

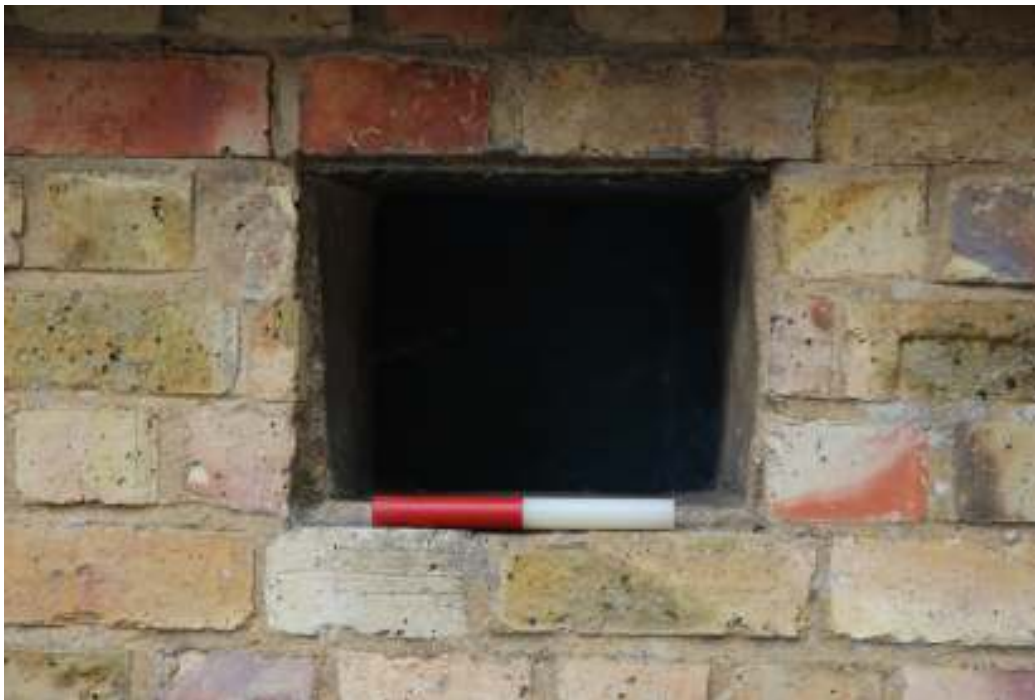
*Fig. 30: Photograph of the vent in the northern wall of the air raid shelter – probably original.*

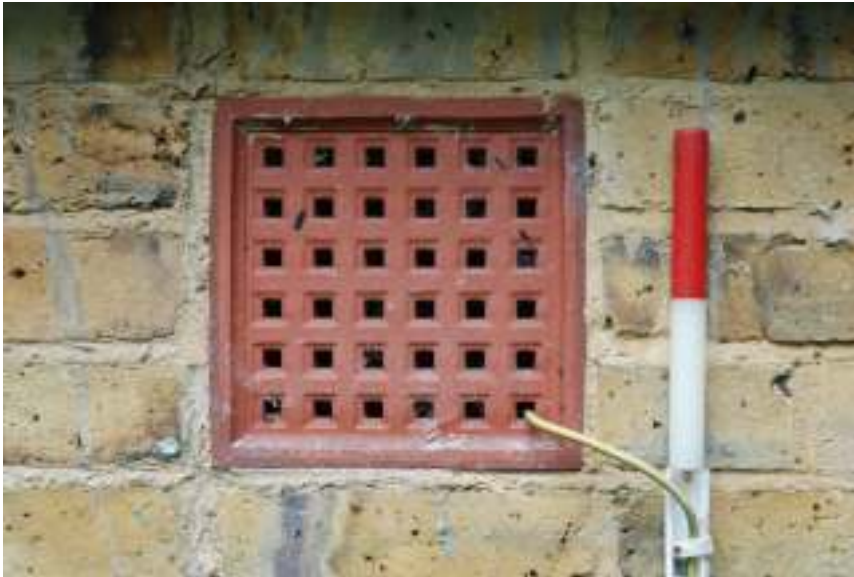
*Fig. 31:  
Photograph of a  
later vent in the  
western wall of the  
structure.*

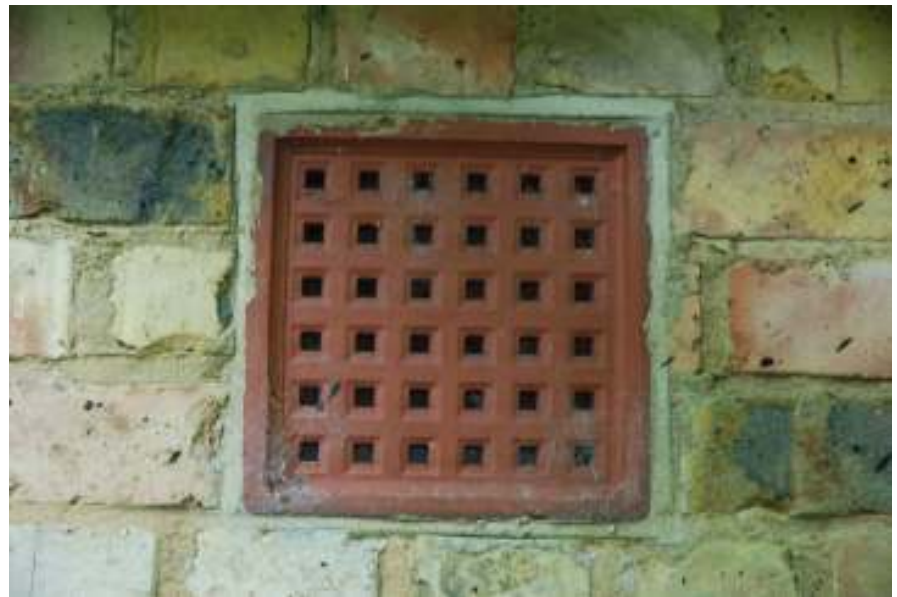
*Fig. 32:  
Photograph of a  
later vent in the  
western wall of  
the structure.*

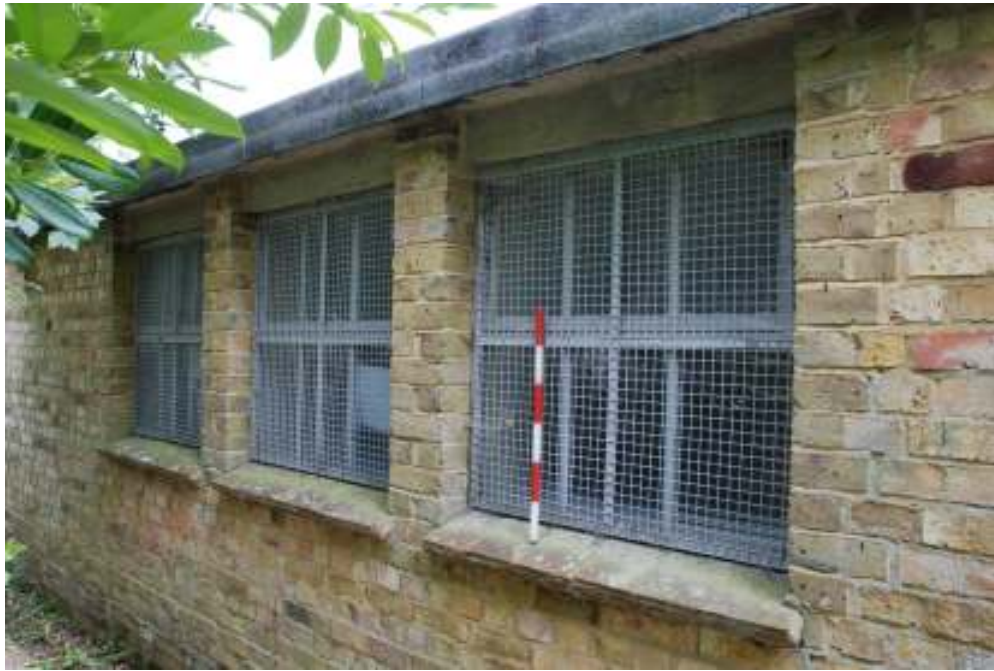
*Fig. 33: Photograph of the windows in the western wall, clearly inserted at a later date.*

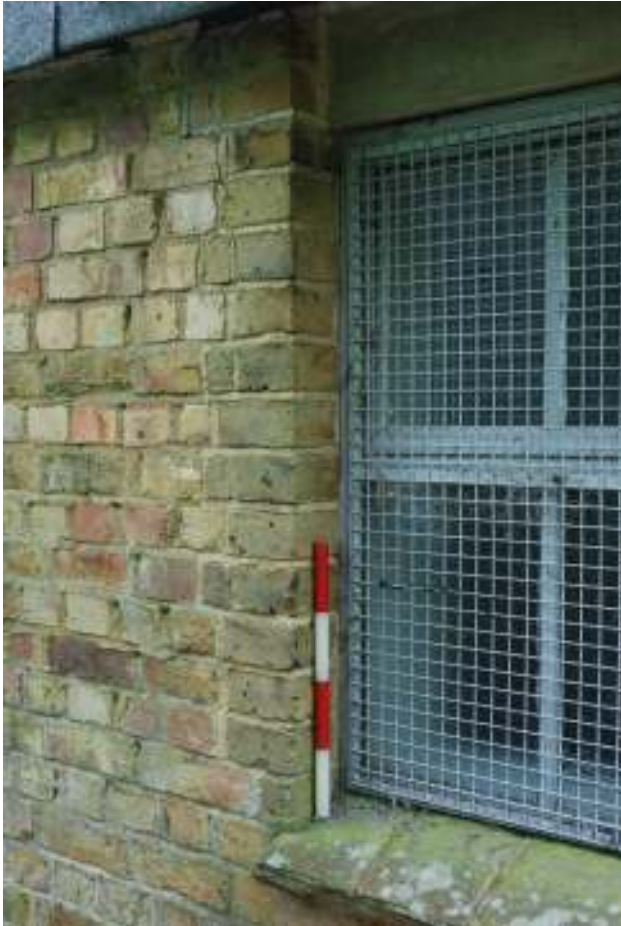
*Fig. 34: Photograph of a window in the western wall. This clearly shows how the brickwork surrounding the windows was cut out, the windows inserted, and new brickwork put back in.*

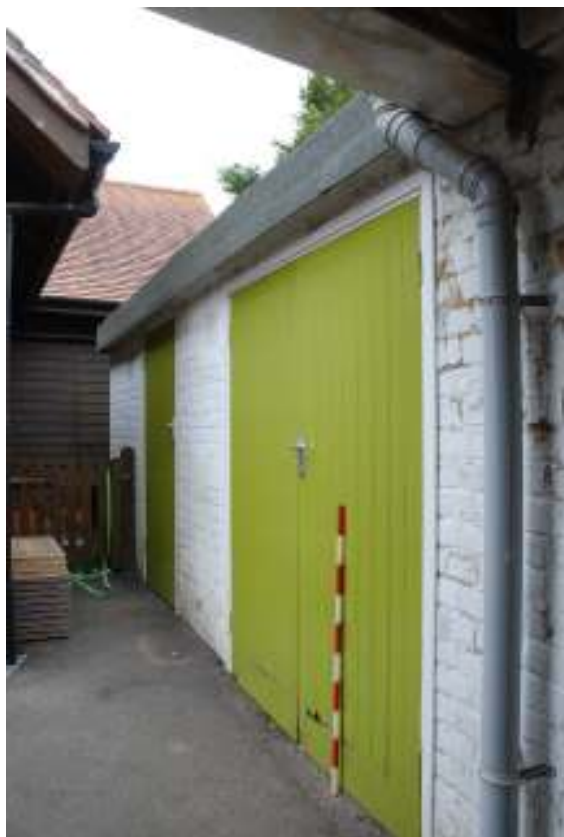
*Fig. 35: Photograph of the doorways in the southern part of the eastern wall (later in date than the original air raid shelter).*

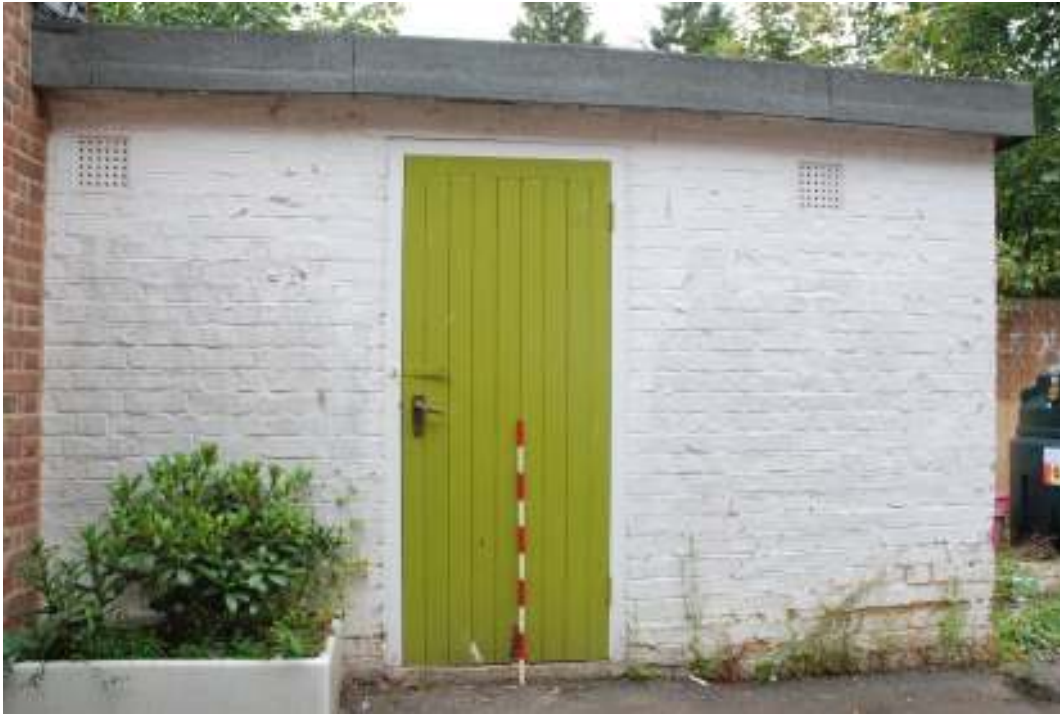
*Fig. 36: Photograph of the northern doorway, in the eastern wall. Although probably a later door and frame, this was probably the location of the original entrance into the air raid shelter.*

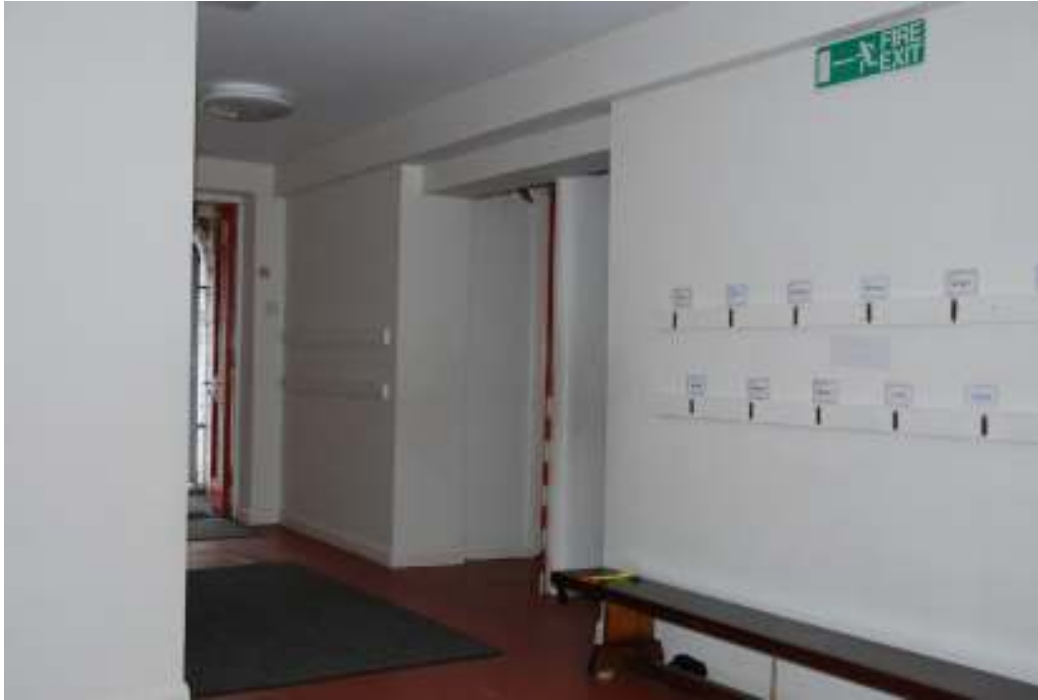
*Fig. 37: Photograph of the central part of the eastern wall, looking south. This is now enclosed, because of the 1997-98 connection to the school.*

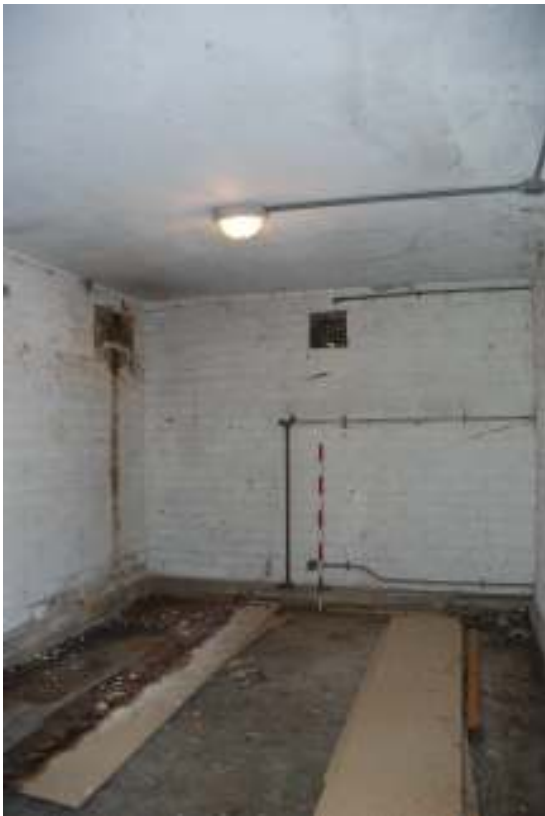
**15.2.1.1** This room measured approximately 2.44m in width (north-south), by 3.06m (east-west), and to a height of 1.95m. The room had a concrete ceiling (now plastered over), whitewashed walls (over the bricks), and a smooth concrete floor with a concrete skirting board (c.130mm high) around the whole room.

*Fig. 38: Photograph of room 1, looking west.*

**15.2.1.2** The door was a typical wooden door, wooden framed, and with a concrete lintel over the top. It seems likely that this was not the original door into this room, as there was a gap of nearly 10mm between the existing doorframe and the concrete skirting (so it seems likely that the original door was wider).

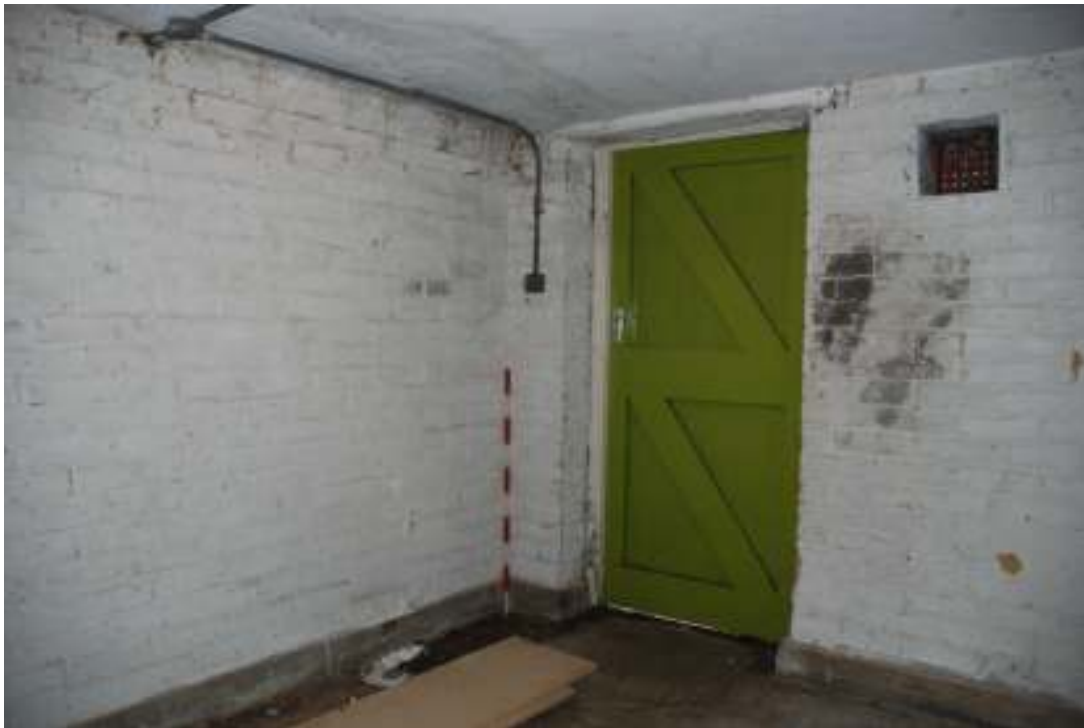
*Fig. 39: Photograph of the door in room 1.*

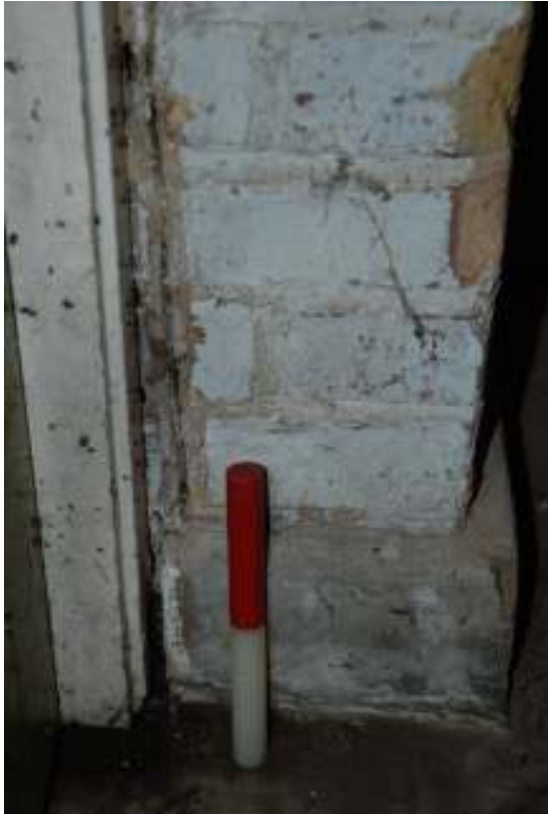
*Fig. 40: Photograph of the gap between the present doorframe and skirting, suggesting that the original frame was wider.*

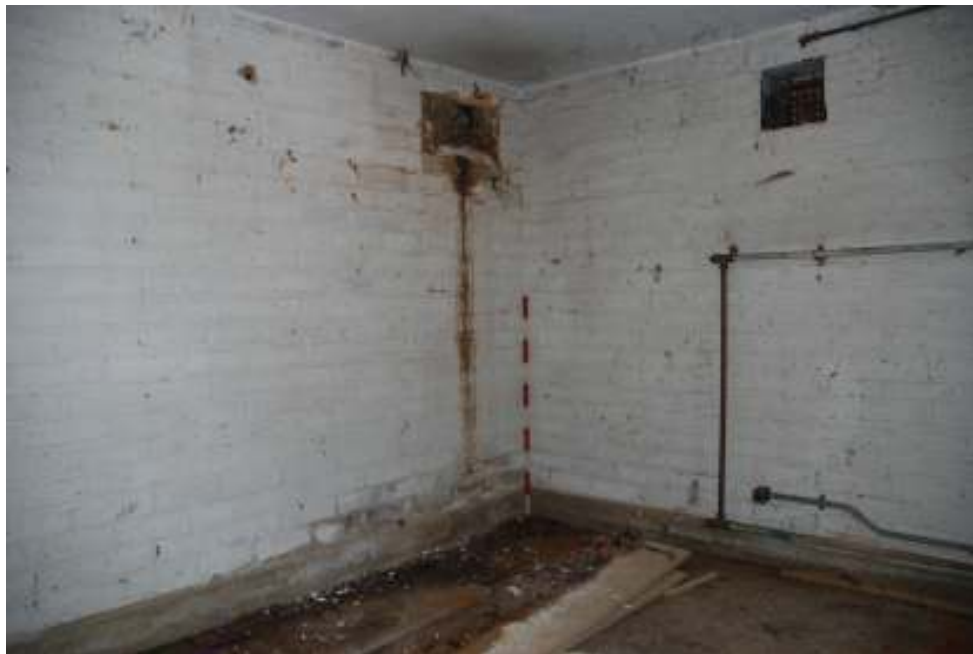
*Fig. 41: Photograph of the hole (possibly associated with an extractor fan) in the south-eastern corner of room 1.*

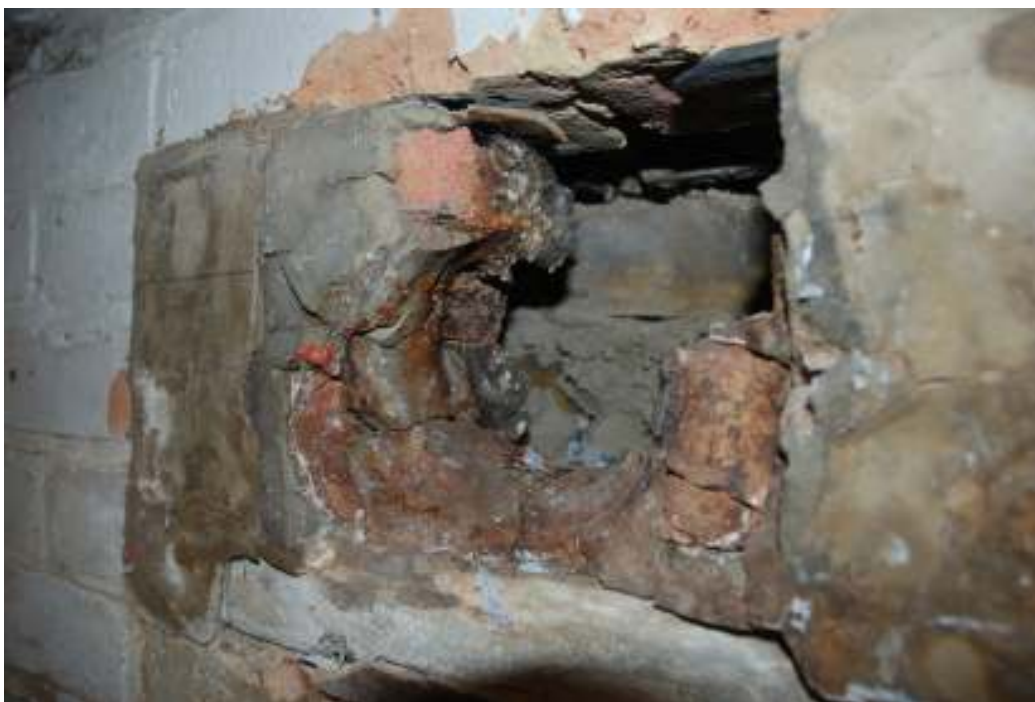
*Fig. 42: Photograph of the hole (possible extractor fan) in room 1.*
