# **FRITTENDEN CHURCH OF ENGLAND PRIMARY SCHOOL, THE STREET, FRITTENDEN**

An Archaeological Watching Brief and Historic Building  
Survey

SITE CODE: FPS 11  
NGR: TQ 81382 40965

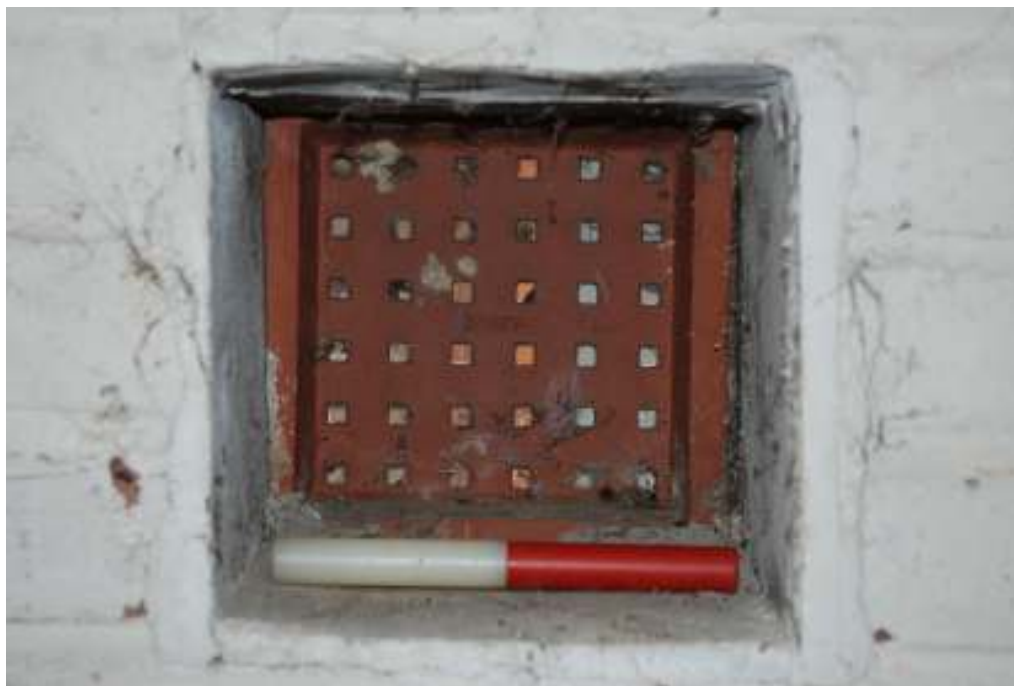
*Fig. 43: Photograph of the inside of a vent.*

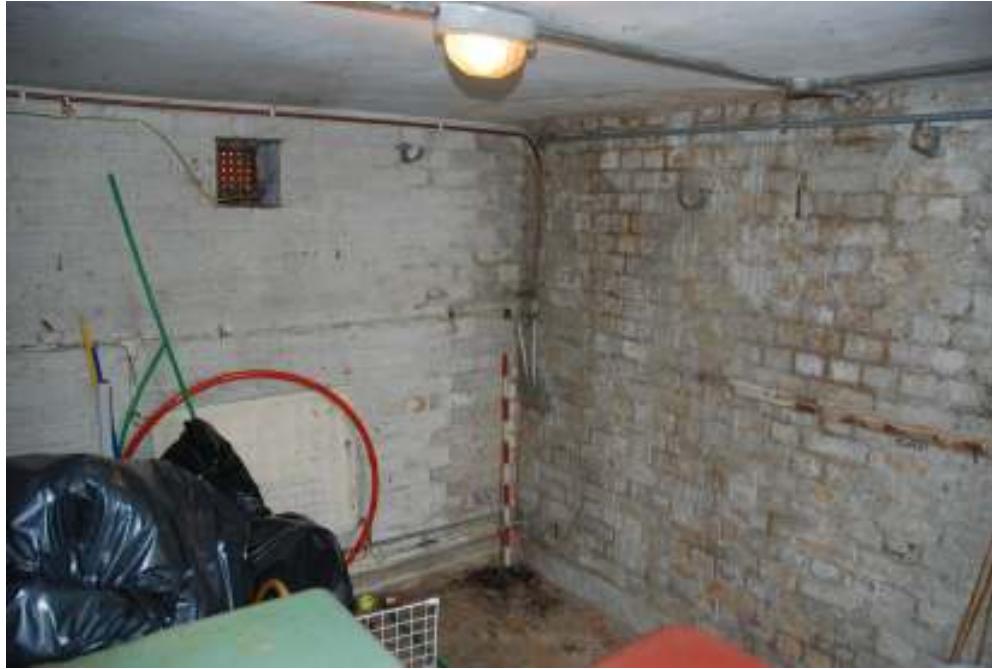
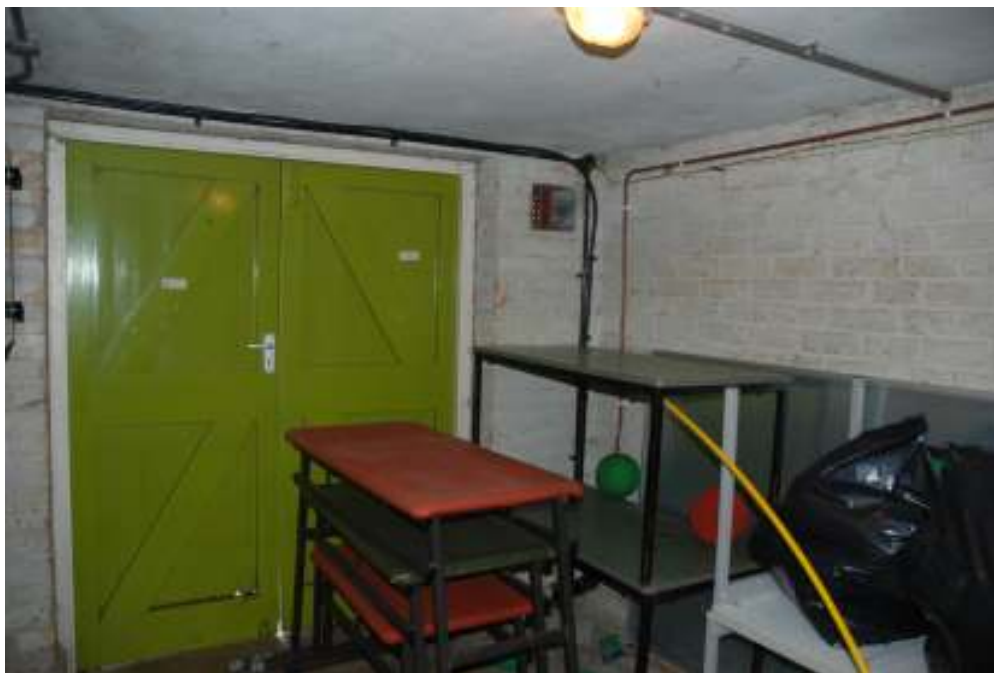
15.2.2.1 This room measured approximately 2.44m in width (north-south), by 3.06m (east-west), and had a height of 2.00m (at its southern end) and 2.01m (at its northern end). This reflects the lower ground surface towards the north, such that the height of the room is greater. The room was broadly similar to room 1 – with a concrete ceiling, whitewashed walls, and a smooth concrete floor with a concrete skirting board.

*Fig. 44: Photograph of room 2, looking north-west.*

*Fig. 45: Photograph of room 2, looking south-east.*

**15.2.2.2** The inside of the vents were seen in a similar way to room 1, and the double-door in this room was also probably a later door set within an earlier and wider doorframe.

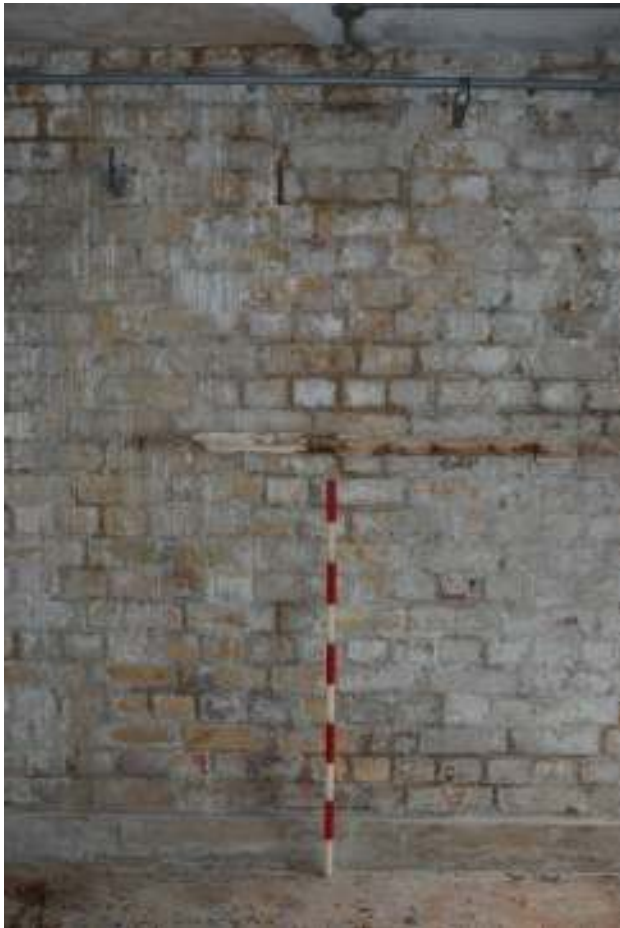
*Fig. 46: Photograph of northern wall of room 2 (original southern wall of the air raid shelter).*

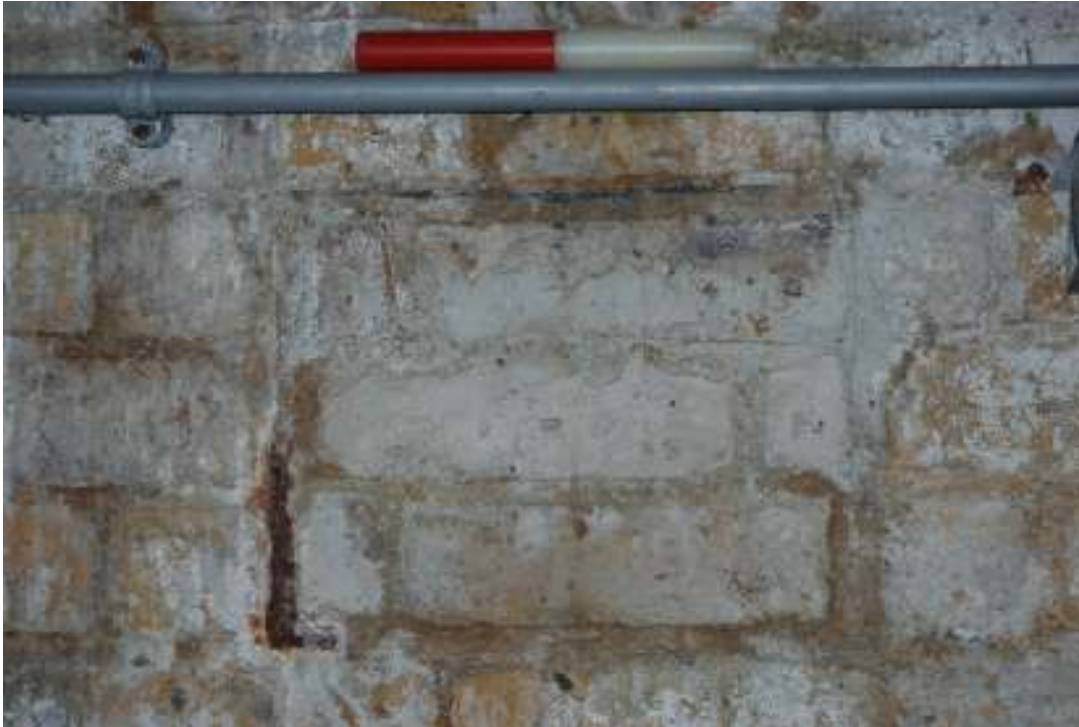
*Fig. 47: Photograph of blocked-up vent in original southern wall of air raid shelter (room 2).*

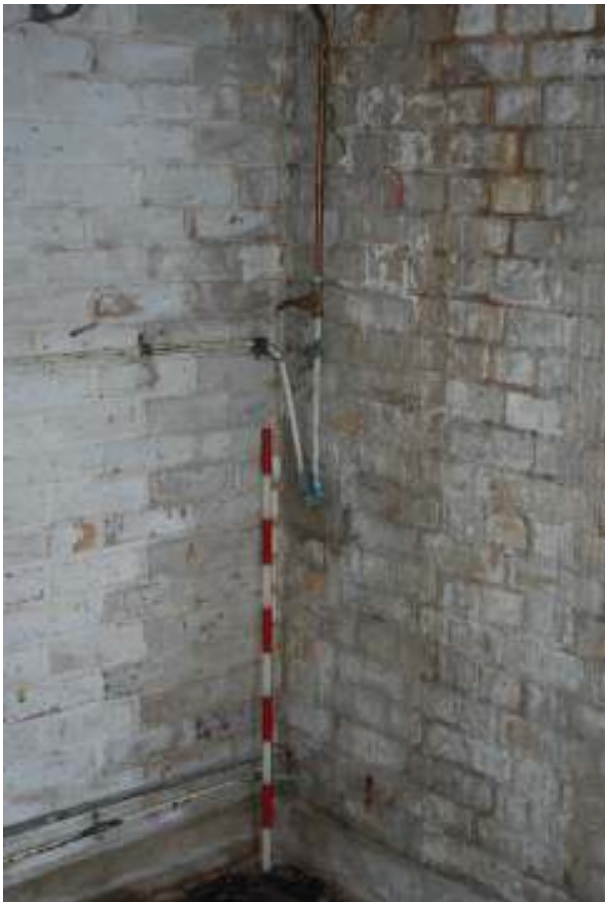
*Fig. 48: Photograph of original southern wall of air raid shelter (right hand side of image) abutted by later southern extension (left hand side of image) – room 2.*

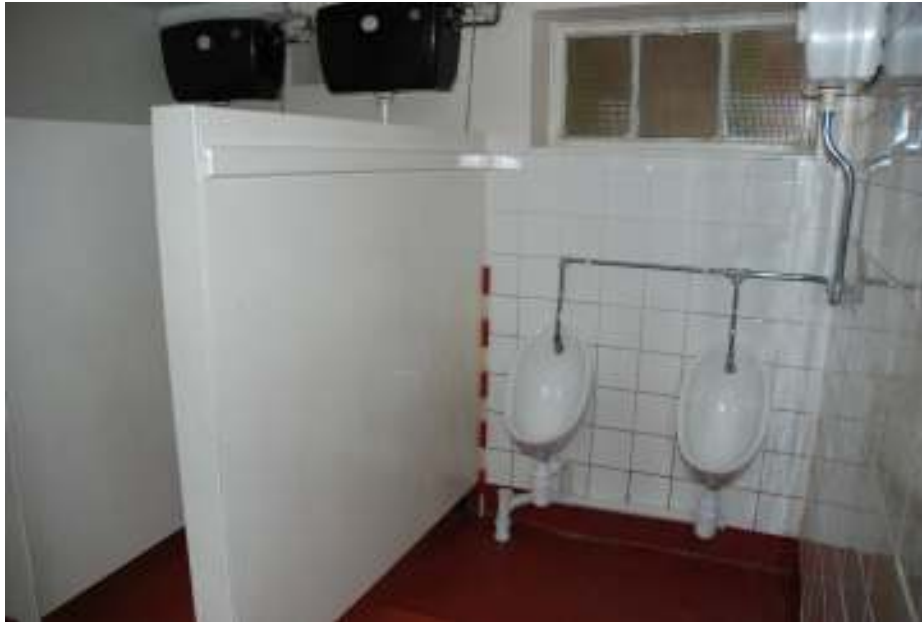
**15.2.3.1** The next room (the boys' toilets) has been completed re-developed, and contains no features original to the air-raid shelter (despite lying within the original area of the shelter). It was being used as a boys' toilets, including urinals, toilets, sinks, pipes, drains, etc.

*Fig. 49:  
Photograph of  
the boys'  
toilets, looking  
east. The  
window can  
also be seen in  
the  
background.*

**15.2.3.2** This room measured 3.77m (north-south), by 2.89m (east-west), by a height of 2.02m (up to the panels, with an extra *c.*30mm for the ceiling tiles and supporting frame / cavity, to reach the height of the concrete).

One further window was observed in the eastern wall – just north of the original southern end of the air-raid shelter (see fig. 49). This measured 0.99m in width, by 0.5m in height, and was clearly inserted at a later date (possibly in association with the southwards extension of the structure).

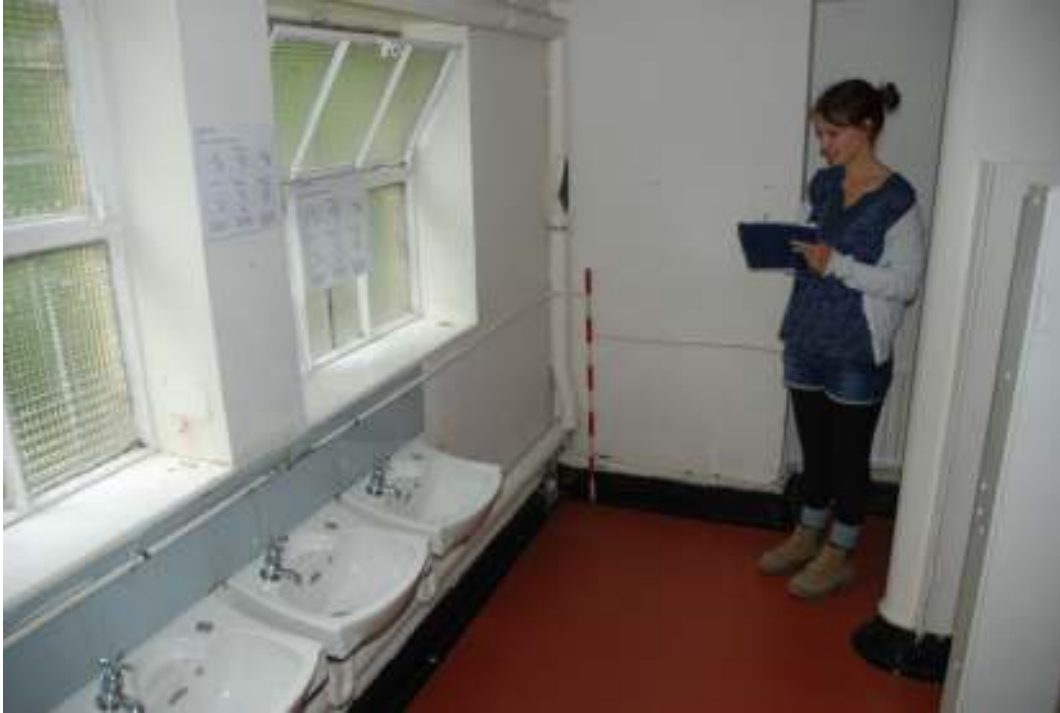
*Fig. 50: Photograph of archaeologist recording the boys' toilets, looking north. The windows, tiled and plastered walls, and linoleum floor can all be seen.*

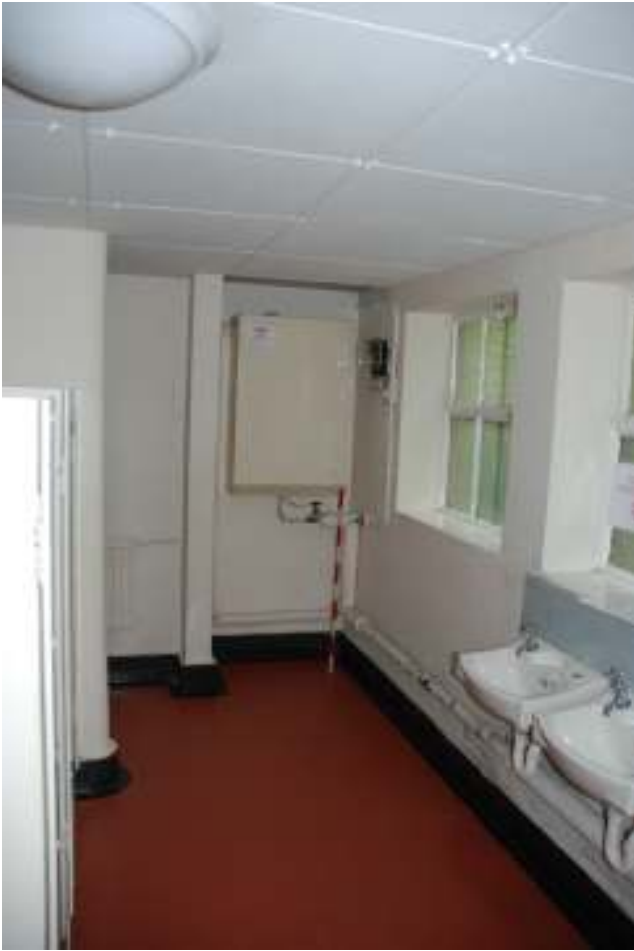
*Fig. 51: Photograph of the girls' toilets, looking south. The panelled ceiling, plastered walls, and linoleum floor can all be clearly seen.*

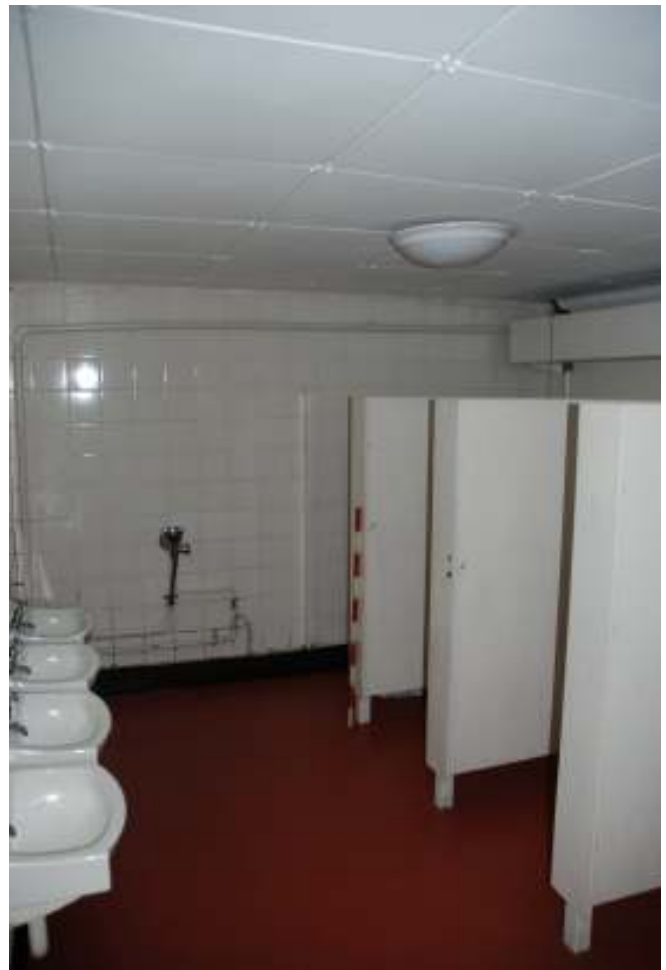
*Fig. 52: Photograph of the girls' toilets, looking north.*

**15.2.4.2** The room measured 4.13m (north-south), by 2.89m (east-west), with a height of 2.07m (up to the concrete slab).

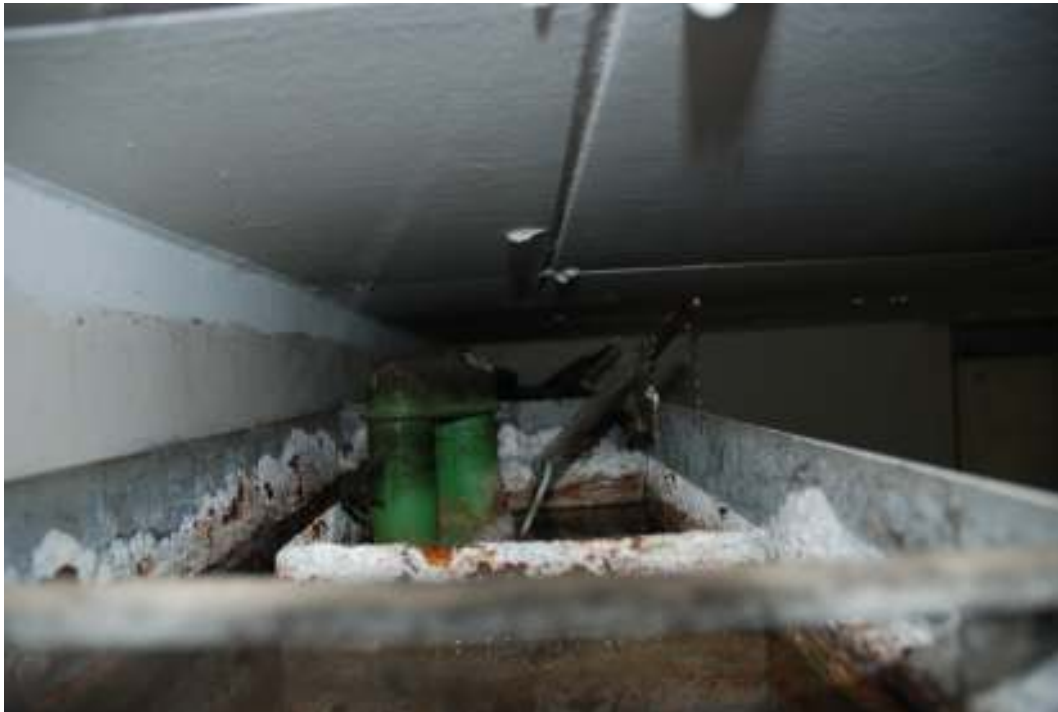
*Fig. 53: Photograph of the high-level cistern in the girls toilets.*

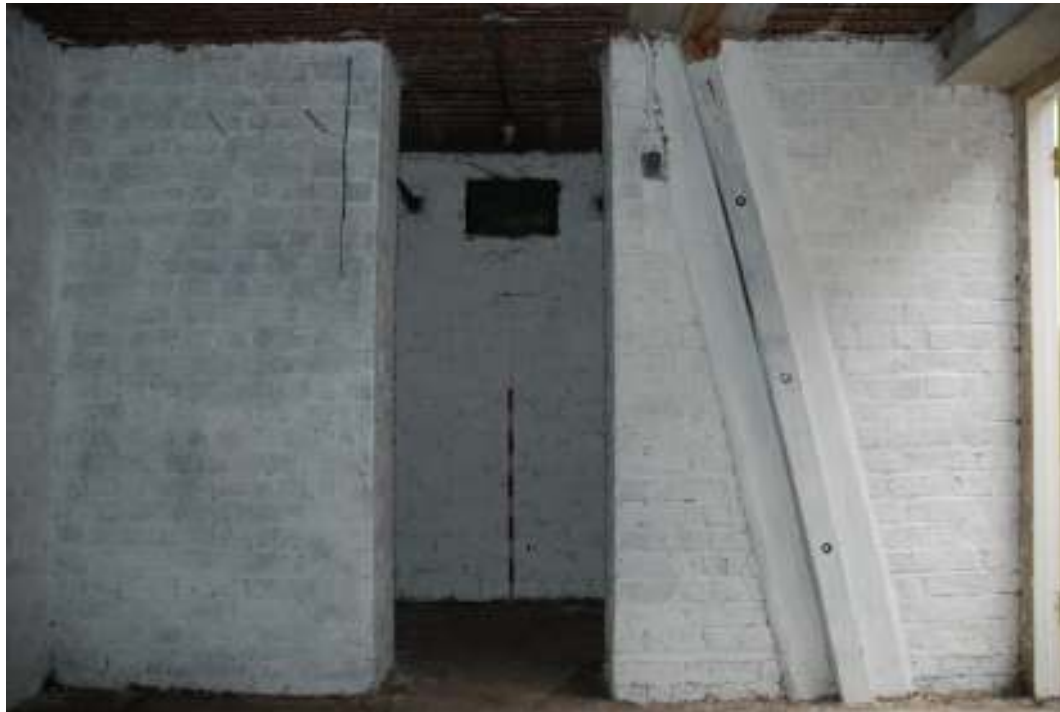
*Fig. 54: Photograph of the 'toilet chamber' in the far northern part of the air raid shelter, looking north.*

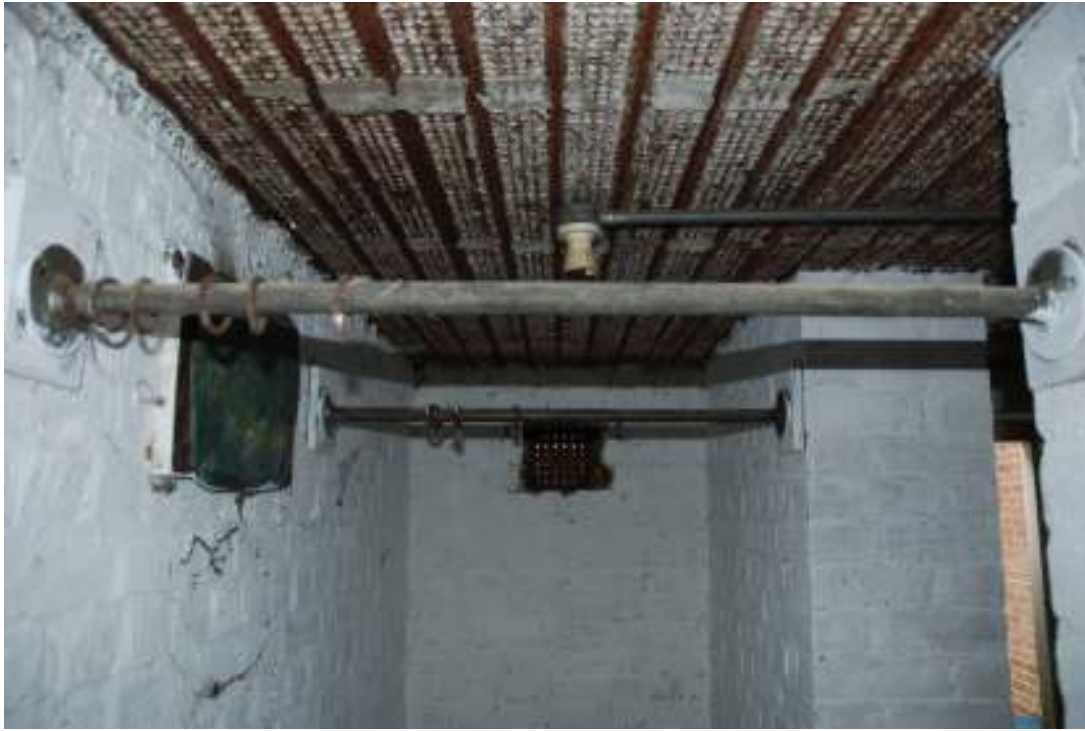
*Fig. 55: Photograph of the curtain rails in the toilets at the far northern end of the air raid shelter, looking east.*

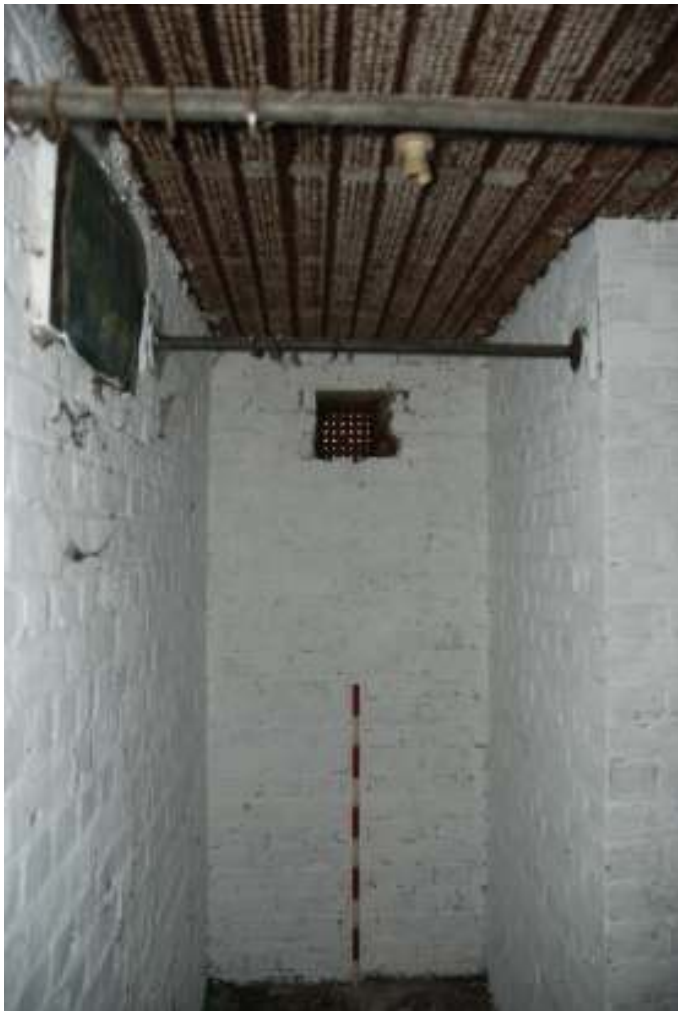
*Fig. 56: Photograph of the 'toilet' chamber in the far northern part of the air raid shelter, looking east. The original ventilator opening is also visible to the left of the frame, between the curtain rails.*

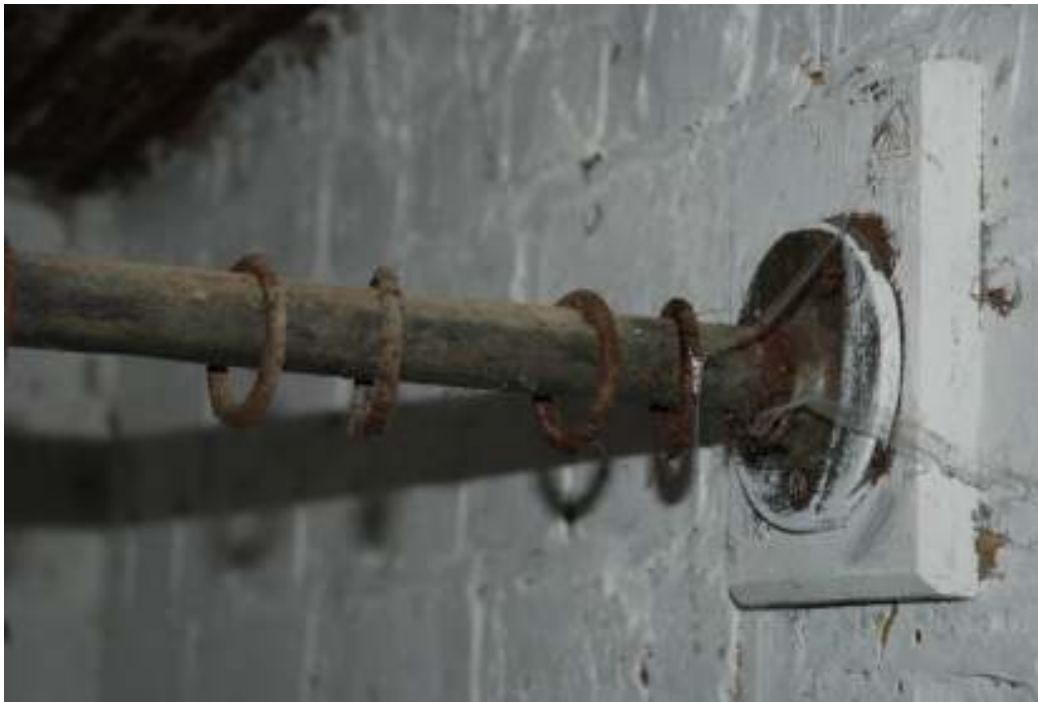
*Fig. 57: Close-up photograph of the curtain-rail in the toilets, with curtain rings still visible. A curtain would have hung from this, to screen the toilets.*

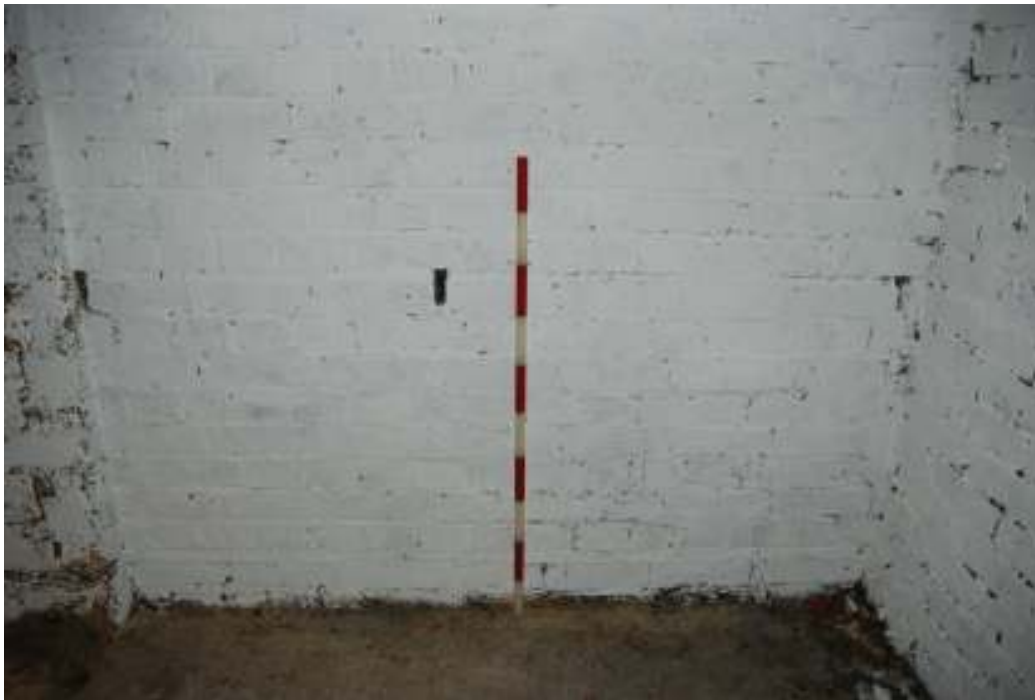
*Fig. 58: Photograph of the small vertical holes in the eastern wall, possibly used to hold the fixtures for benches.*

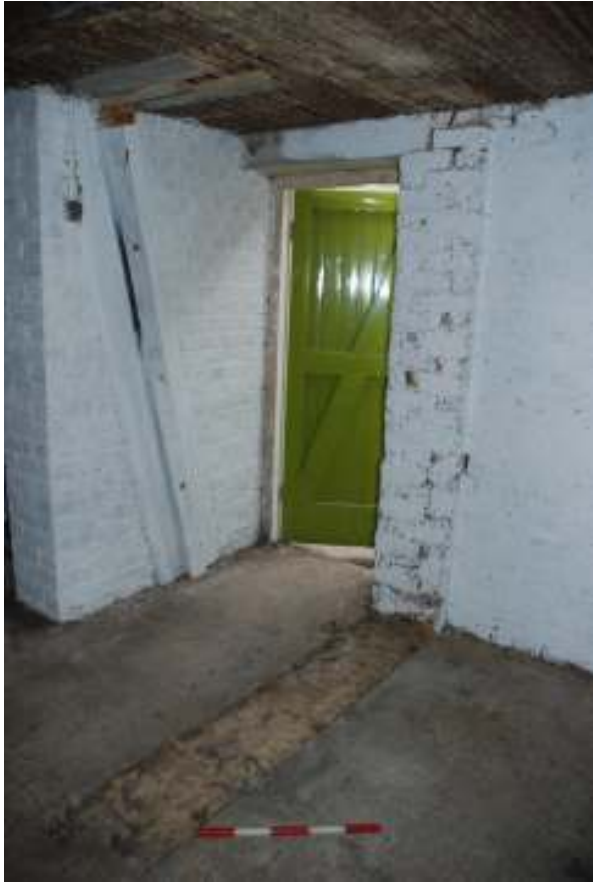
*Fig. 59: Photograph showing part of the 'blast-wall' layout (looking north-east). The present doorway is visible (where the original doorway would have been). The remnants of the wall on the left-hand side of the entrance are also visible, in the floor.*

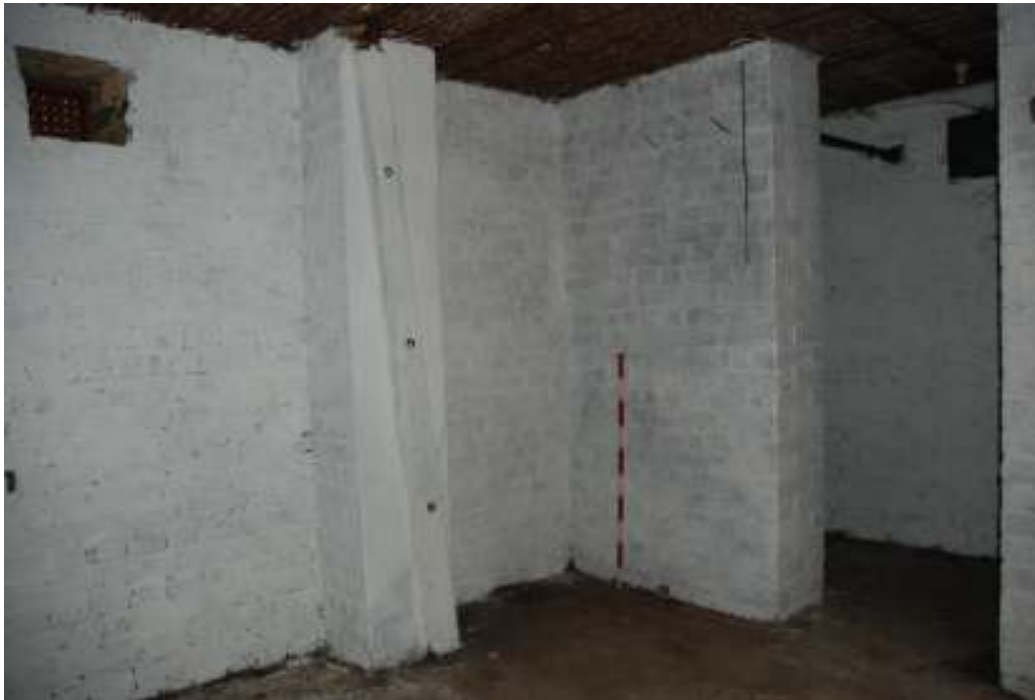
*Fig. 60: Photograph of another part of the 'blast-wall' layout, looking north-west. The small section of east-west projecting wall, which formed one side of the second 'entranceway' into the shelter, is visible in the left-hand side of the image.*

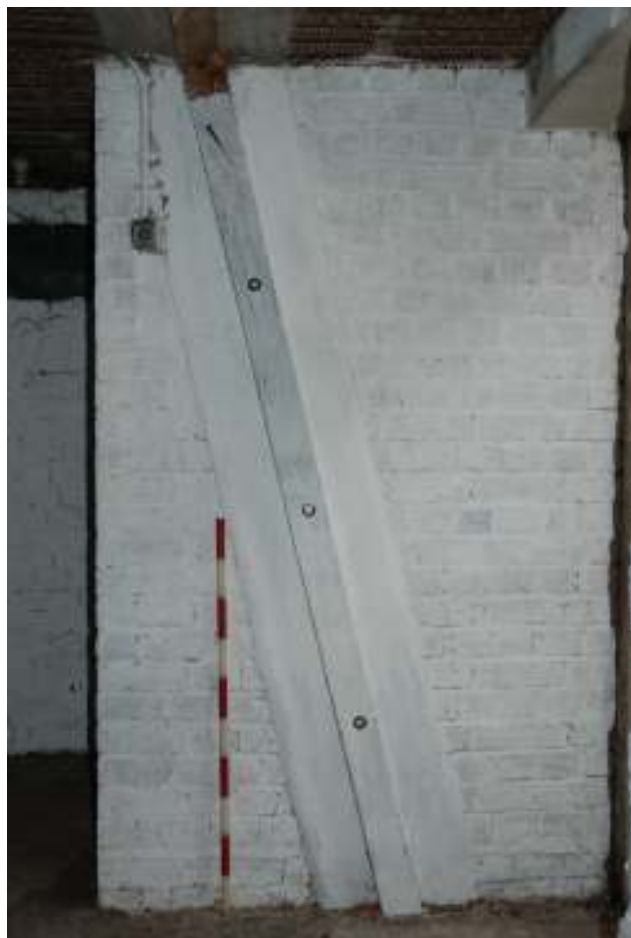
*Fig. 61: Photograph of one of the angled timber / concrete features. This is the one that is located on the wall to the right of the entrance.*

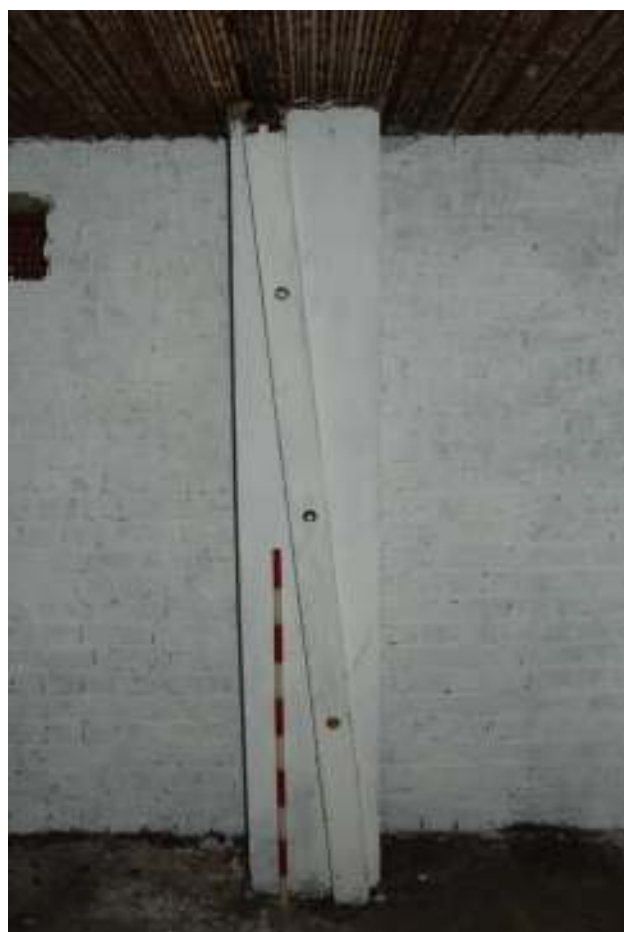
*Fig. 62: Photograph of one of the angled timber / concrete features. This is the one that is located on the small projecting wall positioned adjacent to the 'second entranceway'.*

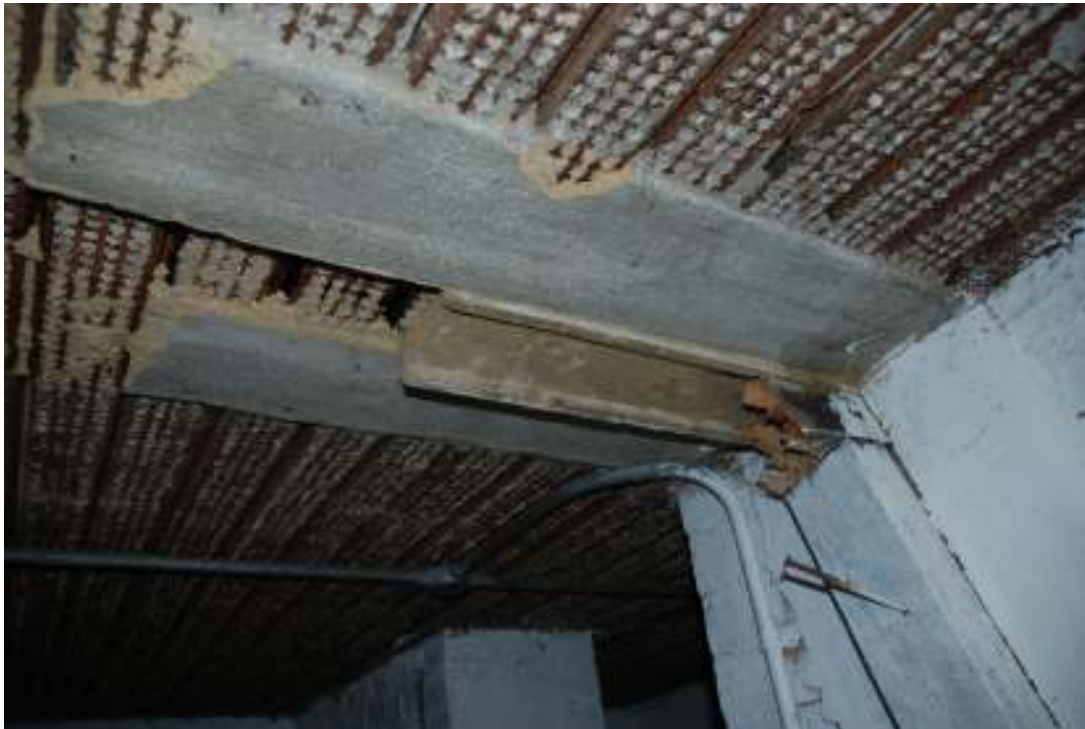
*Fig. 63: Photograph of the top section of the first angled feature, showing how it was morticed in and stretched across the ceiling.*

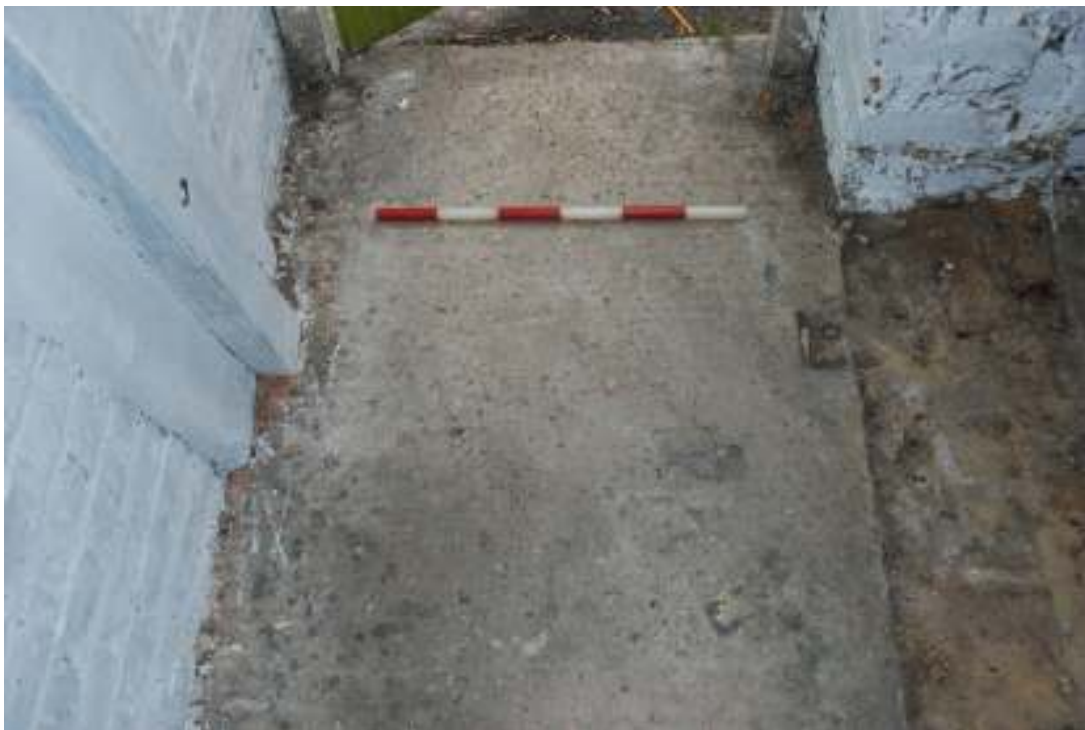
*Fig. 64: Photograph of the floor adjacent to the first angled feature, looking towards the door. The 'cut-out' on the opposite side to the angled feature, where the opposing timber beam would have stood, is visible just beneath the right-hand side of the scale.*

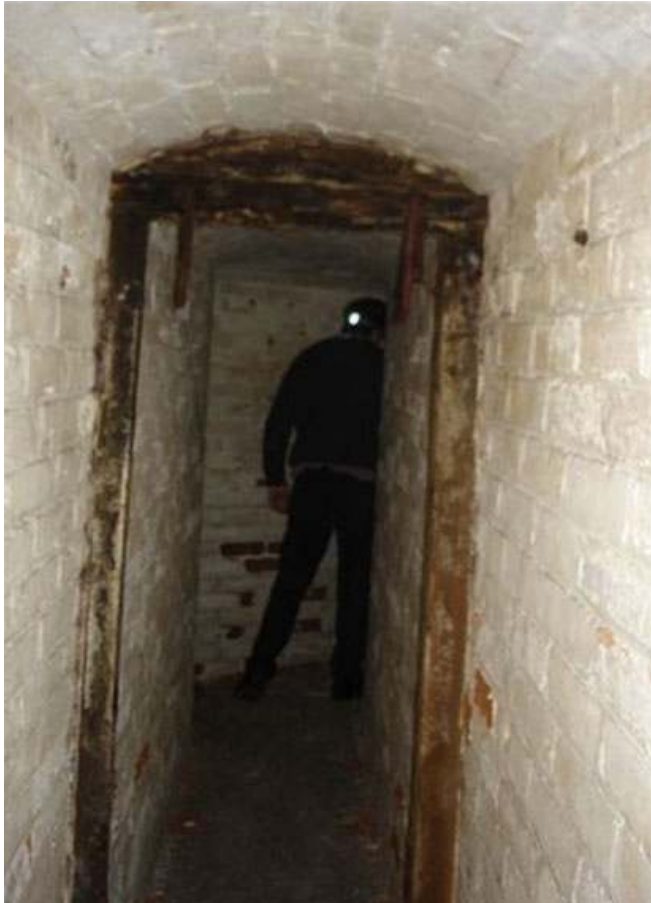
*Fig. 65: Photograph of the angled features in the Ramsgate flour mill air raid tunnels.*

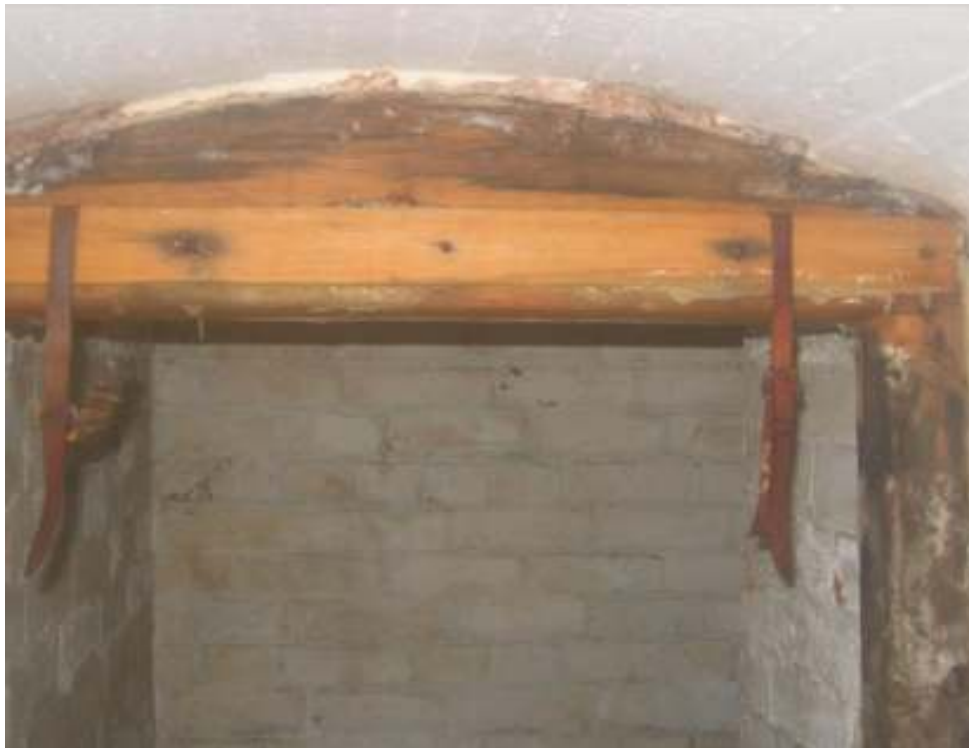
*Fig. 66: Close-up photograph of the beam running across between the two angled features in the Ramsgate Flour Mill air raid tunnels. The leather straps, off which a gas curtain would have hung, are clearly visible.*

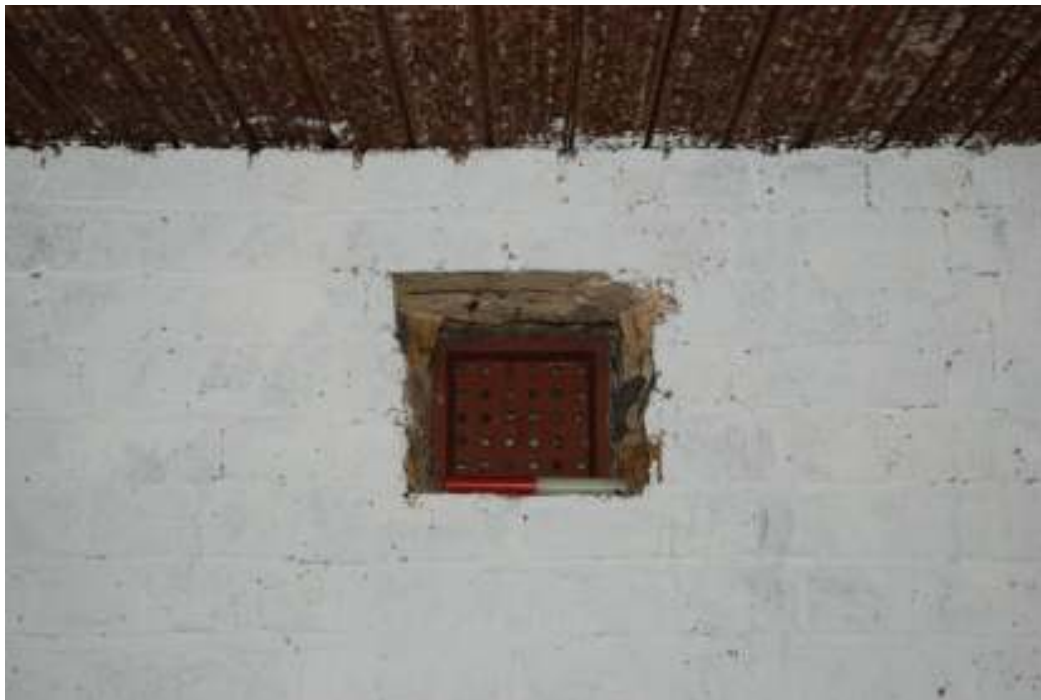
*Fig. 67: Photograph of one of the later vents, clearly showing how it has been bashed through at a later date. The later whitewashing of the walls is also visible.*

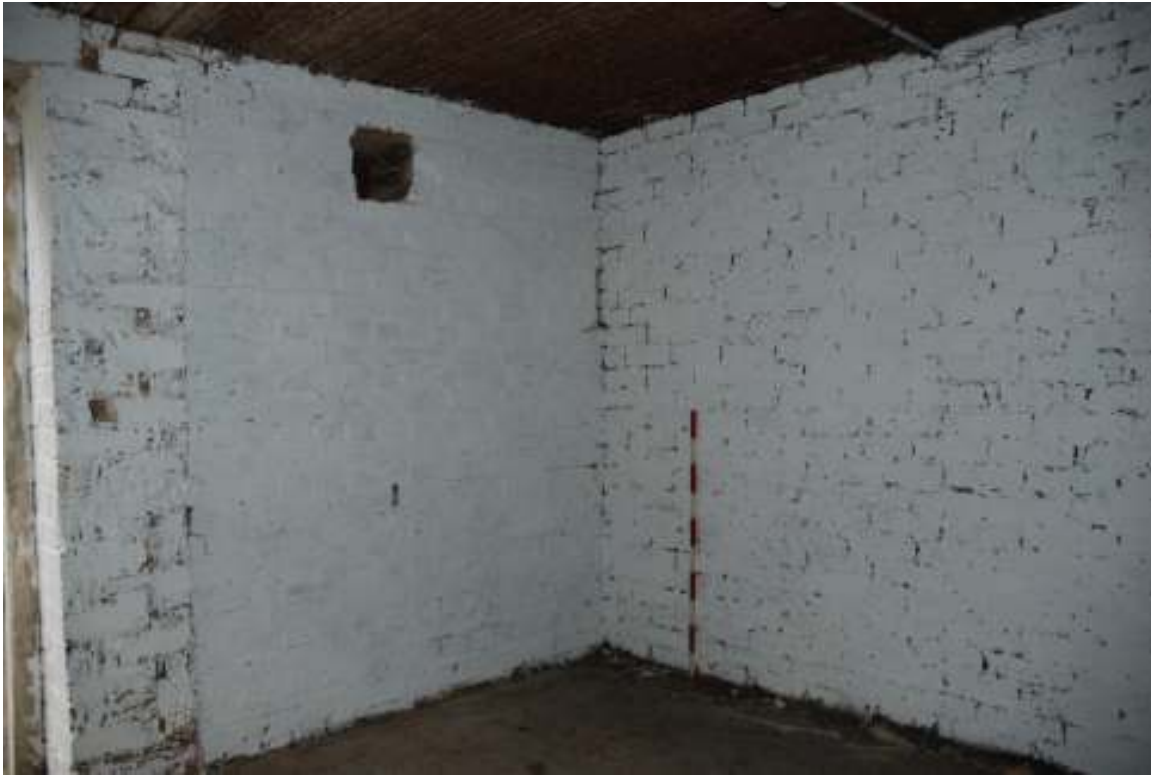
*Fig. 68: Photograph of the southern wall of room 1 (scale up against this wall). This is clearly a later insertion.*

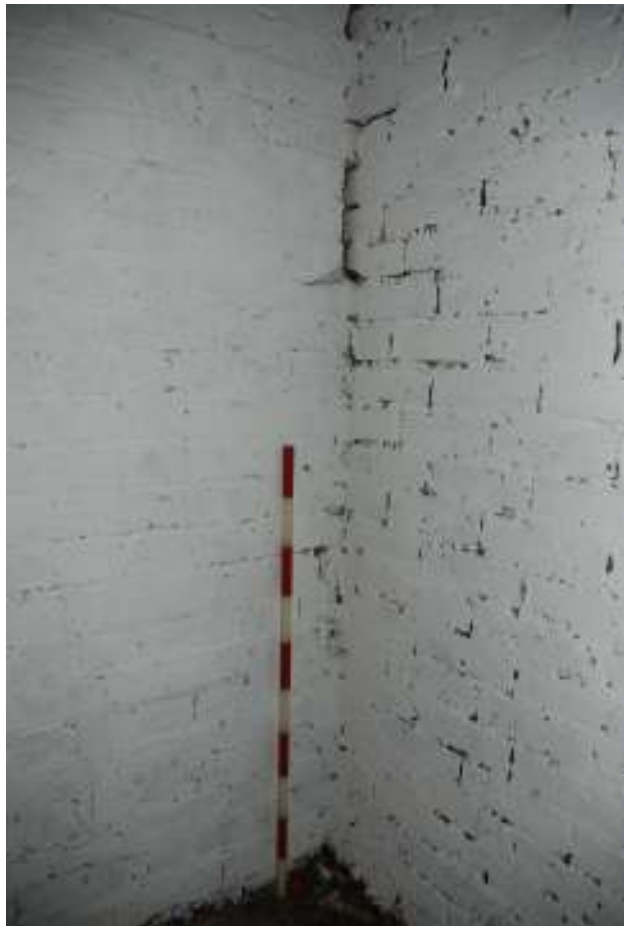
*Fig. 69: Photograph of the join between the eastern and southern walls of room 1. This clearly shows how the southern wall has been inserted in / bashed through the eastern wall, at a later date.*

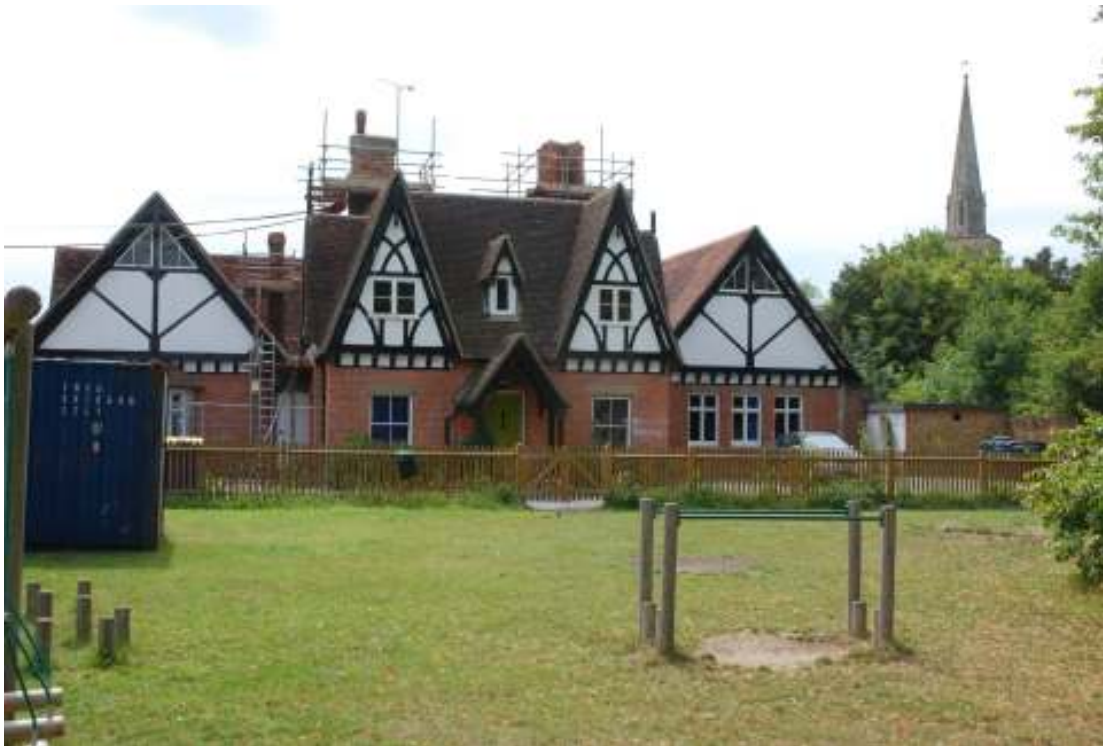
The Frittenden air raid shelter does appear to be located close to the school buildings – definitely close enough that it could be reached in the event of an emergency. It could, however, be argued that it was located a little too close to the buildings, although it must be remembered that Frittenden is a small school so there is little room or space for such structures to be constructed.

*Fig. 70: Photograph of the school and air raid shelter, looking south-west. The air raid shelter is visible in the right-hand side of the image.*
