Summary of a Watching Brief conducted at Manor Farm Stables, Manor Farm, Ruislip, London Borough of Hillingdon

COMPASS ARCHAEOLOGY

December 1st 2011

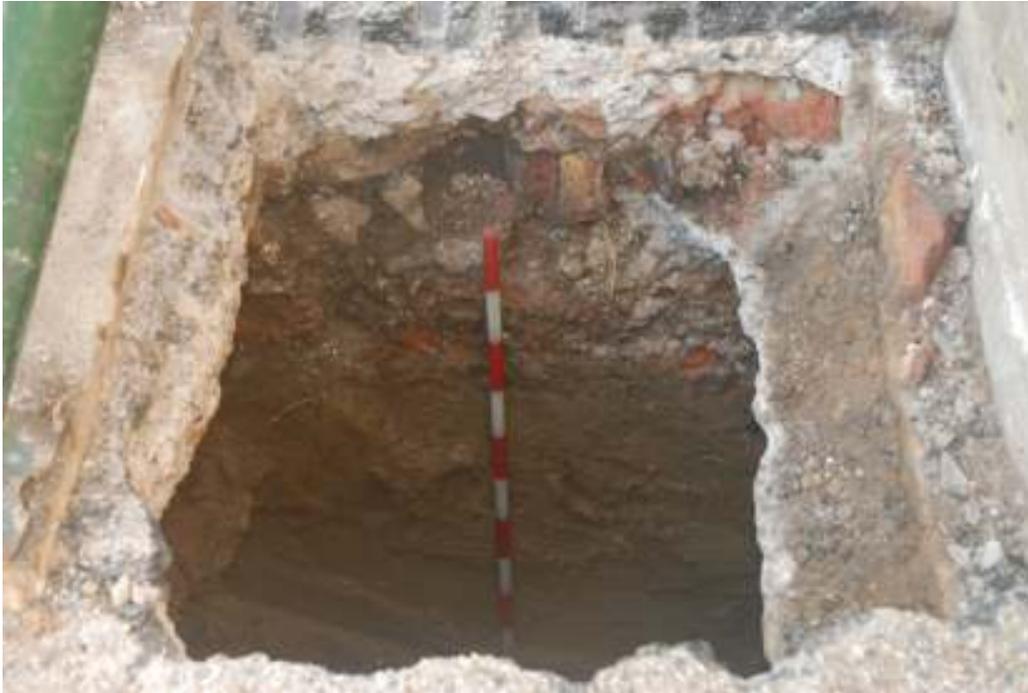
The external portion of the pits revealed natural, solid brown clay, geology approximately 650-700mm below the present ground surface overlain by up to 150mm of made ground deposits consisting of orange-brown clayey gravels and dark-grey-brown clayey-gravels containing the odd fragment of ceramic building material, (CBM). Most of this material dated top between 1480-1700, which was earlier than perhaps expected. Over this made ground was laid a surface of flint cobbles, made up of a course of smaller flints under larger nodules to create a yard surface probably associated with the earlier stable. This was also present within a 4m stretch at the western end of trenching observed on the 30th November, see fig.7. The surface had been truncated 0.32m south from the stable wall due to the insertion of a concrete plinth at the base of the stable wall, perhaps to provide further structural stability. There was evidence of repair to the flint yard surface after this event by the presence of two red bricks at the northern edge of the interface between the cobbles and the concrete. This would suggest that this yard surface was still in use for some time after the concrete was added. Later this yard was buried by a layer of mixed soils and brick rubble between 80-180mm thick prior to the laying on the present tarmac pathway over a bed of concrete.

Fig.1: External shot of Pit 2. East facing section.

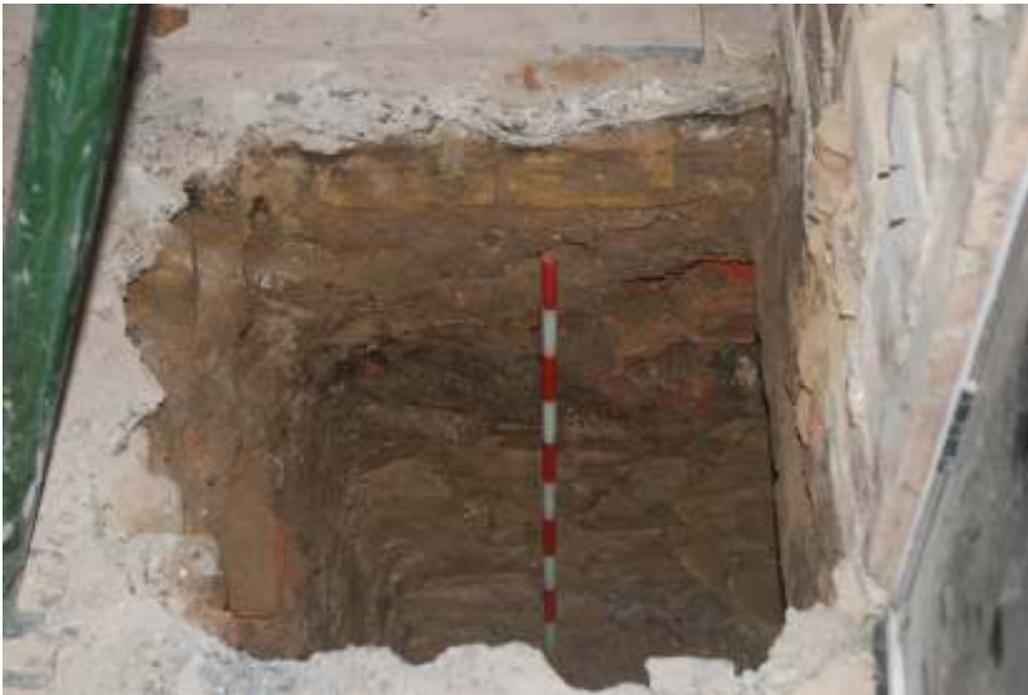
The internal portion of the pits revealed the same natural geology at 690mm below present floor level, overlain by a heavily mixed grey-brown clay with frequent CBM inclusions 350mm thick. Over this was a 130mm thick layer of flint and brick rubble onto which a floor of yellow stock bricks had been lain. This floor was later superseded by the current floor of concrete, 100mm thick. Brick samples taken from the earlier floor were dated to between 1770-1940AD.

Fig.2: Internal shot of Pit 2. West facing section.

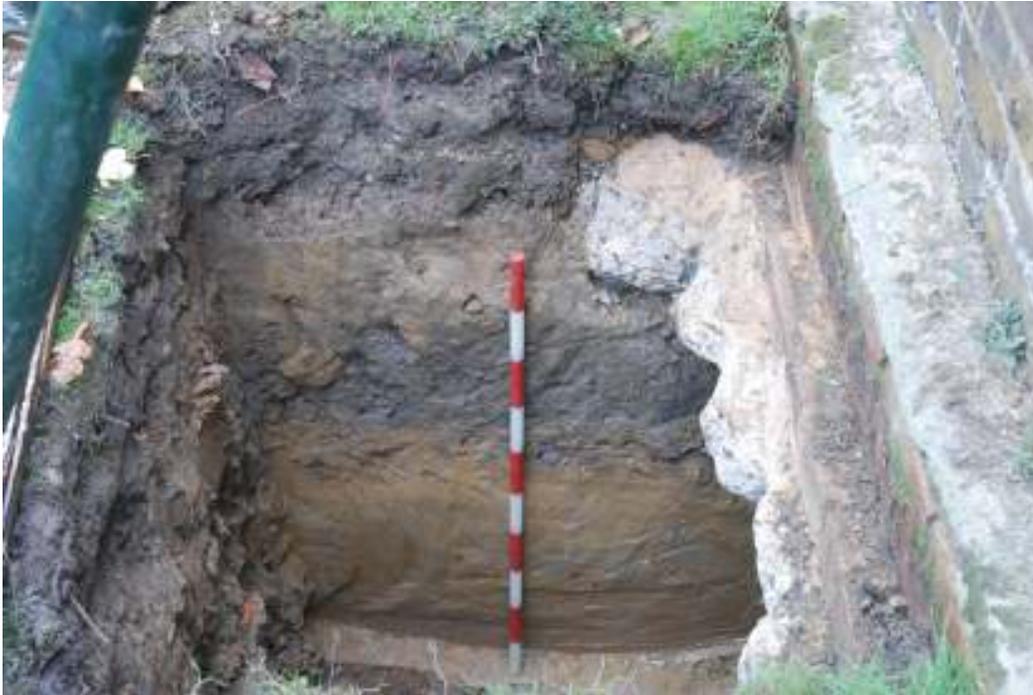
The northern pits revealed somewhat simpler stratigraphy. Externally natural geology was observed 700mm below the ground surface overlain by 250-300mm of mid-grey-brown friable silty-clay containing occasional rounded pebbles, almost certainly representing some form of truncated / buried soil horizon. This, in turn, was overlain by a pale-brown dirty clay, 190-250mm in thickness, containing fragments of CBM.

This layer could be redeposited natural disturbed upon construction of the stables. Over the abovementioned layer was an imported mid-grey-brown sandy-silt forming the new subsoil in the base of which was a scattering of mixed peg-tile and mortar probably representing detritus after an episode of building work associated with the stables, more than likely the insertion of the concrete plinth as observed in the southern pits. This subsoil was overlain by the present grass and topsoil which was up to 100mm thick.

Fig.3: External shot of Pit 3. West facing section.

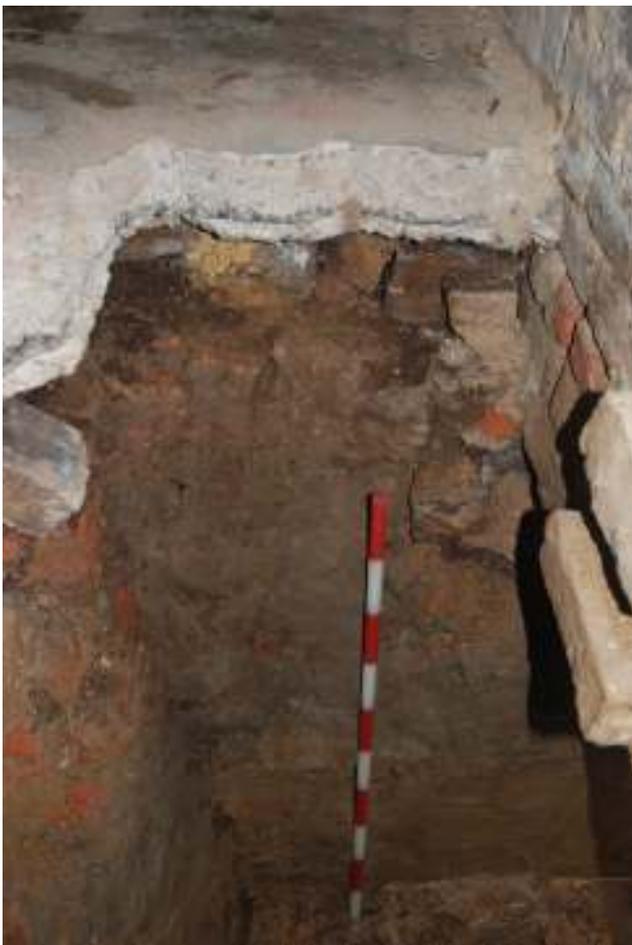
Internally the northern pits revealed further evidence of the earlier brick floor of the stables, although here it was partly constructed of highly fired blue pavers, so-called 'engineering' bricks, these would have assisted with drainage within the stables. They were dated to around 1830-1950, much later than many of the other bricks.

Fig.4: Internal shot of Pit 3. East facing section.

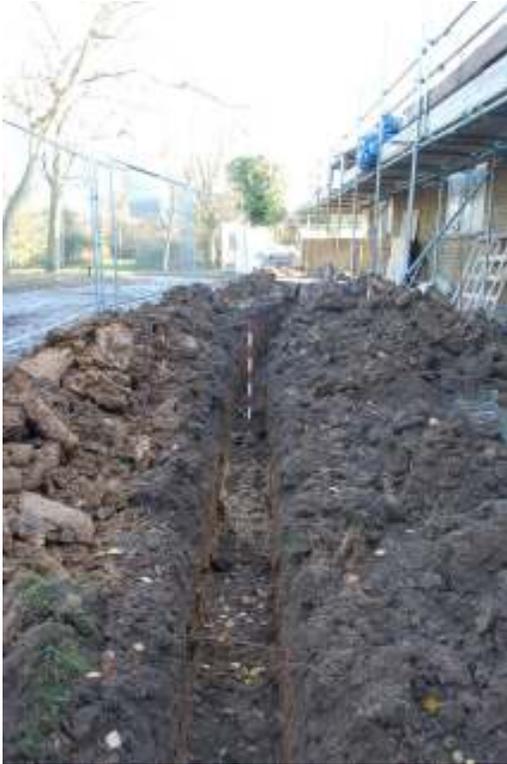
A total of c.70m of trenching was observed between the 25th – 30th November which revealed similar stratigraphy as exposed in the underpinning process. The trenching was up to 0.45m wide and up to 0.70m deep. Stratigraphy on the northern side of the stables constituted natural compacted brown clay 650mm below the present ground surface, overlain by a grey-brown buried soil horizon, 300mm thick and modern imported subsoil containing building debris overlain by topsoil. *See figures 5 and 6.*

Fig.5: Trenching on northern side of stables. Facing East.

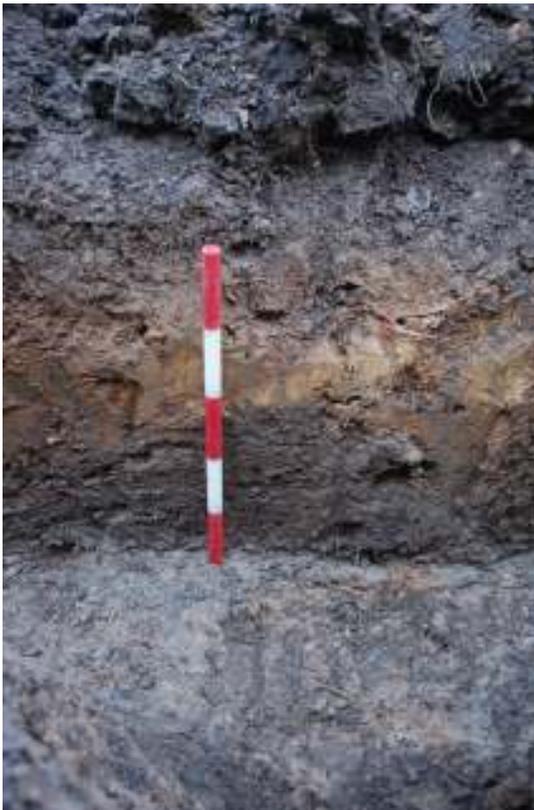
Fig.6: South facing section through trenching on Northern side of stables. Buried soil horizon in base of trench.

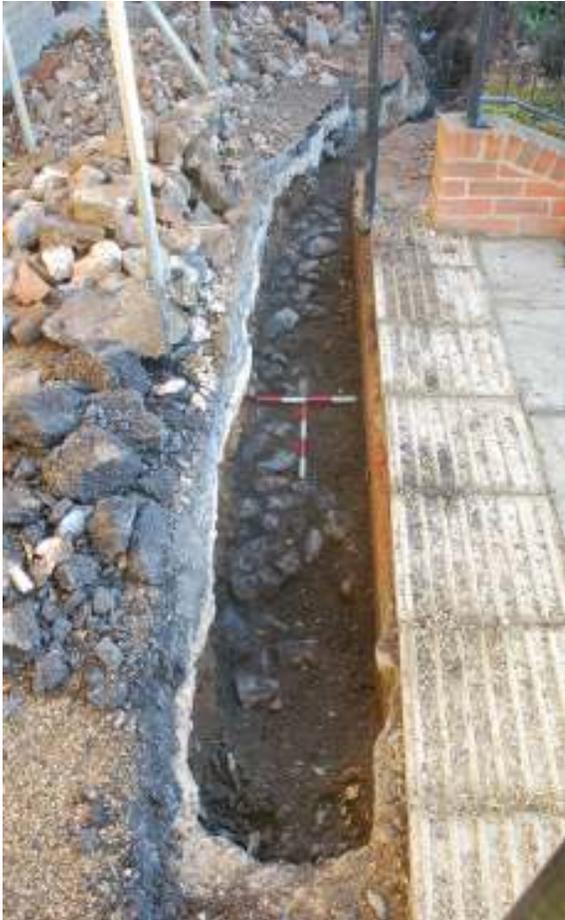
Trenching on the southern side of the stables revealed made ground 300mm below the level of the path, very-dark grey in colour and sterile, overlain by a rubble rich silty-clay containing frequent crushed brick and tile, below the existing tarmac surface. This sequence was largely homogenous except in the far western 4m of trenching opposite the far door to the stables and stairs leading down to the tea-rooms. Here the flint cobbled yard surface observed in the southern underpinning pits was preserved in plan, however it was truncated to the south and east by the retaining wall built along the bank facing into the farm courtyard. *See figures 7 and 8.*

Fig.7: Flint yard surface in west end of trenching, southern side of stables. Facing east.

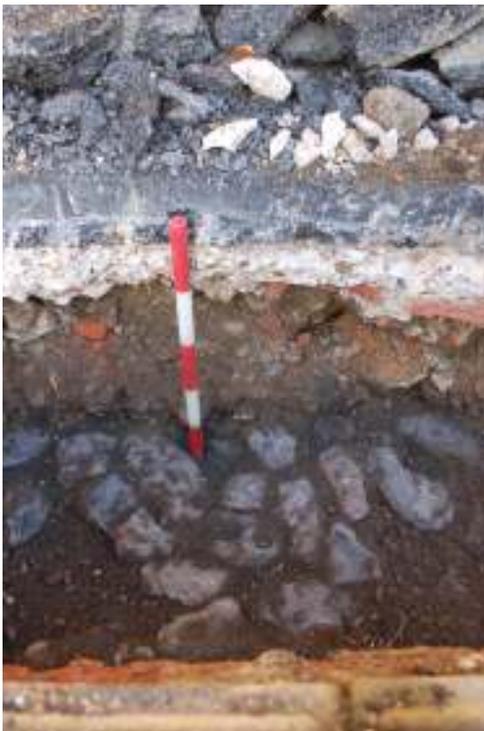
Fig.8: South facing section above cobbled surface.
