**Garden Improvement Works in the churchyard of
St.Botolph without Bishopsgate,
City of London, EC2M 3TL**

An Archaeological Watching Brief

Site Code: BWB12
NGR (centre): TQ 3318 8148

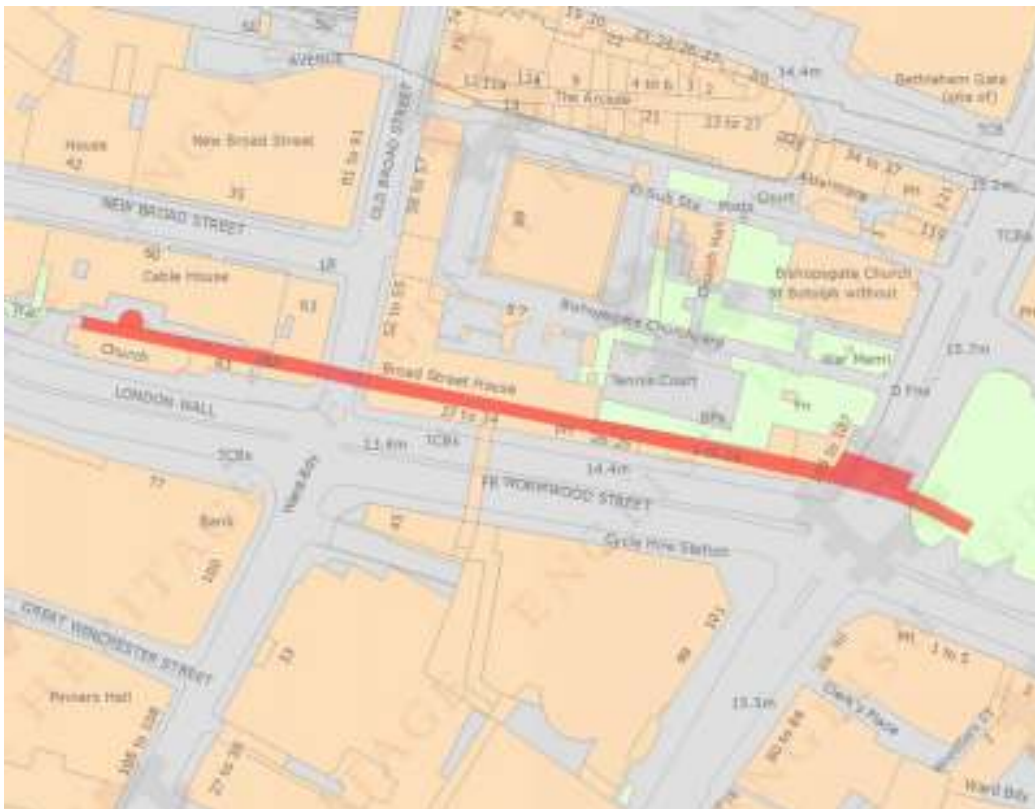
The SE limit of the site fell within the Scheduled Ancient Monument of the Roman and Medieval City Walls and Bishopsgate, (L026N), however no works took place within the physical area of the Scheduled monument in this instance.

Fig.2: Plan of the SAM of London Wall: remains of Roman and medieval Wall from *W end of All Hallows Church to 38 Camomile Street*, The watching brief site is on the *right of frame*. (Reproduced from English Heritage website <http://list.english-heritage.org.uk/resultsingle.aspx?uid=1002050>).

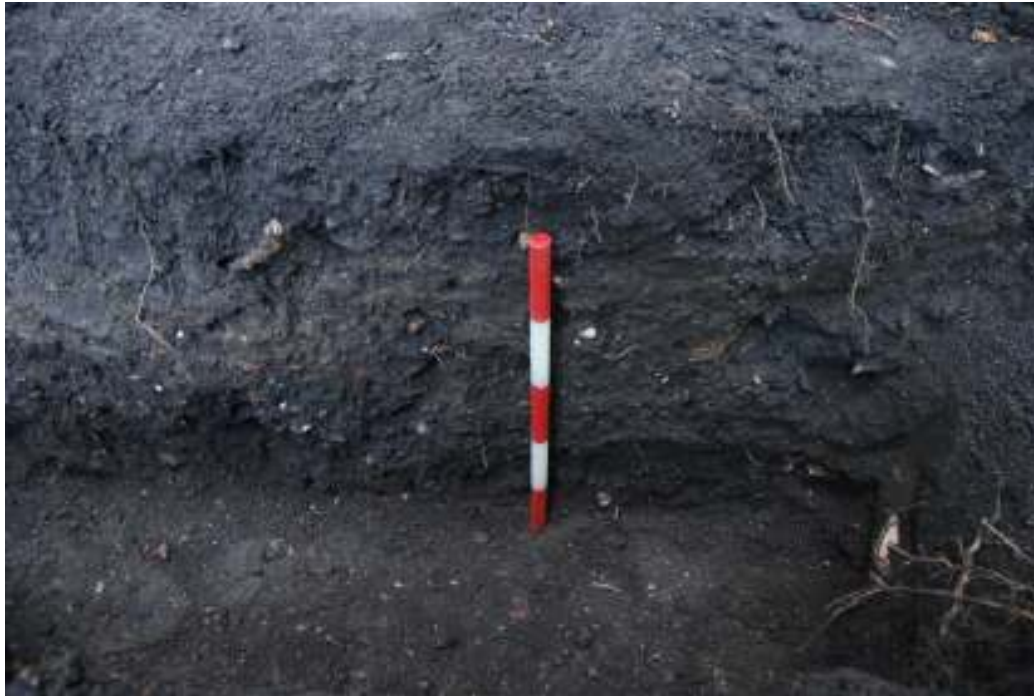
6.2 On the 6th February trenches 1, 2 and the western part of 4 were observed, a total of 20.65m. The trenches averaged 500mm wide by up to 600mm deep at between 15.06 to 15.01mOD. At the NW end of Trench 2 a ceramic drainage pipe was observed, aligned N-S across the base of the trench within an orange-brown clay matrix, and was probably laid down to improve drainage during the conversion of the churchyard to gardens. This and the rest of the observed trenching was sealed below 200mm plus of loose black-grey silty soil containing rooty matter, clay pipe, shell, glass, and some pot sherds (largely late Victorian). Over this basal fill was a 200mm thick subsoil, dark-grey /

brown in colour, and containing inclusions of Ceramic Building Material, (CBM), clay pipe, 19th century 'Ironstone' china and Post-medieval Redware pottery³, and medium sized gravels. These two lower deposits were interpreted as imported soils brought in during the creation of the modern gardens. The existing ground surface comprised a rich loamy topsoil containing humic matter and roots from the surrounding trees and shrubberies, 180mm thick. No archaeologically significant finds or deposits were observed.

Fig.12: Section through SW end of Trench 1, facing SE. (0.5m scale)

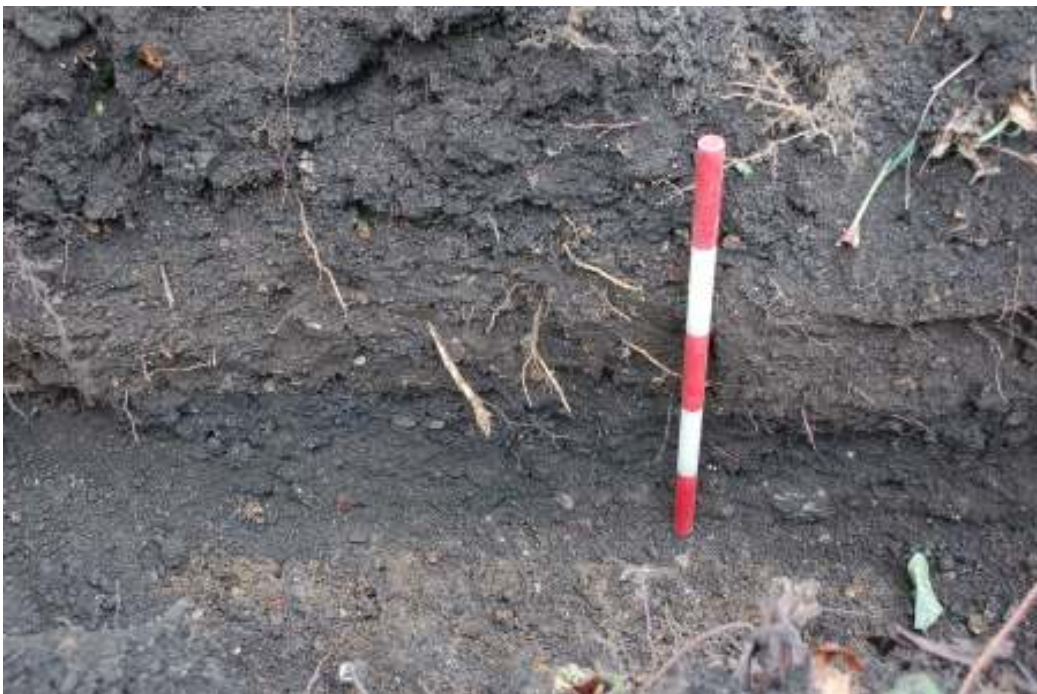
- 6.4 30.4m of trenching was observed on the 8th of February, including the whole of trenches 6-8. The area of trench 6 and the NW end of trench 7 had the potential for exposing remains associated with buildings once fronting Bishopsgate as depicted on the historic maps. Unfortunately on this occasion the trenches did not encounter any deposits or features of this nature, presumably because the depth of the trenches was so limited. In the event the base of the trench exposed a light brown clay-silt at 15.31mOD, overlain by 200mm of the strong-brown / grey clay-silt containing gravels, CBM, clay pipe, and several sherds of pottery. One of these sherds was part of a rim from an Alice Holt 3A everted rim jar and dated to the late 1st-2nd century⁴. This represented the same landscaped material imported from elsewhere, and so although there was a relatively high content of pot etc. only a representative sample was taken. This subsoil was overlain by rich black root-filled topsoil, as thick as 0.25m due to the proximity of bedding plants.

Fig.13: Section through centre of Trench 6, facing SW. (0.5m scale)

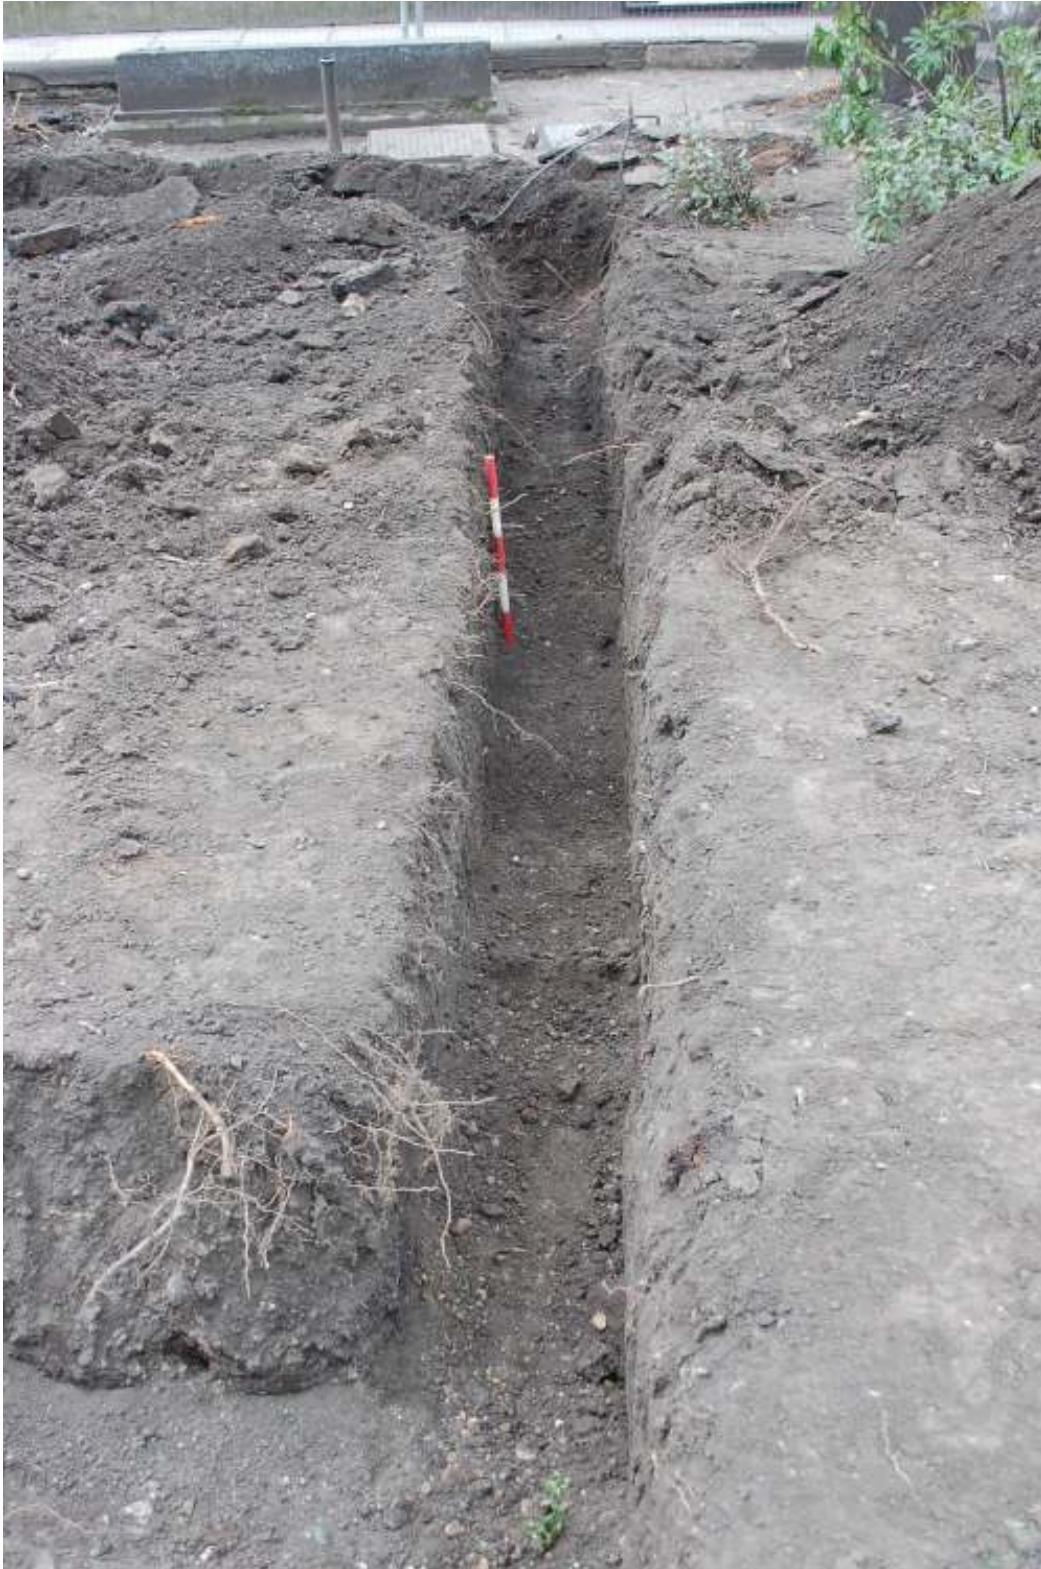
Fig.14: *General shot of Trench 6, with trench 7 towards the top of frame. Facing NW, (0.5m scale)*

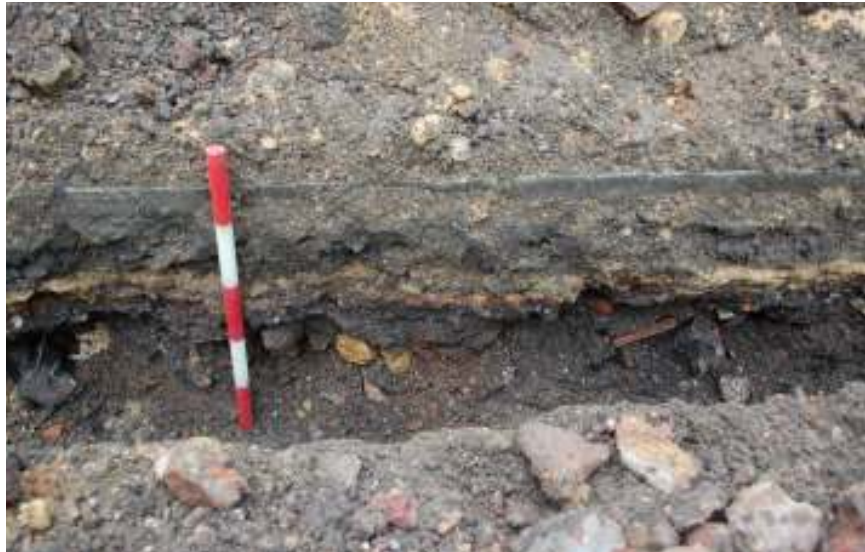
- 6.5 On the 9th of February trench 9, which was aligned NE-SW on the paved area in front of the tennis courts, was investigated. The trench was approximately 400mm wide by up to 420mm deep, (14.94mOD), and 9.25m in length and dug by hand due to the limited space for the mini-digger. The stratigraphy included very dark-grey / black silty-clay made ground from 180mm below the current ground level down to the base of the trench and beyond, overlain by 180mm of orange-yellow builders sand onto which the concrete paving slabs were lain. As before, a large quantity of flower pot, CBM fragments, glass bottles, and some gravels were contained within the imported made ground, but due to their limited archaeological value the majority was not retained.

Fig.15: Section through trench 9. Facing SSE, (0.5m scale)

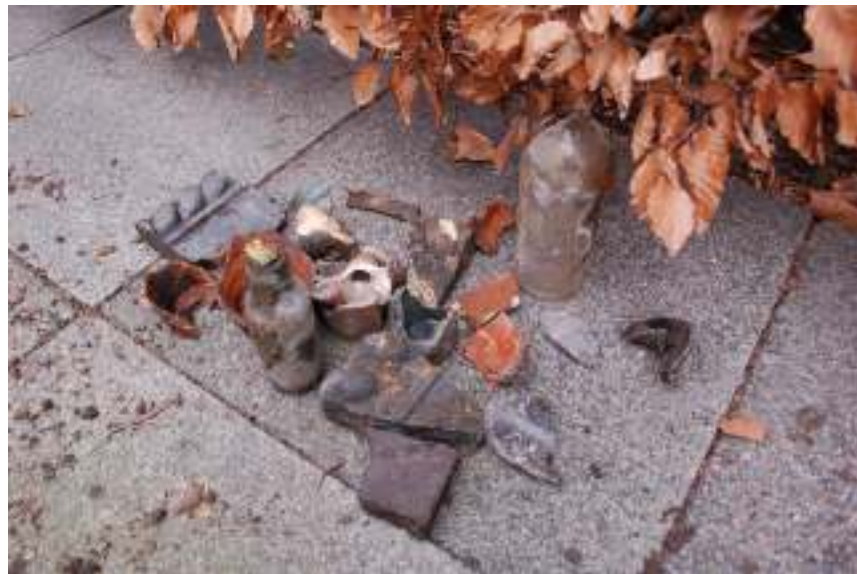
Fig.16: Photo illustrating the mixed material from within the imported subsoil in trench 9, including glass bottles, flower pot, animal bone, and even dark-grey garden kerbing with barleycorn design

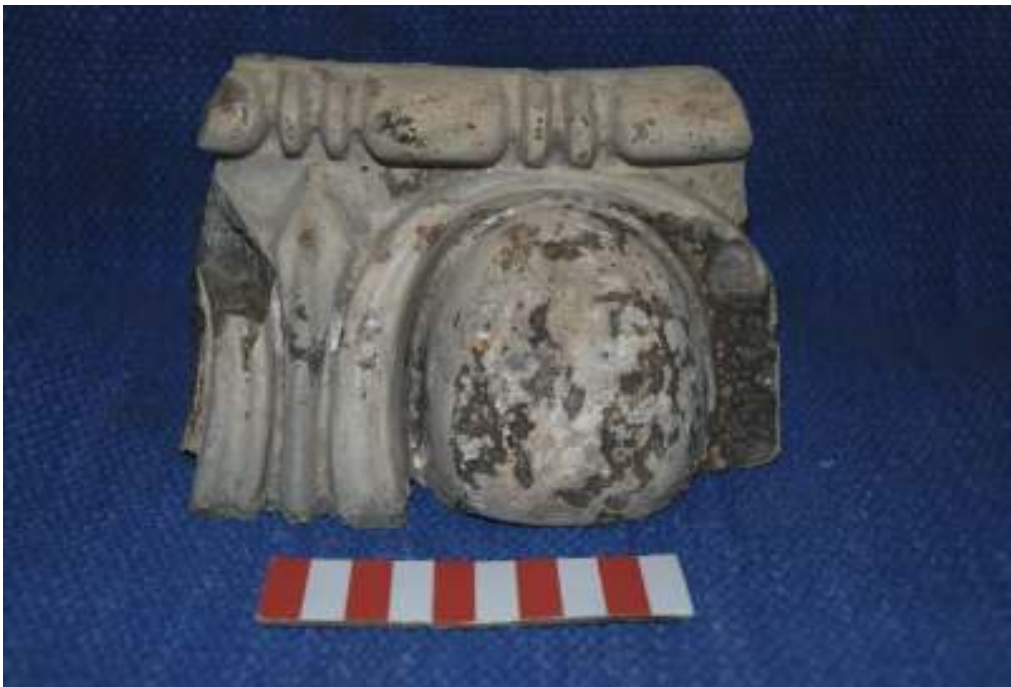
A single architectural fragment was recovered from trench 9 and appears to have formed part of a door or window surround, being slightly curved on its topmost face. The features of the fragment, the beading and roundels, place it within an 18th century neo-classical style. The fragment in question is believed to have been made of coade stone; a particularly hard-wearing form of ceramic-fired artificial stone. The formula was first devised in the late 1760s and the Coade Company was run by Eleanor Coade and her cousin John Sealy from a workshop/gallery in Lambeth from 1799. The product became very popular due to the use of finely ground 'grog', (previously fired ceramic/glass), in the initial mixture which reduced the amount of shrinkage/cracking in the 'second' firing; allowing for more accurate mouldings to be created for large scale architectural projects. As a result Coade stone attracted many famous architects and designers and was used on decorating Buckingham Palace, for creating the figure of Father Thames at Ham House, and the Lion on Westminster Bridge, and also for William Bligh's tomb. It may have been part of a piece commissioned at the same time as the Coade statues of a 'Charity' Boy and 'Charity' Girl that stood within the recesses on the frontage of the Church Hall when it was an Infants School. However, without more positive proof of its origins it is unclear as to how this lone fragment relates specifically to the site.

Fig.17: Fragment of Coade stone recovered from within the landscaped material in trench 9, (10cm scale)

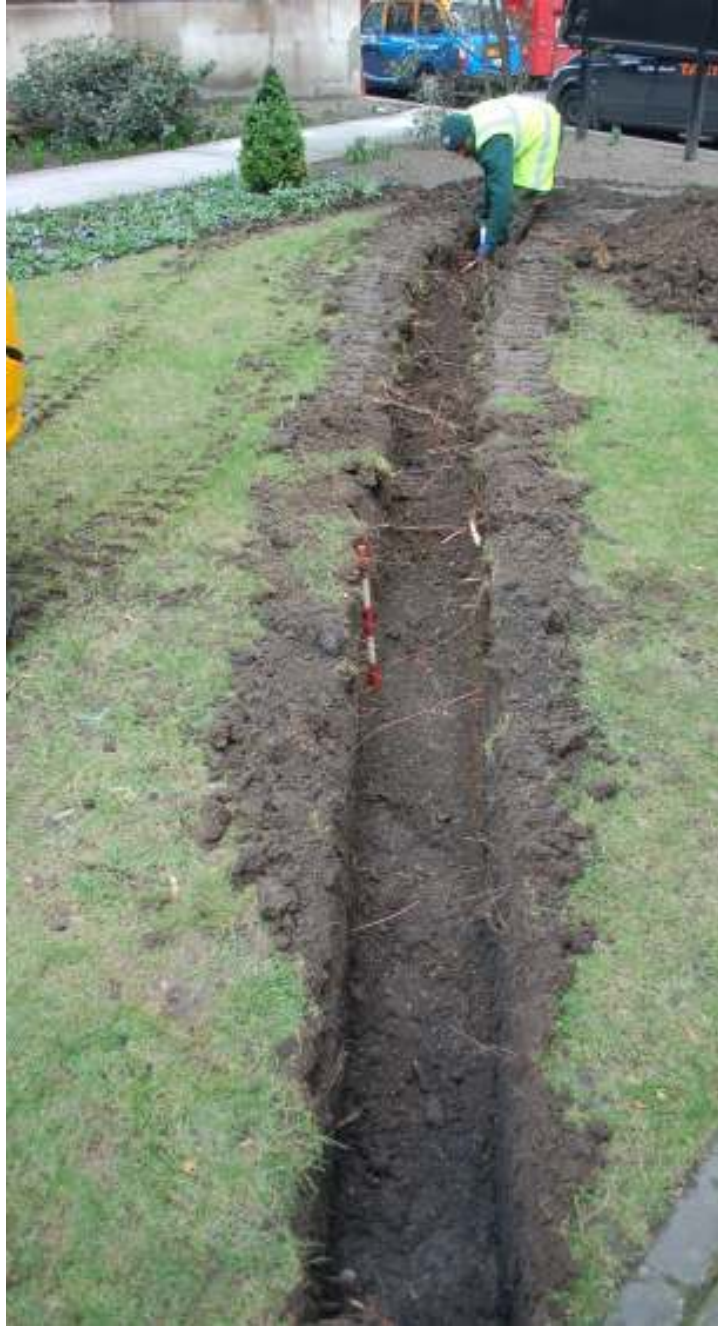
Trench 10 was also excavated on the 9th and was aligned N-S diagonally across the grassed area immediately E of the church, measuring 7m long by 500mm wide and up to 520mm deep. The basal fill of the trench was a made ground deposit of orange-brown clay silt, containing abundant water-worn flint gravels at 15.70mOD below current ground level. This was overlain by dark-grey / black silty clay containing crushed CBM and mortar, 120mm thick, whilst the uppermost 220mm was made up of rich black loamy topsoil containing rooty matter at 16.04-16.21mOD.

Fig.18: *Clearing loose from the base of Trench 10 post machine dig, facing N, (0.5m scale)*

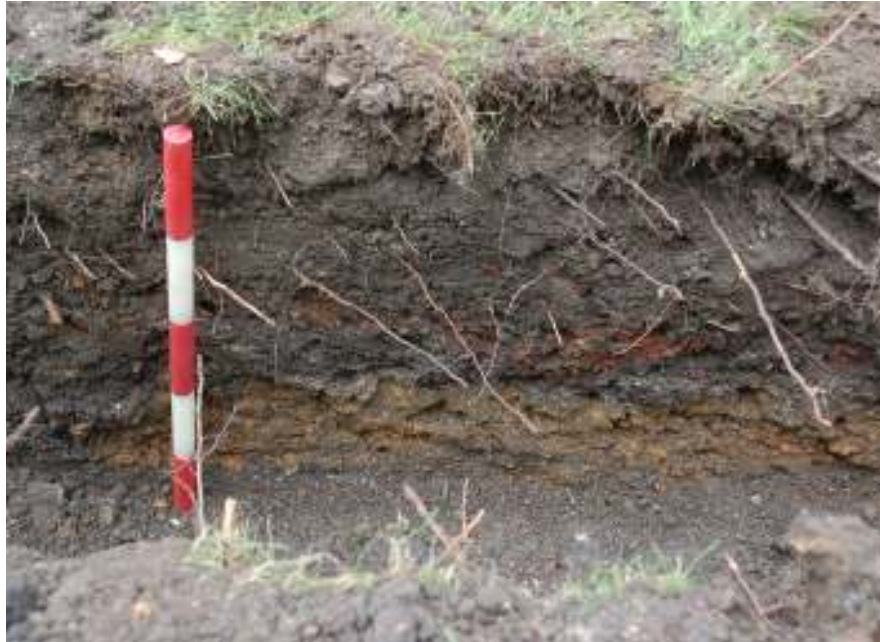
Fig.19: Section through Trench 10, facing W. (0.5m scale)

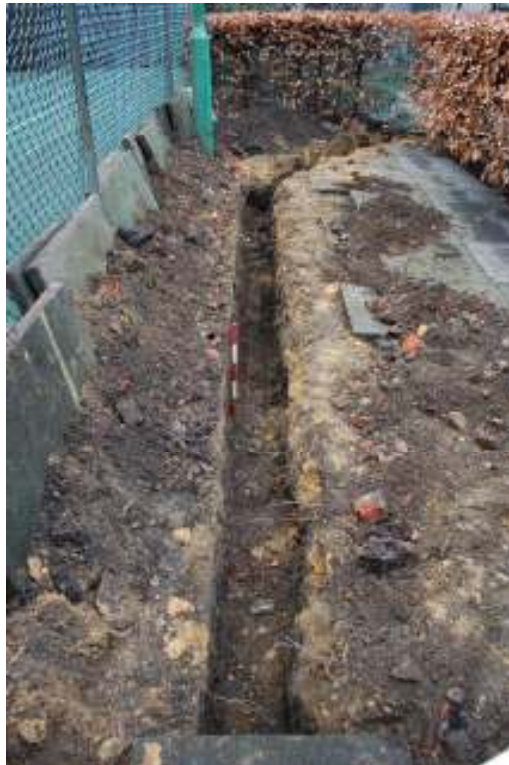
- 6.6** On the 10th of February a second trench, 11, was dug across the NW front of the tennis courts. The trench was aligned NE-SW for 5.3m then was dug E-W for the final 3.2m to the corner of the bedding opposite the final lighting arch crossing the central pathway. The same stratigraphy as observed in trench 9 was also seen in trench 11, comprised of made ground overlain by bedding sand and paving slabs. The trench was 300mm wide and 400mm deep, the base being at 15.03mOD.

Fig.20: Trench 11, facing SW (0.5m scale)

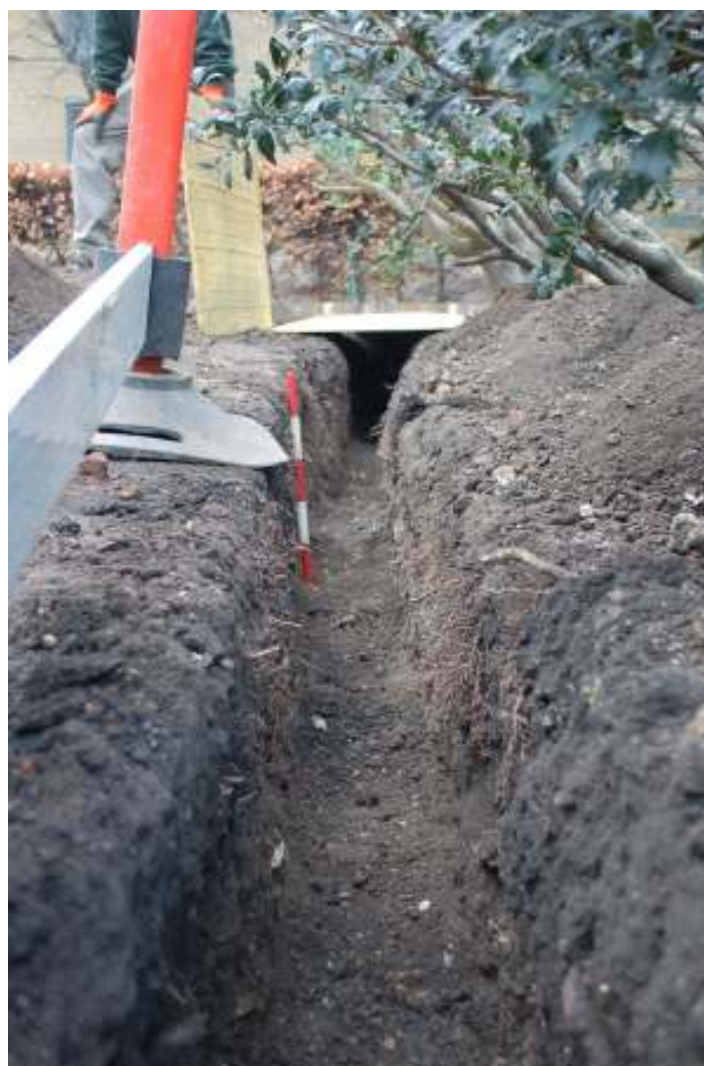
- 6.7 A site visit was made on the 13th of February to monitor trench 12, which was dug north of the central pathway and west of Sir William Rawlins tomb along the raised grass area. It measured approximately 12m long by 300mm wide and 450mm deep, and had 3 short projecting trenches west of the main trench which was aligned NW-SE. The basal fill was friable dark brown-grey clay-silt, containing frequent CBM fragments, clay-pipe stem, and a few bowls, 19th-20th century flower pot and two late 17th-18th century pot sherds including Yellow-glazed Border Ware and English Tin-glazed Ware. This, as elsewhere in the churchyard, seems to have been imported material, probably brought onto site during the reconstruction of the main church in the early 18th century or the church hall in the 19th century. The topsoil was extremely rich black loam with rooty matter from the overlying hedgerow. No archaeologically significant deposits were observed.

Fig.21: Trench 12, facing SE. (0.5m scale)

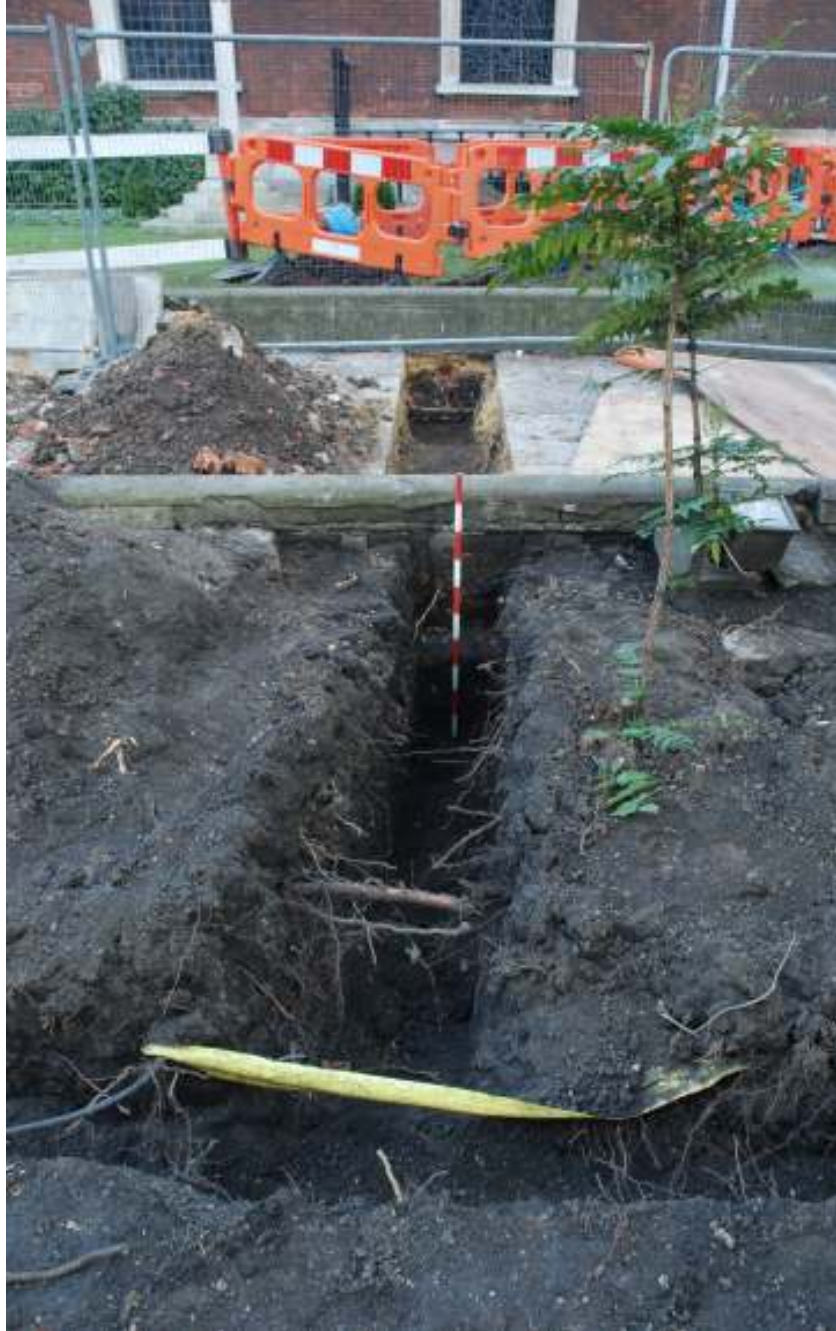
- 6.8 During a visit to site on the 16th February the excavation of a trench, (no.13), NW-SE across the central pedestrian pathway linking trenches 7 and 10 was observed. The trench was approximately 5.85m long by 500-620mm wide and between 430-880mm deep. The majority of the trench was machine dug with hand digging taking place around the subsequent archaeology.

Fig.22: General shot of trench 13 facing NW. Trench 7 in foreground and trench 10 surrounded by orange fencing. (1m scale)

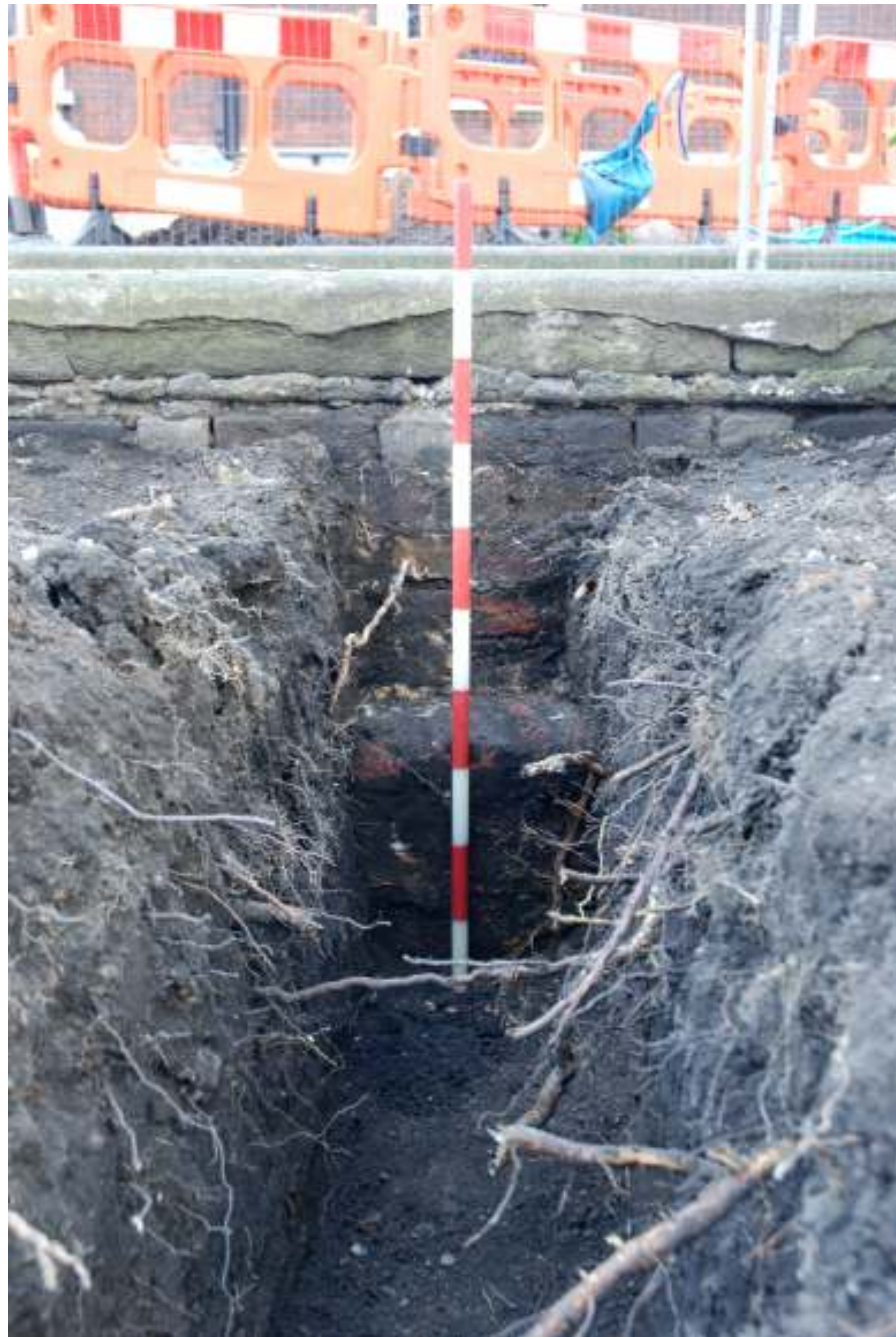
At the SE end of the trench, (branching off of trench 7), the stratigraphy was as observed previously in this area, being very dark-grey, imported subsoil around bedding areas, overlain by rich, black loamy topsoil up to 250mm thick. The total depth of the trench was c.650mm. The trench exposed the footings of the churchyard wall where it met the pathway at c.15.36mOD. These projected either side of the main build by 190mm to the SE and 40mm to the NW. Both the footings and main structure of the wall were made of similar purple-red stock brick bonded with a hard white lime mortar. The upper / main structure was rendered on either face.

Fig.23: Exposed wall footings in SE end of trench 13, facing NW. (1m scale)

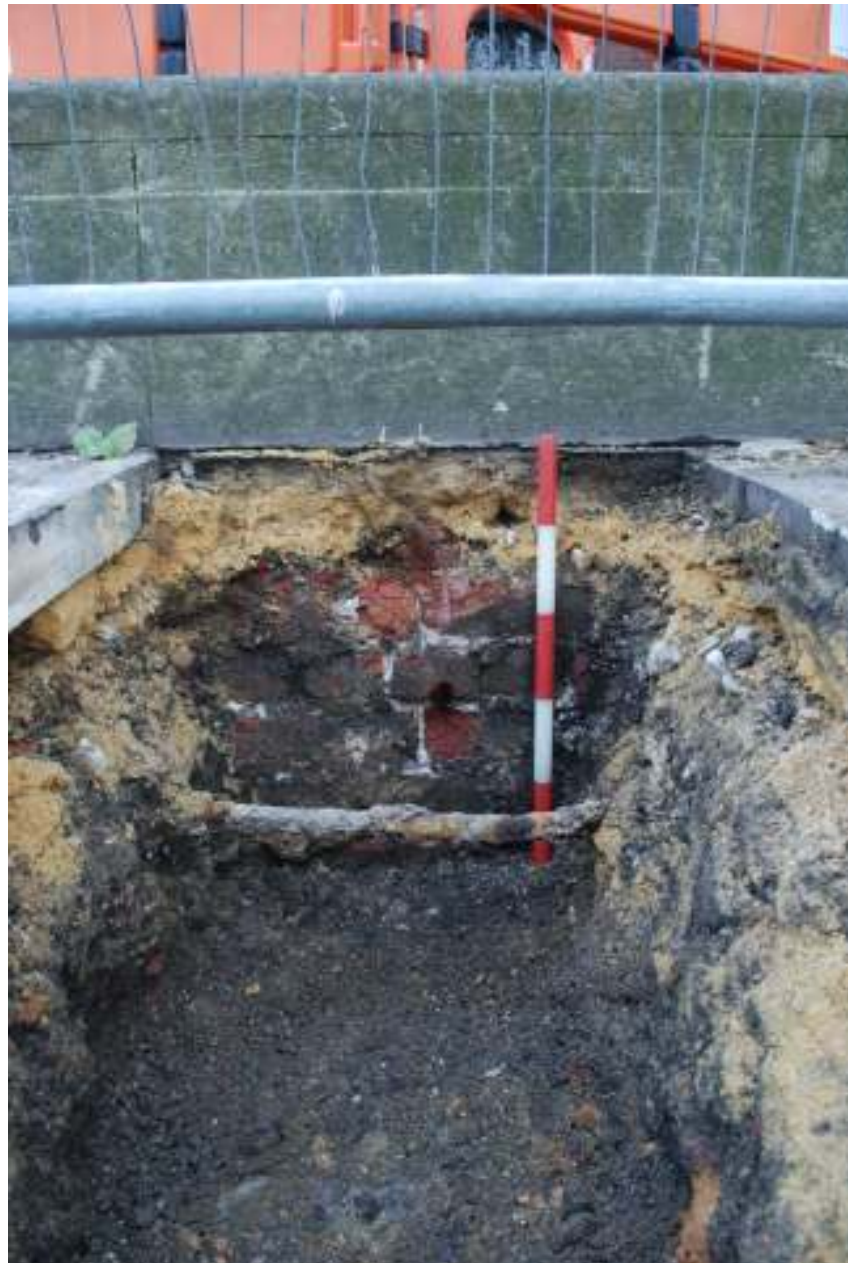
As with the SE portion of the trench the churchyard wall footings were exposed on the NW side of the path, at 15.72mOD.

Fig.24: *Wall footings exposed at NW end of trench 13, facing NW. (0.5m scale)*

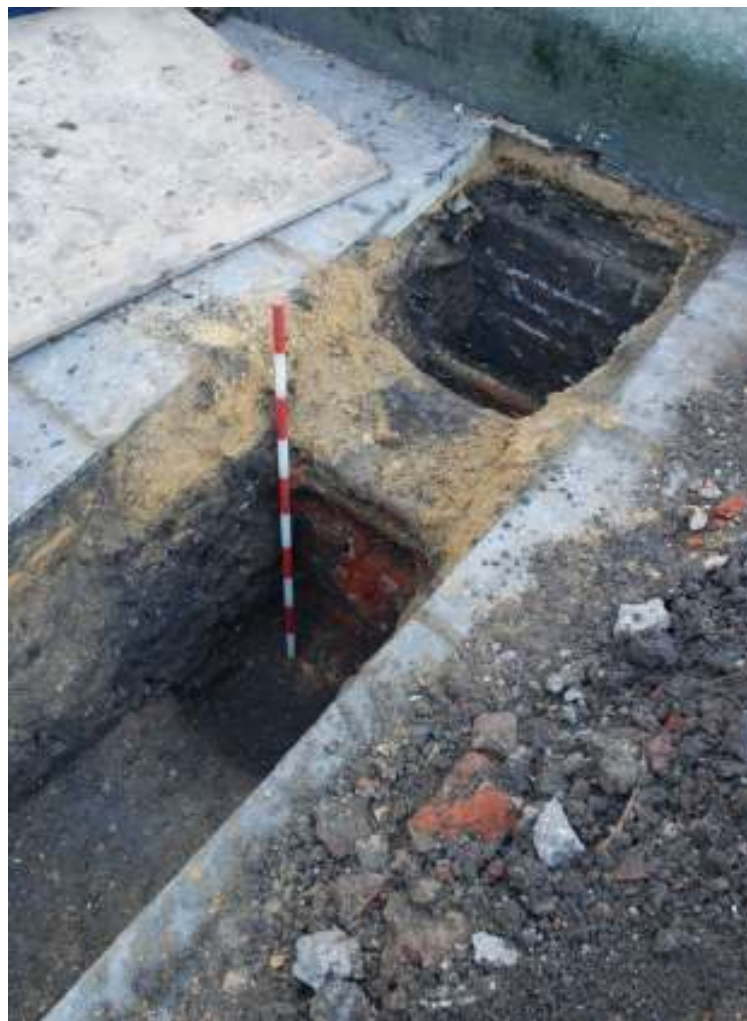
More interestingly was the presence of an earlier brick wall, present from 15.46mOD and 4.50m NW from the SE side of the pathway. The brickwork was aligned NE-SW at a right angle across the trench and was exposed to a depth of at least 14.86mOD, continuing below the base of excavation. This amounted to 7 course of brick, 600mm high, and approximately 450mm, (two stretcher bricks side by side), wide. The wall had been truncated in the upper half by services. No sign of the wall having been plastered was observed; the faces appear to have been bare, suggesting they were below ground, possibly internal walls. The wall's alignment would put it at right angles to those found in the roadway of Bishopsgate in 2006, and is probably part of an adjoining complex of buildings as depicted on earlier maps of the area, (see section 3, figs.5 and 6 and fig.29 below). Brick samples taken from the wall were dated to c.1450-1700AD, but with characteristics of an earlier rather than later date eg. 16th century as opposed to 17th or 18th century, (see Appendix III). It is possible that it survived as this part of the site was always intended to be laid to path and so it was not deemed necessary to fully remove the wall, whereas either side where the gardens were to be constructed required all masonry to be removed. This could explain why this was the only wall to be located when the frontage of Bishopsgate had been considerably built up in the past.

Fig.25: Early wall in Trench 13, facing ESE. (1m scale)

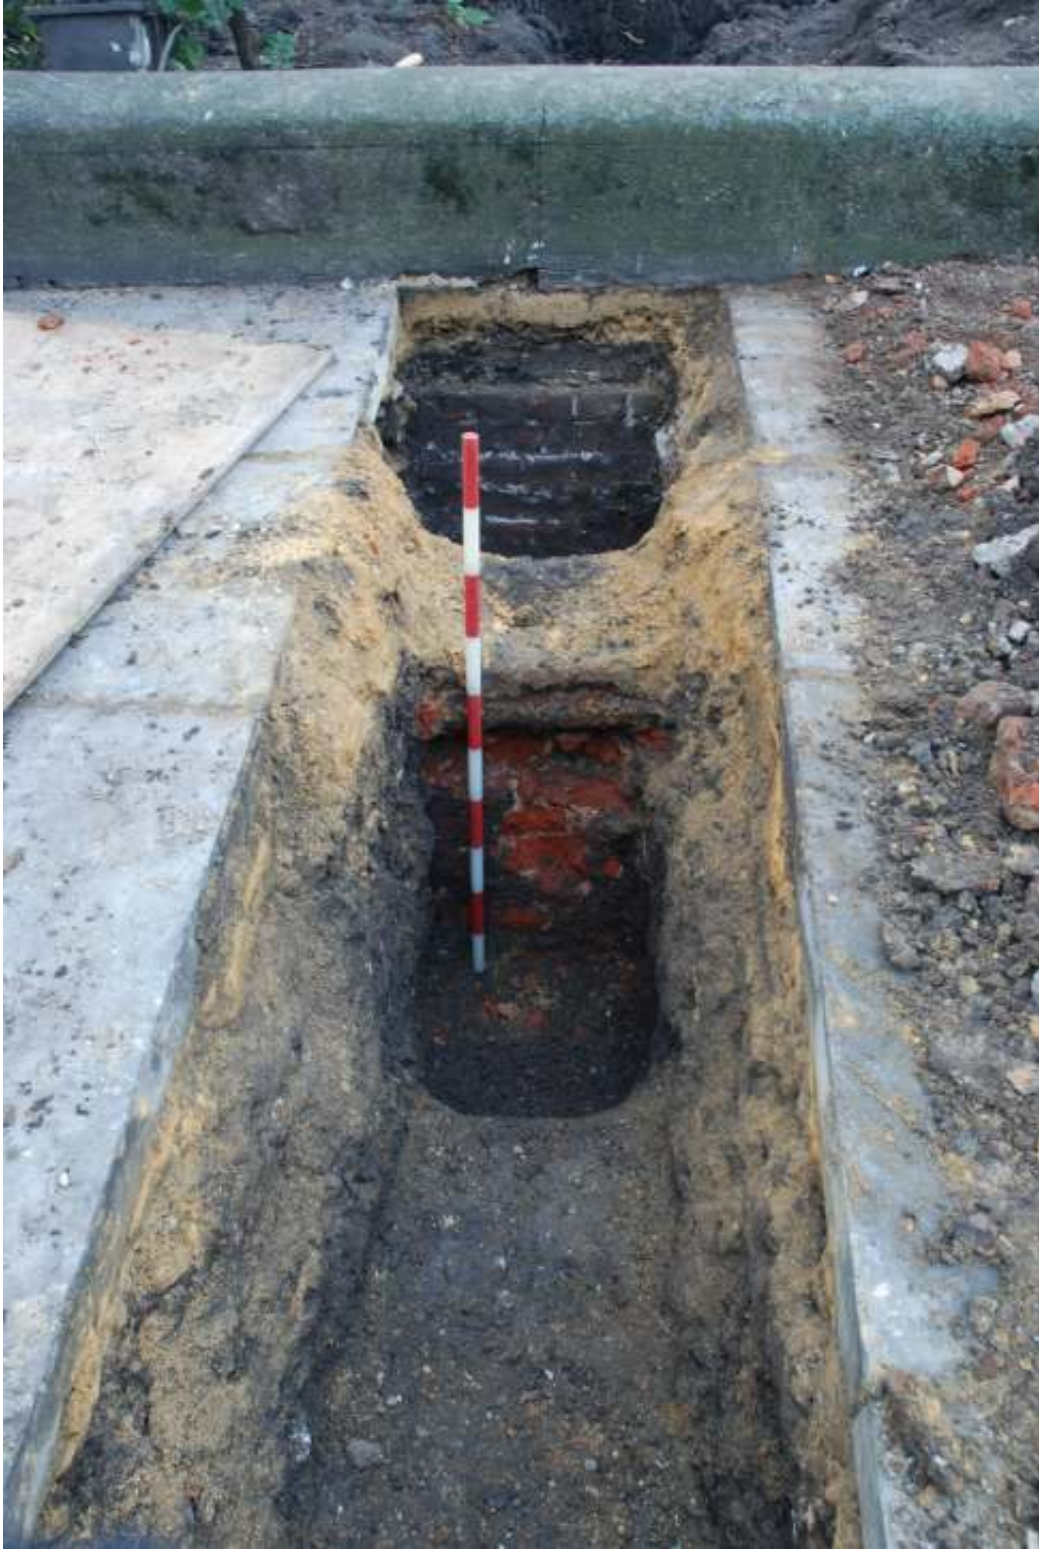
Fig.26: Earlier wall aligned NE-SW across trench 13, facing SE, (1m scale)

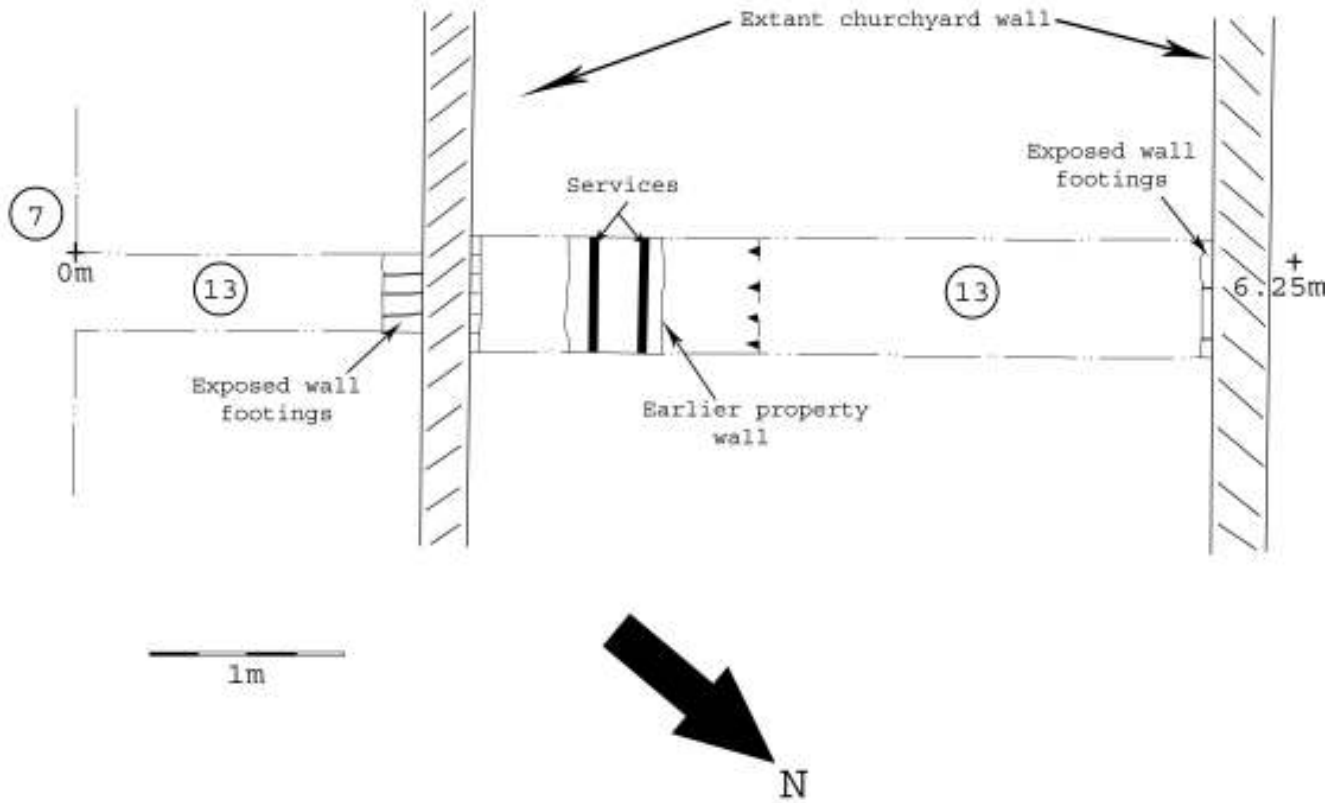
Fig.27: Plan of trench 13. 1:25 scale. See fig.11 for location of trench

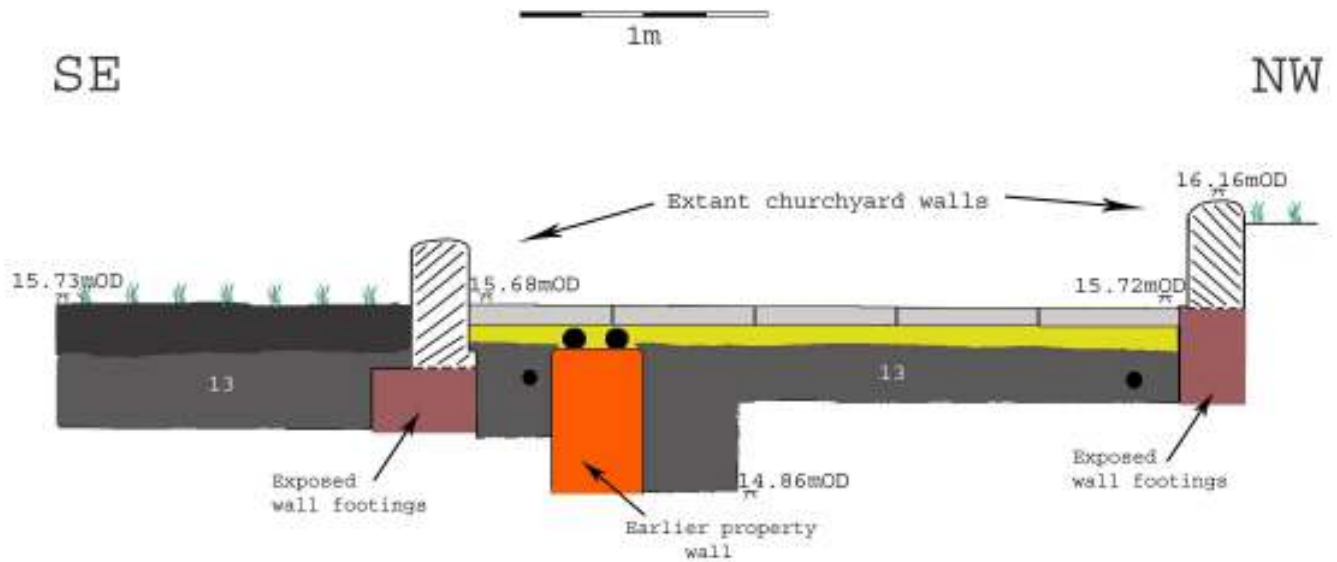
Fig.28: Section through trench 13. 1:25 scale. See fig.11 for location of trench

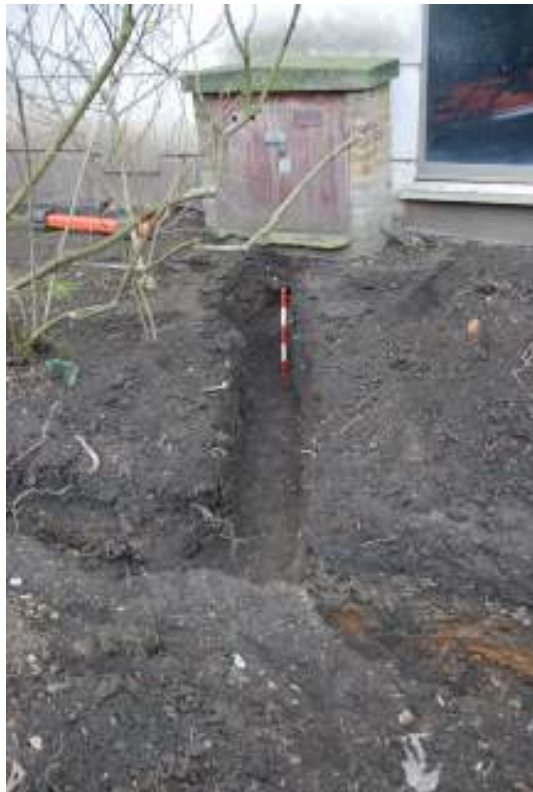
- 6.9 The penultimate visit took place on the 20th February and monitored a short length of open-cut trench connecting the electricity box to trench 4. The trench comprised dark-grey imported subsoil overlain by rich black loamy topsoil containing frequent rooty matter.

Fig.30: Trench from electricity box to trench 4. (0.5m scale)

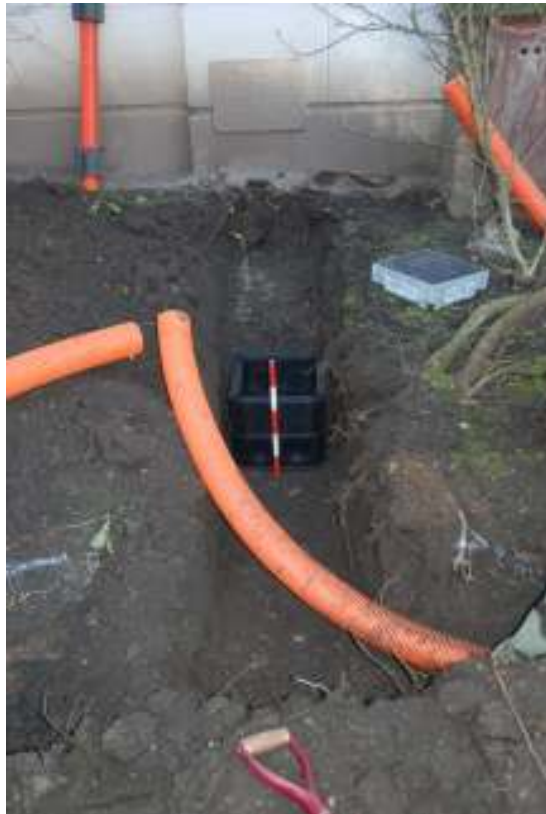
- 6.10** The final visit to site took place on the 12th March 2012 in order to observe the last electrical connection trenches being dug for lighting points. These were located on the south-eastern side of the site, around the building line, (see nos.15-17, Fig.11). The measured approximately 500mm deep, by 600mm wide and amounted to a total length of 10.5m of trenching. They revealed similar stratigraphy as observed elsewhere on the site and no archaeological deposits were encountered. The only observation was that the concrete footings for the adjacent building extended 1.4m out from the wall line.

Fig.31: *Trenching by electricity box on 12th March 2012, facing SE*

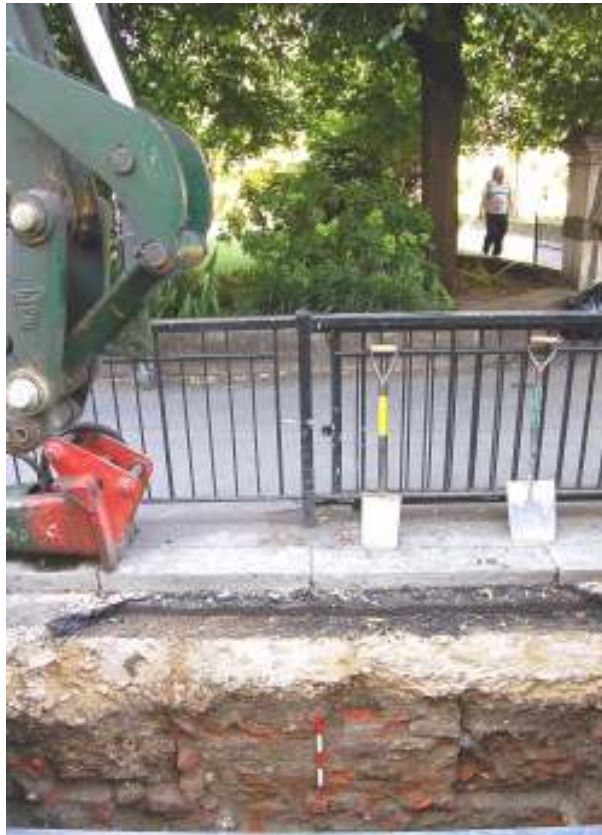
The fact that remains of former buildings have been found in trenching both here and along the kerbside outside the churchyard boundary by Compass Archaeology in 2006 points to the possibility of *in situ* remains surviving at a greater depth than that generally reached during this watching brief. Equally, the scarcity of even disarticulated human bone would suggest that graveyard / burial soils were either truncated by the mid 19th century landscaping or as with structural remains simply survive at a greater depth than that reached.

Fig.32: The wall recorded during Thames Water Replacement works outside St Botolphs Churchyard, 2006. Facing WNW
