# THAMES WATER, MAINS REPLACEMENT WORKS IN THE AREA OF HOLLAND PARK

(AMP5, District Metering Area Barrow Hill 14)

AN ARCHAEOLOGICAL WATCHING BRIEF

SITE CODE: TXG11

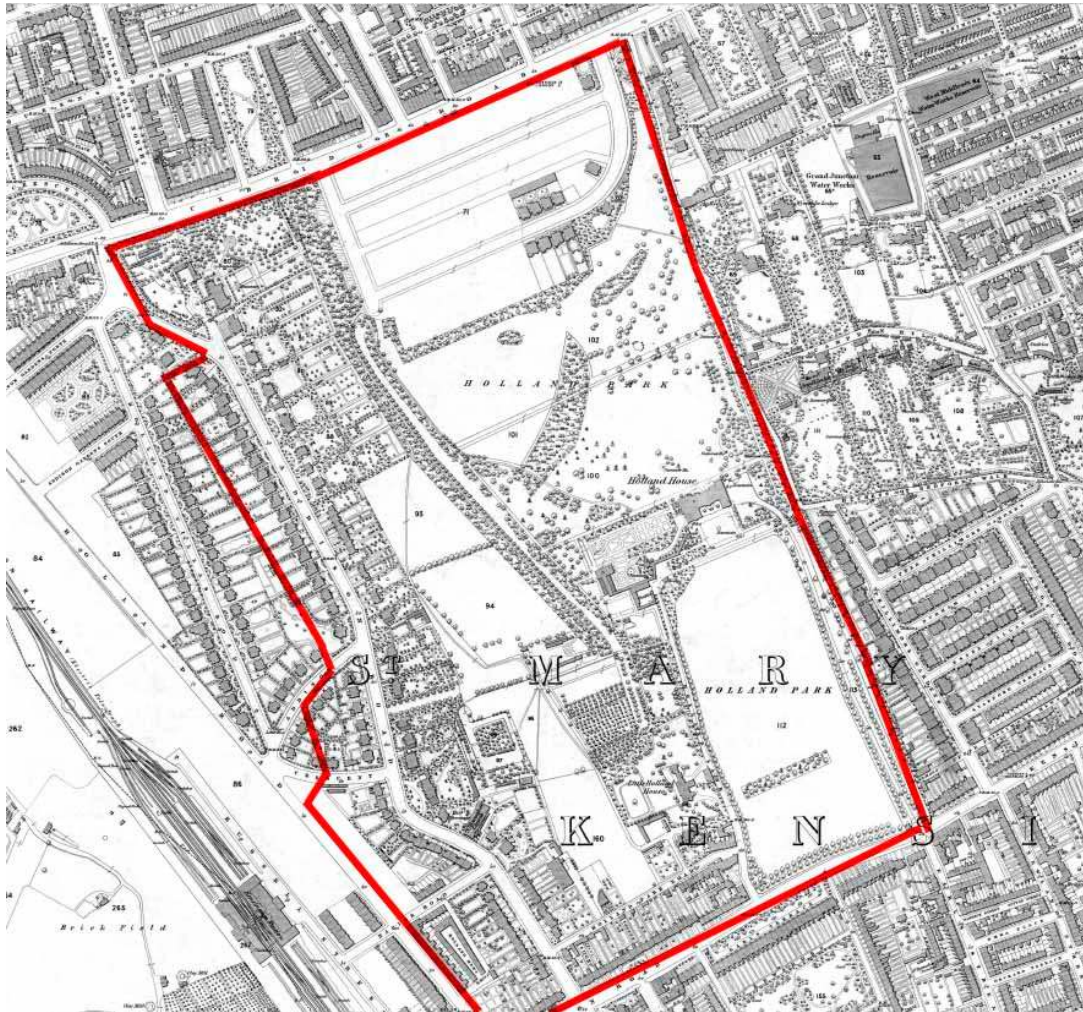
Fig.5: An extract from the 1<sup>st</sup> Edition OS Map, (c.1867) outlining the study area

The First Edition shows a broadly similar layout to the study area.

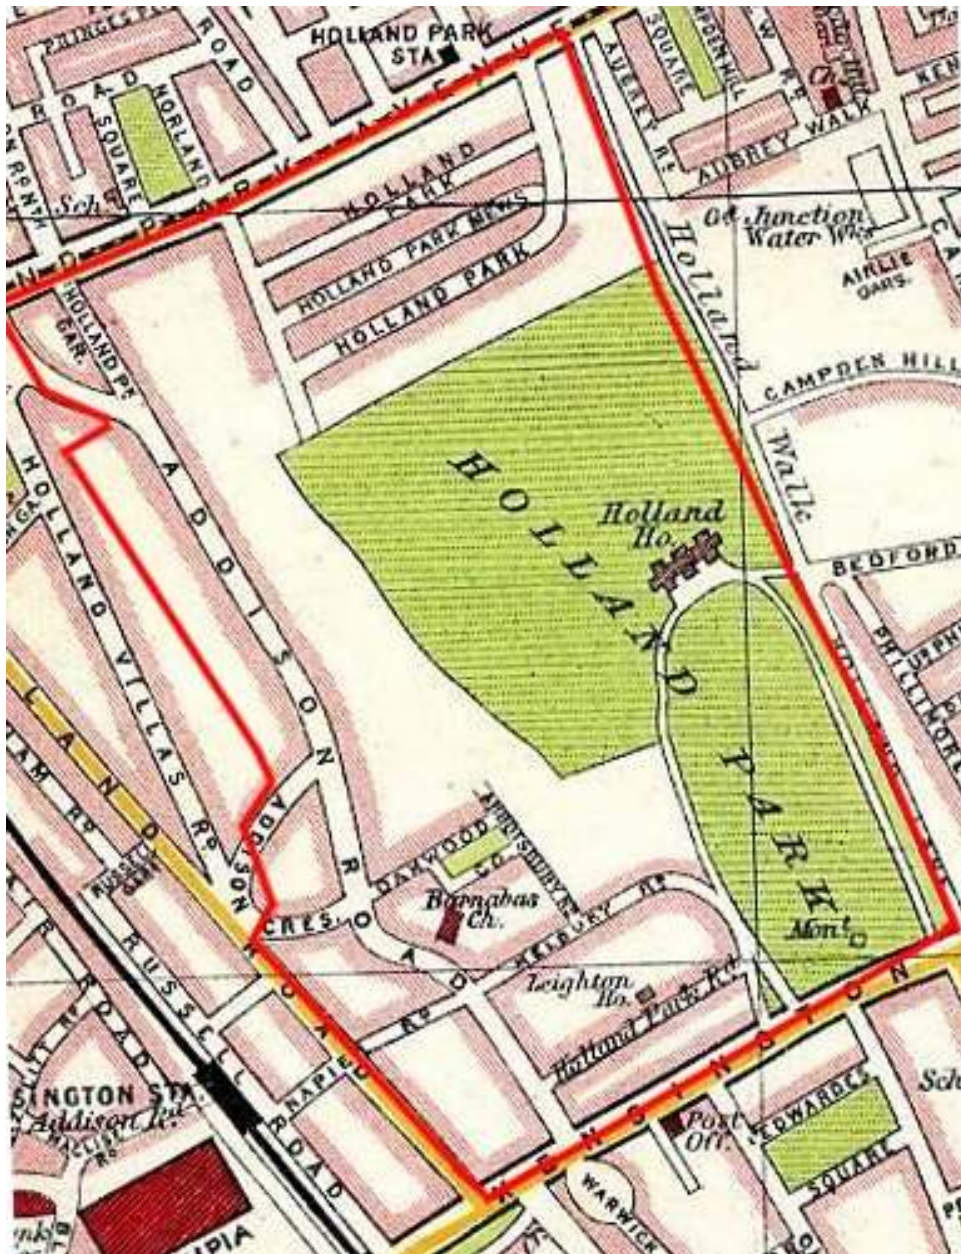
Fig.6: Extract from Bartholomew's 1908 London Atlas

Other than Abbotsbury Road, aligned along the western side of Holland Park, down the centre of the study area, the landscape remains largely unchanged from the layout of this map. The majority of Abbotsbury Road is 1950s in build and Woodford Square, (obviously not yet depicted, but located on the NW corner of the Park, east side of Addison Road), was constructed between 1968-70.

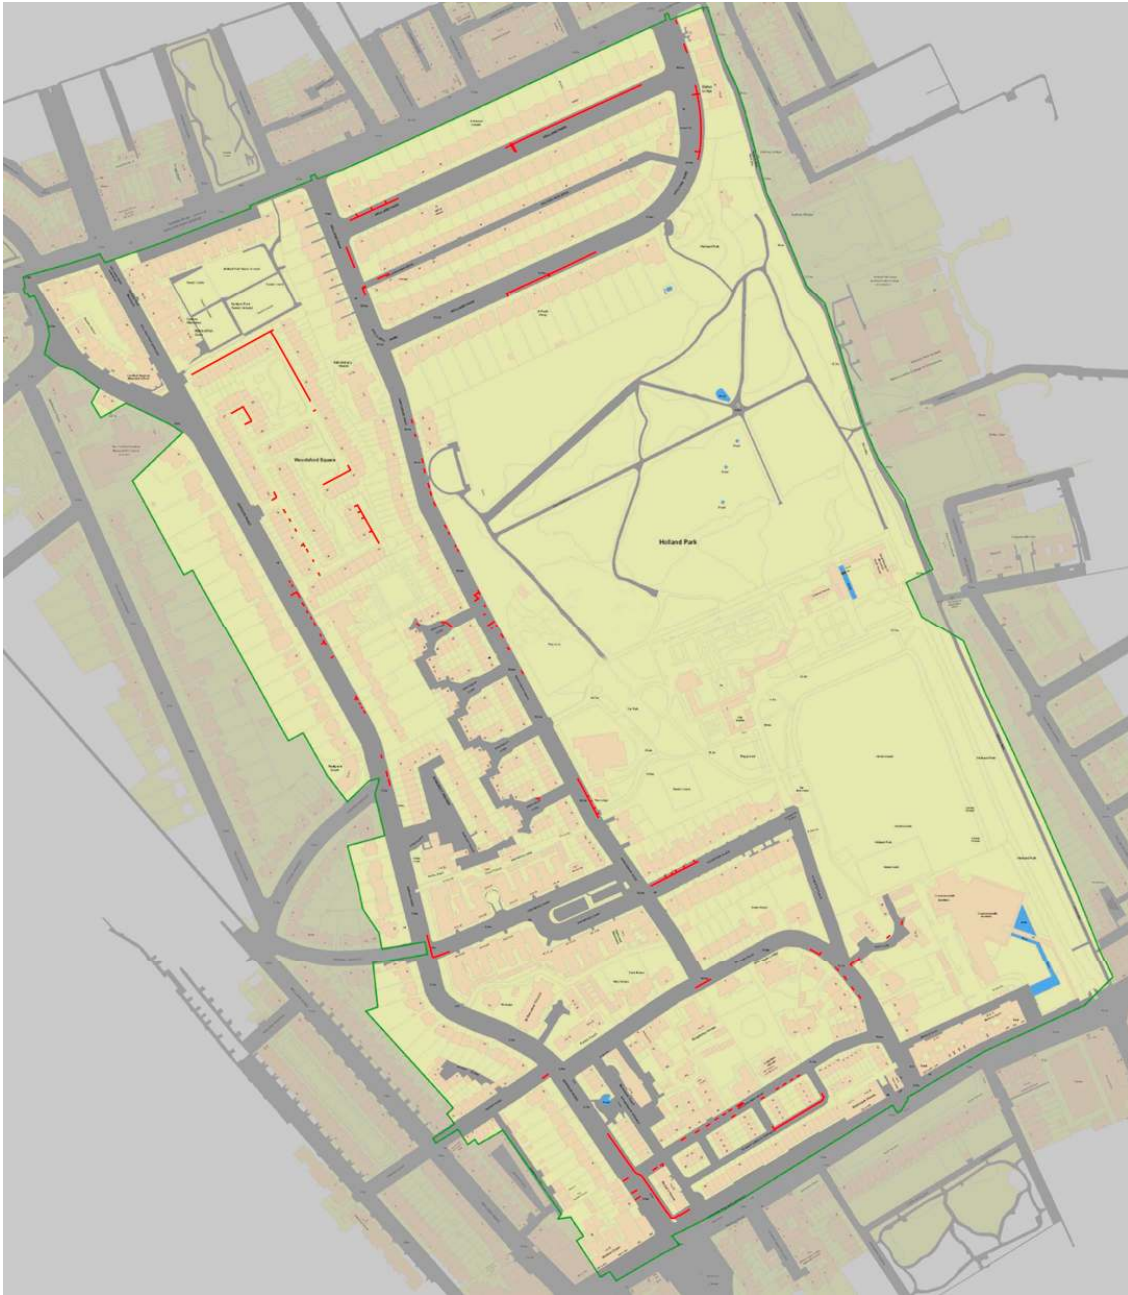
Fig.7: Map of groundworks observed during the Watching Brief. Trenches / pits in red  
*Adapted from map provided by Thames Water*

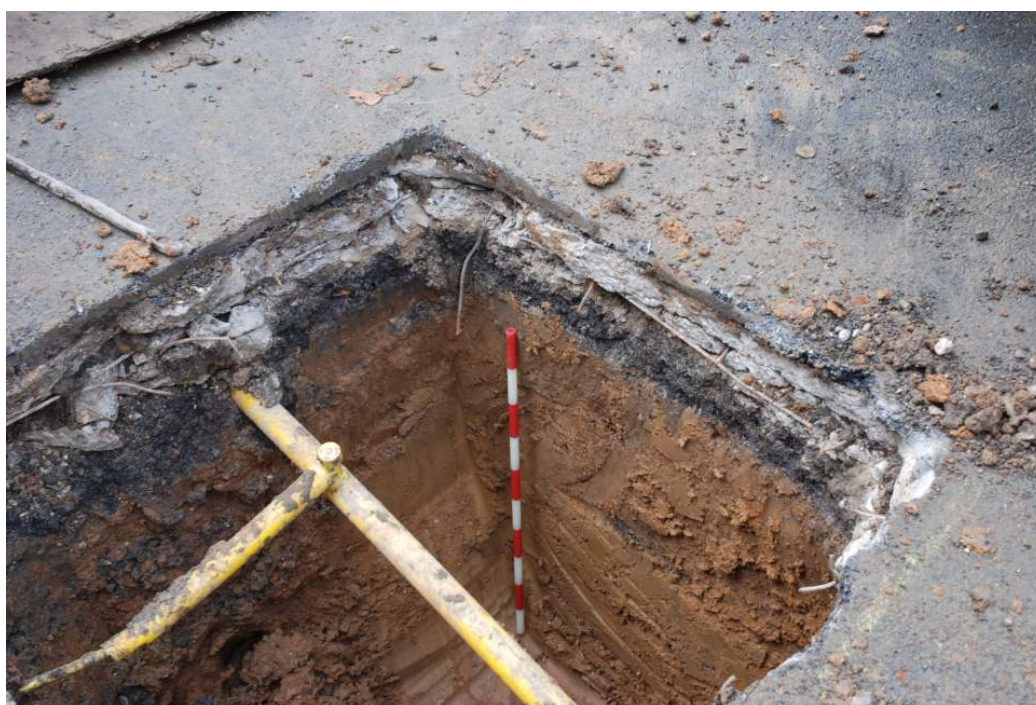
One small pit, directly outside No.19 Abbotsbury Close, was recorded. The modern road-surface (tarmac over reinforced concrete) was 0.25m thick, and overlay a thin (0.15m thick) black silty layer. This sealed the underlying natural, taking the form of clean and compact orange-brown silty-clay deposits, present from as little as 0.35m beneath the modern road-surface to the base of the pit and beyond.

Fig.8: *Natural ground exposed in pit on Abbotsbury Close. (1<sup>st</sup> November 2011)*

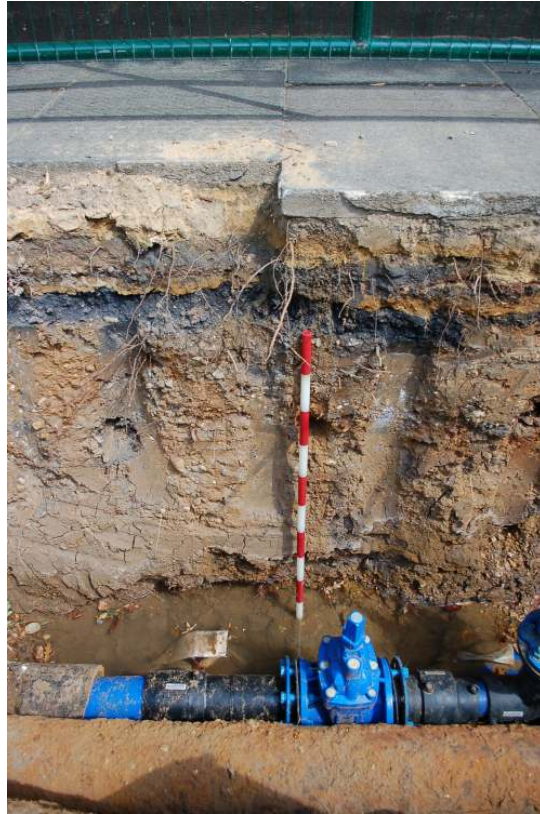
Nine pits, plus two small stretches of trenching, were observed on the eastern side of Abbotsbury Road (on the pavement), between Nos. 59 and 77. Paving slabs over an orange sand levelling deposit (0.14m thick) was observed overlying a possible buried soil (a mid-brown silty deposit with root matter and pebbles, c.0.2m thick), over the natural sterile brown clay (with occasional root disturbance, c.0.35m beneath the modern road-surface).

Fig.9: *Section through service pit, Abbotsbury Road, facing E. (9<sup>th</sup> August 2011)*

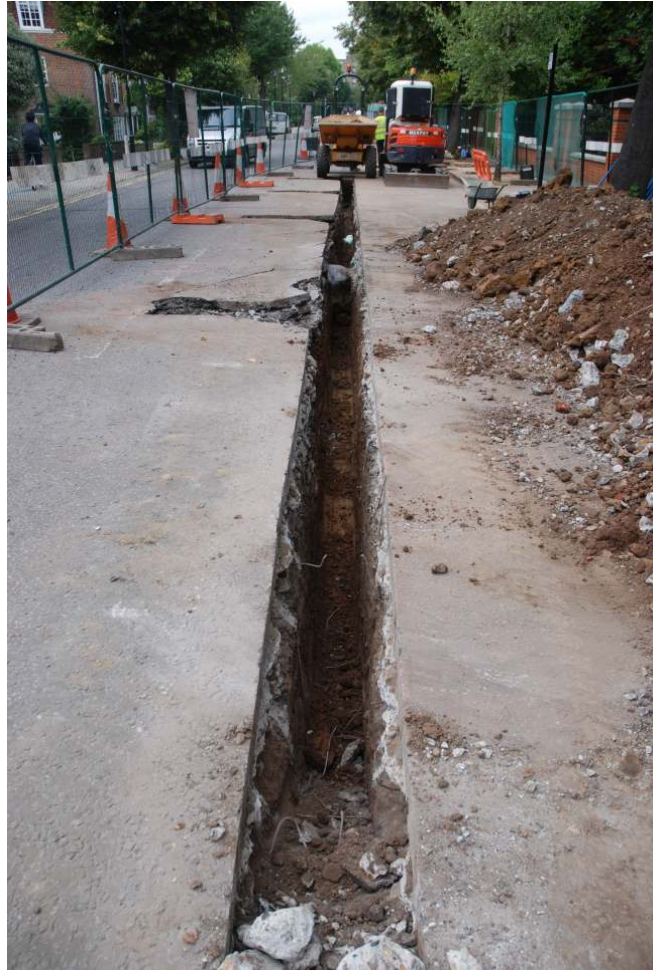
Another 28m of trenching was observed on the 31<sup>st</sup> August aligned north-south along the centre of Abbotsbury Road, between Nos. 17 and 23. The modern road-surface (tarmac over concrete, 0.4m thick), overlay dark brown silty-clay containing occasional ceramic building fragments and pebbles. This was probably an imported subsoil brought in to form part of the original road bed. At the southern end of the trench was a dump of red crushed brick fragments representing another made-ground deposit. This overlay the natural deposit, a sterile orange-brown silty-clay present from *c.*1m beneath the modern ground-surface. This crushed brick layer was observed in several locations across the study area and appears to have been deposited to form a levelling/build up layer and to form a consolidation layer over the natural clay.

Fig.10: *Abbotsbury Road, facing N. (31<sup>st</sup> August 2011)*

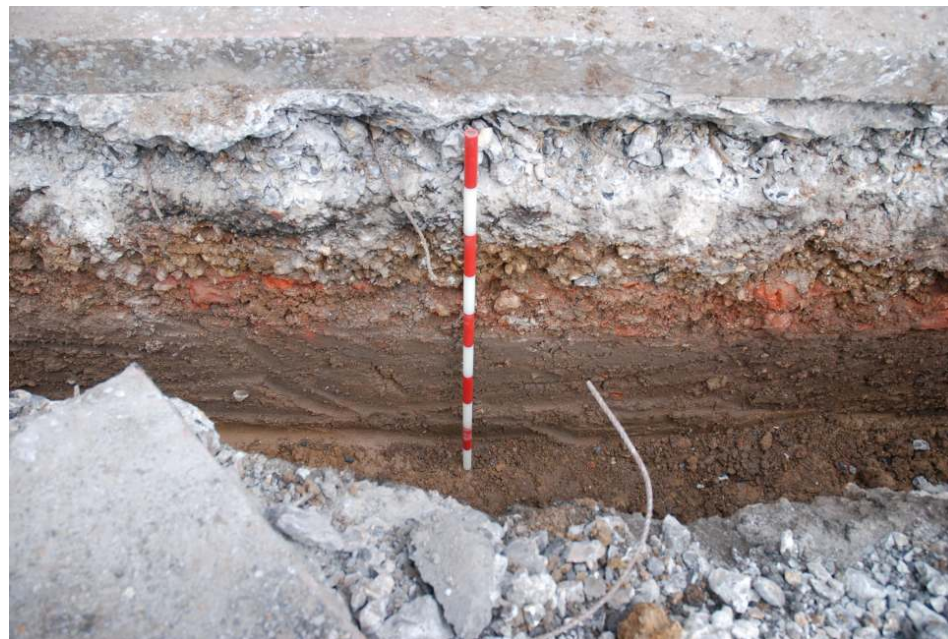
Fig.11: *Crushed brick layer overlying truncated natural within trenching, facing E. (31<sup>st</sup> August 2011)*

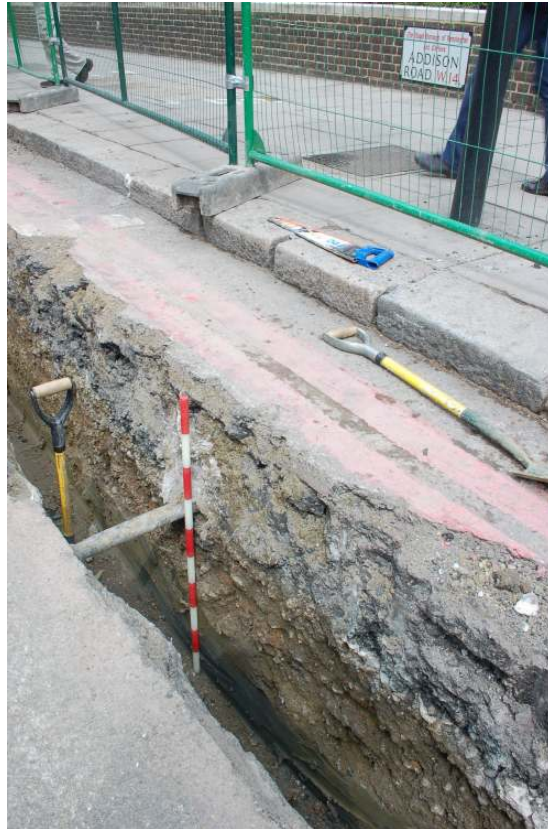
On the 5<sup>th</sup> June 2011 a small stretch of open-cut trenching on the corner of Addison Road and Kensington High Street was observed. The trench measured c.9m long by 0.5m wide and up to 1.06m in depth. Stratigraphy comprised the modern road-surface, (tarmac over road consolidation layers), overlying disturbed service backfills, over truncated natural deposits of compact blue-grey London Clay. These clays were present from 0.8m beneath the modern ground-surface to the base of the trench and continuing below.

*Fig.12: Trenching on the corner of Addison Road and Kensington High Street. Facing NNE. (5<sup>th</sup> June 2011)*

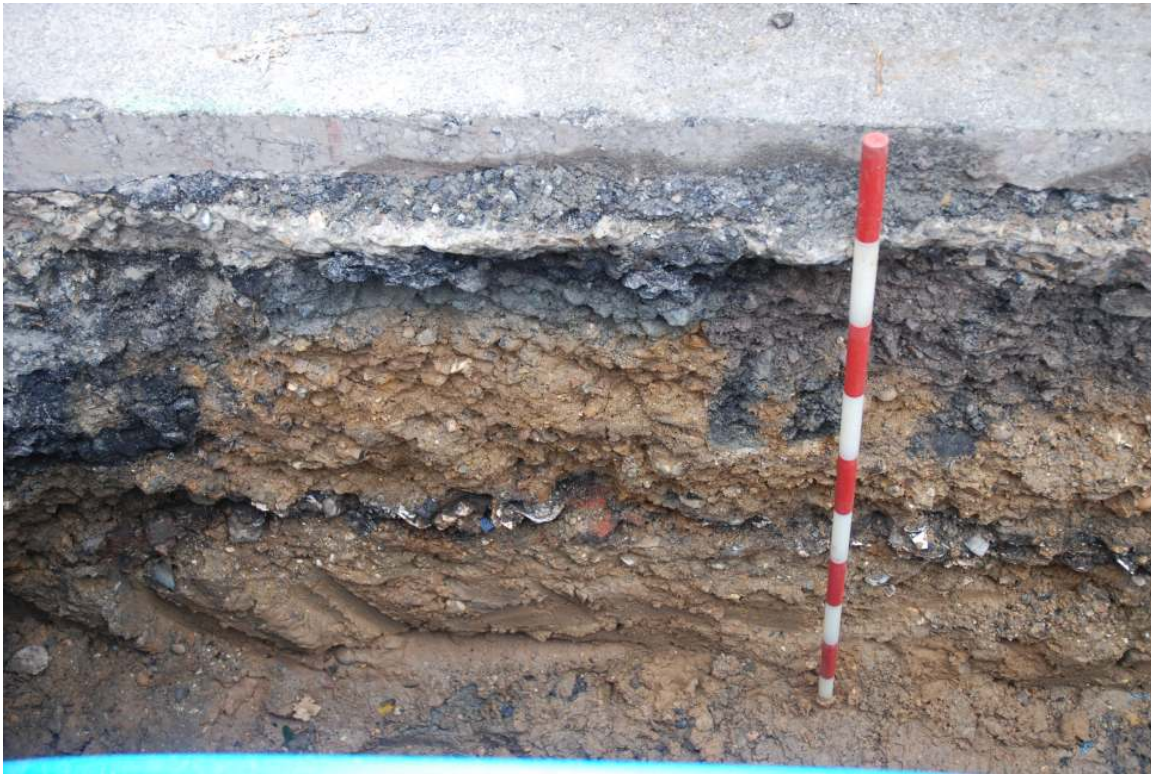
Three east-west sections of open-cut trenching (each about 6.5m long) were observed on the western side of Addison Road, at the southern end, between High Street Kensington and Holland Park Road. The road-surface (tarmac over concrete for 0.38m thick) overlay service backfills. In the centre of the road, a thin lens of dark grey clay-silt, containing early 19<sup>th</sup> century pottery (*cf.* Appendix III) and ceramic building material was observed. This overlay truncated natural comprising brown-yellow silty-clay deposits.

Fig.13: *N facing section through pit in Addison Road. Note grey silt lens containing pottery and CBM overlying truncated natural. (27<sup>th</sup> November 2011)*

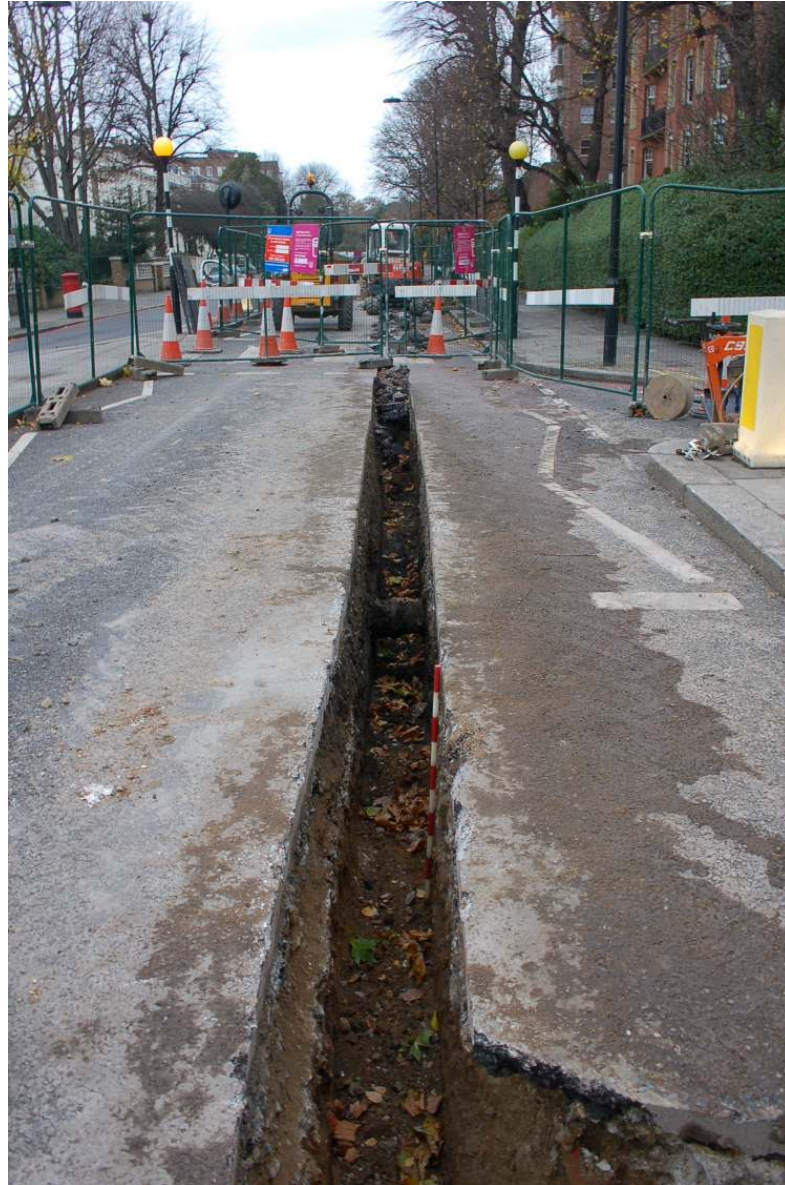
Another L-shaped trench, this time running north-south for 11m along the eastern side of Addison Road and then east-west for 14m into Oakwood Court, was monitored on the 29<sup>th</sup> November 2011. The road-surface (tarmac over bedding material) was observed overlying service backfill (gravel-rich silts and brown-grey clays) in the north-south section of trenching; and a crushed red brick deposit over natural sterile brown clay (from 0.5m beneath the modern ground-surface) in the east-west running section. A lens of dark-grey sandy-silt containing 19<sup>th</sup> century pottery, similar to that observed on the 27<sup>th</sup> November, was also present towards the southern end of the trench and samples of this were retained for dating purposes, (*cf.* appendix III).

Fig.14: *Addison Road facing N from junction with Oakwood Court.* (29<sup>th</sup> November 2011)

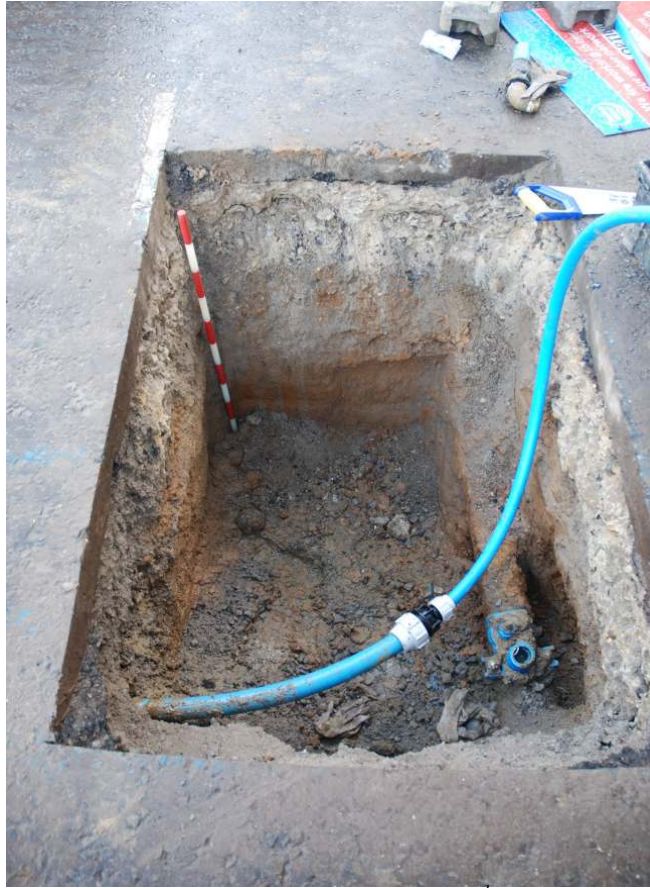
Fig.15: Pit opened on Addison Road 2<sup>nd</sup> February 2012, facing N

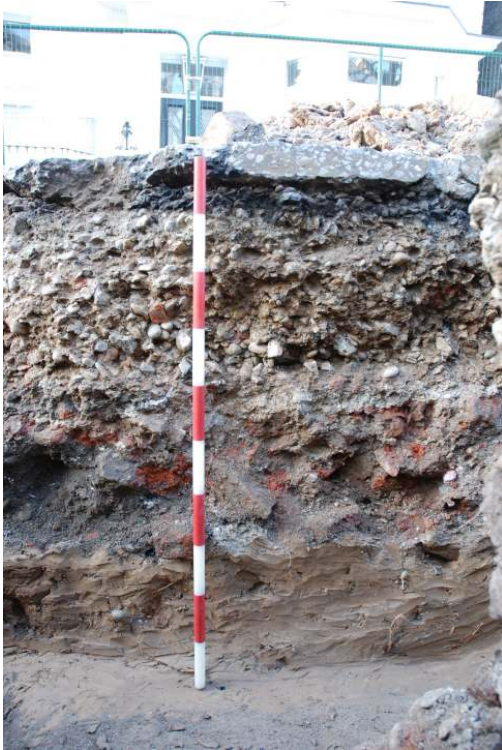
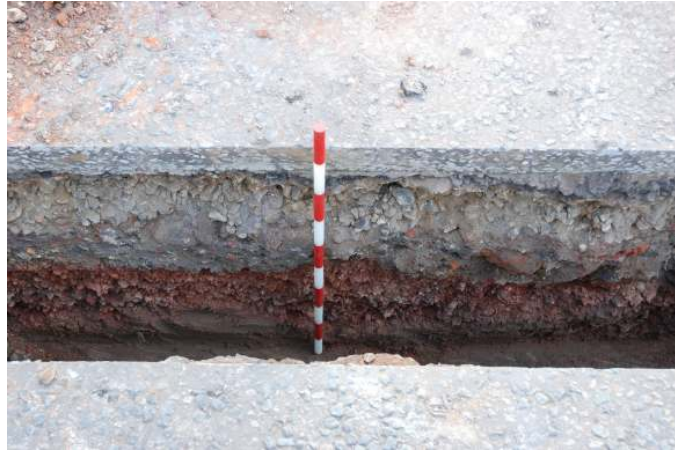
Similar stratigraphy was observed in lengths of trenching excavated between the 2<sup>nd</sup> and 14<sup>th</sup> of March as far as No.74 Holland Park Road. On each occasion the exposed stratigraphy was similar in that the existing tarmac road surface overlay previous road make-up layers containing either large quantities of crushed brick and mortar, or large worn pebbles within a sandy silt matrix. These dumps truncated the upper levels of the natural ground which were exposed at 0.8m below the current ground surface to the base of the trench and beyond.

Fig.16: Sections through trenching on 8<sup>th</sup>, (left), and 14<sup>th</sup>, (right), March 2011 both facing N

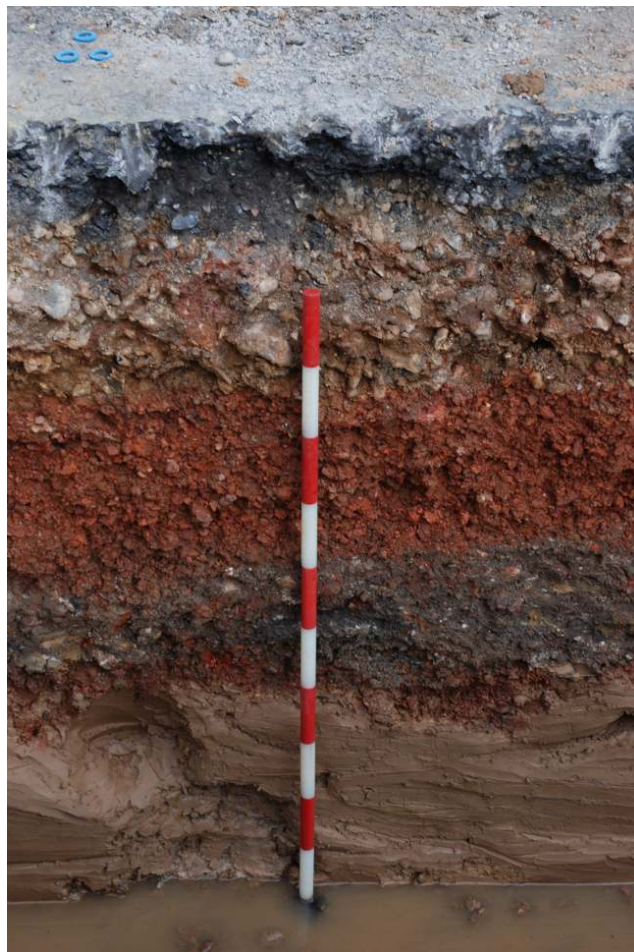
A short stretch of trench 5m long by 1.2m wide and up to 1.4m deep was observed on the 22<sup>nd</sup> March 2011 and revealed similar stratigraphy of tarmac overlying made ground deposits, sealing natural clays. This was also true on the 30<sup>th</sup> March when a 50m long stretch of trench was dug along the far eastern curve of Holland Park.

These observations regarding the underlying stratigraphy were repeated along Holland Park during numerous visits between 6<sup>th</sup> April and the 17<sup>th</sup> June all of which produced generally the same results. In all, a total of approximately 260m of trenching and pits were observed on the roads making up Holland Park and no deposits of particular archaeological significance were observed. It was shown that the natural geology had been truncated in its uppermost regions and the ground subsequently raised in a series of deliberate dumping episodes to create the road surface that is evident today.

*Fig.18: Section through eastern end of trenching along Holland Park on 22<sup>nd</sup> March 2011. Note the sharp contacts between each made ground layer suggesting deliberate truncation of the previous layer each time before laying down the next. Facing N*

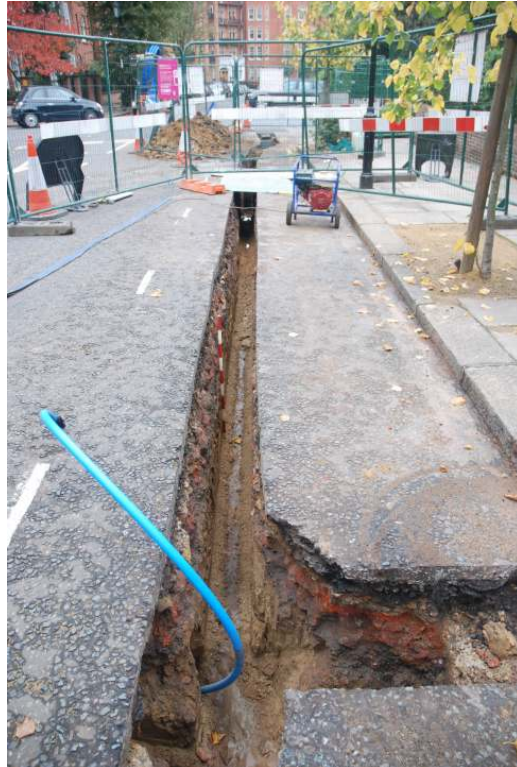
49m of trenching was observed along the northern side of Ilchester Place, running east from the junction with Abbotsbury Road. The modern road-surface (tarmac over tar base) overlay a layer of crushed and broken red / yellow stock bricks, *c.*0.32m thick, directly overlying 0.1m of black silt pea-gravel, and presumably representing a previous levelling surface. This overlay the natural sterile yellow-brown clay, *c.*0.56m beneath the modern road-surface.

Fig.19: *Ilchester Place, open-cut trench facing WSW*  
(27<sup>th</sup> September 2011)

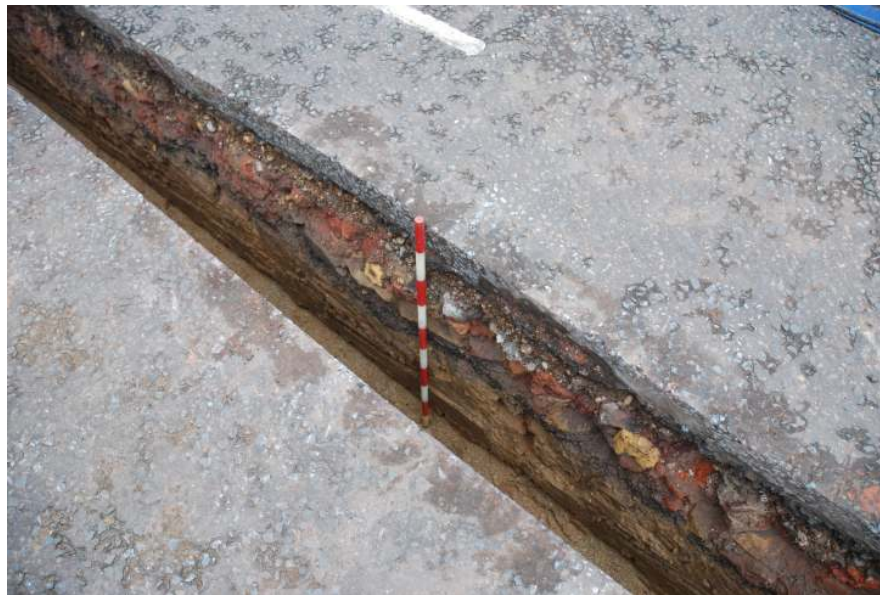
Fig.20: *Oblique shot of section through trenching on Ilchester Place. The crushed brick levelling layer is clearly visible below the current road surface Facing E. (27<sup>th</sup> September 2011)*

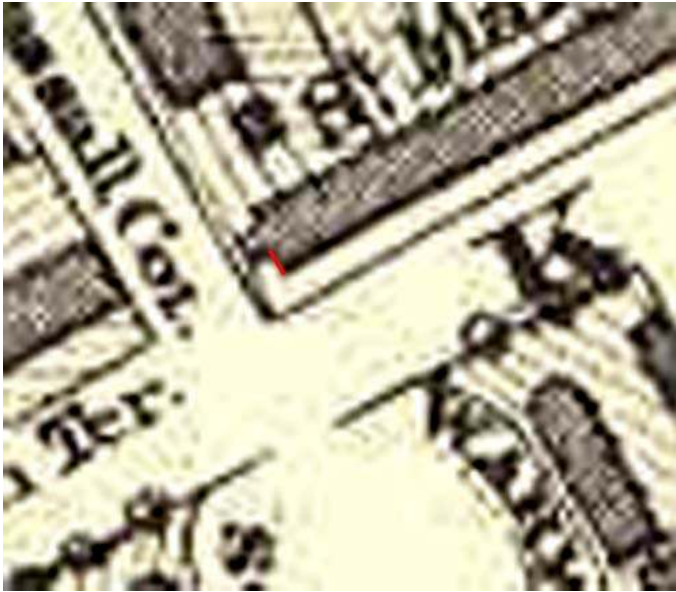
Fig.21: Detail from Stanford's map of 1862. Is the highlighted wall the same as found within trenching on the 5<sup>th</sup> June 2011

On the 5<sup>th</sup> of June 15m of trenching was observed on the northern side of Kensington High Street, from the end of the trench observed on Addison Road, to the end of the trench observed on the 20<sup>th</sup> April. In this section of trenching, a short length of red brick wall bonded with a lime mortar was recorded running north-south across the trench for a distance of 0.5m. This wall was 0.6m in width, and its top was 0.44m beneath the modern ground-surface, continuing for at least six courses, down to 0.9m beneath modern ground-surface and beyond. It was located on the line of the garden walls fronting Addison Road, and was therefore presumably once an extension of one of these garden walls, (*cf.* fig.23 below). This can therefore be used as evidence to illustrate how Kensington High Street must have been widened in this area. Different deposits were observed either side of the exposed wall – to the east of the wall were cess and clayey-silt fills in a fine silt matrix, (presumably disturbed / degraded garden deposits); to the west, fine rubbly silt. This stretched down to approximately 0.8m beneath the modern ground-surface, beneath which was the natural clay.

The brick samples from this wall, (*cf.* appendix IV), were identified as London Fabric Series type [3047] brick, and was dated to the period 1700-1900AD.

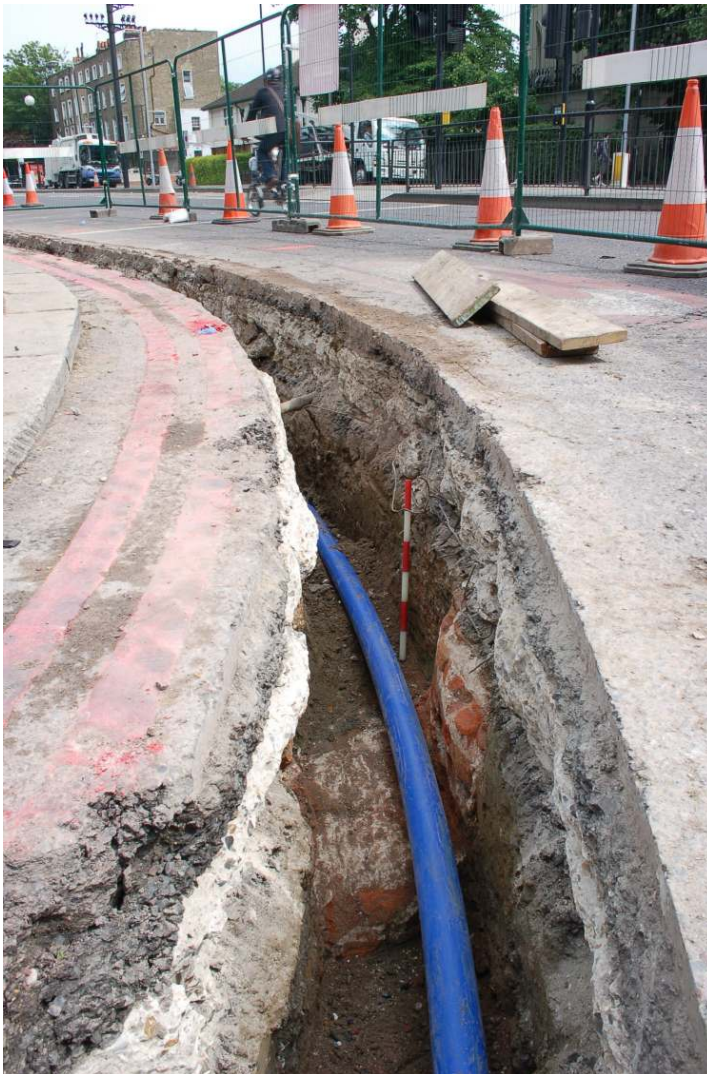
Fig.22: Wall exposed in trenching on Kensington High Street. Facing E, (5<sup>th</sup> June 2011)

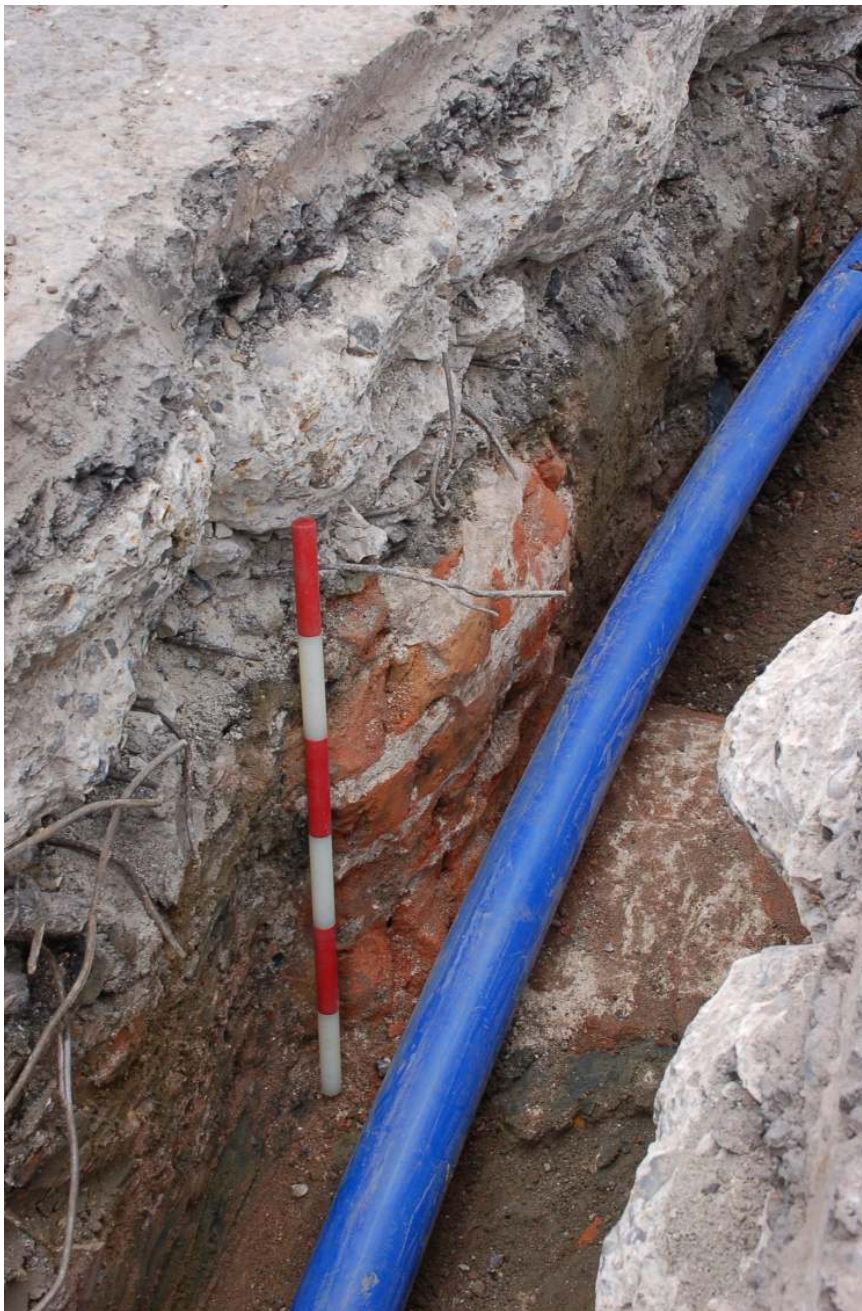
Fig.23: *Brick wall exposed on 5<sup>th</sup> June 2011. Facing NE*

On the 5<sup>th</sup> June 2011 a chunk of masonry, composed of a brick, half brick and fragment, bonded with lime mortar was taken as a sample from a section of wall found in trenching on Kensington High Street. The sample weighed 4400g and the most complete sample of brick measured 200mm+ long and was 105mm broad and 67mm deep. The brick conformed to London fabric Series type 3047, was made from fine moulding sand and was notable for its sharp arrises and finely creased stretcher faces. The sample can be dated to c.1700-1900AD. The brick and mortar samples were not retained.

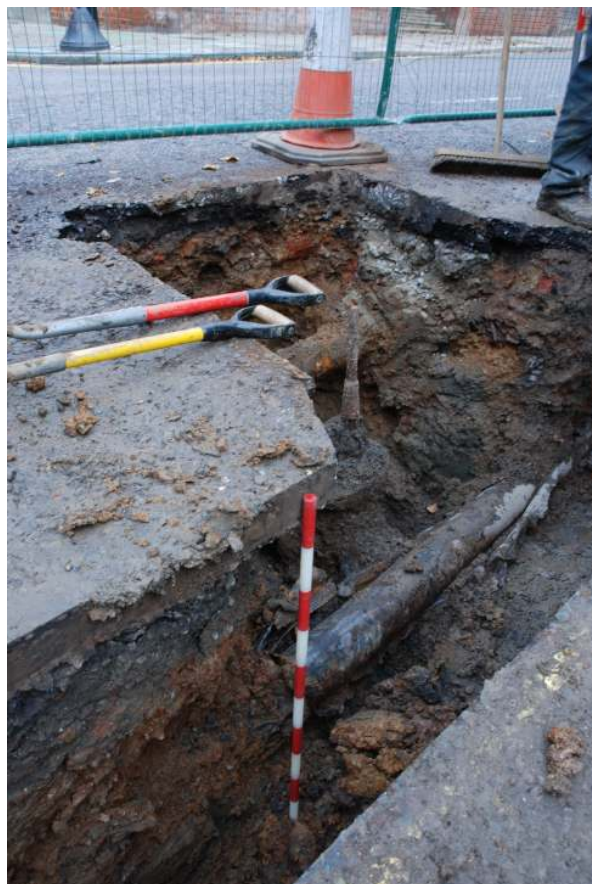
A 10m stretch of trenching was observed on the southern side of Melbury Road, opposite the junction with Abbotsbury Road. A modern road-surface (tarmac over a mixed gravelly road-base) was observed over heavily disturbed loose, orange-brown, silty-clay; disturbed by the large watermain plus several other services running across the trench.

Fig.24: Trenching on Melbury Place, facing NE. (1<sup>st</sup> November 2011)

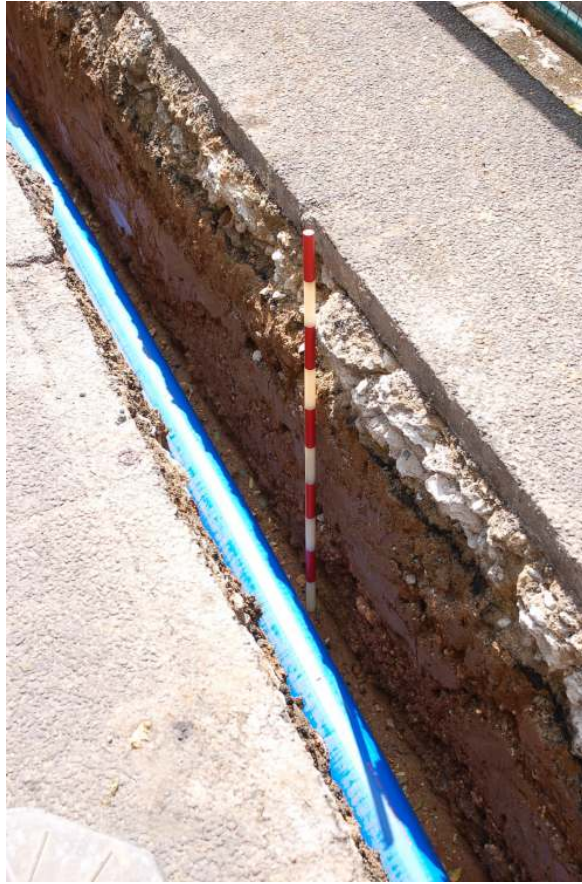
The final visit to Woodsford Square investigated 52.5m of open-cut trenching running north-south along the western side of Woodsford Square, between Nos.68 – 73. The modern road-surface (tarmac over concrete and a sandy levelling deposit, 0.3m thick) directly overlay the natural light-brown clayey-silt (from 0.3m beneath the modern ground-surface), totally sterile in content.

Fig.25: Trenching in Woodsford Square, facing E (9<sup>th</sup> August 2011)
