172 – 174 BALHAM HIGH ROAD
BALHAM
SW12 9BW

LONDON BOROUGH OF WANDSWORTH
ARCHAEOLOGICAL TRIAL TRENCHING

ARCHAEOLOGICAL TRIAL TRENCHING

SITE CODE: BMH12

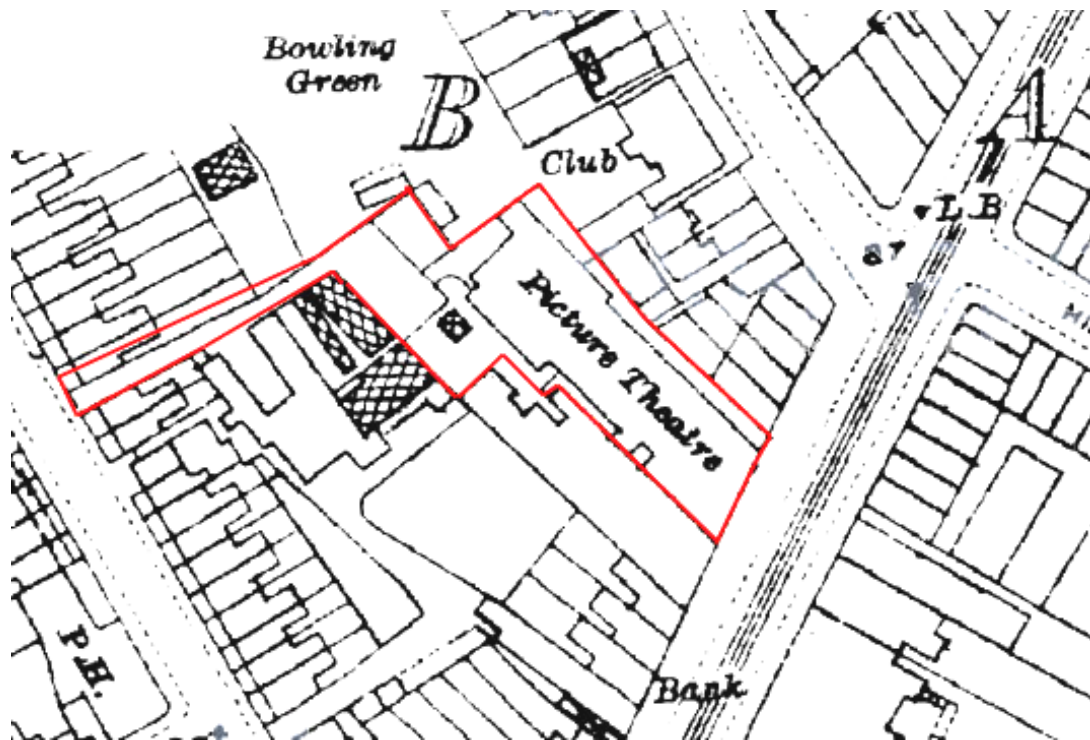
Fig. 7: 1916 OS Map, depicting the 'Picture Theatre', with site outline marked.

In 1911 the Balham Cinematograph Theatre (Cinema) was built on the site (see fig. 7 and 8). It was the fifteenth cinema to open in the chain of Amalgamated Cinematograph Theatres founded by Montagu A. Pyke. It was re-named ‘Picture House’ in 1916 and was operated by Messrs. Norris Ltd, until it was taken over by the Associated British Cinemas in 1933. A new frontage was added in 1953 and the cinema was re-opened as the Ritz Cinema. It was then closed in 1965, and the building taken over by the Bingo and Social Club, until the building was eventually destroyed in 1985.

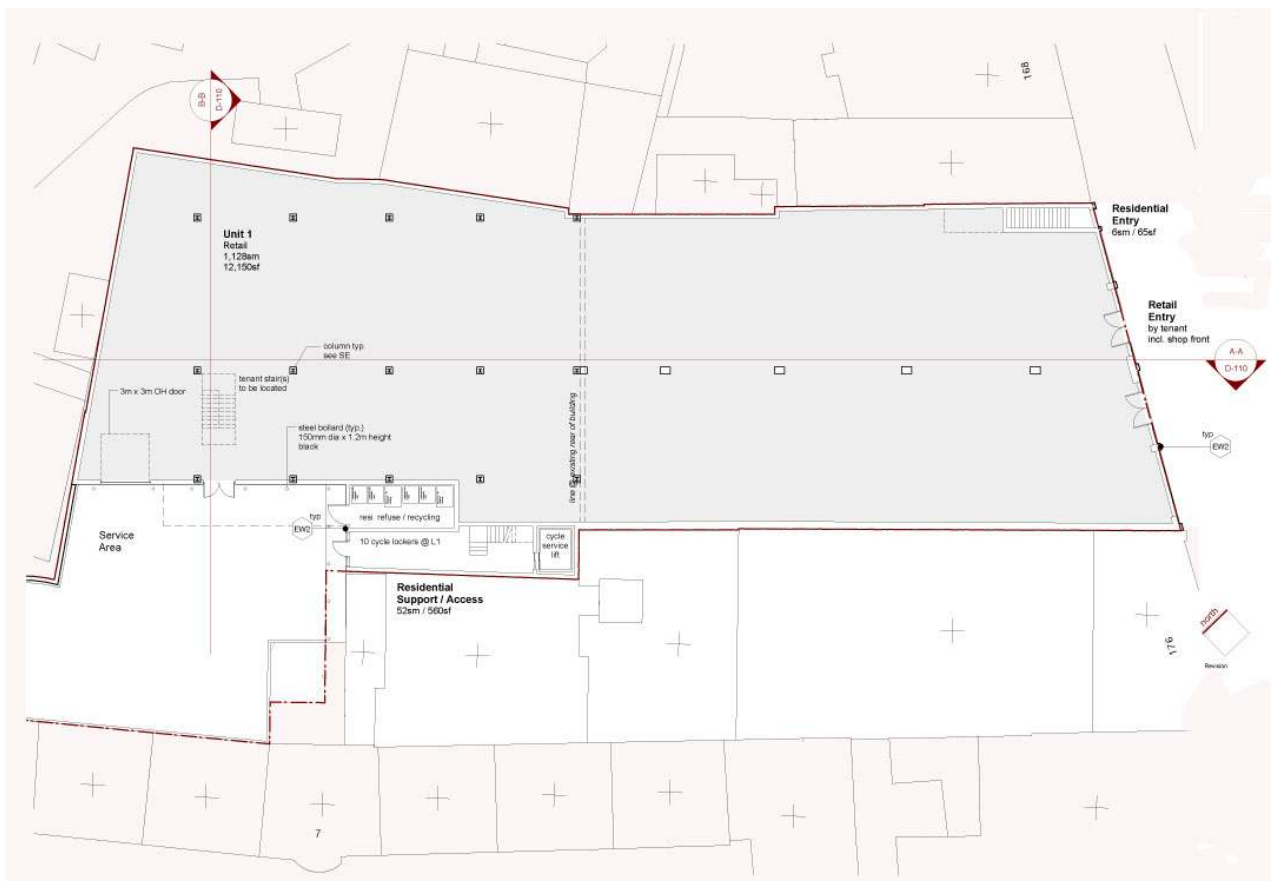
Fig. 9: Proposed ground-floor plan.

The proposed development involves the construction of a four-storey building fronting Balham High Road (utilizing the frame and slab of the existing structure), with a new two-storey addition at the rear, providing retail and residential space (London Borough of Wandsworth Planning Application No: 2011/0289). The footprint of this development measures approximately 20m (north-south) by 60m (east-west) – the present building (where no groundworks will take place) measures c.35m (east-west) X 20m (north-south); with the area of the rear extension (where development groundworks are located) measuring approximately 26m (east-west) X 16 - 20m (north-south). The development footprint (where groundworks are located) is therefore c.470m².

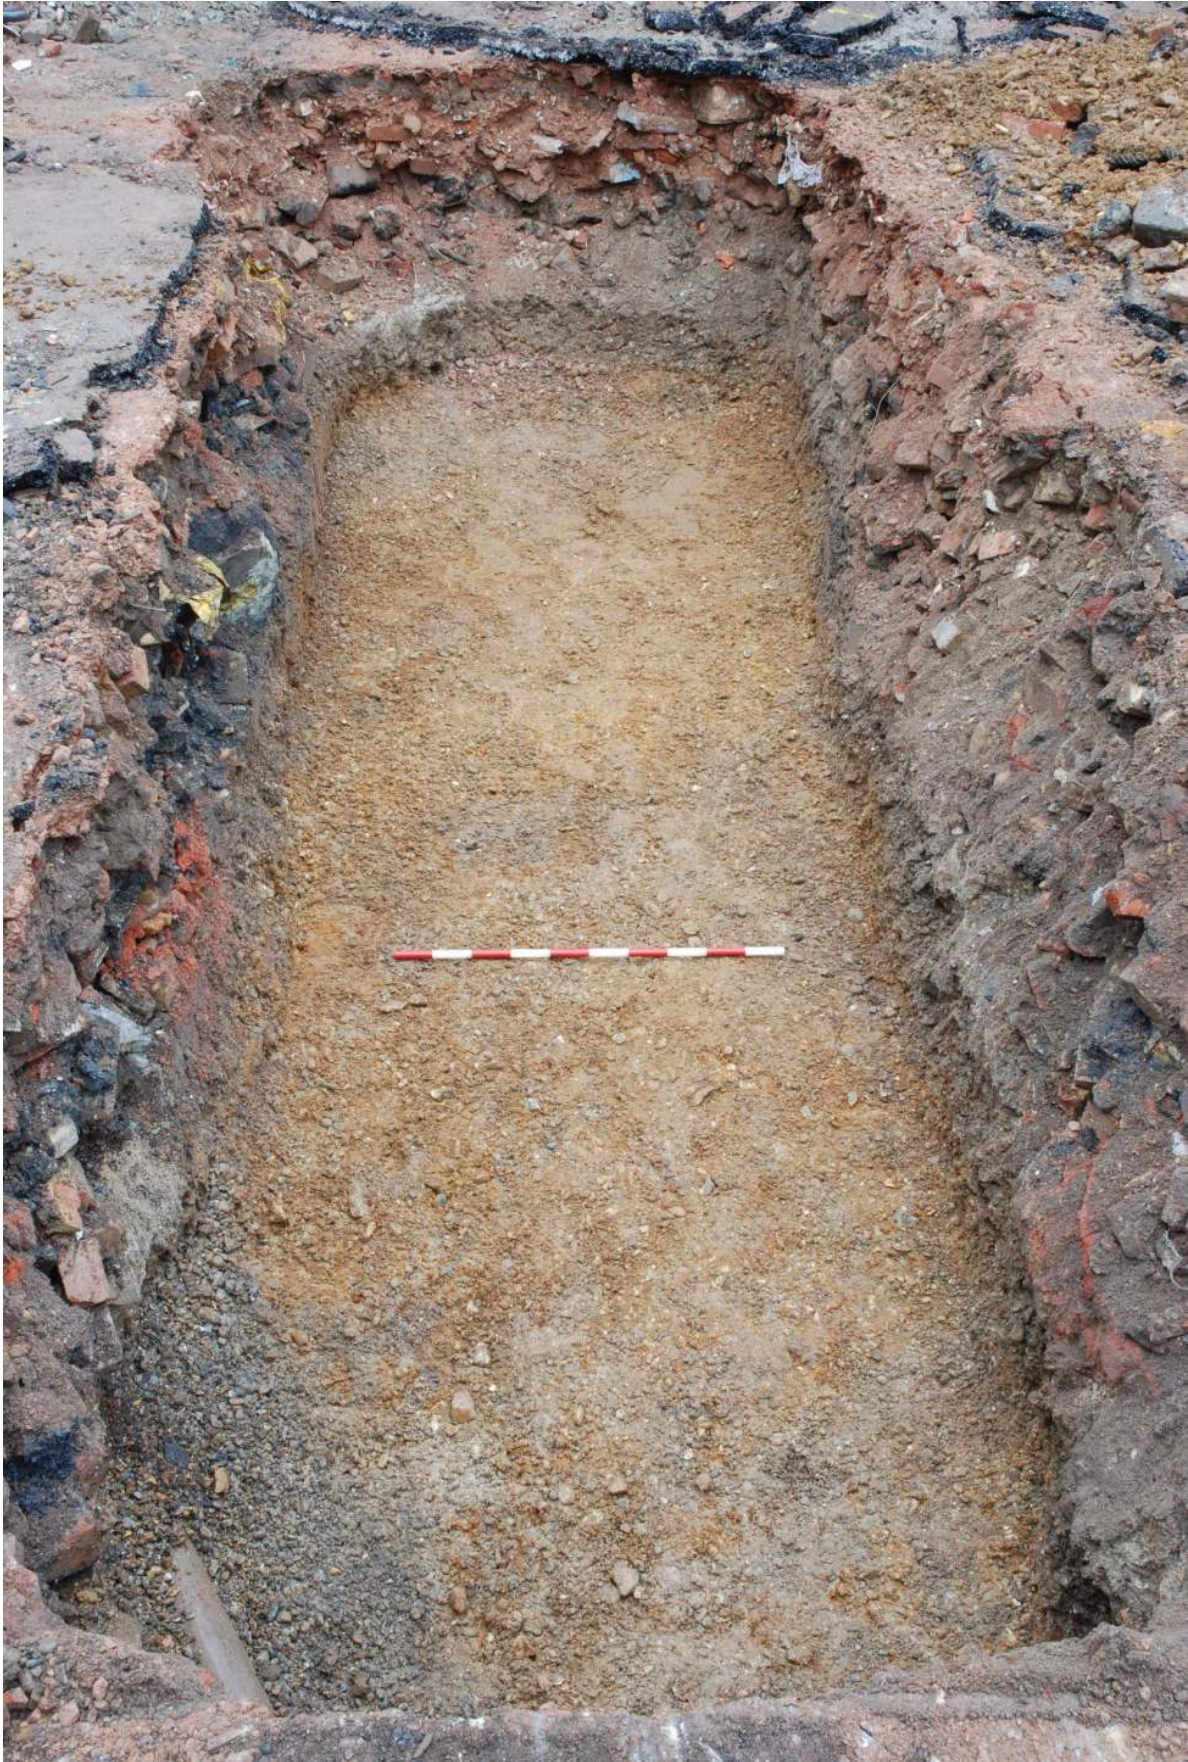
6.3.2 Above the natural gravel deposit, over the whole of the trench, was a thin grey-brown silty-sand layer (2). This was encountered at *c.* 25.3mOD (*c.* 0.95m beneath the modern ground-surface), for a thickness of *c.* 0.2m. At this level, in the northeast corner of trench 1, part of a concrete slab was observed (thickness of 0.1m, overlying *c.* 0.1m of the thin grey silty-sand deposit). It is therefore believed that a concrete slab was once positioned at this level across the whole area of the trench. This was probably the base of the cinema (constructed in 1911).

Fig. 12: Photograph of trench 1, looking east. The remains of part of the concrete slab, thought to form the base of the cinema, can be seen in the top left of frame.

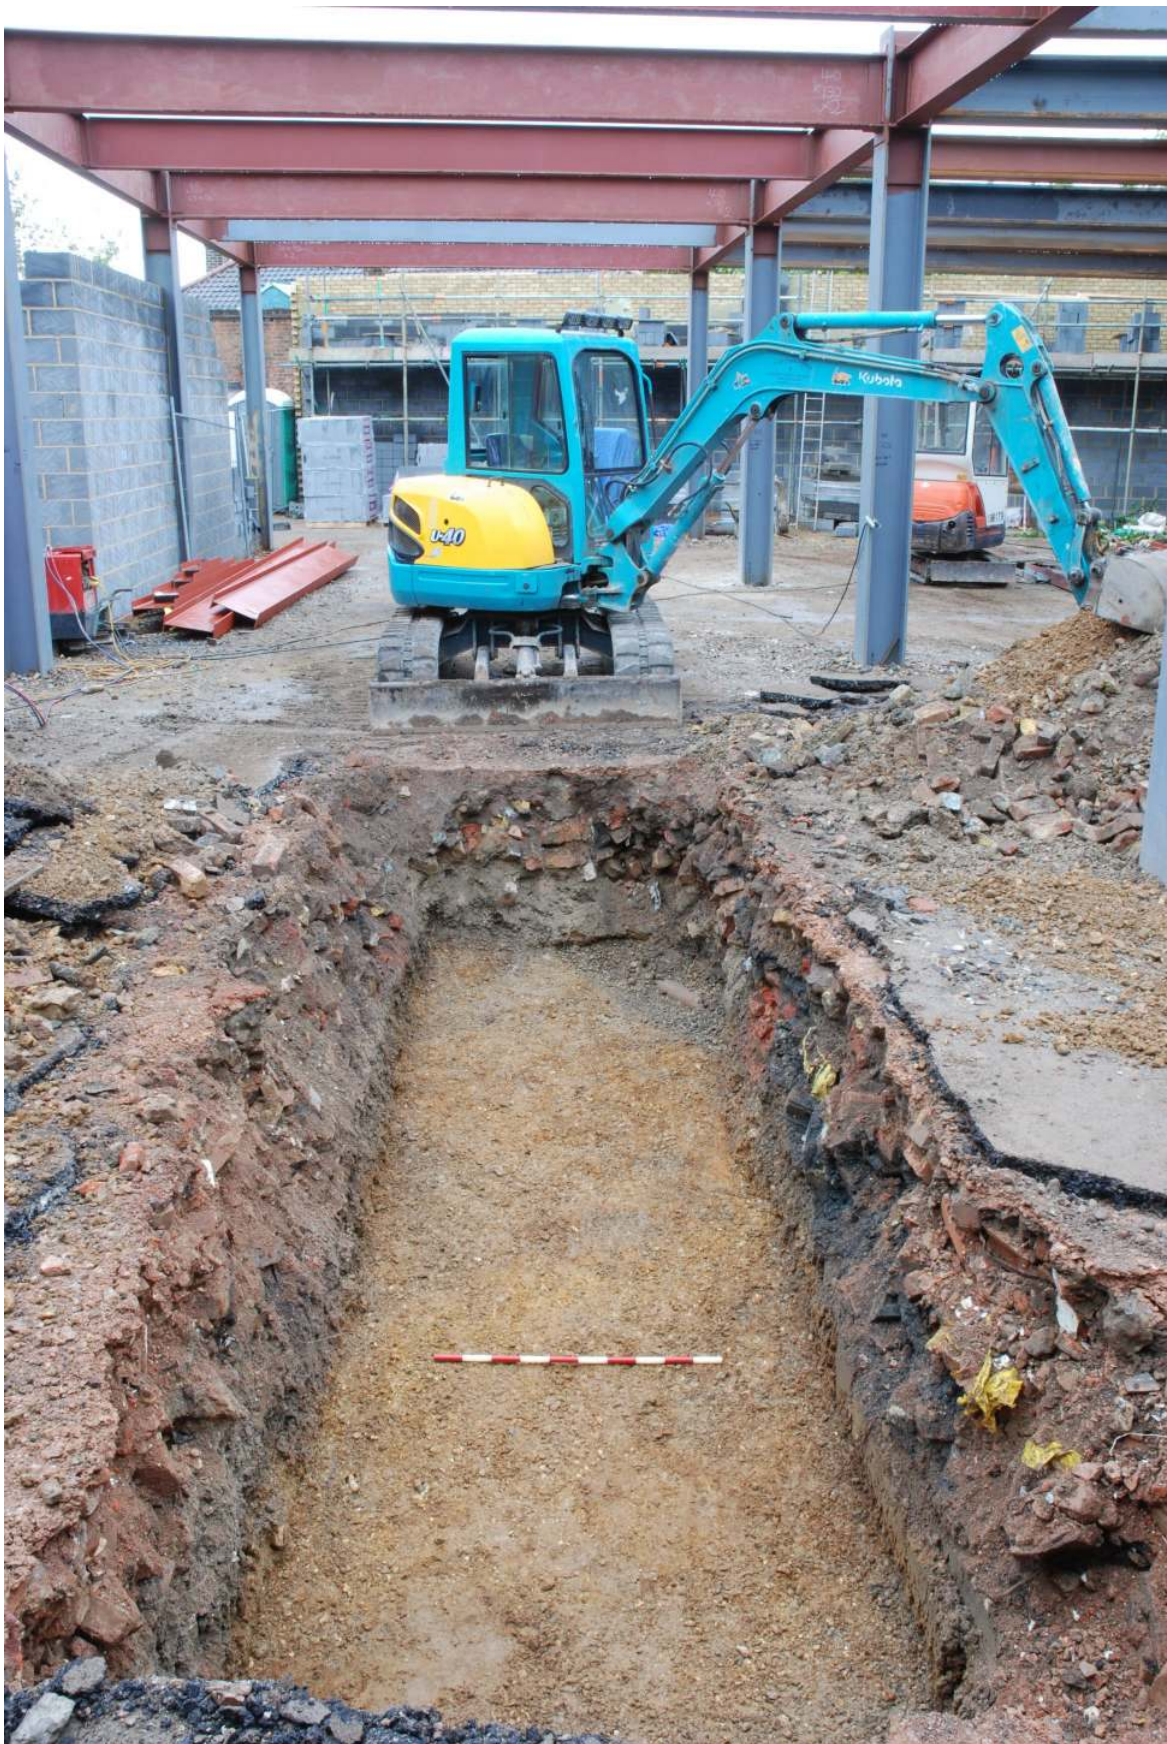
6.3.1 The natural gravel deposit (3) was exposed over the whole base of the trench. This was encountered at approximately 24.92mOD – 24.98mOD (*c.* 1.15 – 1.25m beneath the modern ground-surface). The deposit was a sterile compact orange-brown gravels, with sandy patches. It was cut away in the north-western corner of trench 1 by a drain which ran northeast – southwest across the corner of the trench – the cut for this was infilled with a loose gravel mix for *c.* 0.2m either side of the drain.

Fig. 13: Photograph of trench 1, looking west. The modern drain, cutting into the natural deposits, is visible in the top right of frame.

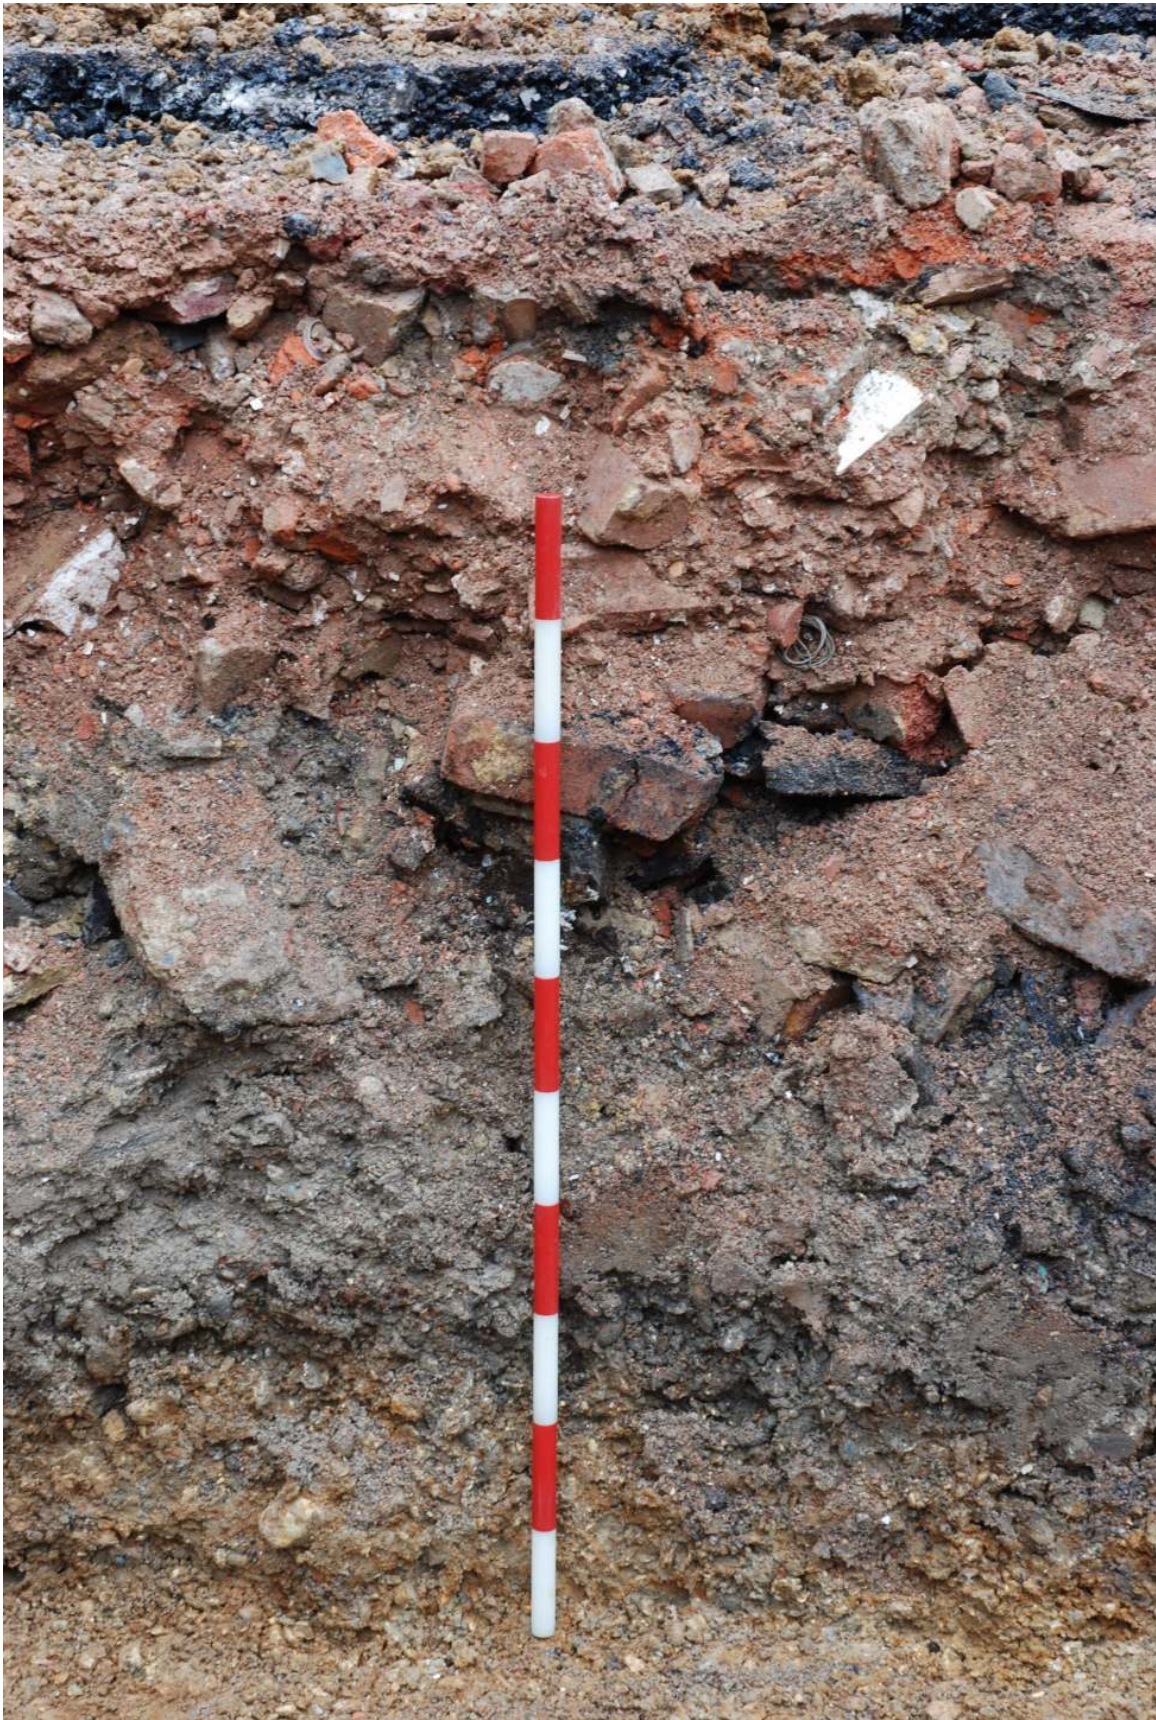
Fig. 14: Photograph of the southern section of trench 1.

concrete, and pieces of plastic bags, etc. This was all very disturbed and loose in nature. *c.*0.7 – 0.85m of this deposit was observed (down to *c.*25.3mOD). This was probably deposited in 1985 when the cinema building was destroyed, and the land needed to be built up / levelled.

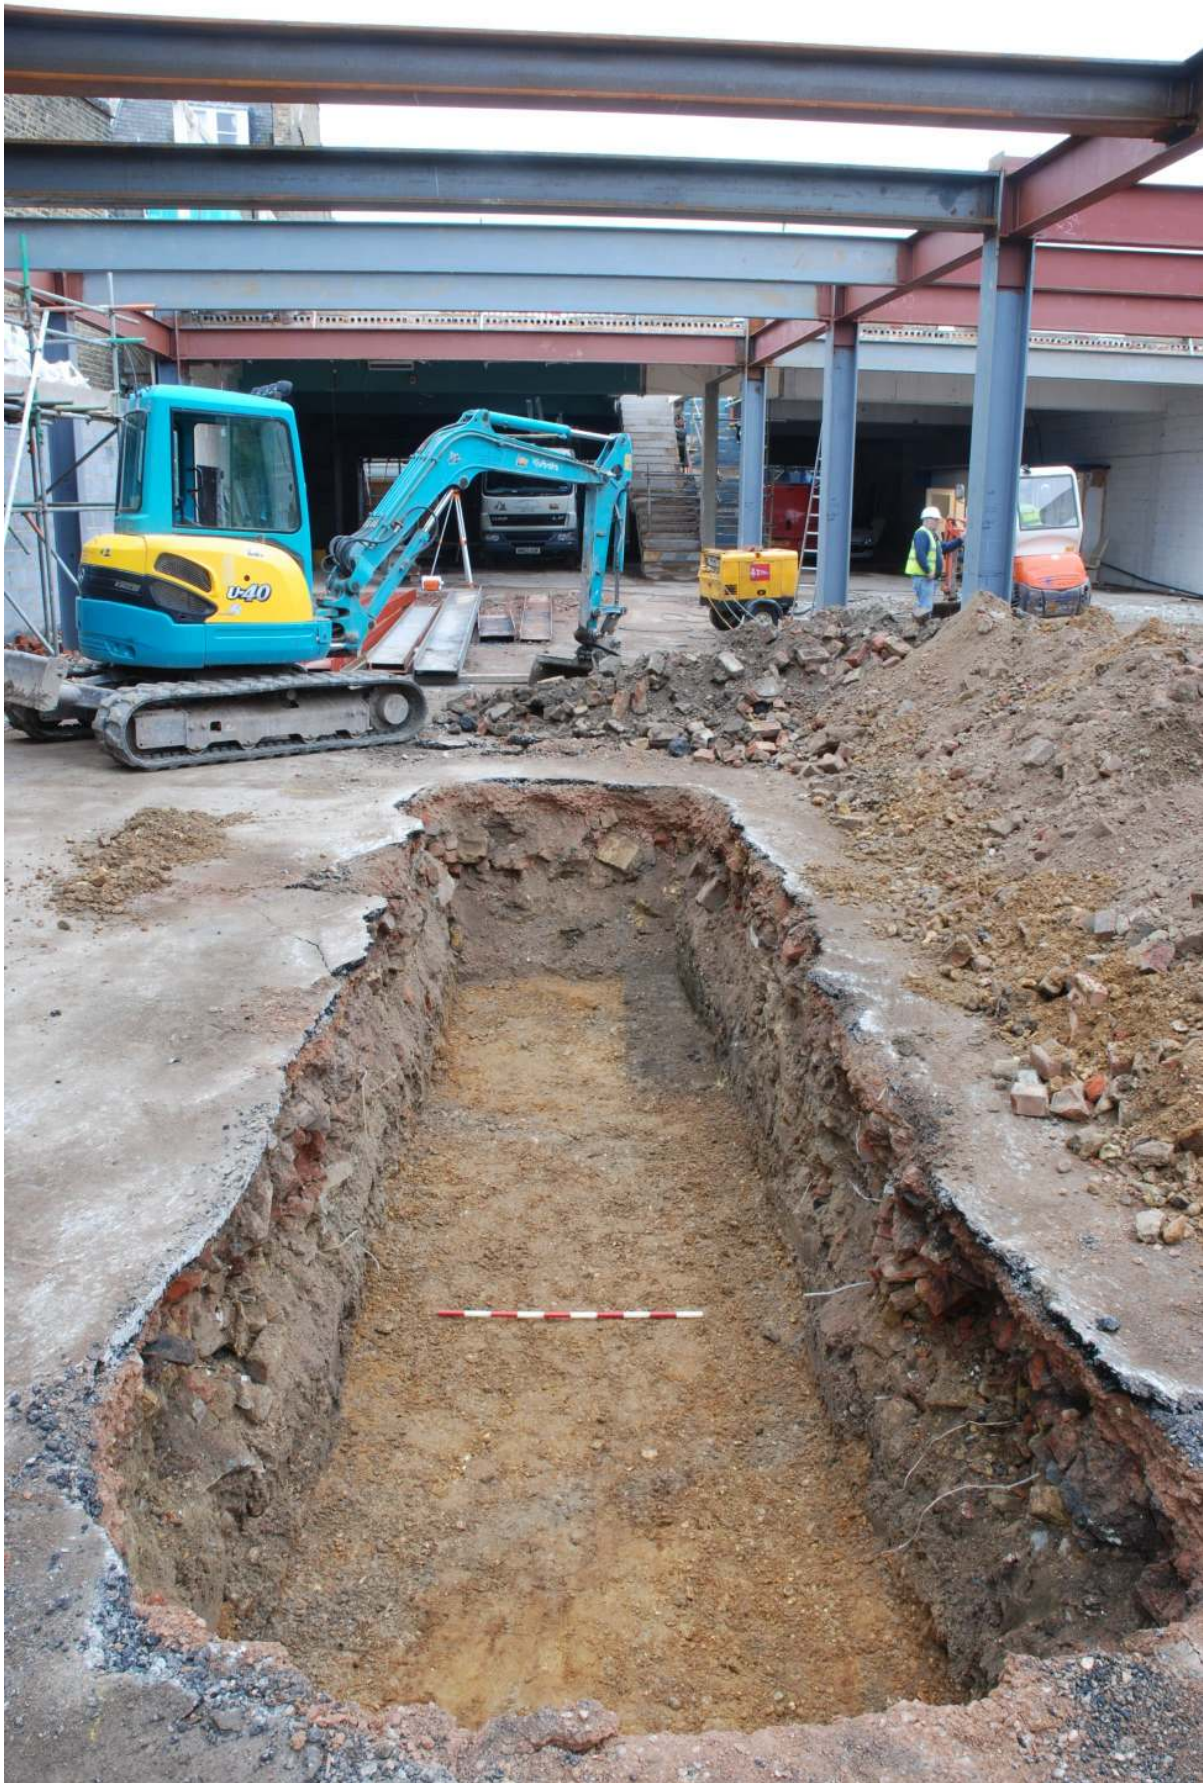
Fig. 15: Photograph of trench 2, looking east.

The trench was dug on an east-west alignment and measured approximately 6.5m by 1.8m in plan. The trench was approximately 1.2m deep.

- 6.4.2** The thin grey-brown silty-sand layer (2) was also observed above the natural gravel deposit in this trench, at *c.* 25.15mOD (*c.* 0.95m beneath the modern ground-surface), for a thickness of *c.* 0.2m. This is the same deposit as that observed in trench 1.

- 6.4.3** A similar substantial quantity of brickwork (3) was observed in this trench, for depths of *c.* 0.7 – 0.85m. This was very similar to that observed in trench 1 – consisting of bricks, concrete, and other modern detritus.

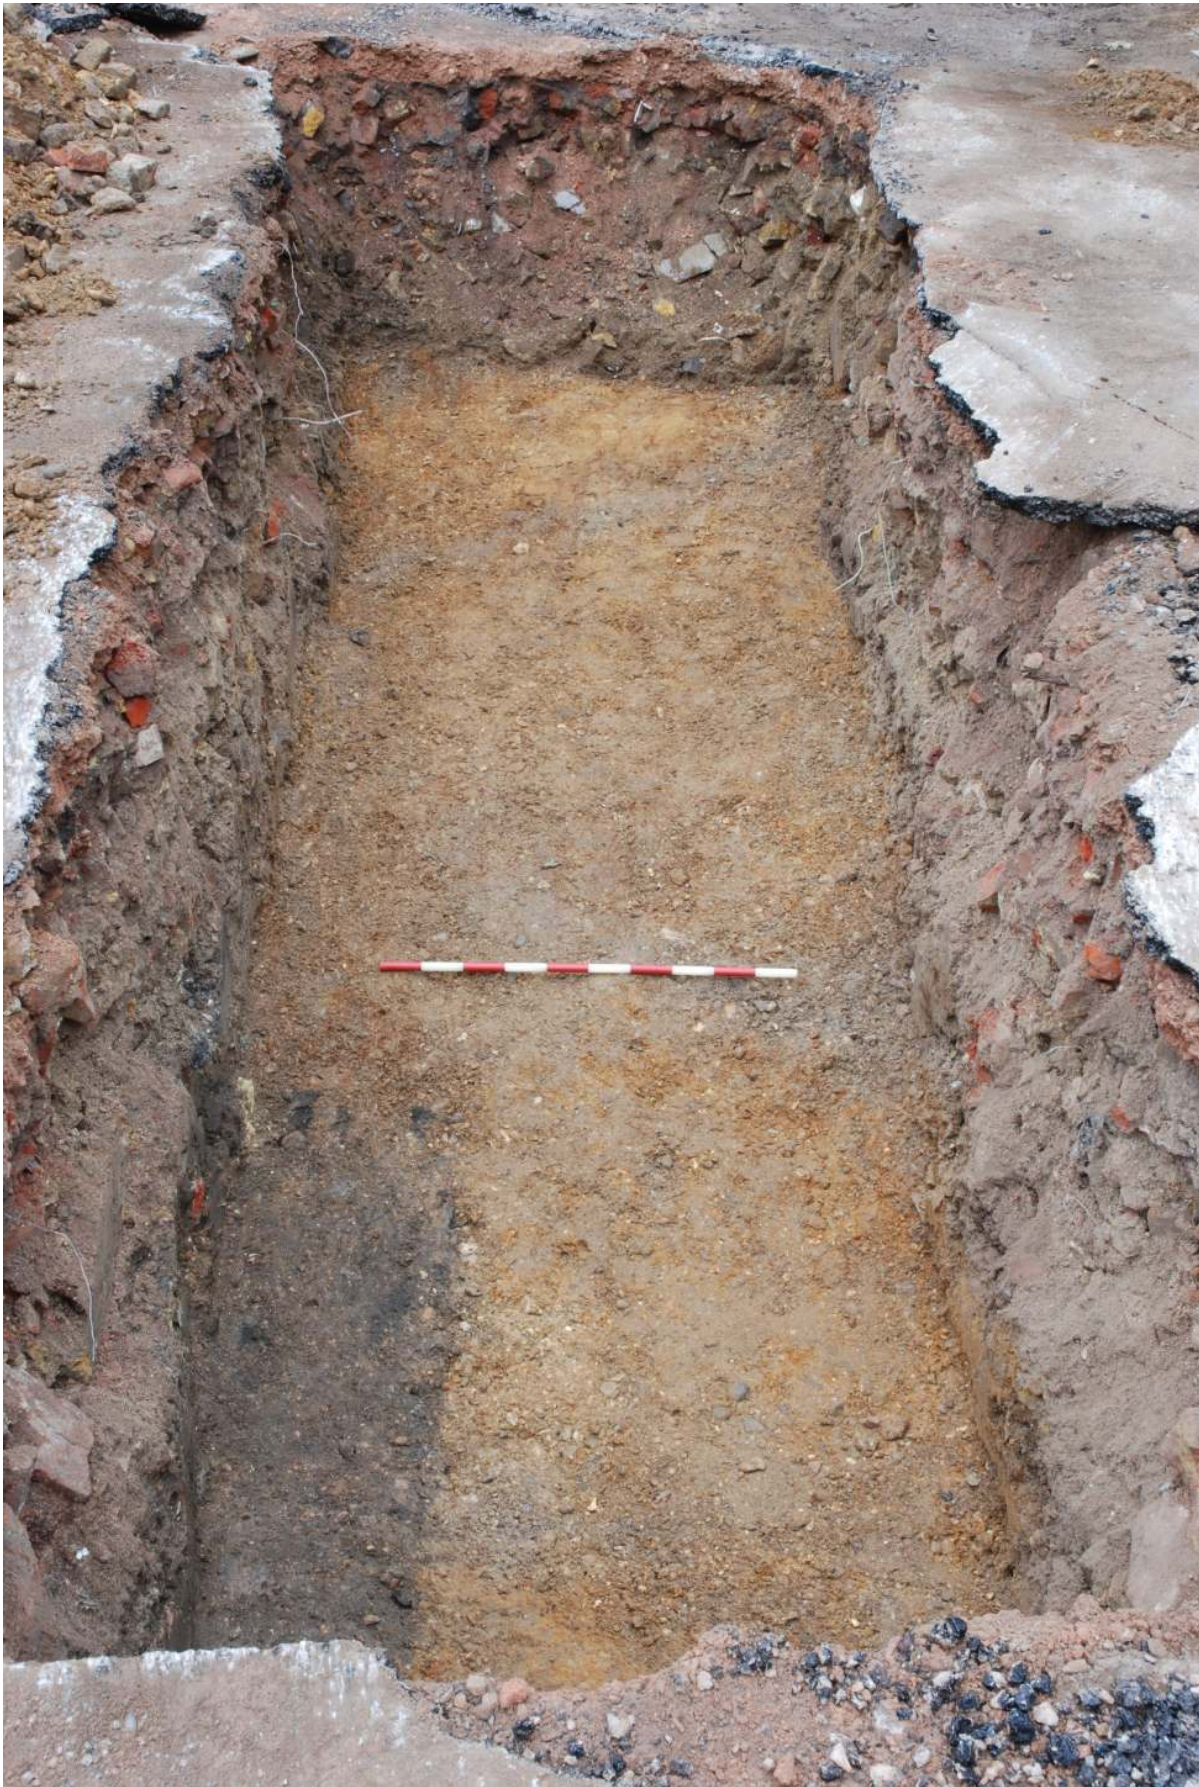
- 6.4.1** The natural gravel deposit (3) was exposed over the whole base of the trench, at 24.91mOD – 24.98mOD (*c.* 1.1 – 1.27m beneath the modern ground-surface). The deposit was a sterile compact orange-brown gravels, with sandy patches and occasional (geological) banding. One small modern feature was observed cut into this deposit in the south-east corner of this trench and running into the unexcavated sections to the south and east. Further excavation revealed it to be only *c.* 0.3m in depth and of no archaeological interest.

Fig. 16: Photograph of trench 2, looking west. The small modern rectangular feature is visible in bottom left of frame.
