THAMES WATER MAINS REPLACEMENT

In the vicinity of the Regent's Canal and Shepherdess Walk
(AMP5, District Metering Area Crouch Hill 29)

AN ARCHAEOLOGICAL WATCHING BRIEF

SITE CODE: TXB11

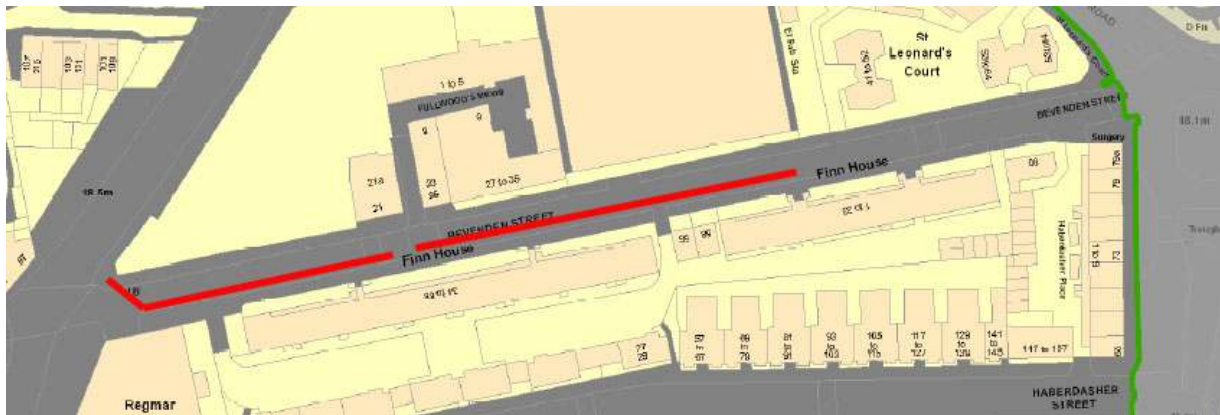
Fig. 7: Plan showing the trenching monitored in Bevenden Street.

56m of open-cut trenching was observed on the southern side of Bevenden Street (Figs 7 to 9), at the western end of the road running east from the junction with East Road (and to a depth of *c.* 1.1m). The modern road-surface (tarmac over a stone / tarmac base *c.* 0.4m thick) overlay mixed dumped / made-ground deposits (generally dark grey-brown compact sandy-silt, plus occasional service backfills). No archaeologically significant finds or features were observed.

A further 45m of open-cut trenching was observed on the southern side of Bevenden Street, running east from the trench seen previously, up to Finn House (to a depth of 1.1m beneath the modern ground-surface). The modern road-surface / kerbing (with a base of mixed concrete rubble and pink aggregates) overlay accumulated made-ground deposits. This was a dark grey silty-clay deposit (contexts 6 and 15) with frequent ceramic building material fragments, rounded pebbles, some orange – brown clay pockets, pottery, glass, and clay pipe. 19th century pottery (Post-medieval redware, English stoneware, Chinese porcelain, and Ironstone China – context 6, see Appendix II) were recovered from this deposit. Context 13 also refers to this deposit, and included two pieces of late 16th century post-medieval redware (see Appendix II), although these are probably residual. Furthermore, two pieces of pan-tile (contexts 6 and 15) were dated 1630-2000, and one piece of peg-tile (context 15) dated 1480-1800 were recovered from this deposit (see Appendix III). This made-ground deposit therefore appears to reflect

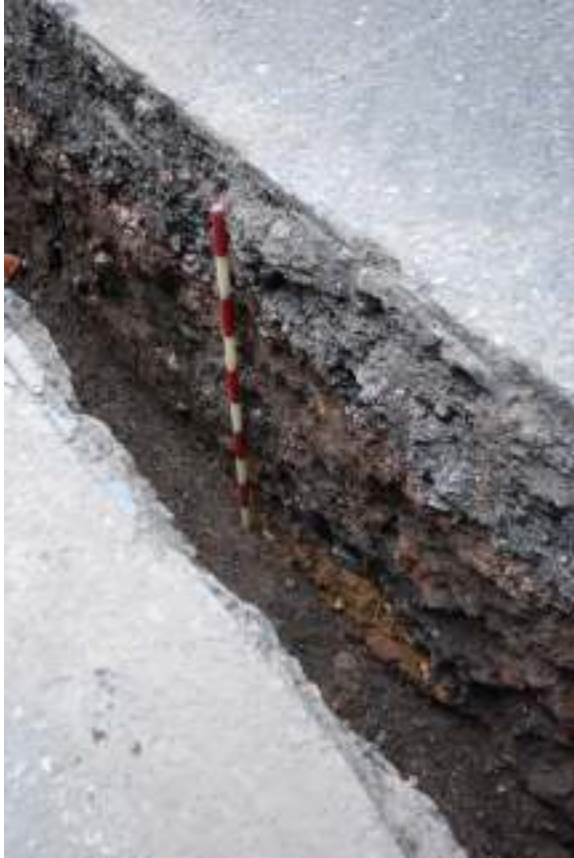
Fig. 8: Photograph of a section of the open-cut trenching on Bevenden Street, showing the modern road-surface overlying various made-ground deposits.

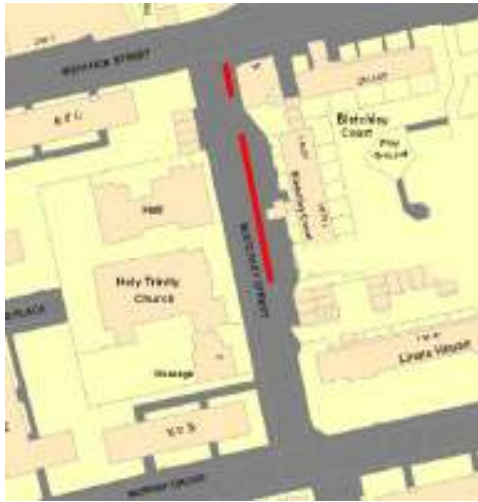
Fig. 10: Plan showing the trenching monitored in Bletchley Street.

25m of open-cut trenching was observed on the eastern side of Bletchley Street, opposite Bletchley Court (0.4m in width and 1m in depth). The modern road-surface (tarmac and brick rubble) overlay the made-ground deposits (a dark brown-grey clay deposit, with frequent ceramic building material fragments). This overlay the natural deposits – a dark brown sterile clay, observed *c.*0.8m beneath the modern ground-surface.

A further 7m of open-cut trenching was observed on the eastern side of Bletchley Street, at the corner with Wenlock Street, and to a depth of *c.*1m beneath modern ground-surface. The modern tarmac and concrete road-surface overlay various made-ground and service backfill deposits (generally mid-brown-grey clay with ceramic building material fragments and clay deposits). No finds or features of archaeological significance were observed.

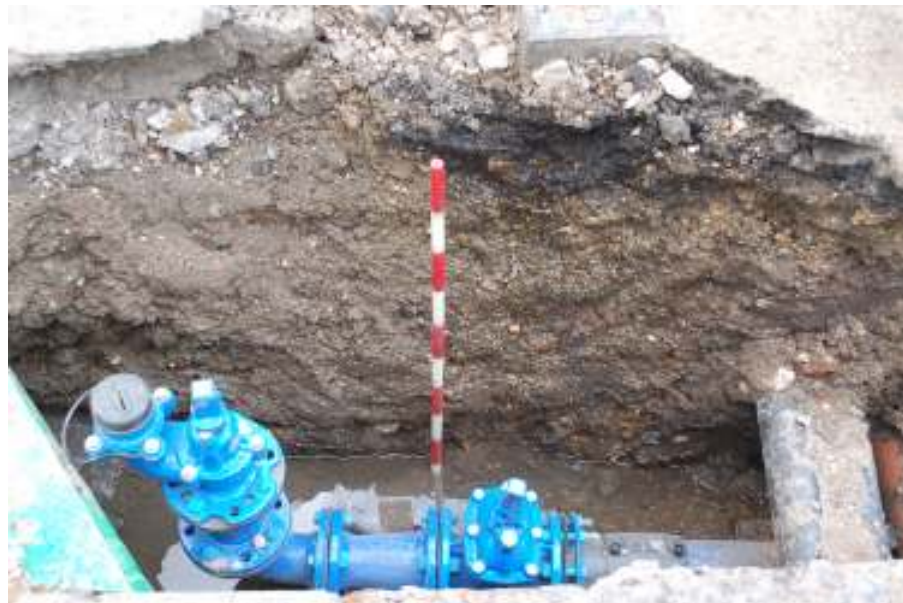
Fig. 11: Photograph of a section in the trenching on Bletchley Street, showing the modern road-surface over service backfill.

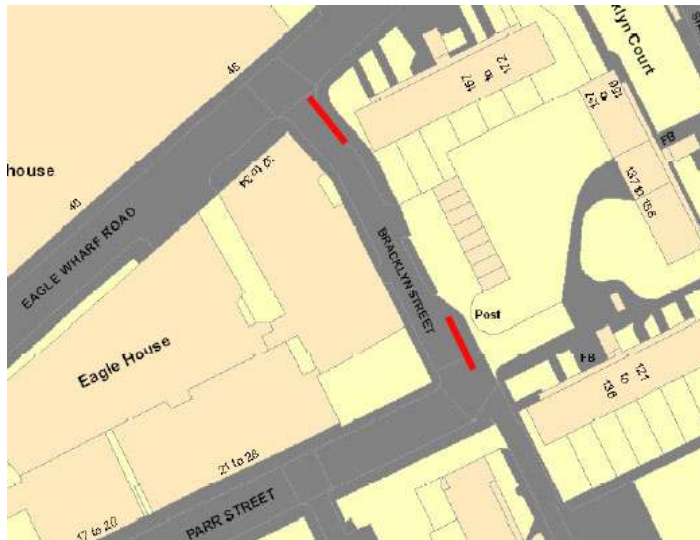
Fig. 12: Plan showing the trenching monitored in Bracklyn Street.

Two sections of open-cut trenching on the eastern side of Bracklyn Street, one at the far northern end (at the junction with Eagle Wharf Road) and measuring approximately 6.5m in length, and one at the southern end (at the junction with Parr Street) and measuring *c.*4m in length, were observed. The modern road-surface (tarmac and concrete, 0.4m in thickness) was observed over service fills, to a depth of *c.*0.9m (limit of excavation). No finds or features of archaeological significance were observed.

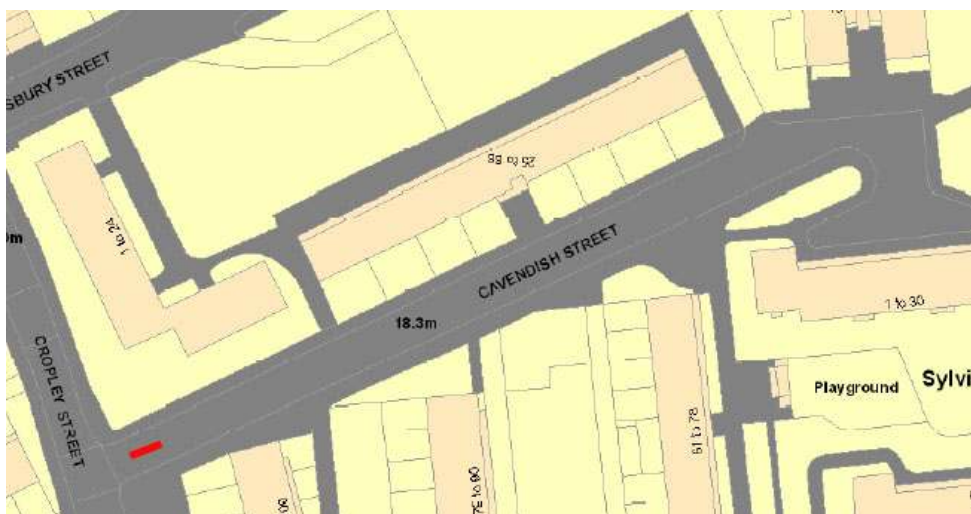
Fig. 13: Plan showing the trenching monitored on Cavendish Street.

A pit (2m x 1.5m, by 1.3m in depth) was observed at the western end of Cavendish Street, at the junction with Cropley Street. The modern road-surface (tarmac over concrete, 0.35m in thickness) overlay 0.95m of service

backfills (grey-purple gravels) within service trenches. No significant archaeological finds or features were observed.

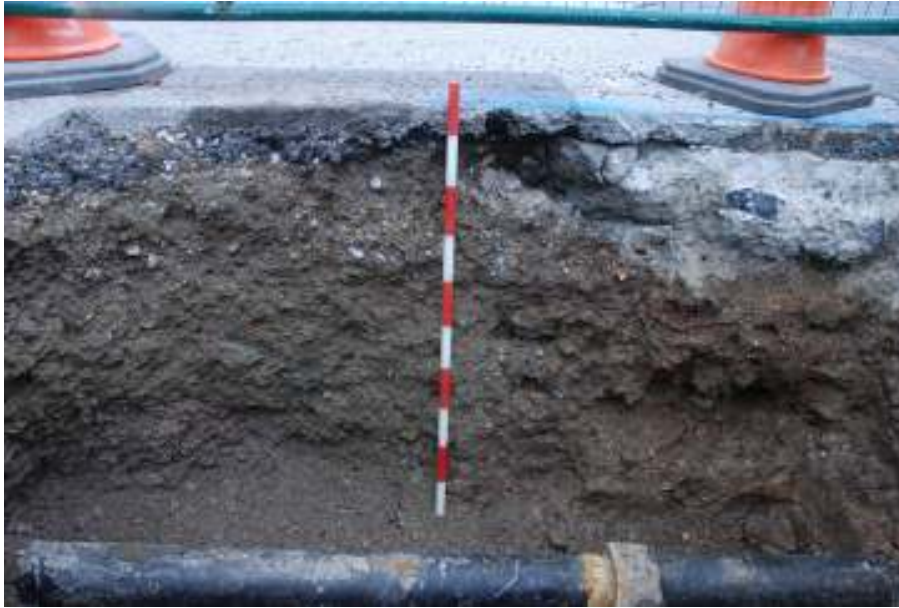
Fig. 14: Photograph of the pit in Cavendish Street, showing the modern road-surface overlying service backfills.

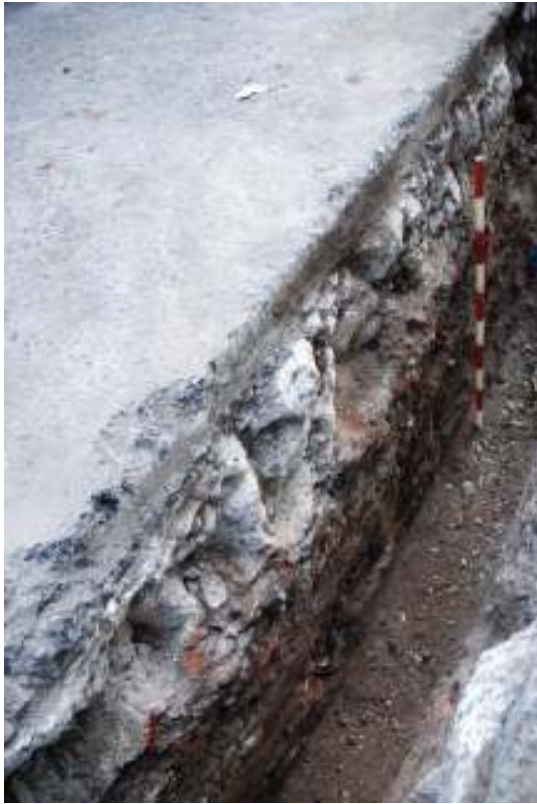
Fig. 16: Photograph of a section of the open-cut trenching on City Road, showing the modern road-surface over a clayey-silt deposit.

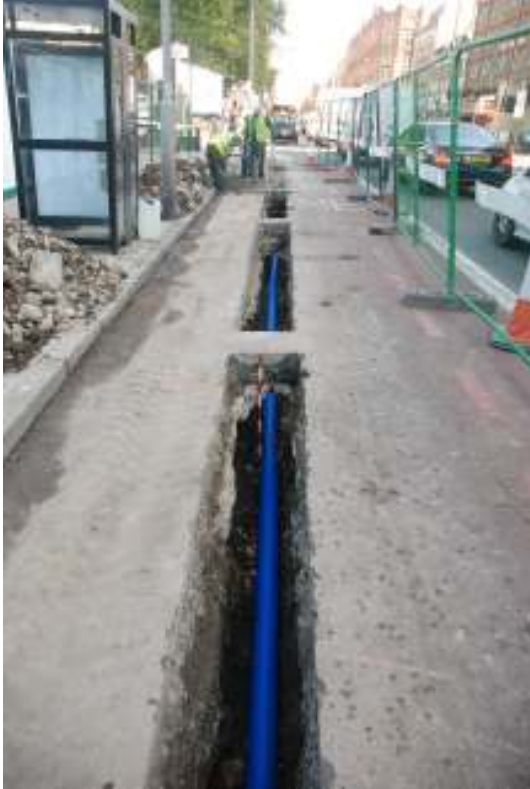
50m of open-cut trenching (up to 1.1m deep) was observed along the northern side of City Road, running from Micawber Court to Shepherdess Walk. The existing road-surface (tarmac and concrete, 0.45m thick) overlay a pipe trench and made-ground deposits (a homogeneous dark grey clay-silt deposit with occasional stones and ceramic building material fragments). No finds or features of archaeological significance were observed.

Fig. 18: Photograph of the trenching along City Road, looking east.

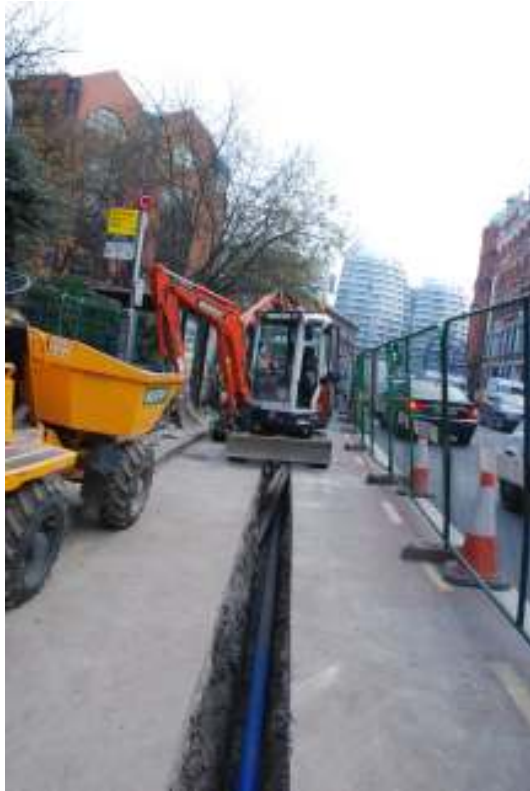
A further 30m of open-cut trenching was observed on the northern side of City Road, continuing east from the trench seen previously up to the junction with East Road. This was dug to approximately 1.2m beneath ground-surface. A modern road-surface (tarmac over concrete, 0.4m thick) overlay a number of services with associated service backfills (stoney, MOT type 1, sandy, etc), within a general mixed loose grey-brown silty-sand. No archaeologically significant finds or features were observed.

Fig. 19: Photograph of the trenching along City Road, looking east.

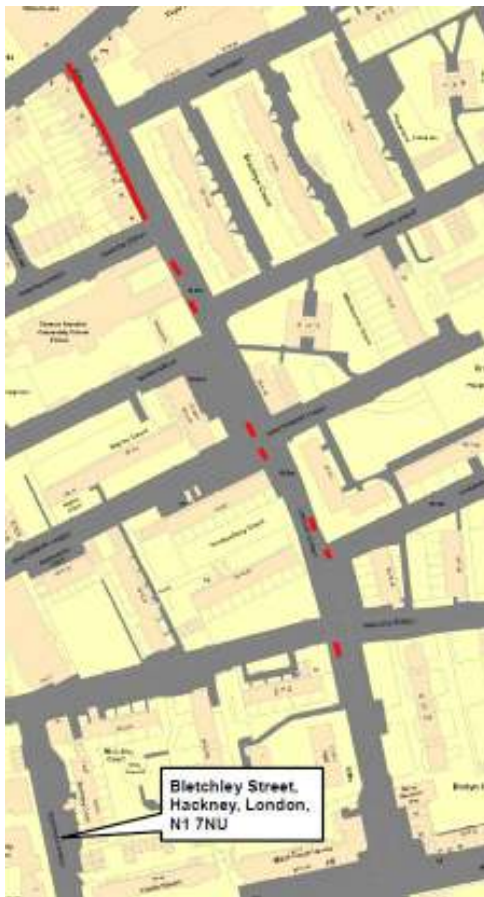
Fig. 20: Plan showing the trenching monitored on Cropley Street.

Three pits on Croyley Street (one on the western side just south of Wenlock Street; one on the eastern side opposite the junction with Cavendish Street; and one on the eastern side just north of this) were observed – all were *c.*0.95m in depth. The modern tarmac road surface over concrete bedding, with service cuts / backfill, was observed to a depth of 0.32m beneath the road-surface. This overlay a made-ground deposit: a strong brown-orange clay-silt, with frequent pebbles and ceramic building material fragments (continuing beyond the limit of excavation). No finds or features of archaeological significance were recorded.

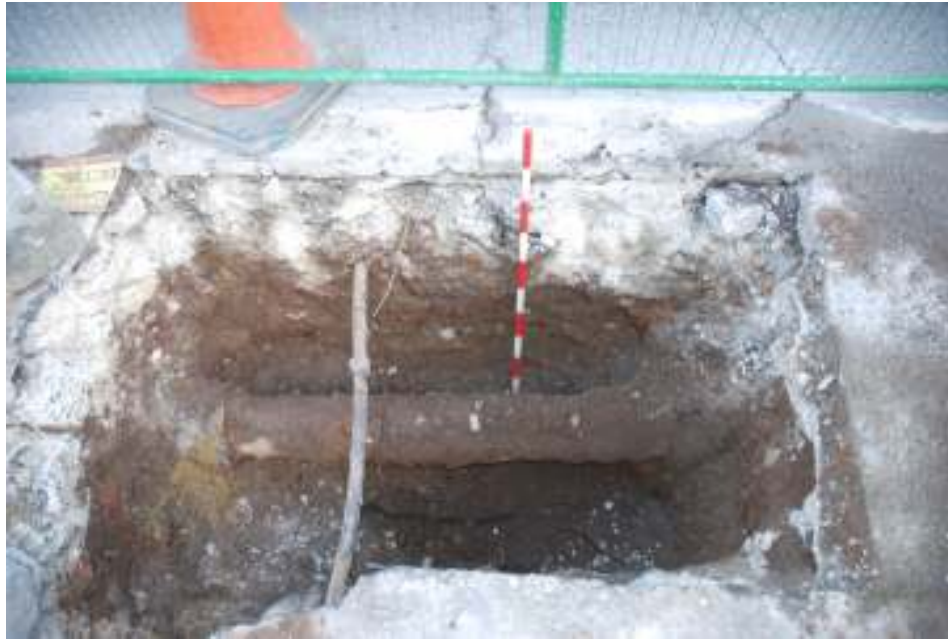
Fig. 21: Photograph of one of the pits on Croyley Street, showing the modern road-surface overlying service backfill and made-ground deposits.

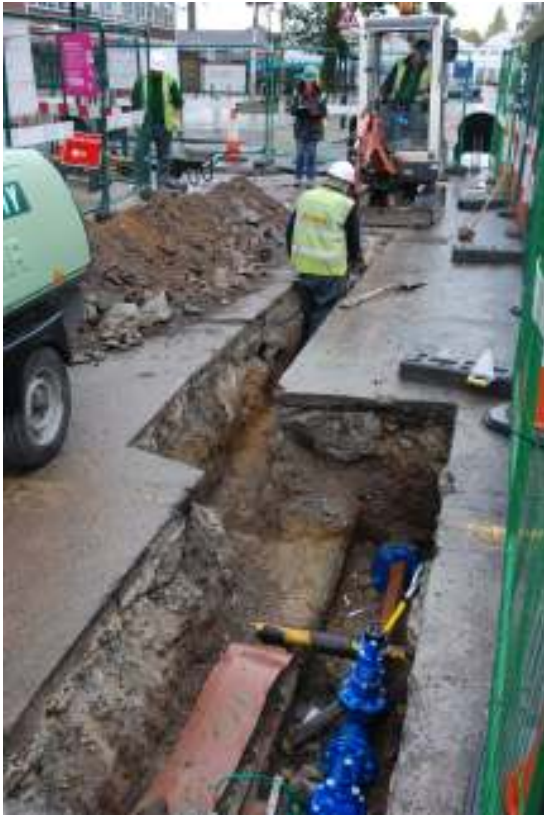
Two more pits, on the western side of Croyley Street at the junction with Shaftesbury Street, were observed (both measured approximately 8m by 0.5m, to *c.*1m in depth). The modern tarmac and concrete road-surface (0.36m thick) overlay numerous services and service backfill (mid grey-brown silty-sand with pebbles, ceramic building fragments, etc). No archaeologically significant finds, features, or deposits, were observed.

Fig. 22: Photograph of one of the pits on Cropley Street.

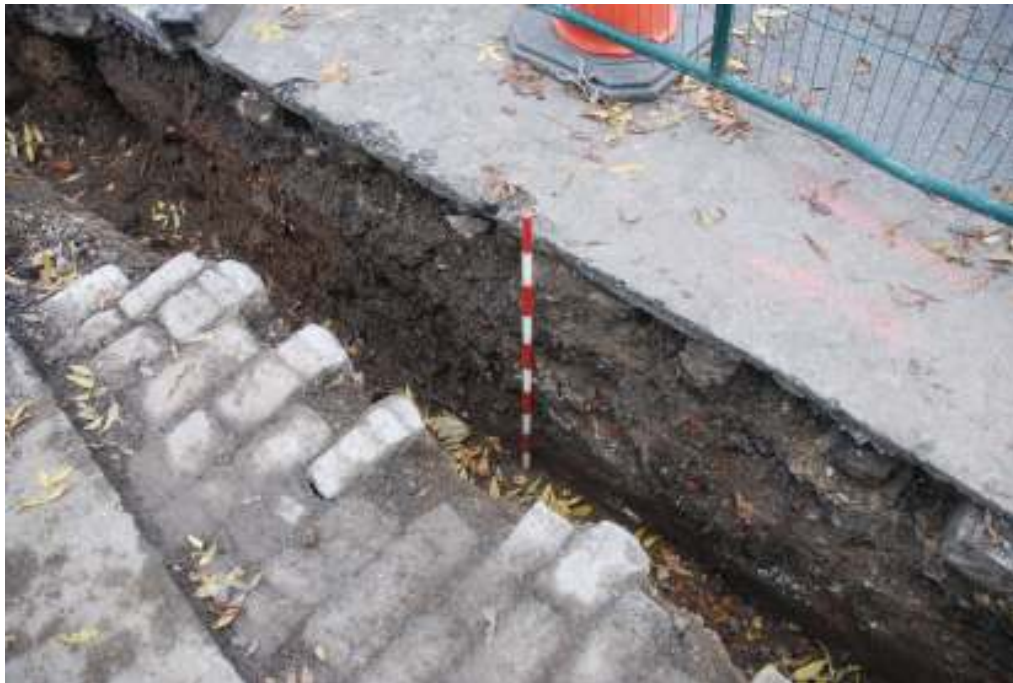
Fig. 23: Photograph of the trenching on Cropley Street, showing the modern road-surface overlying made-ground deposits.

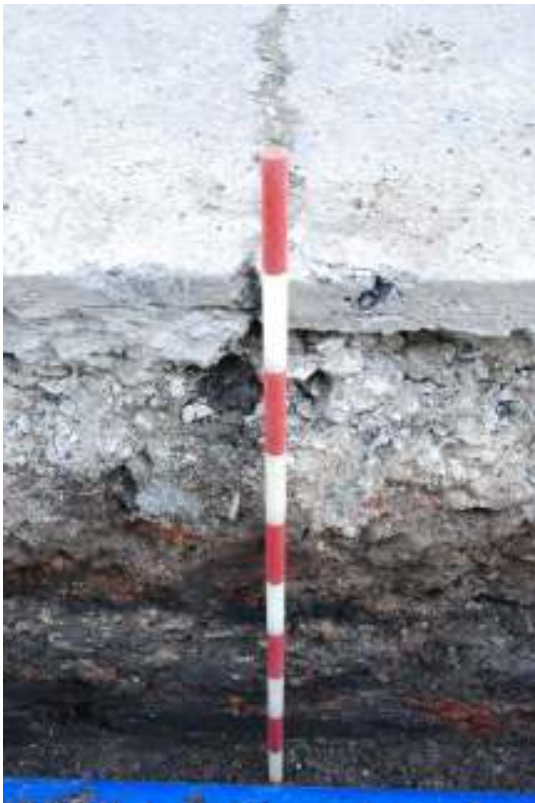
Fig. 24: Photograph of a section in the trenching along Cropley Street, showing the various different made-ground layers.

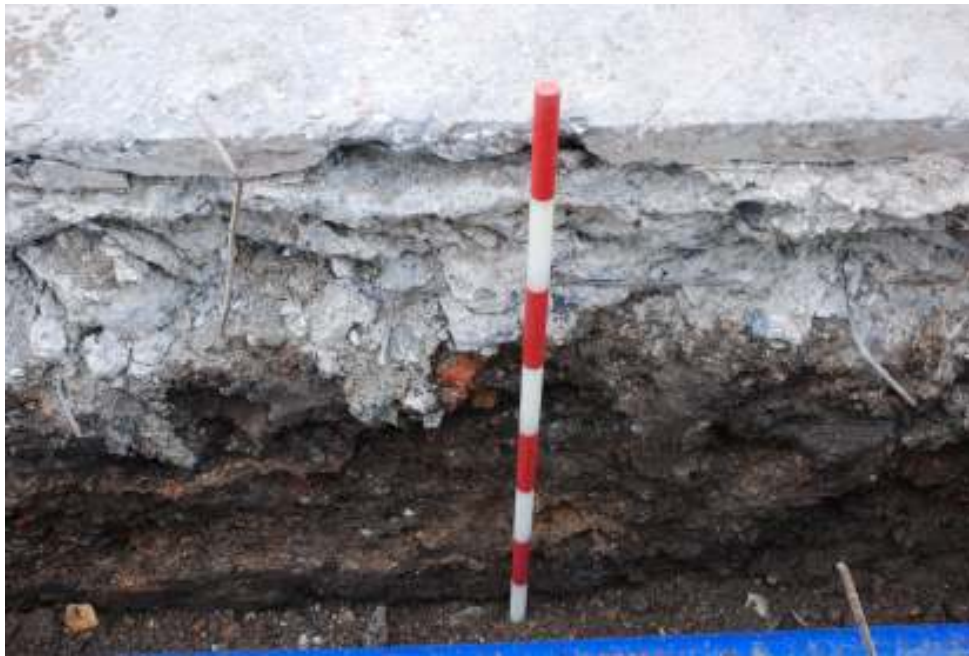
Fig. 25: Photograph of a section in the trenching on Cropley Street, showing the modern road-surface overlying made-ground deposits.

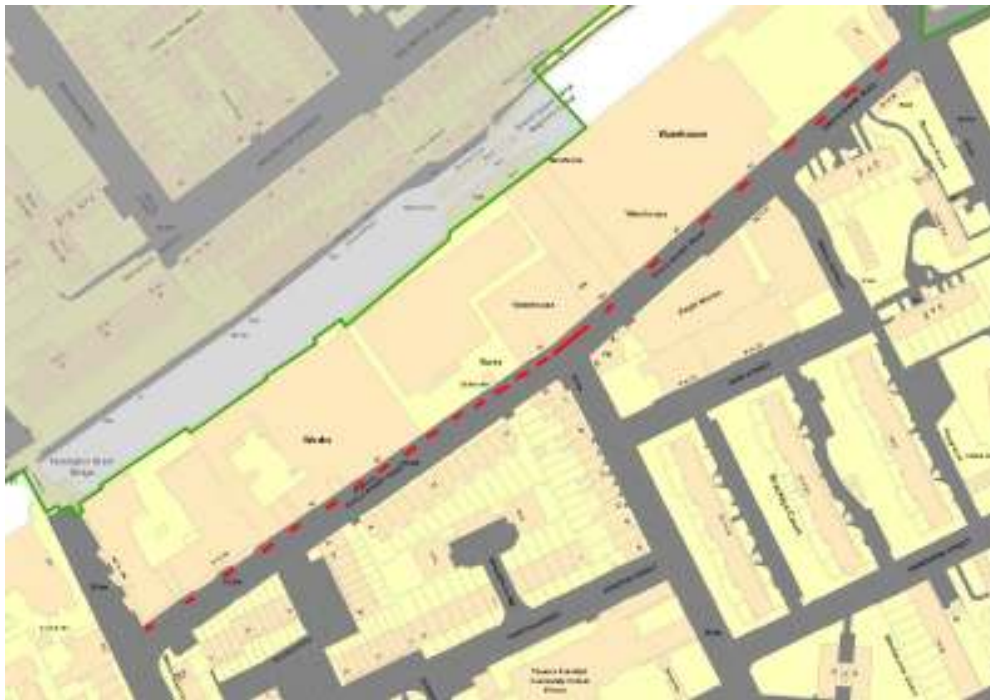
Fig. 26: Plan showing the trenching monitored on Eagle Wharf Road.

Five pits were observed along the northern side of Eagle Wharf Road, running east from the junction with Shepherdess Walk up to outside Holborn Studios. These were of various shapes and sizes, and all dug to between 1.27 and 1.62m in depth. The modern tarmac and concrete road surface overlay various layers and dumps of silty-clays and sandy-silts. Two pieces of 19th century Ironstone China were recovered from one of these pits (context 5 – see

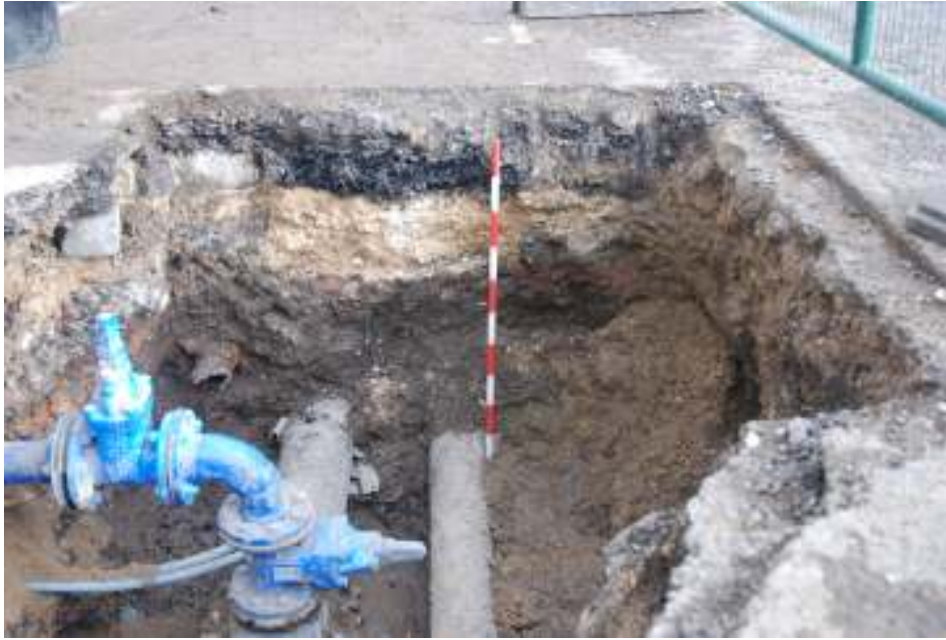
Fig. 27: Photograph of one of the pits on Eagle Wharf Road, showing the modern road-surface overlying disturbed service backfill.

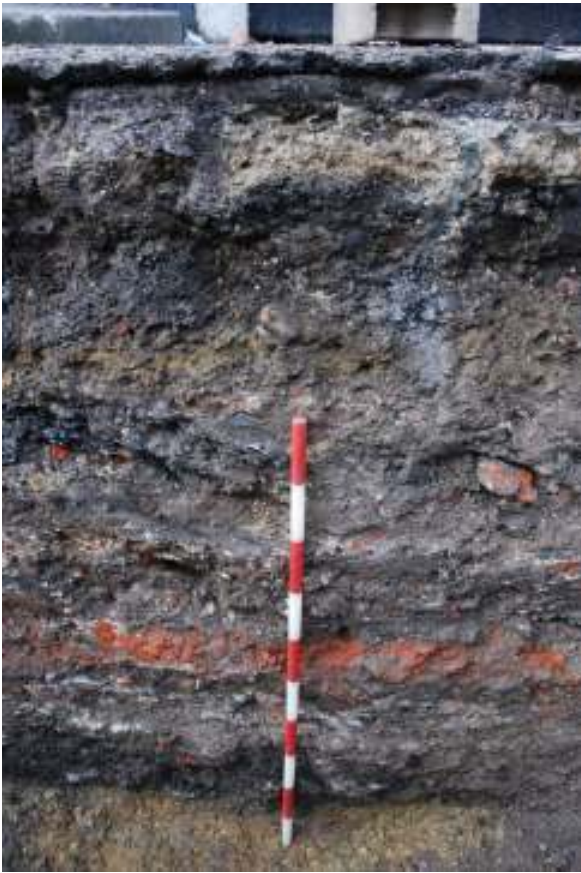
Fig. 28: Photograph of one of the pits on Eagle Wharf Road, showing the stratified layers of made-ground deposits.

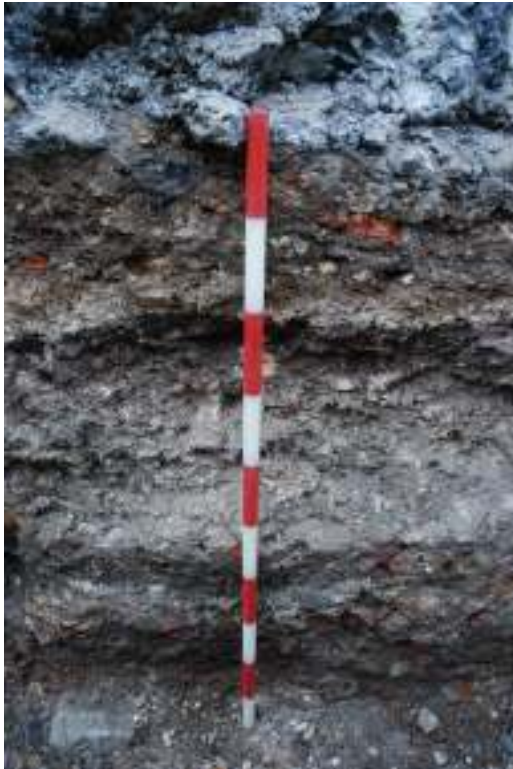
Fig. 29: Photograph of a section in one of the pits on Eagle Wharf Road, showing the modern road-surface over made-ground deposits, with some indication of different layers / stratigraphy within this.

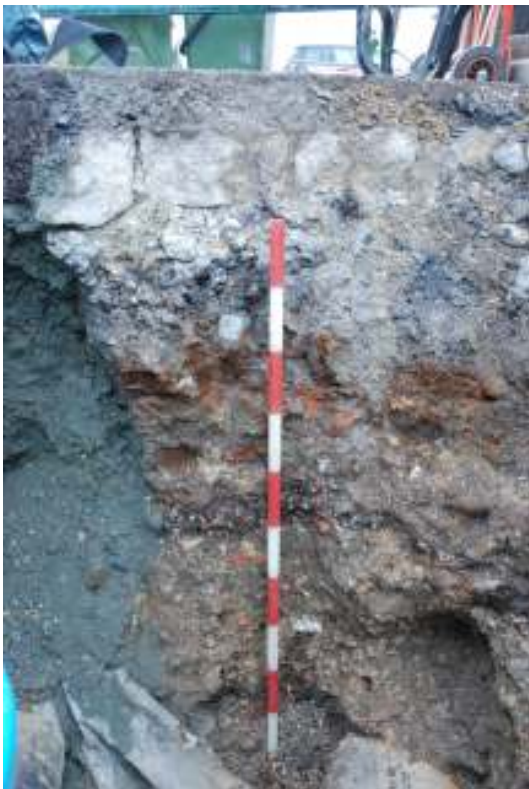
Fig. 30: Photograph of one of the pits on Eagle Wharf Road, showing the disturbed service backfills (left side of image) and layers of made-ground deposits (right side of image).

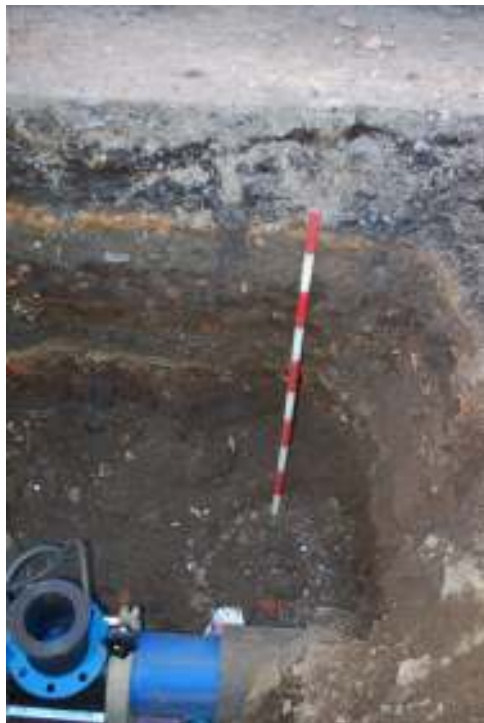
Four further pits were observed on the northern side of Eagle Wharf Road, to the east of Bracklyn Street, around the entrance to Mortimer Wheeler House. All of these pits were approximately 1m – 1.2m in depth. The modern road-surface overlay service trench backfill, over a lense of crushed pottery in an ashy sand concreted mass (context 7). This was dated to the 19th century (see Appendix II), and consisted of Post-medieval redware, English stoneware, English yellow-glazed earthenware, and Ironstone China. This appeared at approximately 0.72m beneath the modern ground-surface, was *c.*80mm thick, and also contained glass, sand, concrete, ceramic building material, clay pipe, etc. This overlay a dark humic fine silty soil deposit (probably the early 19th century ground-surface – possibly a buried garden soil before the residential development of this area).

Fig. 31: Photograph of one of the pits on Eagle Wharf Road, showing the lense of crushed pottery (towards the base of the trench) overlying the dark silty-soil deposit.

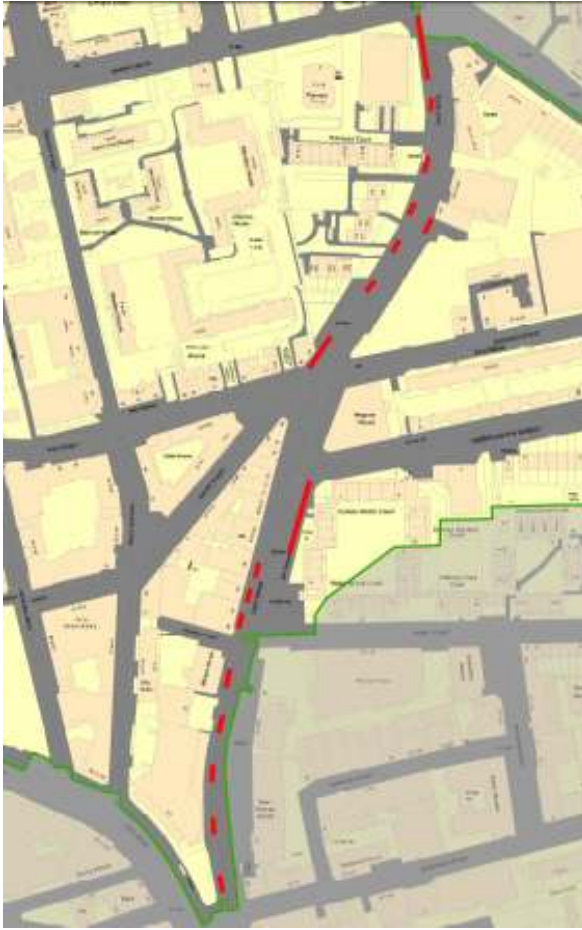
Fig. 32: Plan of the trenching monitored on East Road.

Five test pits along the western carriageway of East Road, at its southern end between City Road and Silbury Street, were observed. These were of various shapes and sizes (from 0.8m^2 to $c.3\text{m}^2$), but were all generally $c.1\text{m}$ in depth. The modern tarmac and concrete road-surface (0.5m in depth) overlay a number of services and service-backfills, with no finds or features of archaeological significance observed.

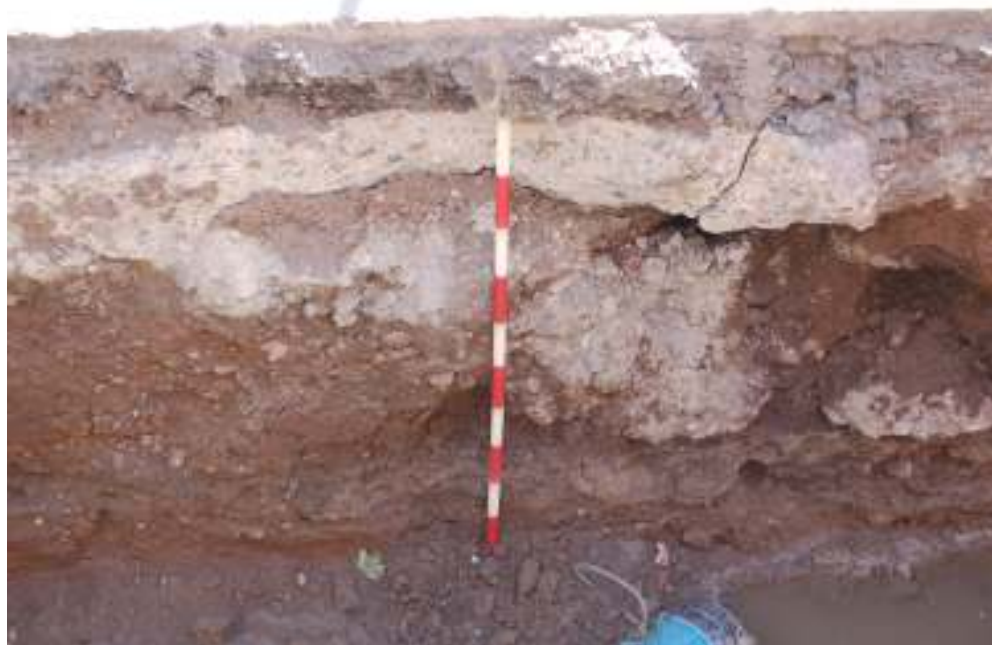
Fig. 33: Photograph of a section in one of the pits on East Road, showing the modern road-surface over the mid grey-brown clay made-ground deposit.

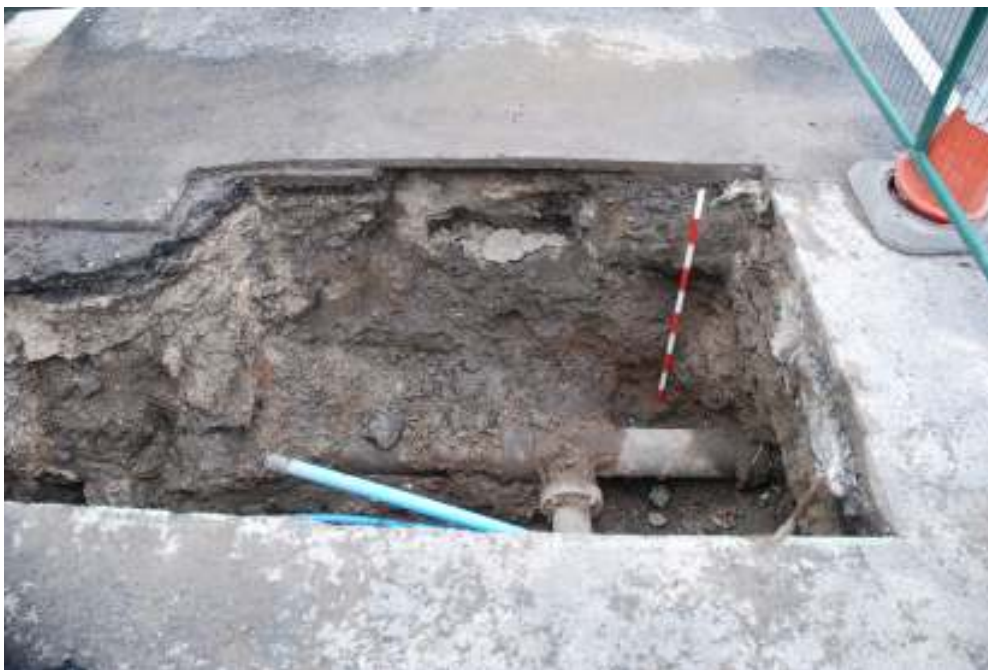
Fig. 34: Photograph of the northern-most pit on East Road, showing the modern road-surface overlying service backfill.

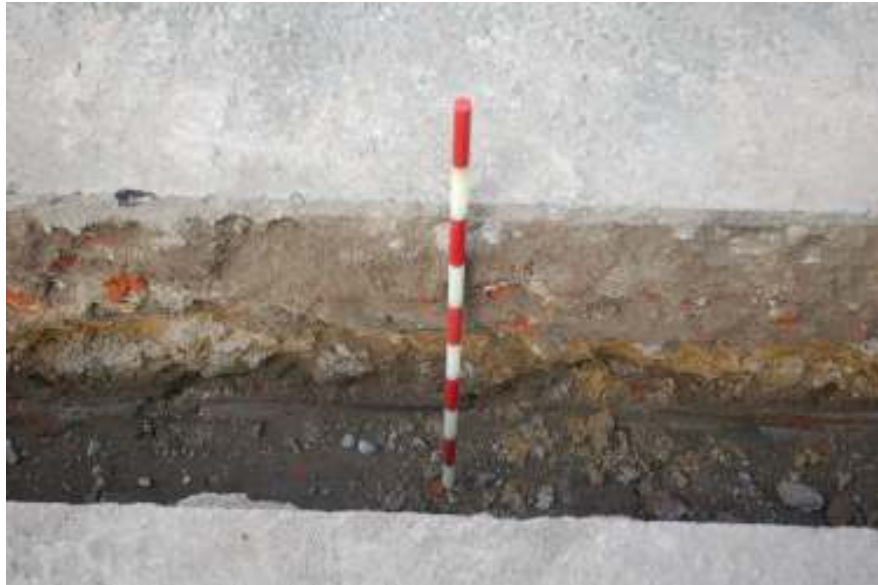
Fig. 36: Photograph of a section in the trenching along Evelyn Walk, showing the various different made-ground layers.

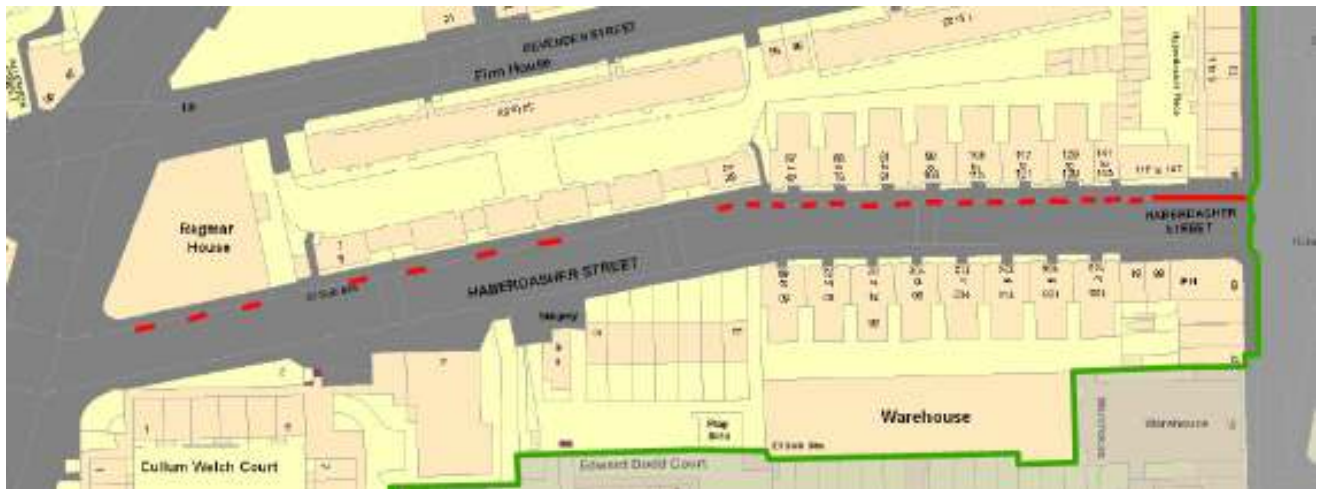
Fig. 37: Plan of the trenching monitored on Haberdasher Street.

A series of pits (seven in total) were observed along the northern side of Haberdasher Street, running east from the junction with East Road up to outside No.17 Haberdasher Street. These were a mix of sizes, however generally measured approximately 1.5m by 1.4m by 1.2m in depth. The modern road-surface (tarmac over concrete) overlay a mixed subsoil (mid-dark brown silty-sand with pebbles, ceramic building material fragments, charcoal specks, and brick rubble, etc). One piece of Chinese porcelain and two pieces of Ironstone China, dated to the 19th century (context 8, see Appendix II) were recovered from this subsoil. This reflects the early 19th century development of Haberdasher Street, as depicted on Horwood's 1813 Map (fig. 39).

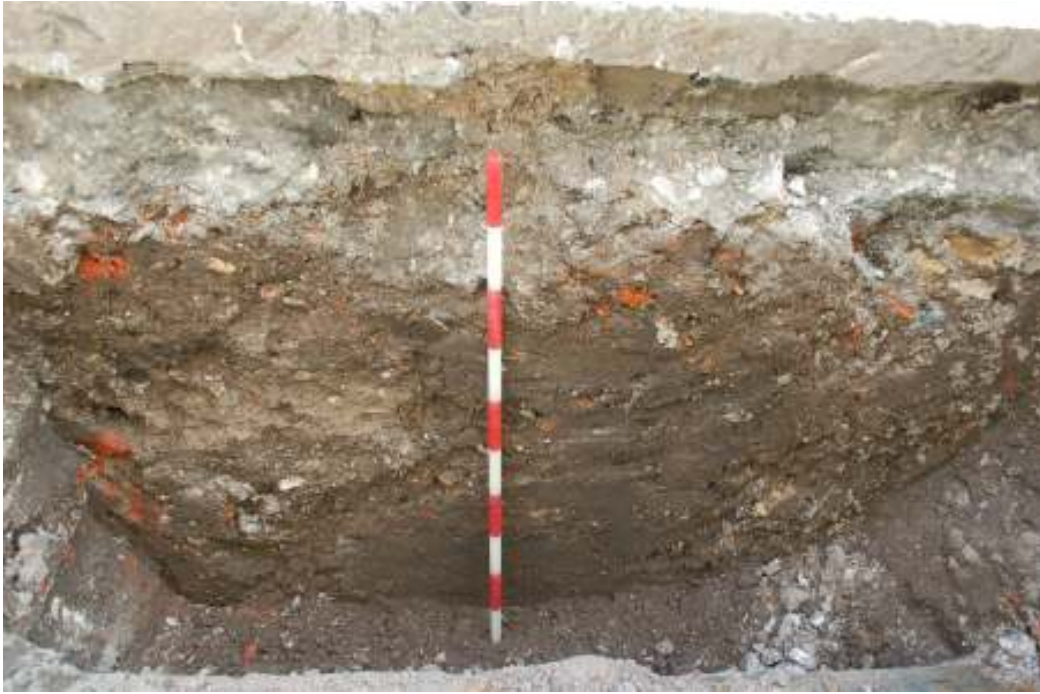
Fig. 38: Photograph of a section in a pit in Haberdasher Street, showing the modern road-surface overlying a mixed subsoil.

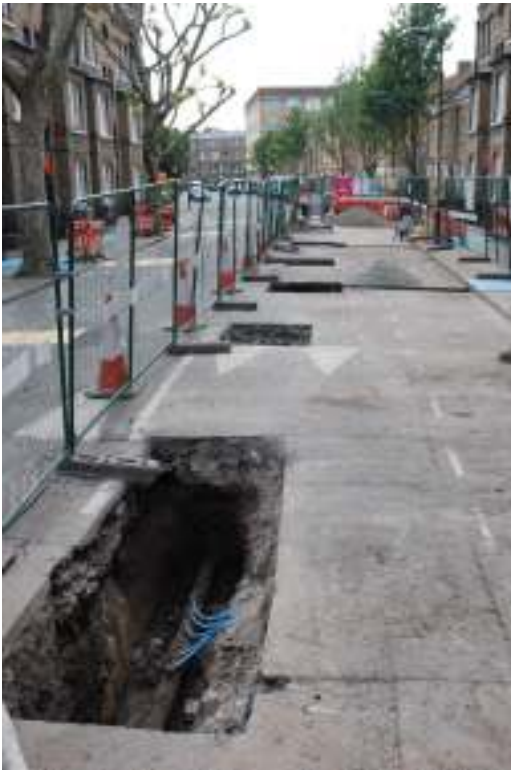
On another occasion, another five pits were observed on the northern side of Haberdasher Street, east of those seen before, up to approximately outside No.103. The modern road-surface (tarmac over concrete) overlay the mid-brown silty-sand made ground, with bits of brick rubble in. No finds or features of archaeological significance were observed.

Fig. 40: Photograph of some of the pits on Haberdasher Street, looking west.

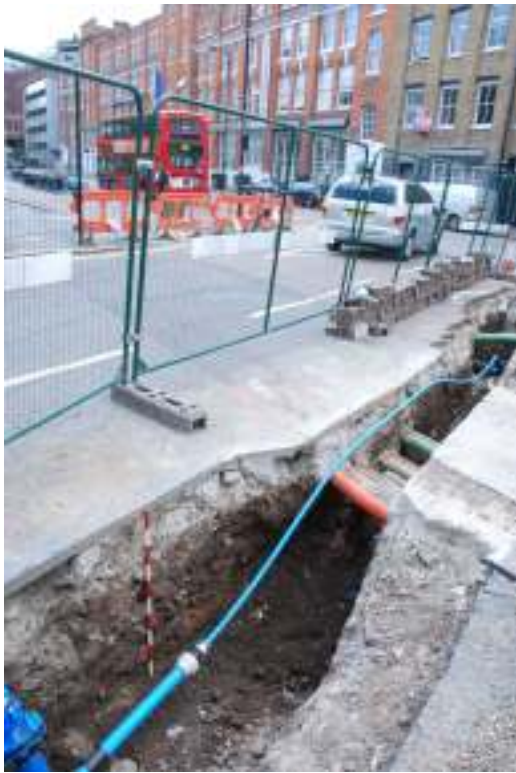
One larger open-cut trench (*c.*16m in length) was observed on the northern side of Haberdasher Street, at its far western end, right up to the junction with East Road. The modern tarmac and concrete road-surface overlay a large number of services and service backfill (mixed mid-brown silty-sand with pebbles, mortar, and ceramic building material in). No finds or features of archaeological significance were observed.

Fig. 41: Photograph of the trenching at the far western end of Haberdasher Street, looking onto East Road.

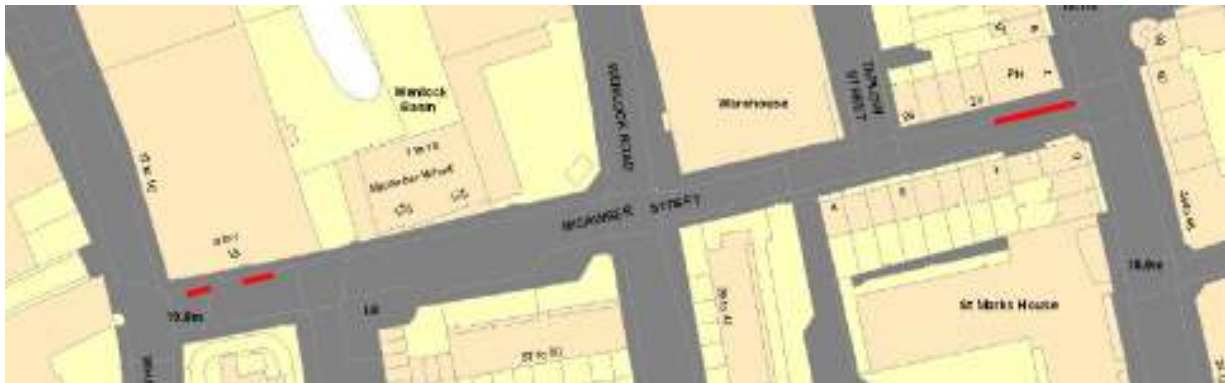
Fig. 42: Plan showing the trenching monitored on Micawber Street.

One trench was observed on the northern side of Micawber Street, at the eastern end, running west from the junction with Shepherdesse Walk for a distance of *c.*12m, and excavated down to a maximum of 0.95m beneath ground-surface. The modern tarmac and concrete road-surface overlay heavily disturbed deposits – disturbed by the multiple services – such that there were patches of MOT Type 1 material; gravelly-loam mix; clay patches; sandy patches, etc. No archaeologically significant finds or features were observed.

Two further pits were observed at the western end of Micawber Street, on the northern side of the street, between the junction with Wharf Road and Thoresby Street. These measured 4.5m and 6.5m in length, and were excavated to *c.*0.85m in depth. The modern tarmac and concrete road-surface (300mm thick) overlay a mixed mid-dark brown clayey-silt with frequent gravel. No archaeologically significant finds or features were uncovered.

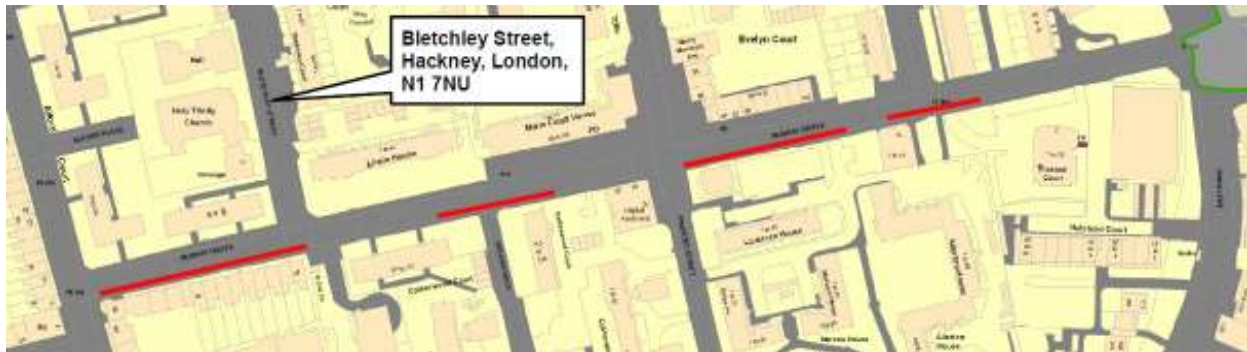
Fig. 43: Plan showing the trenching monitored on Murray Grove.

*c.*76m of open-cut trenching was observed on the southern side of Murray Grove, at its western end (running east from *c.*10m east of the junction with Shepherdess Road up to the junction with Bletchley Street). A modern road-surface (tarmac over concrete), for 0.4m in thickness, overlay mixed made-ground deposits down to the limit of excavation (*c.*0.7m beneath modern ground-surface). This was a dirty mixed silty soil, speckled with brick, clay, and concrete. No finds or features of archaeological significance were observed.

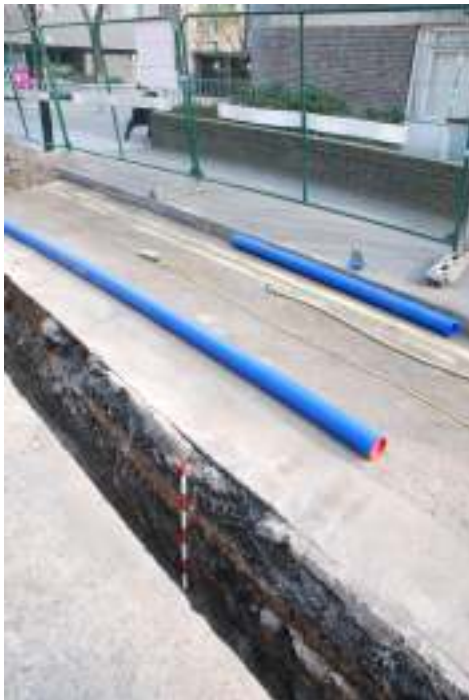
A further 40m of open-cut trenching was observed in the central part of Murray Grove, running across the junction with Britannia Walk. This revealed a modern tarmac and lean-mix road-surface; overlying a compact mid-brown-grey silty-sand with pebbles and occasional flecks of ceramic building material. This had the general appearance of relatively modern made-ground. No finds or features of archaeological significance were observed.

Fig. 44: Photograph of trenching along Murray Grove, looking south-east.

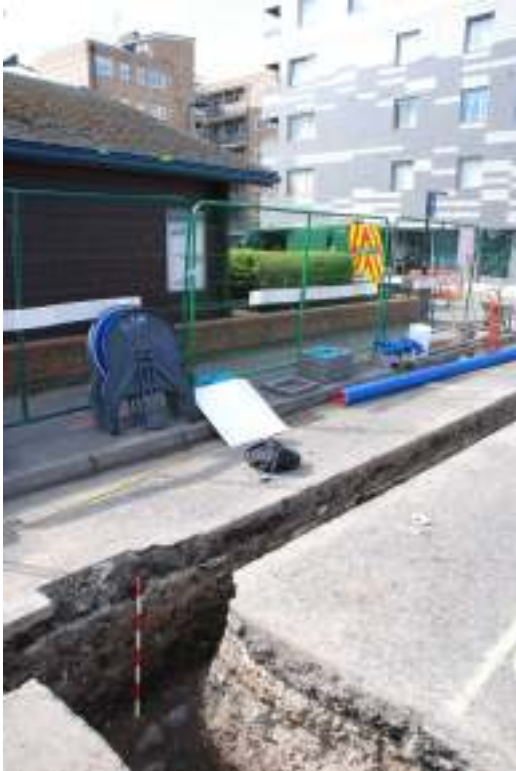
A further 60m of open-cut trenching was observed along the southern side of Murray Grove, running east from the junction with Croyley Street. The modern road-surface (tarmac over a black gravel-loam mix) overlay a large service running along the base of the trench (plus associated service backfill). This was within a general mid-brown silty-sand matrix, with frequent pebble, chalk, and ceramic building material inclusions. No finds or features of archaeological significance were observed.

Fig. 45: Photograph of trenching along Murray Grove, looking south-west.

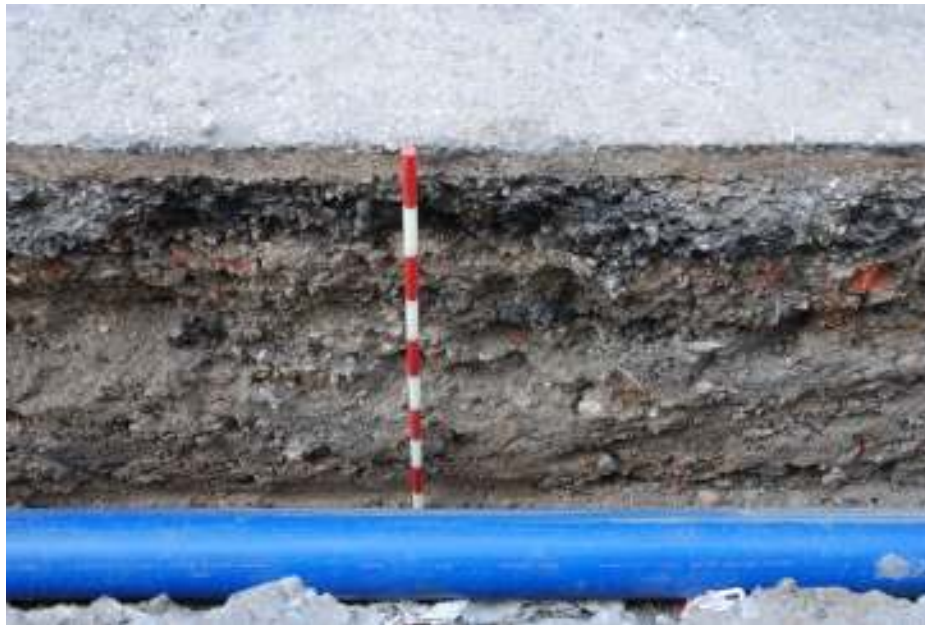
Fig. 46: Photograph of section in trenching along Murray Grove, showing the modern road-surface overlying mixed silty-sand subsoil.

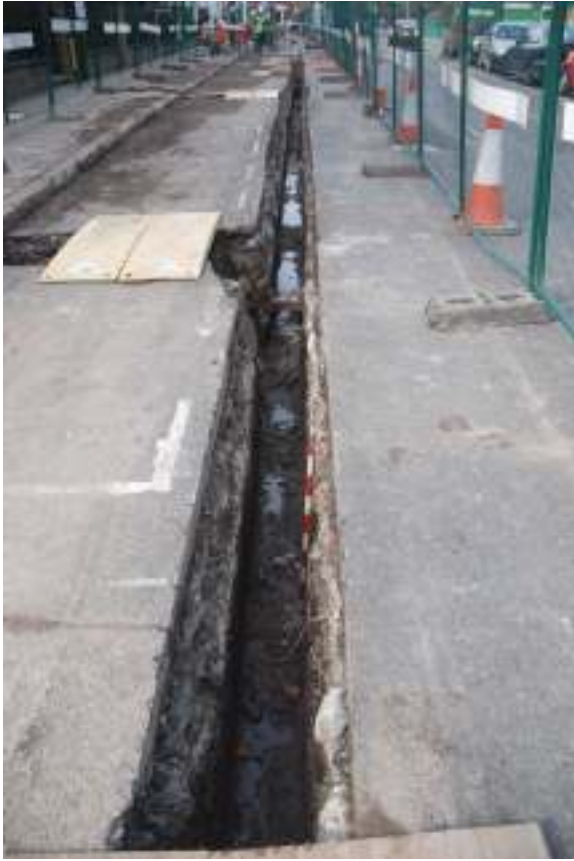
Approximately 35m of open-cut trenching was observed on the south-west carriageway of New North Road, just to the south of the junction with East Road, to a depth of 0.95m. The modern tarmac and concrete road-surface, over crushed lime mortar levelling deposits (0.5m thick in total), overlay a dark grey clay-silt deposit (a made-ground deposit), with bits of ceramic building material and gravels in, continuing to beyond the limit of excavation. Within this were two mid-18th century pieces of Chinese porcelain (context 12, see Appendix II). These are presumably residual, as there is no indication of the presence of this part of New North Road before the First Edition 25inch OS Map.

Fig. 49: Photograph of the trenching on New North Road.
