THAMES WATER MAINS REPLACEMENT

In the vicinity of the Regent's Canal and Shepherdess Walk
(AMP5, District Metering Area Crouch Hill 29)

AN ARCHAEOLOGICAL WATCHING BRIEF

SITE CODE: TXB11

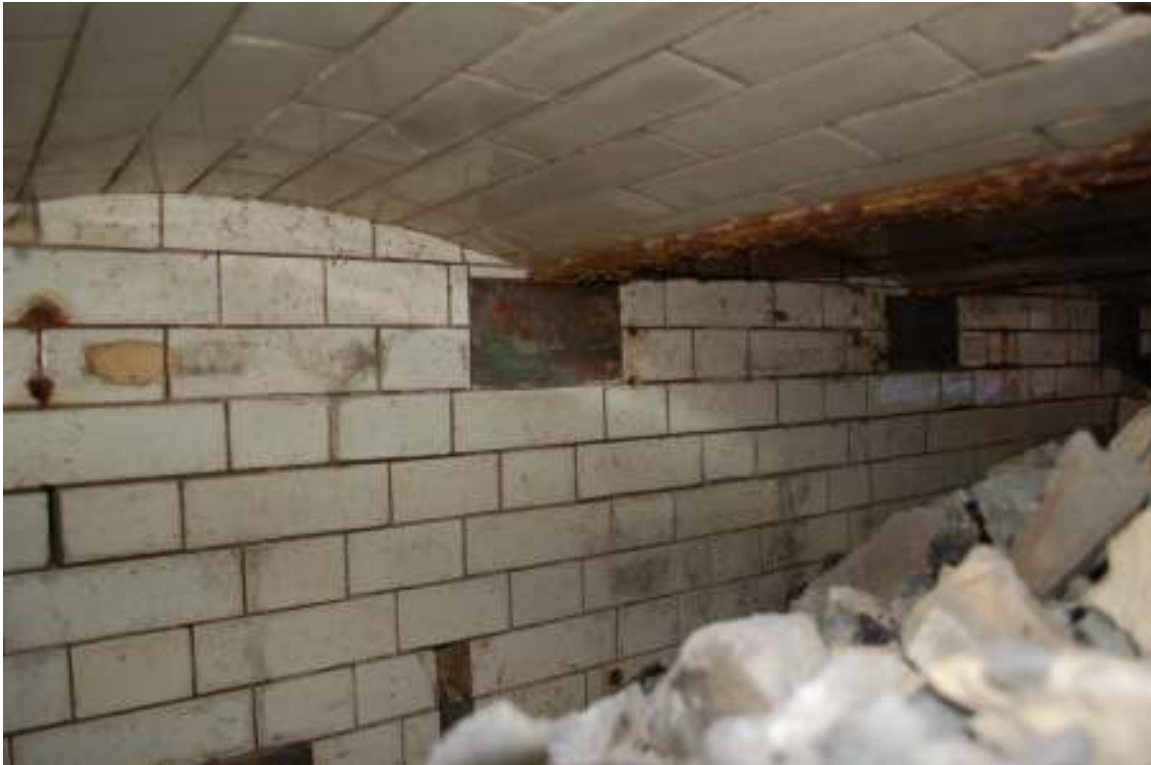
Fig. 50: Photograph of the underground toilet observed on New North Road. The vaulted ceiling, plus white-glazed bricks, are clearly visible.

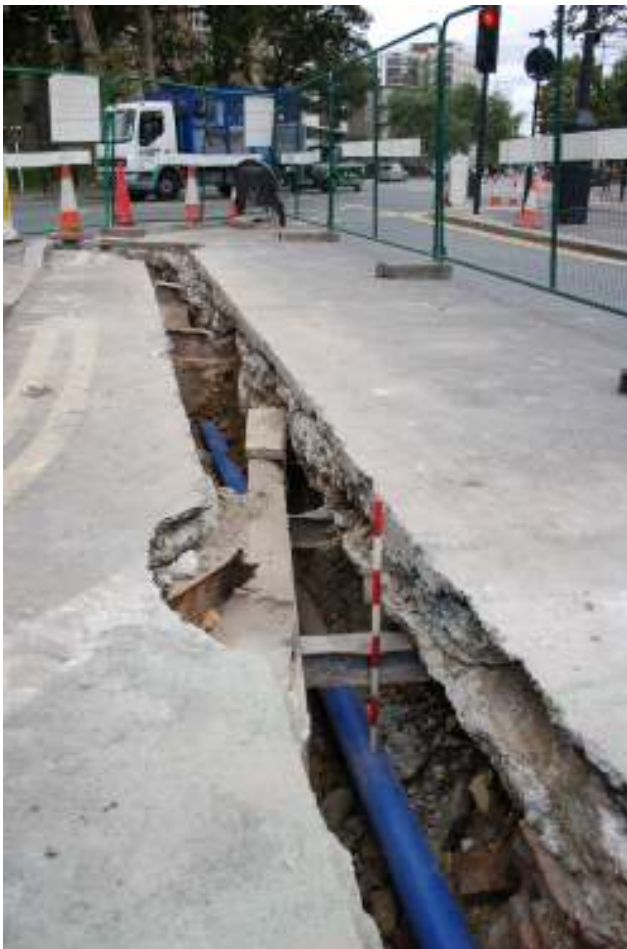
Fig. 51: Photograph of the trenching on New North Road, with the iron girders (supporting the underground toilet's roof) visible.

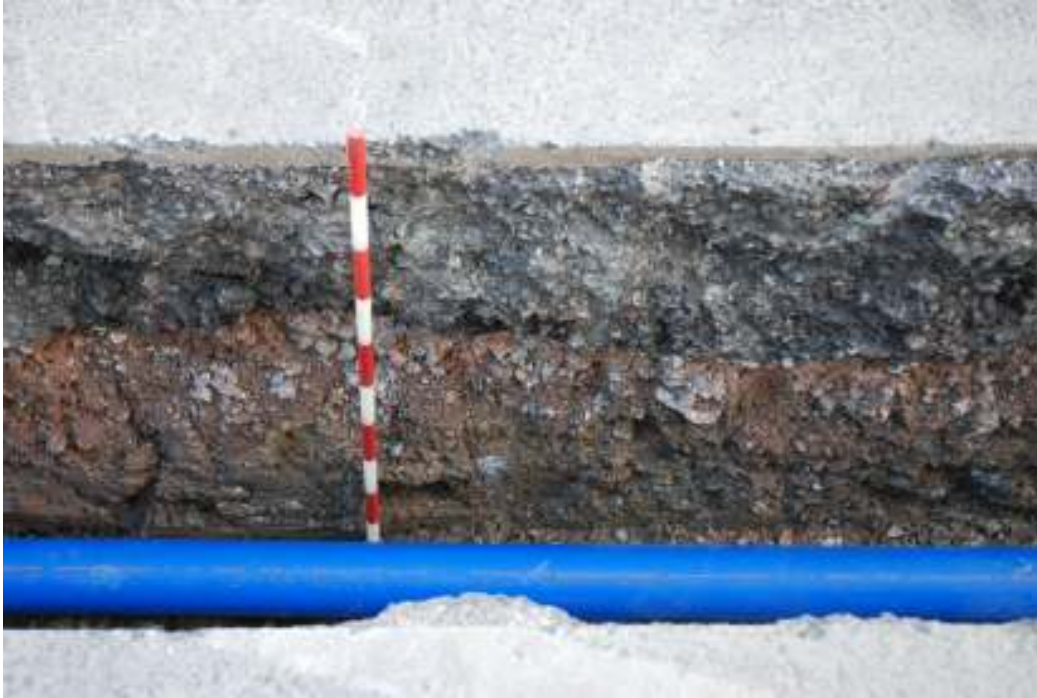
Fig. 52: Photograph of a section in the trenching along New North Road, showing the modern road-surface overlying the made-ground deposit.

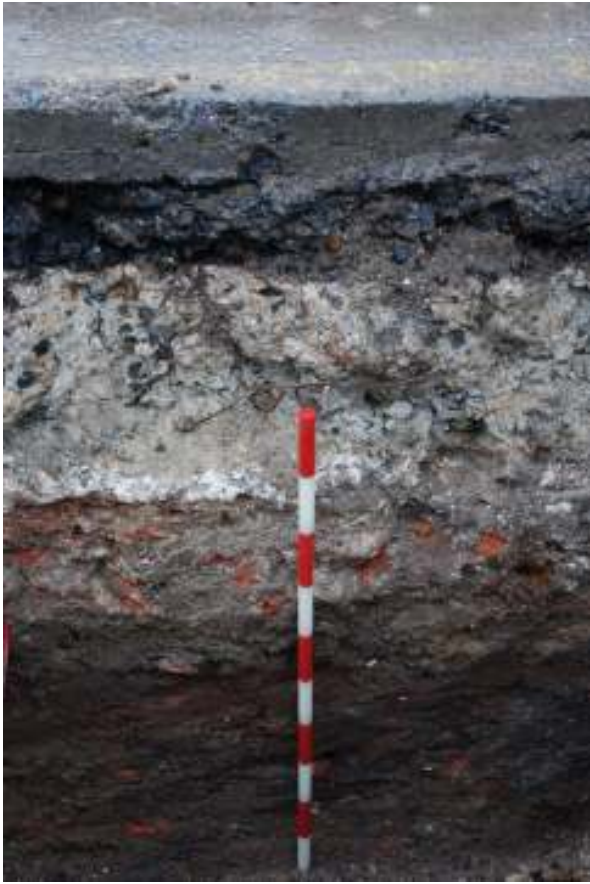
Fig. 53: Photograph of a section in the trenching along New North Road, showing the various layers of made-ground layers.

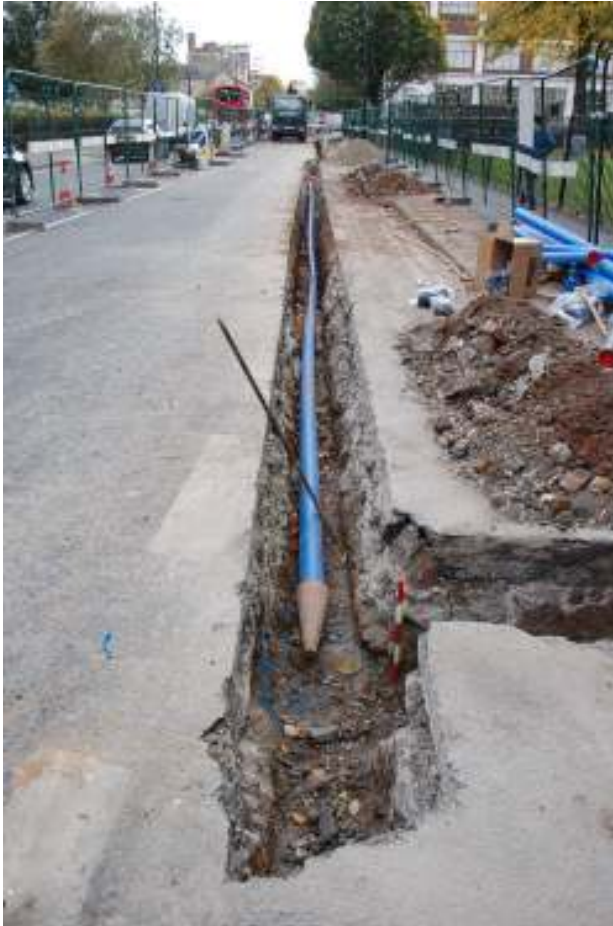
A further 60m of open-cut trenching was observed on the south-western side of New North Road, north of Wimbourne Street and running north from the trench seen previously (to a depth of 0.75m). The modern road-surface (0.5m) overlay a mid-brown silty-clay subsoil, with red brick fragments in. No archaeologically significant finds or features were noted.

Fig. 55: General photograph of the trenching on New North Road, looking south.

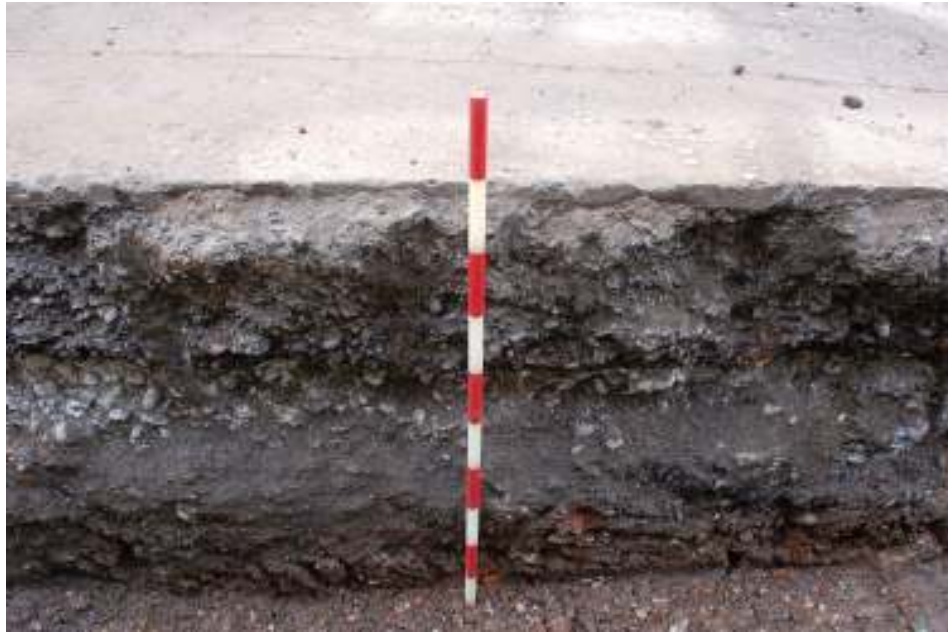
Circa 70m of open-cut trenching (approximately 0.6m in width and 1m in depth) was observed in the centre of Nile Street, running east from the junction with Shepherdess Walk to the junction with Westland Place. The modern road-surface (tarmac over concrete and various road make-up layers) overlay a number of services and associated service backfill. In some places, however, particularly in the northern section, a mid-dark-brown silty-sand deposit, with occasional ceramic building material fragments, pebbles, and mortar patches, was observed, stretching to the limit of excavation. This was a made-ground deposit.

Fig. 57: Photograph of northern section in trench on Nile Street.

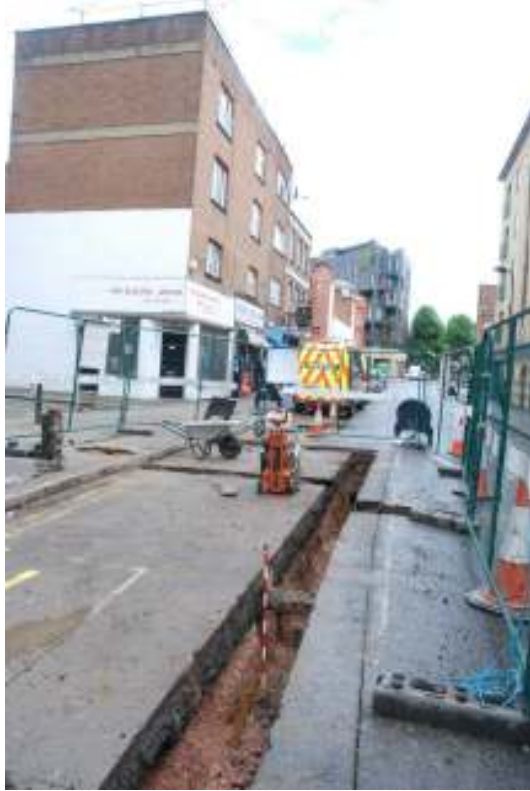
The final stretch of open-cut trenching observed along Nile Street ran east from the junction of Provost Street for 25m, up to No.65 Nile Street, and was 0.55m in width and 1m in depth. The modern road-surface (tarmac over a tar-concrete road-base) overlay disturbed deposits, disturbed by services (with associated sandy backfills), MOT Type 1 material, etc. In some places, a relatively homogeneous mid – light brown sandy-silt deposit was observed, with ceramic building material fragments and pebbles in. Nothing of archaeological significance was observed here.

Fig. 59: Photograph of trenching on Nile Street, looking east.

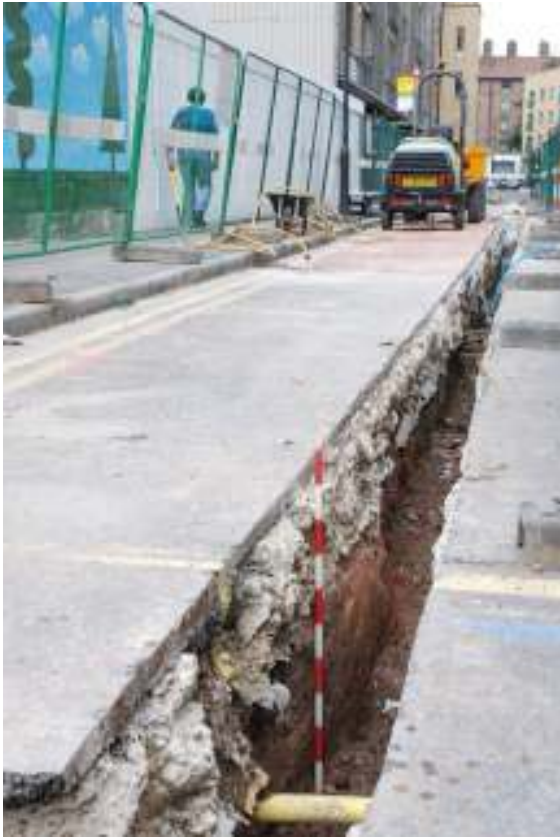
Fig. 63: Photograph of the brick wall base observed towards the southern end of Provost Street.

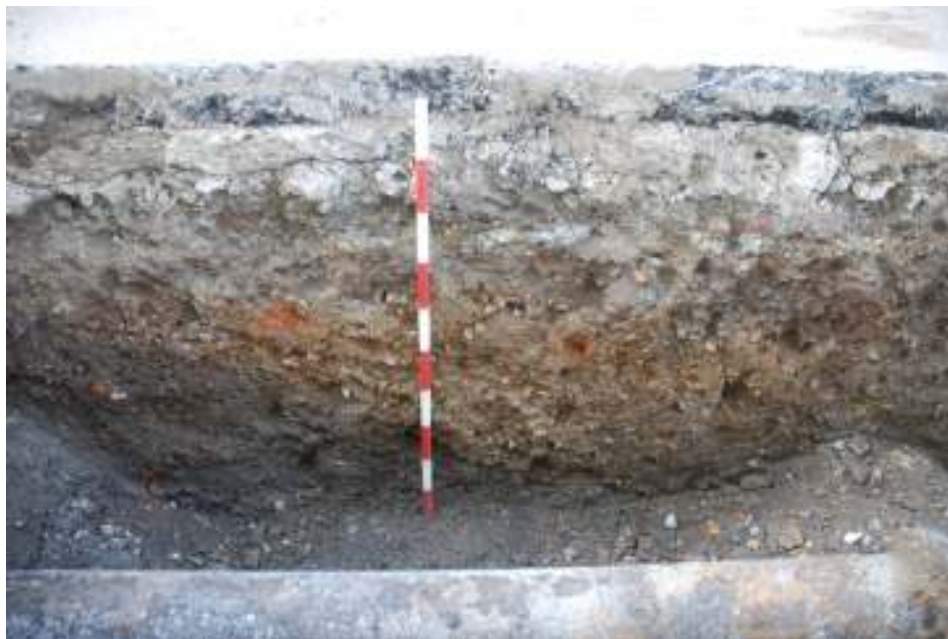
Fig. 65: Photograph of one of the pits in the northern part of Provost Street, showing the modern road-surface over mixed made-ground deposits.

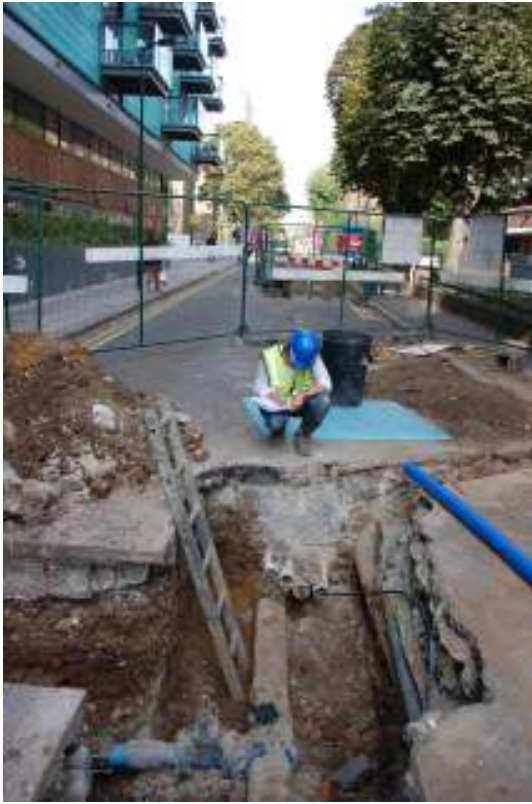
Thirteen pits were also observed in the northern part of Provost Street, between Nile Street and Murray Grove. These were of various shapes and sizes, but all dug to a depth of approximately 1.1m beneath the modern ground-surface. The modern tarmac and concrete road-base (0.46m thick) overlay mixed dumps of dark-grey silty-clay with fragments of ceramic building material, stones, and patches of orange-brown gravelly-clays. This was a mix of made-ground deposits and service backfills (most of the pits follow the route of the existing mains pipe). No finds or features of archaeological significance were observed.

Fig. 66: Photograph of an archaeologist recording one of the pits on Provost Street (looking north).

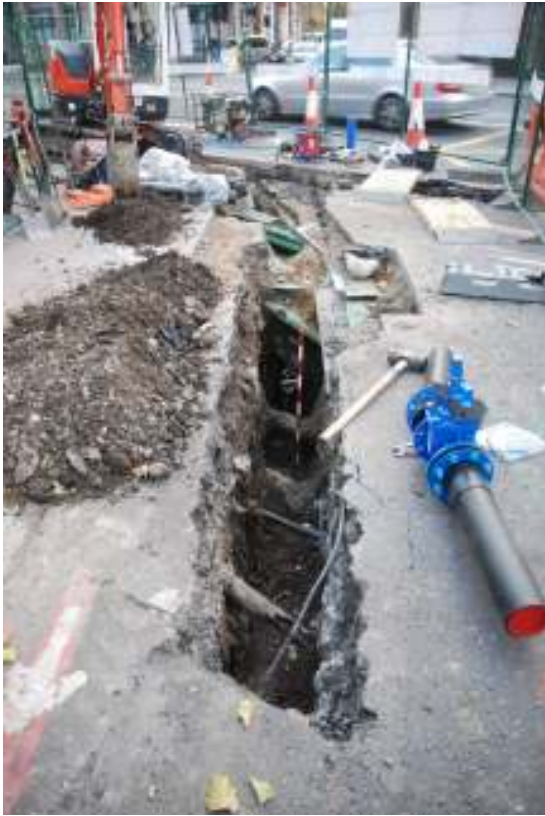
Fig. 71: Photograph of the trenching at the far southern end of Shepherdess Walk, showing modern road-surface over made-ground deposits.

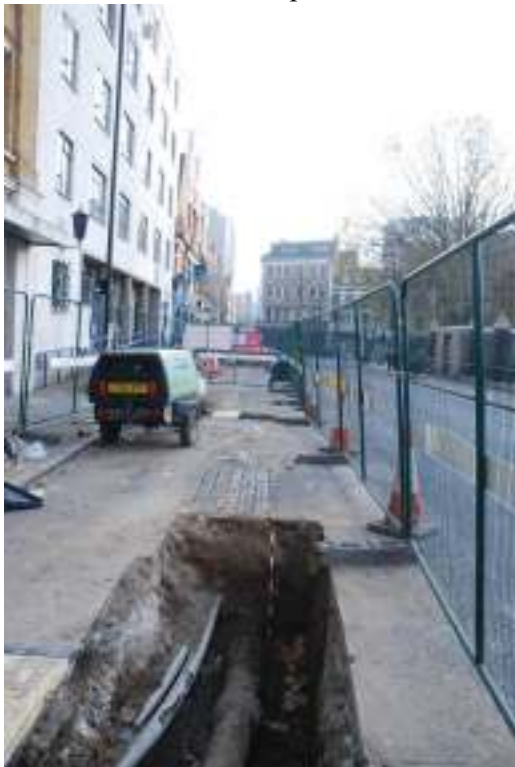
Four pits were observed on the eastern side of Shepherdess Walk, between City Road and Nile Street, and dug to depths of between 0.6m and 1.1m beneath ground-surface. The modern road-surface (tarmac over concrete – 0.4m thick) overlay mixed service backfill (grey-brown silty-sand, sandy patches, pebbles, concrete, etc). No archaeologically significant finds, features, or deposits, were observed.

Fig. 72: General photographs of the pits along Shepherdess Walk, looking south.

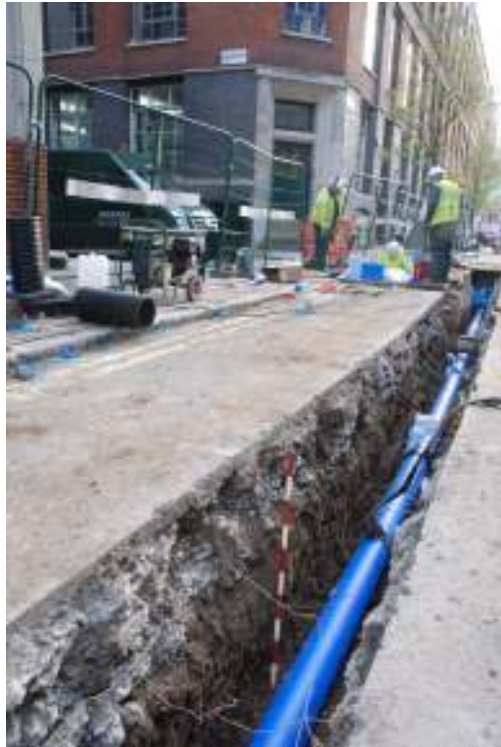
A further 12m of open-cut trenching was observed on the eastern side of Shepherdess Walk, running north from the junction with Underwood Row, and excavated to a depth of approximately 1.2m beneath modern ground-surface. A modern road-surface (tarmac over concrete) overlay a general mixed mid-light brown silty-sand with occasional pebbles, plus services and service backfill. No finds or features of archaeological significance were observed.

Fig. 73: Photograph of the open-cut trenching on Shepherdess Walk, looking south (towards Underwood Row).

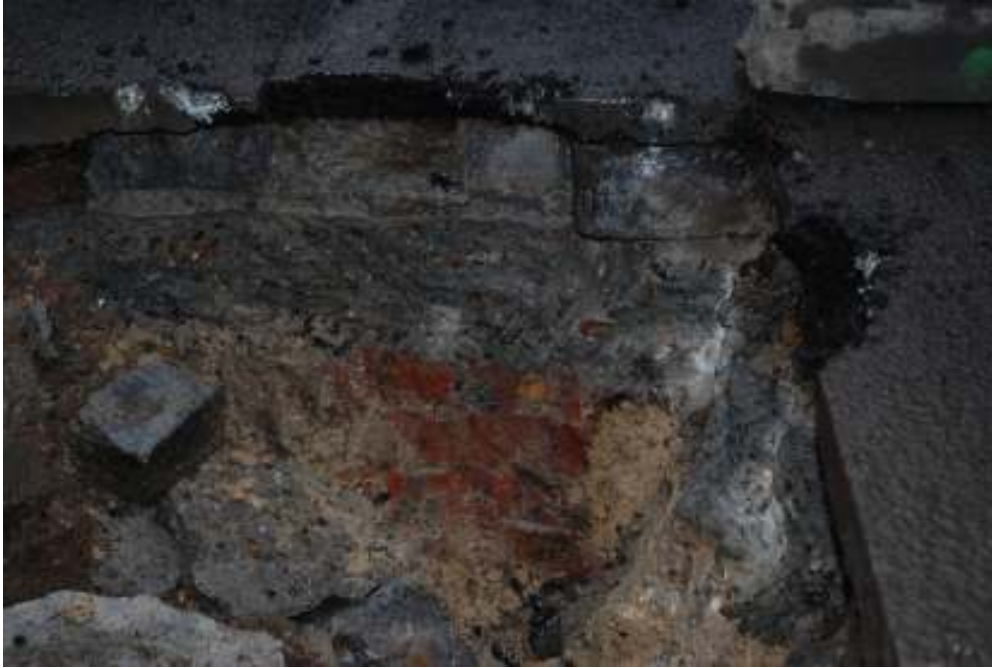
Fig. 74: Photograph of the small section of brickwork seen in the southern section of the trenching on Shepherdess Walk.

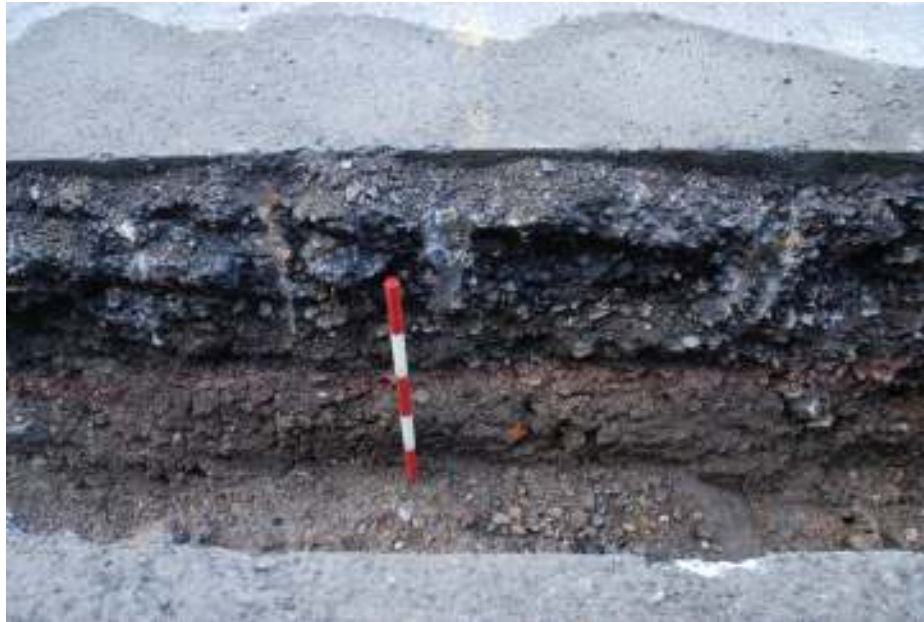
Fig. 76: Photograph of a section of the trenching on Shepherdess Walk, showing the modern road-surface overlying various road make-up layers and made-ground deposits.

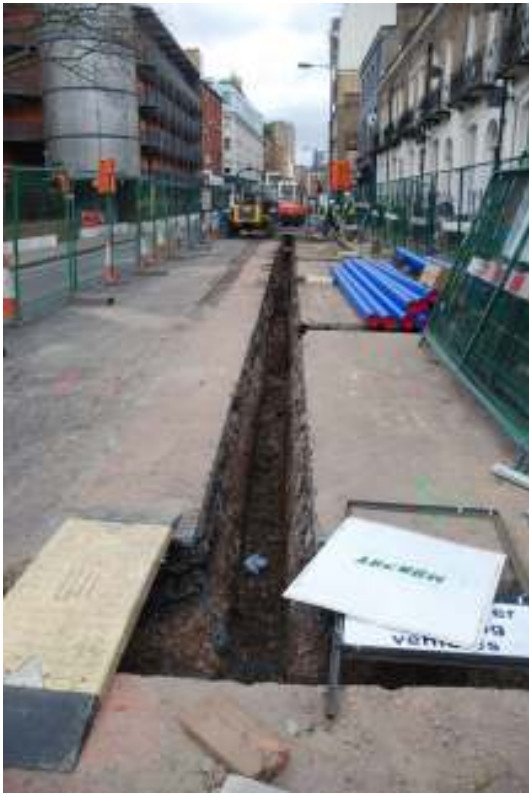
35m of open-cut trenching was observed on the western side of Shepherdess Walk, running between Micawber Street and Alford Place, and excavated to a depth of approximately 1.05m. The modern road-surface (tarmac over MOT Type 1 material – c.0.65m thick) overlay a dark grey/brown clay-silt, containing occasional ceramic building material fragments and gravels. No archaeologically significant finds or features were observed.

Fig. 77: Photograph of trenching on Shepherdess Walk, looking south.

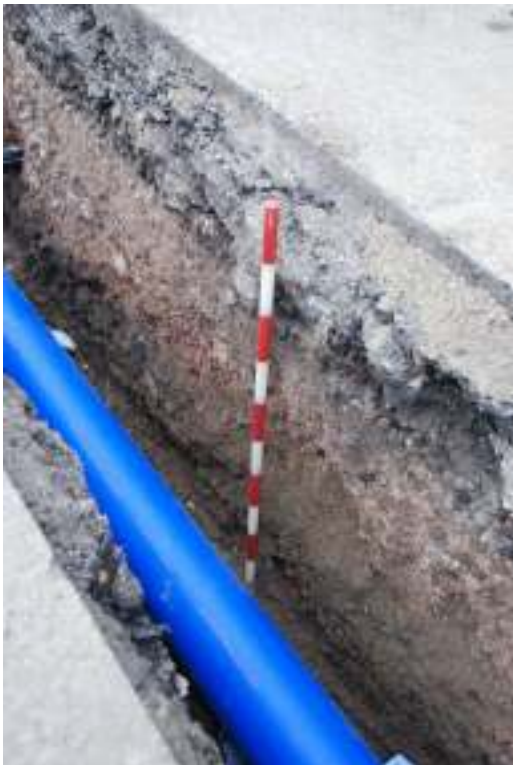
A further *c.*30m of open-cut trenching was observed on the western side of Shepherdess Walk, running along between 21 to 35 Shepherdess Walk, and excavated to a depth of *c.*1.1m. A modern road-surface (tarmac over concrete over MOT Type 1 material – 0.8m thick) overlay a light brown sandy silty subsoil, with flecks of chalk and occasional fragments of red brick, for *c.*0.3m (to the limit of excavation). This appears to be a reworked natural deposit – possibly a plough-soil. This makes sense as this northern area was open land before the construction of Shepherdess Walk.

Fig. 78: Photograph of a section of the trenching along Shepherdess Walk, showing the modern road-surface and road make-up deposits, overlying the lighter subsoil.

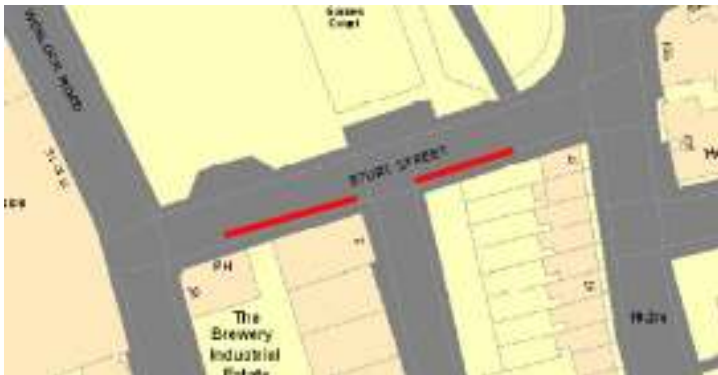
Fig. 79: Plan showing the trenching monitored on Sturt Street.

Two stretches of open-cut trenching (measuring 10.5m – eastern section; and 12.8m – western section; by c.0.5m in width by c.1m in depth) were observed on the southern side of Sturt Street. The modern tarmac and concrete road-surface overlay a large yellow gas main, alongside general silty fill. Nothing of archaeological significance was observed.

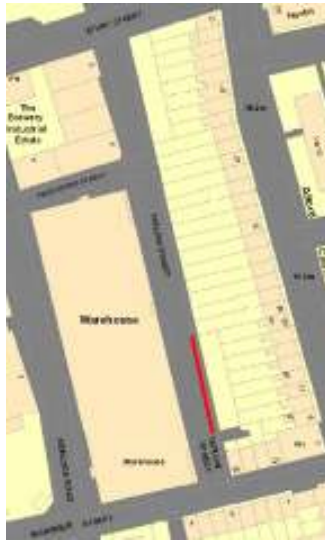
Fig. 80: Plan showing the trenching monitored on Taplow Street.

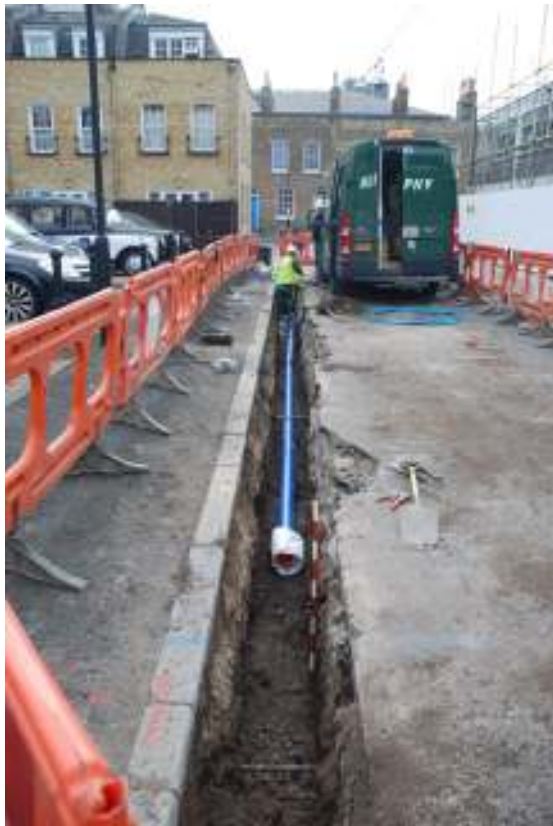
18m of open-cut trenching was observed on the eastern side of Taplow Street, just north of Micawber Street (along the line of the car-parks). A modern road-surface (tarmac over gravel and concrete – 0.5m thick) overlay a dark brown / black silty soil, with crushed red brick and mortar (from 0.75m beneath ground-surface). This is probably an earlier buried soil horizon, but contained no archaeological features or finds.

Fig. 81: General photograph of the trenching along Taplow Street.

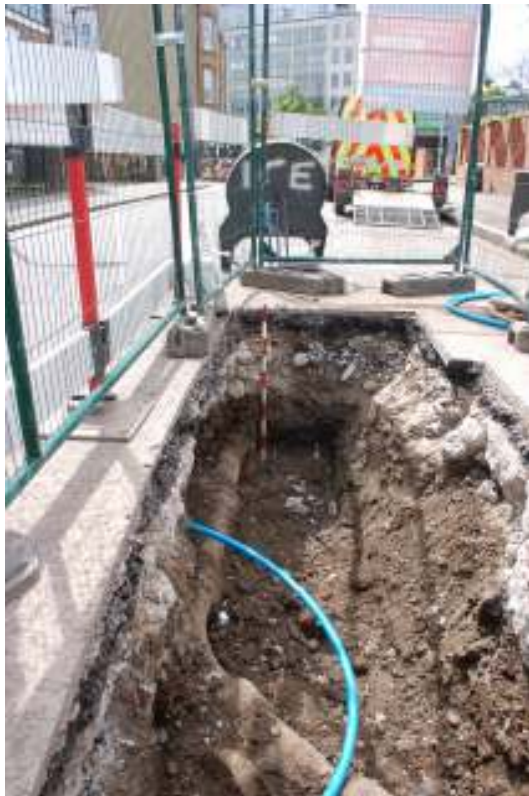
Fig. 83: Photograph of pit on Thoresby Street, showing the large watermain and disturbed deposits.

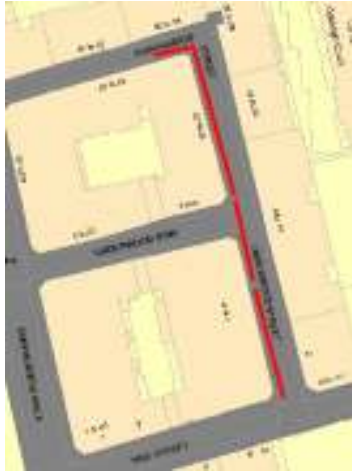
Fig. 84: Plan showing the trenching monitored on Underwood Street.

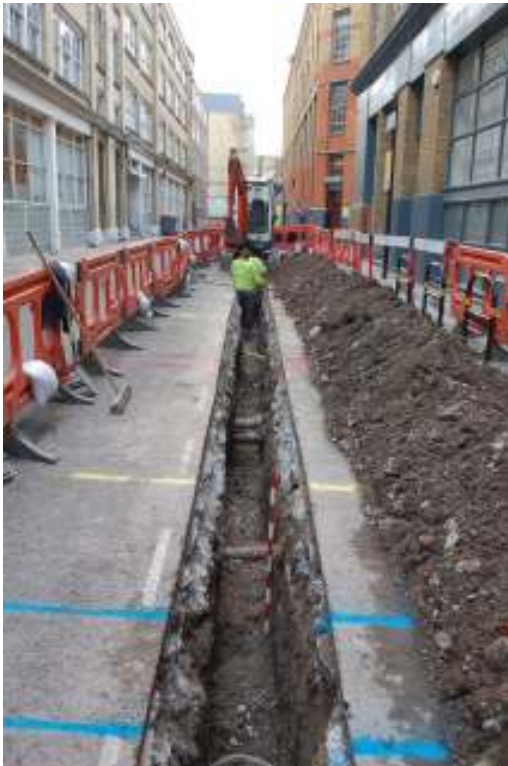
A 35m stretch of open-cut trenching was observed on the western side of Underwood Street, running north from the junction with Underwood Row (0.6m in width and 0.95m in depth). The modern tarmac and concrete road-surface overlay east-west aligned services (and associated service backfills), within a general mid-light brown silty-sand made ground deposit, with occasional pebbles, ceramic building material fragments, and mortar patches.

Fig. 85: Photograph of trenching on Underwood Street, looking south.

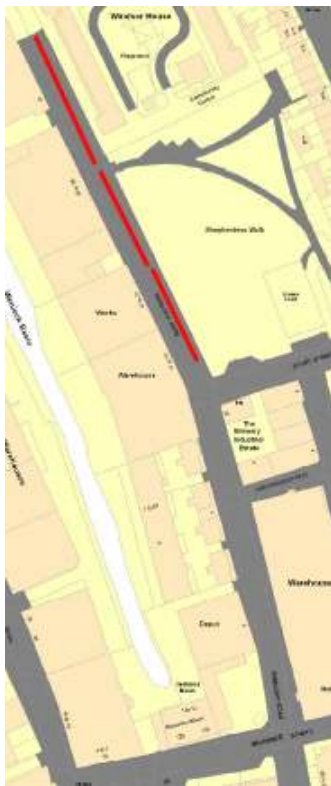
Fig. 87: Photograph of section in trenching along Wenlock Road, northern end.

Fig. 86: Plan showing the trenching monitored on Wenlock Road.

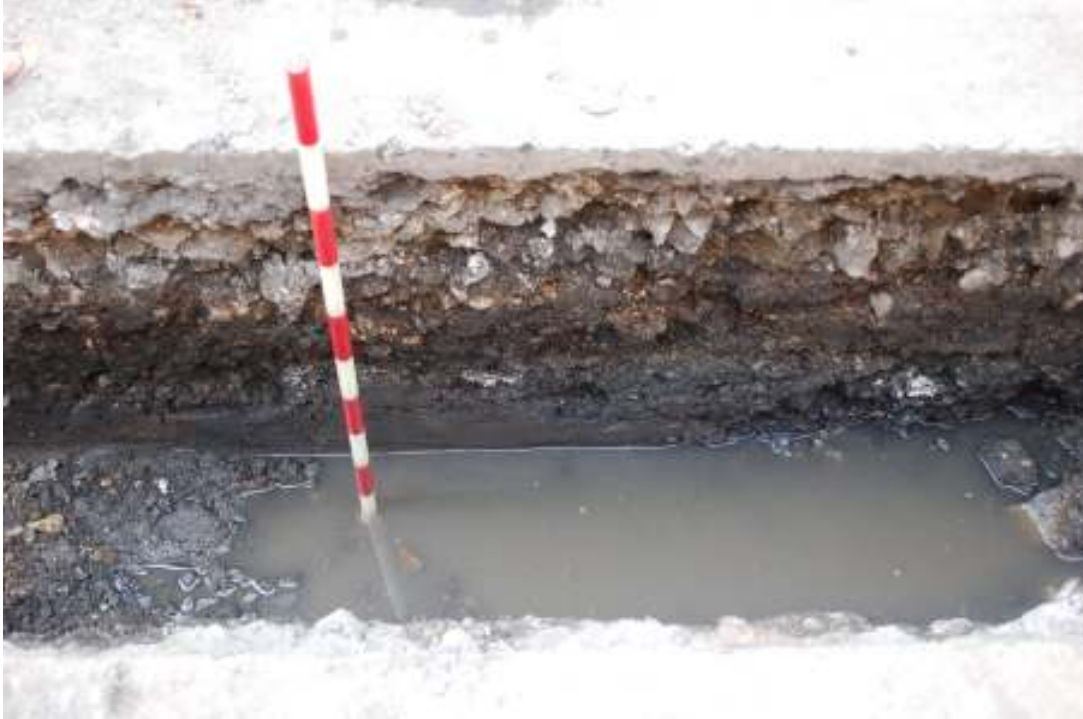
Another 35m of trenching was observed on the eastern side of Wenlock Road, running north from the northern end of Shepherdess Walk Park up to the end of the road. The modern tarmac and concrete road-base overlay numerous layers of made-ground deposits, mainly silts and gravels. The basal fill is a thick black organic clay-silt, which is thicker at its northern end. It is possible that this is associated with the creation of the canal basins in this area in the early 19th century.

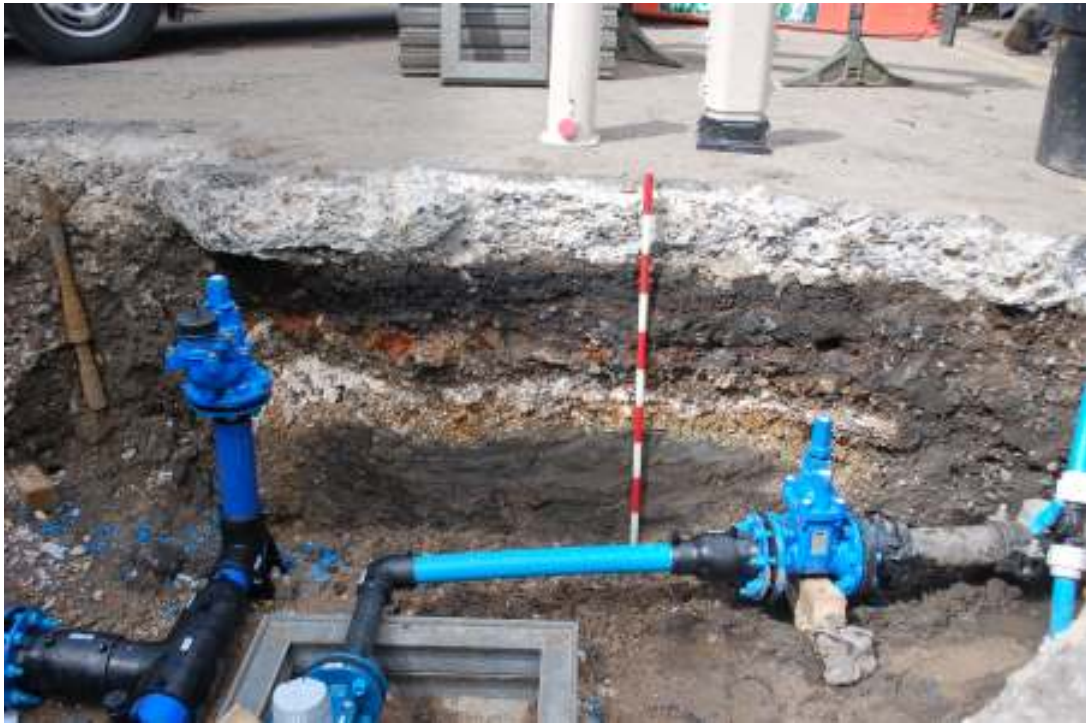
Fig. 88: Photograph of pit at far northern end of Wenlock Road, showing various made-ground layers over blue / black alluvium.

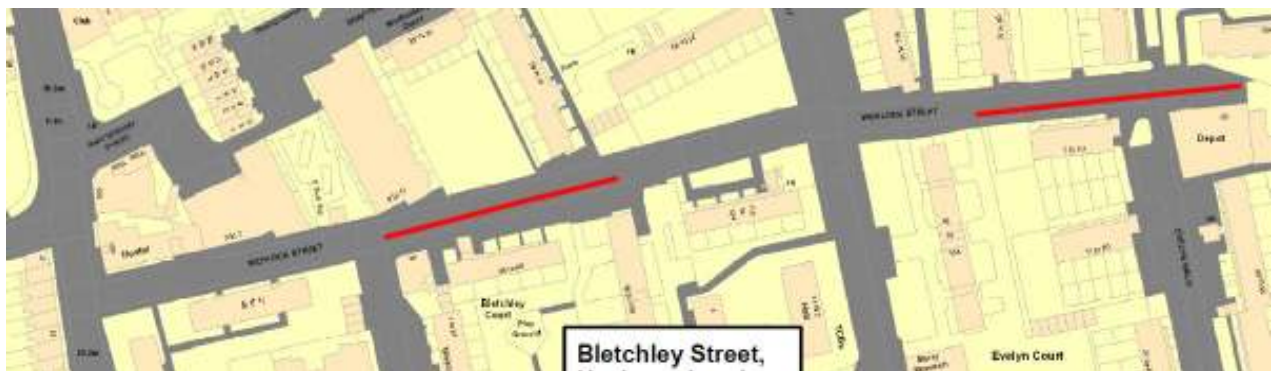
Fig. 89: Plan showing the trenching monitored on Wenlock Street.

43m of east-west trenching was observed in the central part of Wenlock Street, running east from the junction with Bletchley Street, and dug to a depth of 1.1m. The modern tarmac and concrete road-surface overlay service backfill / made-ground deposits (a mid grey-brown sandy clay deposit, with frequent ceramic building material and mortar fragments); with no finds or features of archaeological significance observed.

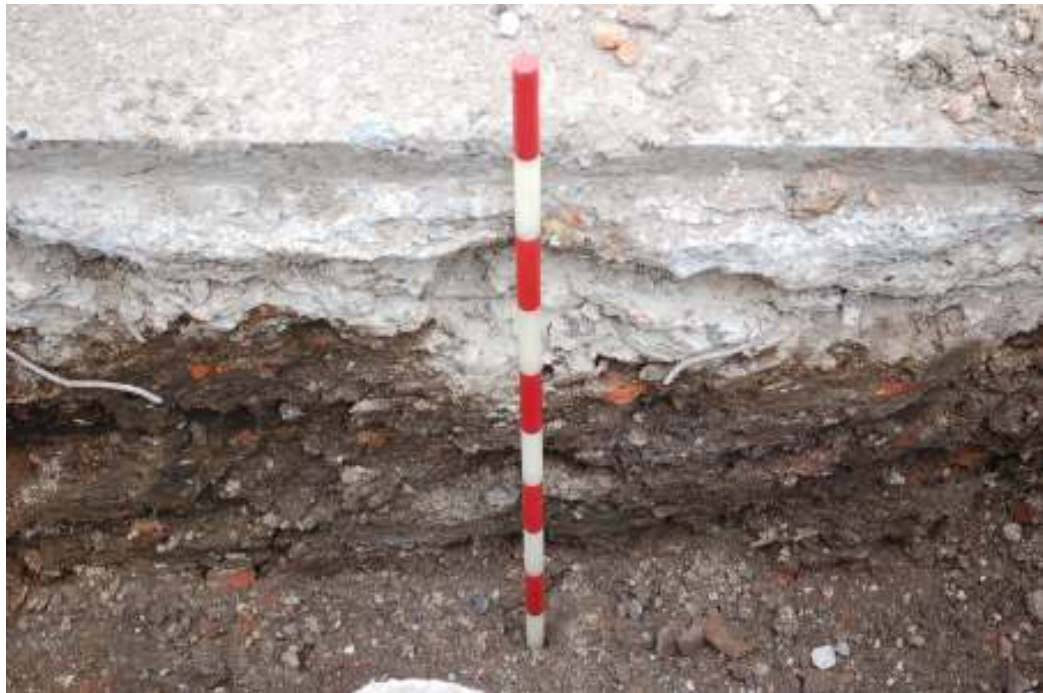
Fig. 90: Photograph of a section in the trenching on Wenlock Street, showing the modern road-surface overlying made-ground deposits.

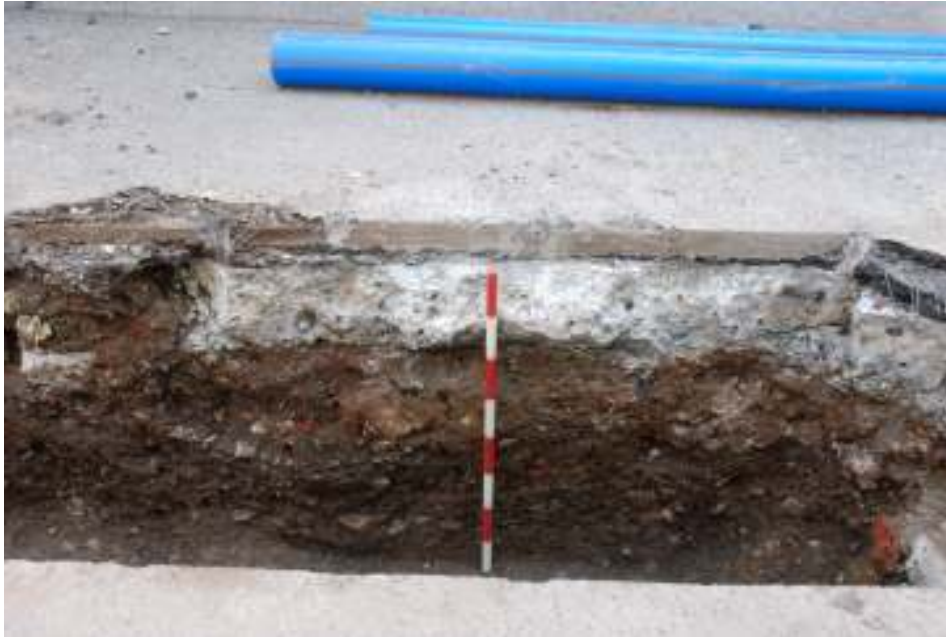
Fig. 92: Photograph of a section in the trenching on Wenlock Street, showing the modern road-surface overlying silty-sand made-ground deposits over more compact clayey deposits.

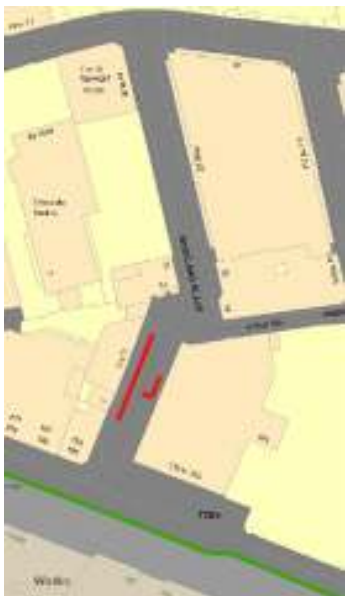
Fig. 93: Plan showing the trenching monitored on Westland Place.

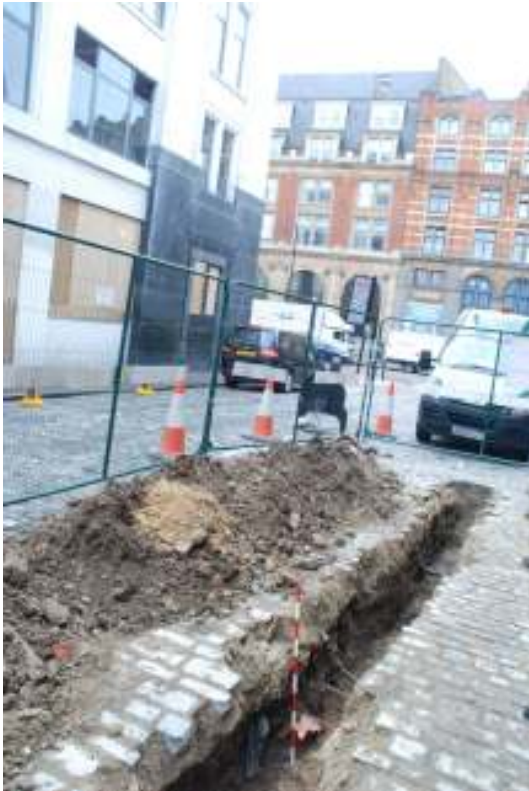
One stretch of open-cut trenching was observed on the western side of Westland Place, just north of City Road. This measured 15m in length, by 0.6m in width, by 0.8m in depth. The modern road-surface (cobble over sand bedding in this case) overlay heavily disturbed deposits (a loose mixed silty deposit, with sandy patches and fragments of ceramic building material and pebbles) – disturbed by gas mains and other services. Nothing of archaeological significance was observed.

Fig. 94: Photograph of trenching on Westland Place, looking south.

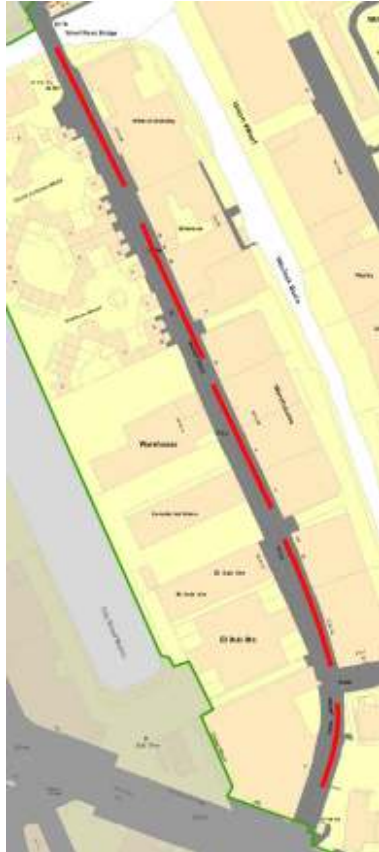
Fig. 95: Plan showing the trenching monitored on Wharf Road.

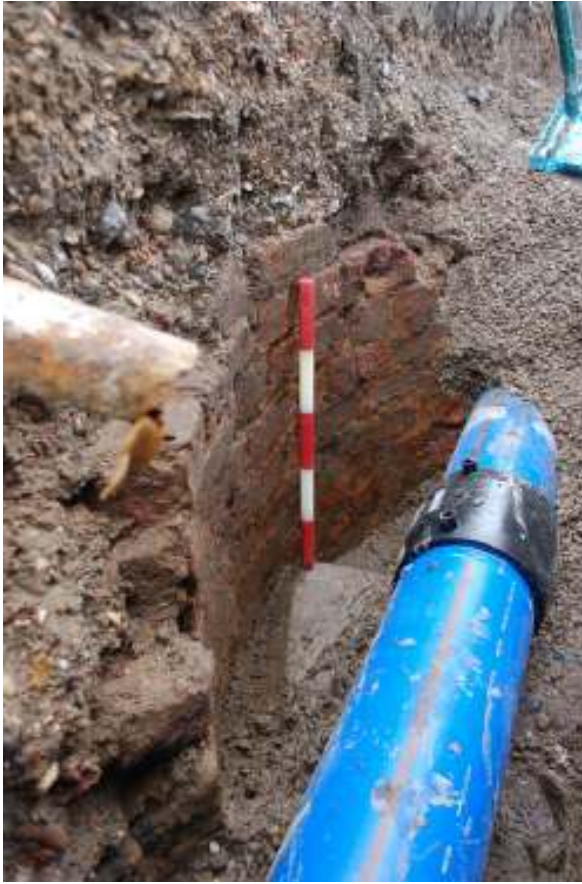
Fig. 96: Photograph of a brick lined soakaway observed in trenching on Wharf Road.

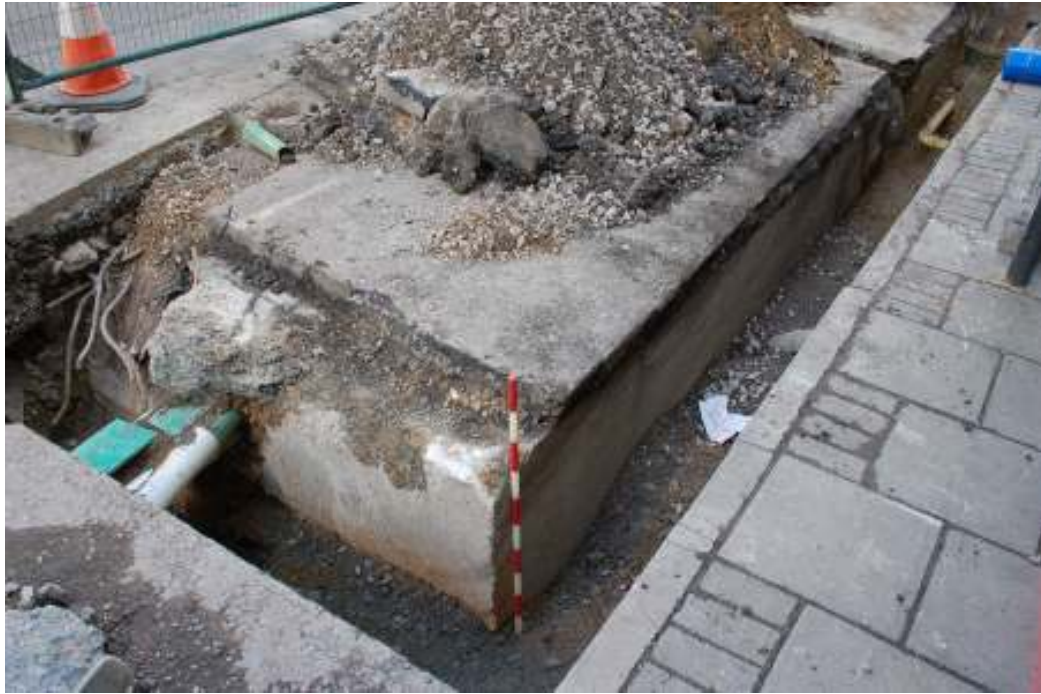
Fig. 97: Photograph of the modern basement slabs observed in the northern end of the trenching on Wharf Road.

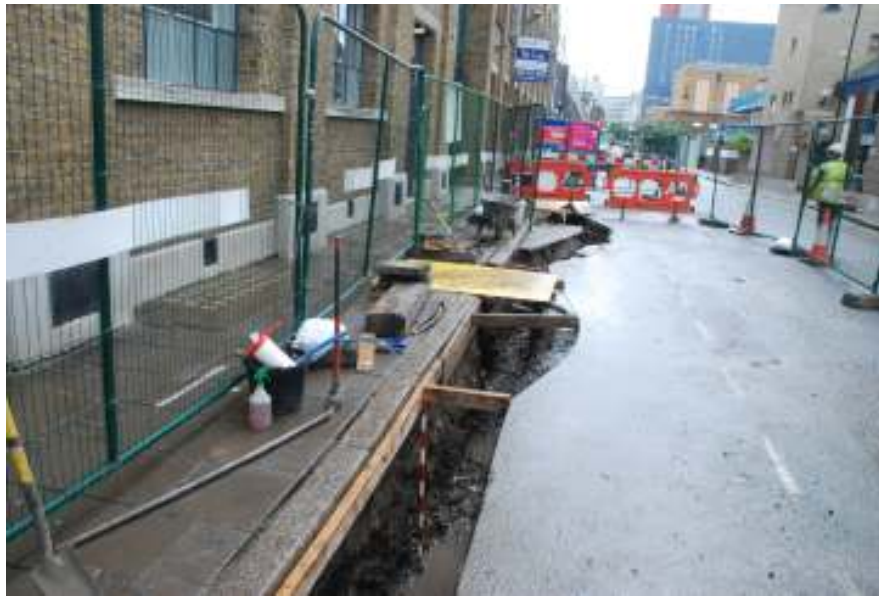
30m of open-cut trenching was observed on the eastern side of Wharf Road, between No.44 and No.48 Wharf Road (0.5m wide and 1m deep). The modern road-surface (tarmac over granite setts over concrete in places, and tarmac over a stoney road-base in other places) overlay a general loose mixed disturbed silty-sand deposit, with stones, ceramic building material fragments, mortar patches, etc, in. This trench had also been disturbed by services (service fills were noted in several places), and more heavily disturbed by lumps of concrete / modern brick rubble, *etc.*

Fig. 98: General photograph of trenching on Wharf Road, looking south.

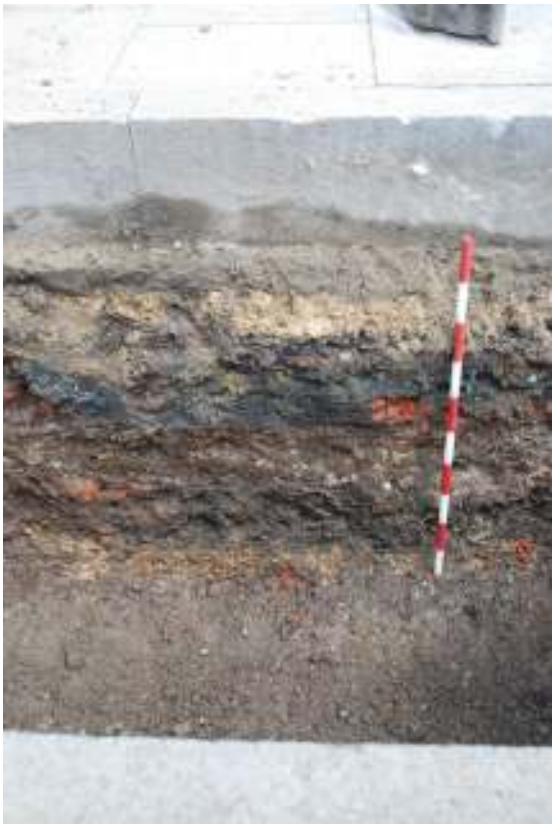
Fig. 99: Photograph of western section in trenching on Wharf Road, showing the various made-ground deposits.

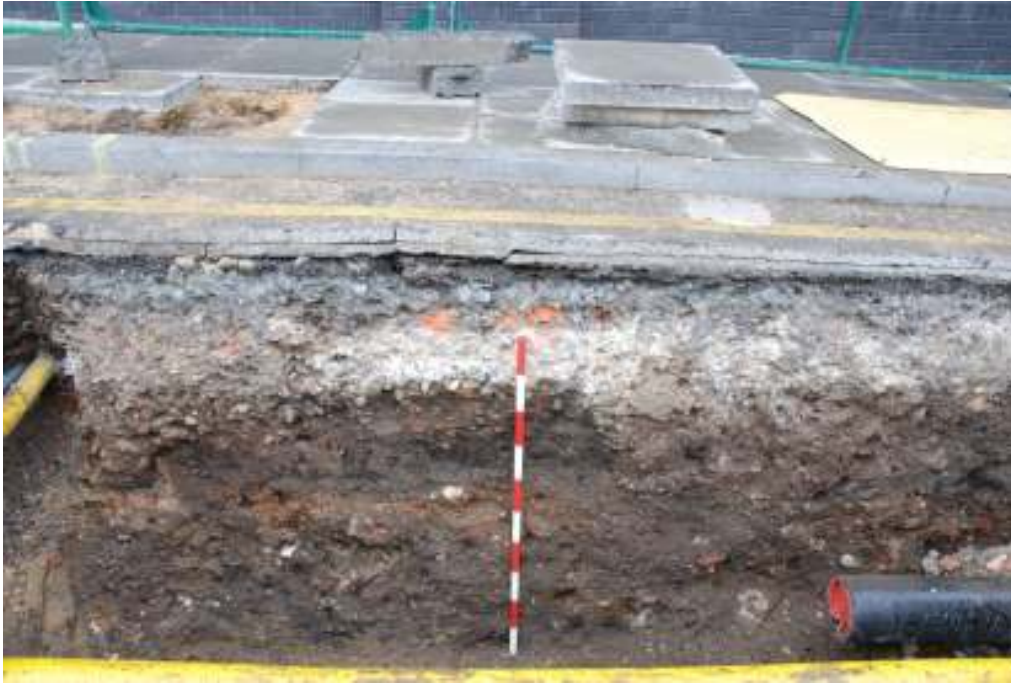
The final stretch of trenching observed on Wharf Road consisted of c.47m of open-cut trenching at the far northern end of the road, running up to the bridge (0.5m wide and 1.1m deep). 0.25m of tarmac over concreted gravels overlay c.0.8m of largely homogeneous grey-brown silty-clays, containing gravels and some crushed ceramic building material fragments (although the western side of the trench had been heavily disturbed by an existing gas-main). This was presumably upcast and made-ground deposited when the canal bridge was constructed, although far less stratified than that seen in the previous trench.

Fig. 100: Photograph of eastern section in trenching at far northern end of Wharf Road.

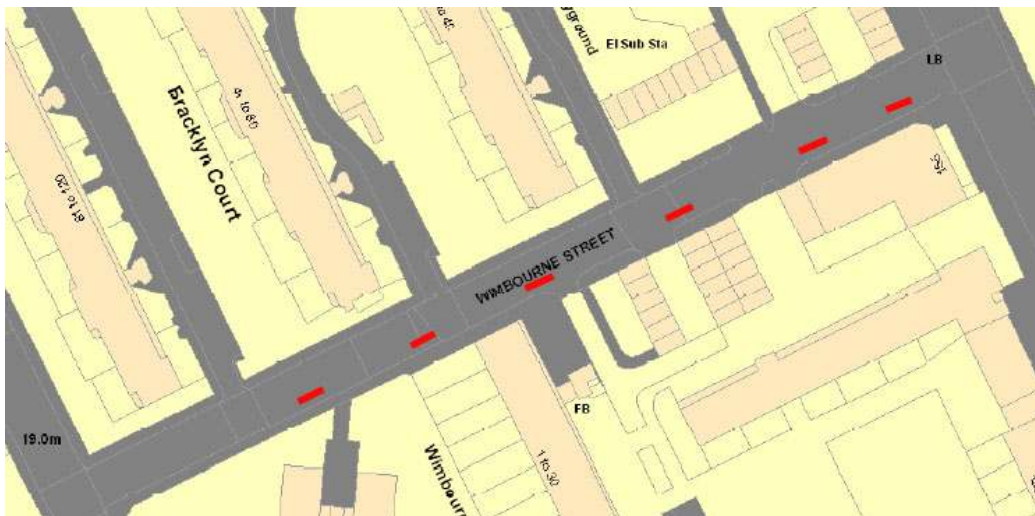
Fig. 101: Plan showing the trenching monitored on Wimbourne Street.

Six pits were observed on the southern / central side of Wimbourne Street, between the junction with New North Road and Cropley Street (excavated to approximately 1.1m beneath modern ground-surface). The modern road-surface overlay mixed deposits – pebbly deposits, ceramic building material, silty-sand deposits, mortar layers, etc. This was all very mixed, with no clear stratigraphy and no archaeological features were noted.
