**An underground structure in Petersham Playground
Richmond Park,
London Borough of Richmond-Upon-Thames**

A Level 2 Historic Building Survey

September 2012

COMPASS ARCHAEOLOGY LIMITED
5-7 SOUTHWARK STREET
LONDON SE1 1RQ

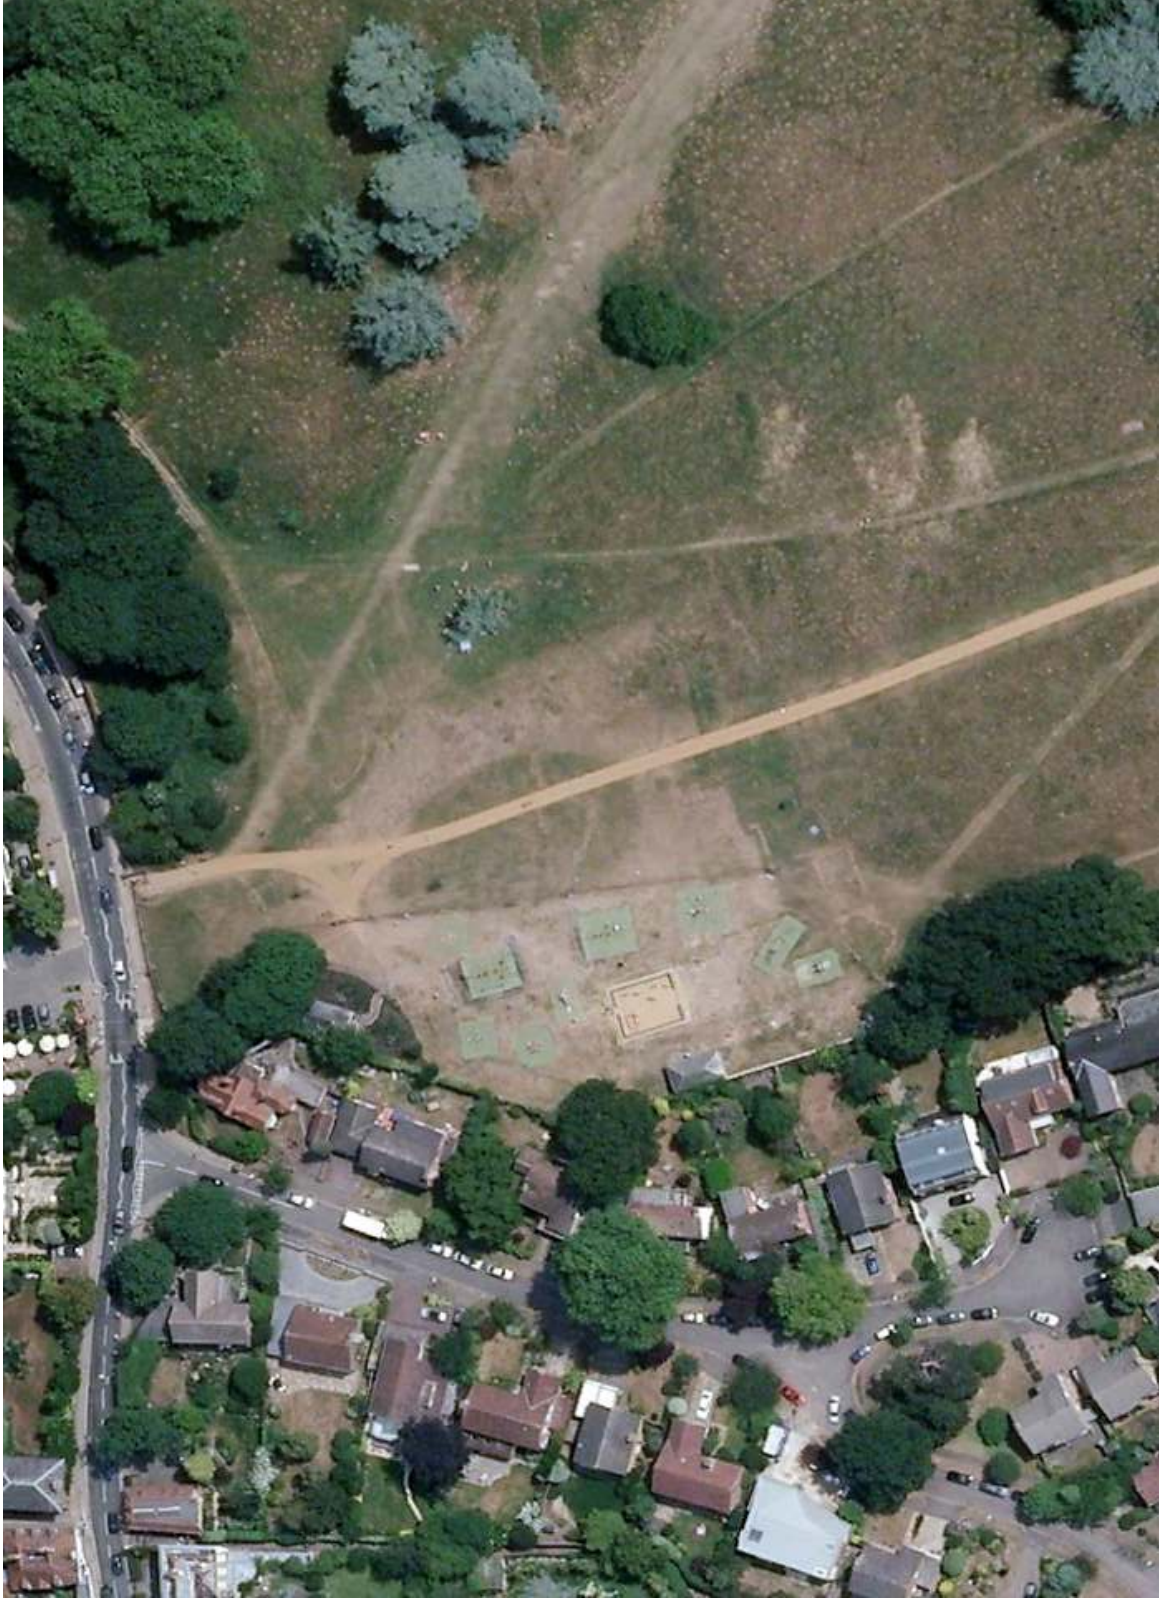
Fig.11: An aerial image of Petersham playground, extracted from Google Earth, showing the extensive parch marks associated with Petersham Lodge

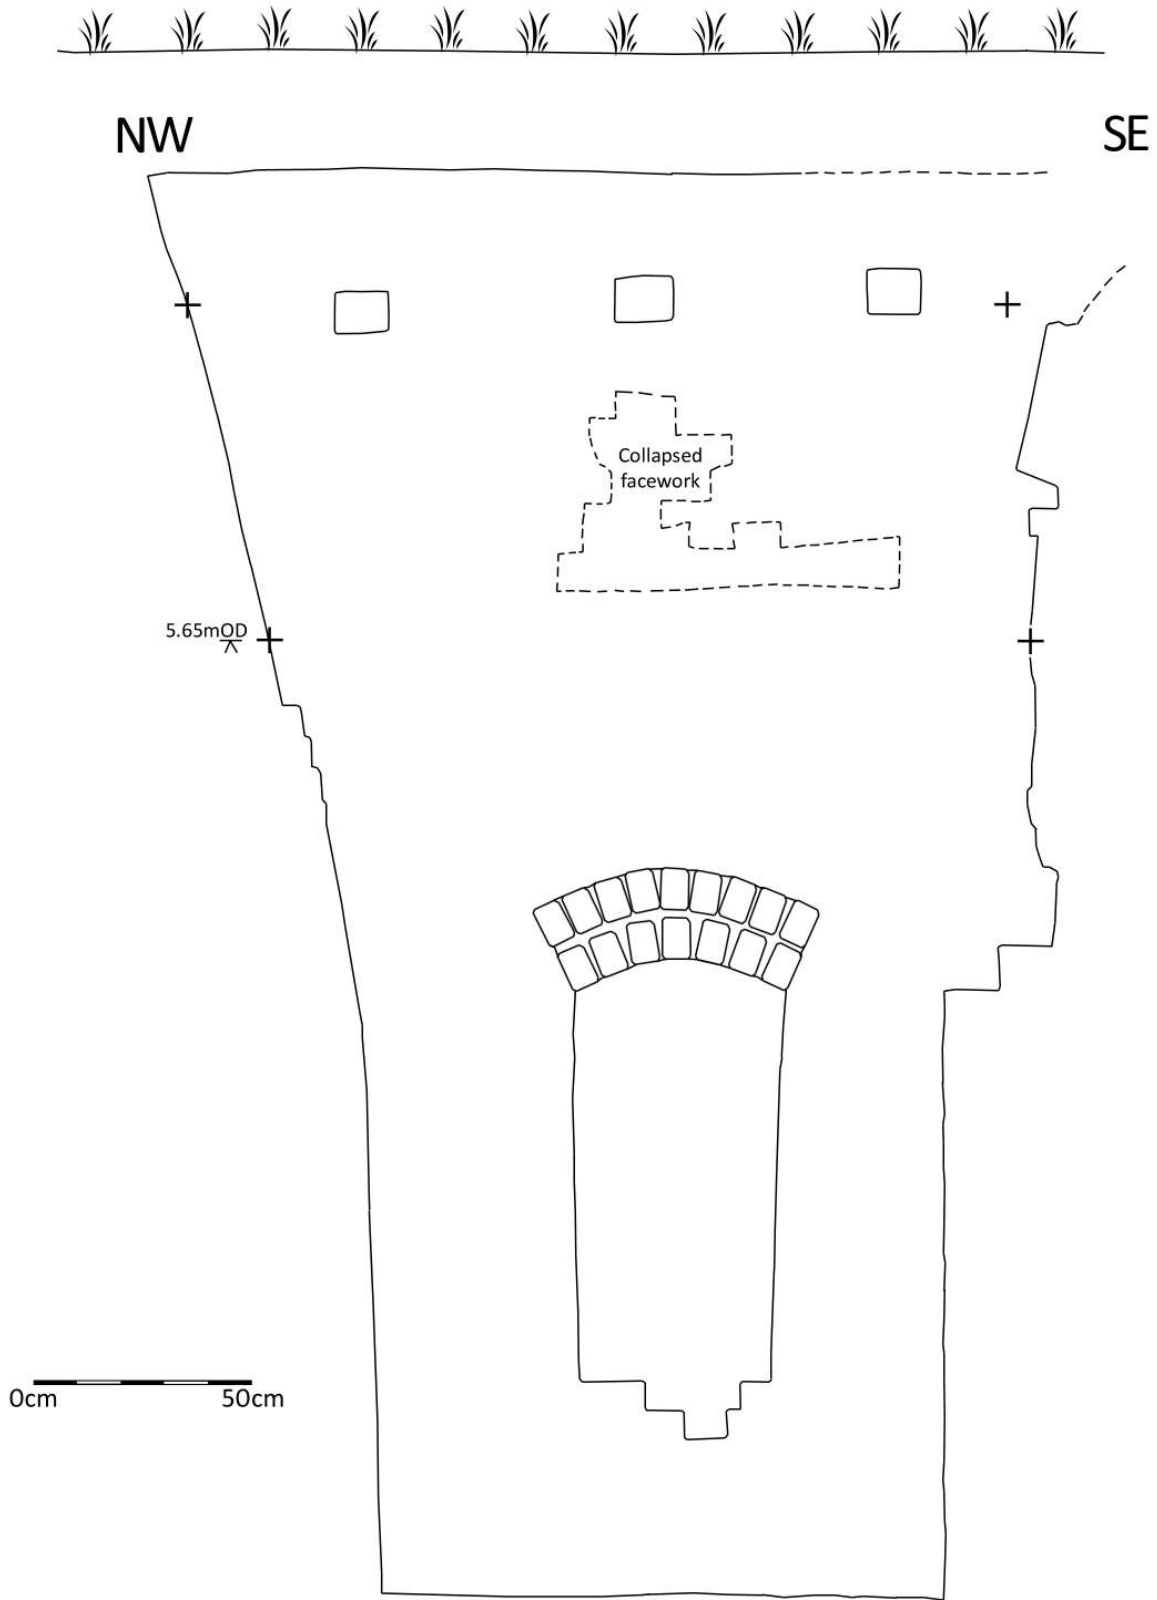
Fig.15: Elevation 5 North Eastern wall of structure

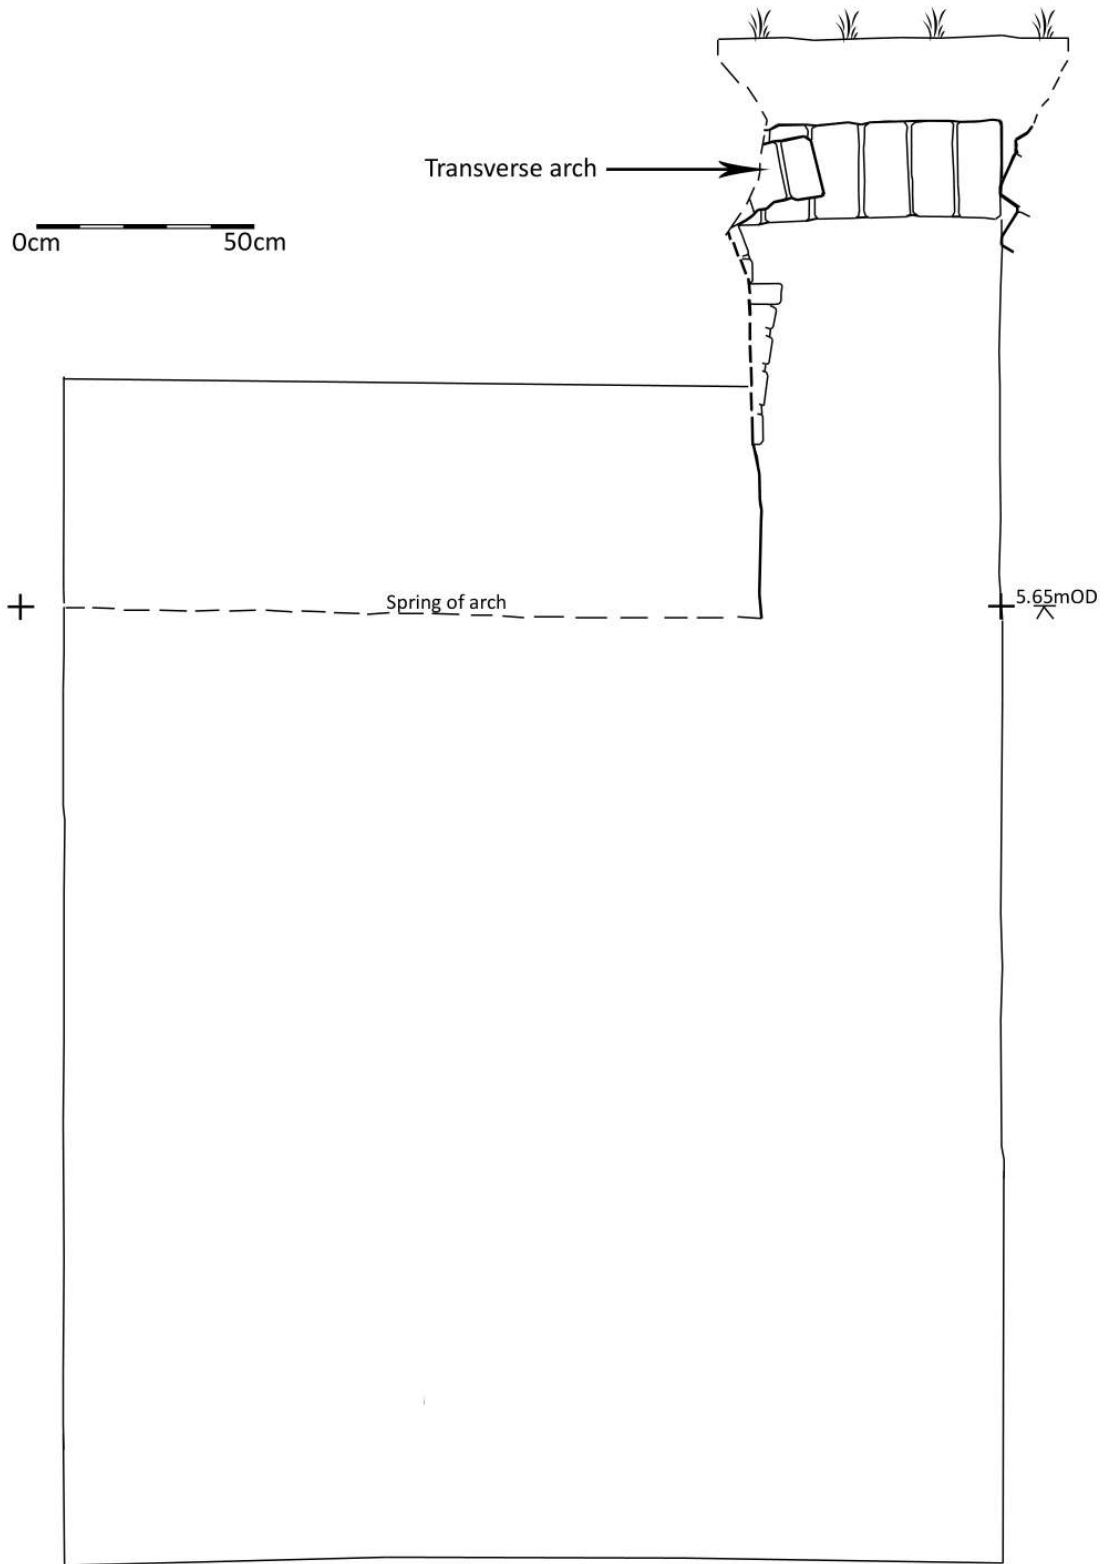
Fig.16: Elevation 2 North western wall of structure

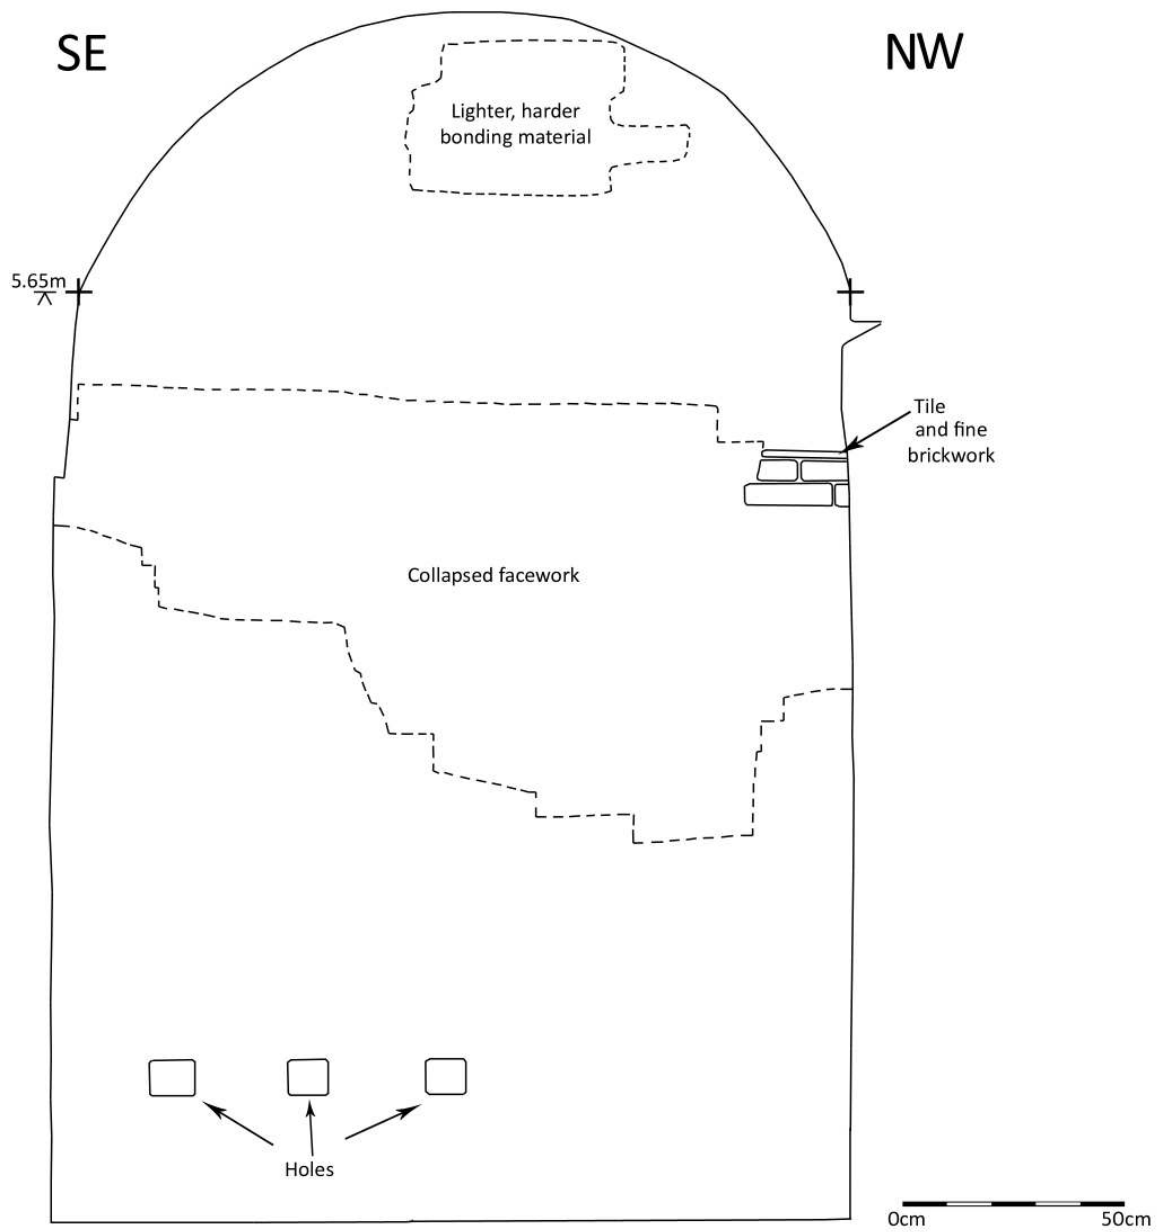
Fig.17: Elevation 3 South western wall of structure

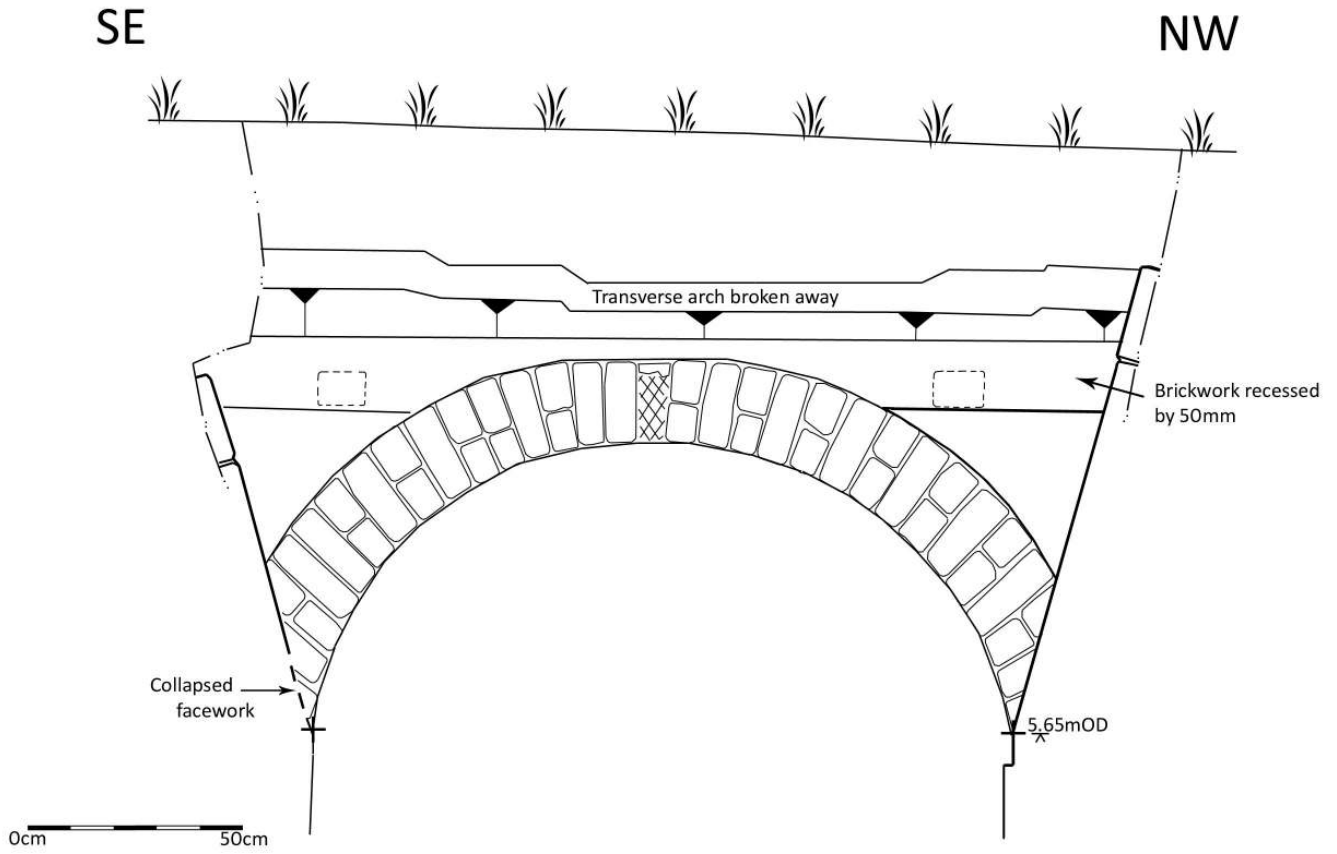
Fig.19: *Elevation 6 NE face of arched roof*

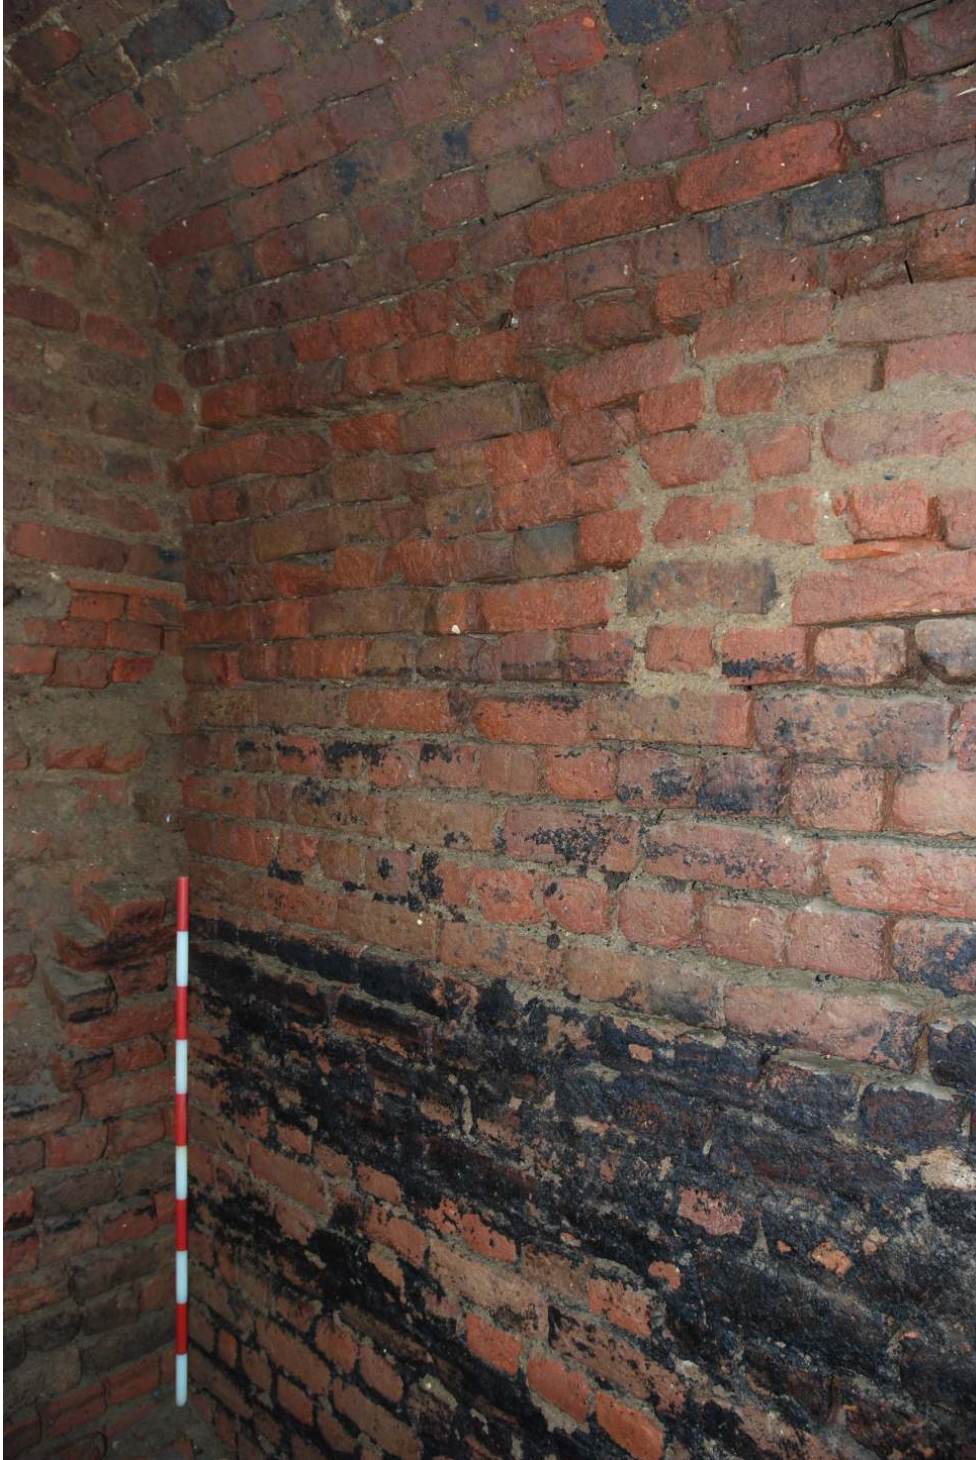
Interestingly the individual walls did not appear to be keyed into one another in any of the corners. The SW, (rear), wall was not keyed into either the SE, (right), or NW, (left), walls. Equally the NE, (front), wall was not keyed in to the NW wall and only partially towards the lower half of the SE wall. This would not at first inspection make for a very stable structure.

Fig.20: Detail of the W corner of the structure, (left side of frame), illustrating the fact that neither the SW or NW walls are keyed into one another. Facing W, (1m scale)

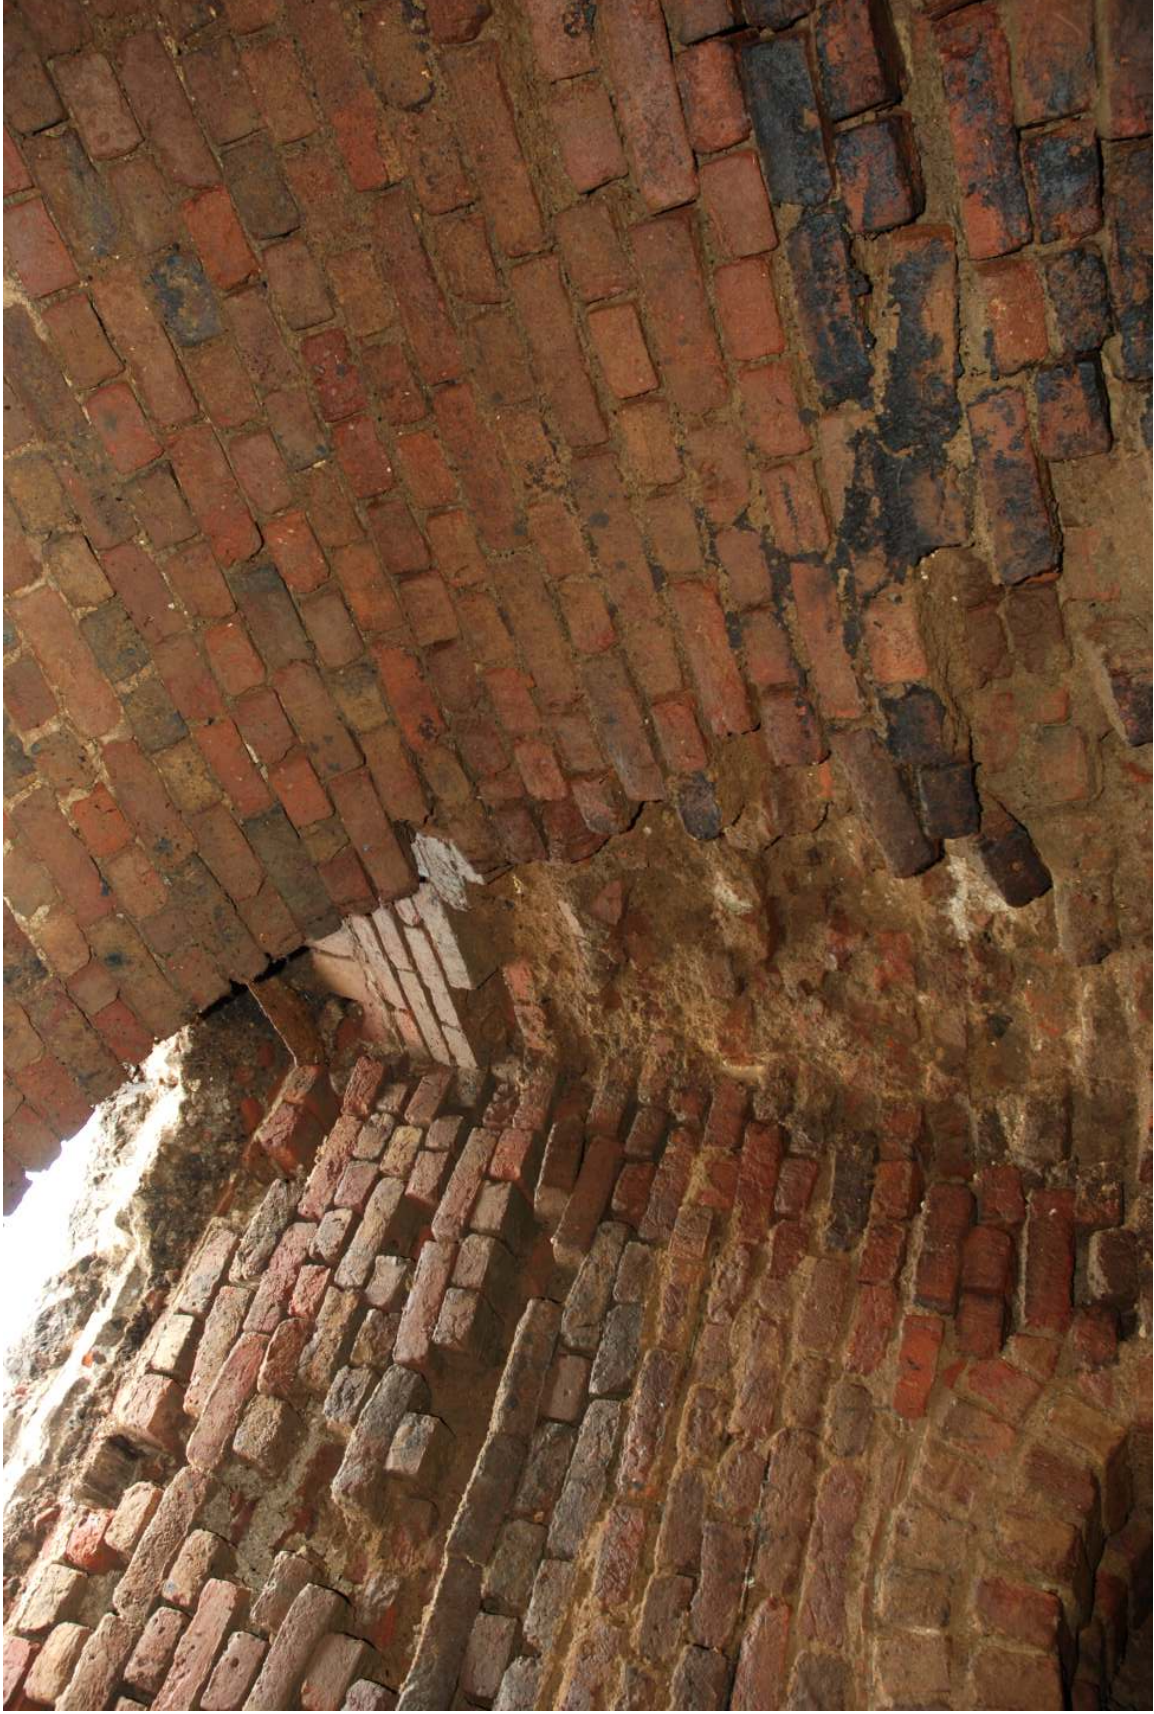
Fig.21: Oblique view of E corner of structure looking up towards the battered face of the SE wall. The arch of the vaulted roof is visible to the right and top of doorway visible to the bottom left of frame

- 4.10** At the NE end of both side walls, between the end of the arched ceiling and the interior face of the NE wall, the walls had been battered to slope up and away from the main wall face. This has given the NE end of the structure an elongated and splayed profile and the sloping sides make it appear almost like a chute of some sort. Several theories can be put forward as to what purpose this may serve and these include: maximising light from above, similar to a light well or aiding with the loading of goods from above, (suggesting some form of overhead access within the arch as proposed in 4.9).

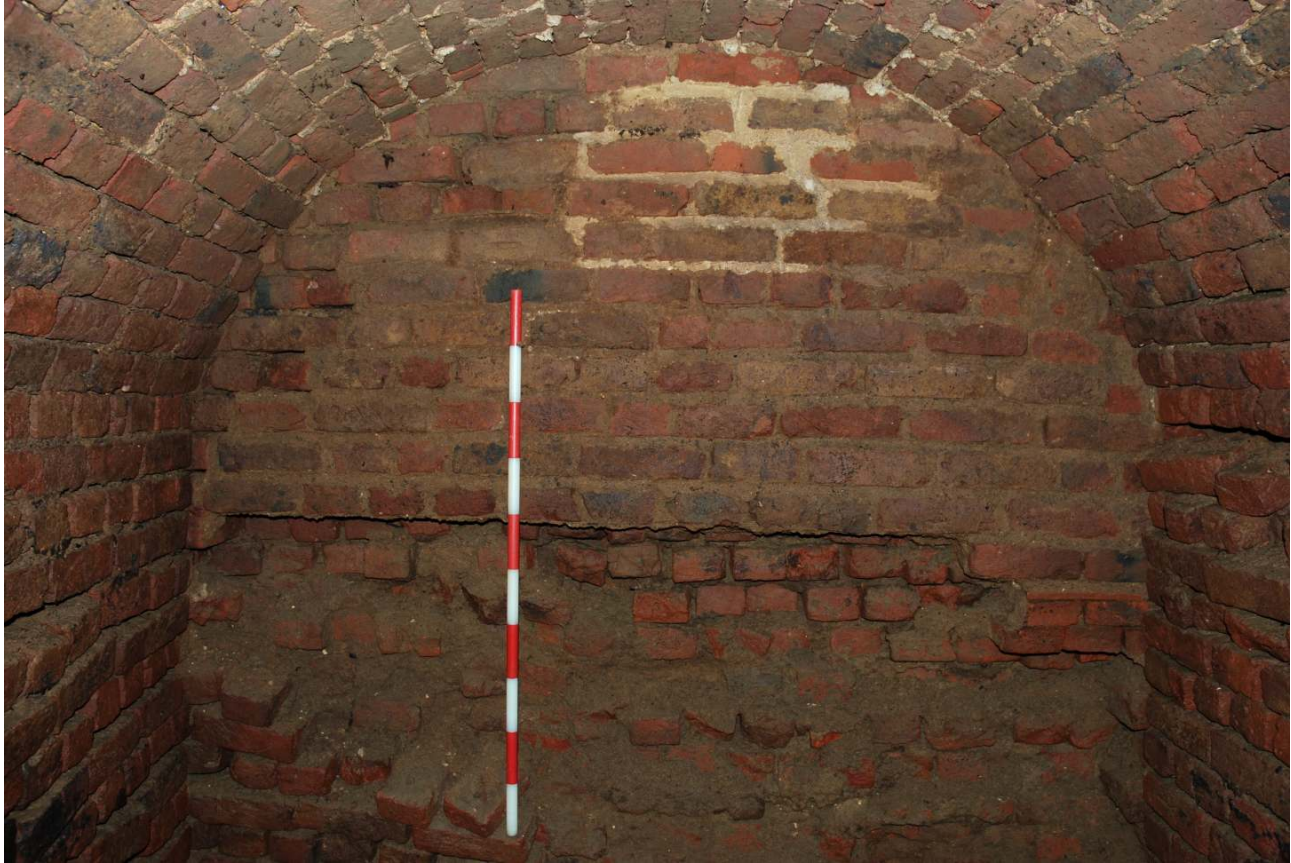
In several instances collapse had occurred on the internal faces of the structure, this revealed the walls to have been constructed with a layer of more finely finished bricks on the internal faces with rougher coursework making up the majority of the build. This was most visible on the rear wall of the chamber where a large portion of the face work had ‘peeled off’ and collapsed into the room.

Fig.22: Collapsed face work on the rear wall of the structure. The scale, (1m), rests on surviving face work at the base and the top 40cm, the space in between has collapsed revealing less finely finished brickwork behind. Facing SW

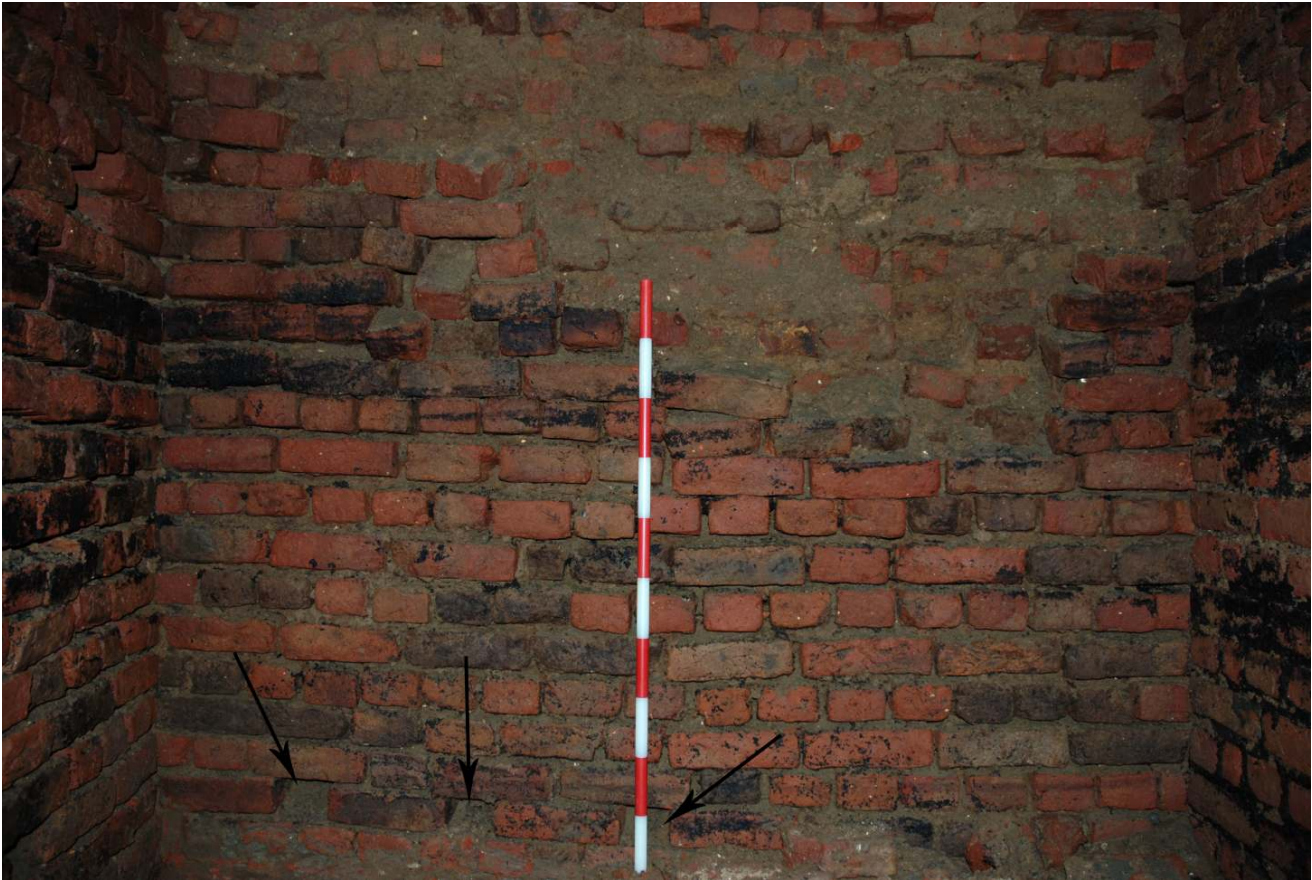
- 4.5** Four brick courses, (290mm), up from the floor on the rear wall there were three square openings in the brickwork, roughly the same size as the head of a brick eg.100mm wide by 80mm high. The openings were evenly spaced from the southern corner of the structure 220mm apart, roughly a bricks length. The northern most of these openings was found to be at least 320mm deep, and surrounded by brickwork suggesting the opening extended through the thickness of the wall as a narrow shaft.

The shafts were flat based, and did not appear to slope up or down which may have suggested use as drainage holes. Instead they may have served some form of air circulatory function or ventilation? But this seems unlikely due to the structure being below ground. The fact that similar openings were not observed in the front or NW walls would also argue against the holes having housed a series of overlapping floor joists.

Fig.23: Rear wall showing the three openings near the base of the chamber, the third is visible behind the bottom of the scale, (1m), and measured 320mm deep and continued back. The other two openings are visible to the left. Facing SW

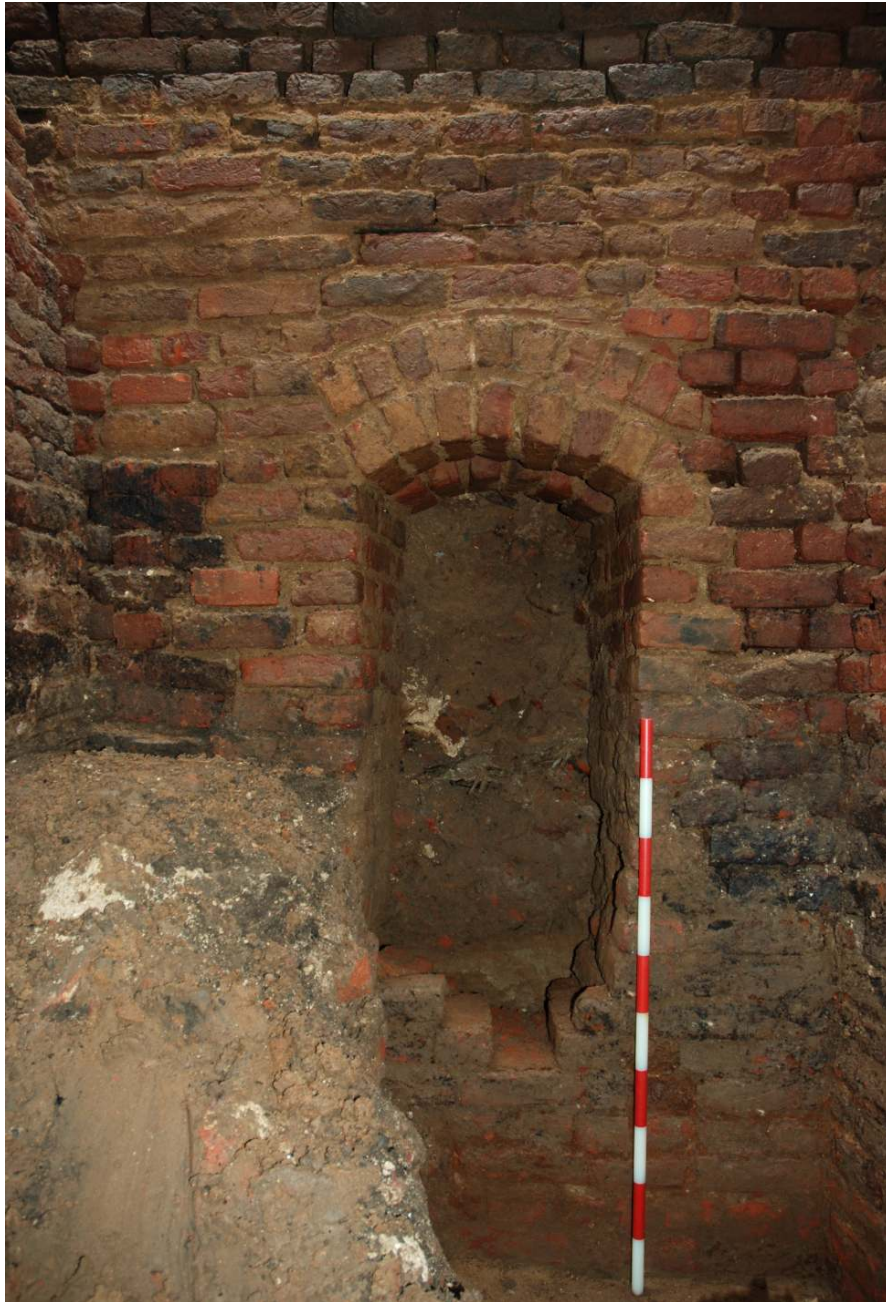
- 4.6** In the front wall of the chamber there was an opening with a flat base and arched ceiling. The opening was 500mm above floor level and situated slightly right of centre in the wall face. The opening itself measured 900mm tall in the slightly tapering sides, rising to 970mm in the centre with the apex of the arched ceiling, and was 440mm wide at the base and 480mm wide at the top to accommodate the arch. The opening was 380mm deep at the base of the vertical walls and 500mm deep at the apex of the archway. The arch opened out into another chamber, which was solidly backfilled with demolition rubble and clay. Alongside numerous bricks within the rubble there was also a lens of window glass and lead framework giving the appearance of a whole window

having been cast into the backfill of the chamber. The floor level of this second chamber was at the same level as the base of the doorway. This meant that the chamber being surveyed was actually deeper than the adjoining room by up to half a metre and anyone accessing the chamber through the opening would have stepped down into it. Again there was no sign of *in situ* flooring though it is likely that a series of stone flags or similar material would have covered the whole area

Fig.24: Doorway in the NE wall leading to a second unexplored chamber. The remains of almost an entire crushed window are visible in the centre of the background within the rubble backfill of the chamber (1m scale)

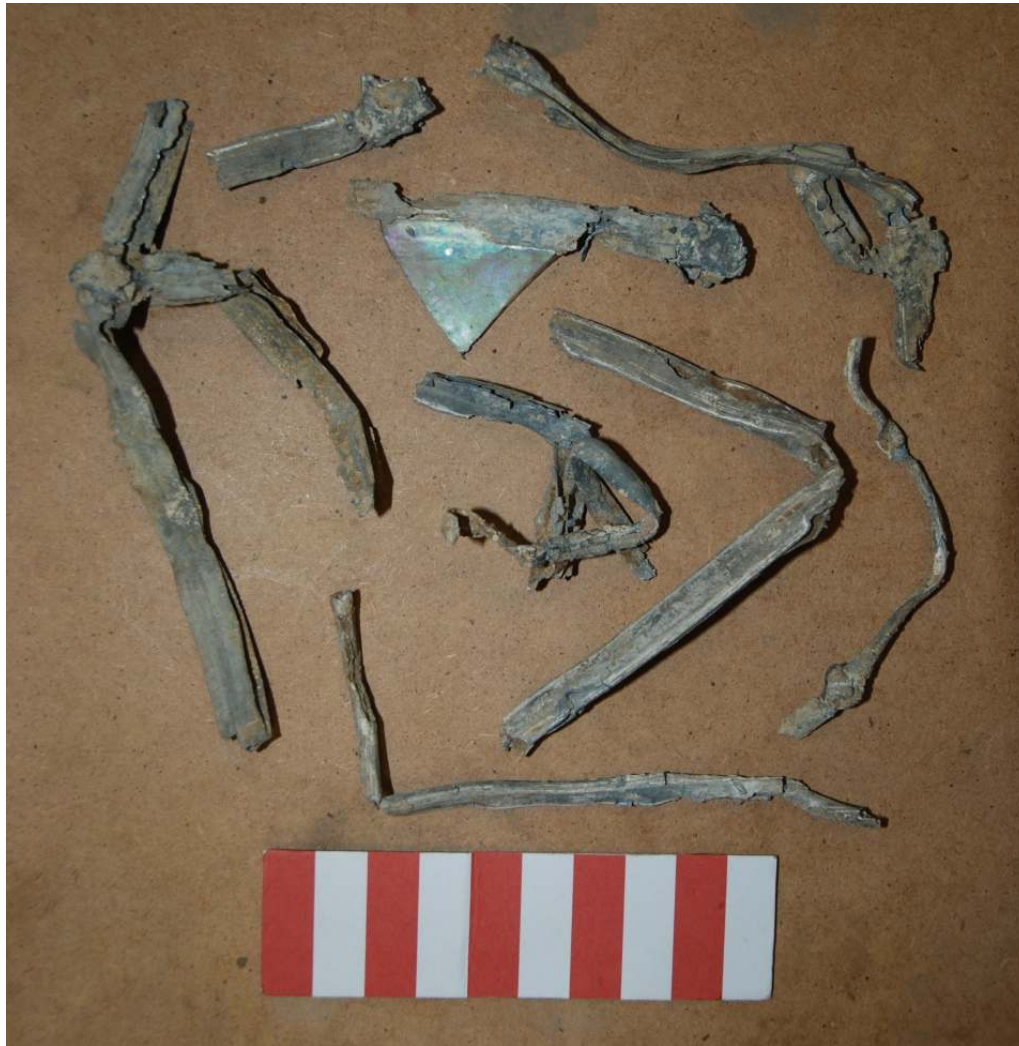
Fig.25: Remains of the lead framework of the window found within the backfill of the unexplored cellar, some with glass still retained. Note the rounded joins in the framework in the top left pieces (scale 10cm)

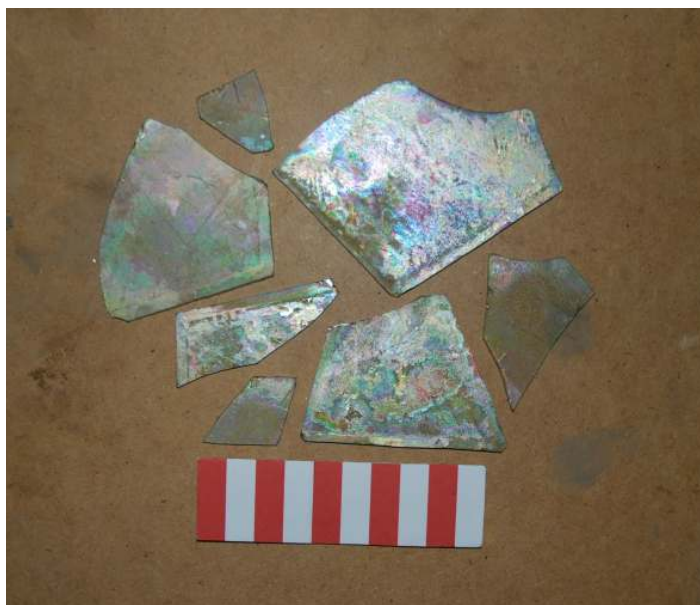
Fig.26: Window glass from backfilled cellar. Note the impression of the lead framework on the edges of several pieces, and the diamond shape of the glass pieces suggesting diamond shaped latticework on the windows (scale 10cm)

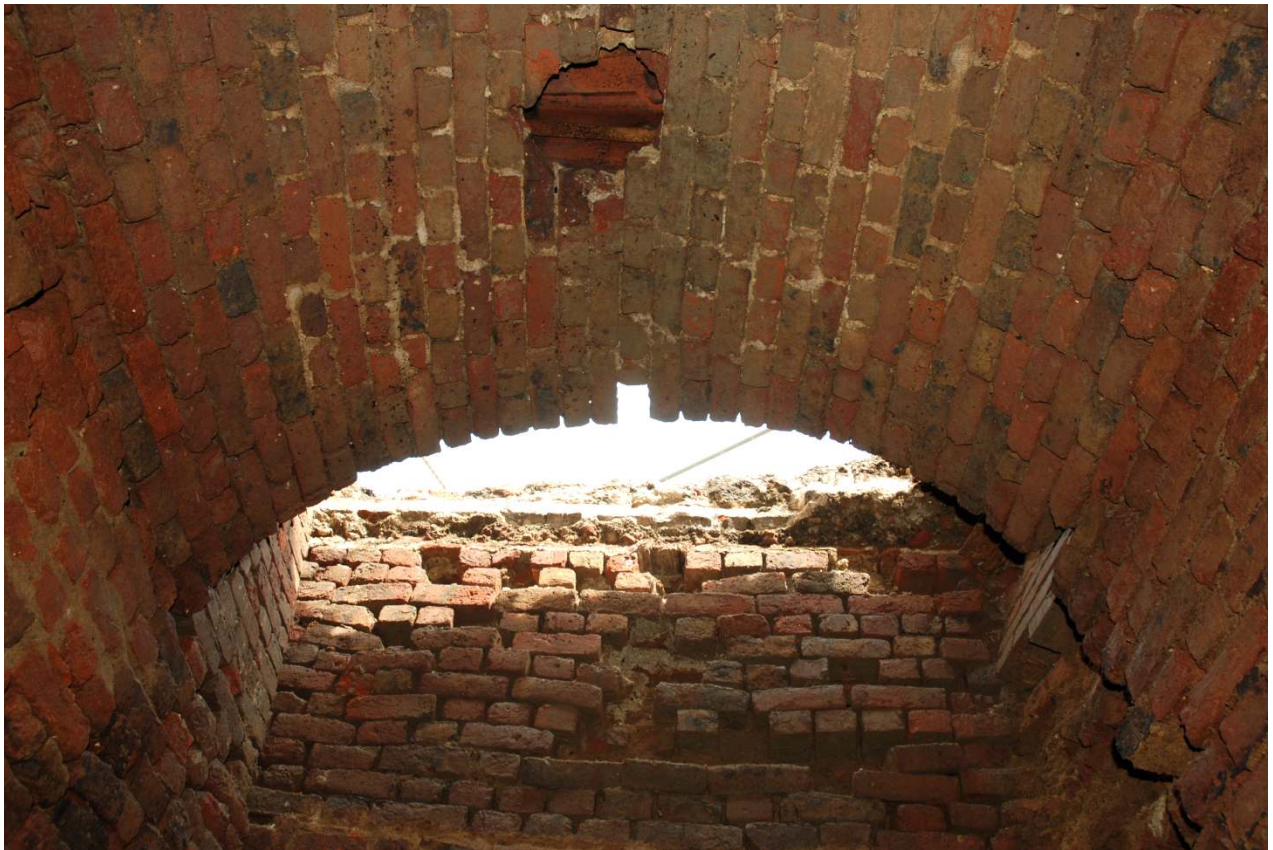
- 4.7 The structure was almost completely enclosed by an arched vault extending from the rear wall, bonded using a cream coloured lime mortar, and terminating as an open fronted arch 520mm from the internal face of the front, (NE), wall. The arch was approximately 630mm high and sprung from the left and right wall faces at a height of 2.20m from floor level. As with the main walls the arched ceiling was not keyed into the wall at the rear of the structure. In fact the archway appeared to abut the rear wall with the brickwork of the rear wall extending beyond the curve of the arch, as if the arch abuts a squared off wall. As the archway follows the alignment of the left and right walls of the structure it too tapers inwards towards the NE end, which makes it of unusual construction and shape.

Fig.27: Photograph of the open-ended arched ceiling, taken from the rear wall of the chamber, facing NE. The far spring work of the transverse arch is just visible as a white line towards the top of the front wall. A hole has been crudely patched in the roof with metal slats and pan tiles. The hole does not appear deliberate and there is no sign of a structural feature having been removed. It may have been an earlier case of collapse, or accidental damage

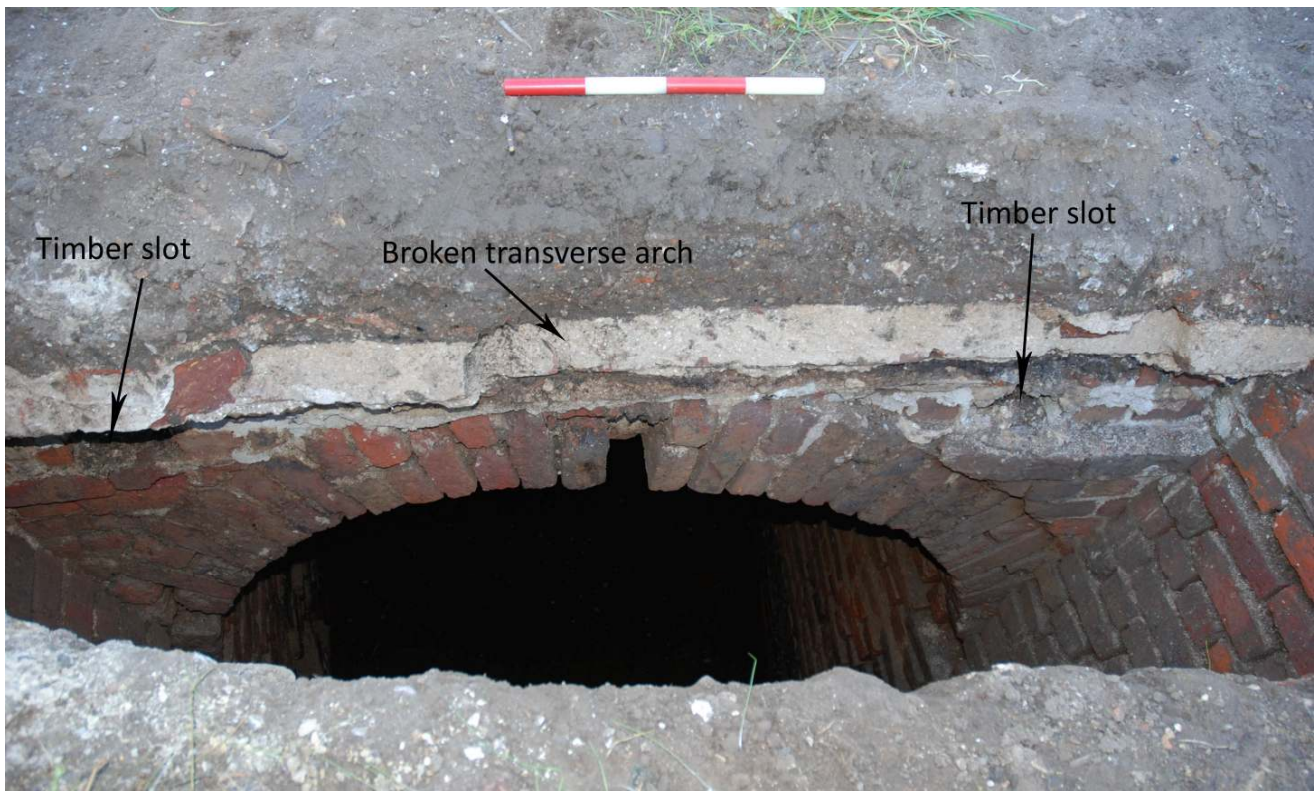
4.8 The NE end of the chamber was presently open to the sky and provided access to the structure. However this had not always been the case as there were remains of a transverse arch, (aligned NW-SE at right angles to the main ceiling), visible in section at the SE end and in elements of surviving brickwork at the NW end. The brickwork visible was of red brick bonded with white lime mortar liberally applied. The full length of the original arch was only partly visible due to the heavy truncation, but the span was approximately 650mm. It is interesting that the spring of the arch begins *above* the apex of the arched roof of the main chamber. This could mean that the external face of the transverse arch may have been exposed at former ground level, with the rest of the chamber buried deeper.

Fig.28: NE end of arched ceiling showing the construction / finish of the brickwork. The broken transverse arch is visible as the white line of mortar bonded brickwork. Facing SW, (40cm scale)

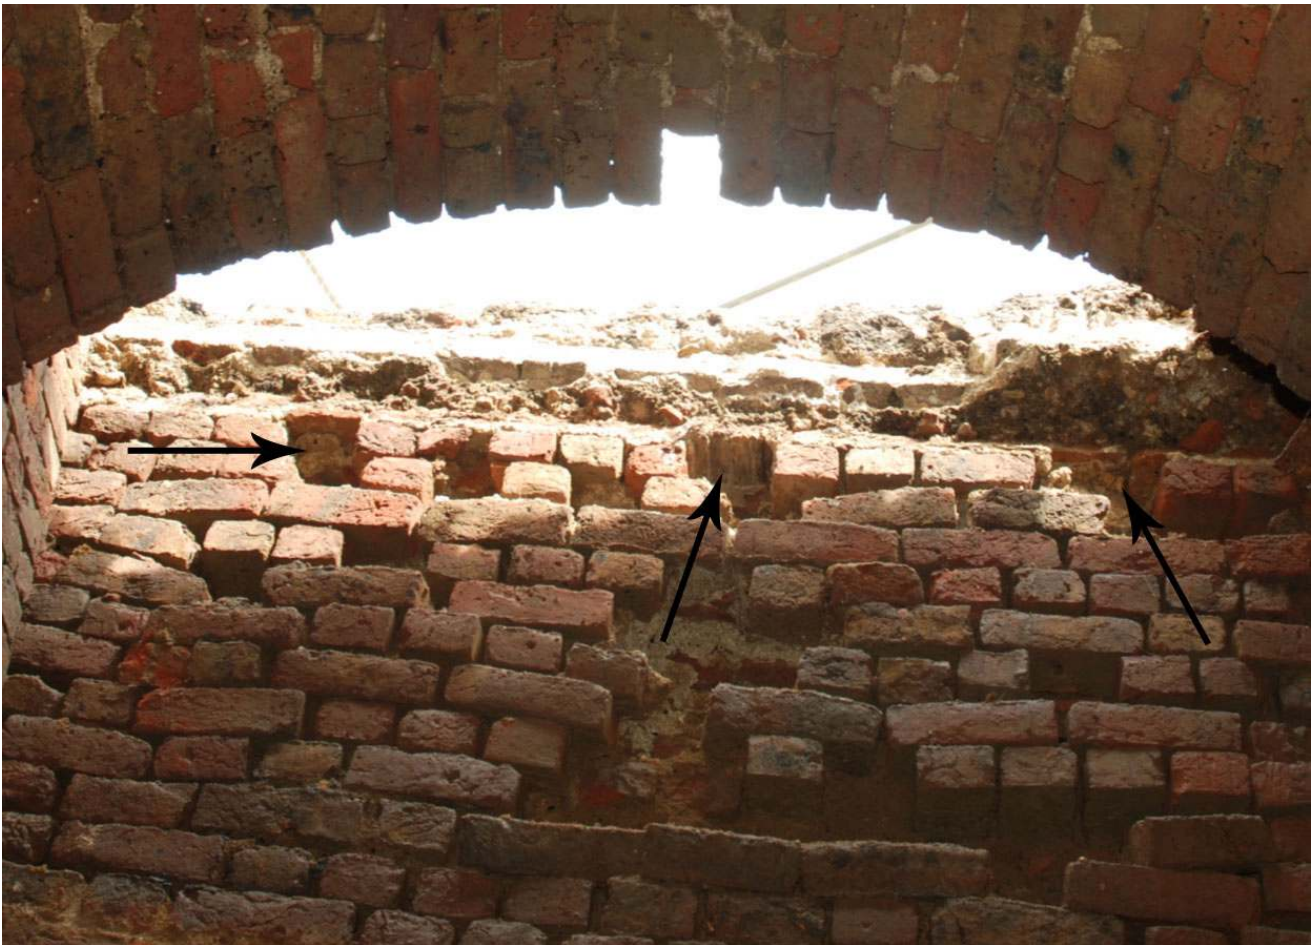
4.9 Almost immediately below the spring of the transverse arch, were a series of three timber holes in the upper courses of the NE wall with two opposing holes in the brickwork above the arched opening to the main chamber. These holes were 220-280mm below the top of the wall face and measured approximately 120-130mm wide and 90-100mm tall and were at least 60-100mm deep. Several of the slots had remnants or imprints of timbers still present within them. There were also surviving elements of timber beams aligned along the length of the transverse arch at the base of the springing brickwork. The spacing of the timber slots relatively evenly across the span between the walls may suggest that they supported some sort of wooden ceiling, perhaps including another access point incorporated into the construction of the transverse arch.

Fig.29: Photograph showing the timber slots on the NE wall face. Note that the central and right hand slot still contains elements of timber. Facing NE

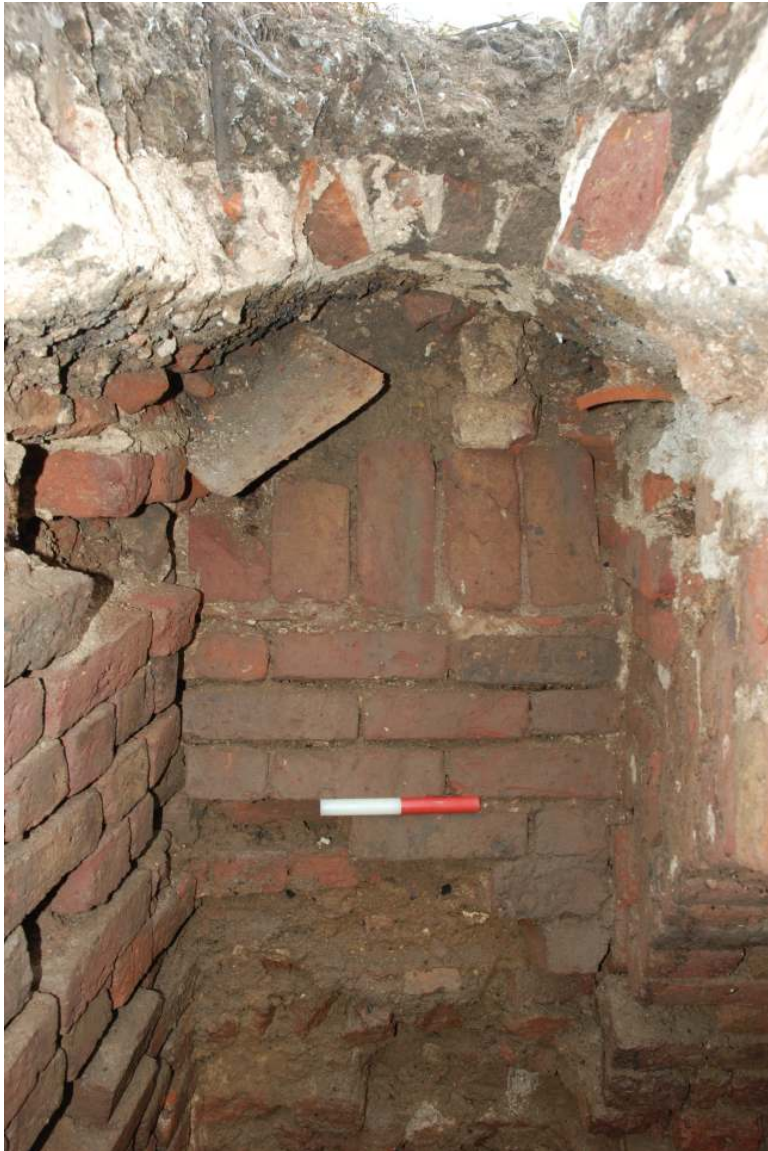
Fig.30: *Remains of the transverse arch, which once covered the NE end of the structure. The main arched ceiling of the chamber is visible in the bottom right of the frame. Facing SE, (20cm scale. Note the shovel blade protruding from the section. Obviously the result of some previous episode of disturbance!)*
