NORWOOD HALL JOINT SERVICE CENTRE
25 DEVANE WAY, KNIGHTS HILL
LAMBETH, SE27 0DF

AN ARCHAEOLOGICAL WATCHING BRIEF

An Archaeological Watching Brief

Site Code: DVW12
NGR (centre): TQ 31743 72037
Application No: 10/02230/RG4

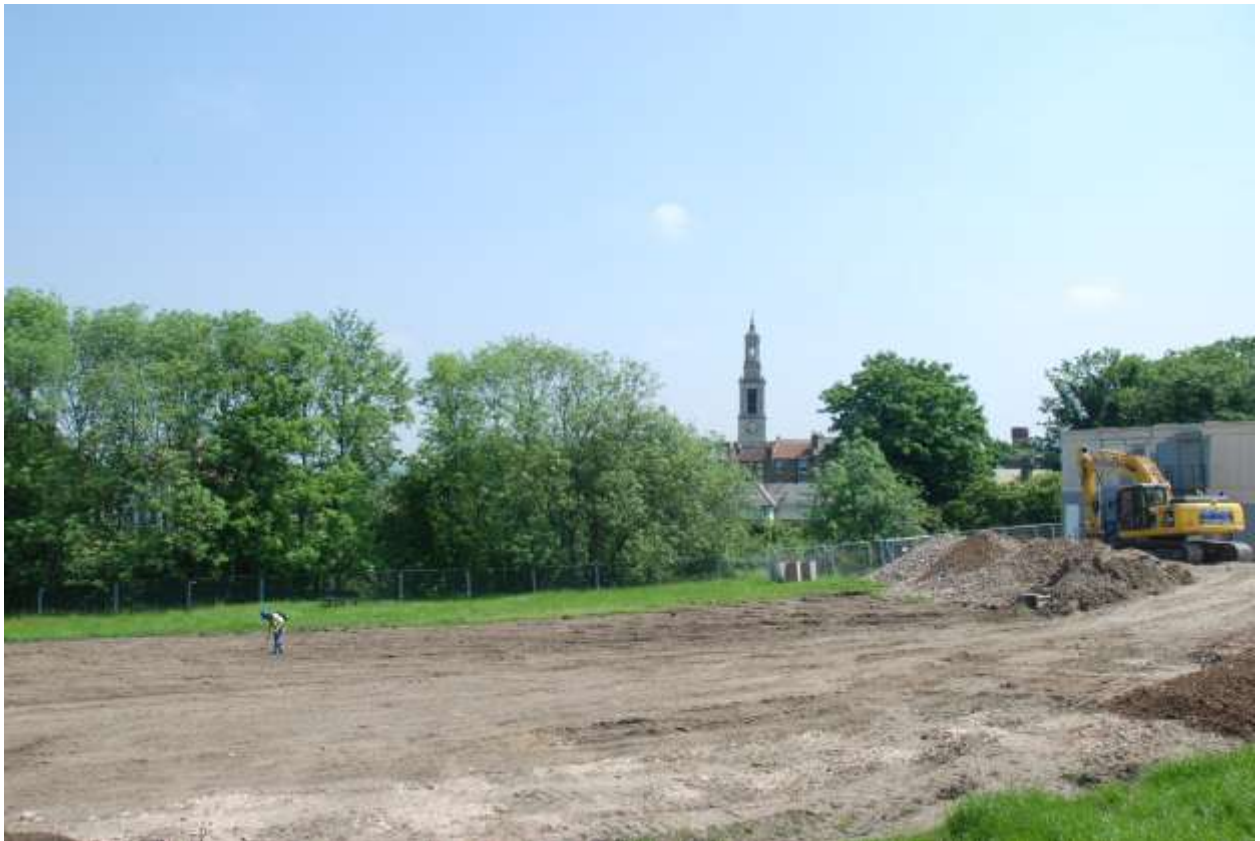
Fig 10 Photograph of an archaeologist fieldwalking the north-eastern part of the site, after it had been stripped, image taken looking east

Fieldwalking was carried out on this area, looking for any archaeological features or finds. Nothing of archaeological significance was noted, with the only finds being several modern golf balls.

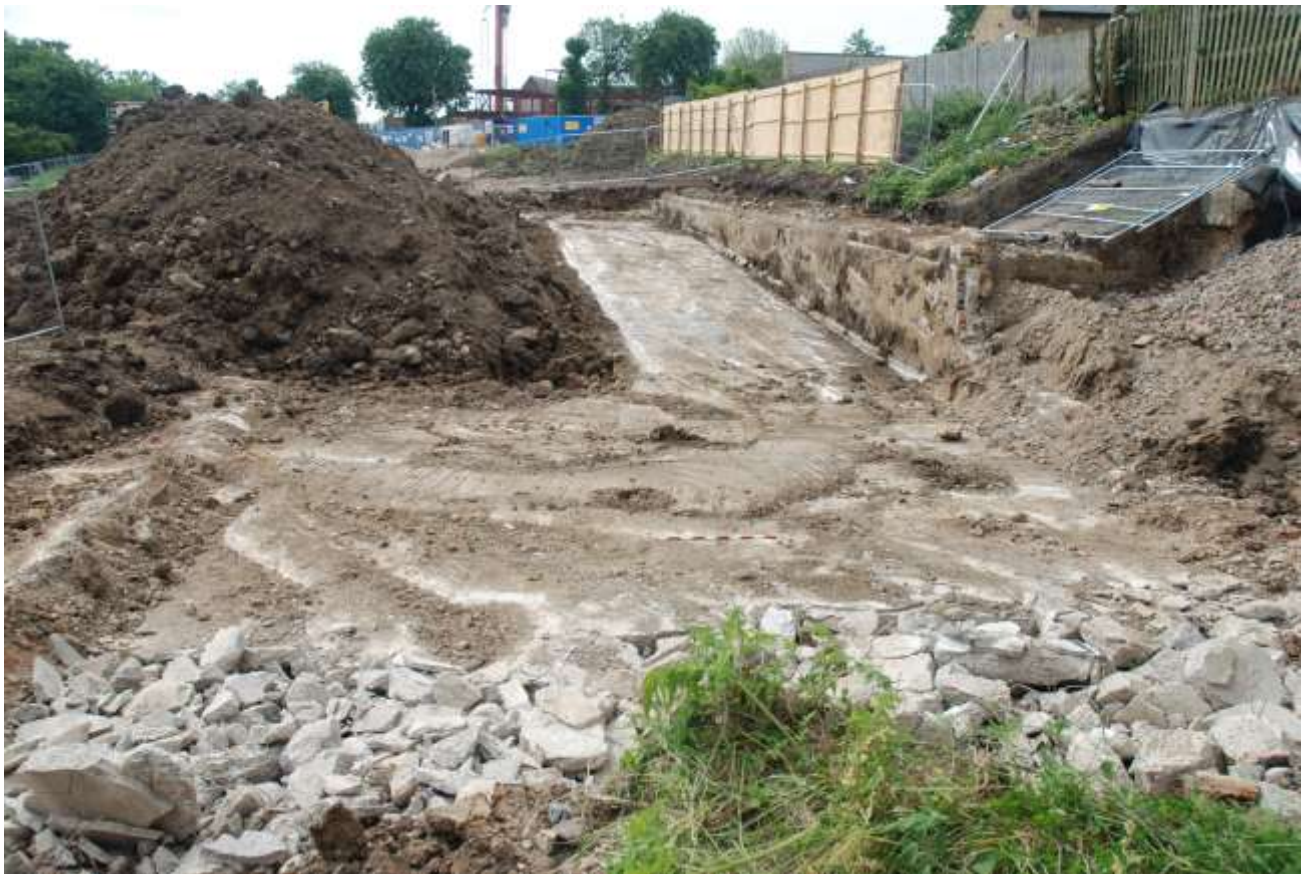
Fig 12 Photograph of the large concrete feature in the north-western corner of the playing fields, image taken looking south

This was a large concrete subterranean base, with a long sloping base area measuring *c.*35m in length (sloping down from the south to the north, running along the western boundary of the playing fields), by 10m in width (east-west) at its northern end), and 3.8m in width at its southern end. It broadly formed an 'L-shape' (see Figs 9,12-13), with the northern end stretching for *c.*10m to the south before turning to the west (for *c.*6.2m) and heading south for a further 25m.

The surrounding walls of this concrete feature were observed on the northern, western, southern, and north-eastern sides (see Figs 12-13). No walls appeared to be present on the other two sides (see Fig 13), with the concrete base appearing to simply stop and the natural clay deposits begin.

This feature as clearly a modern feature, based on its concrete and yellow stock brick construction, there were three down-pipes for toilet cubicles in the northern (east to west running) area. It is unclear precisely what it was – but apparently a pavilion/changing rooms of some sort in association with the playing fields.

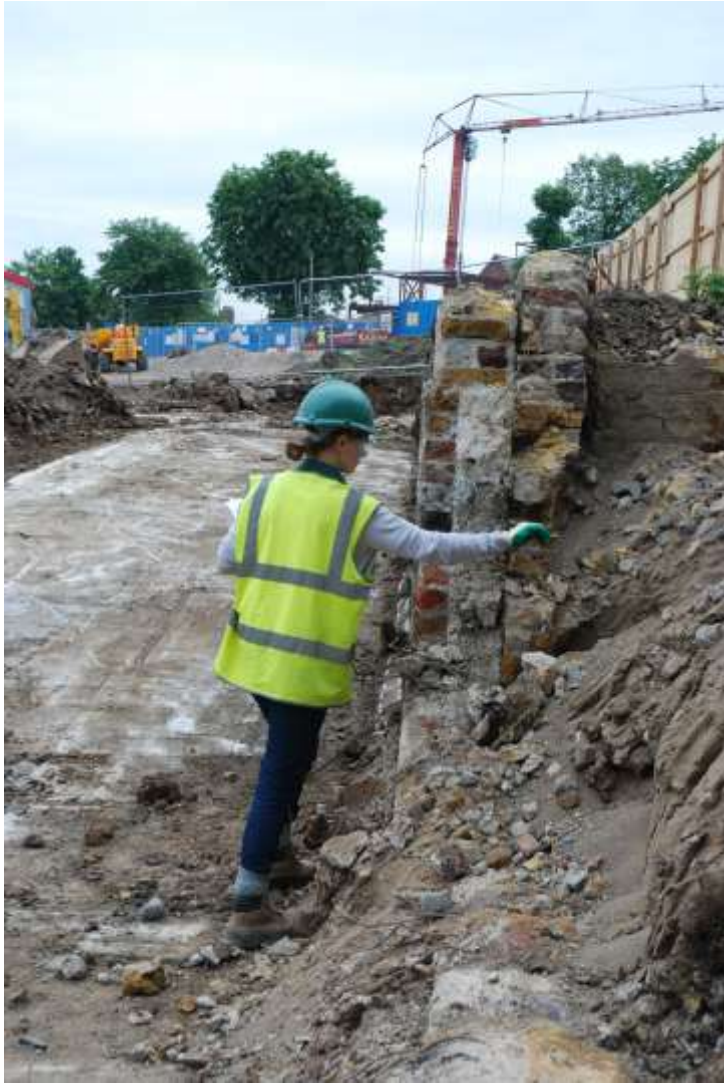
Fig 13 Photograph of an archaeologist recording the western wall of the concrete feature. The two abutting yellow stock brick walls, and concrete render on the internal face, can be seen

The walls of this feature were *c.*0.5m thick, and made of a mixture of yellow stock and red / purple brick. This brick was regularly coursed, and set within a hard grey concrete mortar. A concrete render was observed on the inner faces of the walls, and in some places (particularly along the western wall), the walls appeared to be made of two abutting walls. The base of this western wall was also slightly rounded.

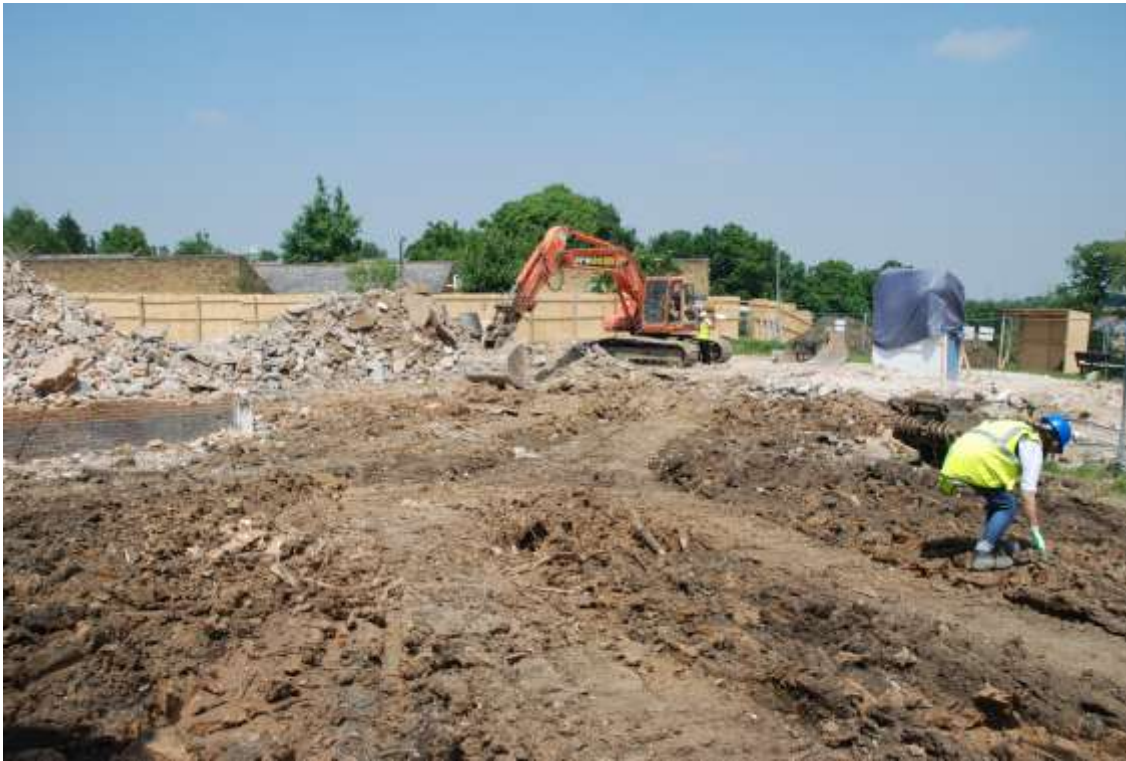
Fig 14 Photograph of the area under the 1960s community centre building, during demolition, image looking north-east

The area of the 1960s synagogue / community centre was monitored during the demolition of this structure, and the removal of its foundations. Nothing of archaeological significance was observed here, with the underlying deposits just consisting of the natural clay deposits observed elsewhere on the site. There was, therefore, no sign of the older (1866) Jewish Hospital, which spread into the far northern part of this area (see Figs 14-15). Trench 5 was excavated in this area of the site and is discussed below (see Figs 26-28) .

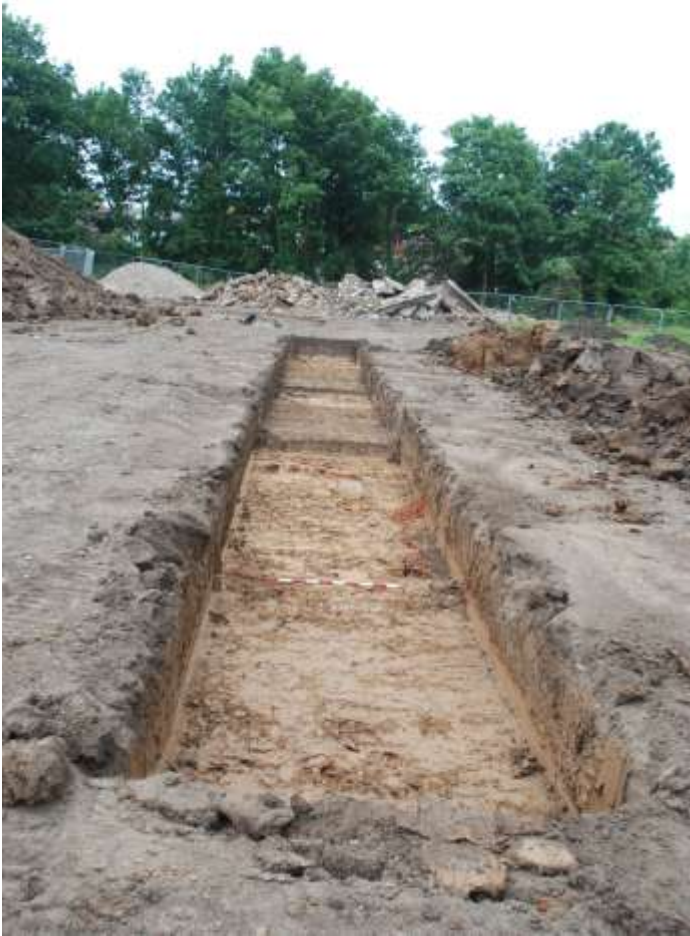
Fig 16 Photograph of Trench 1, looking north and showing natural clay, beneath the humic subsoil of the playing fields. Some ceramic land drains crossed the trench, but these were relatively modern, Scale 1m.

The modern topsoil (a loose grey-brown silty-sand, 0.18m in thickness) overlay yellow-brown silty subsoil. This subsoil had occasional pebbles and ceramic building material flecks in, and was disturbed by roots in places, although showed no signs of having been heavily affected by human activity. This subsoil was 0.28m in thickness.

Beneath this were the natural deposits –compact yellow clay, exposed *c.*0.46m beneath the modern ground-surface. Two ceramic land drains were observed within this, running southwest to northeast across the trench. These were *c.*10m apart, had a diameter of *c.*80mm, and were observed at an uppermost level of 0.65m beneath the modern ground-surface.

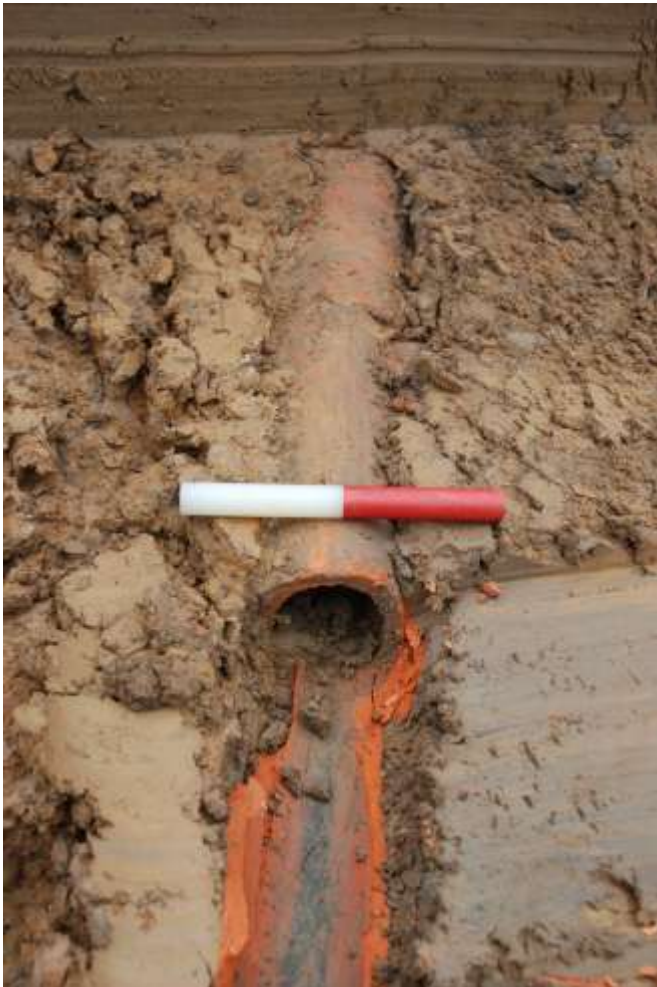
Fig 18 Photograph of a section of the ceramic land drain in Trench 1 (Scale 0.2m).

A sample of the ceramic land drain, was retained for identification and was found to be probably mid to later 19th century (*pers comm* Sue Pringle) and was made through the extrusion technique; the first extrusion process was patented in 1797 (for making lead pipe) and the process developed after 1820 with introduction of the hydraulic powered press.

The pipe was in lengths 306 ± 3 mm, with an internal diameter of 76 ± 2 mm and wall thickness of 12 ± 1 mm. The nominal dimensions as manufactured were based upon a 12 inches x 3 inch bore.

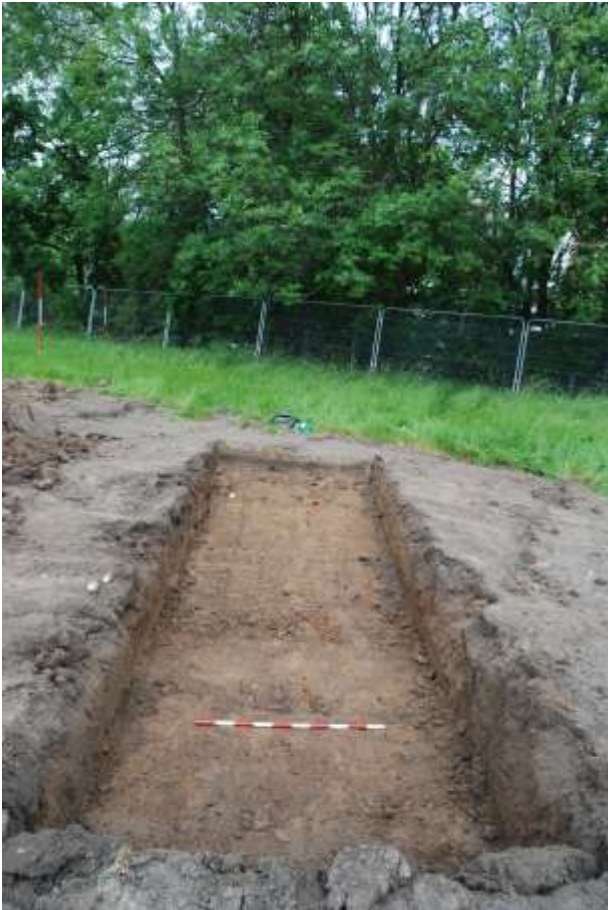
Fig 19 Photograph of Trench 2, looking north-east (Scale 1m)

The same deposits as in trench 1 were observed in this trench – modern loose grey-brown silty-sand garden topsoil (*c.*0.15m thick), over yellow-brown silty subsoil (*c.*0.25m thick), over the natural compact yellow clay (observed *c.*0.4m beneath the modern ground-surface). No finds or features of archaeological significance were observed in this trench.

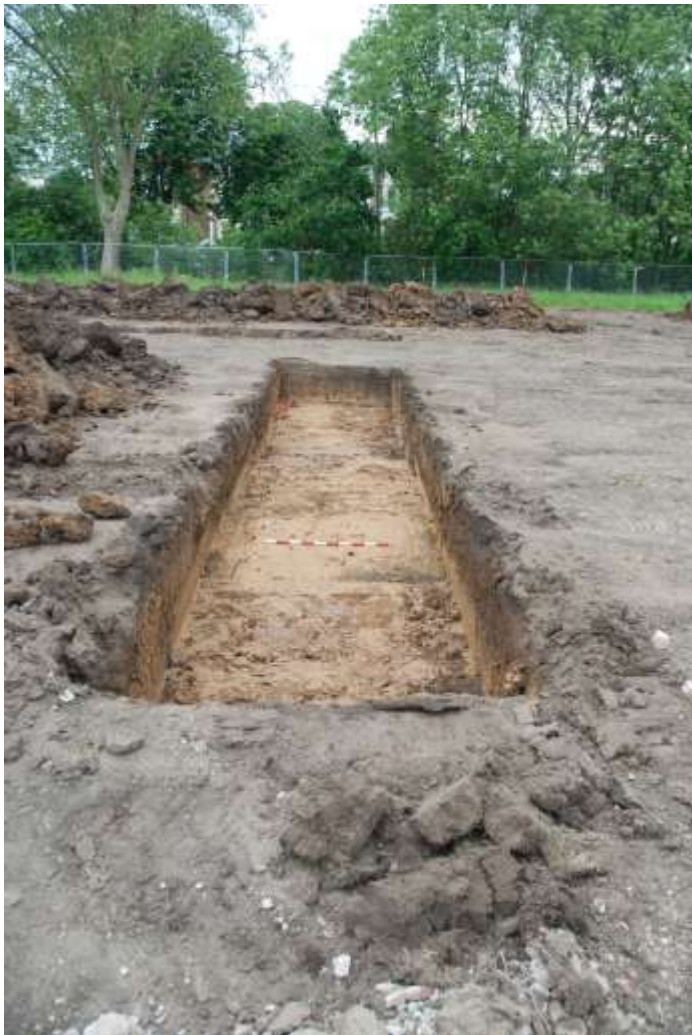
Fig 21 Photograph of Trench 3, looking east

This trench exposed similar deposits to those observed in trenches 1 and 2 – 0.22m of loose garden topsoil, over 0.28m of light brown subsoil (with some pebbles, ceramic building material flecks, etc, in it), over the compact yellow clay (at c. 0.5m beneath the modern ground-surface).

One ceramic land drain was observed in the north-east corner of this trench, running northwest to southeast across the trench. This had the same diameter (80mm) and was observed at the same level (0.65m beneath the modern ground-surface), as those in Trench 1.

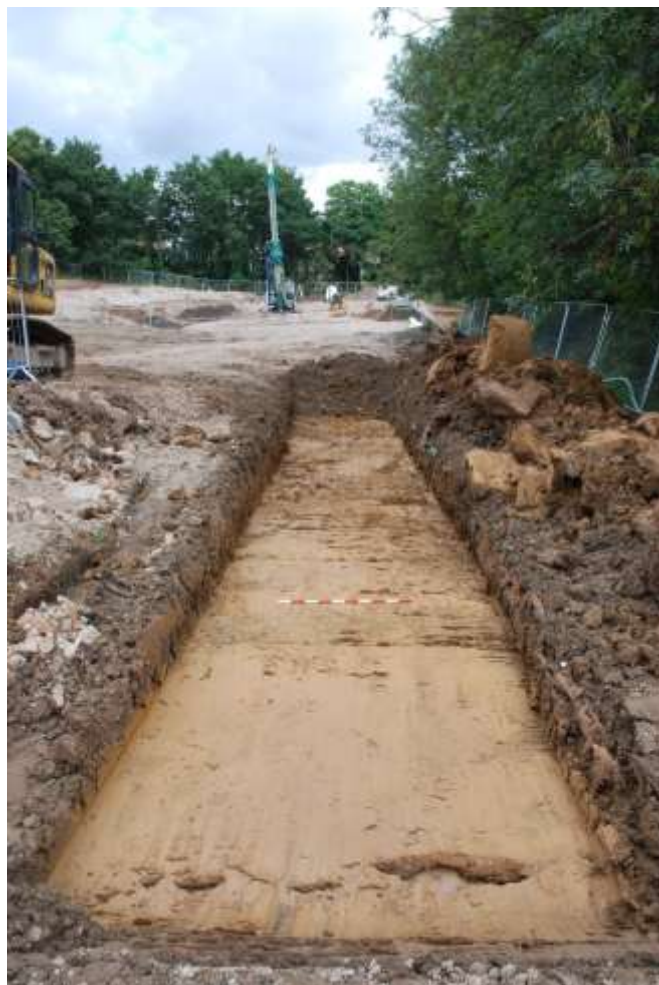
Fig 24 Photograph of Trench 4, looking north

The loose mixed dark-grey-black silty-sand topsoil, with pebbles, mortar, and ceramic building material fragments, was 0.4m thick in this trench. This overlay a dump of mixed modern material, consisting mainly of chunks of brick rubble and clay, *c.*0.3m thick. This was probably a dump of material used to build up the land surface, possibly when the railway was constructed (as the railway runs adjacent to this trench).

This dump of modern material overlay a light brown silty-clay, with occasional pieces of ceramic building material in. This was only 0.1m in thickness, and so was probably a previous land-surface (before the land was raised for the railway).

The natural deposits – a yellow-brown compact clay – was observed at an uppermost level of 0.35m beneath the modern ground-surface at the southern end of the trench (where only topsoil overlay it), sloping down to *c.*0.8m beneath the modern ground-surface at the northern end of the trench. This deposit was largely sterile, although with a few roots and a ceramic land drain (like those in trenches 1 and 3) running southwest to northeast across the trench.

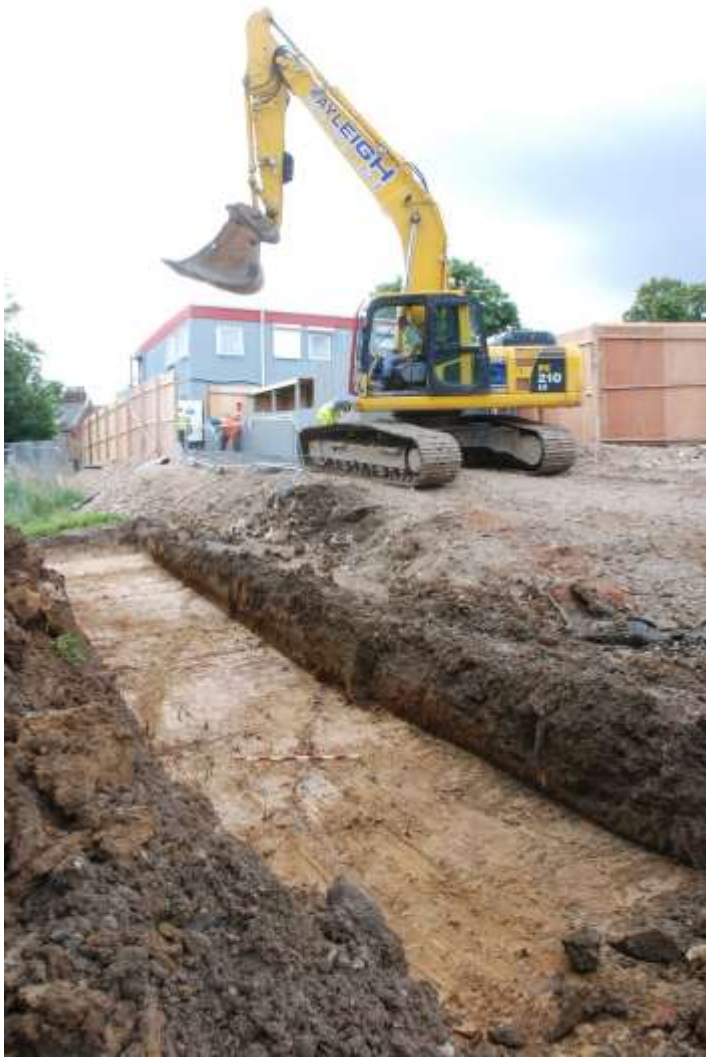
Fig 25 Photograph of Trench 4, looking south-west

A 16m trench (2.2m in width and 0.5 – 0.8m in depth) was observed in the far southern area of the site (see Figs 9, 24-25).

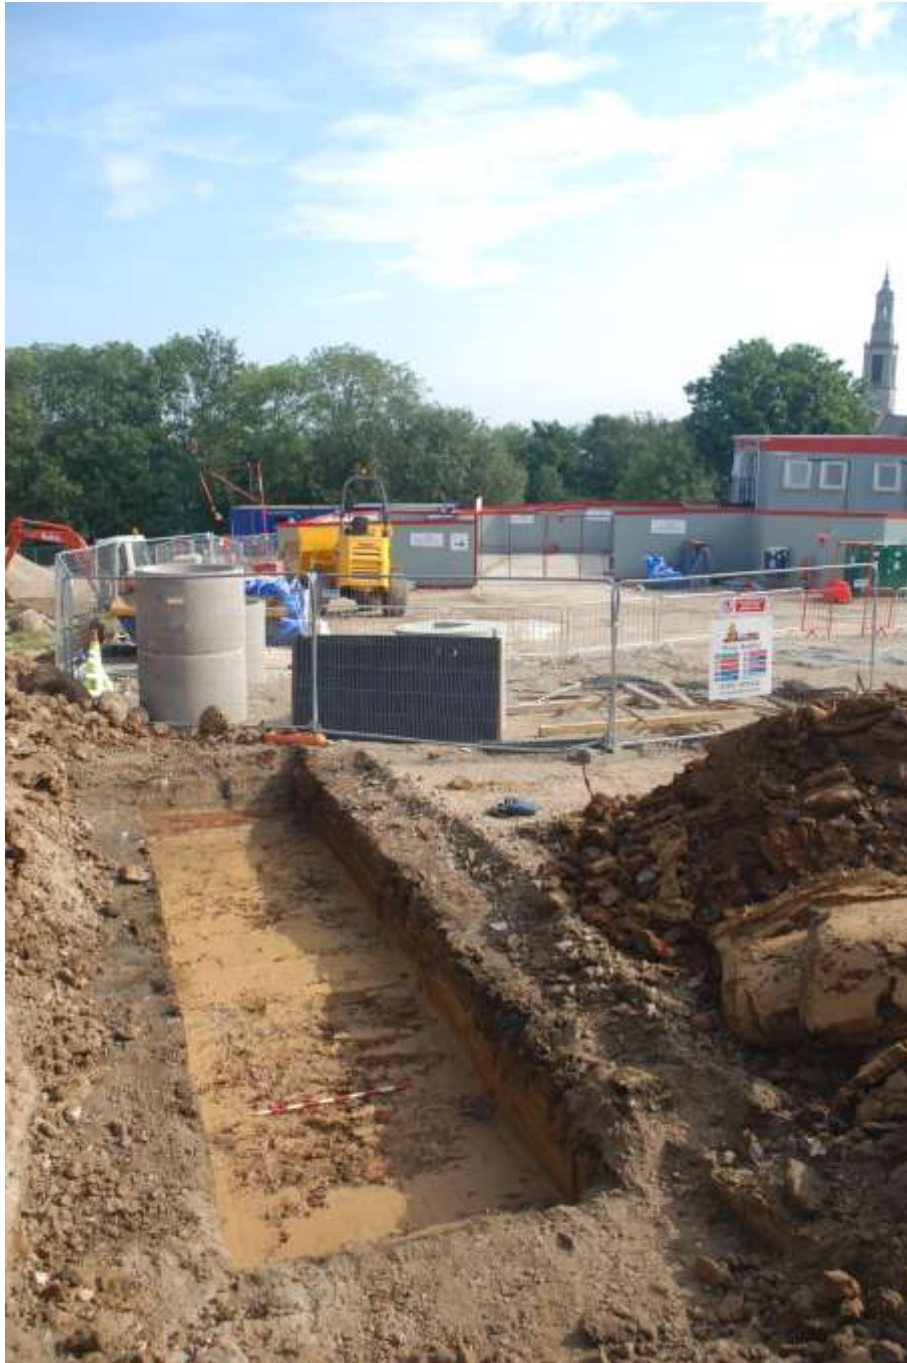
Fig 26 Photograph of Trench 5, looking north east.

The trench was in an area close to the locations of the original hospital, orphanage and synagogue, however, no archaeological structures, features or finds were encountered. The surface deposits had been reworked by demolition of the former synagogue and probably by works relating to the demolition of the former hospital and orphanage. There were some upper layers and lenses of demolition rubble, including a patch of crushed red brick visible in the trenches, but these deposits merely represented modern demolition events. These formed dumps of mixed modern material, consisting mainly of chunks of concrete, brick rubble and clay, *c.*0.5m thick.

This dump of modern material overlay the truncated surface of the natural light yellow-brown compact clay, with contained occasional rounded pebbles. The clay was sterile, but was rising in the trench section towards the south, it was apparent that the top of the hill here had been landscaped and the surface

The natural deposits – a yellow-brown compact clay – were observed at an uppermost level of 0.28m beneath the modern ground-surface at the southern end of the trench (where only topsoil overlay it), sloping down to *c.*0.7m beneath the modern ground-surface at the northern end of the trench. This deposit was largely sterile, although with a few roots which caused the surface of the clay to peel off in fissures during excavation (as seen in some of the other trenches to the north).

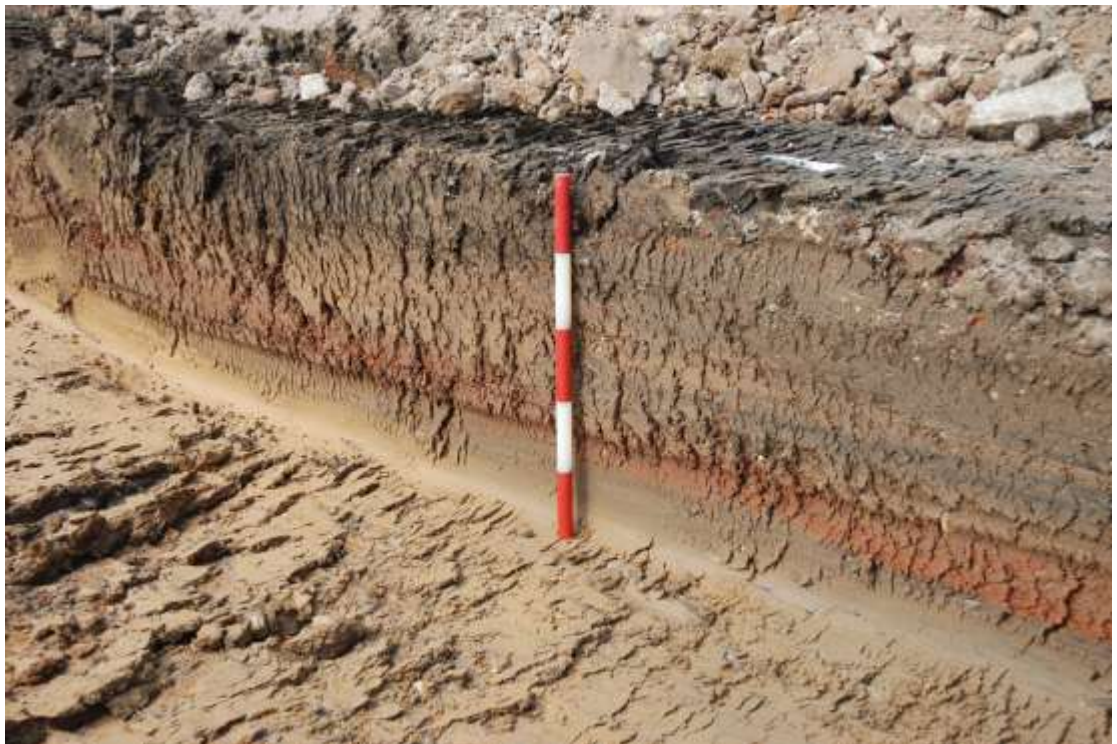
Fig 28 Detail of the western (east facing) section in Trench 5 at the NNE end, a shallow dump of crushed red brick can be seen above the truncated surface of the natural clay, but this is contiguous with the overlying reworking of the subsoil deposits caused by demolition of the former synagogue, located slightly to the west of this trench (see Fig 9).
