5 WESTSIDE COMMON, WIMBLEDON SW19 4UD

AN ARCHAEOLOGICAL WATCHING BRIEF

SITE CODE: WCB06

Project 270

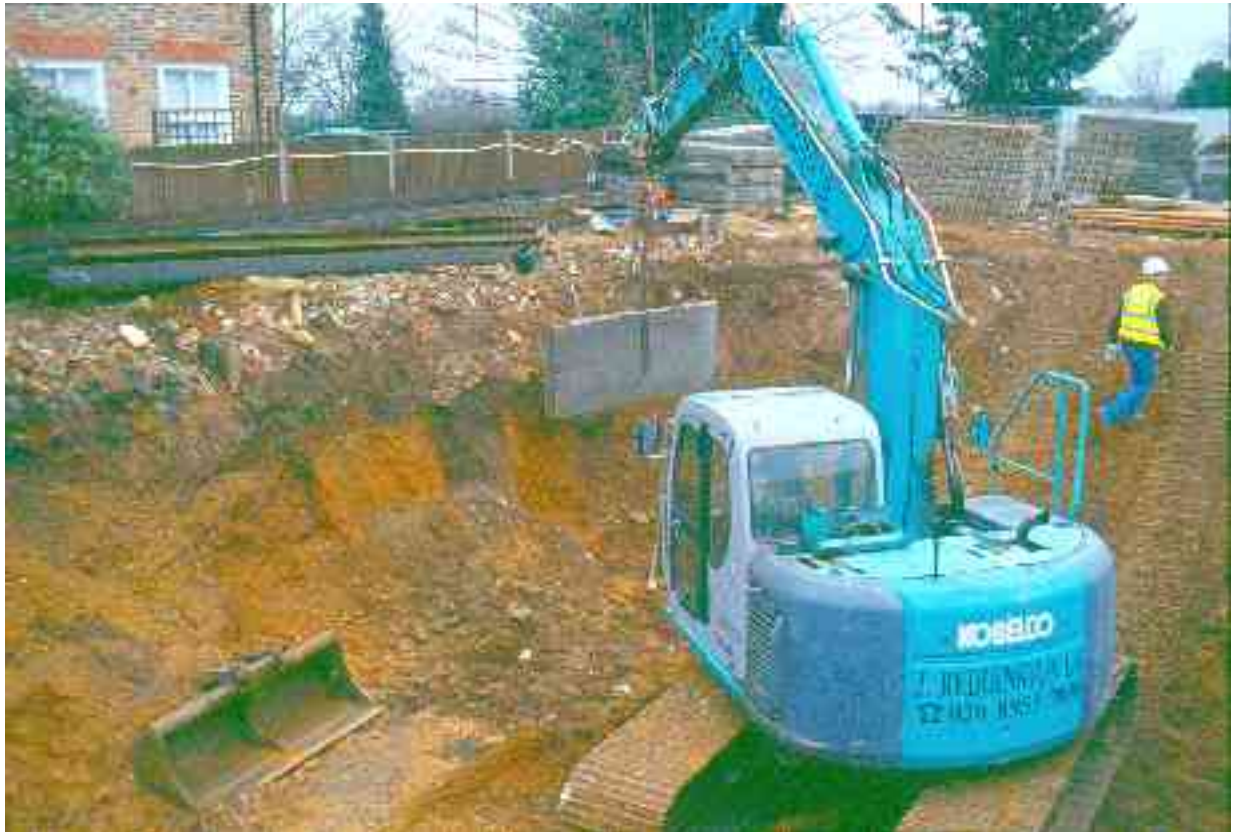
Fig 4 View during the bulk excavation, looking northeast toward the Common

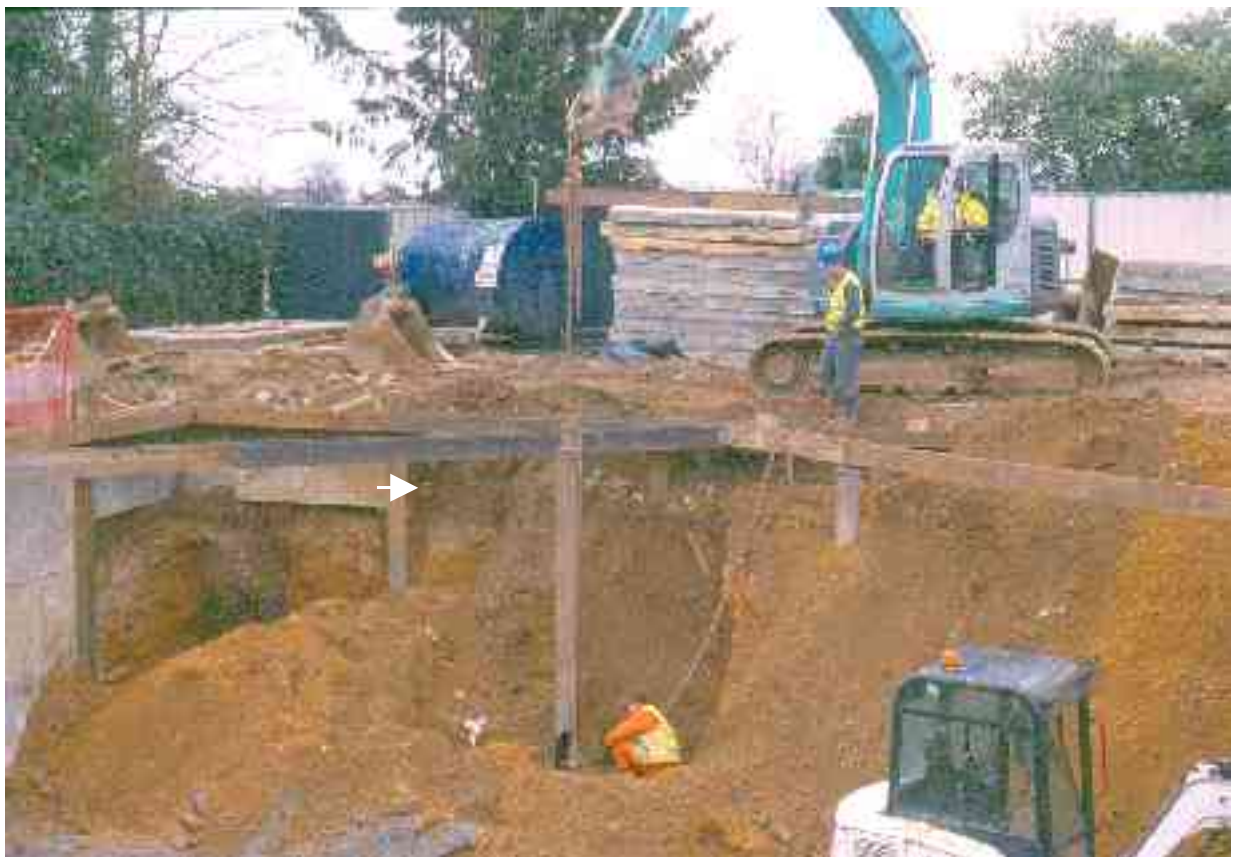
Fig 5 View looking east during the final stage of the excavation, with the small area of *in situ* brickwork in Figures 6 & 7 arrowed

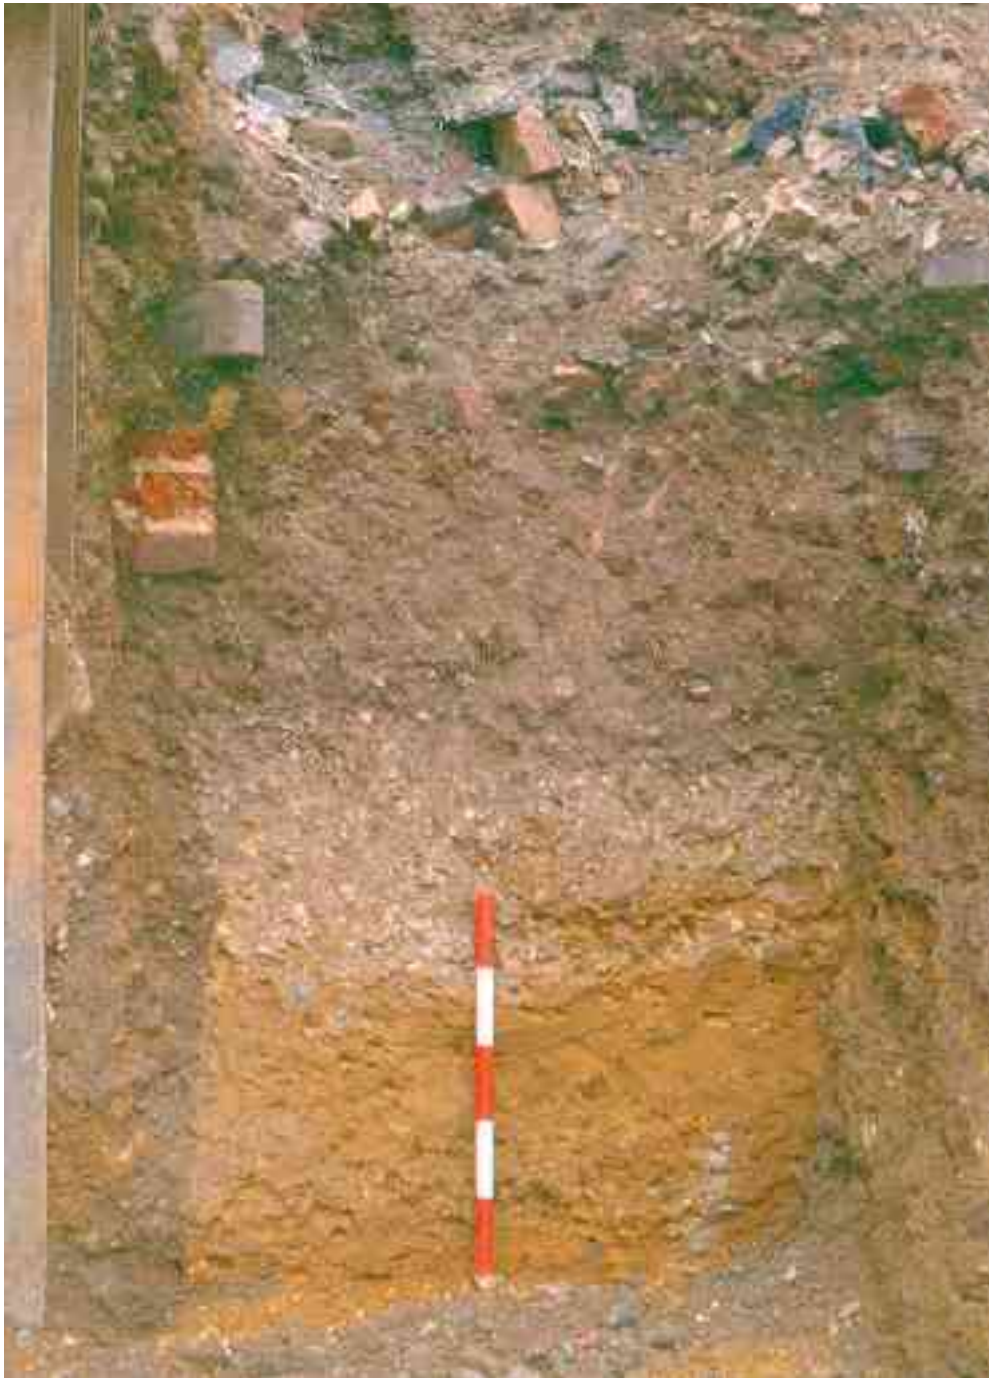
Located on Fig 3; see also drawn section (Fig 7) overleaf

Fig 6 Detail of the exposed section at the eastern end of the site, including at top left the partly-exposed *in situ* brickwork (0.5m scale)

Almost all evidence for previous development on the site related to the recently-demolished house (6.6 below). The only earlier remains comprised one piece of *in situ* brickwork that was exposed in the eastern section of the excavation, immediately behind the new steel frame.

The brickwork took the form of a southwest-facing corner, with a total of six extant courses when fully exposed (Fig 7). The adjacent brick faces were traced for no more than 0.35m, but it is assumed that these represent wall foundations running off to the north and east.

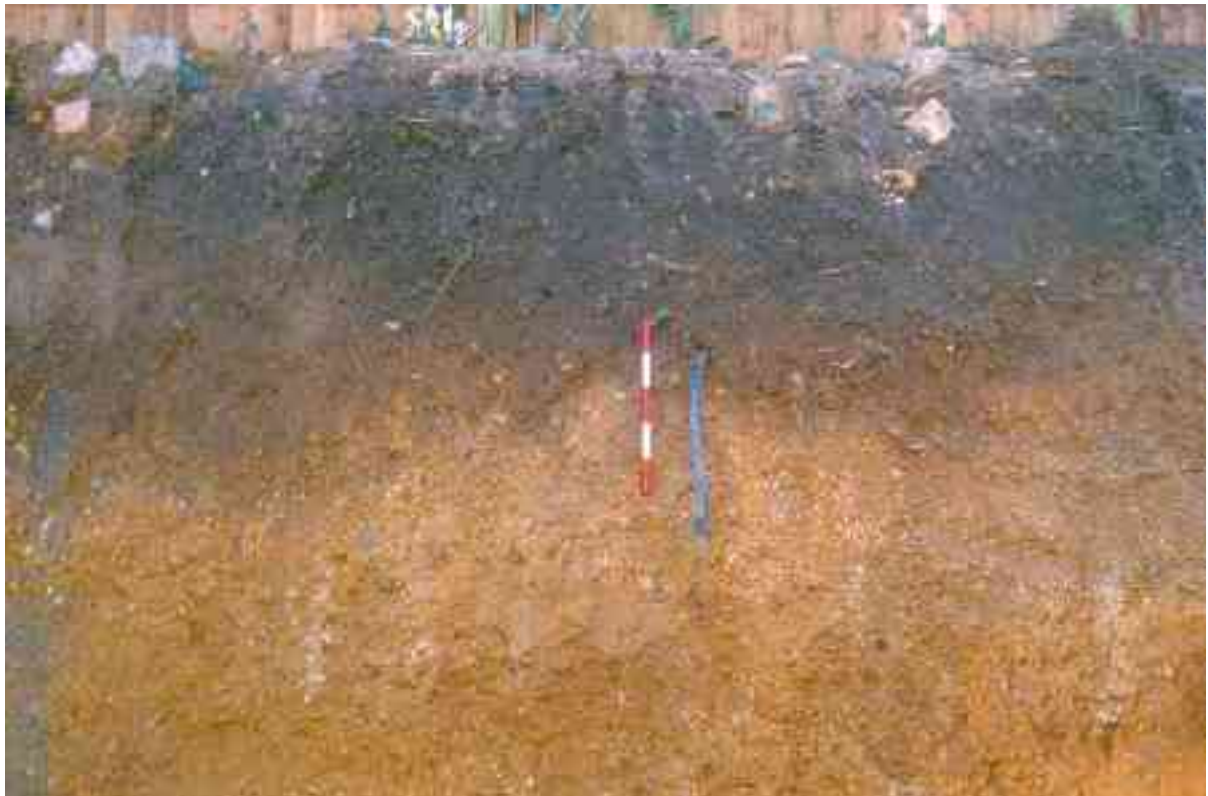
Fig 9 Photograph and drawing showing reworked soil horizons towards the southwest corner of the site (located on Fig 3)

Where not truncated or disturbed by recent activity the natural deposit retained a weathered upper horizon, overlain or merging into a medium-light brown sandy subsoil. This was mainly present in the southwestern part of the excavated area (Figure 9), although occasionally apparent elsewhere (*eg*, Figures 6/7). These horizons were typically some 200mm to 400mm thick, with the upper subsoil yielding occasional fragments of ceramic building material (brick/tile) and a few sherds of commonly occurring 19th or early 20th pottery (plain and transfer-printed earthenware).

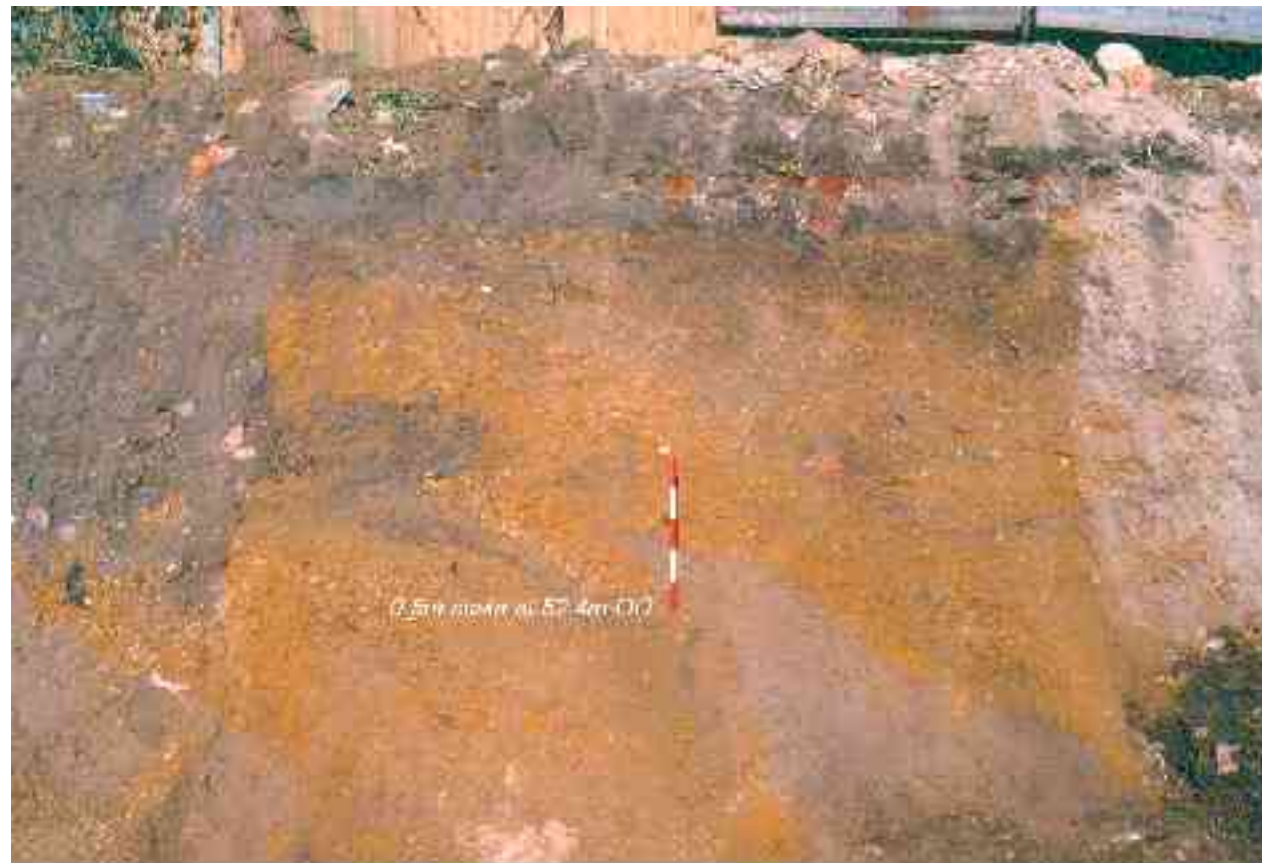
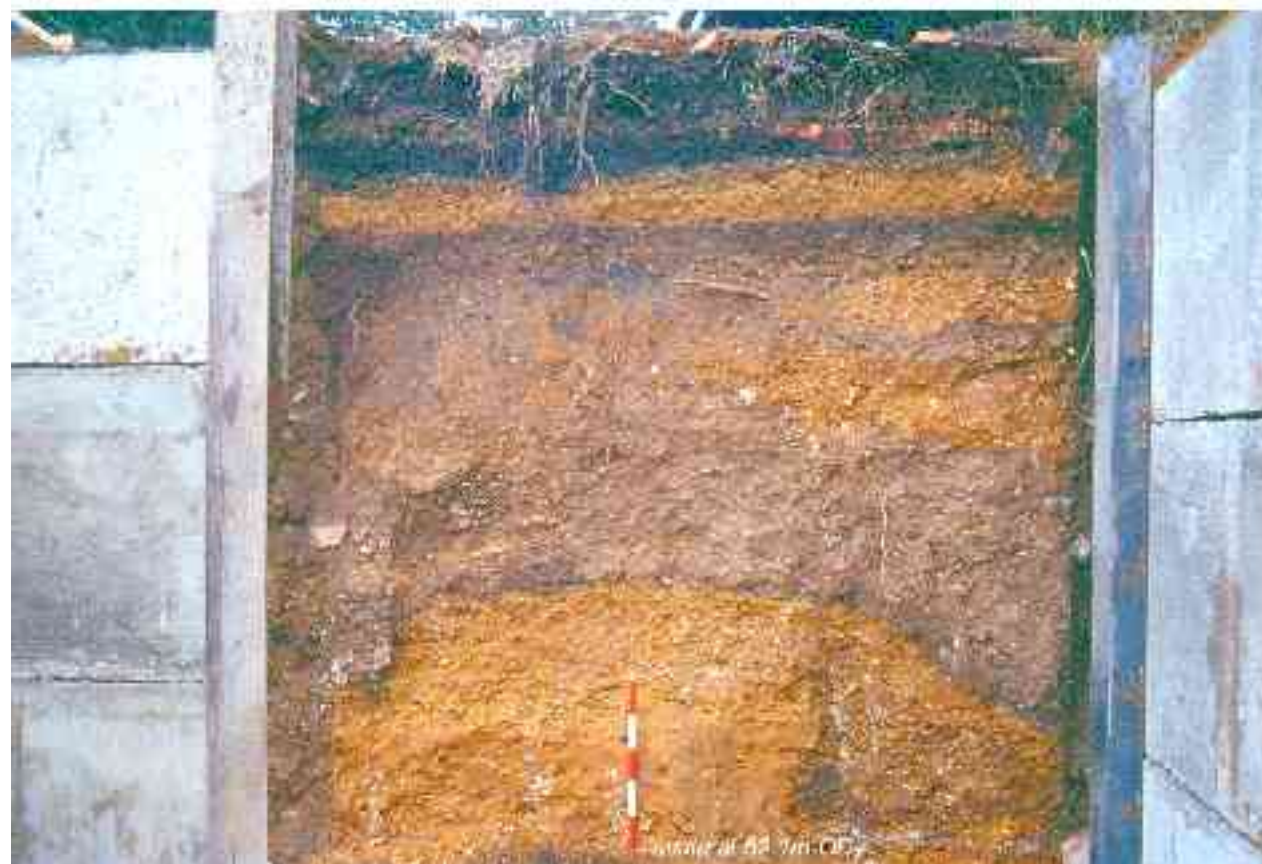
ground level at c 54.6m OD

c. 4-500mm mixed soil & recent demolition material, etc

c. 250mm compact sandy silt with some gravel & brick rubble

Fill: lenses of mid grey-brown silty sand, some darker soil and occ. brick fragments with fairly clean sandy gravel (repositioned natural)

Note the series of tip lines running down from west to east

limit of excavation at c 51.9m OD

c. 400mm compact sandy silt with intermediate layer of brick rubble

Fill: clean sandy gravel (repositioned natural) interleaved with darker silty sand with pebbles & silty soil

Natural sandy gravel at c. 52.5m OD, rising to a maximum of 52.92m to west

Figs 10 & 11 Views at the northwestern corner of the excavation, showing deep fills within the assumed gravel extraction pit (located on Fig 3)

Natural deposits to the northwestern were heavily truncated by a large pit, which extended some 8.5m to 11m into the area of excavation and also continued beyond this to the north and west. The sides were quite steeply inclined, and to the southwest were visible cutting the lower soil horizons some 0.8m below present ground level (*c* 54.0m OD). The base of the pit was up to 2.8m below ground level, although shallower at the western limit of excavation (*c* 1.5m to 2.0m) and apparently rising in this direction.

The purpose of this feature is not definitely known and it does not appear on any of the consulted maps, but it is assumed that it represents a gravel/sand extraction pit. The fill was also quite clean, and indeed contained quantities of redeposited natural material (*cf.* Fig 10). However, there were occasional pieces of 19th century brick (red and very rarely yellow stock). Together with the overlying reworked soil this would suggest a date in the later 19th or earlier 20th century.

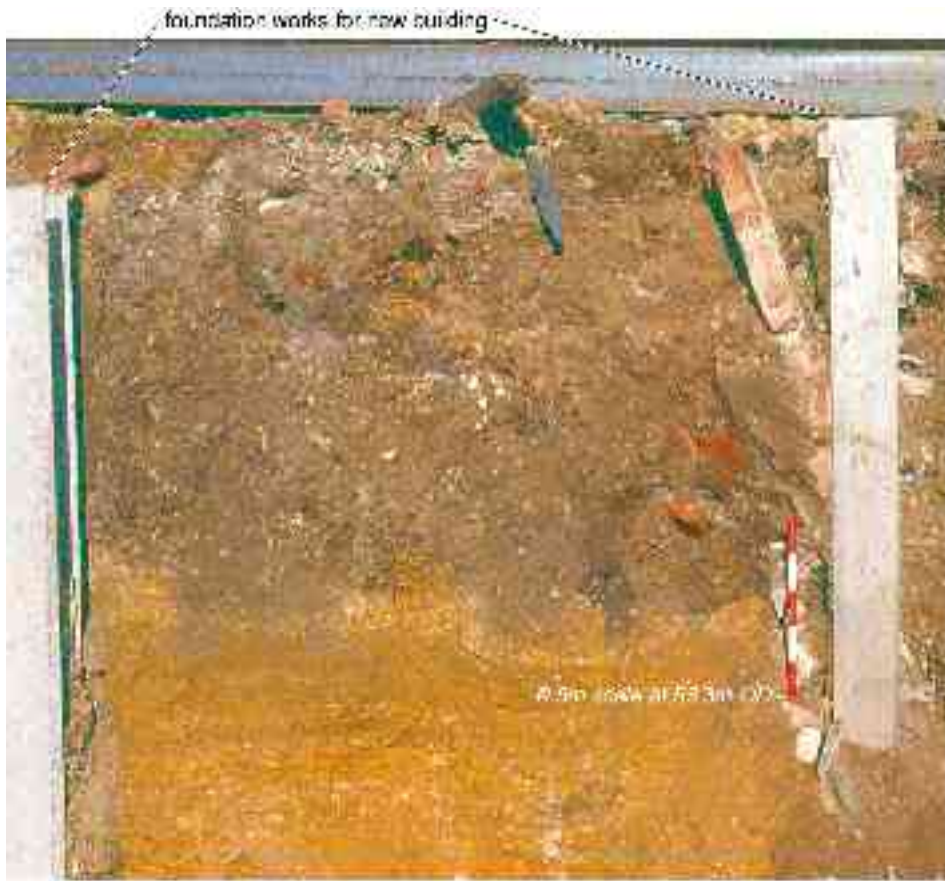
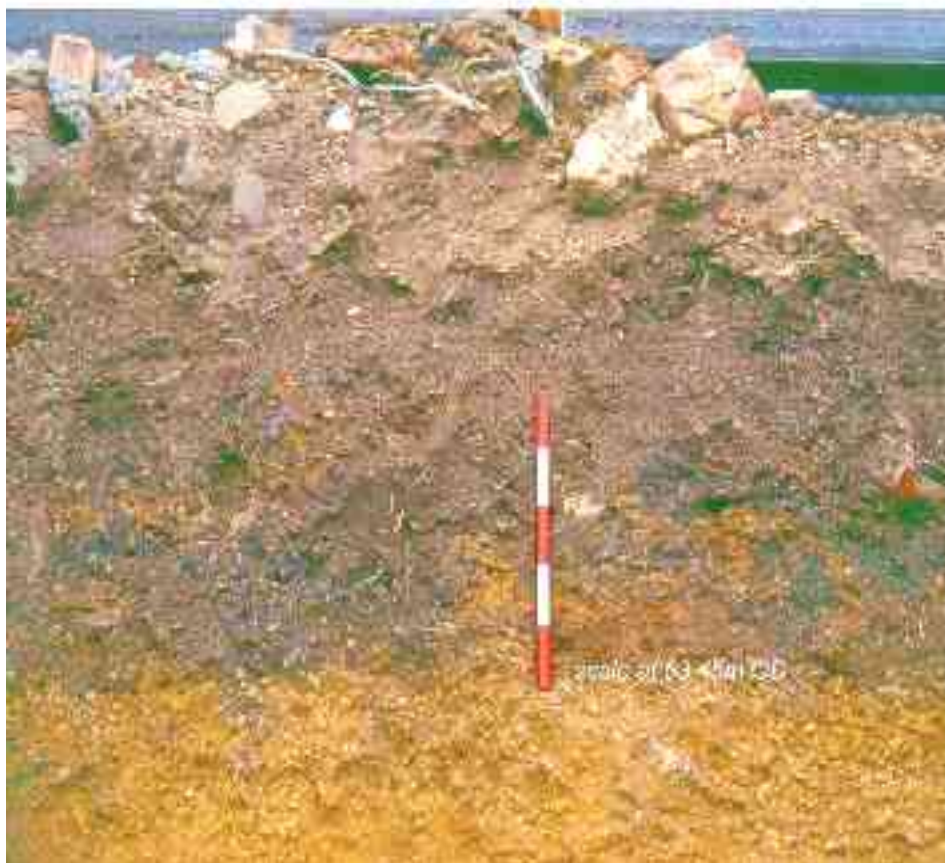
ground level at c 54.9m OD

mixed soil & recent demolition material

Disturbed & made ground, loose silt soil with building rubble (brick, concrete & some plaster)

Natural: up to 150mm fine gravel over sand and coarser gravel layers

ground level at c 54.5m OD

Disturbed/made ground, fairly loose silty sand/gravel with some building rubble

slightly silty sand/gravel (?disturbed subsoil)

Natural sandy gravel, becoming more sandy with depth

Figs 12 & 13 Exposed sections showing extensive ground disturbance in the area of the previous house

The natural sand and gravel (Black Park Gravel; *cf* 3.1 above) was exposed throughout the excavated area, although in many places more or less truncated by modern activity. In detail the deposit was mainly a firm sandy gravel, but with layers of more homogenous sand or occasionally medium to fine gravel. These variations are clearly seen in the surviving upper levels in Figure 12.

The previous house on the site was probably built in the 1960s, and underwent subsequent extension to the south and west. These developments caused considerable ground disturbance in the central and eastern parts of the new footprint. The depth of this varied between *c* 0.7m and 1.4m below the existing surface, but it had generally removed previous soil horizons and any other evidence of occupation.
