An Archaeological Evaluation at No.94-96 Cheyne Walk,

London Borough of Kensington & Chelsea, SW10 0DQ

Site code: CHY11

COMPASS ARCHAEOLOGY LIMITED

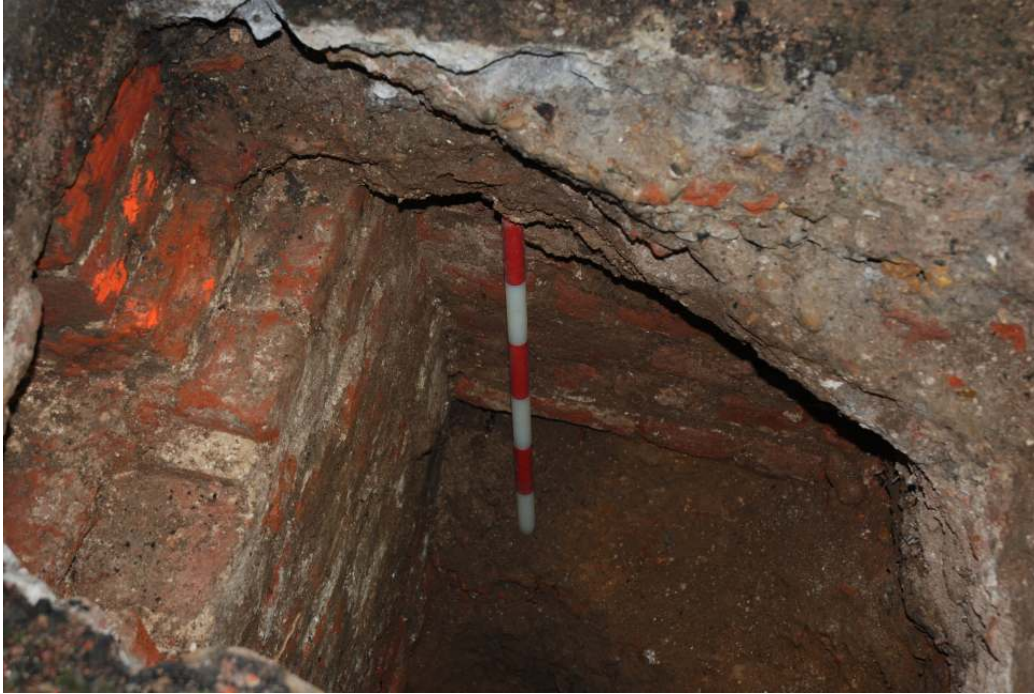
Fig.7: Walls within Trial pit 8. The wall to the left of frame is an earlier incarnation of the eastern garden wall, with the beginning of a doorjam just visible by the remnants of spray paint. The brick wall to the right abuts this at right angles and runs E-W across the present courtyard. (1m scale)

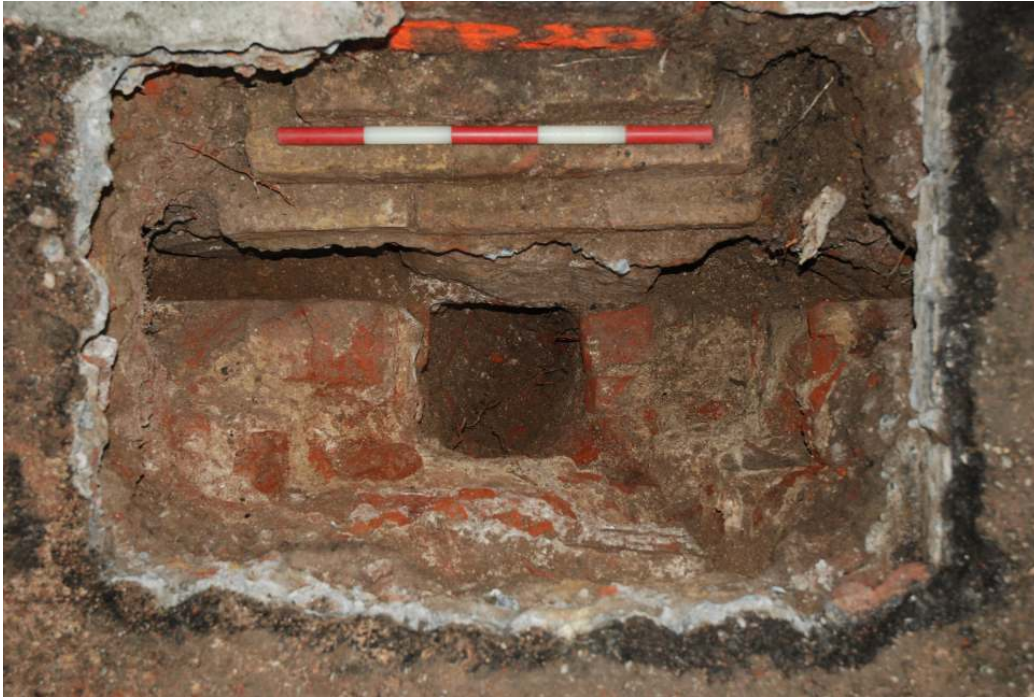
Fig.8: Trial pit 20 showing existing footings to north wall of 94 Cheyne Walk and continuation of E-W aligned wall from Trial pit 8 in bottom of frame. (50cm scale)

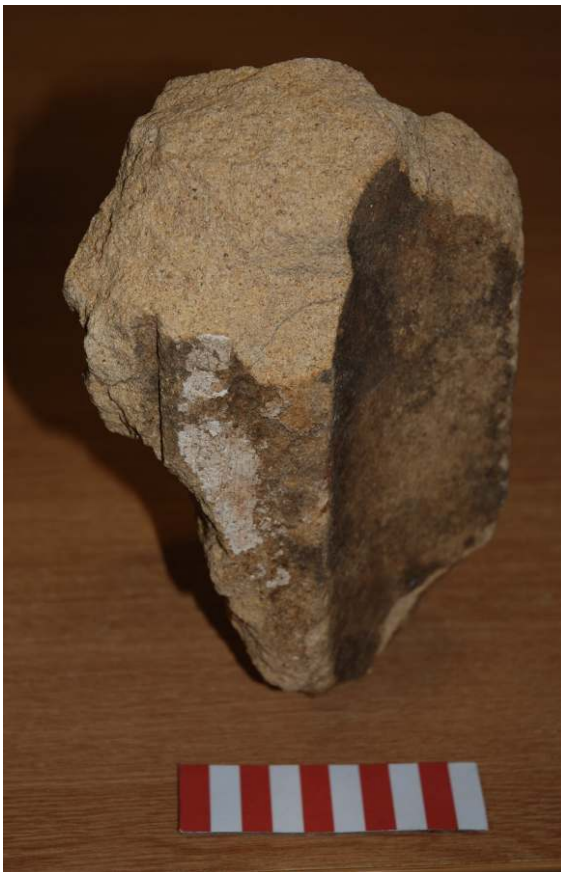
Fig.9: Fragment of window moulding recovered from wall in Trial pit 20. Note groove for windowpane immediately left of lime-wash. (10cm scale)

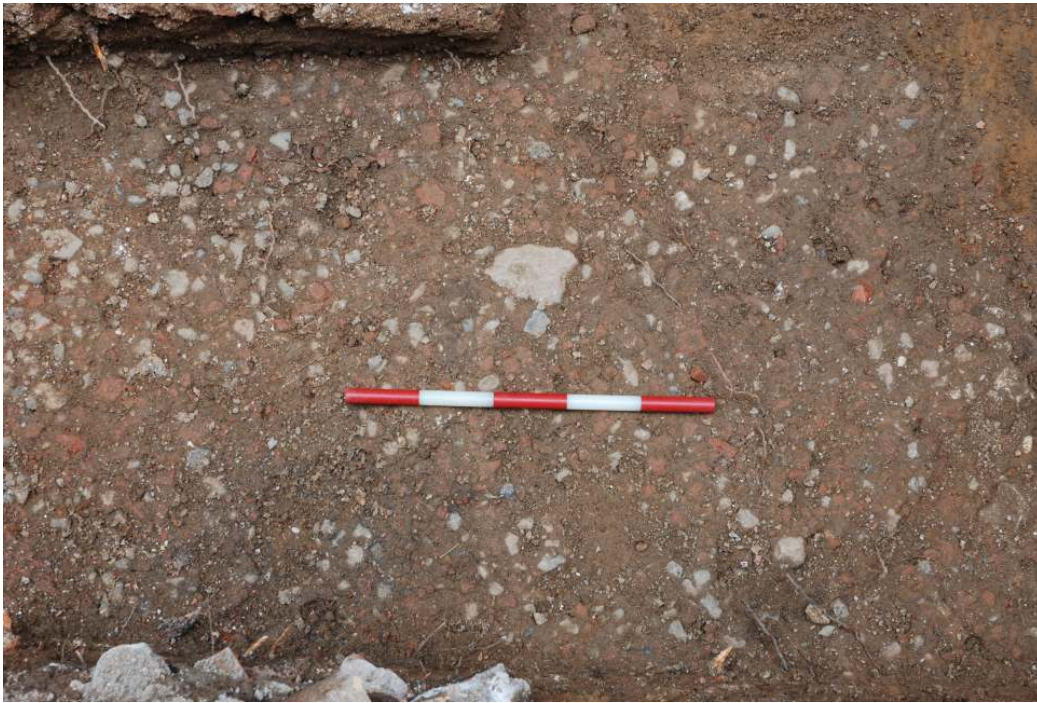
6.2.2 The natural was not directly overlain by any buried soil horizons or accumulated deposits as might have been expected. These had been deliberately removed and subsequently overlain by a thin, 70mm, layer of fine silt-based levelling material, (31), into which had been lain / impressed a pebble and crushed tile derived metallated surface, (12). This surface survived to a varying extent across the entire length and width of the trench between 4.45mOD - 4.55mOD, unless disturbed by later intrusions, and was not more than 20mm thick.

Fig.11: *Detail of metallated surface (12) at northern end of Trench 1, facing W. Note the underlying natural just visible in top-right of frame. (50cm scale)*

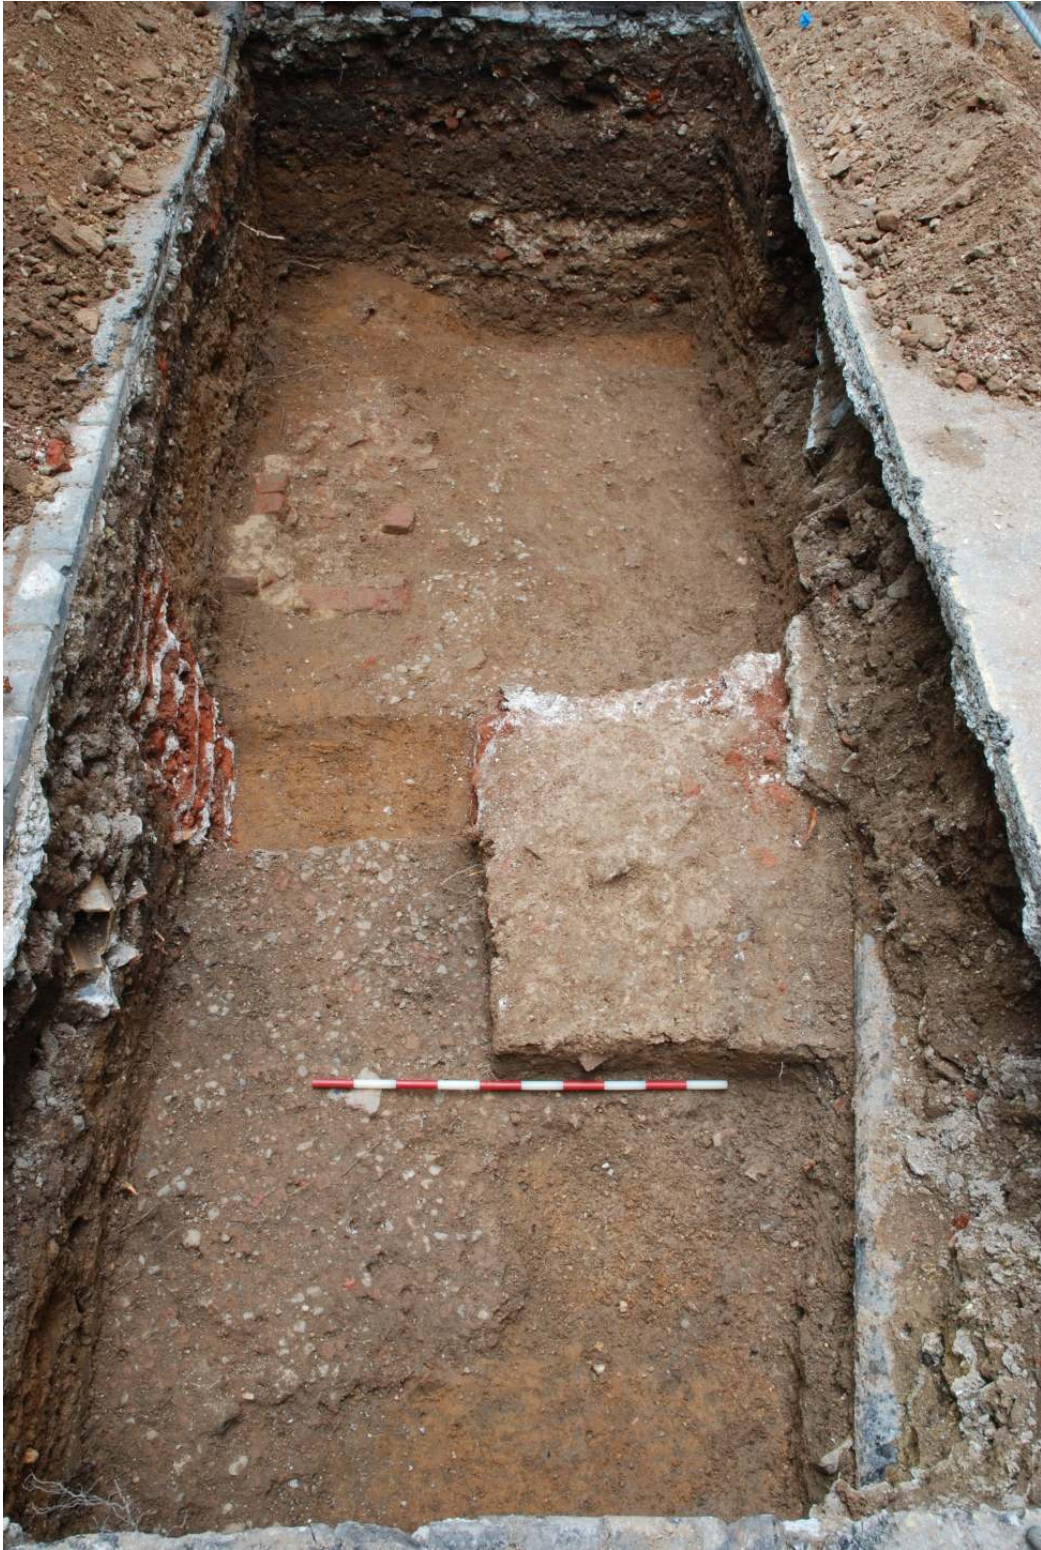
Fig.12: Trench 1 facing S. Metalled surface (12) visible in lower-left and upper-right centre of frame. (1m scale)

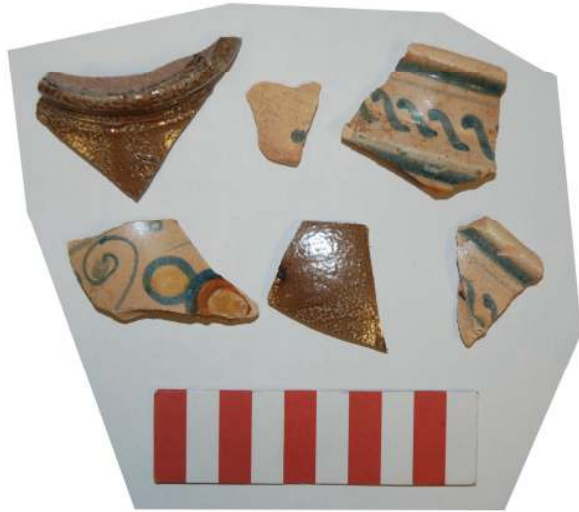
Fig.13: *Some of the pottery recovered from context (8), English tin-glazed ware and Frechen Stoneware (10cm scale)*

6.2.3 Sealing this surface was a silty-sand deposit up to 250mm thick, light grey in colouration and relatively compacted. This deposit, (8), contained considerable amounts of broken peg tile, (1480-1700AD), along with pottery of various wares, including Post-medieval Redware, Post-medieval Slipped Redware and 'Tudor Green' Ware. The pottery dated the context to the earlier to mid part of the 17th century⁴. The pottery was in good condition and was not abraded suggesting they were dumped in a single episode, perhaps having only been broken upon the act of deposition and then quickly buried. The same deposit was present at the northern end of the trench as context (28); the separate context number is due to the presence of the later dividing wall [7], discussed in 6.2.7 below.

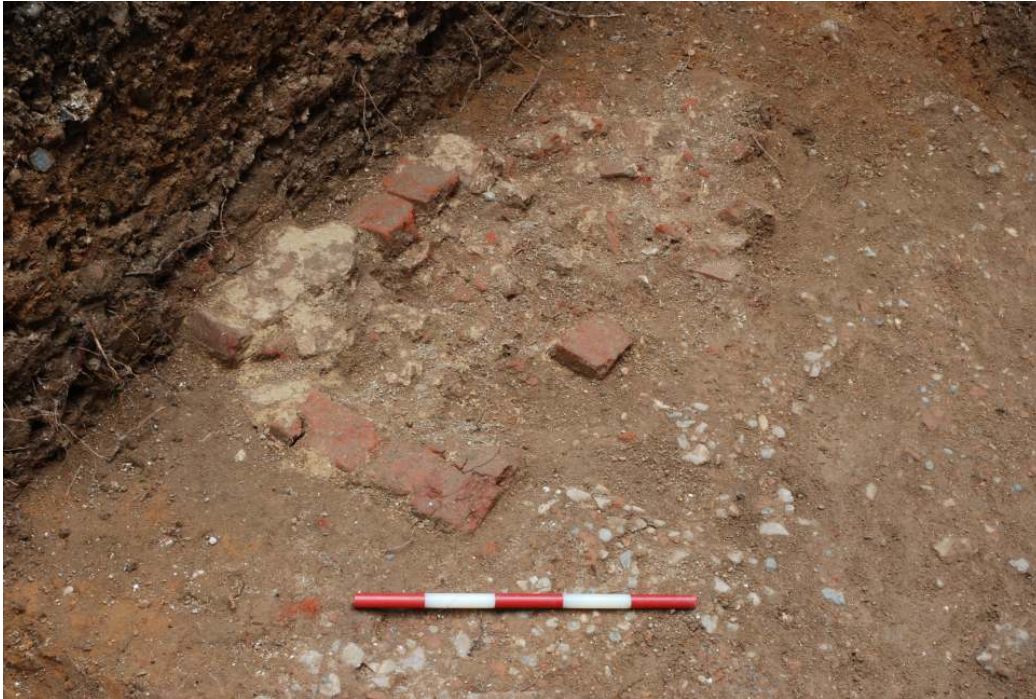
- 6.2.5** Surface (12) was in places built up around brick footings [11] present in the eastern section of the trench. Structure [11] was first observed at a depth of 4.37mOD as a wide spread of brick rubble and lime mortar. This consolidated itself in section to reveal 4 courses of *in situ* brickwork representing a wall footing. It survived to 240mm in height and 300mm wide, and extended westwards into the trench for 380mm. Brick samples taken from the wall suggested a wide date range of 1450-1700AD, but its relationship to surface (12), would suggest it could perhaps be more narrowly be dated to the 17th century. It sat with construction cut [35], which was backfilled with a grey-silt, (34), similar in consistency to context (8).

Fig.16: Wall stub [11] in Trench 1 facing SE. The brickwork up against the section consolidated itself into a short wall stub, with the lighter spread near the top of frame being demolition rubble. 50cm scale rests atop surface (12)

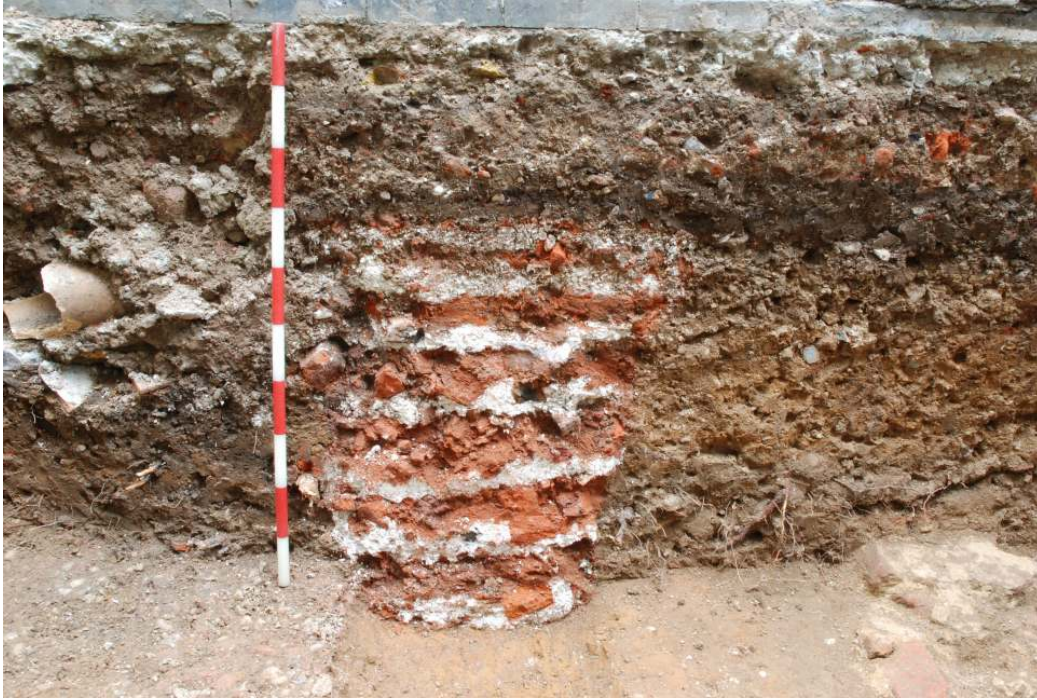
- 6.2.7** Context (9) was cut by several features. The first of these was context [7], present within the eastern section. This was an E-W orientated wall foundation made up of alternating layers of crushed and compacted brick and chalk. This footing survived to a maximum height of 800mm from the base of the trench to 420mm below the current ground surface, (4.40mOD – 5.15mOD respectively), and was between 500-600mm wide, tapering slightly on its southern side towards the base. The foundation was therefore cut from quite high up in the section suggesting a relatively late date for the construction. However, the material used in its construction does not easily lend itself to accurate dating. Following demolition of the standing wall that would have been built on the foundation, [7] was sealed below a dark-grey gravelly silt, (10), which may be a buried soil horizon. A single piece of clay pipe stem was recovered from the deposit with a shamrock / trefoil stamp impressed onto the base of the heel. As the pipe was missing its bowl, dating was difficult. However the pronounced nature of the heel and thickness of the stem suggests it is relatively late in date, possibly mid to late 18th century.

Fig.17: Wall [7] facing E, cutting through gravels, (9), deposit (8), and surface (12) into natural ground. Sealed below (10), (1m scale)

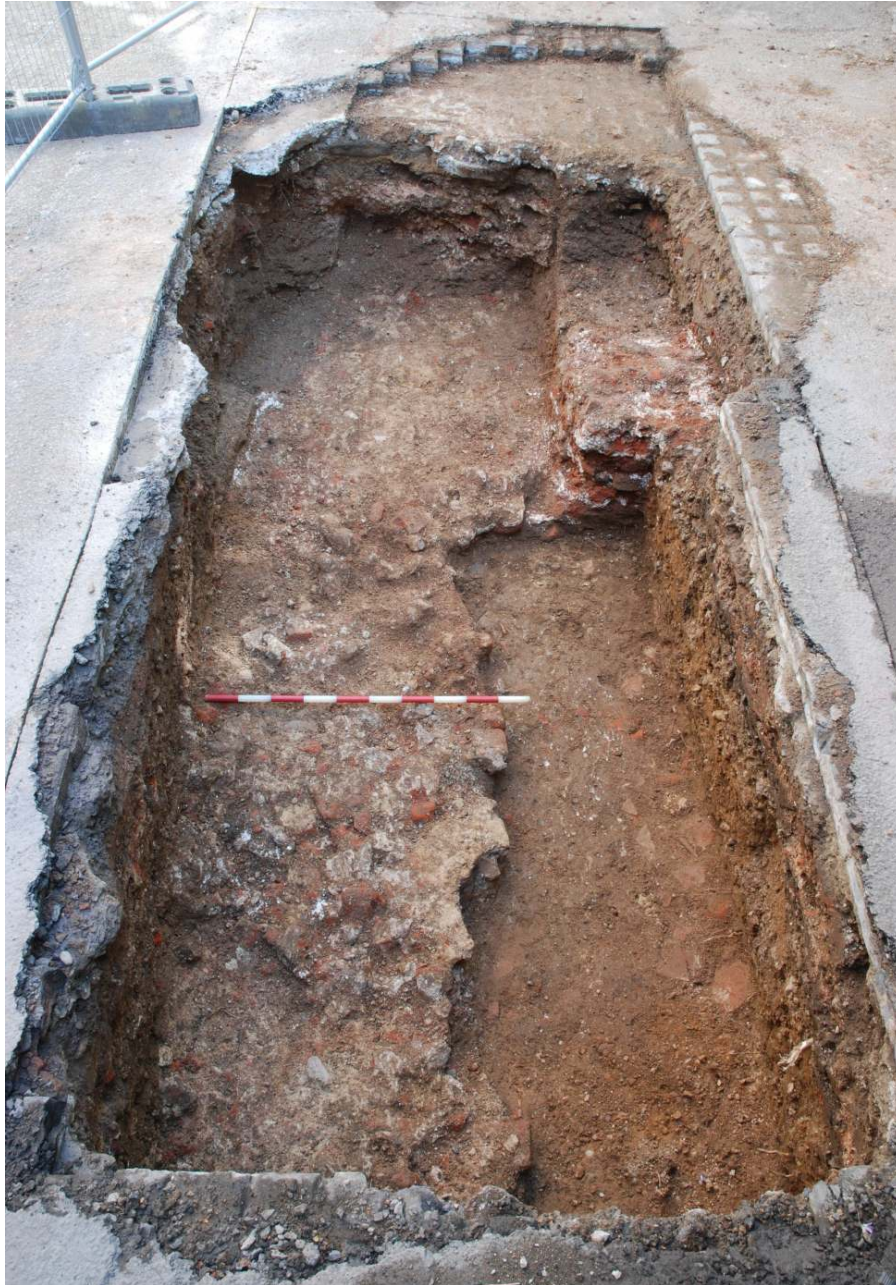
Fig.18: Foundations [5], left, and [7], right, in Trench 1 facing N. (1m scale)

The foundations also overlay brick and chalk foundations [7] where the two met. Foundations [7] had been truncated and overlain by a thin layer of orange-brown silty-clay, context (6), over which were lain foundations [5]. It therefore seems likely that the two wall foundations were not associated eg. separate phases of the a single building; but rather they supported entirely different structures all together.

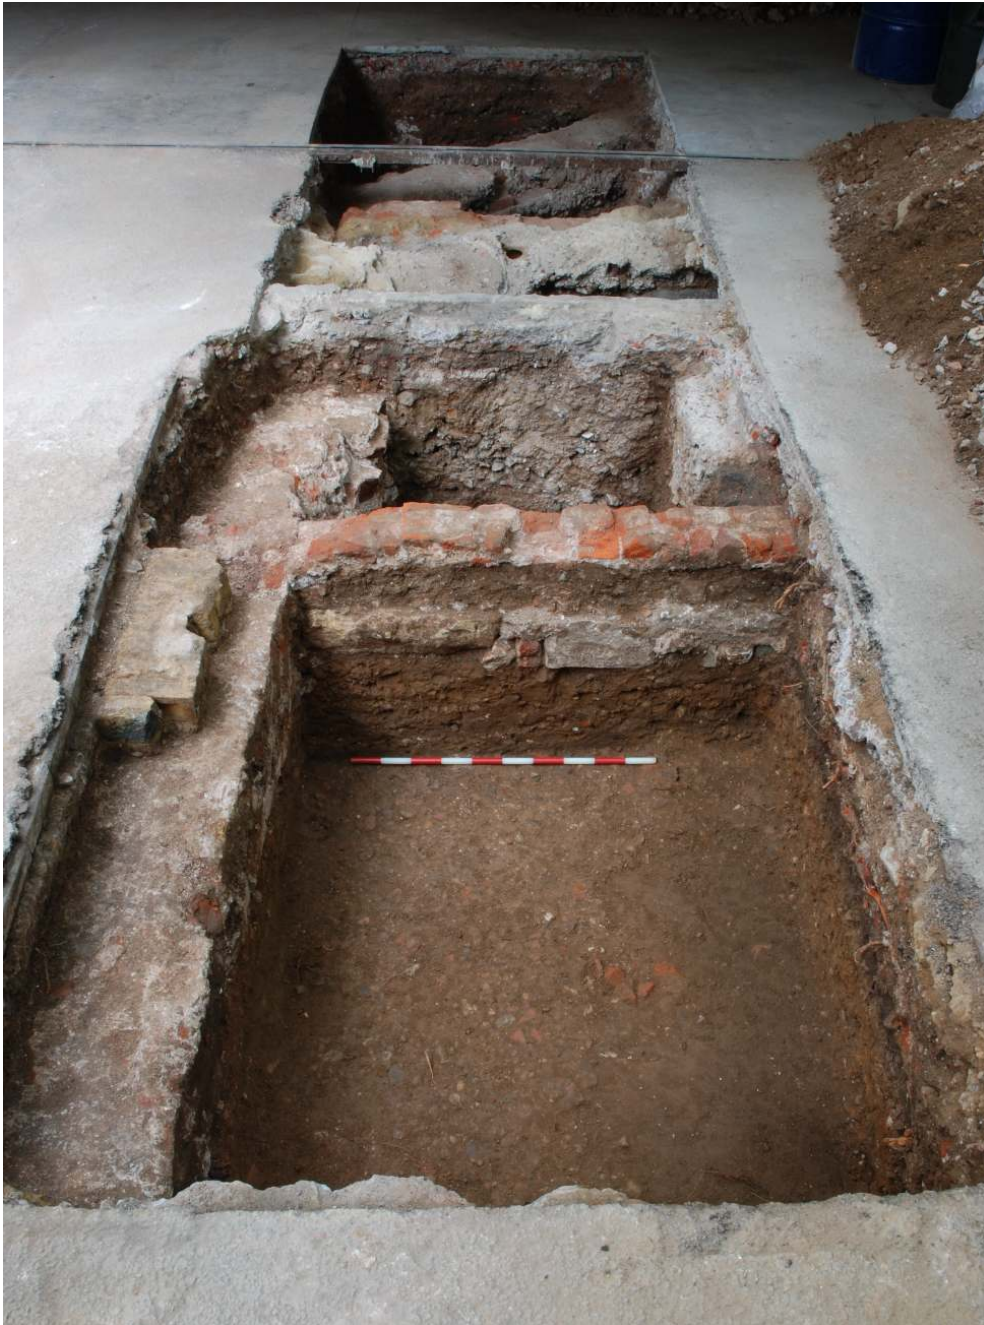
Fig.20: Trench 2 facing N. Wall [20] to left, with [16] atop. Metalled surface (21) in foreground with 1m scale. Wall [17] resting atop stone foundations north of scale, and wall [18] just visible in background behind concrete encased drain

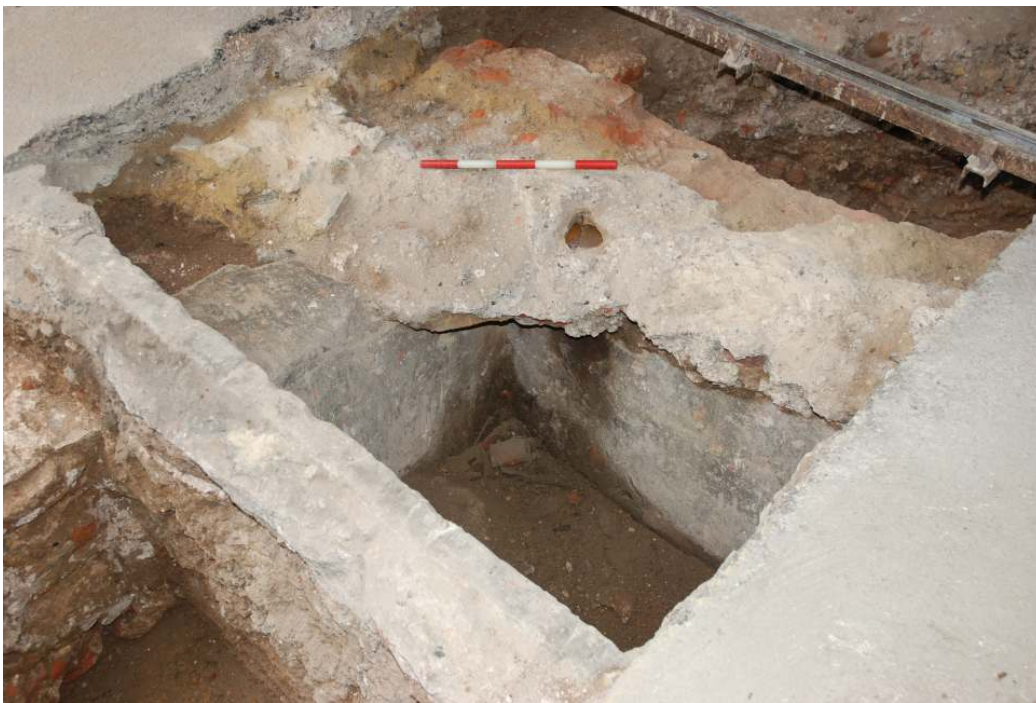
The concrete-lined chamber was rectangular in shape with internal dimensions of approximately 0.86m wide by >1.08m long, (it extended beyond the eastern limit of excavation), and survived to a height of 1.15m. The chamber had a concrete floor to it and a slight step up at the eastern end suggestive of the beginning of a flight of steps. It was backfilled with large quantities of silt, along with 20th century flowerpots, an old sprung bicycle seat and miscellaneous modern junk. As such it was deemed of limited archaeological value.

Fig.21: Chamber [19] facing NW with modern flowerpots and wood, etc. within backfill, (50cm scale)

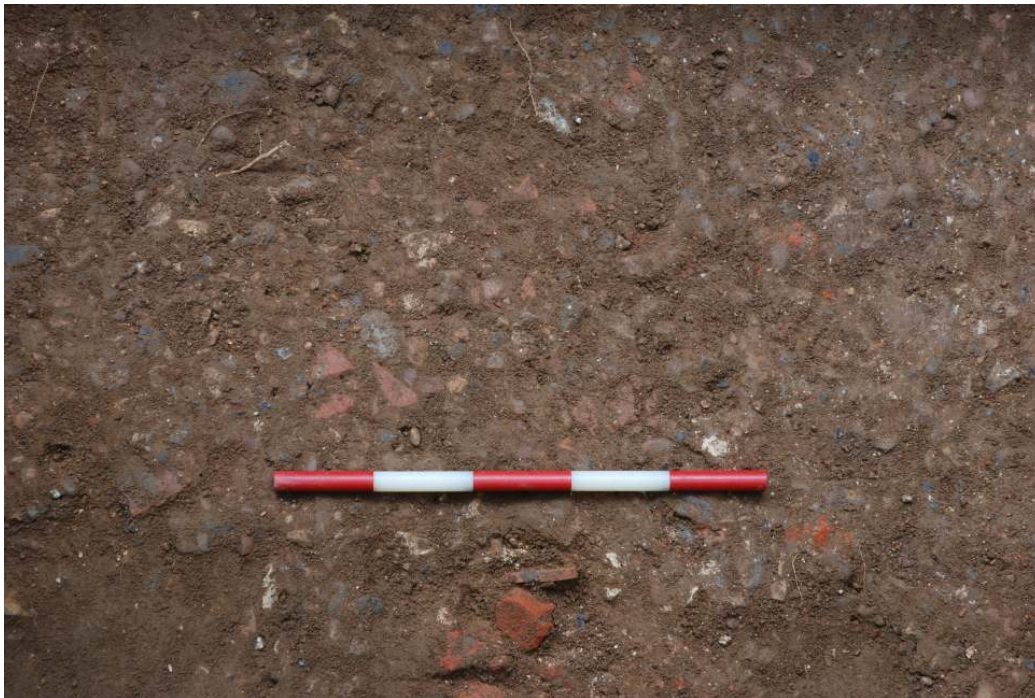
- 6.3.6** As in Trench 1 the natural is not overlain with any accumulated soils, but rather is overlain with the same / a similar metallated surface, (21), comprised of flint pebbles and small fragments of tile, as observed in Trench 1, (12). The top of this surface was visible at 4.73mOD, at the south end of the trench and at 4.52mOD at the northern end. This followed the same downward slope of the natural ground – at least overall but with an abrupt drop near the southern end as seen in fig.34. The surface was impressed into deposit (22) across the length of the trench. A single sherd of pottery from (22) was recovered in the southern end of Trench 2, possibly within the upper levels of cut [27]. It was identified as South Hertfordshire-type greyware, in use between 1170-1350AD.

Fig.22: Detail of metallated surface, (21), at southern end of Trench 2, (50cm scale)

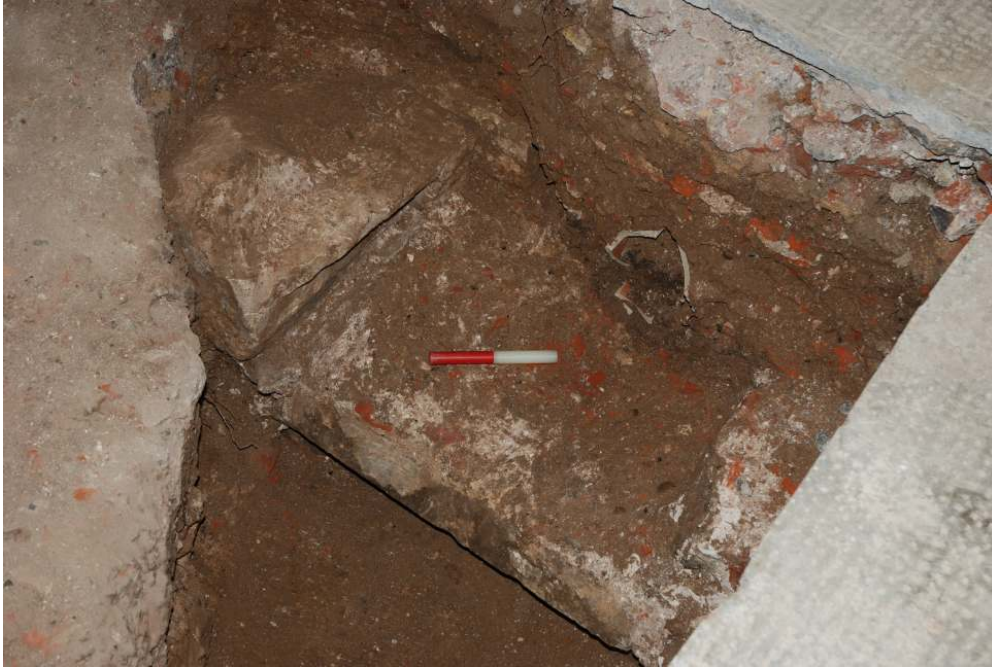
- 6.3.9** Cut through and constructed within deposits (23) and (30) was wall base [20]. This wall was present along much of the western edge of the trench stopping c2.10m from the southern end and was in places up to 600mm wide, extending beyond the western limit of excavation. It survived from 300mm, (5.35mOD), below ground level at the southern end and 450mm, (5.17mOD), at the northern end. It was built largely from red brick, bonded with white lime mortar cement, but at both ends also contained large fragments of re-used monumental masonry as footings / foundations. At the southern end it was replaced by a modern concrete footing, [32].

In total, 8 pieces of masonry were recovered from Trench 2, all from within the fabric of the foundations for wall [20]. Several other pieces were left in situ to be recovered and examined in any later stages of work. Of the pieces recovered all had at least 2 surviving worked and dressed faces, and 5 had visible tool marks. They ranged in size from 140mm x 160mm x 135mm blocks, (A), 310mm x 180mm x 120mm decorative scrollwork, (B), to large 660mm long sections of potential window mullion framework, (H).

Fig.23: Wall [20] at far northern end of Trench 2. The 20cm scale rests atop re-used stone Block H, with Block G to the left

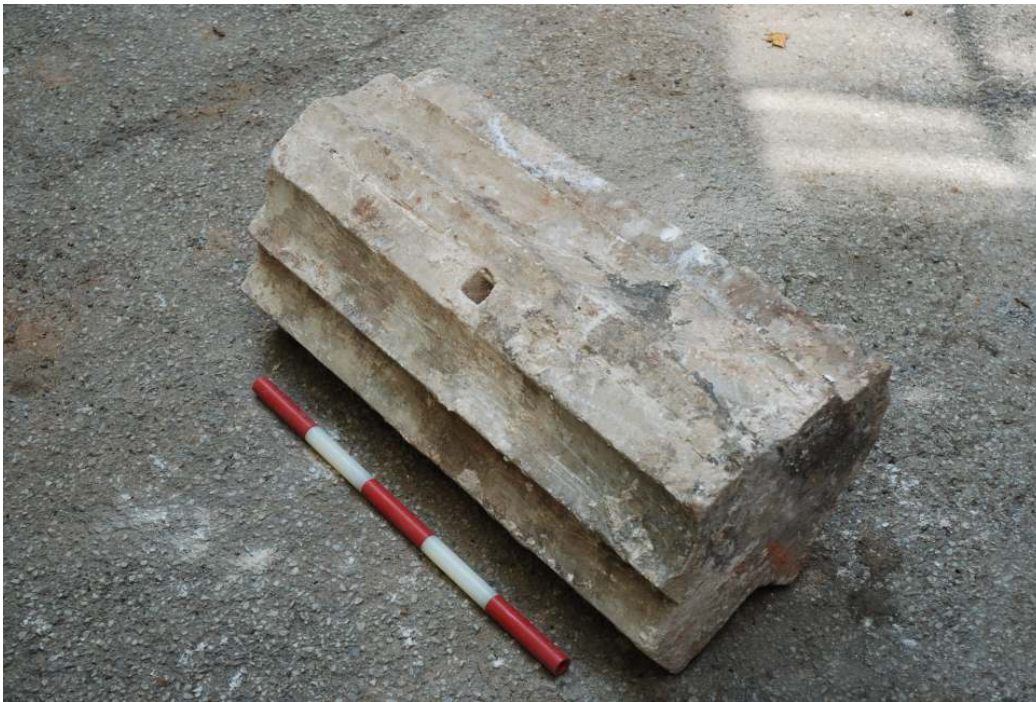
Fig.24: Block H having been removed from foundations. It shows the opposite side to that visible in fig.23 above. (50cm scale)

| Name | Context | L | B | T | Worked? | No. of faces | Comments | Fig nos. |
|---|---|---|---|---|---|---|--|---|
| H | [20] | 660 | 340 | 260 | Y | 14 | Long fragment of possible window mullion frame. Three level design with two curved steps cut into external face. A single 35mm square by 30mm deep hole cut midway down external face probably to house some form of fitting. Opposite face is cut on one side with a 10mm wide and 85mm deep cut-out along the length of the block. | 44-46 |

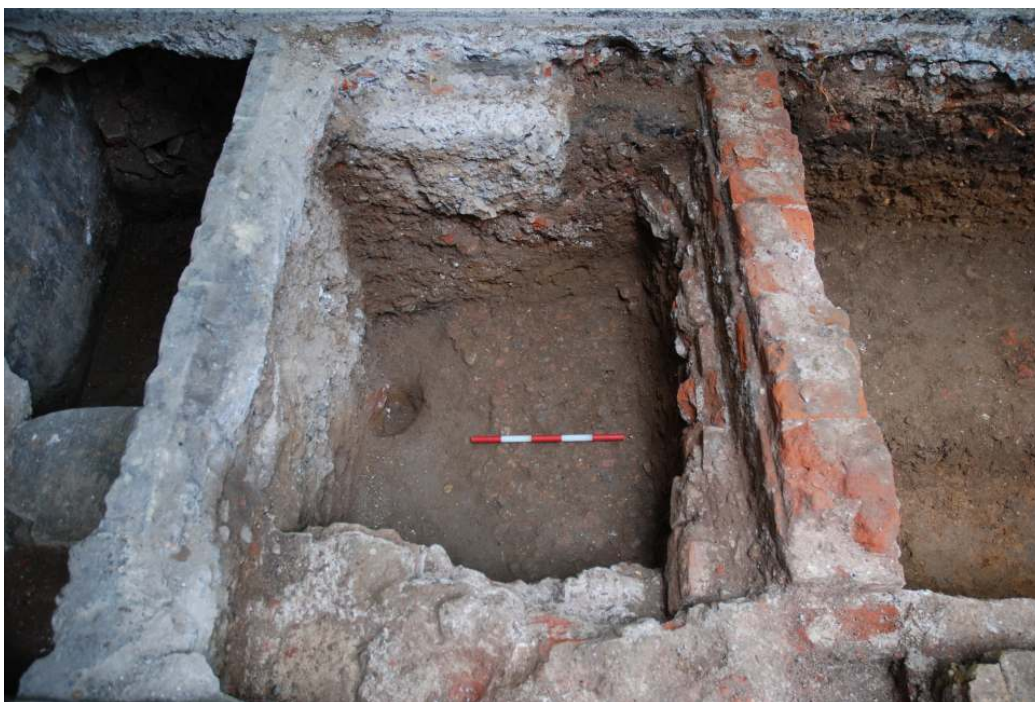
6.3.11 Wall [20] was abutted twice by E-W aligned wall footings extending across the trench, at 1.96m from the southern end, [17], and 4.70m from the southern end, [18]. These footings were both similarly constructed from red brick and off-white lime mortar cement to one another, but shallower and less substantial than wall [20]. They both survived to approximately three courses in height and were built over stone and rubble based foundations bonded with coarse cement. Wall [17] was present at 5.51mOD and wall [18] at 5.49mOD.

Fig.25: Wall [17] to right of frame, with 50cm scale resting atop surface (21) and posthole [26] to left. Wall [20] in foreground. Chamber [19] to extreme left of frame

Wall [17] was >1.5m long by 0.42m wide at foundation level and was constructed from bricks 210mm long by 95mm wide and 70mm thick. Wall [18] was >1.4m long by 0.26m wide and made from bricks 225mm long by 95mm wide and up to 65mm thick.

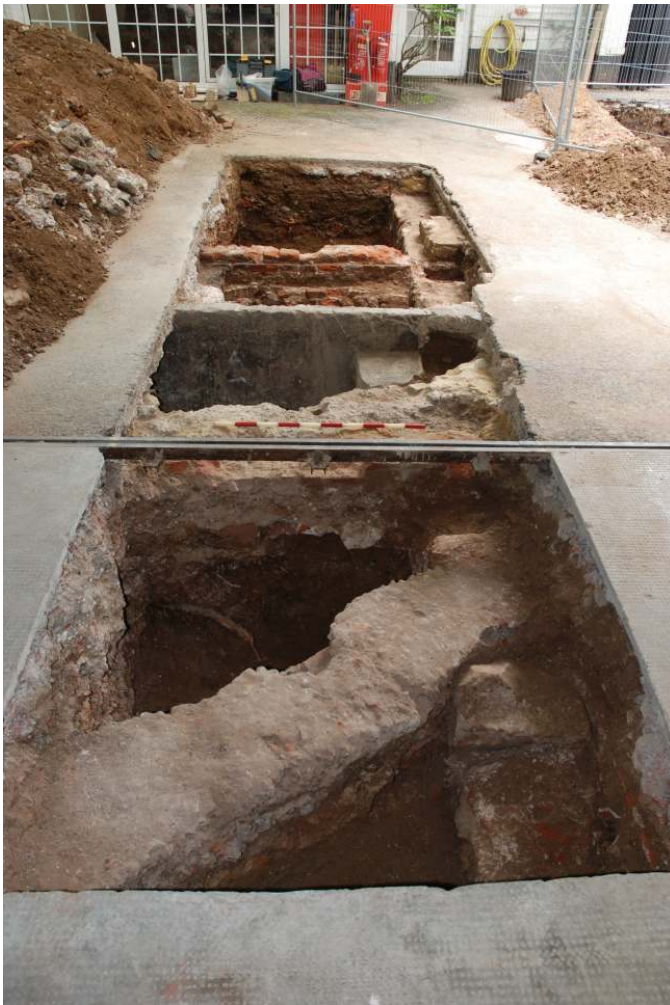
Fig.26: Trench 2 facing S, 1m scale rests atop wall [18], wall [20] visible on the right hand side of the trench. Wall [17] visible in background

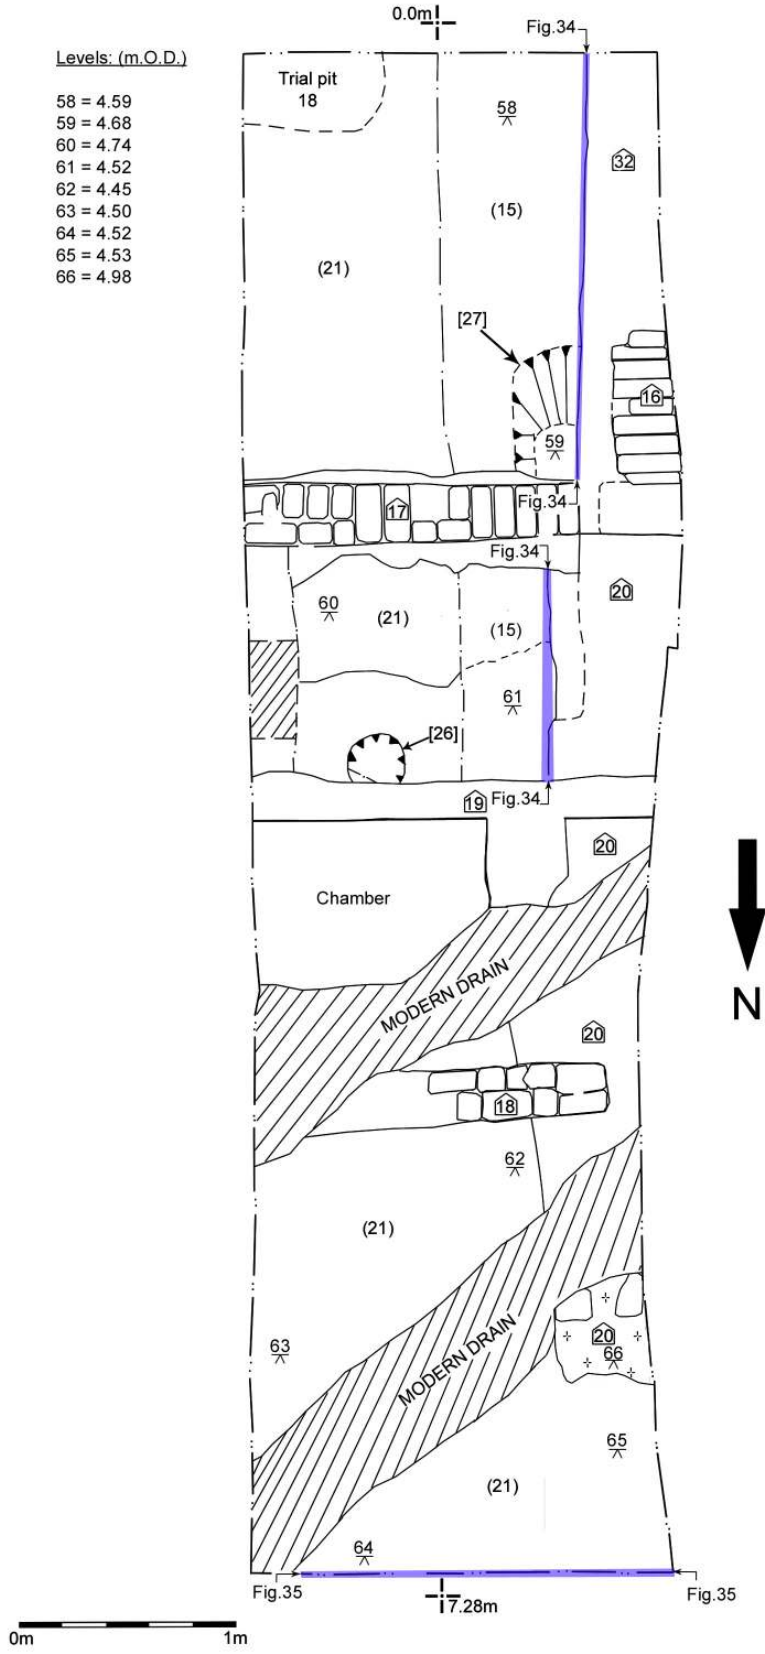
Fig.33: Plan of Trench 2, secondary stage

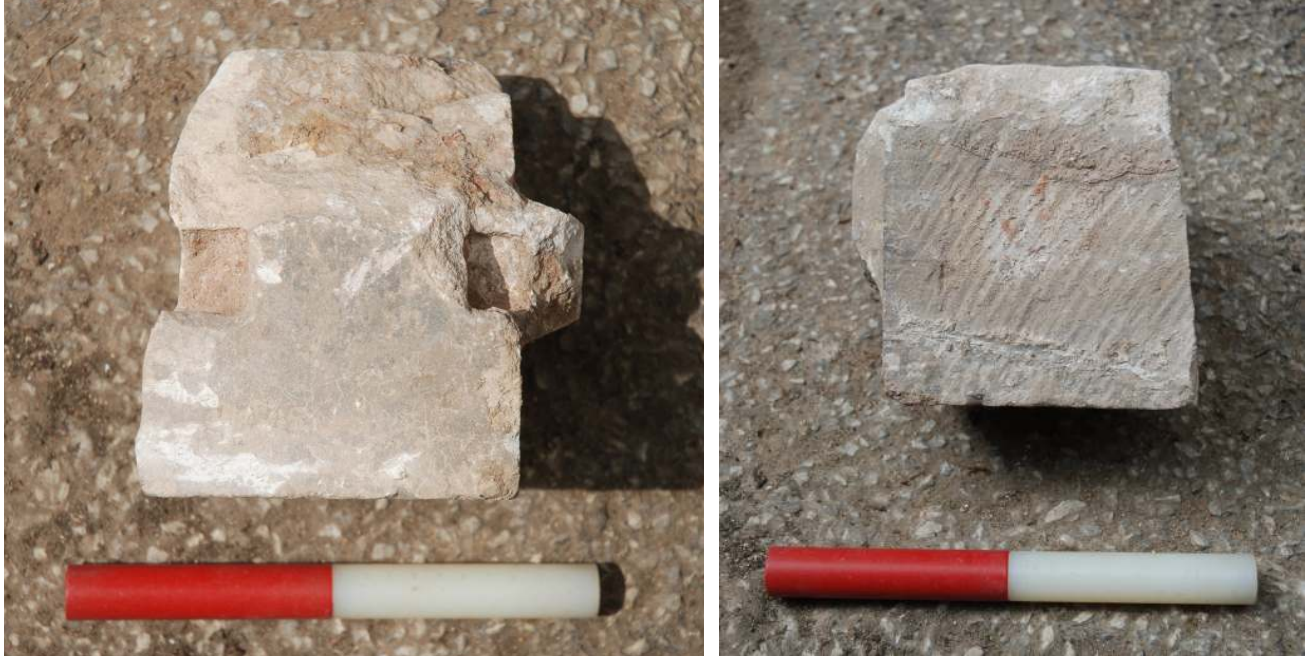
Fig.36: *Block A showing two housing notches, (left), and tool marks, (right) (20cm scale)*

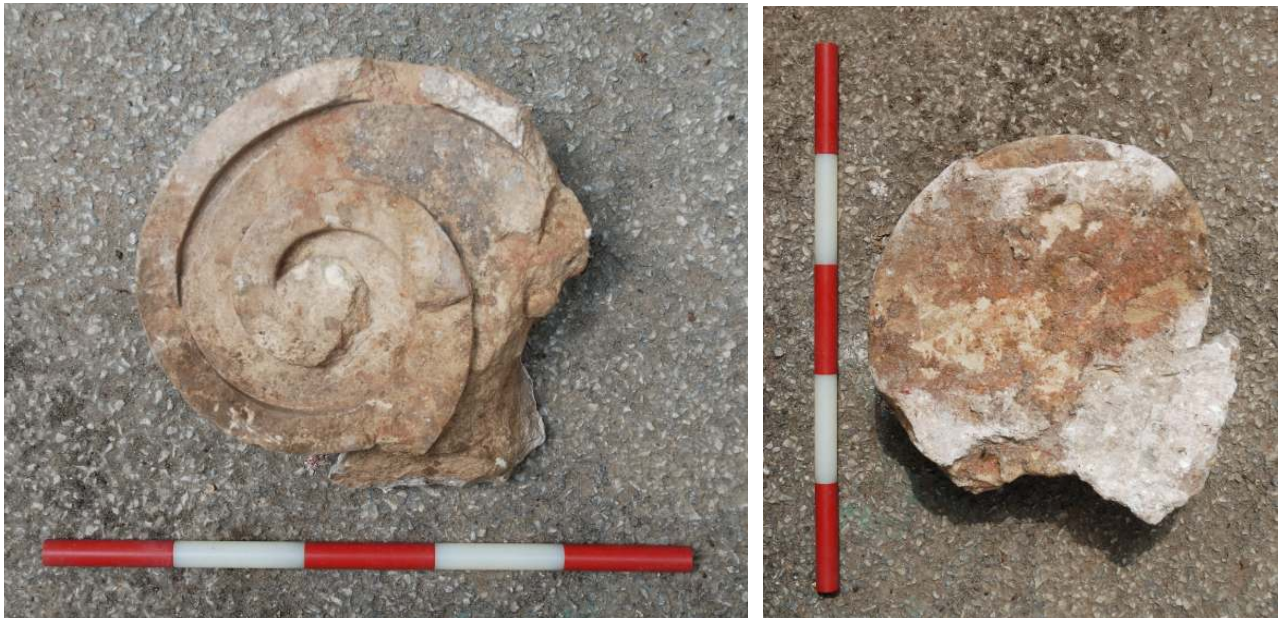
Fig.37: *Block B showing decorative scrollwork and rough face to opposite side (50cm scale)*

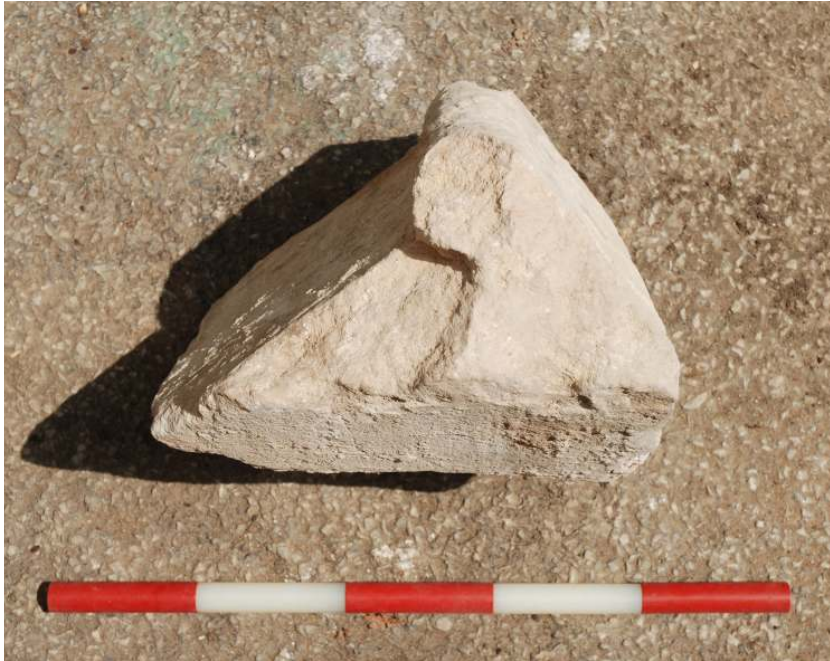
Fig.38: *Block C showing mouldwork and facings (50cm scale)*

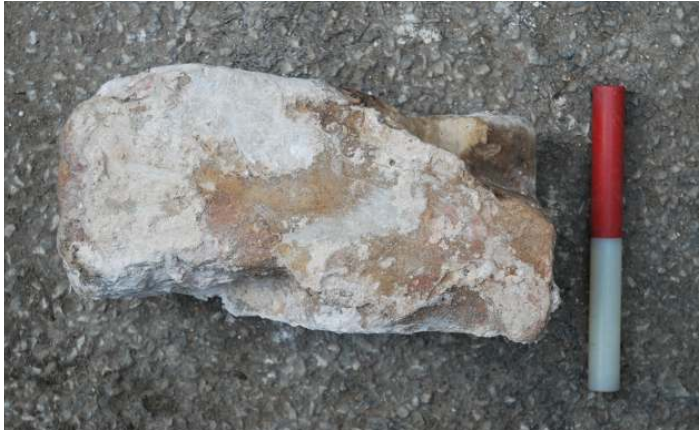
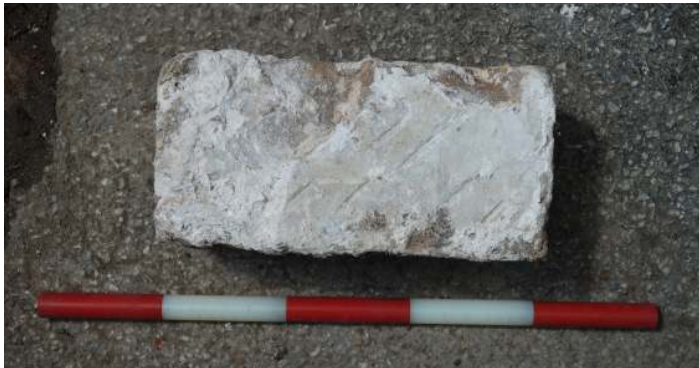
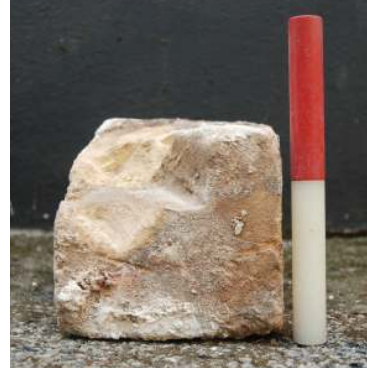
| Name | Context | L | B | T | Worked? | No. of faces | Comments | Fig nos. |
|---|---|---|---|---|---|---|--|---|
| E | [20] | 285 | 130 | 130 | Y | 5 | Rectangular block, damage to most faces. Small chamfered notch cut out of one corner. One face shows tool marks | 40 |

Fig.40: Block E showing notch and tool marks, (20cm and 50cm scales)

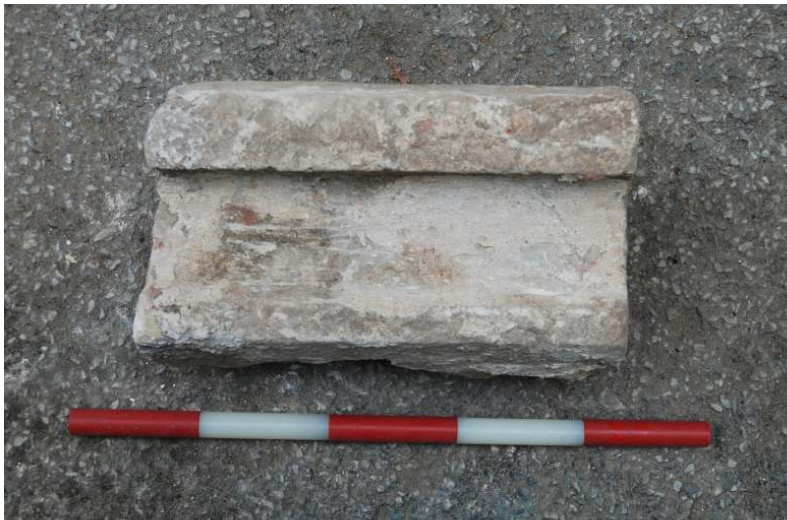
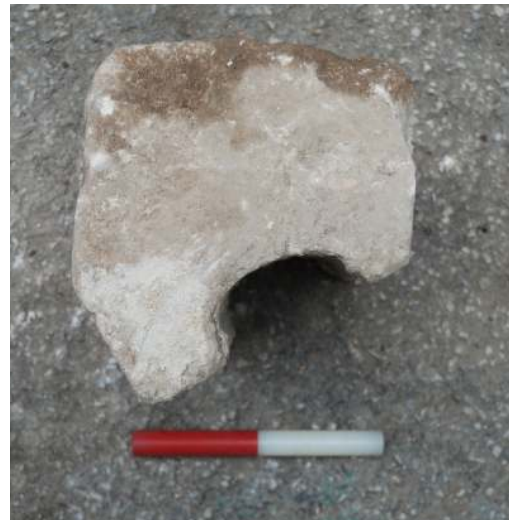
| Name | Context | L | B | T | Worked? | No. of faces | Comments | Fig nos. |
|---|---|---|---|---|---|---|--|---|
| F | [20] | 380 | 180-210 | 130-210 | Y | 9 | A smooth, curved, groove has been cut into one side of the block, 95mm in diameter and c45mm deep. One face only partial / damaged | 41 |

Fig.41: Block F showing groove and profile, (50cm and 20cm scales)

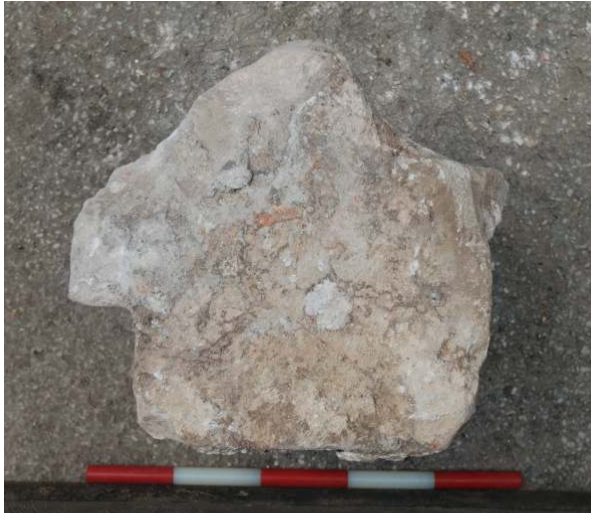
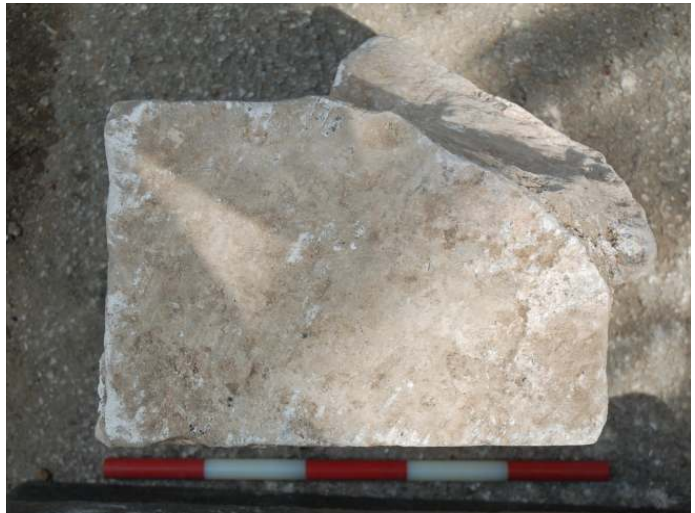
| Name | Context | L | B | T | Worked? | No. of faces | Comments | Fig nos. |
|---|---|---|---|---|---|---|--|---|
| G | [20] | 480 | 360 | 310 | Y | 11 | Several faces damaged or partially obscured by mortar due to re-use of masonry. One long side has a 100mm wide x 50mm deep notch cut. Opposite side has a 195mm wide x 38mm long x 50mm deep section cut out with moulded finish. | 42- 43 |

Fig.42: *Block G showing two ends, (50cm scale)*

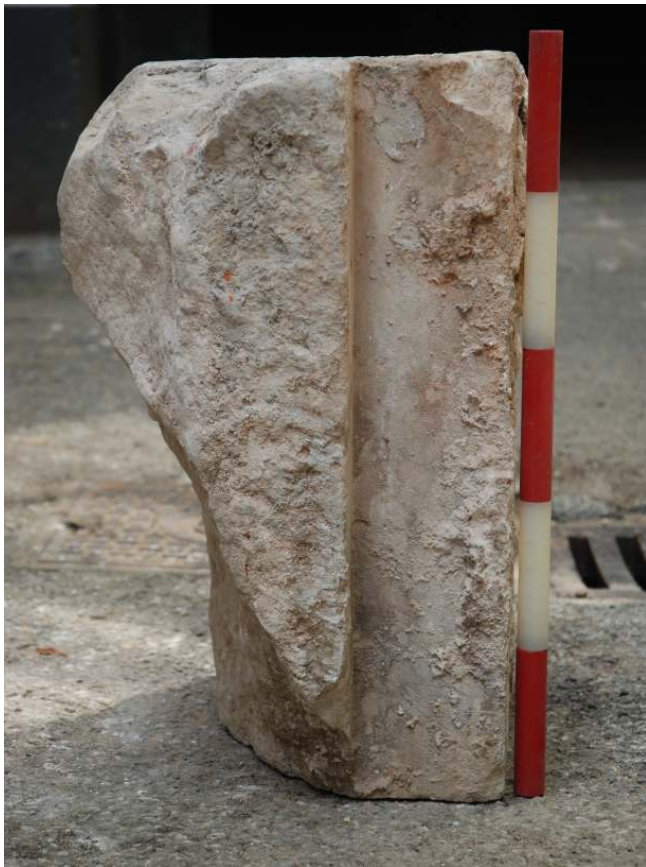
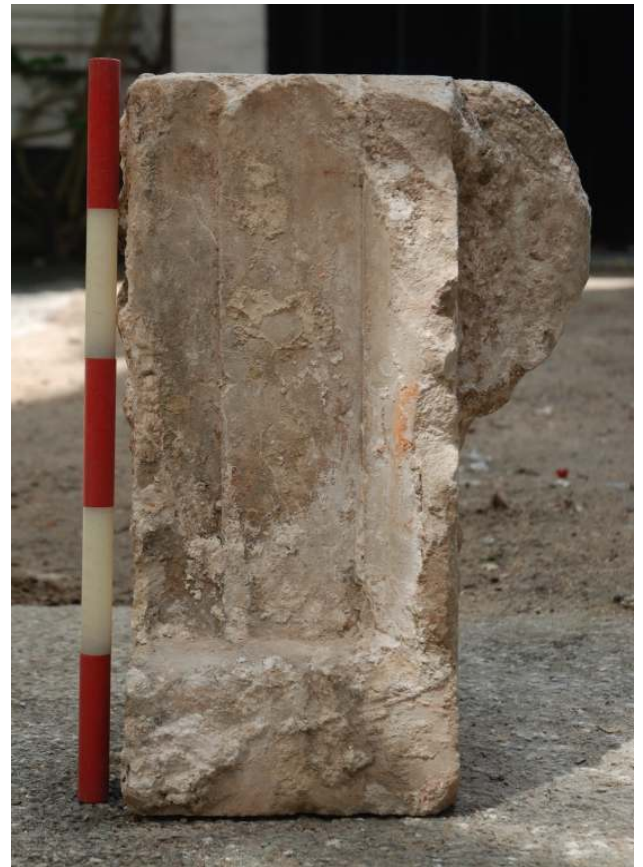
Fig.43: *Block G showing two faces, notch and moulding, (50cm scale)*

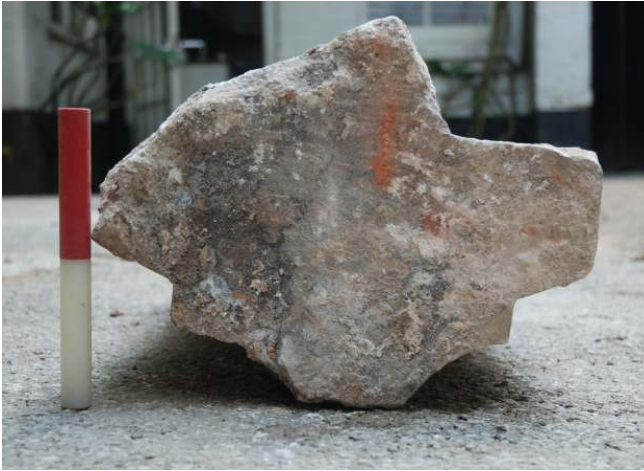
Fig.44: *Block H showing two ends, (20cm scale)*
