An Archaeological Evaluation at No.94-96 Cheyne Walk,

London Borough of Kensington & Chelsea, SW10 0DQ

Site code: CHY11

COMPASS ARCHAEOLOGY LIMITED

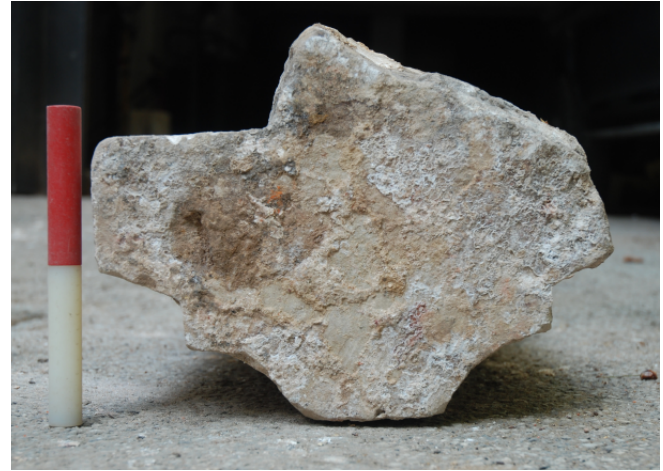
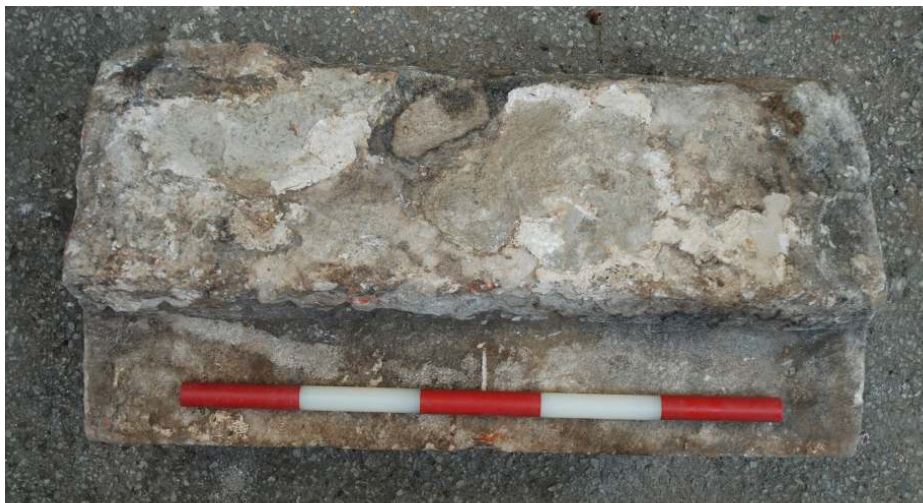
| Name | Context | L | B | T | Worked? | No. of faces | Comments | Fig nos. |
|---|---|---|---|---|---|---|--|---|
| H | [20] | 660 | 340 | 260 | Y | 14 | Long fragment of possible window mullion frame. Three level design with two curved steps cut into external face. A single 35mm square by 30mm deep hole cut midway down external face probably to house some form of fitting. Opposite face is cut on one side with a 10mm wide and 85mm deep cut-out along the length of the block. | 44-46 |

Fig.45: *Block H showing underside with cut-out, (50cm scale)*

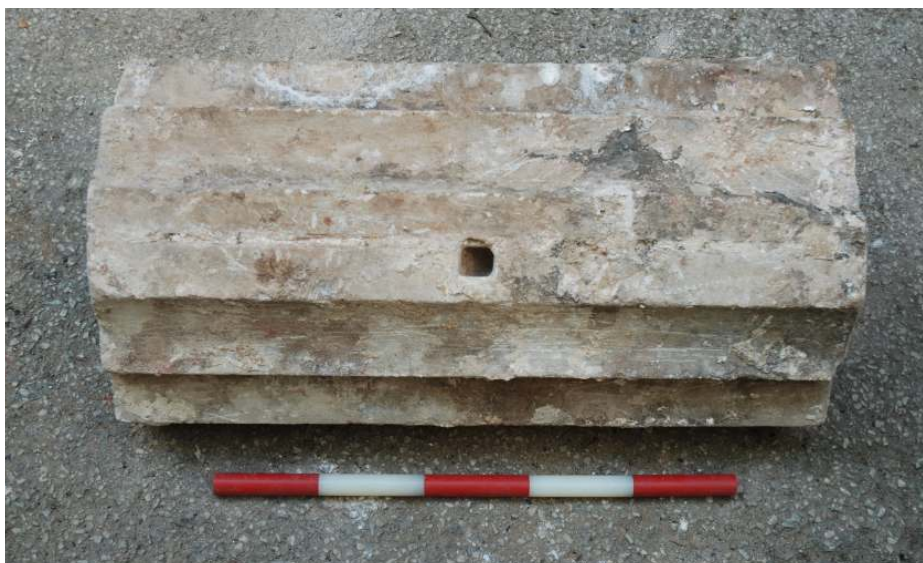
Fig.46: *Block H showing internal face of possible window mullion fragment with hole for fitting, and groove just visible above this (50cm scale)*
