**ROMAN ROAD PRIMARY SCHOOL,
ROMAN ROAD, LONDON BOROUGH OF
NEWHAM, E6 3SQ**

ARCHAEOLOGICAL EVALUATION

November 2013

SITE CODE: RMN13

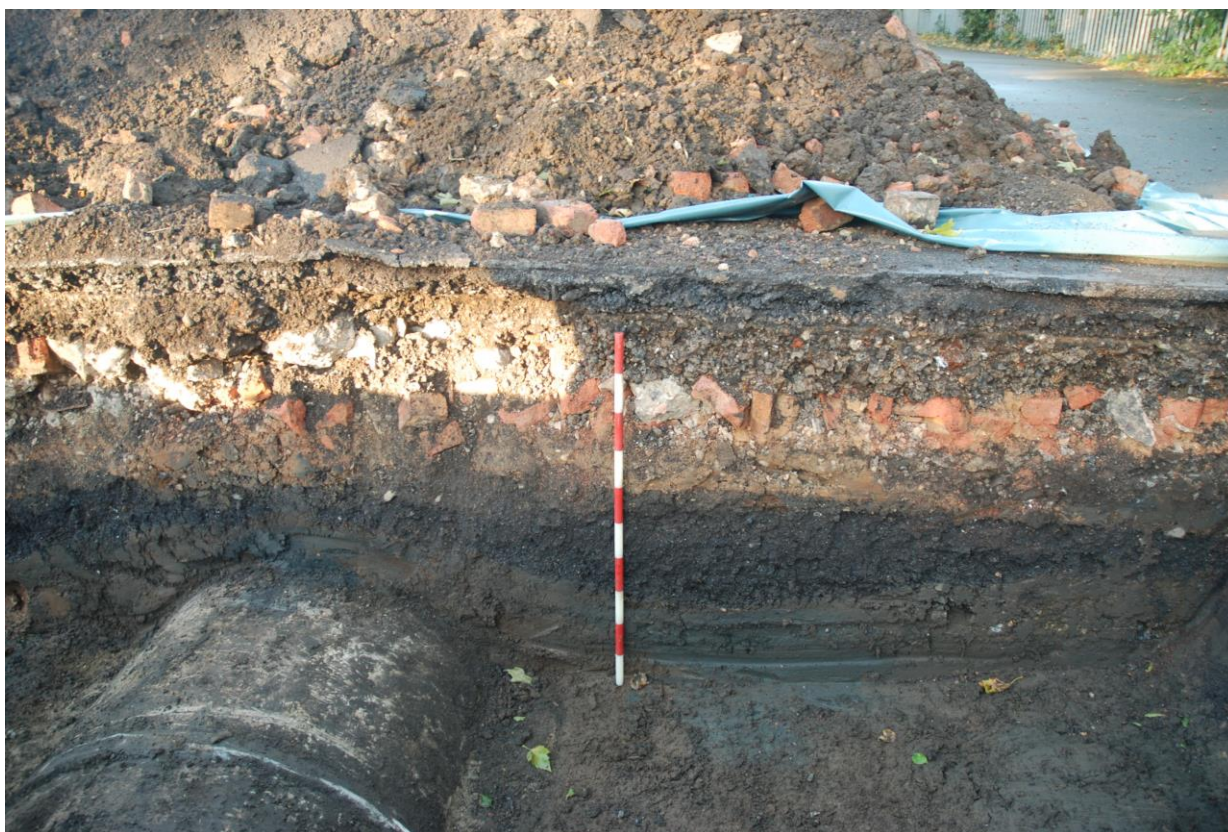
Front Cover: Photo of section showing culverted stream in trench 3

The only feature of interest was the culverted stream exposed in the eastern part of trench 3. This stream ran along the eastern edge of the site until the mid-20th century, when the site was developed and stream culverted within a concrete pipe.

Interestingly, what is believed to be the culverted stream which once ran along the eastern side of the site was observed in this trench. This was within a large segmental concrete pipe (c1.5m in diameter), which was aligned north-south across the eastern end of the trench (context 15). The cut for this was also observed – c0.3m either side of the exposed upper section of pipe, with grey clay-silt within it (context 16). The top of the pipe was approximately 0.9m below the present surface of the playground (c1.2m OD).

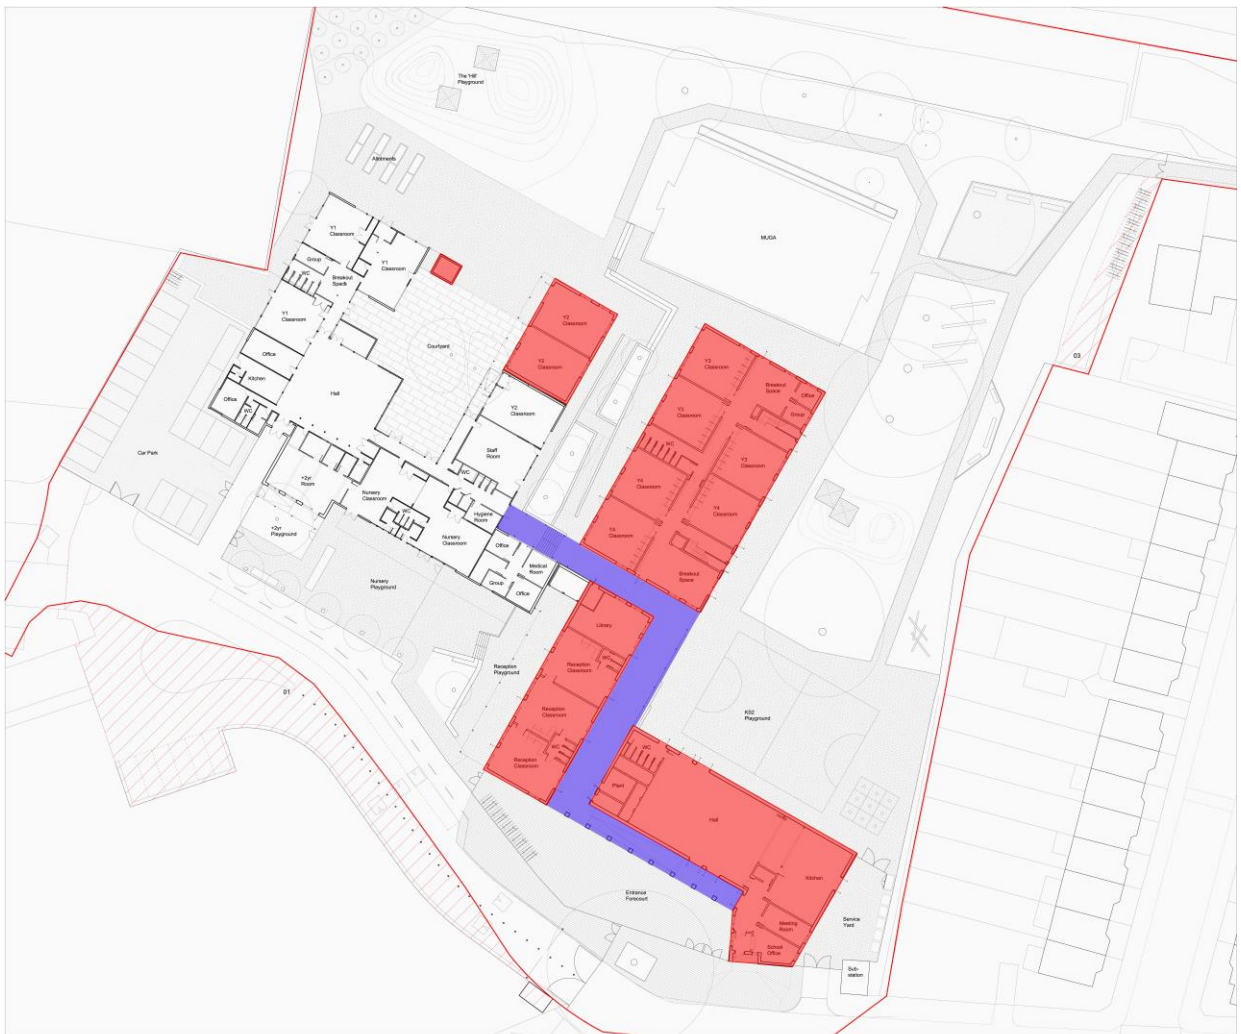
Fig.9: Plan of the proposed new development

The proposed redevelopment involves the construction of three main buildings in the eastern part of the site, plus an extension to the north of the present school, and another small block to the west of this (the areas in red on fig.9 show the areas of this new build). This new build will consist of approximately 1630 square metres. The excavations for the foundations for the exterior walls of these new buildings will consist of trenches *c*450mm wide, and *c*1m deep. Trenches will also be dug for the foundations for the interior walls – these will also be *c*450mm wide, but only *c*750mm deep.

There will also be some ‘canopy build’ - areas with roofs connecting different parts of the site, and not such substantial structures (shaded in blue on fig.9). These will cover an area of approximately 320 square metres, and will be positioned in the areas between the new buildings in the eastern part of the site. The groundworks for the construction of the ‘canopy build’ areas will consist of pads – 750mm by 750mm, and 750mm deep.

- 1.1** This report presents a summary of archaeological trial trenching carried out on land at Roman Road Primary School, London Borough of Newham (approximately centred at NGR TQ 41970 82280). The proposed development is concentrated in the eastern part of the school grounds, which is positioned at the western end of Roman Road, to the north of the A13 and between Plaistow and East Ham (figs.1+2). The proposed development involves the construction of three major new buildings, extensions to other parts of the school, some ‘canopy’ buildings, and landscaping (fig.9) (Planning Ref: 13/01561/LA3).

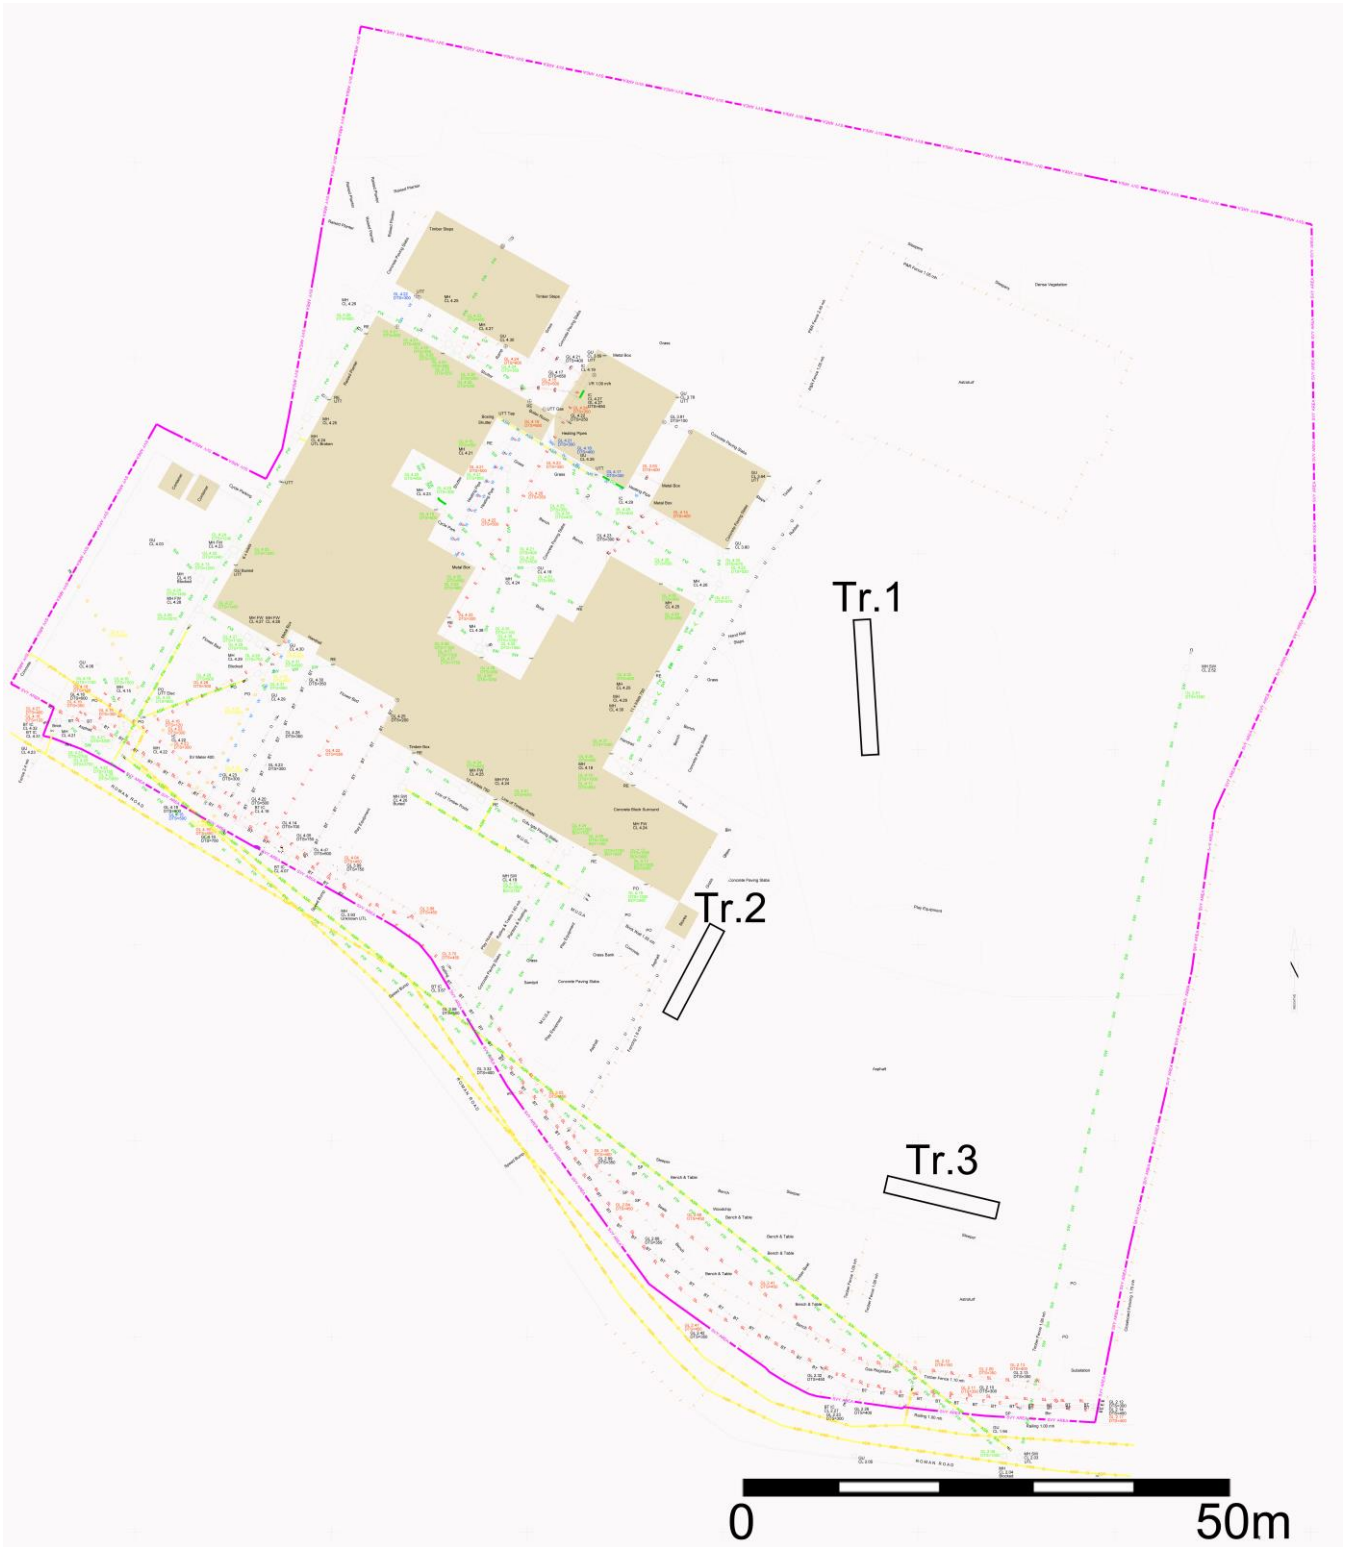
Fig.10: Plan showing trench locations

5.2 The work comprised of three trenches located in the area of the proposed development (fig.10). Trench 1 measured 14m in length by 2m in width; trench 2 measured 10m in length by 2m in width; and trench 3 measured 12m in length by 2m in width. This covered an area of approximately 72m².

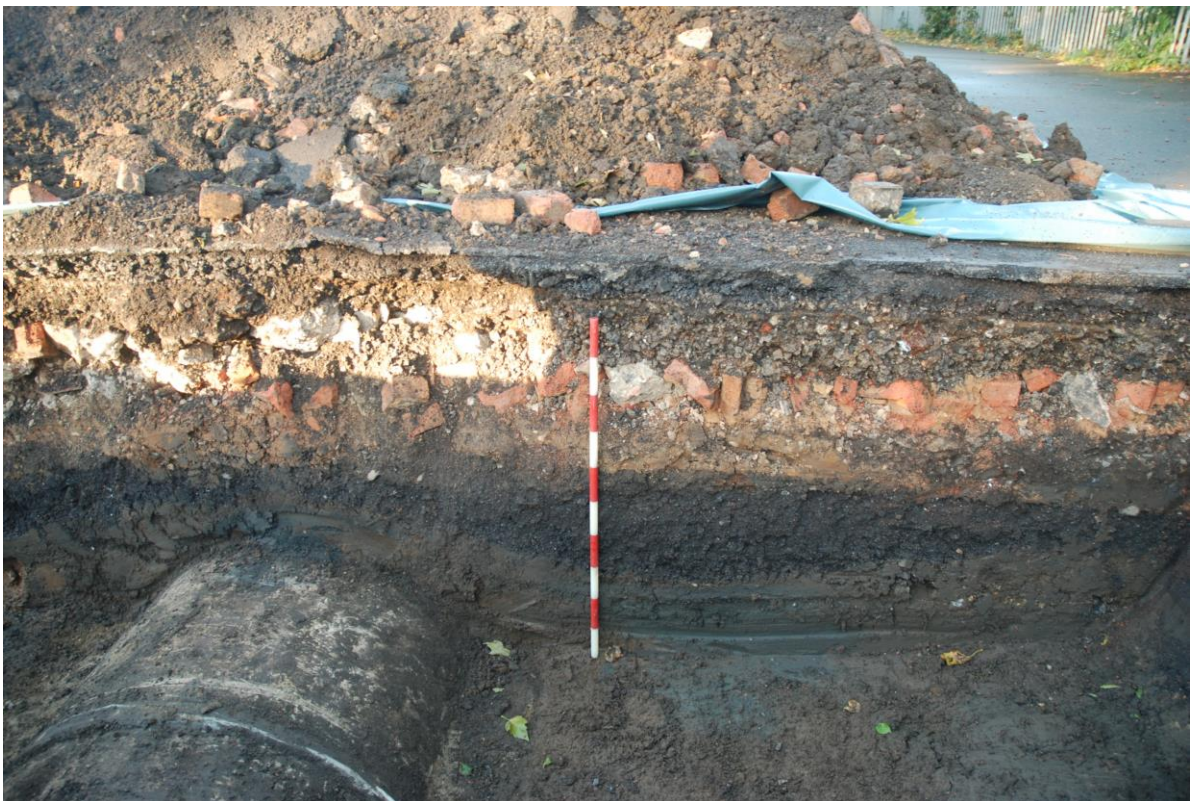
Fig.25: Photo of section in trench 3, the concrete pipe assumed to contain the culverted stream to left of frame
