**A NEW PROPAGATION GLASSHOUSE  
AT THE ROYAL BOTANIC GARDENS KEW,  
TW9 3AB**

**An Archaeological Watching Brief**

**April 2014**

Site code: RBK14  
Planning Application ref: 13/4168/FUL  
NGR: TQ 18346 77316

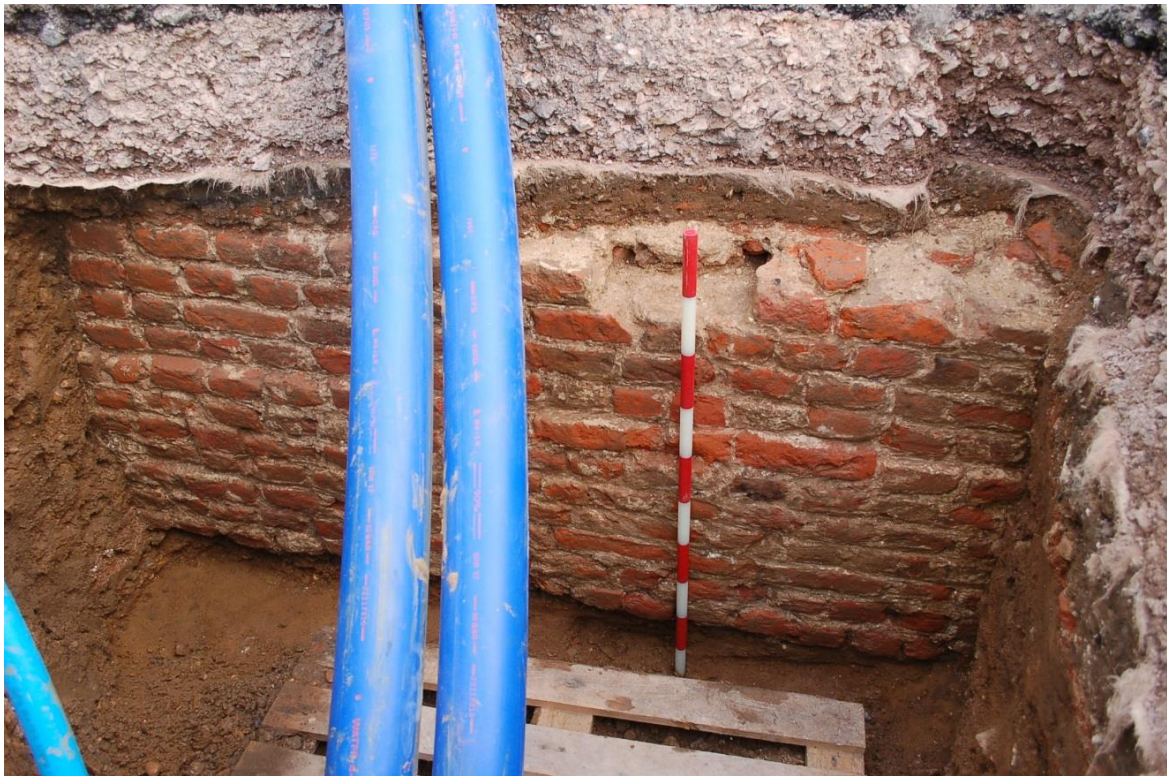
*Fig.4: Wall in Trench 1 of the 2010 watching brief, facing SE. This wall would potentially continue through Zone 1 of the proposed glasshouse*

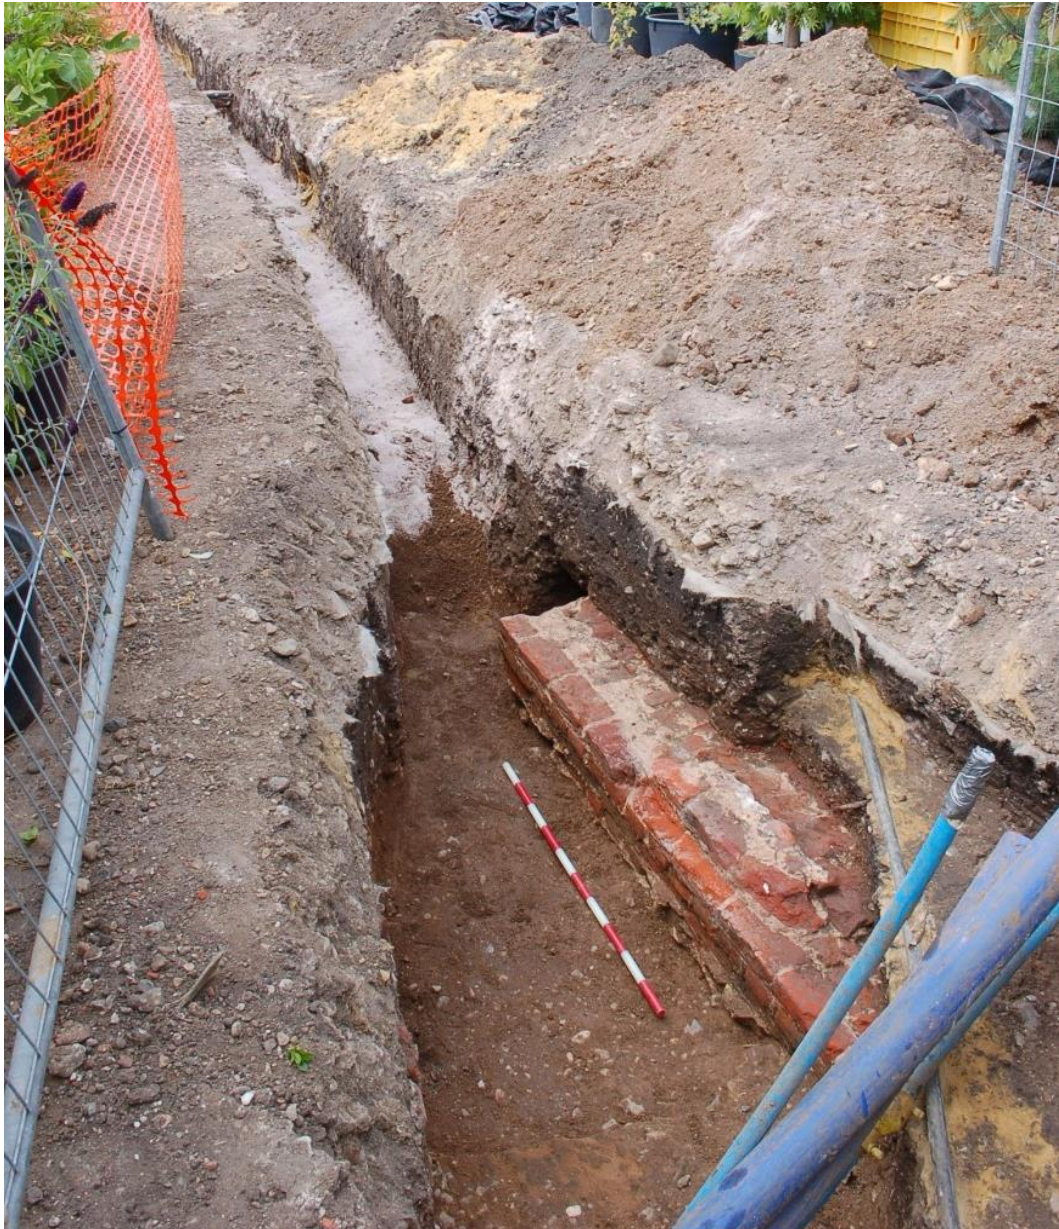
*Fig.5: Truncated wall in Trench 2 of the 2010 watching brief, facing W (towards the NW end of the proposed glasshouse). It is possible the wall may survive at a greater depth elsewhere within the glasshouse footprint, but is not visible here.*

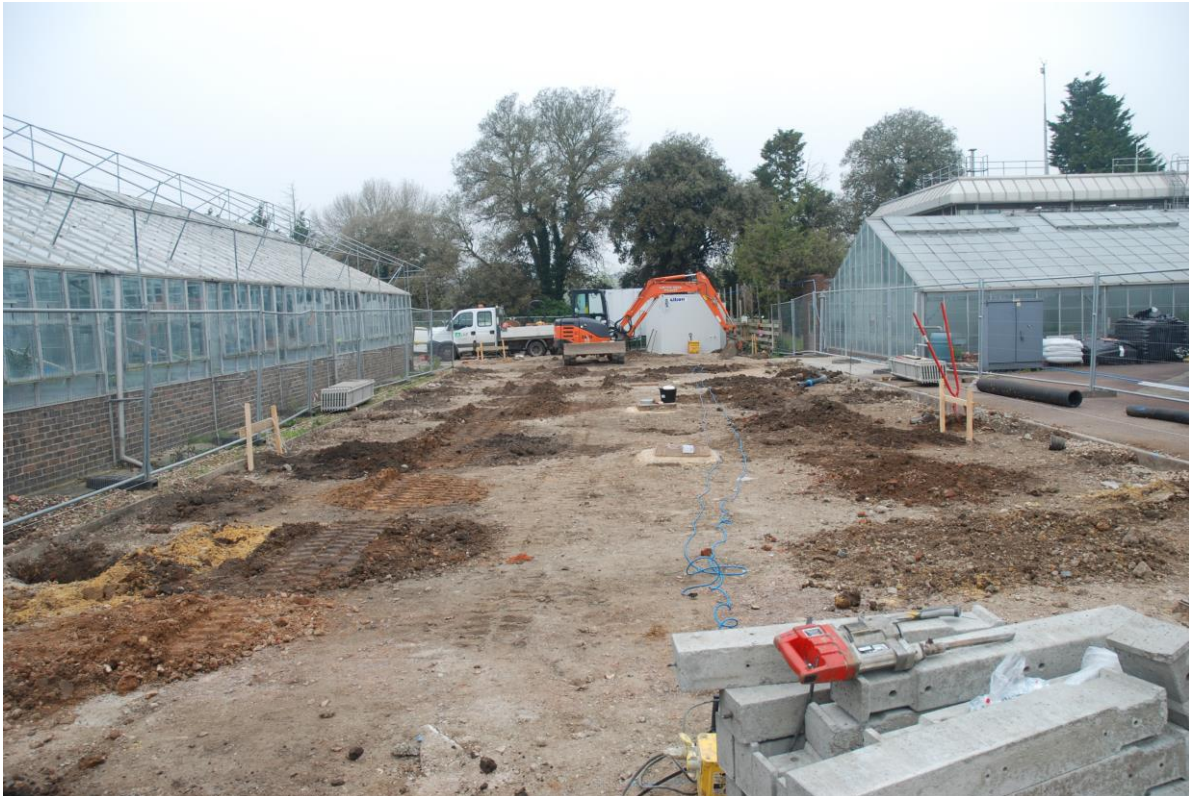
Fig.9: *The site facing NW*

**6.3** The site was initially cleared of the existing polytunnel and its concrete floor slab, with a further 200mm of ground reduction across the entire footprint of the new glasshouse. The removed stratigraphy consisted solely of made ground deposits, largely a mix of hardcore and sandy silts.

The ground was then raised by approximately 400mm at the NW end to compensate for the falling slope at this end, and to create a level formation level from which to excavate the pile pits.

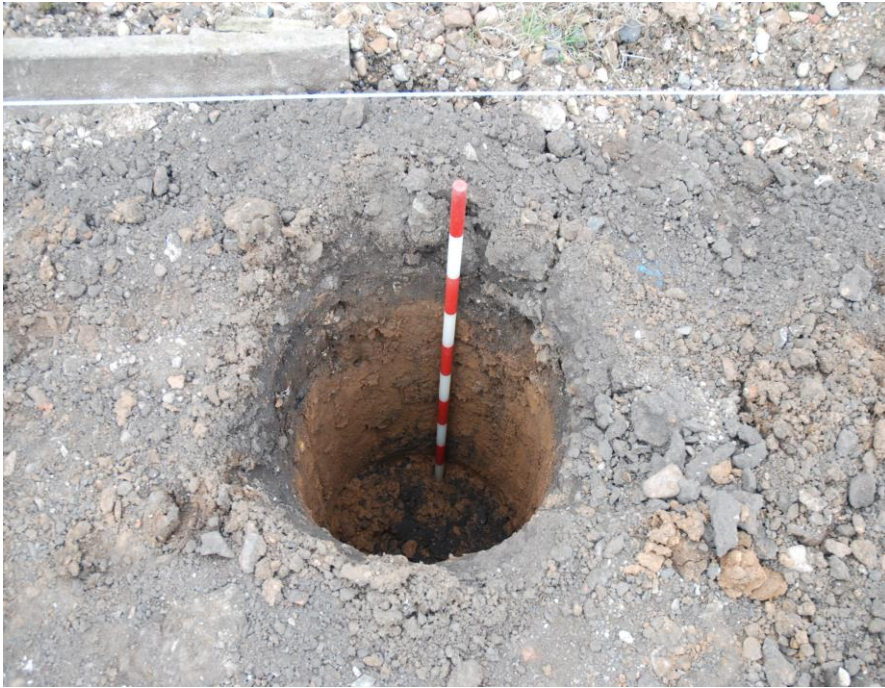
Fig.10: *Pit 3 facing SW*, (1m scale)

**6.4** Most of the pits observed followed one of two stratigraphic sequences; the first being a thin, (200-350mm), layer of dark grey clayey-silt containing infrequent crushed ceramic building material, (CBM), overlying natural orange-brown clayey-silt containing occasional flint nodules but essentially sterile in nature. The second sequence consisted of nothing but dark-grey clayey-silt for the full depth of the pit, representing areas of more heavily truncated ground.

Typical examples of the former are Pits 3, 5, and 32; of the latter Pits, 6, 23, and 23 are most representative.

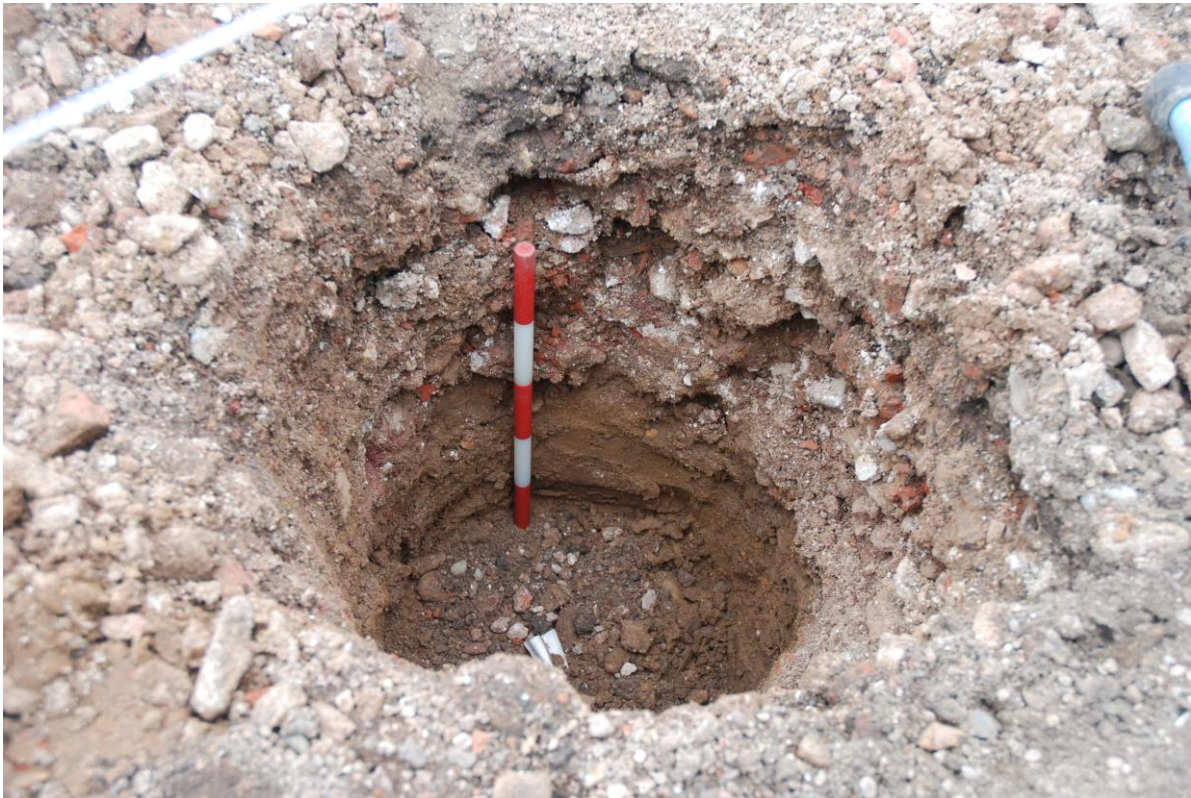
Fig.14: Pit 2 facing SE, (0.5m scale)

Pit 2 contained a 200mm layer of crushed CBM and mortar over 600mm of clean natural. Brick samples recovered from this deposit dated to the 17<sup>th</sup> / 18<sup>th</sup> century representing both structural elements along with a possible floor cobble<sup>4</sup>. A single sherd of high quality 18<sup>th</sup> century Tin-glazed Ware pottery was also recovered from this rubble layer<sup>5</sup>.

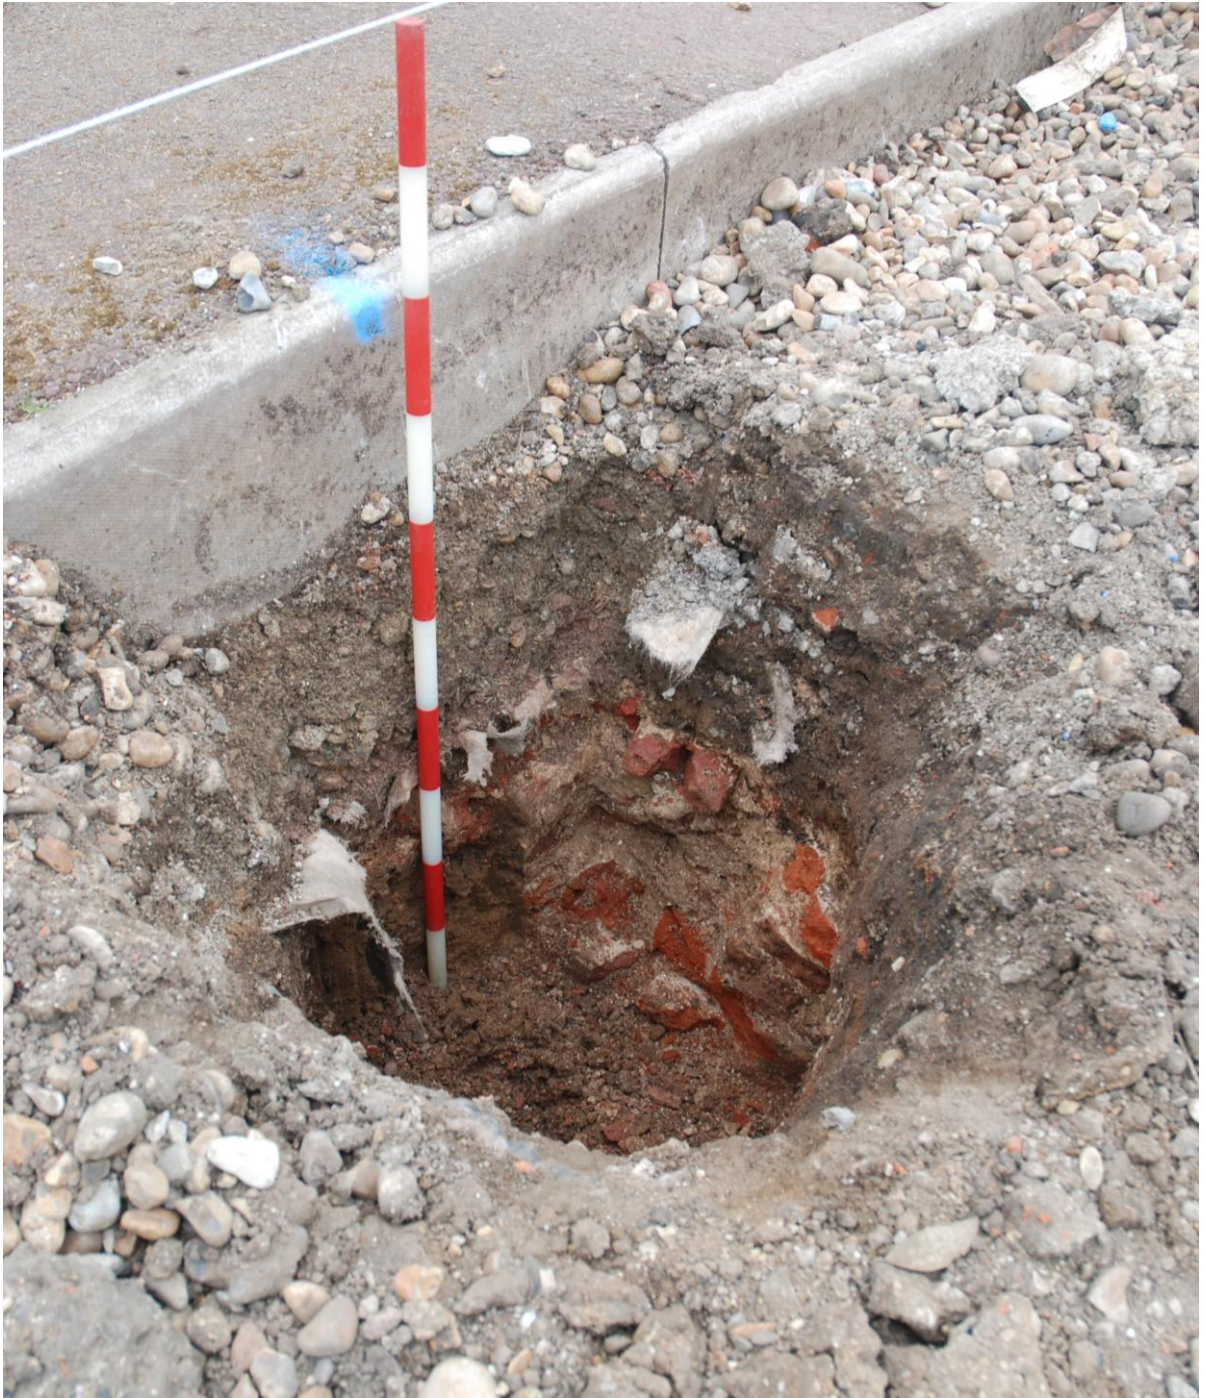
Pit 20 was the most archaeologically significant in that it exposed the 17<sup>th</sup> century wall previously observed in the 2010 watching brief, (see section 3). The wall was observed as a faced section of red brickwork extant in the SE section of the pit. The brickwork consisted of 6 courses, (amounting to 360mm in height), projecting 130mm from the section, and continuing below the limit of excavation. The brickwork was aligned on an N-S alignment and continued beyond the confines of the pile pit. The wall was surrounded by and buried below 150mm of brown-grey clayey-silt of backfilled material. The wall was left *in situ* and no samples were taken as it was not deemed necessary in the interpretation of the archaeology.

Fig.15: Pit 20 facing E, showing the 17<sup>th</sup>-century brick wall in the pit section, (1m scale)

The watching brief confirmed the presence of a probable 17<sup>th</sup> century brick wall, previously observed in Trench 1 of the 2010 watching brief. The wall was within 300mm of the ground surface, and survived in a relatively good condition, (probably for a considerable depth). It also illustrated that the majority of the site was devoid of archaeologically significant deposits. The presence of made ground is not exceptional given the level of modern development in the vicinity.

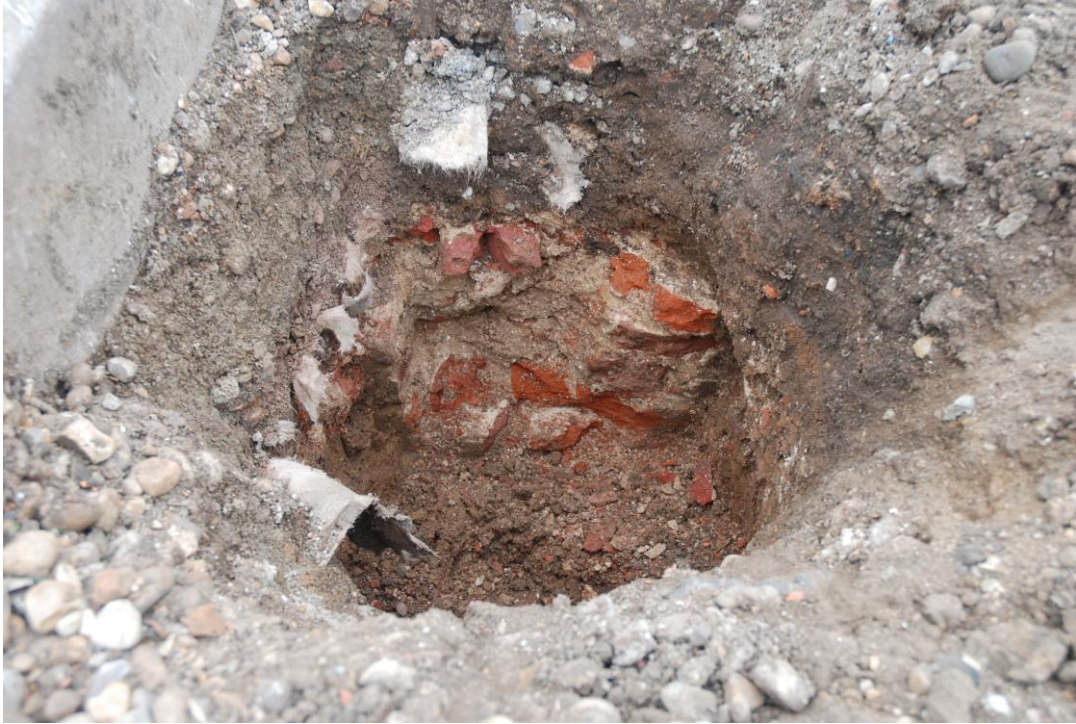
Fig.16: *The brick wall in Pit 20 facing ESE*
