# LAND TO THE SOUTH OF WALLIS AVENUE PARK WOOD, MAIDSTONE ME15 KENT

### AN ARCHAEOLOGICAL WATCHING BRIEF

SITE CODE: WAL14

PLANNING REF: MA/13/0566

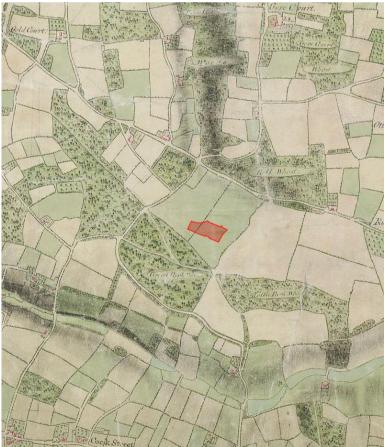
Fig. 5: The site outlined on the surveyors' drawing of 1797 for the First Edition Ordnance Survey of Kent (extract from OSD 117 Maidstone).

The landscape is entirely rural: the green colouration of the fields denotes untilled /pasture, with brown being cultivated. The nearest building lies on the road to the northeast, identifiable as the 17<sup>th</sup> century Briarwood (see above 3.2, HER ref. TQ 75SE 309)

Four of the above entries relate to post-medieval features or buildings, although in three cases of quite recent (19<sup>th</sup> or 20<sup>th</sup> century) date. The only significant record is to Briarwood (TQ 75 SE 309) – a probable 17<sup>th</sup> century building on Sutton Road, some 400m to the northeast of the site, and in fact the nearest building to appear on the First Ordnance Survey of 1797 (Fig. 5 below).

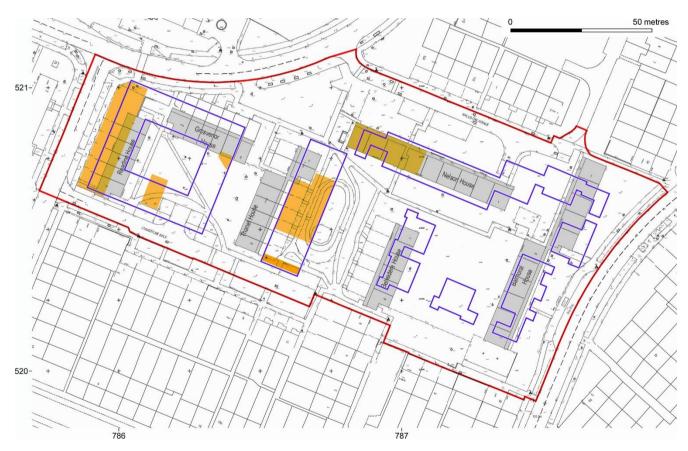
Fig. 11: Site area showing the archaeologically monitored areas (shaded orange), overlaid on the 1960s and new development footprints

Plan extracted from the Topographic Land Survey (Brotherton & Partners Dec. 2011)

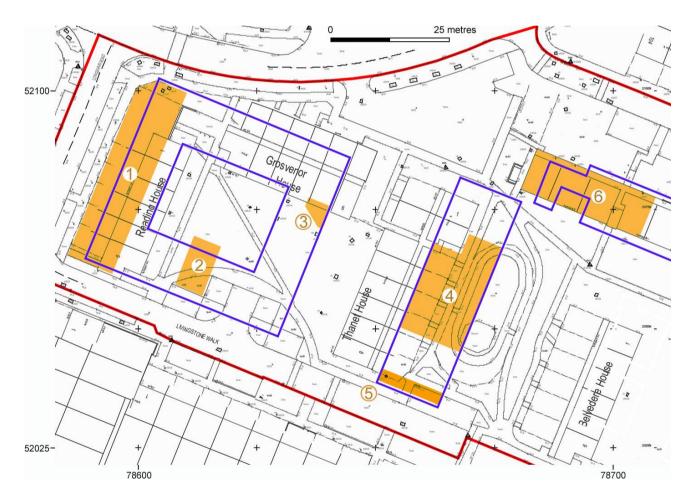
Fig. 12: Plan of the western part of the site, showing areas observed and recorded during the archaeological watching brief (1-6)

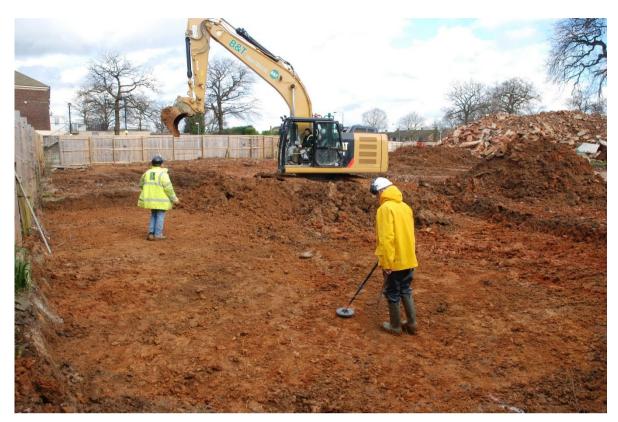
Fig. 13: General view of machine stripping and metal detecting in the southern part of Area 1, looking NNE towards Wallis Avenue and showing the exposed natural deposits

No archaeological features or finds were recorded: Apart from the modern service trenches the only finds of any description were a few decimal coins, 1p and 2p plus one 5p piece, that were recovered by metal detector.

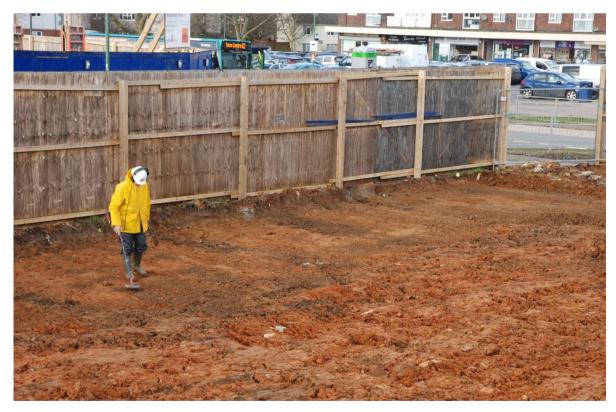
Fig. 14: The northern part of Area 1, looking northwest towards the junction of Longshaw Road and Wallis Avenue. Note the distinction between the disturbed area in the foreground (from the demolished buildings), and the former front gardens adjoining the site boundary where exposed natural is cut by a series of darker lines representing infilled service trenches

By contrast, in the eastern part of the area the ground was heavily disturbed by the previous building, which had formed an unbroken north-south block (Fig 14). To the west disturbance was confined to a series of discrete east-west lines, reflecting the location of service trenches connecting the former houses with Longshaw Road (Figs. 15 & 16).

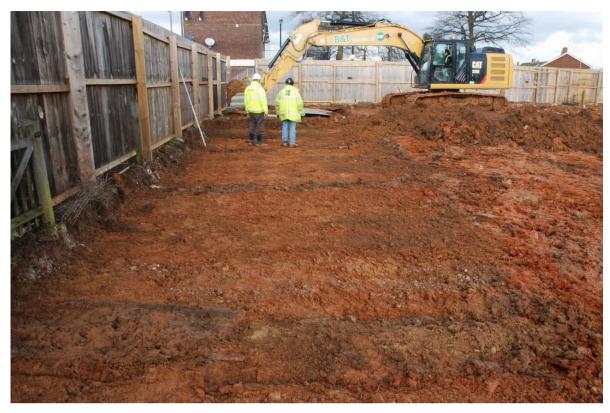
Fig. 15: Another view of the former front garden area, looking approx. north and again showing the darker lines of service trenches crossing from west to east

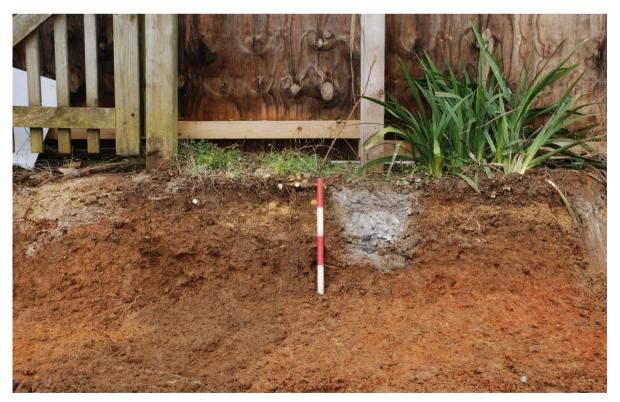
Fig. 16: Exposed section on the western boundary of the site, c 3m north of the southwest corner of Area 1 (0.4m scale). A shallow soil profile ( $\leq$ 100mm) overlies lighter yellow-brown made ground and thence either clean natural or – immediately left of the scale – a slightly darker band some 600mm wide representing an infilled service trench

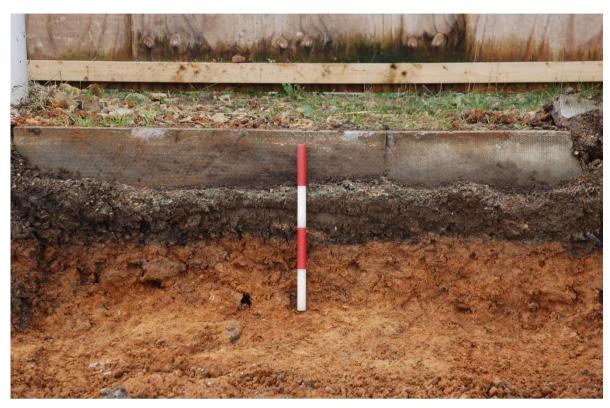
Fig. 17: Exposed section on the southern boundary of Area 1, c 6m east of the southwest corner. Again the soil profile has been truncated, and here the clean natural deposit is sharply differentiated from the dark overlying made ground

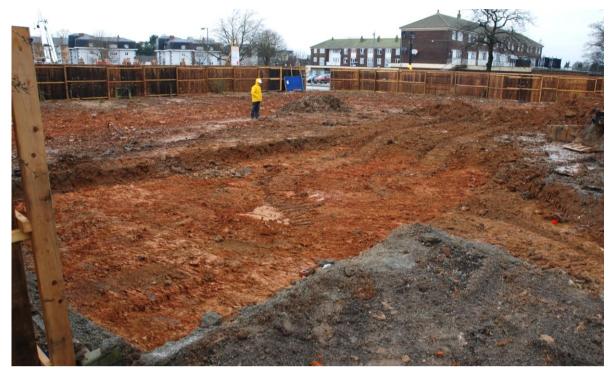
Fig. 18: General view looking northwest across the site, with clean natural deposits exposed across Area 2 in the foreground

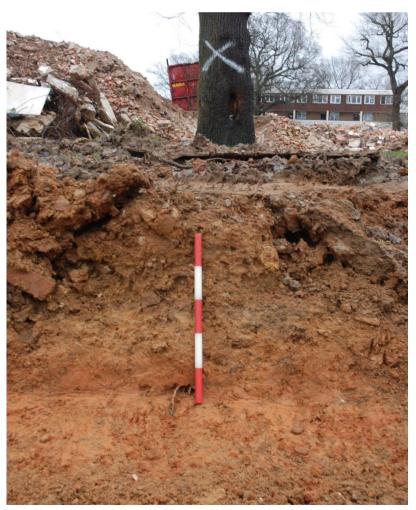
Fig. 19: Exposed section on the eastern side/north end of Area 2 (0.5m scale).

The top c 100m of topsoil has been removed to expose a deeper deposit (c 300mm) of recent made ground with brick & concrete tile. This overlies a shallow (c 50mm) truncated subsoil, merging into weathered natural at c 101.00 m OD

No features or finds of archaeological interest were observed in this trench, with - as in Area 1. The level of the natural Head - an orange-brown stiff silty clay with occasional ragstone fragments - was fairly consistent, at about or just below 101.00m OD. To the east this was overlain by a remnant of sterile subsoil, otherwise truncated in previous development of the site (cf. Fig 19).

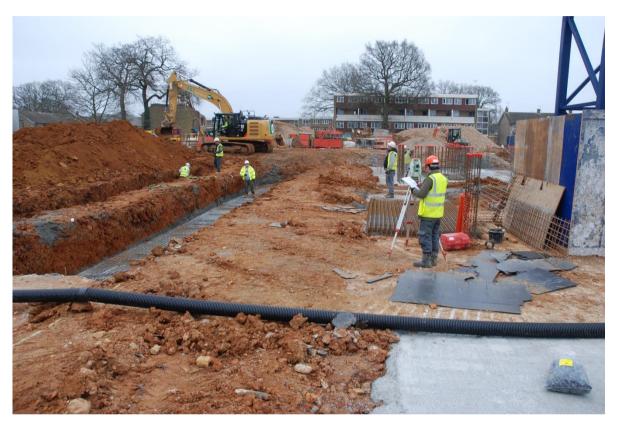
Fig. 20: General view looking east across the site towards Area 3 (located just to the right of the tracked machine)

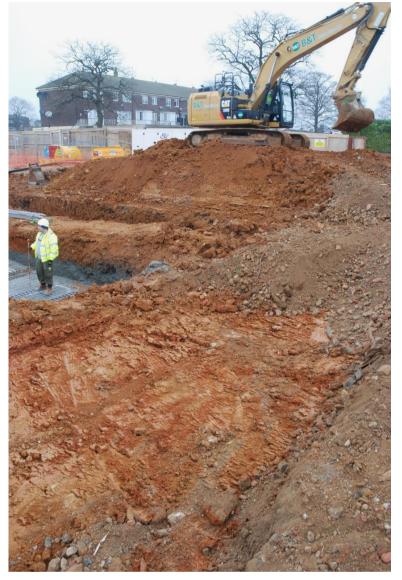
Fig. 21: View of Area 3 during machine stripping, looking north towards Wallis Avenue.

Recent and fairly loose made ground/rubble deposits directly overlie the exposed natural

This reduction revealed nothing except natural silty clay (Fig 21). The whole exposed area had been truncated by modern activity, with the natural overlain by a layer of terram-type material, and thereafter fairly loose rubble and made ground.

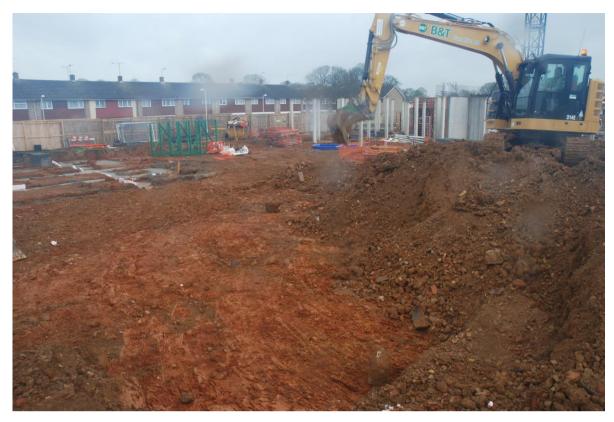
Fig. 22: General view during stripping of Area 4, looking southwest towards Livingstone Walk and showing the undisturbed natural deposit

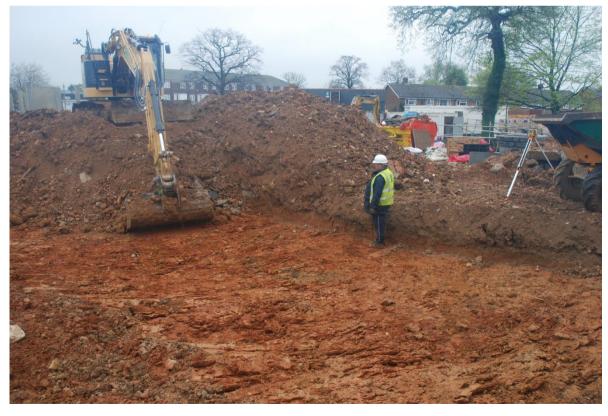
Fig. 23: A further view of the northern part of Area 4 during machine reduction, looking northwest towards Wallis Avenue

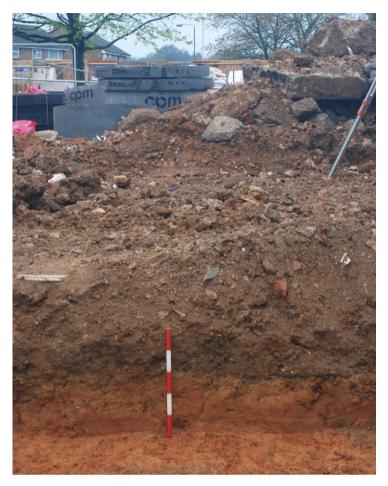
Fig. 24: Exposed section midway along the northern side of Area 4, showing c 200mm of made ground over the natural deposit (0.5m scale)

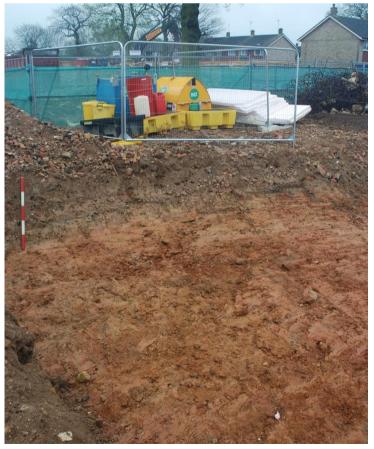
Fig. 25: Exposed section on the eastern side of Area 4, close to the northeast corner. Some 200mm of original subsoil appears to survive here, truncated and overlain by recent made ground

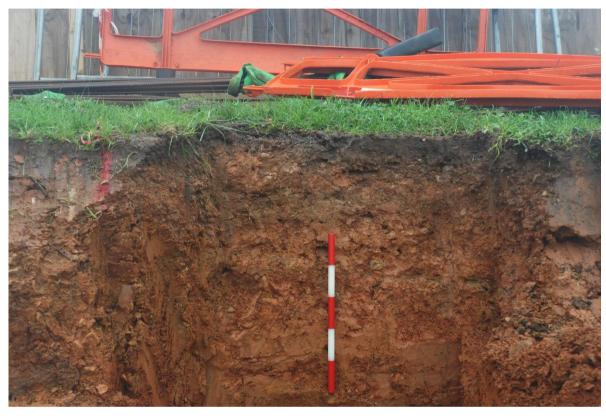
Fig. 26: The exposed southern section near the western end of Area 5 (0.5m scale). A shallow imported topsoil ( $\leq 150$ mm) overlies a slightly thicker layer of made ground, and below this the natural deposit at approximately 101.05m OD

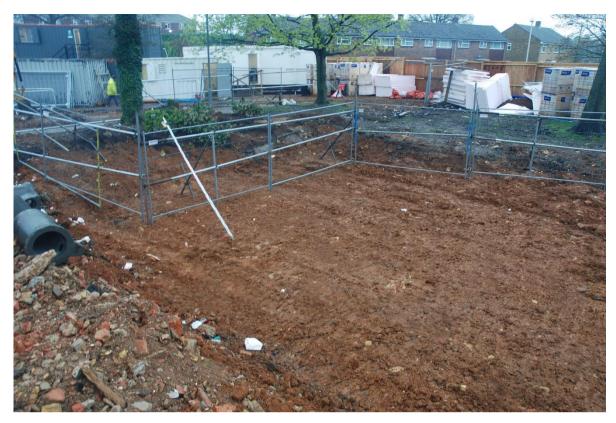
Fig. 27: The western end of Area 6, looking approximately northwest towards Wallis Avenue

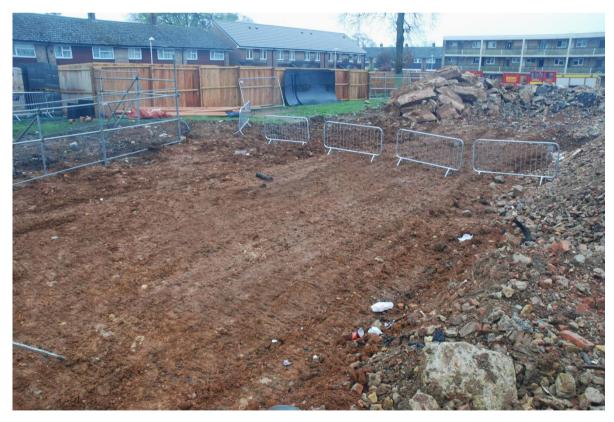
Fig. 28: The eastern part of Area 6, looking northeast towards the boundary with Wallis Oak Avenue. Recently removed demolition concrete footings, etc., can be seen in the background
