**Land at No. 101 Christchurch Road
Colliers Wood, SW19 2QR
London Borough of Merton
An Archaeological Investigation**

An Archaeological Investigation

Site Code: CSC14

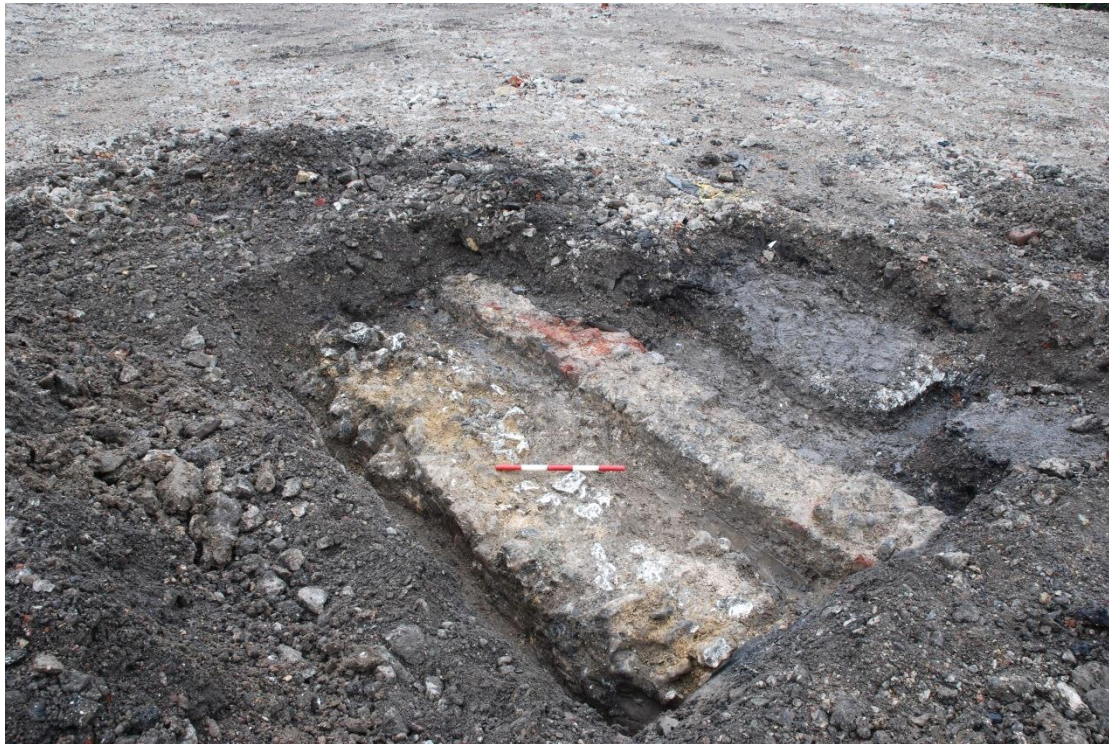
Front cover: View of the outer precinct wall base (in foreground), following initial clearance and looking approximately south

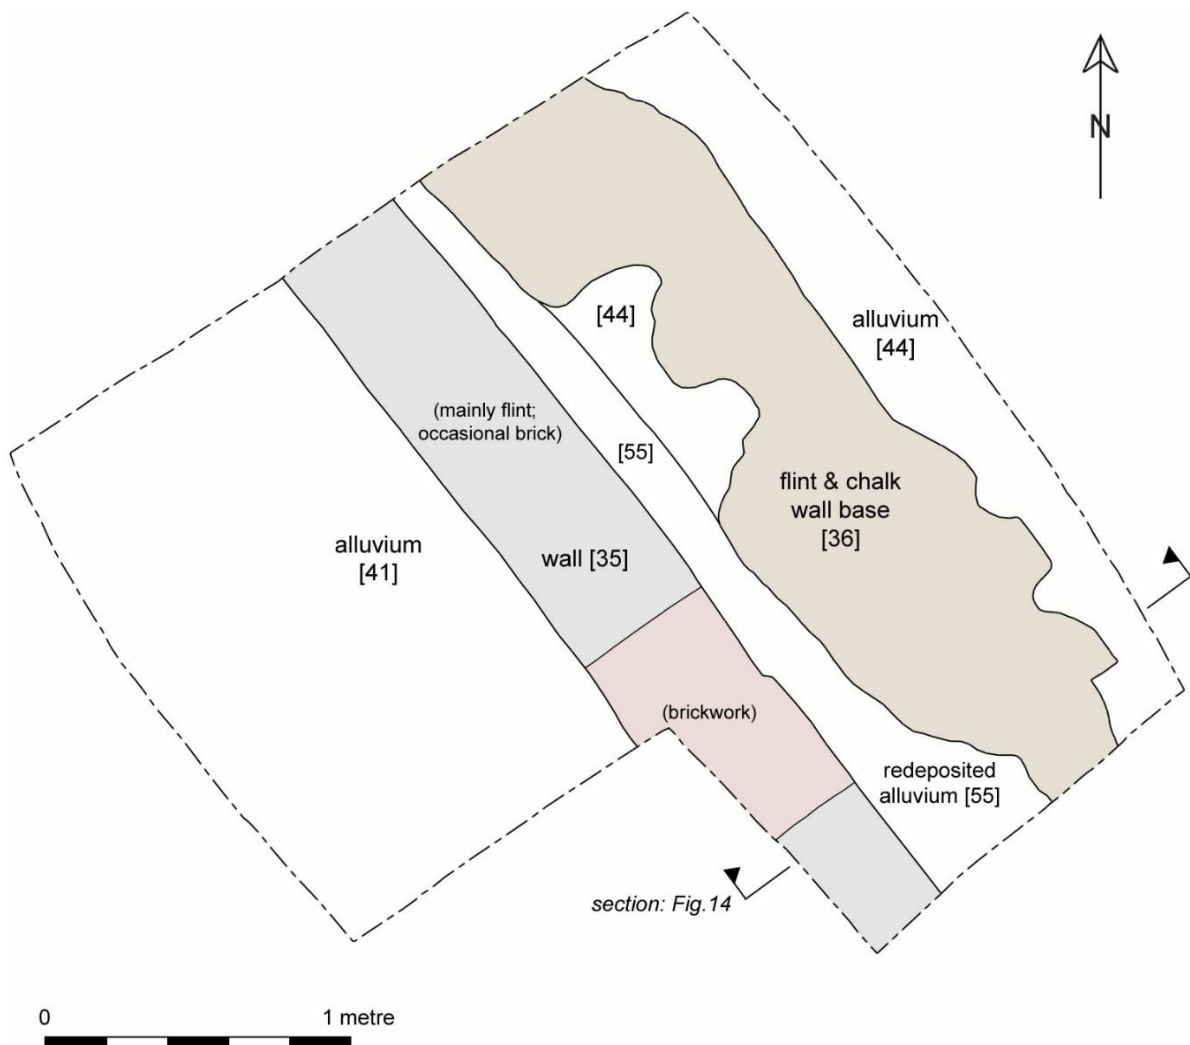
Fig. 6: Plan of the investigation area after initial clearance and cleaning: the base of the outer precinct wall [36] is to the east

The exposed surface of the precinct wall base [36] was made up of large flint nodules and rough pieces of chalk in a fairly soft gritty/sandy mortar, with the flint being mostly found to the east and chalk to the west (as clearly shown in Fig 8). The extant top of the wall was levelled at approximately 12.5m OD.

The line of the wall was also more clearly defined to the east, although with a fairly straight edge to the north and rougher/slightly projecting finish to the south: this contrast reflects the underlying foundation design, as described below (5.3). The extant depth of the stone wall base on the eastern side was about 300mm, whereas to the west it appeared to be shallower or even absent, with underlying alluvium [44] exposed in plan in one area (Fig 6). As a result the width of the wall, east to west, ranged from about 0.35m to 0.75m

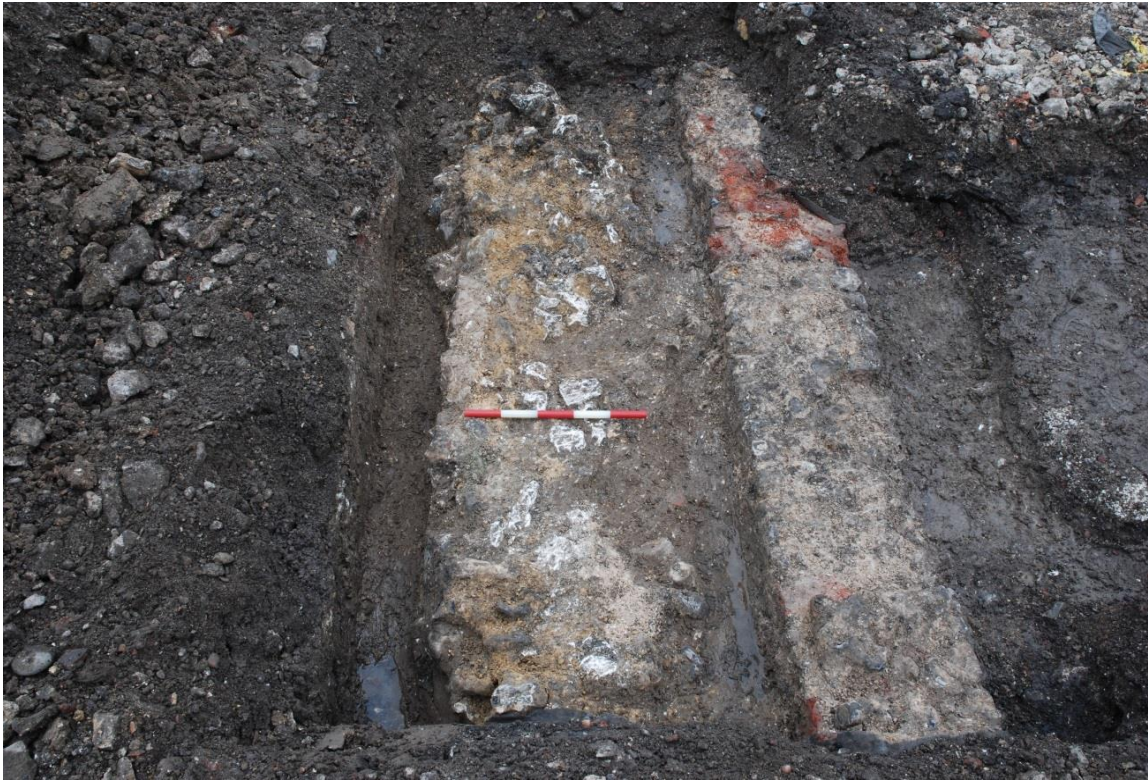
Fig. 7: View looking southeast along the line of the outer precinct wall [36] (below the 0.5m scale). Post-medieval wall [35] to the right of the frame

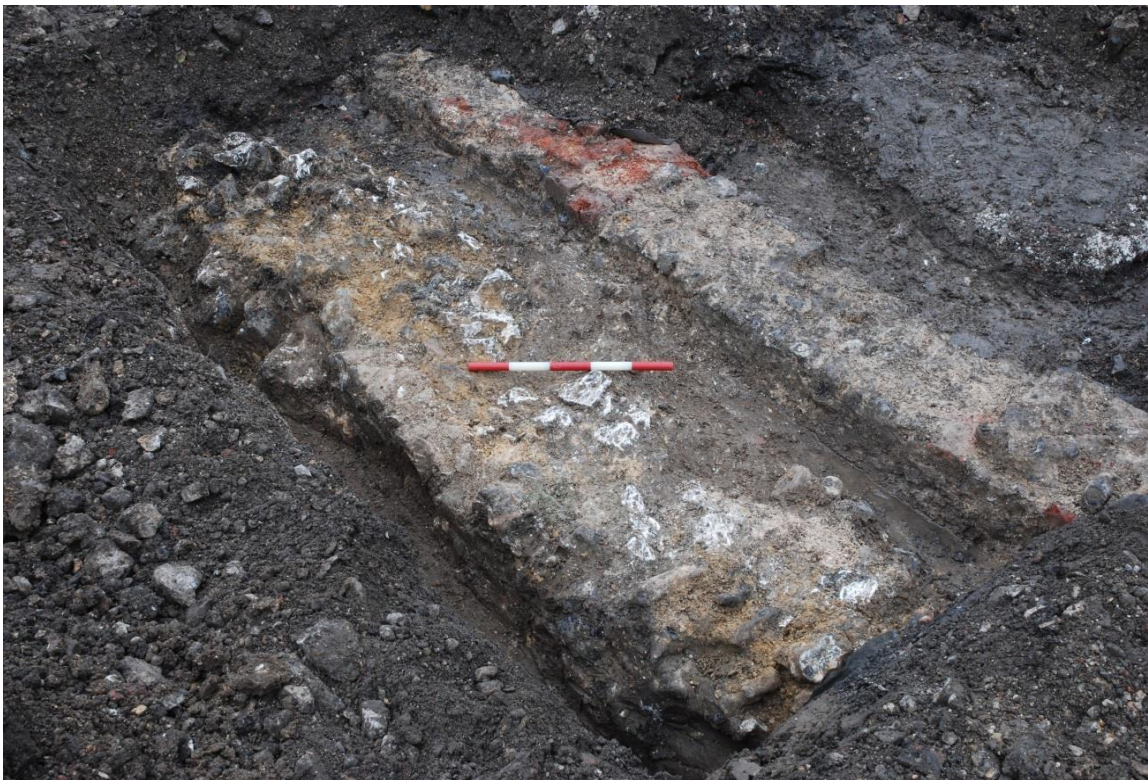
Fig. 8: A further view looking approximately south, the outer precinct wall base in the foreground. The contrast in the wall face – quite regular to the north, rougher and projecting to the south – is clearly visible

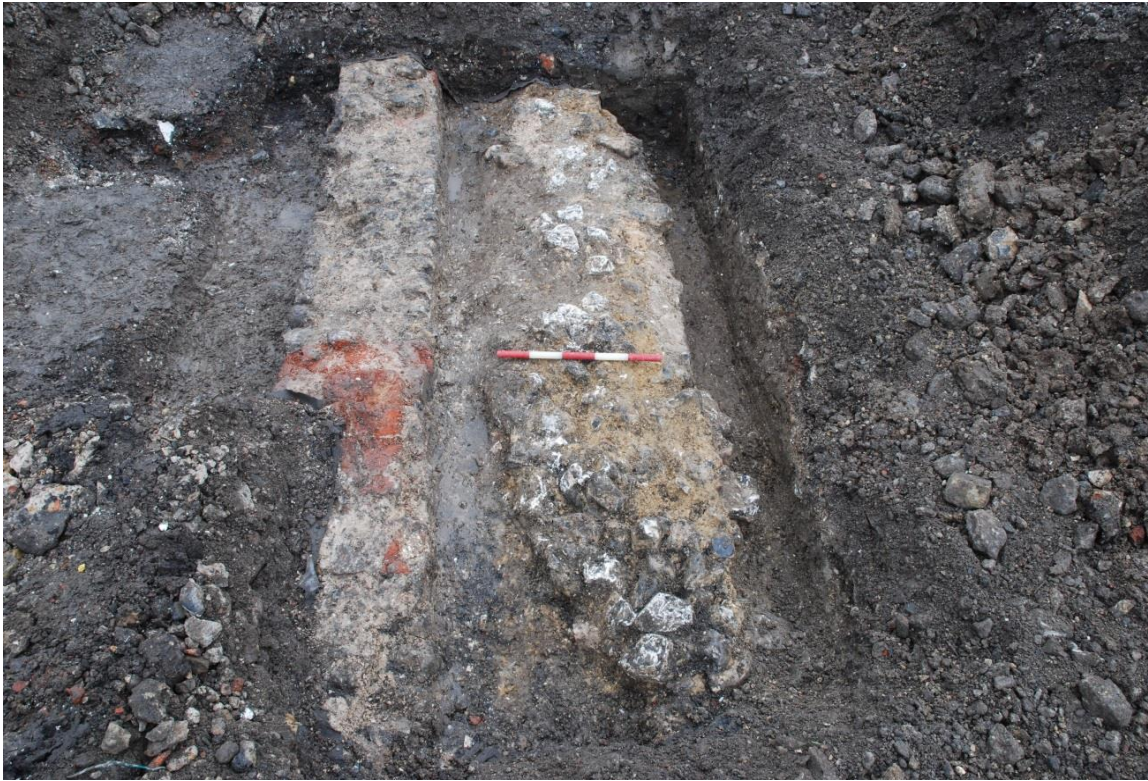
Fig. 9: View looking northwest along the line of the precinct wall [36] (below the 0.5m scale), with post-medieval wall [35] to the left

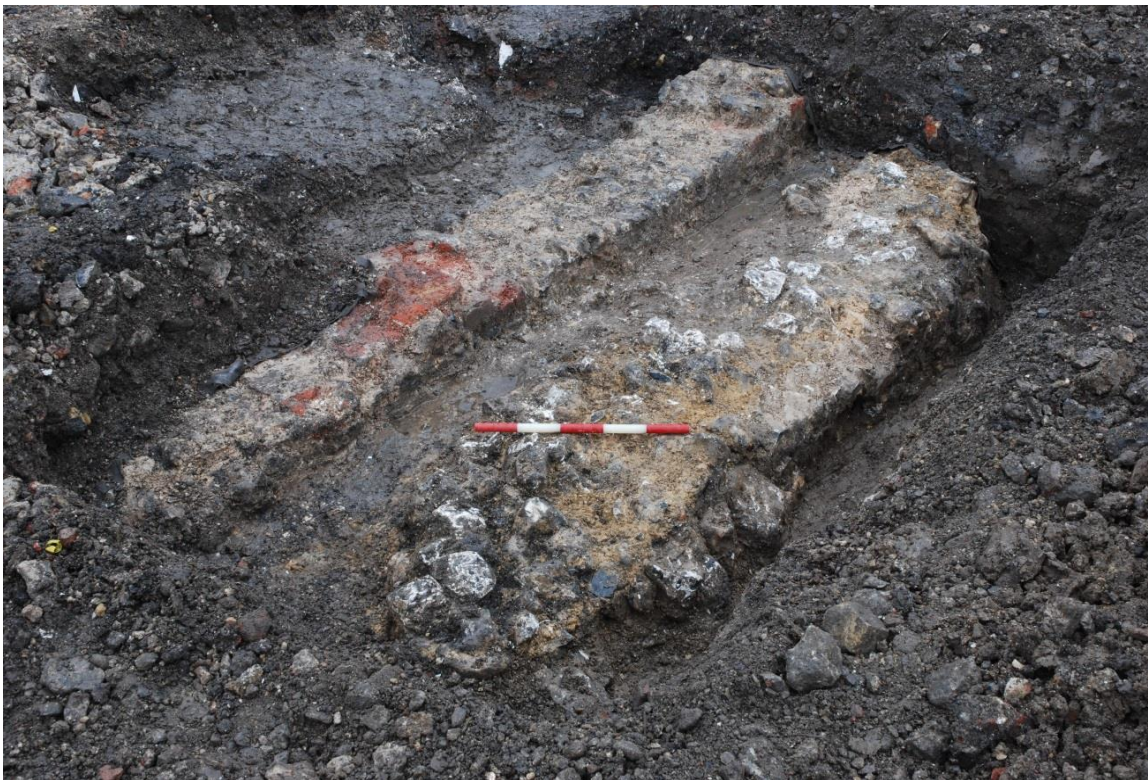
Fig. 10: View looking approximately WNW, the outer precinct wall base in the foreground

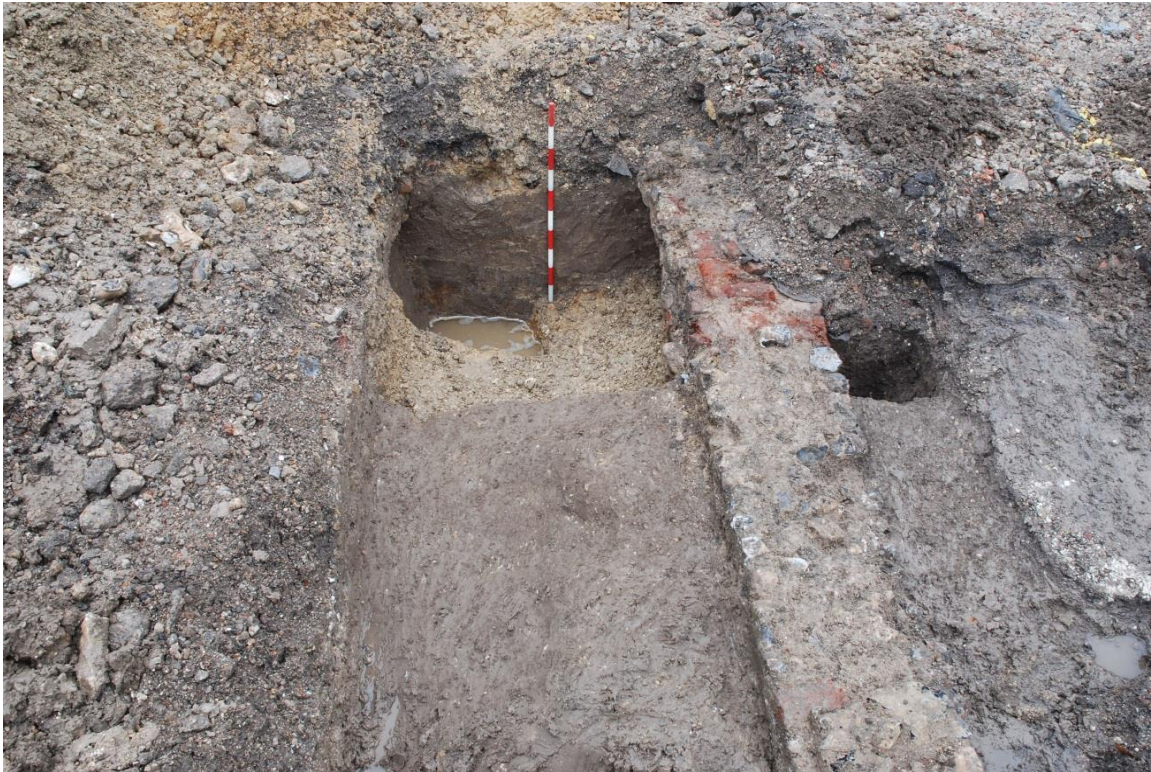
Fig. 12: *View looking southeast after removal of the wall base [36], showing at the far end the partially excavated foundation pad [56/57] – its south side represented by the exposed alluvium [44] immediately behind the 1.0m scale*

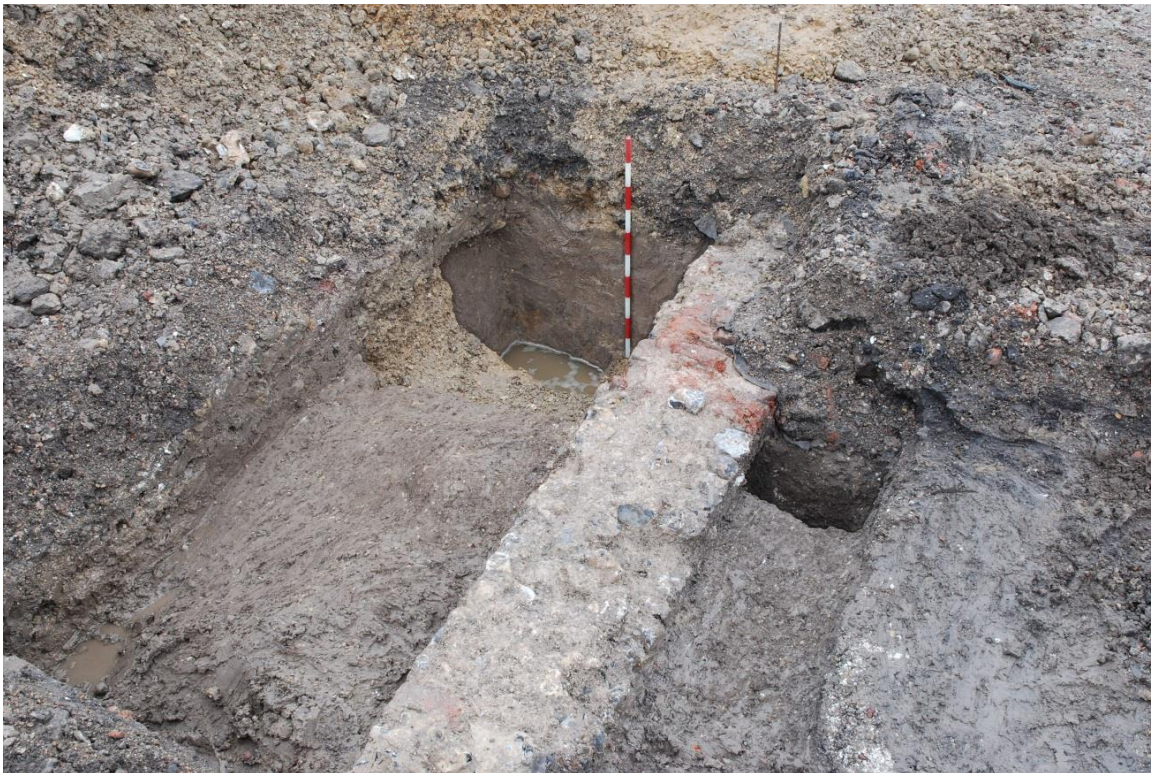
Fig. 13: *A further view of the above looking approximately ESE, the post-medieval wall [35] in the foreground*

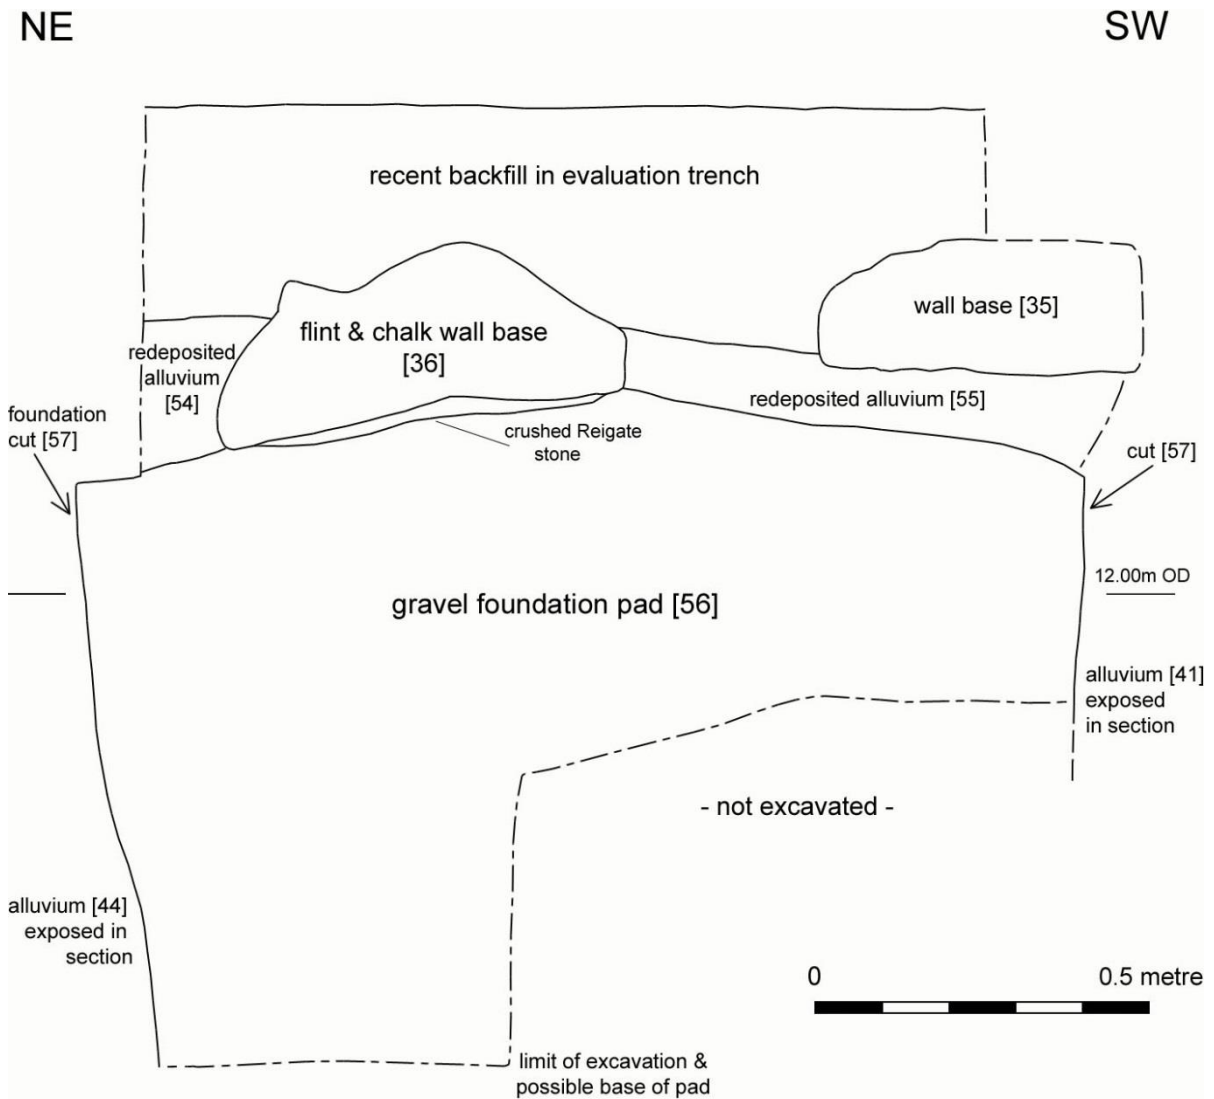
The pad [56] / [57] was slightly offset to the west from the overlying wall line [36], projecting some 250mm beyond it to the east but at least 500mm to the west (Fig. 14) and was on both sides overlain by the presumed construction backfill, respectively [54] and [55]. This offset may not be significant (and is partly accounted for by the projection of the eastern side of [36]), although it is worth noting that the pad in evaluation Trench 1 [42]/[43] seems to have been similarly positioned.

Fig. 14: Section across the southern part of the investigation pit and through the precinct wall base [36] and partially excavated foundation pad [56/57].

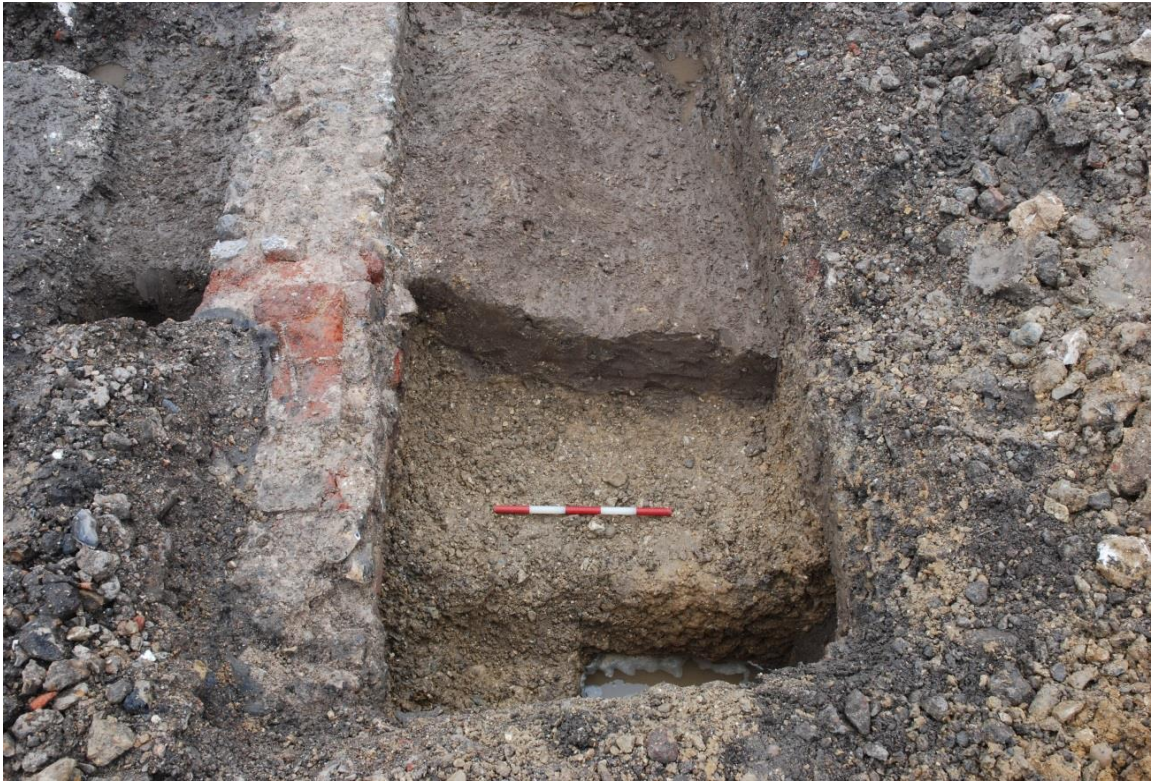
Fig. 15: View looking northwest, with the partly excavated gravel foundation pad [56] in the foreground (below the 0.5m scale) and post-medieval wall [35] to the left

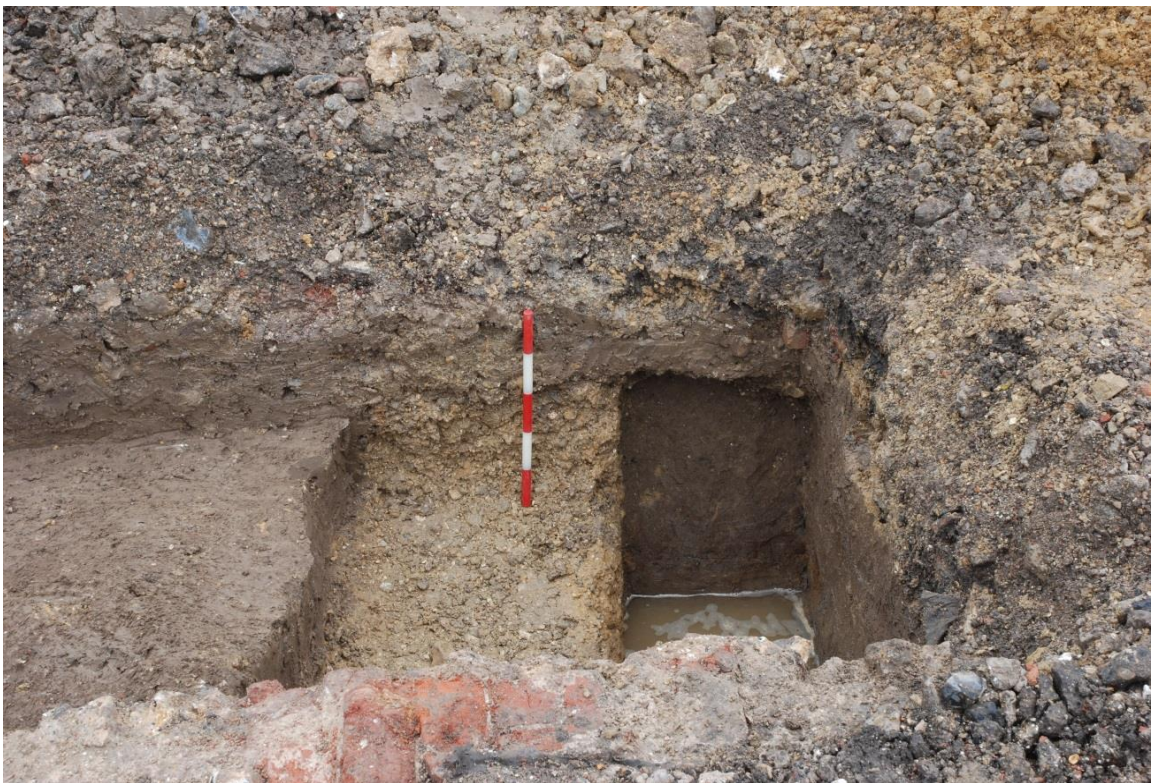
Fig. 16: View of the foundation pad looking northeast; to the right of the 0.5m scale the gravel fill [56] fully removed to expose the darker alluvium [44] into which the pad was cut
