THE CHURCH OF ST. ANDREW HOLBORN **Redevelopment of the North and West Gardens**

An Archaeological Watching Brief

September 2014

Site Code: SAH14

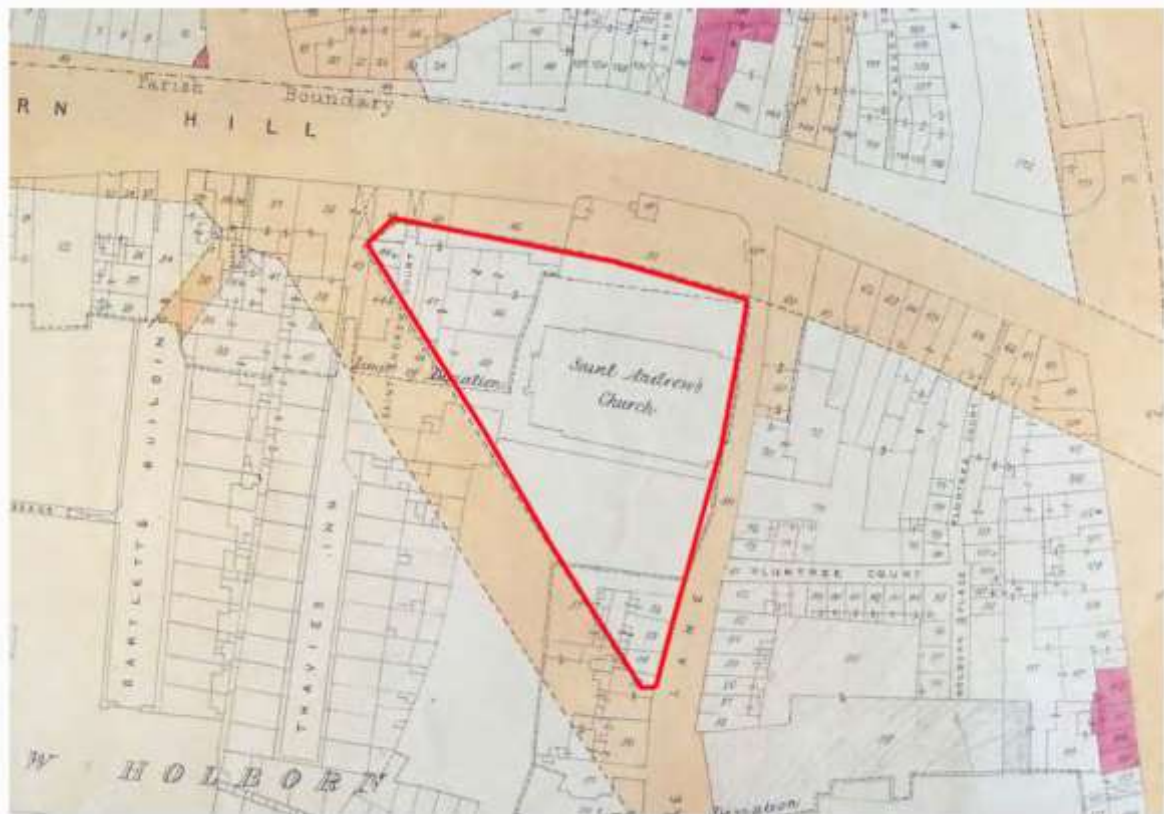
Fig.4: Extract from a proposals plan for the Holborn Viaduct. Note how much of the churchyard to the north and south are to be encroached upon / affected by the scheme

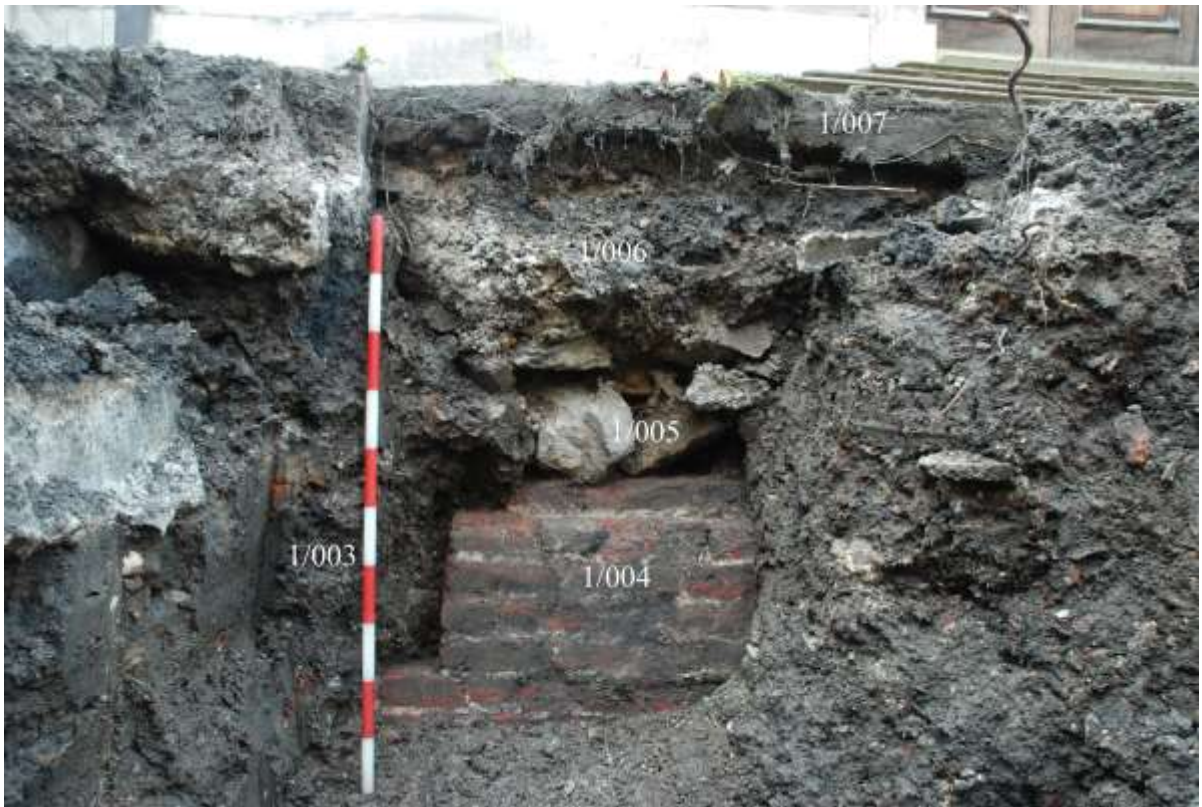
7.5.3 Bone, together with building rubble and other remains, were observed from surface level to the base of the trench. However, all material was distributed randomly; the bones were not arranged in anatomical order, nor did they form any clusters. The only archaeological feature was the face of a wall made of red bricks, (1/004), partially uncovered in the southern part of the trench (fig.9). This wall was aligned parallel with the church wall. It was most likely forming part of a former crypt or burial vault. The masonry was buried beneath a pile of stones, (1/005), overlain by concrete, (1/006), and covered by stone slabs, (1/007). No cut for wall 1/004 was observed. In the eastern section of the trench, the foundations for a modern gully, (1/008), were observed.

Fig.9: Photo showing Section 2 at the southern end of Trench 1, facing S, (1m scale).

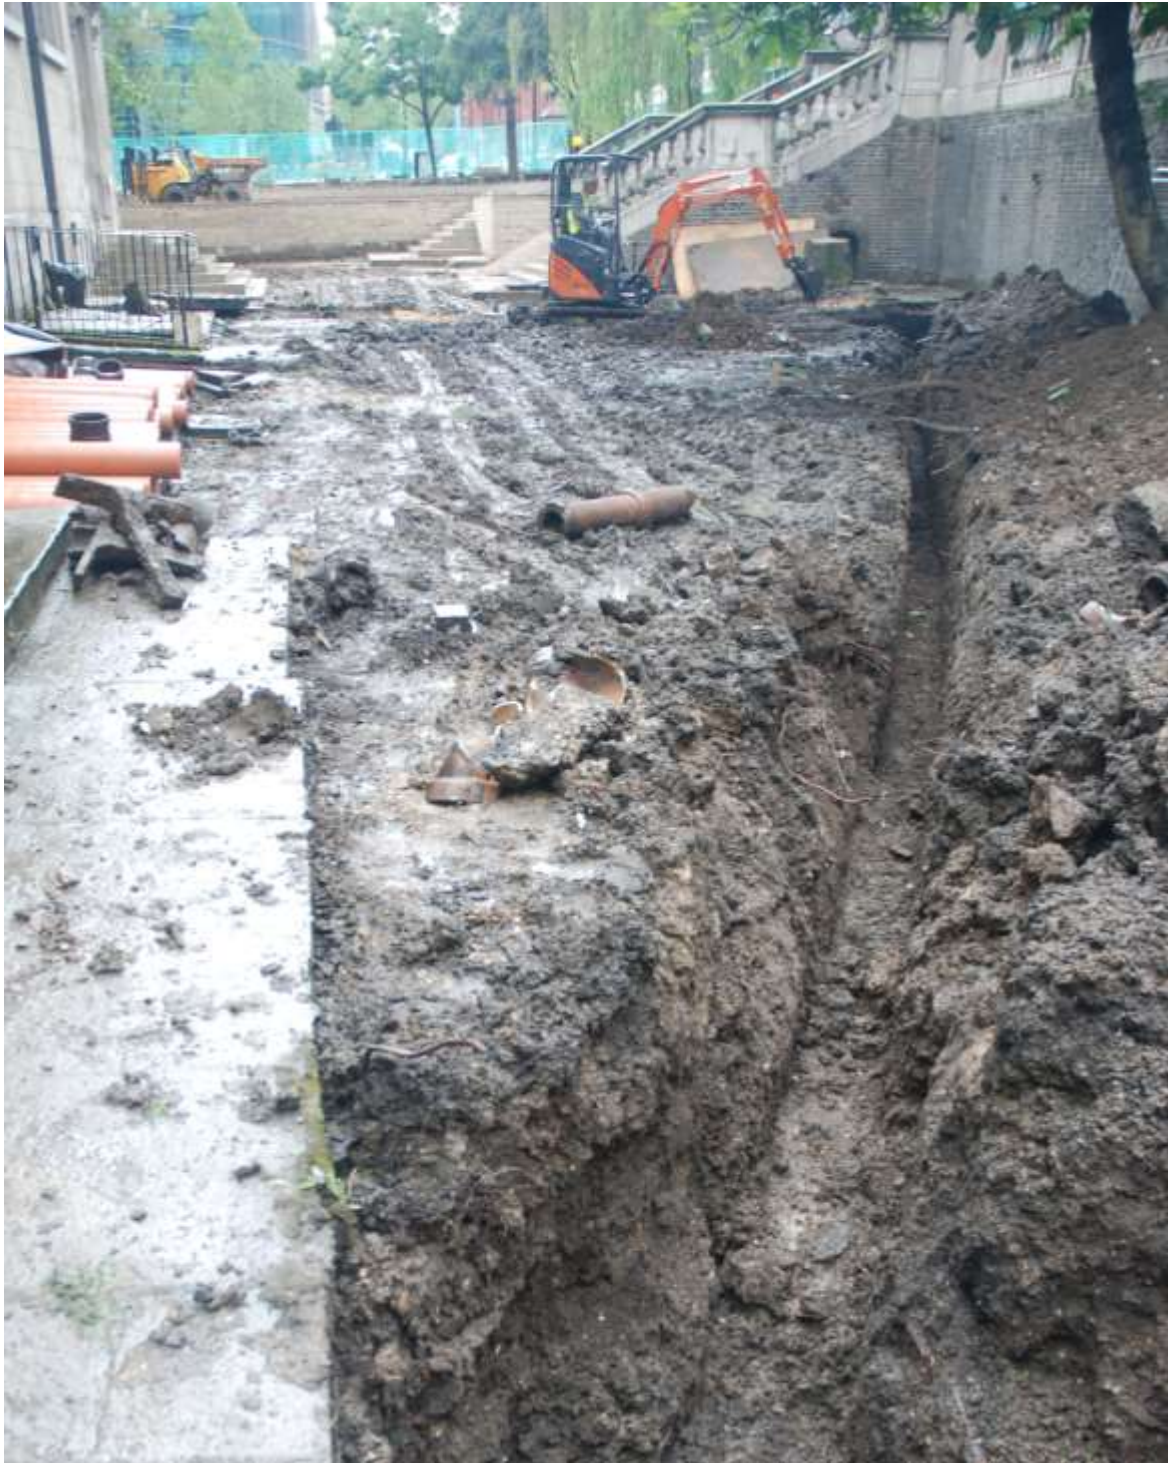
Fig.11: *Trench 2 facing NW, 13th of May 2014*

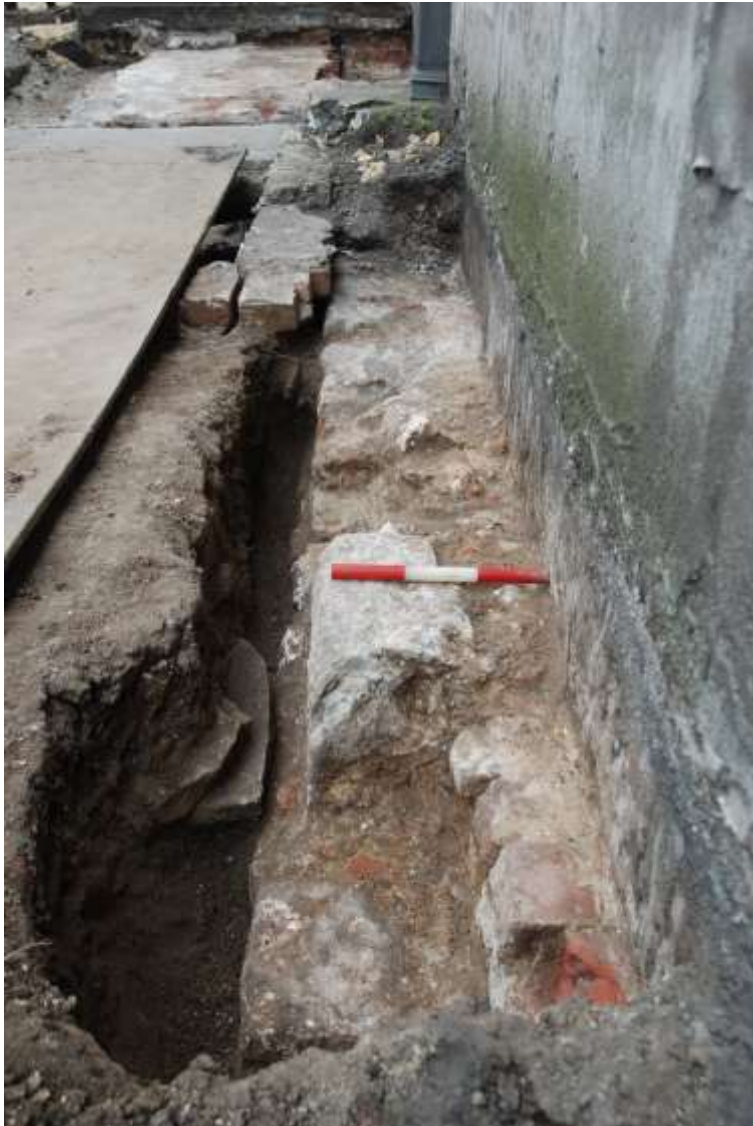
7.8.2 The oldest phase of construction identified was an earlier church wall, (v/001; shown on fig. 8 as W1), which was situated below the current church wall, (fig.13). It was constructed mainly from stone blocks and mortar and was later incorporated as the southern wall for vault v/003, (fig.12). It was partially covered by red bricks and tiles, which are not part of the original construction, but kept it visually consistent with the rest of the vault. The observed thickness of the wall was 0.40m and was seen to continue down at least 2m. No construction cut for the vault, (v/002), was observed.

Fig.13: *Photograph of early wall v/001, facing east, with the present church built on top but set back c 0.35m to the south (0.3 scale)*

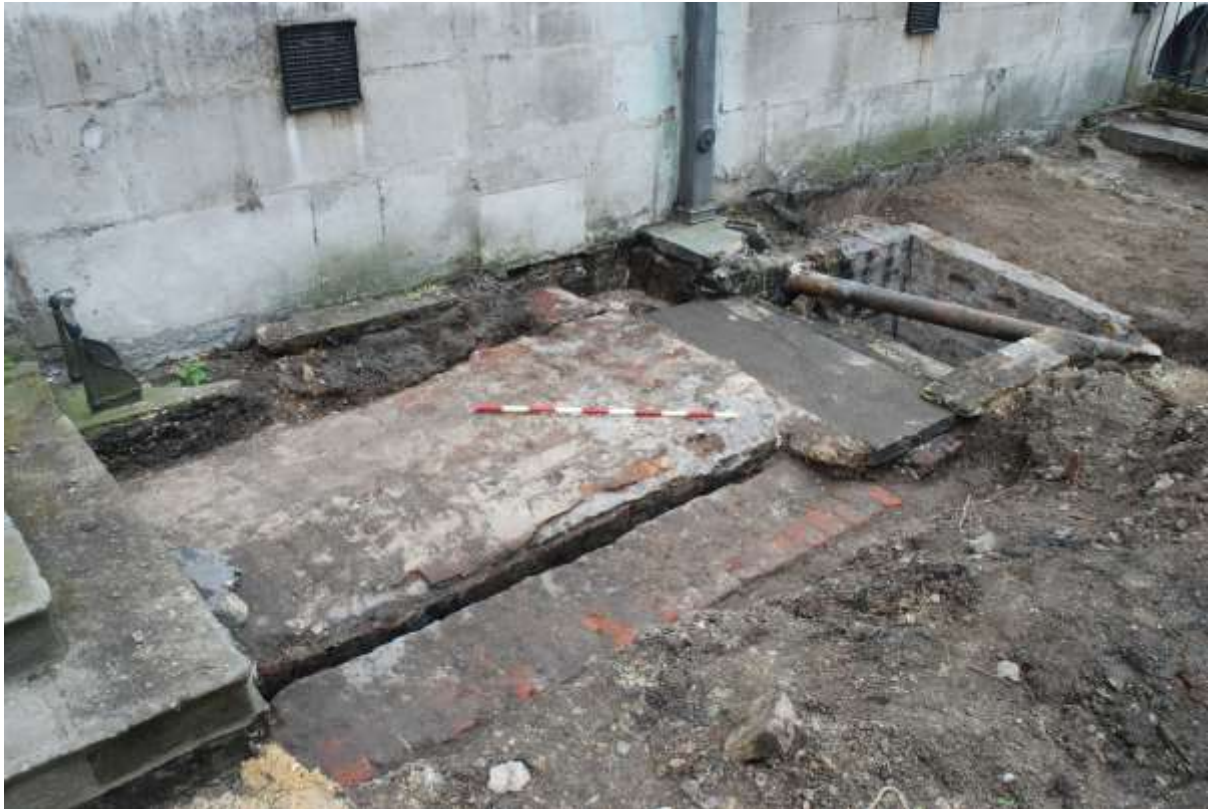
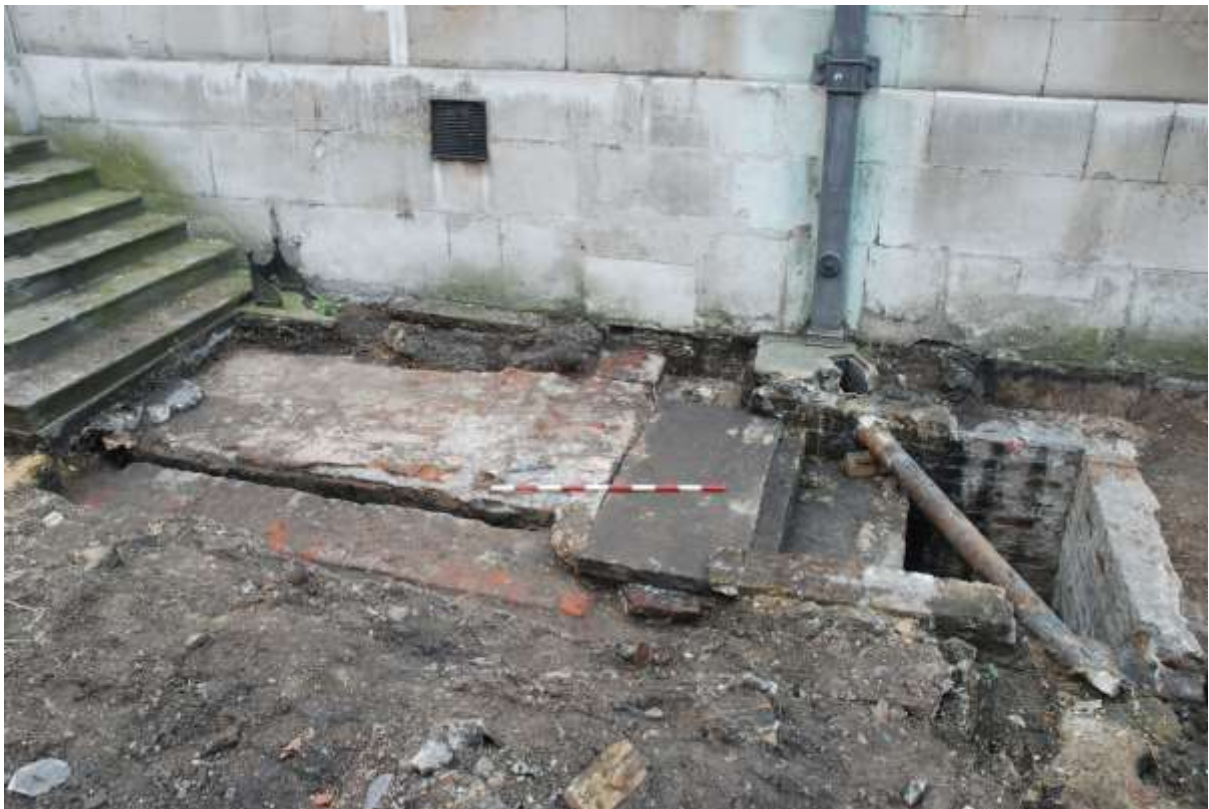
7.8.3 A brick-built vault, (v/003), was built adjoining earlier church wall v/001. It was roofed with red bricks and housed several coffins. The original entrance in the form of an arch was visible in the eastern side of the second vault, (v/004), the original west side of the early vault. This arch would no doubt have originally included steps leading down to it from ground level, providing access to the vault, but the stairs had been removed and archway sealed upon construction of vault v/004.

Fig.14: *The two vaults, looking towards the north wall of the Church: the brick-roofed v/003 on the left of the frame and the partly-open v/004 to the right (1m scale)*

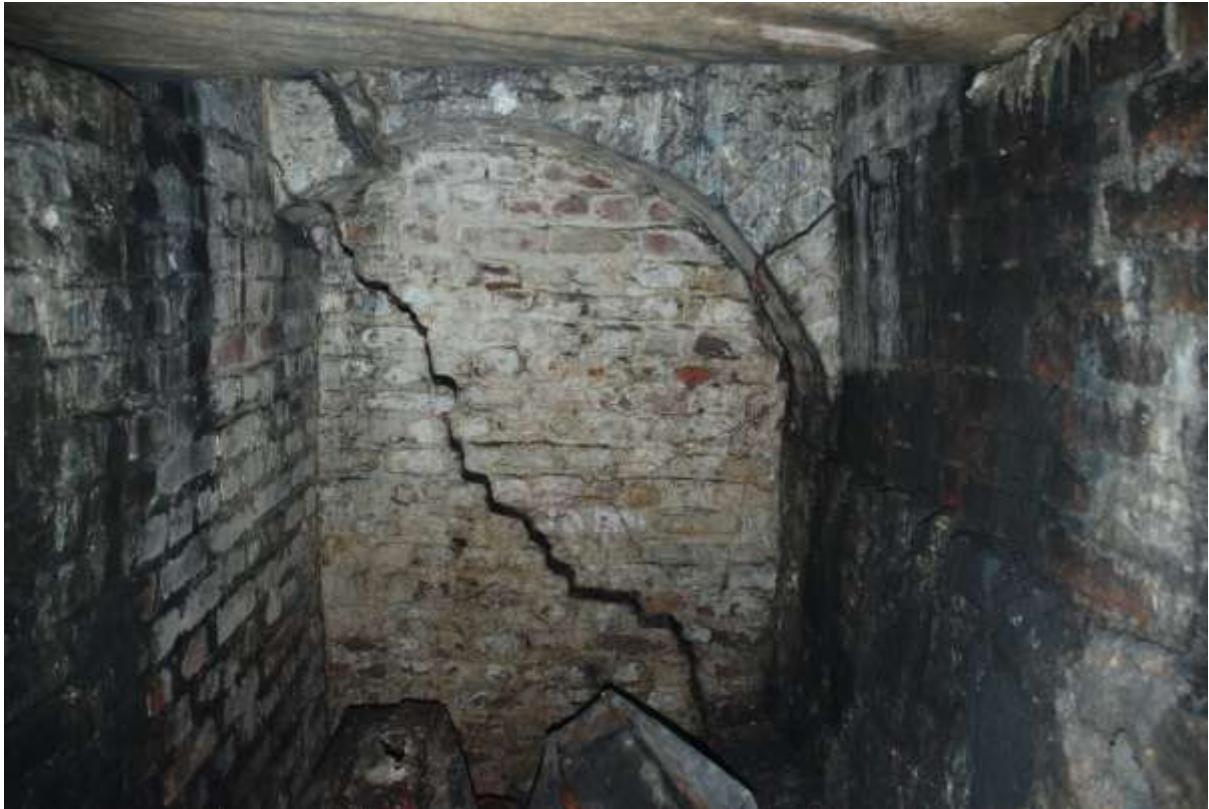
Fig.15: *The east end of v/004, showing the blocked up entrance to v/003, including the truncated arch. This entrance would once have had steps leading up to ground level*

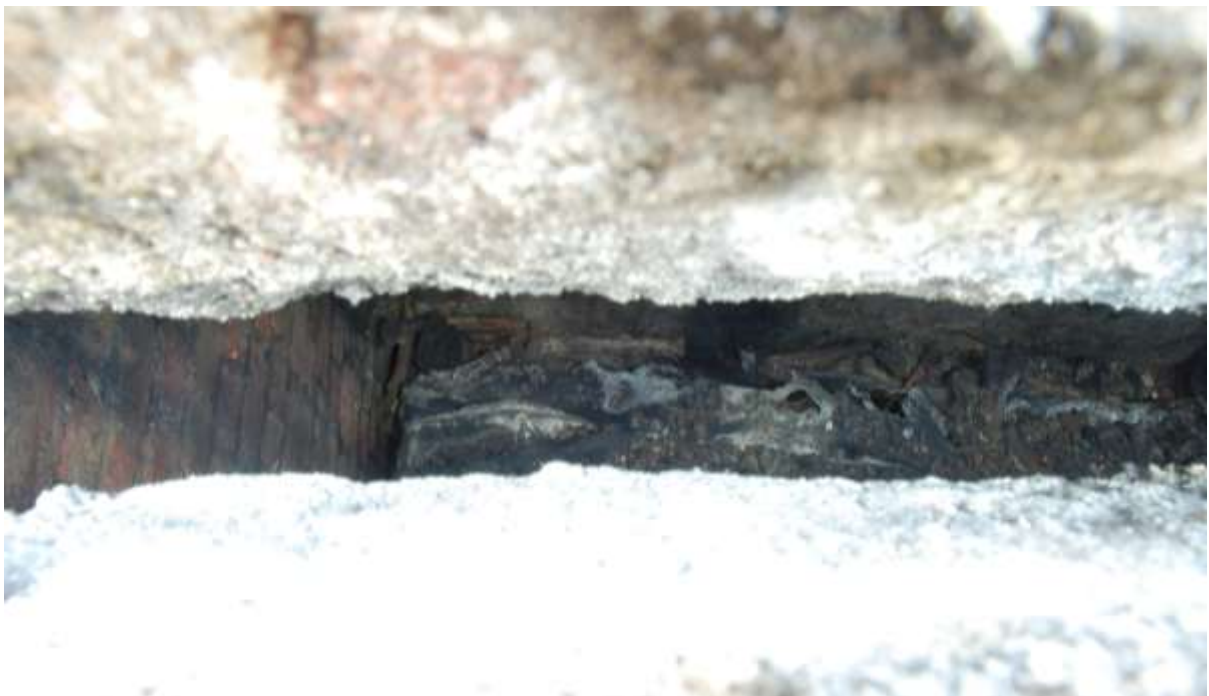
The vault was not opened, but through a crack along the northern side of the roof several decaying and seemingly overturned, lead coffins were visible, with a collection of long bones and other disarticulated remains strewn about, (fig.16). It may have been that the vault was substantially disturbed during construction of v/004.

Fig.16: *Interior of v/003 as viewed through the crack in the roof from existing ground level. Note the disturbed and decaying coffins and disarticulated bones. Facing S*

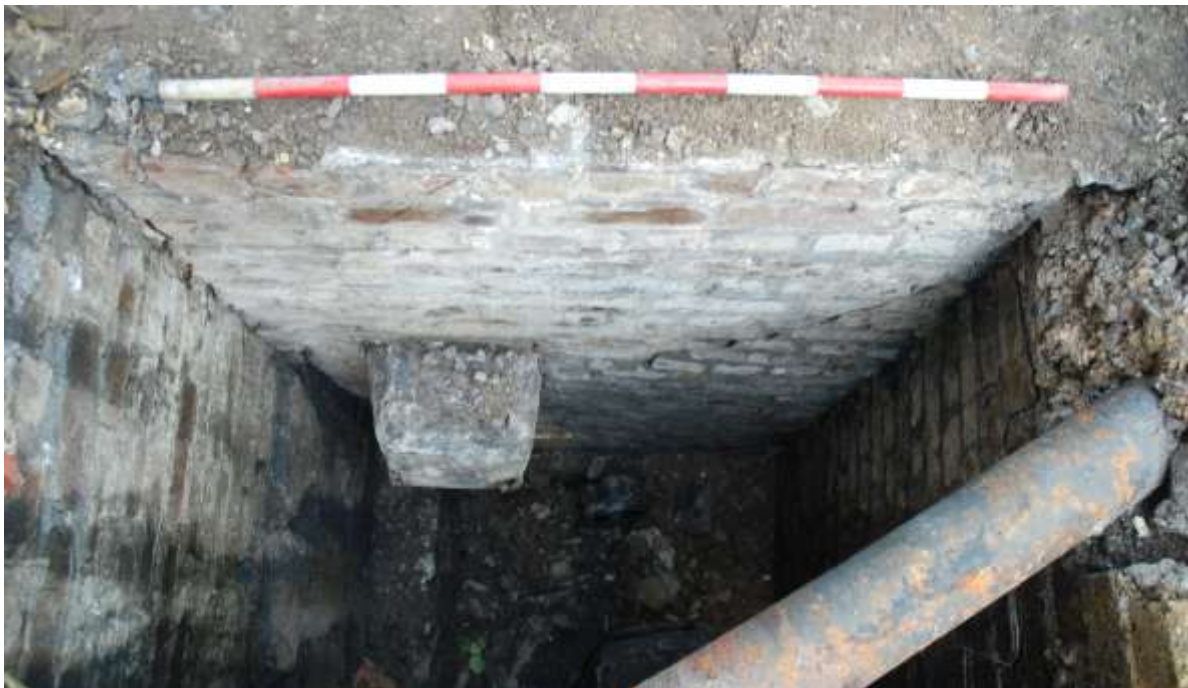
7.8.4 A second vault, also built of red bricks, was attached to the eastern side of the earlier one. The original arched entrance belonging to the earlier vault had been sealed by a brick wall, (fig.15), to form the eastern wall of the new vault, and a very peculiar thing was observed in the western wall of the new vault. The wall had been built up around a lead coffin. This resulted in the coffin partially sticking out of the wall, (figs.17 and 18), and into the interior of the vault itself. It must be presumed that this coffin predates the construction of the burial vault, and was perhaps originally buried within the open ground of the churchyard. It was then exposed when construction of vault v/004 began and instead of moving the burial, (which may have taken considerable effort and time), the work team simply built around it. What the relatives of the recipients of the new vault made of this odd arrangement can only be imagined!

Fig.17: *The lead coffin sticking out into the new vault, v/004, facing west, (1m scale)*

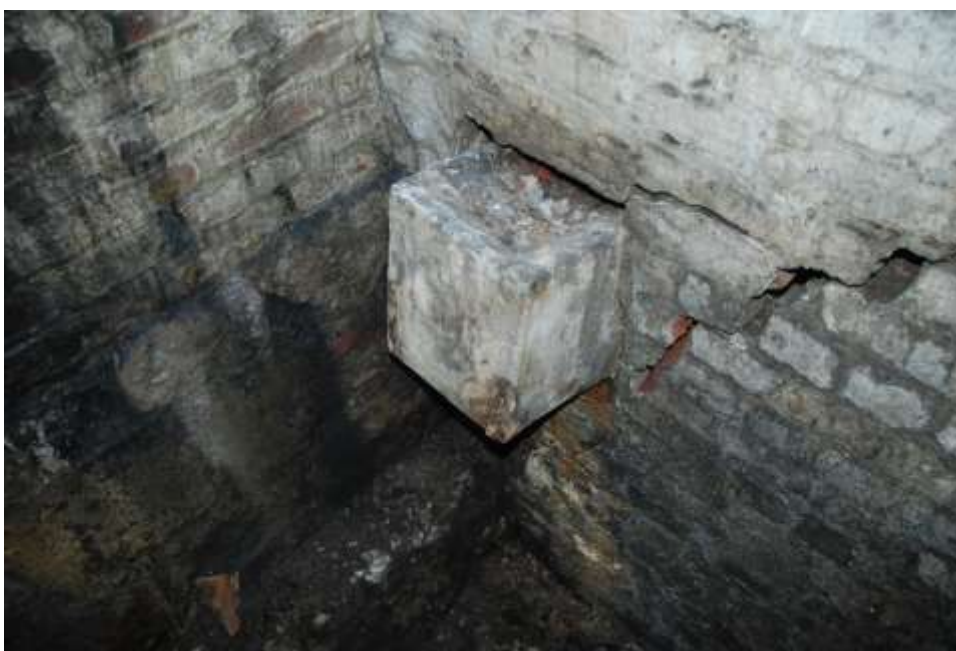
Fig.18: *Coffin projecting into the vault, showing how the wall of the vault has been built around it*

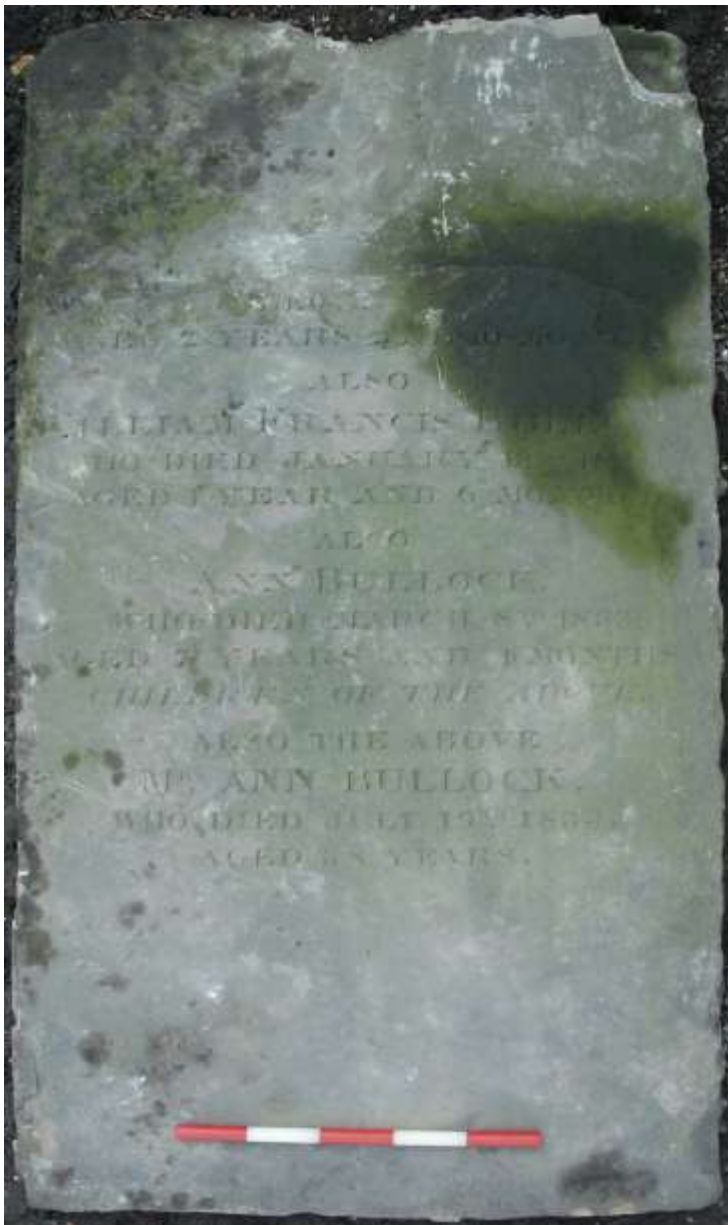
7.8.5 Five lead coffins were situated inside the opened burial vault. Three of them, due to their smaller size, were believed to belong to children. They were lain one atop the other. Two additional coffins were larger and were therefore originally thought to contain the parents, these were also placed one on top of another. Although there was a ledger stone with inscriptions covering the vault, it was partially weathered and not all the names and dates were legible¹. What follows is a photograph and transcript of the inscription on the aforementioned slab dating the vault to the early 19th-century:

..... WHO DIED DECEM(BER)

AGED 2 YEARS AND 10 MONTHS

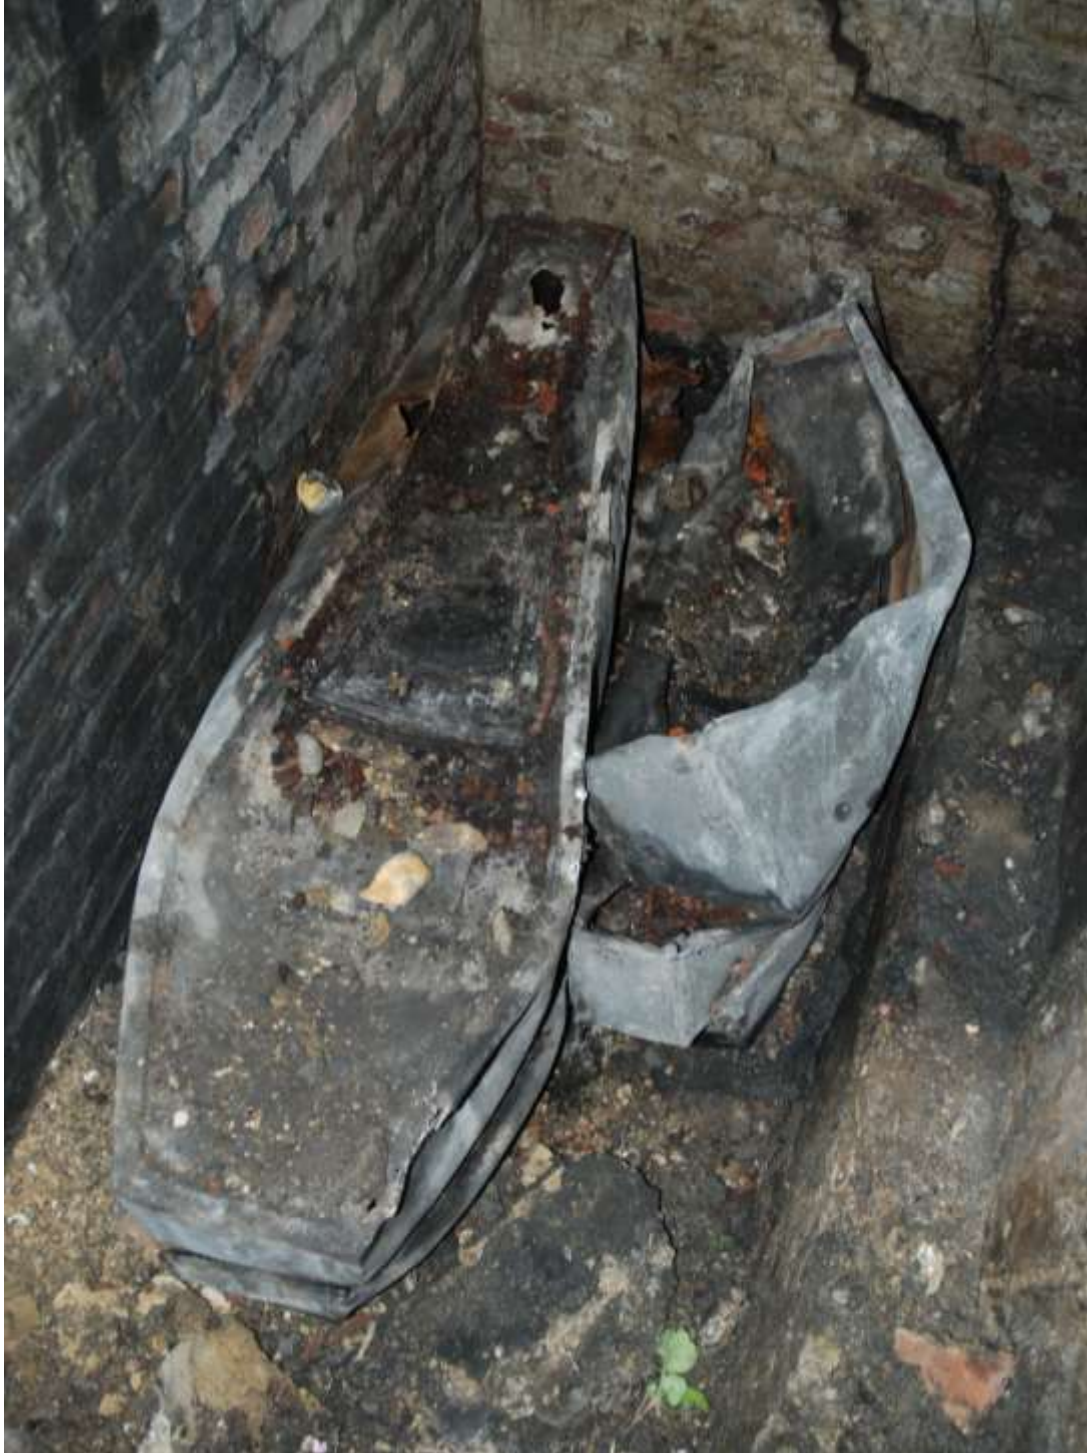
7.8.6 The coffins themselves were made of lead, and had begun to deteriorate, buckling and splitting apart. They were left in the vault and are not planned to be removed. As part of the garden's redevelopment stone slabs will be returned to their original positions where possible, supplemented by replacement stone as necessary.

Fig.20: The five lead coffins in v/004 facing east, the three children's coffins are stacked to the right, and two adults to the left. The wall at the top of frame is a later insertion, blocking up the former access to vault v/003 to the east

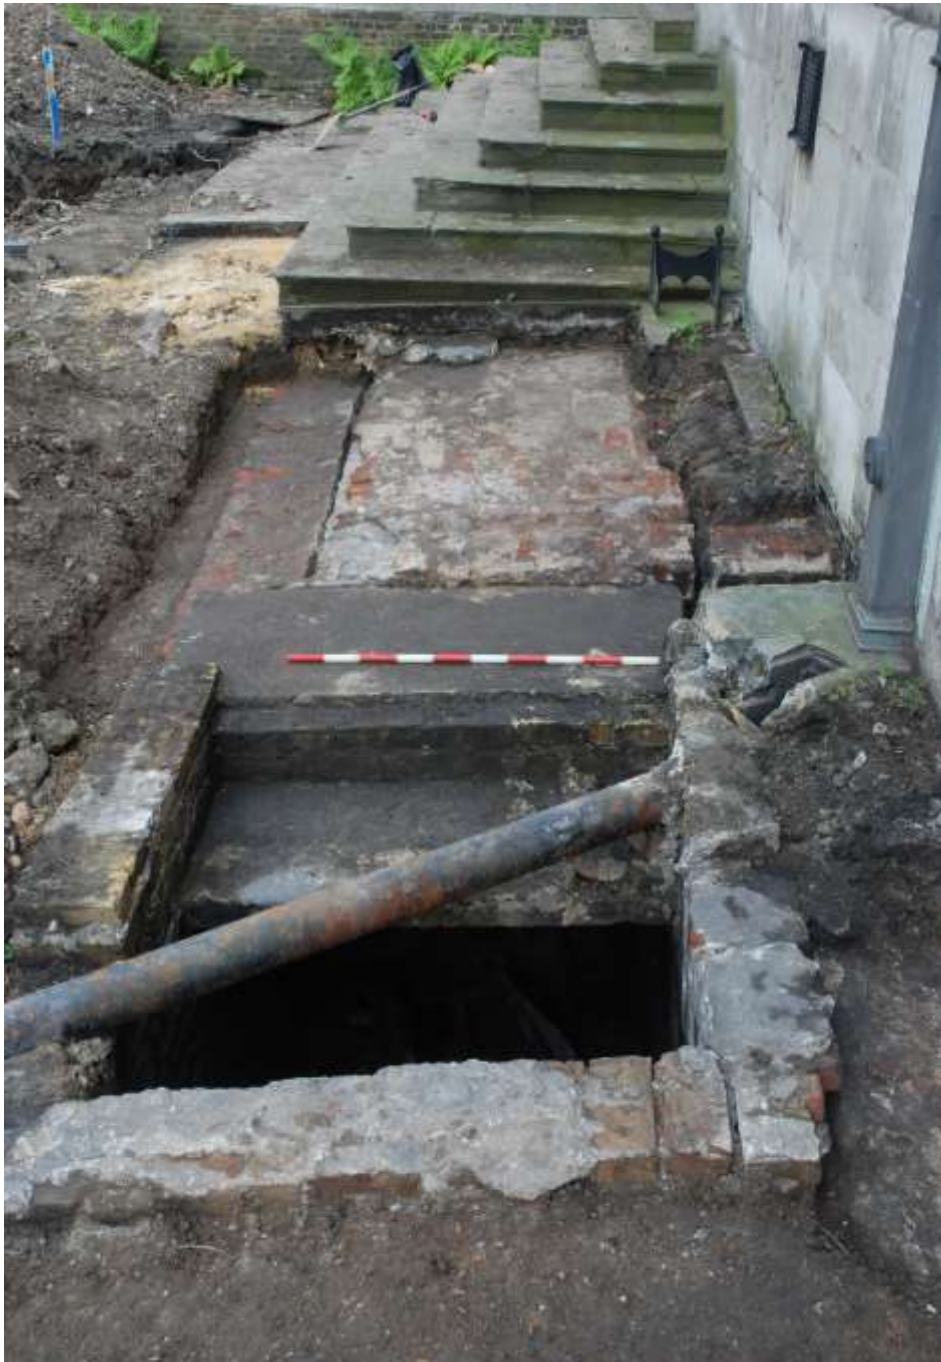
- 7.8.7 A modern intrusion caused by the instalment of a modern gutter pipe across the vault led to vault v/004 being slightly disturbed and damaged. A plain stone slab had been added into the eastern wall of v/004 to create a support for the drain. Everything was then sealed beneath the re-laid stone paving.
- 7.8.8 No archaeological artefacts were recovered during the investigation of the vault. The oldest element was the earlier church wall, which seems to be of late medieval / early post-medieval origin, (possibly 16th century), judging by the brick samples taken².

Fig.21: *The vault(s) facing east towards the northern entrance to St Andrews Church. v/004 is in the foreground, whilst earlier vault v/003 is the more obviously red-brick structure in the background. Also note the earlier church wall, v/001, on the right of frame, (1m scale)*

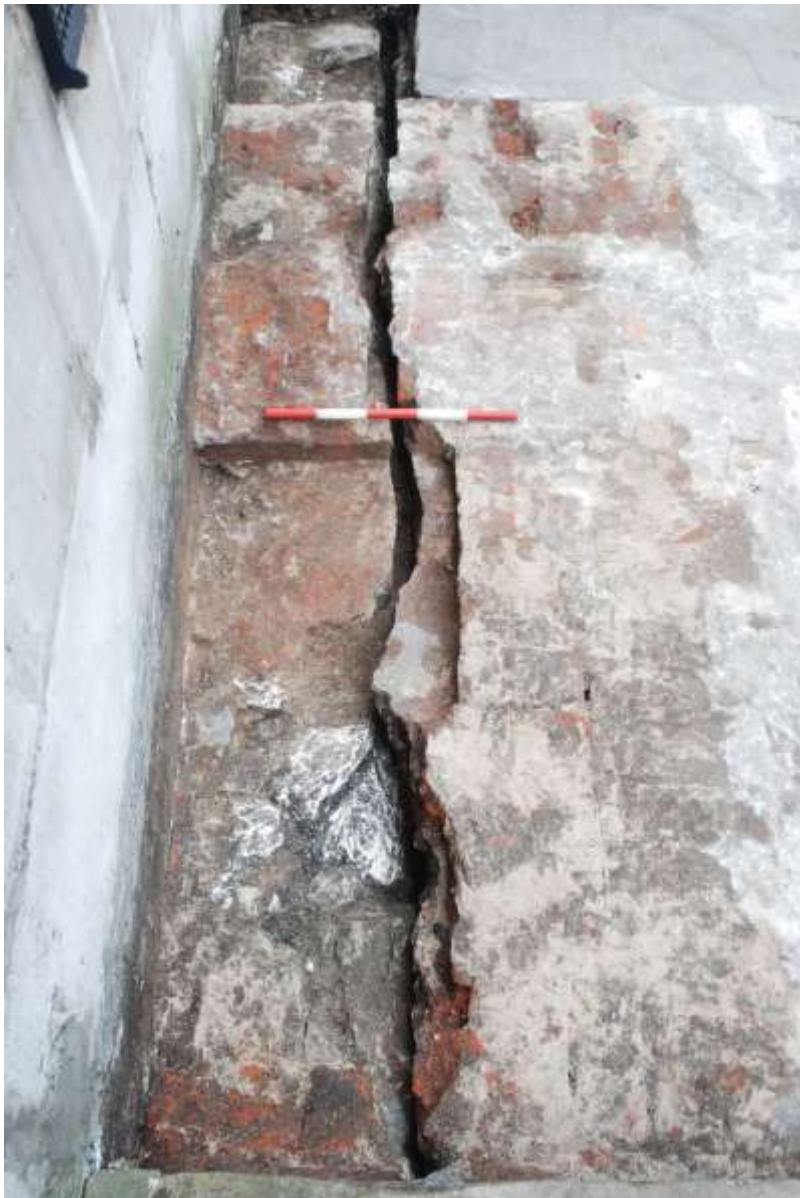
7.9.2 The exposed wall was shown to be constructed from a mixture of different stones and brick, (of which samples were taken), bonded with a coarse lime mortar. The wall, as seen, measured 1.73m long, 0.32 to 0.38m wide and was excavated to a depth of c0.40m. There was also an apparently plain stone slab, or at least part of one, buried next to the northern face of the wall. This was not fully exposed.

Fig.22: *The eastern end of Wall 1 as exposed, showing the mixture of materials used in its construction. Vault v/003 is to the right of frame, built up against and slightly over the wall, (0.5m scale)*

7.9.3 The wall itself is marked as W1 on a general plan of extensions to the original excavated area (fig.8), and shown as part of v/001, (blue), on the more detailed phase plan, (fig.12).

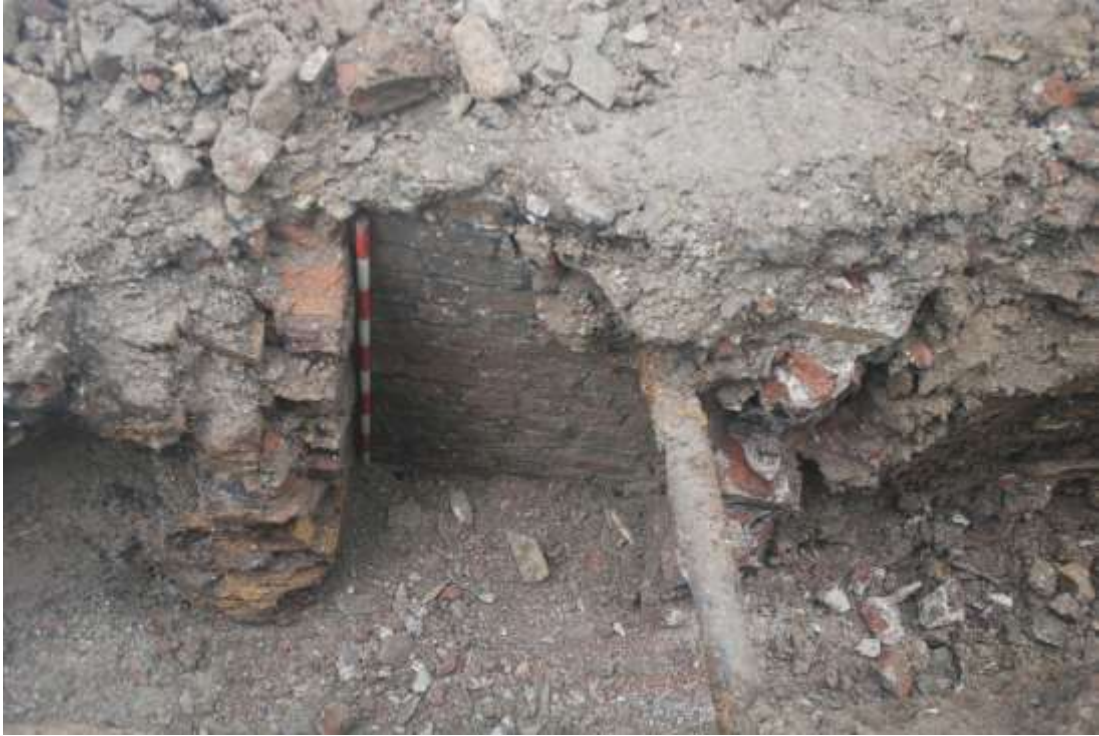
Furthermore there was a more or less continuous layer of former drainage, formed of red bricks placed into the surrounding material, (8/004). This early drainage method was later replaced by a metal drain pipe, (8/007). Another pipe, (8/008), was observed running alongside the wall to the West Garden. Separate layers of mortar and building rubble, (8/005), was identified in-between the two phases of former drainage.

Fig.24: *Former drainage box at the northern end of Trench 8, facing ESE, (1m scale)*

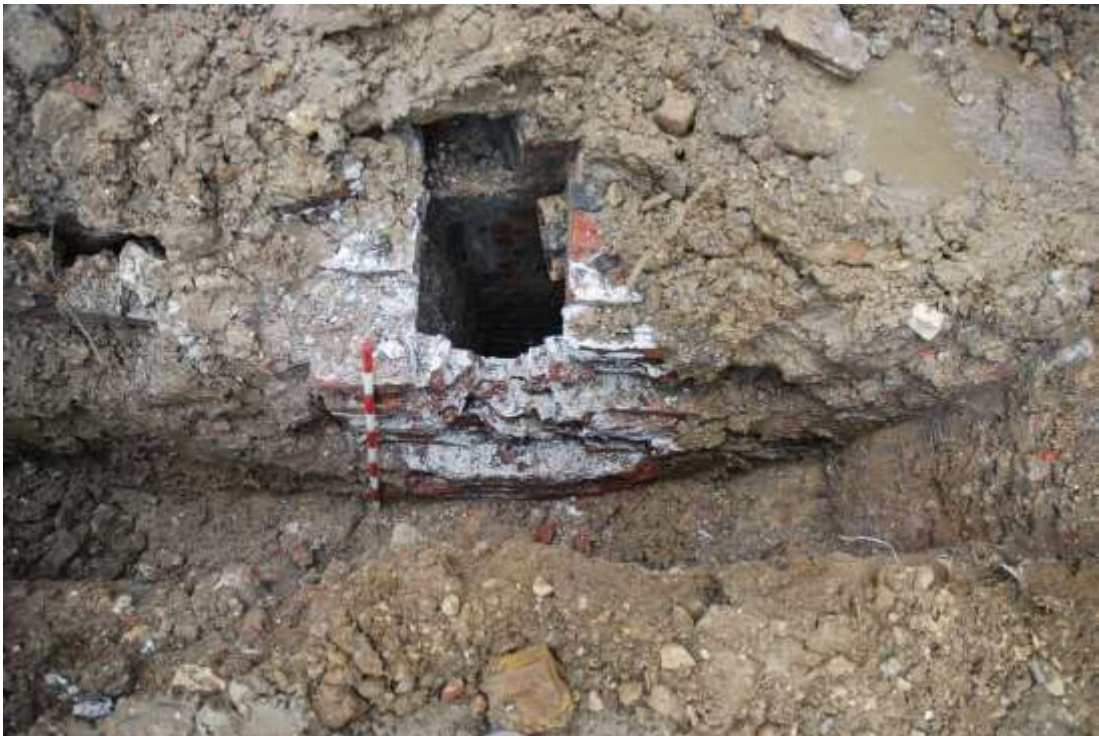
Fig.25: *Former drainage box at the southern end of Trench 8, facing ESE, (1m scale)*

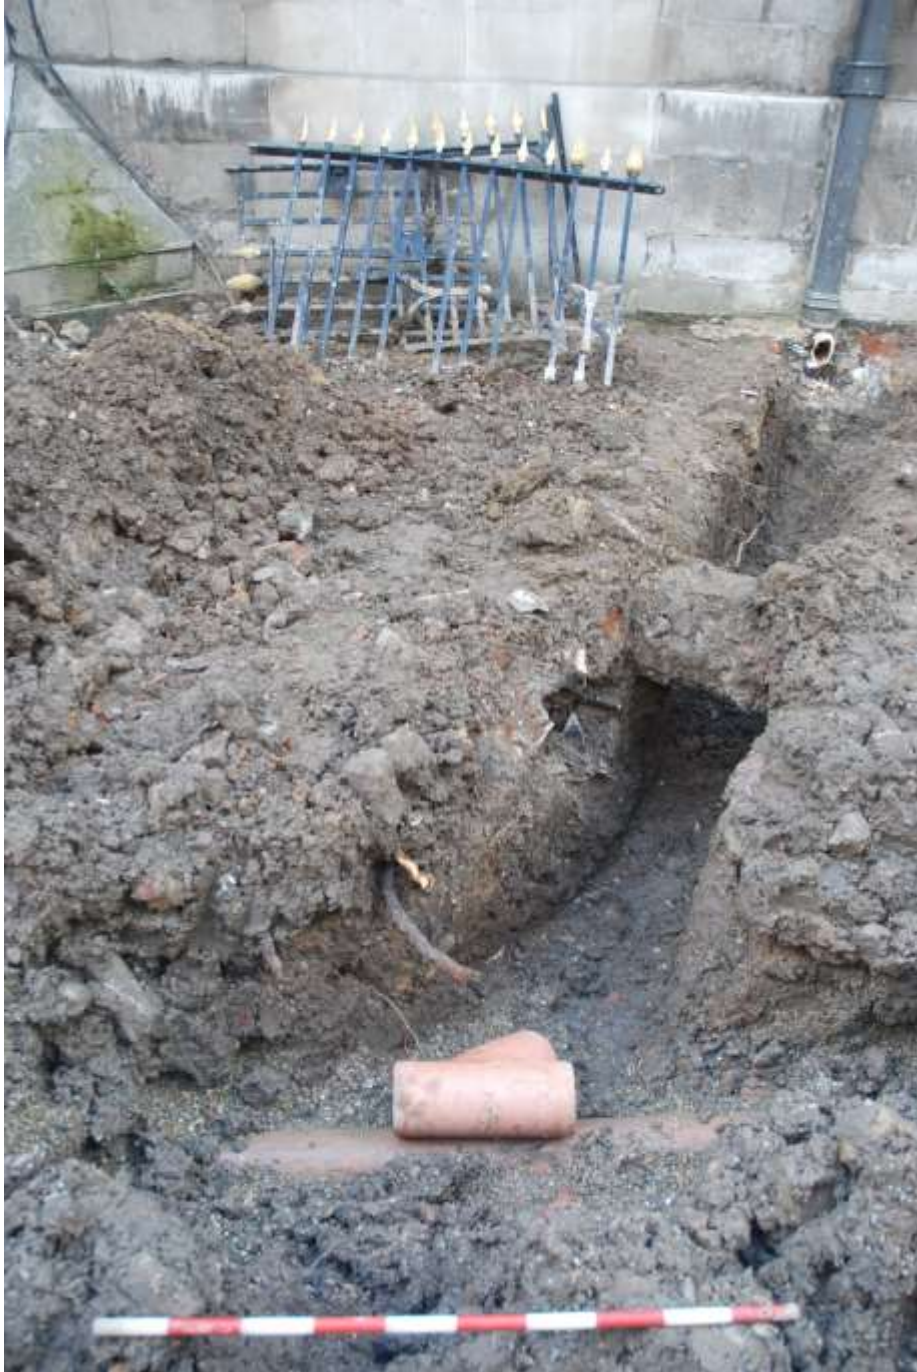
Fig.26: *Trench 9, facing SW towards the north wall of the Church. The line of Trench 7 is visible in the foreground, (1m scale)*

7.15.2 Stratigraphically, there was only one layer. This was a grey layer containing degraded CBM, pieces of human bone and stones, (9/001), similar to that observed across the churchyard throughout the watching brief, (see 7/005). There was a concrete pipe, (9/002), placed within this layer and also a concrete base for the existing gutter, (9/003).

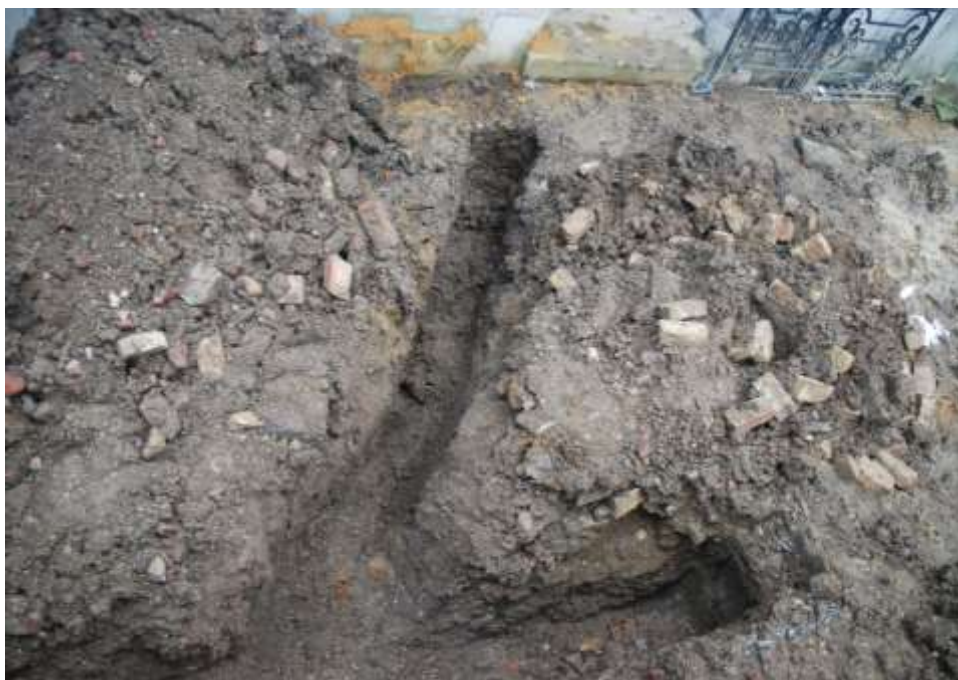
7.16.2 There were only two layers visible in Trench 10. These were an upper layer of building rubble, (10/001), sealing a compact brown clayey deposit, (10/002), with building debris within it. It was the same soil as observed in Trench 8, (see 8/006).

Fig.27: Trench 10 facing E, towards the west face of the Church

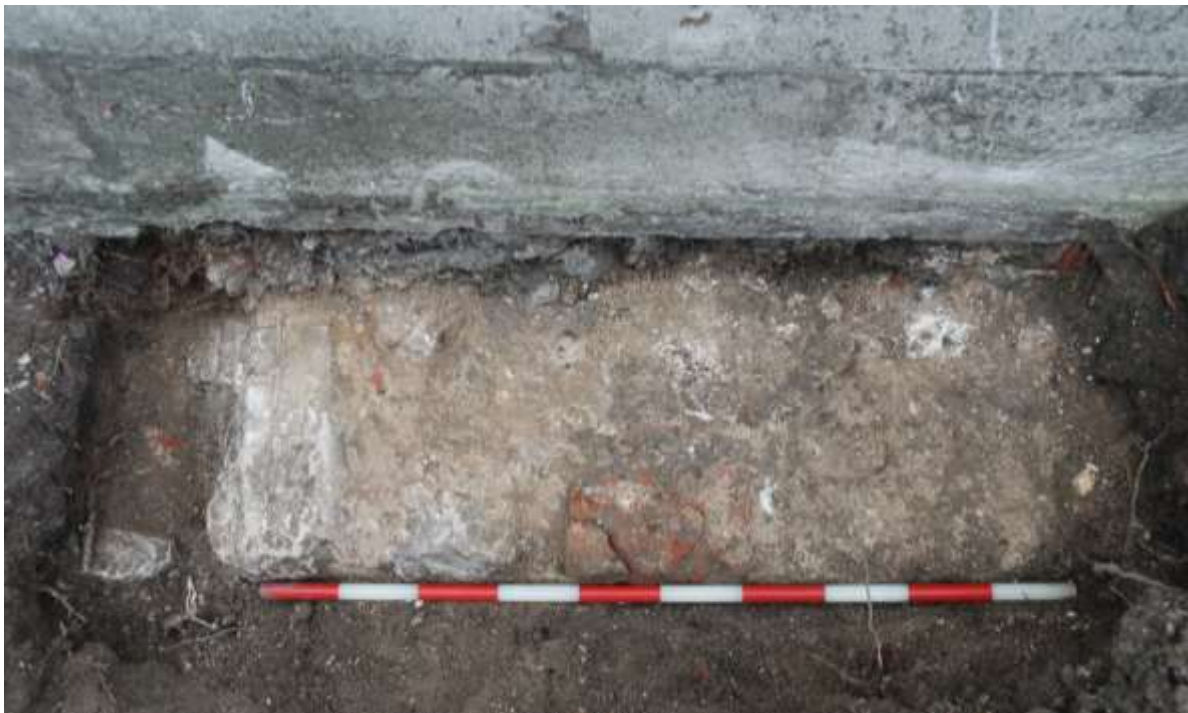
7.17.2 Wall 2 was uncovered for a length of 1.38m and was observed stepping out c0.38m from below the extant church wall. It was made from stone and mortar, but also included elements of red brick. One of the larger stone blocks bore marks of stone masonry, possibly identifying it as re-used or unfinished window tracery, (fig.28).

Fig.28: Wall 2 facing south. The extant northern wall of the church is at the top of frame. The stone at the left end of the scale showed signs of having once been part of a window, (1m scale)

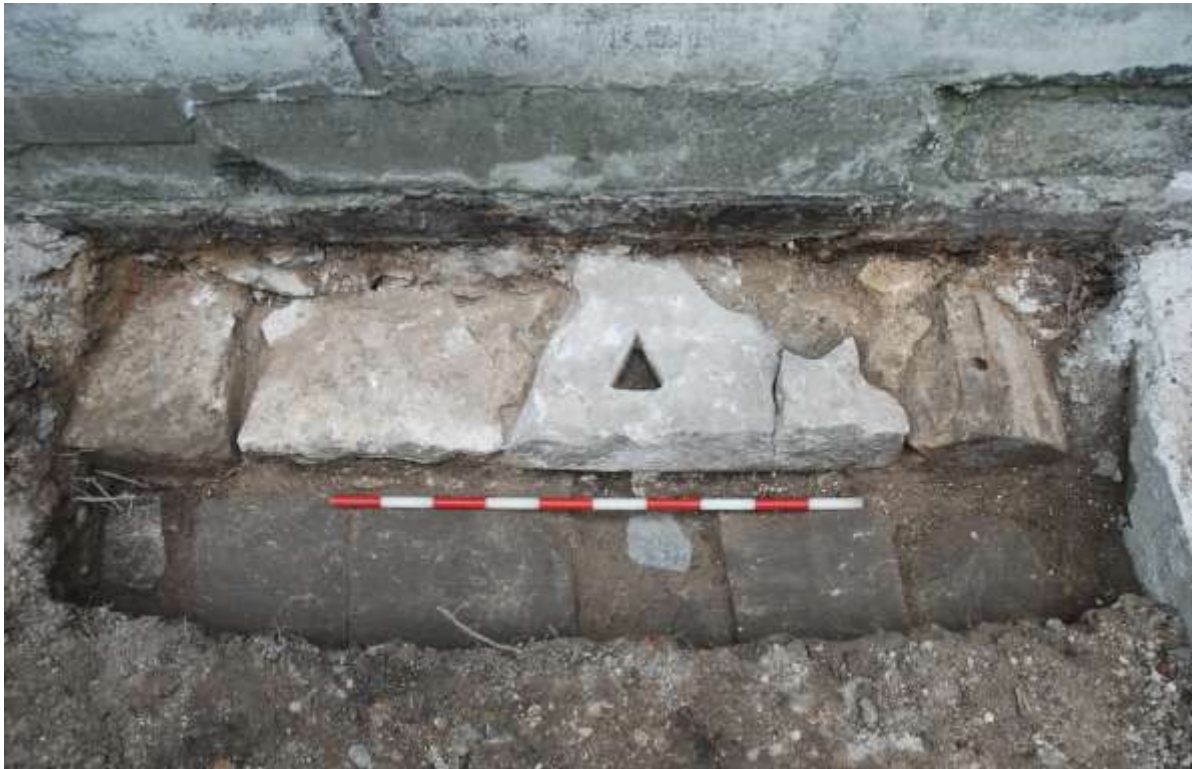
7.17.3 Wall 3 was observed as a length of 1.90m stepping out 0.35m from below the current church wall. This section of the wall was also made of roughly shaped stone and mortar, but no bricks were observed. The stonework included a couple of pieces of medieval window tracery, (figs.30 & 31, and appendix V). Immediately adjacent to this wall there was a layer of stone paving slabs, a few centimetres lower than the wall which could have been part of an earlier floor / ground surface.

Fig.30: Wall 3, facing south, with at least two re-used architectural fragments including part of a window mullion at the far right end, and a larger piece of tracery above the 1m scale. Note the stone slabs below the scale, apparently representing a former paved surface

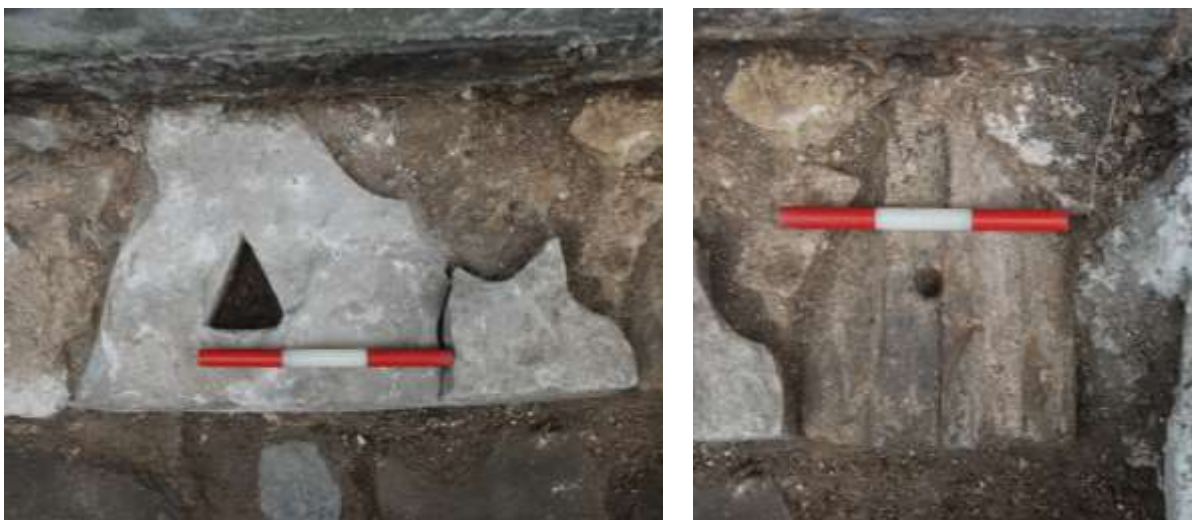
Fig.31: Detailed shots of the re-used stonework, (0.3m scales)
