THE CHURCH OF ST. ANDREW HOLBORN **Redevelopment of the North and West Gardens**

An Archaeological Watching Brief

September 2014

Site Code: SAH14

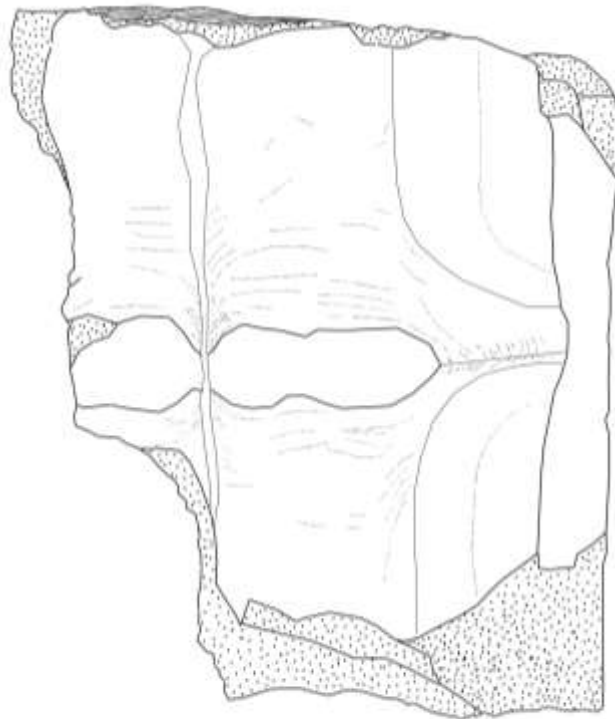
Fig.34: Drawings of second fragment of window tracery, interior face, (left), and side on, (right)

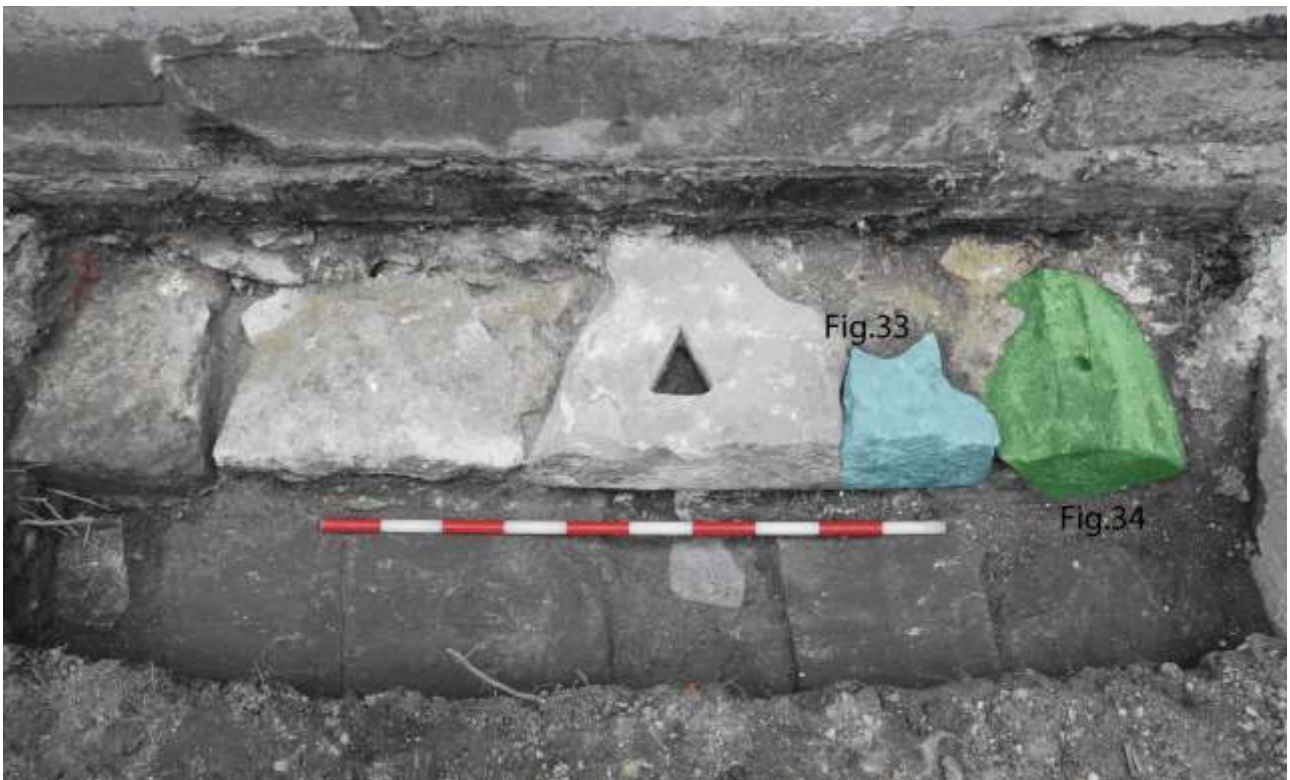
Fig.36: Photograph showing the location of masonry fragments illustrated above within W3
