**389-393 LONDON ROAD**

**AN ARCHAEOLOGICAL POST-EXCAVATION ASSESSMENT AND  
PHOTOGRAPHIC STANDING BUILDING SURVEY**

SITE CODE: LMY 06

Author: Colin Reid

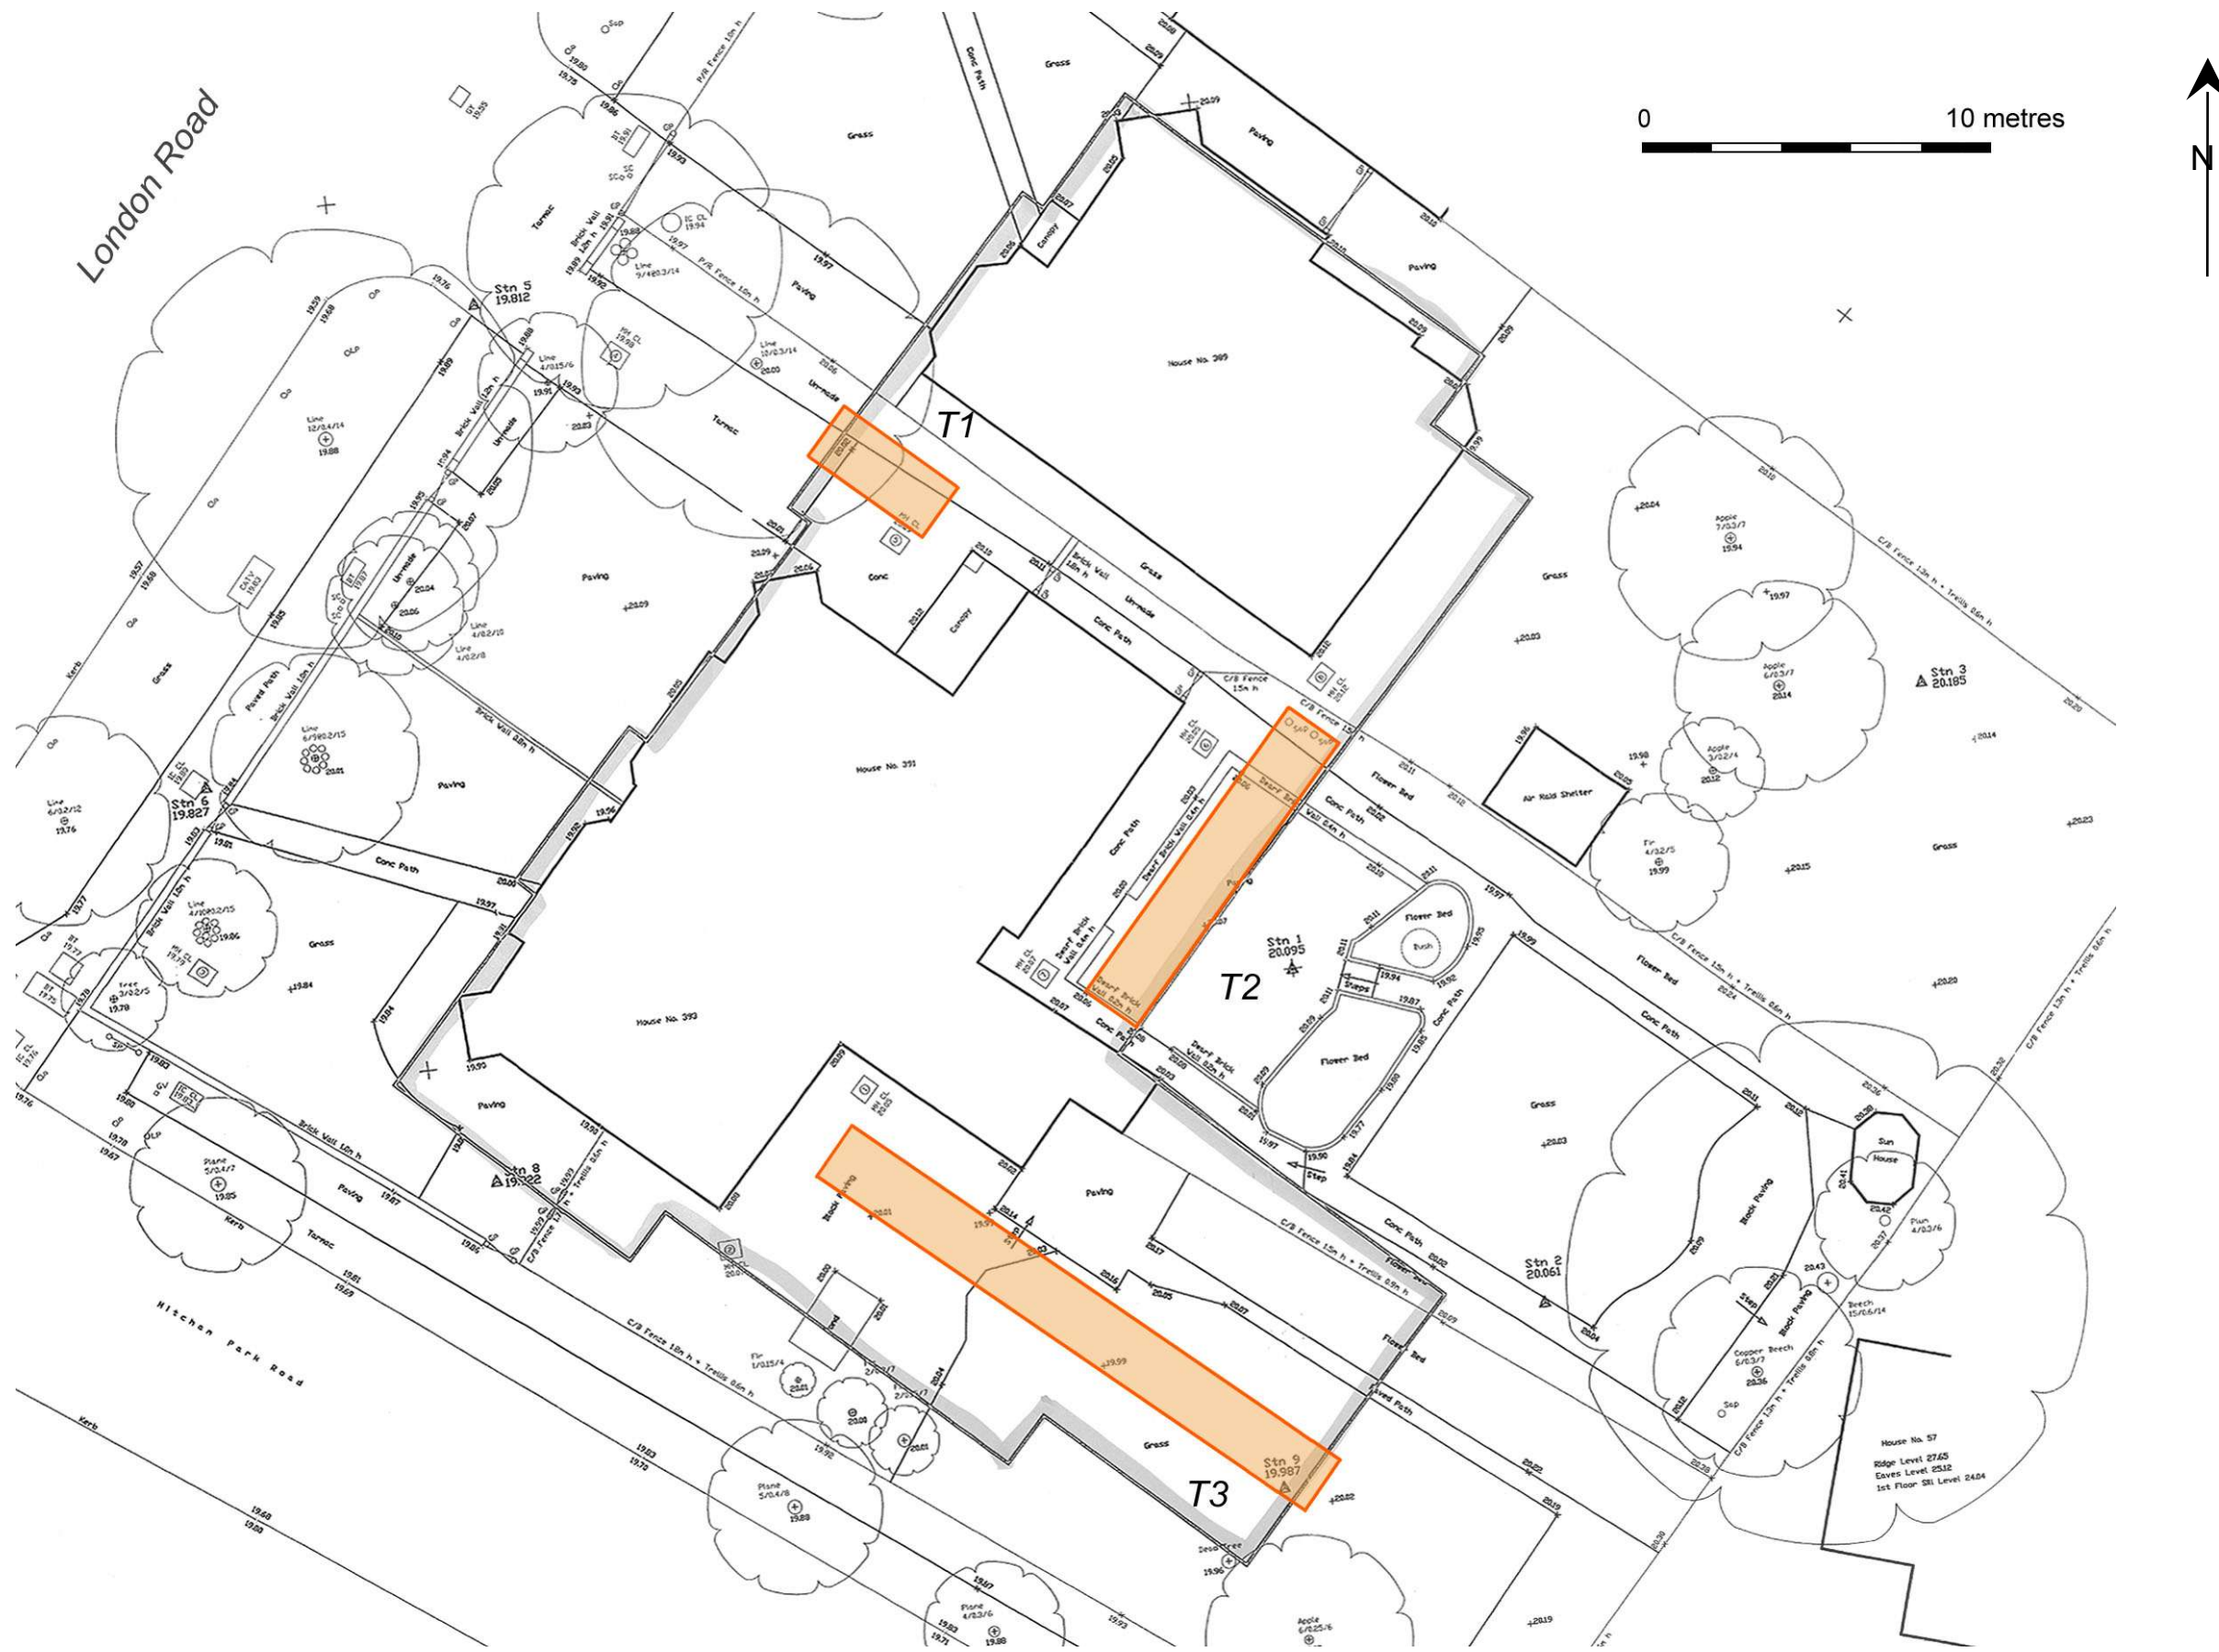
Fig 2 The location of evaluation trenches 1-3 in relation to the predevelopment site survey

Trench 2 was initially dug as a trial trench c 10m by 1.8m in plan (Fig 2). The trench was aligned approximately northeast-southwest and was dug from a fairly level surface of 19.9m OD

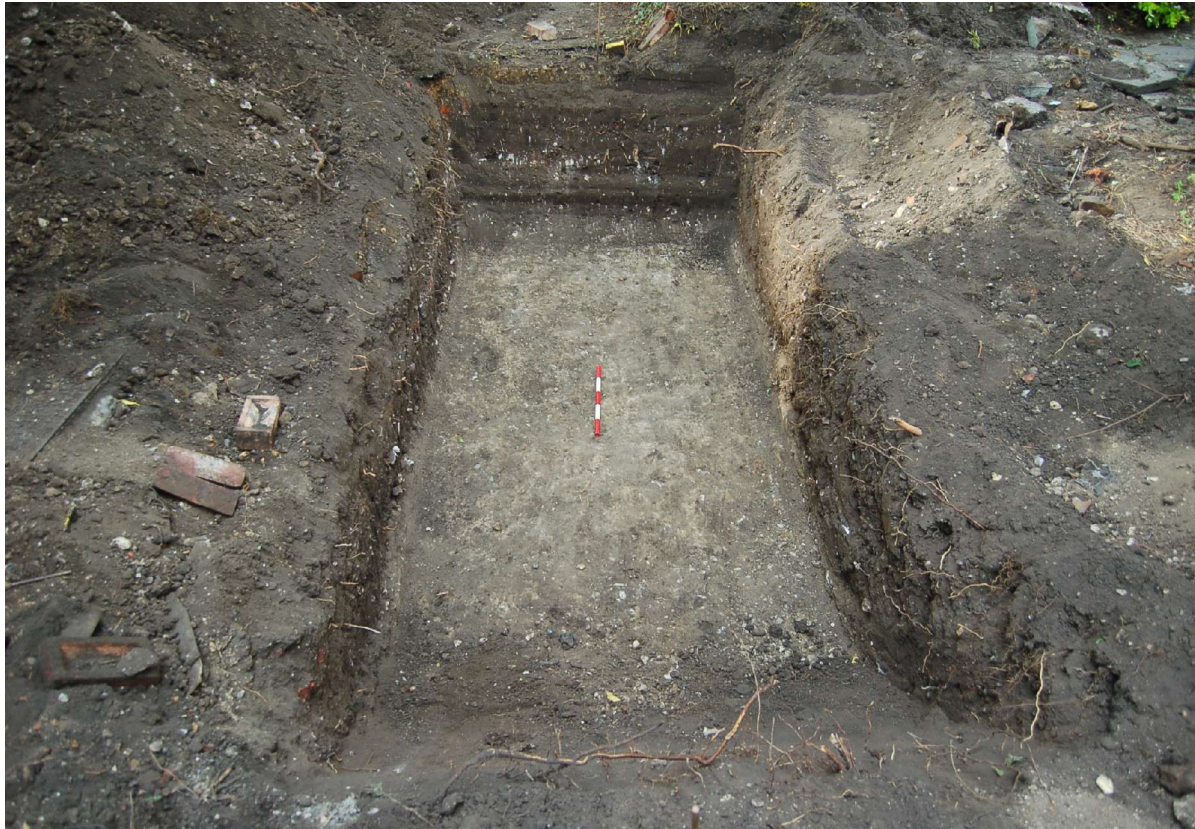
Fig 4 Evaluation Trench 1, view looking northwest after surface cleaning (0.5m scale)

Trench 1 was aligned roughly northwest-southeast and was located in the northern corner of the site, opposite the existing site entrance. The trench was dug from a relatively flat surface of 19.65m OD.

The lowest deposit recorded was a yellow coarse sand containing occasional gravel patches. This represented the top of the natural River Terrace sand and gravels [3] as recorded by a previous geological survey. This deposit was recorded at 19.17m OD at the northwest end of the trench, rising slightly to 19.12m OD at the southeast end of the trench.

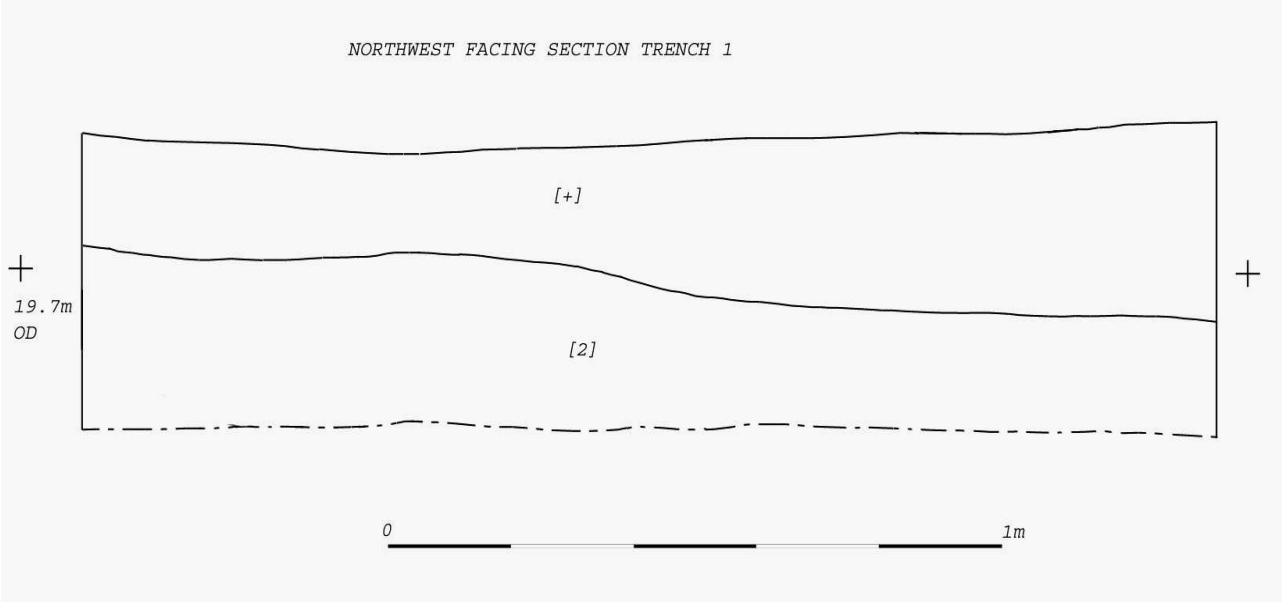
Fig 5 Part of the northwest facing section of Trench 1

The River Terrace sand was sealed – and presumably truncated – by a reworked silty subsoil [2] approximately 0.25m thick. This was a fairly clean deposit, with finds limited to occasional fragments of ceramic building material at the upper level, and probably represents the period when the land was open and in use for agricultural purposes.

The subsoil was sealed and apparently truncated by an overlying made ground layer [+] 0.20m thick consisting of a mixed sandy silt with frequent building rubble and other modern inclusions. This layer no doubt represents the development of the site for residential purposes in the late 19<sup>th</sup> century.

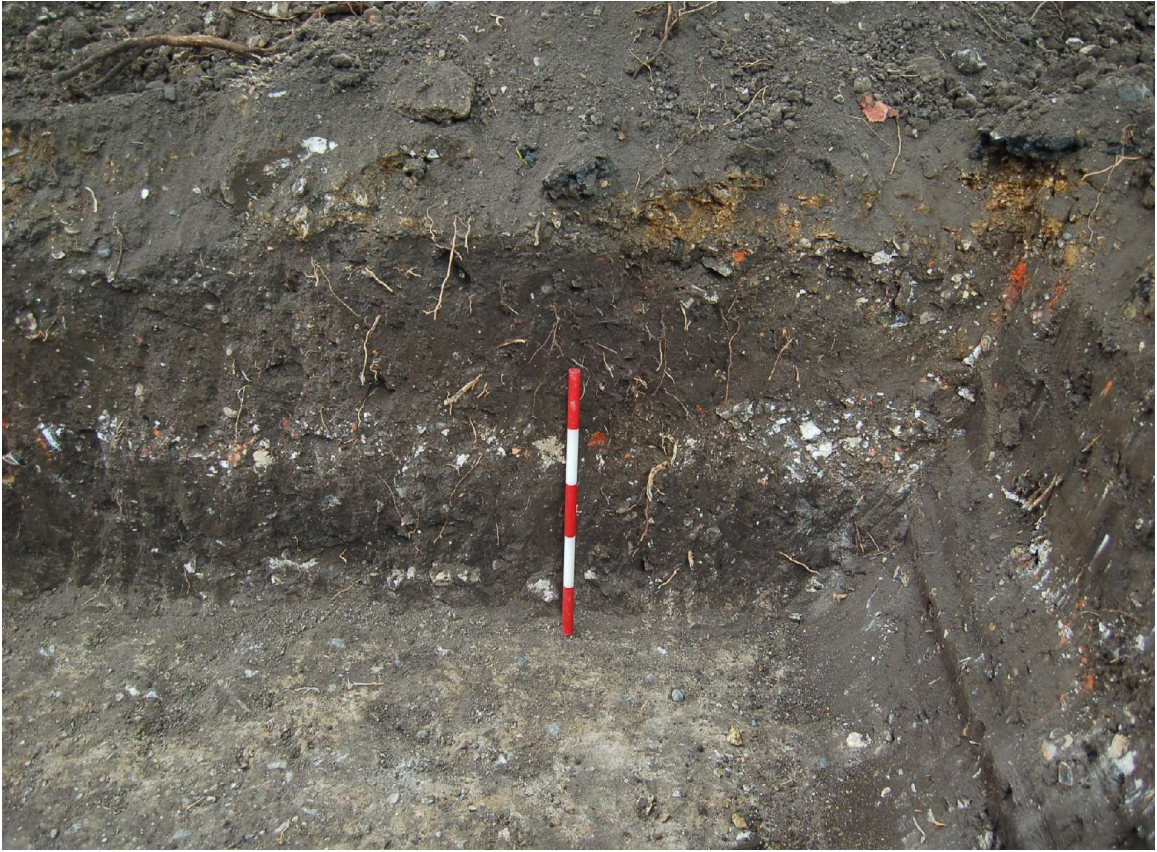
Fig 6 View of the deposits shown in Figure 5 (*0.5m scale*)

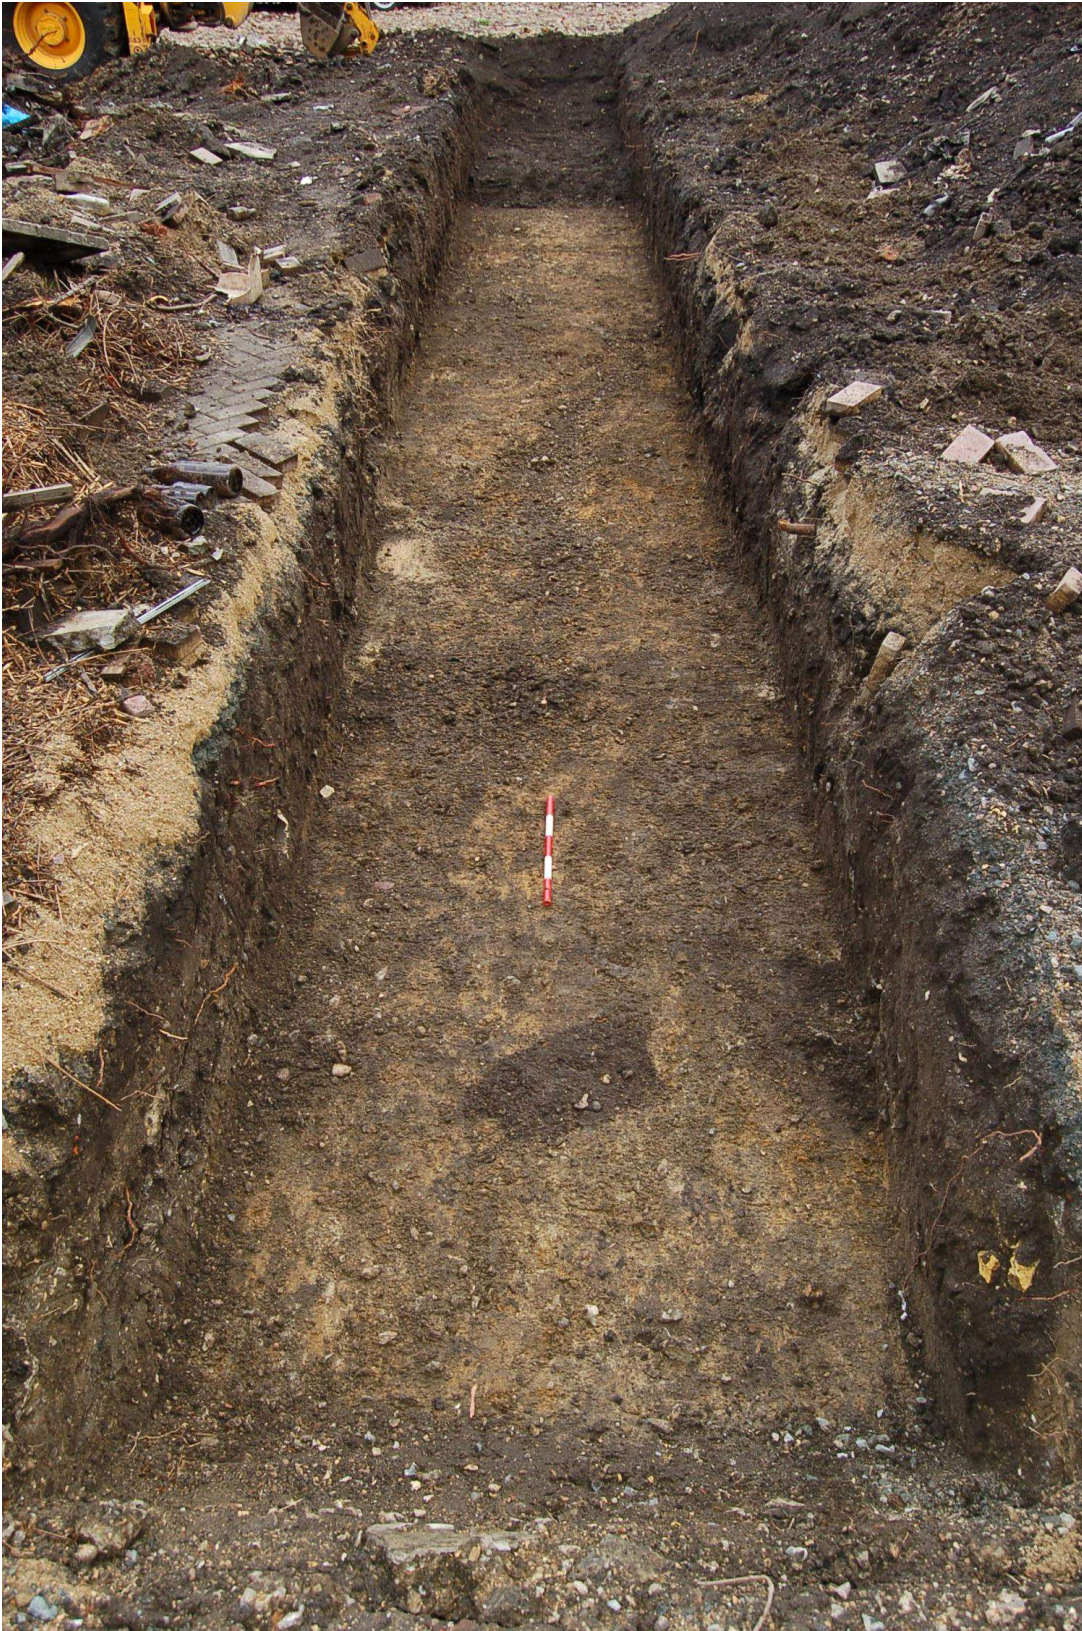
Fig 8 Evaluation trench 3, view looking southeast after surface cleaning (*0.5m scale*)

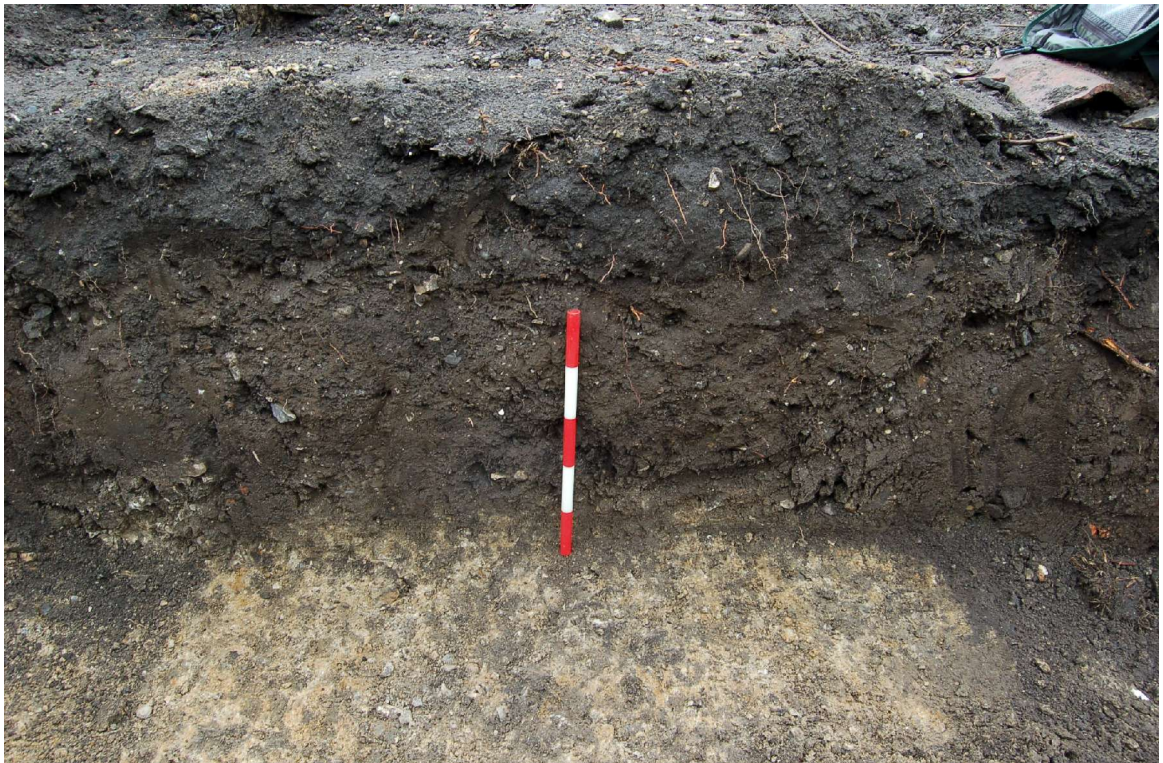
Fig 10 View of deposits shown as shown in Fig 9 (0.5m scale)

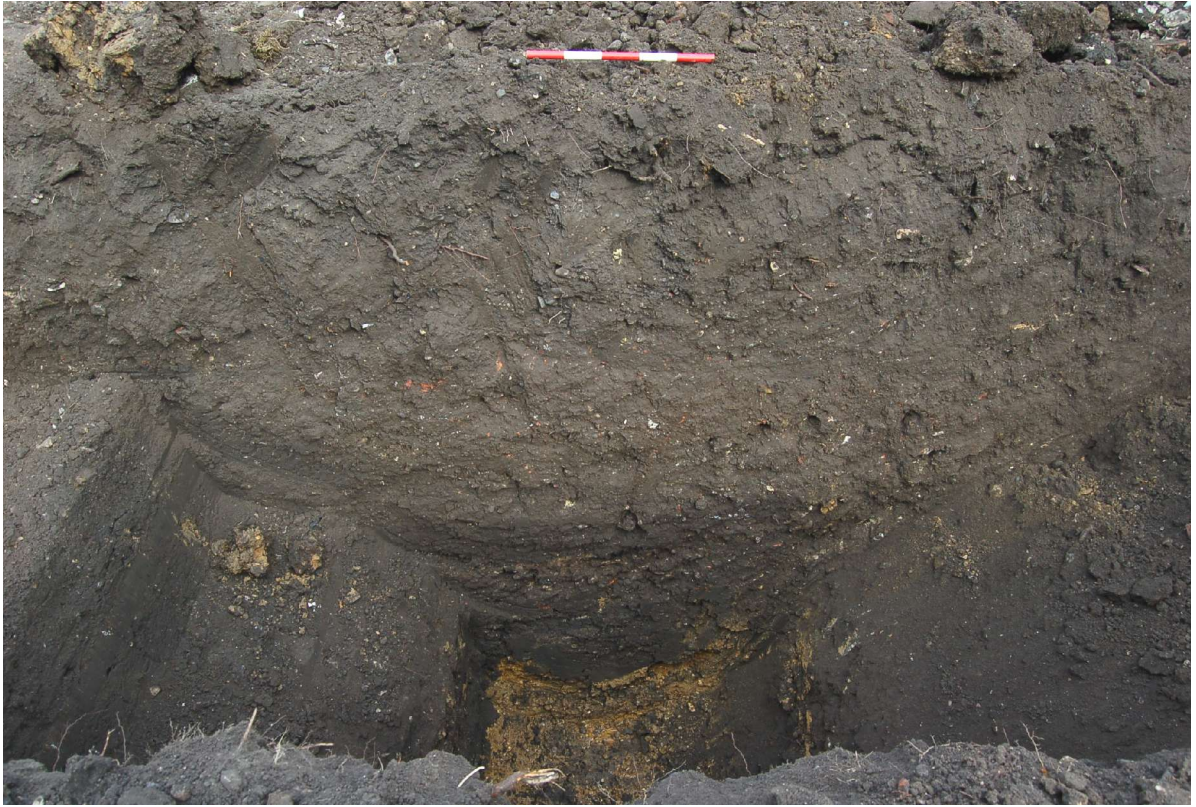
Fig 11 View of cross-section of post-medieval pit [43] as shown in plan in fig 7

The natural River Terrace sand and gravel was exposed at 19.04m OD at the west end of the trench, sloping slightly to 19.14m OD at the east. Cutting the natural at the east end of the trench was a deep pit feature [43]. The feature's western extremity is visible within the trench, but its northern, southern and eastern extremities go beyond the limit of excavation in this trench. In cross-section the cut was up to 5.5m wide, with sides that sloped in at *c* 70° to a generally flat base and a depth of 3.2m.

The feature contained a dark brown clayey silt fill with modern, probably 19<sup>th</sup> century, inclusions and finds such as unfrosted red and yellow stock bricks and many sherds of post-medieval pottery. This feature can be interpreted as a late post-medieval rubbish pit or as a gravel/sand extraction pit subsequently backfilled with rubbish and is not considered to be of archaeological significance.

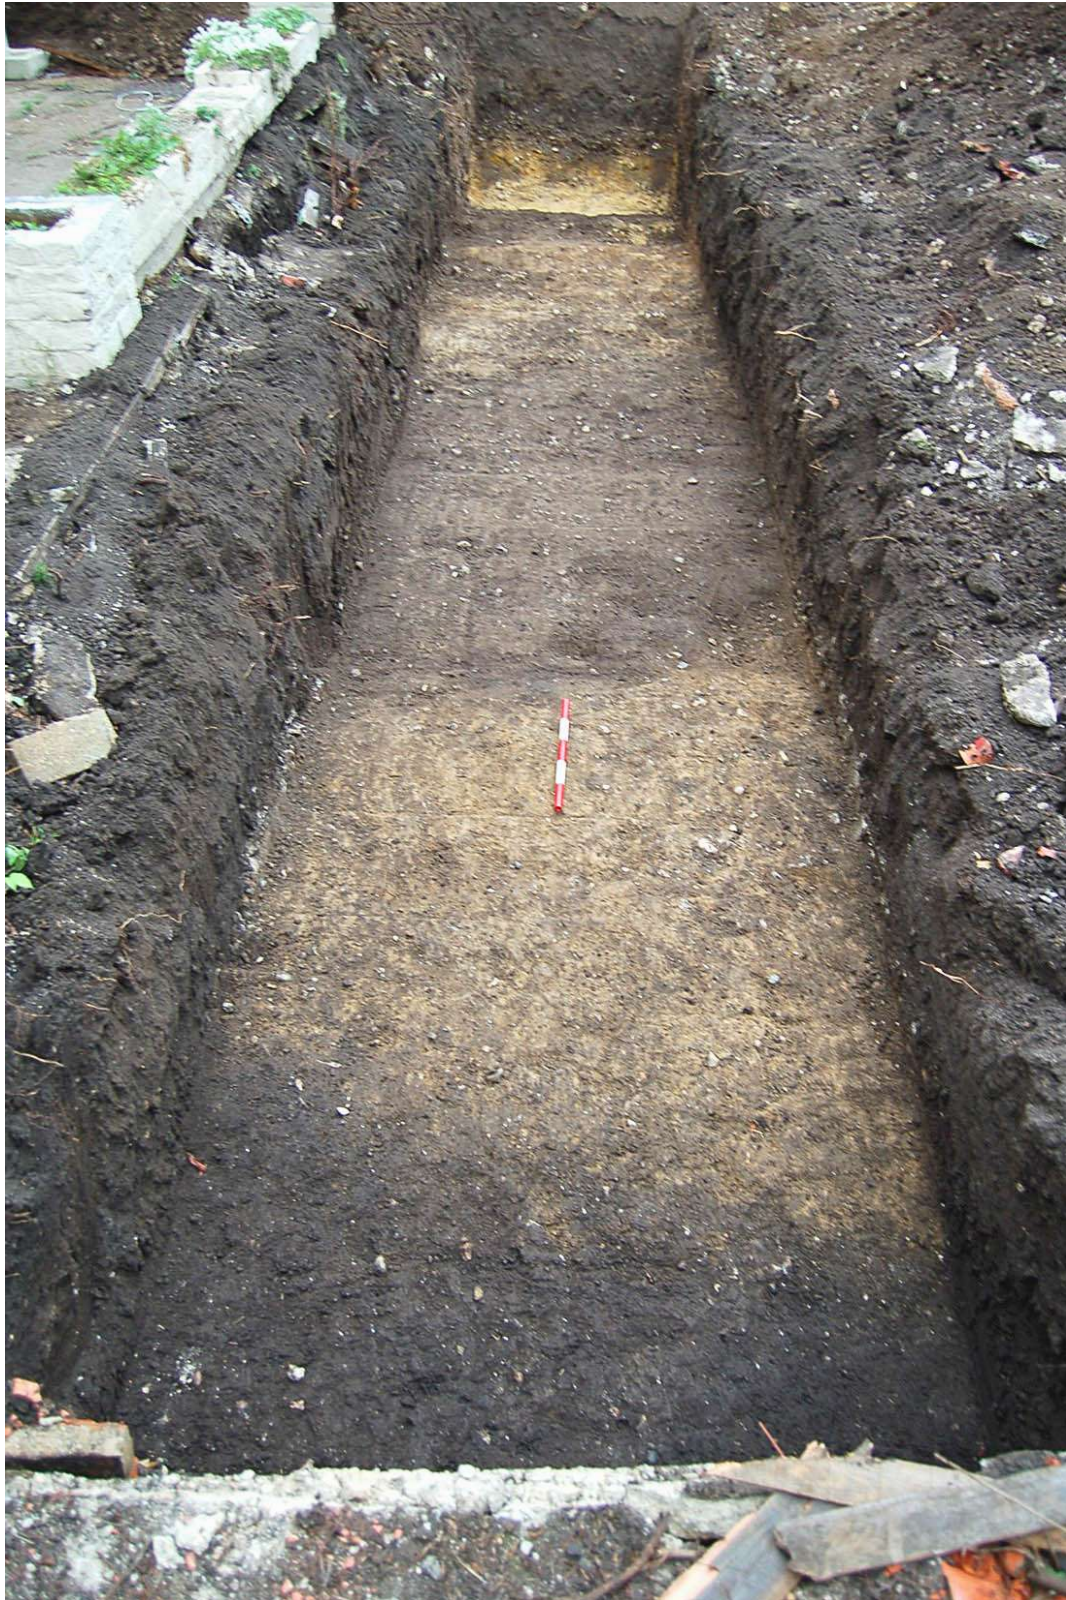
Fig 13 View of cut features in Evaluation Trench 2 as detailed in fig 12 (*0.5m scale*)

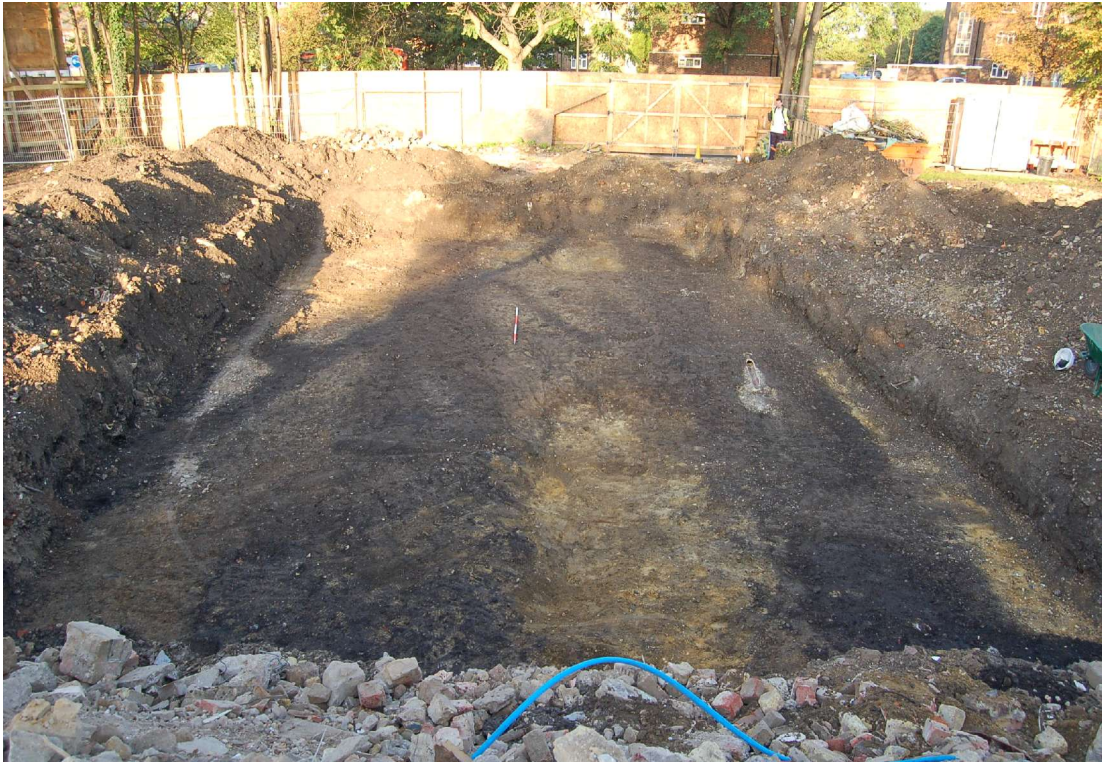
Fig 15 Pre-excavation view of features in the extended area of Trench 2

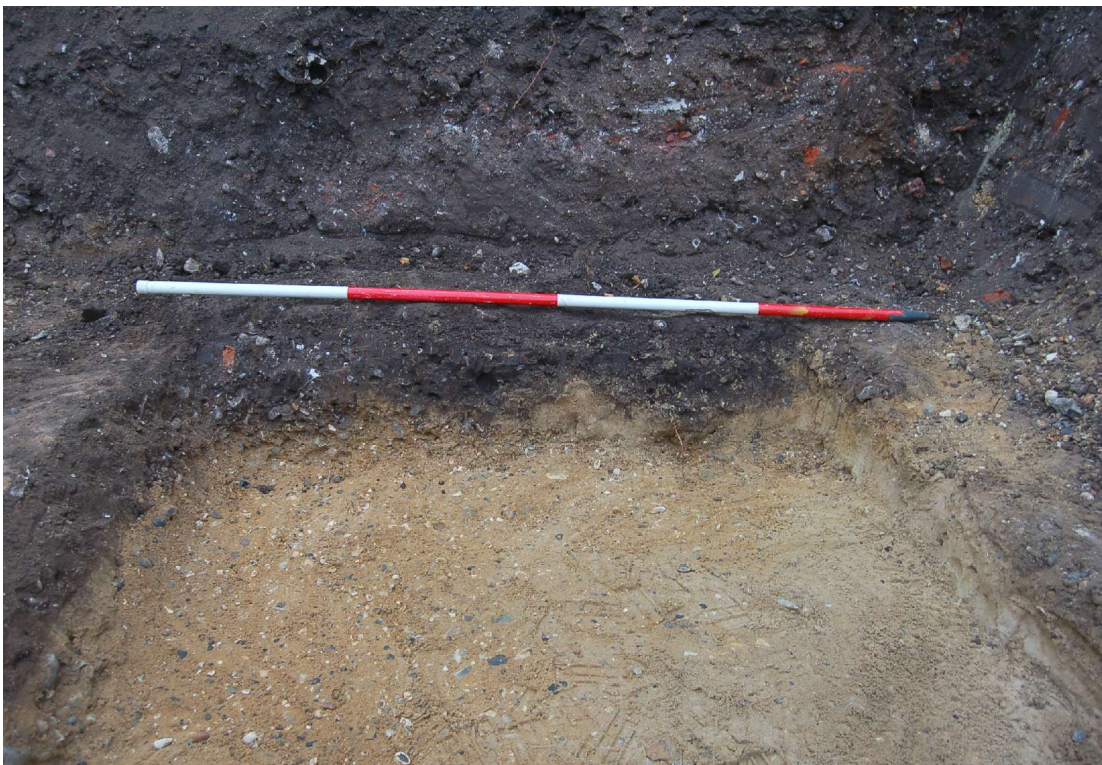
Fig 16 View of deposits in the northern ditch [5]

The northern ditch [5] was exposed cutting the natural River Terrace [3] deposit at c 18.94m OD and held fairly level across the length of the site. A total of four sections were excavated across the width of the ditch. Section 1 was dug at the northwest end of the trench (Fig 17). In the cross-section the cut was up to 1.4m wide by 0.38m deep with sided that sloped in at about 70° onto a fairly flat base. The base itself fell slightly to the southeast by some 0.20m from 18.62m OD in the northwest to 18.82m OD at the southeast end of the ditch. The ditch was filled by a compact dark brown sandy silt [4].

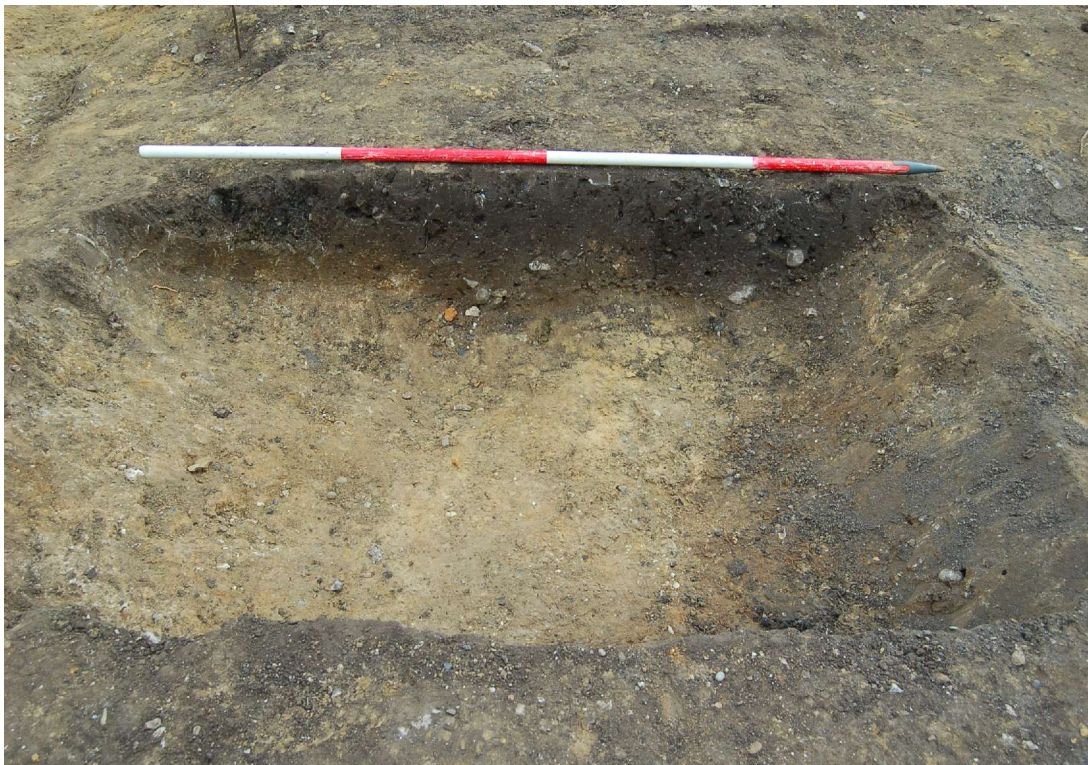
Fig 18 View of northwest facing section of southern ditch [16]

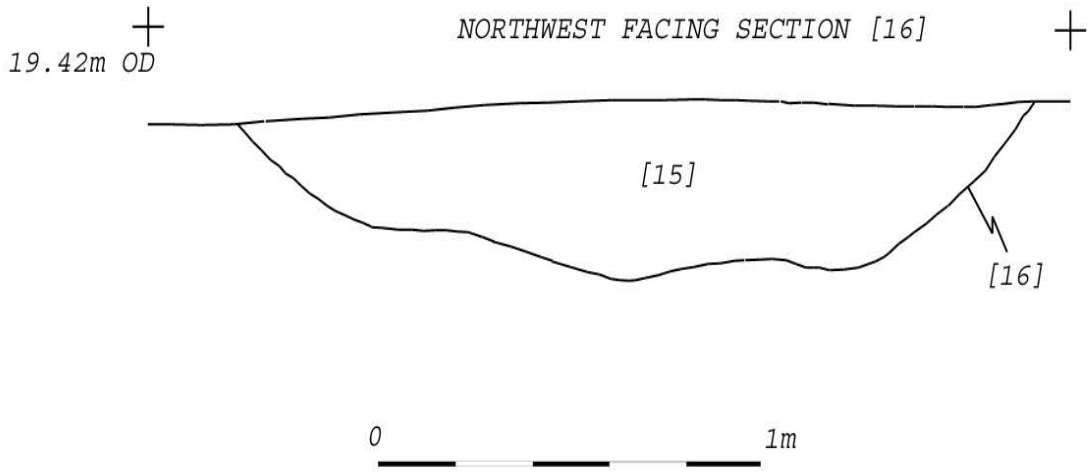
Fig 19 View of deposits in northwest facing ditch [16]

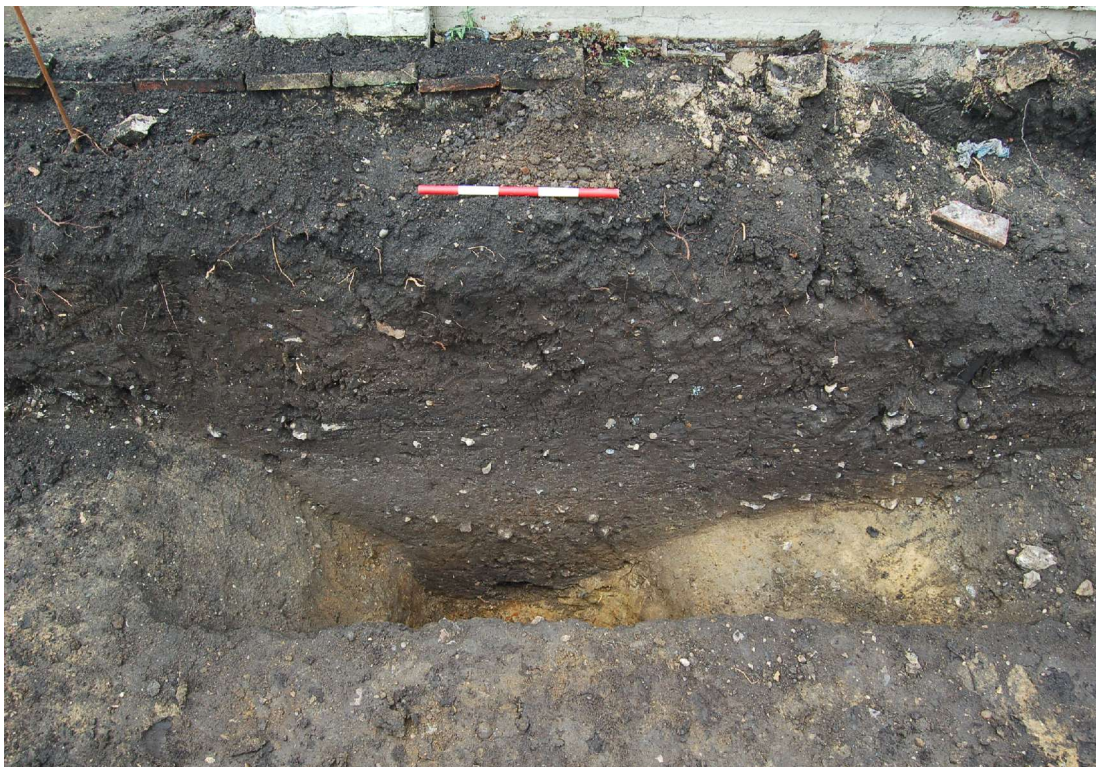
Fig 20 View of deposits in southern ditch [49]

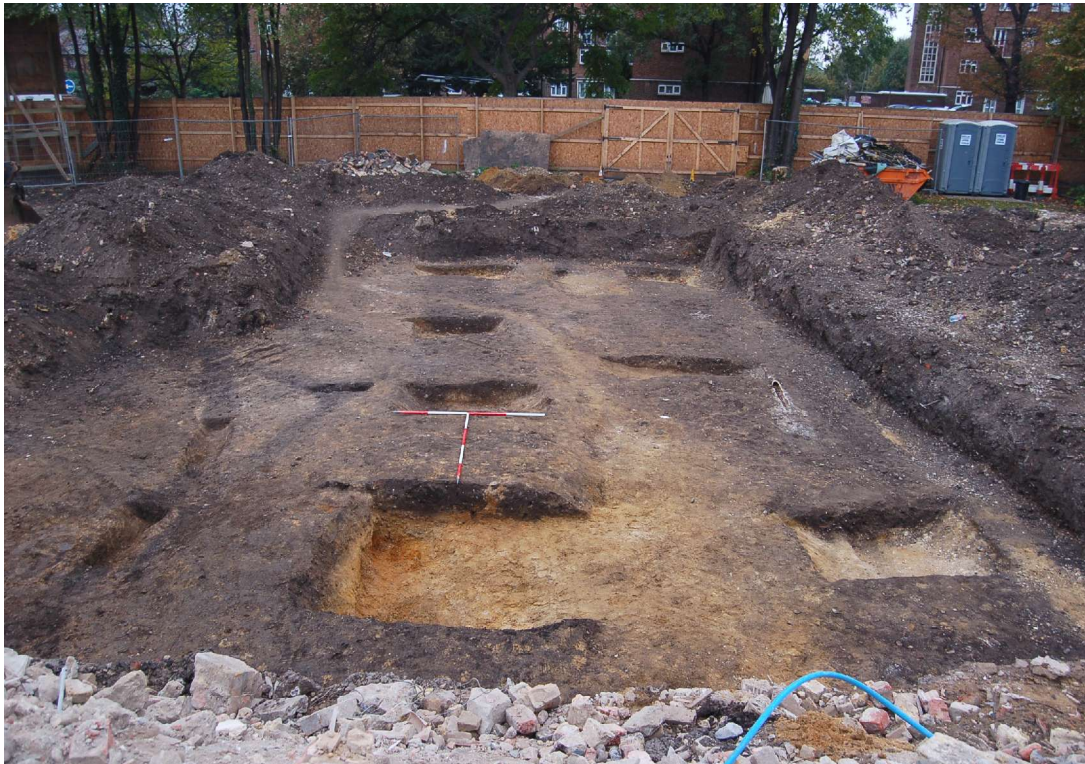
Fig 22 Post-excavation shot of Trench 2 looking northwest

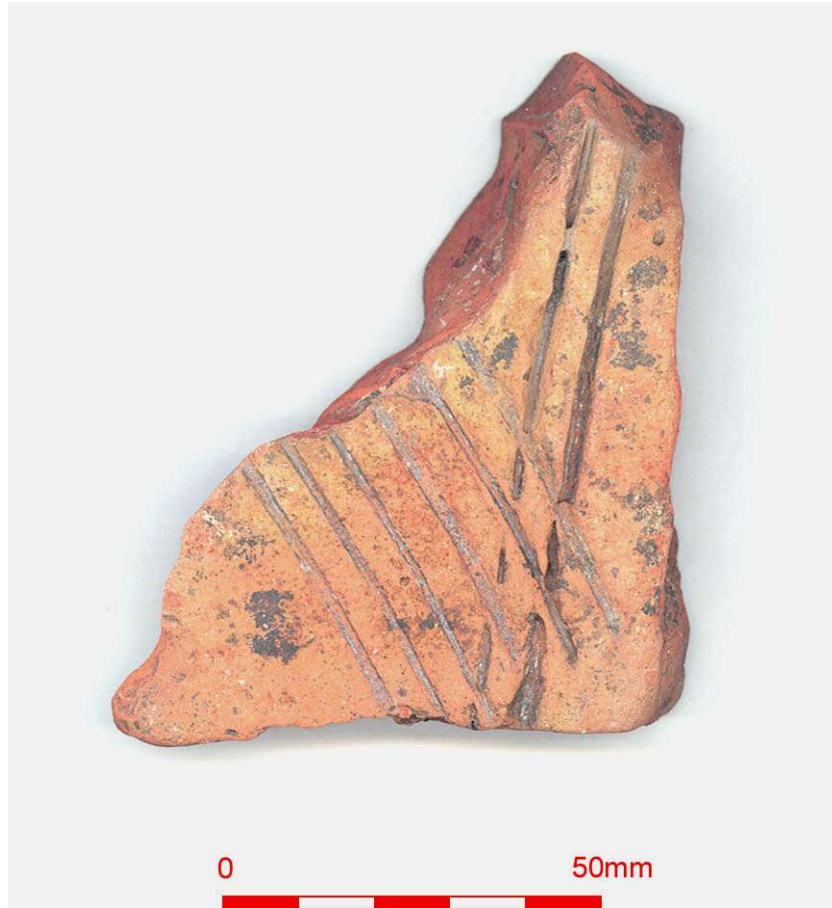
Fig 23 Fragment of Roman combed flue tile from context [21] (*see Appendix II*)

A single abraded fragment of Roman tile was recovered from the upper fill [21] of the large southern ditch [7]. This is assumed to be a residual find, as evidence suggests that the ditch was backfilled in the 13<sup>th</sup> century. There was no other evidence of Roman activity on the site. Roman remains have been found during excavations in the vicinity of the site, and the residual tile fragment backs up evidence for Roman activity in the immediate area.

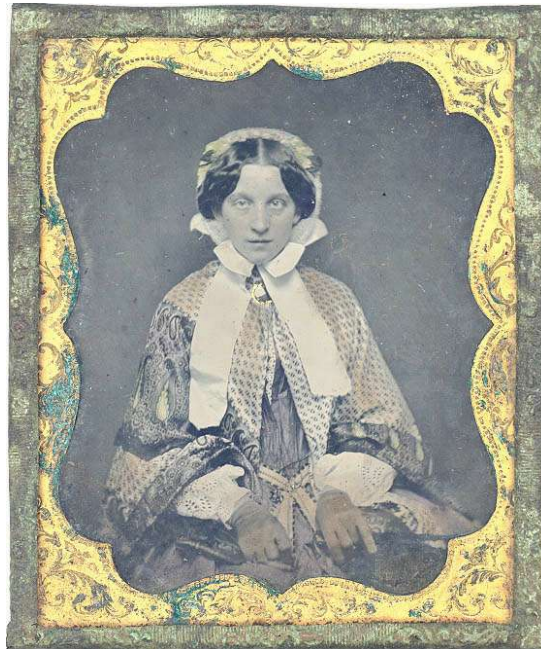
Fig 34 19<sup>th</sup> century photograph on glass and in a part-gilded brass frame <5>, found during metal detecting of the upper soil horizon [+]. Shown actual size (see *Appendix V*)

A small 19<sup>th</sup> century photograph on glass and with brass frame was found during metal detecting of the upper soil horizon [+] in evaluation Trench 3.

The photograph is of a young woman and stylistically probably dates to the 1860s. It appears to be a collodion positive on glass (otherwise known as an ambrotype), which was developed from the wet collodion process *c* 1852 and widely used thereafter for portrait photography in preference to the daguerreotype. The image was basically a negative but appeared positive against a black background; this was most commonly applied (as here) as varnish to the back of the plate.

Overall the photograph measures 71mm by 84mm by up to 5mm thick, and comprises the glass plate, a plain glass protective cover, a gilt brass decorative surround held between these and the brass frame. There is no evidence for a support or stand, and the photograph was probably originally contained in a leather case.
