DROP SHAFT FOR SOUTHAMPTON BUILDINGS HIGHWAY IMPROVEMENT SCHEME, CITY OF LONDON WC2A

An Archaeological Watching Brief

Abstract

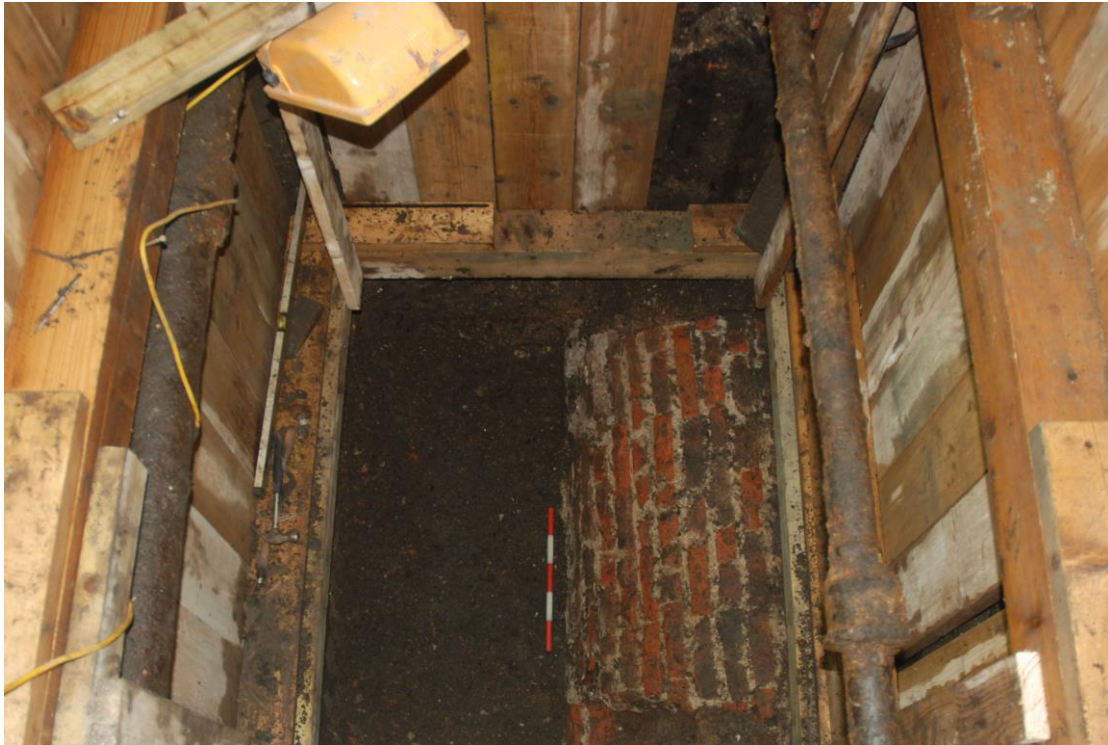
Fig.12: View of brick drain from top of drop shaft facing NE, with 0.5m scale. Most of the exposed extent of the brick drain running NE-SW can be seen, as well as the upper dark fill of context (3) to the north of the drain (left of image).

The shaft was located at the south-eastern end of Southampton Buildings (see fig.2). It measured 1.88m NW-SE and 2.15m NE-SW, and was investigated on the 21st of October 2015 at a level of 17.43m OD at the north-eastern end. On the 22nd of October it was investigated to the level of 16.17m OD (eastern side) and on the 23rd of October to the level 15.17m OD.

- 6.2** This brick drain, first excavated on the 21st of October, was exposed at a length of 1.56m running NE-SW, 0.55m deep at its NE end and 0.52m deep at its SW end.

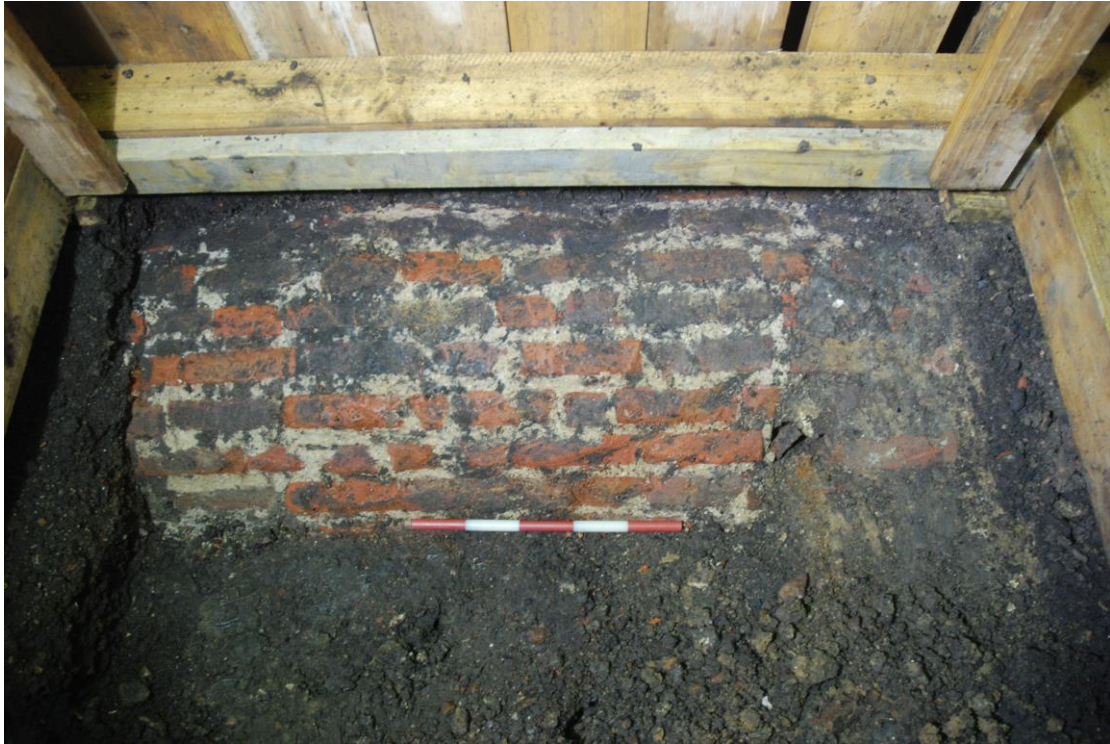
Fig.13: View of exposed drain, facing SE with 0.5m scale. The south-western extent of the drain appears to have been remade (right of image).

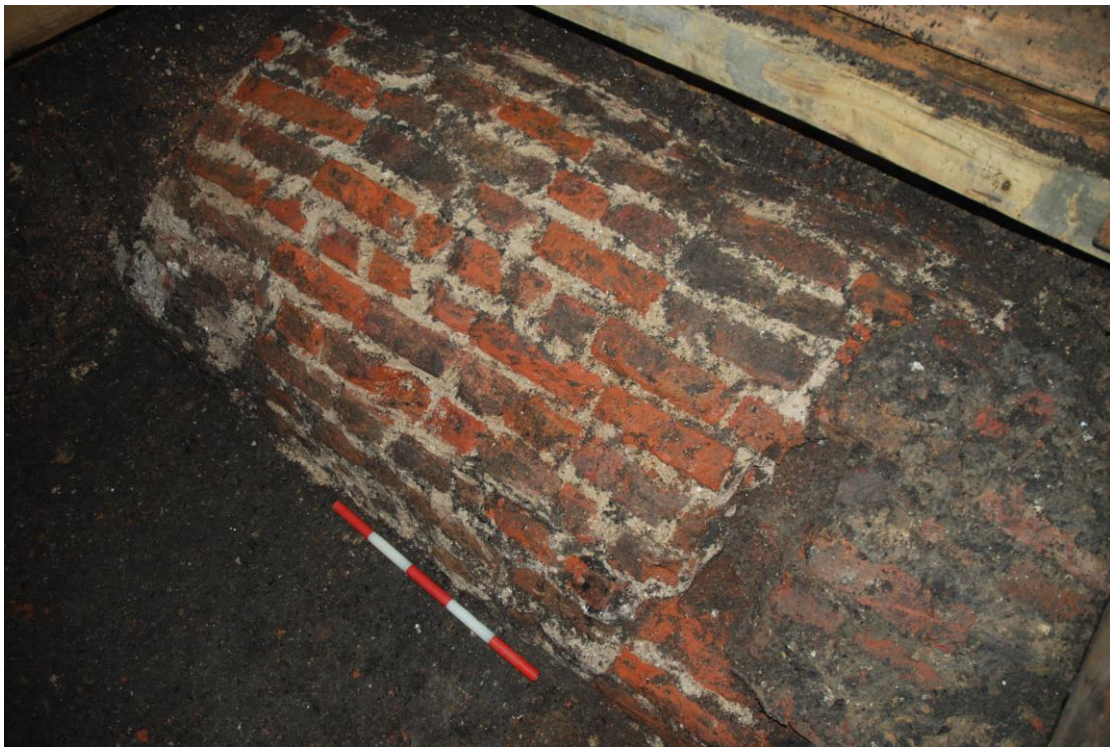
Fig.14: Oblique view of brick drain exposed after further digging, facing E with 0.5m scale, including disturbed area to the south-west (right of image)

It appears that a portion of the drain at its south-western extent was potentially disturbed at some stage, as the bricks are not arranged in the same standardised form as they appear on the rest of the drain, as can be seen from fig. 14. The width across the exposed disturbed area was 0.53m, and it started 0.3m from the SE limit of excavation and extended to 0.49m below the top of the drain.

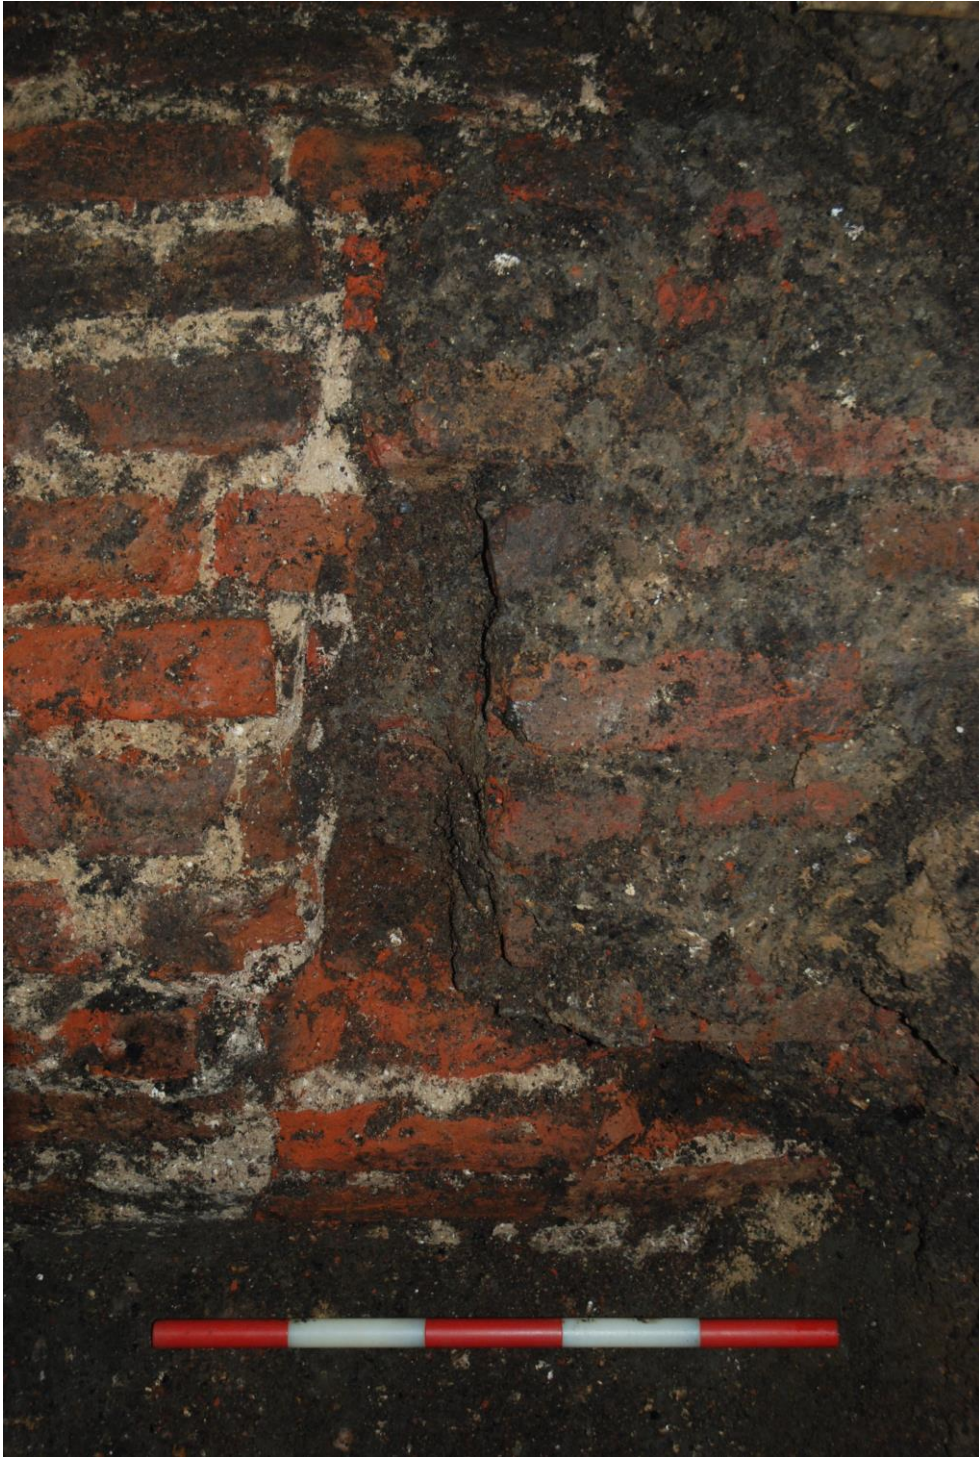
Fig.15: Detail of brick drain 'disturbed' at its south-western extent, facing SE with 0.5m scale.

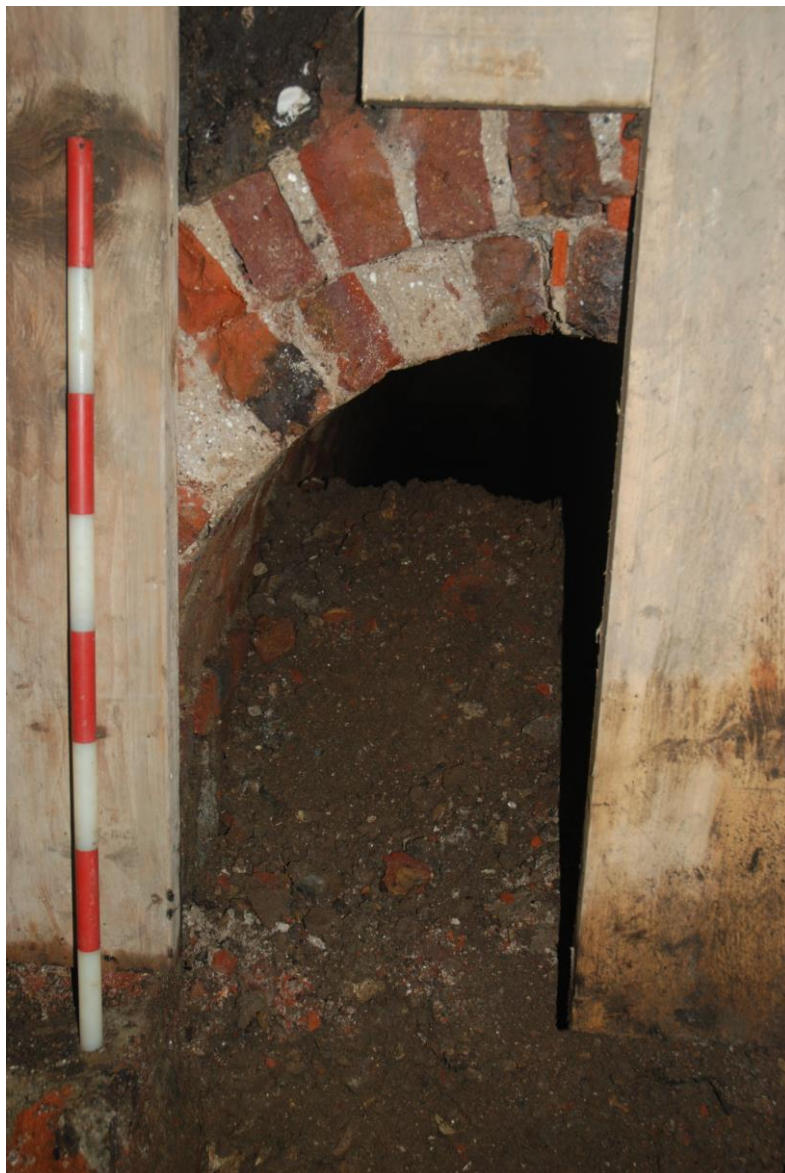
By the 22nd of October 2015, a section through the drain itself had been exposed. In particular, the brick arch of the NE extent of the exposed drain could be clearly seen (see fig. 16 below). The brick ring itself measured c.0.23m across at the top, and roughly 0.1m at the bottom where there was only one brick course. In addition, the internal drain height was 1.51m. The width across the internal drain was 0.76m at its NE exposed extent and 0.77m at its SW exposed extent.

In figs.16 and 17 context (2) can be seen which reaches a depth of roughly 1.3m in the interior of the drain at the NE end. Some of this fill, especially at the SW end, may represent some kind of backfill which occurred when a portion of the SW end of the drain was disturbed.

Fig. 16: Detail of brick arch of the NE extent of the exposed drain facing NE with 0.8m scale

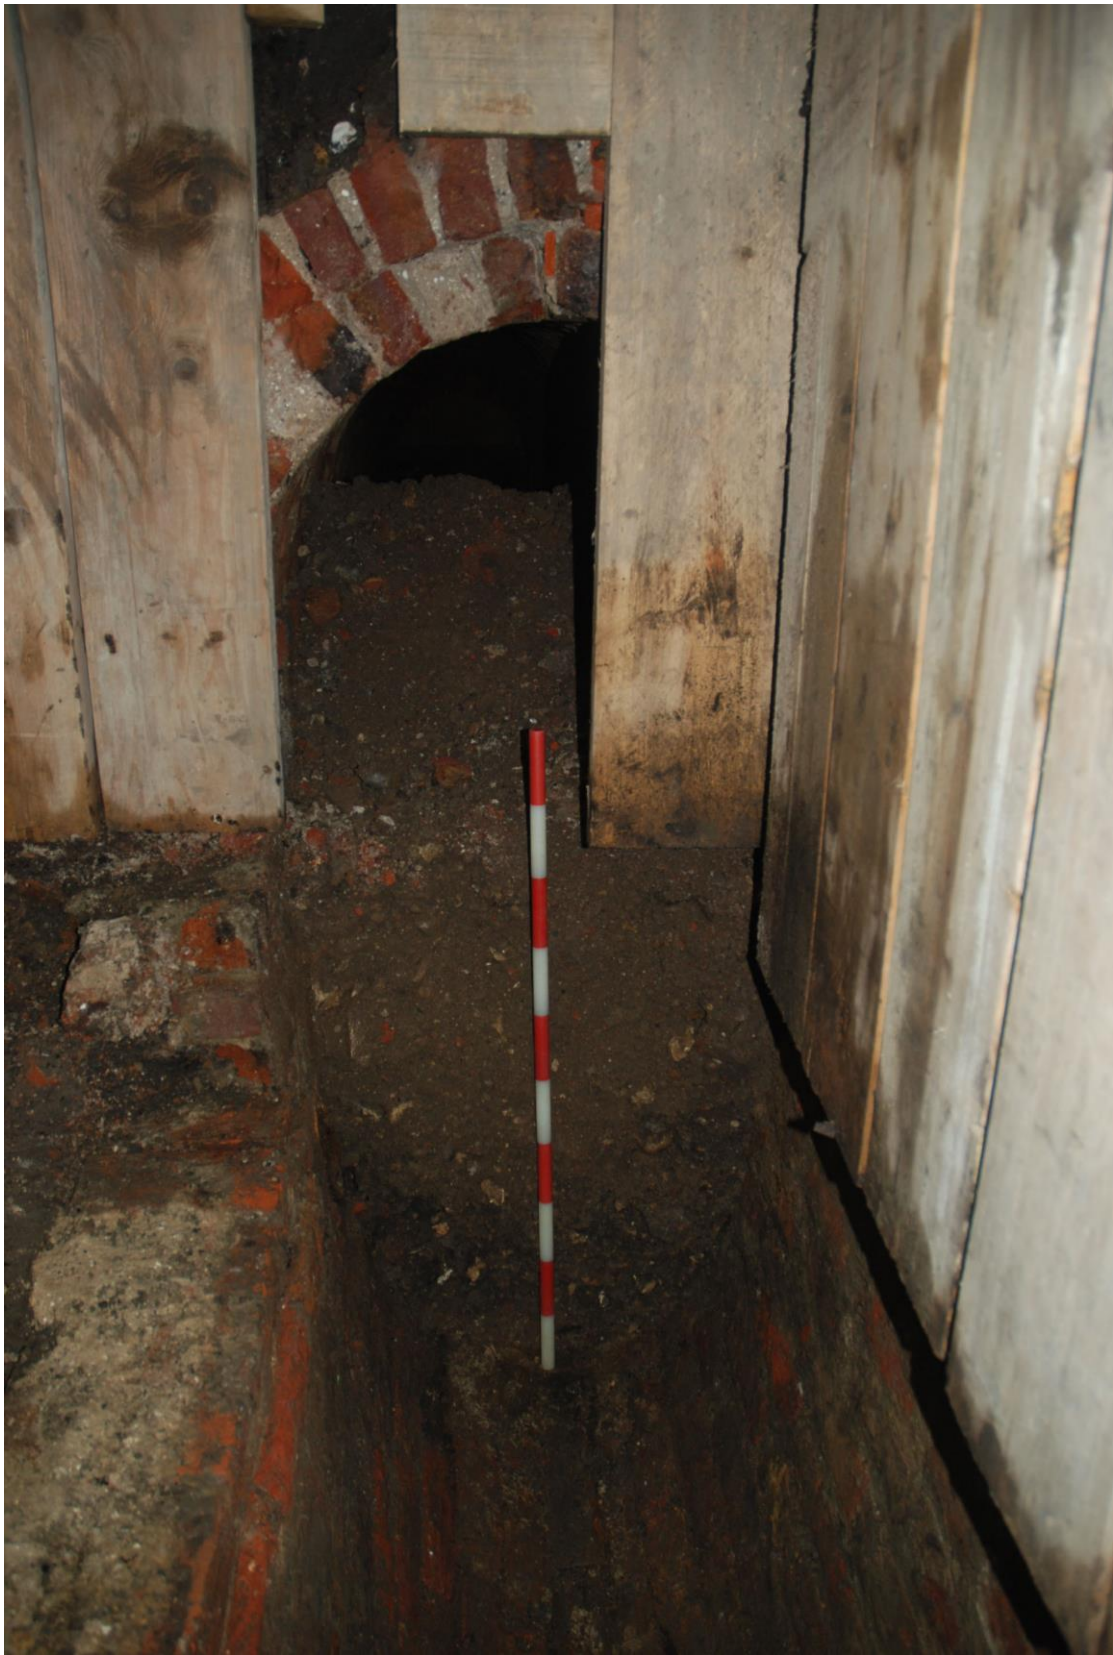
Fig.17: View of brick arch of the NE extent of the exposed drain, and the NW side of the drain (left of image)which measures 0.23m wide, facing NE with 1m scale

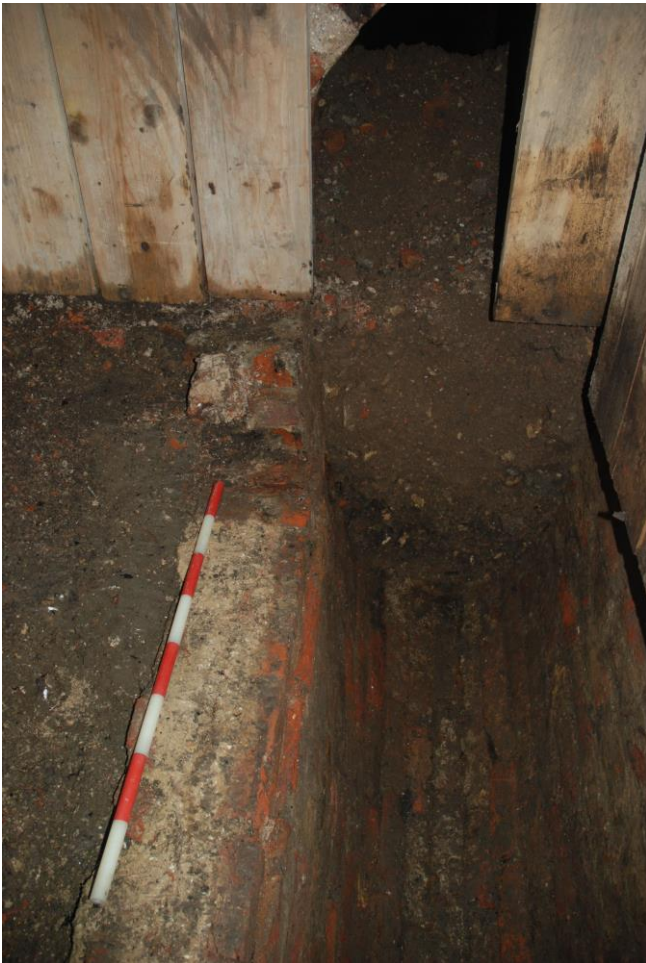
Fig.18: Further view of brick drain arch and side, facing NE with 0.8m scale

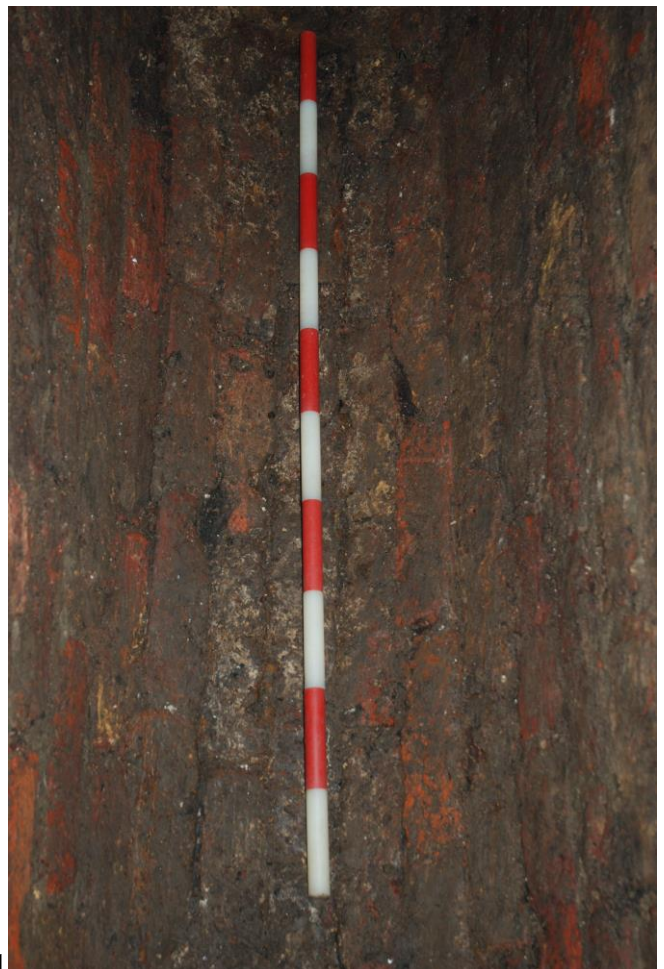
Fig.19: Detail of brick drain bottom, NE at top of frame with 1m scale

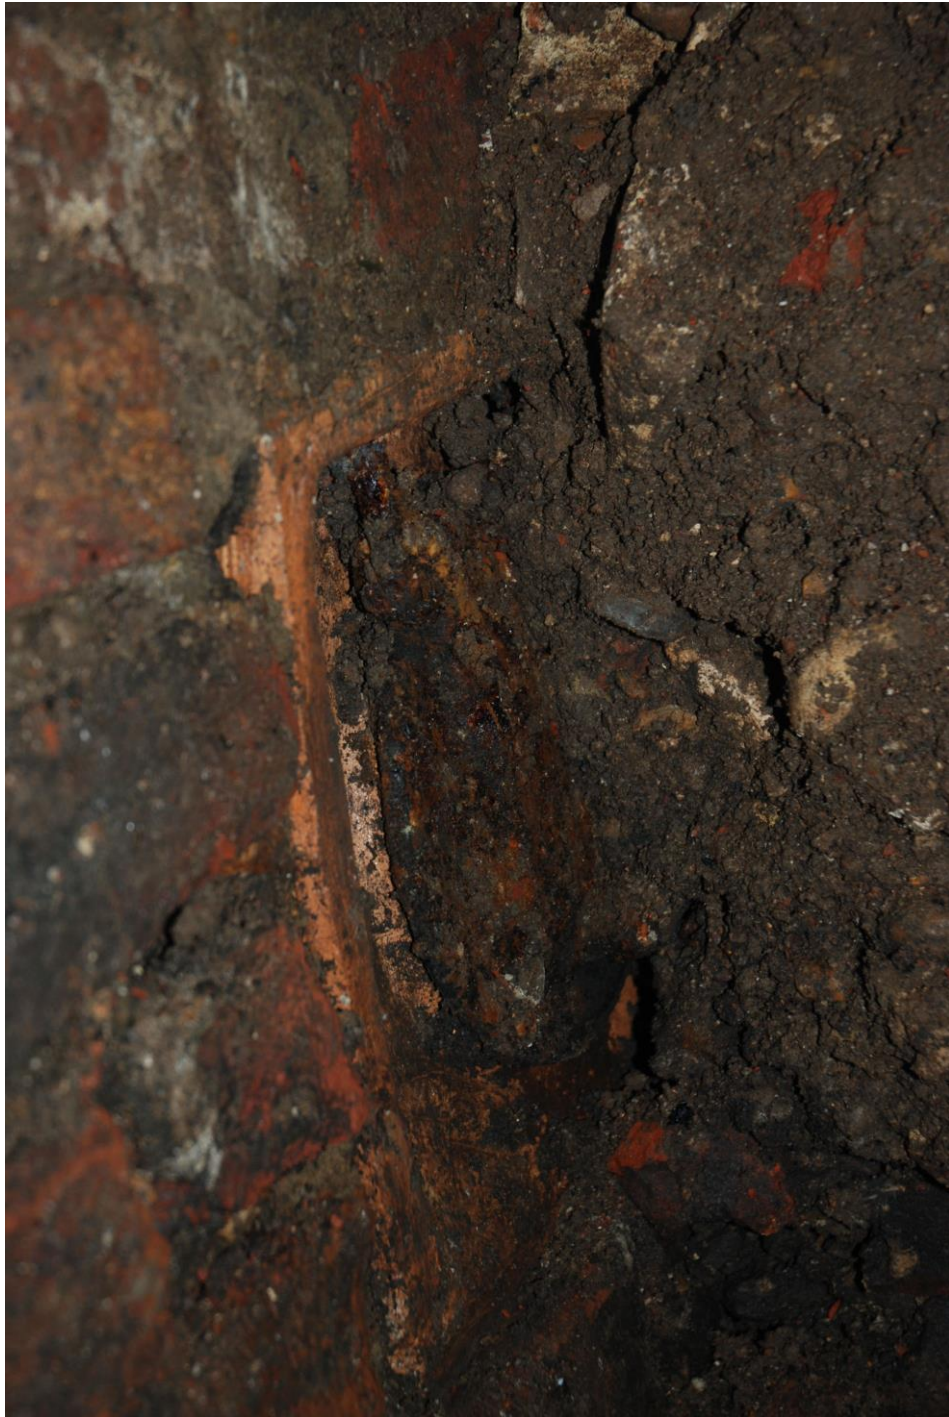
Fig.20: Detail of ceramic square drain inlet in the side of brick drain, facing N and partially exposed in section

In the north-western side of the brick drain, evidence for a smaller connecting drain with a ceramic lining was found near the north-eastern extent of excavation. The drain surround itself, seen above in fig. 20, was 0.26m wide and 0.28m high. This appeared to contain a smaller circular pipe with a metal cover at the revealed end. Its form and material is indicative of a date contemporary with the brick drain. A hinge can be seen in the above image which would have allowed the drain cover to open and close according to pressure on either side.

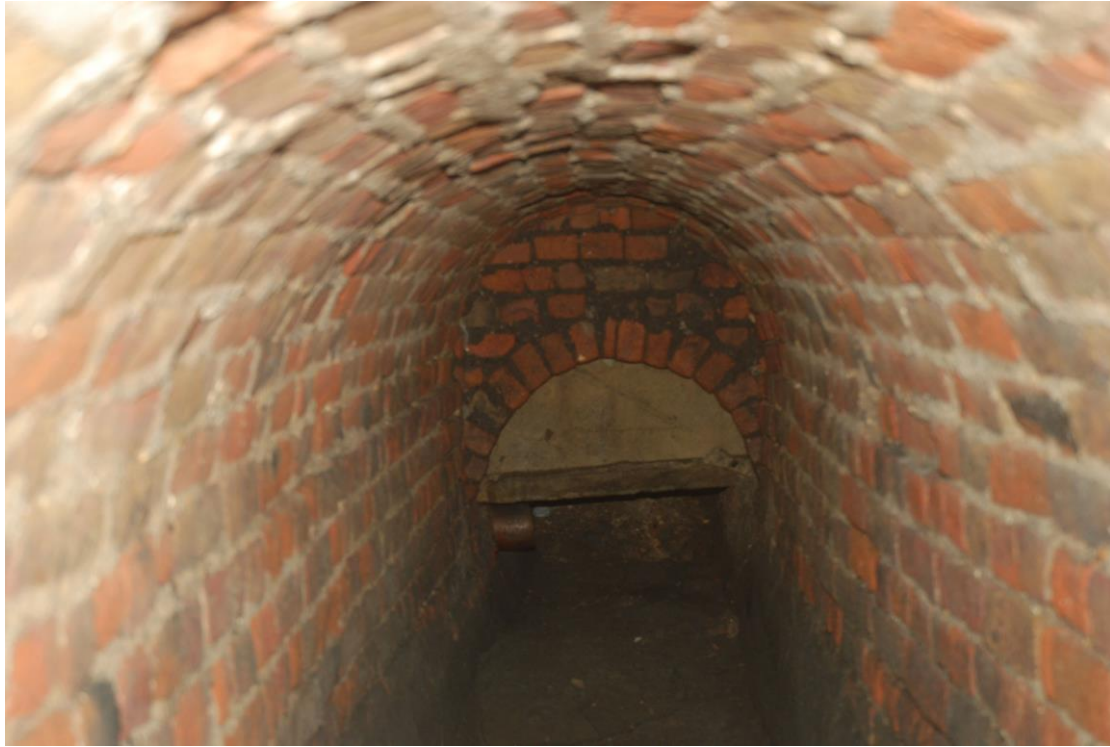
Fig.21: View of the absolute extent of the NE end of the drain beyond the limit of excavation, facing NE

Figure 21 shows that the drain may have gone through several stages of alteration. The view of the drain beyond the limit of the drop shaft excavation at the SE end shows that it might abut a wall running NNW-SSE. The existence of a lower arch in this wall could suggest that the drain within the area of excavation may represent an enlargement of drain facilities. A lintel is also present which may have been an attempt to secure the structural integrity of the smaller arch. Another drain in the NW wall can also be seen, although this seems to be of a different form than that seen in fig.20.

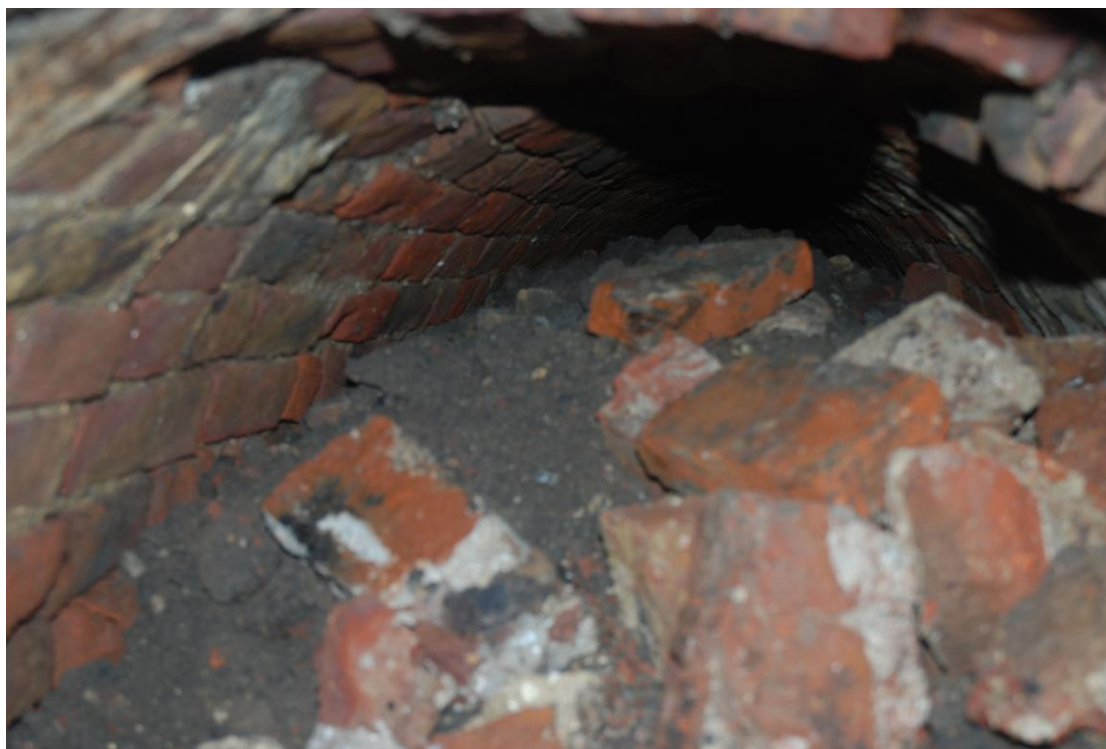
Fig.22: View of the absolute extent of the SW end of the drain beyond the limit of excavation, obscured by debris, facing SW. The NE end of the drain was chosen as the representative section of the drain for all photos as it was less obscured

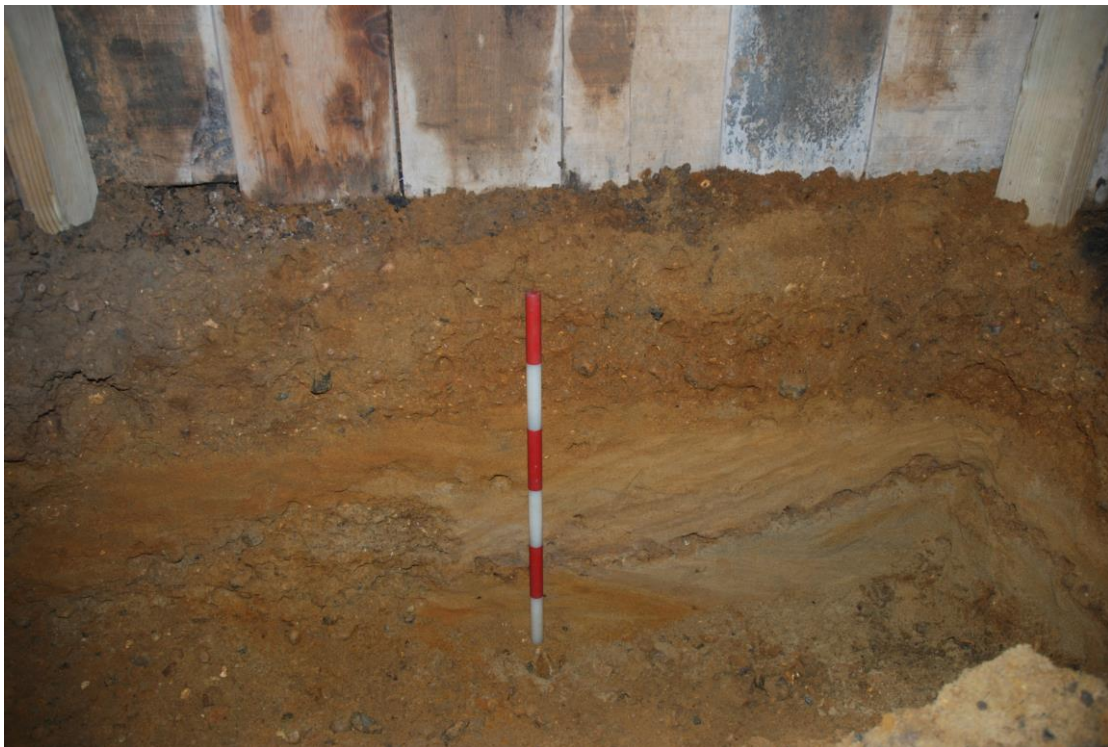
On the 23rd of October, the lower dark fill of context (4) appearing below the base of the drain had been revealed, and this reached to 0.5m below the base of the brick drain in the eastern corner of the SE section of the shaft, but dipping down to c.0.7m towards the SW (see fig.24) and at only c.0.3m below the base of the drain in the NE section. Below this, the silty orangey-yellow natural sand of context (6) can be seen. In the NW section of the shaft, context (4) dives down to a depth of 1m below the level of the base of the drain (see fig.25 below). This fill contained some pottery, CBM and animal bone fragments. Both this deposit (4) and the overlying (3) appear to be fills within a large cut feature, extending in all directions beyond the limits of the dropshaft and dug into the natural sand. This is most likely to be a quarry pit, of which there are a number of post-medieval examples in the area. In this particular case the finds indicate that backfilling took place in the early 18th century, although there was also some earlier residual material.

Fig. 23: View of NE section of the bottom of the shaft, facing NE. The orangey-yellow natural can clearly be seen, as well as some of the darker fill above.

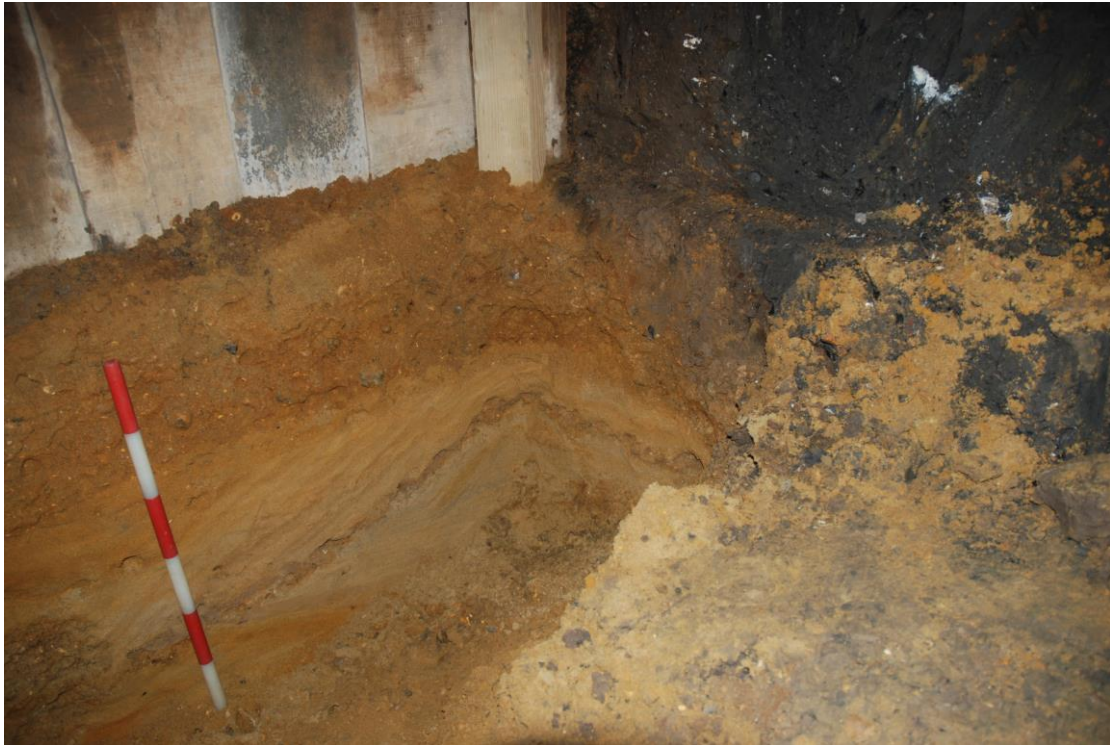
Fig.24: Oblique view of bottom of shaft, with the dark fill (4) in the SE section visible (upper right-hand corner of image), facing E with 0.6m scale

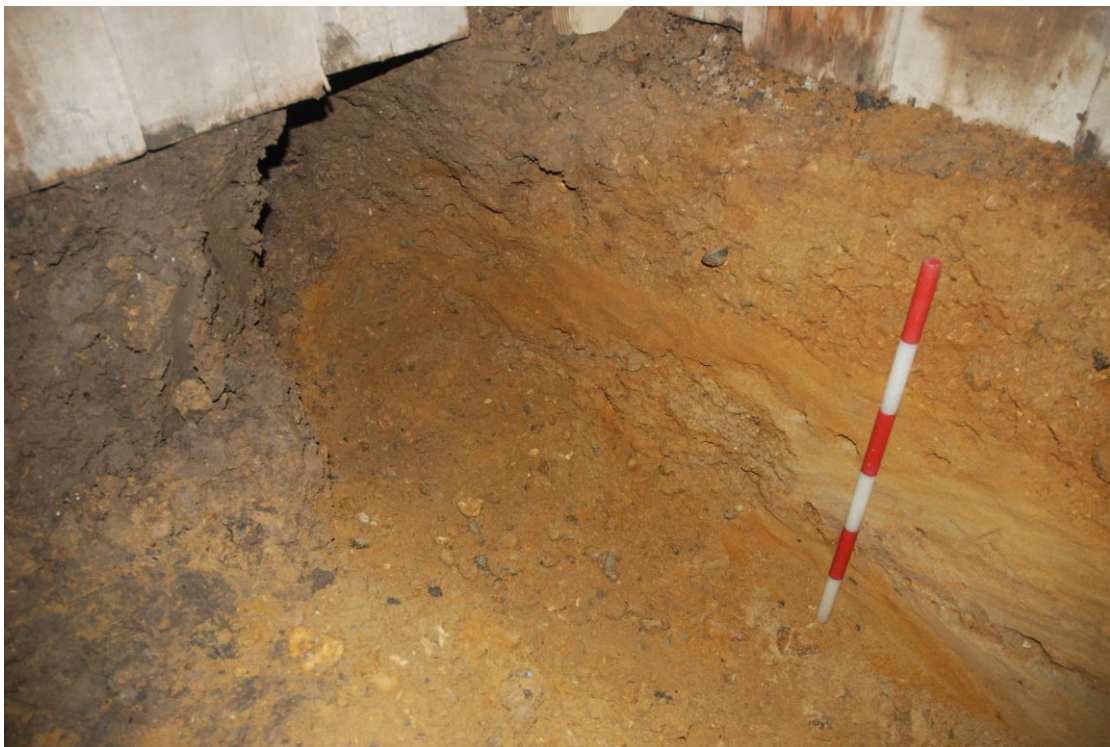
Fig.25: Oblique view of the bottom of the shaft, with the dark fill (4) diving down to the NW visible (upper left of image), facing N with 0.6m scale

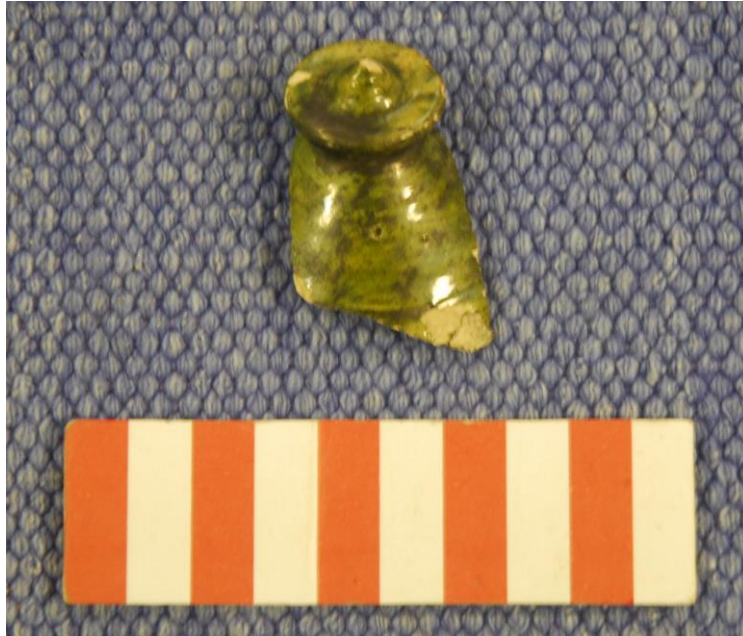
Fig.26: A fragment of green-glazed border ware from context (4), dating to the period 1550-1700

All the pottery occurred in context 3, other than a single sherd of BORDG (14g) (*fig.26*) in the form of a knob from a lid and another of MG (2g), both of which occurred in context 4, suggesting a date of the mid-late 16th century from the former.

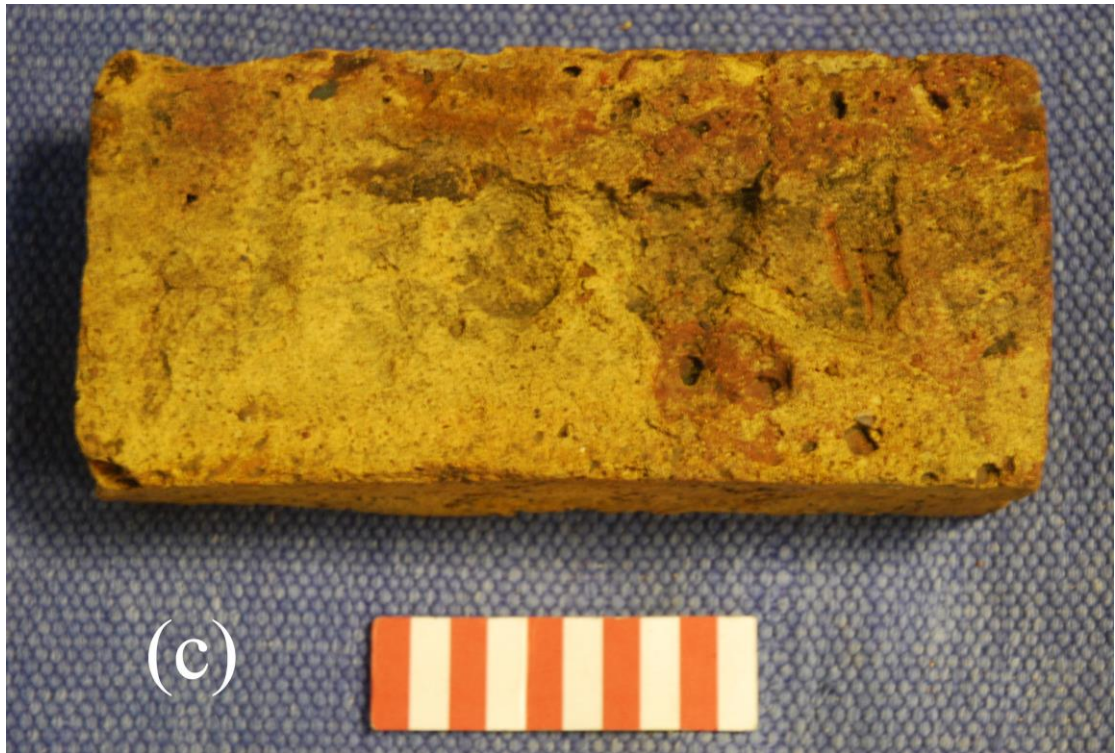
Fig. 30: Brick sample C

Brick C has a frogged base with an illegible stamp. It appears to be in a local post-fire red fabric with calcareous lenses and yellow skin, fabric 3034, which has a date range of c. 1666 to 1900. The presence of a frog indicates a date after c.1750, probably between c. 1750 and 1850.
