# **A SERIES OF ARCHAEOLOGICAL WATCHING BRIEFS AT ELTHAM PALACE**

**LONDON BOROUGH OF GREENWICH, SE9 5QE**

**NOVEMBER 2015**

SITE CODE: ELT13

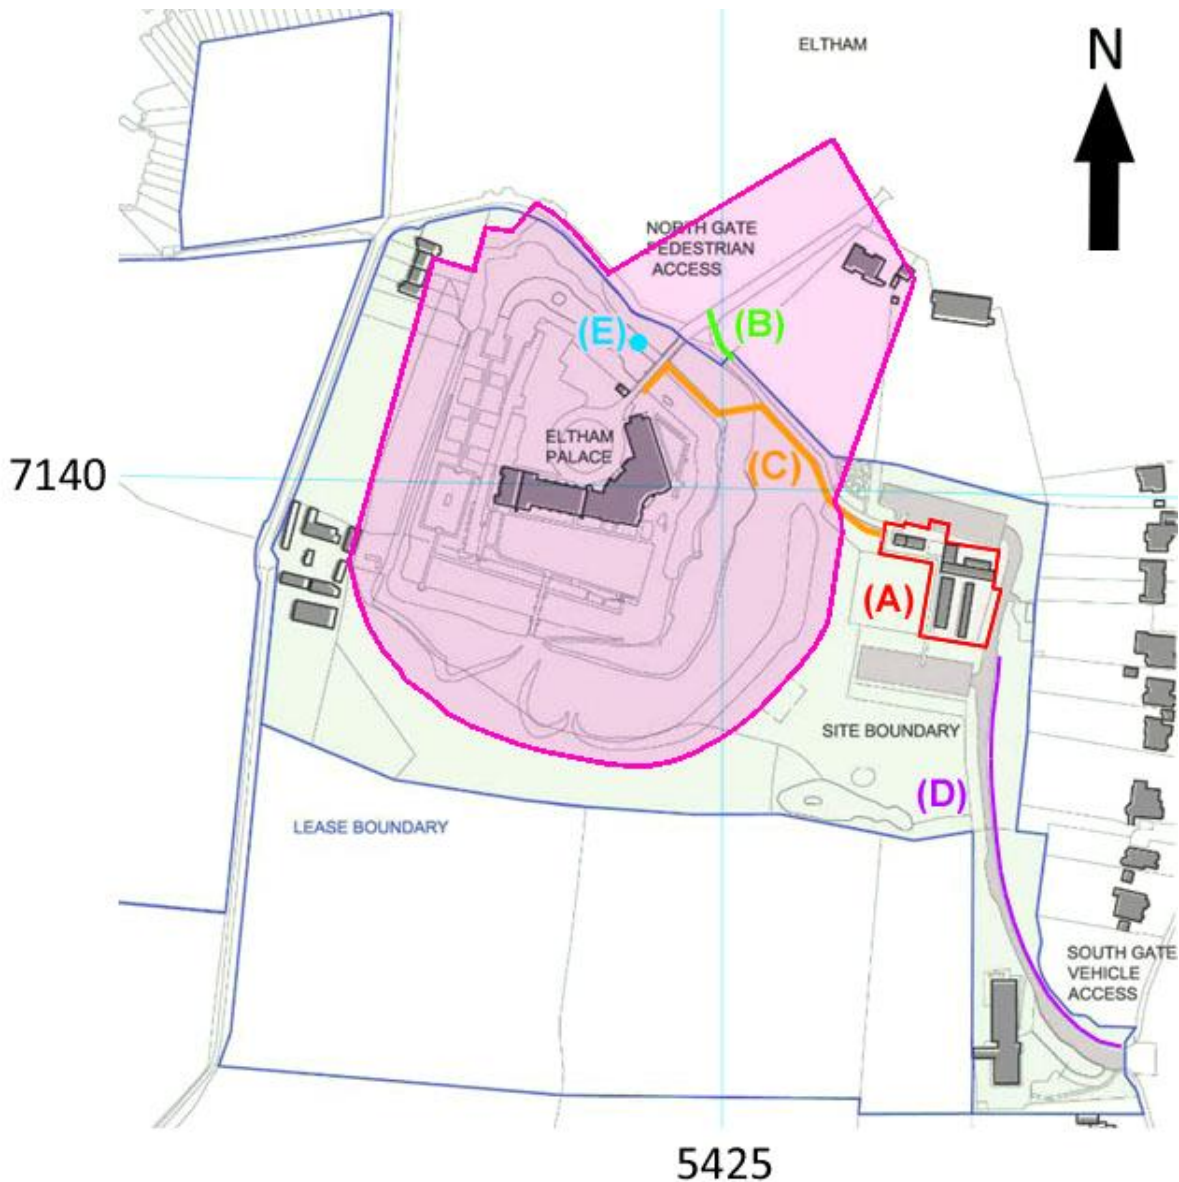
Fig.2: Plan showing the approximate locations of the various watching briefs. A = New Visitor's Centre; B = Gas connection works; C = I.T. cable trenching; D = New access path; E = Water pipe repair works. The pink shaded area represents the area of the Scheduled Ancient Monument

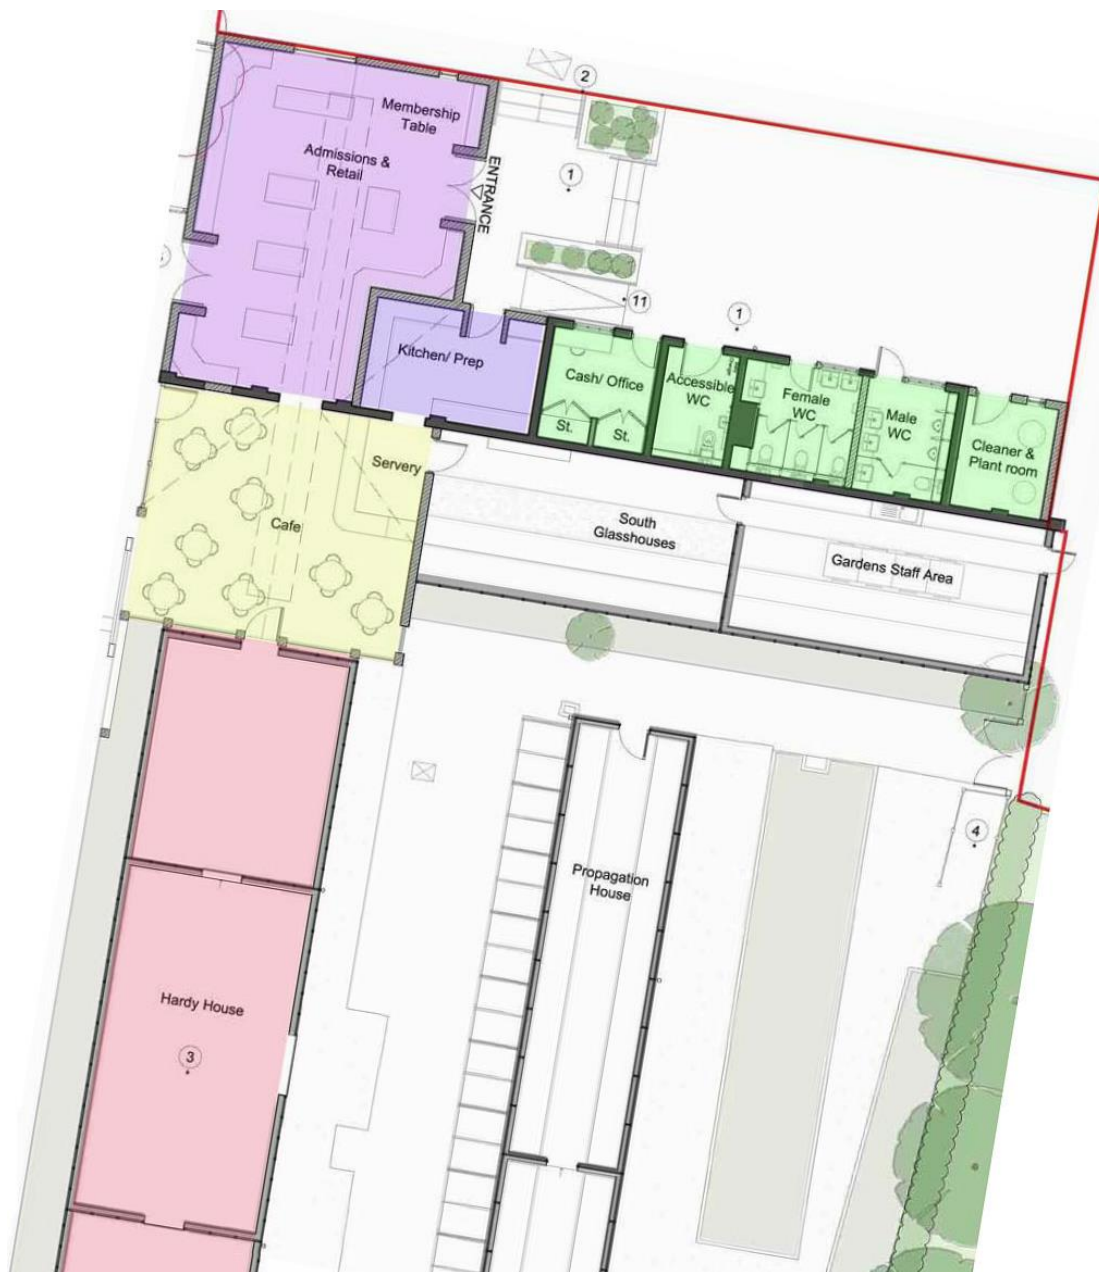
Fig.4: Simplified ground floor plan of the new Visitor Centre (from Simpson & Brown Architects 2014, Fig 7)

**6.2.1** Development of the new Visitor Centre mainly involved rebuilding and extension at the northwest corner of the existing complex of garden buildings and glasshouses, with a further smaller building addition to the northeast. Archaeological monitoring and recording around this have been broken down into six principal areas, as outlined on the plan below (Fig. 5, A to F) and described in the following text (sections 6.2.2 to 6.2.7).

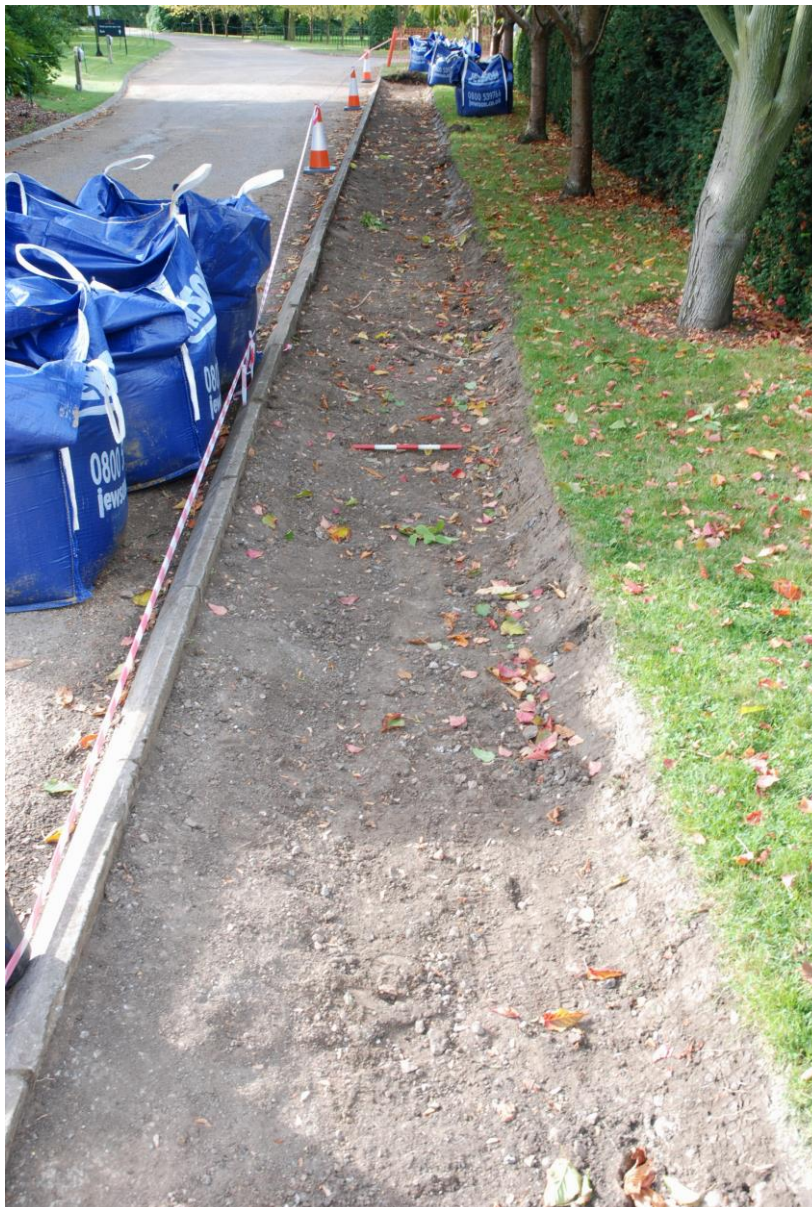
Turf and a fairly shallow topsoil were removed to reveal a firm mottled grey-brown sandy silt with occasional pebbles. In some areas (particularly to the north) the ground appeared quite disturbed, with patches of yellow clay and inclusions of ceramic building material, clinker and crushed mortar. This may date from the 1930s, or even the remodelling of the areas in the mid 1990s.

Fig.6: *Turf and topsoil removed for the new pathway. View looking south (0.50m scale)*

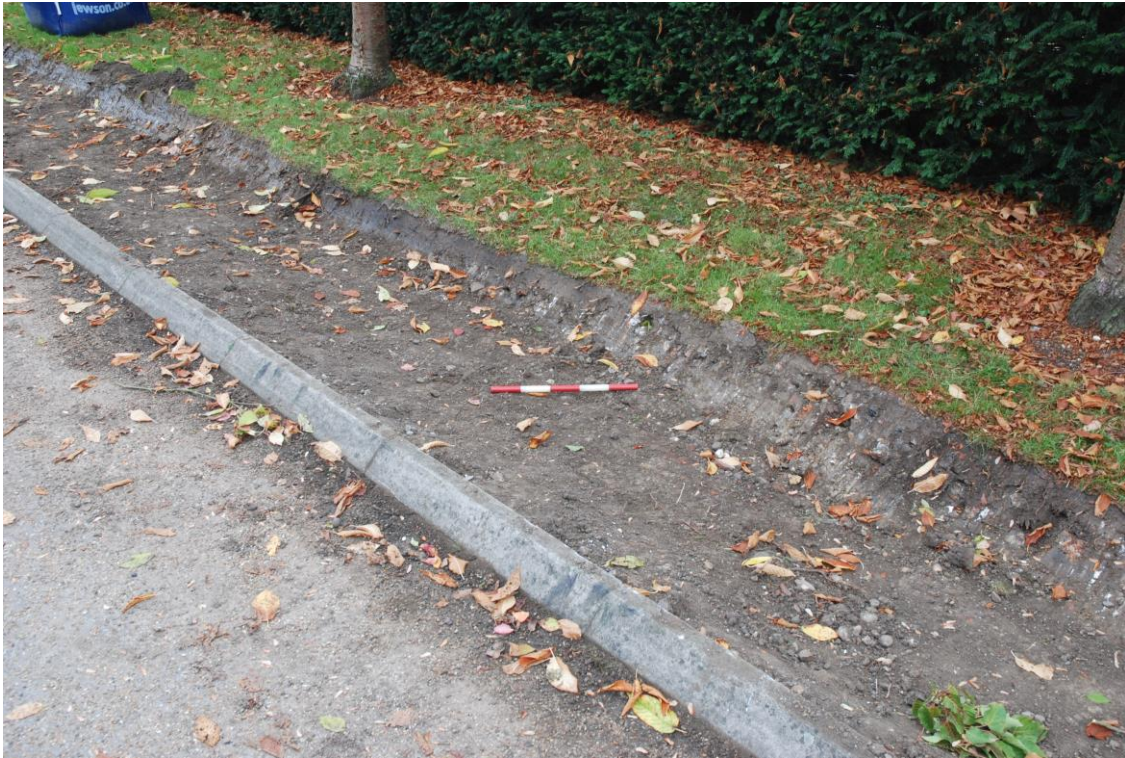
Fig.7: Detail in the central part of the stripped area, looking southwest (0.50m scale)

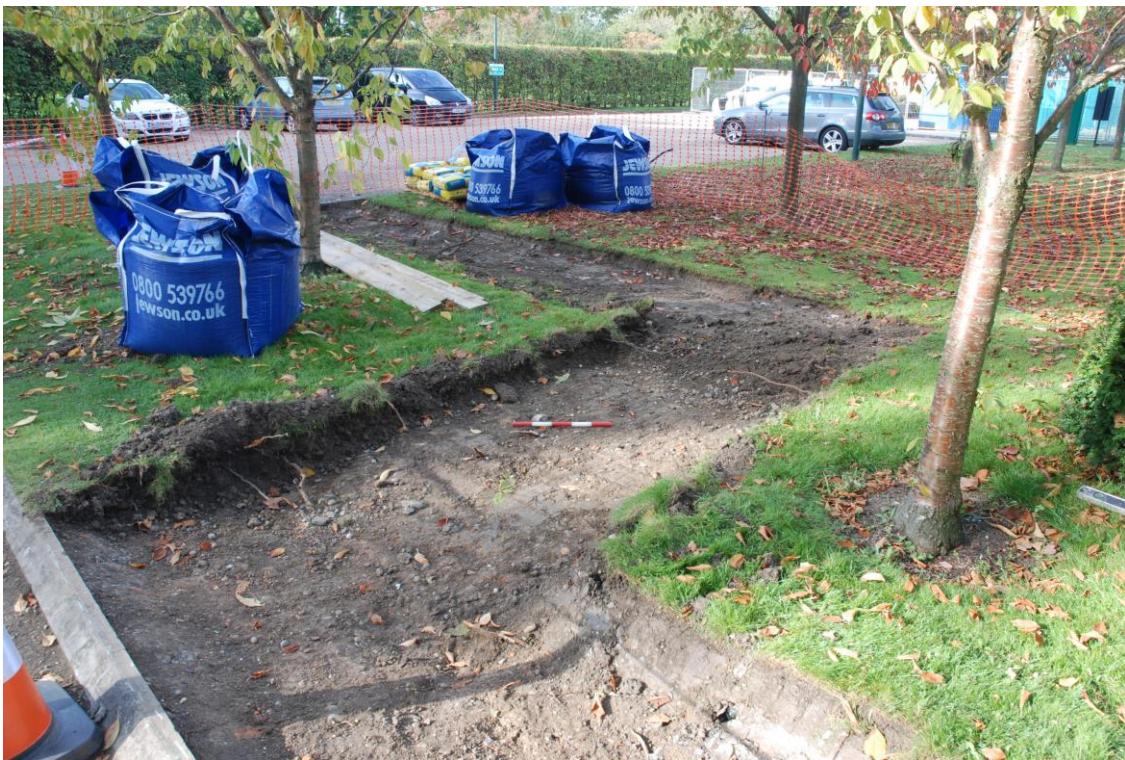
Fig.8: The southern end of the new pathway, stepped to the west into the south car park

The overall length of the new pathway was just over 40m, and the width as excavated c 1.2m to 1.3m. The excavation was generally between 200mm and 230mm, although slightly shallower at the southern end (Fig.8). The base of the long trench also shallowed out to the east as it reached the concrete footings for the existing kerb (Fig.6).

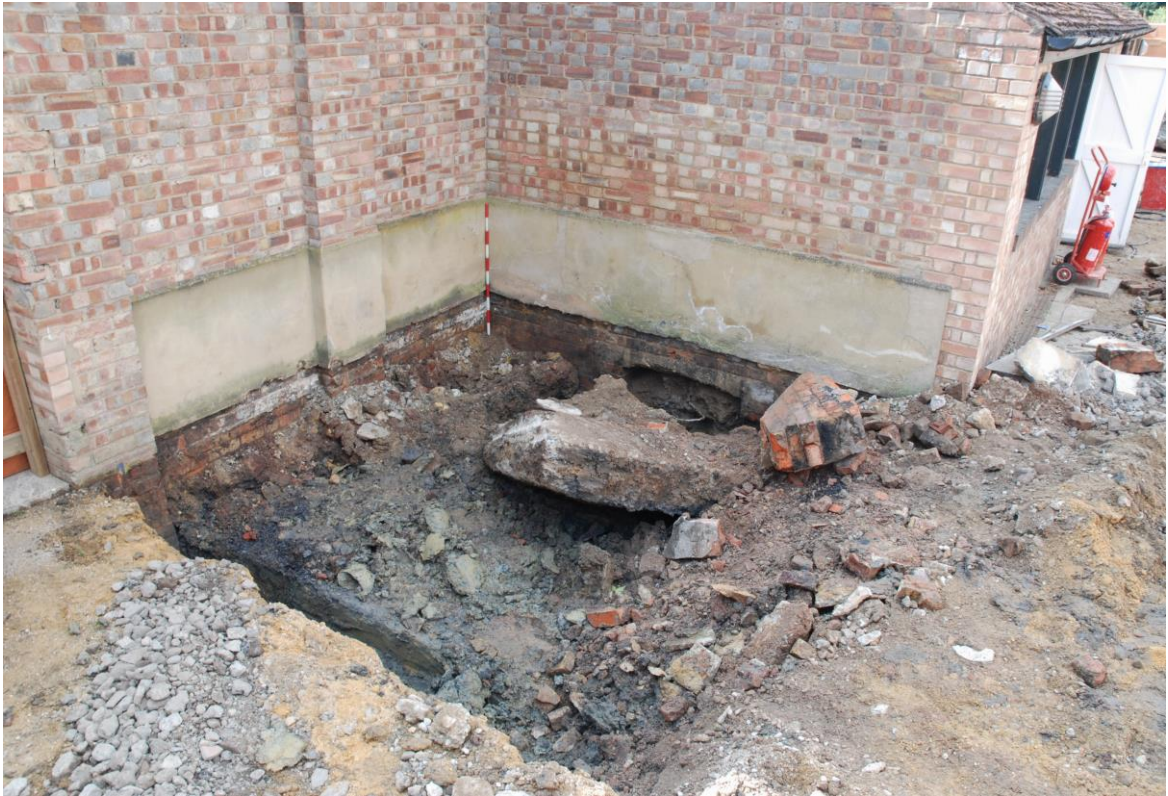
Fig.9: *General view of the area between the easternmost glasshouse and (to right of frame) the gardeners' bothy, looking SW*

Further investigation revealed elements of the projecting structure within the adjacent backfill and demolition material, including parts of the brick walls and a large concrete slab that would have formed a slide (at about 20° from horizontal & c 1.22m long) into the opening. Parts of this structure can be seen in front of the wall in Fig.9.

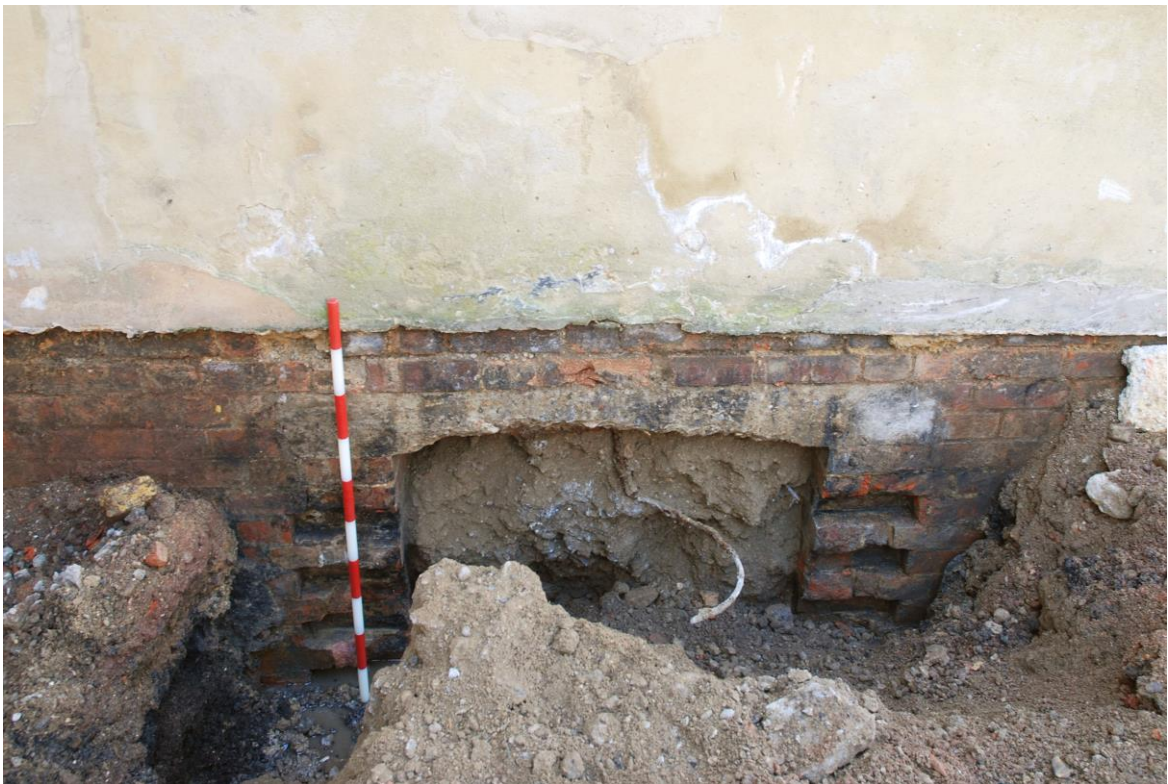
Fig.10: *Former cellar access in the eastern wall of the gardeners' bothy (1.0m scale)*

- 6.2.3.1** It was known that the bothy had contained a cellar, originally accessed by from steps along the northern frontage but now backfilled and sealed up. The excavation revealed a further access point in the eastern wall, presumably for coal or similar material. The opening itself was 925mm wide and 760mm (10 brick courses) high, the lintel formed by a reinforced concrete beam (Fig.10) and rebates within the brickwork on either side for projecting walls.

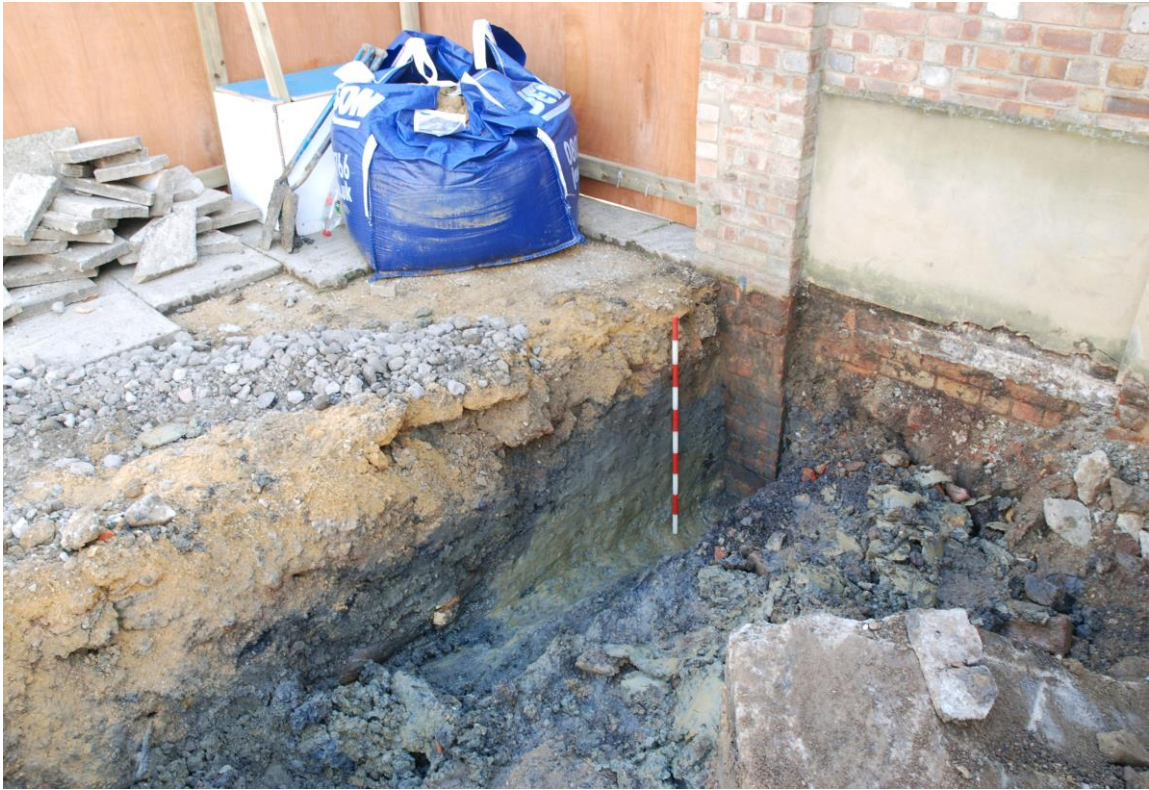
Fig.11: *Excavation at the NE corner of glasshouse range, facing southeast (1.0m scale)*

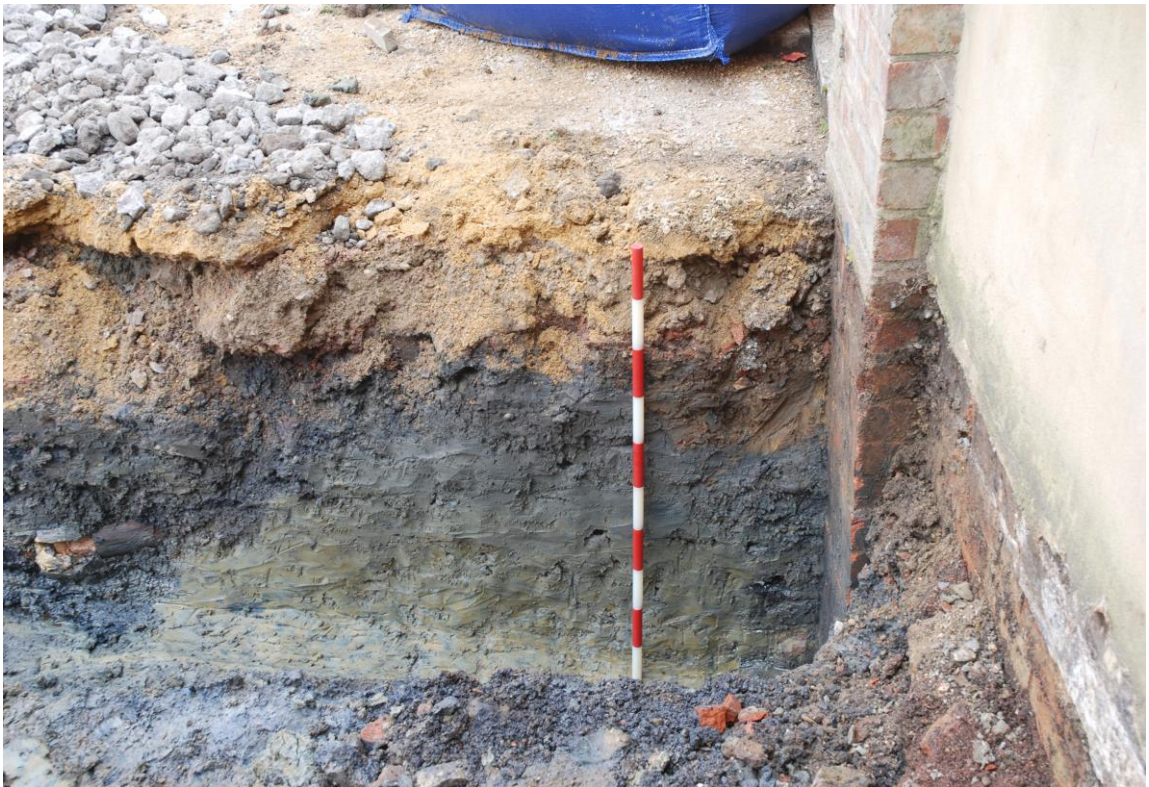
Fig.12: *Detail of the above area, facing east and showing natural deposits & residual subsoil overlain by recent made ground*

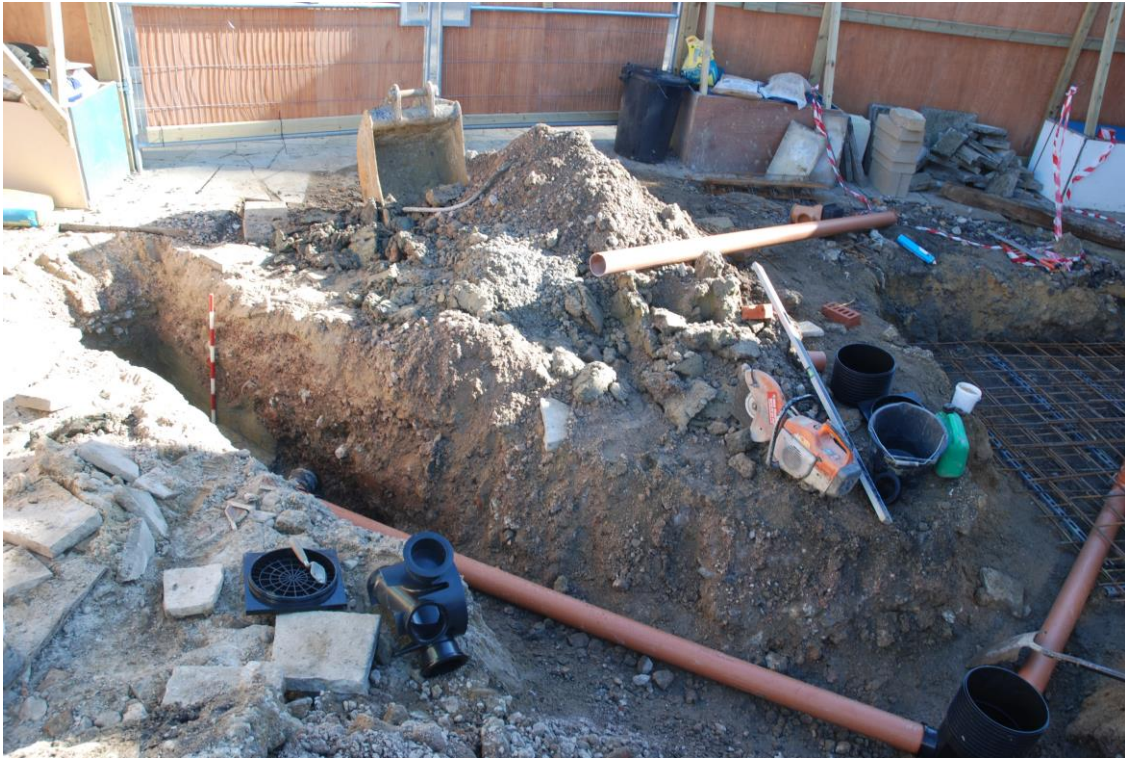
Fig.13: *Service trenching to the northeast of the gardeners' bothy, looking east*

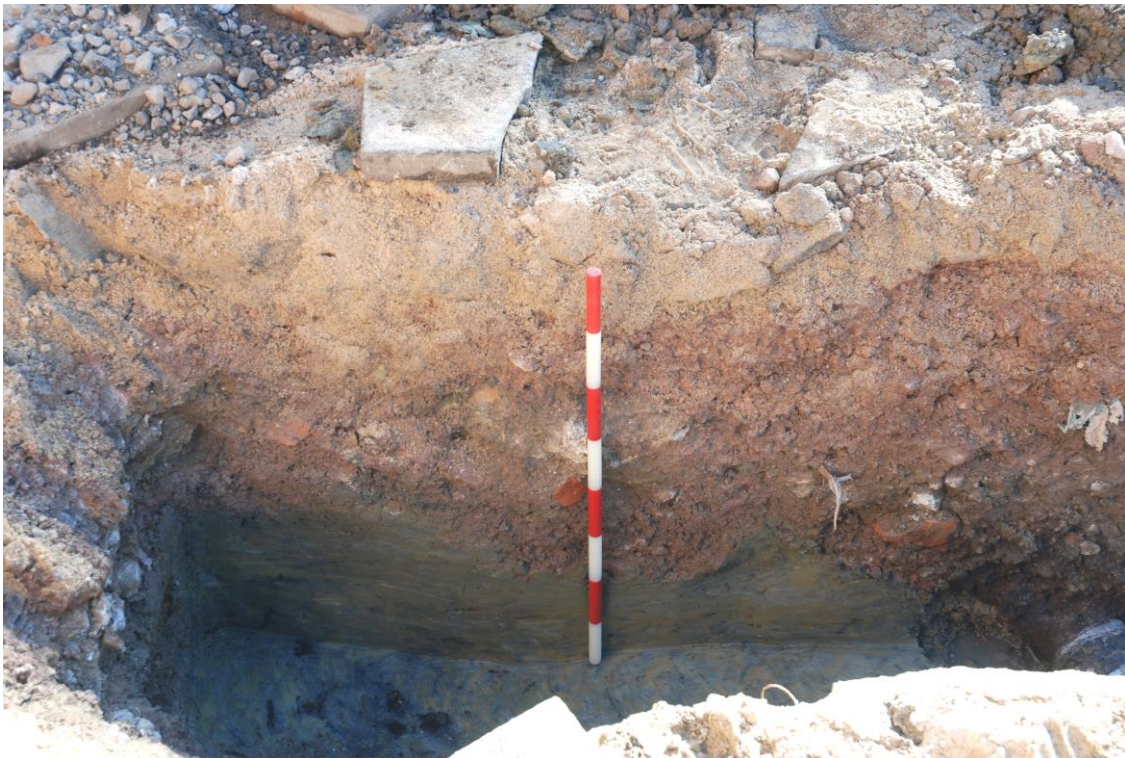
Fig.14: *Detail of the northeastern end of the service trench: truncated natural deposits overlain by probable 1990s made ground*

A very similar picture was observed in the subsequent service trenching, with slightly higher deposits (but no surviving soil horizons) recorded at the far end of the trench, some 5.5m northeast of the corner of the bothy (Fig.14). The maximum height of the natural deposit here was about 59.75m OD: occasional finds within the overlying made ground clearly indicate that this dated from the alterations of the mid 1990s rather than the 1930s.

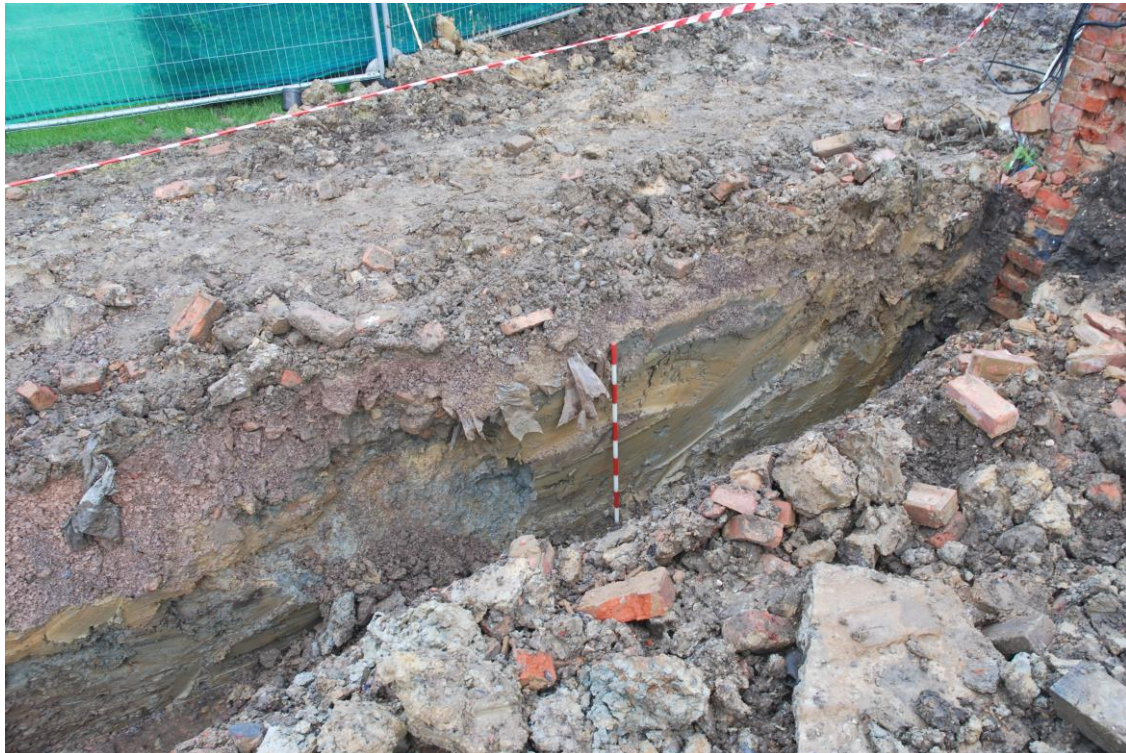
- 6.2.4.1** Excavations along the western and southern sides of this area showed that in most areas natural deposits were directly overlain by modern deposits and made ground, relating either to the 1930s development or to later remodelling and alteration – most likely that in the mid 1990s. There was also some deeper disturbance, from previous wall foundations on similar alignments and from service trenches between the previous building and the glasshouse to the south.

Fig.15: *General view of the western foundation trench, looking northwest (1.0m scale). Previous soil horizons have been wholly removed, and the truncated surface overlain with a mixture of modern building rubble, gravel and crushed stone (MOT Type 1)*

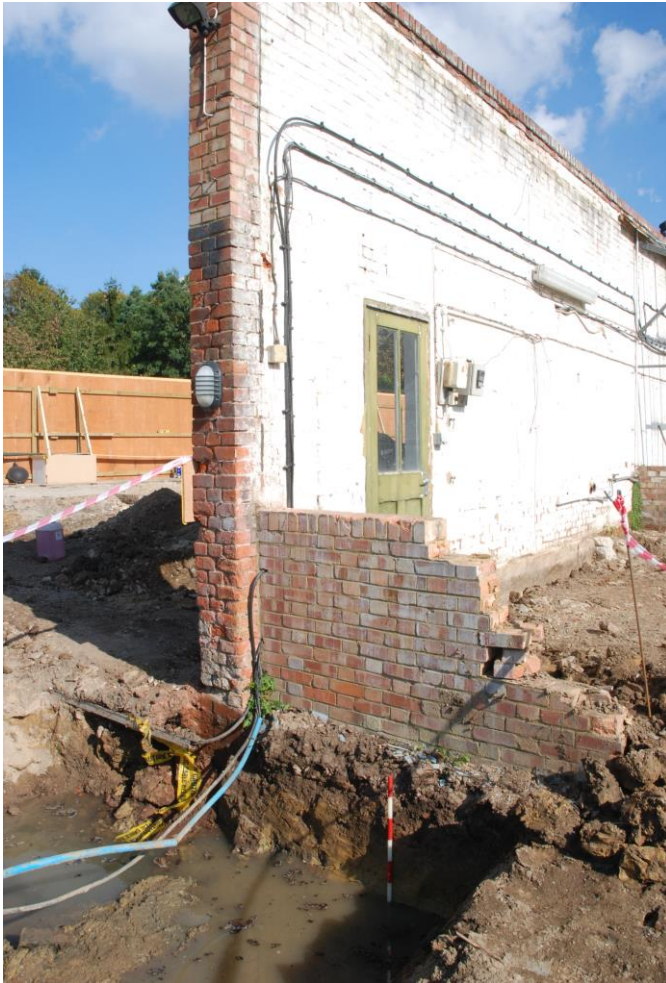
Fig.16: *The western end of the spine wall, following demolition of the glasshouses to north and south and prior to excavation of the new foundations*

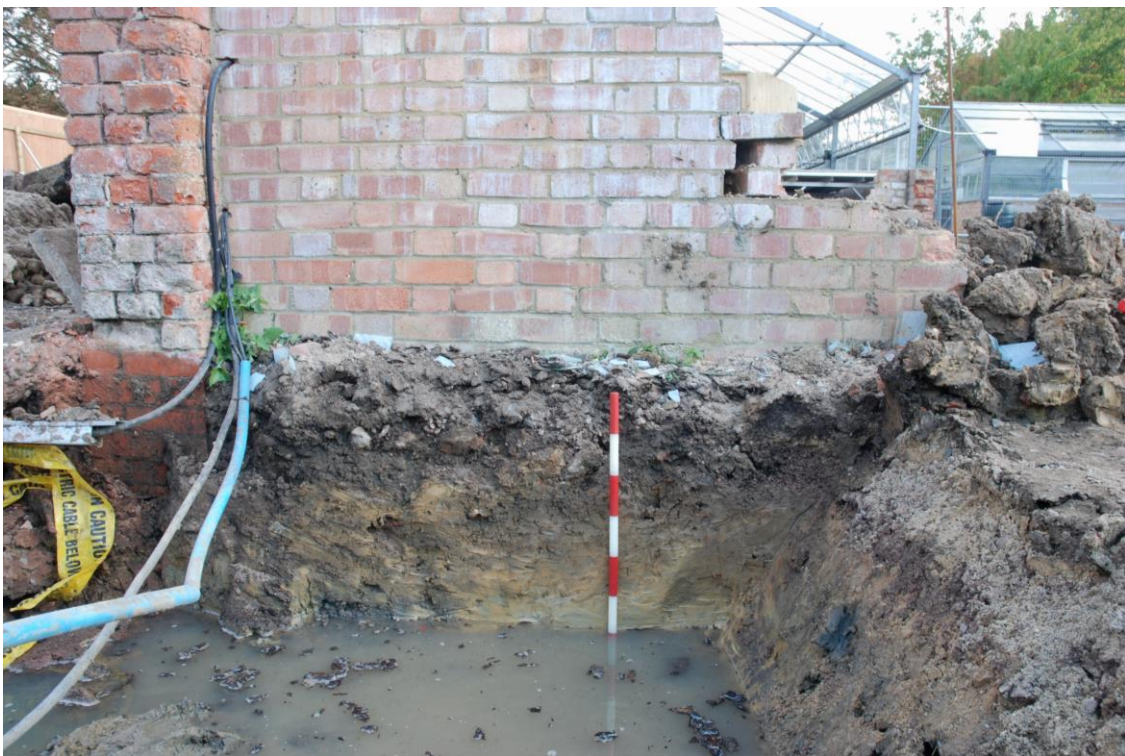
Fig.17: *Detail of the above area, showing mottled mid brown subsoil overlain by recent disturbed and made ground (at c 59.4m OD). The base of the subsoil grades into firm natural yellow clay*

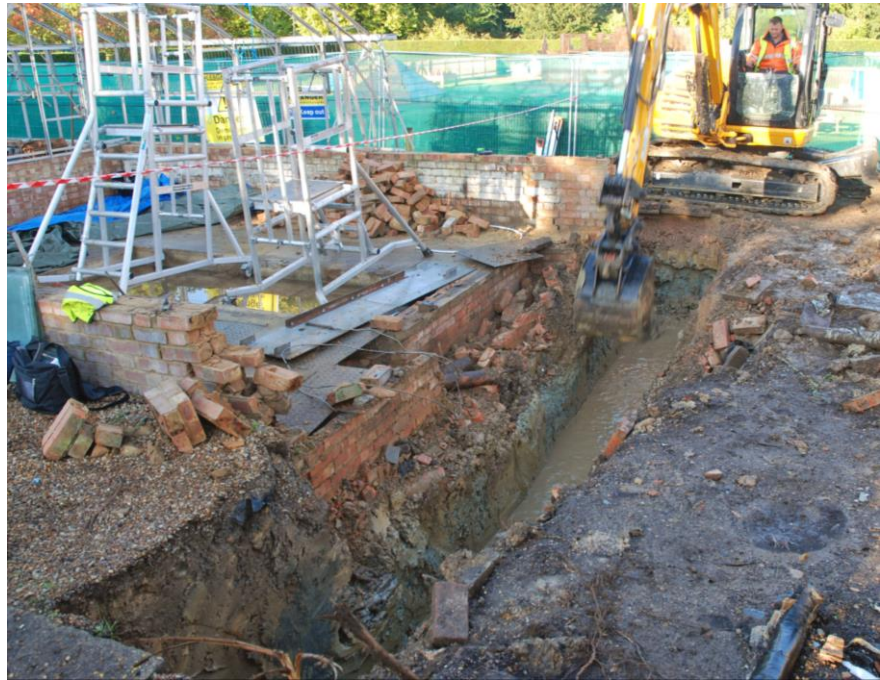
Fig.19: *The east end of the above foundation cut, facing S (1m scale)*

At the southeastern corner of the excavation the solid natural clay appeared to be more or less directly overlaid by a modern gravel path, at about 59.80m OD (Fig.19). This is clearly a higher level of survival than seen in the southwestern corner or along the line of the western trench, particularly given that the land surface is also lower by up to c 200mm.

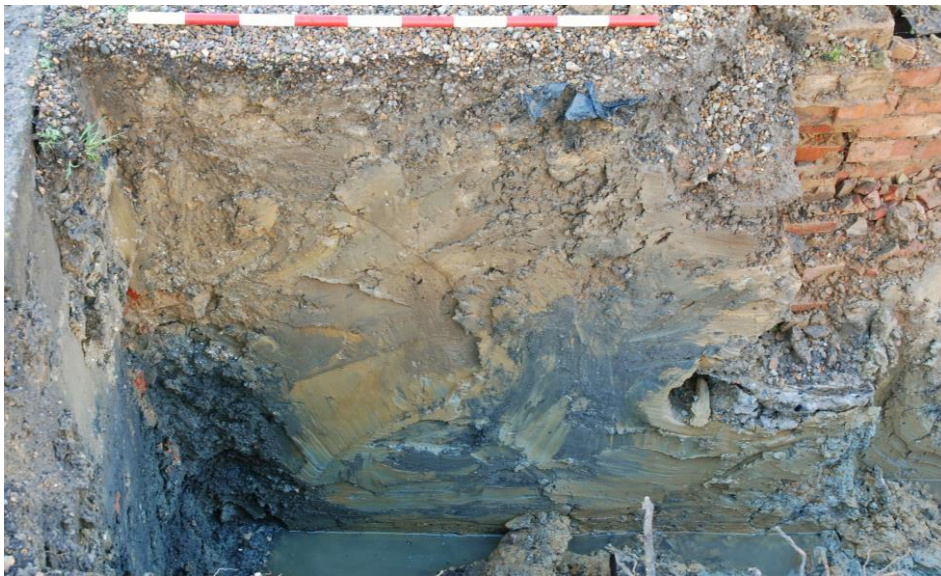
Fig.20: *The western end & SW corner of the foundation cut*

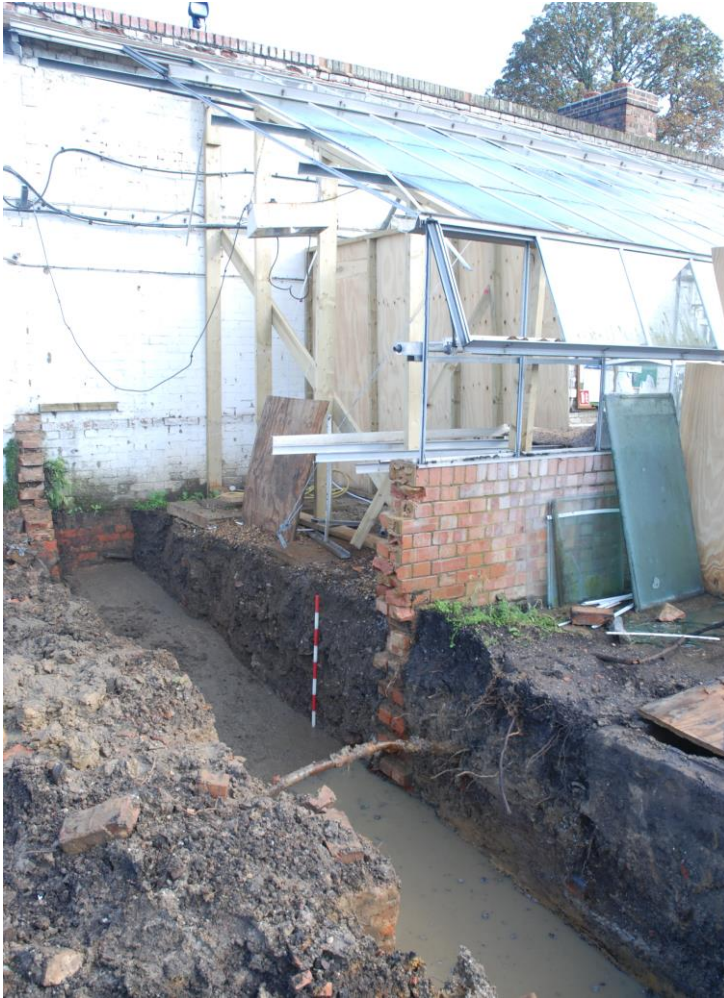
Fig.21: *The new cafe eastern foundation trench, looking NE*

**6.2.4.2** Excavation for the strip foundation on the eastern side of the new cafe revealed a different picture to the other two sides, related to the original design and construction of the 1930s glasshouse. Within the glasshouse was a thick deposit of made ground, overlying a concrete slab that sloped down from north to south (*ie.*, towards the outer wall of the glasshouse; see Figs.21 & 22 below). The slab itself appeared to be about 160mm thick, and on its southern side supported the brick outer wall – continuing some 180mm beyond this line.

The modern ground level in this area was about 60m OD, and the depth of made ground within the glasshouse some 560mm to 950mm (increasing N-S). It seems unlikely that the floor was originally at this level, but may rather have been a suspended construction – perhaps associated with underfloor heating. The other (& perhaps more likely) possibility is that the glasshouse was constructed as a closed environment, plants being rooted directly into the ground but contained by both the walls and a solid floor. The slope of the floor may simply have been to facilitate drainage to the exterior, whatever the precise role of the overlying space.

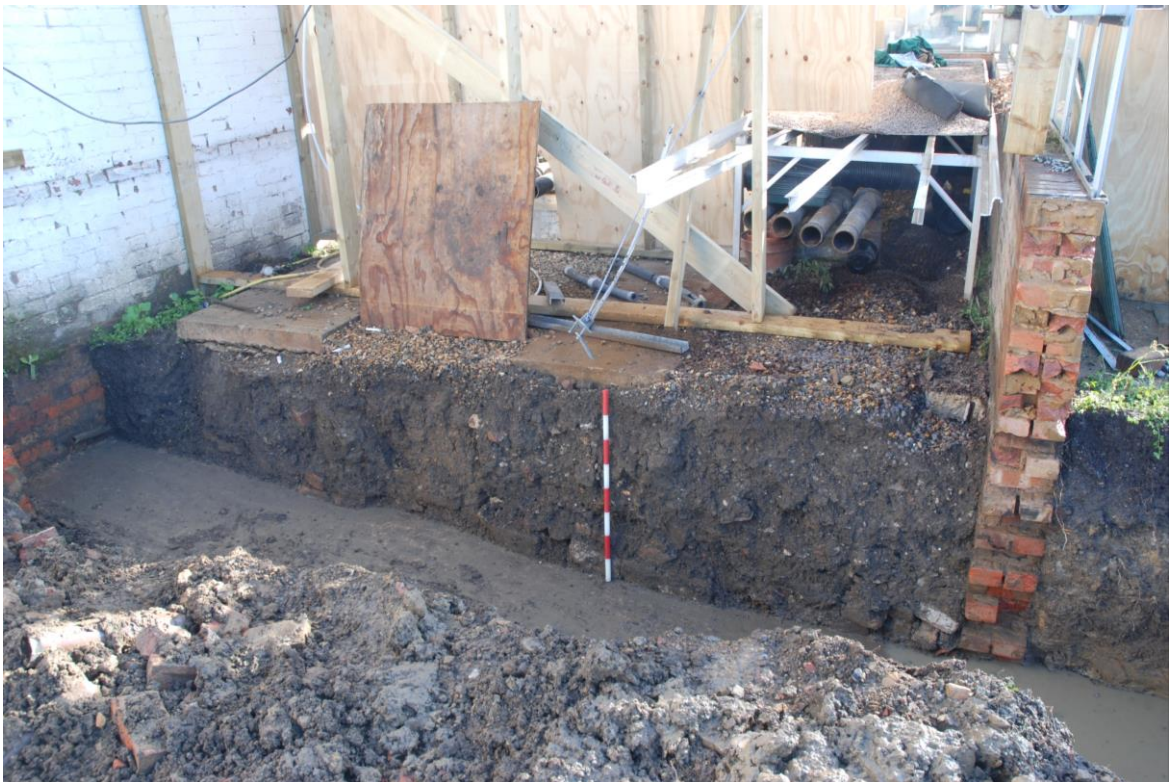
Outside the glasshouse was a fairly narrow strip of quite heavily disturbed ground – in part the result of the glasshouse construction, and also due to a large concrete attenuation tank that was located about 2.2m further to the south.

Fig.22: *Detailed view of the above within the area of the former glasshouse, the scale standing on a sloping concrete slab (0.80m scale)*

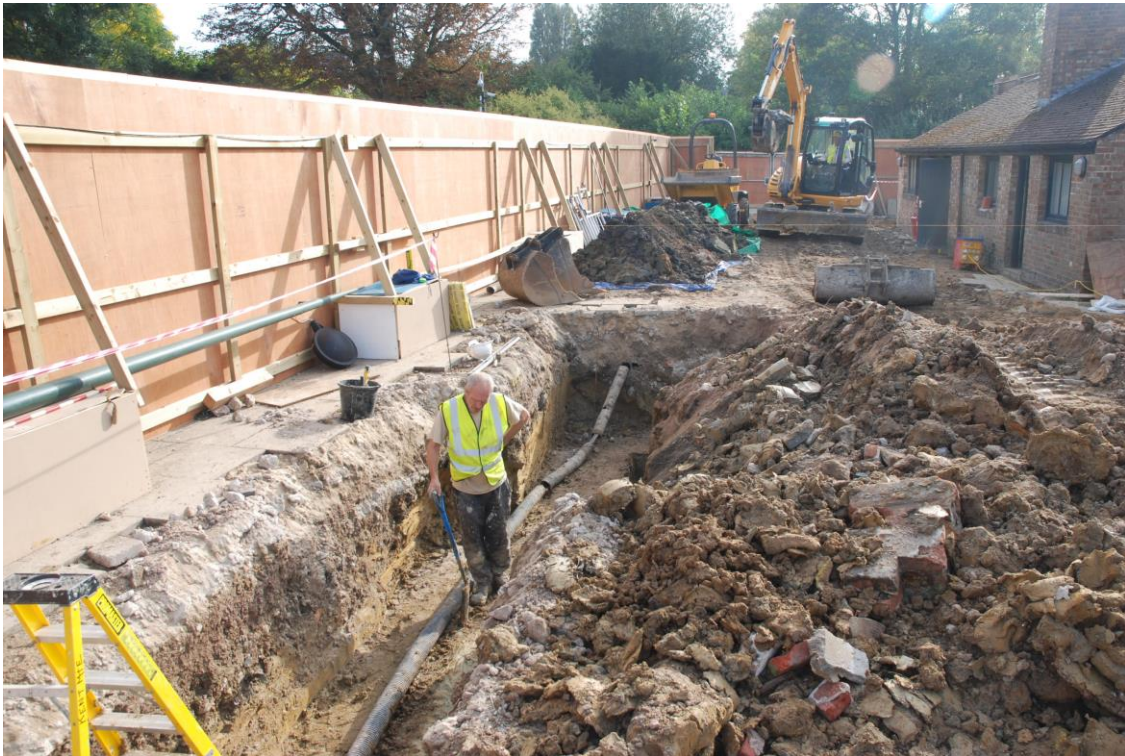
Fig.23: *The northernmost foundation trench, view looking east*

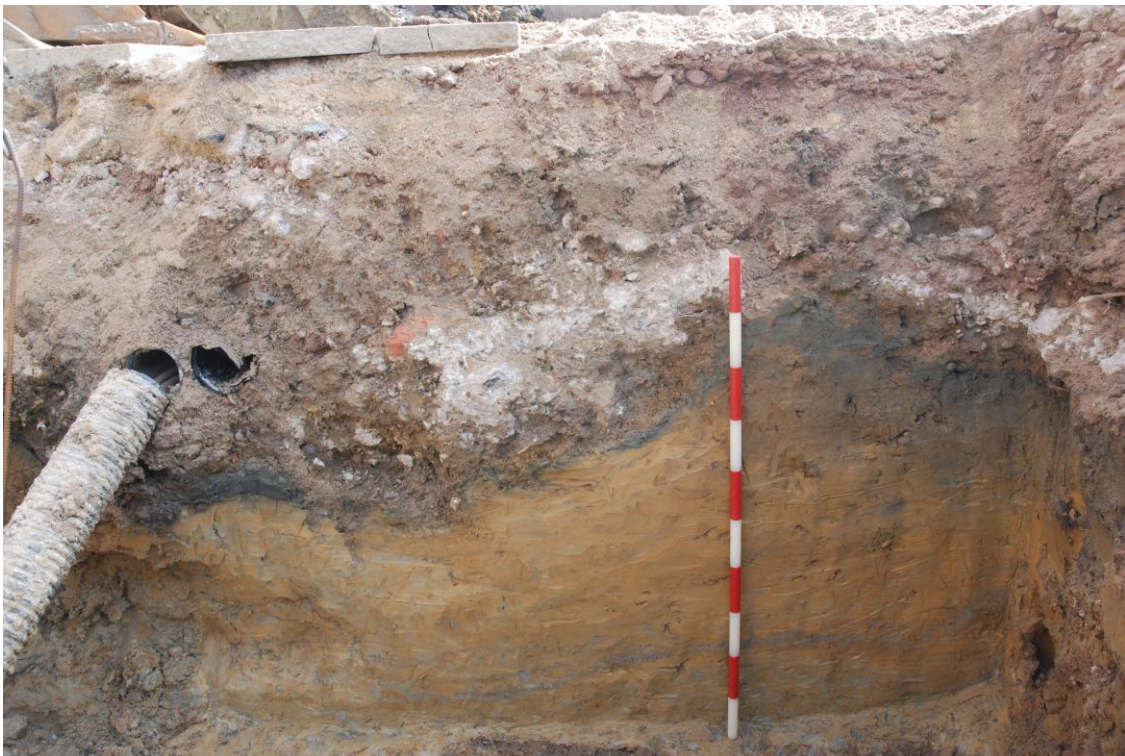
Fig.24: *West-facing section at the northeast corner of the new admissions and retail area (1.0m scale). Natural deposits (here reaching c 59.55m OD) & possible residual subsoil are overlain/truncated by recent made ground*

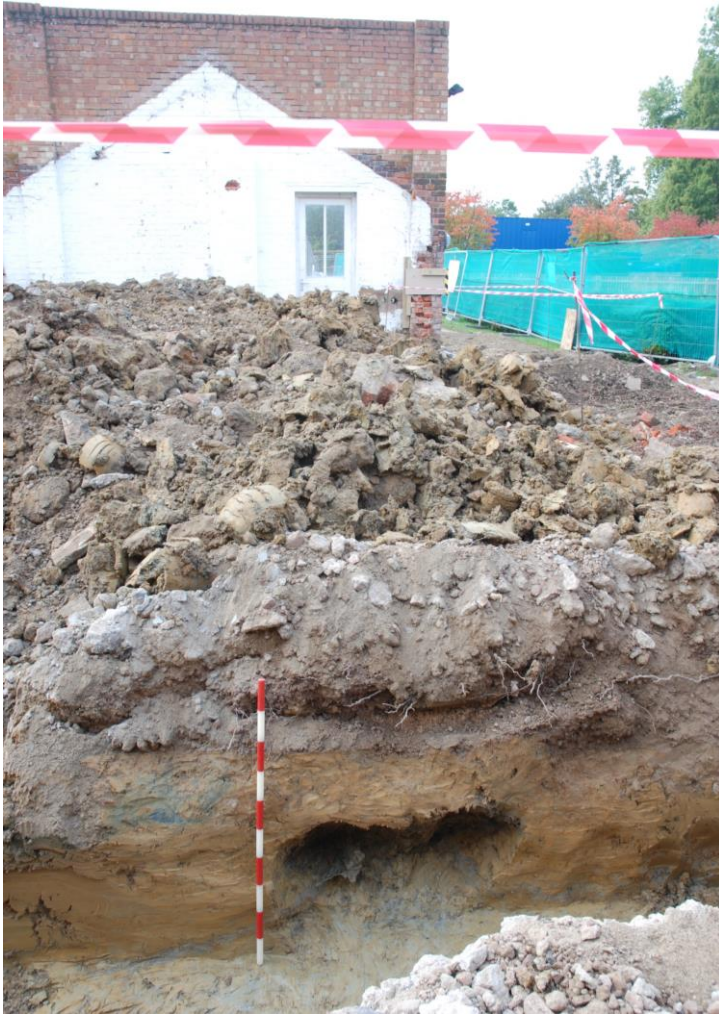
Fig.25: North-facing section on the northern side of the new admissions and retail area, the western part containing a pit [42] with animal bone (1.0m scale)

**6.2.5.2** The only feature of note was exposed in the northern foundation trench, about a quarter of the way along from the western end. The trench cut through the northern side of a pit, otherwise retained in the south section and up to *c* 1.10m wide by 0.68m deep (context [42]; Figs. 25 & 26). The majority of the fill (41) was a solid mottled yellow-grey clay with occasional small pebbles, but the lower section – *c* 300mm – also contained a substantial assemblage of adult cow bone, some still partially articulated and probably all from a single animal that had been butchered (Appendix IV).

There were no other finds and the date of the pit and remains was not firmly established. However, the southern edge of the feature was cut and overlain by the foundation for the previous glasshouse north wall, which was constructed in the mid-1930s. The surviving top of the pit was recorded at about 59.77m OD, some 0.58m below the modern (pre-development) land surface.

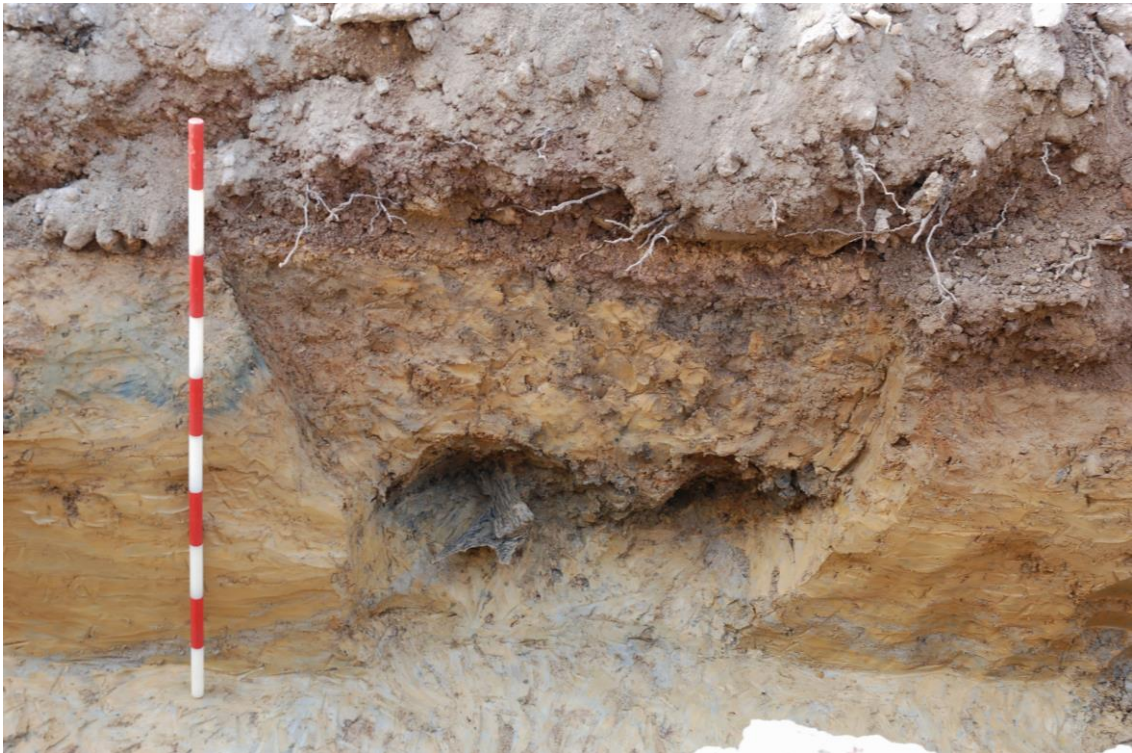
Fig.26: Detail of the pit [42] and fill (41), with bone inclusions near the base

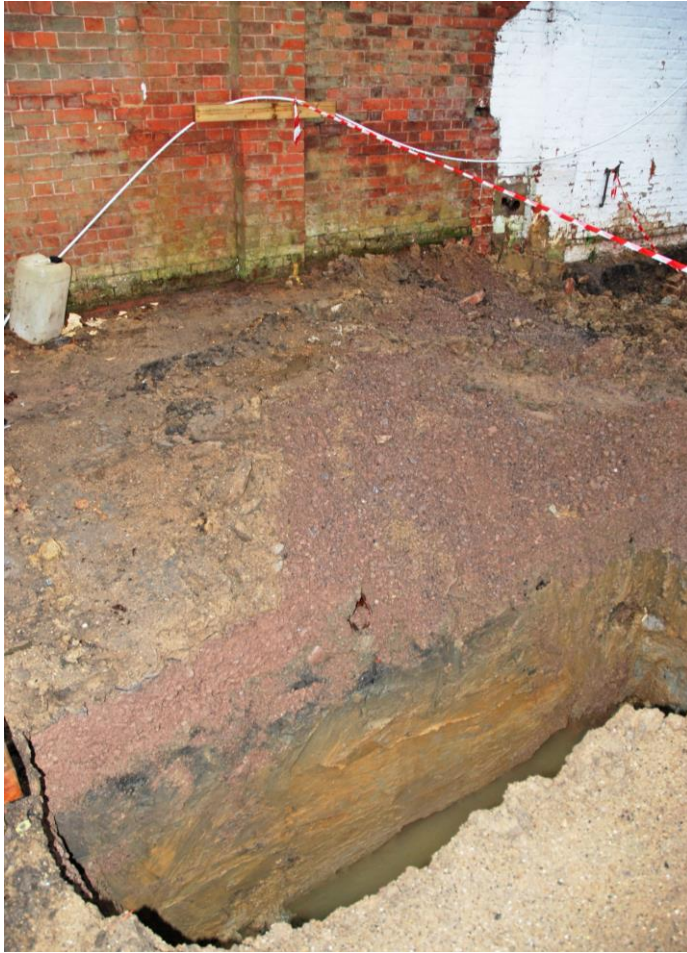
Fig.27: A section of E-W foundation trench adjoining the gardeners' bothy (to the left), with truncated subsoil overlain by modern crushed stone (MOT Type 1)
