# **A SERIES OF ARCHAEOLOGICAL WATCHING BRIEFS AT ELTHAM PALACE**

**LONDON BOROUGH OF GREENWICH, SE9 5QE**

**NOVEMBER 2015**

SITE CODE: ELT13

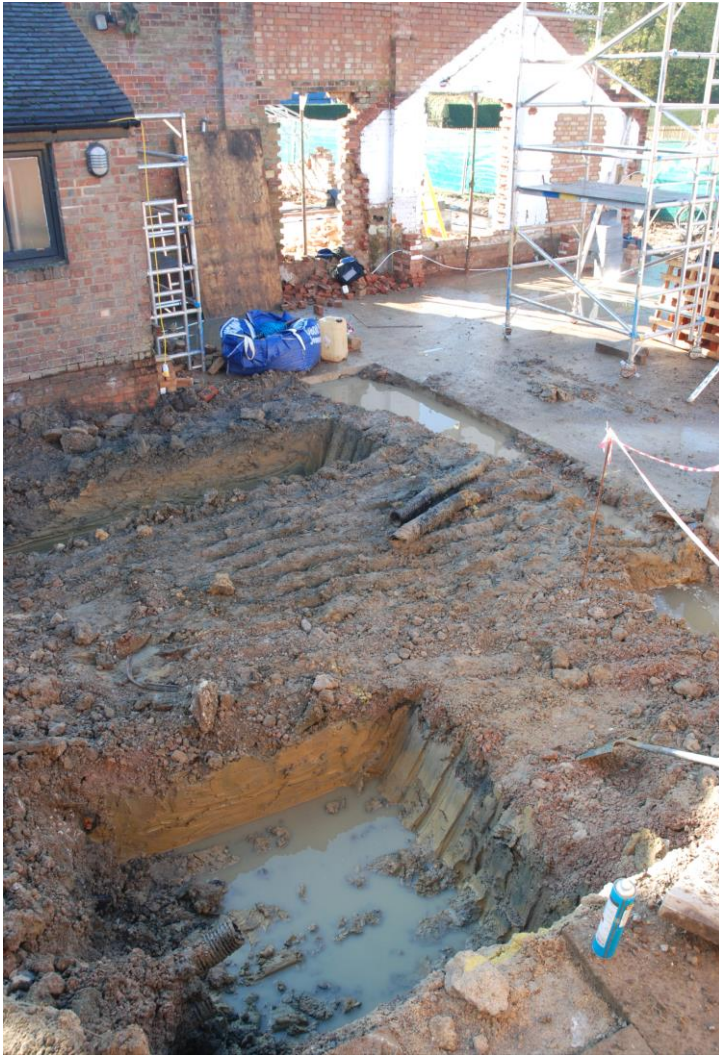
Fig.29: *View looking SW, in the foreground excavation for planters outside the new admissions and retail area*

This area principally consisted of foundation trenching to the north, east and west for the new visitor admissions and retail area. The trenches themselves were of similar dimensions to those to the south as described above, *c* 0.90m to 1.20m wide and between 1.25m and 1.80m deep. Subsequently two planting pits were also dug just to the east of the new building, the southern approximately 0.90m by 3.60m in plan and the northern 1.80m by 1.60m, and both about 1.10m to 1.30m deep (Figs.29-30).

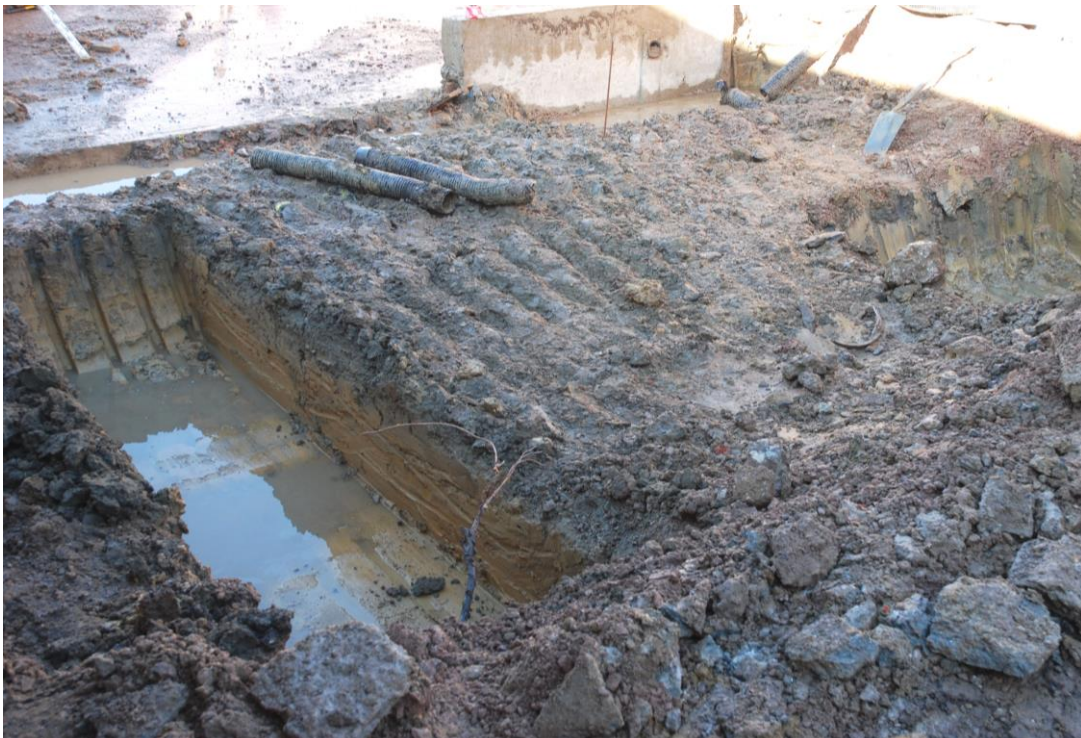
Fig.30: *Another view of the area above, looking northwest*

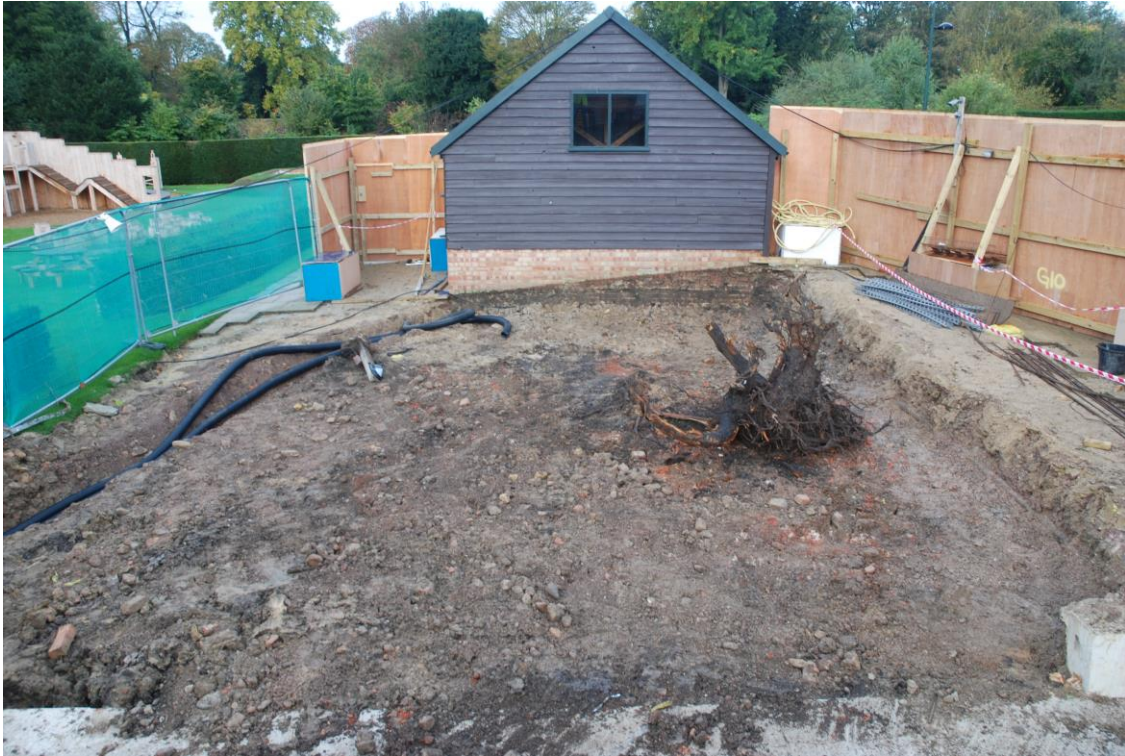
Fig.31: *A general view across Area E, looking west and after initial ground reduction*

To the west of the new visitor admissions and retail building an area of sloping ground some 10m square was graded down to a fairly level surface, to the north – previously the highest area – to a maximum depth of 600mm to 700mm (*c* 59.65m OD; Figs. 31 & 32). Subsequently two deeper foundation trenches were dug, principally for a retaining wall along the northern side of this area (Fig.34). These were both about 0.50m wide and were excavated to an overall depth of *c* 59.00m to 59.10m OD. A new but shallower (*c* 400mm-500mm deep) service trench was also dug across the southern part of the area, from the southeast corner of the former Tennis Pavilion to the new Visitor Centre.

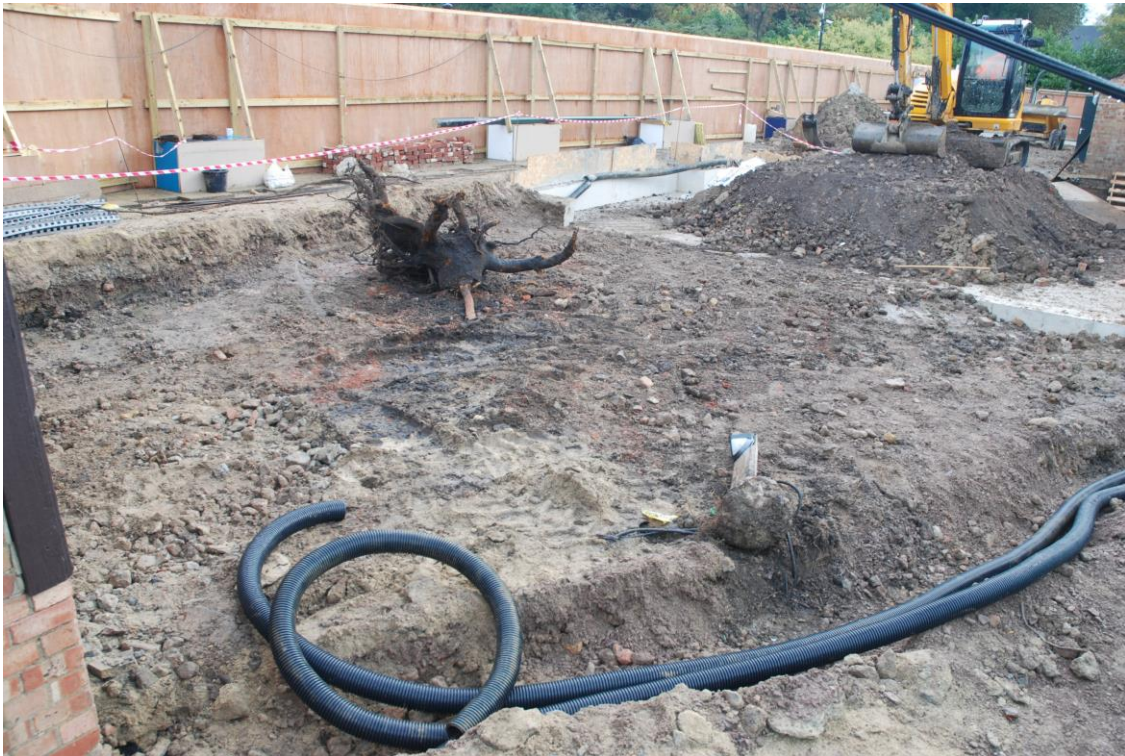
Fig.32: *The same area viewed from the southwest*

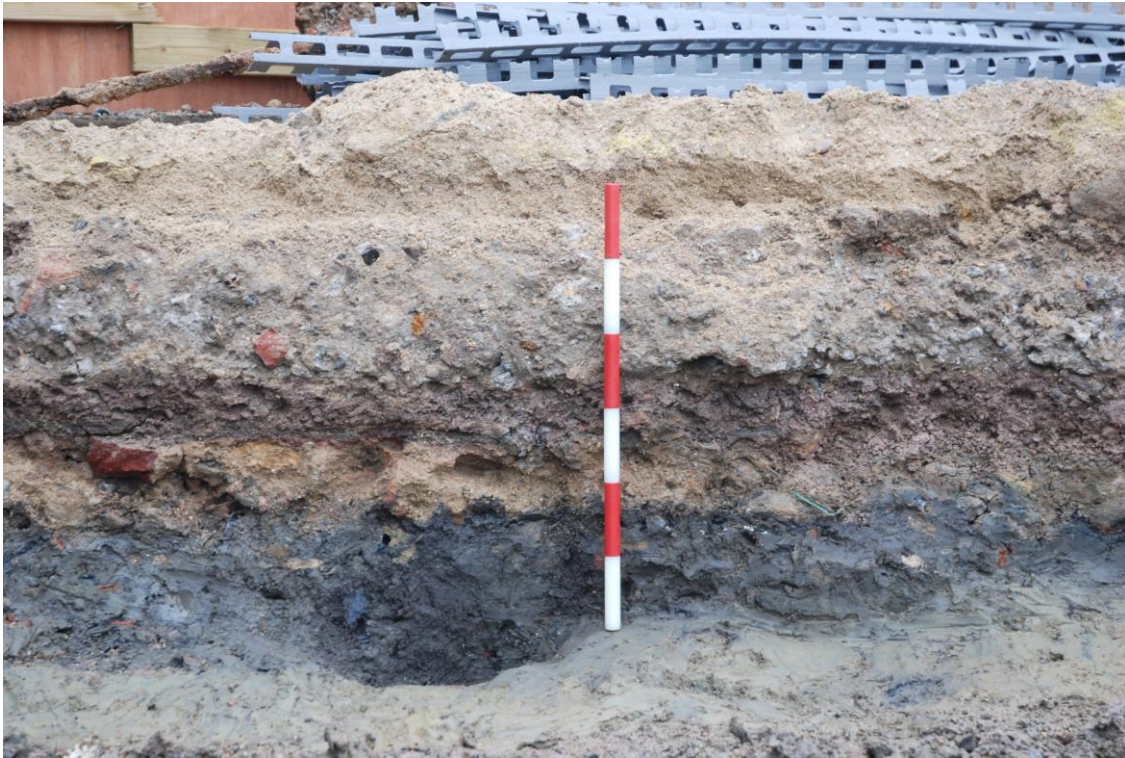
Fig.33: Detail of the northern section of Area E, with modern deposits, crushed stone and concrete overlying truncated subsoil (44). 0.6m scale

**6.2.6.2** At the southern end of the foundation trenching the made ground extended almost to the base of excavation, at this point overlying truncated and clean yellow natural clay. However, in the northern section a more complete sequence was preserved, with clean and then mottled greyish-yellow clay overlain by about 150mm of darker green/grey silty clay, context (44). This latter produced several sherds of 19<sup>th</sup>-20<sup>th</sup> century horticultural earthenware (*cf.* Appendix II).

Layer (44) is assumed to represent a residual subsoil, its surface at about 59.80m OD. As elsewhere on the site it was sealed by a series of modern levelling/ made ground deposits, including sand, crushed stone and concrete (*cf.* Figs.33-34).

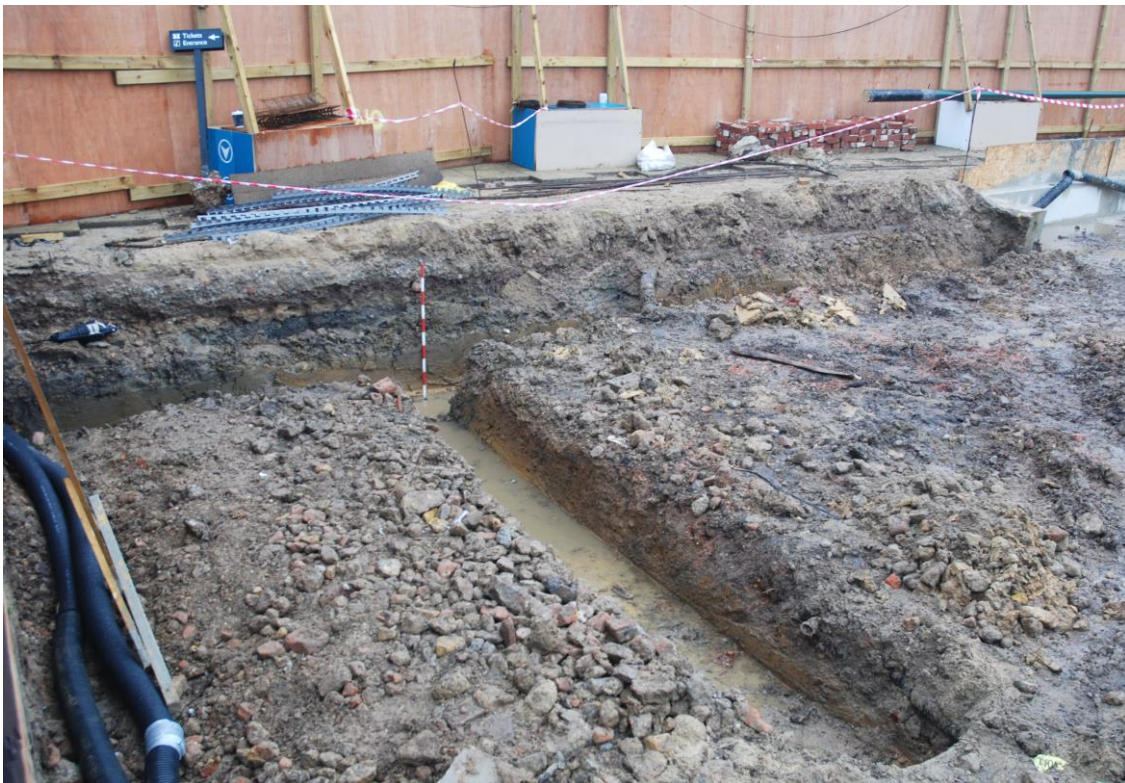
Fig.34: The area after deeper trench excavation along the northern section and southwards across the centre, looking northeast (1.0m scale)

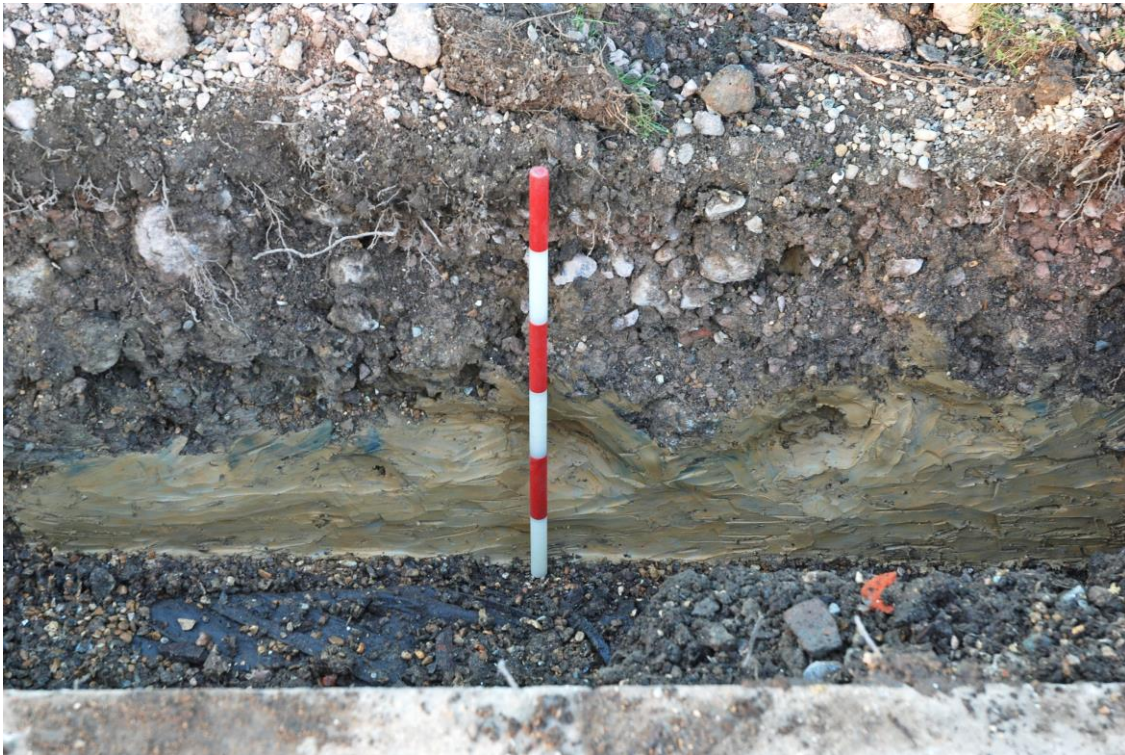
*Fig.35: Part of the east-facing section of a new soakaway to the west of the Hardy House, and showing recent made ground directly over clean natural clay*

- 6.2.7.1** Excavation of a new soakaway on the western side of the adjacent path revealed natural deposits directly overlain and truncated by recent made ground (at about 59.00m to 59.20m OD). As elsewhere, it seems most likely that this dates from the re-landscaping works in the 1990s.

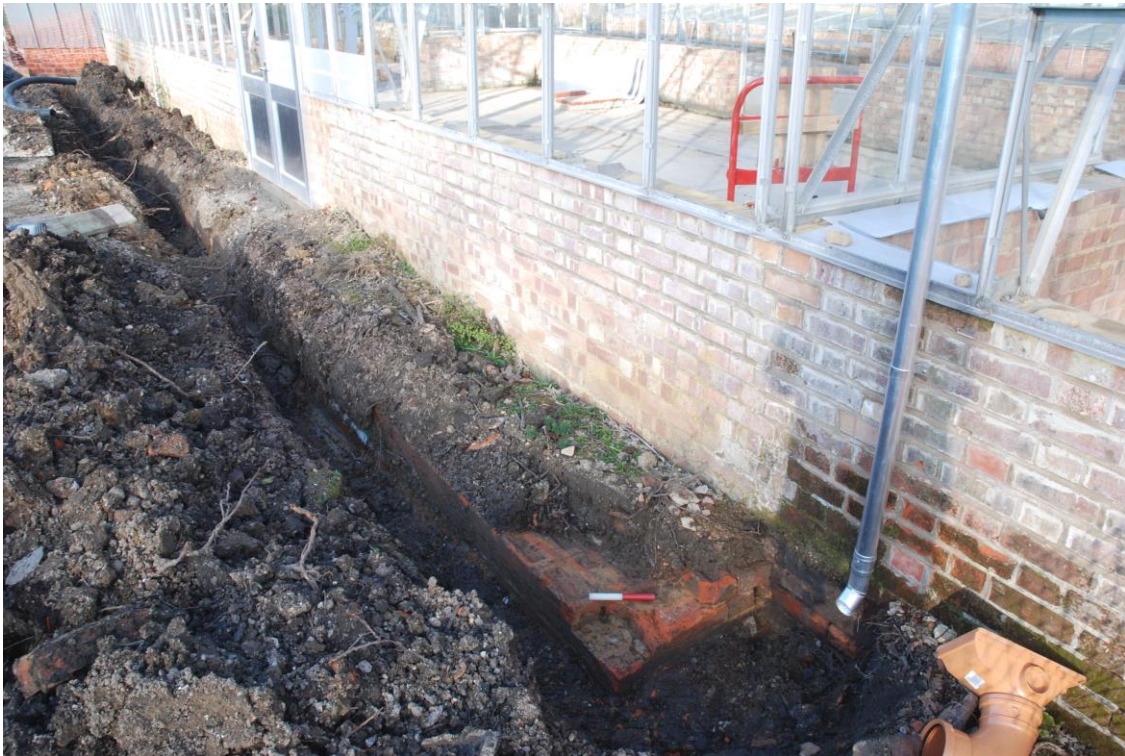
Fig.36: *Truncated brickwork built onto the western side of the Hardy House, looking northeast. Perhaps originally an external planter*

- 6.2.7.2** Excavation of a small N-S trench alongside the glasshouse itself (c 300mm wide by 350mm to 500mm deep) exposed some partly demolished brickwork as illustrated in Figs. 36-37 overleaf. Essentially the brickwork formed a low wall, at least three courses high and running parallel with and some 600mm out from the glasshouse. Its overall length was 10.70m, and at either end it turned through 90° to be bonded into the main structure.

This evidently formed part of the glasshouse construction: it may have been an external planter, although it seems too narrow to have been a covered cold frame or similar.

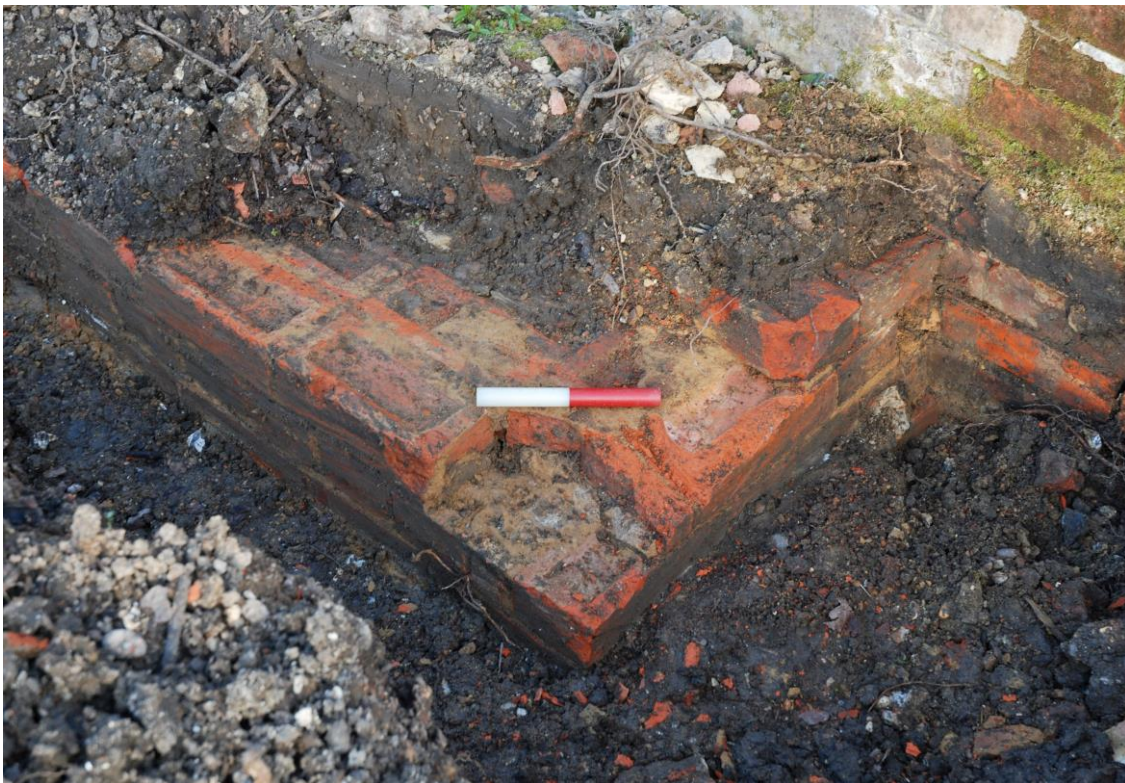
Fig.37: *Detail of the above brickwork, southwest corner (0.20m scale)*

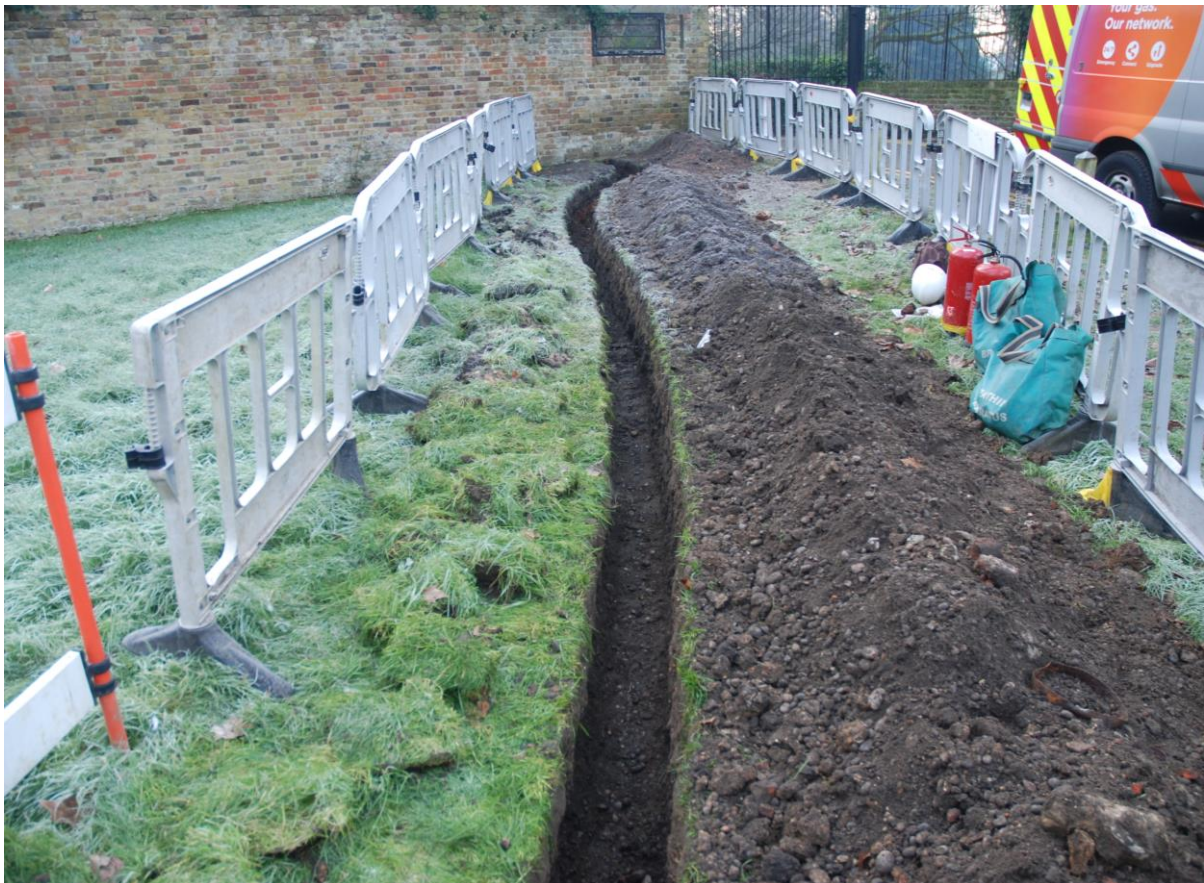
Fig.39: Gas connection trench facing south, towards the existing garden wall and northern access gate, 20<sup>th</sup> January 2015

boundary wall to the north, from 35mm to 90-110mm thick, (21). The lighter material overlay dark-grey / brown stony sandy silt containing occasional small pebbles and charcoal flecking. To the north the deposits coalesced and thinned out, giving way to an underlying made ground deposit (25) – renumbered (26) below the road base at the north end of the trench. In the centre and southern part of the trench (21) also sealed a 100mm-120mm thick deposit containing crushed ceramic building material (CBM), very occasional fine stone and mortar fragments, and moderate sized pebbles, (22). This rubble-rich layer must have represented a deliberate attempt to raise / level out the ground surface below and probably derived from localised demolition. Layer (22) was above a probable further dumped layer, comprising a mid-brown clayey-silt with occasional finely crushed CBM, very occasional fine mortar and stone fragments, (23).

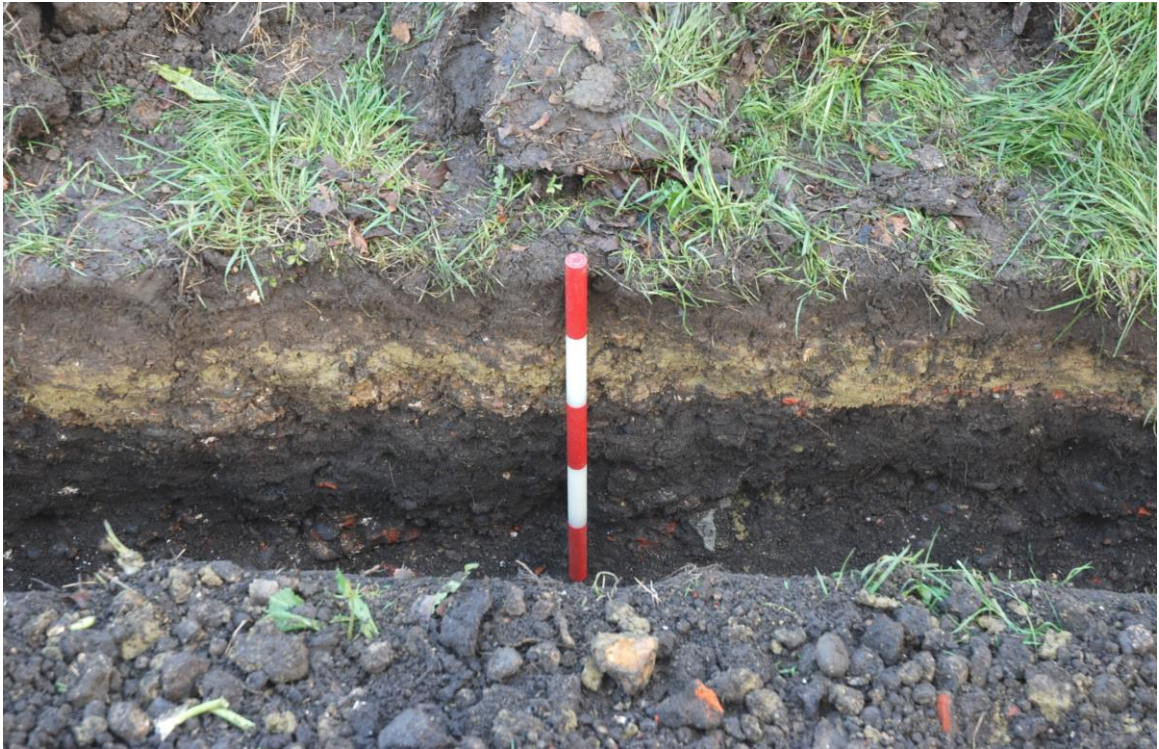
Fig.40: Trench section facing E and approximately midway across the grassed area, showing the light-coloured deposit (21) and (23) below. 0.50m scale

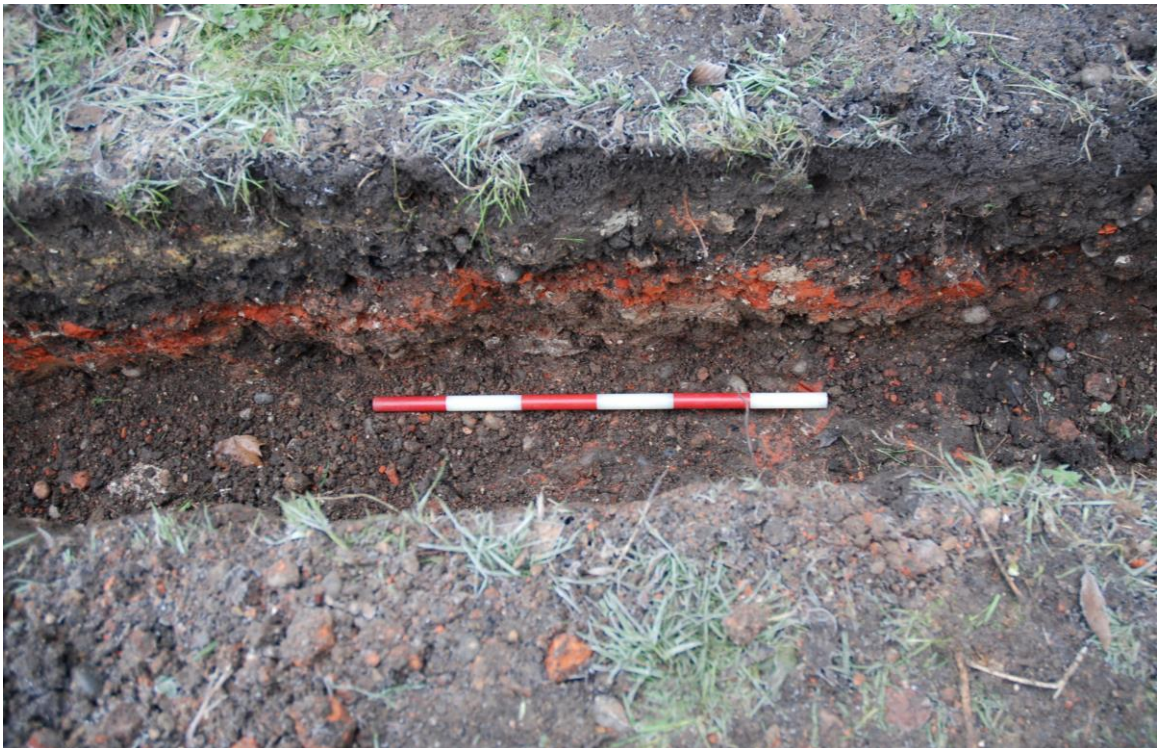
Fig.41: Trench section facing E and just to the north of the wall base [24], showing the crushed brick deposit (21) and (23) below. 0.60m scale

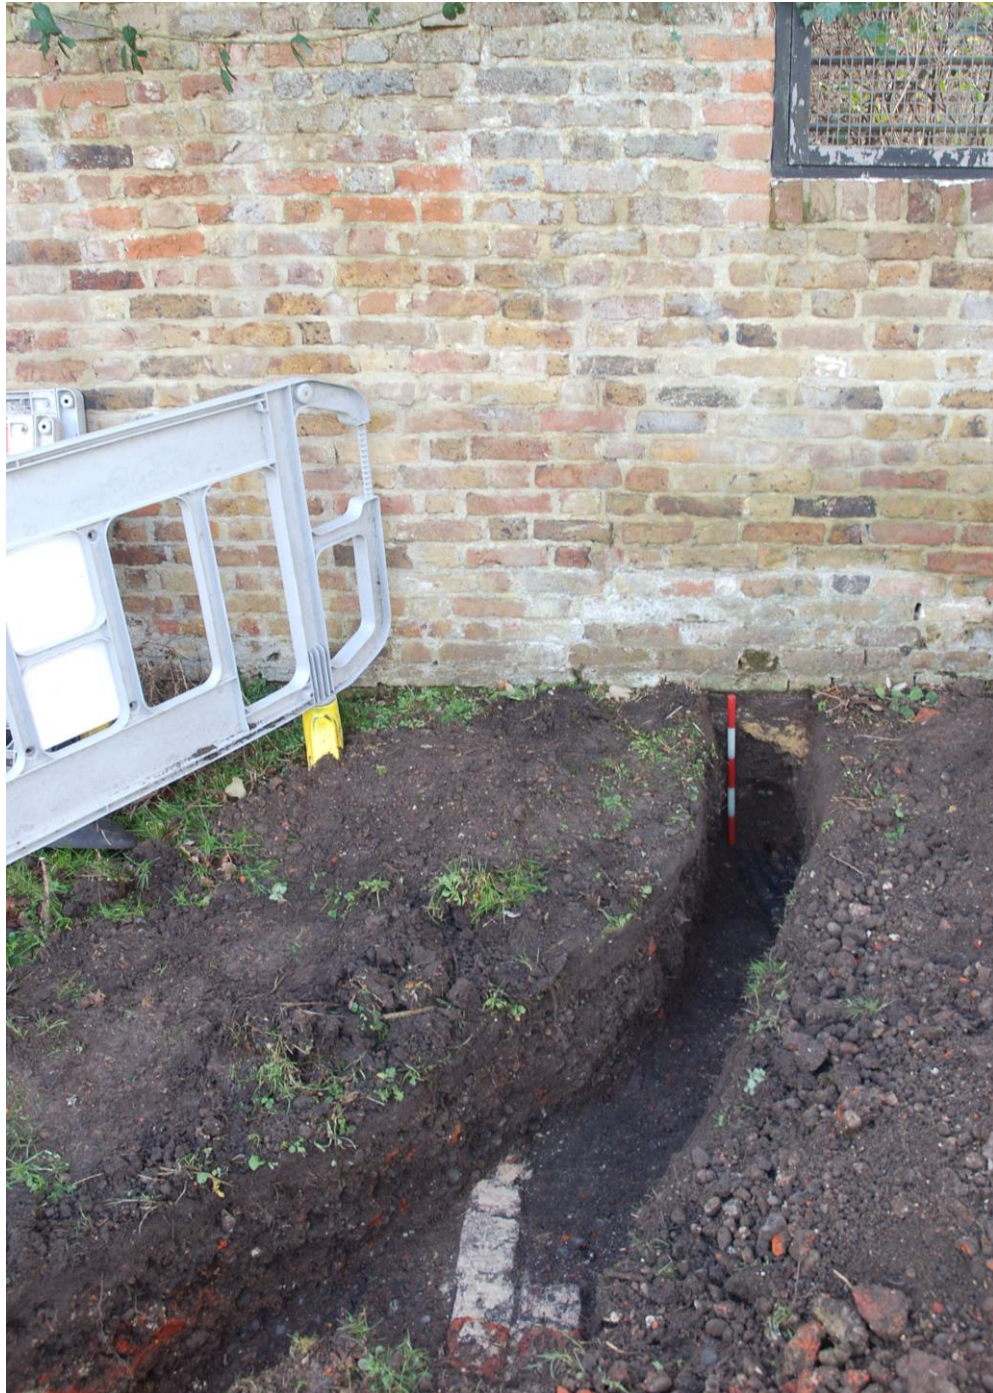
**6.3.3** The only significant feature observed during the excavation was a short section of brick wall base, [24], aligned NW-SE across a curved section of the trench near its southern end and close to the existing garden walls. The uppermost portion of the brickwork was *c* 30mm to 45mm below existing

ground level (higher to the north, at *c* 60.05m OD). The surviving masonry measured *c* 660mm long, (extending beyond the limits of the excavation), and 230mm (a single stretcher) wide. The brickwork survived to at least three courses in height (although the base was not observed), but was largely truncated to two lower visible courses. See also Appendix I, Fig.78 for a detailed plan.

Fig.42: Brick wall base [24], looking southeast. This presumably extends up to the existing boundary and appears to represent a continuation of the similarly-aligned wall beyond, which is still largely standing today. 0.5m scale

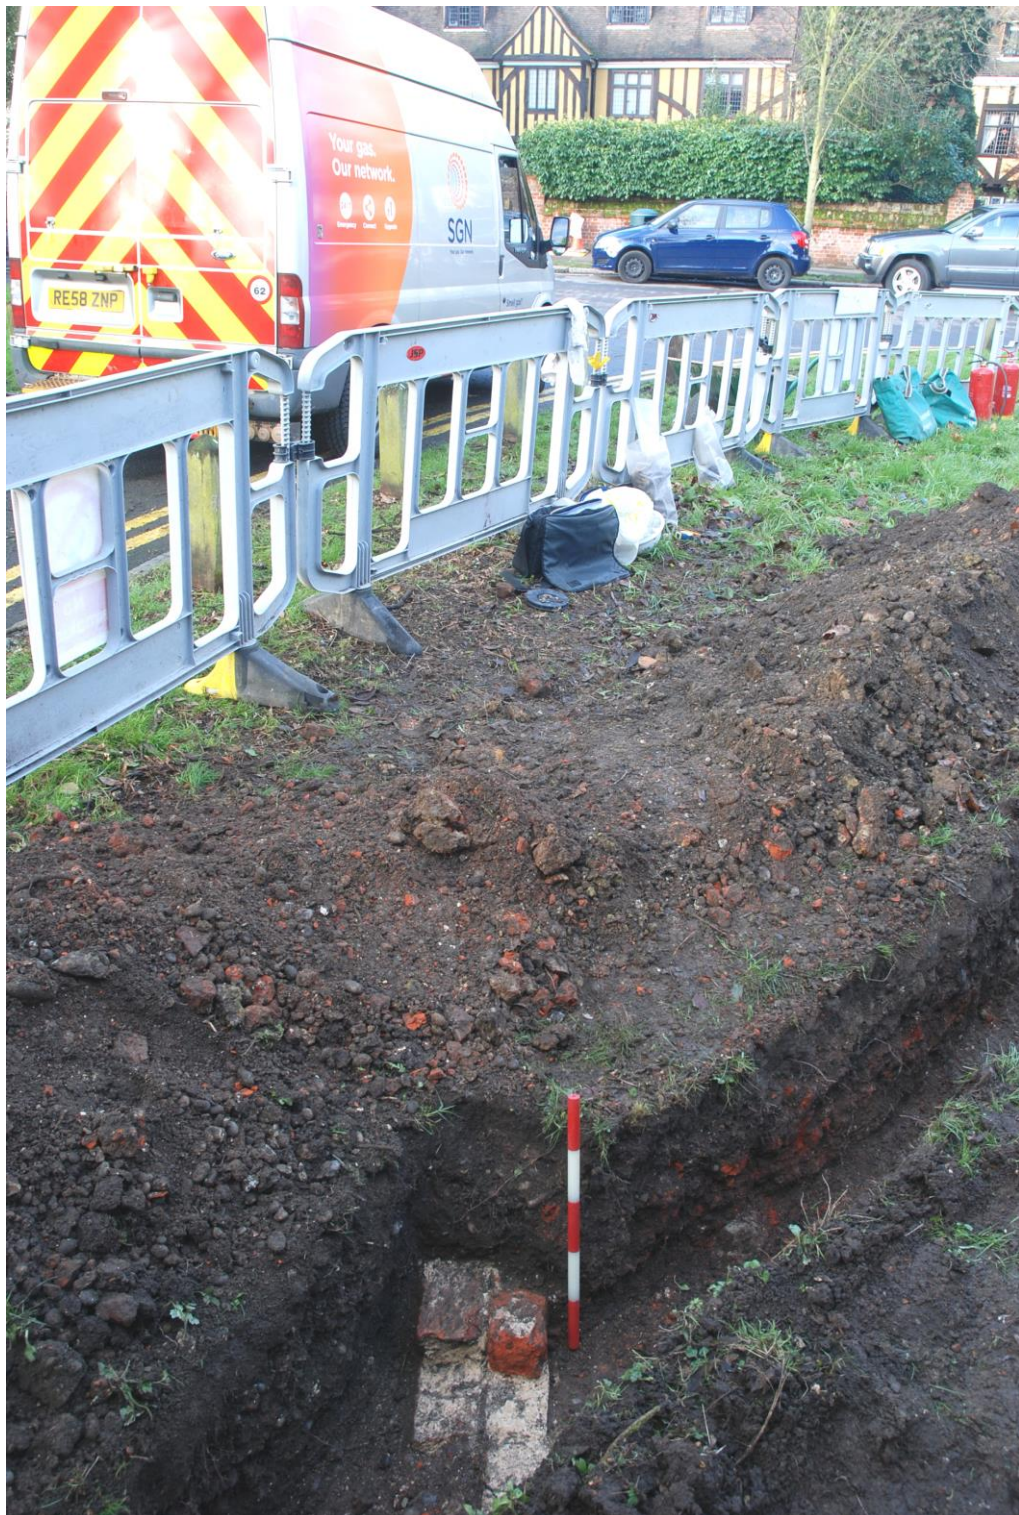
(23), but these contexts also produced a number of pieces of brick very similar to those within the wall itself, which have been uniformly dated to 1450/80-1650 (*cf.* Appendix III).

Fig.43: *Brick wall base [24] looking northwest (0.5m scale), with Court Yard in the background*

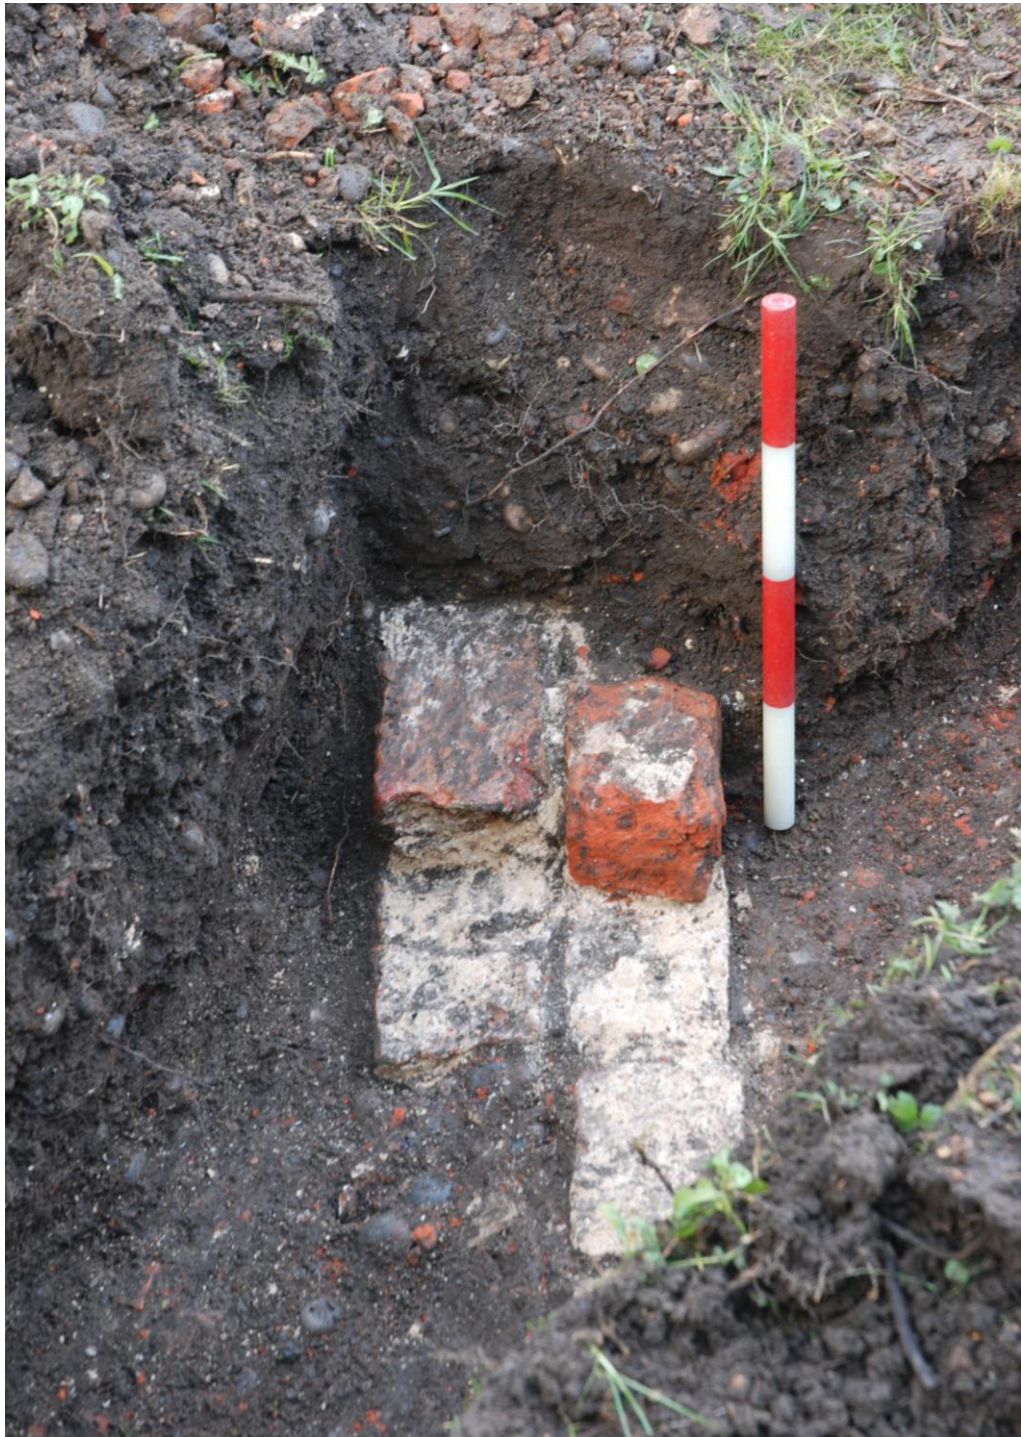
Fig.44: *Detail shot of the wall base [24] facing NW, 0.40m scale*

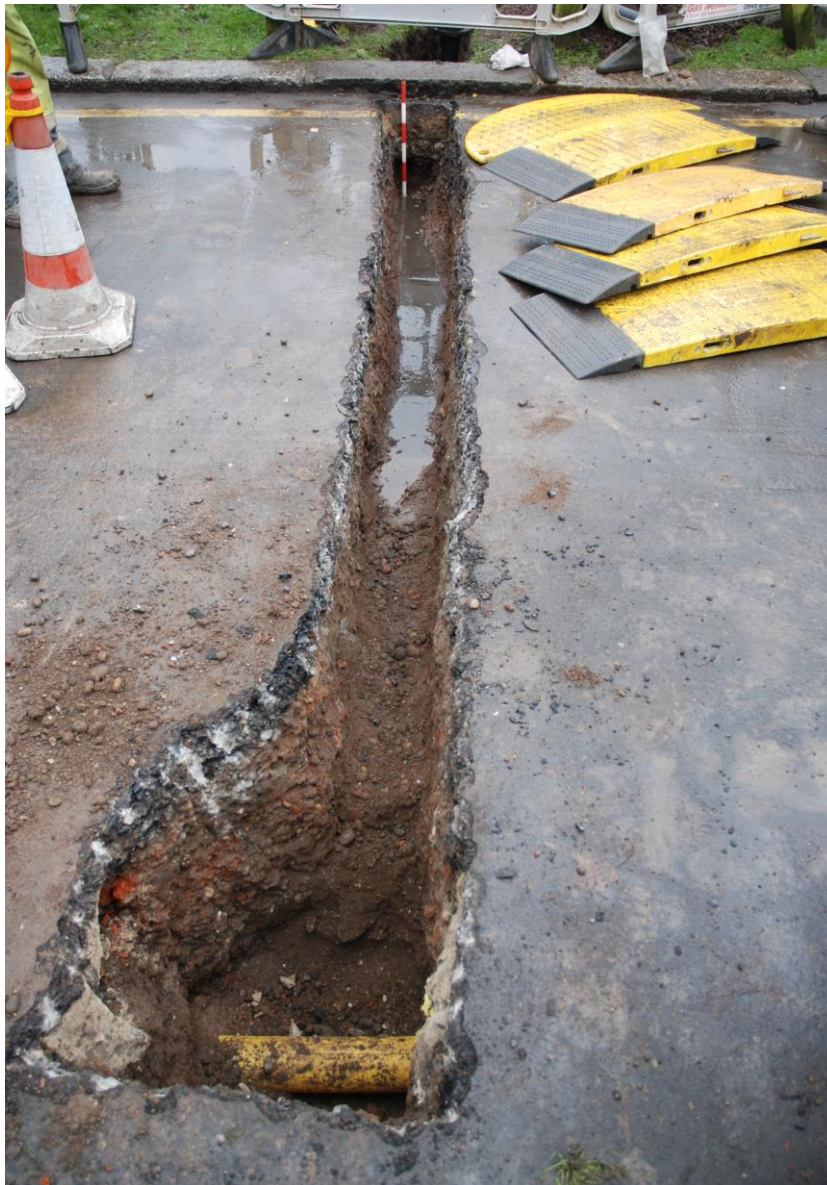
Fig.45: *Gas connection trench on the 19<sup>th</sup> January, facing NW, 0.6m scale*

At the far northern end of the trench (foreground above) the excavation was somewhat deeper in order to expose the existing gas main, but this was through previously disturbed ground and did not reveal any archaeological remains.

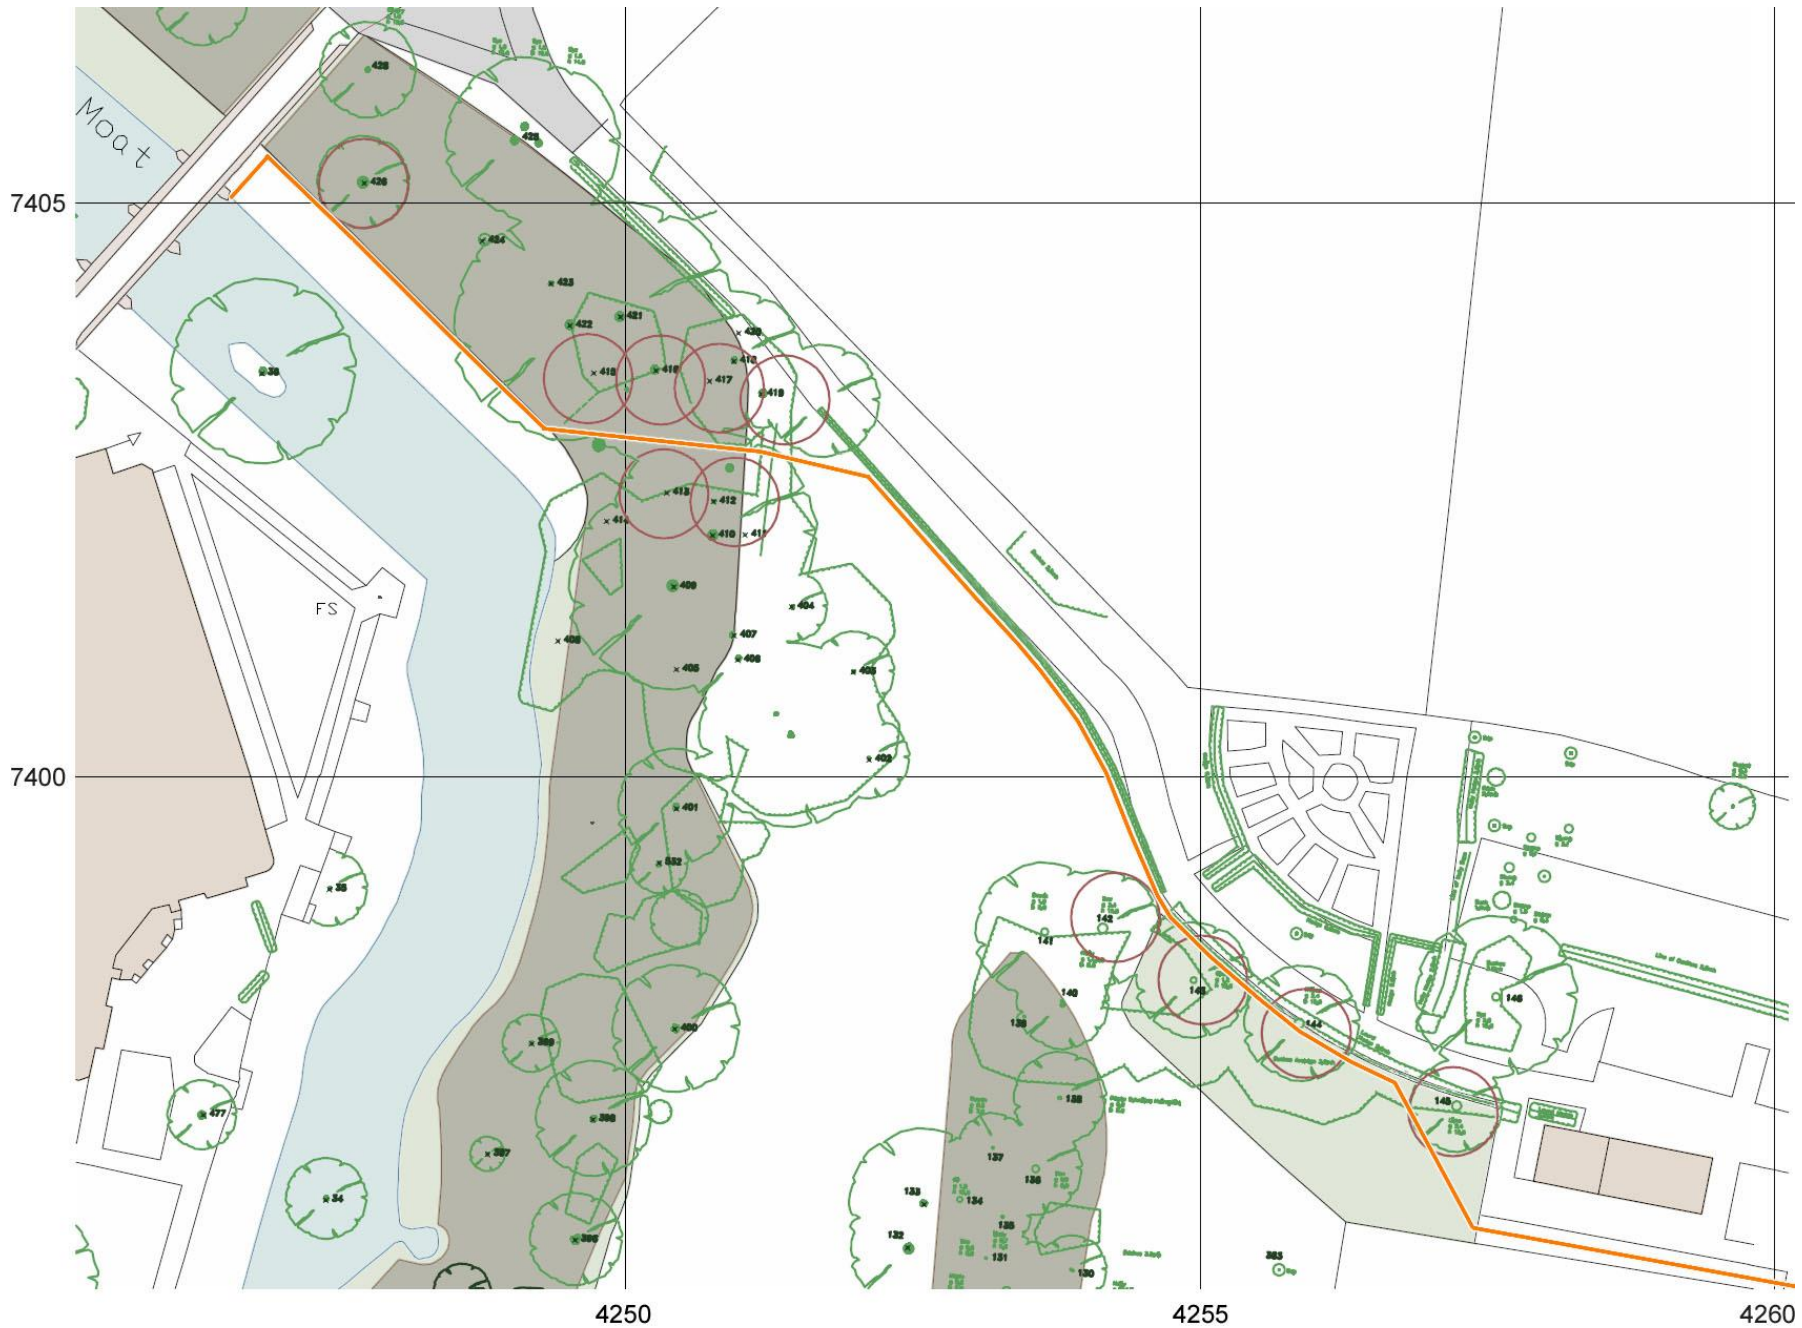
Fig.46: The route of the I.T trench (marked orange)

The line of the I.T trench shown overleaf, with descriptive text and illustrations following. More detailed plans of the principal features are included in Appendix I, figs.80 & 81.

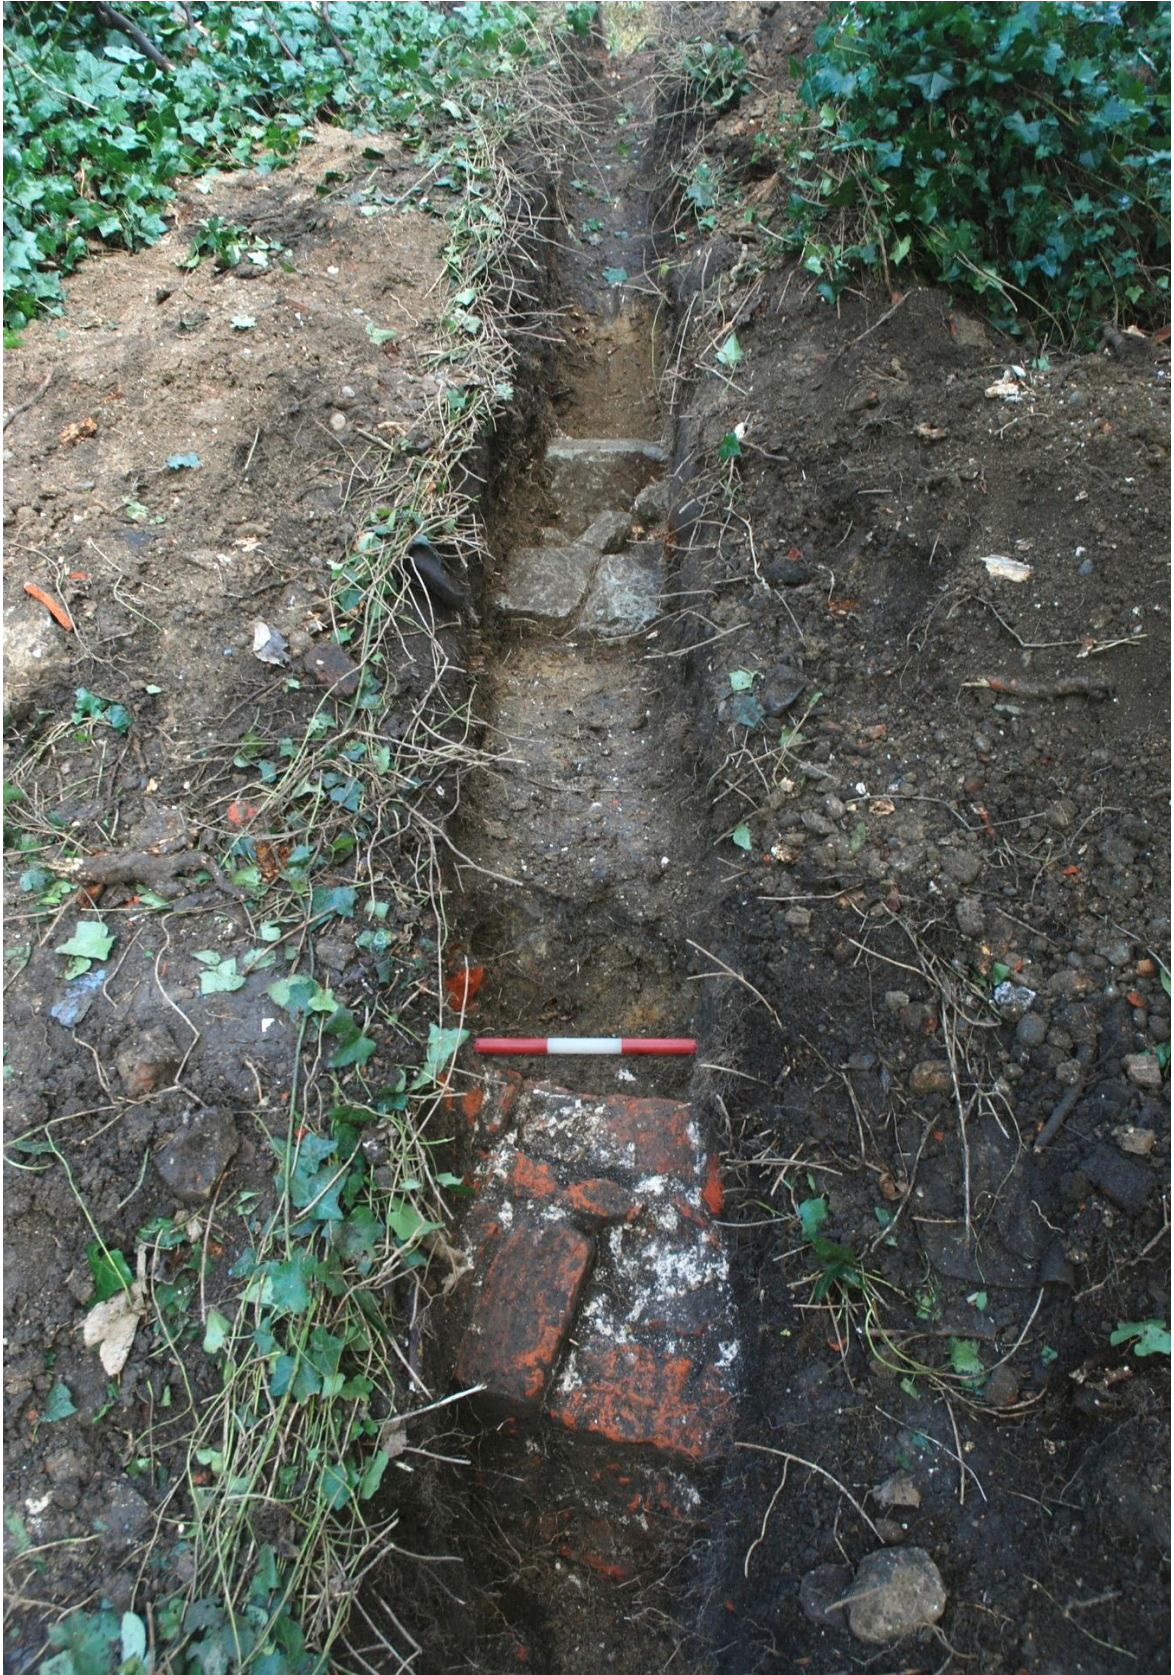
Fig.47: Wall base [10], (foreground), and unmortared stone wall base [11] beyond, looking NE and towards the top of the moat bank (0.30m scale)
