# **A SERIES OF ARCHAEOLOGICAL WATCHING BRIEFS AT ELTHAM PALACE**

**LONDON BOROUGH OF GREENWICH, SE9 5QE**

**NOVEMBER 2015**

SITE CODE: ELT13

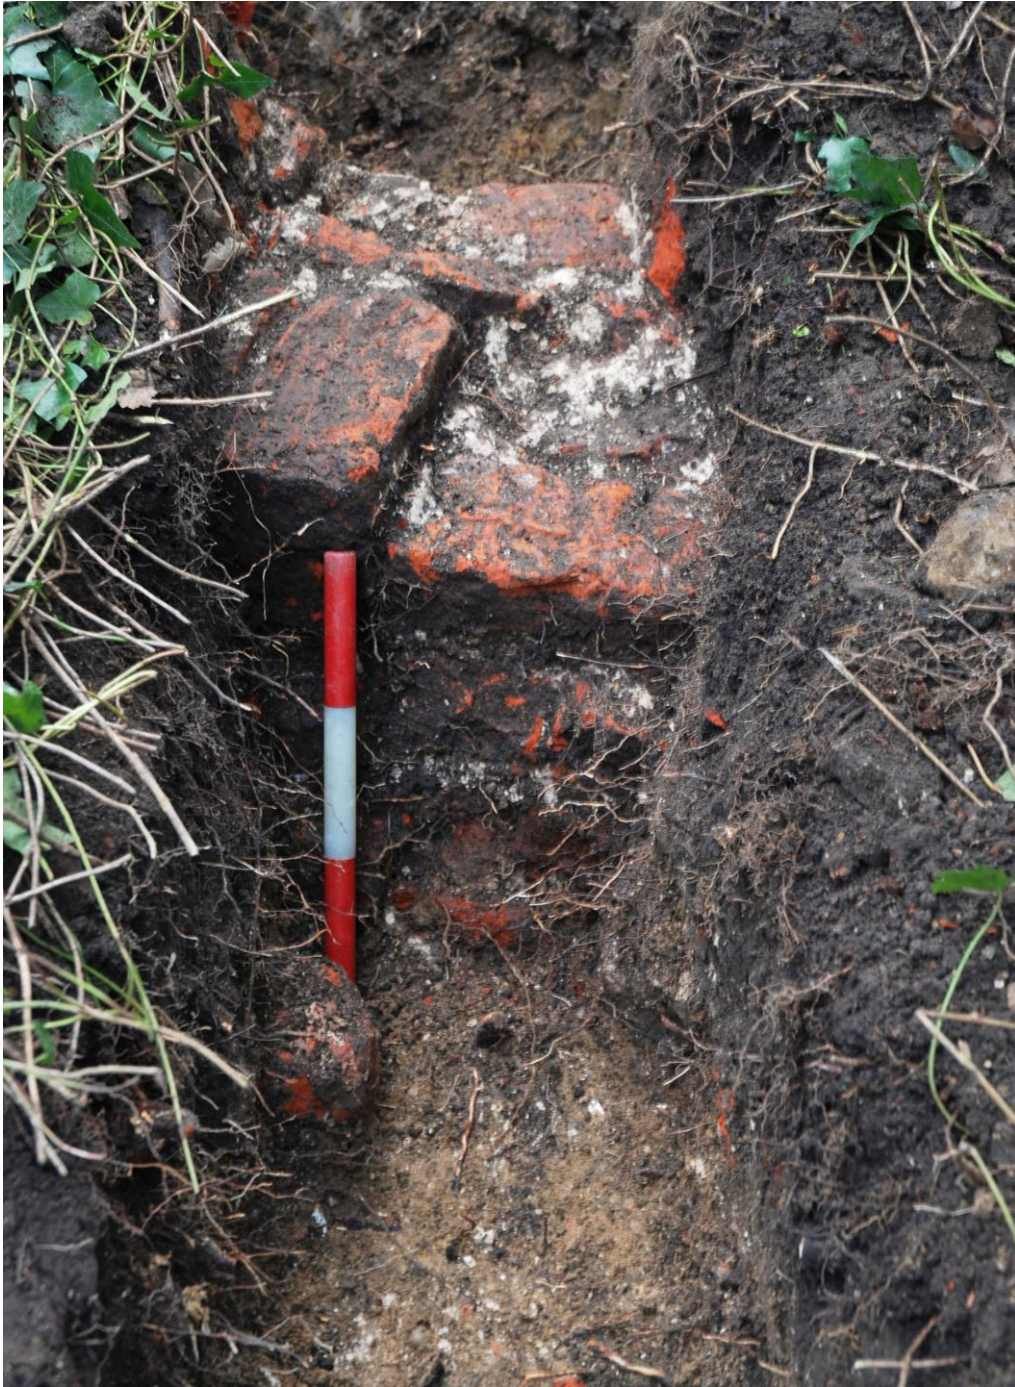
Fig.48: *Wall base [10], southwest face. (0.30m scale)*

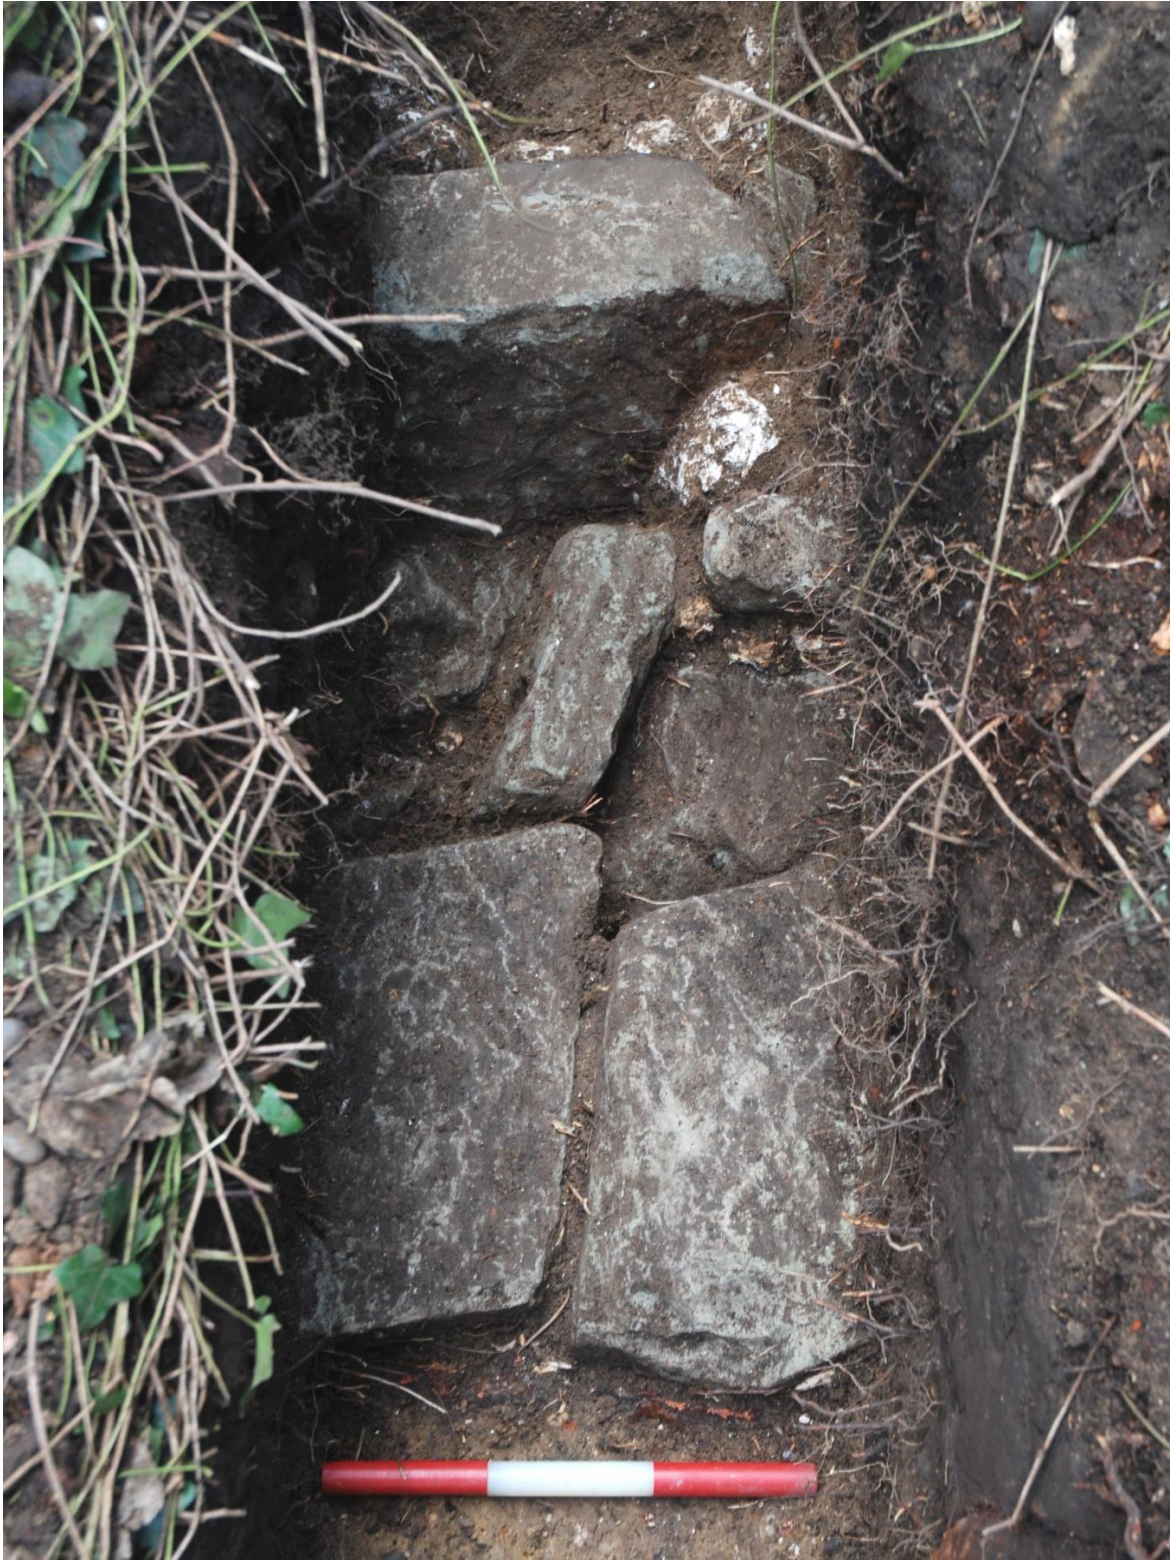
Fig.49: *Detail of wall base [11], facing NE, (0.30m scale)*

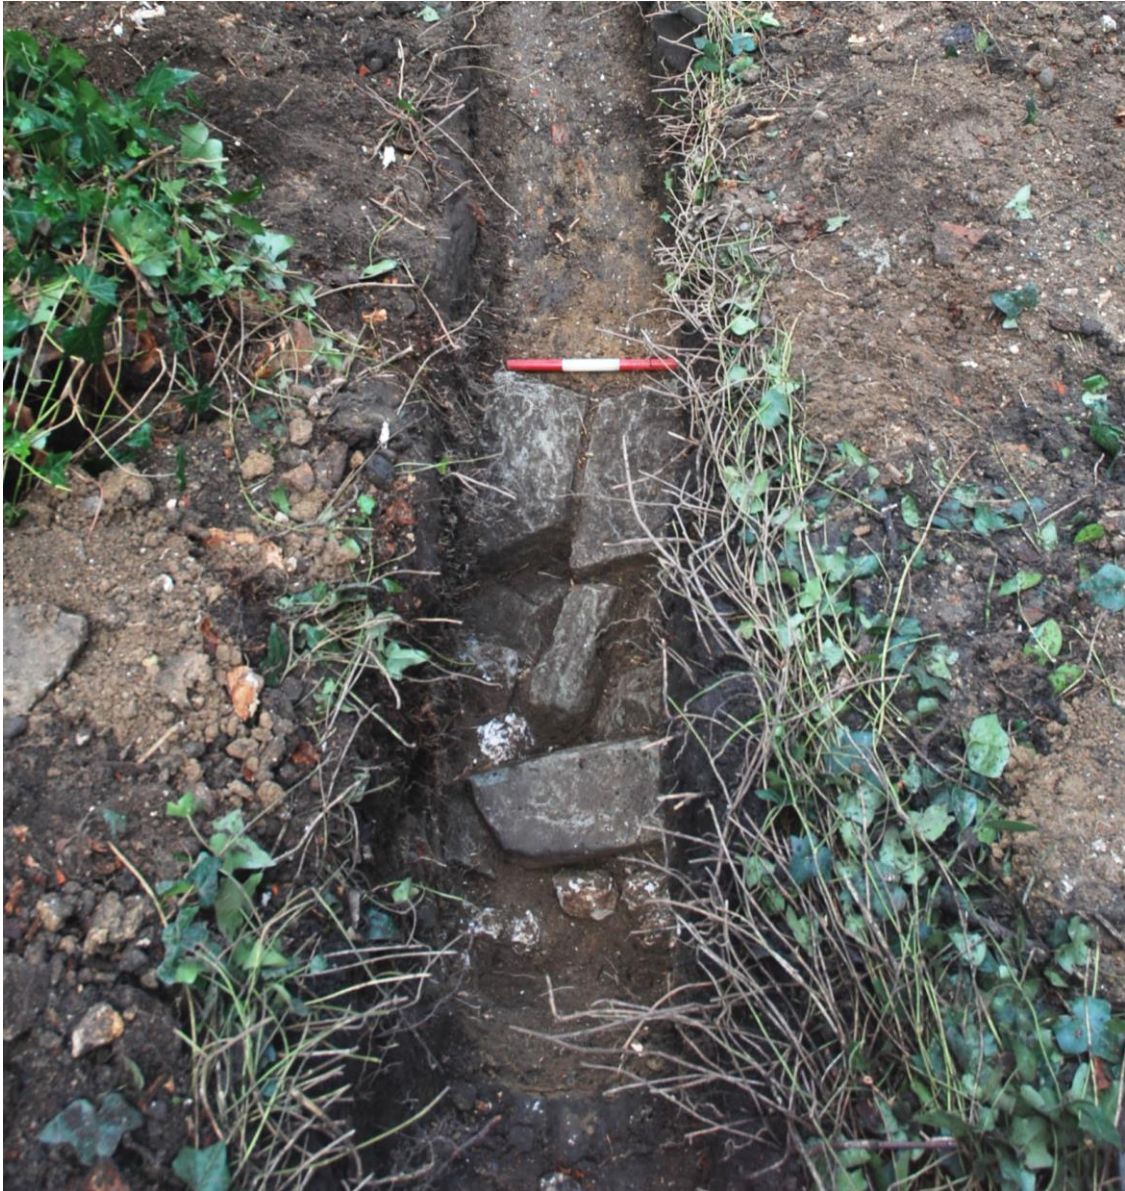
Fig.50: Wall base [11], looking down the moat bank to the southwest

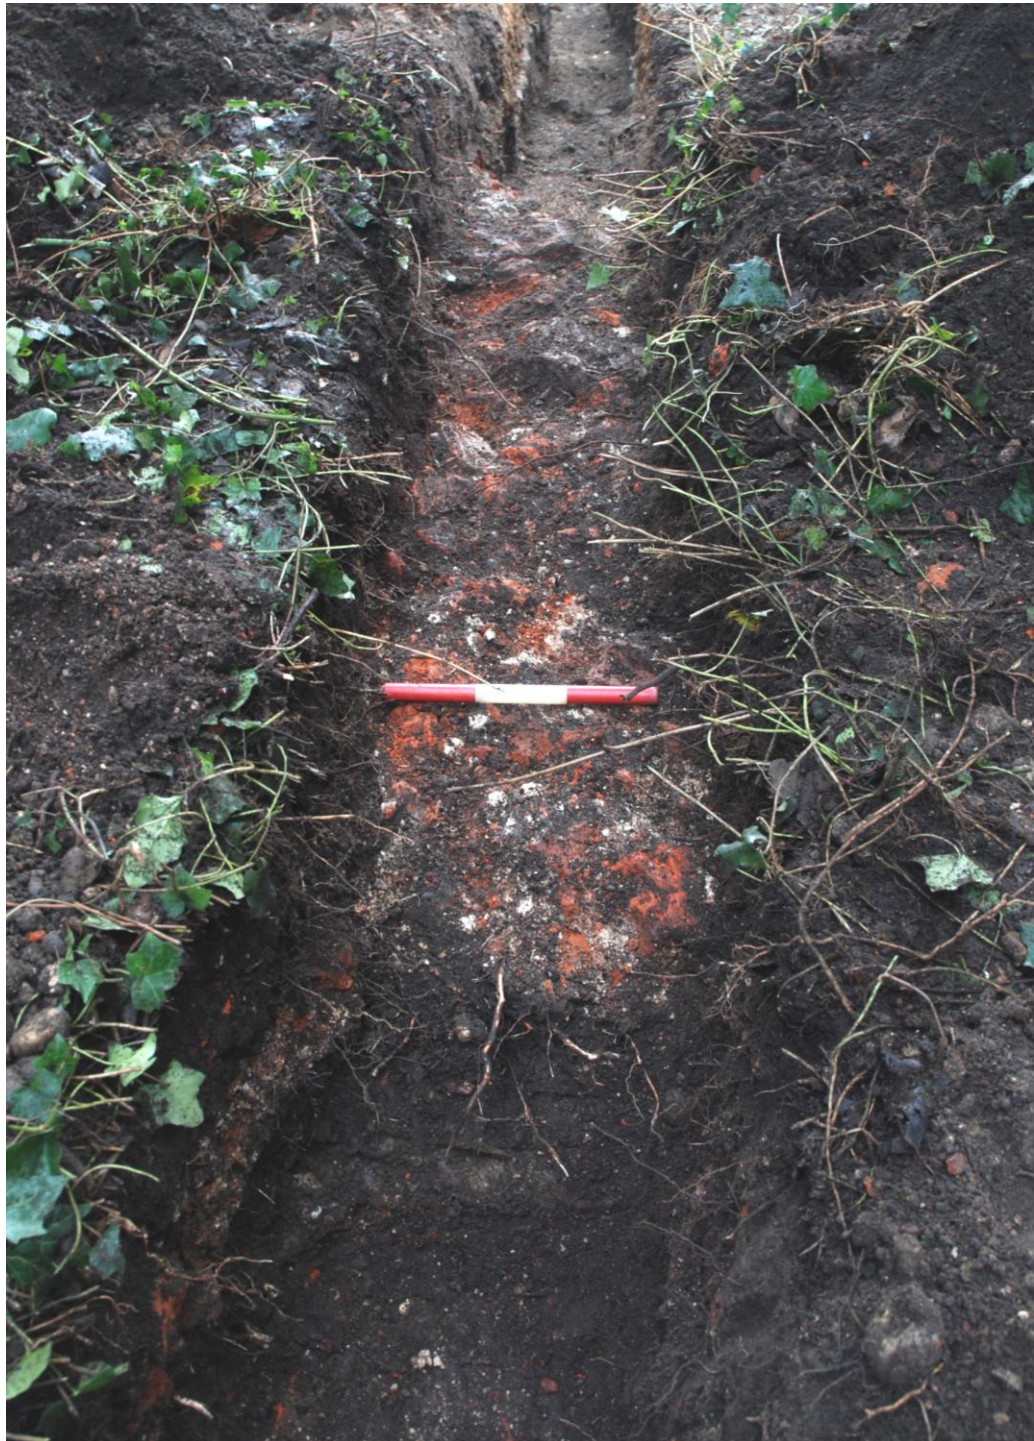
Fig.51: *Former path, (9), facing SW, downslope, (0.30m scale)*

- 6.4.7** Beyond the eastern edge of the garden path, (9), deposit (2) overlay a dark-brown silty-clay containing occasional crushed, residual probable medieval CBM, 19<sup>th</sup> century pottery and roots. This deposit, although physically separated from the western side of the trench by the former path was considered to be the same as deposit (3). At the far eastern end of this stretch (& some 4.2m southeast of the present gateway) the trench turned to the

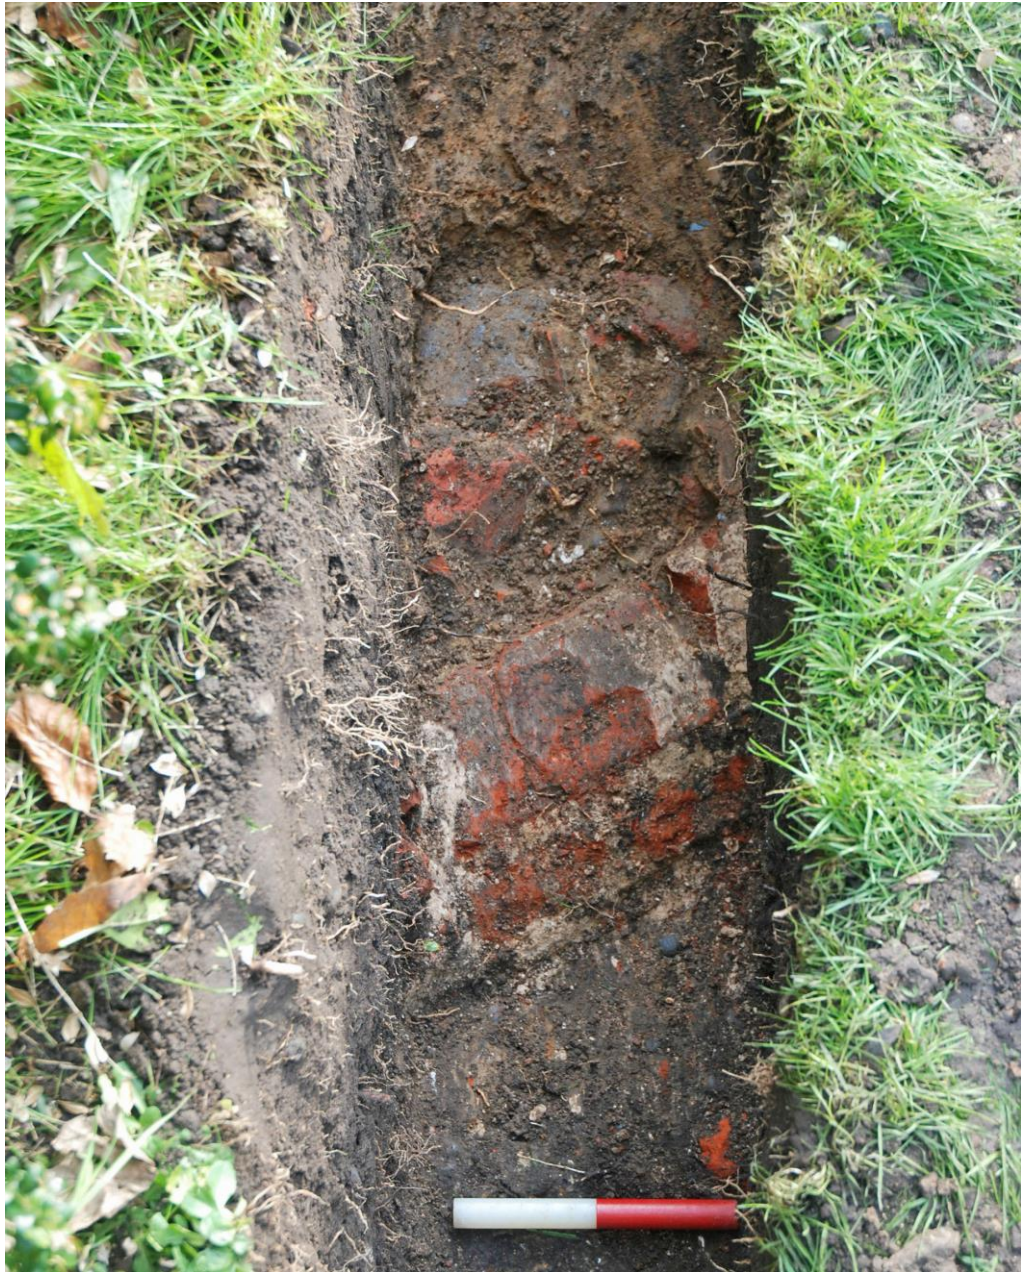
Fig.52: *Wall base [7], overhead view with SE to top of frame (0.20m scale)*

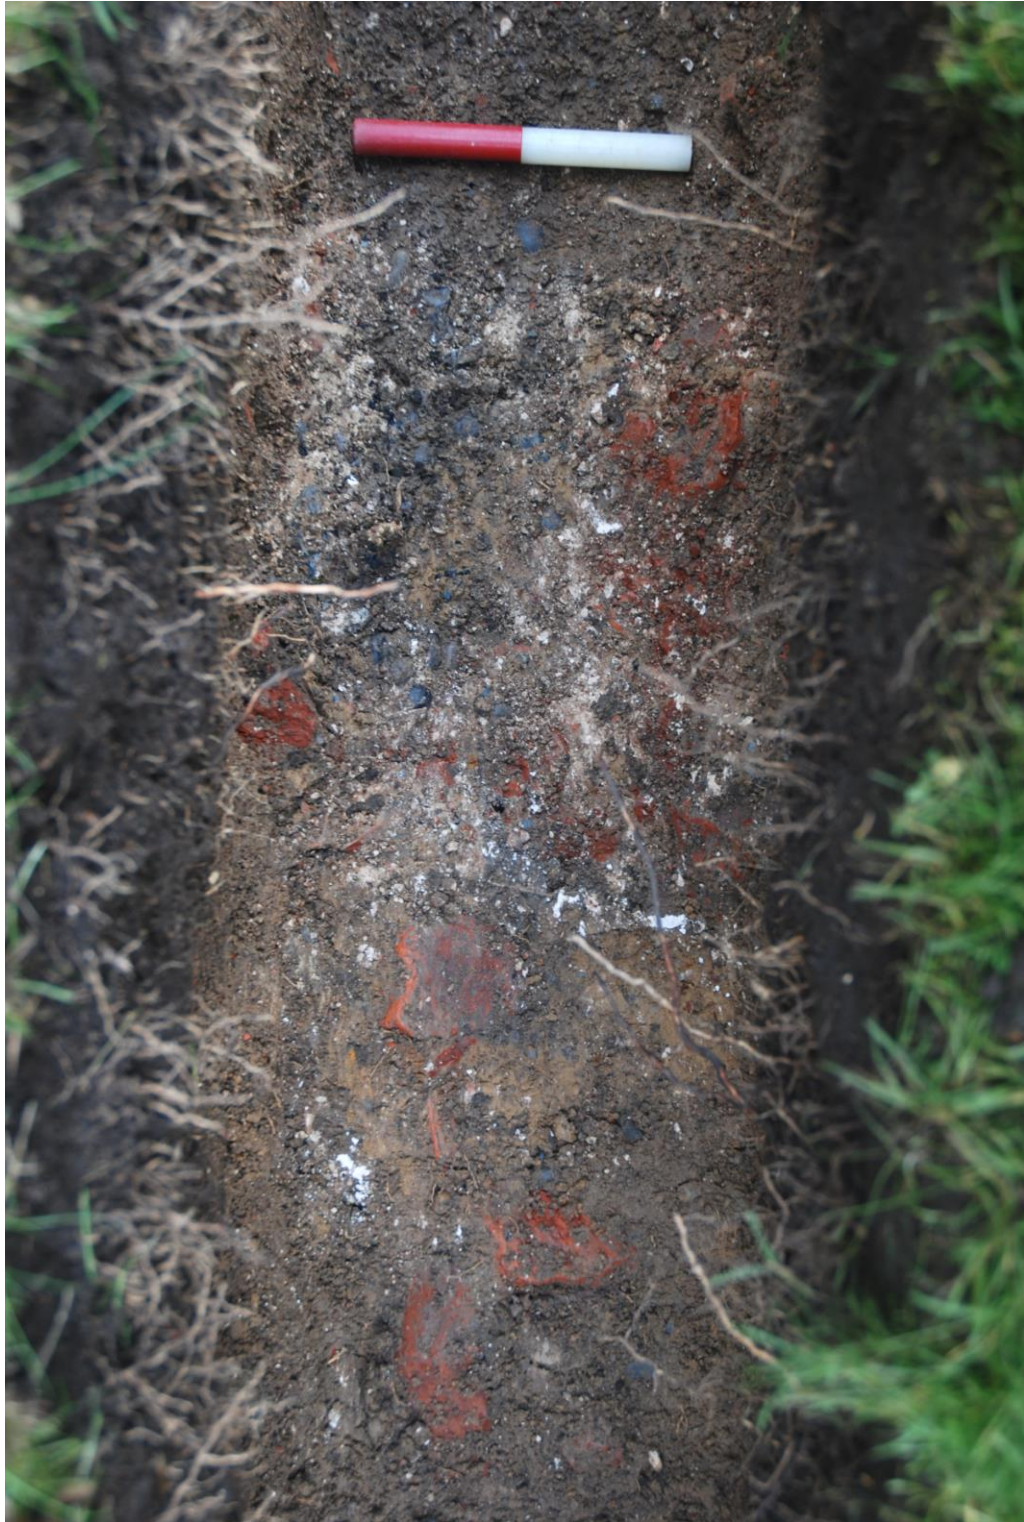
- 6.4.10** Another 2.30m southeast from wall base [7] were the remnants of possible further brick wall footing (or more likely robbed-out foundation) [12], comprising crushed CBM, mortar, some charcoal and small rounded pebbles. This feature was *c* 370mm wide and disappeared into both sections of the

Fig.53: *Possible robbed-out wall footing [12], overhead view with SE to top (0.20m scale)*

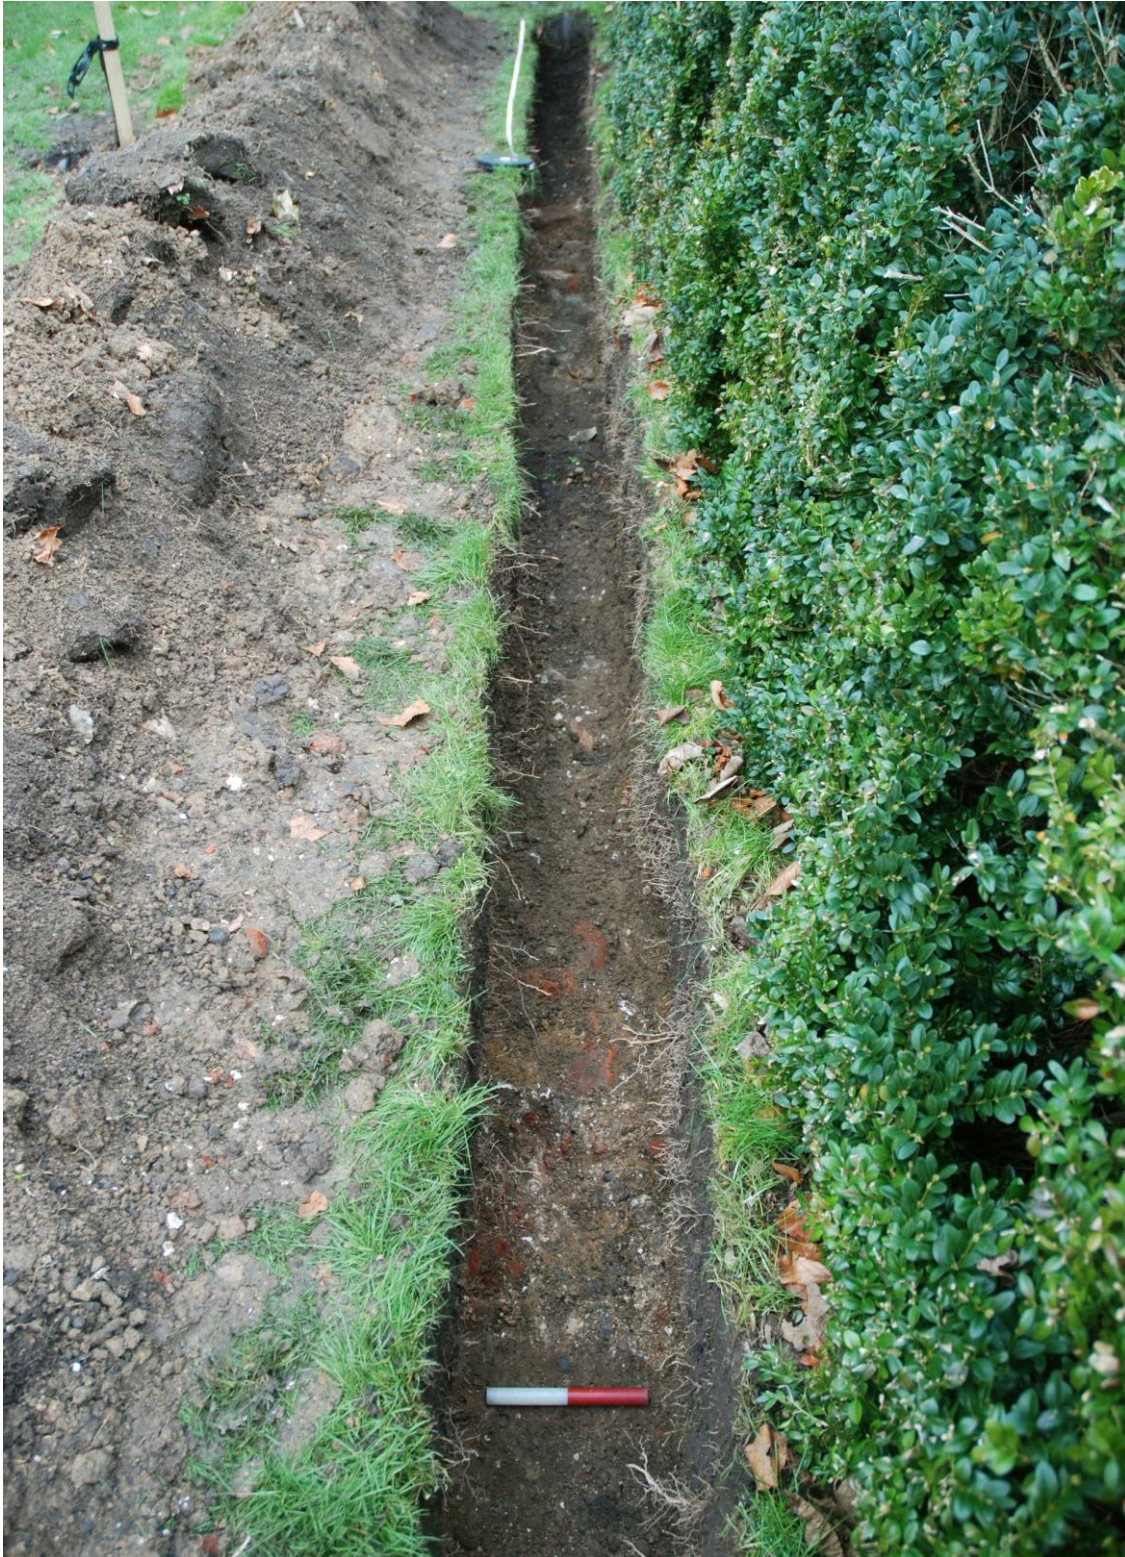
Fig.54: *General view of the cable trench looking northwest; possible robbed-out wall footing [12] in the foreground, just beyond the 0.20m scale*

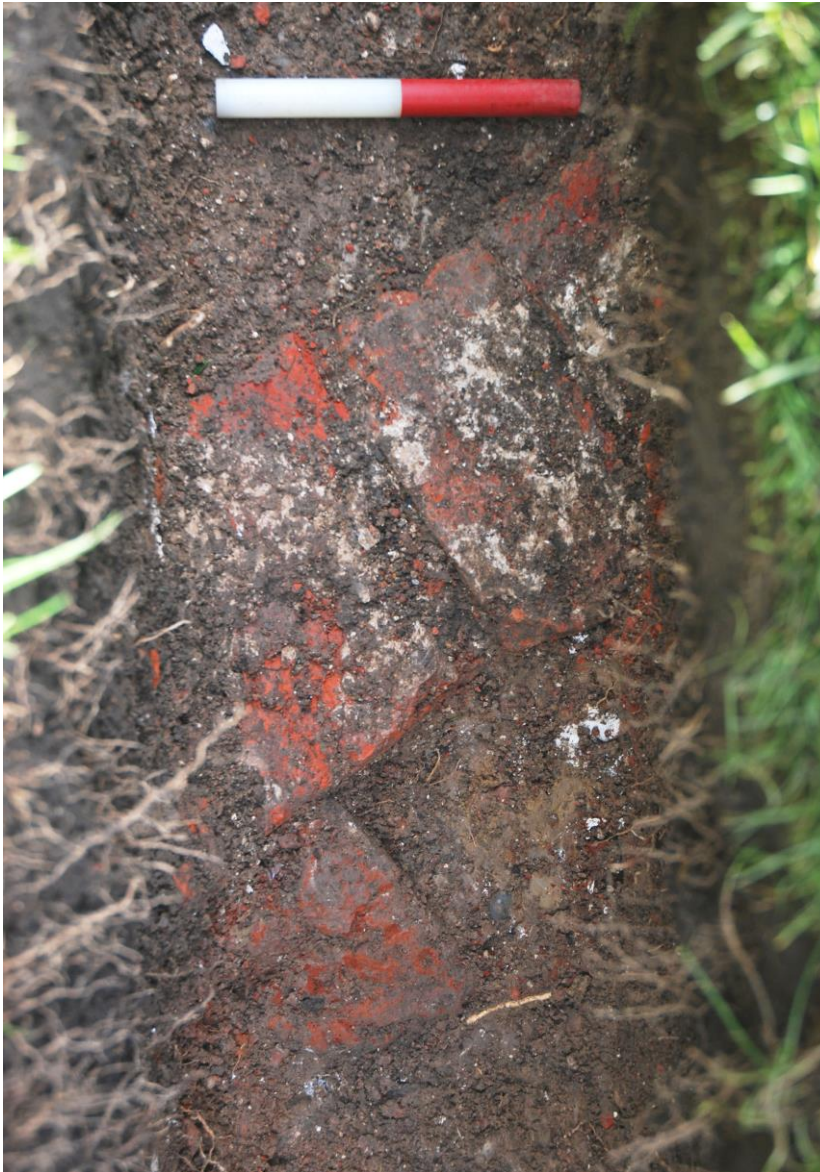
*Fig.55: Overhead view of wall base [13]; SE at top of frame (0.20m scale)*

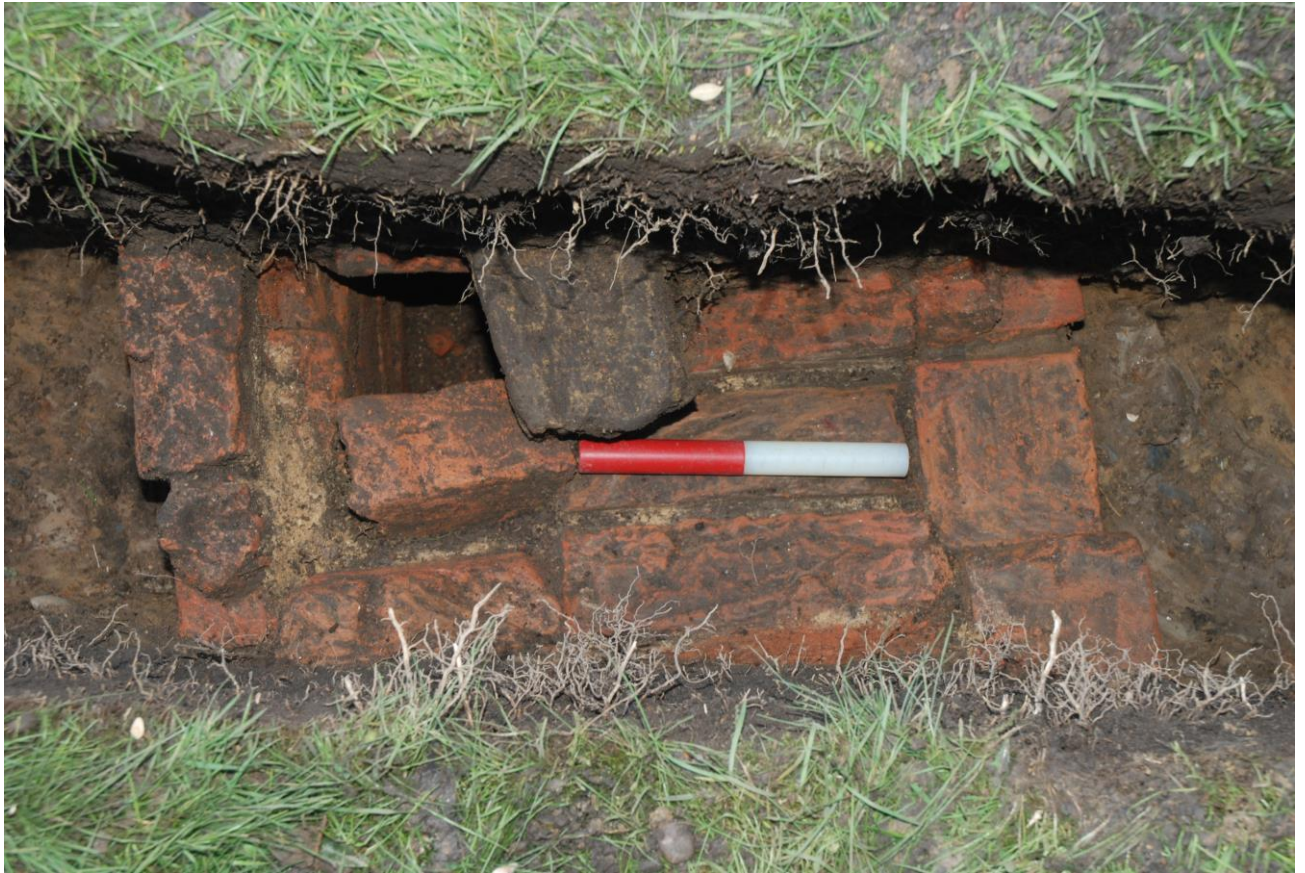
Fig.56: *Brick-lined drain [14], overhead view with SW to top of frame, (0.20m scale)*

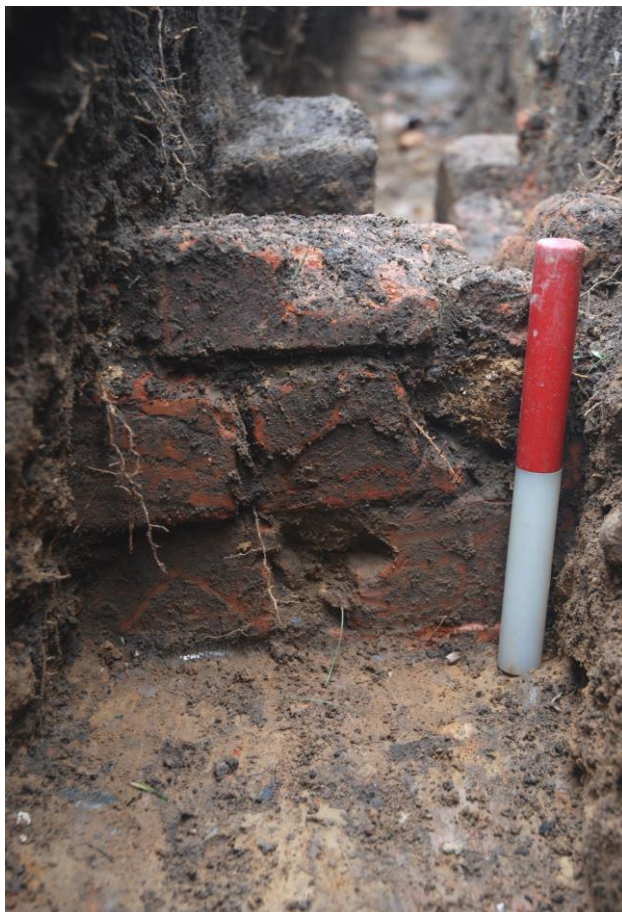
Fig.57: *Drain [14], eastern side, facing NW along base of trench, (0.20m scale)*

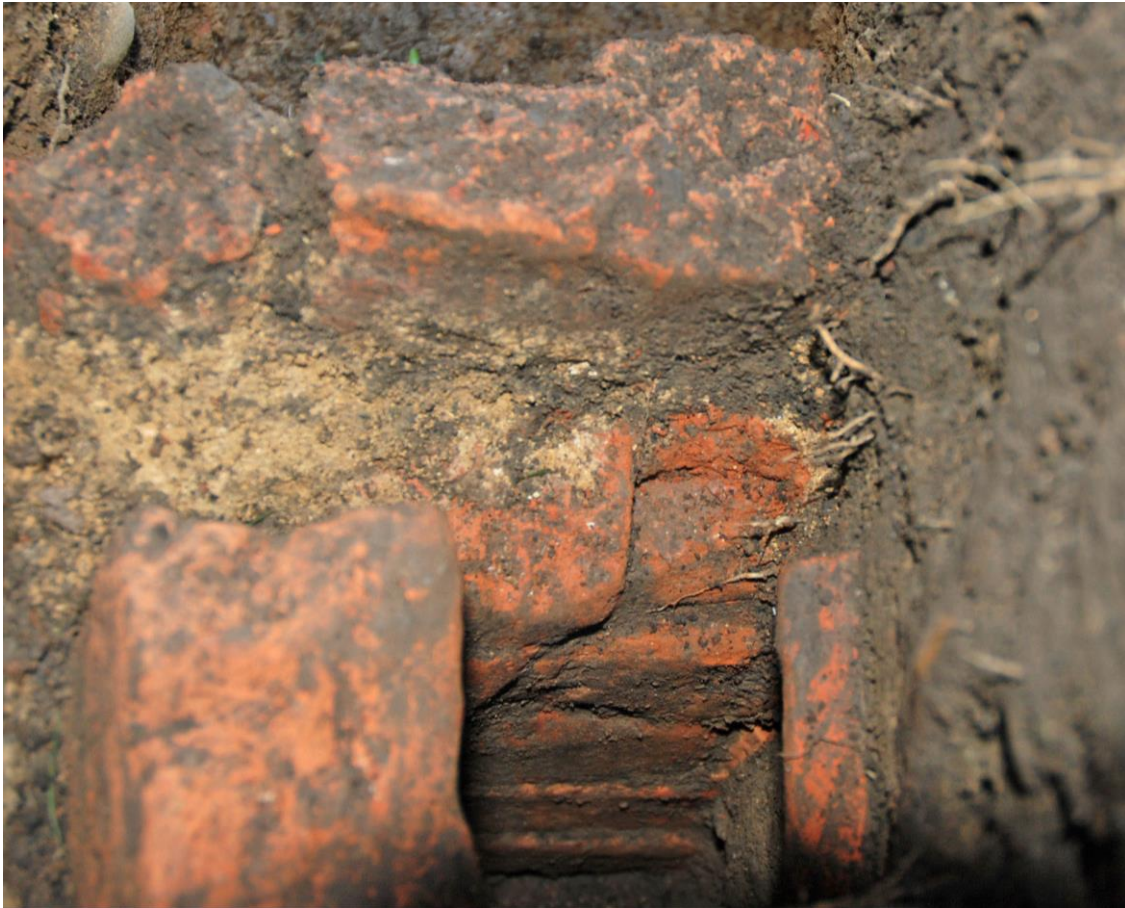
Fig.58: *Detail of the interior of drain [14], southeast side*

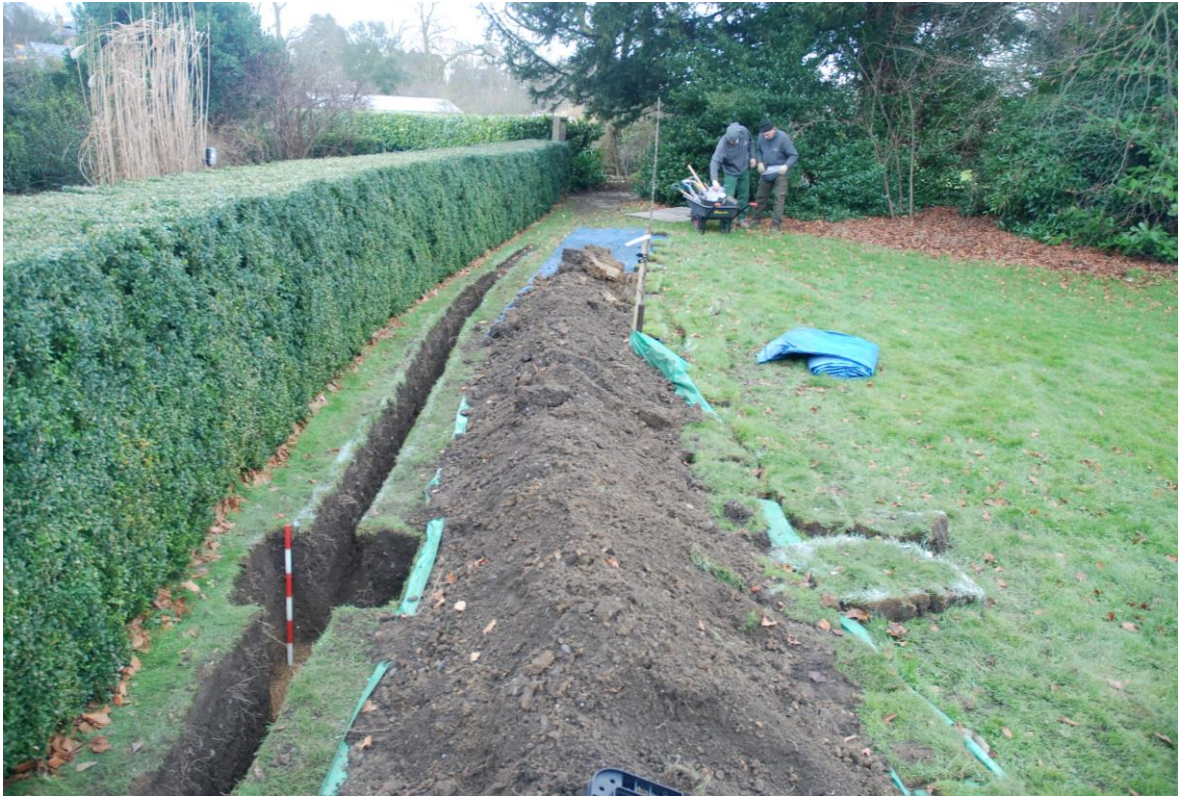
*Fig.59: Looking SE approximately at the mid-point of the I.T trench (& just to the E of the brick-lined drain [14]), the larger cut for a cable draw pit in the left foreground*

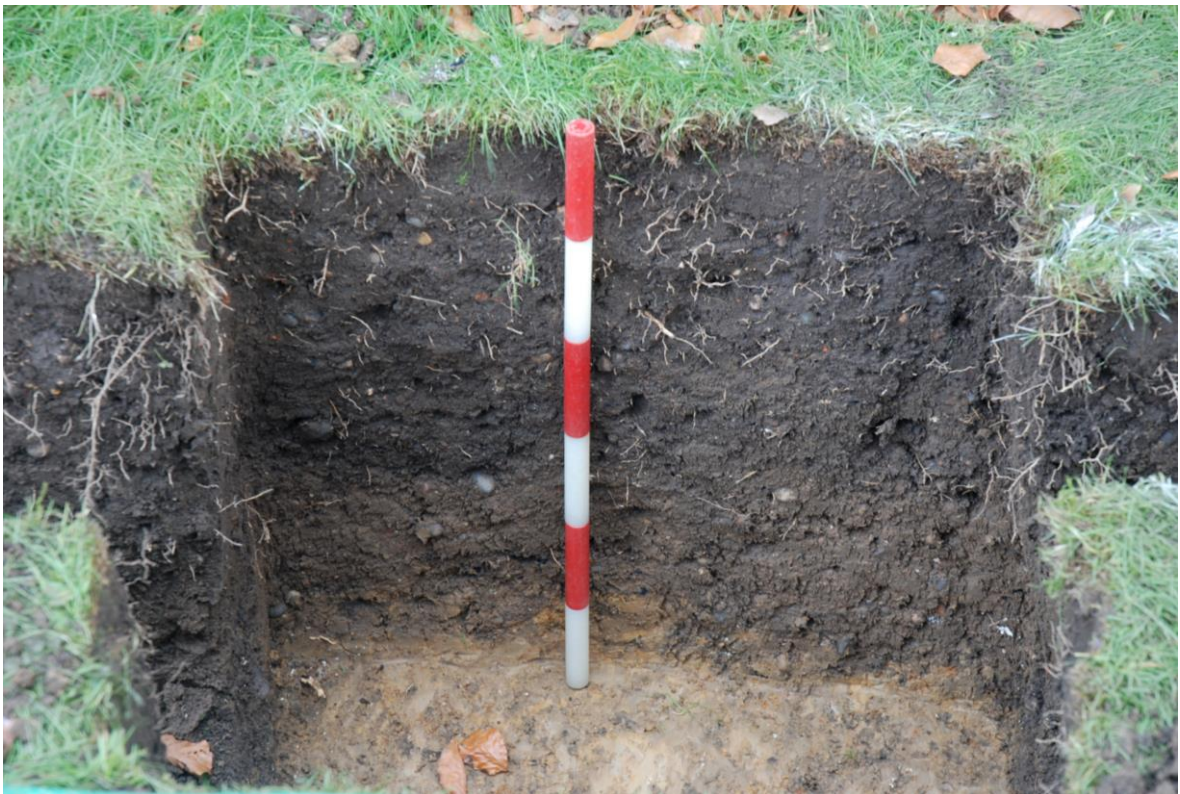
*Fig.60: Detail of the SW-facing section of the cable draw pit (0.60m scale)*

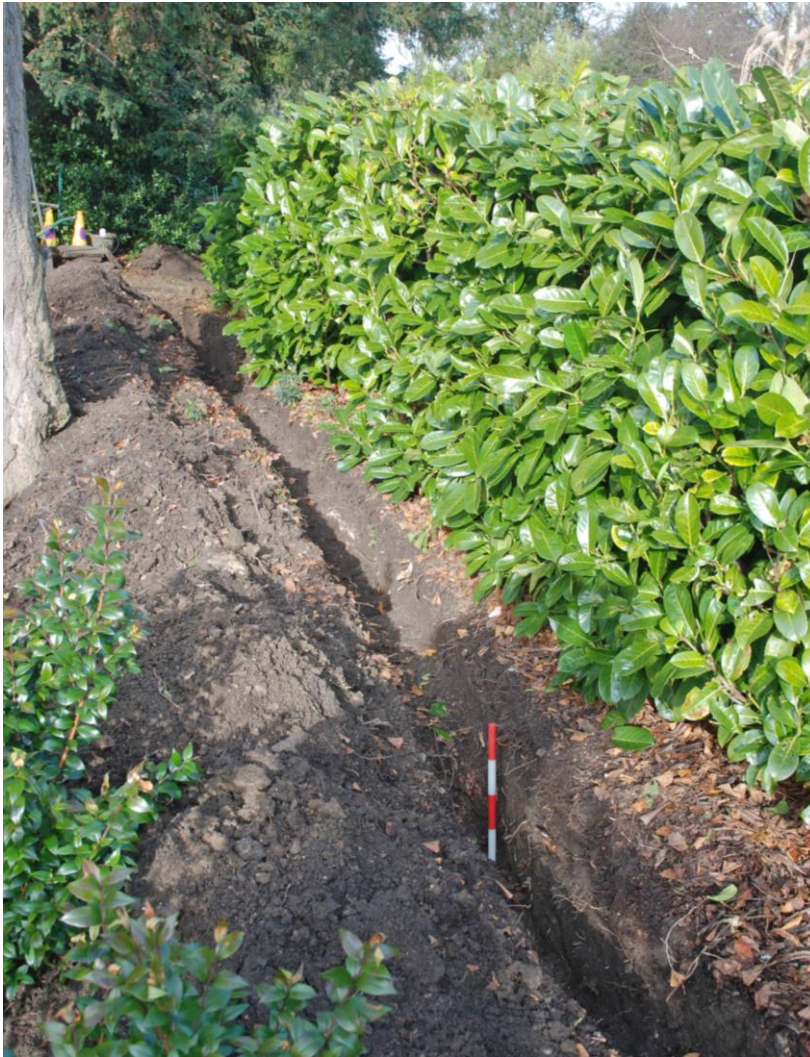
Fig.61: *Looking roughly northwest & towards the second gate (0.4m scale)*

- 6.4.14** Further to the southeast and beyond the second gate through the hedge the ground dropped slightly (to *c* 60.0m OD), though the topsoil also became deeper (*c* 350mm to 400mm), being more heavily reworked and disturbed by root action. Below this deposits become slightly lighter and more silty,

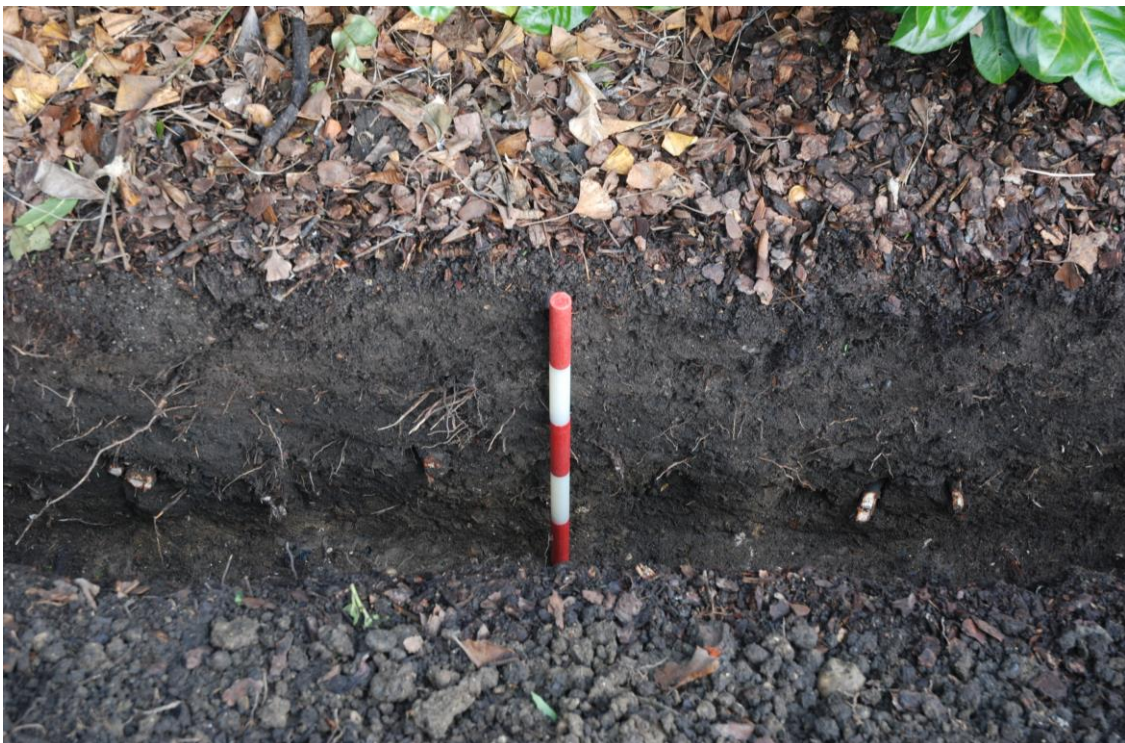
Fig.62: *Detail of southwest-facing section (0.50m scale)*

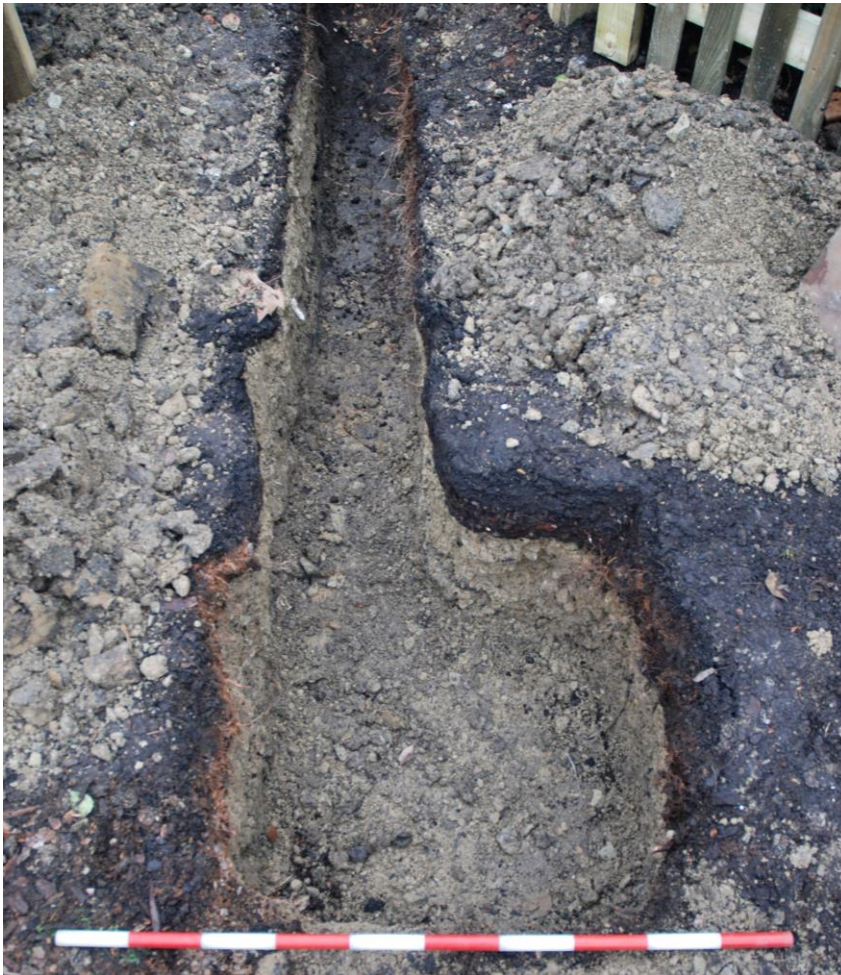
Fig.63: *Looking west with gateway to the garden at the top of the frame (1.0m scale)*

**6.4.15** Towards the eastern end of the hedge line the trench turned southwards to run through the gateway leading to the former Tennis Pavilion; there was also a further slight drop in level, to about 59.5m OD. It then ran west-east just in front of the Pavilion, and across the adjacent pathway into the new Visitor centre. Excavations in these areas revealed only heavily disturbed and made ground, the Pavilion itself being built up on a raised terrace.

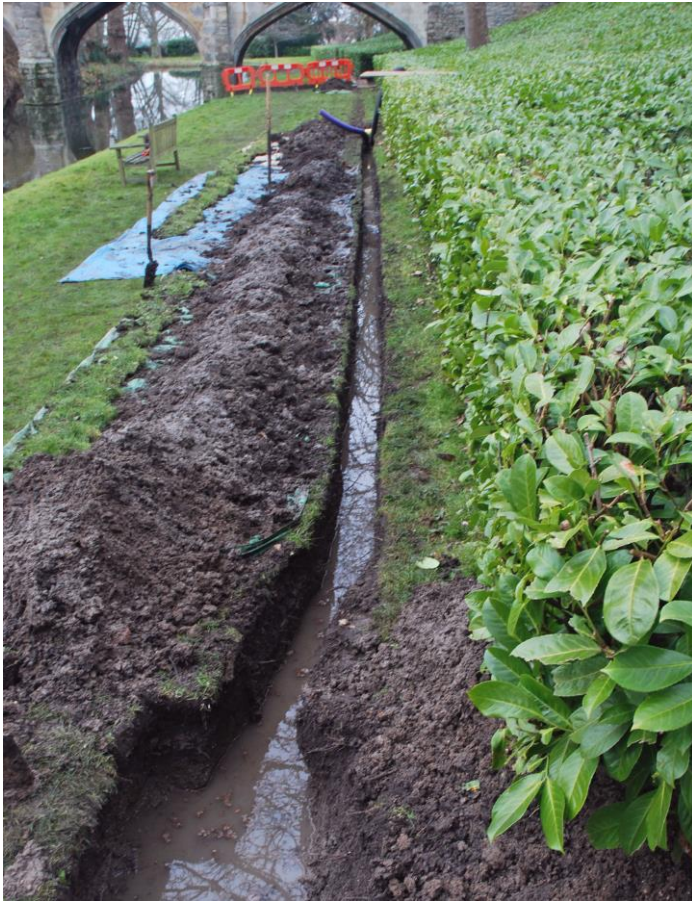
Fig.64: *View of cable trenching alongside the moat, looking northwest towards the Bridge*

**6.4.16** At its western end and from the base of the moat bank (6.4.4 above) the cable trench was excavated to the northwest, parallel with and about 5.5m from edge of the moat itself.

No significant archaeological features or remains were revealed in this area. The ground was very wet (see photos overleaf) but was largely a dark topsoil (c 200mm) over slightly lighter and more mixed material. From the mains water pipe investigations on the other side of the bridge (see 6.6 below) it seems most likely this lower material represented quite recent made ground, most likely dating to the refurbishment of the estate in the 1930s.

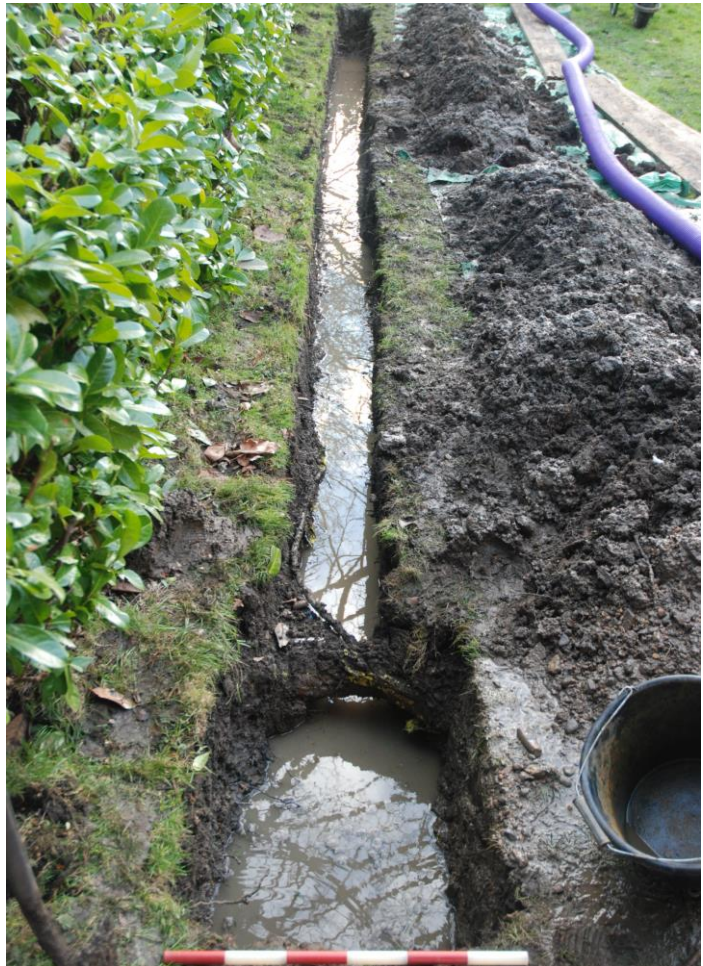
Fig.65: *View of the trench from the Bridge end and looking southeast (0.60m scale)*

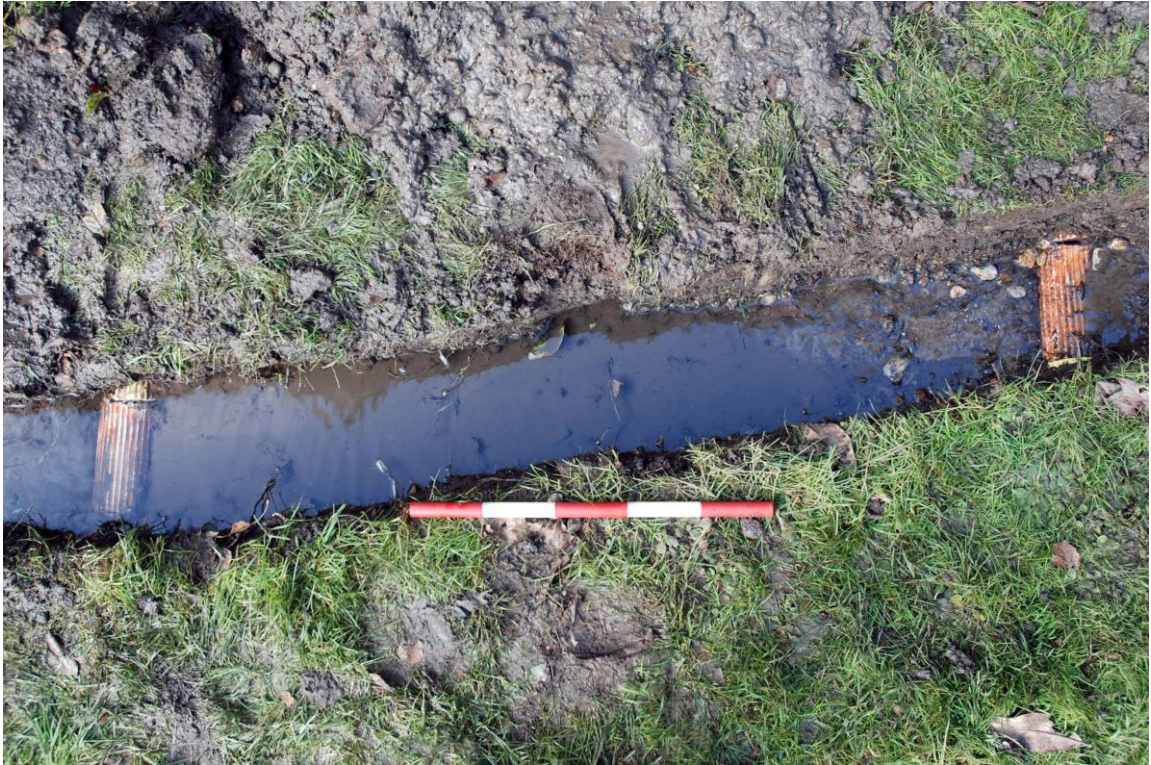
*Fig.66: Parallel ceramic land drains running alongside the moat: view from above with NW to top of the frame (0.50m scale)*

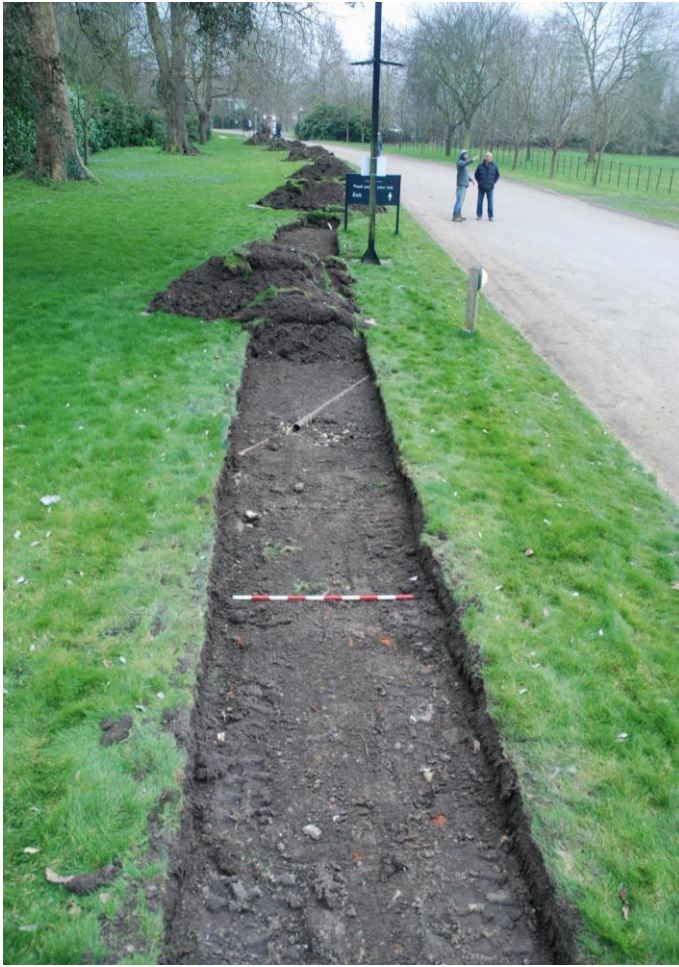
Fig.68: *Looking south from the northern end of the new pathway (1.0m scale)*

- 6.5.3** Although no archaeological features or deposits were exposed two areas should be mentioned. Towards its northern end the stripping revealed a continuous line of made ground on the western side of the trench, over a distance of nearly 40m. It is most likely that this represents backfill within a 50m north-south archaeological evaluation trench that was dug in 1996 (Oxford Archaeological Unit 1996). The trench itself is recorded as being about 0.5m deep, and revealed two minor and apparently post-medieval features (*ibid.* 8; see also Figs. xx below).
