# **A SERIES OF ARCHAEOLOGICAL WATCHING BRIEFS AT ELTHAM PALACE**

**LONDON BOROUGH OF GREENWICH, SE9 5QE**

**NOVEMBER 2015**

SITE CODE: ELT13

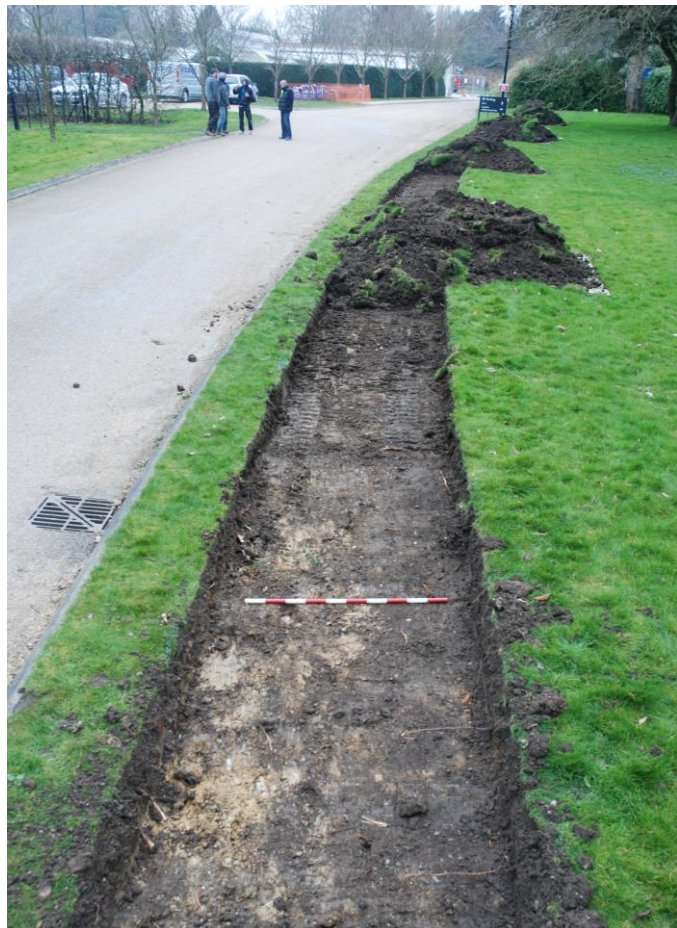
Fig.69: *The same area viewed from the opposite direction, the Visitor Centre at top right*

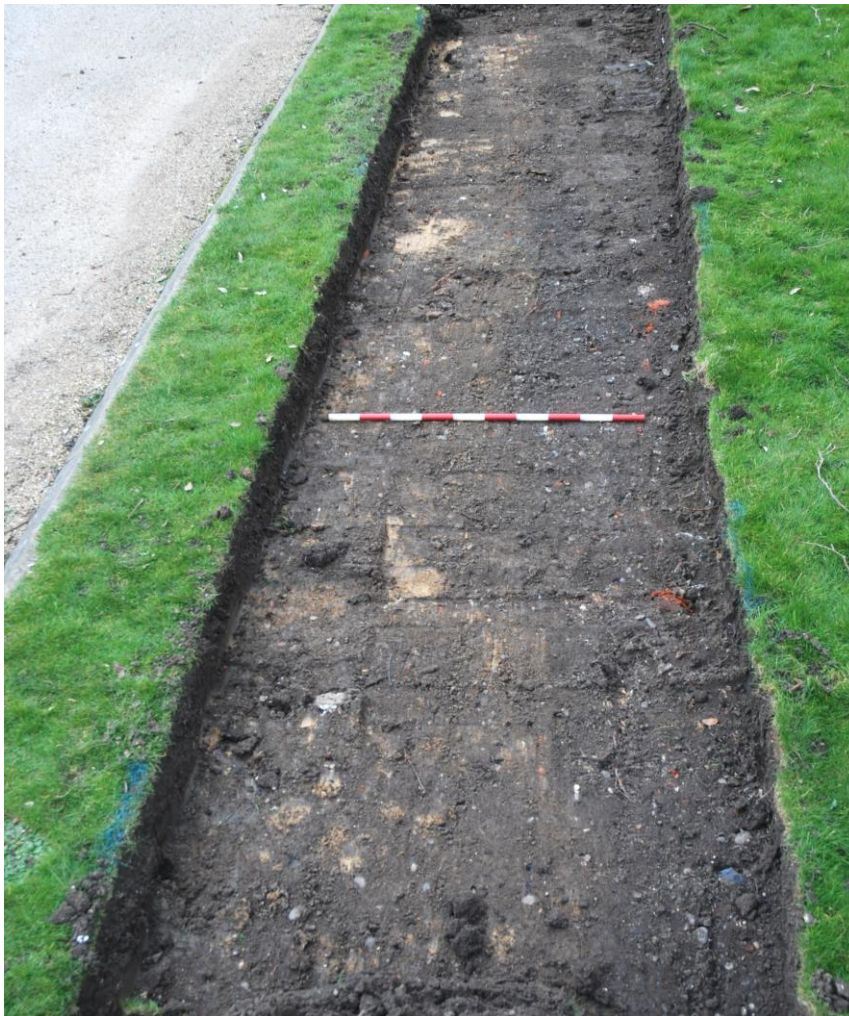
Fig.70: *Detail of topsoil stripping between the two previous figures, looking north (1.0m scale)*

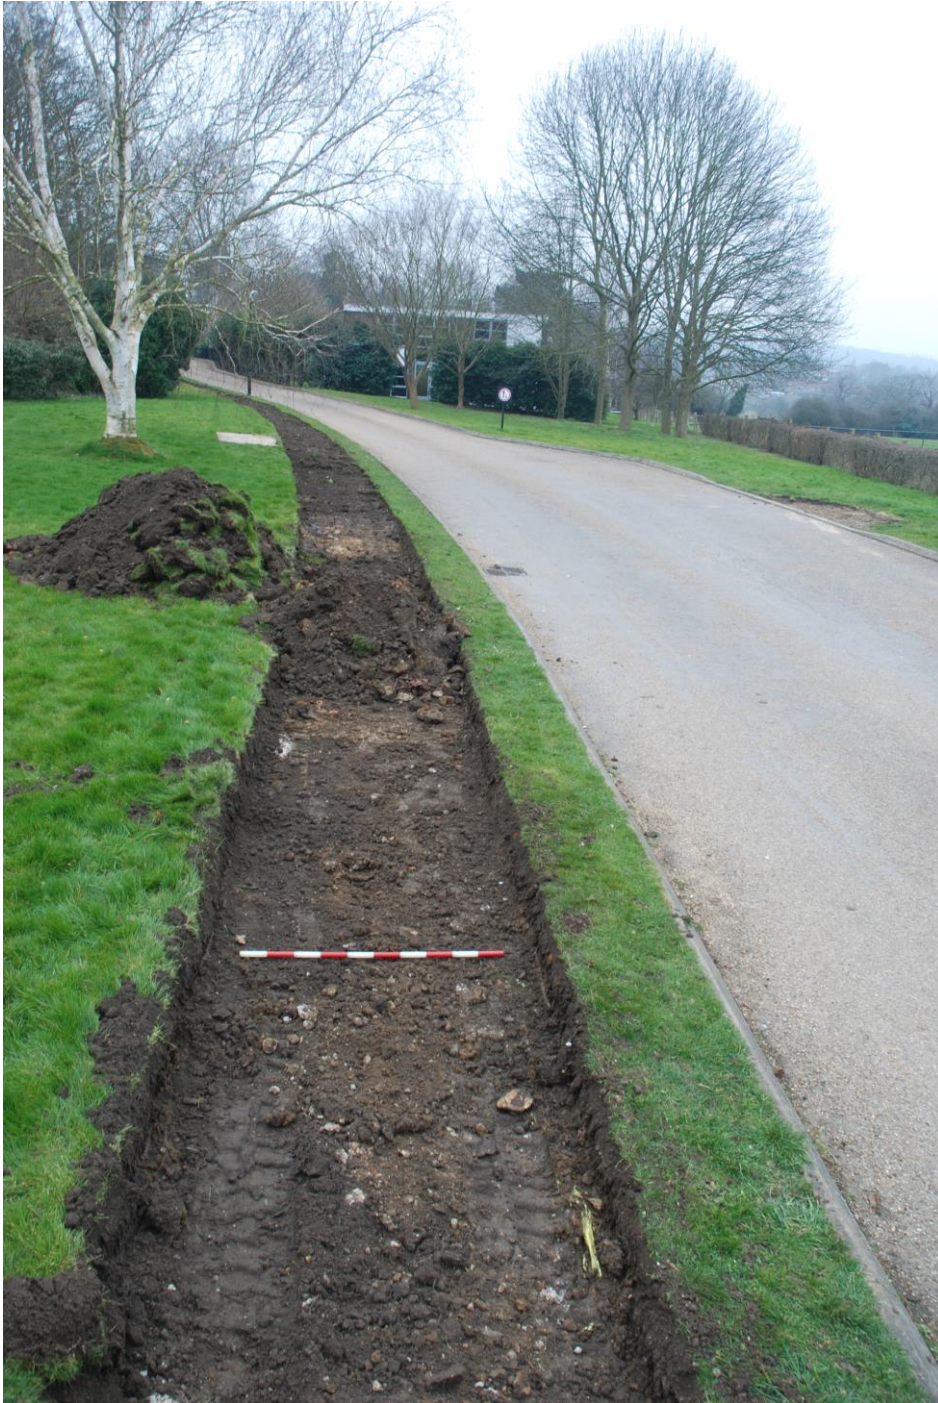
A further substantial area of made ground was noted between *c* 43m and 76m from the southern end of the new pathway. The depth of this was not established, but it is possible that it represents levelling up of a previously low area or hollow in the landscape – just to west of the road the ground still falls away by up to 2m. The date is also uncertain but most likely to have been when the access road was constructed, which appears to be between the late 1950s and mid-60s.

*Fig.72: View looking south from just outside the inner gateway. A substantial area of made ground where the path line curves out of view may represent levelling up of an original hollow*

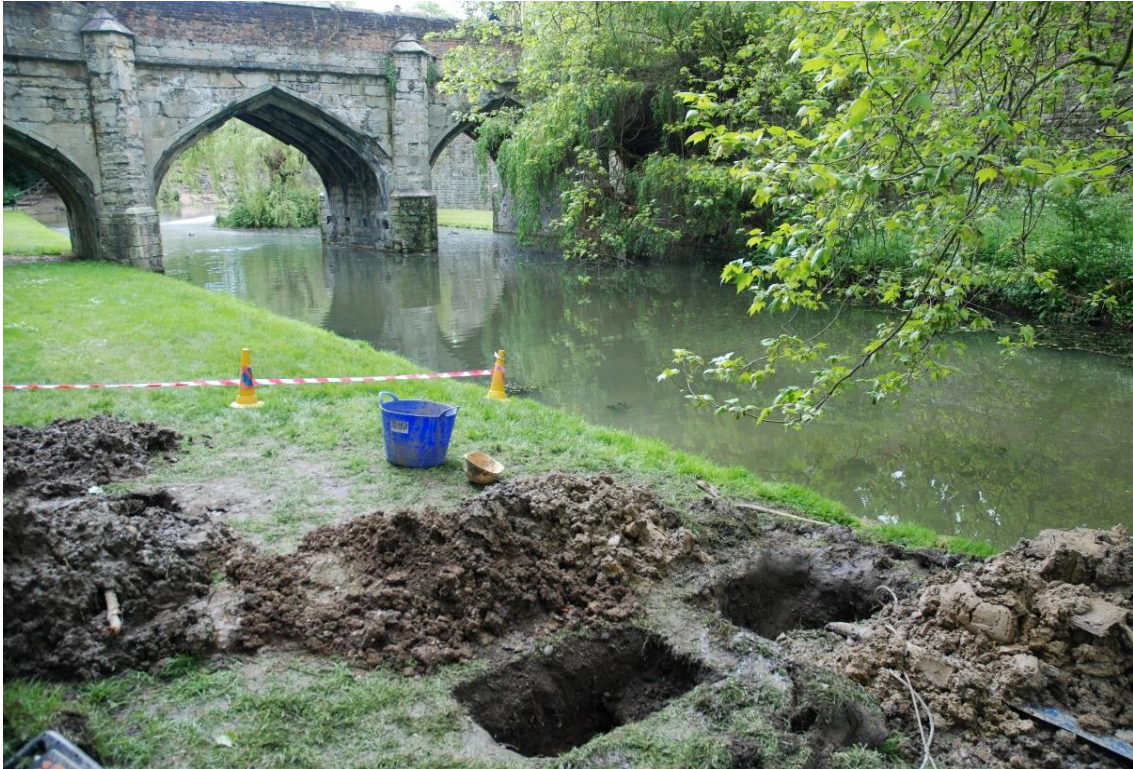
*Fig.74: Pits 2 and 4 on the edge of the moat, facing SE towards the bridge*

**6.6.2** The four pits were excavated on the grassed area next to the moat before the bank rises to the north, and about 17m northwest of the bridge. The ground here was fairly level, at about 5.25m OD at the base of the bank and falling slightly further towards the moat itself. Pit No.2 was located approximately 1.00mm north of the moat, and the other three were spaced at intervals within an overall

area measuring *c* 3.2m by 4.5m in plan. Three of the pits (nos. 2, 3 & 4) were aligned more or less in line with one another, with the fourth (No.1) offset to the southeast. Individual pits measured approximately 800mm long and between 400mm and up to 700mm wide, whilst overall depth was up to about 1.15m.

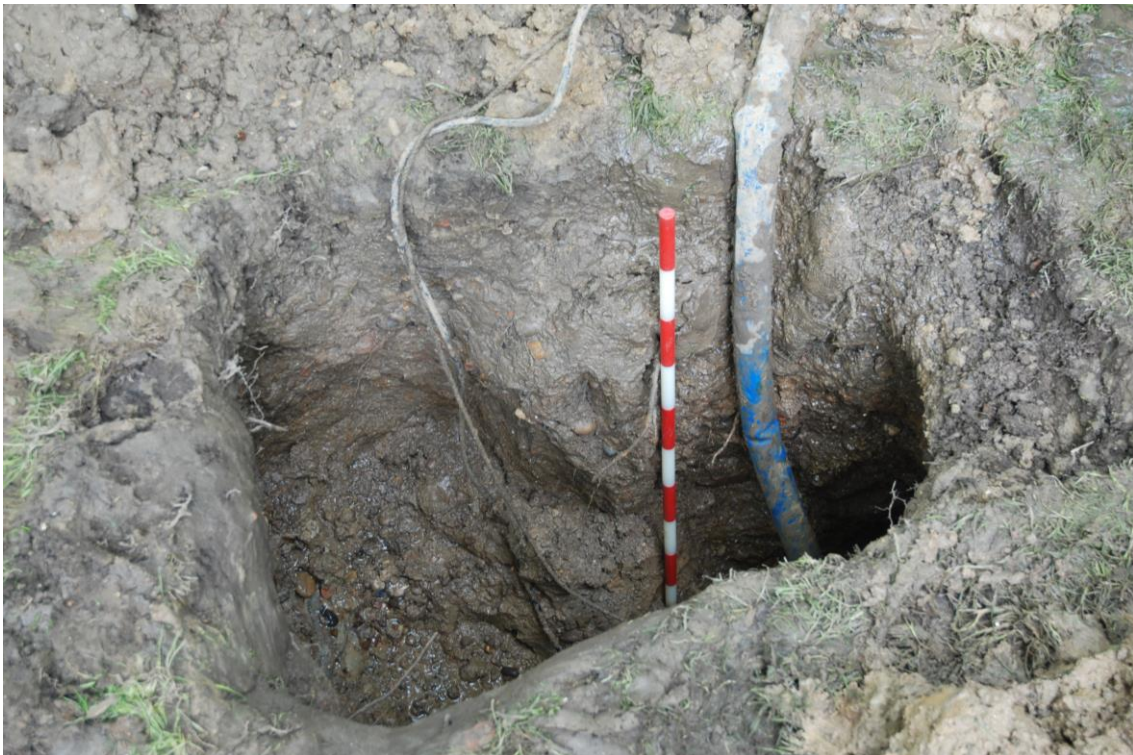
*Fig.75: Pit 2 facing NW (1m scale). The edge of the moat is just out of view to the left of the frame*

- 6.6.3** The pits invariably filled with water due to their proximity to the moat, the subsequent water table, and also the leak in the mains system. The observed stratigraphy was broadly similar in all four pits. Pit 2 is here taken as an example: 300mm of topsoil overlying 400mm of mixed silty-sandy clay, (context (32), and elsewhere (31) / (33) / (34) respectively), containing post-medieval pottery, occasional ceramic building material (CBM) fragments and moderate to frequent rounded pebbles. This sealed a further 500mm of fairly soft but compacted mottled, light-grey/ orange-brown silt-clay, containing very occasional rounded pebbles but otherwise free from inclusions. The pottery and CBM broadly dated the deposits to the 19<sup>th</sup> (or even early 20<sup>th</sup>) century, with some earlier – 16<sup>th</sup> to 18<sup>th</sup> century – residual material (see Appendices II and III).

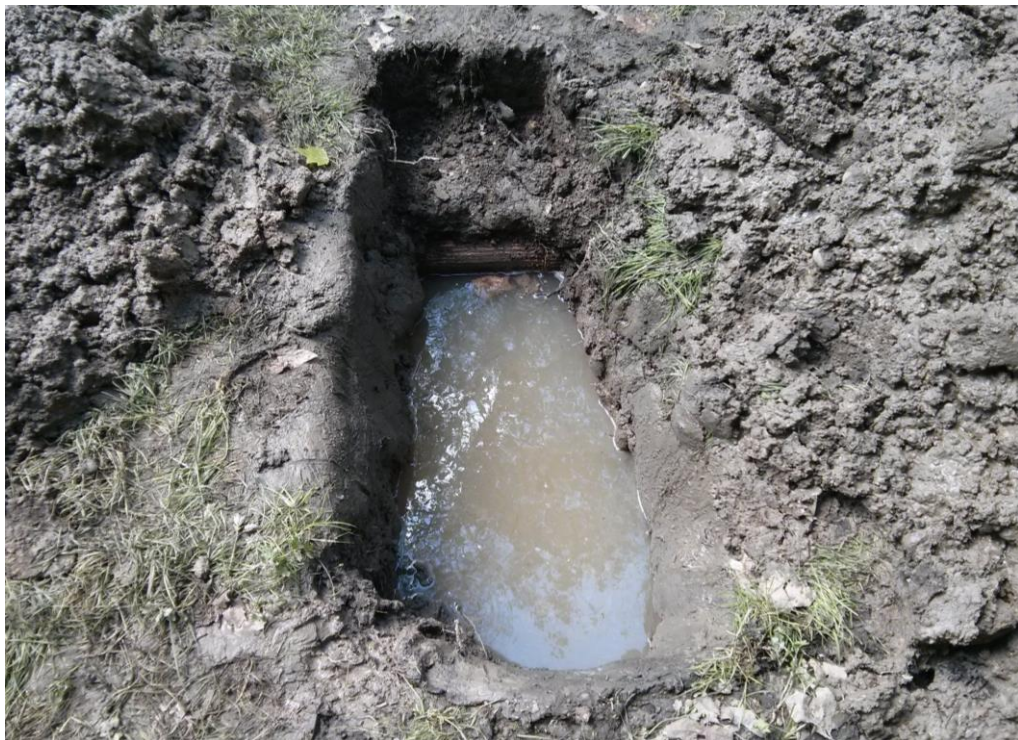
*Fig.76: Pit 1 facing SE, with existing ceramic land drain at the far end just above water level*

- 6.6.4** Pits 1, 2 and 4 also exposed three lines of ceramic land drains, running southeast-northwest (parallel with the moat) and *c* 1.5m to 1.65m apart (see plan: Appendix I, Fig.86). The drains were between 200mm and 350mm below the present land surface (becoming shallower as this sloped down towards the moat). They were also identical to those exposed at the western end of the I.T cable trench excavation (*cf.* 6.4.16 above), and presumably date to the landscaping and improvement works of the mid 1930s.

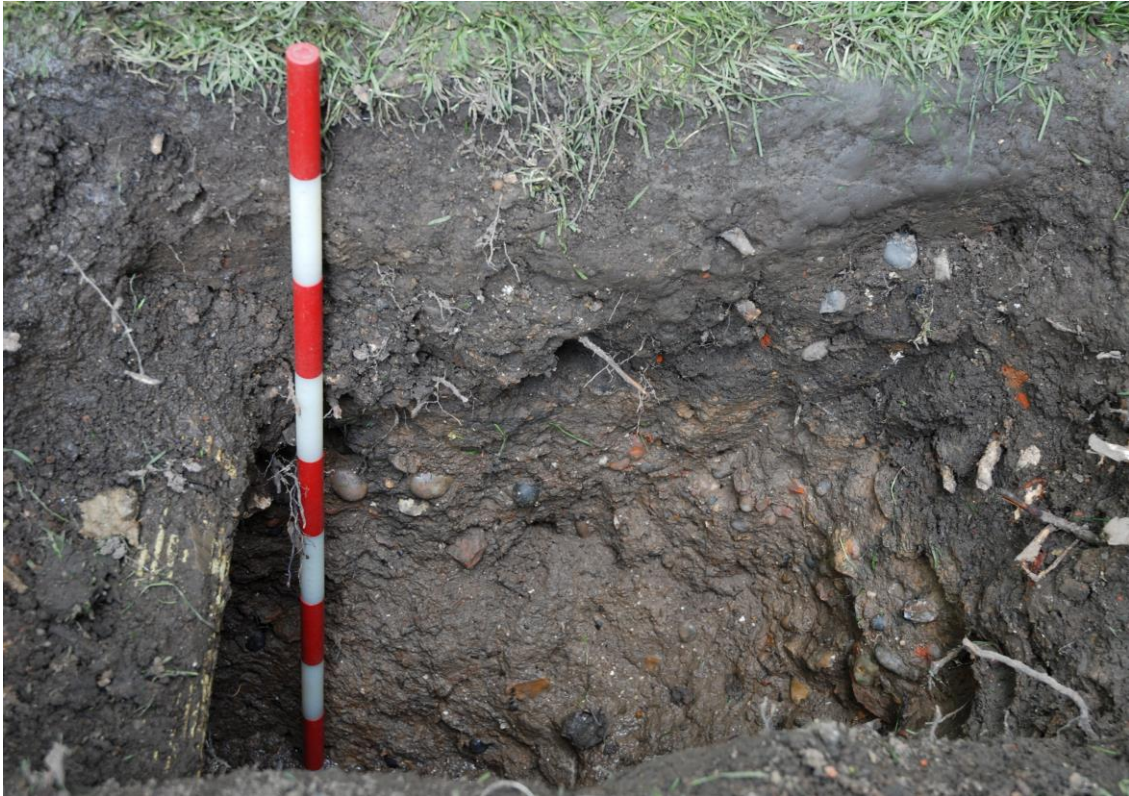
*Fig.77: The SE-facing section of Pit 4, with a land drain to the left of frame. 1.0m scale*

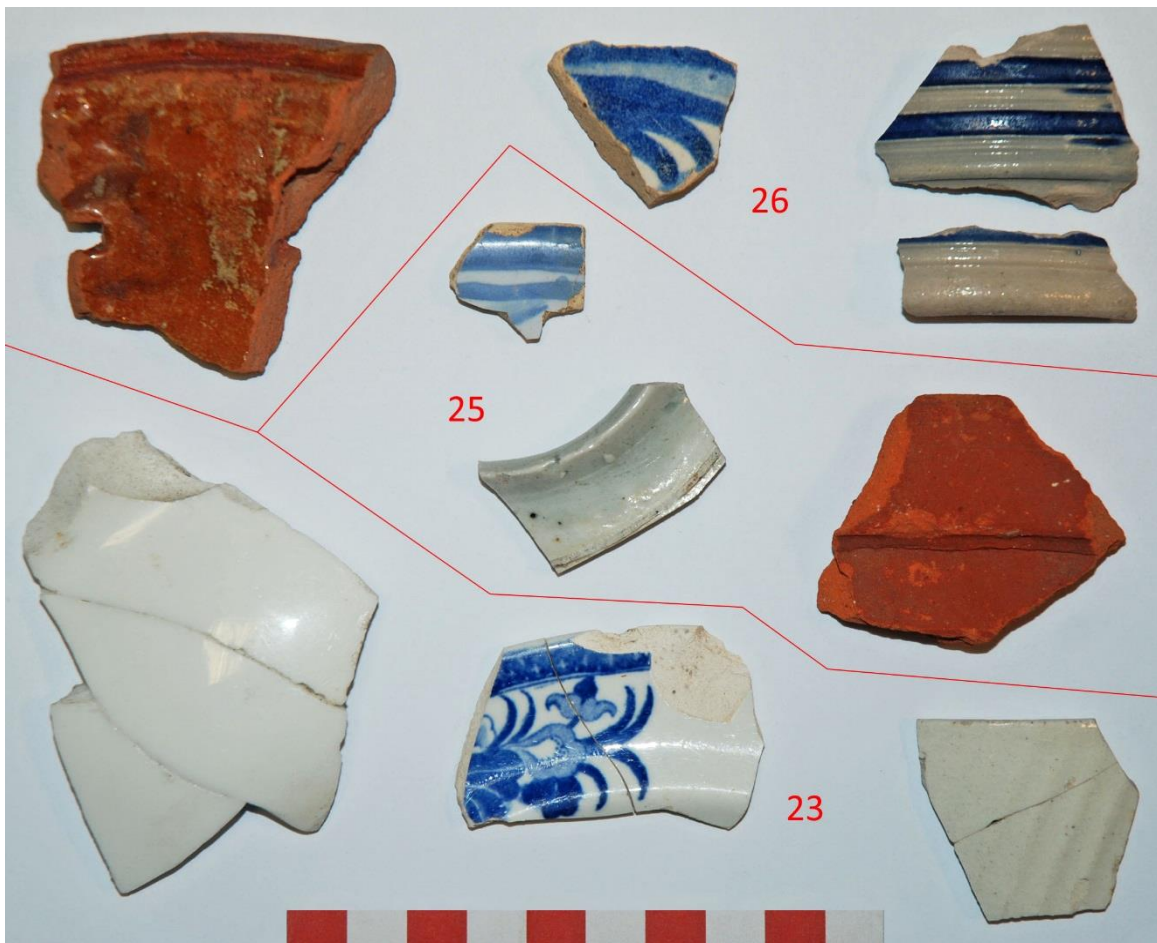
Fig.89: Pottery from the gas mains connection trench

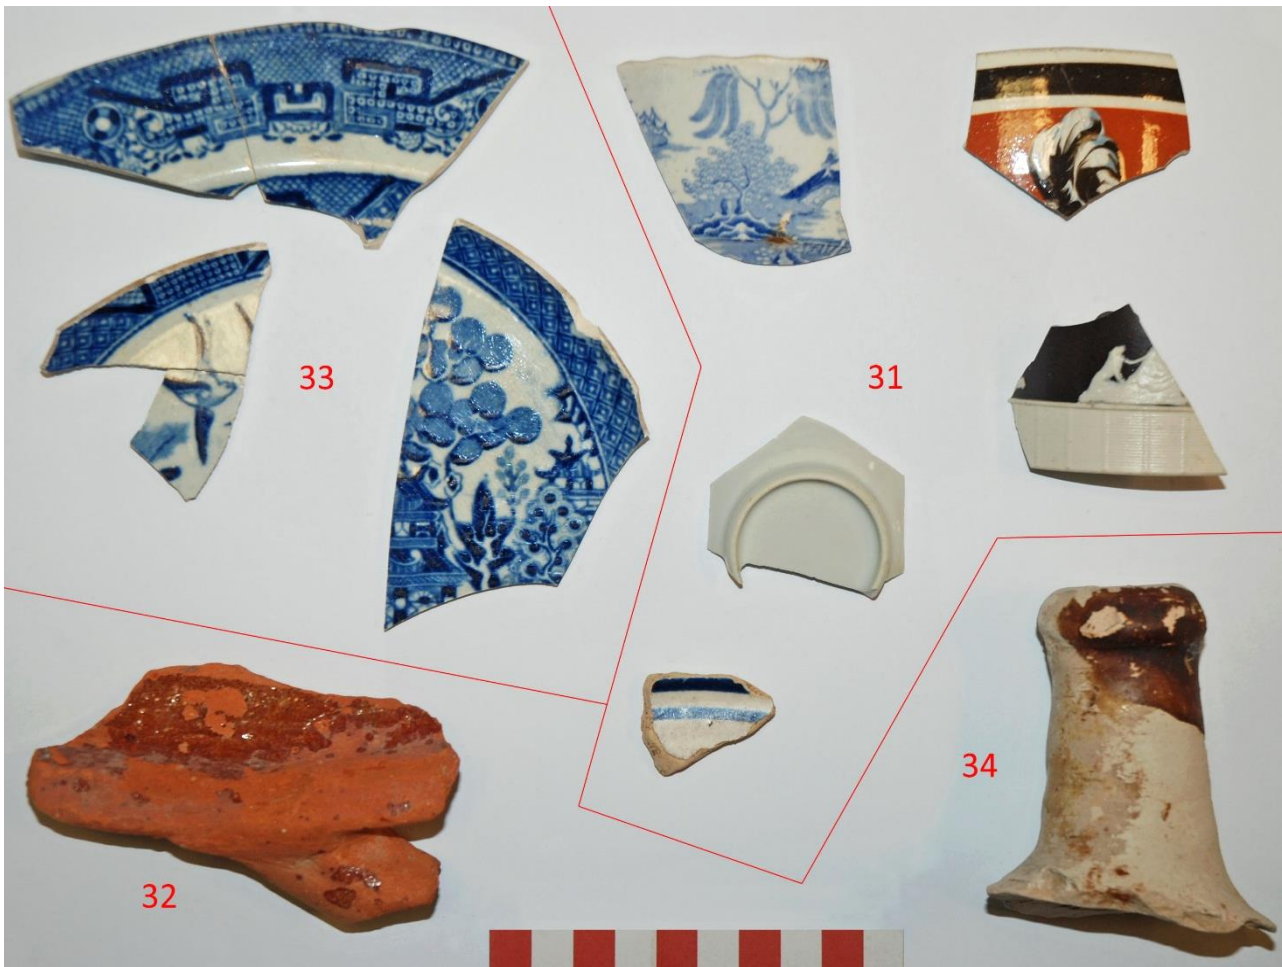
Fig.90: Pottery from the water mains investigation pits (0.10m scale)

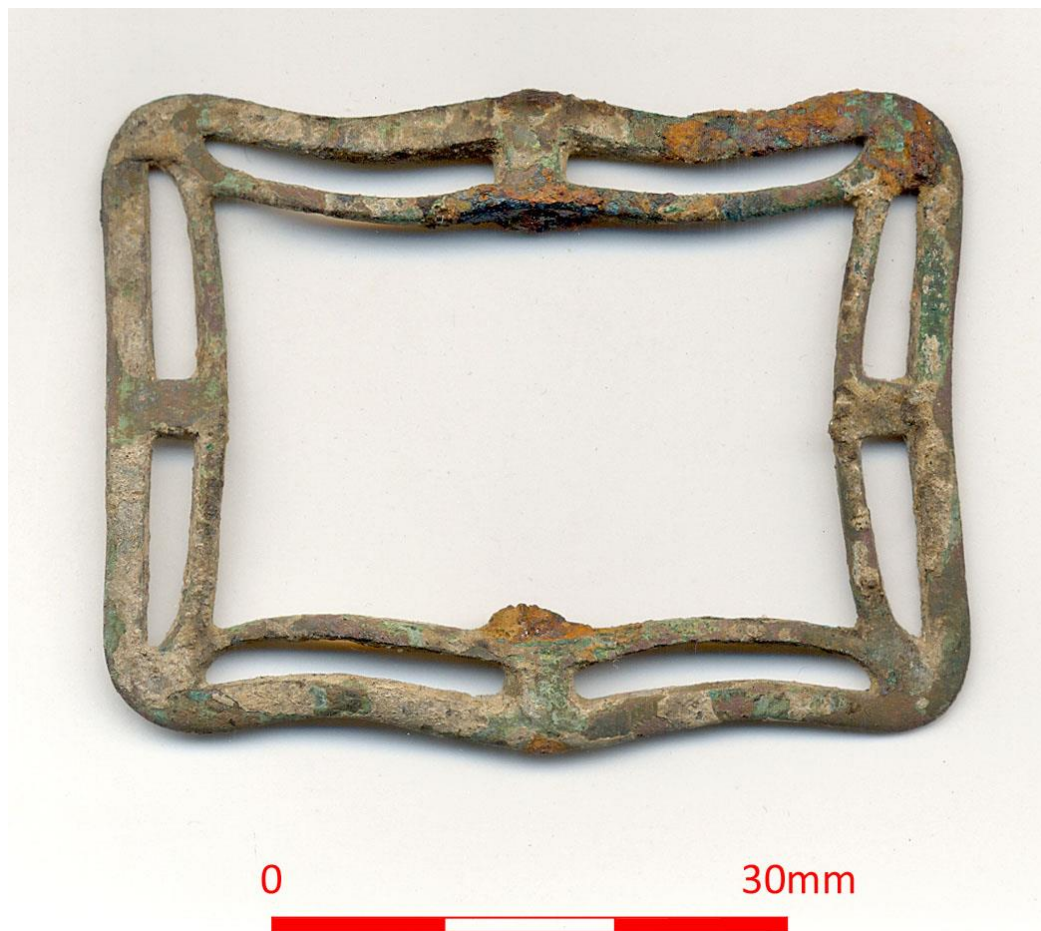
The buckle is a shoe buckle with sub-rectangular, ladder-like openwork copper alloy frame and (now missing) iron bar for the attachment of the hook which would have had one or two prongs. The date range is *c* 1720 to *c* 1800, although the size of the buckle makes it likely that it dates to the middle quarters of the 18<sup>th</sup> century.

Fig.91: *The copper alloy shoe buckle*

- 1.1 A single buckle was recovered from context (26), at the northern end of the gas mains trench (*Dr Jörn Schuster*).
