LAND AT 20-28 STAINES ROAD, HOUNSLOW, TW3 LONDON BOROUGH OF HOUNSLOW AN ARCHAEOLOGICAL EVALUATION

> SITE CODE SIZ 07 SITE CENTRE NGR TQ 13540 75500 PLANNING REF P/2006/0197

COMPASS ARCHAEOLOGY LIMITED 5-7 SOUTHWARK STREET LONDON SE1 1RQ Telephone: 020 7403 9660 Facsimile: 020 7403 9661 e-mail: mail@compassarchaeology.co.uk February 2007 Abstract

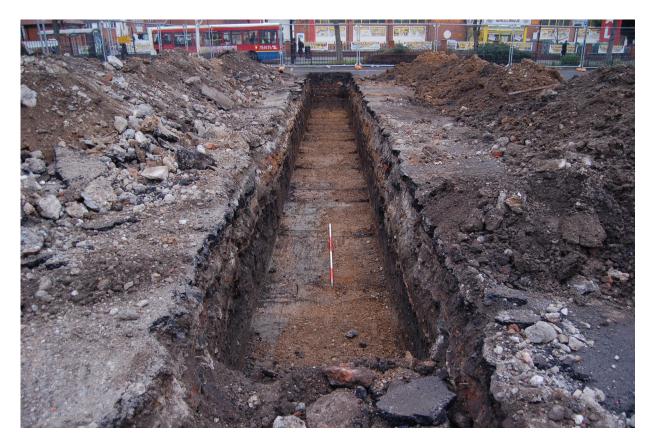
Fig 2 View of evaluation trenches 1 & 2 in relation to the 1:1250 Ordnance Survey Map

The evaluation consisted of two trenches each measuring 1.6m wide by 20m in length, covering a total area of 64 square metres. These trenches were located across the site as shown in Figure 2.

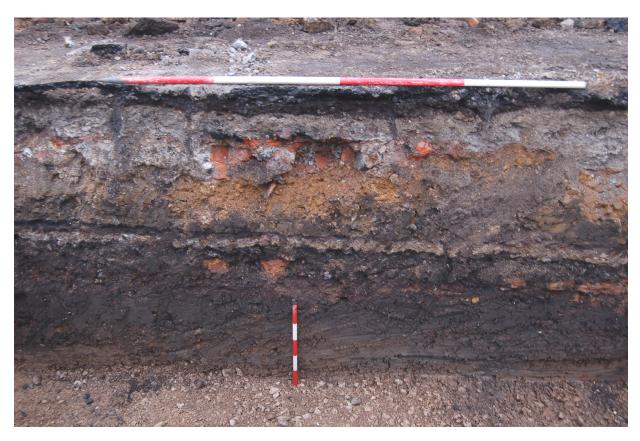
Fig 3 View of Trench 1 looking east

Trench 1 was located in the centre of the site running in an east-west direction (Fig 3), measuring 1.6m wide by 20m in length. The trench was excavated from a preexcavation level of 21.53m OD. The present ground surface, made ground and subsoil layers were removed by machine to expose the natural Taplow Terrace Deposits (C2).

The trench contained no significant features or finds. The tarmac and hardcore deposits represent the current usage of the site as a car park, while the made ground and demolition layers represent how the site was developed from the early 1800's to the present day. The trench contained a modern drain encased in concrete at the eastern end of the trench, which probably serviced the now demolished cinema that was located at the northern end of the site.

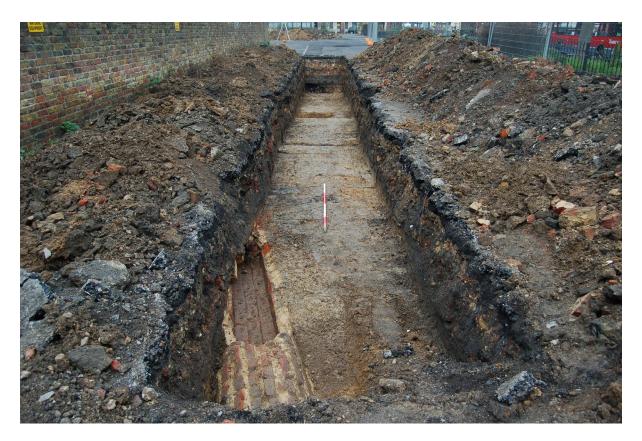
Fig 5 Detail of deposits shown in fig 4

the Taplow Terrace deposits were exposed at a fairly level 20.04m OD across the trench. Overlying the natural deposits was a clean grey/brown clay subsoil layer (C1) approximately 0.4m thick. Overlying – and presumably truncating – the subsoil was a series of demolition and made ground/levelling layers beneath the present tar ground surface with a combined thickness of 1m.

Fig 4 View of north facing section of Trench 1, approximately midway along the excavation

Tar	
	Hardcore	
	Made Ground/Crush Layer	
	Made Ground/Levelling Layer	
	Mortar Levelling Layer	
20.44m OD +	Demolition Layer	
	Subsoil (C1)	
0	<u> </u>

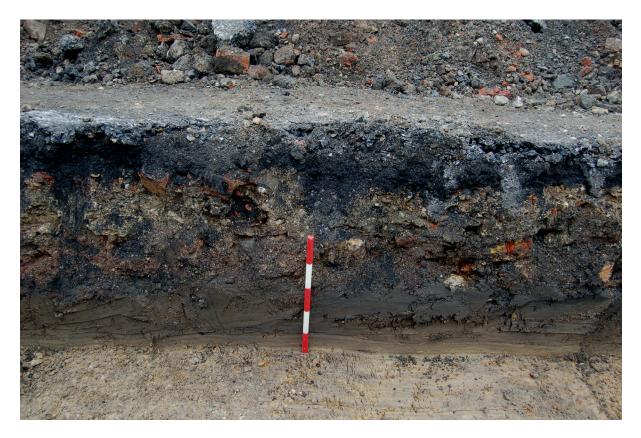
Fig 6 View of Trench 2 looking north

Trench 2 was located approximately 30m south of Trench 1, running in a north-south direction. The trench measured 1.6m wide by 20m in length. The present ground surface prior to excavation was recorded at 20.86m OD at the southern end of the trench, sloping to 21.27m OD at the northern end.

The present ground surface, made ground deposits and subsoil layer was removed to expose the natural Taplow Terrace Deposits (C2). This was recorded at 20.16m OD at the south of the trench, sloping to 19.86m OD at the north end. The exposed profile was broadly similar to that of Trench 1. Overlying the natural was a dark grey clay subsoil (C1) some 0.35m thick. This was truncated and overlain by demolition, made ground and levelling layers sealed by hardcore and tarmac of the present ground surface. These deposits had a combined thickness of 0.7m, giving an overall trench profile some 1.05m thick.

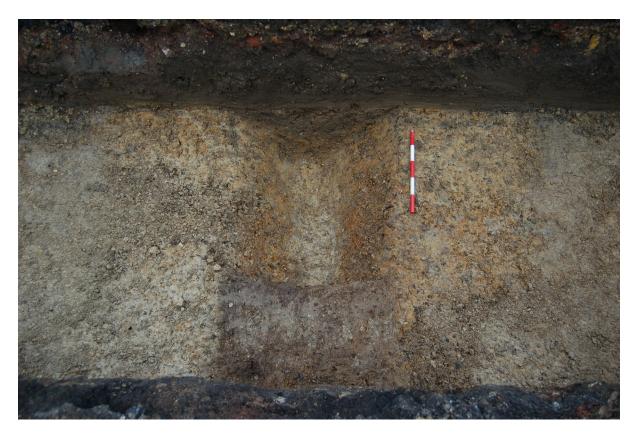
Fig 9 Detail of features within southern half of Trench 2

The trench contained two features, a linear ditch and a brick lined drain, of an early and later post-medieval date respectively. The linear ditch [6] was located roughly in the centre of the trench, running in an east-west direction. Its principal measurements were 0.85m wide by 0.35m deep. In profile, the ditch had sides sloping at roughly 45 degrees down to a slightly rounded base. The ditch was filled by contexts (C4) and (C5). The lower fill, (C5), was a light grey clay approximately 0.15m thick. It is likely that the ditch was in open use, probably in a drainage capacity. Indeed, the gully shaped profile of the base suggests water once flowed through the ditch before silting up with (C5). It is likely that the ditch was then deliberately backfilled with (C4), a greyish brown sandy clay some 0.2m thick. This layer produced a single sherd of post-medieval pottery dating from AD 1480 - 1600, which would support evidence for post-medieval agricultural activity recorded during archaeological investigations in the vicinity of the site.

The second feature recorded in Trench 2 was an arched, brick lined drain (C3). Located at the southern end of Trench 2, the drain ran in a northwest-southeast direction, continuing beyond the western and southern limits of excavation. The drain was approximately 0.6m wide with a height of 0.25m, and in profile had an arched

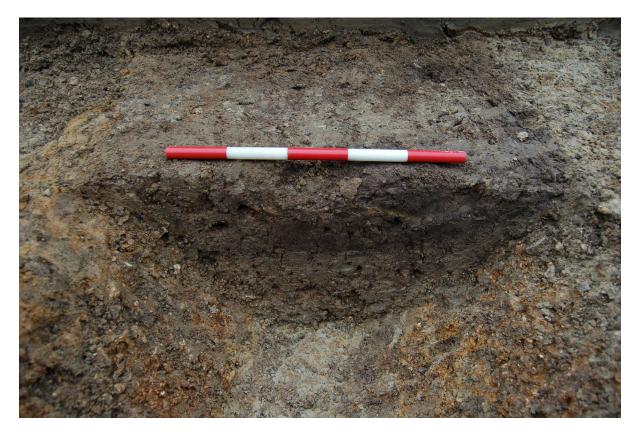
Fig 10 View of linear ditch [6] looking west

The linear ditch [C6] within Trench 2 produced pottery dating to the 16th century. The ditch may have acted as an agricultural drainage/field boundary ditch, and it certainly appears to have been in open use before it silted up and was subsequently backfilled.

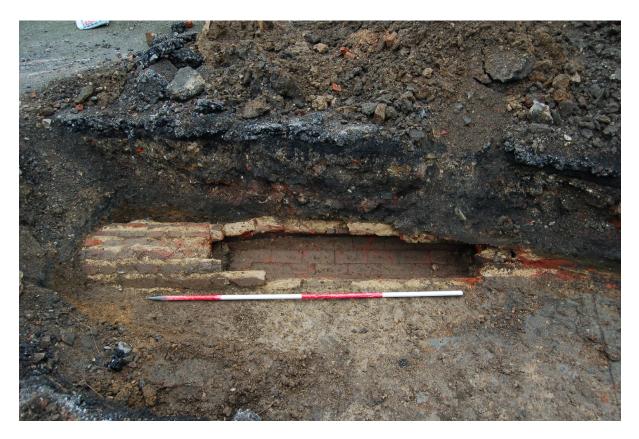
Fig 13 View of post-medieval drain (3) looking west

roof with a slightly concave base. Approximately 3.5m of the drain was visible in the trench.

The drain was constructed from coarse red (and occasionally yellow) stock brick with a slight frog, average dimensions 221 x 105 x 65mm. It is unlikely that these were manufactured before c 1800, and they probably date to the first quarter of the 19th century. Some of the bricks were of a poor quality with irregular dimensions, probably factory seconds. In others a shallow concave frog was scored by about four deeper impressions across the line of the brick, to an overall depth of about 10mm. The bricks were bound by a loose, sandy, pale yellow lime mortar. A construction cut [C7] was dug to facilitate construction of the drain. It was backfilled with a brown sandy clay (C8) containing occasional brick and tile. The drain was probably constructed around the time the area was developed for the first time in the 19th century, as map evidence from 1819 shows the site as undeveloped agricultural/open land.
