**ST MARY-AT-HILL, LOVAT LANE,
CITY OF LONDON EC3R 8EE**

AN ARCHAEOLOGICAL EVALUATION REPORT

January 2016

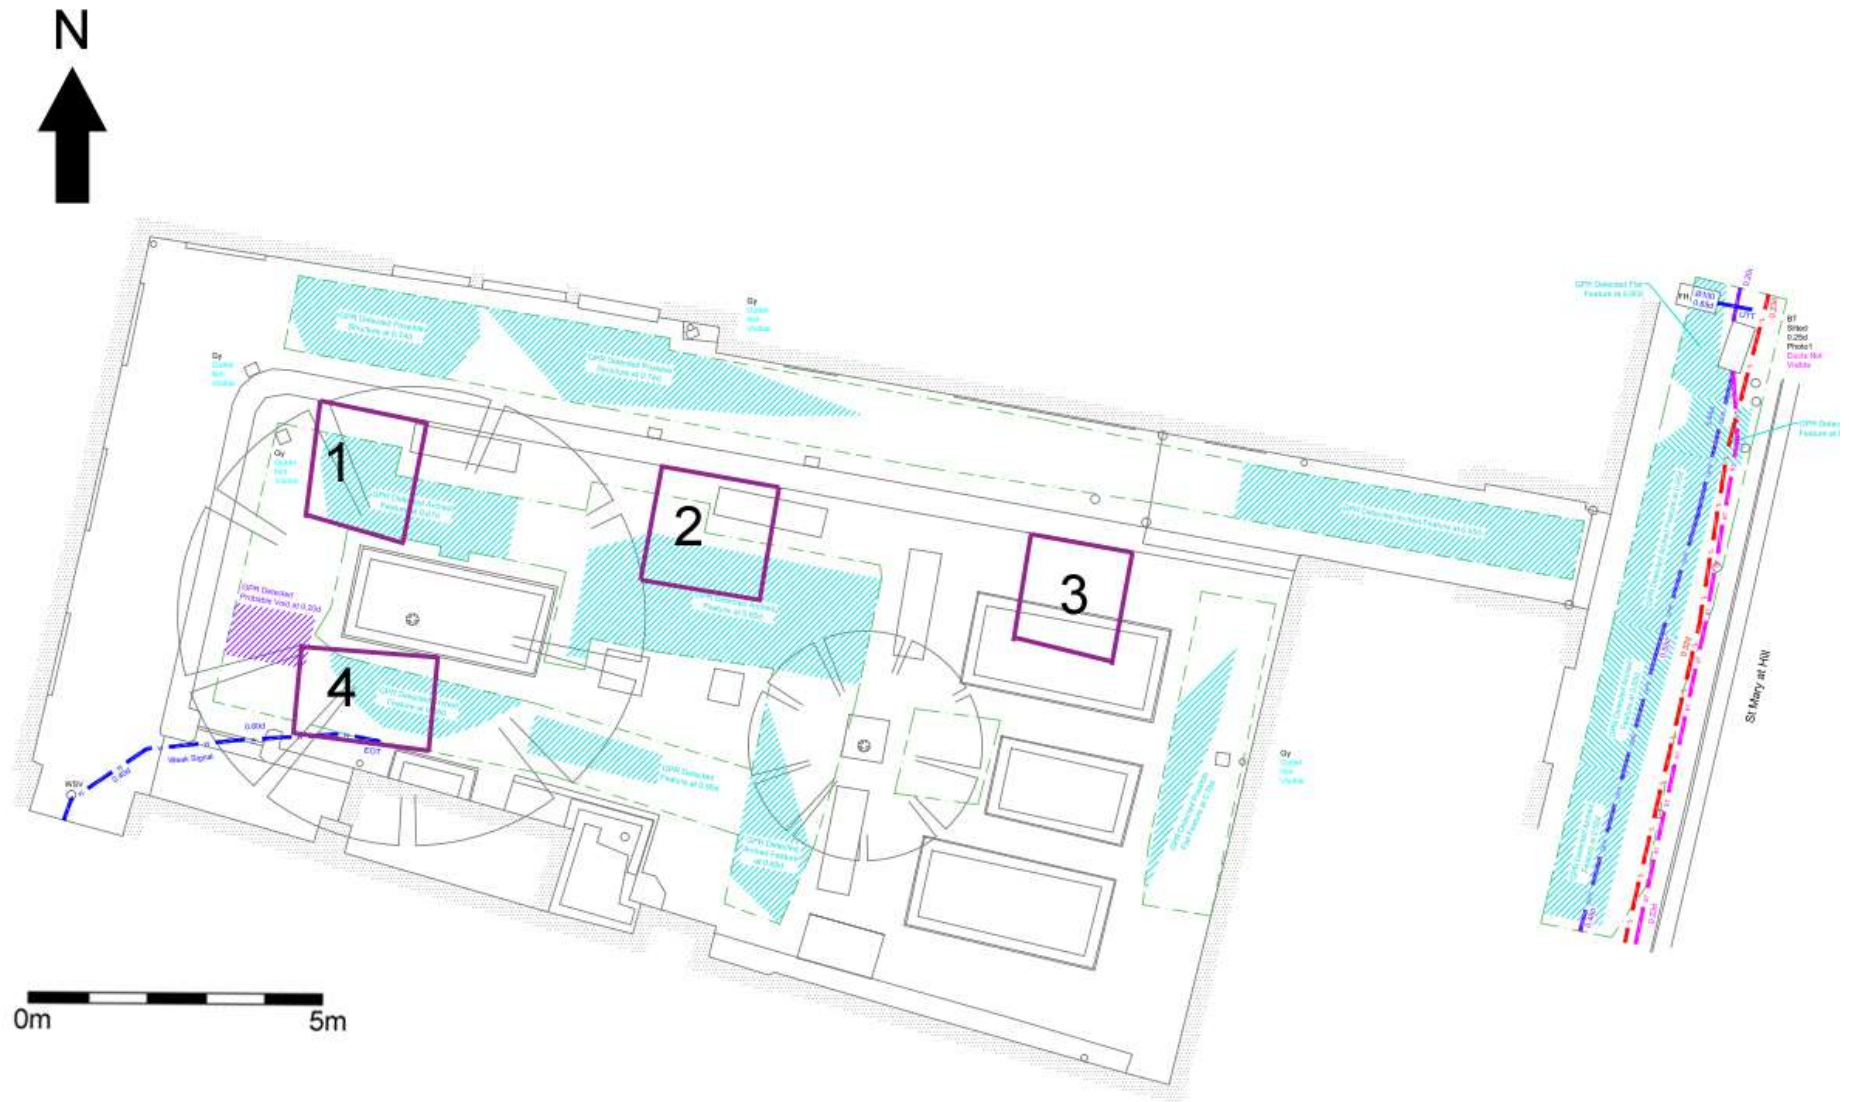
Figure 9: Location of excavated pits.

Each pit will be discussed in turn (see fig.9 below for their locations). This will include a discussion of their stratigraphy, features, any finds, plus a selection of illustrative photographs.

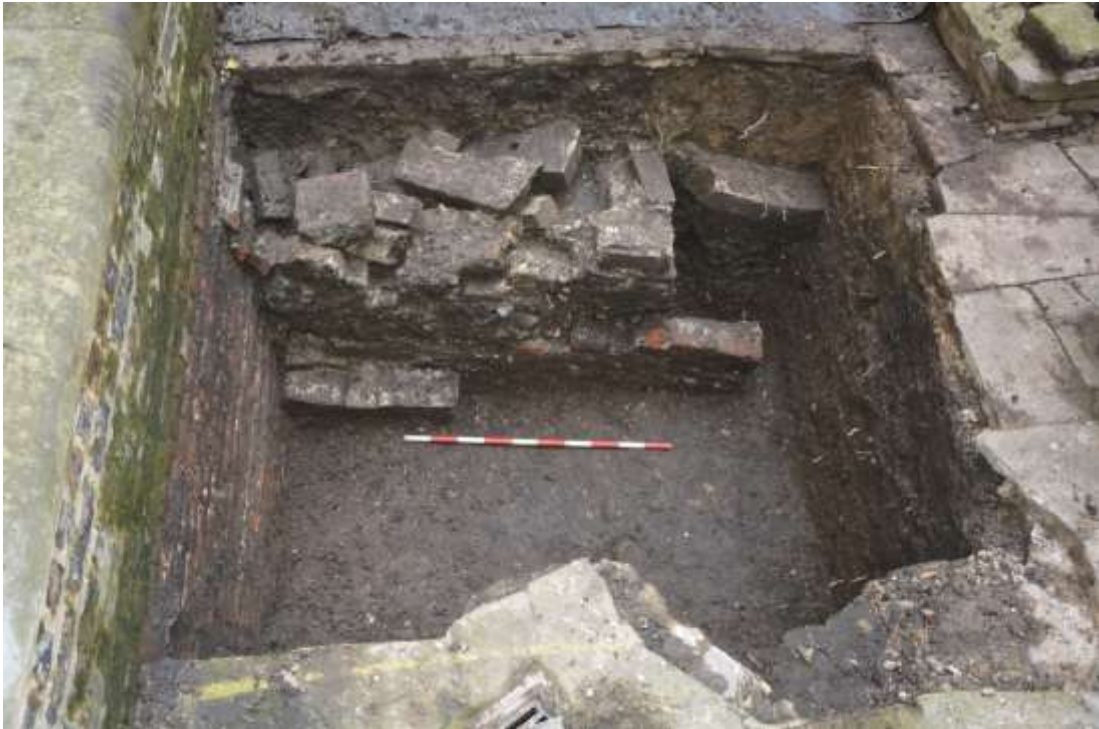
Figure 10: Overview of pit 1. Facing east.

A deposit of clay measuring 1.5m in length x 0.4m in length was observed in the north and west facing sections. This was a continuation of the planter situated to the immediate south of the trench.

Below this, the pit comprised a dark grey silt, moderately abundant with ceramic building material rubble, stones and rounded gravel. Some variations in colour were noted but it can be considered part of the same context.

Further evidence of the construction phases of the wall can be seen in figure 10. The lower part comprises red brick stretchers with a rowlock course of headers at the present ground level (14.23mOD), above which is a messy repaired course and more recent stock brick wall.

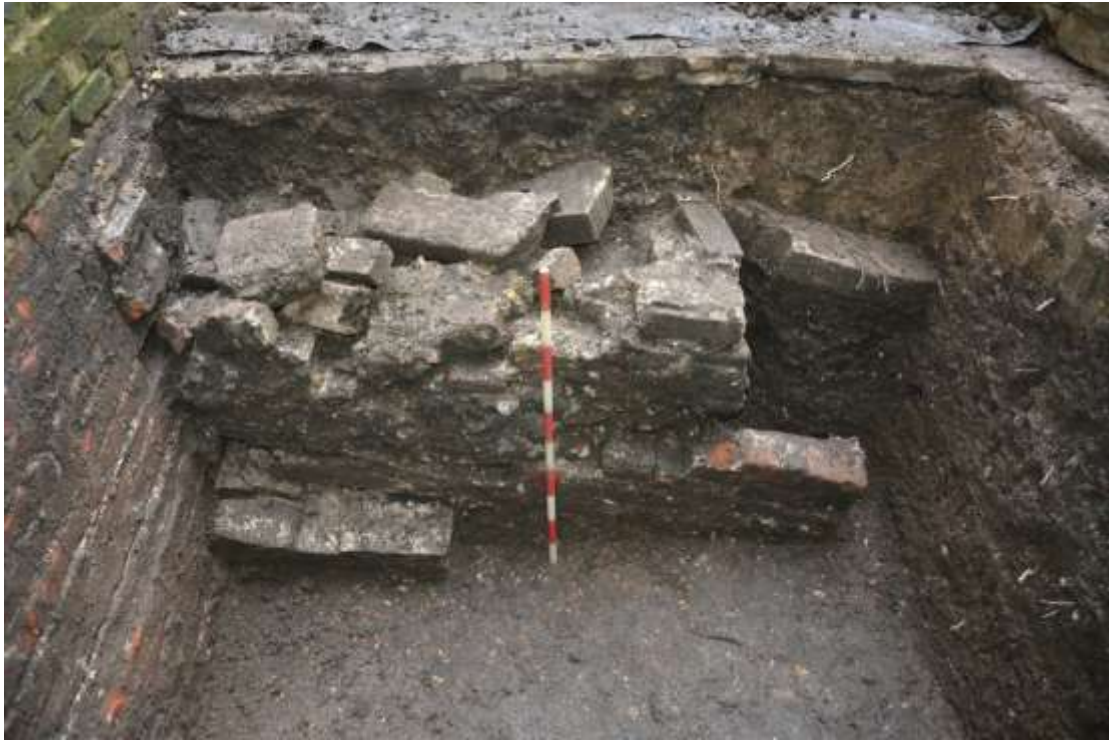
A red and yellow stock brick structure was observed along the eastern edge of the pit. The feature measured 1.8m in length x 0.5m in width x 0.95m (see fig. 11). The top was observed 0.3-4m below the top of the section (13.81OD)

Figure 11: post-medieval brick structure. 2 phases of building, and significant displacement are visible. Facing east.

There are at least two observable phases of construction to the structure. The first is a red brick wall running north-south along the base of the trench. This wall comprises rows of stretchers bonded with a light grey mortar and measures 1.8m in length x 0.3-0.4m in height. The top was encountered at 13.81mOD. In figure 11, above, a row of headers can be seen at the south end of this phase, projecting away from the phase above by 0.5m, and may indicate this was the top of the original feature. It is constructed from the same bricks seen in the existing wall, and a scar on the south face implies this phase was keyed in, but has since been significantly displaced, up to approximately 0.5m as a result of subsidence.

Pit 1 uncovered a substantial post-medieval brick feature. The feature showed two clear phases; an initial construction and later repair. The use of red brick keyed in to the existing church wall supports the theory that the lower part of this structure, at least, was contemporary with the graveyard. It is unclear what its purpose was, and whether or not this remained the same after it was repaired, however the significant subsidence noted in this area in the churchyard would indicate the ground below is hollow or unstable. A vault, or similar feature can be proposed.

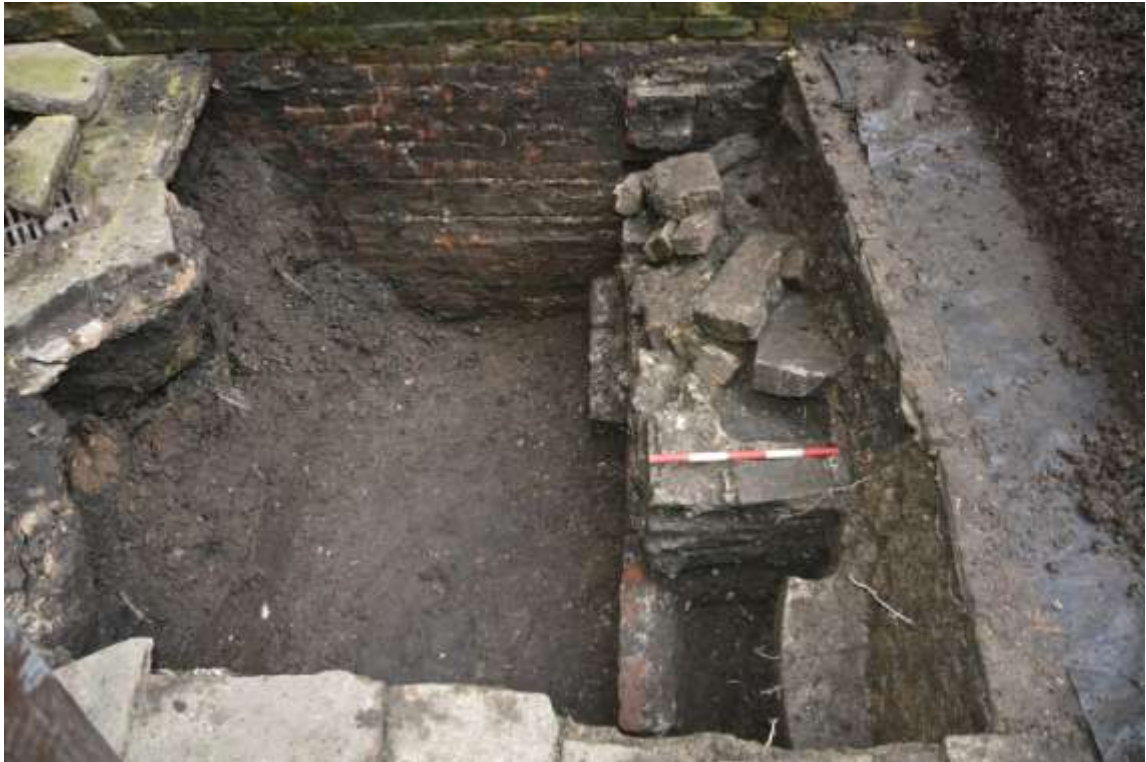
The second phases comprises an extension, or repair to the first phase. Constructed from yellow stock brick, this part of the feature measures 1.2m in length in a north-south direction, with a further 0.5m running east-west before reaching the west facing section. A lining of broken stones on top suggests the feature was once capped off with a solid slab. Probing revealed that the interior is hollow.

Figure 12: Yellow stock brick and stone capping elements of the brick structure. The lower red brick phase can be seen projecting out to the south below. A headstone can be seen in the bottom right corner, taken to be coincidental. Facing north.

This phase does not appear to have been keyed into the existing wall and may have been freestanding. It is unclear if it was repaired to be used for the same purpose. The boundary wall was repaired and believed to have been refaced on the north side, with the yellow stock bricks in 1873. This suggests that the first phase was constructed before this time and may be contemporary with the graveyard. The second phase may have been added during these later works.

Although now partially collapsed, there appears to have been a deliberate attempt made to make the structure level, both at the base, above the red bricks, and the top, with the addition of stone slabs. (see fig 12 above). It is not known how much further this feature continues to the east, but it was not observed in Pit 2.

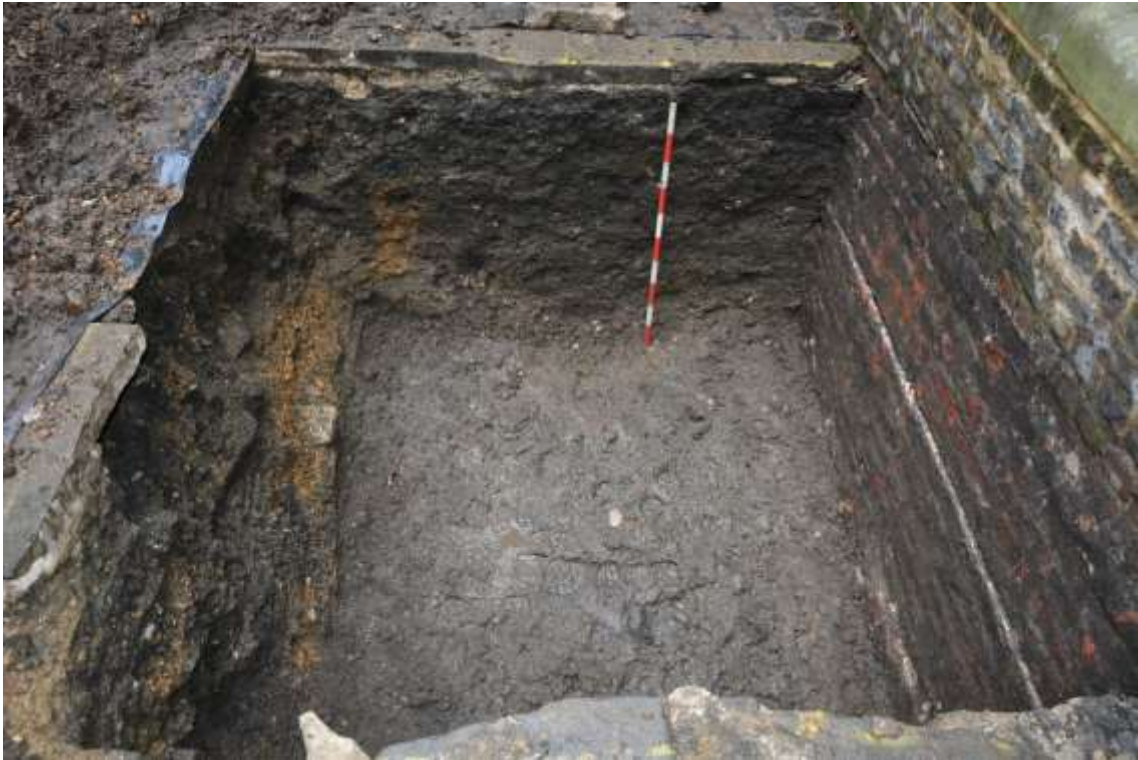
Figure 13: Overview of pit 2. The existing churchyard wall can be seen on the right. Facing west.

Two deposits of orange-brown sandy gravel were recorded in the north and east facing sections (see fig 13). They are taken to be contemporaneous. The layer in the north facing section was observed at a depth of 0.72m and was 0.2-0.35m thick.

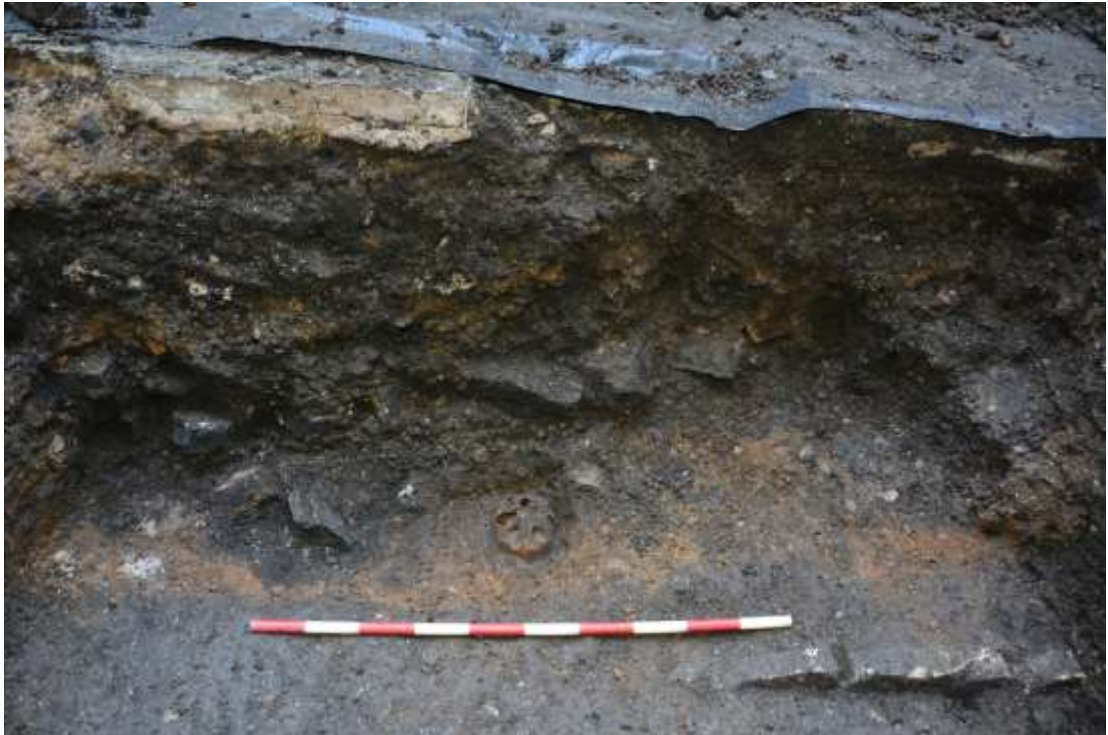
Figure 14: Gravel layer containing human remains. Facing south.

The gravel layer observed in the north facing section was abundant with disarticulated human remains. The remains are not in-situ and have most likely been deposited in this area during a previous attempt to remove the burials from the graveyard probably sometime in the 1850s / 1860s.

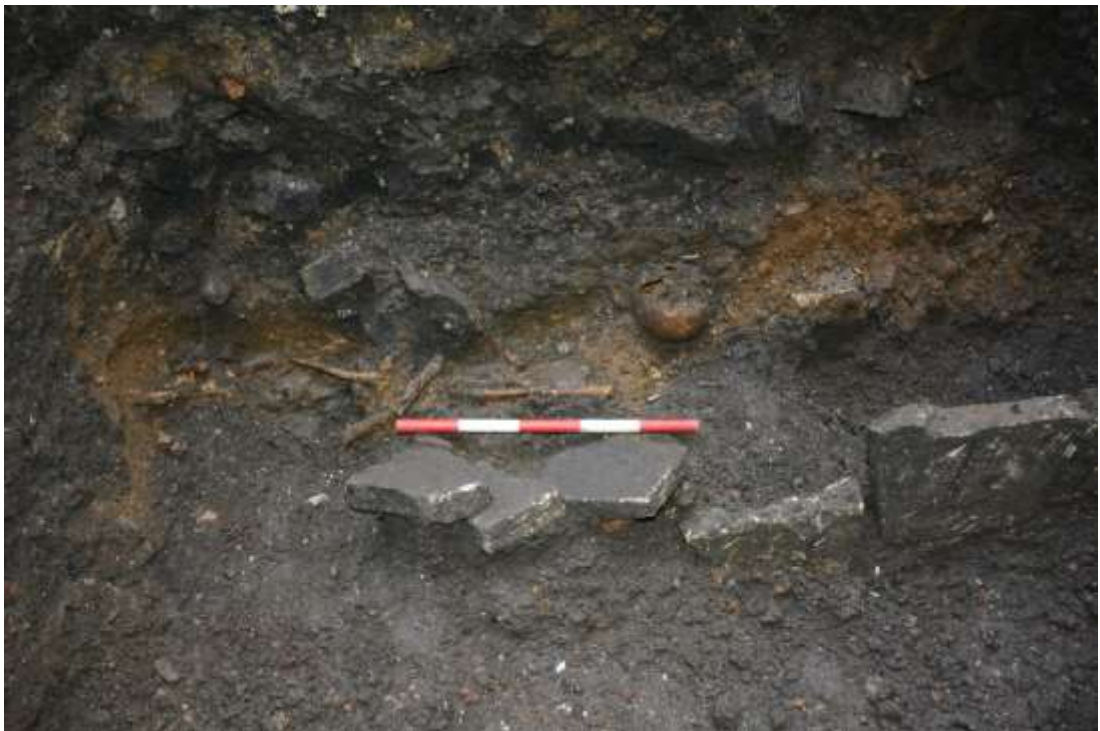
Figure 15: Collapsed slabs and disarticulated human remains. Facing south.

A layer of stone slabs placed vertically was situated north of the gravel layer (see figs. 14 and 15). The slabs measured approximately 0.3m² and were aligned east-west in a row measuring 0.9m from the west section before they are present, but collapsed. This is unlikely to have supported another structure and is most likely a demarcation, or edging for the 'charnel pit' type feature to the south.

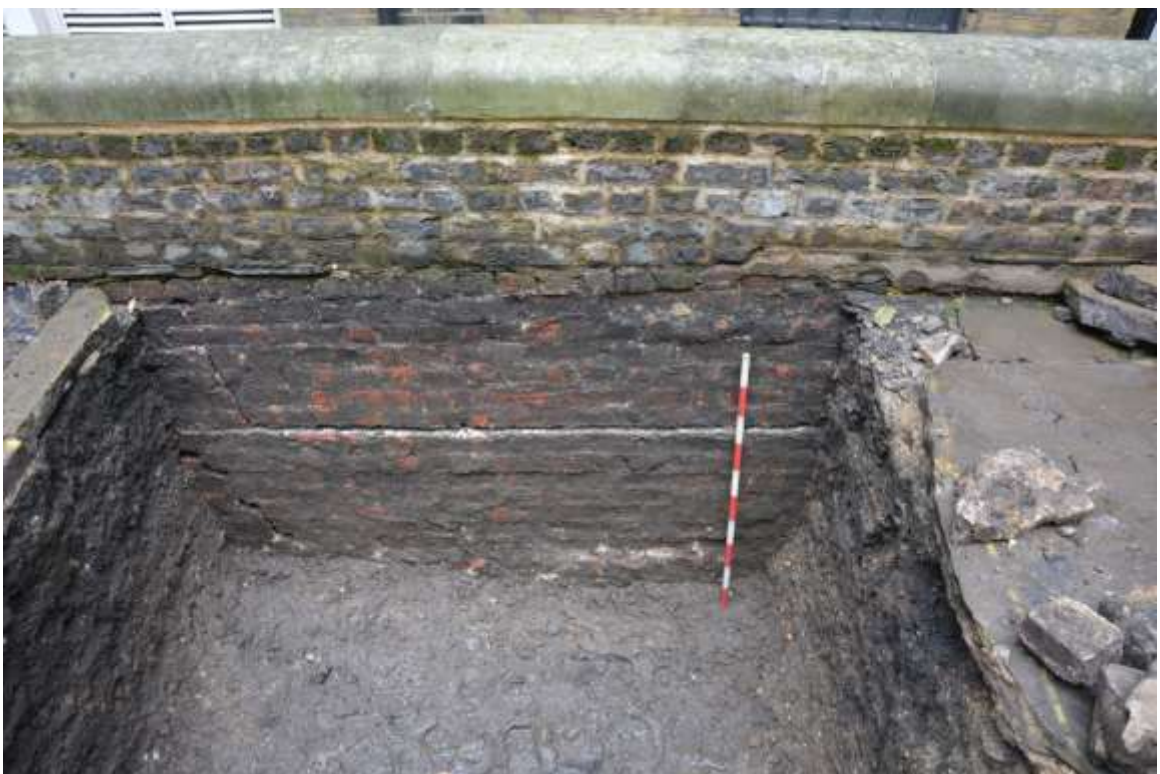
Figure 16: Existing churchyard wall. Facing north.

The red brick wall shows significant displacement, with a large crack east-west through the centre, and a further crack can be seen on the west side. Above the crack the entire section is sloping from east to west. It would appear that to counteract this, the upper wall has simply been built on top, level, providing stability for the newer courses.

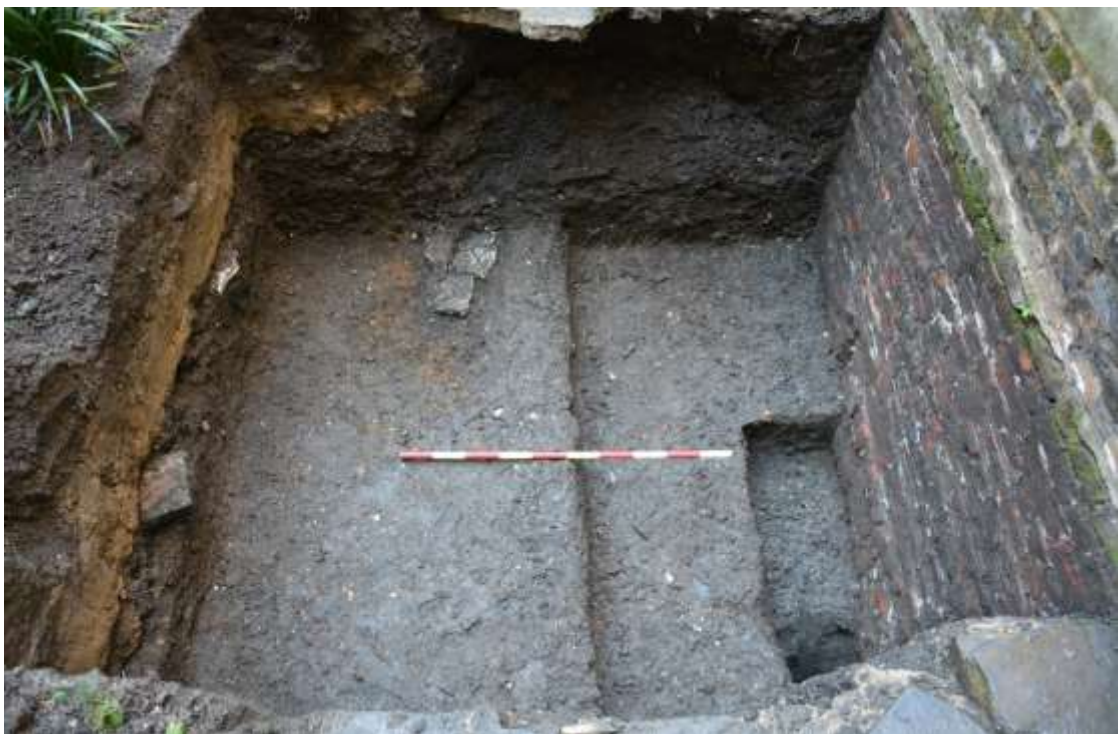
Figure 17: Overview of pit 3. Facing west.

Pit 3 was located in the north east corner of the churchyard, adjacent to a metal entrance gate. The existing wall was exposed in the northern section. The ground level in this area was approximately 14.30mOD. The pit measured 1.8m x 1.9m and excavated to a depth of 1.1m (13.20mOD). An additional slot was dug along the northern edge to expose the foundations of the red brick wall, increasing the maximum depth to 2.05m (12.25mOD).

The stratigraphy consisted of an upper layer of light brown clay from the modern planter (seen in the north, east and west facing sections) extending to a depth of 0.41m below the paving, above two layers of silty clay.

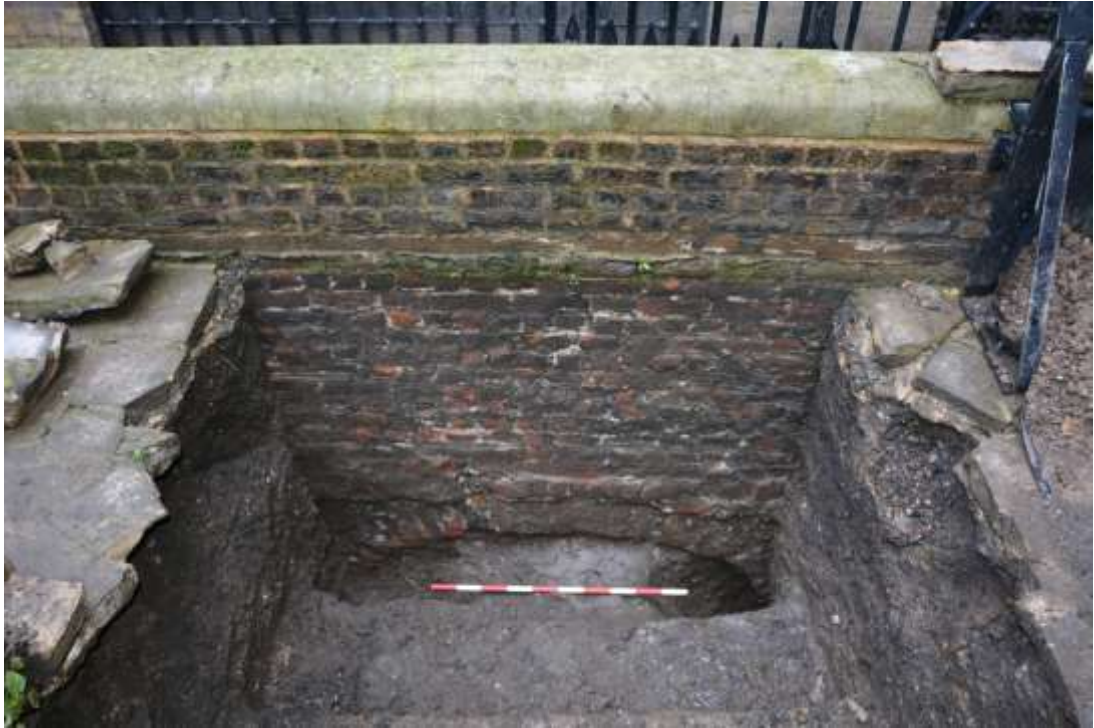
Figure 18: South face of wall and supporting arch post-excavation. Facing north.

A slot dug along the north edge of the trench base revealed a single arch supporting the wall above. The arch was built from red brick, with stretchers arranged vertically. It measured 1.8m in length and was separated from the main wall by a rowlock course of headers. The top of the arch sits at 13.29mOD and the base at approximately 12.20mOD. It is therefore believed that the full length the wall is built upon a series of relieving arches.

The excavation also revealed the foundations of the lower part of the existing wall in pit 3. The construction is of red brick, supported by a series of brick relieving arches. This has later been repaired and raised using yellow stock bricks to produce the present day level.

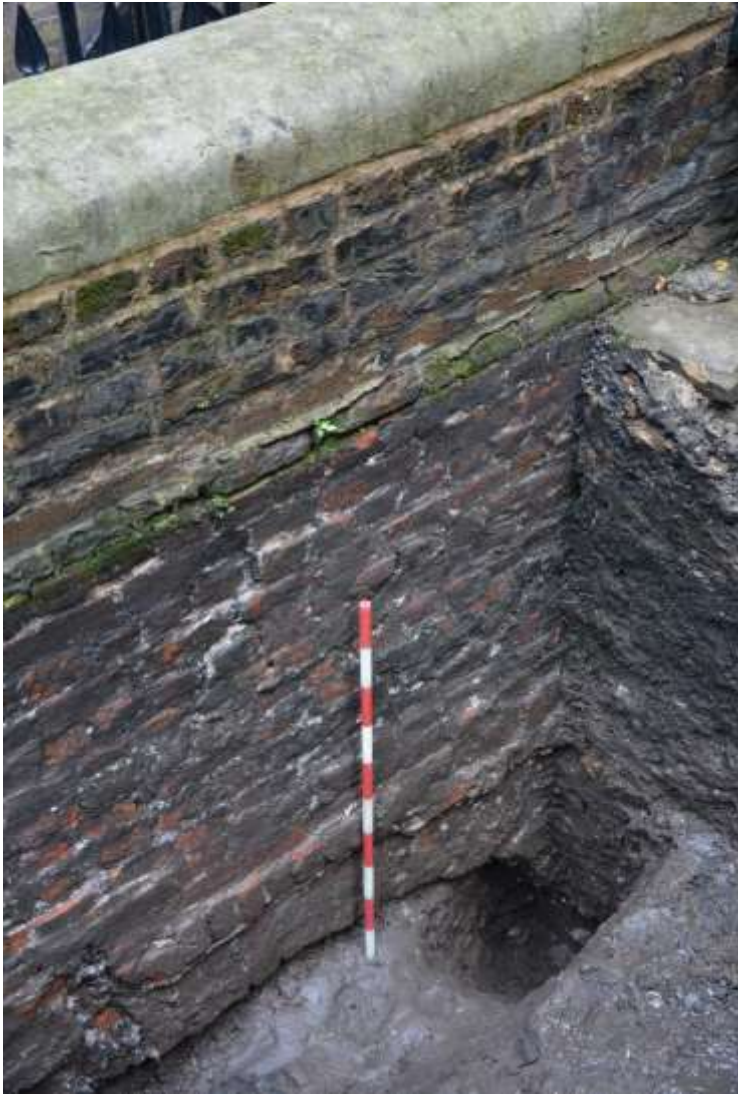
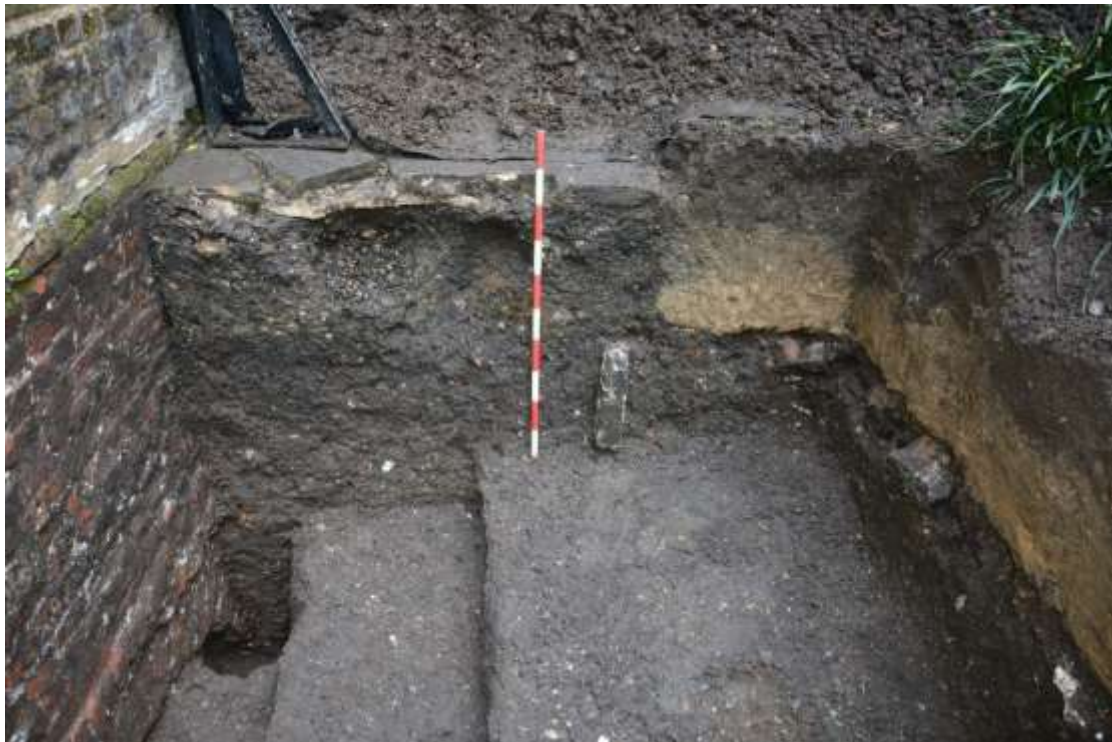
Figure 19: Detail of arch. The division between the two phases can be seen. There is a small scar to the left of the scale - purpose unknown. Facing north-east.

Figure 20: Overview of wall, stone and planter material in section. Facing east.

Figures 19 and 20 above show the extent of the post-medieval wall. Similarly to the section recorded in pit 2, the division between the phases can be seen. At the junction of the red and yellow bricks is a single course of messy repair work (14.40mOD).

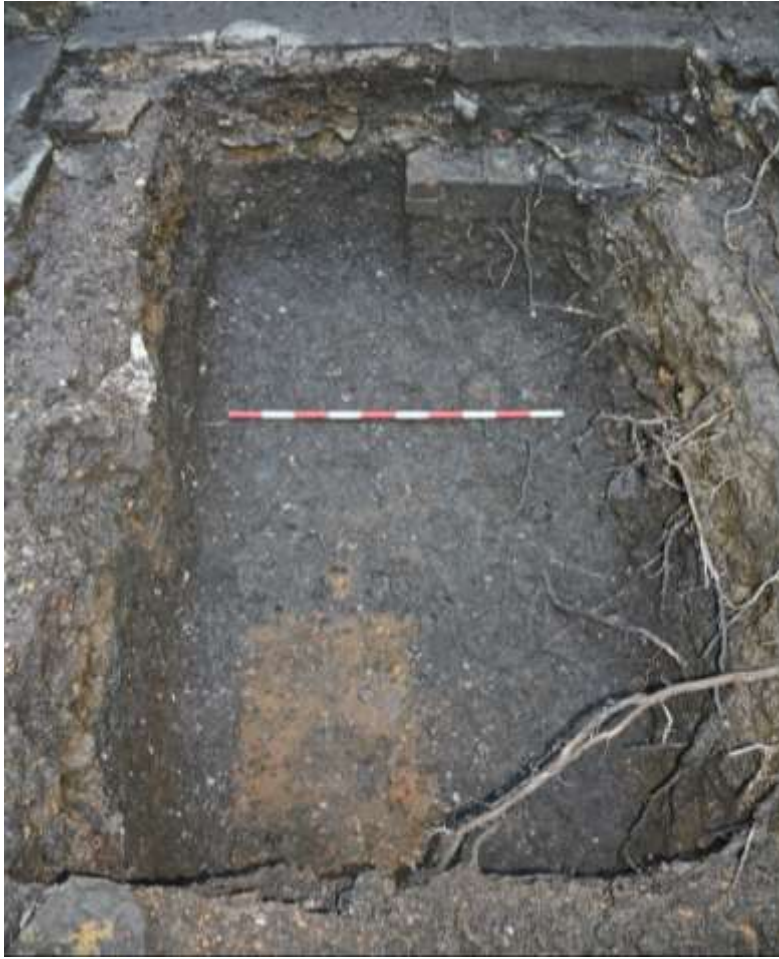
Figure 21: Overview of pit 4. Facing west.

Pit 4 was located in the south-west corner of the churchyard, north of the entrance steps and adjacent to the current boiler room. The ground level in this area was 14.25mOD. The pit measured 2.5m in length (E-W) x 1.6m in width x 0.8m, with a maximum depth of 0.8m (13.45mOD). A clay baulk was retained on the north side to prevent damage to vegetation in the existing planter.

A deposit of clay measuring 1.5m in length x 1.0m in width x 0.3-0.4m in thickness covered approximately half of the trench. This was removed to reveal patches of orange gravel and a mid-brown silty soil abundant with rubble and stones. The patches of gravel measured between 50 and 100mm in thickness, extending to a depth of approximately 13.90mOD. The shallow depth at which these were encountered suggests they have been deposited recently. This is supported by the modern brick drain in the north-west corner of the pit which immediately underlies this horizon.

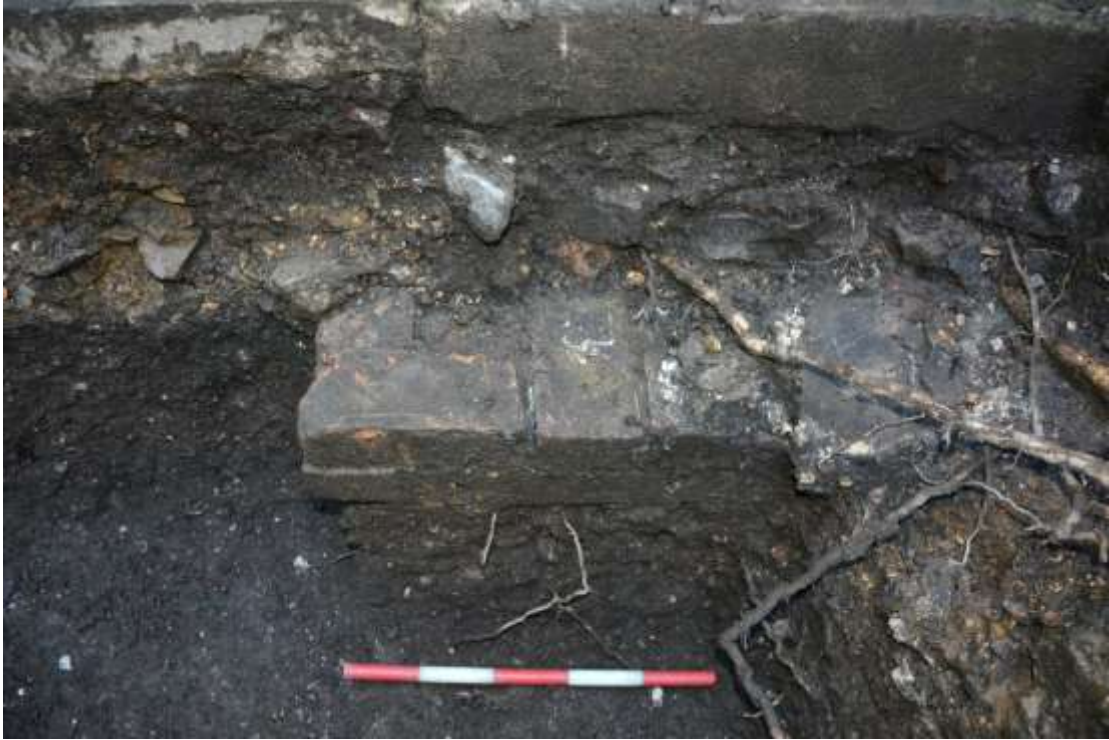
Figure 22: post-medieval brick drain structure at west end of pit. Facing west.

The brick feature, shown above in fig 22, taken to be a modern drain, was constructed of two courses of frogged orange bricks. It measured 0.9m in length x 0.26m in width x 0.24m in depth. Stone slabs cap the feature, or more likely, have been dumped, at the north end.

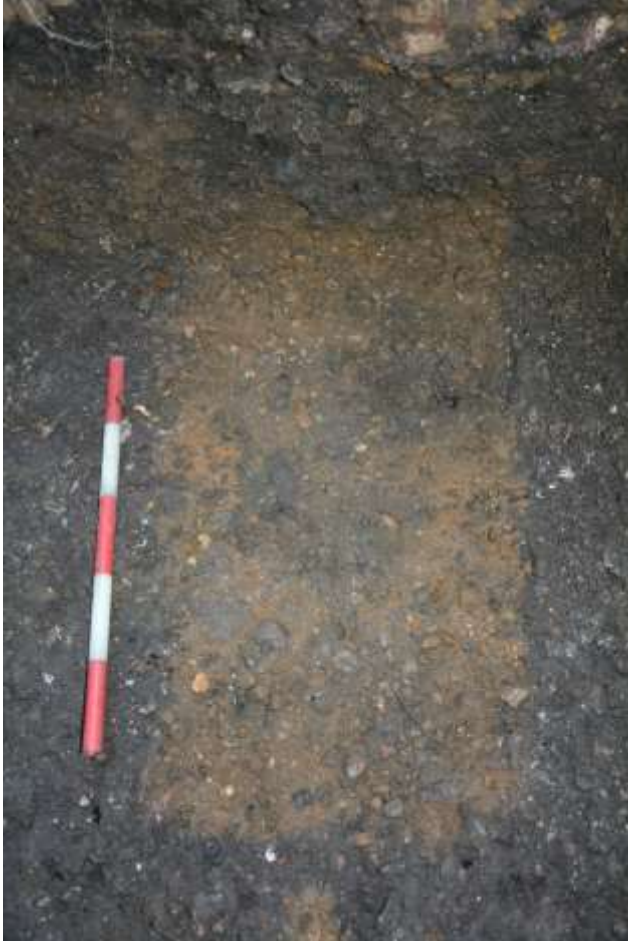
Excavations at the east end of pit 4 uncovered a rectangular cut along the trench base. The cut was aligned east-west and filled with the same orange gravel seen elsewhere in pit 4, and also pit 2. The feature measured 0.78m in length x 0.38m in width, the depth is unknown.

Figure 23: Rectangular gravel filled cut at east end of pit 4. Facing east.

It is unclear what this feature is, however, one hypothesis is that it may be a backfilled grave. The shape and alignment would support this theory. Because of the similarities in gravel fills between pit 4 and pit 2, the backfilling of this cut may be contemporary with the creation of the charnel pit feature in pit 2 and associated with the burial clearance. However it should be noted that this feature is relatively narrow and may not have been wide enough for a burial.

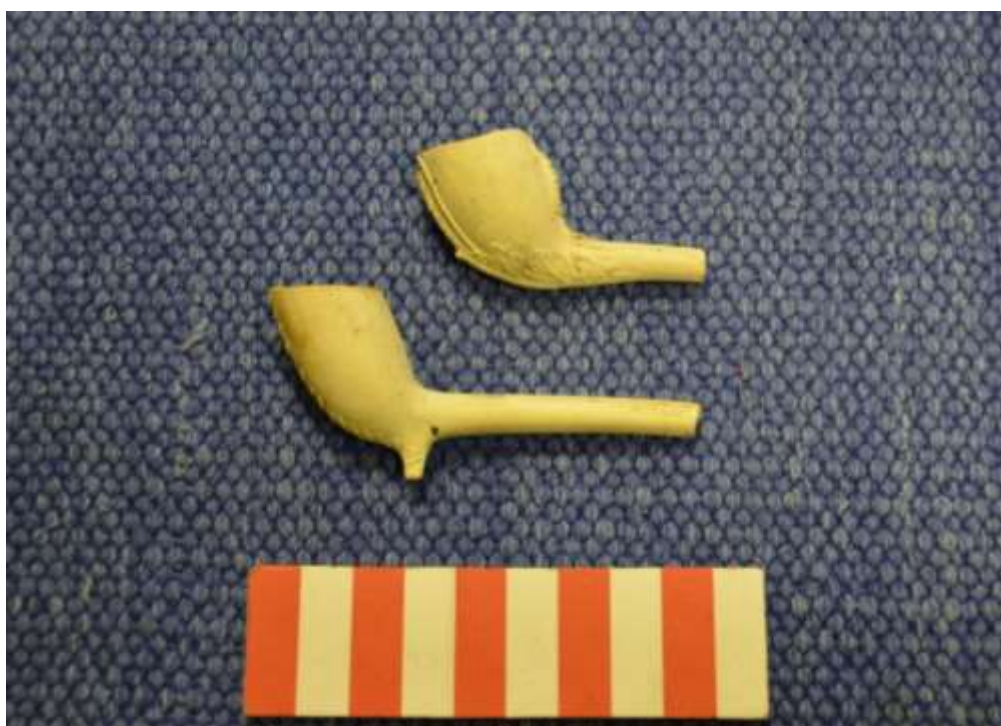
Figure 33: Decorated clay tobacco pipes recovered from pit 2.

A total of 69 clay tobacco pipe fragments were recovered from four pits. These included 2 complete pipe bowls with partial stems attached, 1 almost complete bowl with a partially attached stem and 3 partial stems with partial bowl fragments attached. A total of 63 stem fragments were recovered ranging in length from 18-88mm and width from 3-11mm, however these are less diagnostic than bowls. The collection is in a fairly typical state of preservation, and many fragments show little signs of wear. The pipes were recovered from the main backfill of each pit, which although varies slightly are believed to be contemporary, if not the same.

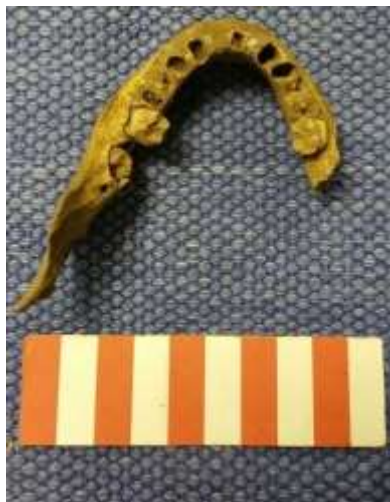
Figure 34: Child mandible from Pit 3

The human bones assemblage contained remains of both adult and children, unfortunately only a few could be aged or sexed due to their high fragmentation level and their commingled state. However, some basic analysis could be carried out. A juvenile humerus diaphysis from pit 3 was intact and could be measured, indicating that the child was about 5 to 6 years at the time of death. A child mandible (fig. 34) could be aged by teeth eruption and gave an age at death of 5 years (plus or minus 9 to 16 months). Both child humerus and mandible were from pit 3 and could potentially belong to the same individual, but unfortunately it is impossible to say with any certainty. Juvenile bones were recovered also from pit 2, but unfortunately were too incomplete to allow measurements and ageing, however by the level of fusion observable, they were all under 15 years of age at the time of death.

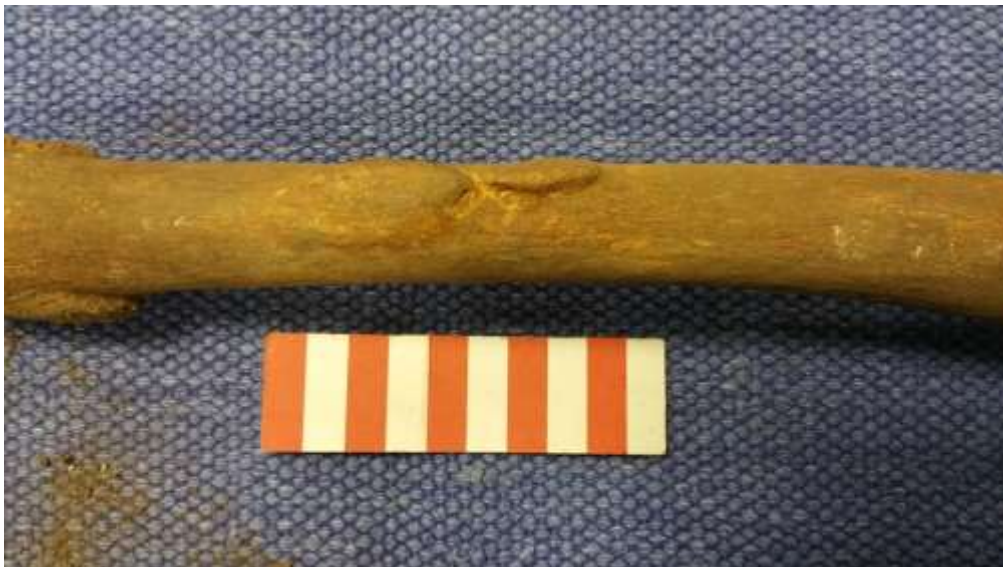
Figure 36: Ossified haematomas on a human adult femur from pit 3

femur. One haematoma was about 4cm in length and 1cm in width, while the second was about 2.5cm in length and 50cm in width (fig. 36).
