PHASE 1 WORKS, EXCALIBUR ESTATE, LEWISHAM, SE6

AN ARCHAEOLOGICAL EVALUATION

Site code: EXC16

Abstract

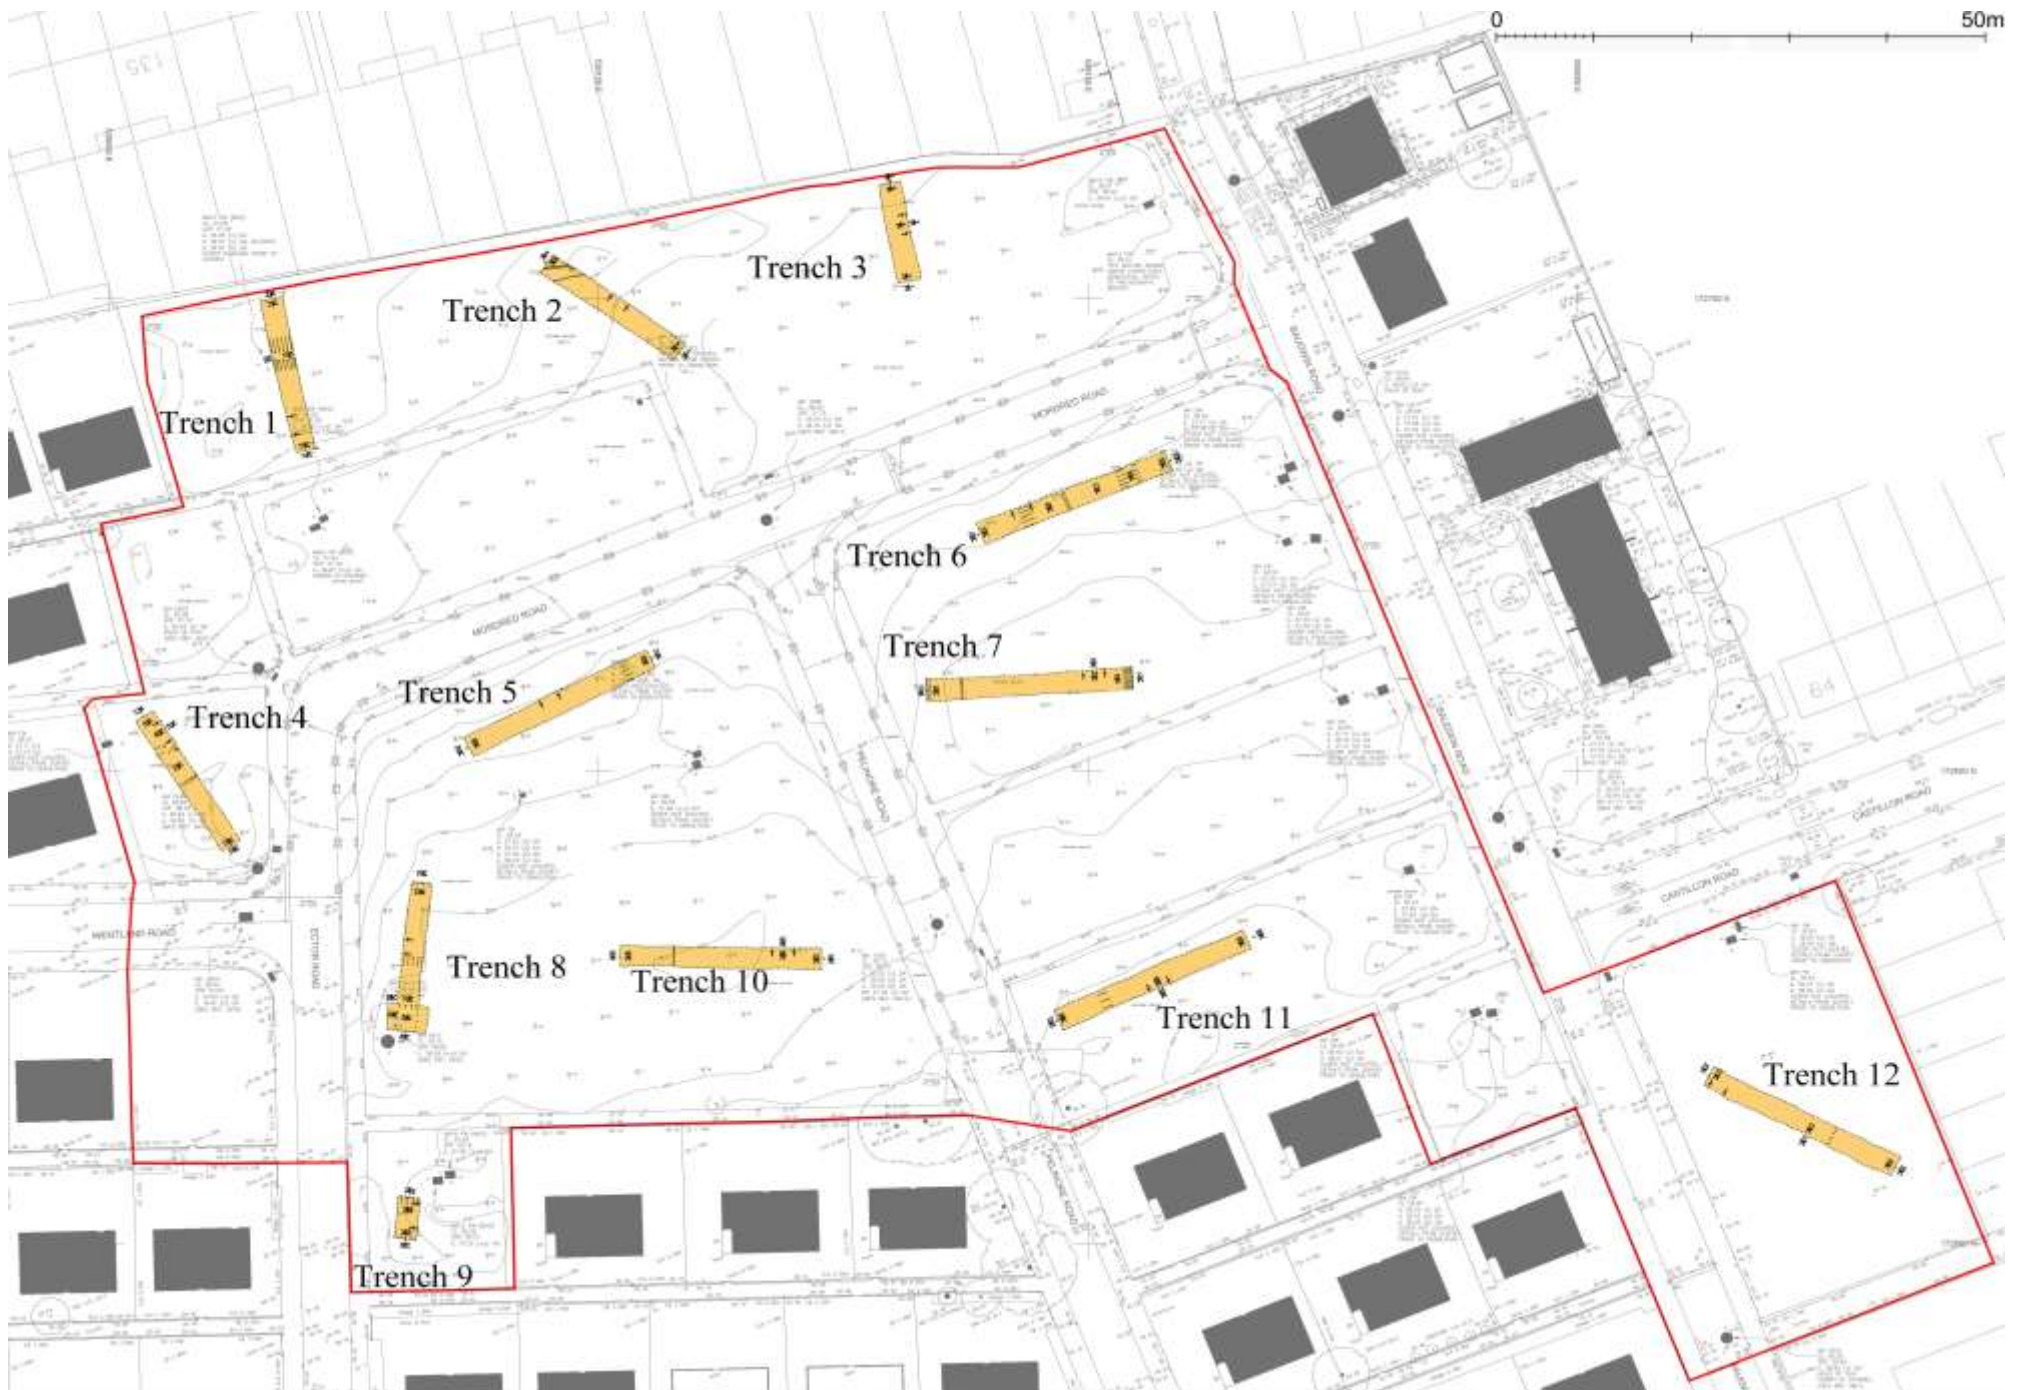
Fig. 7: Site plan with trench plans

The following section is a summary of the twelve trenches including reference to the stratigraphy observed, features of interest and a selection of illustrative photographs. Section drawings are also provided with can be cross-referenced with the overall site plan fig.7.

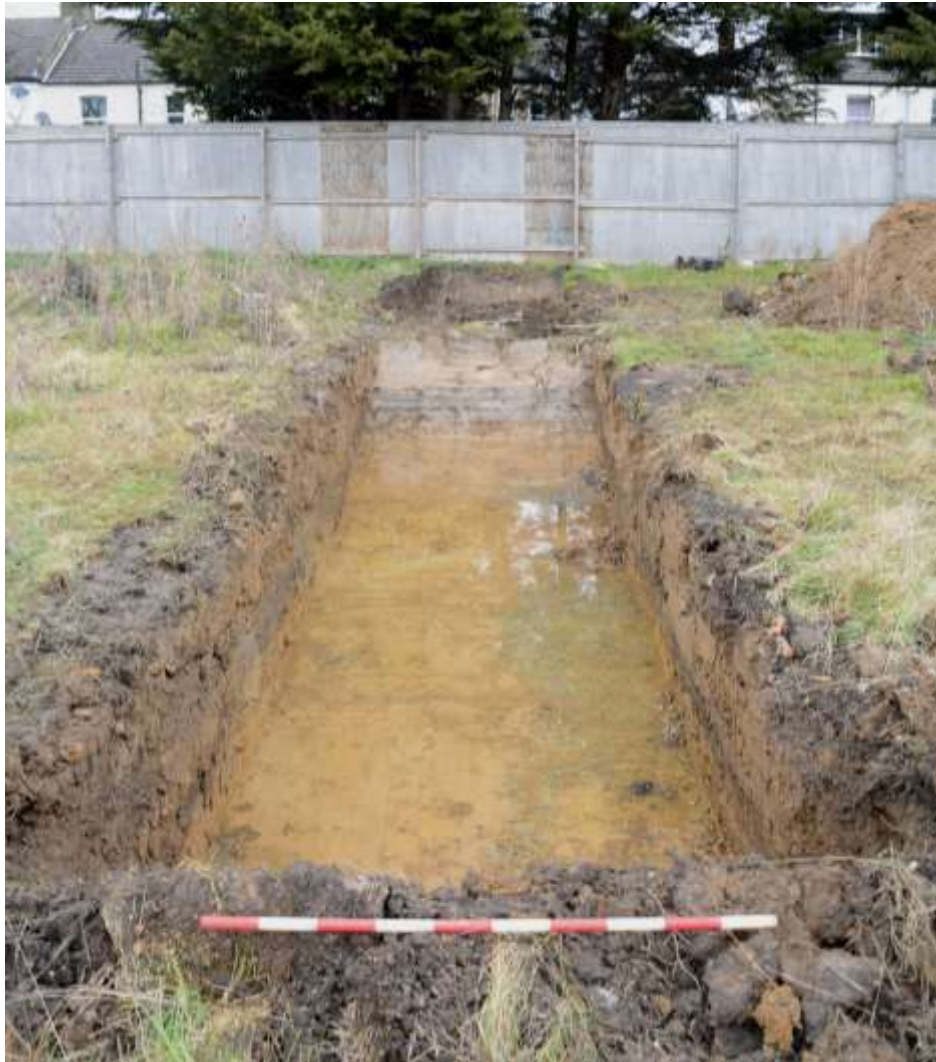
Trench 1 was located in the north-west corner of the site, on the north side of Wentland Close (see fig.7). The trench measured 16.5m in length x 2.0m in width x 1.10m in depth at its greatest extent and aligned north-west. An east-west baulk of 3.5m was retained towards to the northern end of the trench to provide cover for two exposed water mains.

Fig.9: Overview of Trench 1. The east-west baulk can be seen towards the far end of the trench. Facing N. Scale 1m

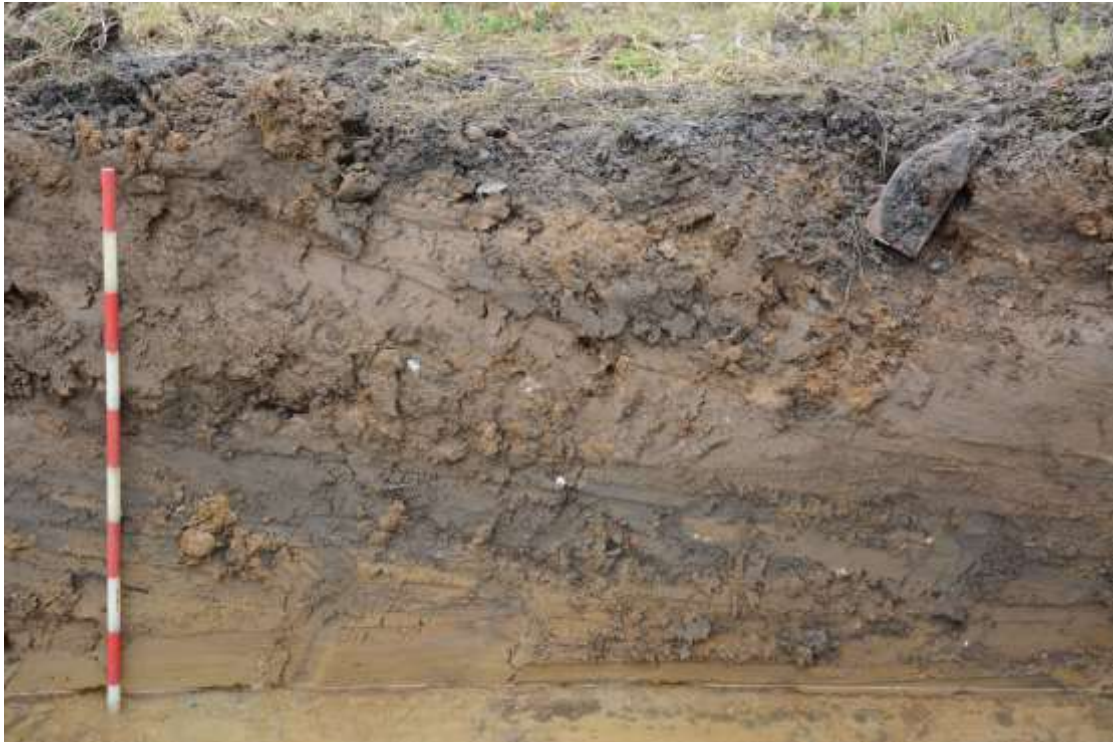
The stratigraphy comprised the following: 100-300mm of brown/black topsoil (101) containing frequent fragments of ceramic building material, rounded stones and angular gravel; above 300-400mm of light brown clay (102) with infrequent inclusions of gravel; 200-300mm of mid-brown loamy soil (103) above a minimum of 350mm (approximately 220mm seen in the west section) of orange brown sticky clay (104) abundant with gravels (see fig.10). The clay is taken to be natural, and continuing below the level of excavation (36.39mOD-36.47mOD). A pipe can be seen cutting into (102) in the section drawing (see fig.8).

Fig. 10: *Stratigraphic sequence in west facing section. Facing W. Scale 1m*

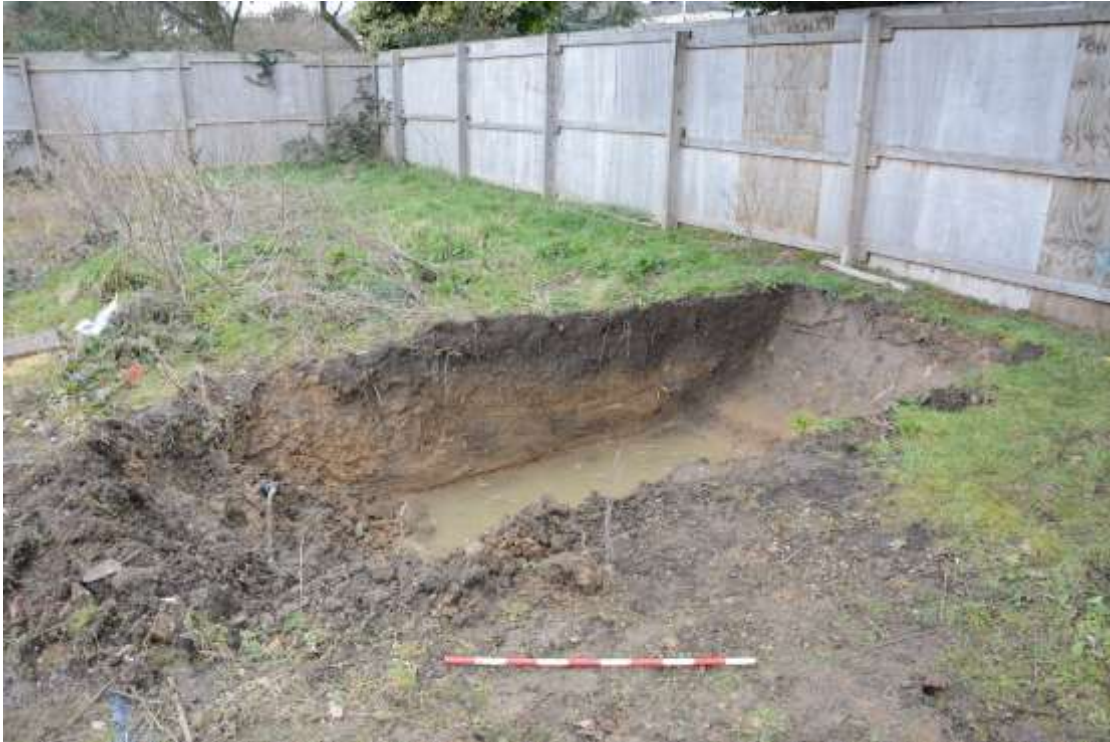
No finds or features were recorded in the southern part of the trench. The topsoil at the northern end of the trench was darker in colour, with some commingling with the clay beneath. The topsoil was 300mm in thickness with a U-shaped profile (see fig.11). This cut measured a minimum of 1.5m in length x 0.25-.030m in width, aligned east-west with a gently sloping southern edge. The fill contained frequent fragments of building rubble and modern rubbish, including, most notably, an entire folded away pram. The topsoil was directly overlying the clay below, the subsoil observed in the northern part was not present. This small cut was attributed to a modern ditch or hole dug with the purpose of being filled with refuse.

Fig. 11: *Shallow ditch at northern end of Trench 1. Facing NW. Scale 1m*

No further features were observed in Trench 1 and no artefacts recovered. The stratigraphy recorded in the trench was interpreted as modern made ground above the natural, with a recent, (within the last fifty years) shallow ditch dug in a former garden to be used as a refuse tip. Natural was encountered at 36.79mOD.

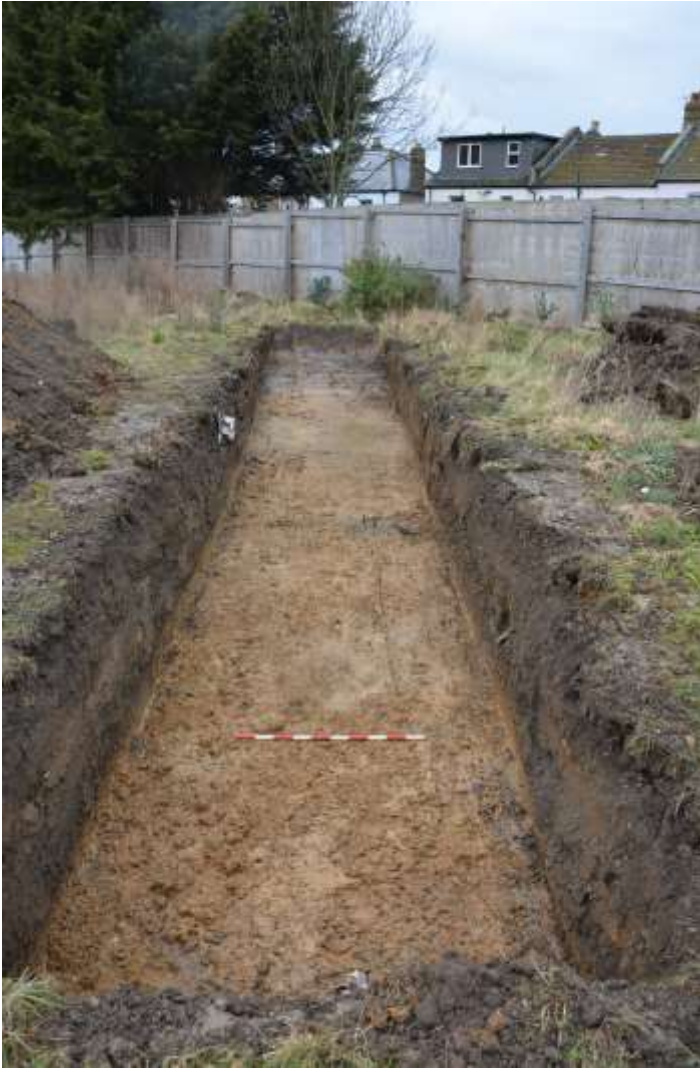
Trench 2 was located on the northern side of the site (see fig. 13), approximately 30m east of Trench 1. The trench was aligned NW-SE, measuring 16.50m in length x 2.0m in width x 1.10m in depth. This depth was reduced to 0.5m at the north-west end to provide adequate cover for 2 ceramic service pipes.

Fig. 13: *Overview of Trench 2. Facing NW. Scale 1m*

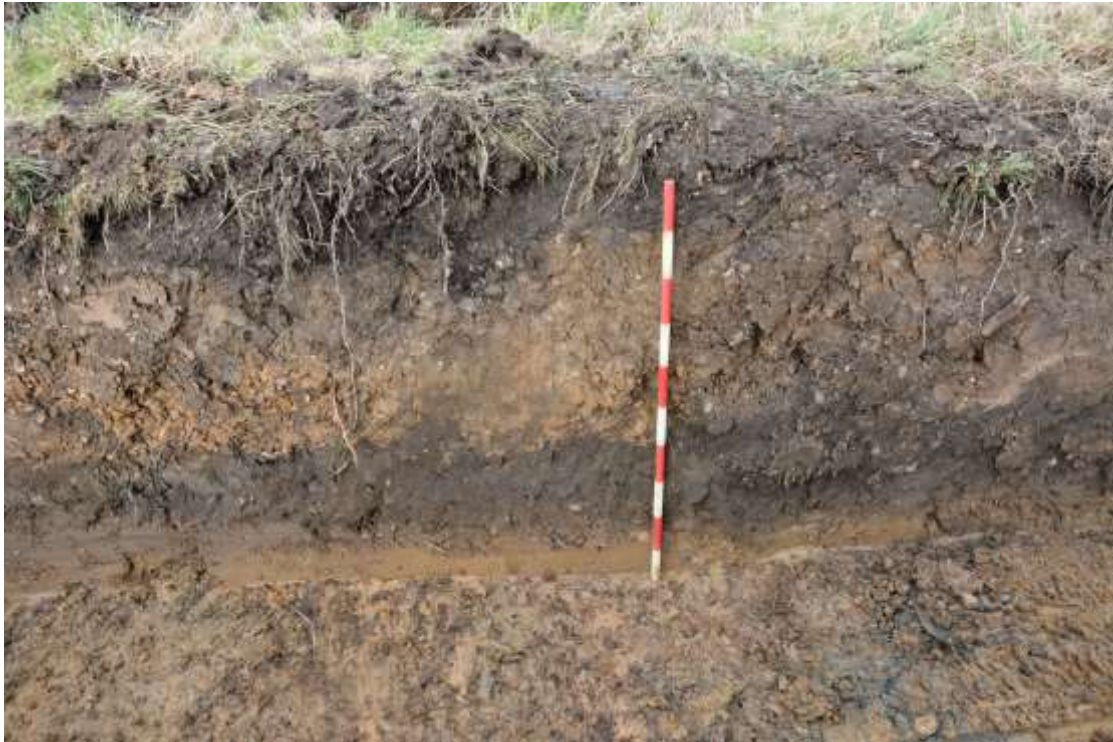
The stratigraphy (see fig.14) comprised an undulating layer of mid-brown topsoil (201) containing fairly frequent fragments of rubble and general debris, 100-300mm thick, above 420mm of orange clay (202) abundant with rounded gravel and infrequent roots. This orange clay sat directly above 270-310mm of lighter brown clayey soil (203) containing infrequent black flecks. Closer to the trench base the clay became browner and more gravelly (204), measuring 180mm in thickness and continuing below the level of excavation (37.19-37.21mOD).

Fig. 14: NE facing section of Trench 2. Facing NE. Scale 1m

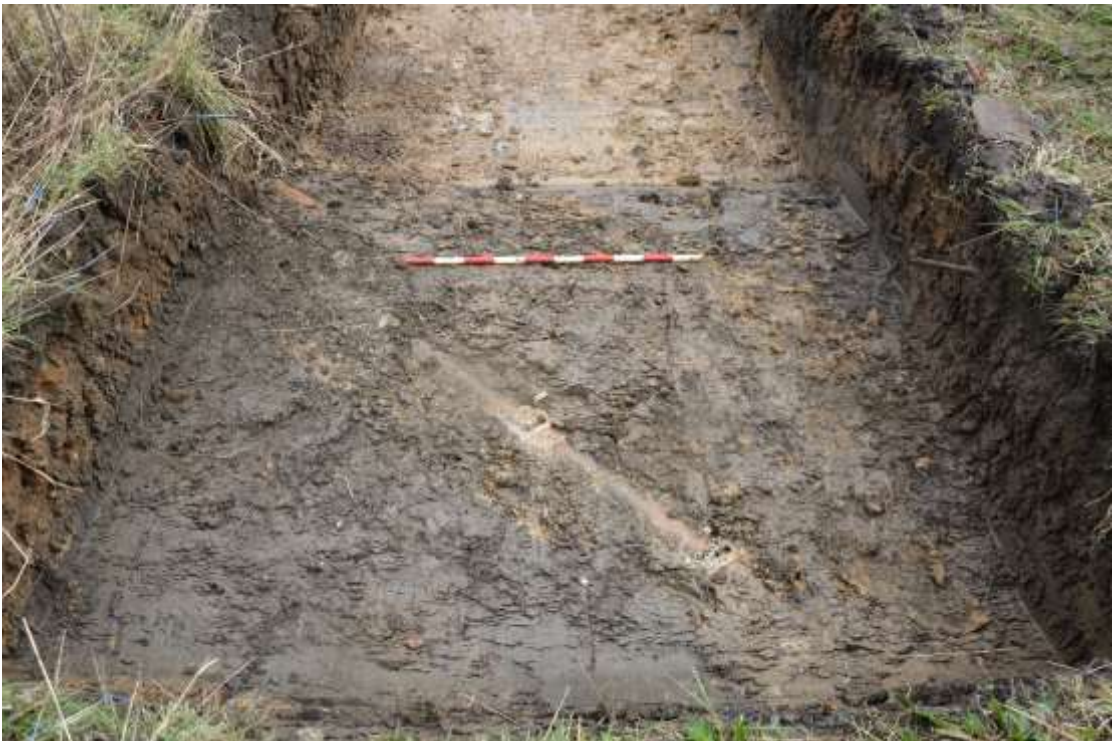
Fig. 15: Two existing services aligned approximately E-W at north-western end of trench. Facing SE. Scale 1m

The services (see fig. 15) were located at a depth of 0.5m and were aligned approximately east-west. They were filled by a linear stretch of gravel running parallel with the pipes. The services were not observed in any of the other trenches located on the northern side of the development site. No archaeological features were observed in this trench. Natural was encountered at 37.39mOD.

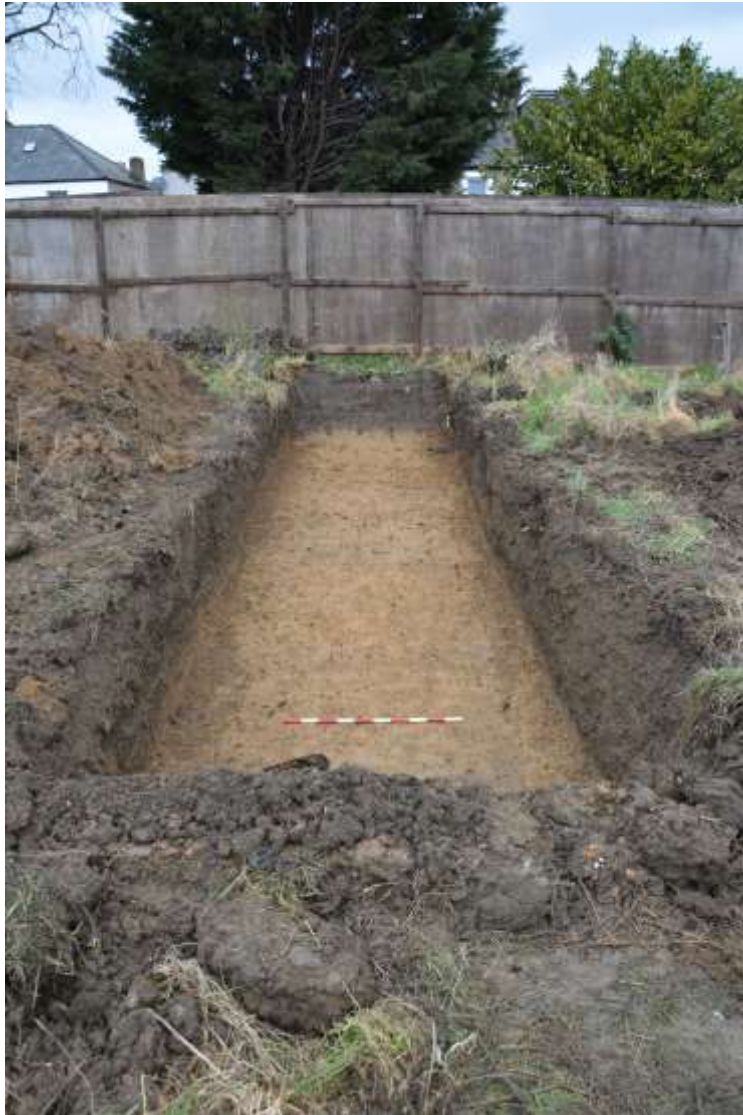
Trench 3 (see fig.17) was located towards the north-eastern corner of the site, north of Mordred Road and approximately 20m east of Trench 2. The trench was aligned north-south and measured 10.5m in length x 2.20m in width x approximately 0.95m in depth.

Fig. 17: *Overview of Trench 3. Facing N. Scale 1m*

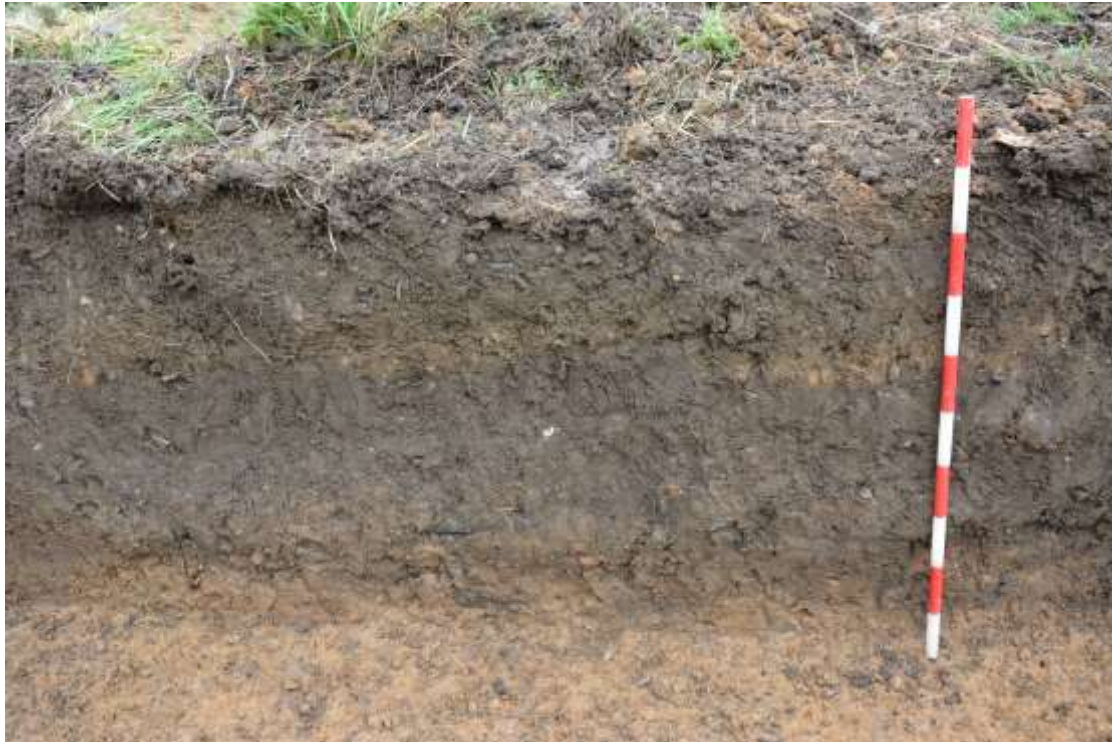
The stratigraphy in Trench 3 (see fig.18) comprised 280mm of dark brown-grey clayey topsoil (301) abundant with rounded pebbles, above 400mm of brown-grey clay (302) with infrequent black flecks above 200mm of mottled brown-orange clay (303), becoming cleaner and more orange towards the trench base. This layer was abundant with gravel and infrequent fragments of brick.

Fig. 18: *Stratigraphic sequence in west facing section of Trench 3. Facing E.*
Scale 1m

The sequence in Trench 3 was interpreted as modern made ground above the natural, with some disturbance indicated by the presence of ceramic building material towards the trench base. No archaeological features were observed in this trench and no finds were recovered. Natural was encountered at 37.61mOD.

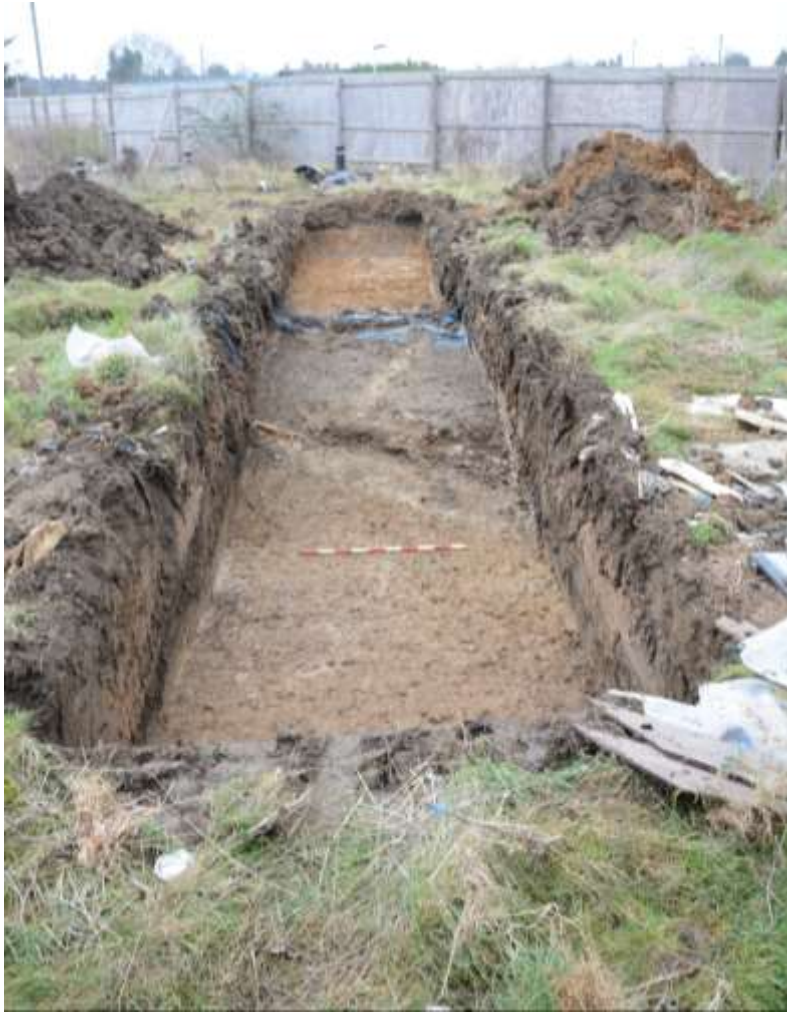
Trench 4 (see fig. 20) was located on the western side of the site, bounded by Ector Road to the east and the north-south hoarding crossing Wentland Road to the west. The trench was aligned NNW-SSE and measured 16.50m in length x 2.30m in width x 0.71m in depth at the south end. The depth was increased to 1.15m at the north end due to a dip in the natural. A central baulk measuring c4.0m was retained to provide cover for existing services including both ceramic and plastic pipes running approximately NW-SE.

Fig. 20: *Overview of Trench 4, showing existing services and natural gravels at the southern end. Facing SSE. Scale 1m.*

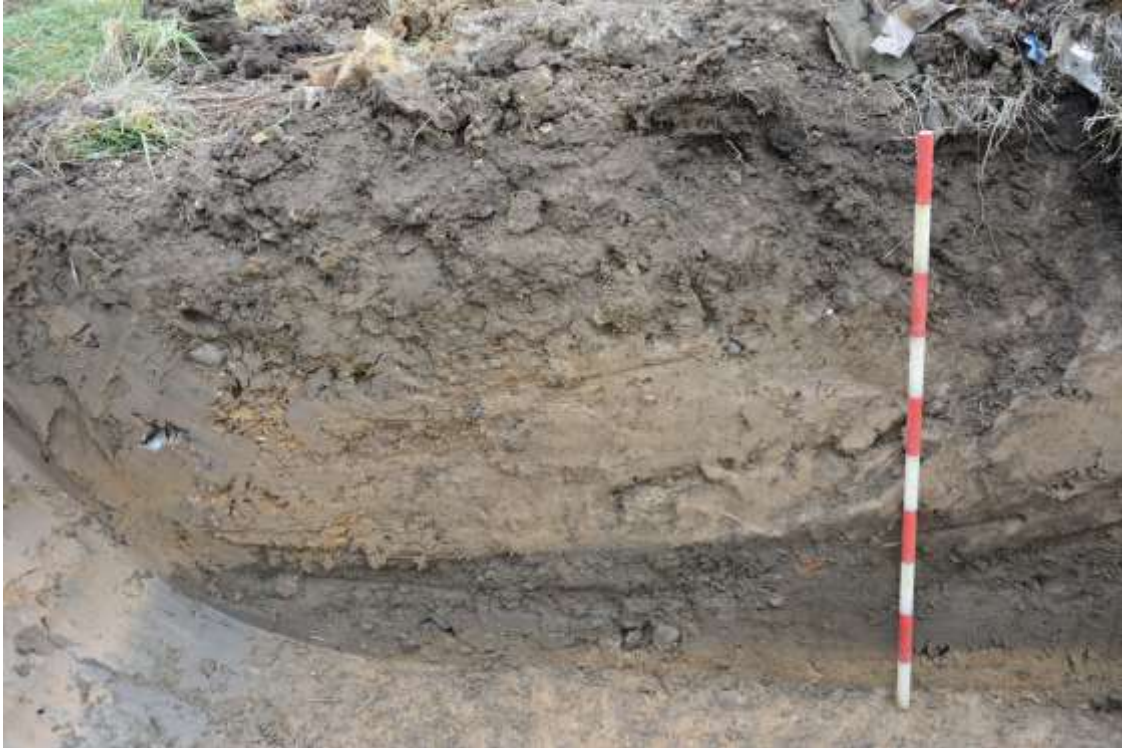
The stratigraphy (see fig.21) comprised 200mm of brownish topsoil (401) with infrequent pebble inclusions at the southern end of the trench, increasing to 380mm at the northern end. Below this was a layer of mid greyish-brown silty clay (402) 140mm in thickness at the southern end and 350mm in thickness at the northern end, and beneath this a layer of mid greyish-brown soil (403) 120mm in thickness at the southern end of the trench and increasing to 330mm in thickness at the north end at its greatest extent. Below the soil a minimum of 190mm (120mm at the northern end) of natural (404) was observed, taken to continue below the level of excavation (37.10-37.33mOD).

Fig. 21: *Stratigraphic sequence at deeper northern end of Trench 4. Facing NE. Scale 1m.*

The stratigraphy recorded in Trench 4 was taken to be a series of modern make up layers and fills for services. It is likely that the deeper northern end of the trench had been dug on a previous occasion due to the presence of a buried soil layer recorded at a depth of 0.6m, which would account for the increased depth at which natural gravel and clay was encountered. No dating evidence was recovered from this soil layer but it is likely to be associated with either the construction or demolition of the pre-fab on the site in the 20th century. No other features were observed in this trench. Natural was encountered at approximately 37.42mOD at its highest depth on the trench.

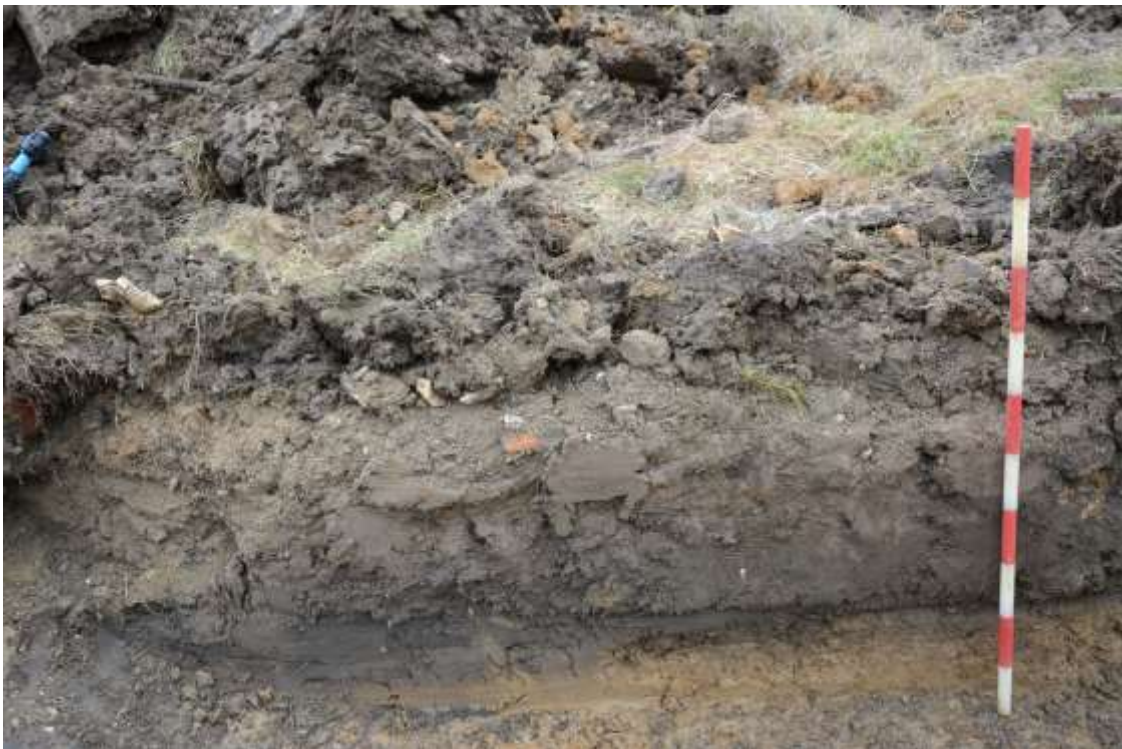
Fig. 22: *Stratigraphic sequence at the southern end of the trench. Facing NE. Scale 1m*

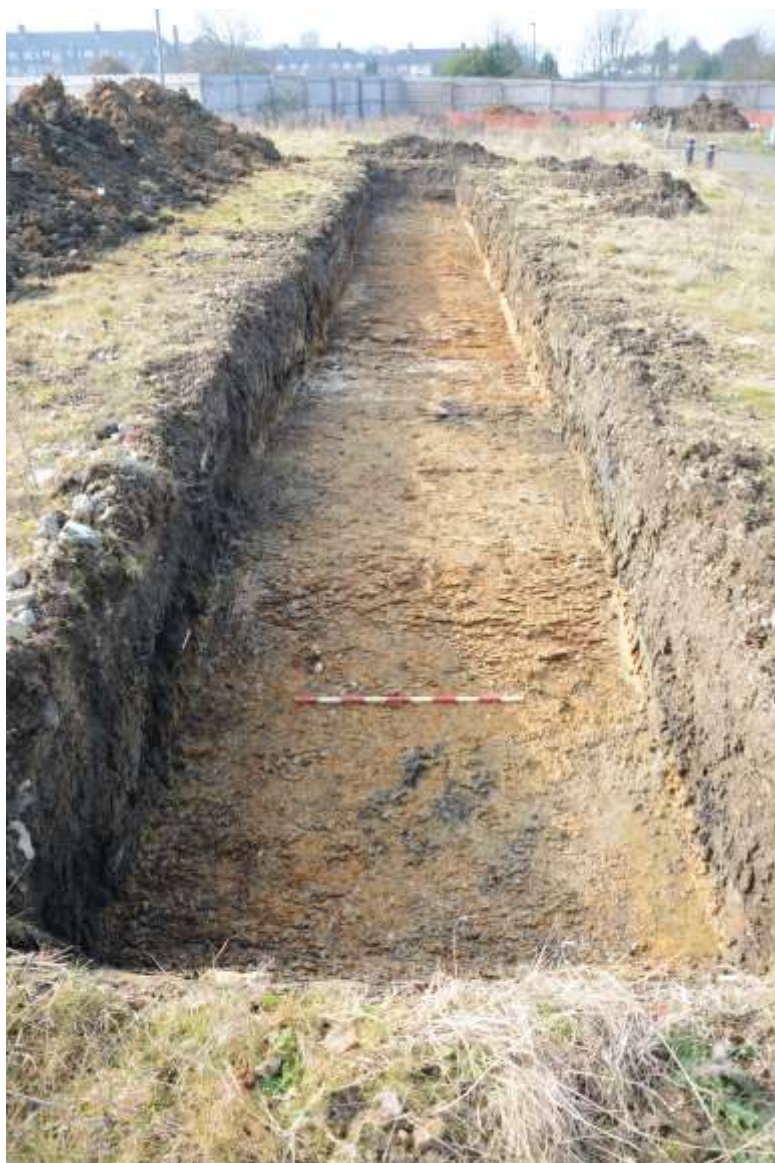
Trench 5 (fig. 24) was located approximately 4-6m south of Mordred Road, bounded by Pellinore Road to the east and Ector Road to the south. The trench measured 20.5m in length x 2.2m in width x 0.9-0.98m in depth and was aligned ENE-WSW.

Fig. 24: Overview of Trench 5. The orange mesh fencing in the background marks the location of Trench 4. Facing W. Scale 1m

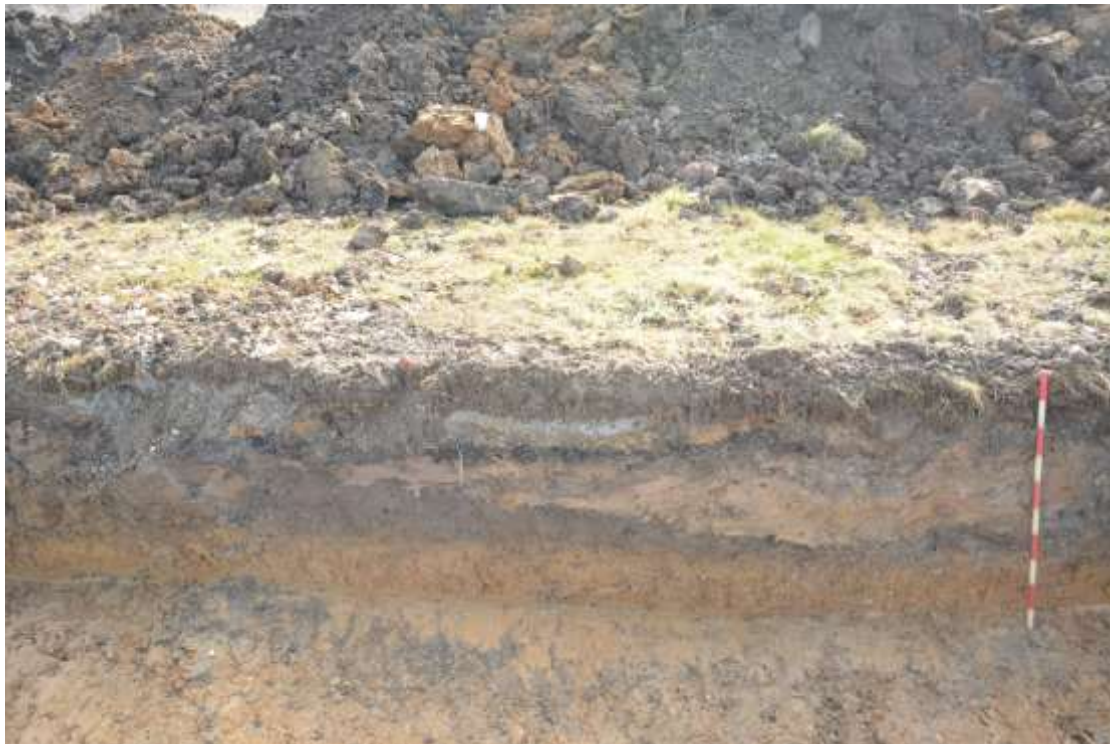
The stratigraphy of Trench 5 (see fig. 25) generally comprised 200mm of light brown friable topsoil (501) containing frequent fragments of concrete and infrequent fragments of CBM, above 350-550mm of subsoil (504). In the NW section, a slab of concrete as well as a 150mm deposit of light brown-orange clay (502) and 80mm of brown-black silt (503) can be seen cutting into the subsoil. This was above 50-250mm of dark brown silt (505). Natural gravelly clay (506) was encountered at a depth of 0.68-0.75m and was taken to continue to below the level of excavation.

Fig. 25: *Stratigraphic sequence with some modern disturbance observed in the north facing section. Facing NW. Scale 1m*

Fig. 25 above shows a localised section of disturbance observed approximately 10m from the eastern end of the trench. Remains of a concrete slab can be seen above a thin horizon of black silt and a larger deposit of light brown redeposited clay within the darker brown subsoil. This was taken to be 20th century make up layers associated with the digging, and subsequent laying the foundations for a house. No finds were recovered from these layers.

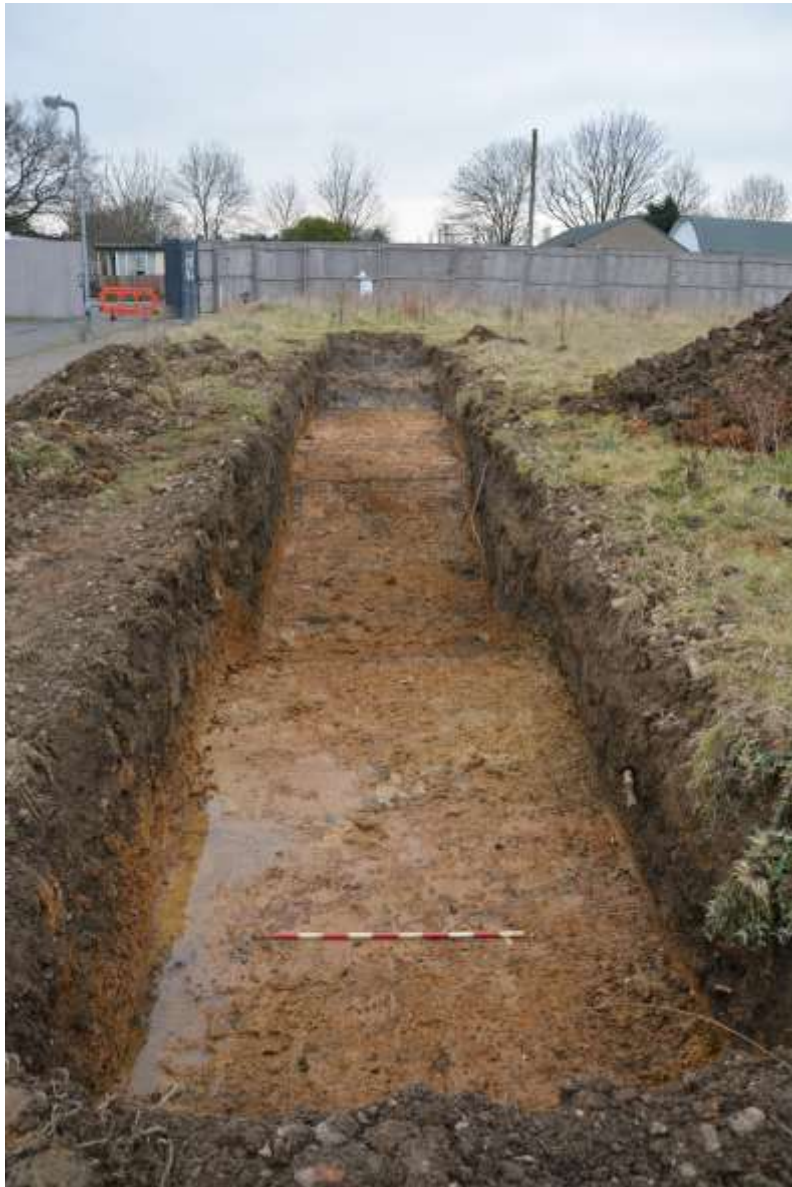
Trench 6 (see fig.27) was located 7.32m south of Mordred Road, bounded by Baudwin Road to the east and Pellinore Road to the west. The trench measured 20.35m in length x 2.4m in width x 0.4-1.58m in depth, and was aligned approximately ENE-WSW. A 1.0m north-south baulk was retained at the eastern end of the trench to provide adequate cover for existing services.

Fig. 27: Overview of Trench 6 showing sloping base and baulk. Baudwin Road runs N-S behind the hoarding. Facing E. Scale 1m

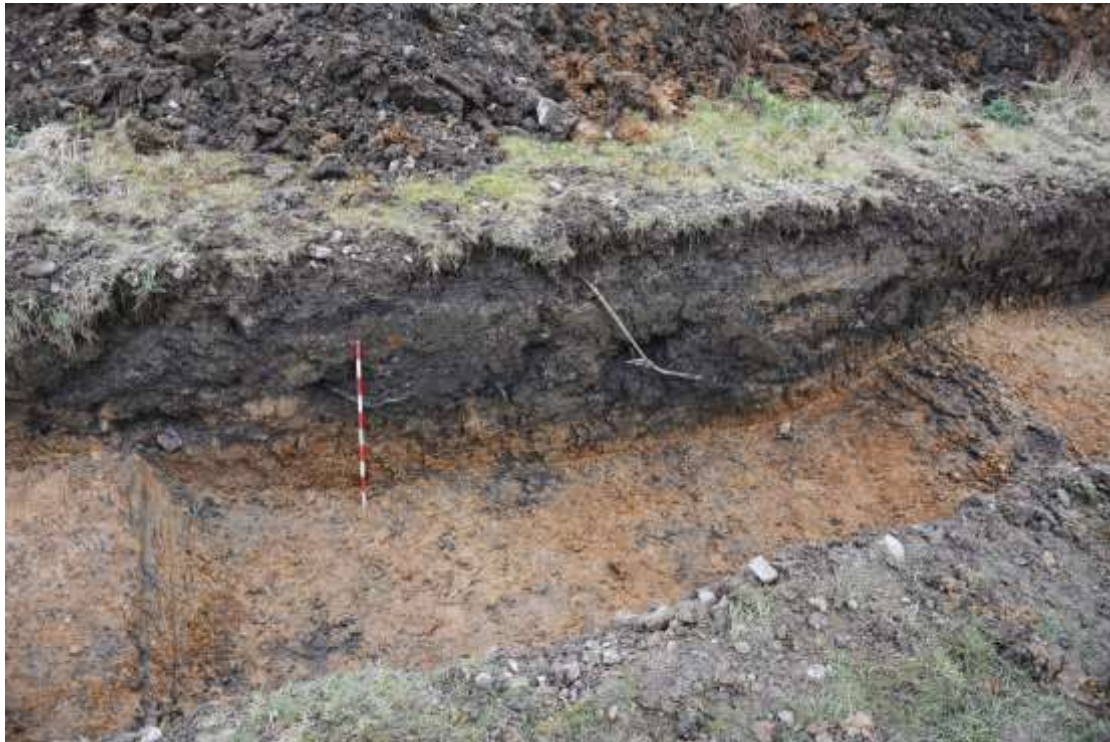
Fig. 28: *Depression cut into the natural. A small vertical intrusion of orange clay can be seen to the right of the scale bar. Facing NW. Scale 1m*

A shallow depression (see fig. 28) aligned north-south measuring 5.10m in width x 0.35m in depth was observed 4.75m from the west end of the trench, cutting into the natural gravel and clay. The area above was filled by a mix of topsoil, subsoil and lead services. A degree of commingling between the layers was noted. This feature was interpreted as a backfilled ditch, formed as a result of previous groundworks. It is likely that during clearance of a site a machine dug the slightly deeper depression to remove footings/services and backfilled the area using spoil. The level at which natural was observed otherwise remained fairly consistent across the rest of the trench (generally 38.26mOD, 37.47mOD at its deepest in the trench).

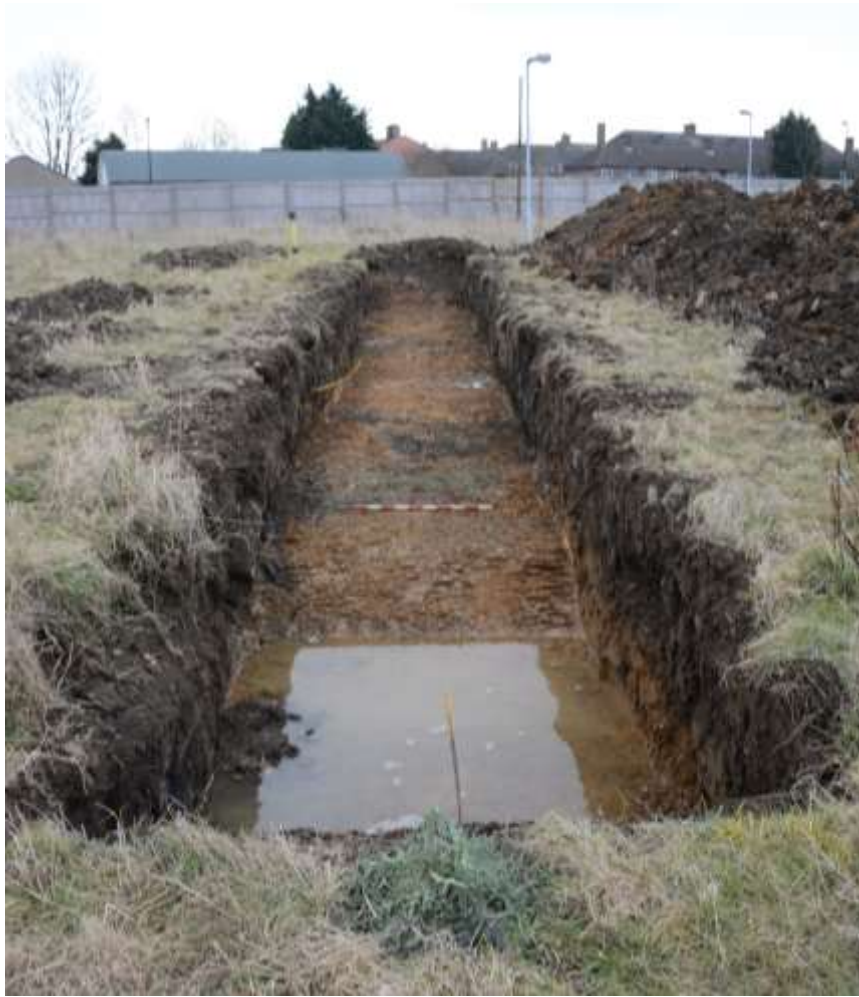
Trench 7 (see fig. 30) was located 12m south of Trench 6, adjacent to Pellinore Road in the west. The trench measured 20.7m in length x 2.2-4m in width x 1.0m in depth at the eastern end, increasing to 1.3m at the western end, and was aligned east-west. Approximately 3m of the east and west ends of the trench were not recorded as they were filled with water from nearby drains.

Figure 30: *Overview of Trench 7. Both the east and west ends could not be drained. Facing E. Scale 1m.*

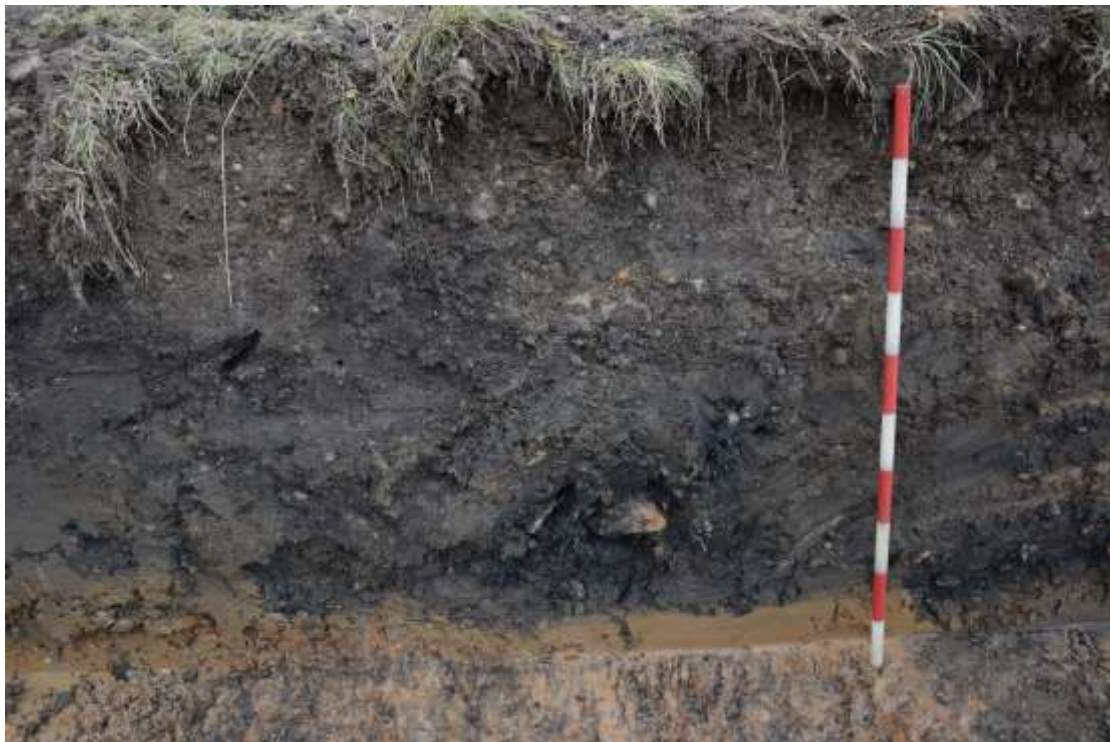
The stratigraphy in Trench 7 comprised a simple sequence of 260-380mm of mid brown topsoil (701) with frequent pebble inclusions, above 200-410mm of light brown-orange clay (702), above 100-290mm of dark greyish-black silty soil (703) containing some fragments of ceramic building material, which sat directly above the natural (704). The natural measured a minimum of 150mm in thickness and was taken to continue below the level of excavation. It comprised an orangey clay abundant with gravel. Some undulations in the light brown-orange clay were recorded although no features were present. This layer appeared as isolated deposits, particularly towards the ends of the trenches, and not indicative of the trench as a whole.

Fig. 31: *Representative section of stratigraphy in Trench 7. Facing NW. Scale 1m*

The patches of clay described above are taken to be redeposited material associated with the clearance of the site. No archaeological finds or features were observed in this trench. Natural was encountered at 38.26mOD.

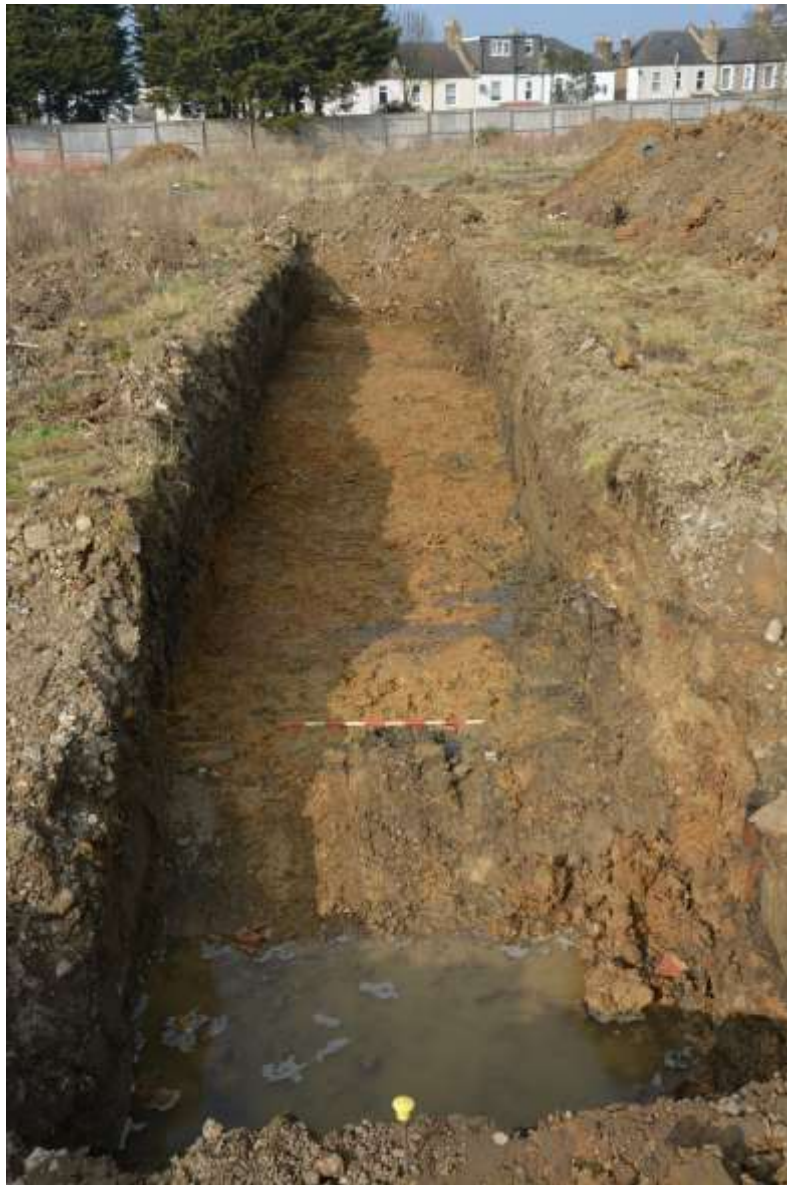
Trench 8 (see fig.33) was located in the south-west corner of the site, to the east of Ector Road. Originally intended to be 10m in length, the trench was extended to 15.50m in length to compensate for the foreshortening of Trench 9. The trench measured 2.0-2.20m in width x 0.94m in depth at the north end, increasing to 1.70m at the south end, and was aligned north-south. The south end of the trench was battered due to the increase in depth and to prevent water ingress.

Fig. 33: *Overview of Trench 8. Facing N. Scale 1m*

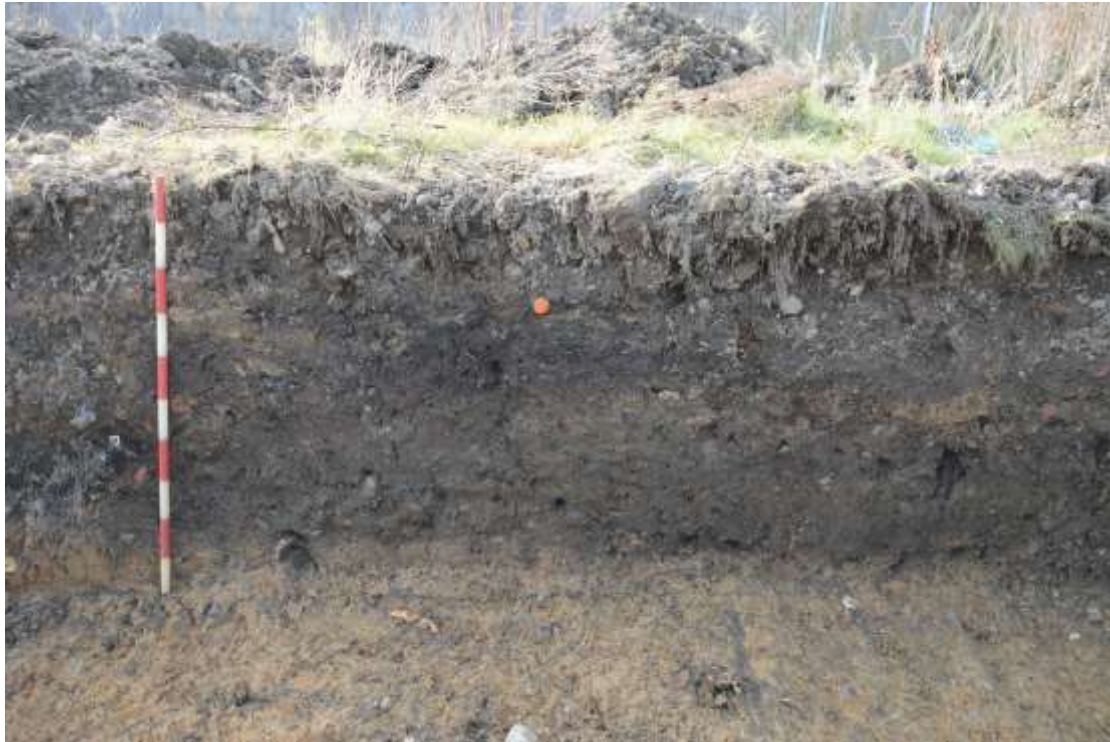
The stratigraphy comprised topsoil (801) consisting of a mixed soil/clay and demolition spread from clearance of the estate, measuring 500-650mm in thickness (up to 1.7m at the south end), above a sterile weathered subsoil (802), grey-brown in colour with some occasional gravel and crushed CBM inclusions c300-400mm in thickness, above a sterile orange/white/blue veined clay-silt (803). Some ceramic land drains were present at the base of the trench (37.86mOD).

Fig. 34: *West section of Trench 8. Facing W. Scale 1m*

The sequence (see fig.34) in this trench was interpreted as being a deposit of mixed topsoil and rubble associated with the clearance of the estate overlying a weathered subsoil – potentially truncated or left exposed during a construction/clearance event. These overlaid compacted ground. The increased in depth at the south end was the result of a cut into the natural which was filled with modern debris. No other features or finds were observed in this trench. Natural was encountered at 37.99mOD at its deepest extent.
