PHASE 1 WORKS, EXCALIBUR ESTATE, LEWISHAM, SE6

AN ARCHAEOLOGICAL EVALUATION

Site code: EXC16

Abstract

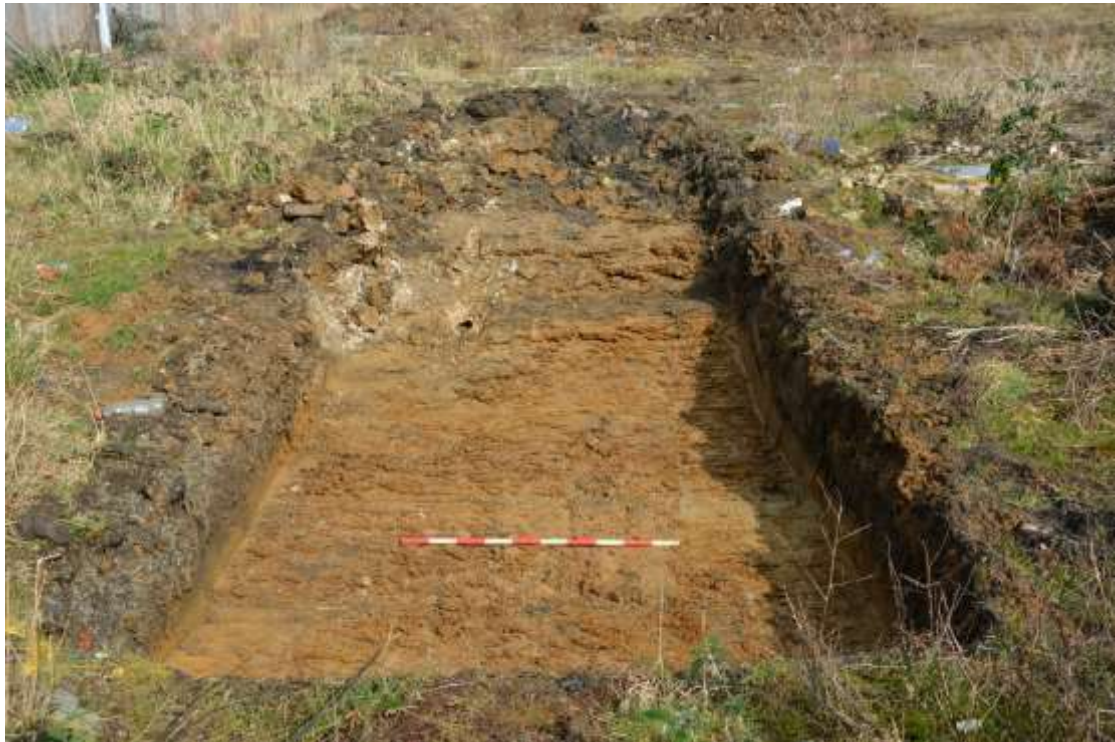
Trench 9 (see fig.36) was located in the south-west corner of the site, lying to the south of Trench 8. Originally intended to be 10m in length it was foreshortened due to the presence of live services in the area. The overall dimensions measured 4.45m in length x 2.20m in width x 0.65m in depth, and was aligned north-south.

Fig. 36: *Overview of Trench 9. Facing N. Scale 1m*

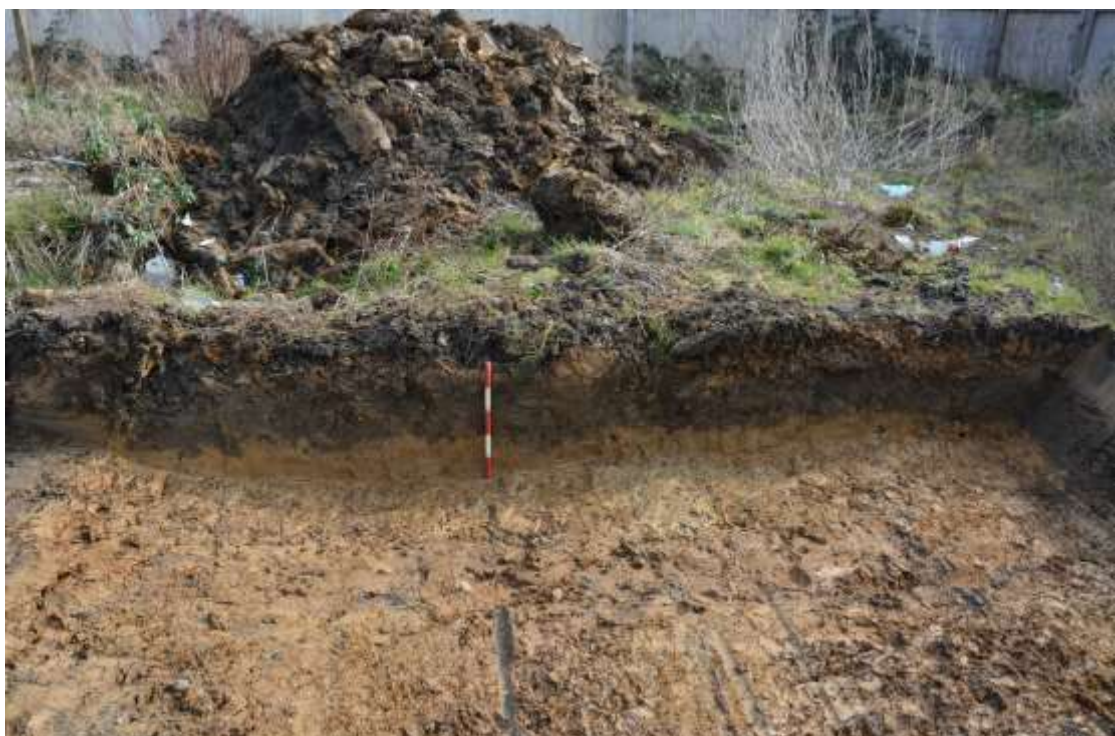
The stratigraphy was similar in character to that exposed in Trench 8 to the north. It comprised up to 280mm of worked over ground (901), consisting of a mix of soil, gravel, building debris and modern refuse, above 270mm of a weathered grey-brown clay-silt (902) containing infrequent rounded gravels up to 20mm in size. This subsoil overlay at least 120mm of a sterile orange/white/blue veined clay-silt (903) containing occasional pockets of smooth river-worn gravels (<20mm). The undulations reflect the natural topography.

Fig. 37: *Stratigraphic sequence in east section. Facing E. Scale 0.5m*

The sequence noted above was interpreted as a deposit of potentially imported or reworked topsoil from the demolition of former properties overlying a weathered subsoil, possibly truncated/exposed for a period during a construction/clearance phase. Remnants of garden landscaping (cultivated plants and a washing line) surrounding the trench suggests the property was demolished and some of the debris dumped *in situ*, resulting in the disturbance recorded. Trench 9 was noted as being the shallowest level at which natural was encountered (38.79-38.40mOD) suggesting a natural southward slope in topography. No other archaeological finds or features were observed in this trench.

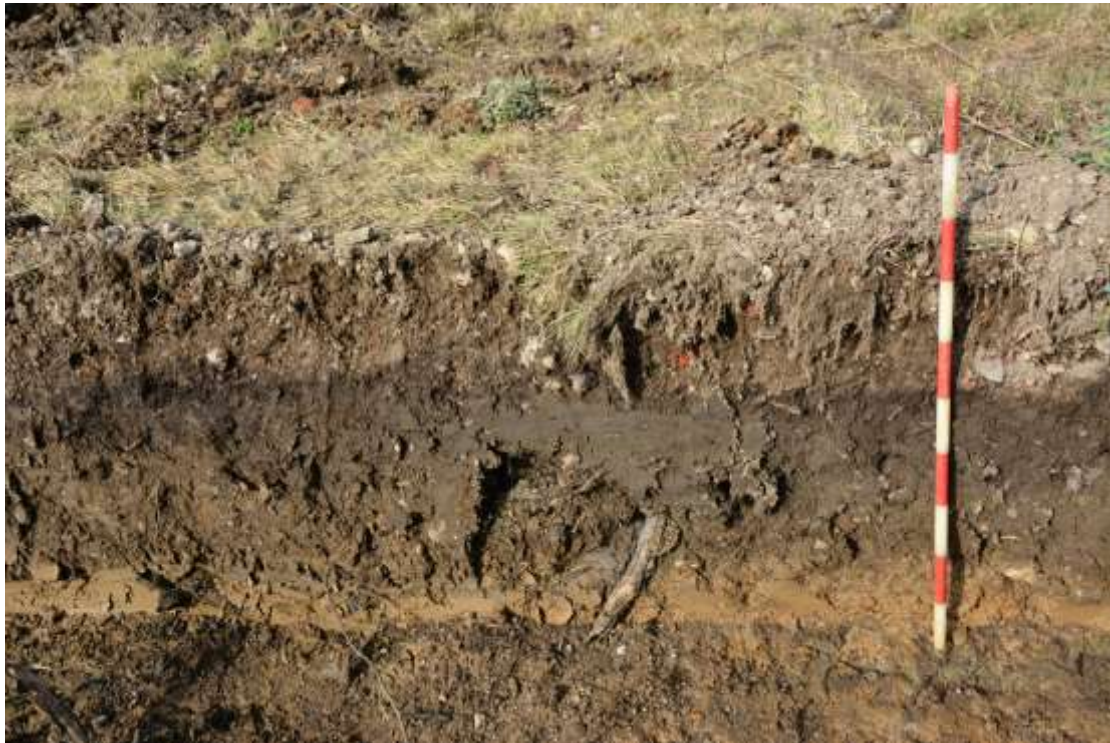
The stratigraphy (see fig.40) comprised 260-480mm of mid brown topsoil (1001) containing frequent fragments of ceramic building material, above 100-190mm on dark brown-black silty soil (1002) containing CBM fragments, above 260-360mm of relatively clean light brown clay (1003) which overlay at least 240mm of natural orange clay (1004) and gravel, taken to continue below the level of excavation (37.97- 38.50mOD). A slight slope along the trench base was noted from west to east.

Fig.40: *Stratigraphic sequence observed in the north section. Facing N. Scale 1m*

The trench was relatively shallow, and abundant with tree roots and vegetation. The west end was partially filled with water at the time of recording. The stratigraphy is taken to be modern make up layers over the natural, containing dumped debris from the clearance of the estate. No archaeological finds or features were recorded. Natural was encountered at approximately 38.35-38.65mOD.

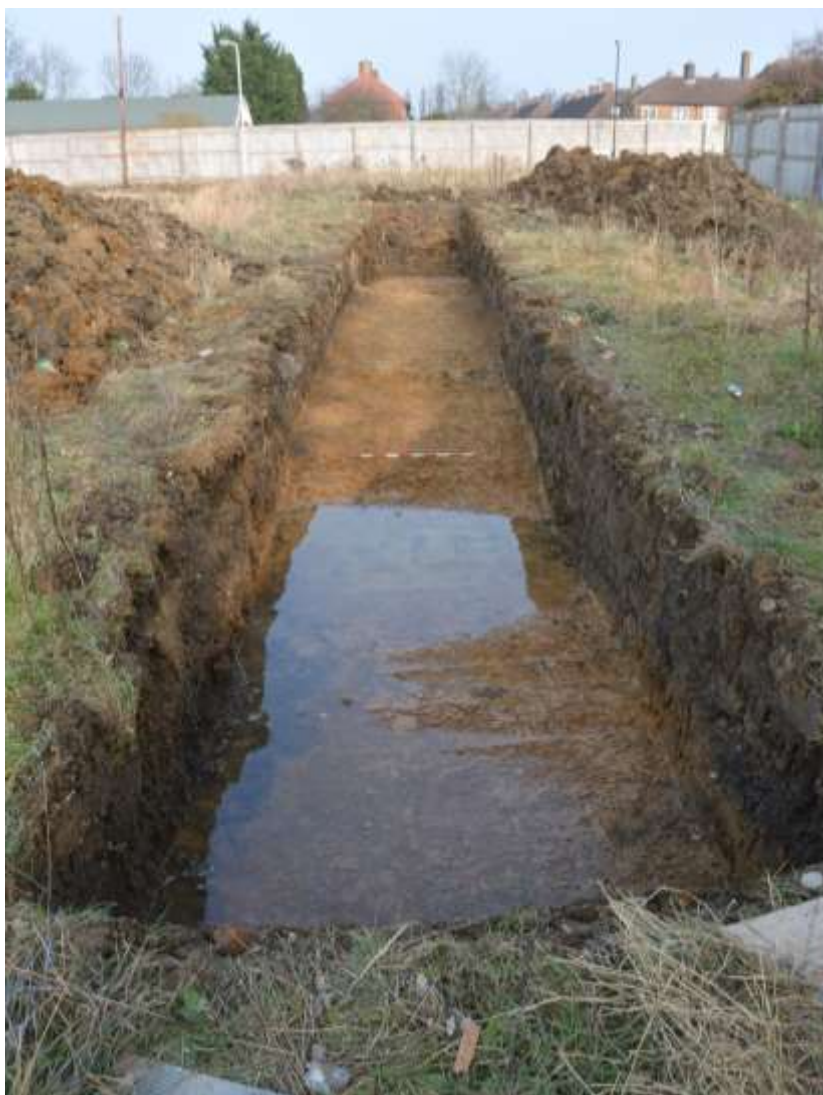
Trench 11 (fig. 42) was located in the south-east corner of the site, to the west of Pellinore Road and south of Trench 7. The trench measured 20.2m in length x 2.15-30m in width x a maximum of 1.20m in depth. The trench was slightly deeper at both ends due to the greater depth of made ground. The central section of the trench was higher, with a maximum depth of c.0.70m. Trench 11 was aligned approximately ENE-WSW.

Fig. 42: *Overview of Trench 11. Facing E. Scale 1m*

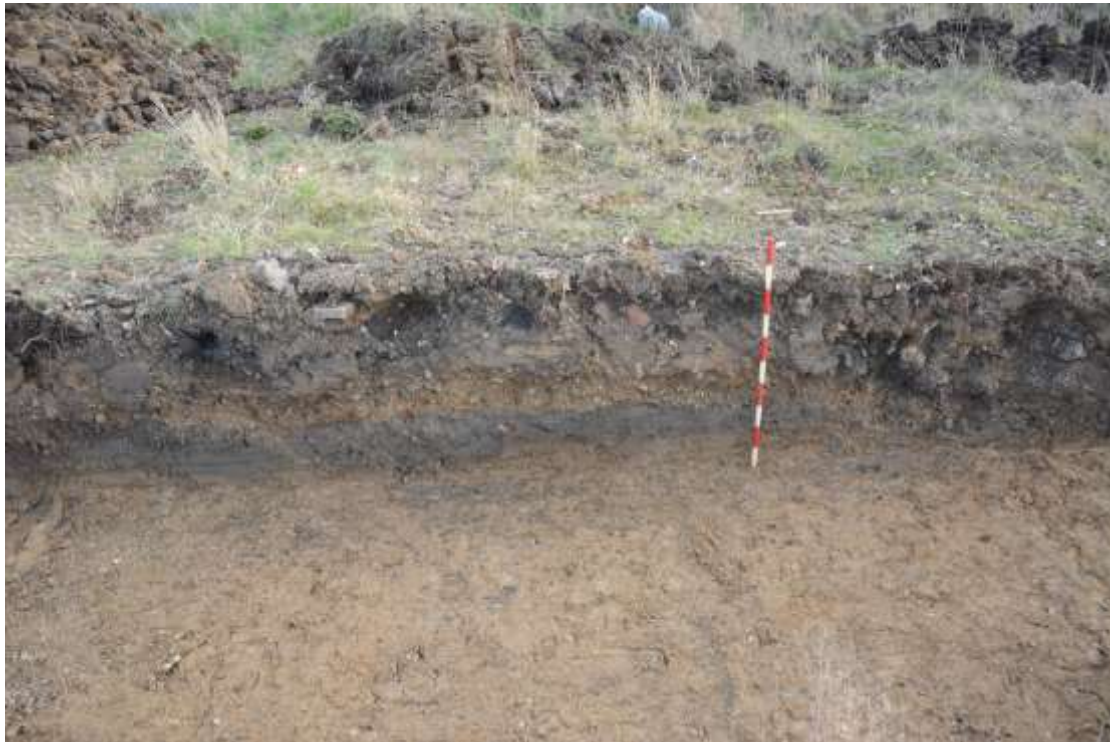
The stratigraphy comprised 450-900mm of topsoil (1101), consisting of a mix of soil/turf/clay/gravel with crushed CBM/plastic/mortar dust, and frequent pebble inclusions from a depth of 400mm (represented by a dashed line in fig. 36), above a grey/dark-grey clay silt (1102) contacting the occasional rounded flint pebble (<20mm), measuring 100-240mm in thickness, above a mottled orange/white/blue veined clay-silt (1103) with occasional pockets of small rounded gravel, which measures a minimum of 100mm in thickness and continues below the level of excavation.

Fig. 43: *Stratigraphic sequence observed in the north facing section. Facing S. Scale 1m*

The stratigraphy (see fig. 43) observed in Trench 11 was interpreted as being a modern clearance/dumping deposit over a buried/truncated subsoil, overlying natural clays. Some former services and land drains were present, visible in section. No finds or features of archaeological interest were recovered from the trench. Natural was encountered at approximately 38.79mOD.

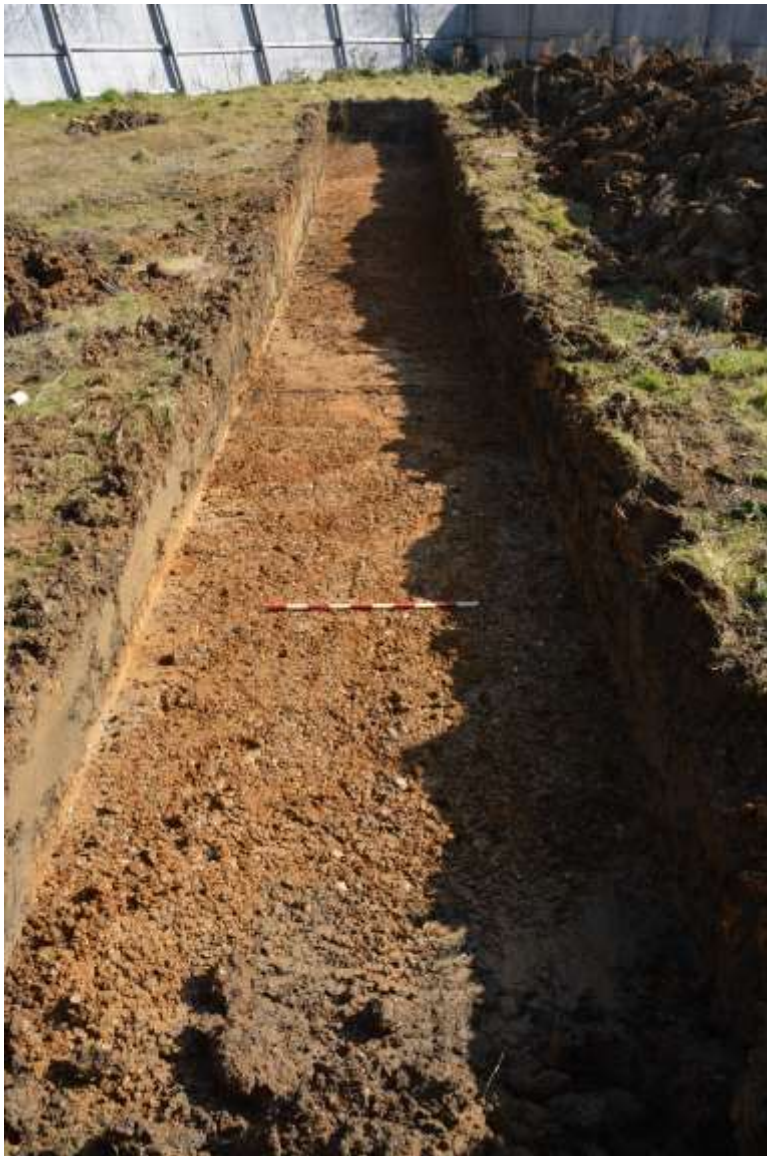
Trench 12 (see fig. 45) was located in the south-east corner of the site, on Castillon Road, opposite St Mark's Church. This trench was separated from the main part of the estate by Baudwin Road. The trench measured 21m in length x 2.0m in width x up to 1.0m in depth (getting gradually shallower from south-east to north-west, and was aligned NW-SE.

Fig. 45: *Overview of Trench 12. Facing SE. Scale 1m*

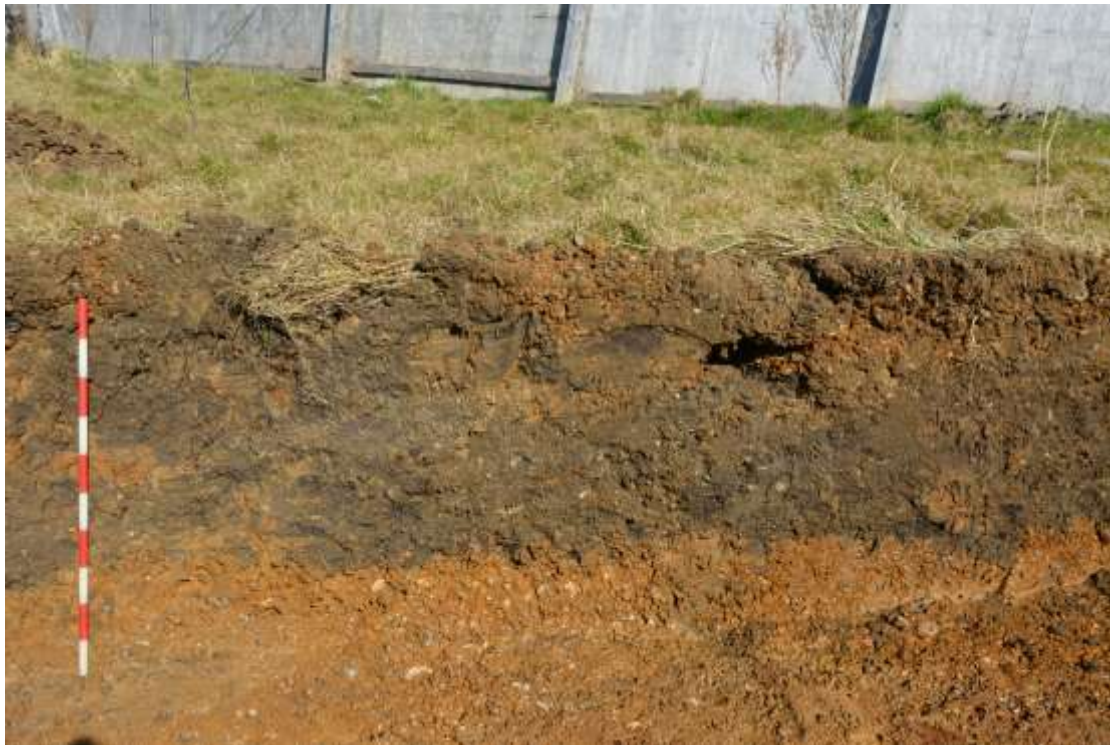
The stratigraphy in this trench (see fig.46) comprised 740-850mm of topsoil (1201), consisting of a mixture of soil/clay/gravels containing frequent crushed CBM and old services, above a layer of mottled orange/brown and beige/blue veined clay-silt (1202) with pockets of smooth gravels (<20mm) continuing to the level of excavation (38.97-39.01mOD).

Fig. 46: *Stratigraphic section observed in the north-east facing section. Facing SW. Scale 1m*

The stratigraphy observed in Trench 12 was interpreted as a mixed demolition spread derived from clearance of the former estate, directly overlying natural clay/gravels. No previous subsoils or surfaces were recorded. No finds or features of archaeological interest were observed in this trench. Natural was encountered at approximately 39.19mOD.
