**OAK BALUSTRADE AND ROCKERY BANK STEPS  
REPLACEMENT WORKS  
ELTHAM PALACE, LONDON BOROUGH OF GREENWICH  
SE9 5QE**

**AN ARCHAEOLOGICAL WATCHING BRIEF REPORT**

**October 2016**

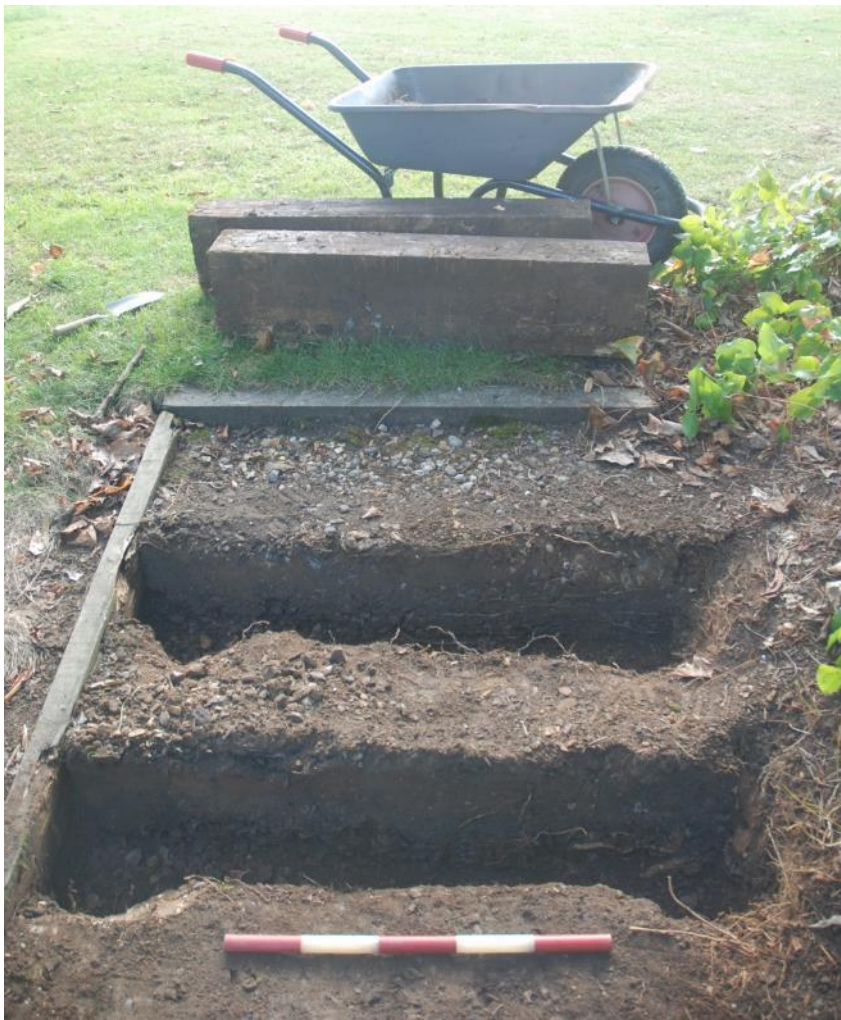
*Figure 3: Post-removal of boards 1 and 2 at the top of the flight of steps. The indentations at both ends of the trench mark the location of the securing wooden pegs, which held the board in place. Facing E. Scale 0.5m.*

7.2.1 A total of 5 wooden boards were removed and replaced from the top, middle and bottom of the steps. The small trenches left were recorded as being 1.10m in length x 120-230mm in width x 100-250mm in depth (the depth varying according to the height of the next step).

**7.2.5** Once each defective wooden board had been removed, it was replaced by a like-for-like version, measuring 1.10m in length x 0.2m in width x 0.3m in height. These were secured by two 0.5m long wooden pegs and the works completed by securing with wire mesh and wood chippings.

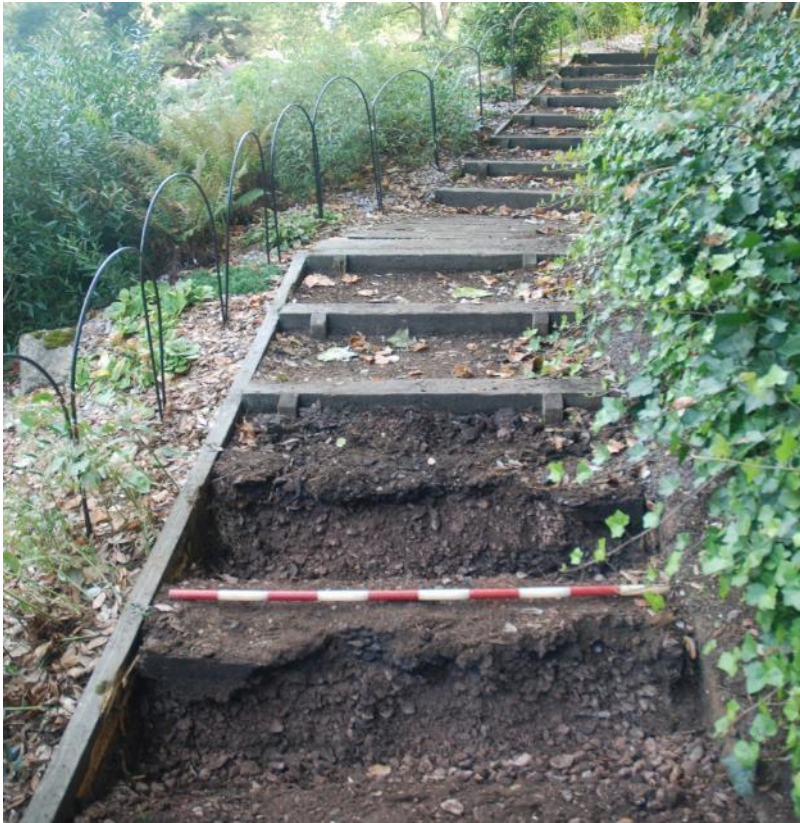
*Figure 4: Post-removal of boards from the 10th and 11th steps (from the bottom of the flight). Facing NE. Scale 1m.*

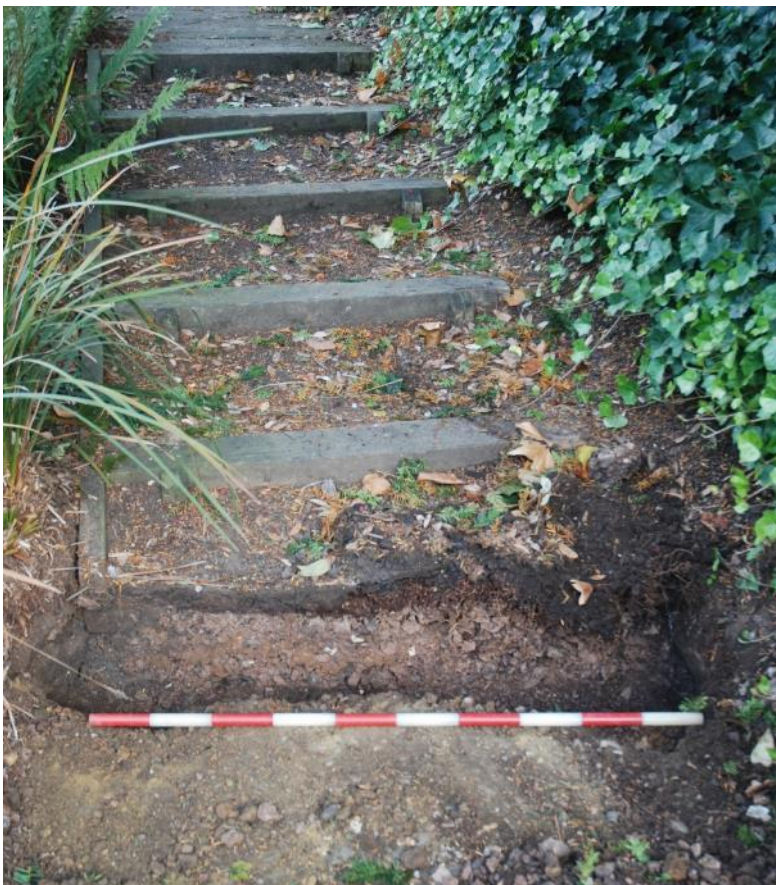
*Figure 5: Post-removal of the bottom step. Facing ENE. Scale 1m.*

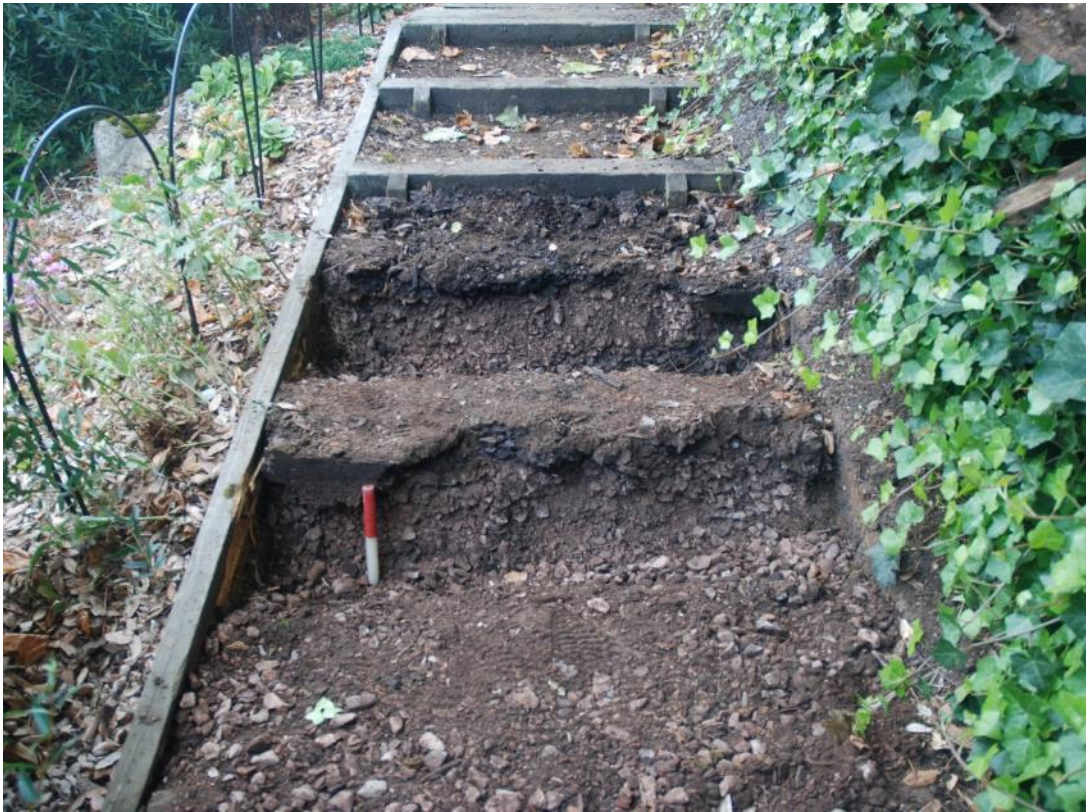
**7.2.2** The exposed stratigraphy for each step was relatively similar, comprising 50-200mm of mid-brown topsoil (1), which was noticeably thicker in steps 1 and 2, above 30-200mm of pinkish angular stones, taken to be MOT Type 1 (2).

*Figure 6: A sample of exposed stratigraphy from the 10th step. Facing ENE. Scale 0.2m.*

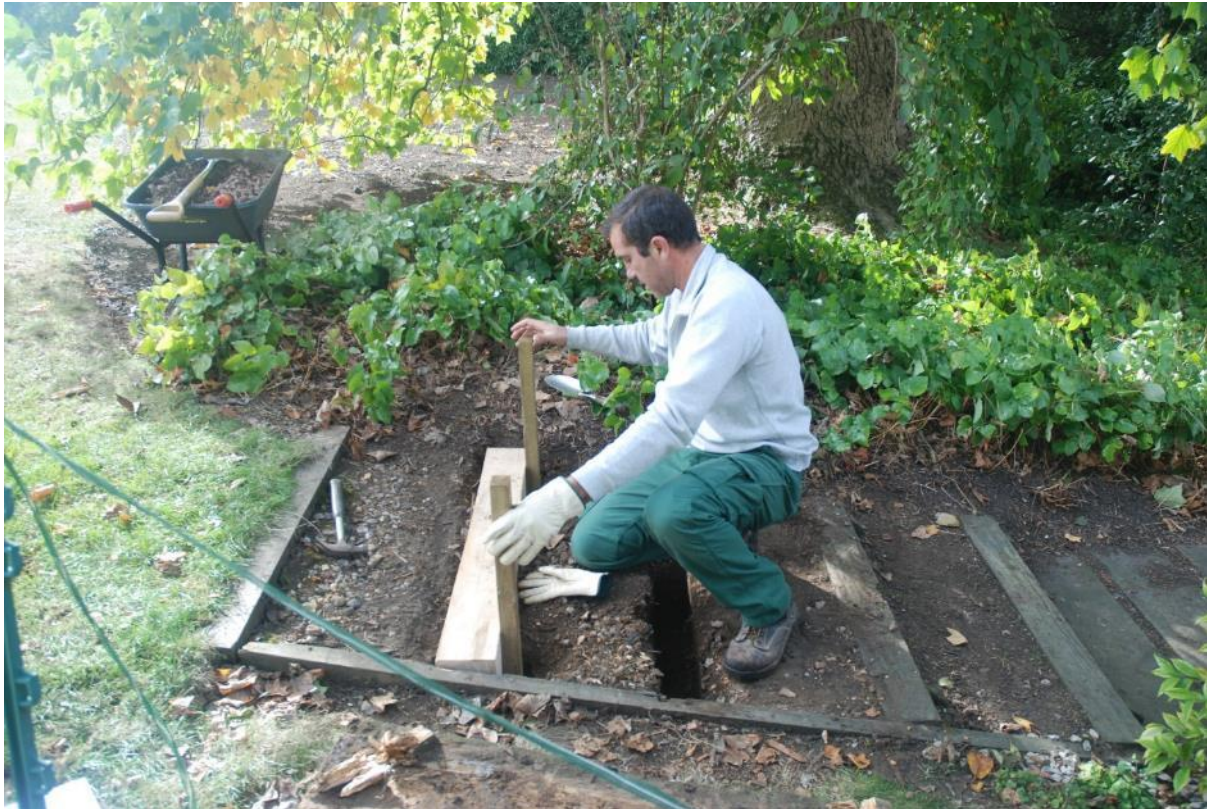
Figure 7: Working shot showing the installation of the new steps in the trench created by the removal of the old. Facing S. No scale.

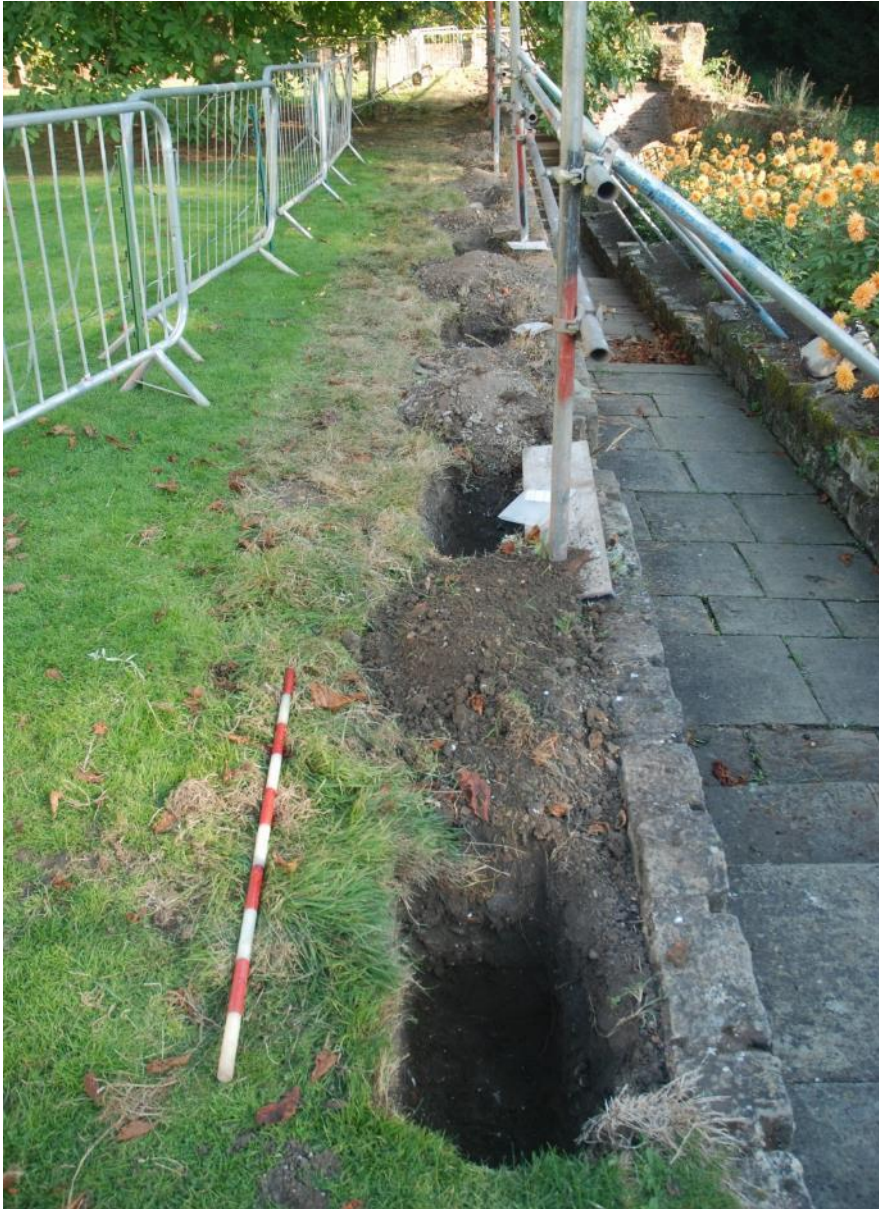
**7.3.2** Removal of the concrete footings created 14 similarly sized pits, rectangular in plan, reaching a maximum depth of 470mm (c59.04mOD). The level of excavation reached varied between 260 and 470mm, depending upon the area needed to remove the concrete pads. Each pit was located an average of 1.3m apart (fig.8). Below is a selection of the stratigraphy exposed across all 14 pits.

*Figure 9: Completed trenches following the removal of the balustrade. Photograph taken from the west end, facing E. Scale 1m.*

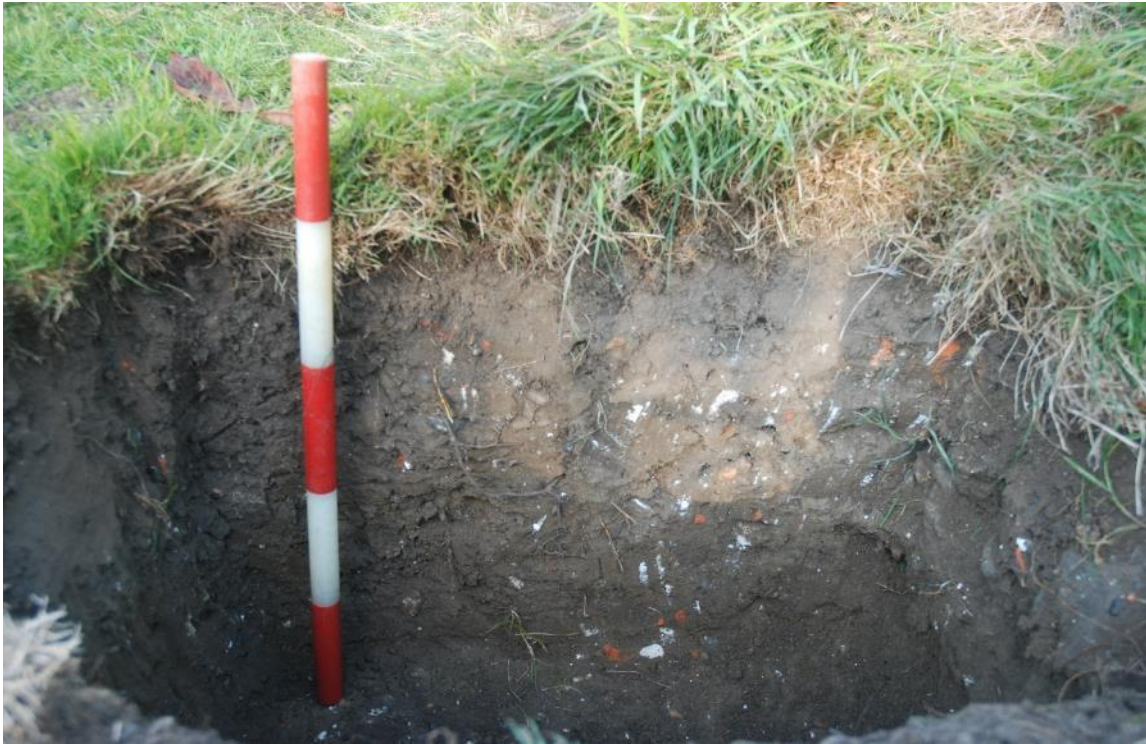
Figure 10: South facing section of pit 1, showing the compact brick and mortar flecked backfill (4) below topsoil (3). Facing N. Scale 0.5m.

- 7.3.3** The stratigraphy observed across the 14 pits was broadly similar, comprising a thin layer of loose dark brown topsoil (3), often no more than 50mm in thickness, above an extremely well compacted deposit of light-mid brown fine soil, abundant with white mortar flecks, rounded pebbles and less frequently, fragments of ceramic building material (4). The layer measured up to 420mm in thickness, overlying the concrete foundations for the existing east-west wall [5]. This deposit was seen in 13 of the 14 pits, with the stratigraphy in pit 14 comprising a darker brown, less compacted, yet equally as mortar flecked soil (6) observed across the pit entirety.

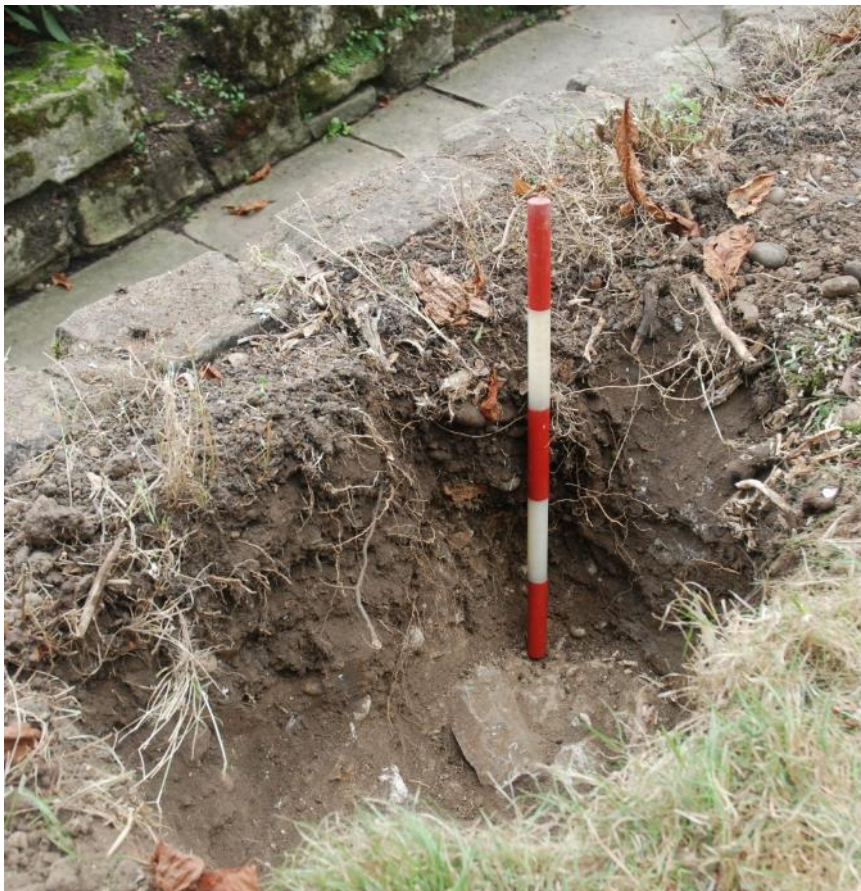
Figure 11: Pit 3, towards the western end of the balustrade. The stone seen below the scale is taken to be part of the 1930s wall foundation, seen above and to the left of the scale bar. Facing SW. Scale 0.5m.

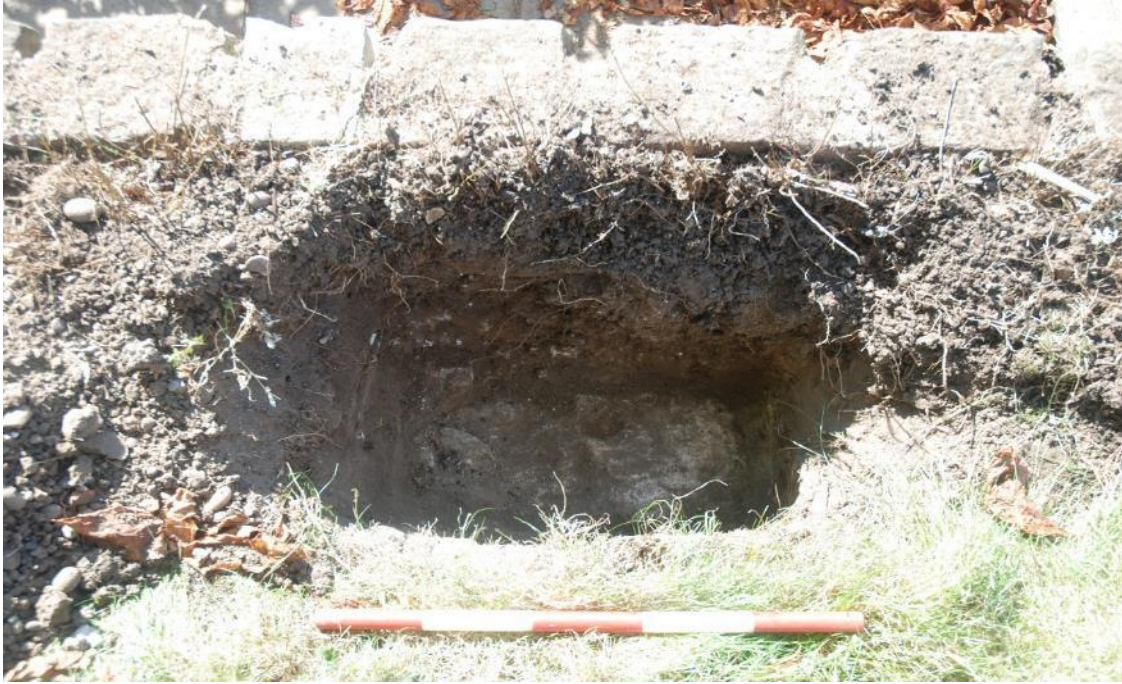
Figure 12: Pit 5, east of Pit 3 above. Concrete foundations for the wall seen at the top of the frame can be seen at the trench base. Facing S. Scale 0.5m.

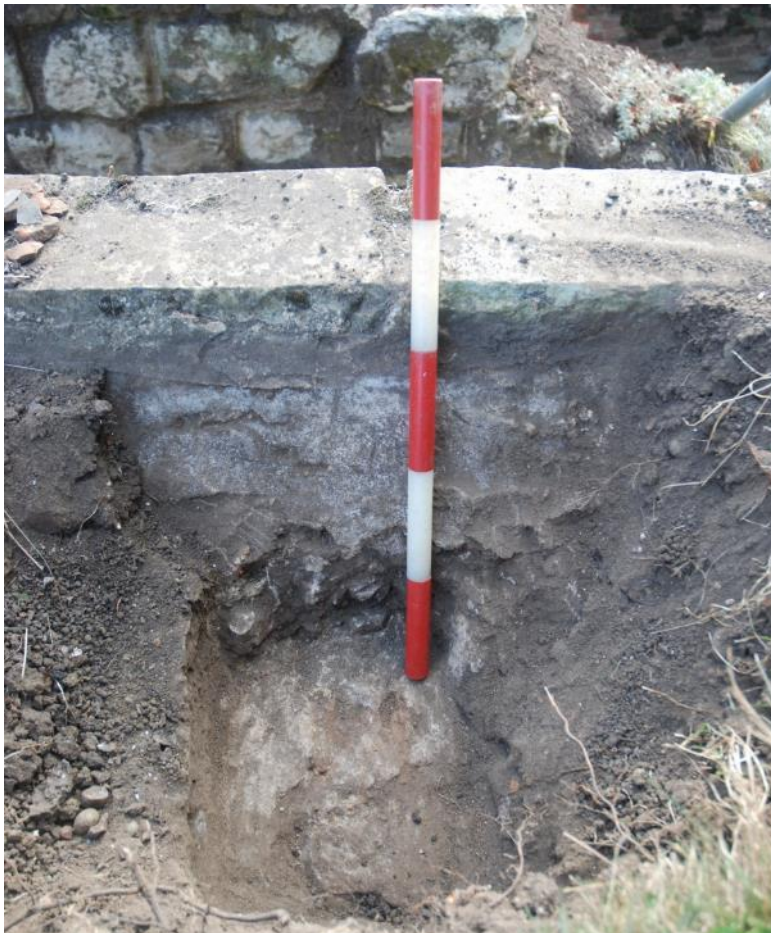
Figure 13: Pit 12, east end of balustrade. North facing section, showing the sloping rear-side of the wall, coming down on to a wider concrete footing. Facing S. Scale 0.5m.
