**THE STABLE BLOCK, MARBLE HILL PARK.  
RICHMOND ROAD, TWICKENHAM, TW1 2NL**

**AN ARCHAEOLOGICAL WATCHING BRIEF REPORT**

Site code: RCR16  
Site NGR (centre): TQ17296 73627

December 2016

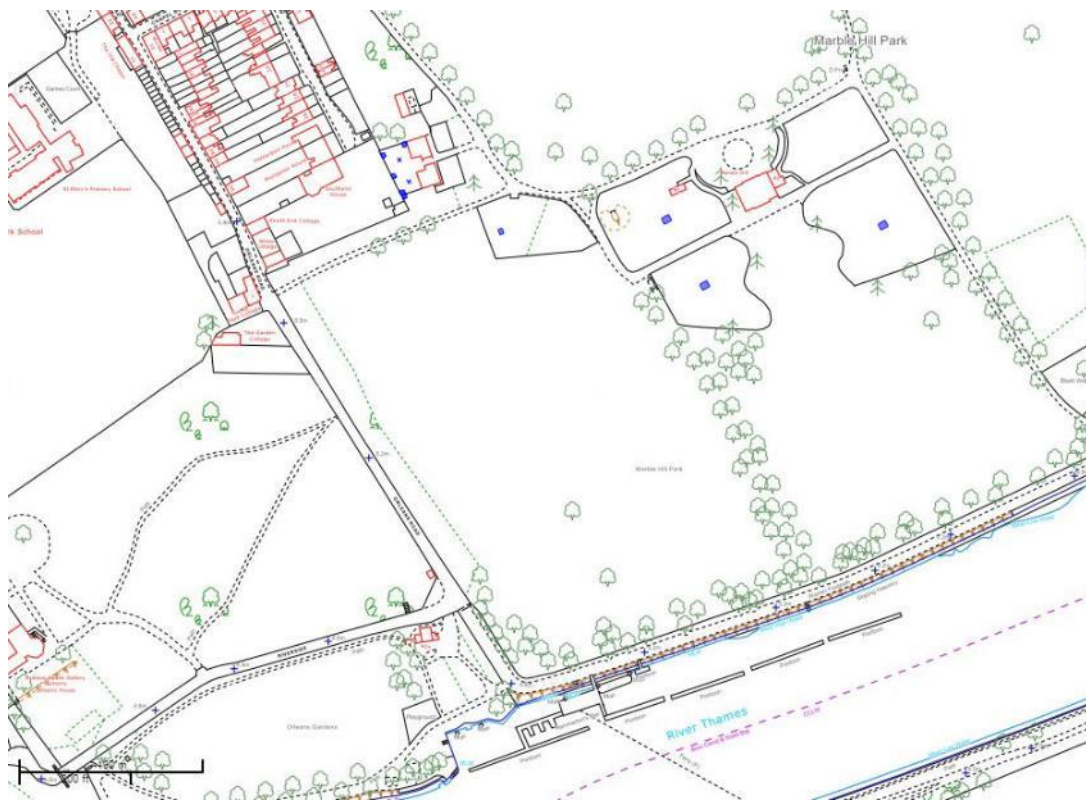
Figure 8: Overview map showing the locations of the groundworks (blue). Note: the map is indicative only, the trenches are not to scale.

- 5.1 The archaeological watching brief monitored the completion of 5 soil investigation test pits in the stable yard, two boreholes also located in the yard, a single hand auger pit located in an open area to the west of the house, and three additional test pits located in the wooded areas surrounding the house (fig.8).

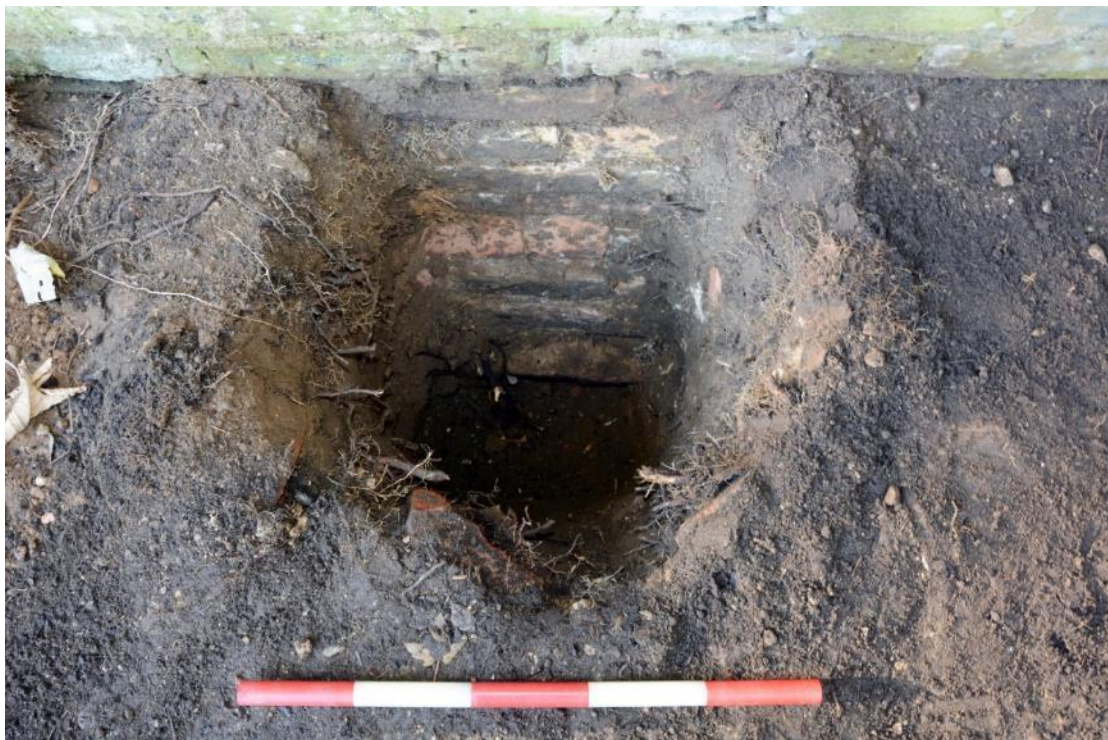
*Figure 11: TP1 - exposed foundations of existing N-S party wall. Facing W. Scale 0.5m.*

- 7.2.2** The stratigraphy comprised 340mm of moderately well compacted very dark brown soil containing frequent roots and small rounded stones (1), interpreted as a layer of topsoil. This overlay a layer of very loosely compacted, dry, light brown soil (2). The deposit contained frequent rounded stones, less frequent angular gravels, slate fragments and occasional fragments of Ceramic Building Material (CBM) and pottery. This layer continued to the trench base, measuring a minimum of 390mm in thickness.

These foundations of the existing wall exposed in the trench comprised 4 courses of footings, stepping out to a total of 180mm in an eastwards direction. Context (2)

becomes more friable and loosely compacted below the footings, suggesting that it is backfill, of post-medieval or modern date, based on the finds recovered.

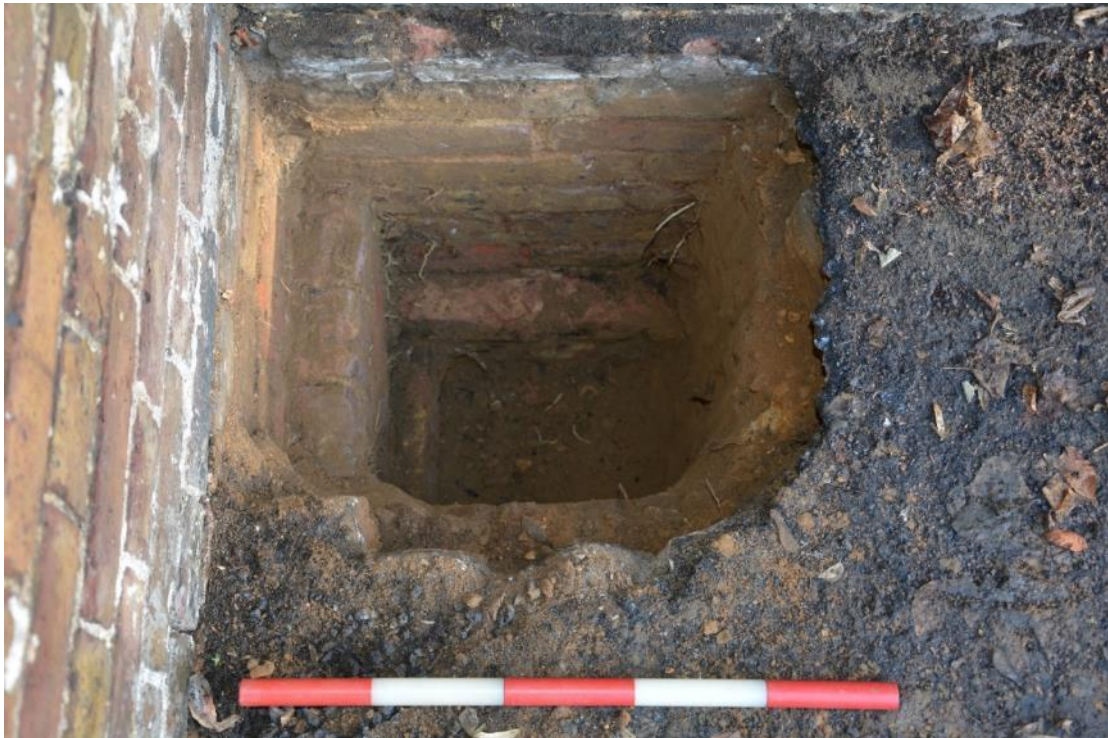
*Figure 12: TP2 - exposed overlapping foundations of standing walls. Facing E. Scale 0.5m.*

**7.3.2** The stratigraphy comprised a thin layer of well compacted macadam (3), 10mm in thickness, overlying a stone cobbled surface (4). The cobbles were rectangular, measuring 140mm in thickness and were uniform in size and appearance. There was no sign of any mortar. The cobbles lay on top of a bedding layer of firm orange sand containing frequent angular gravels (5), measuring 50mm in thickness. Below this gravel was a layer of moderately well compacted mid brown-orange sand (6), observed at a depth of 200mm. The sand comprised the main fill of the pit and may have been a backfill deposit, although it did appear similar in appearance to the natural Langley Silt, which may be the correct interpretation.

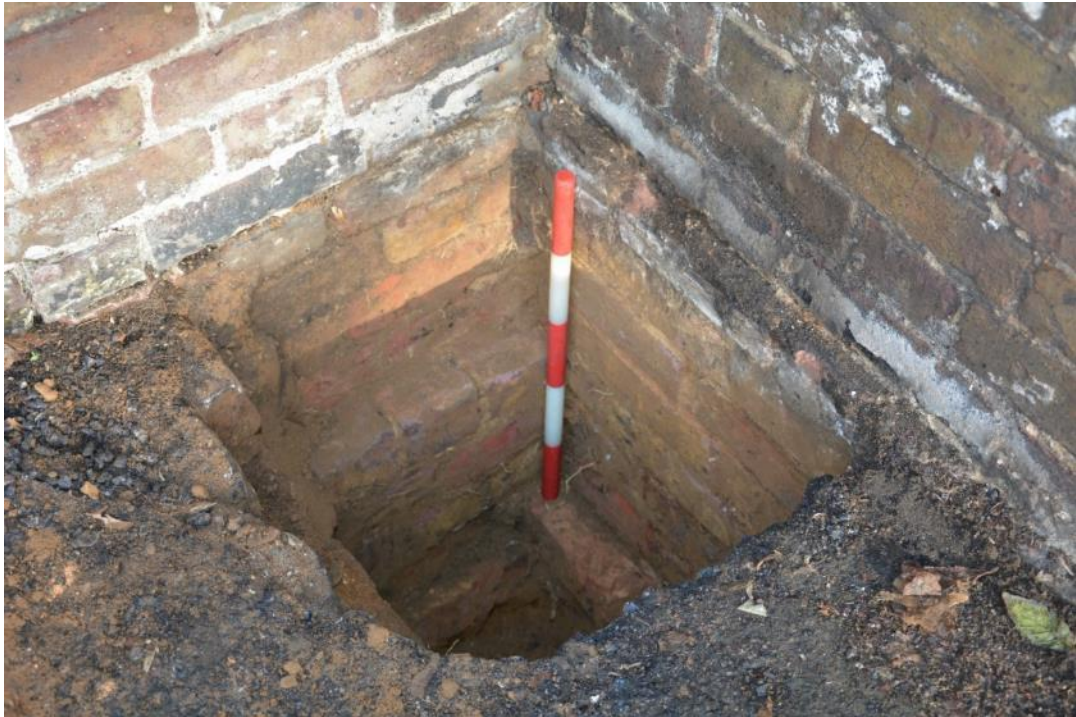
**7.3.3** The footings of both walls were exposed and appeared to be interconnected. The foundations of the modern wall running E-W four rows of headers, stepping out by 70mm at a depth of 400m (7.70mOD), and again by 50mm at a depth of 600mm (7.50mOD). The footings of the coach house were encountered at the increased depth of 600mm, below 6 rows of stretchers. The footings stepped out once to the west by 50mm before continuing down, where they terminated at a depth of 0.76m (7.34mOD).

*Figure 13: TP2 - exposed foundations of the modern, and coach house walls. Facing NE. Scale 0.5m.*

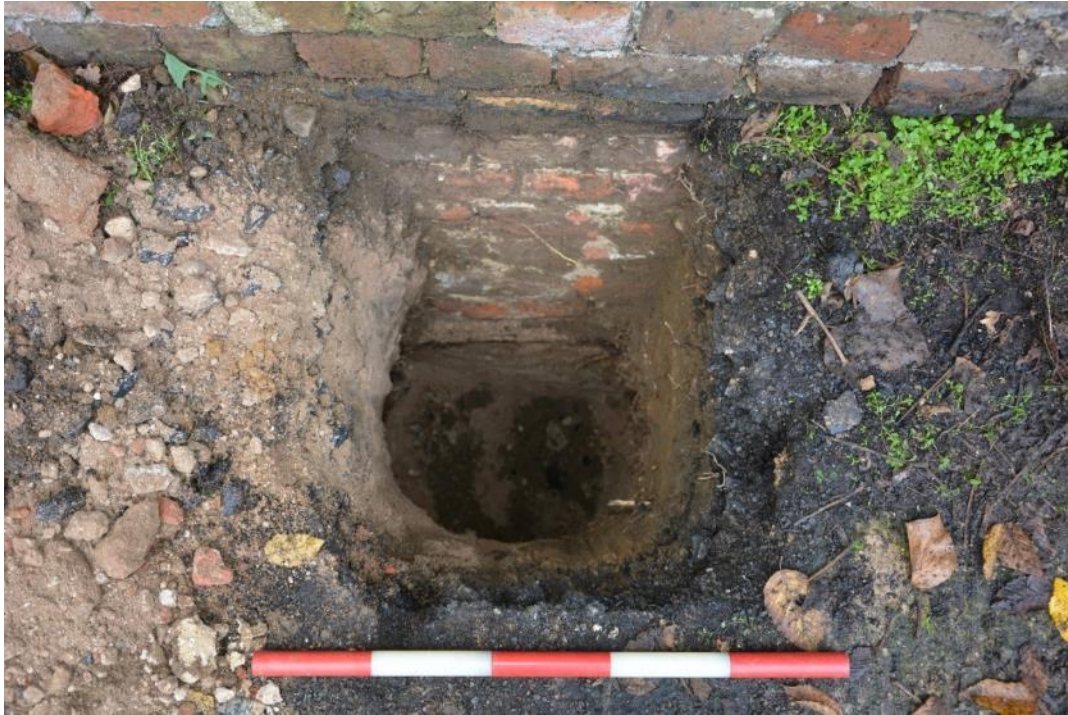
Figure 14: TP3 - exposed footings, significantly deeper than those exposed in TP1. Facing W. Scale 0.5m.

- 7.4.3** The foundations of the wall comprised 8 or 9 courses of orange brick bonded with a gritty mortar, the base of which was recorded at 1.2m (6.69mOD). A slight stepping out was noted at a depth of 400mm, which continued to the base. The wall did not appear to be cutting the natural (9) implying the wall was built on top of it, possibly using the degree of compacted as a firm base.
- 7.4.4** No finds or features of archaeological interest were encountered in this pit.

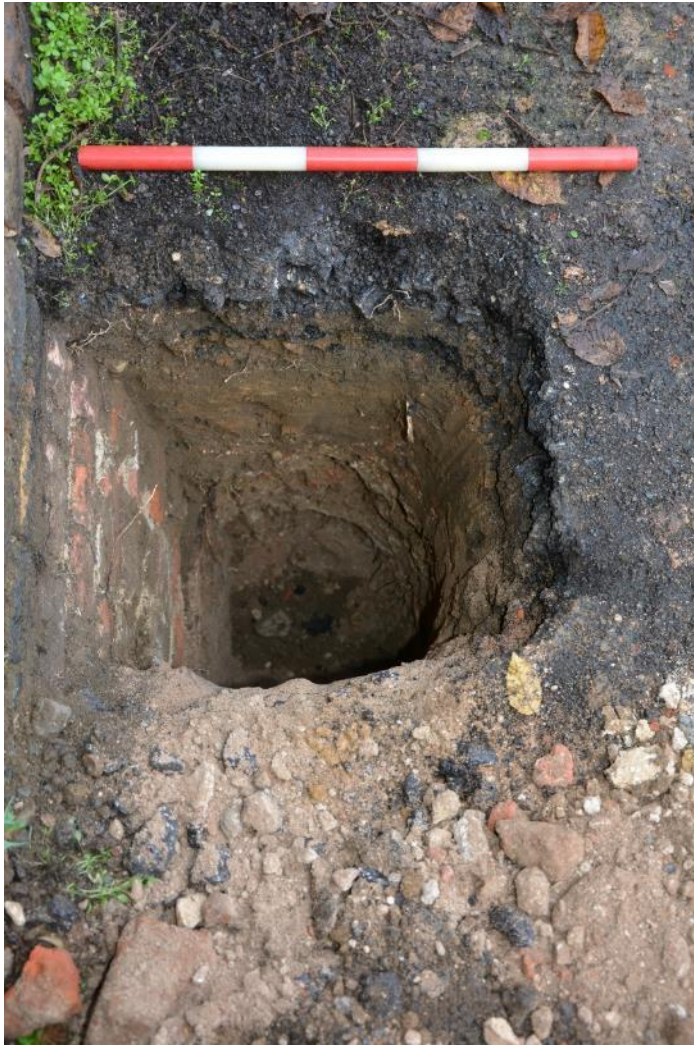
- 7.4.2 The stratigraphy recorded in the pit comprises 150mm of the macadam car park surface (3), seen across the entirety of the car park, above a layer of very firm mid to dark brown smooth silty clay (7), containing some yellow flecking, and some darker flecking, taken to be soil. This layer measured 220mm in thickness, the bottom being recorded at 7.52mOD. Below this was a moderately well compacted deposit of brownish soil, abundant with loose, powdery lime mortar and CBM fragments (8), measuring c830mm in thick, extending to just above the trench base. This was interpreted as a demolition layer, and may include material from the ancillary building seen on the maps shown above. At the base of the trench a layer of brownish clayey sand was observed (9), below the footings of the wall, measuring approximately 100mm, although taken to continue below the level of excavation. This material was interpreted as a natural deposit, similar to that recorded in TP2.

*Figure 15: Stratigraphy of the SSE facing section, showing the macadam (3) above compacted silty clay (7), loose demolition material (8) and natural at the base (9). Facing approximately NW. Scale 0.5m.*

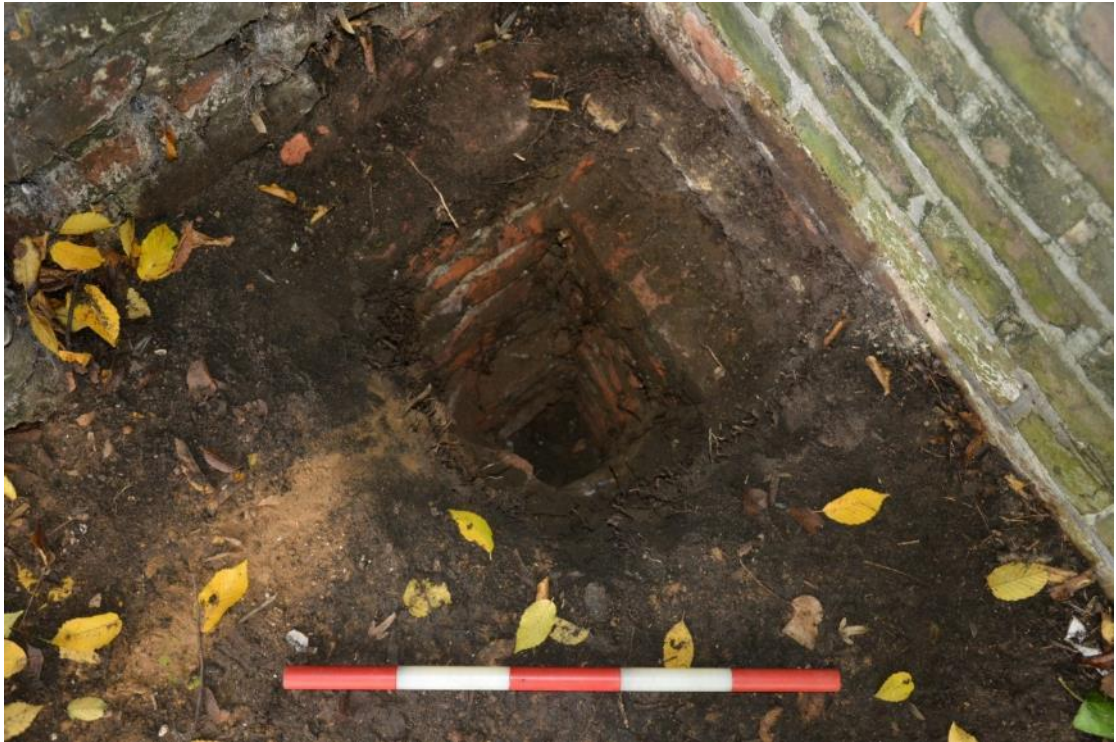
*Figure 16: TP4 - exposed footings of two phases of construction. Facing W. Scale 0.5m.*

**7.5.3** The distinction between the two phases of masonry noted in figure 16 is illustrated by both their differing appearance and differing forms. The older wall, forming the boundary of Southend House, which is potentially 18<sup>th</sup> century in date is constructed of red bricks measuring 210mm x 60mm x 90mm, whereas the bricks in the newer wall have a more uniform and more angular appearance, measuring 230mm x 100mm x 60mm. The bonds too differ, with the modern wall being in the Flemish garden wall style, whilst the Southend House boundary wall appears to be in an English garden wall bond, with possible alterations to the upper part. The remains of a small buttress is also visible to the left of the scale in the figure 16, above the spoil heap.

The footings for the older wall were recorded at a depth of 0.95m (6.86mOD), with two steps: the first at 80mm and the second at 88mm. In regards to the newer wall, the base of the footings were deeper, recorded at 1.1m (6.71mOD), with two steps out at depths of 110mm and 230mm. This narrowed the trench considerably, with the dimensions at the base being recorded as 350 x 500mm. It would appear that a degree of truncation occurred with the footings when the newer wall was constructed. The stratigraphy observed was most likely backfill from this event, and general build up due to the location of the pit.

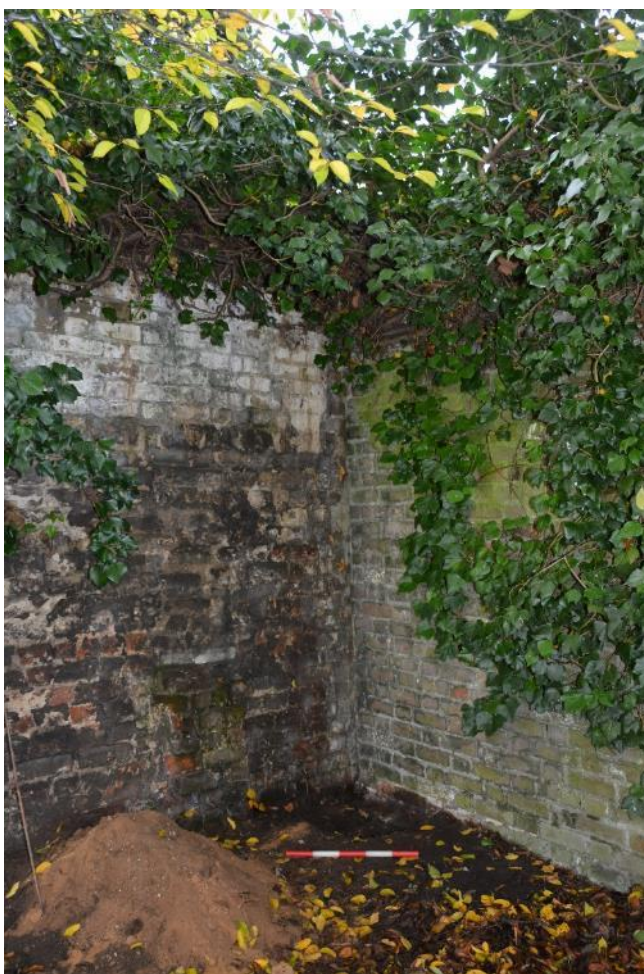
*Figure 17: TP4 - seen in relation to the boundary wall of Southend House (left of frame) and the more modern wall which forms the side entrance to the stable yard (right). Facing W. Scale 0.5m.*

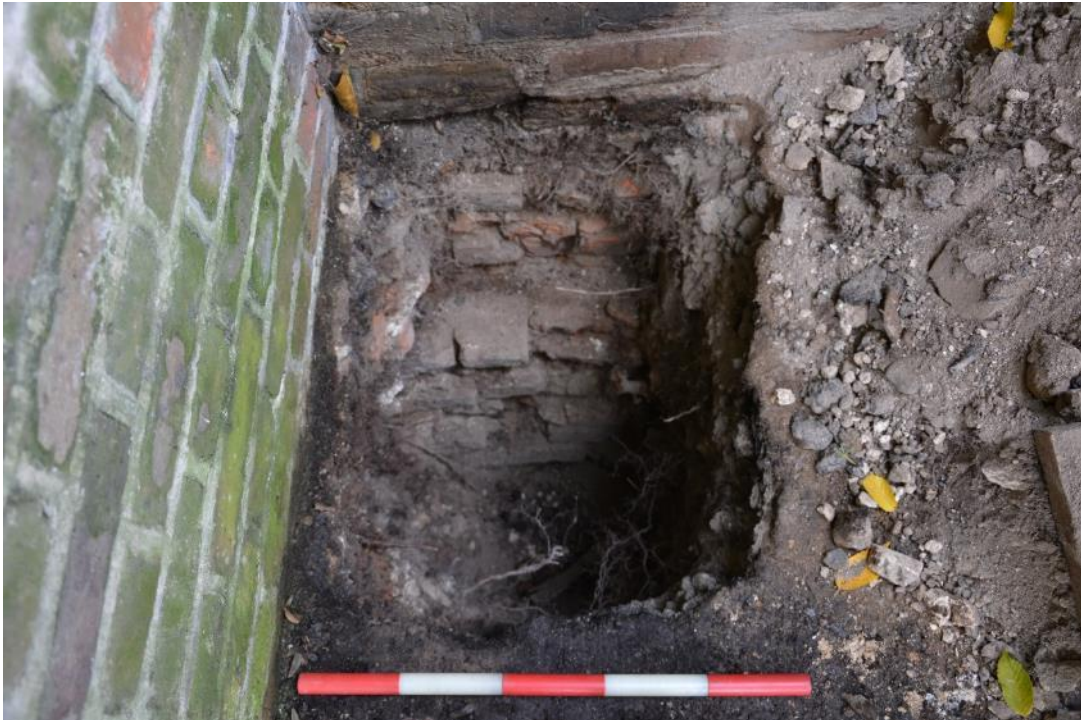
*Figure 18: TP5 - extremely loose and fragmented foundations of the party wall. Facing W. Scale 0.5m.*

**7.6.2** The stratigraphy comprised 40mm of macadam (3) above a minimum of 1.5m of moderately, to very loose grey mortar abundant backfill, containing frequent fragments of brick, stone and lime mortar (12). A small quantity of CBM and pottery was recovered. The pit was dug to a total depth of 1.9m at which the base of the foundations were reached (5.89mOD).

**7.6.3** Of particular interest in this pit is the damaged state of the foundations. Whilst the wall above ground appears to be relatively modern and structurally sound, the foundations are crumbling, with several bits falling away during the hand excavation. Two steps were recorded, the first at a depth of 180mm and the second at 400mm, extending eastwards by 180mm. Further, the bricks appear to be larger and more orange in colour than those above ground and also, built to a surprised depth for a property boundary wall. At this stage, this is interpreted as being an older wall, possibly associated with the ancillary building shown on early maps, which has been truncated and the modern wall built on top of the foundations. The rubble abundant backfill is therefore interpreted as demolition material.

- 7.6.4** Once recorded, the pit was backfilled and reinstated with concrete and cold-set macadam to prevent any structural damage. No further features were recorded in this pit.
- 7.7** On the 17<sup>th</sup> November works commenced again in the Stable Block, with the completion of 2 boreholes (BH1 and BH2). A single hand auger pit was also undertaken on this date.

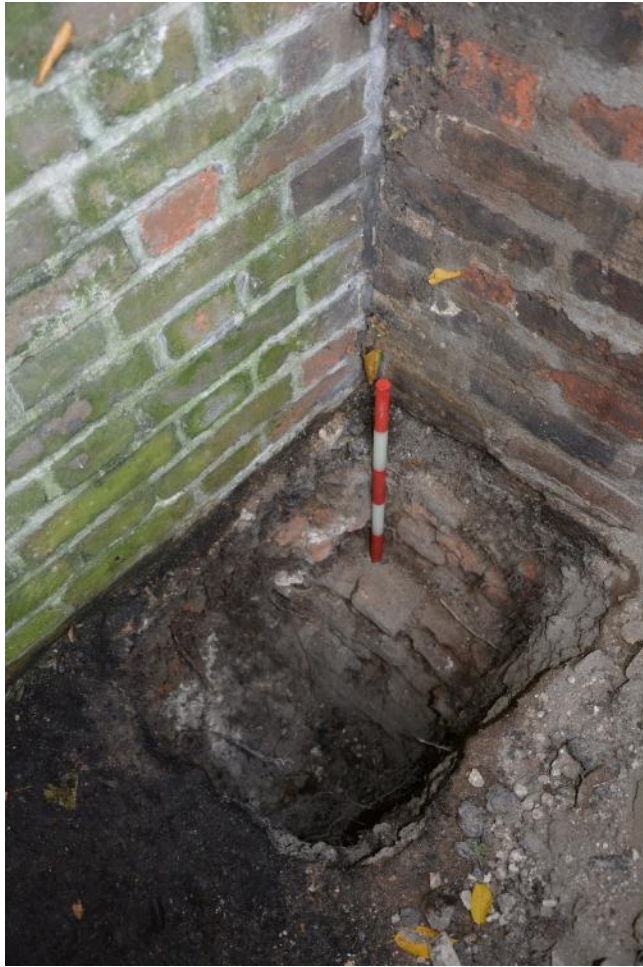
*Figure 19: TP5 - crumbling foundations and rubble abundant backfill below macadam surface. Facing SSW. Scale 0.5m.*

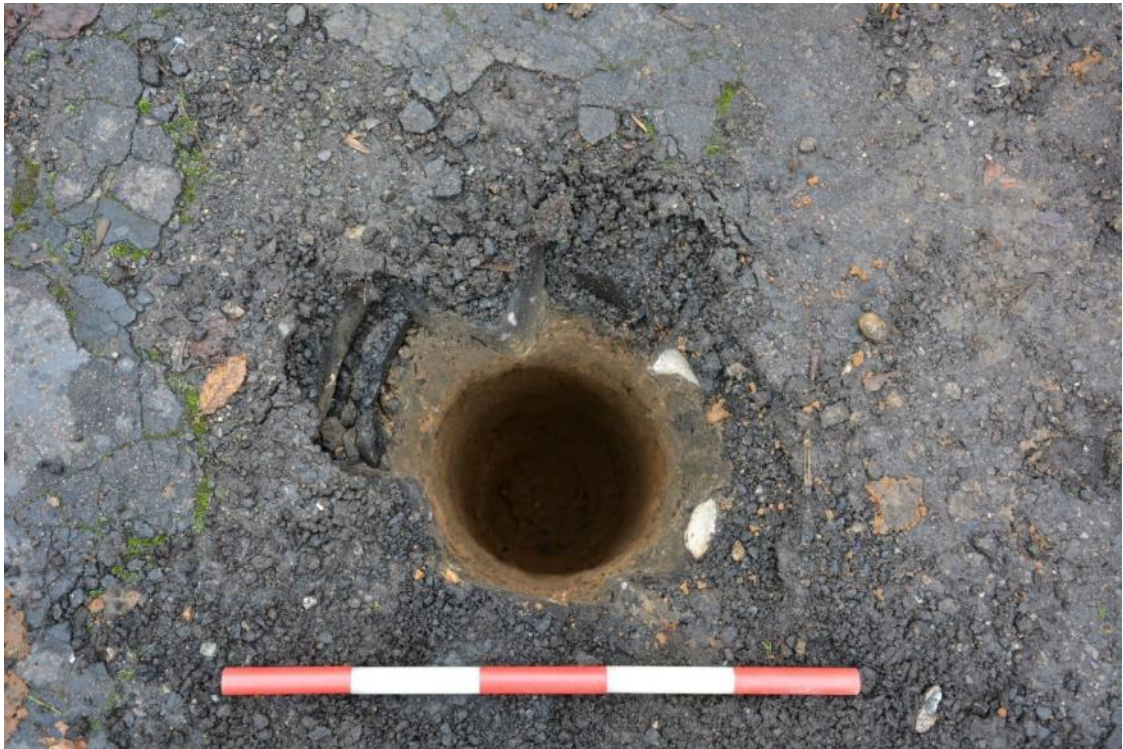
Figure 20 - Borehole 1, upper metre prior to window sampling.

- 7.7.2 The stratigraphy comprised 50mm of compact macadam (3) above stone cobbles (4) measuring 110mm in thickness, similar to those observed in TP2. Below the cobbles was a layer of moderately well compacted dark brown gravelly soil, mixed with orange-brown clay, measuring 160mm in thickness. The stratigraphy below this comprised deposits of natural gravel, grouped together as context (14). Between 0.34 and 1.5m (6.38mOD) context (14) comprised a layer of moderately well compacted fairly clean mid brown-orange sandy silt, containing occasional fine roots. Below this, between 1.5 and 1.9m (5.98mOD) the material became slightly lighter brown in colour, with a higher proportion of sand. Between 1.9m and 2.75m (5.13mOD) a slightly higher proportion of sand was noted again, but similar in colour. At 2.75m the sample became increasingly more clayey, with some gravel and black flecking noted. Finally, at a depth of 3.4m solid natural gravels (15) were reached and the borehole sample was completed.

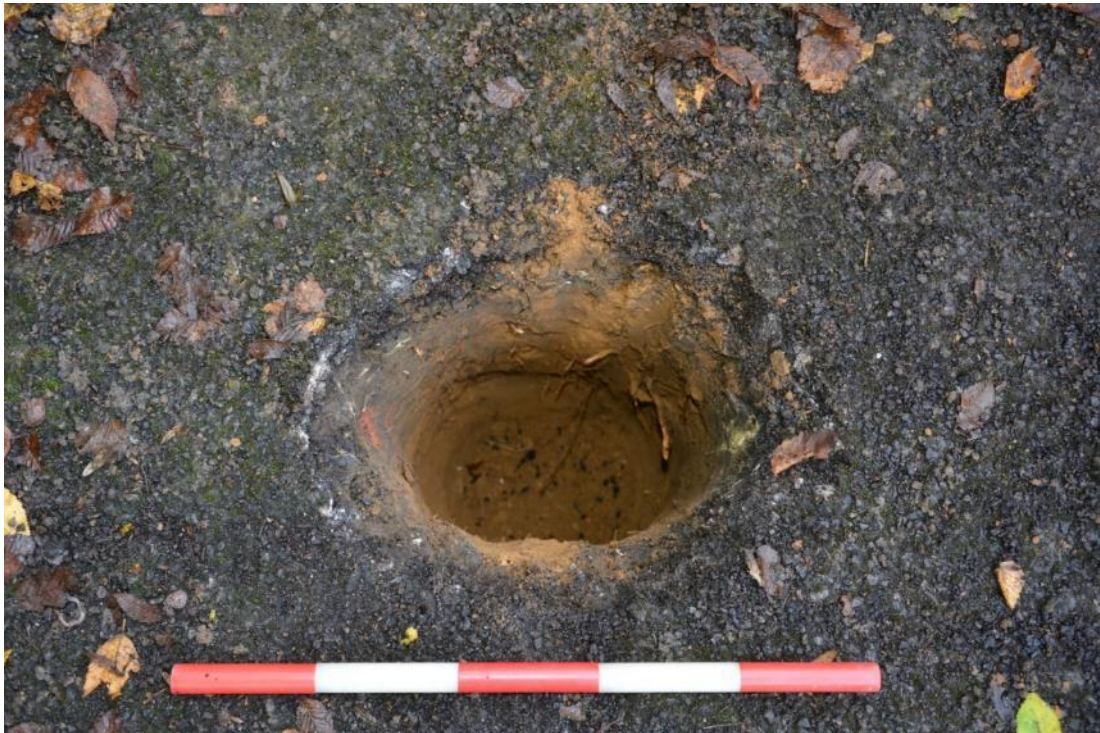
*Figure 21: Borehole 2 prior to window sampling. Scale 0.5m.*

- 7.8.2** The stratigraphy comprised 90mm of compact macadam (3) above, predominantly in the southern section, 250mm of moderately compacted dark brown soil containing fairly frequent fragments of CBM, and in the northern section, fairly loose fine orange sand (17). Similarly to (14) discussed above, this layer showed some variation but was recorded under the same context. The fine orange sand continued to a depth of one metre where it became more commingled with an extremely hard and compact fine sand containing small angular stones and some fine roots. At a depth of 1.75m (5.94mOD) the sand became coarse and more yellow in colour. Below (17) at a depth of 2.26m extremely compacted natural gravel was encountered (15) and the sampling was ceased.
- 7.8.3** With the exception of the small pocket of CBM below (3) no further finds or features of archaeological interest were observed.

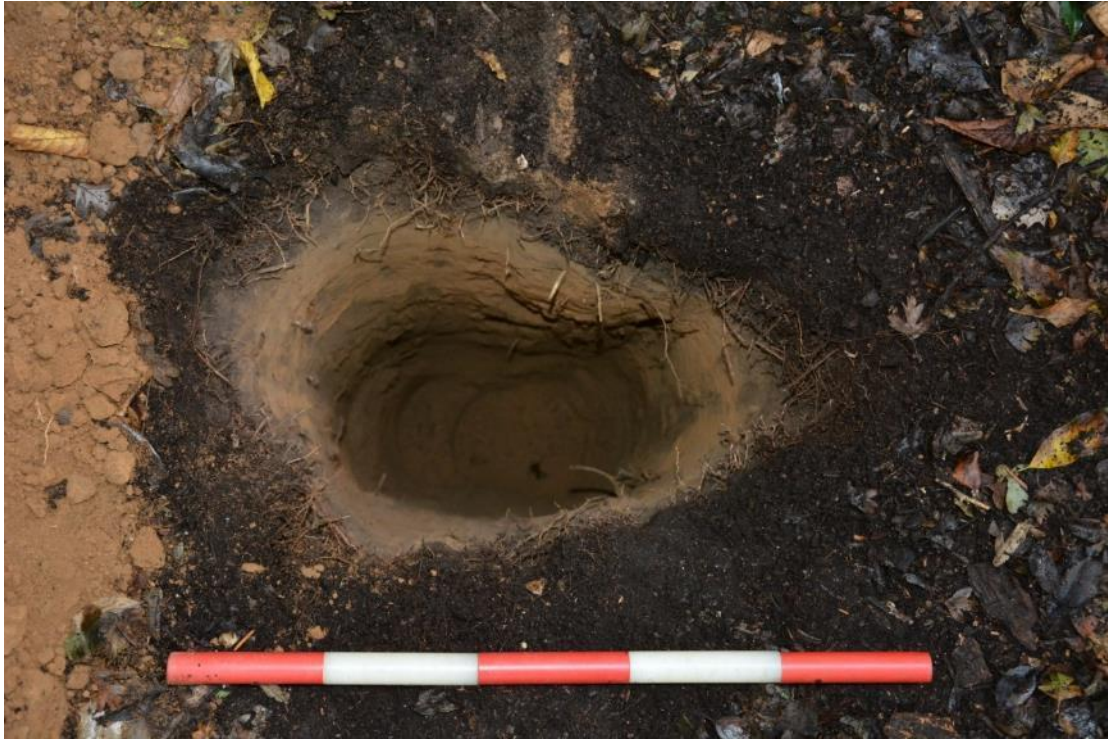
Figure 23: TP6 - completed. Facing E. Scale 0.5m.

- 7.11.2 The stratigraphy of the pit comprised three layers, the upper two being most distinct. A layer of fairly loose, good, dark brown-black topsoil (21) abundant with small roots and general detritus was recorded to a depth of 50mm. This scraped off easily on to an equally thin layer of light to medium brown friable soil containing frequent roots and some small stone inclusions (22), 70mm in thickness, taken to extend across the surrounding area. Below this was a thicker layer of very hard and compacted light brown-orange fine sandy soil (23), with very few inclusions – the occasional small stone or root. This layer measured a minimum of 0.83m in thickness and was taken to continue below the level of excavation at 7.36mOD. It should be noted here that a small piece of a plastic wrapper was found in the section between a depth of 0.83m and 1m.

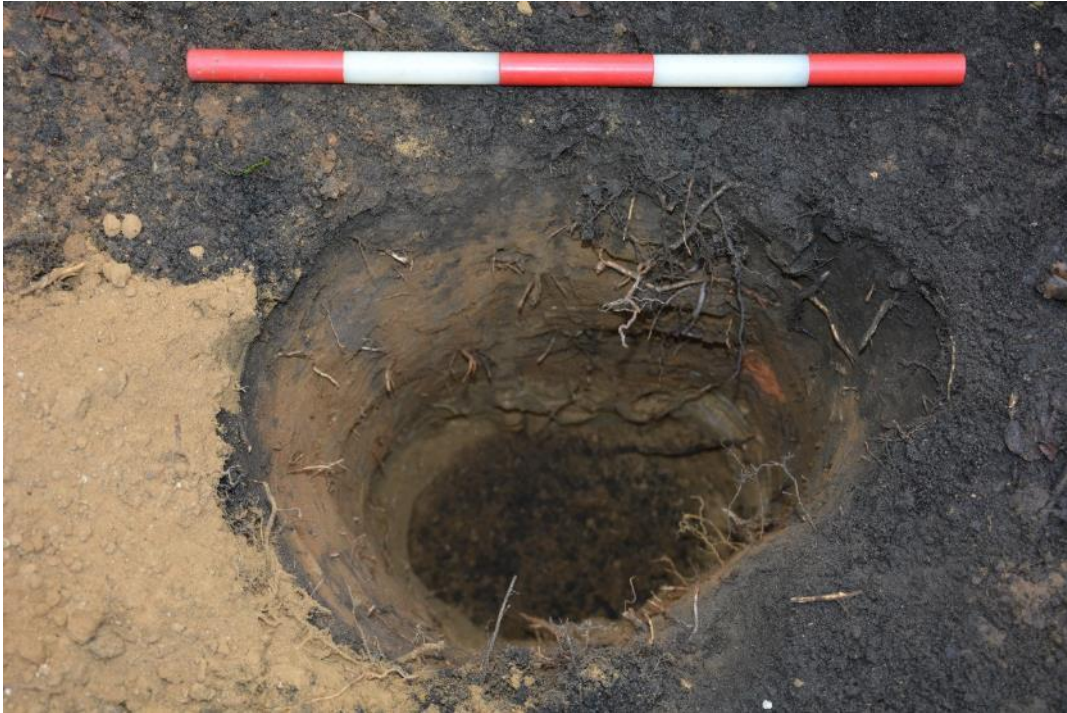
*Figure 24: TP7 - completed pit. A fragment of CBM can be seen in section to the right of frame. Facing S. Scale 0.5m.*

**7.12.2** The stratigraphy in the upper part of the pit was the same as that recorded in TP6, comprising 50mm of dark brown – black topsoil (21) above 60mm of lighter soil (22) and 380mm of compacted sand (23). At a depth of 490mm the ground being very soft, consisting of a layer of loosely compacted mid to dark yellow sand (24) measuring a minimum of 510mm in thickness, taken to continue below the level of excavation.

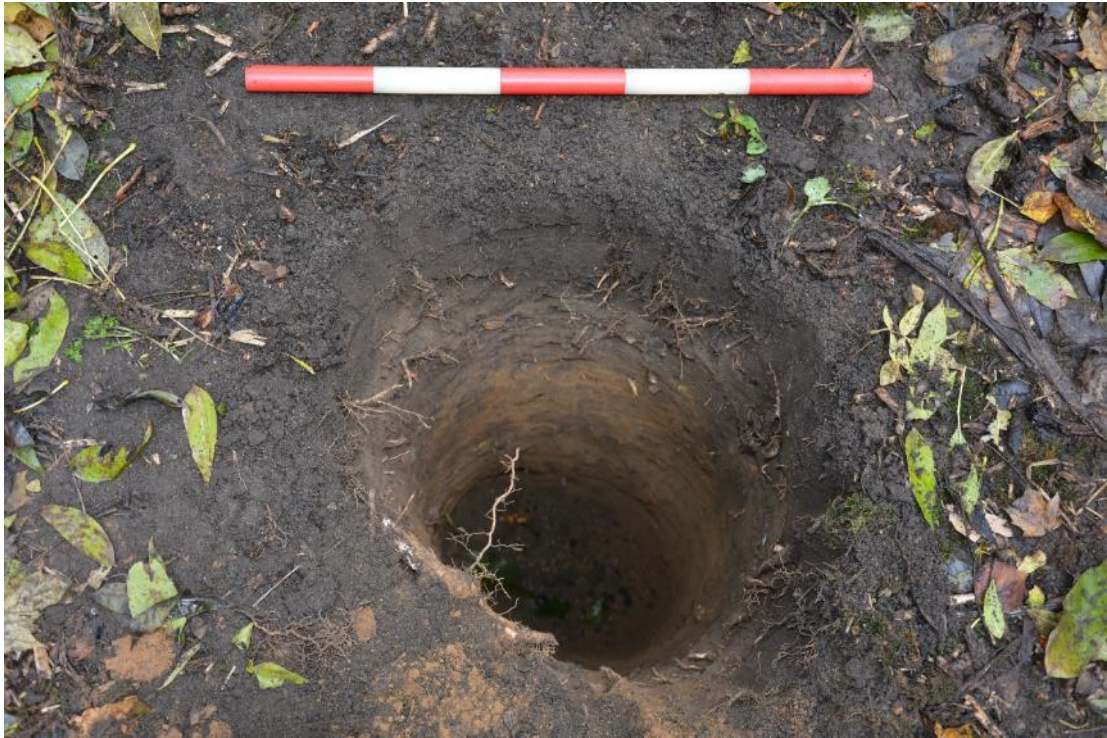
*Figure 25: TP8 - completed. Facing W. Scale 0.5m.*

- 7.13.2** The stratigraphy in the final pit comprised a layer of topsoil (21), similar in composition to that observed in the previous two pits, measuring 140mm in thickness. A small number of modern finds, including a plastic bottle lid were recovered from this context. This overlay moderately well compacted mid to light brown soil, with frequent roots and small stones (25), measuring between 140 and 200mm in thickness. A small quantity of post-medieval finds were recovered from this context. Below (25) was a layer of very compacted mid to light orange-brown sand, with some darker brown mottling (26). It was observed at a depth of c340mm (7.84mOD) and measured a minimum of 600mm, continuing below the level of excavation at 7.18mOD.

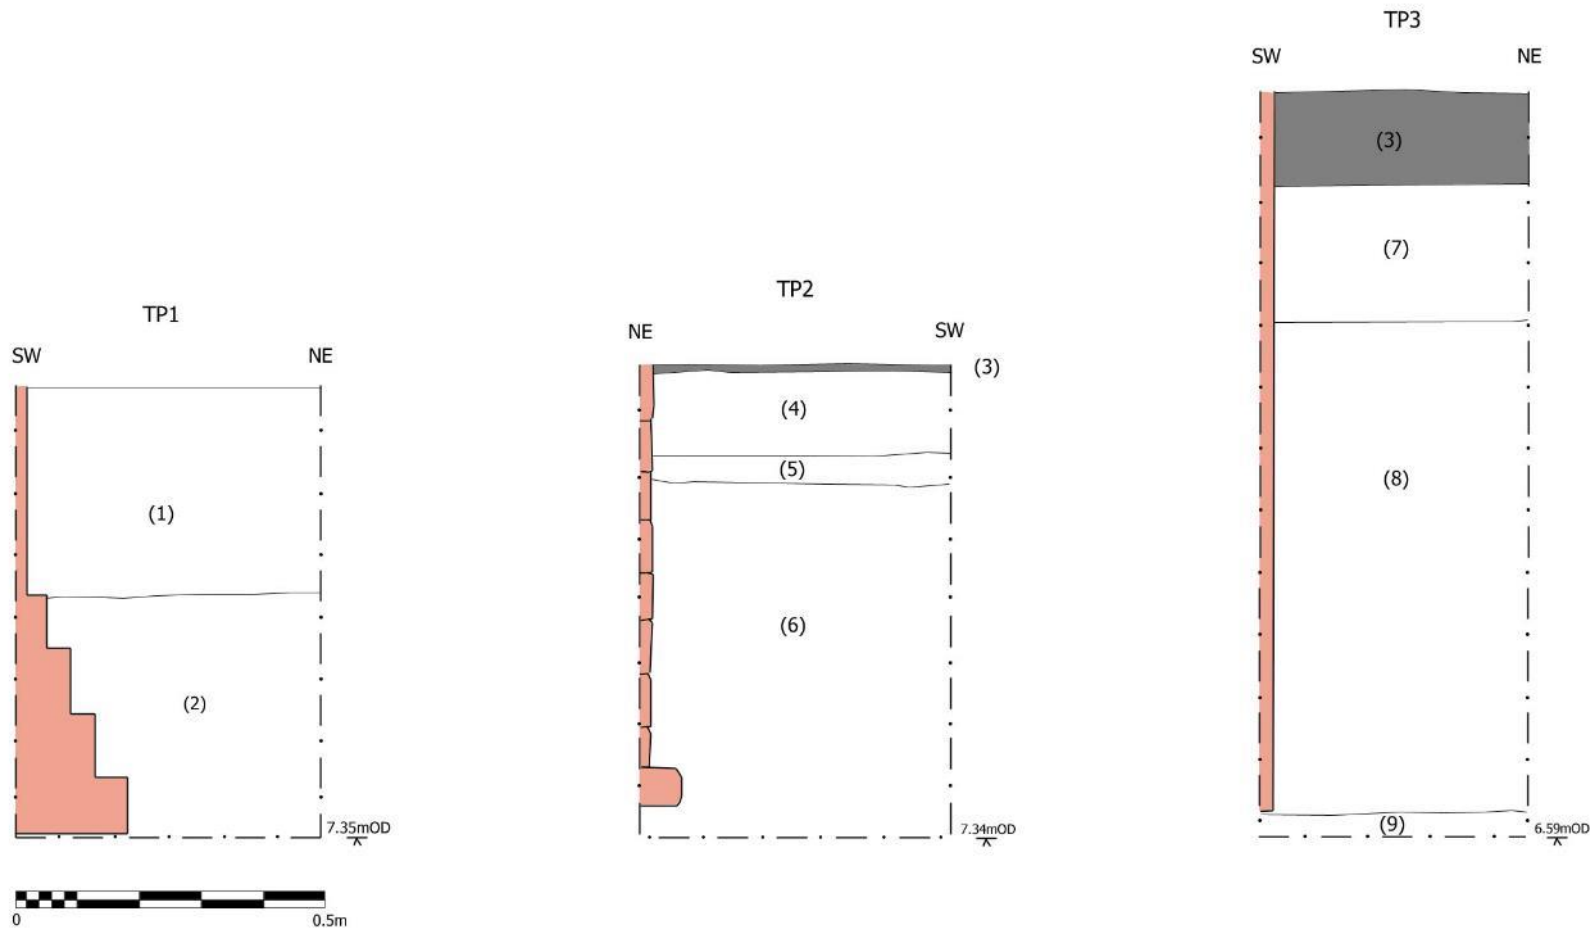
Figure 28: TP1 - NW facing section, with party wall foundation shown in red. TP2 - SE facing section, modern wall foundation shown in red. TP3 - NW facing section, party wall foundation shown in red. Originals drawn at 1:10.

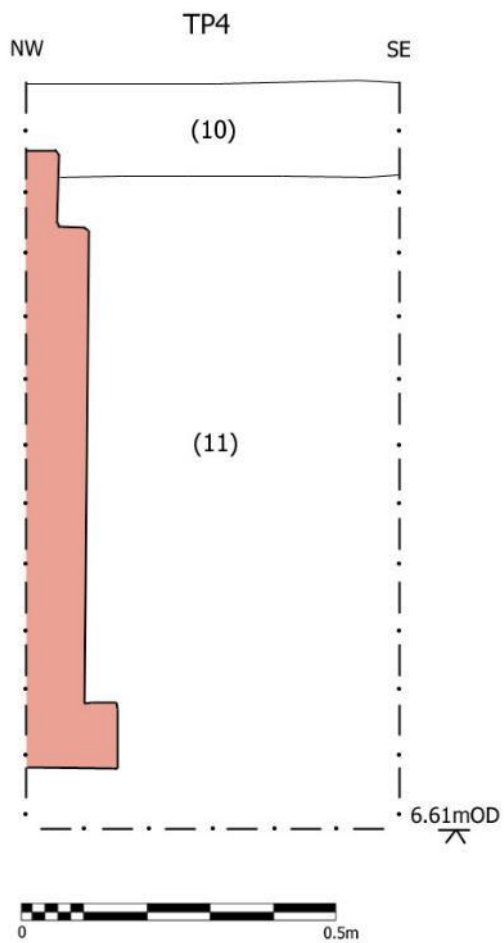
Figure 269: NE facing section of TP4, with party wall foundation shown in red. Original drawn at 1:10.

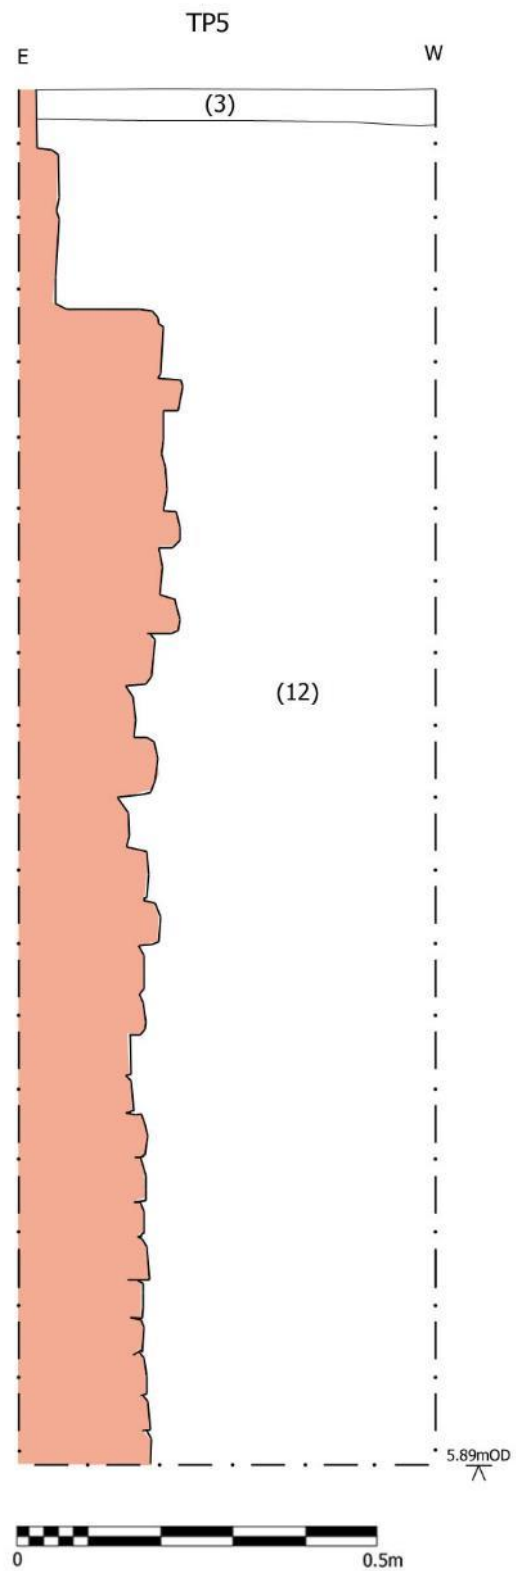
Figure 30: N facing section of TP5, with party wall foundation shown in red. Original drawn at 1:10.

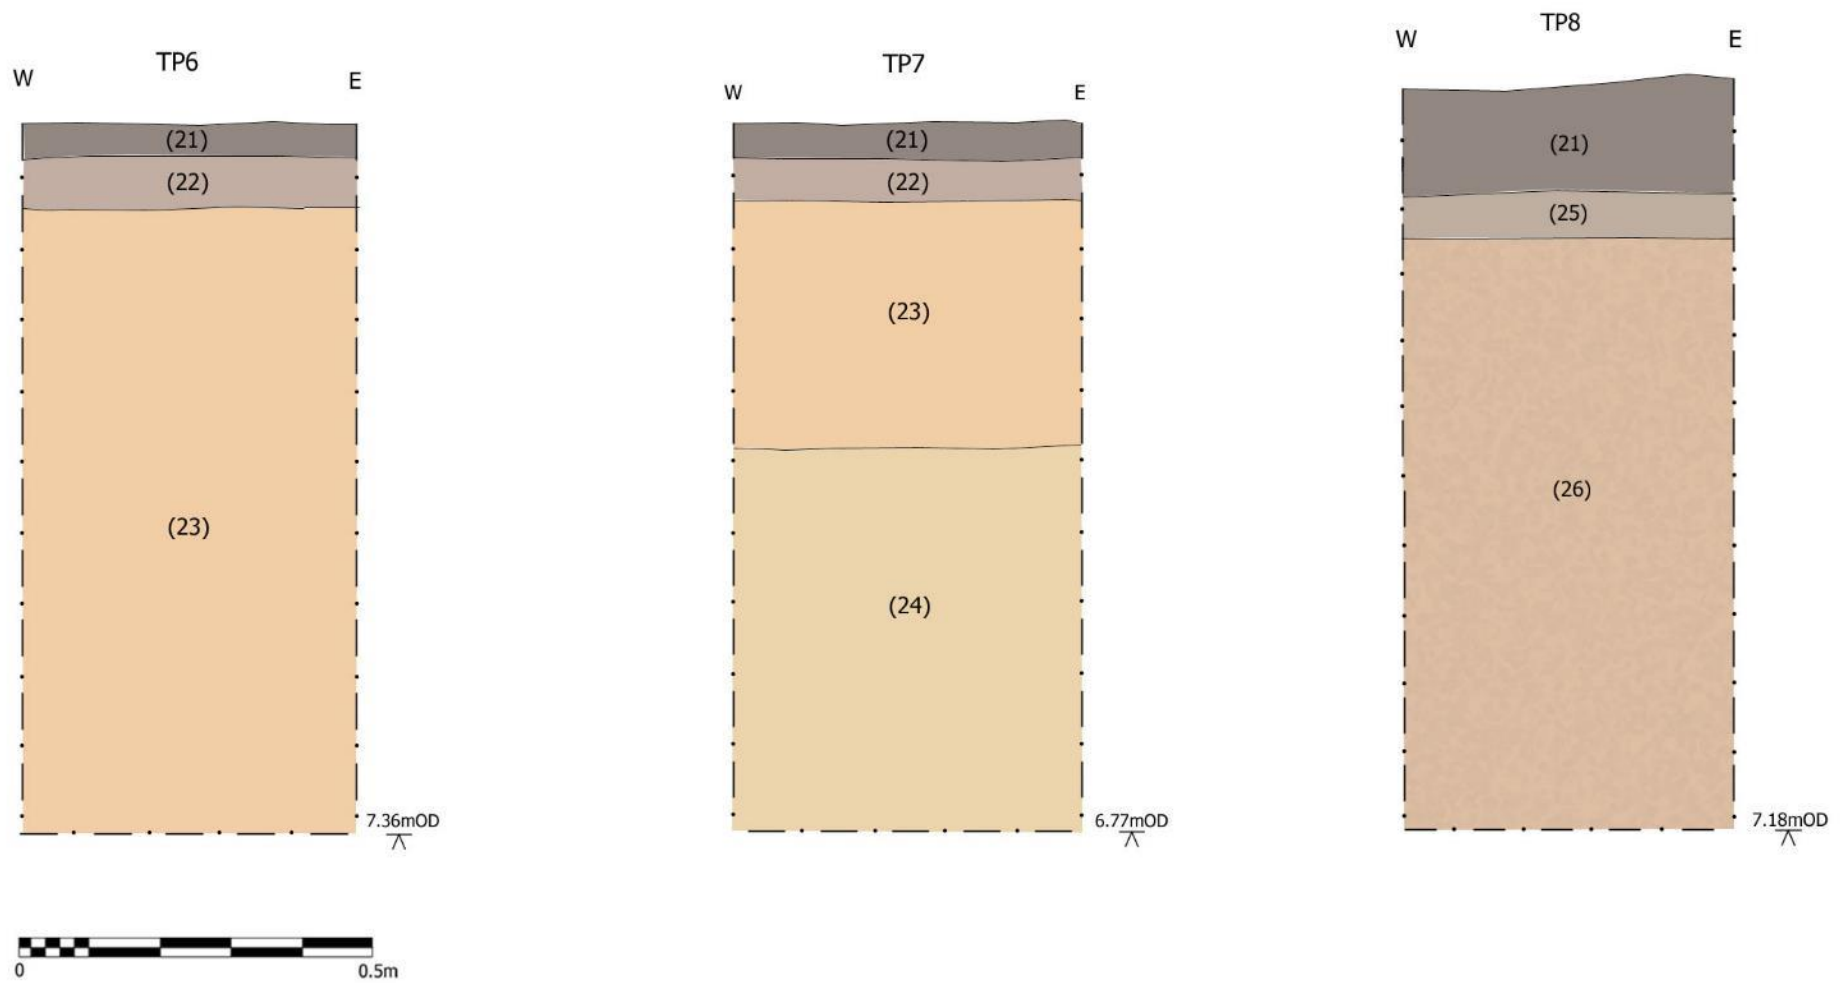
Figure 31: South facing sections of Trial Pits 6, 7 and 8. Originals drawn at 1:10.

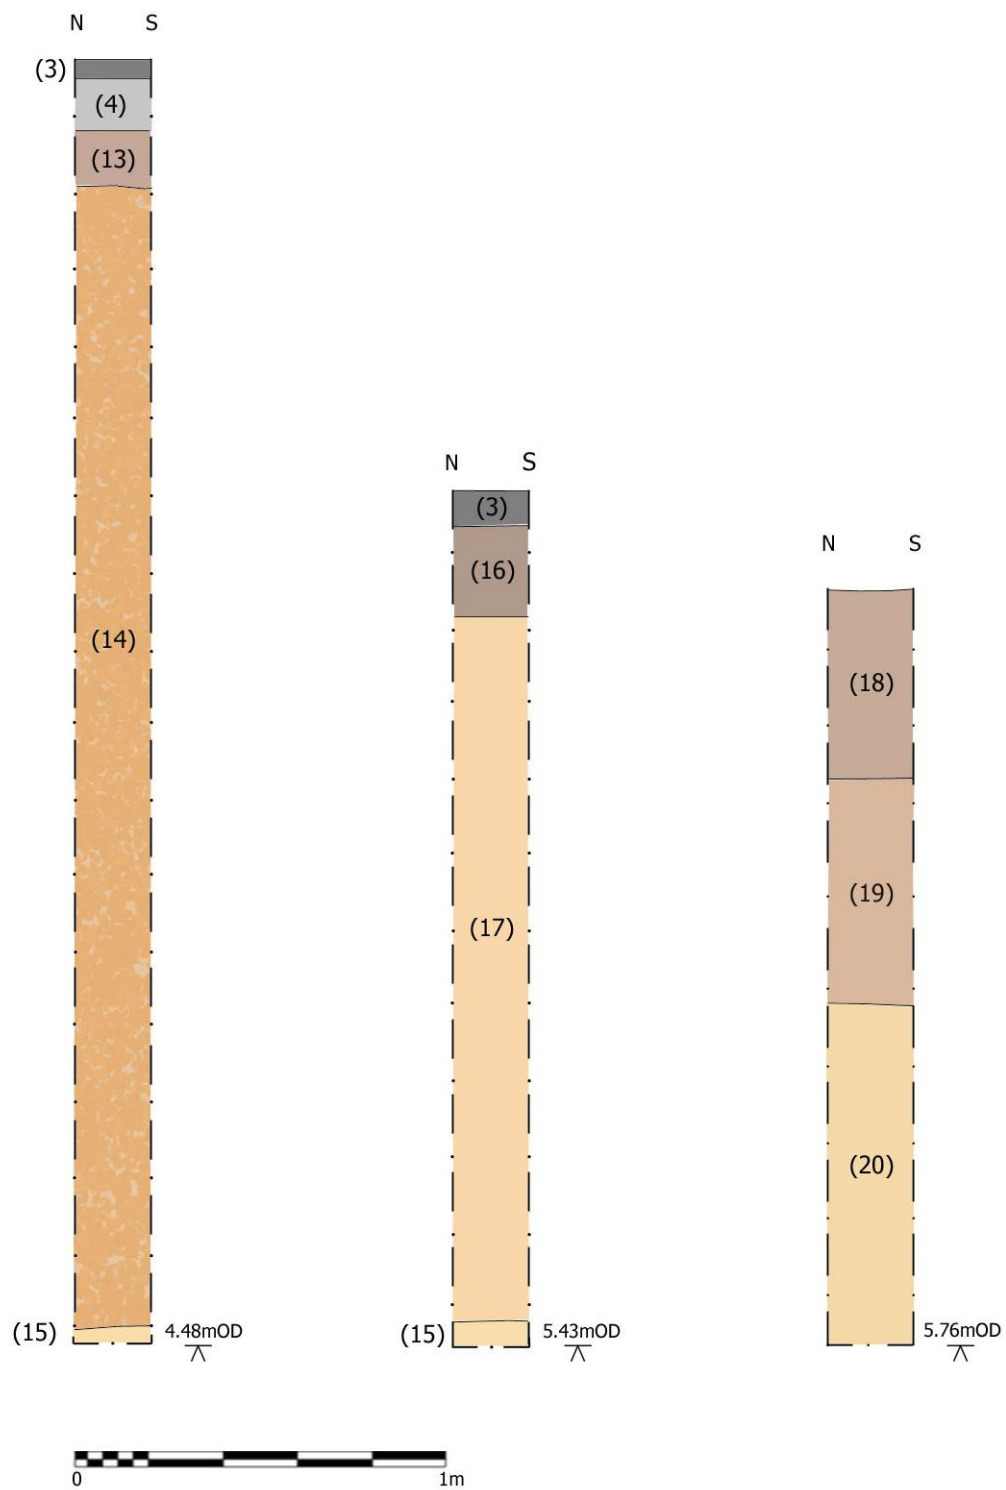
Figure 272: West facing sections of boreholes 1 and 2, and hand auger pit 1. Originals drawn at 1:20.
