**ST MARY-AT-HILL, LOVAT LANE,
CITY OF LONDON EC3R 8EE**

An Archaeological Watching Brief

April 2017

Site code: MHL16

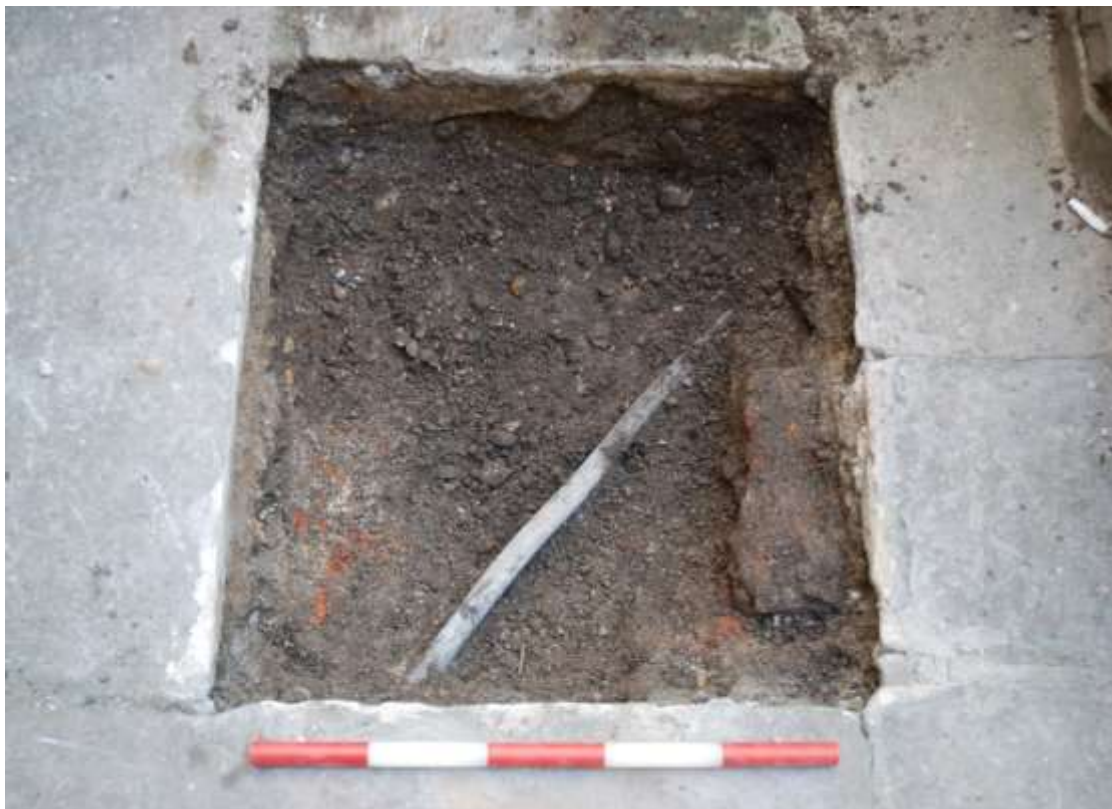
- 7.1.1** The first pit was located adjacent to the rear door of the church, butting up against the north-south inner churchyard wall and steps, leading to the raised area. The pit measured 0.6m in length x 0.65m in length x 0.3m in depth (fig.5).

Figure 5: Pit 5, showing post-medieval backfill below the existing paved surface and water pipe. Facing N, scale 0.5m.

- 7.1.2** The stratigraphy comprised 250mm of dark brown soil containing frequent small stones and fragment of orange-red brick (31) below the existing stone paving slabs and bedding [30], measuring approximately 40-50mm in thickness.
- 7.1.3** The targeted water pipe was observed running in a northeast-southwest alignment through the centre of the trench, at a depth of 0.2m below ground level (13.650mOD at the south end and 13.566mOD at the north end).
- 7.1.4** Remains of some orange-red brickwork were noted in the east and west sections, however, it was unclear as to whether this had been a feature truncated by the installation of the pipe, or brick rubble within the backfill. No further features of archaeological interest were recorded and no finds were recovered.

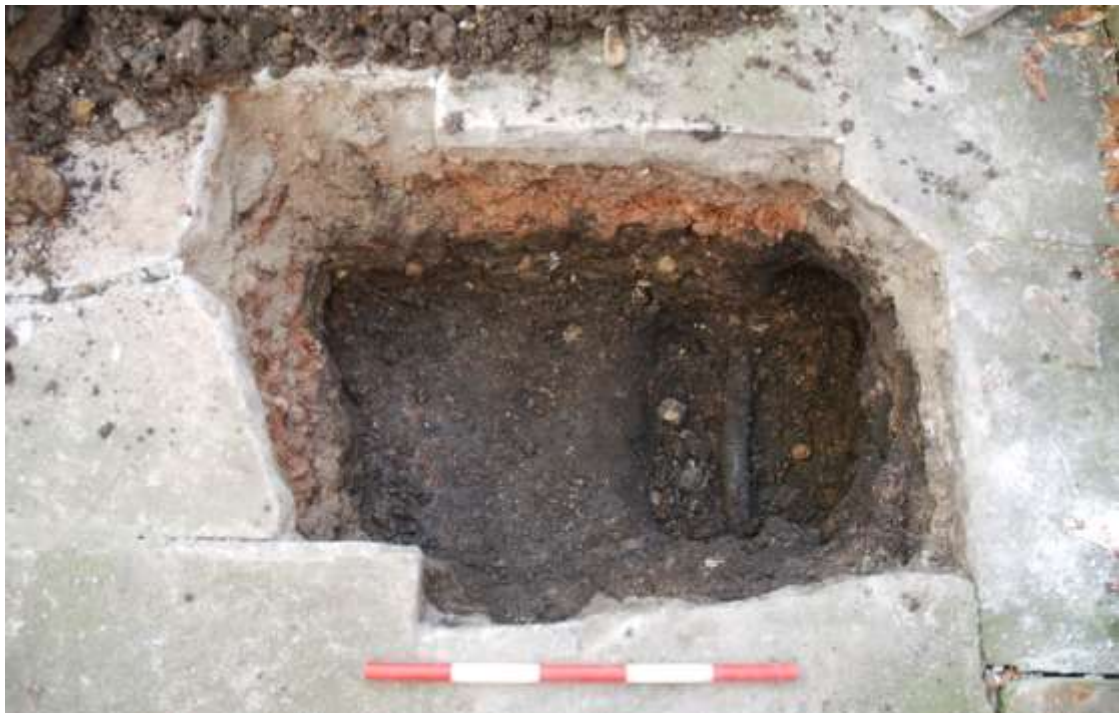
- 7.2.1** The second pit undertaken was located on the raised area of the churchyard, east of the north-south steps leading up to the space. The pit was located immediately west of Compass Archaeology Evaluation Trench 4 (2016), the backfill of which was observed in the east section. The pit was an irregular rectangle in plan, a result of the crazy paving, measuring 1.03m in length x 0.64m in width x 0.54-0.70m in depth (fig.6).

Figure 6: Pit 6, showing backfill below MOT Type 1 and existing paving. Facing E, scale 0.5m.

- 7.2.2** The stratigraphy in the pit comprised 70mm of stone paving slabs and loose bedding sandy mortar [32] above 170mm of MOT Type 1 (33), taken to be the backfill of the Compass Archaeology Evaluation Trench, overlying 300 – 460mm of dark brown soil (34), similar in composition to that observed in Pit 5.

7.2.3 The water pipe was observed in the south side of the trench, running in an east-west direction, adjacent to the churchyard wall, recorded at a depth of 0.6m (13.717mOD).

7.2.4 No finds or features of archaeological interest were observed in this pit.

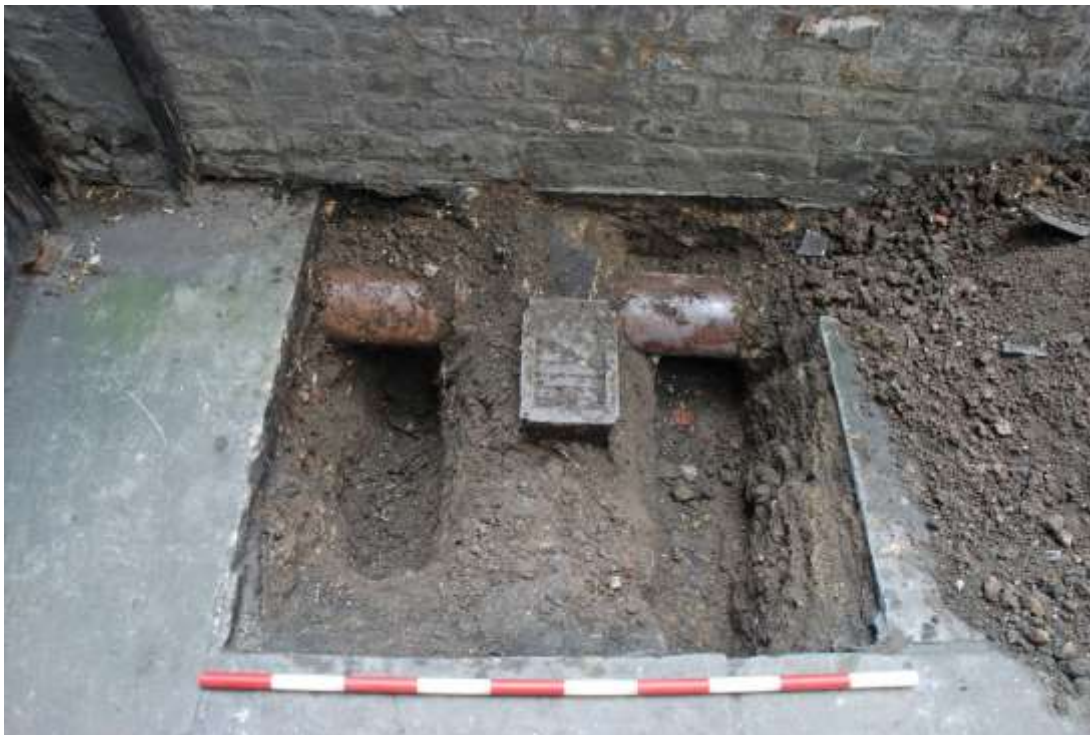
7.3.1 The final pit was located on the north side of the churchyard wall, within the east-west perimeter path, 0.47m west of the metal entrance gate. This trench was almost square in plan, with the southern edge abutting the wall, measuring 1.0m x 0.9m x 0.5m in depth (13.090mOD) (fig.7).

Figure 7: Pit 8, showing backfill surrounding ceramic pipe and associated metal drain. Facing S, scale 1m.

7.3.2 The stratigraphy in the final trench consisted of a looser, lighter brown soil (35), containing frequent angular stones and small fragments of CBM below the existing paving slabs [30].

7.3.3 A ceramic pipe ran through the southern side of the trench in an east-west direction, with an associated metal drain and connection to the north. No cut for this feature was visible.

7.3.4 The surveyed water pipe was not detected in this pit, and there were no finds or features of archaeological interest recorded.
