HIGHWAY IMPROVEMENT WORKS THE MALL/MARLBOROUGH ROAD, CITY OF WESTMINSTER, SW1A 1BG

AN ARCHAEOLOGICAL WATCHING BRIEF

April 2017

Site code: MBH17 Site Location NGR: TQ 29465 79960

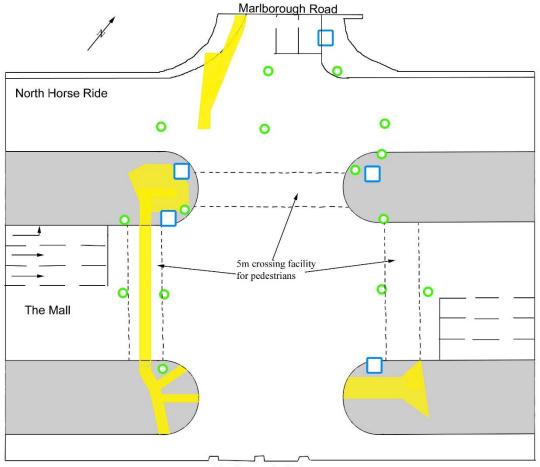
Figure 5: Plan of the works carried out on The Mall/Marlborough Road. Trenching in yellow, new lighting columns: blue squares and new traffic signals: green circles. Adapted from a plan provided by Peter Brett Associates.

The installation of the new traffic signal poles, including lighting systems and pedestrian crossing measures comprised several small trenches around the junction, situated on raised kerbs or protected by existing plastic bollards. The maximum depth of these excavations was also 700mm. The groundworks outlined above were connected by a series of new cable ducts. The majority of this trenching measured 500mm wide X 600mm deep (fig. 5).

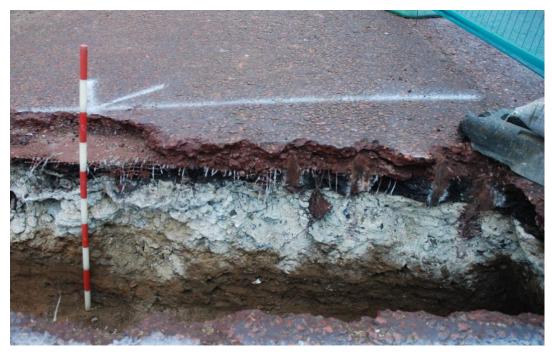
Figure 6: Stratigraphy of N-S trench at N end. Facing W. Scale 1m.

- **7.2** In total the lengths of trench excavated across the site made up c. 125m. They were generally c.0.60m wide and c. 0.20-0.75m deep. The stratigraphy was homogenous across the majority of the trenching on site, comprising red asphalt (1) c. 0.10m thick, overlying black asphalt (2) c. 0.08m thick. This lay above a concrete layer (3) c. 0.22-0.26m thick with a mid-brown silty sand layer (4), beneath that. This layer was c. 0.28-0.30m, though its full extent is unknown (fig. 6). Rare inclusions of ceramic building material (CBM) were found in this layer across the site.

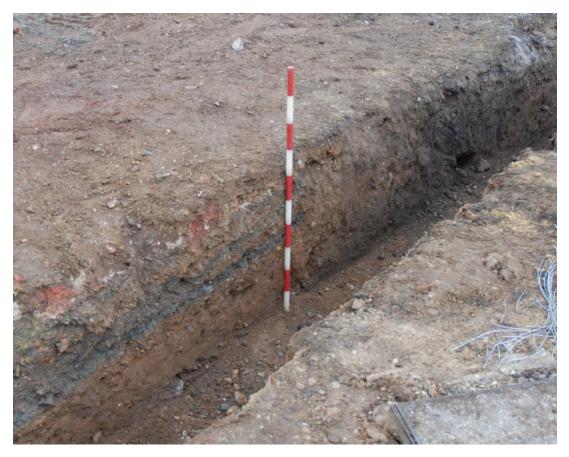
Figure 7: Stratigraphy in small trench SE of N-S trench. Facing SW. Scale 1m.

- 7.2.1 No finds or features of an archaeological nature were recovered from the trenching.
- **7.3** A short trench c. 2m long and c. 0.67m deep was dug to the southeast of the N-S running trench which comprised of made ground (5) c. 0.06m thick, overlying a whitish lens (6) 0.05m thick, followed by another layer of made ground (5) c. 0.12m thick. A grey lens (7) lay under this, c. 0.04m thick, followed by the mid-brown silty sand (4), c. 0.40m thick, though its full extent is unknown (fig. 7).

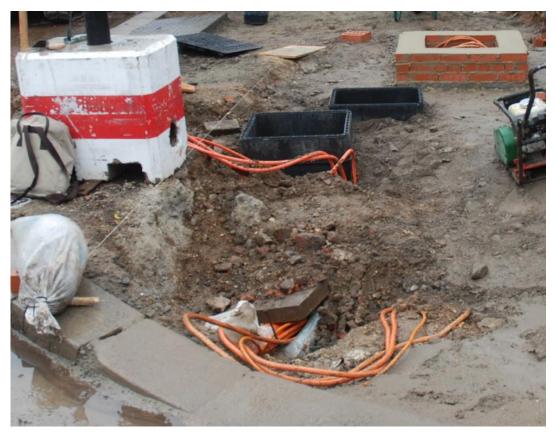
Figure 8: Backfill from small post-hole on NW traffic island. Facing S. No scale.

7.3 The excavation of a pole on the northwest traffic island created a slight depression of 0.20-0.30m deep. This was filled with a mixed backfill (8) which contained a small quantity of post-medieval finds, CBM and pottery (appendix II). These were taken to have been imported from somewhere else and were not *in situ* (fig. 8).

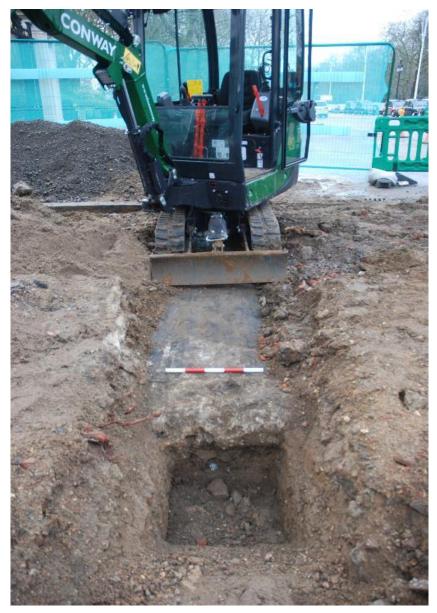
Figure 9: Slab beneath walkway on southern side of The Mall. Taken to be a previous road surface or similar. Facing SW, scale 0.5m.

7.4 Excavations on the southwest traffic island uncovered a concrete slab at a depth of 0.45m below the surface. This was taken to be a previous road surface or similar. The slab was 0.70m wide, and 0.18m thick. The total length was unknown as it fell outside the limit of excavation. A layer of gravelly sand backfill (9) was excavated from above the slab on the southern side (fig. 9). Several moulded decorative stone pieces were recovered from this backfill, their date and origin is unknown (fig. 10, 11, 12), some post-medieval pottery was also recovered.

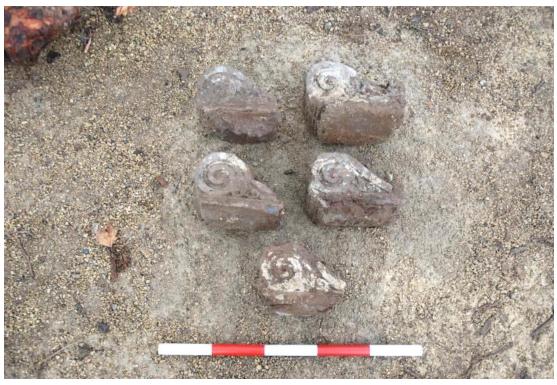
Figure 10: Moulded decorative pieces, mostly broken, found above the road / slab in fig. 9. Scale 0.5m

5 moulded decorative elements were recovered from context (9). All five pieces appear to be produced from a relatively lean mix concrete poured into a mould, and potentially finished with a finer mix slip, coated with white paint.

Date unknown, although their high position within the stratigraphy and method of production suggests they are late post-medieval in date, if not modern.

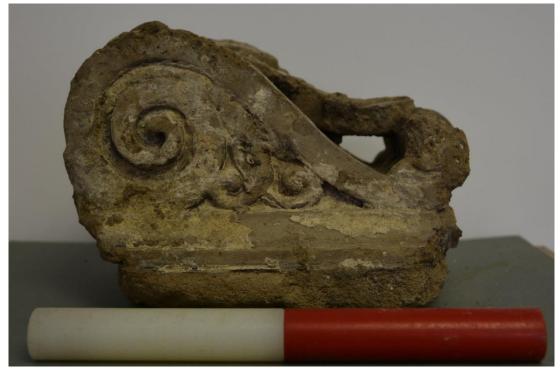
Figure 11: Side detail of moulded decoration. Scale 0.20m

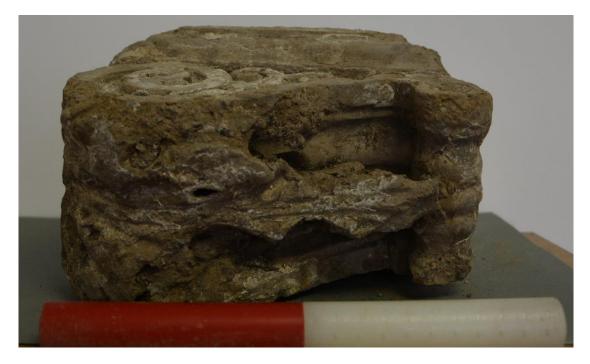
Figure 12: Top detail of moulded decoration. Scale 0.20m.
