**ST BOTOLPH ROW, ALDGATE HIGH STREET
CITY OF LONDON EC3N**

**PRELIMINARY TRIAL HOLE
& HIGHWAY IMPROVEMENT WORKS**

An Archaeological Watching Brief

Site code: SBL17
Site NGR (centre): TQ 33595 81225

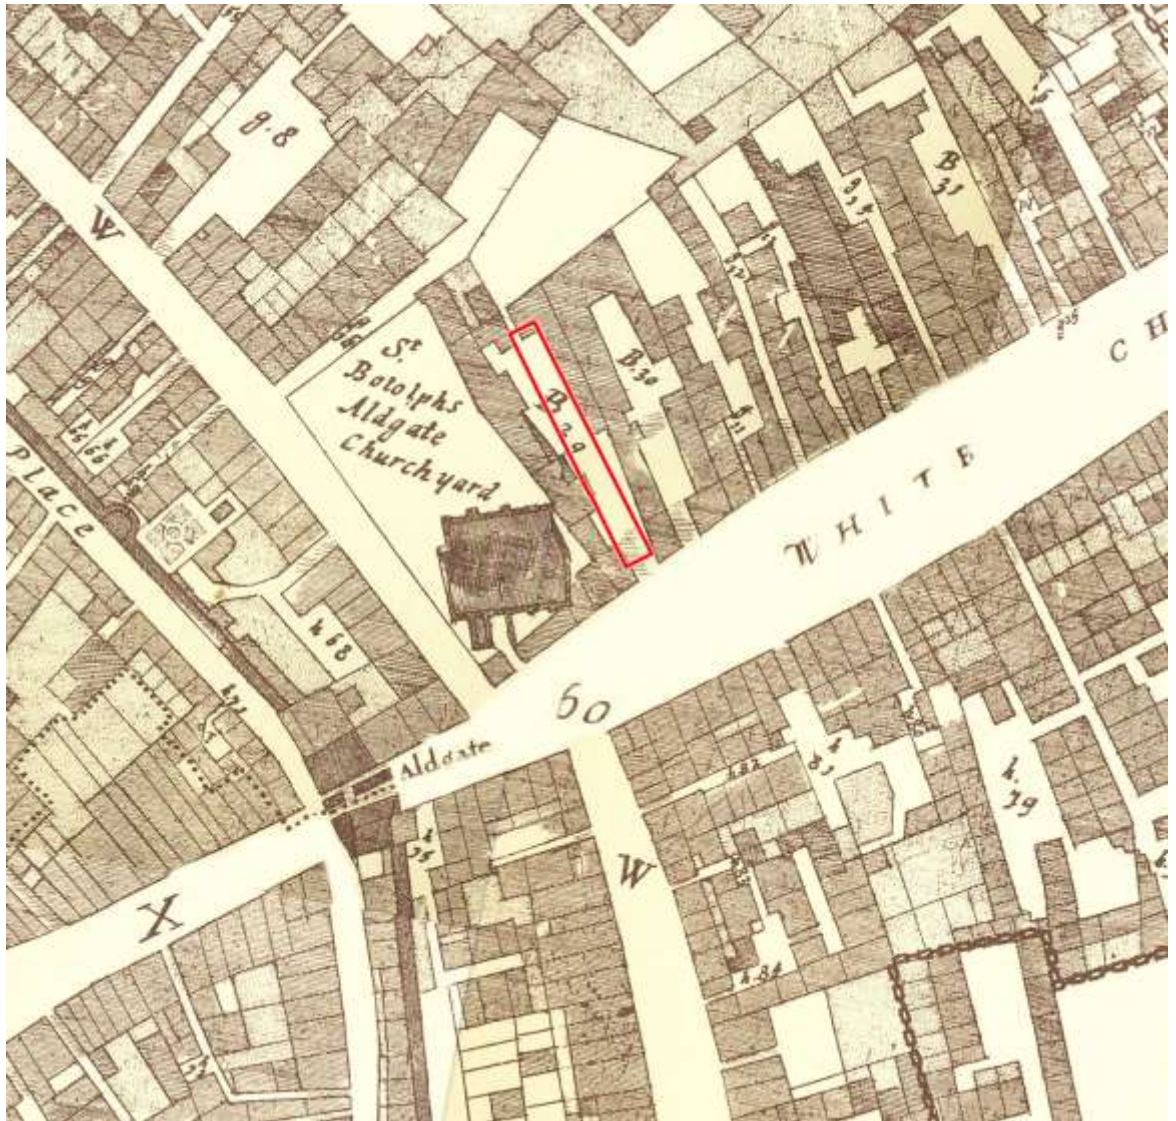
Figure 3: Site boundary located on an extract from Ogilby & Morgan's Survey of the City of London, c 1676

The Row was in existence by the second half of the 17th century (figures 2 and 3), but the layout and alignment seems to have changed quite radically by the mid-18th century – possibly contemporary with the rebuilding of the Church in the early 1740s, and apparently narrowing the previous yard area to something more like an alley (see figure 5).

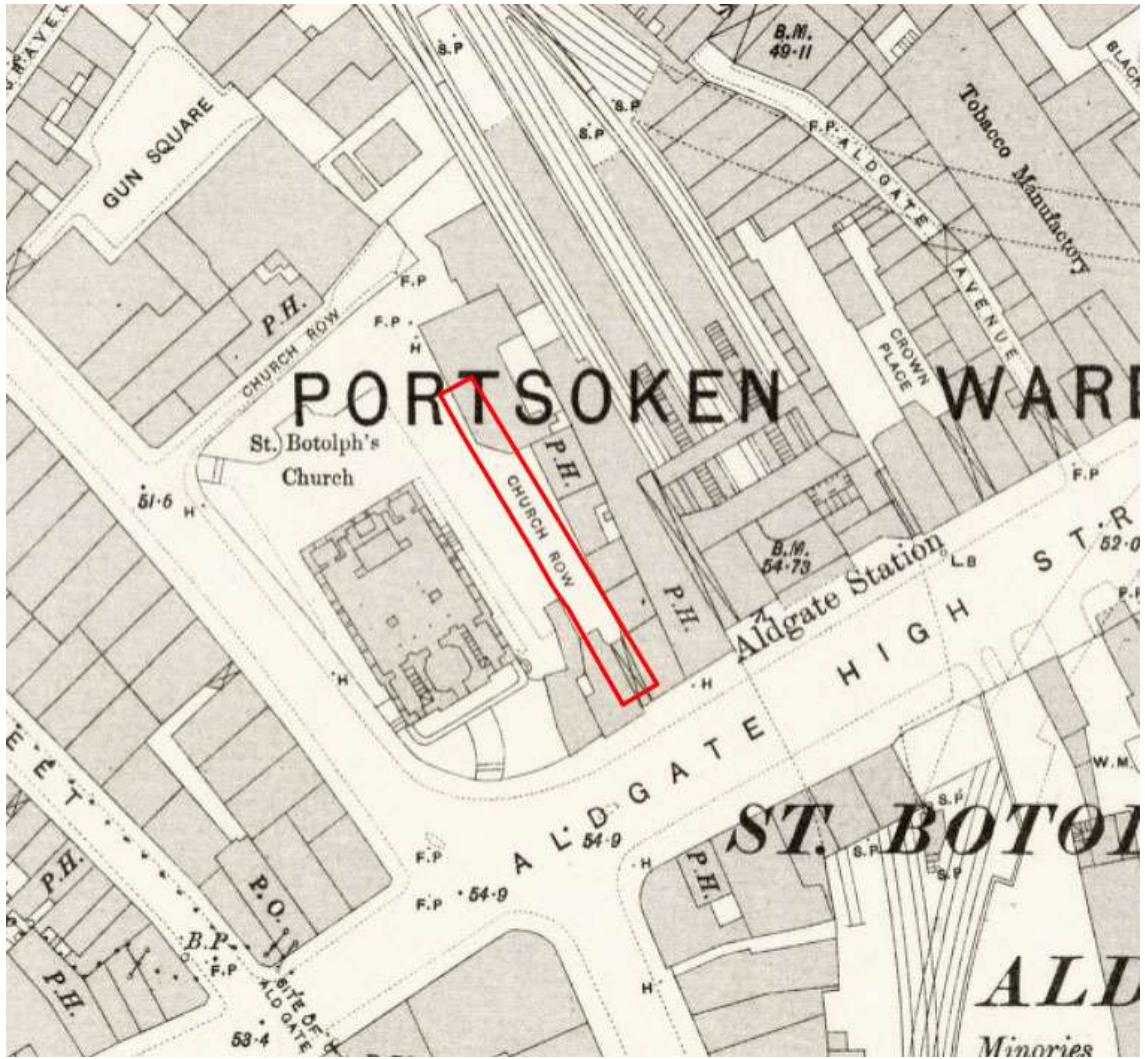
Figure 10: Extract from the Ordnance Survey 5 foot: mile map of 1894-96 (London Sheet VII.67)

A further major change occurred from the mid-1890s, with the realignment of the northern part of the Row and associated rebuilding (figures 8-10). A final change occurred in the later 20th century, with the whole passageway straightened and moved slightly or at least widened to the west.

As shown in the 1894-6 OS map above (figure 10), by the end of the 19th century the shops on the western side of Church Row had been demolished. By 1916 (as indicated by the OS map from that year, figure 11 above) Church Row had been cleared and redeveloped with the alignment of the Row itself substantially altered. Context (7), which produced what can be characterised as a generally late 19th century-early 20th century assemblage of artefacts including pottery and glass, was deposited over and up against the walls in trench 1. This would suggest that this potentially formed a deposit associated with the demolition of the 18th-19th century buildings.

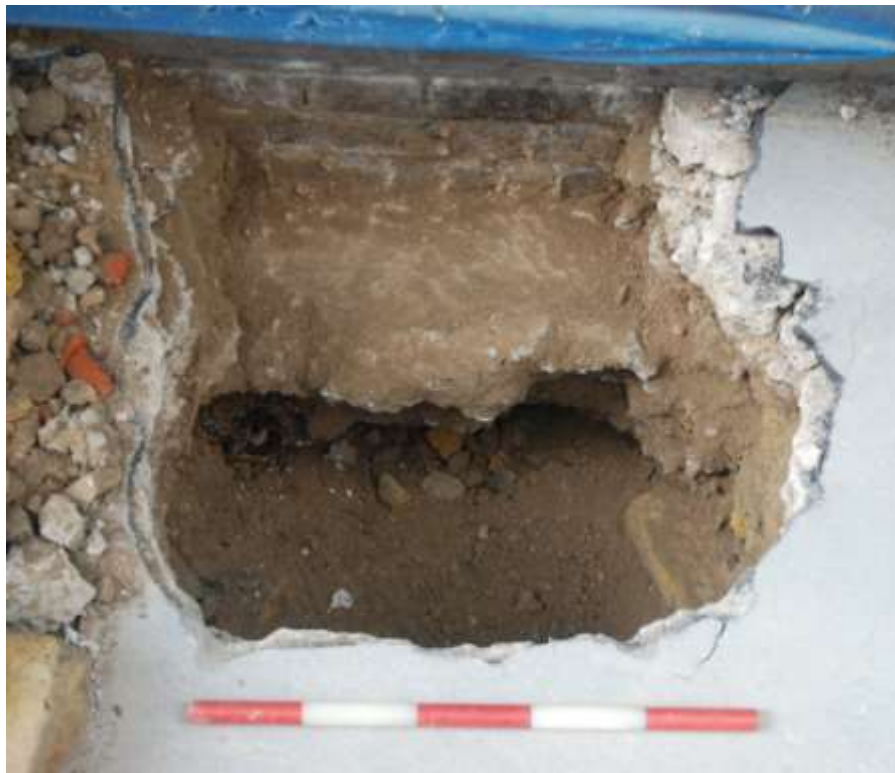
Figure 16: Trial hole 1, facing SW, 0.5m scale

7.3.2 In general, the stratigraphy in the trial hole can be summarised as follows; 20mm of asphalt (1) overlaid 70mm of concrete (2) and a 40mm loose mortar soil horizon (3), with 470mm of demolition rubble (4) with frequent yellow stock brick inclusions. Overall, the trial hole was dug to a maximum depth of 600mm (c.15.62mOD).

7.3.3 As can be seen in the figure below, in the SW section of the trial hole a layer of concrete was encountered up against the planter wall at a depth of 260mm-560/570mm, extending 270mm from the wall. The large void underneath this and associated demolition rubble suggests that this represented backfill within a basement.

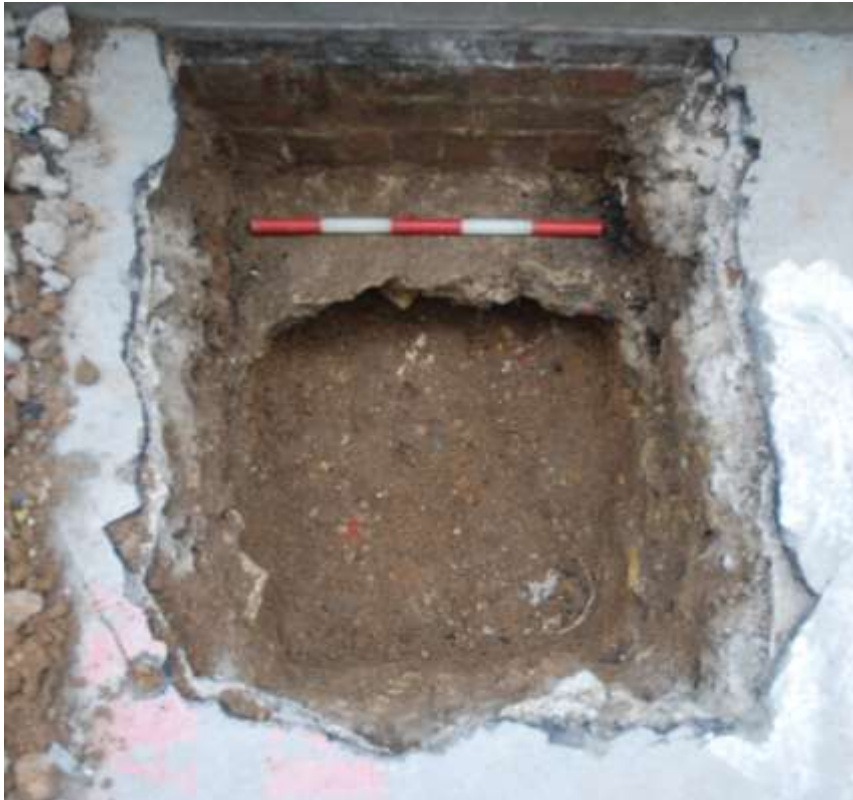
Figure 18: Trial hole 2, facing SW, 0.5m scale

- 7.4.1** Trial hole 2 was located the furthest to the north out of the three, and was oriented NW-SE, measuring c.670mm NW-SE and 800mm NE-SW.
- 7.4.2** The stratigraphic sequence in trial hole 2 was very similar to that in trial hole 1, with asphalt (1) (20mm in thickness) overlying concrete (2) (110mm in thickness) and 400mm of backfill (5) which consisted of orange-brown coarse sand and gravel with infrequent brick fragment inclusions. Within the backfill, a piece of embossed wall tile with a foliate design and circular motif was found, which has been dated to the late 19th or early 20th century (see Appendix IV).
- 7.4.3** As was the case in trail hole 1, a layer of concrete was deposited up against the planter wall; in this case it appeared at a depth of 350mm-560/570mm and was 150mm wide. Overall, the trial hole reached a maximum depth of 570mm (c.15.65mOD).

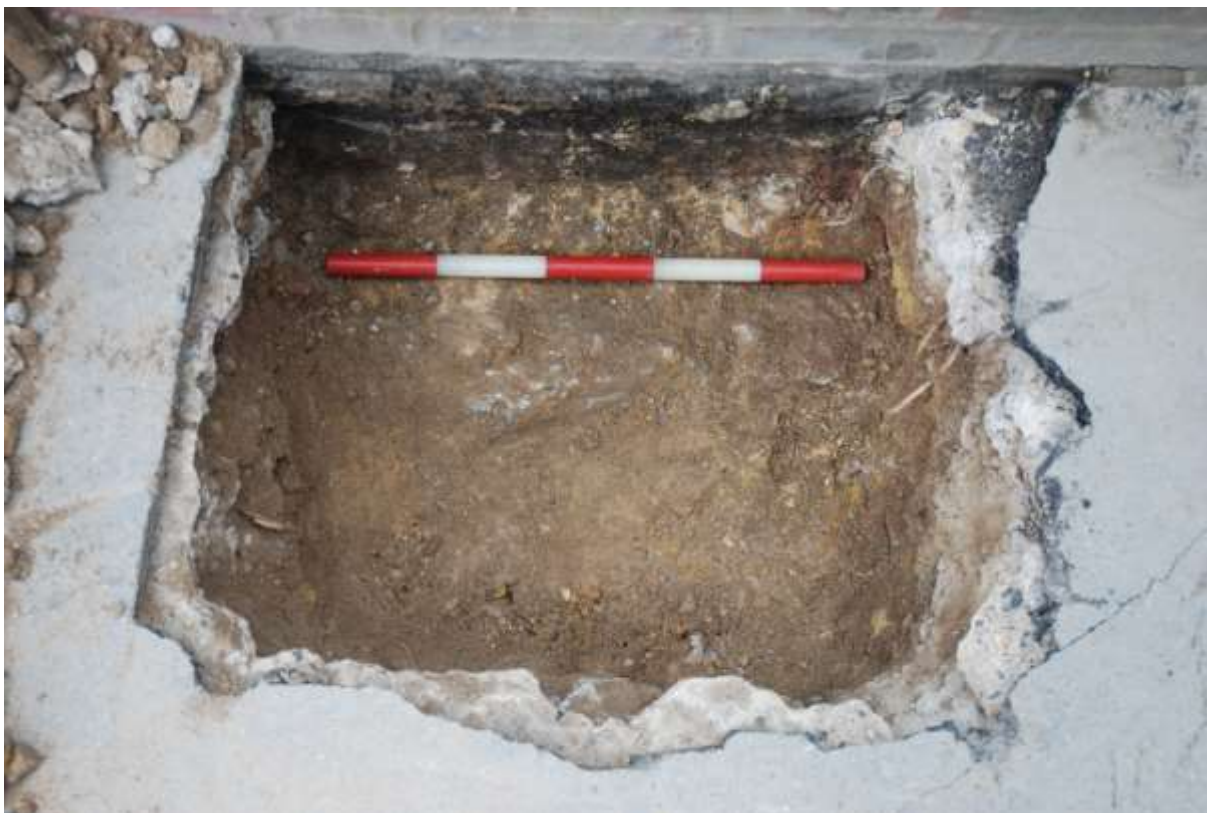
Figure 20: Trial hole 3, facing SW, 0.5m scale

- 7.5.1** Trial hole 3 was located the furthest to the south out of the three, and was oriented NW-SE, measuring c.620mm NW-SE and 500mm NE-SW.
- 7.5.2** In trial hole 3, there was 30mm of asphalt overlying 100mm of concrete and 250-270mm of loose mid-beige-brown sandy mortar (6). Overall, the trial hole was dug to a maximum of 400mm below ground level (c.15.76mOD).
- 7.5.3** Like that seen in trial holes 1 and 2, a thick layer of concrete was observed in trial hole 3 which was first encountered at a depth of 270mm with a base at 350mm.

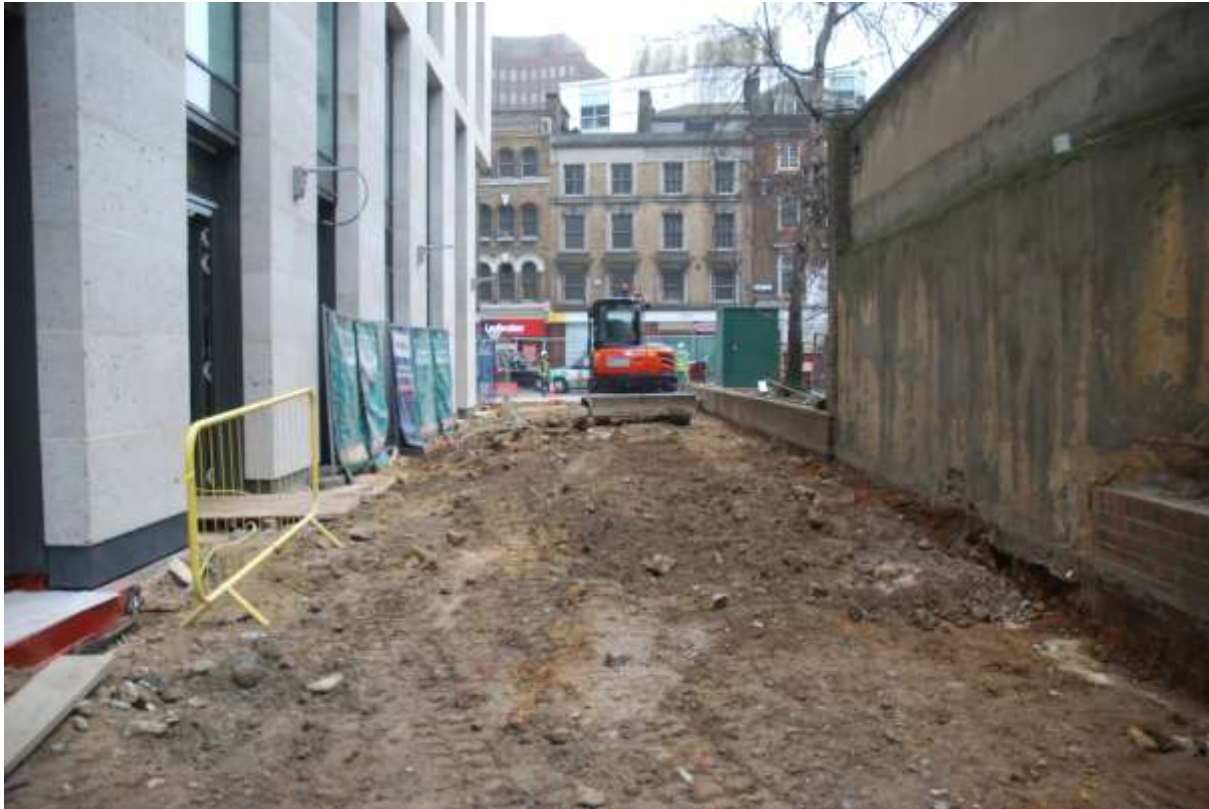
Figure 21: View of St Botolph row during general ground reduction, facing SE

- 7.6.1** On the 8th and 9th of February 2017 two visits were made to the site, at which time a general ground reduction was made across the site and part of the modern brick wall along the western side of St Botolph Row was removed (this area will be discussed in more detail below in section).

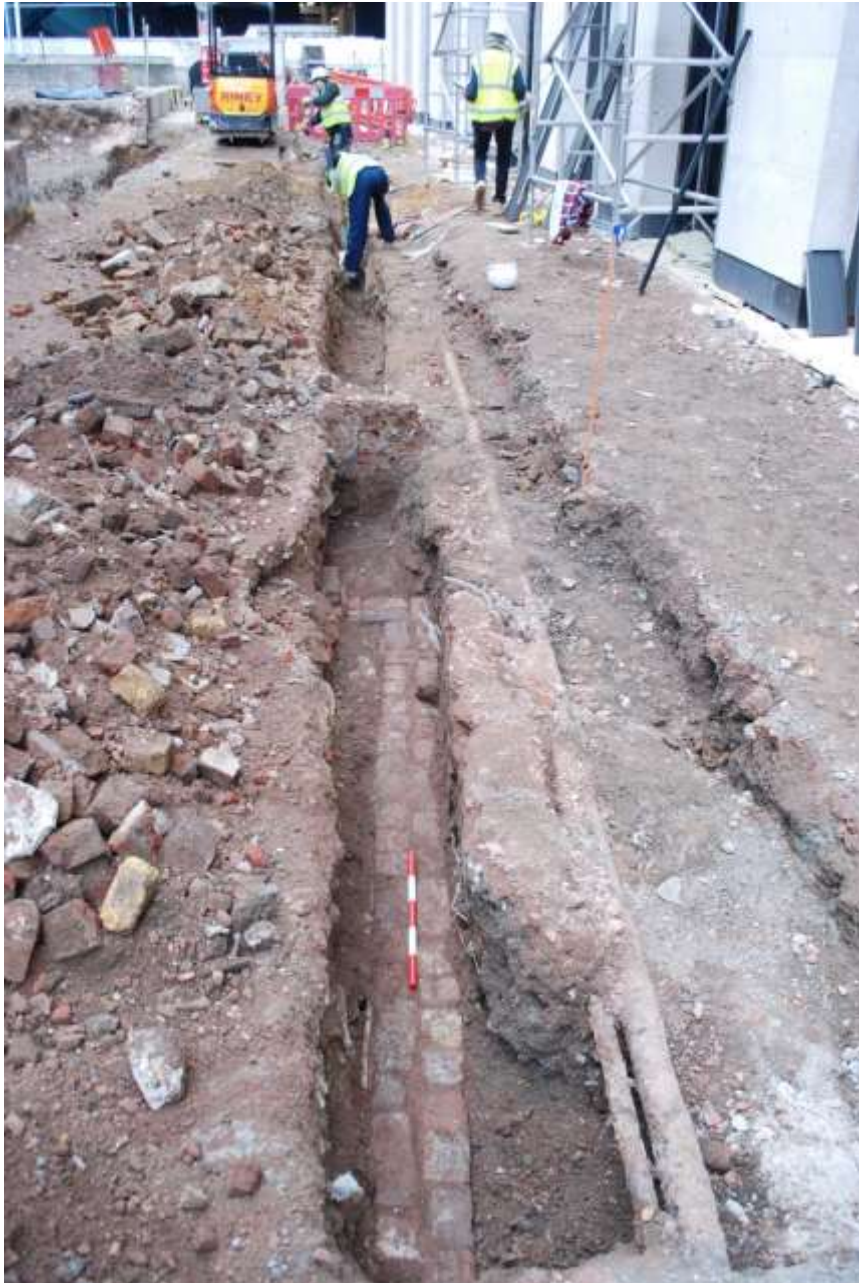
Figure 23: Trench 1 and walls [8] and [9], facing NW, 0.5m scale

The first visit to monitor the trenches on St Botolph Row was on the 21st of February 2017. By this point the south west extent of trench 4 had been excavated and wall [8] was observed (see below). The stratigraphy within the trench was very simple, with a dark reddish-brown silty demolition rubble [7] deposited over and up against the wall. Context [7] was the richest in finds, including post-medieval pottery, glass and animal bone. The pottery assemblage has been dated to the 19th century, indicating that the context is associated with the demolition of the shops which previously existed on the western side of what was then 'Church Row' from the mid-18th to the late 19th century. Two brick samples were taken from wall [8] which have been very broadly dated to the period 1650-1900.

The wall itself appeared in a kind of 'dog-leg' formation. It was aligned roughly NNW-SSE composed of dark red stock bricks, and its main NNW-SSE portion was 320-380mm wide. There were limited areas of render which survived on the NNW face of the wall, whilst some of the bricks had remains of white paint or limewash on them. The NNE-SSW running portion of the wall was 490mm in length and 240mm wide including the patches of render that survived on its SSE face. The NNW-most 'leg' of the wall was only partially visible in the NW section of the trench but was visible in height to at least three courses (c.300mm, first encountered at c.15.52mOD) and ran at least 850mm NNW-SSE. Towards its NNW end, the wall was seen at a depth of 550mm below ground level (c.15.27mOD) to c.610mm towards its SSE extent (c.15.21mOD).

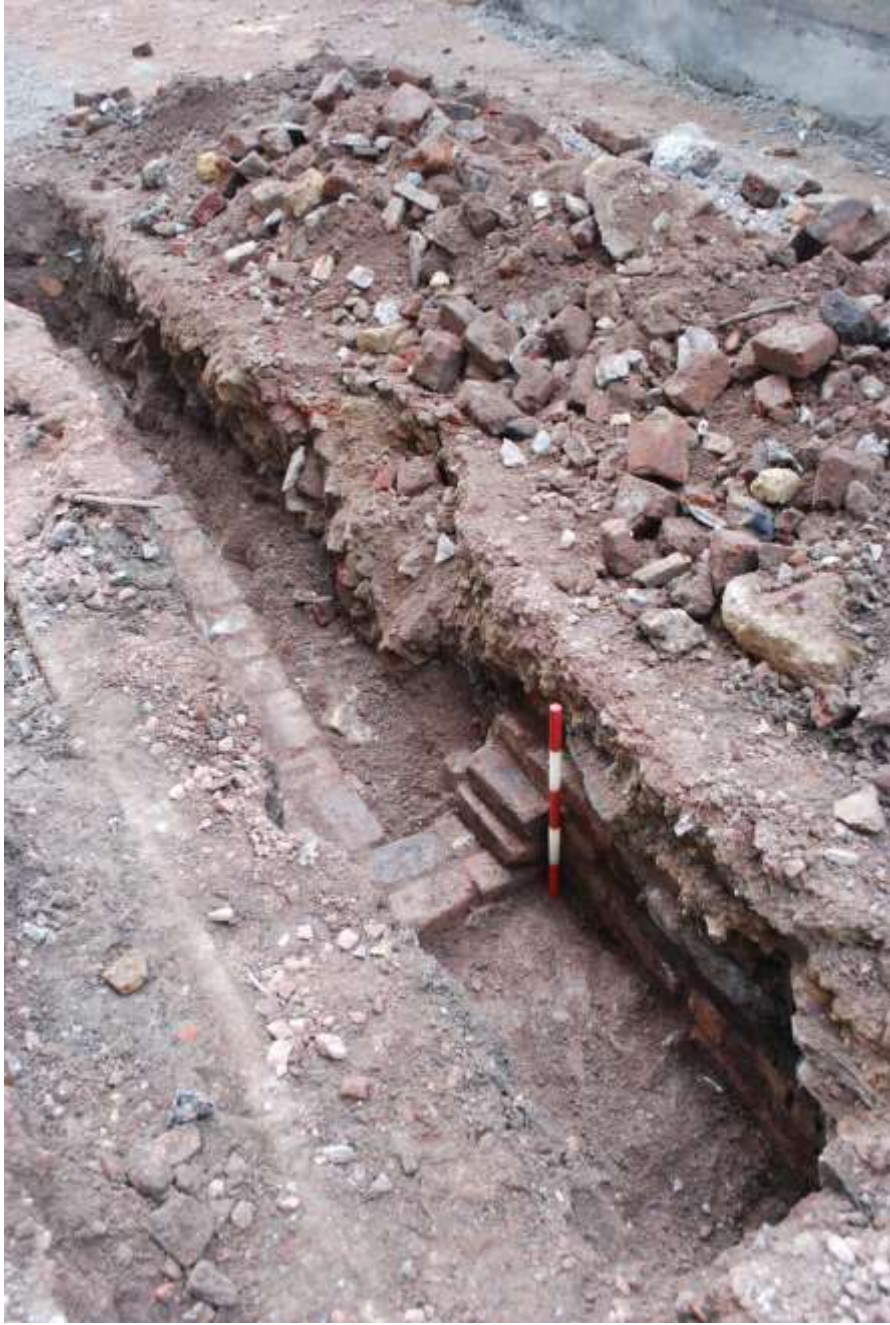
Figure 26: Detail of NWW end of wall [8], facing S, 0.5m scale

The solid red brick wall base [9] was 180mm NW of wall [8], 600mm in width and ran across the full width of the trench (c.360mm at this point). Like [8], it was aligned NWW-SEE and thus can be assumed to be associated with it. This was visible from the top of the trench (c.15.82mOD)

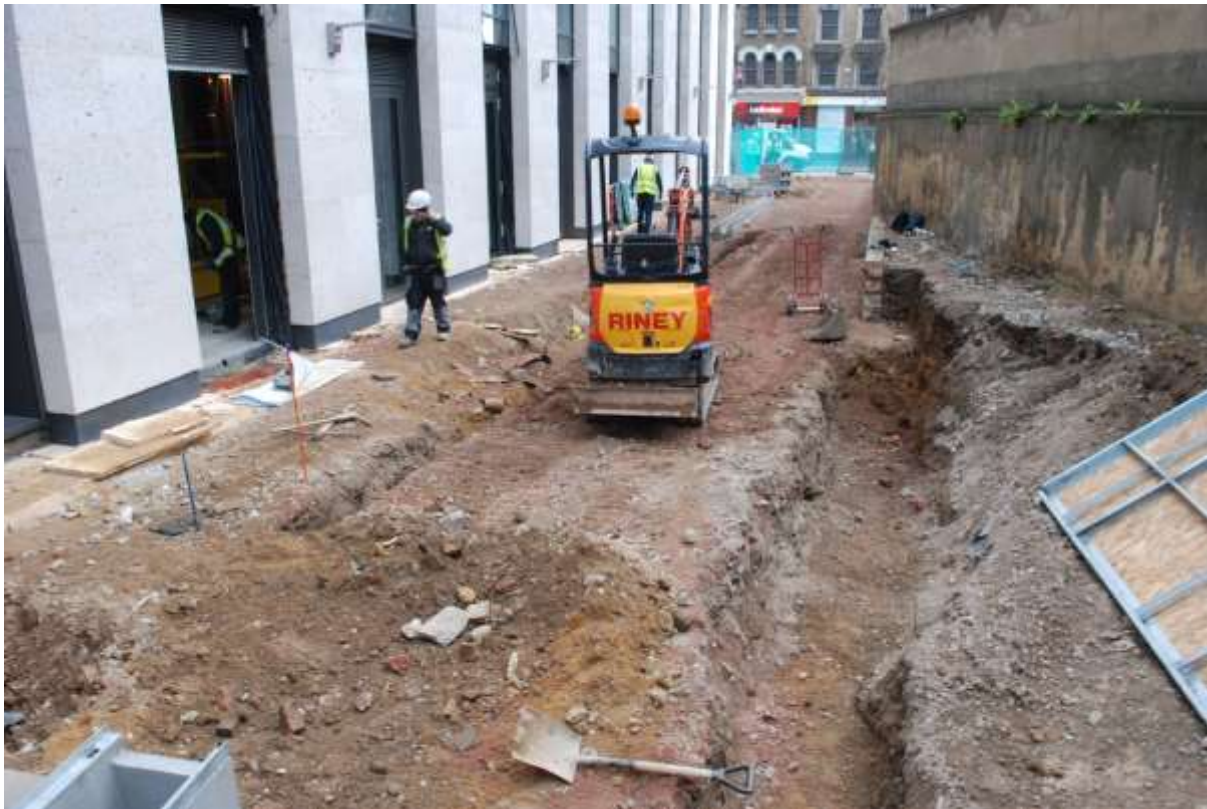
Figure 27: View of trench 1, facing E

On the 22nd of February the NW extent of trench 1 was observed. A rendered wall, [10], with two visible bays was recorded. Like [8] and [9], its main extent was aligned NNW-SSE, first appearing roughly 230mm NW from wall [9] and 4.7m long in total. Three walls, also rendered, ran across the trench perpendicular to the NNW-SSE portion of the wall, delineating the two bays. These were 250-255mm in thickness and at least 4 courses (c.400mm) in height. The fact that [10] was rendered suggests that it likely formed part of a basement. As was the case with [8] and [9], it had (7) deposited up against it. Wall [10] was encountered approximately from a depth of approximately 100mm below the top of the trench (c.15.73mOD).

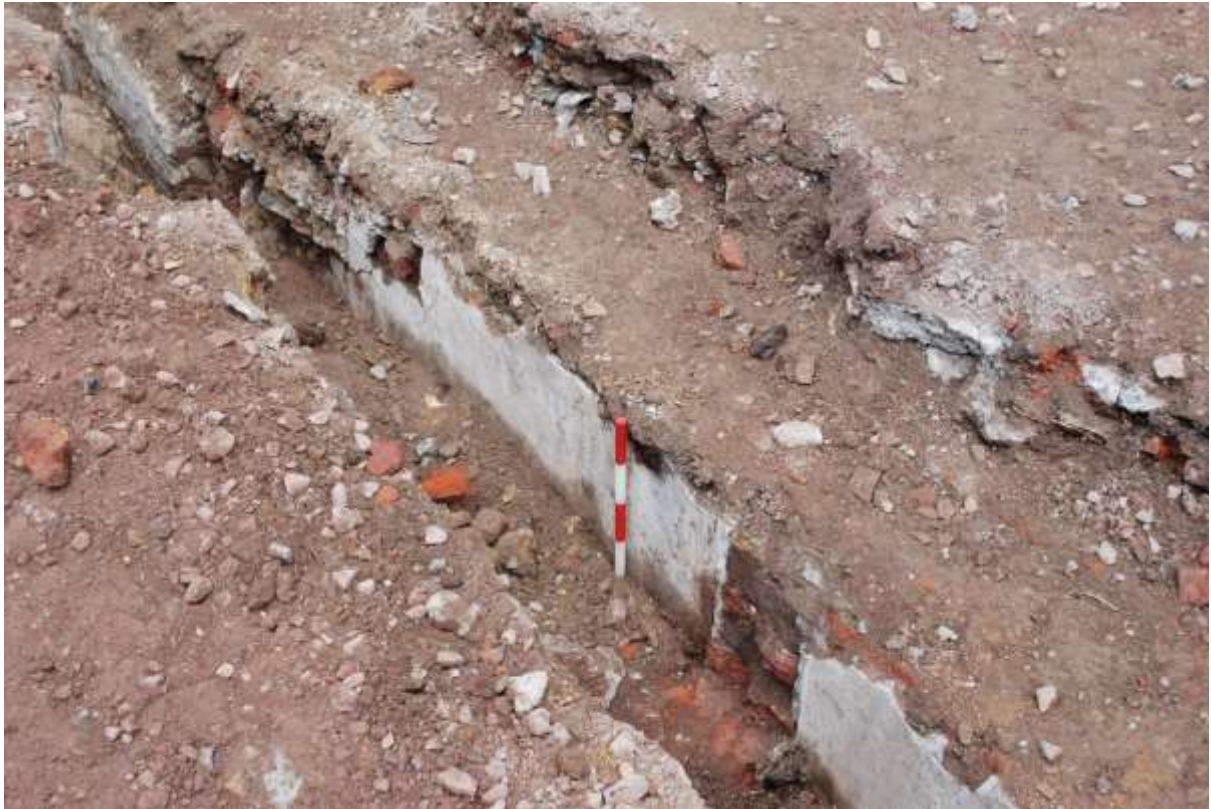
Figure 32: Oblique view of SSE bay of [10] and [11], facing NE, 0.4m scale

Another wall [11], which was limewashed, abutted the SEE-most perpendicular wall of [10] and extended out approximately 190mm from the NE section of the trench. The wall was slightly offset from [10], but was still roughly aligned NNE-SSW, extending at least 900mm NNW before it was truncated by services. Given that it was limewashed, like [10], this wall could have also formed part of a basement, though perhaps its offset alignment indicates a clear demarcation between it and [10]. It was also seen at a depth of approximately 100mm below the top of the trench (c.15.73mOD).

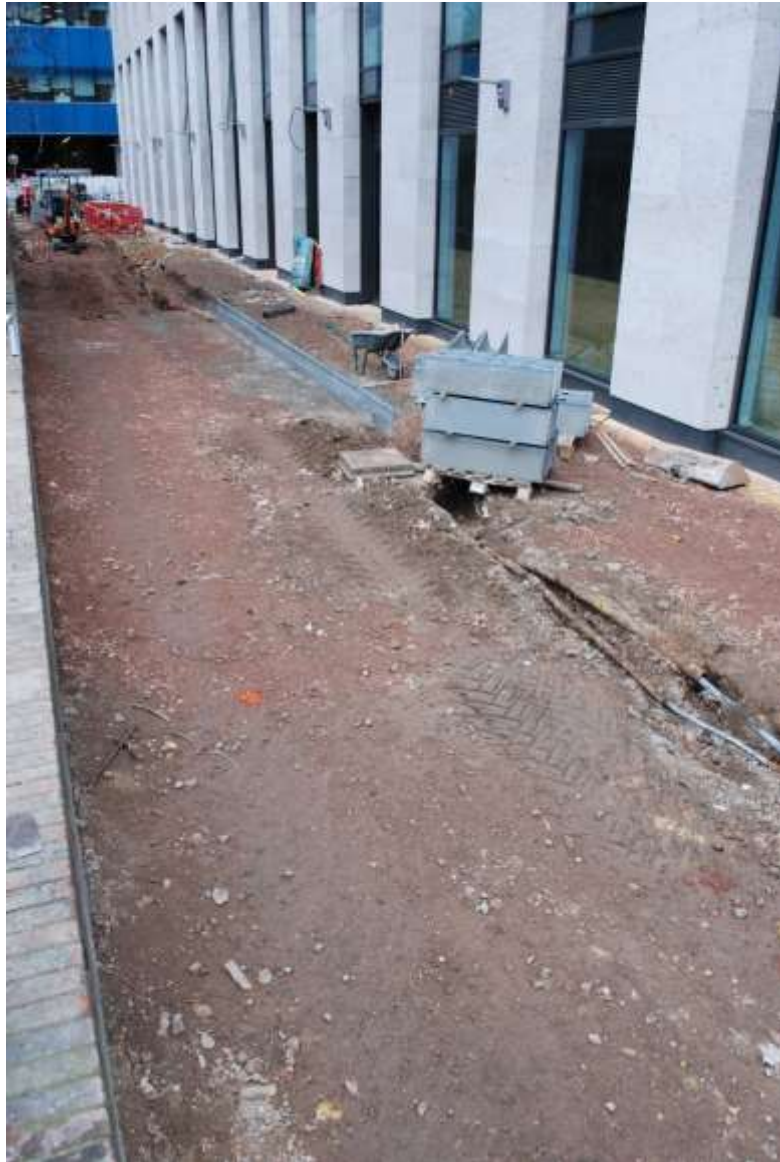
Figure 34: View of the extent of trench 1, facing N

The most significant evidence for previous development on the site was the brick wall remains found in trench 1; walls [8], [9], [10] and [11]. All of these, apart from the brick wall base [9] and wall [11], were at least partly rendered and are theorised to have formed part of the basements of shops which occupied the western side of what was then Church Row in the mid-18th to late 19th century. This is corroborated by the fact that bricks from wall [8] have been broadly dated to the period 1650-1900. Whilst wall [8] was encountered at a depth of approximately 550-610mm (c.15.27-15.21mOD) and at c.15.52mOD in the NW section, [9] was visible from the top of the trench section (c.15.82mOD), [10] was visible from a depth of approximately 100mm (c.15.73mOD) whilst [11] was also visible from a depth of c.100mm in the trench (c.15.73mOD).

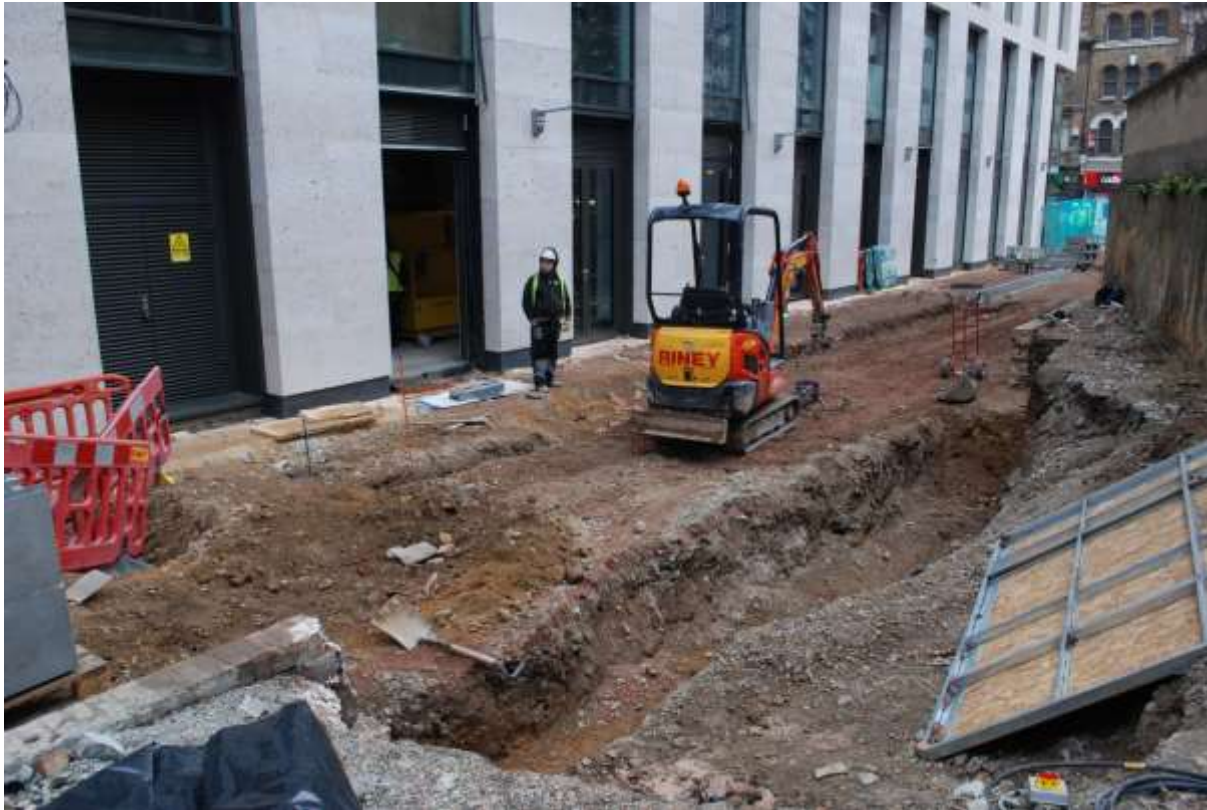
Figure 35: Oblique view of trench 2, facing SE

7.9.1 On the 22nd of February trench 2, which was dug where the modern brick wall on the western side of St Botolph Row had been removed, was observed. The trench was aligned NW-SE and measured approximately 8.65m long and 950mm wide.

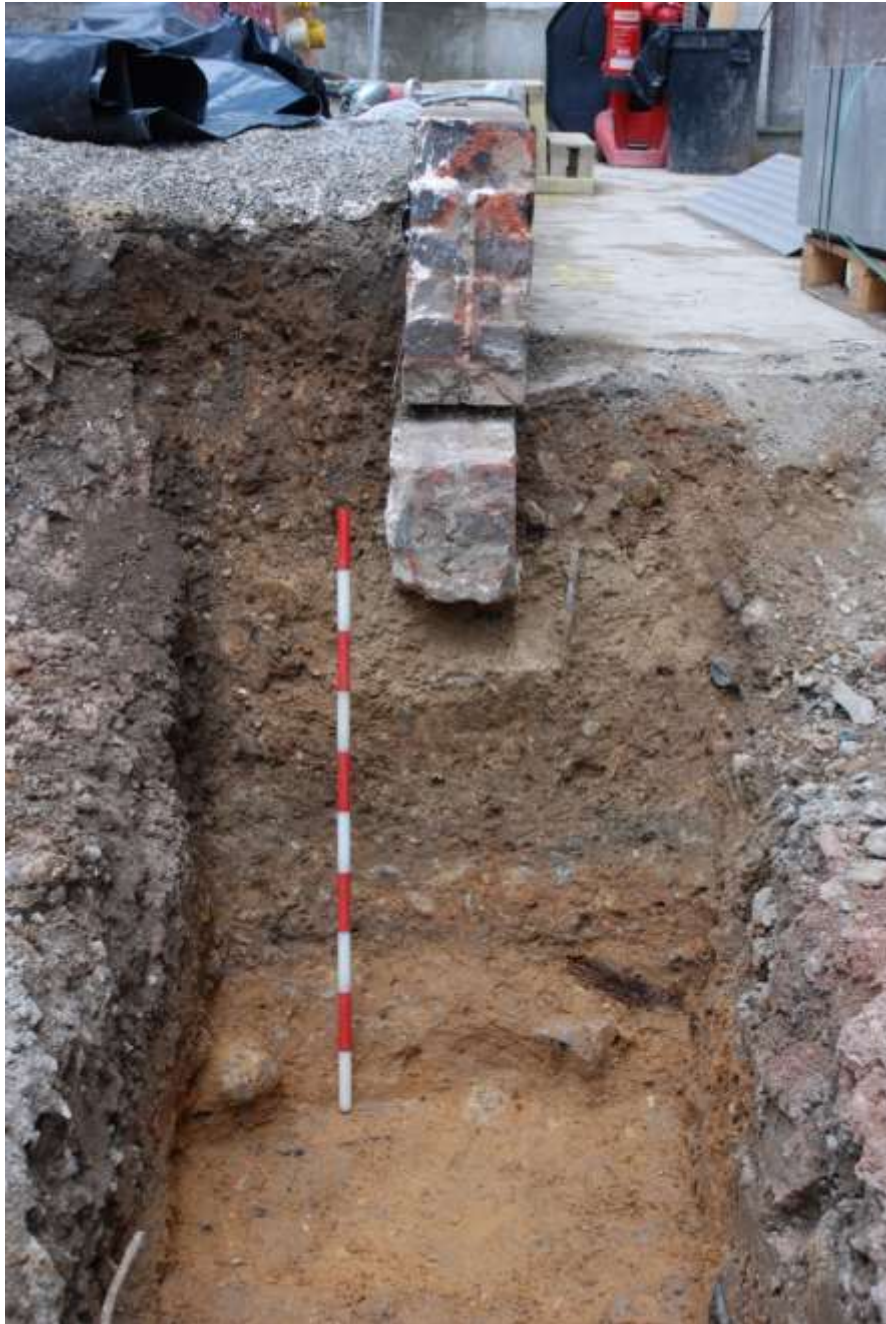
Figure 36: View of NE section in trench 2, facing NE, 1m scale

400mm in thickness. A piece of plastic was found in this deposit which suggests that it has been subjected to modern disturbance.

From the top of (13), the trench reached a depth of 1.4m at the NNE end (c.14.43mOD).

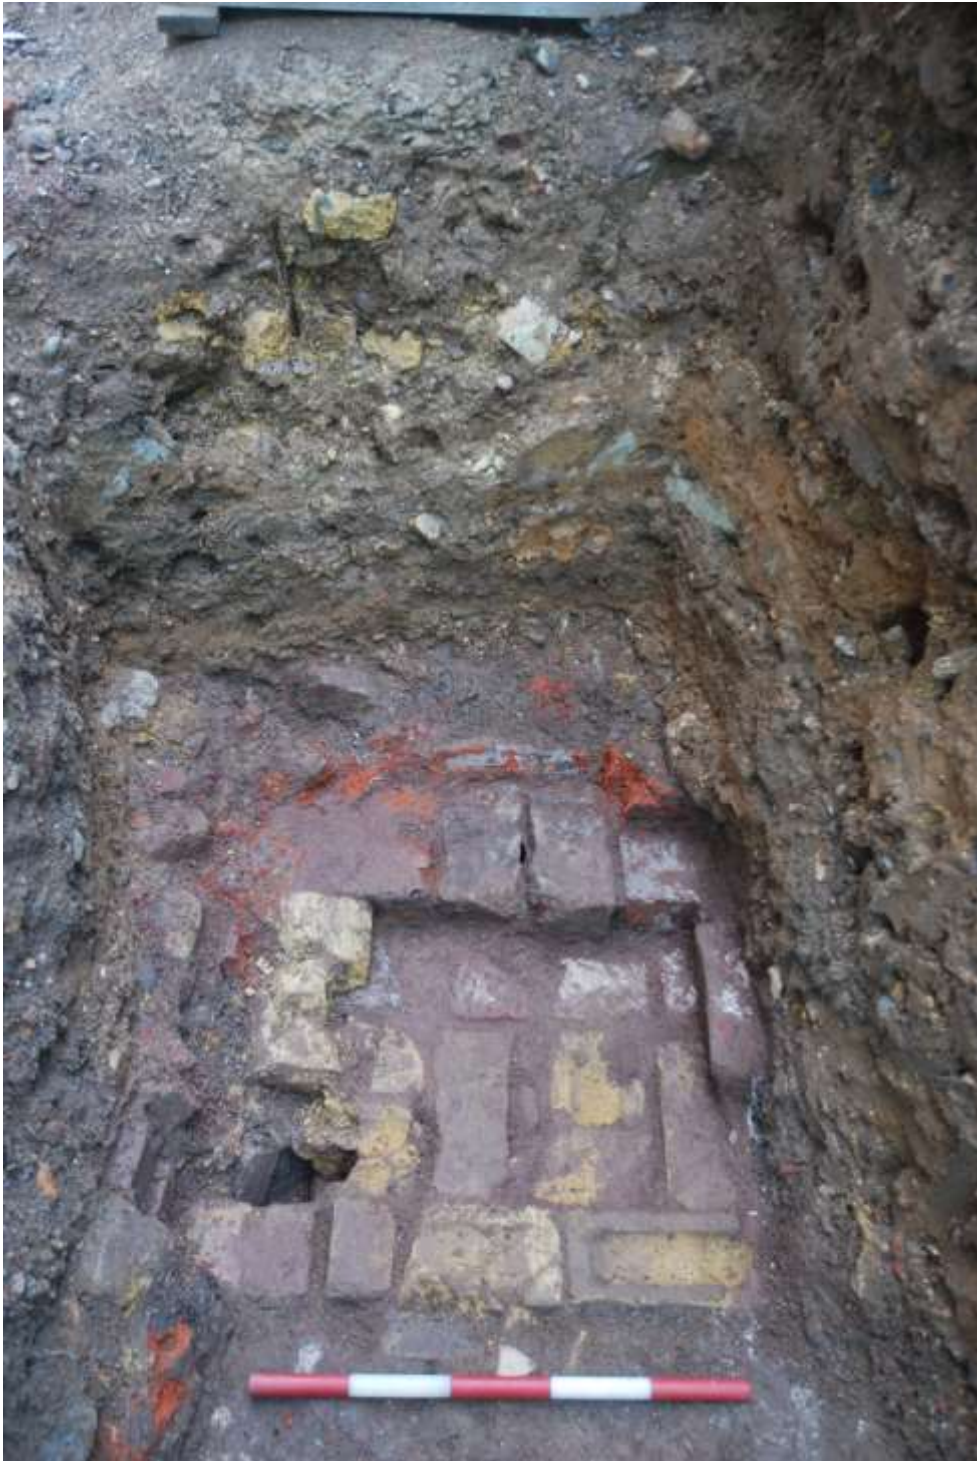
Figure 37: Wall [18], facing SE, 0.5m scale

On the 6th of March 2017, another visit was made to St Botolph Row to monitor trench 2. At the SE end of the trench the remains of a red and yellow stock wall were observed at a depth of approximately 700-800mm (c.15.13-15.03mOD). These were mainly in stretcher formation though there was a row of at least three headers at the NE end. The feature measured 850mm NW-SE and 800mm NE-SW. The stratigraphy observed in the SE end of the trench can be summarised as follows; the demolition rubble (14) was a maximum of 300mm thick and, as was the case with the NNW section overlaid (15) which was a light beige-yellow silty sand and approximately 200mm thick. Underneath this was the beige-brown silty clay deposit (16), which was 200mm thick in section, and 100mm of the mid-yellow-orange silty clay (17) which appears to have been deposited over the top and up against wall [18].

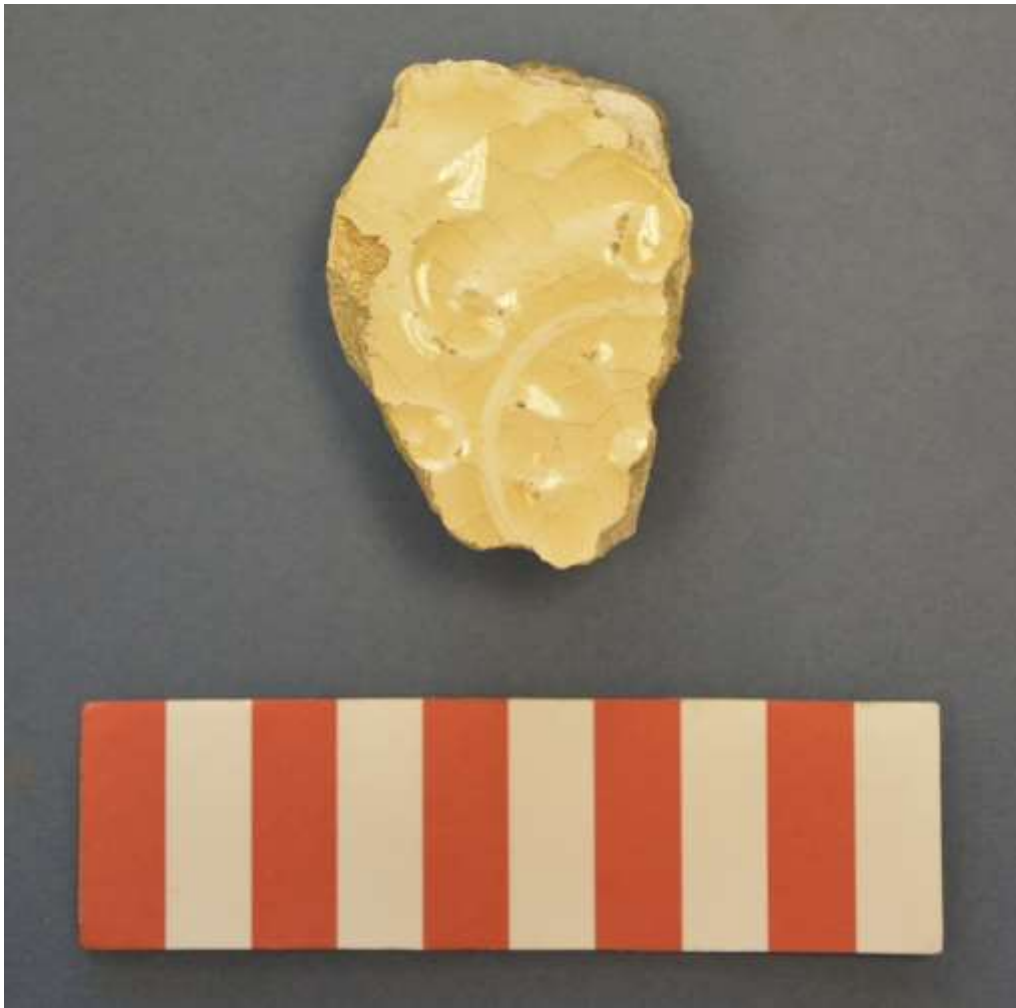
Figure 40: Embossed wall tile from context (5)

contained an embossed wall tile which has been dated between 1870 and 1950, which indicates that this context either relates to the late 19th or early 20th century reconfiguration of the Row.

Site code	Site	Context	CBM/ context date	Period	Fabric	Form	Count	Weight	L	B	T	Condition	Comments
SBL17	St. Botolph Row	5	1870-1950	PM	white	wall tile	1	45	55+	40+	10		Embossed wall tile, probably machine moulded. Foliate design with circular motif with raised central dot. White fabric and glaze. No surviving edges. Reverse not visible as covered in layer of hard grey cement c. 11mm thick. Late 19th/early 20th c?
SBL17	St. Botolph Row	8	1750-1900	PM	3032	brick	1	1606	225	98	66	M, H	Shallow frog? Depression in base c. 120 x 30 mm Lime mortar - mid-grey with flecks of white lime and black ?coal. Frog suggests later 18th c date.
SBL17	St. Botolph Row	8	1750-1900	PM	3032	brick	1	1651	222	103	65	M, Rd, S, R	Unfrogged. Reduced on most of surface. Traces of pinkish mortar containing brick dust on top and base. 1 stretcher has traces of white paint/lime-wash apparently applied over reduced surface.

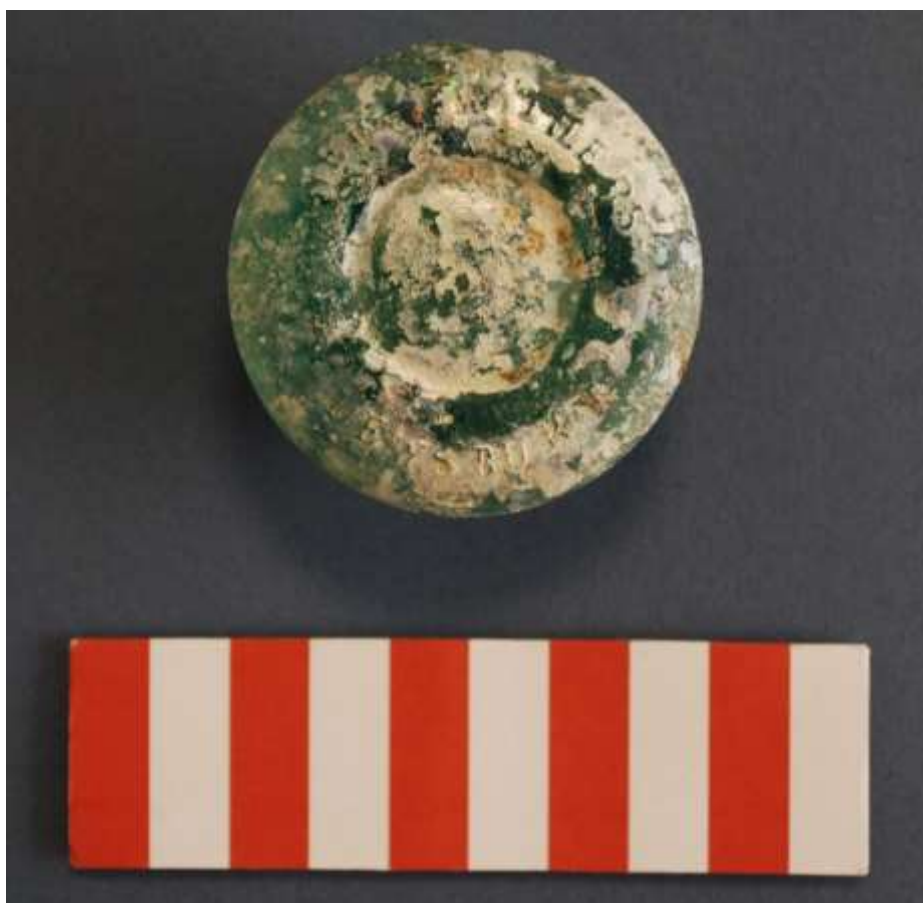
Figure 41: Kilner Brothers glass stopper from context (7)

A blue aqua circular glass stopper is one of the more distinctive pieces in the assemblage. It has a circular, ground shank 16mm in height, no neck and a flat circular finial with a radius of 56mm; it is chipped and has a creamy white patina.

It is suggested that this piece be dated generally to the late 19th century.

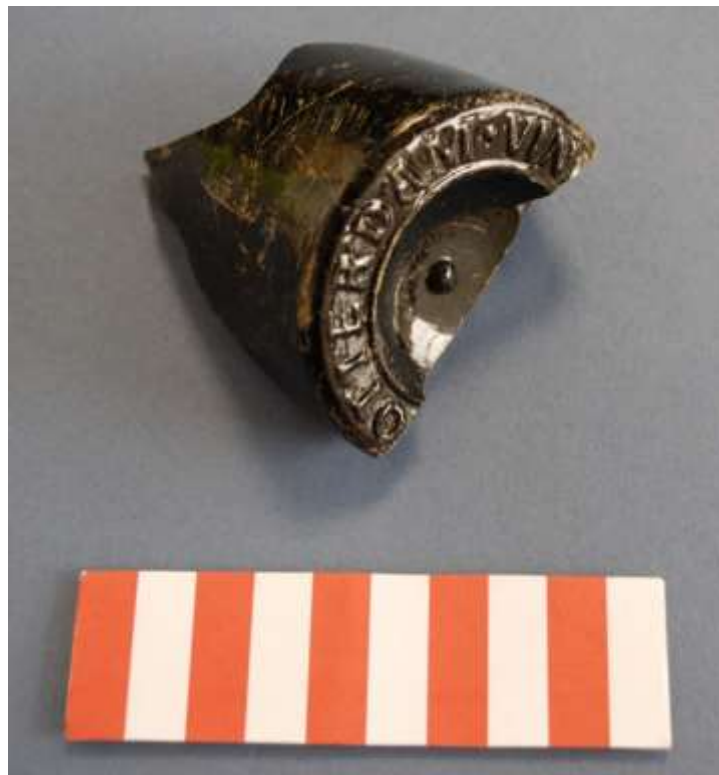
Figure 42: Brown glass bottle base from context (7)

Part of a brown glass bottle base was also found in context (7). The base itself was circular and had a radius of 66mm, with a slight kick-up, and the embossed words: ‘...OTTERDAM/ VIN...’ seen around the rim, which presumably indicates that the vessel originated from Rotterdam and was potentially a vinegar bottle. The fragmentary nature of the piece renders it
