**FOOTPATH IMPROVEMENT WORKS, MARBLE HILL PARK.
RICHMOND ROAD, TWICKENHAM, TW1 2NL**

AN ARCHAEOLOGICAL WATCHING BRIEF REPORT

Site code: MHP17
Site NGR (centre): TQ17223 73598

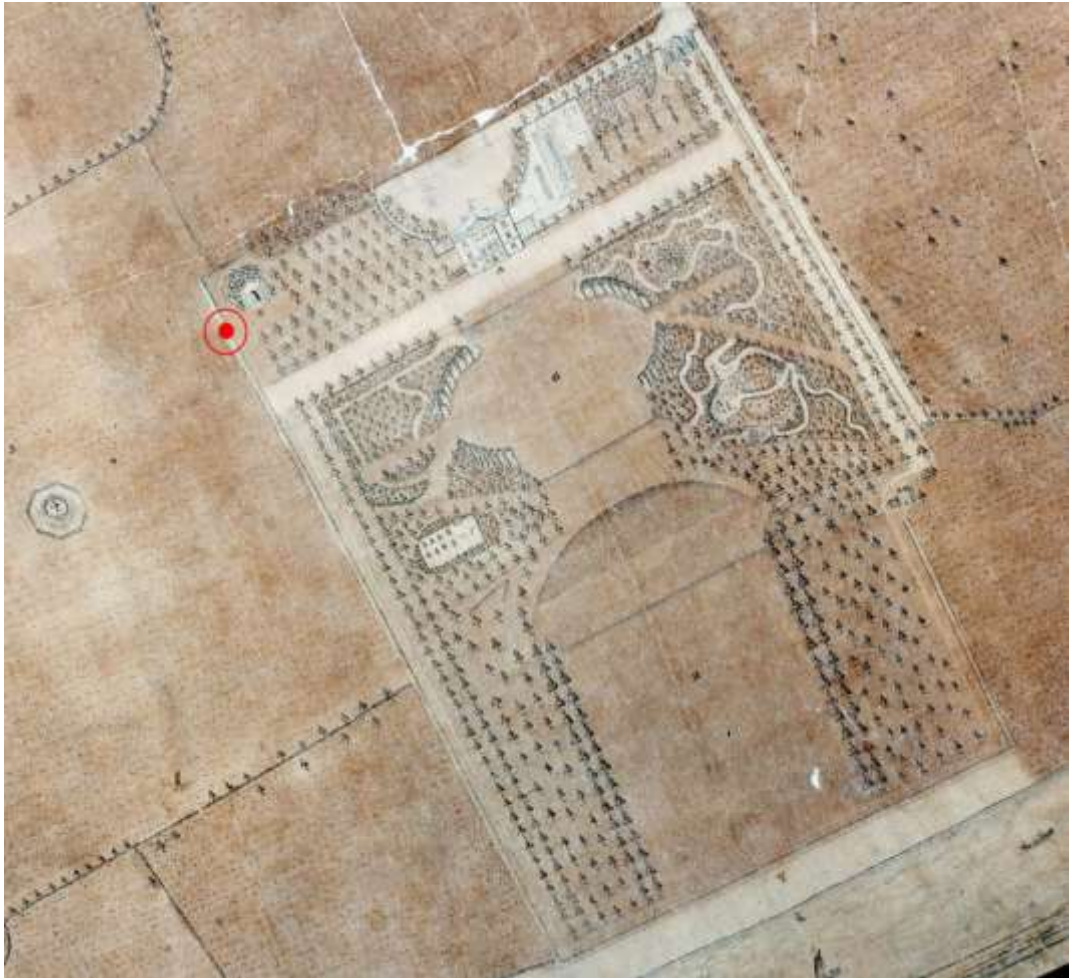
A plan of the park from 1752 (fig.3) shows the house flanked by wooded avenues to either side, a greenhouse to the east and ice house to the west, with lawns to the south leading to the river. This complex appears to be flanked on four sides by a narrow ditch, indicated on the plan by a series of hachures), which is believed to be a ha-ha ditch. Ha-ha walls are a recessed landscape feature, comprising a wall and ditch, often seen encircling large estates. They serve to keep grazing livestock at a distance from the house, but provide an uninterrupted and seamless view of the land (Taylor 2008).

Figure 3: Extract from the 1752 plan of the estate, with approximate trench location marked in red.

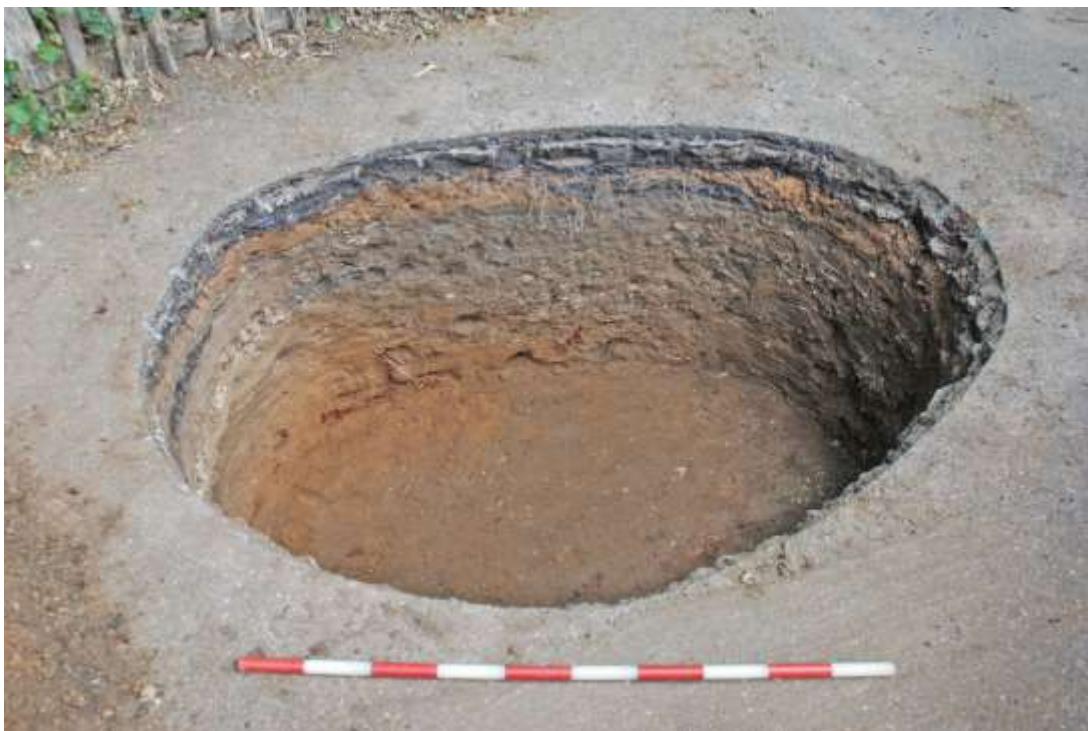
7.2 The single trench was oval in plan, measuring 2.1m in length x 1.4m in width x 1.0m in depth (7.11-7.17mOD), with the limit of excavation following the extent of a previous episode of groundworks (fig.4).

Figure 4: Completed trench, at a depth of 1.0m. Facing ESE. Scale 1m.

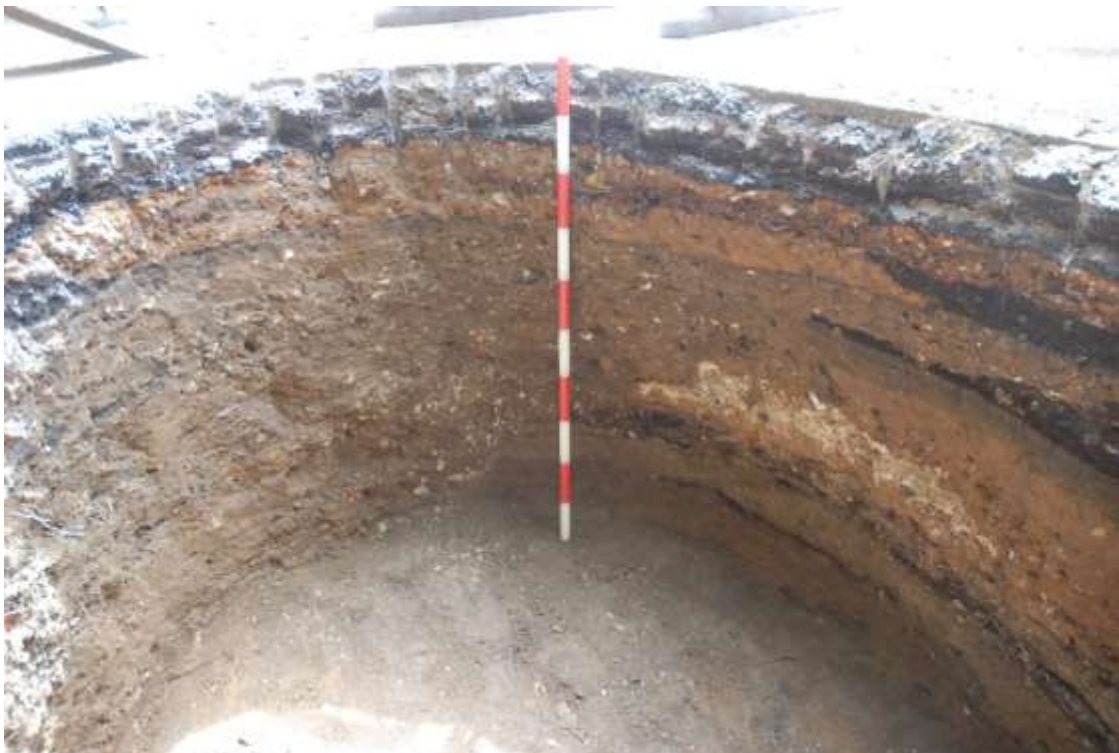
- 7.5** This was overlain by a further 120mm of redeposited natural sand (14), however this band was stained grey due to leeching from a large band of grey-black to black soil layer (12) abundant with angular stones and what appeared to be the rotted remains of a tree root (fig.5). This band followed the east-west slope of the natural, measuring 120mm at the eastern end, widening to 300mm towards the centre of the section, then narrowing to a point at a depth of 320mm below ground level.

Figure 5: North and east facing sections, showing the bands of stratigraphy to the right of the scale in contrast to the single backfill event (8) of cut [13] to the left. Facing S. Scale 1m.

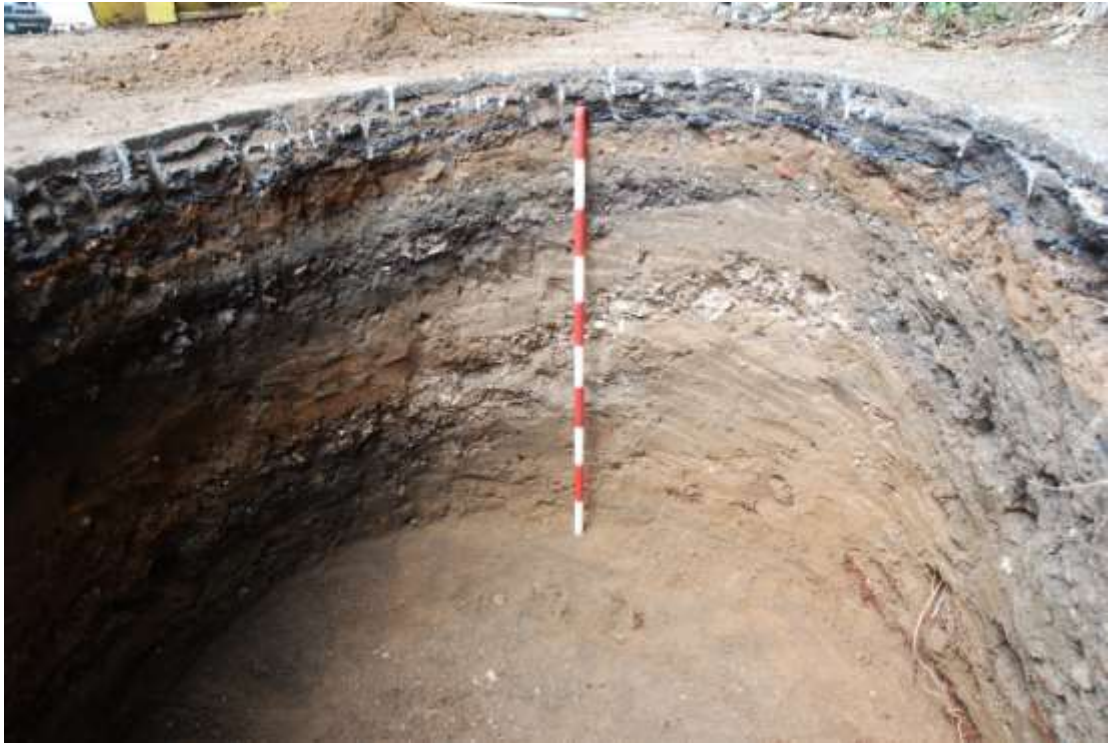
- 7.6** The most notable feature in the trench was a large cut observed in the east and west sections, sloping from north to south. The cut [13] was observed at a depth of 220m (c7.92mOD), with relatively steep sloping sides continuing below the level of excavation at 1m. In the west facing section the cut truncated the natural sand (14) and loose stone layer (9), and in the east facing section the cut truncated the natural and stained sand (14) and the grey-black stone and soil layer (12).

The cut was filled by a homogenous deposit of mid brown soil, containing frequent charcoal and mortar flecks, with occasional small fragments of red brick (8). A thin band of this material, <60mm extended across the entirety of the trench in a matter which suggests the cut feature had been backfilled and the excess material spread across the vicinity to create a level surface (fig.6).

Figure 6: Completed trench. The linear feature [13] can be seen cutting into the sand (14) sloping towards the bottom right of frame, and backfilled by (8). Facing NNE. Scale 1m.

8.1 The most significant feature in the trench, cut [13] appears to represent a feature running on an east-west alignment, contrary to the north-south alignment of the ha-ha shown on the 1752 plan above. This factor, in addition to the relatively shallow depth at which it was encountered, c220mm below the modern path, would suggest it is an isolated feature, such as a tree bowl or similar landscape feature, rather than part of a larger linear structure.

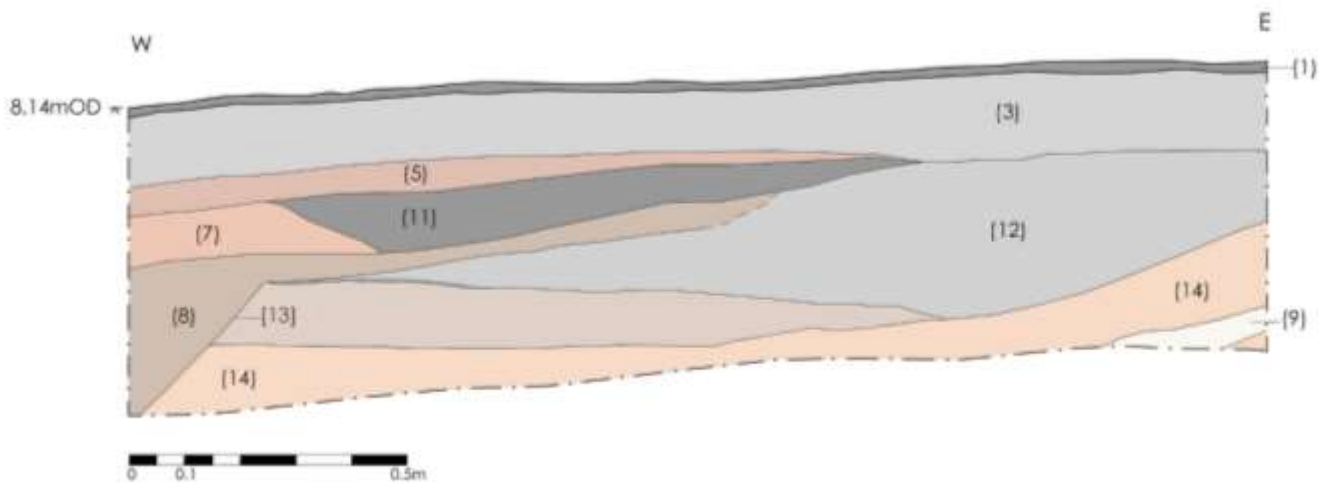
APPENDIX II: ARCHAEOLOGICAL SECTION

Number	Description
(1)	Tarmac
(2)	MOT Type 1
(3)	Sunken tarmac layers
(4)	Very light brown soil with small roots
(5)	Orange gravel
(6)	Mid brown sand with brick fragments
(7)	Paler orange sand
(8)	Mid brown sandy soil with charcoal and mortar flecks. Fill of [13]
(9)	Mortar/chalk/stone deposit
(10)	Chalky deposit on south side
(11)	Black 'tarmac' layer
(12)	Grey-black sand/stone layer
[13]	Cut of feature
(14)	Natural sand

Figure 7: South facing section of the trench, showing the levelling and dumping layers truncated by [13]. Original drawn at 1:10.
