**EXCAVATIONS AT
230 ST MARY'S LANE, UPMINSTER
LONDON BOROUGH OF HAVERING, RM14 3DH**

An Archaeological Assessment Report

Site code: SMS16

Planning ref: PO811.14

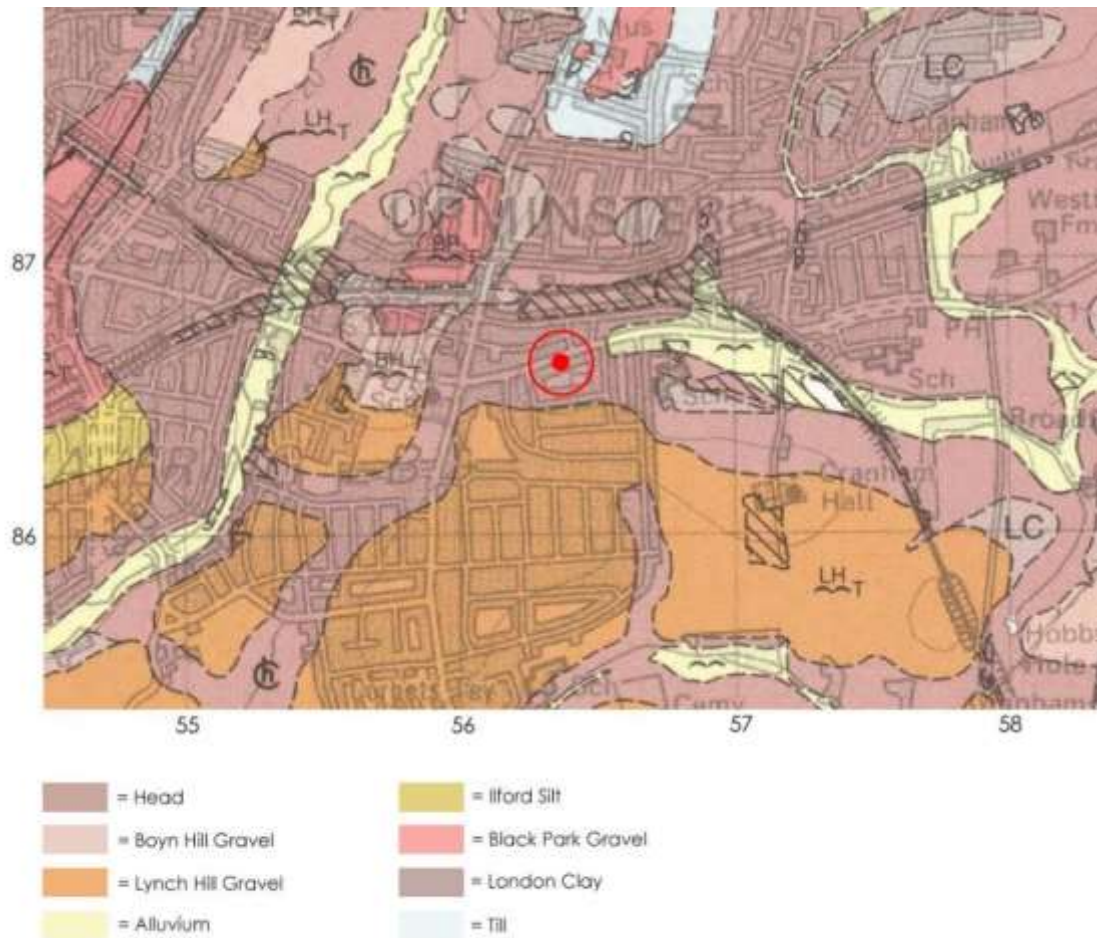
Figure 3: Extract from the British Geological Survey (Sheet 257: Romford) with site location marked in red.

3.2.1 The site overlies Head, a variably pebbly sandy clay, which was confirmed by borehole tests in the front and rear of the property, conduction by Soil Investigation Eastern Limited¹. Head was observed 1.3m below ground at the front of the property and 1.2m at the rear (fig.3).

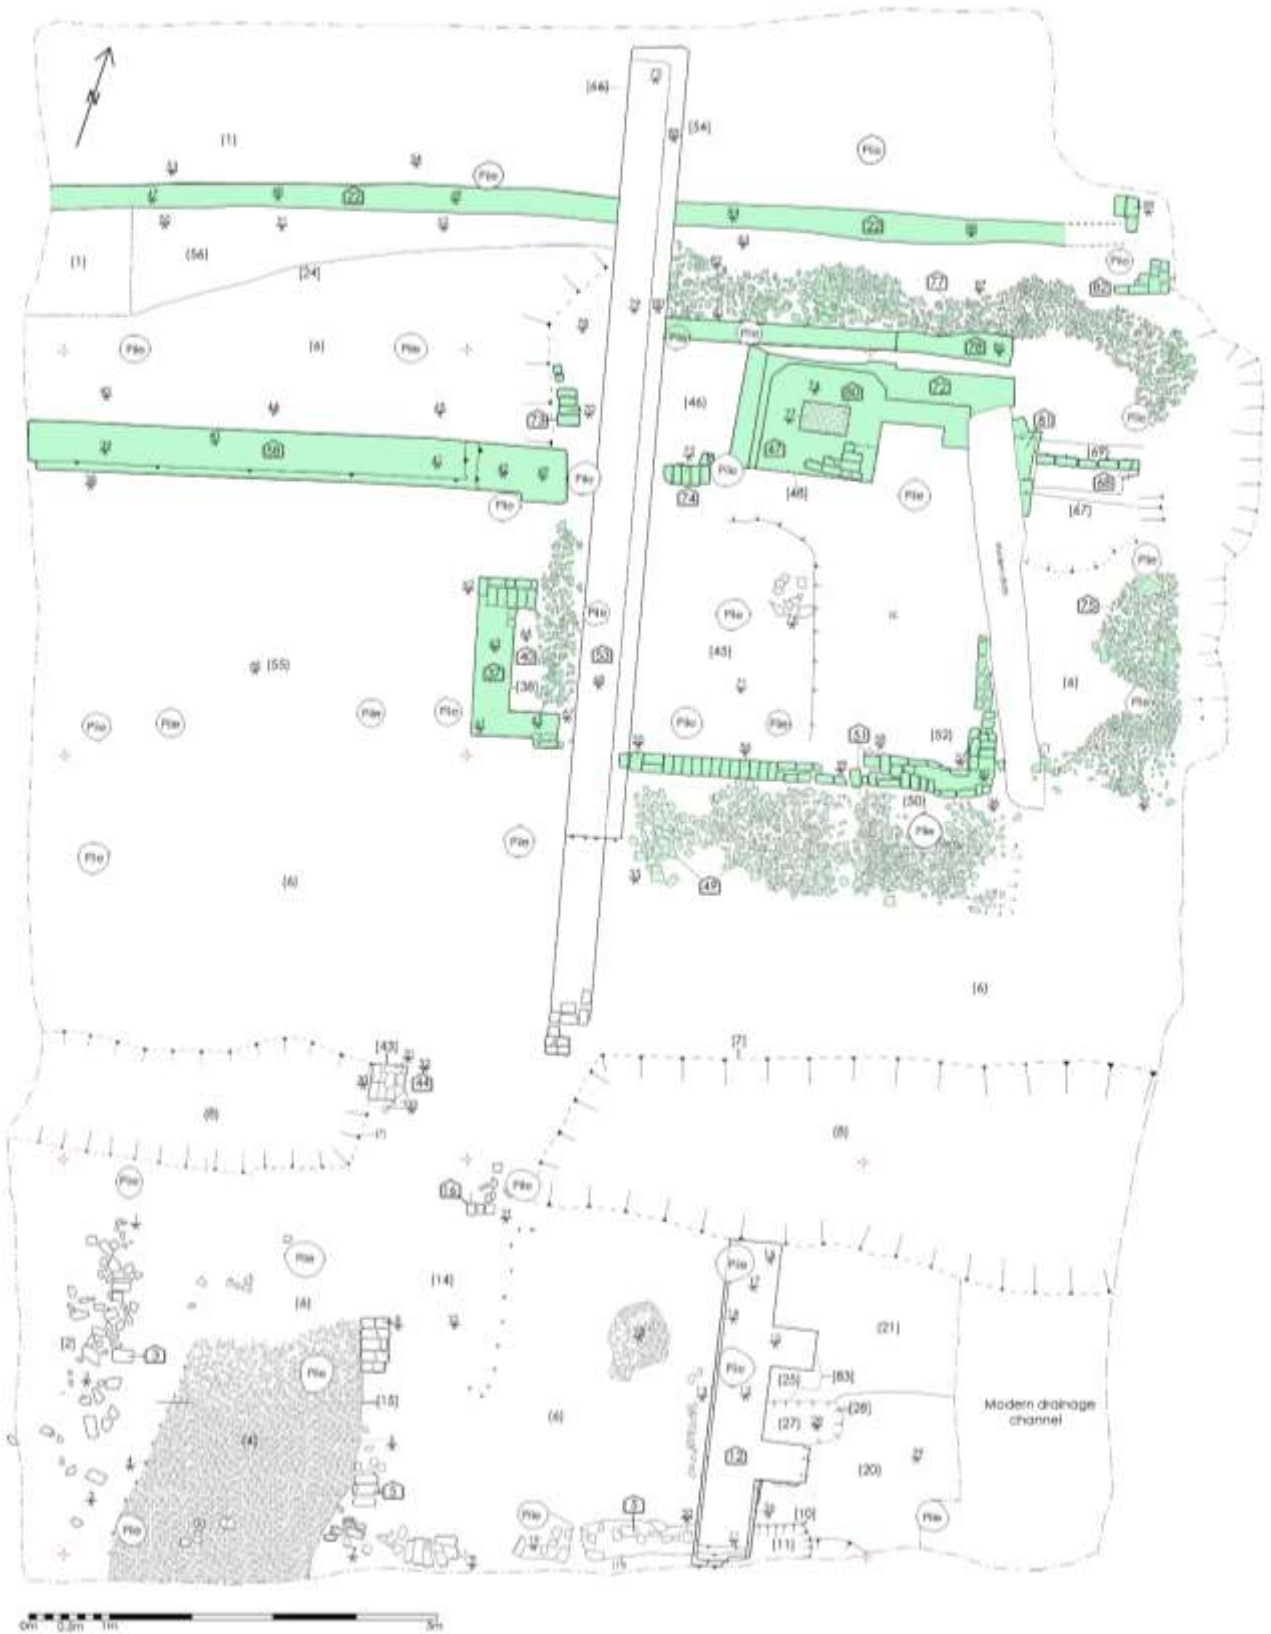
Figure 7: New Place Phase 1 (green). Original drawn at 1:20.

- 7.3.1** The first major phase is characterised by a series of archaeological finds and features recorded were situated in the northern half of the site, with 14 distinct masonry structures and associated contexts forming at least one room of the house (fig.7). The archaeology recorded can be split into three categories: walls; surfaces; and drainage, discussed in turn below.

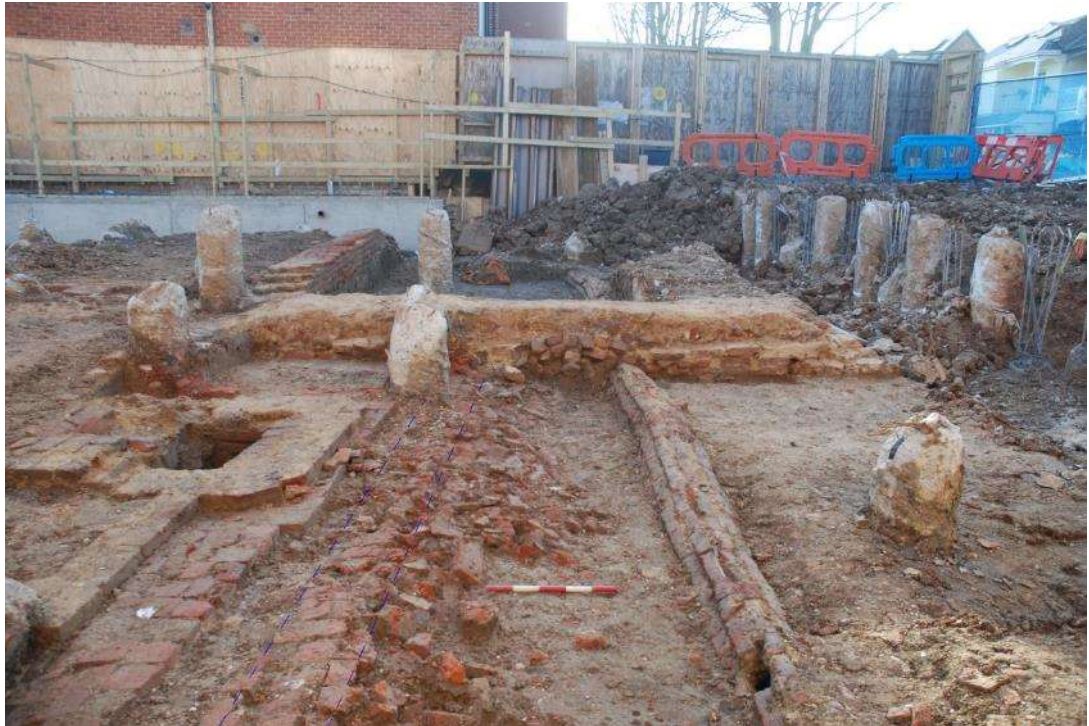
Figure 8: Wall [78] (marked in blue) running approximately E-W between the drain [47] and culvert [22]. Facing W. Scale 0.5m.

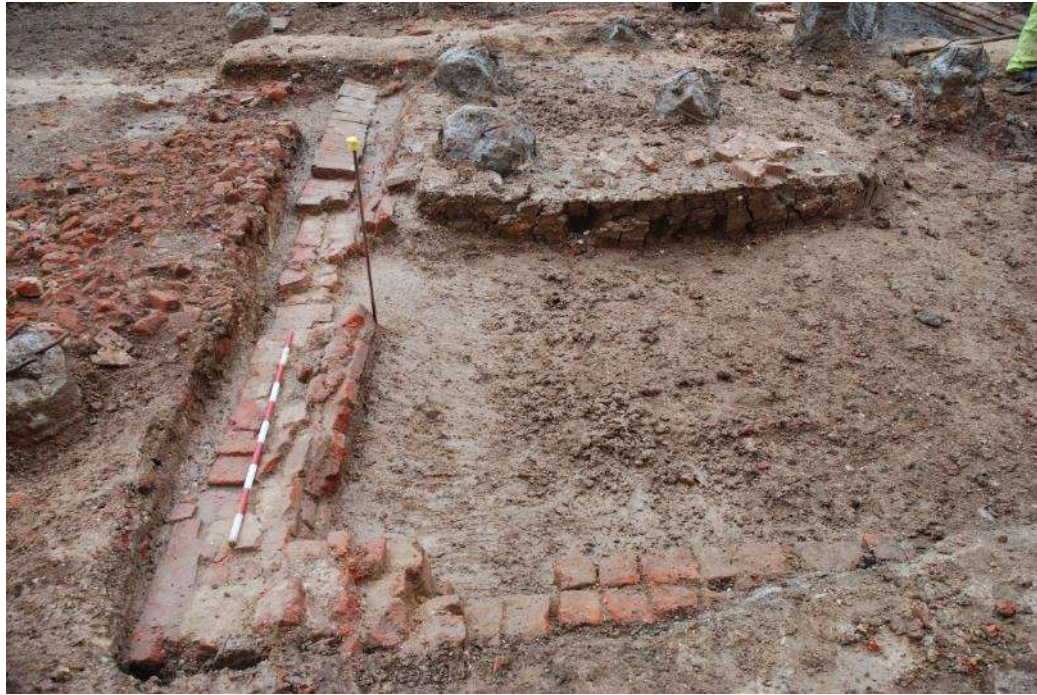
Figure 10: L-shaped wall W[51] bounded by a brick surface S[49] to the south and natural clay to the north (6). Facing W. Scale 1m.

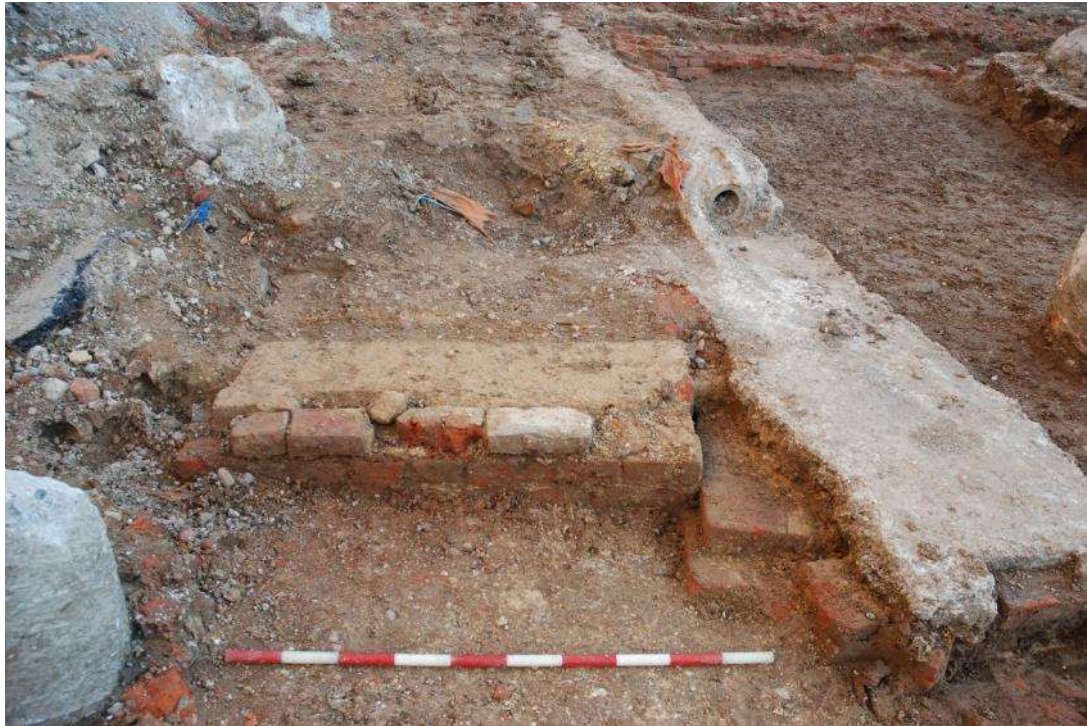
Figure 11: Walls W[68] (parallel to scale) and W[81] (below concrete), as seen in the northeastern corner of the excavation. Facing S. Scale 1m.

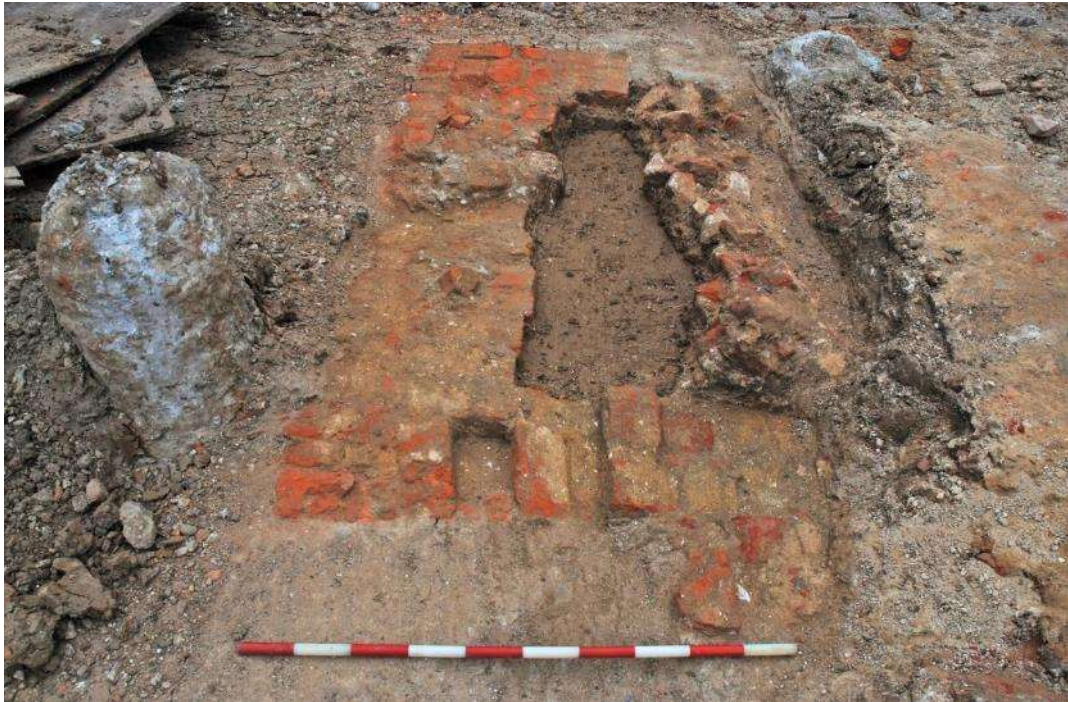
Figure 12: Wall [37] and CBM rubble (40). The remains of wall [53] can be seen to the right of frame. Facing N. Scale 1m.

- 7.3.2.6** The alignment between W[37] and W[51] is slightly skewed, with W[51] sitting 0.1m further south. Due to the truncation caused by W[53] (discussed below) it is unclear if these two walls were part of the same feature, with a slight dog-leg. Again, due to the matching date ranges this seems more plausible than two phases of building in a short amount of time.

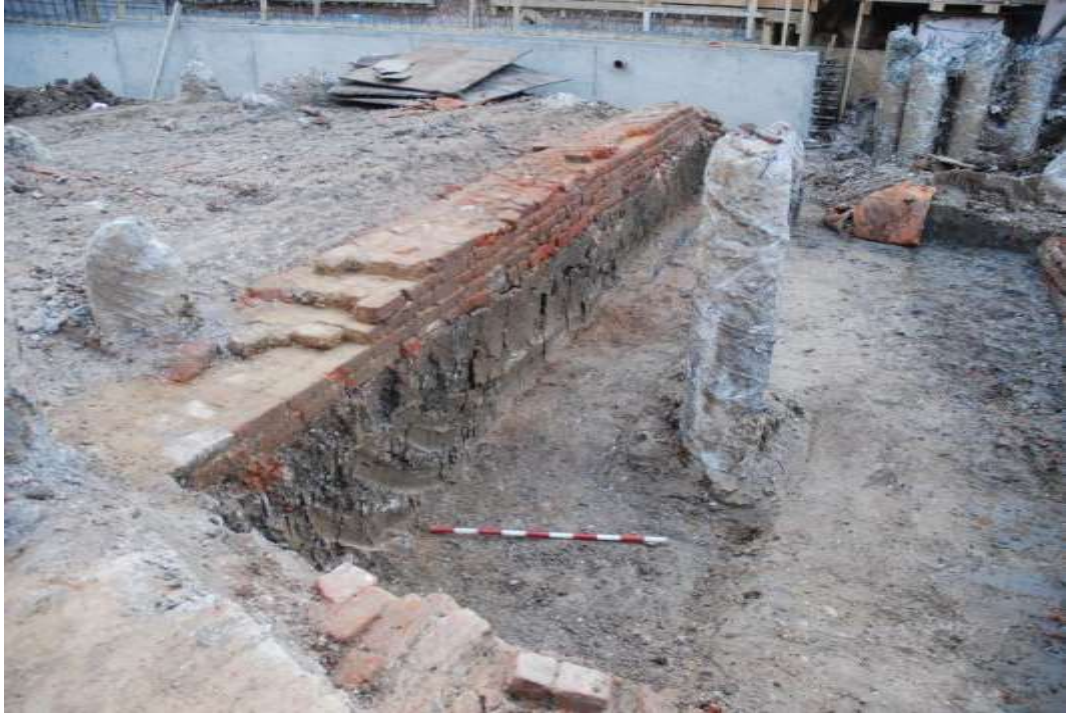
Figure 13: Wall [58], north face. Another brick surface, S[73] can be seen in the foreground. Facing WSW. Scale 1m.

- 7.3.2.13** Further, the function of the main wall W[58] itself remains unclear. There does not appear to be any returns to the wall and it is not tied in to other sections of masonry. It is taken to be contemporary with the first phase of New Place based on the specialist dating and its parallel alignment with the surrounding features. A large garden or 'boundary wall' is suggested at this stage.

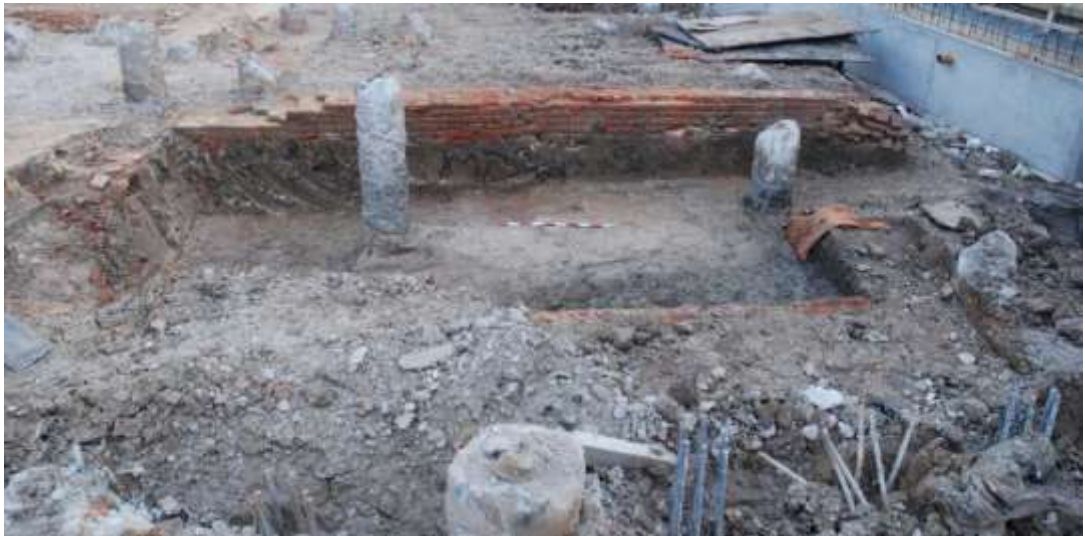
Figure 14: North face of W[58]. The culvert [22] can be seen in the foreground. Facing S. Scale 1m.

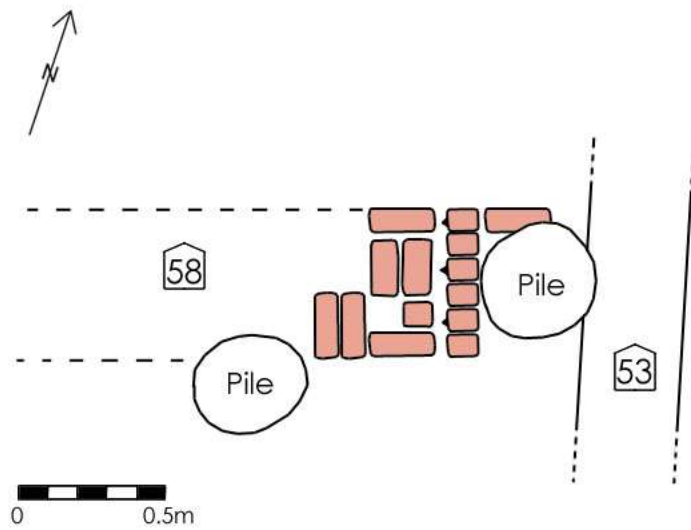
Figure 15: East end of W[58], showing the change in form. Original plan drawn at 1:20.

- 7.3.2.11** The western end was truncated by a drainage channel dug during the most recent groundworks. The eastern end of the structure displayed a slight variation to the remainder, with an additional row of headers added to the width on the southern side, observed for a length of 0.45m (fig.15). A final north-south row of headers, aligned east-west was set 40mm further east from the main structure, set 30-35mm high than the bricks to the west.

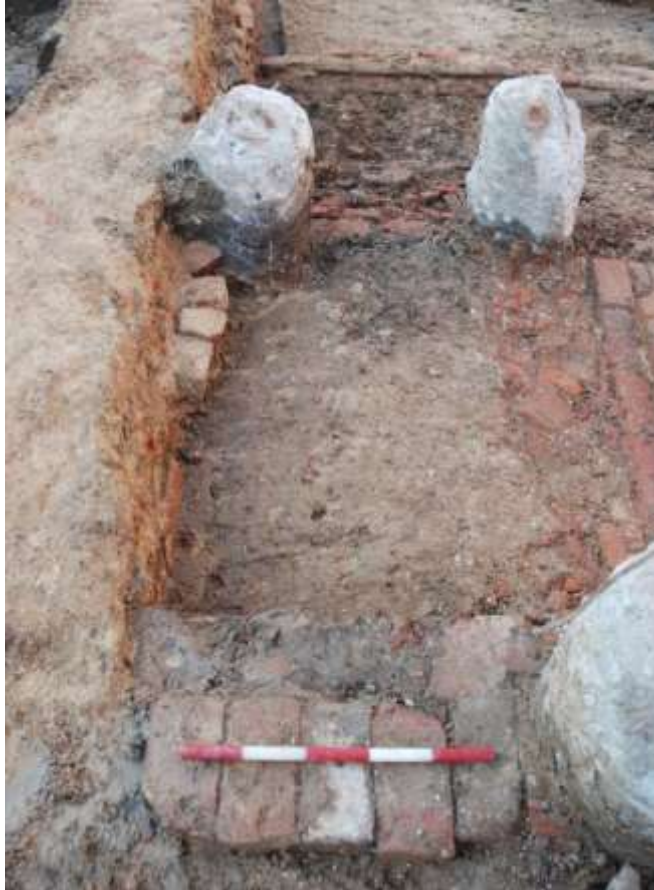
Figure 16: 'Step' [74], with wall W[53] to the left of frame and drain [47] to the right. The slight step with a CBM tile base can be seen above the scale. Facing N. Scale 0.5m.

- 7.3.2.14** Finally, a small step-like feature was recorded, situated to the north of wall W[51] and immediately to the southwest of the drain [47] described below. The feature was small, but well defined, comprising 5 red brick stretchers laid side by side, running E-W, with no observable mortar [74] (fig.16). The bricks appeared to be faced with fragments of ceramic tile on the northern side, stepping down 50mm on to a ceramic tile surface. Only one broken tile remained in-situ, the remainder of the step was indicated by a well-defined edge to the natural clay.

- 7.3.3.15** The step was potentially truncated by wall W[53] at the western end and by a pile at the eastern, so it is unclear if the feature continued in either direction. The slightly higher level at which it was encountered, 17.63mOD, and its alignment would suggest it may be related to the drain feature [47], its function provisionally ranging from an entranceway to a simple ledge.

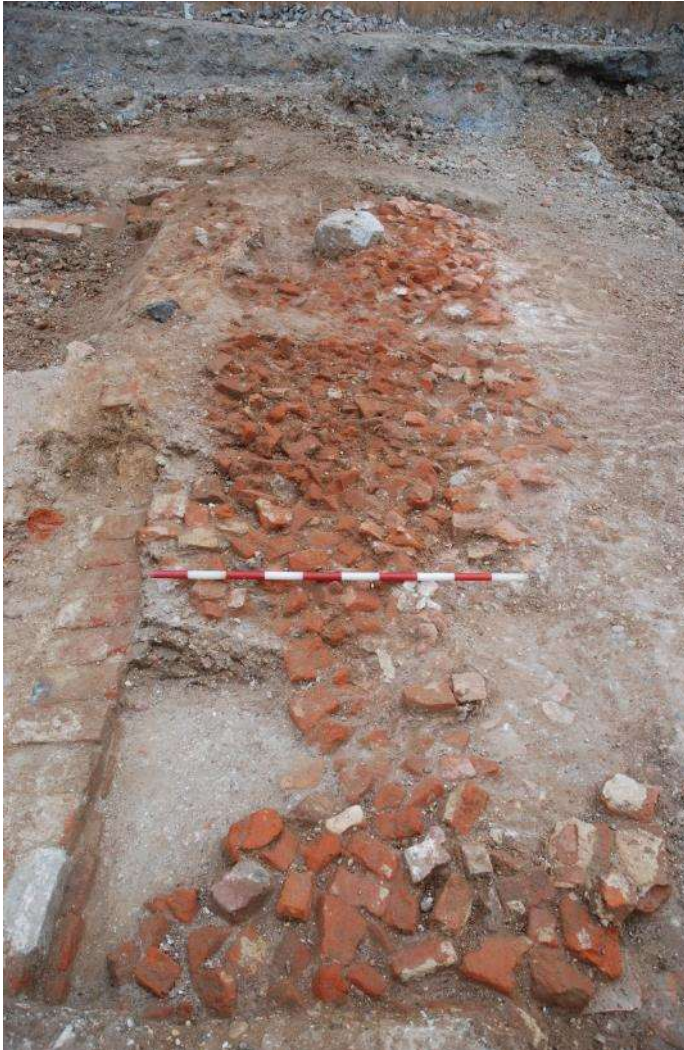
Figure 17: Surface S[49] to the south of a partially exposed wall W[51]. Facing E. Scale 1m.

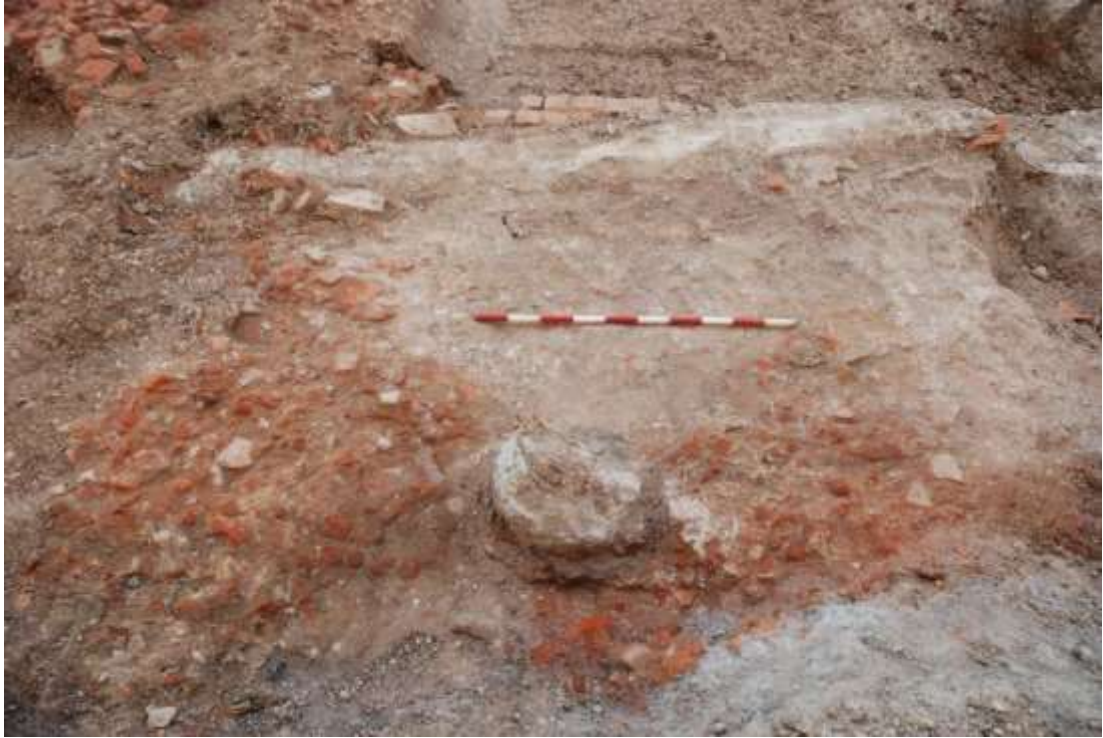
Figure 18: N-S section of path (partially excavated). The path was truncated by a modern concrete drain which can be seen towards the top of frame. Facing W. Scale 1m.

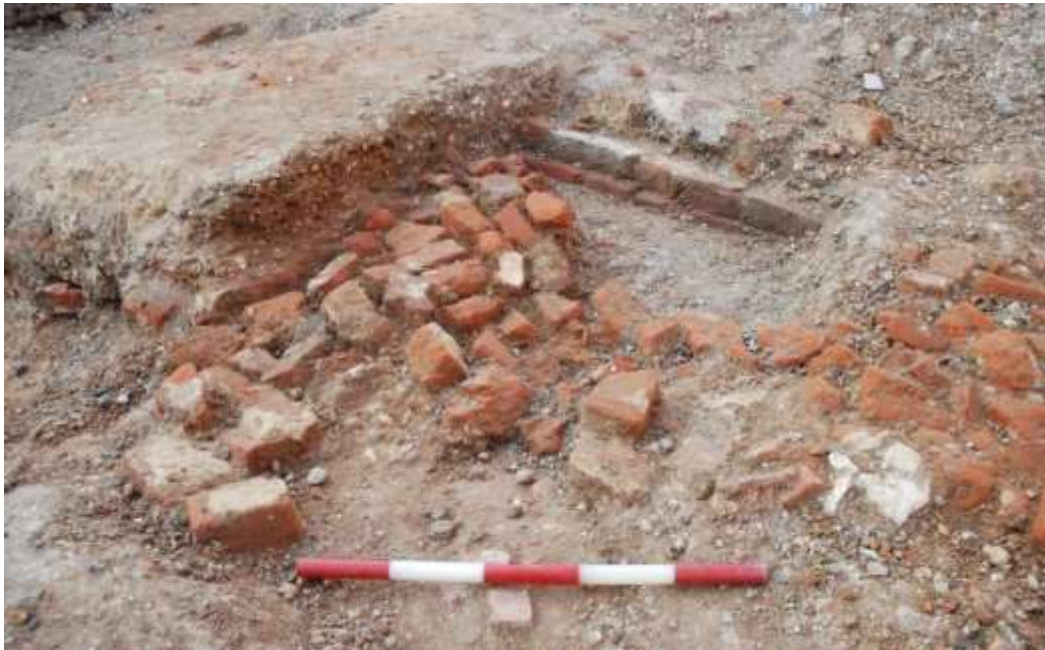
Figure 19: Detail of bedding layer S[49] and gravel (50) which can be seen in section. Facing NW. Scale 0.5m.

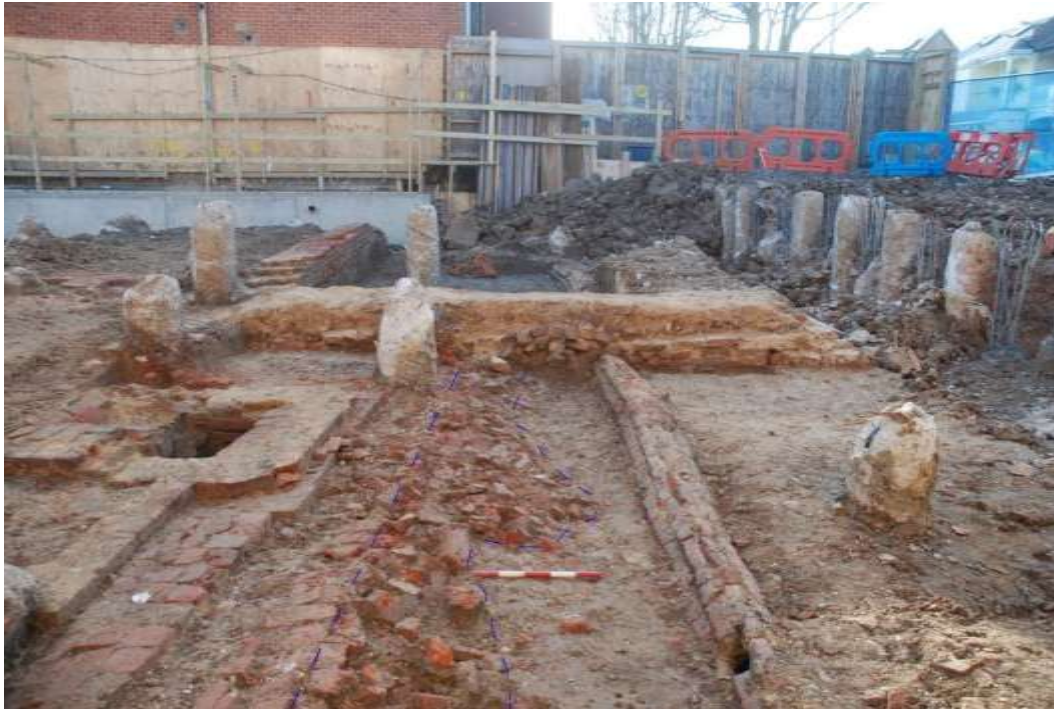
Figure 20: S[77] lying between W[78] and culvert [22]. Facing W. Scale 0.5m.

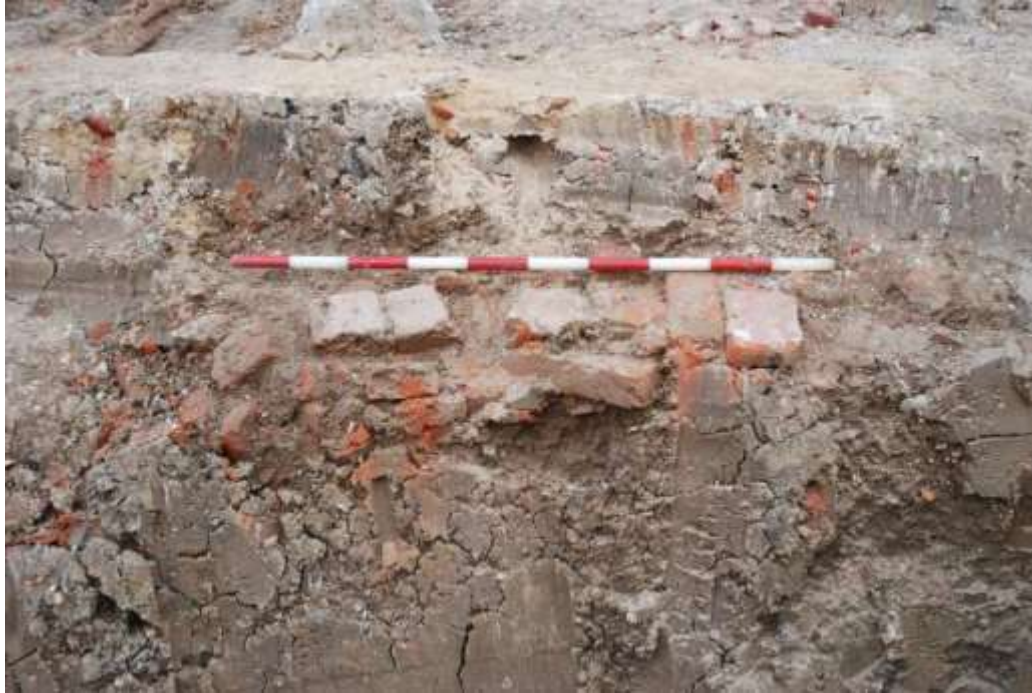
Figure 21: Surviving remnants of S[73] observed at the eastern end of W[58]. Facing E. Scale 1m.

Only one course of the feature survived, however some heavily fragmented brickwork is visible in section. The western side was truncated by W[53]. It is suggested that it is related to W[58] immediately to the south, however its original form appears to be unclear. Due to its limited depth it is taken to be a surface rather than a wall at this stage.

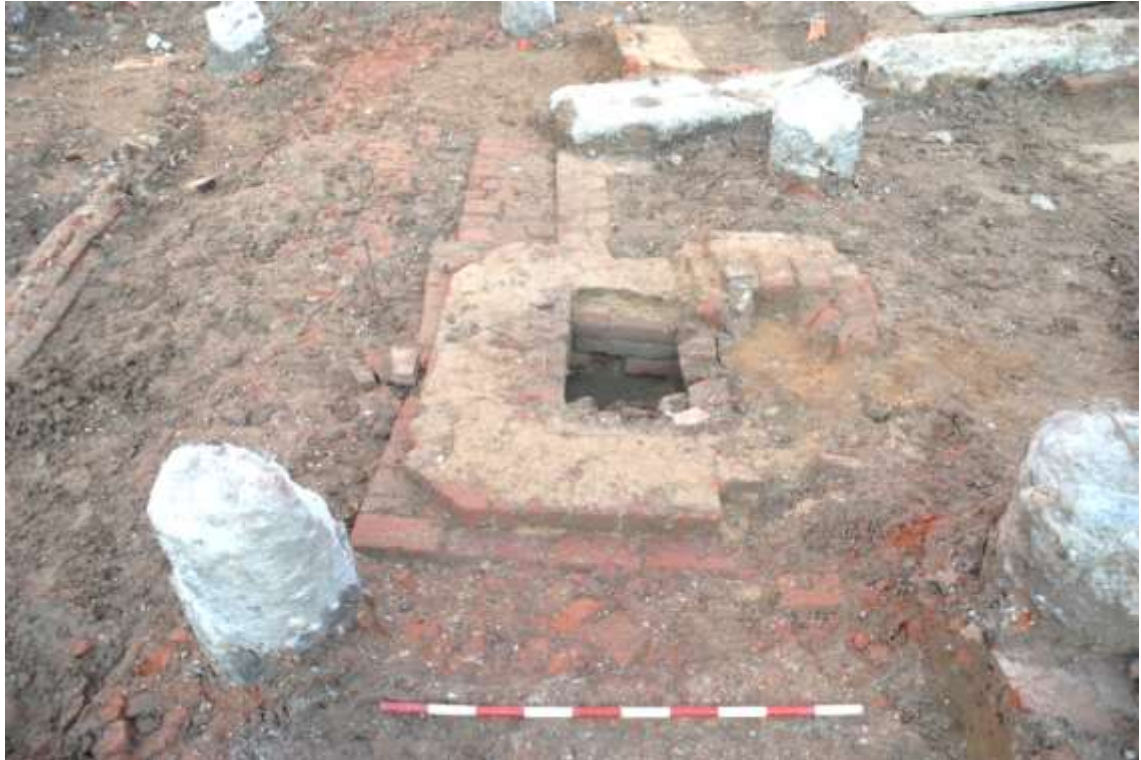
Figure 22: Drain [47], with E-W arm and brick surround, [72]. Facing E. Scale 1m.

7.3.4.2 The ‘drain’ part of the structure was rectangular in plan, bordered by a well finished dark orange brick surround with chamfered corners on the northern side. The southern side stood to a height of three courses, but was more fragmentary and less well finished – no sign of a symmetrical chamfer was observed. The structure measured 1.48m in length x 1.36m in width, constructed of dark orange bricks measuring 230mm x 110-120mm x 50-60mm, aligned north-south. The internal chamber measured 0.6m in length x 0.4m in width x 0.6m in depth (16.85mOD), completed with a widely spaced brick base [80]. On the east and west faces the chamber wall was constructed of three courses of stretchers, directly overlying a mid-brown silty fill (79). The northern face of the chamber comprised a brick arch, constructed using headers, leaving a space of 390 x 390mm through which water could flow (fig.23). The southern section of the chamber was damaged, with most of the brick surround falling inwards, however, no sign of a symmetrical arch was observed. This would imply that whilst water flowed into the feature, it was not a continuous flow running southwards. One hypothesis is that the feature forms the base of a well or storage receptacle, or water pump, hence its neat finish and construction.

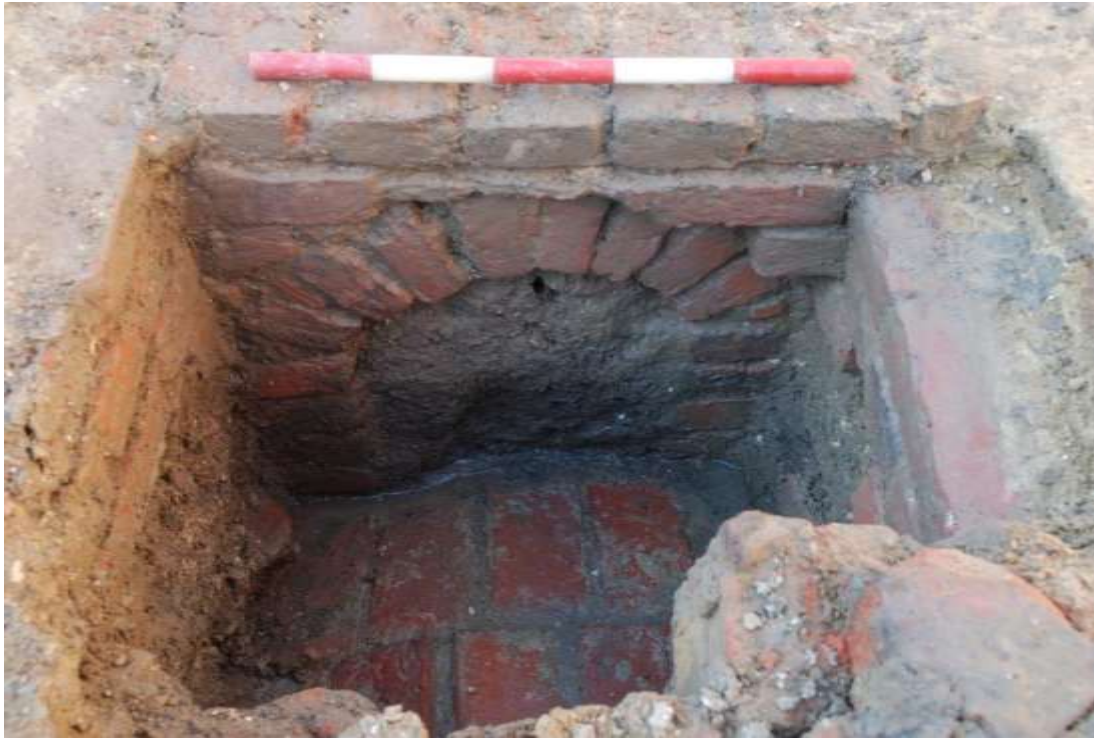
Figure 23: Interior of the chamber, [47]. The most substantial brickwork was seen in the south-facing section, terminating at a slightly arched brick base, [80].

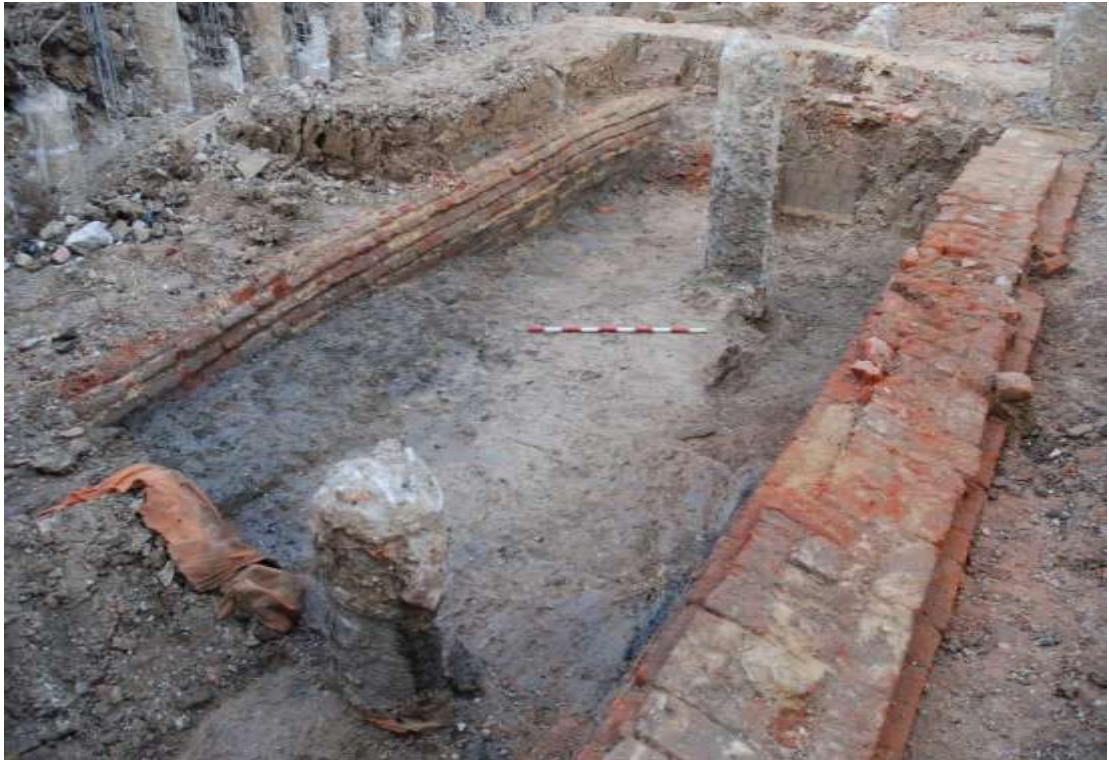
Figure 24: Western end of culvert [22] to left, and wall [58] to right of frame. Facing approximately NE. Scale 1m.

7.3.4.7 The north-south aligned arched section of the drain was taken to adjoin a substantial brick culvert, running in an approximately east-west direction through the northern extent of the site (fig.24). This feature was partially recorded during the 2016 evaluation, and also observed during the archaeological evaluation next door in 240-242 St Mary's Lane. The culvert, [22], was partially excavated in the western section of the site, strongly indicating the structure continued westwards into the adjacent plot.

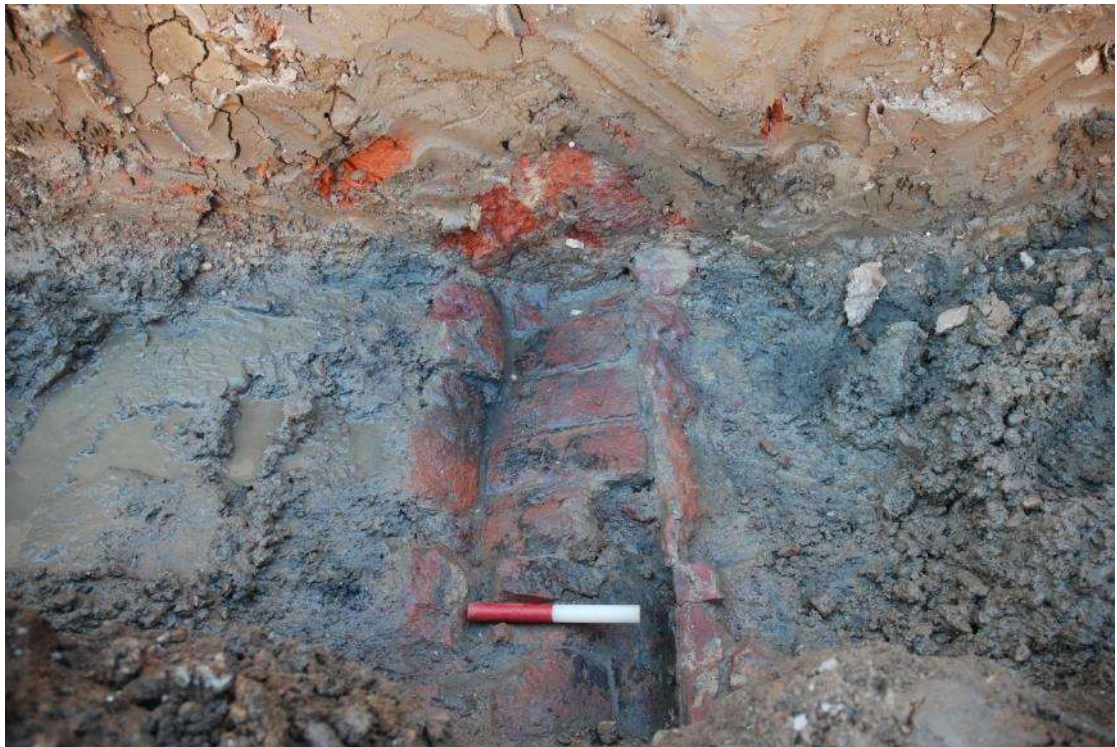
Figure 25: Base of culvert [22] as seen at the western limit of excavation, with the remnants of the arch seen in section. Facing W. Scale 0.2m.

7.3.4.9 The culvert was relatively uniform in appearance and well-constructed throughout its length. Aside from a few dips in the arch, in general the top of the structure presents a slight slope from 17.45mOD at the eastern end to 17.28mOD at the west, indicating the direction of flow.

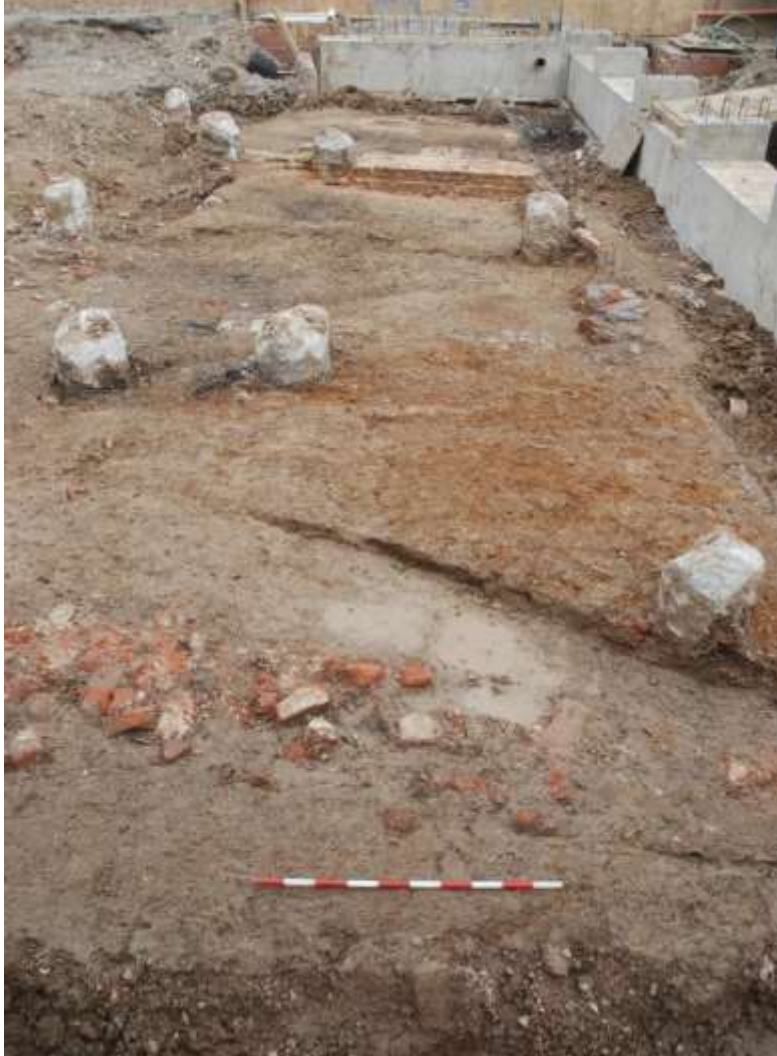
Figure 27: Southern part of the site. The gravel surface can be seen in the centre of frame, with wall W[3] in the foreground. Facing E. Scale 1m.

- 7.4.2** A compacted orange gravel surface measuring 3.2m in length (N-S) x 1.4-1.65m in width x 0.05-0.1m in thickness, with no other inclusions observed was recorded in the southwestern corner of the site (fig.27). The gravel directly overlay the natural clay (6) and was mostly uniform and homogenous throughout, thinning slightly towards the northern extent. The top of the layer was encountered at 17.47-17.45mOD. No finds were recovered from this spread and there did not appear to be a bedding layer such as was recorded below the gravel (50) discussed above.

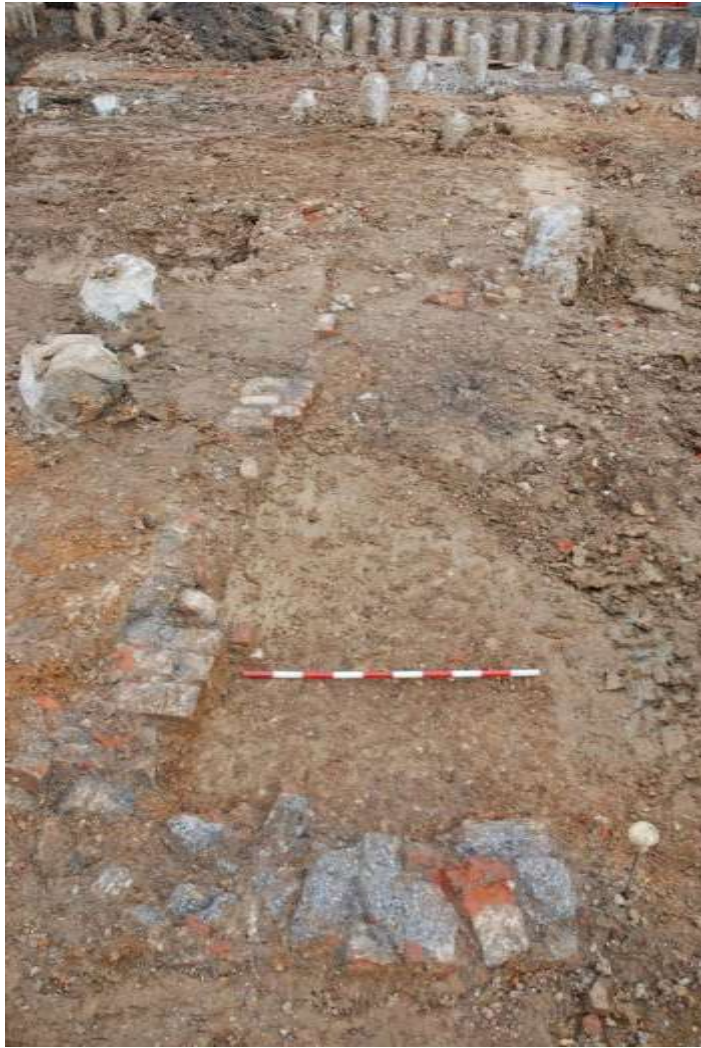
Figure 28: L-shaped wall W[5], with the western edge cutting into orange gravel (4). Facing N. Scale 1m.

- 7.4.3** At present such a feature may be interpreted as a surface, such as a yard or garden path, however it cannot accurately be dated.
- 7.4.4** The eastern end of the gravel surface was later cut by a brick L-shaped wall W[5]. The cut, [15], was linear, running on an N-S alignment with vertical sloping sides terminating at a horizontal base (figs.28-29). The 'tail' of the 'L' was less well defined but still visible. This cut was then filled by a moderately loosely compacted black ashy deposit (13), taken to be a bedding layer, followed by the wall W[5] itself.

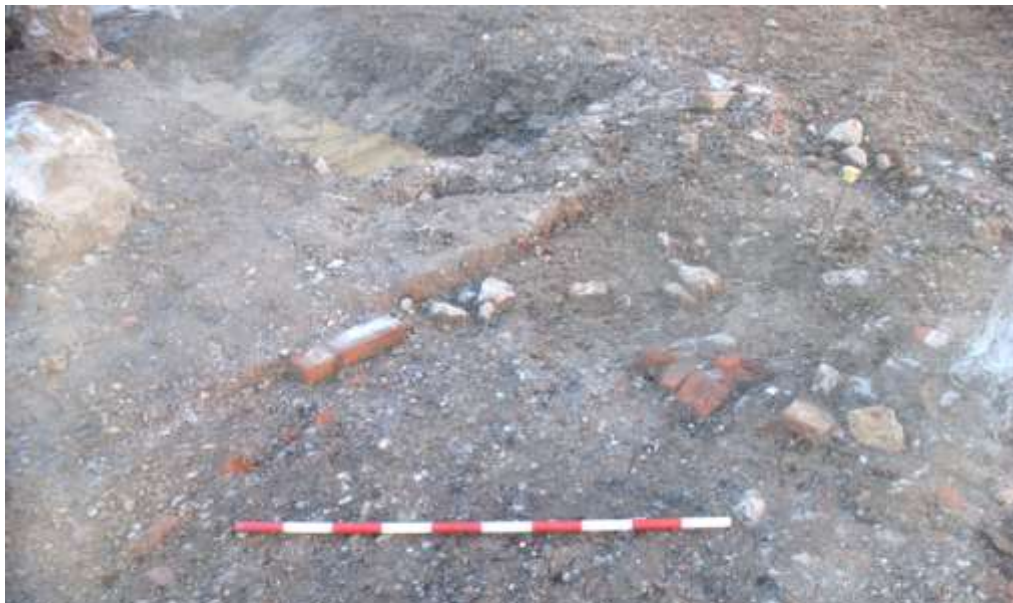
Figure 29: Northern end of W[5] and pottery abundant gravel (14) below scale. The brickwork seen above the right end of the scale, [16] is possibly the return of wall W[5], although due to the truncation this cannot yet be confirmed. Facing NW. Scale 1m.

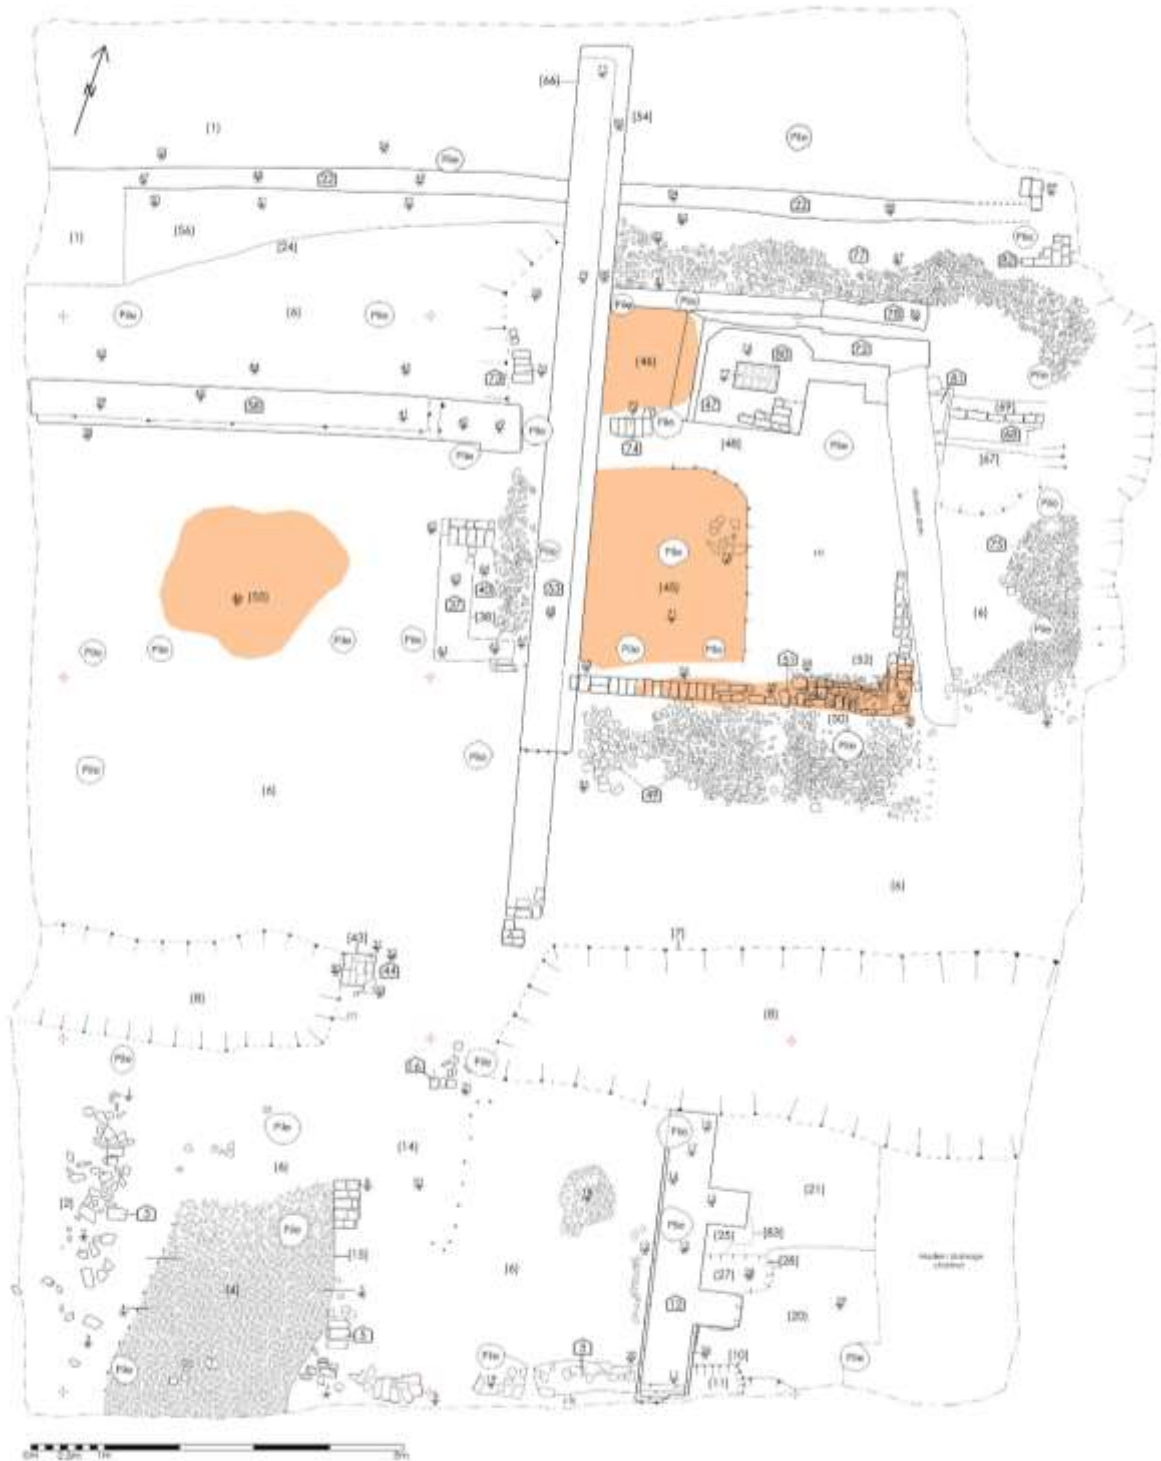
Figure 30: Plan of New Place showing Phase 2: Demolition and Clearance. Original drawn at 1:20.

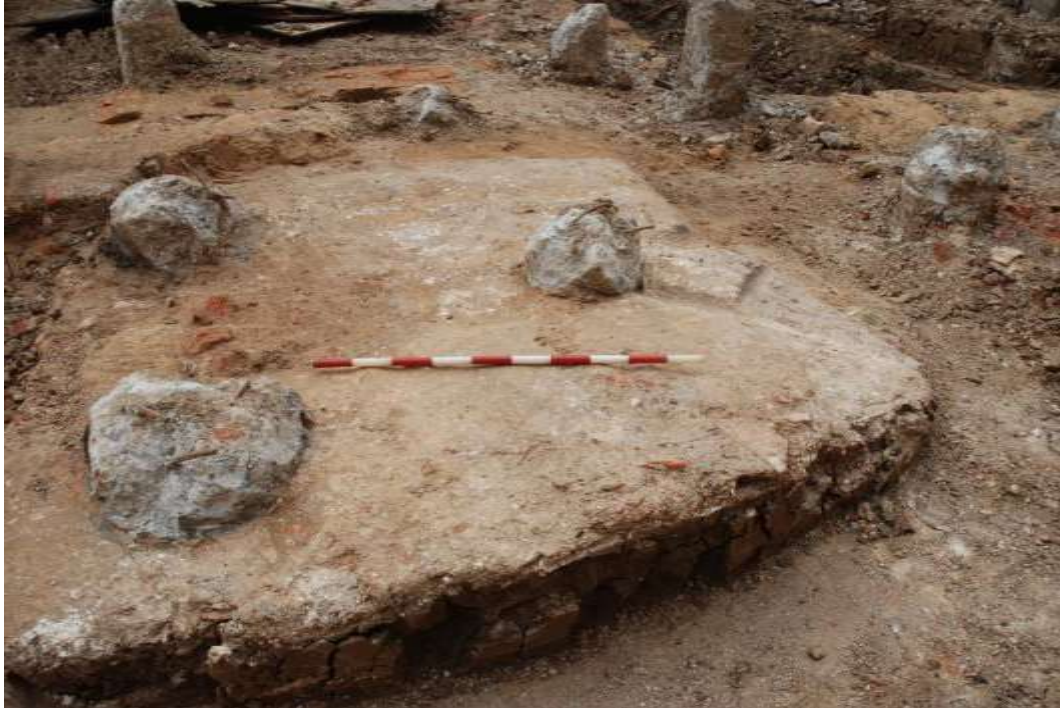
Figure 31: Demolition scatter (45), characterised by whitish mortar spreads and CBM fragments, typical of the scatters observed across the site. Facing approximately NW. Scale 1m.

- 7.5.2** (45) was observed on a raised area of clay³ to the east of wall W[37] consisting of a thin (<20mm) spread of whitish mortar, reddish brown sand and red flecks of CBM (fig.31). The spread was square, measuring 2.04m E-W x 2.05m N-S, recorded at 17.71mOD. The context produced one fragment of unidentified long bone from a medium sized mammal, three partial stem fragments of clay tobacco pipe and a quantity of CBM, including several large fragments of peg tile dating from the 16th-18th century.
